HISTORIC SOUTHSIDE COMMERCIAL AREA

MISSOURI HISTORIC PROPERTY INVENTORY FORM

REFERENCE NUMBER CO AS003-001		A. HISTORIC NAME					
B. COUNTY 054 Cole		C. OTHER NAME(S)					
D. ADDRESS 102 East Ashley Street			E. CITY Jefferson City		F. VICINITY <input type="checkbox"/>	G. RESTRICTED	H. ACREAGE

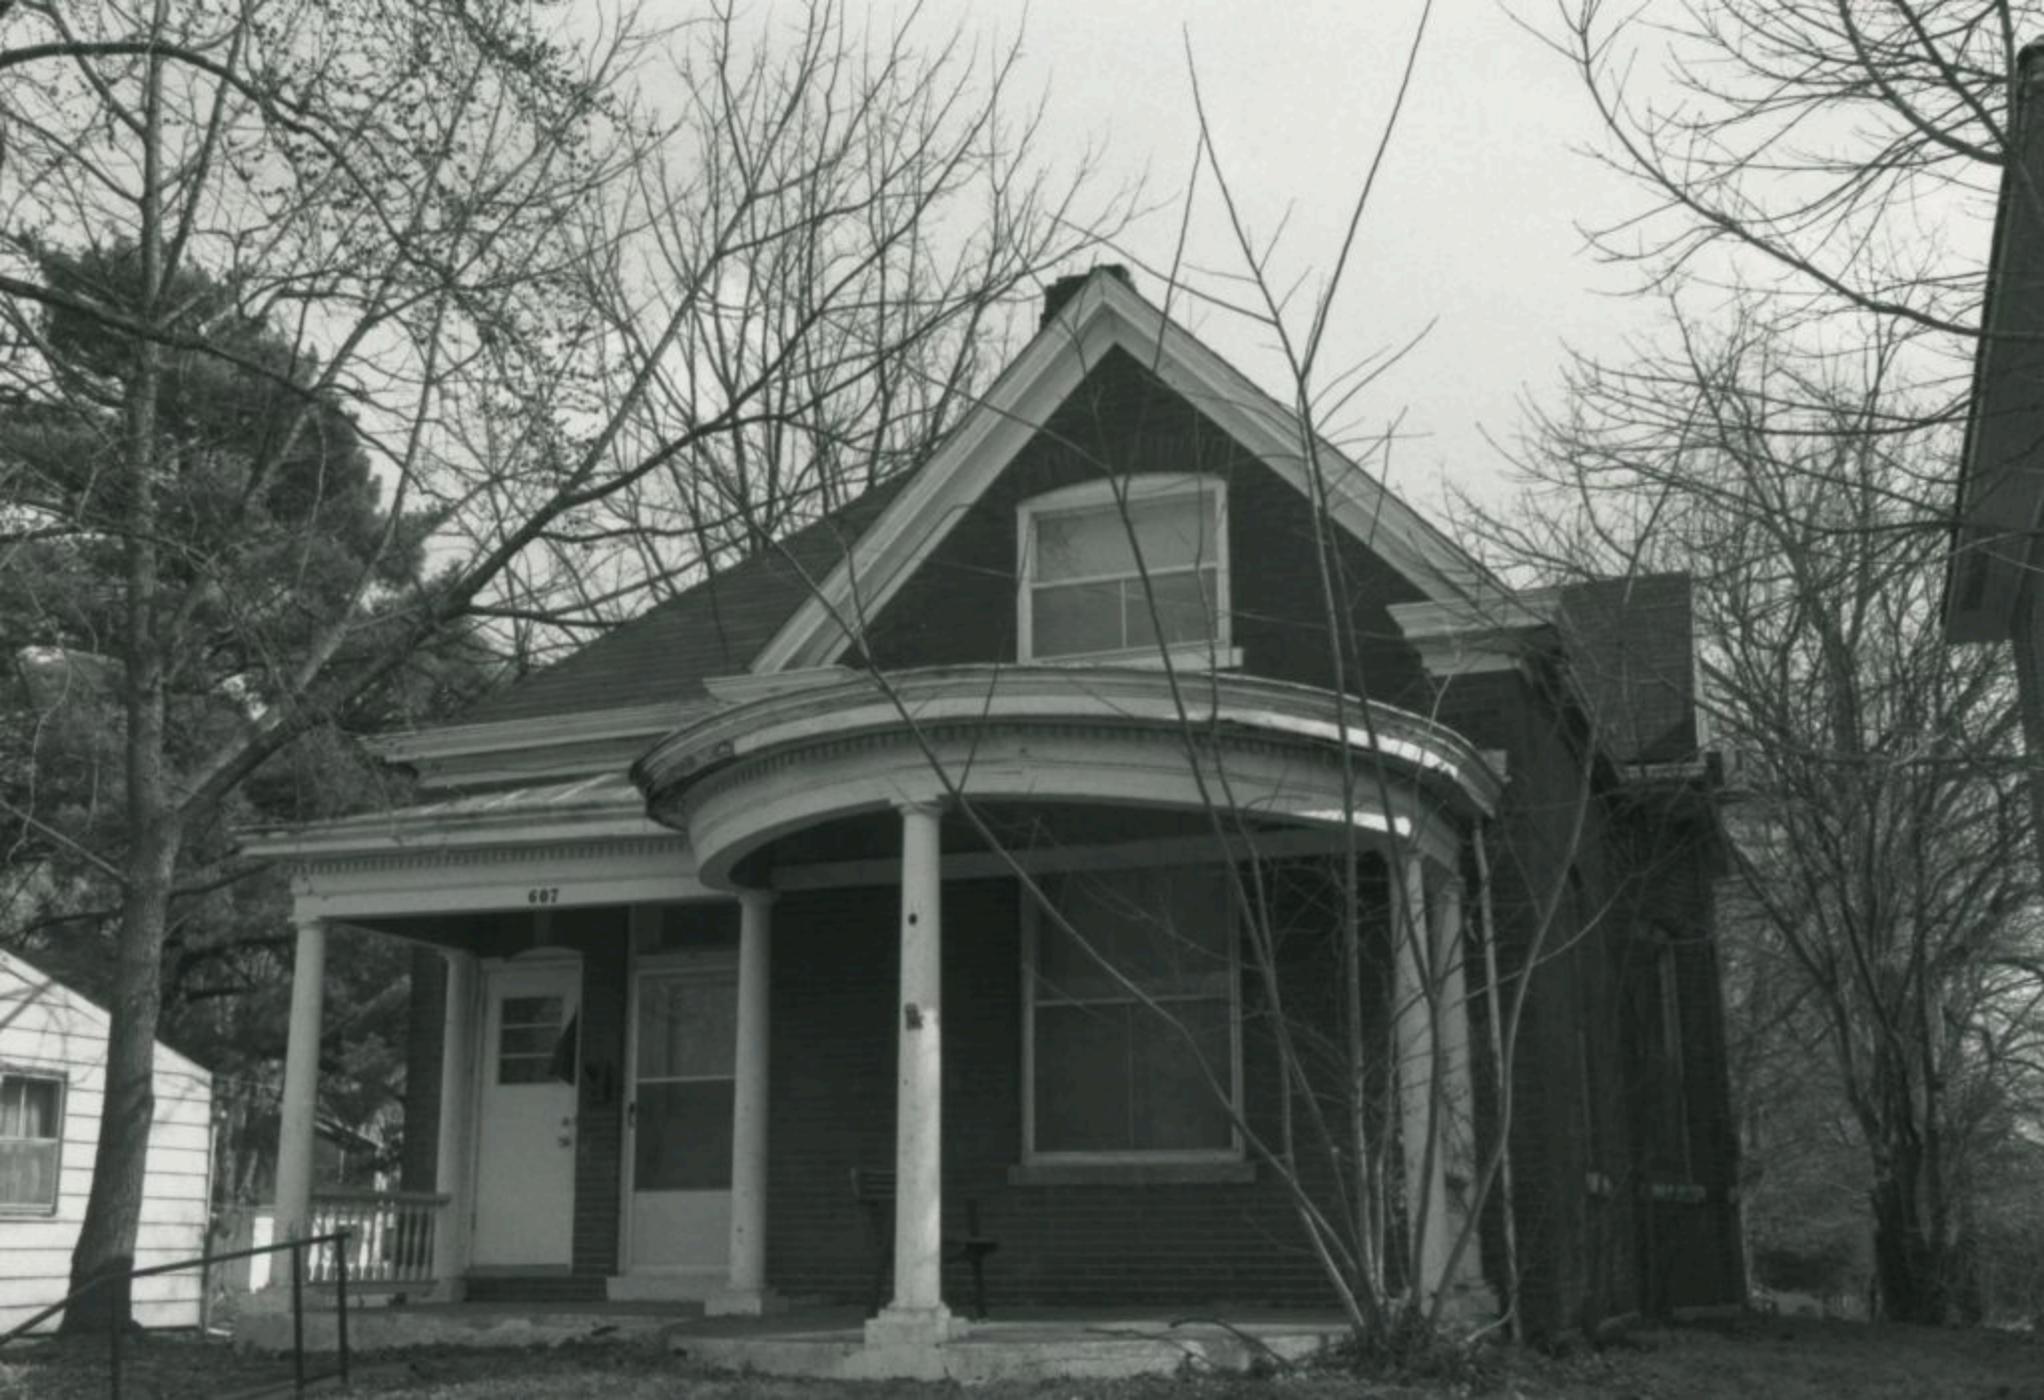
607

1-1/2 stories. Colonial Revival influence. cross plan, 2 bay asymmetrical facade. coursed stone foundation, brick (7-course common bond) walls. hip and cross gable (asphalt shingle) roof, center apex chimney. full-width porch with standing seam metal roof, hip roof section in north bay with corner Doric column and engaged column, open shaped wood balustrade along north side; south bay with rounded projecting section with three Doric columns and engaged column; both sections with low concrete deck, wide wood entablature with dentils and narrow overhanging boxed eaves. north bay with two entries (1-light with 1-light transom to south, added modern door to north set in original small window opening with keystone), narrow wood frieze and molded cornice; south bay with large 1/1 window on 1st story, wall gable with wide 1/1 window, rake boards, cornice returns. windows as 1/1 double hung with soldier segmental arched openings, stone lug sills. north and south elevations with central shallow cut-away bays below cross gable roofs, 1/1 windows, lower rear wings, gables with scalloped wood shingles. rear with lower gable roof brick wing with end chimney, gable with two windows, small center hip roof frame enclosed porch.

The 1908, 1923 and 1939 Sanborn maps show this dwelling with the curved front porch.

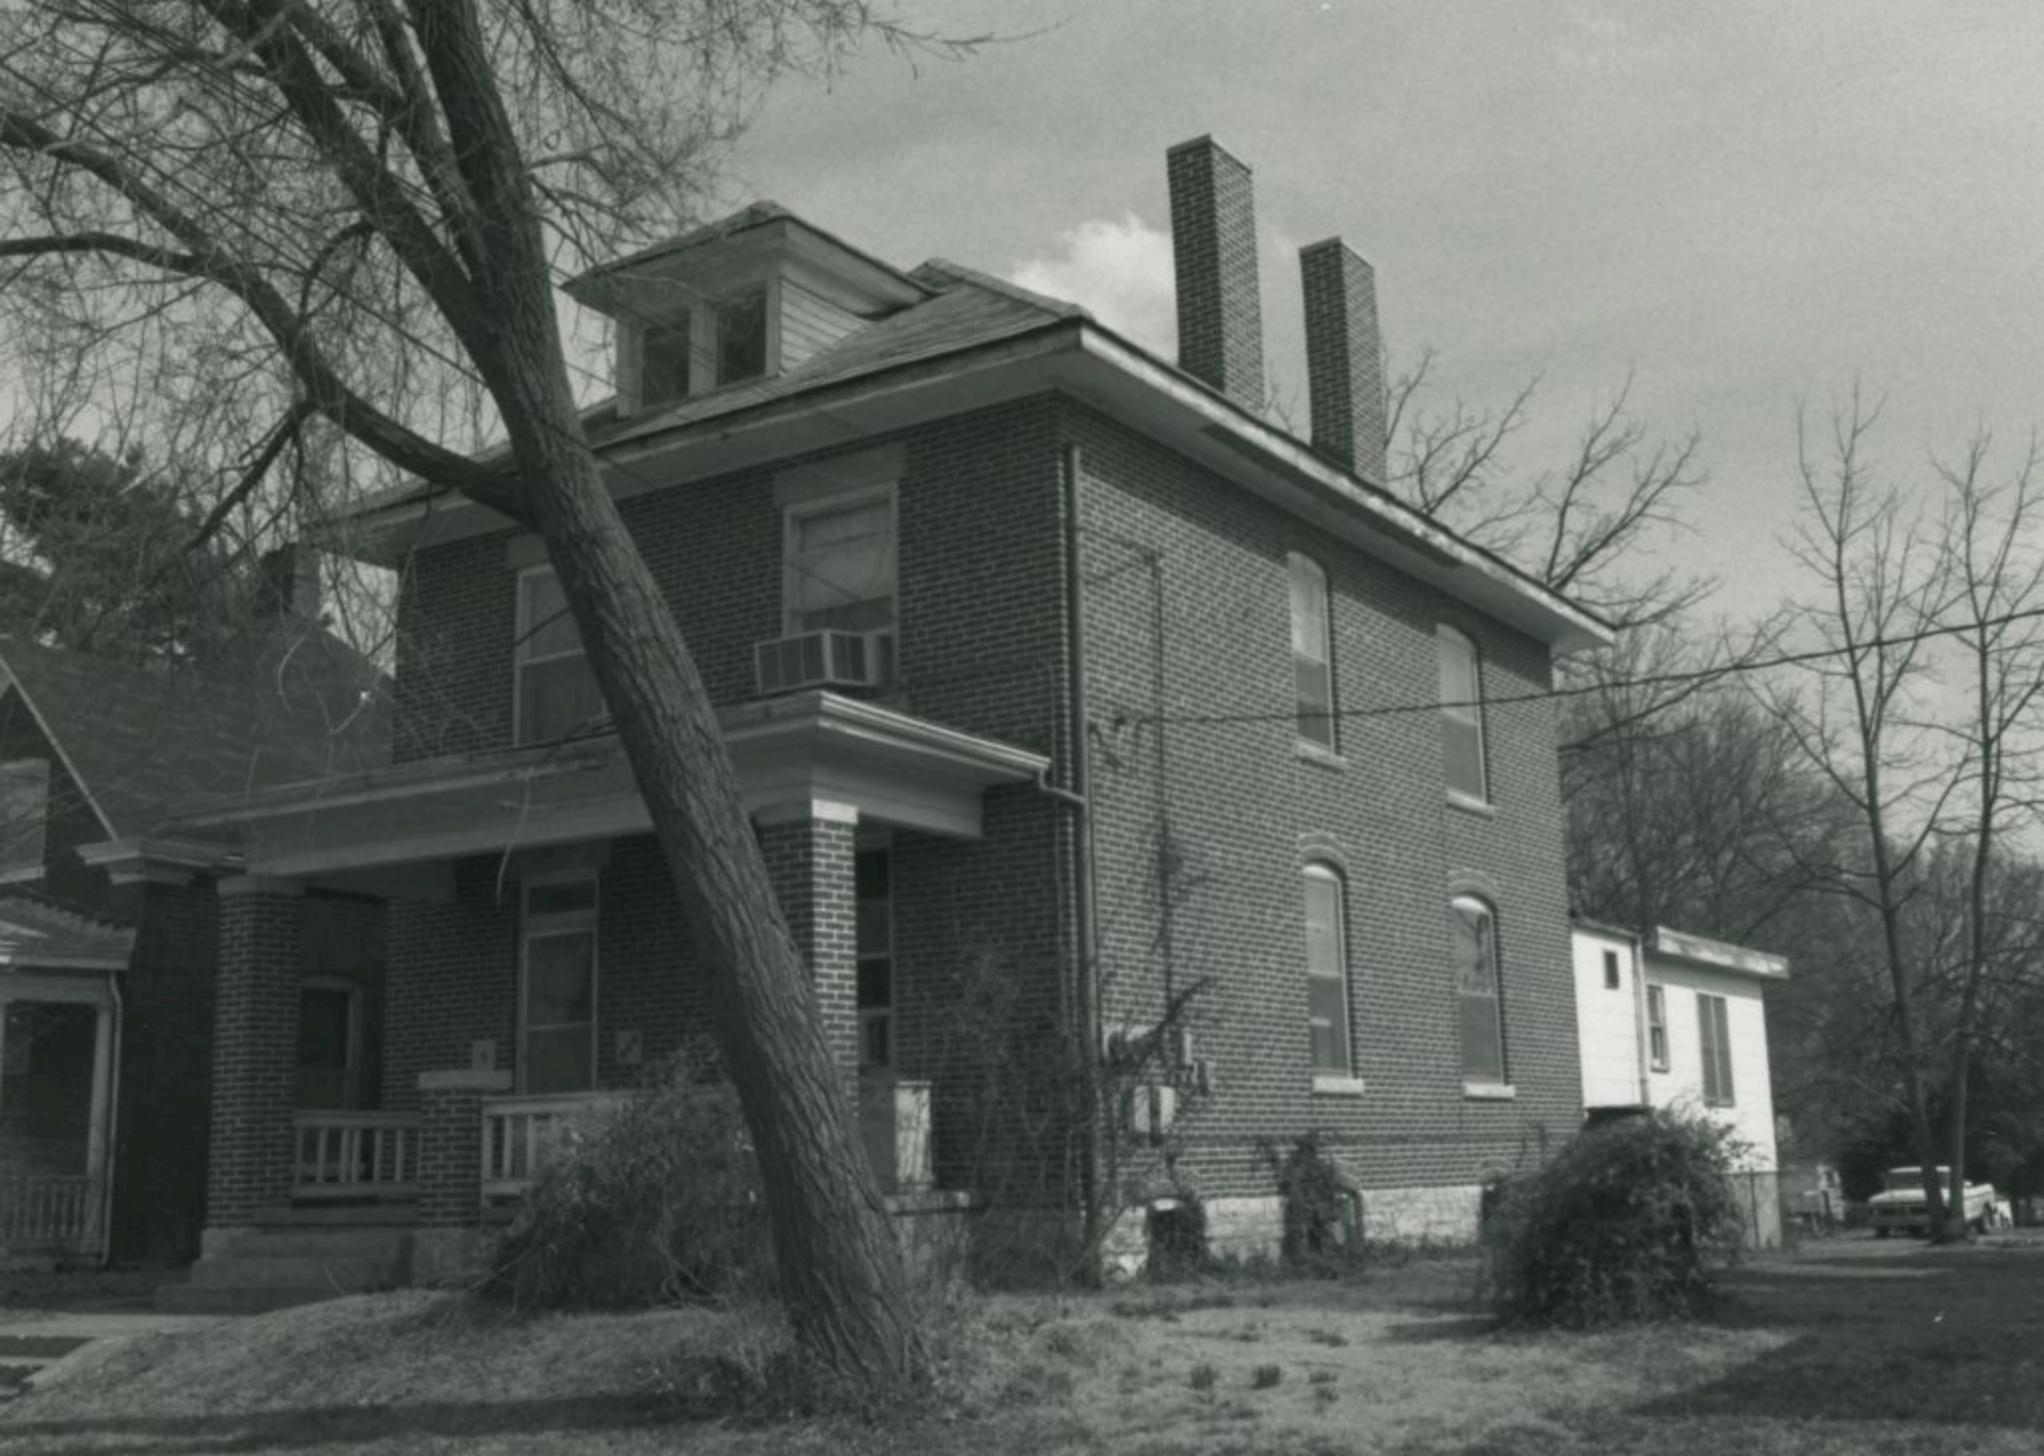
2-1/2 stories. American Four Square type, rectangular plan, 2 bay symmetrical facade. stone foundation, brick (5-course glazed Flemish header bond) walls. hip (asphalt shingle) roof. full-width hip roof porch with two corner brick piers and single step pedestal, open wood railing, concrete steps; modern door with 1-light transom in north bay, small decorative stone blocks flank entry at midpoint (north: plain, south: "609"). 1/1 window in south bay; 2nd story with two 1/1 windows; overhanging boxed eaves, center hip roof dormer with two 1-light sash. windows as 1/1 double hung with stone lintels and sills; double rowlock segmental arches on side elevations. south elevation with two windows per story, two tall interior end chimneys. north elevation with multiple windows, interior end northeast corner chimney. 1-story frame (asbestos shingle sided, concrete block foundation) addition across rear with center shed roof 2-story section, 1/1 windows.

The 1908 Sanborn Map does not show this lot. This 2-story dwelling appears on the 1923 and 1939 Sanborn maps with front and rear porches.

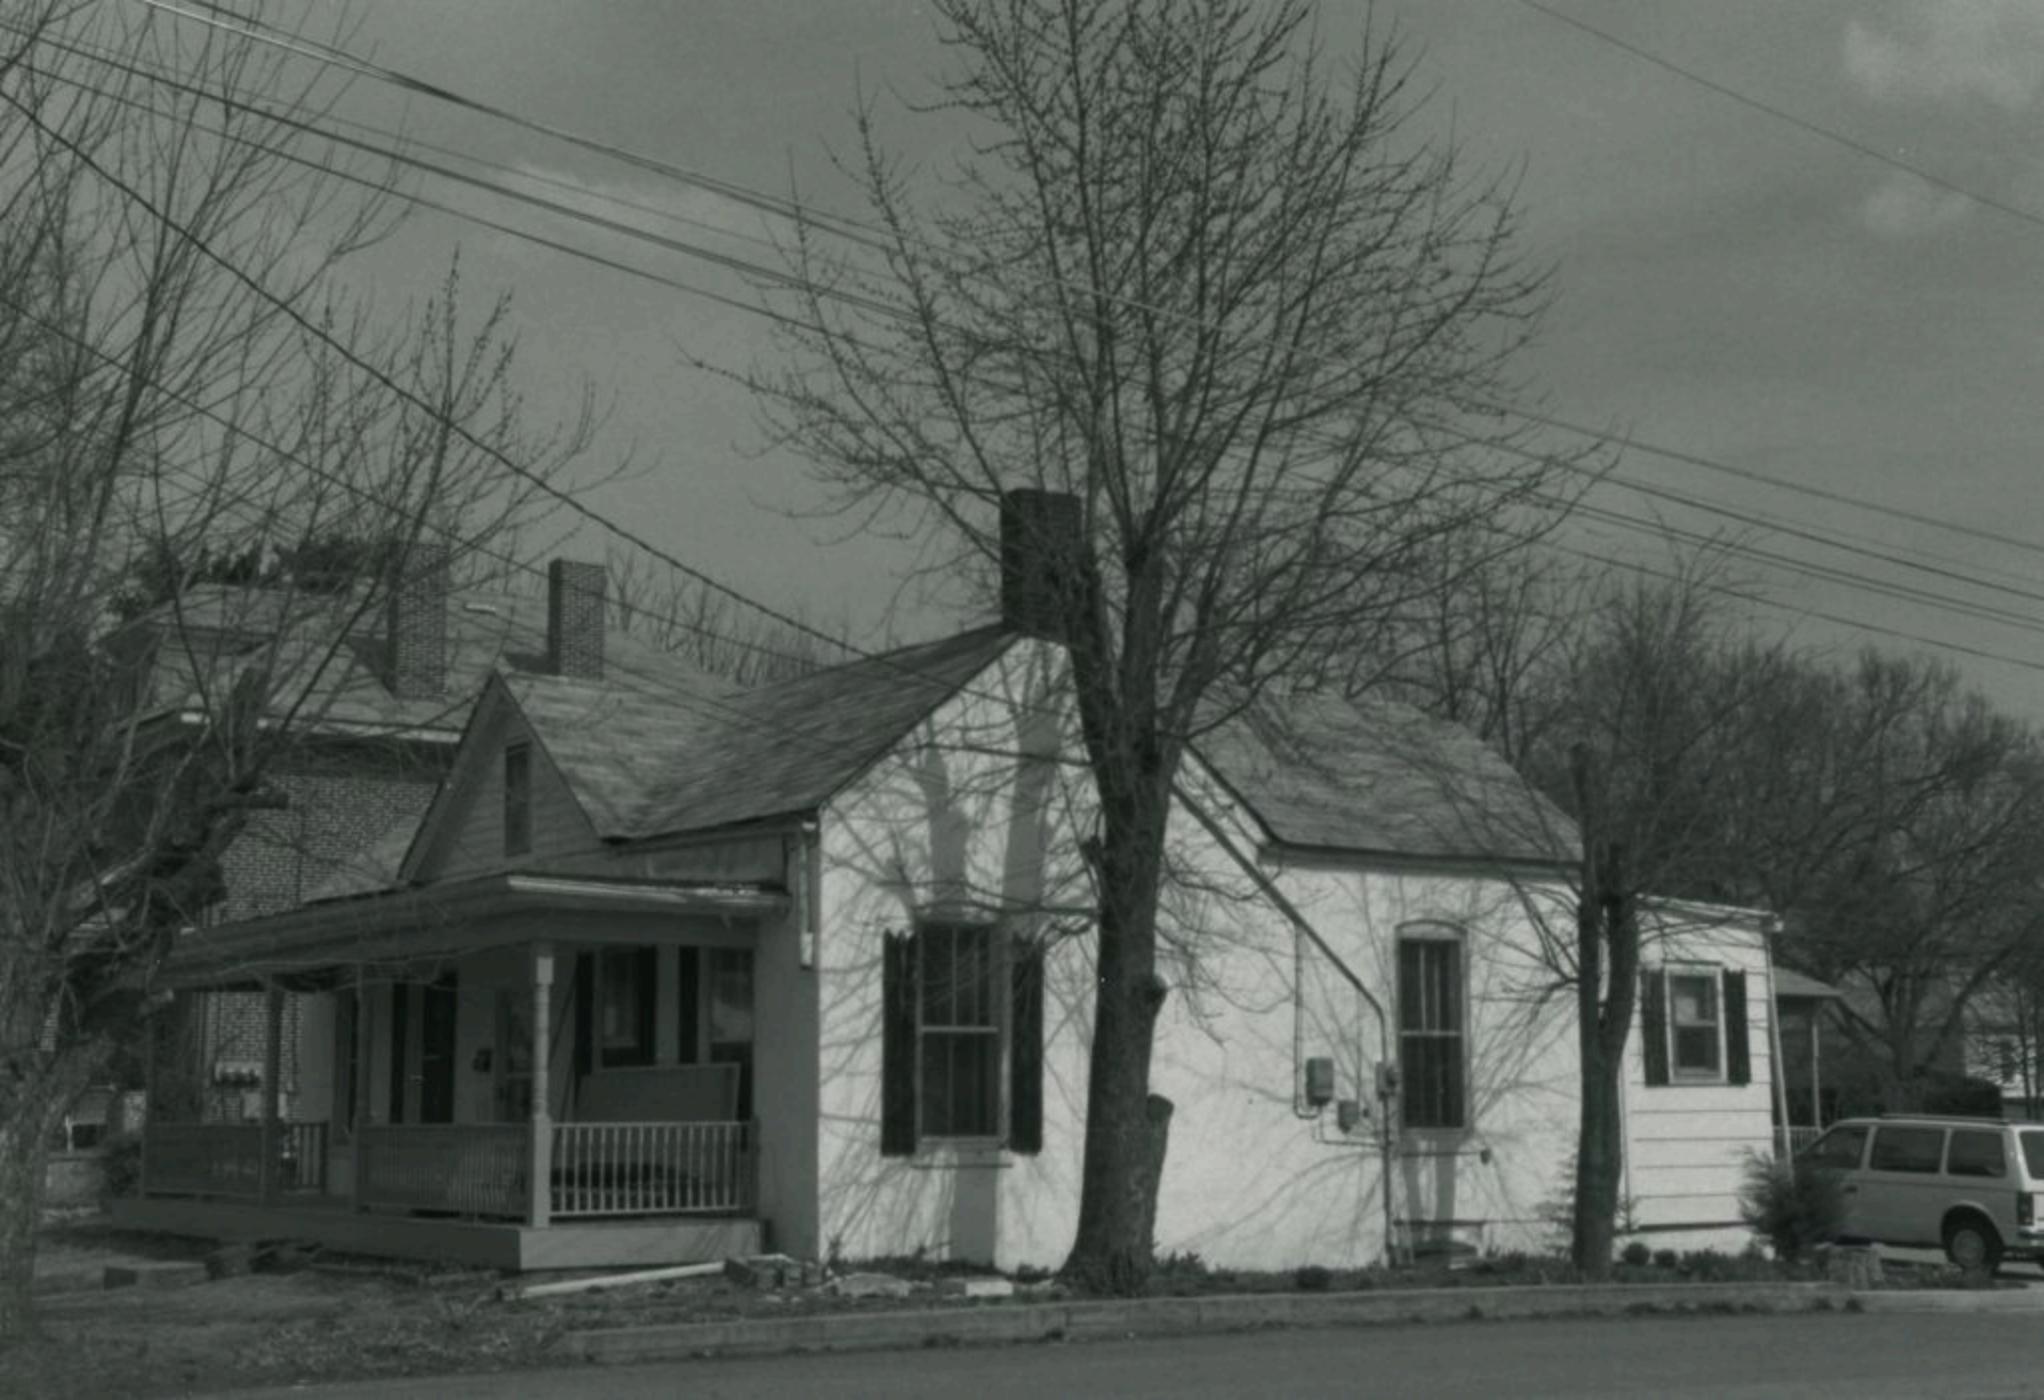
One story with attic. Central Passage vernacular type. Rectangular plan. Five bay symmetrical facade. Foundation not visible; stucco-clad (white) walls; blue painted trim. Gable (asphalt shingle) roof. 1/1 replacement and 2/2 double hung sash; segmental arches and plain window heads. Central entrance (replacement door) with replacement 1/1 double hung sash in the two end bays to each side. Nearly full-facade flat roof porch with modern open rail (turned balusters appears to be reproductions) and turned posts (which appear to be historic.) Low wood deck. Central gable wall dormer with fish scale shingles; single 1/1 window. Rear wing with shed dormer north. Brick chimney north at side gable's apex. South with interior end chimney; some 2 vertical/2 vertical double hung sash remain here. Rear with U-plan with north rear wing having "truncated gable" roof; south wing with clipped gable. One story small shed wing off south gable; artificial siding.

Shown as 613 on the 1908 Sanborn Map; central entrance porch and rear ell with one story reentrant angle infill wing. One story outbuilding. Full facade porch shown on the 1923 Sanborn Map. One story garage at side alley/Cedar Street, a change from before. The same is shown on the 1939 Sanborn Map.

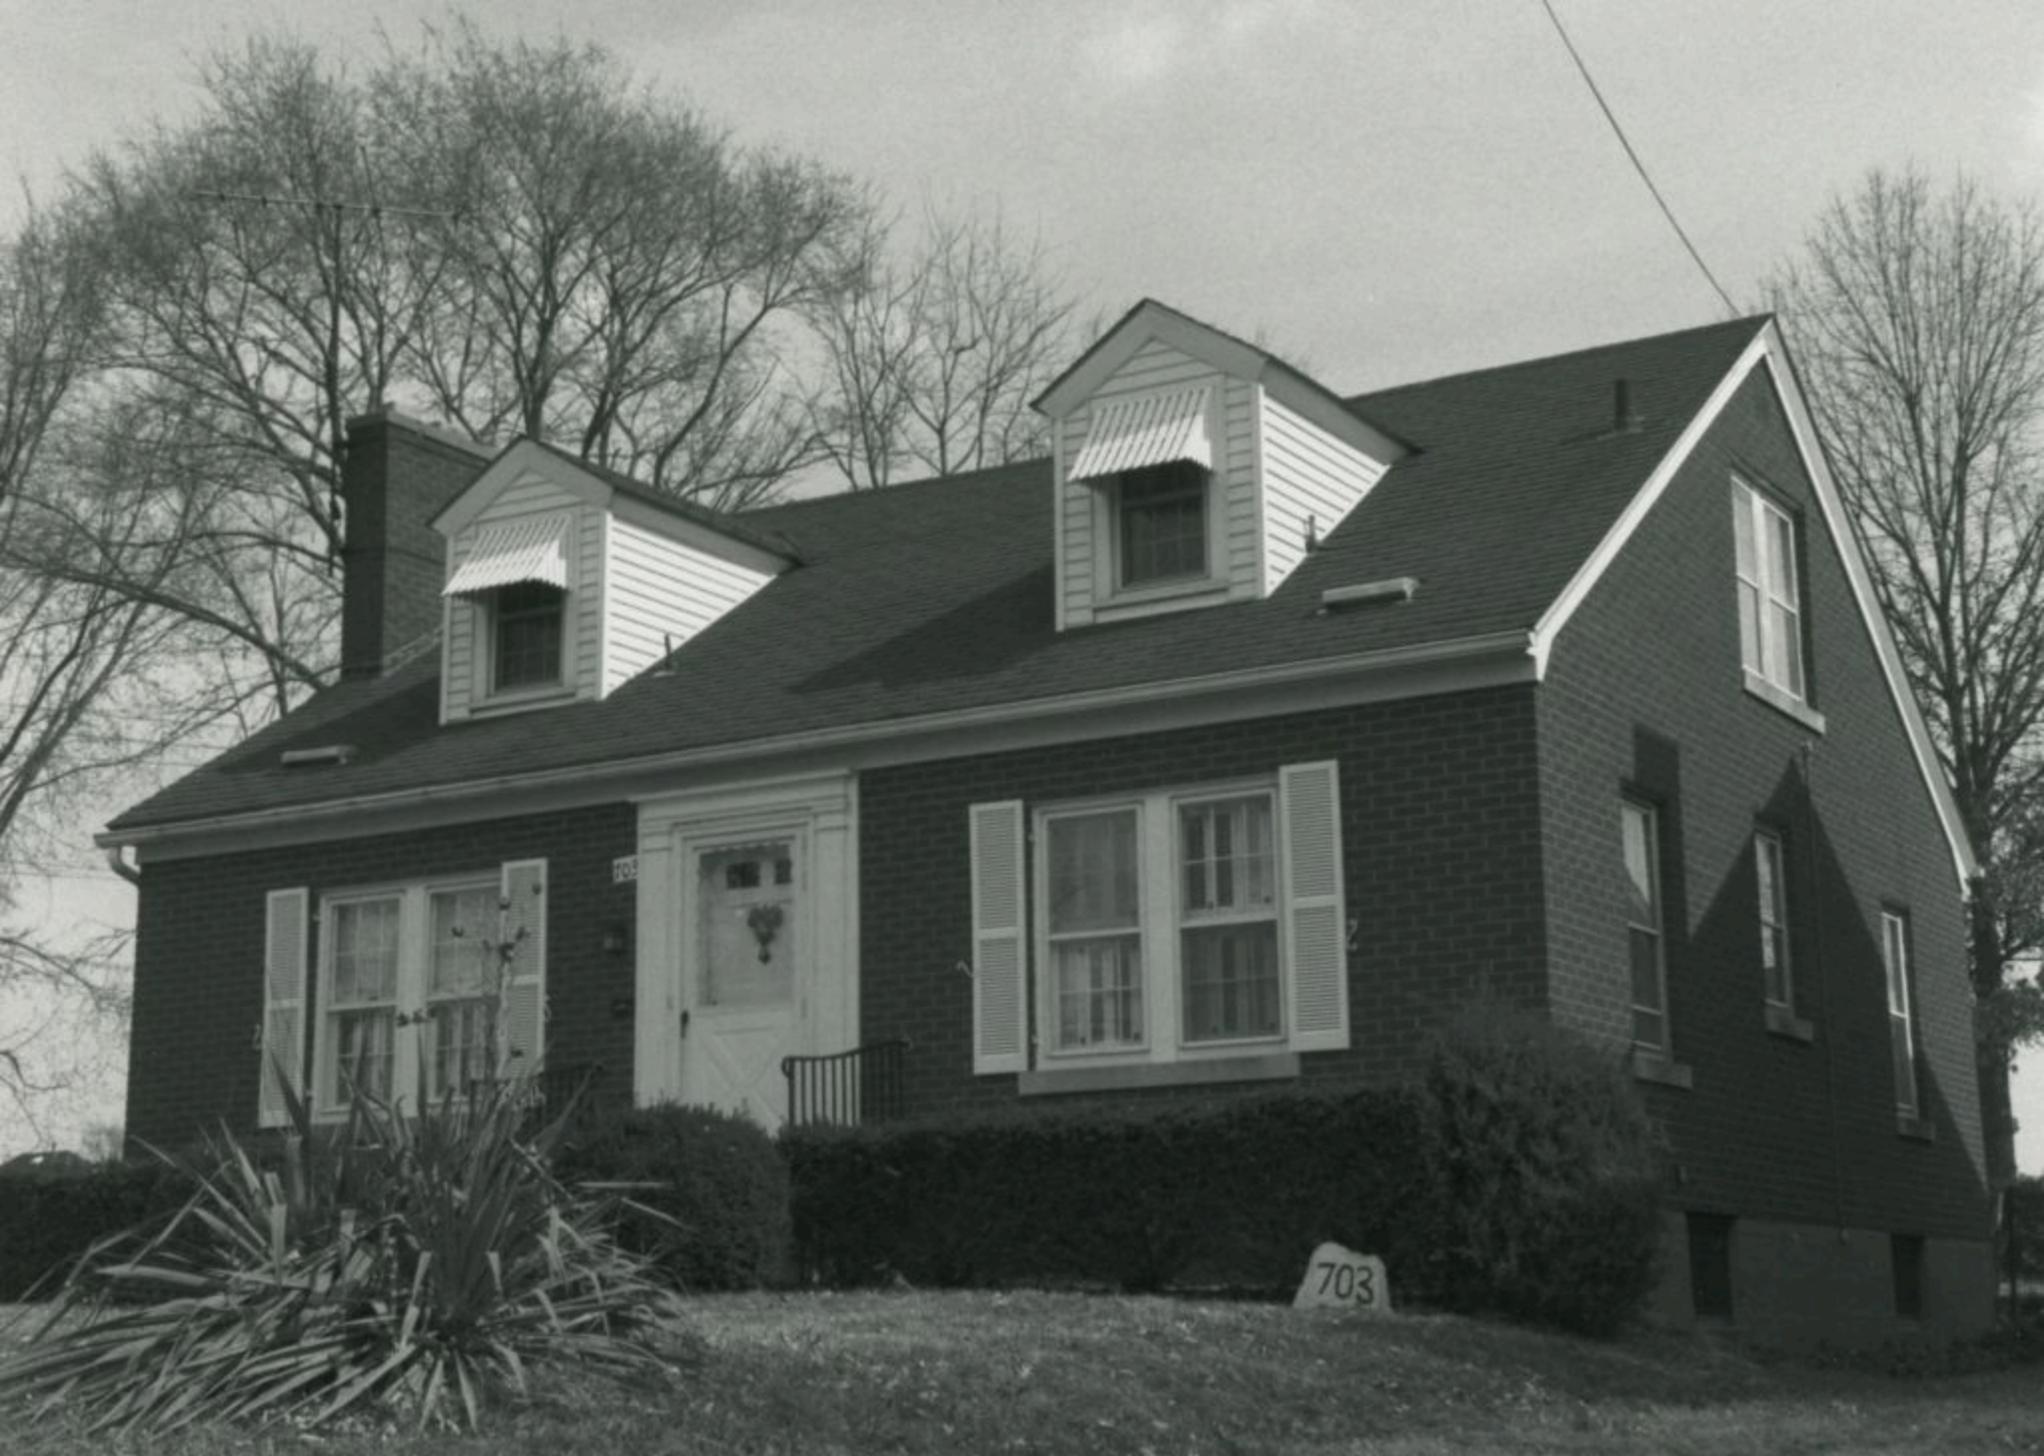
703

1-1/2 stories. Colonial Revival (Cape Cod type), rectangular plan, 3 bay symmetrical facade. concrete foundation, brick (running bond) walls. side gable (asphalt shingle) roof. center panel door entry with wood Colonial Revival surround of fluted pilasters and flat entablature, concrete stoop with metal railing; flanking paired 6/6 windows with modern louvered blinds, narrow wood frieze, artificially covered soffits; two artificially sided gable roof dormers with 6/6 windows, modern metal awnings. windows as 6/6 double hung with concrete sills. north elevation with exterior chimney to west with flanking windows, paired windows in gable, central entry with flanking windows, screened-in porch on rear half. south elevation with three windows on 1st story, paired windows in gable, exposed basement. large artificially sided shed roof dormer on rear with two windows.

This lot does not appear on the 1923 Sanborn Map. The 1-1/2 story dwelling does appear on the 1939 map.

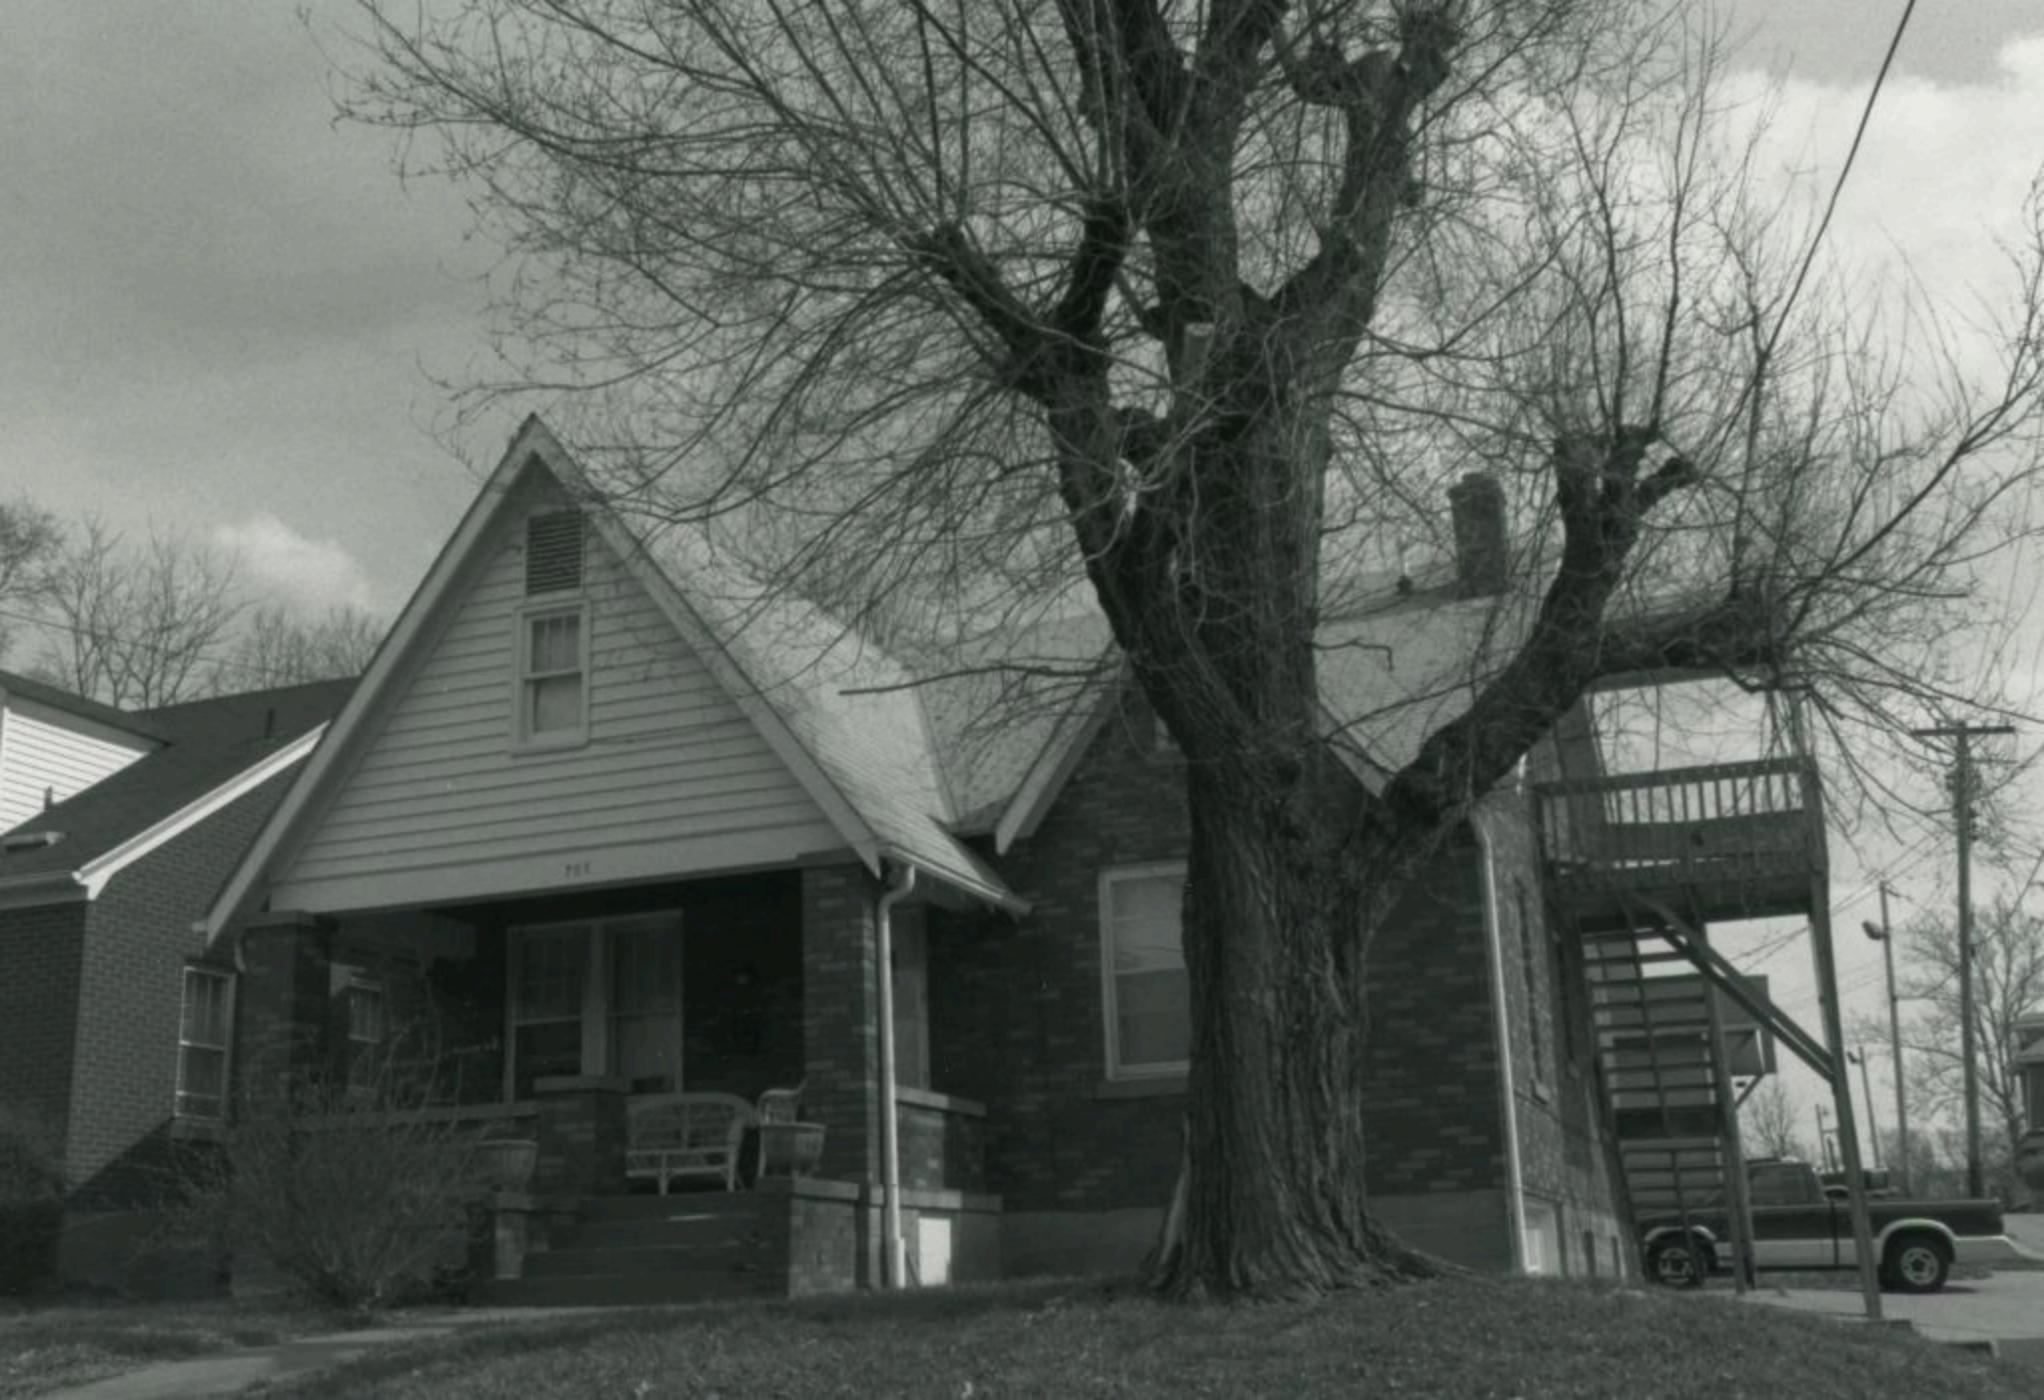
1-1/2 stories. Late Tudor Revival influence. Single family converted to multi-family. Rectangular plan. Three bay asymmetrical facade. Parged foundation. Mottled brick (reds, greens, and yellows) walls. Gable front (asphalt shingle) roof; artificially sided (medium exposure) gable front. 3 vertical/1 double hung sash pair in left/north bay and entrance (middle bay) under porch created by gable roof pavilion with upper story living space. Porch with brick posts and brick solid rail; cheek pieces frame poured concrete stairs. Small 3 vertical/1 in upper story with large vent above in apex. Gable wall dormer third/right bay; 6/6 on first story below smaller gable window. South elevation with an interior end chimney. Basement garage with historic multi-light swing doors. A second story entrance has been created in the south side gable, with a modern exterior straight-run staircase from the rear elevation; small landing at added entrance. North elevation with exterior end chimney. Rear elevation with small rear shed half porch enclosed with 3/1 double hung sash.

This house first appears on the 1939 Sanborn Map; the front wing and the rear porch are shown as are currently extant. A basement garage is indicated; a large one story garage is also in the rear lot.

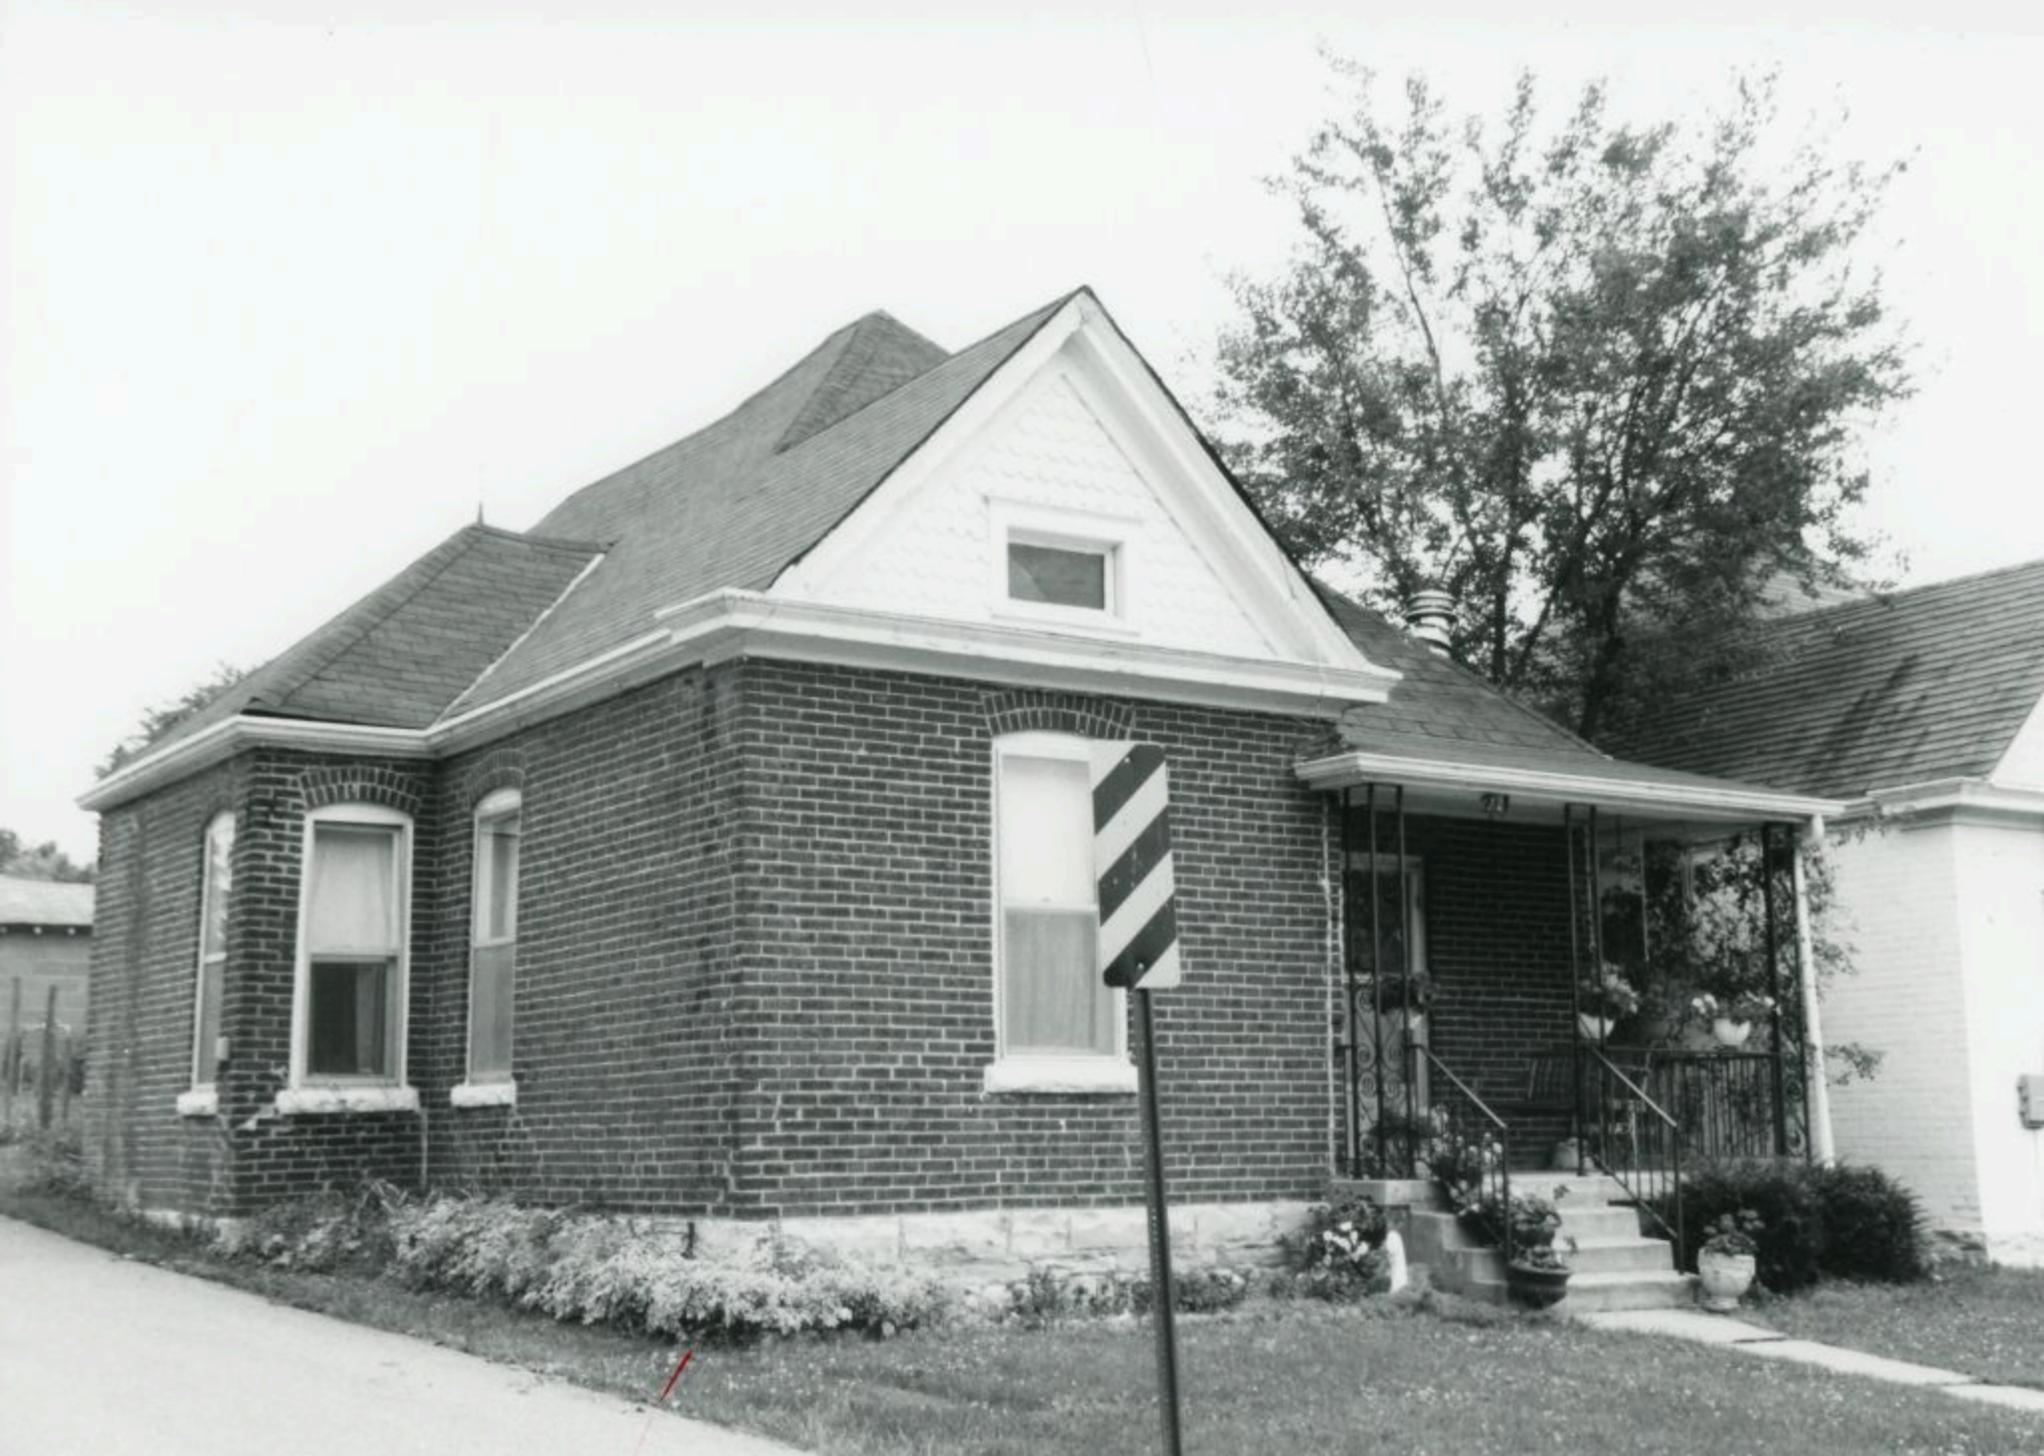
1 story with attic. composite type (gable on hip cottage). irregular plan, 2 bay asymmetrical facade. coursed stone foundation, brick (7-course Flemish header) walls. hip and gable (asphalt shingle) roof. L-plan facade with south re-entrant corner porch with three modern metal posts and railing, raised concrete deck and steps, narrow wood cornice, corner doors: modern door facing west, original doorway facing south brick infilled; north bay as lower projecting gable roof pavilion with center 1/1 window, projecting wood cornice returns slightly on side elevations, gable with 1-light rectangular window with wood surround and drip cap, decorative wood shingles and molded rake/cornice boards. windows as 1/1 double hung with stone sills (painted) and double rowlock segmental arch openings. north elevation as T-plan with lower center hip roof pavilion with east/west facing side windows, window at west end of pavilion facing north and on main house in corner with pavilion; narrow 1/1 in center of rear section. south elevation with two windows, aluminum sided frame addition projects to south on rear corner. rear with large center hip roof pavilion with window to south, frame shed roof enclosed entry with wide aluminum siding on south corner; bulkhead to cellar.

This area does not appear on the 1908 Sanborn Map. The 1923 map shows this irregular plan dwelling with no porches depicted. The south corner porches and garage are shown on the 1939 map.

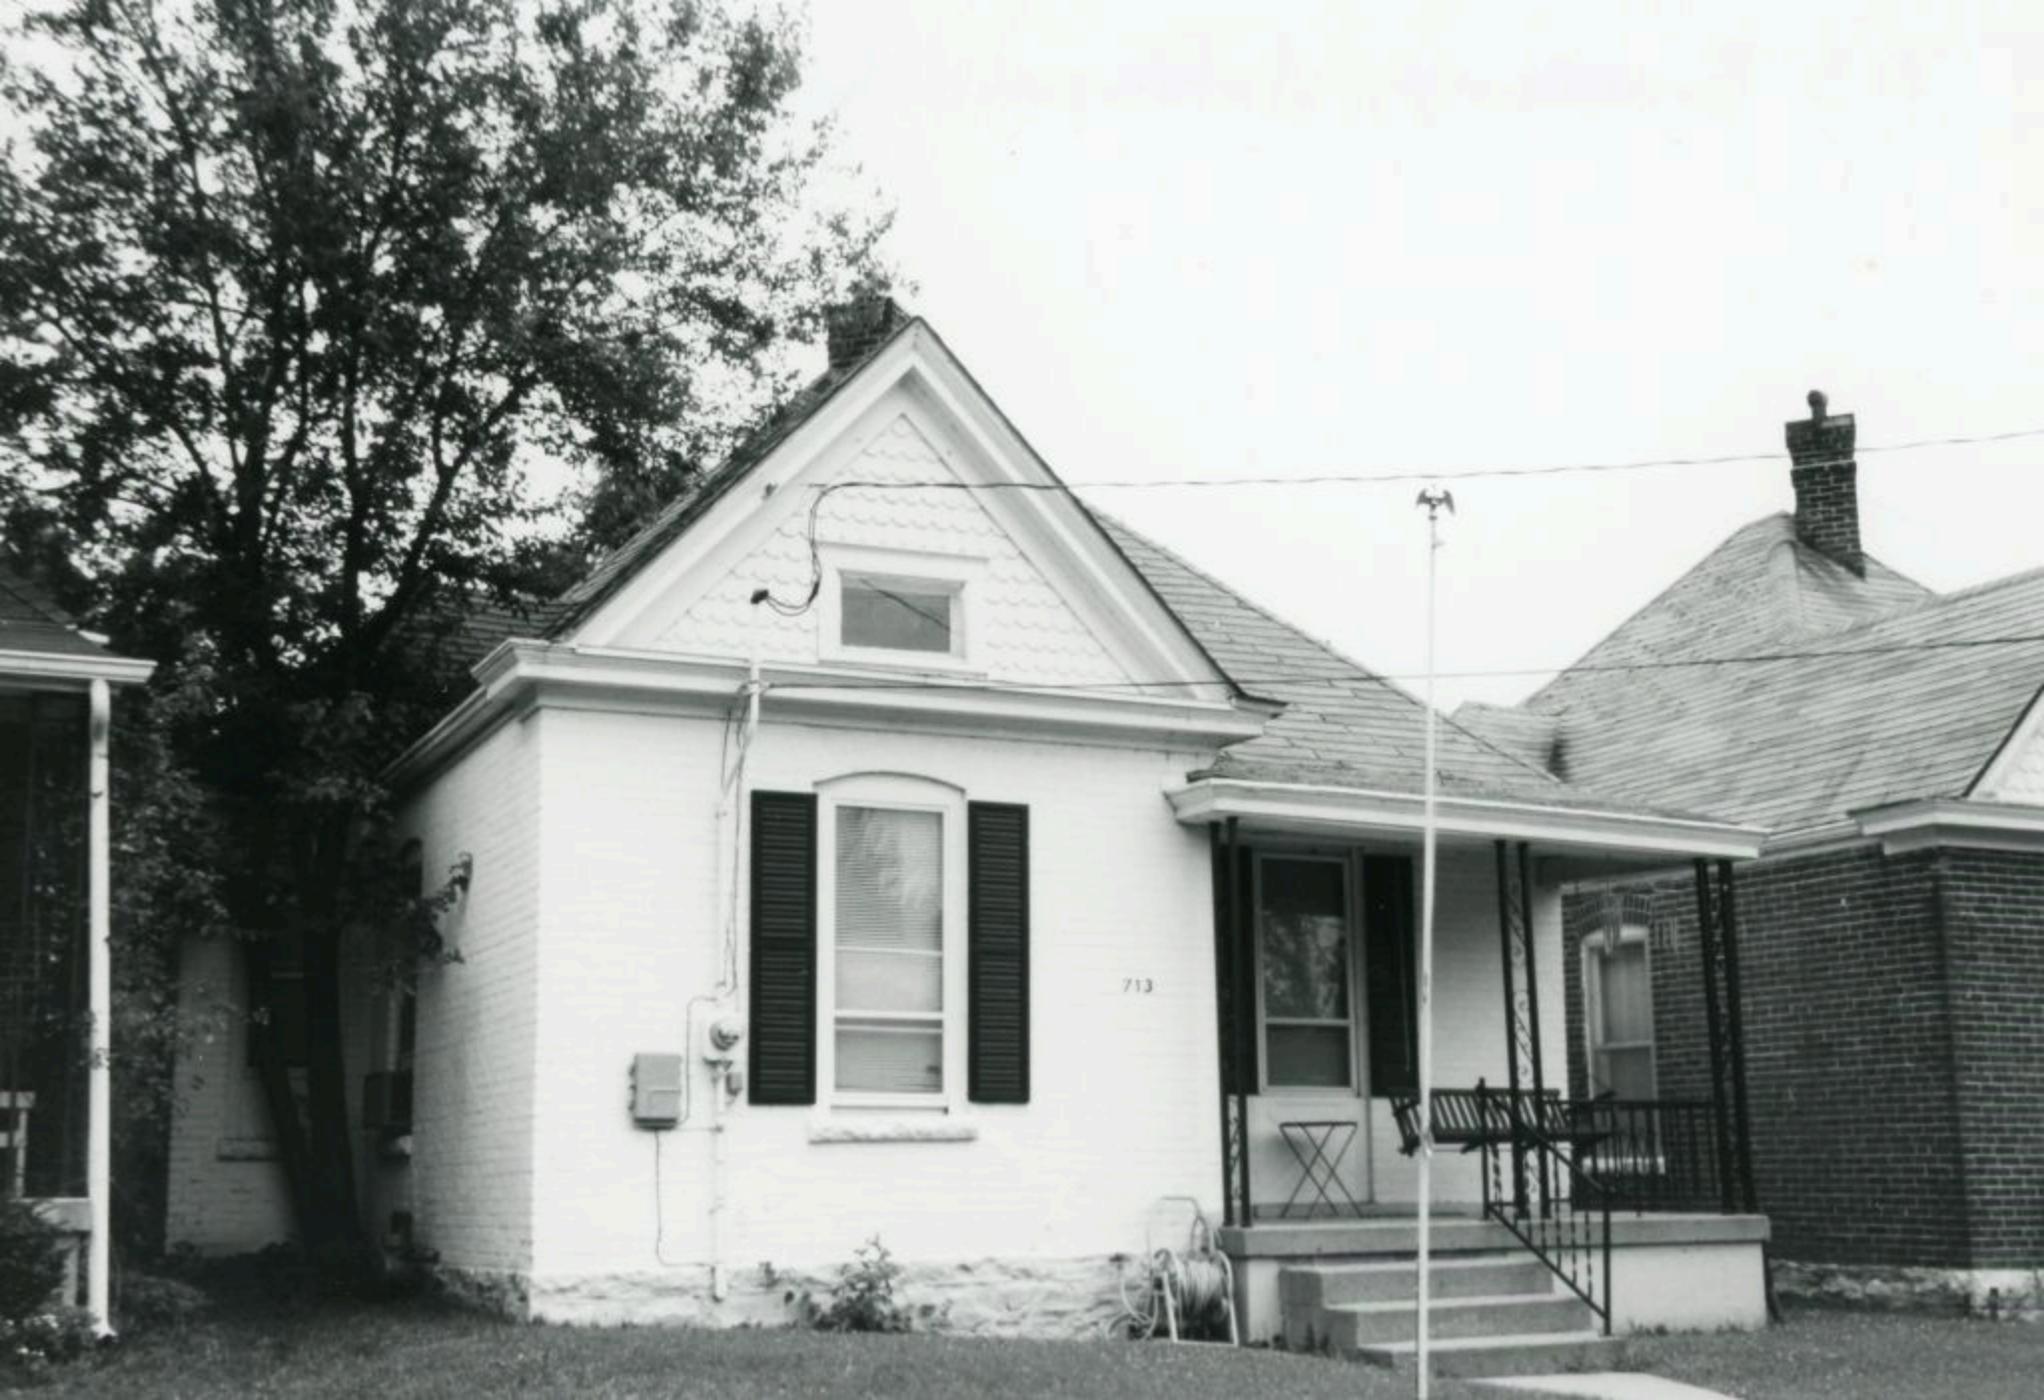
713

1 story with attic. composite type (gable on hip cottage). irregular plan, 2 bay asymmetrical facade. coursed stone (painted) foundation, brick (7-course Flemish header, painted) walls. hip and gable (asphalt shingle) roof. L-plan facade with south re-entrant corner porch with three modern metal posts and railing, raised concrete deck and steps, narrow wood cornice, corner doors: original west facing doorway infilled with modern window and louvered blinds, modern entry with blocked transom facing south; north bay as lower projecting gable roof pavilion with center modern replacement 1/1 window with modern louvered blinds, projecting wood cornice returns slightly on side elevations, gable with 1-light rectangular window with wood surround and drip cap, decorative wood shingles and molded rake/cornice boards. windows as smaller modern replacement 1/1 double hung with stone sills (painted) and double rowlock segmental arch openings, some modern louvered blinds. diagonally placed corbelled chimney at hip roof apex. north elevation as T-plan with lower center hip roof pavilion with east/west facing side windows, window at west end of pavilion facing north and on main house in corner with pavilion. south elevation with two windows, shed roof frame enclosed porch on rear corner. rear with shallow lower hip roof pavilion to north with center narrow replacement 1/1 window, bulkhead to cellar below; projecting shed roof enclosed porch with wide aluminum siding on south corner with two windows to south and door to north.

This area does not appear on the 1908 Sanborn Map. The 1923 map shows this irregular plan dwelling with no porches depicted; the garage is shown. The south corner porches and garage are shown on the 1939 map.
