HISTORIC SOUTHSIDE COMMERCIAL AREA

MISSOURI HISTORIC PROPERTY INVENTORY FORM

REFERENCE NUMBER CO AS003-001		A. HISTORIC NAME					
B. COUNTY 054 Cole		C. OTHER NAME(S)					
D. ADDRESS 102 East Ashley Street			E. CITY Jefferson City		F. VICINITY <input type="checkbox"/>	G. RESTRICTED	H. ACREAGE

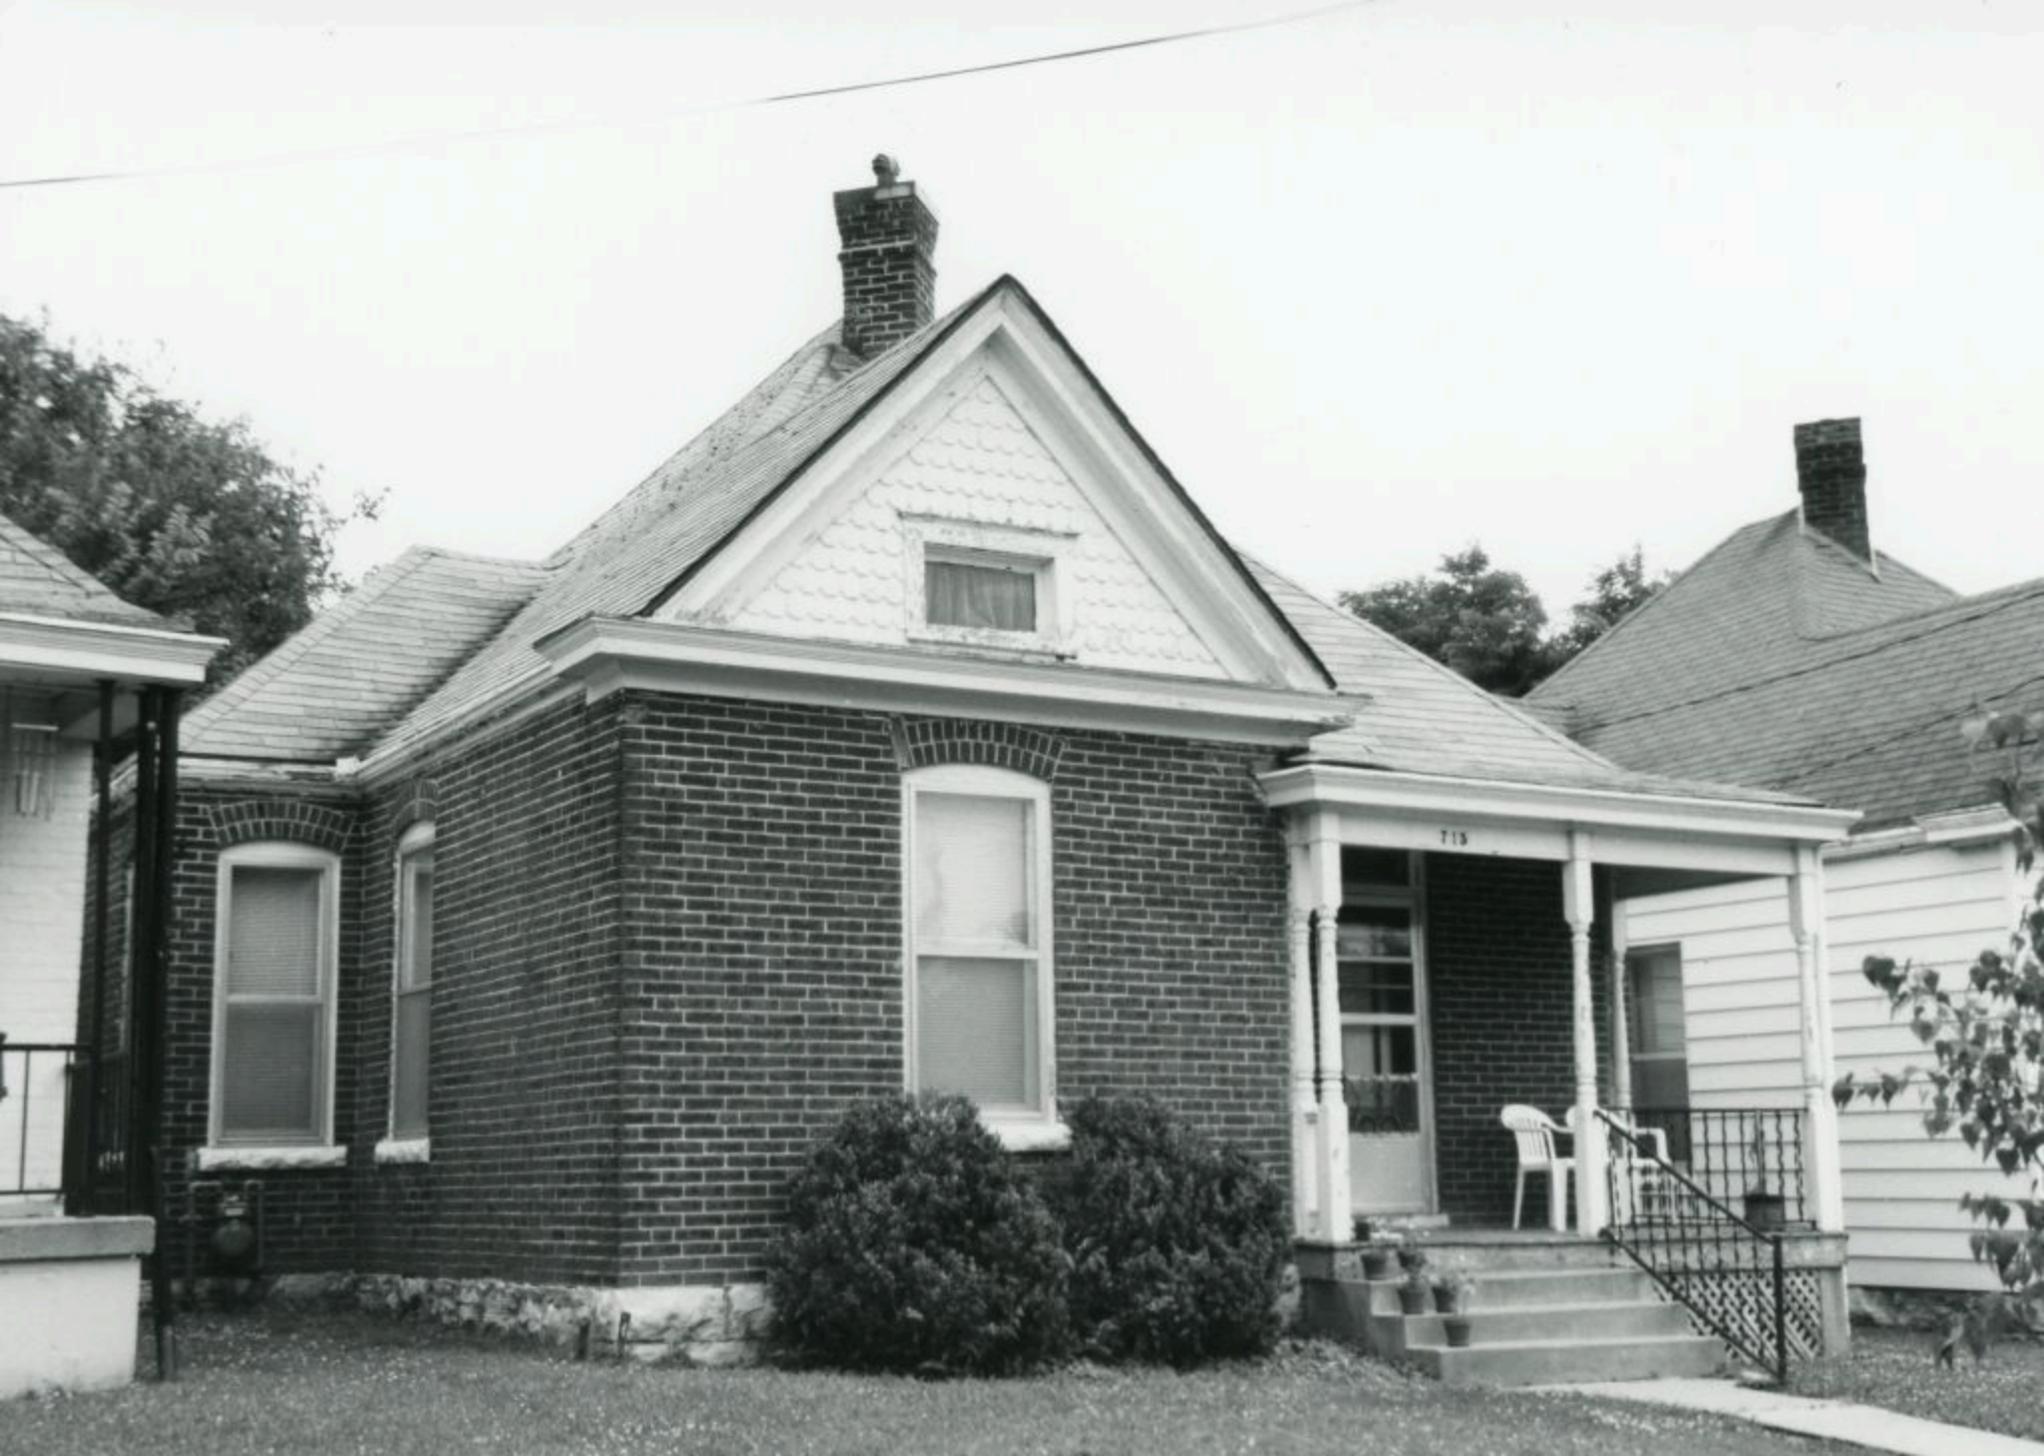
1 story with attic. composite type (gable on hip cottage). irregular plan, 2 bay asymmetrical facade. coursed stone foundation, brick (7-course Flemish header) walls. hip and gable (asphalt shingle) roof. L-plan facade with south re-entrant corner porch with three original turned wood posts and two pilasters, wood frieze and modern metal railing, wood deck and concrete steps, narrow wood cornice, corner doors with 1-light transoms: Craftsman type facing west, 1-light/panel facing south; north bay as lower projecting gable roof pavilion with center 1/1 window, projecting wood cornice returns slightly on side elevations, gable with 1-light rectangular window with wood surround and drip cap, decorative wood shingles and molded rake/cornice boards. windows as 1/1 double hung with stone sills (painted) and double rowlock segmental arch openings. diagonally placed corbelled chimney at hip roof apex. north elevation as T-plan with lower center hip roof pavilion with east/west facing side windows, window at west end of pavilion facing north and on main house in corner with pavilion. south elevation with two windows, shed roof frame addition on rear corner. rear with shallow lower hip roof pavilion to north with shed roof frame addition (wide aluminum siding) around pavilion and across rear, entry to south with 1/1 at south end, two 1/1 to north.

This area does not appear on the 1908 Sanborn Map. The 1923 map shows this irregular plan dwelling with no porches depicted; the garage is shown. The south corner porches and garage are shown on the 1939 map.

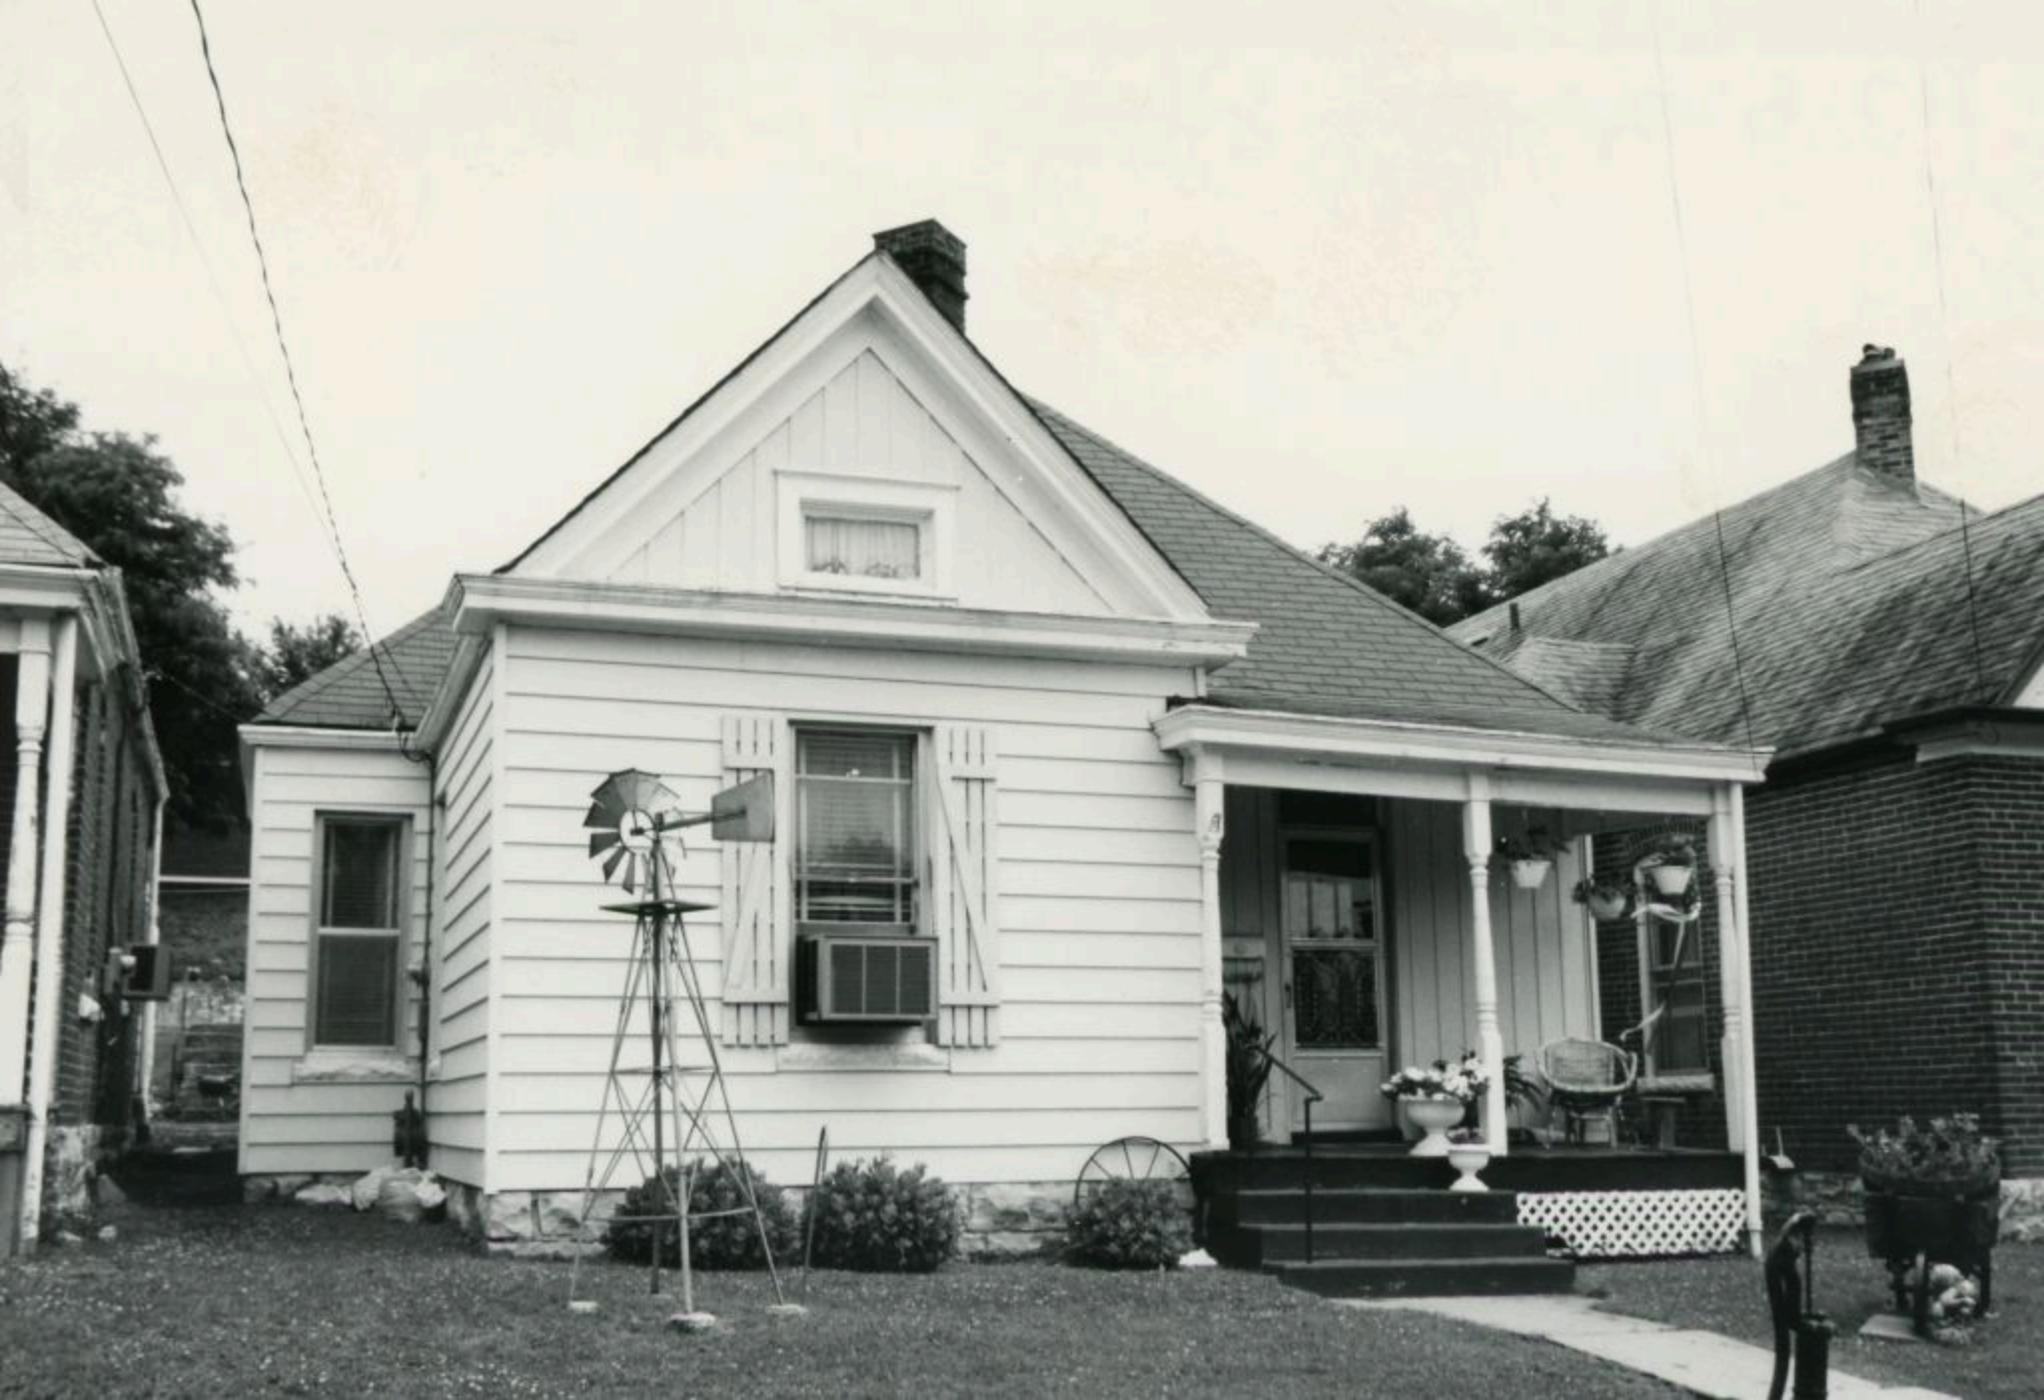
1 story with attic. composite type (gable on hip cottage). irregular plan, 2 bay asymmetrical facade. coursed stone foundation, wide aluminum siding (over brick) walls. hip and gable (asphalt shingle) roof. L-plan facade with south re-entrant corner porch with three original turned wood posts, wood frieze, no railing, wood deck and concrete steps, narrow wood cornice; Craftsman-type door with transom facing west, modern board and batten siding on 1st-story below porch; north bay as lower projecting gable roof pavilion with center 1/1 window with modern slat blinds, projecting wood cornice returns slightly on side elevations, gable with 1-light rectangular window, board and batten siding in gable with molded rake/cornice boards. windows as 1/1 double hung with stone sills (painted), double rowlock segmental arch openings covered by siding. diagonally placed corbelled chimney at hip roof apex. north elevation as T-plan with lower center hip roof pavilion with east/west facing side windows, window at west end of pavilion facing north and on main house in corner with pavilion. south elevation with two windows, shed roof frame addition on rear corner. rear with shallow lower hip roof pavilion to north with large shed roof frame addition (wide aluminum and asbestos shingle siding) around pavilion and across rear, entry to south with paired 1/1 windows at north and south ends.

This area does not appear on the 1908 Sanborn Map. The 1923 map shows this irregular plan dwelling with no porches depicted; a garage is shown. The south corner porches and a garage are shown on the 1939 map.

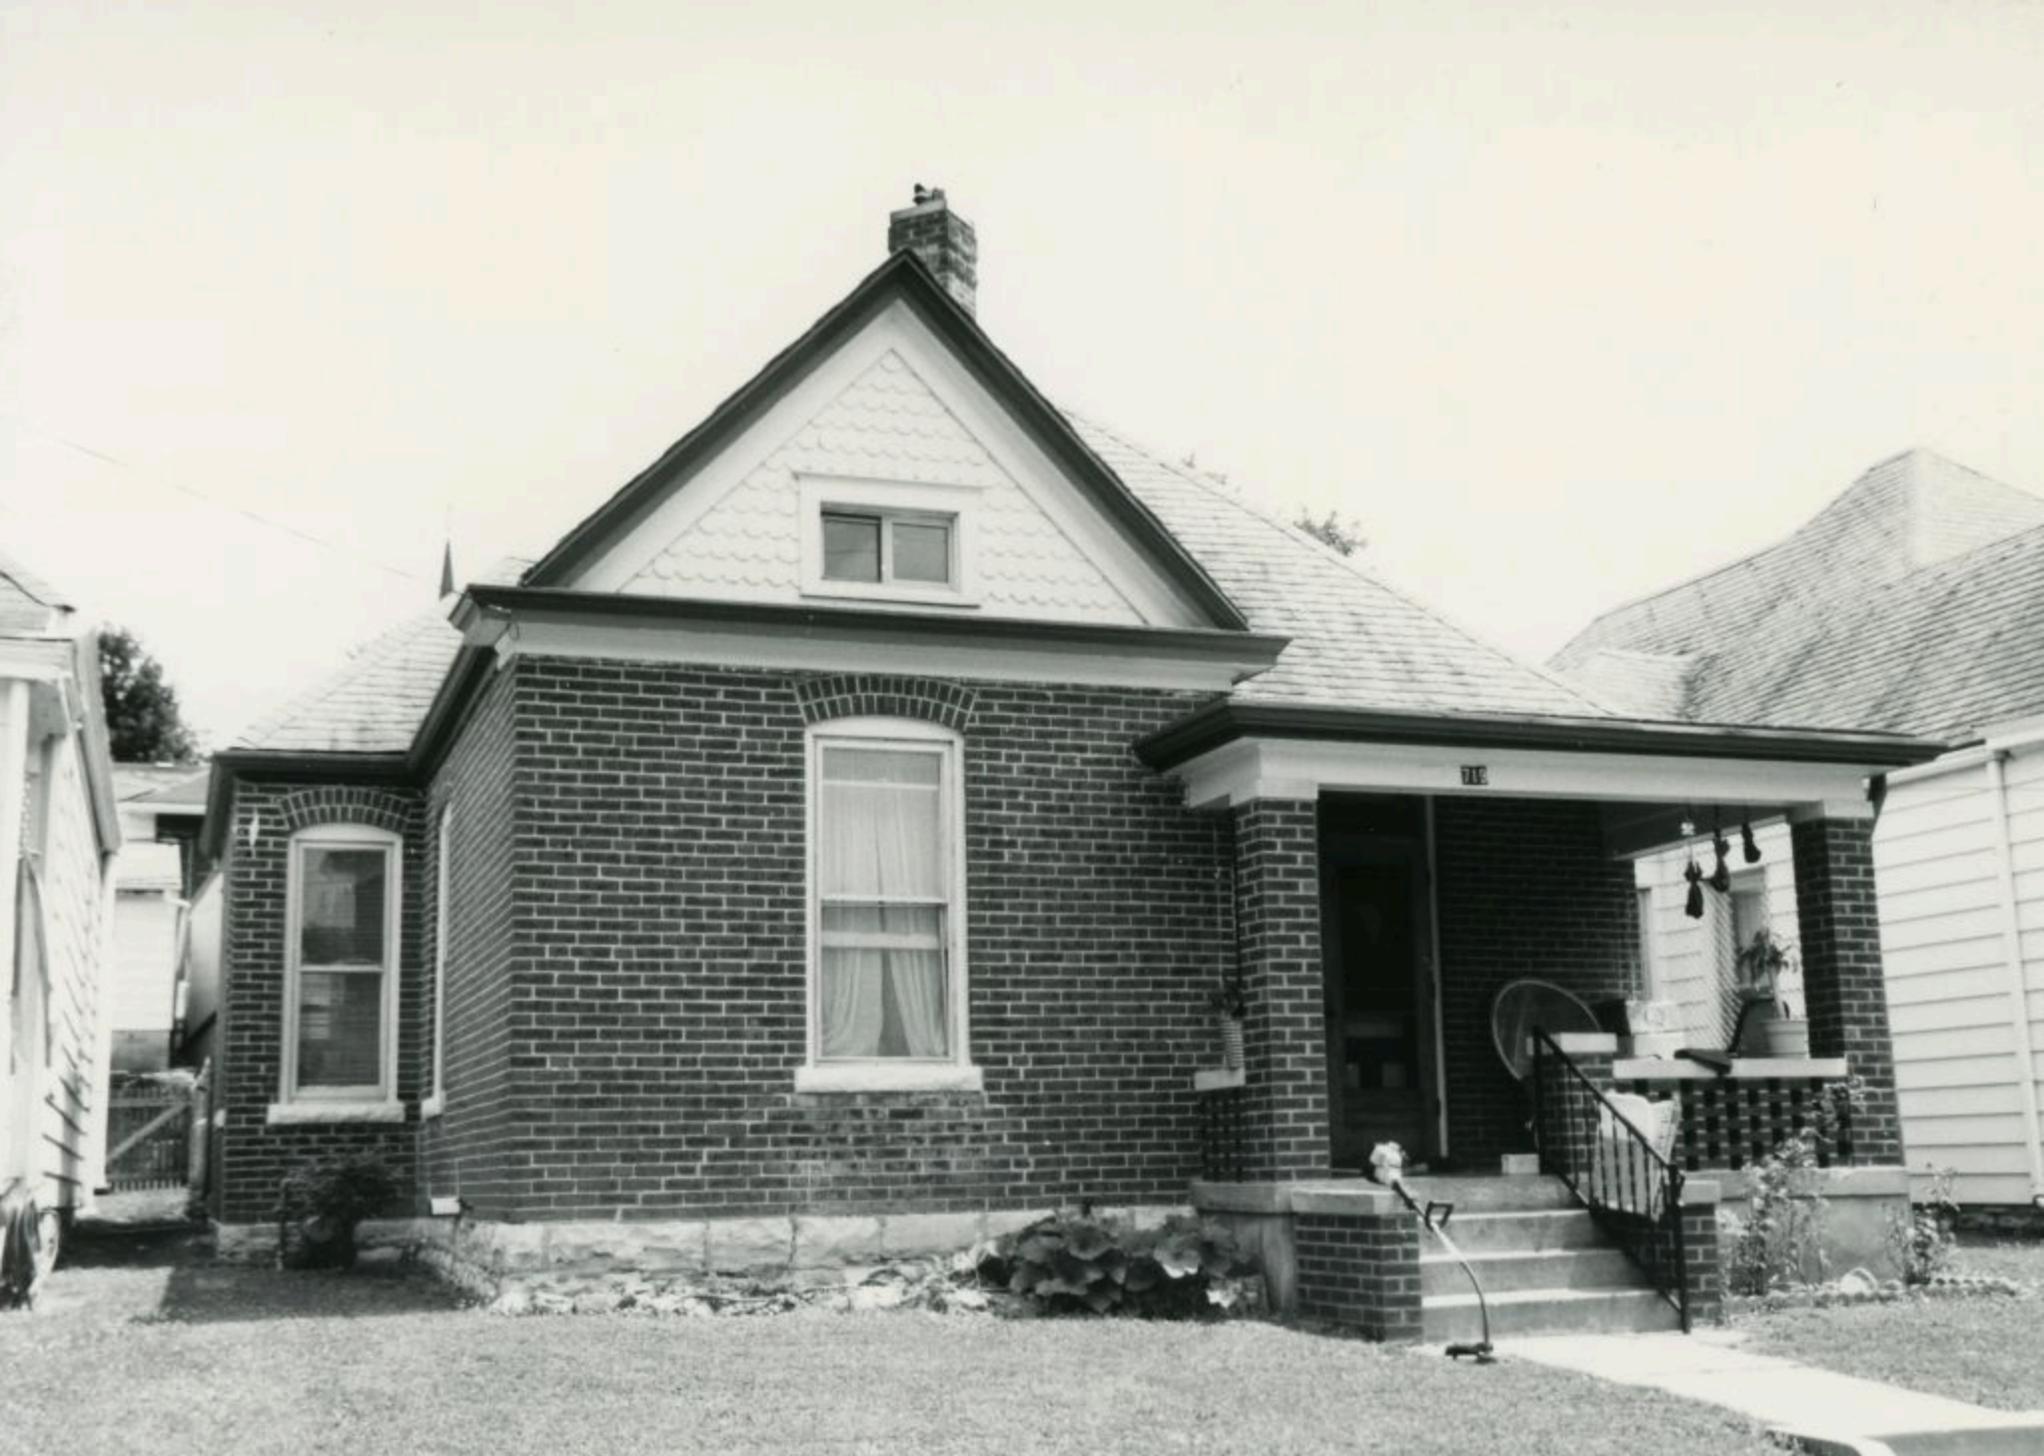
This area does not appear on the 1908 Sanborn Map. The 1923 map shows this irregular plan dwelling with no porches depicted. The south corner porches and a garage are shown on the 1939 map.

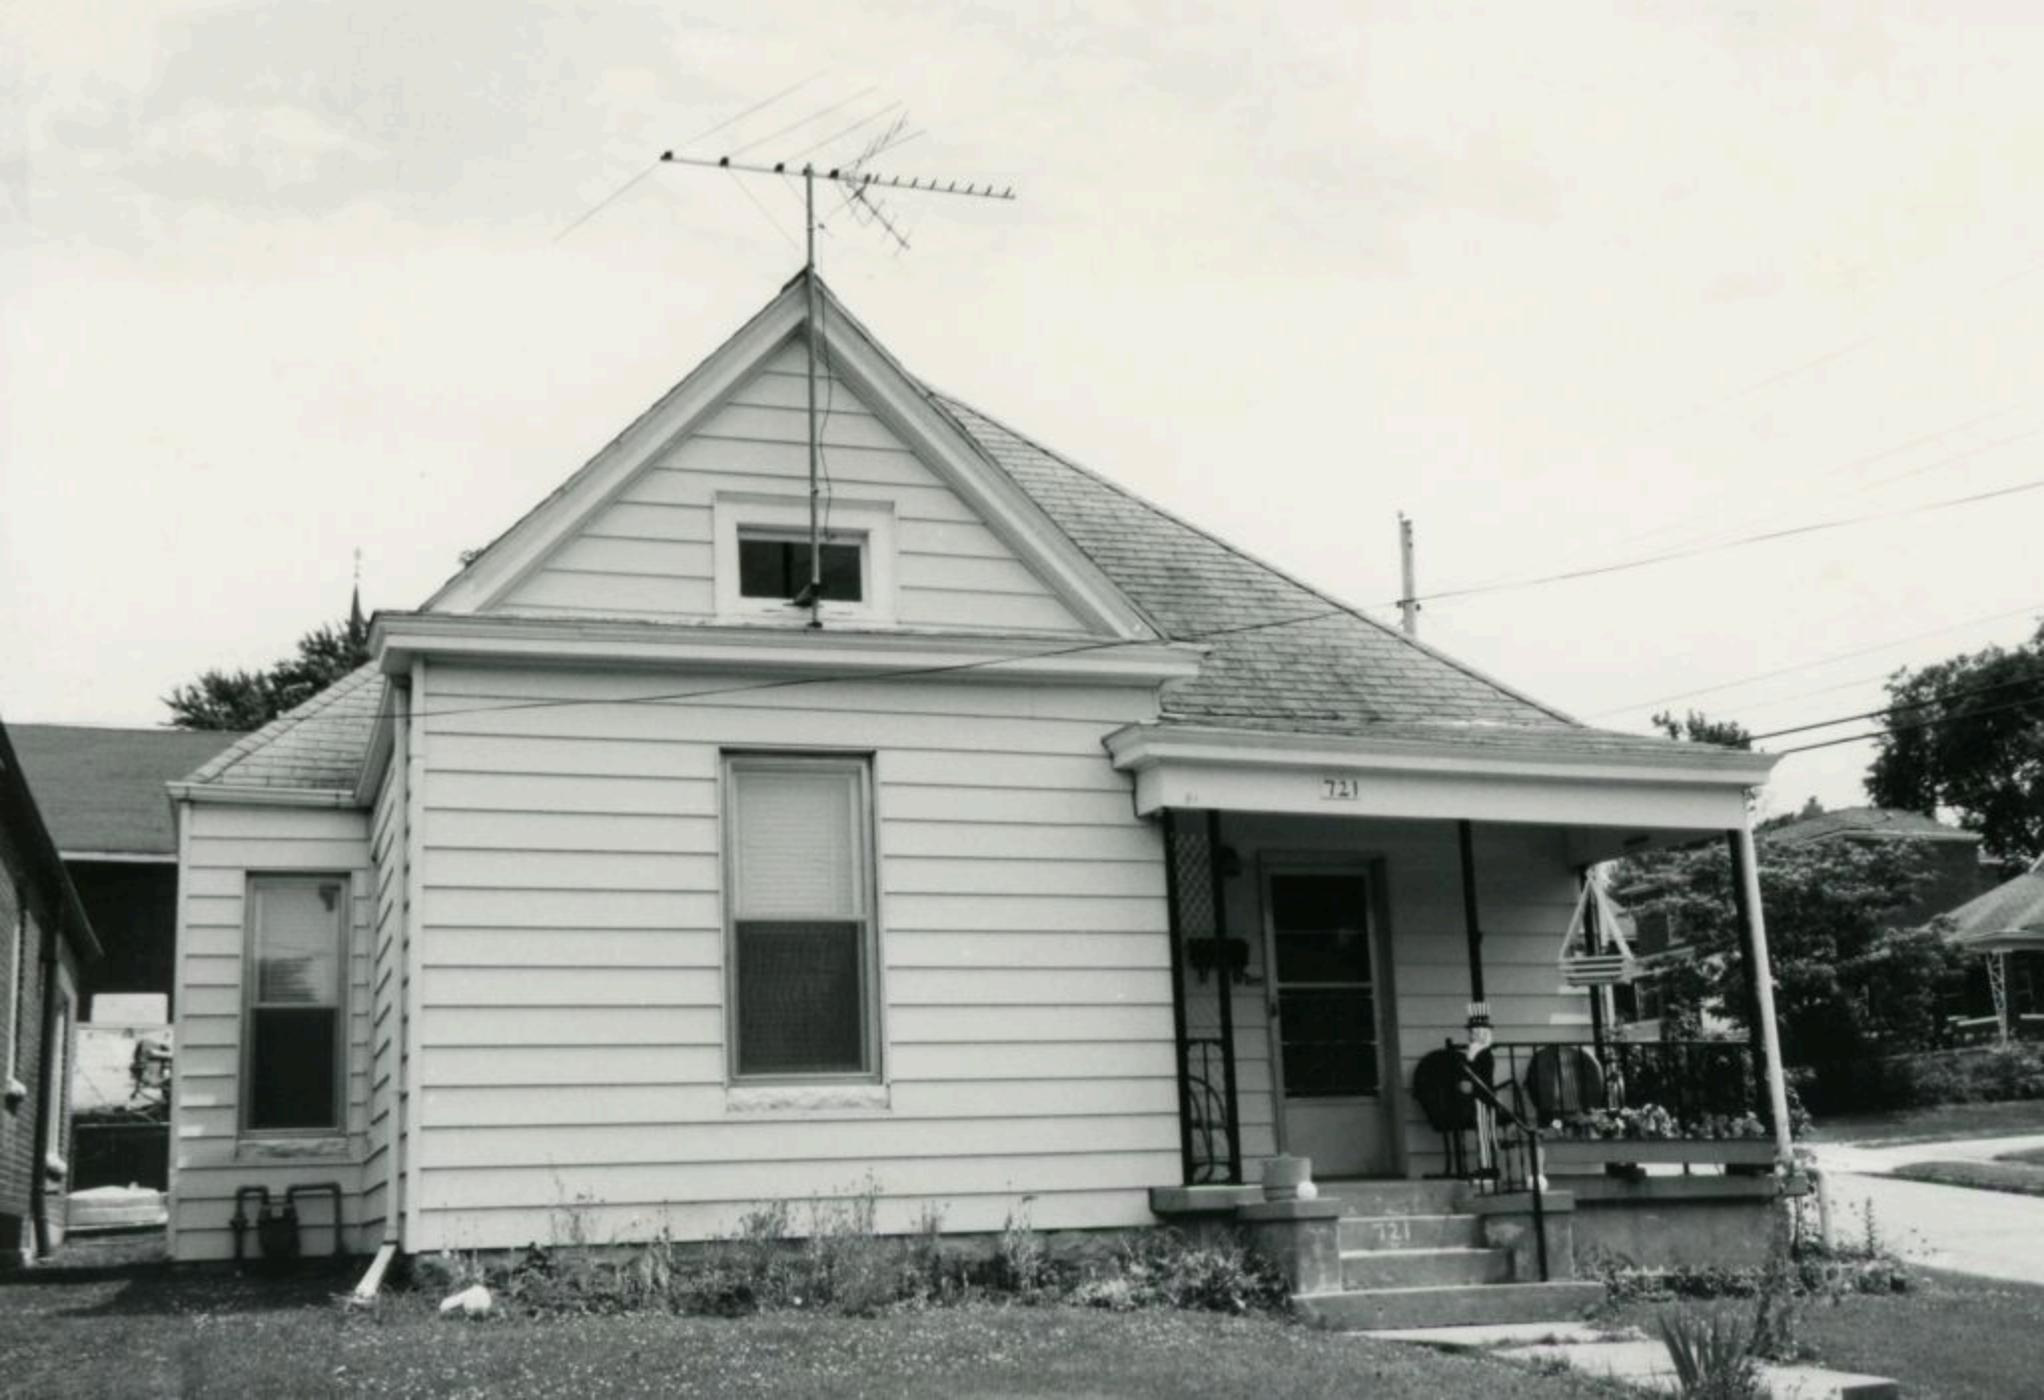
721

This area does not appear on the 1908 Sanborn Map. The 1923 map shows this irregular plan dwelling with a porch across the rear pavilion. The 1939 map shows the front and rear porches; the garage is shown on the 1939 map.

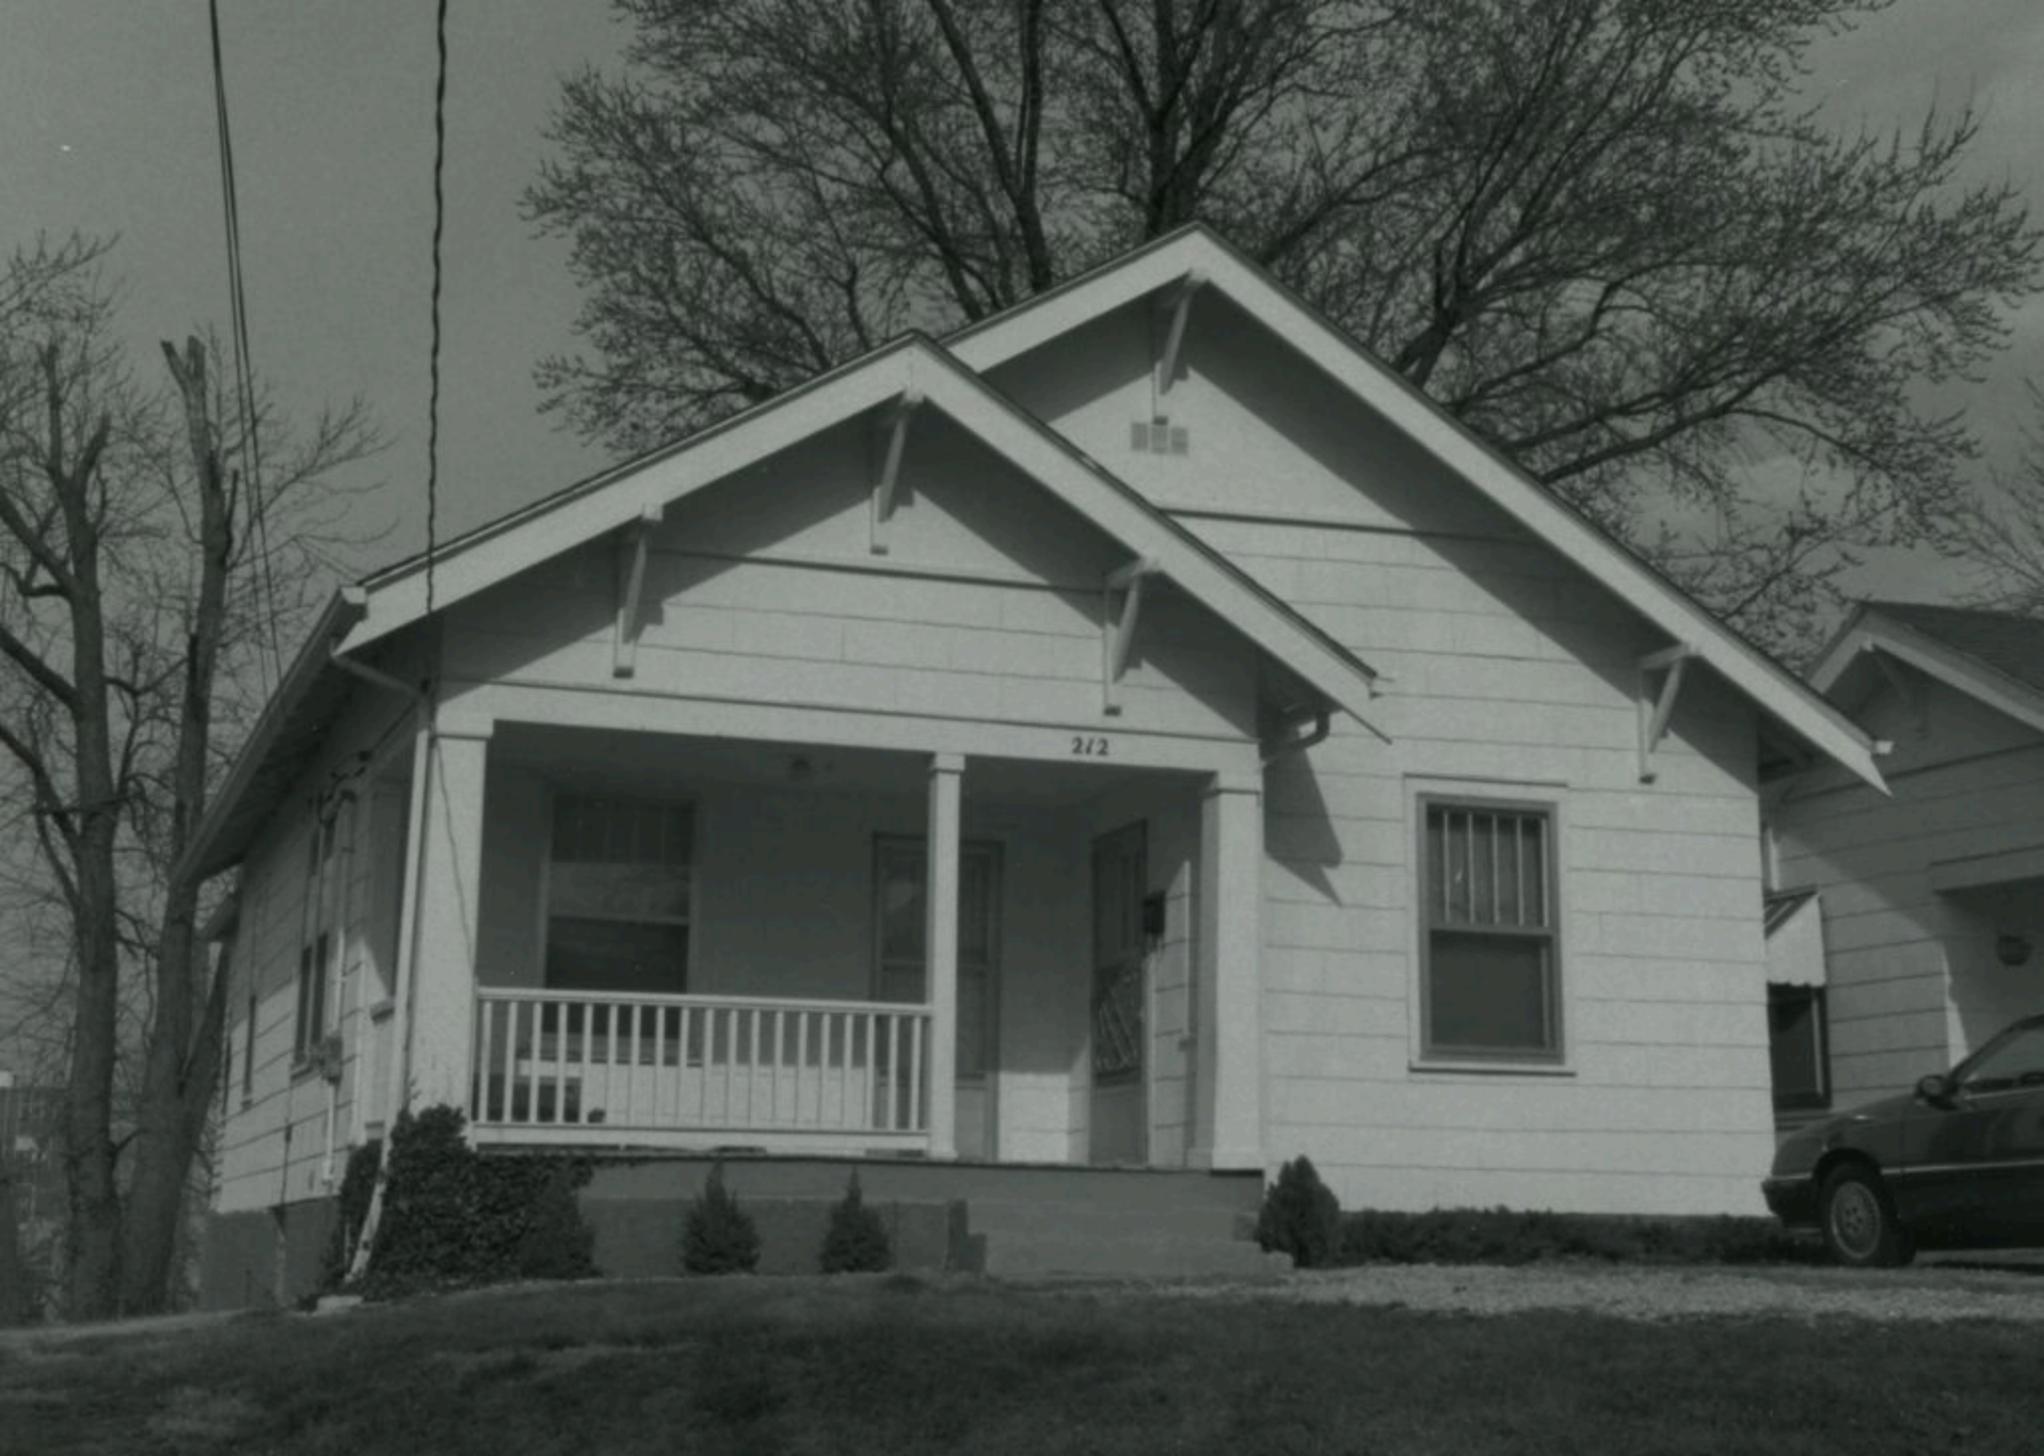
212

The 1908 Sanborn Map does not cover this area. A 1-story rectangular building with a front porch on the east half appears on the 1923 map. The current building configuration of a west side projecting porch and rear porch is shown on the 1939 map.

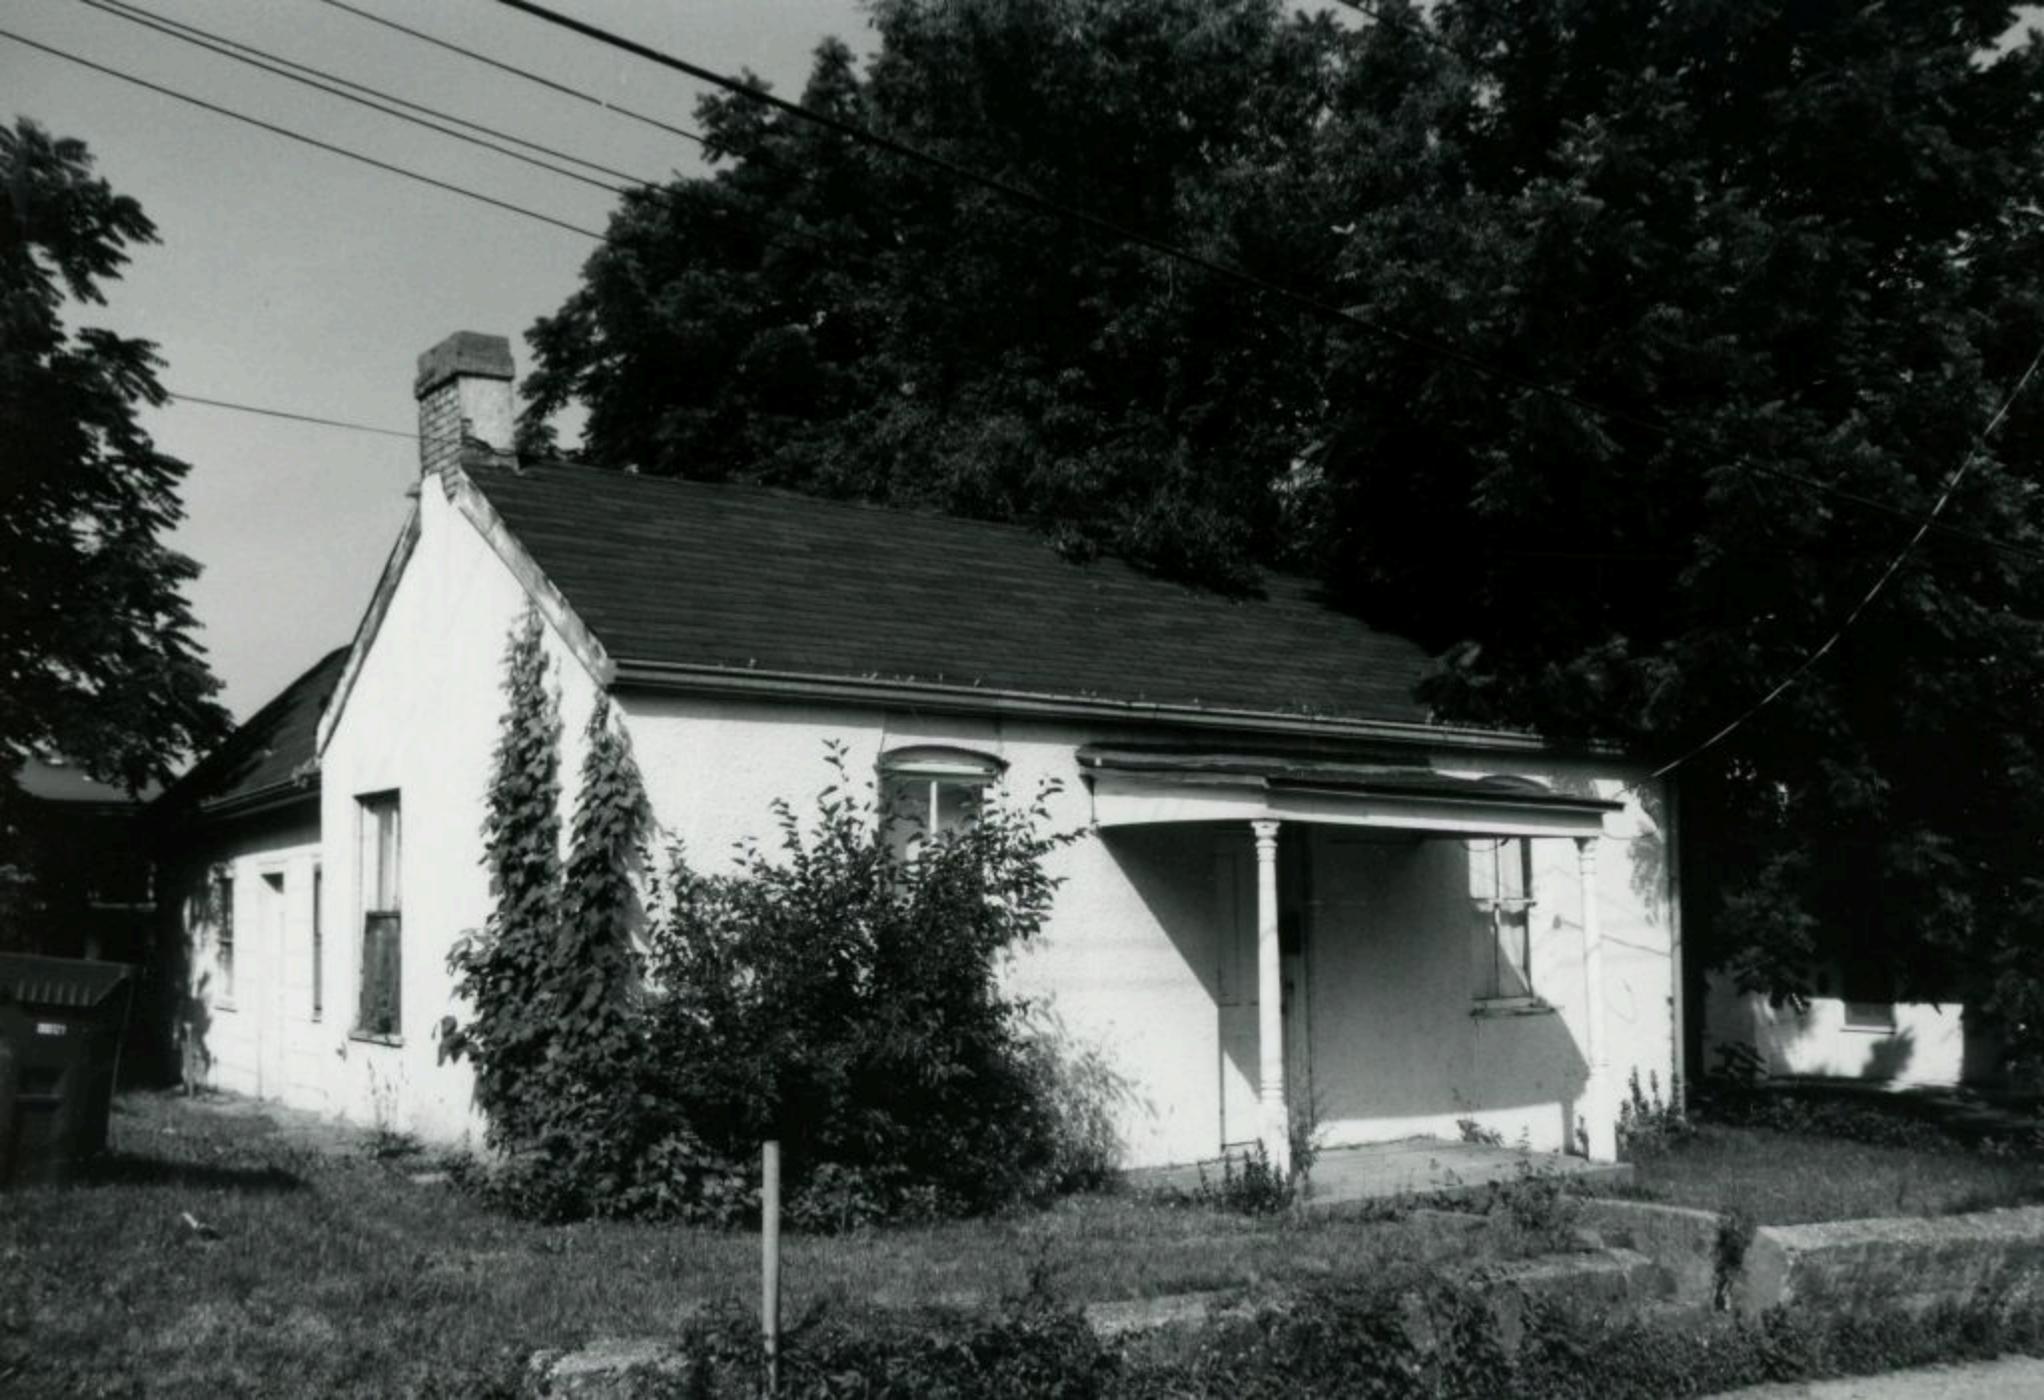
Appears on the 1923 Sanborn Map, the earliest to show this section. Cedar is not labeled; the houses are noted "on High Hill. E. Elm Street beyond." The house was shown with a rear ell and rear reentrant angle porch. The 1939 Sanborn Map labels the street Cedar Avenue; the house was unchanged.

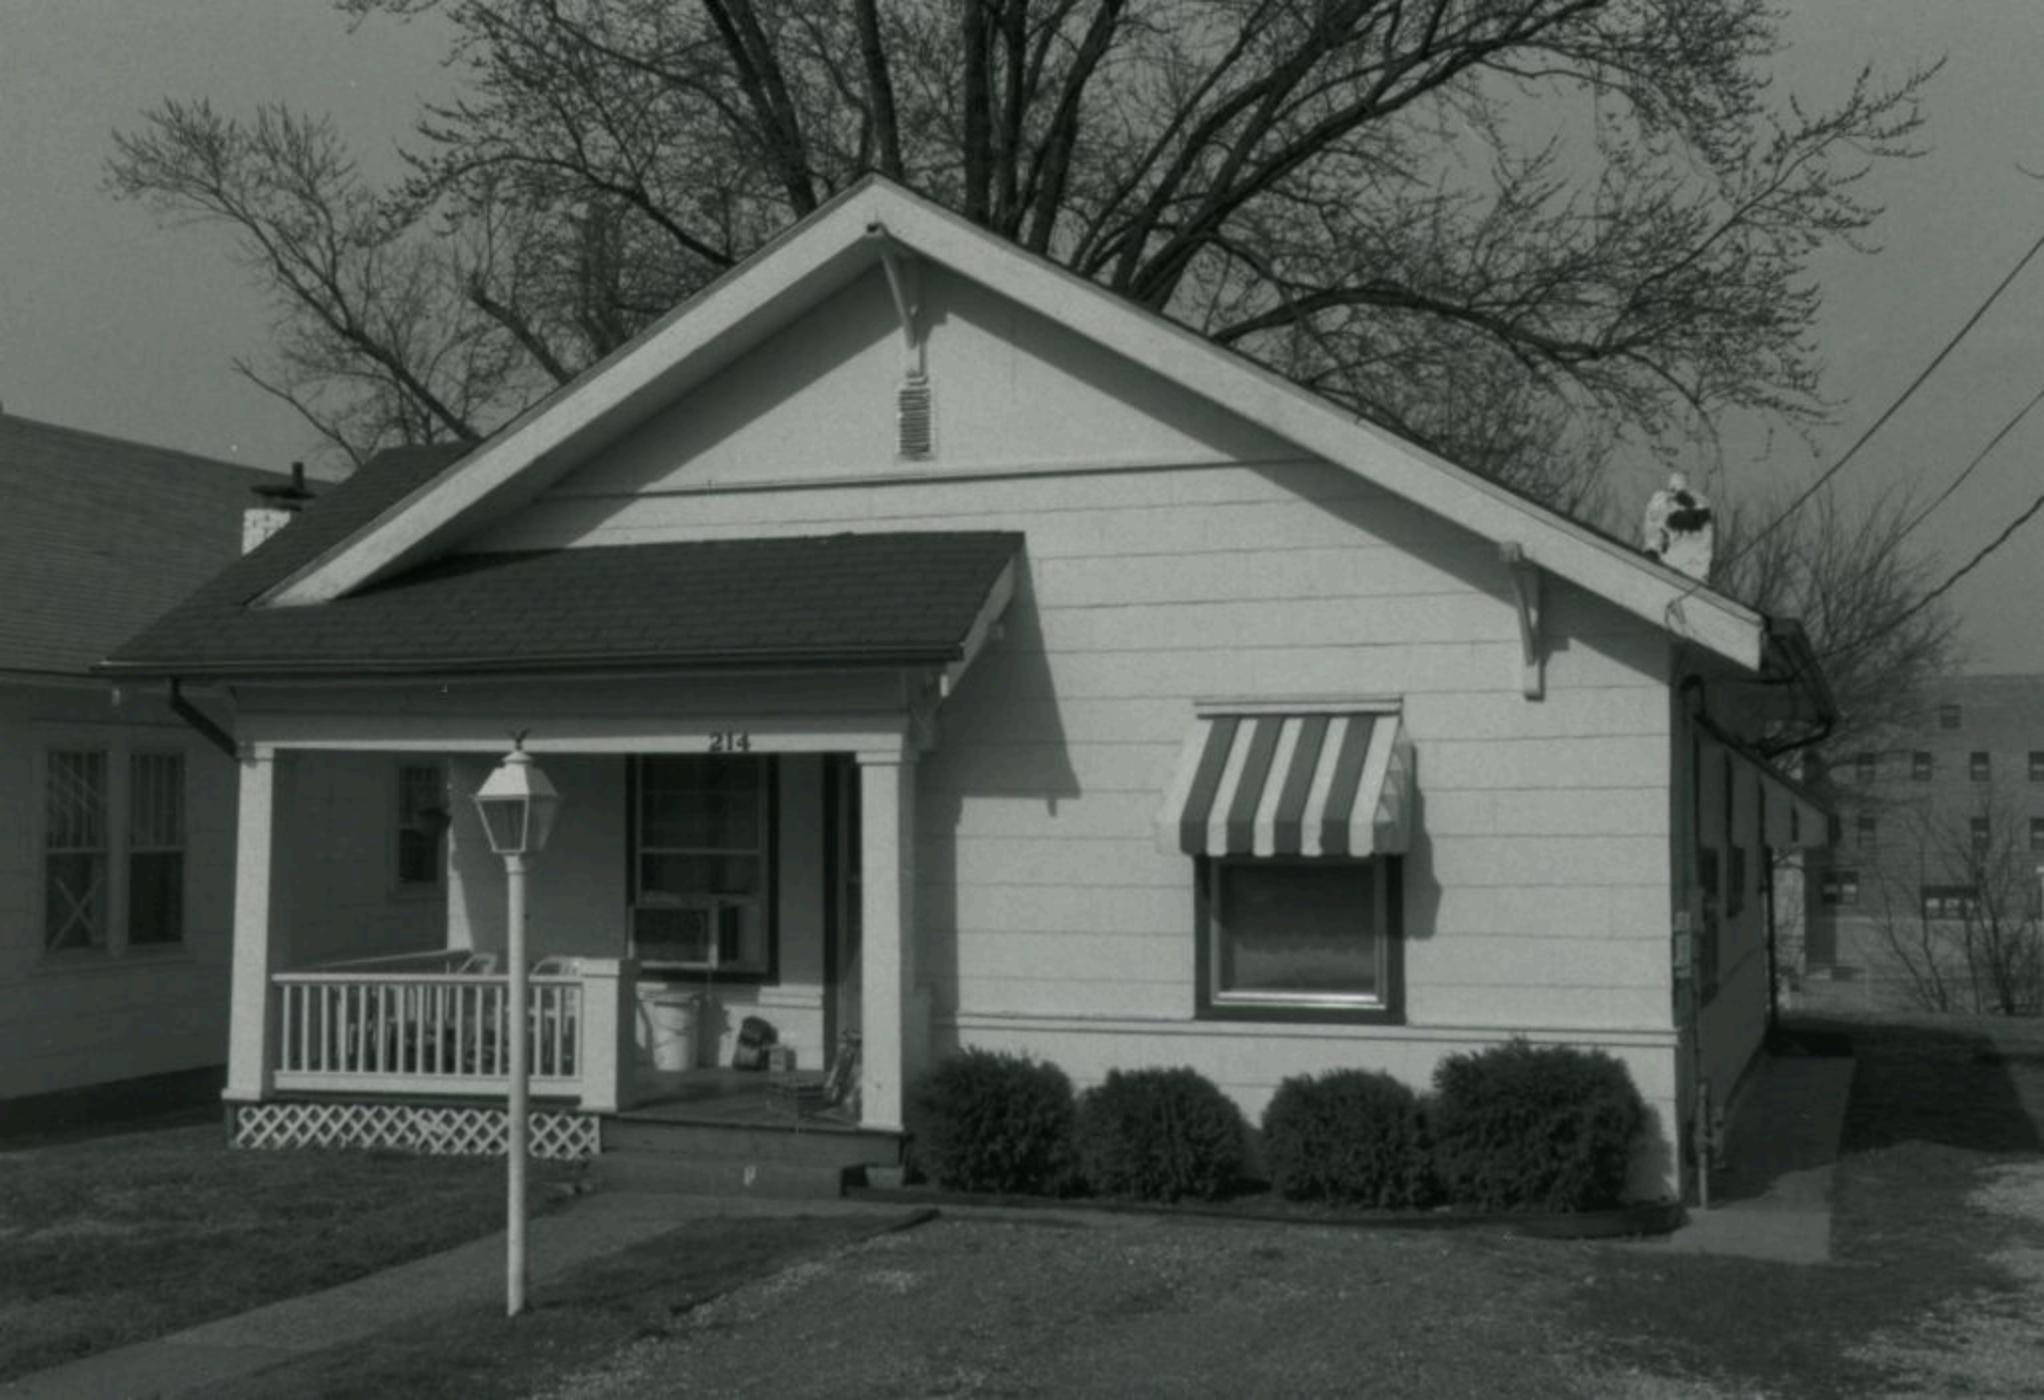
The 1908 Sanborn Map does not show this area. A frame 1-story dwelling with a full-width front porch appears on the 1923 map. The 1939 map shows the current plan with the inset west corner porch; Cedar Ave. is named.
