HISTORIC SOUTHSIDE COMMERCIAL AREA

MISSOURI HISTORIC PROPERTY INVENTORY FORM

REFERENCE NUMBER CO AS003-001		A. HISTORIC NAME					
B. COUNTY 054 Cole		C. OTHER NAME(S)					
D. ADDRESS 102 East Ashley Street			E. CITY Jefferson City		F. VICINITY <input type="checkbox"/>	G. RESTRICTED	H. ACREAGE

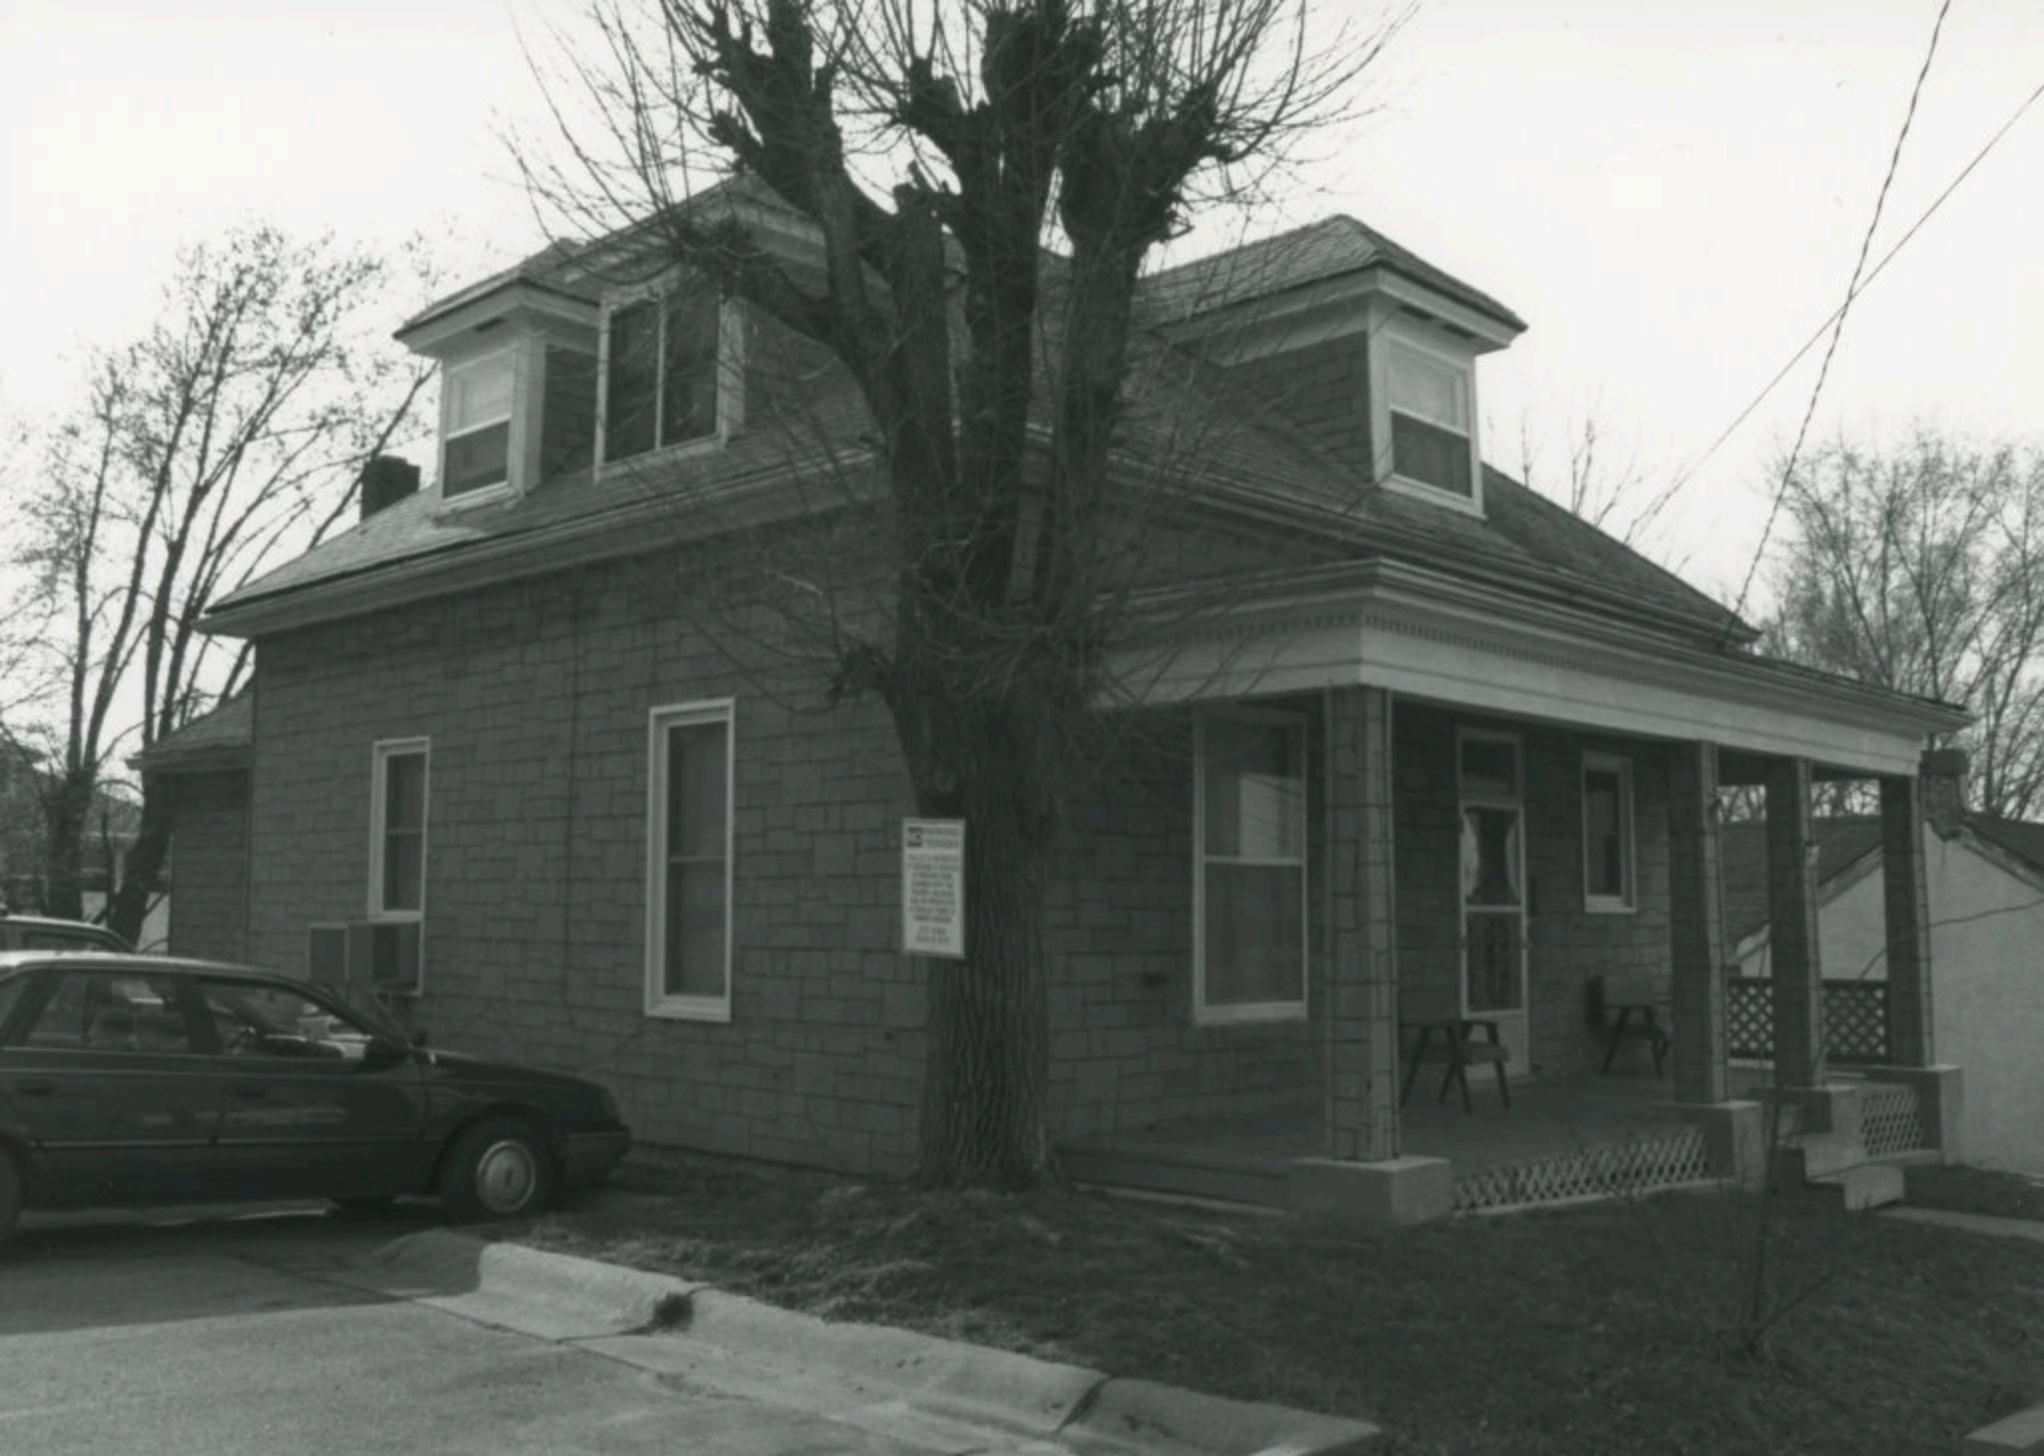
1-1/2 stories. Pyramidal cottage type. L-plan. rubble stone foundation, asphalt shingle (rock coursed) covered walls. truncated pyramidal hip (asphalt shingle) roof. full-width hip roof porch with four covered posts, modern wood deck and steps, wide wood entablature with dentils; off-center (to west) multi-light door with transom, 1/1 window to east, high 1/1 window to west; center hip roof dormer with 1/1 window. windows as 1/1 double hung. east elevation with two 1/1 windows and two hip roof dormers (single and paired 1/1 windows). west elevation with high 1/1 window to north, 1/1 to south, rear wing and exposed basement. L-plan rear with lower hip roof wing on west half with entry to west with 1/1 window and bulkhead in center, south slope chimney, exposed basement; recessed east half with entry with transom facing south.

The 1908 Sanborn Map does not cover this area. This building with a full-width porch and central rear wing appear on the 1923 map; the 1939 map is similar with a rear porch in the southwest corner.

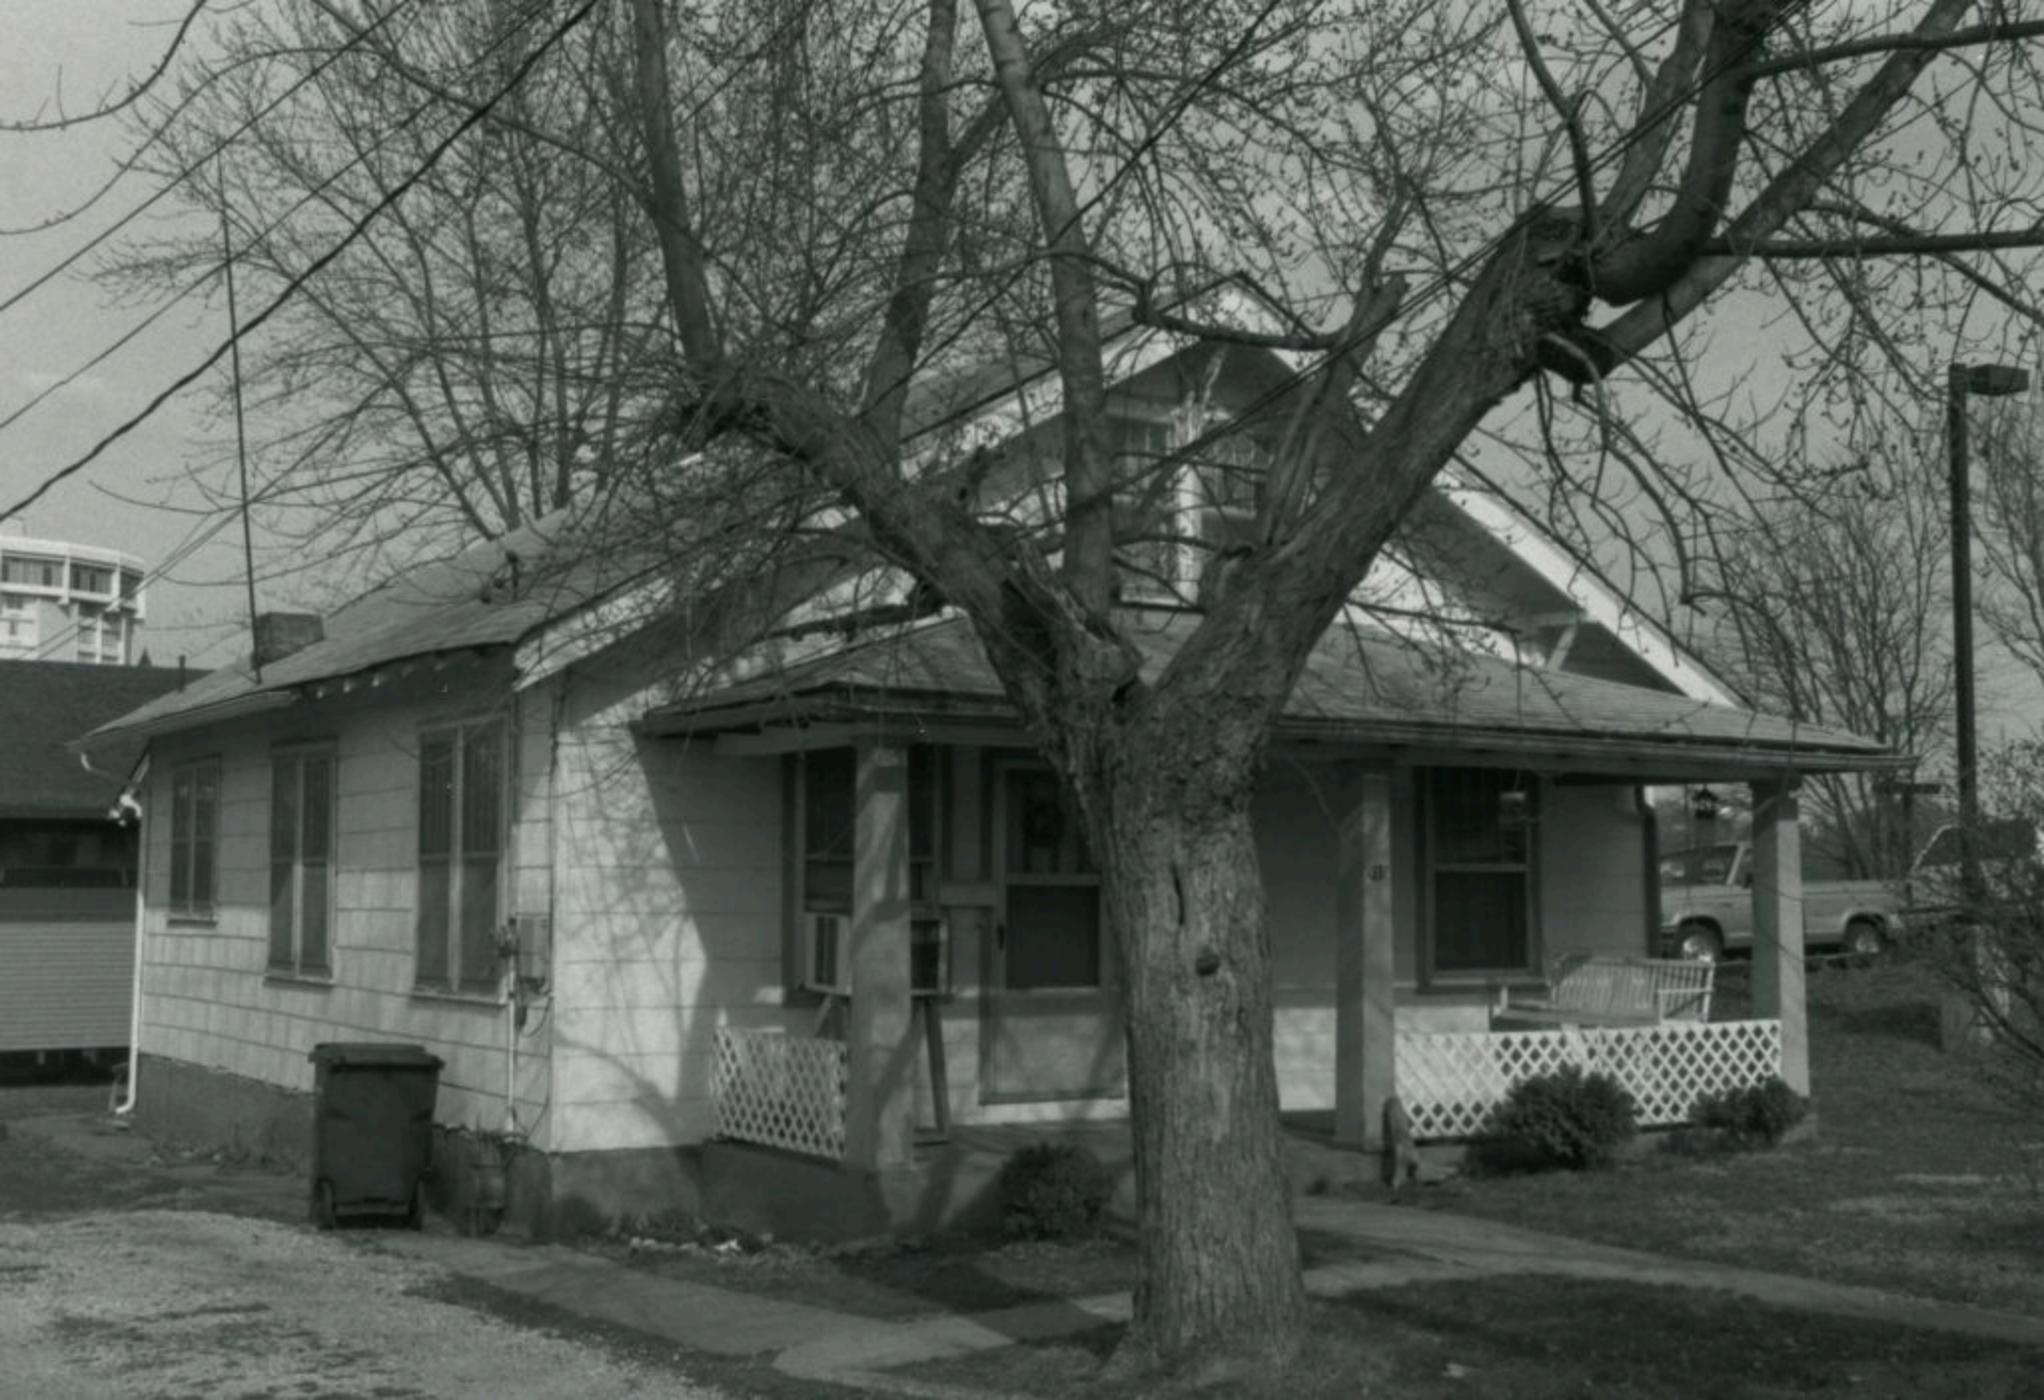
1-1/2 stories. Bungalow type. rectangular plan. concrete foundation, asbestos shingle covered walls. front gable (asphalt shingle) roof. three-quarter width hip roof porch with three tapered posts, modern lattice railing and poured concrete deck; 3-vertical light/panel door off-center (to west) with 5-vertical/1 window to west and at east end. gable with paired 4-vertical/1 windows, three braces and wide overhanging open eaves with exposed rafter tails, rake boards with notched ends. windows as 4 or 5-vertical/1 double hung. east elevation with three 4-vertical/1 windows. west elevation with 3 sets of paired 4-vertical/1 windows, truncated slope chimney. rear with shed roof porch with enclosed west half, gable window.

The 1908 Sanborn Map does not show this area. This building appears on the 1923 map as a frame, 1-story dwelling with a full front porch; the 1939 map shows the current configuration of an almost full-width front porch and rear porch.

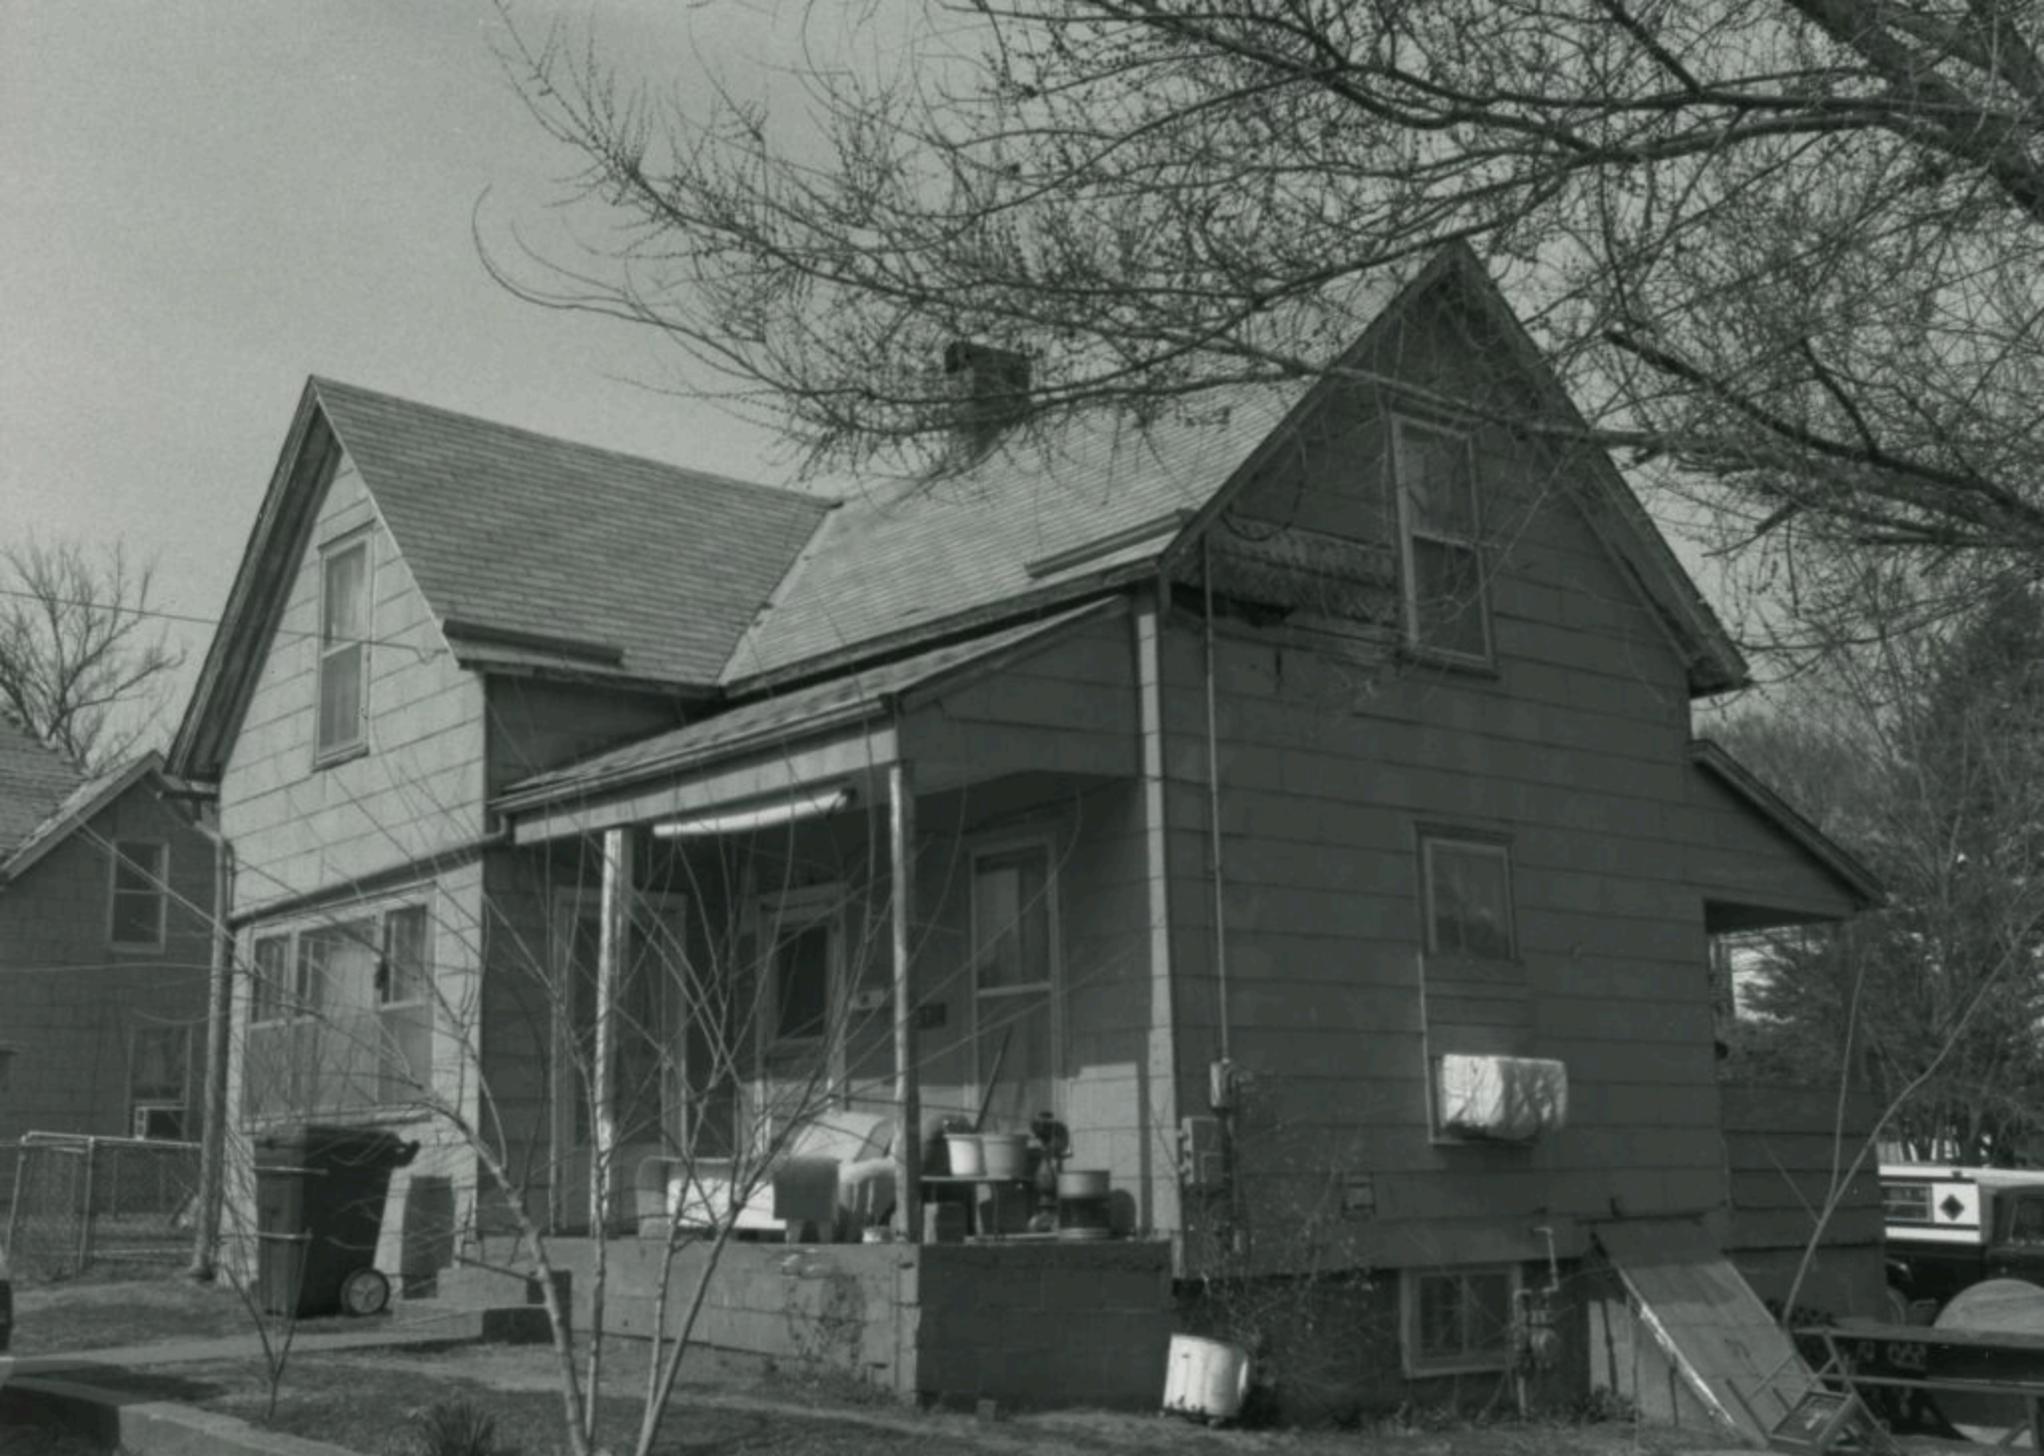
1-1/2 stories. Gabled Ell type. L-plan, 2 bay facade. Concrete parged foundation, asbestos shingled (green) over clapboard and sawn shingle walls. Second story of east elevation reveals a glimpse of extensive woodwork on the including diamond patterned wood shingle course with sawn shingle above. Gable (asphalt shingle) roof. L-plan facade with left/west gable roof projecting pavilion with c. 1935 Chicago-style window (3-vertical/1 side windows), 2/2 in gable, narrow overhanging boxed eaves. Re-entrant left/east bay with shed roof (half) porch with two wood turned posts, poured concrete deck on concrete block foundation; corner entry doors face east and south, 2/2 to east, ridge chimney. Windows as 2/2 double hung. East elevation with center 2/2 on 1st-story and in gable, cellar bulkhead to north, decorative shingles partially exposed in gable. Open rear shed roof porch at east end of rear.

Appears on the 1908 Sanborn Map, the first to show this area. Reentrant angle porch and small rear porch. Shared lot with 606 Washington. Noted as 207 rear on the 1923 Sanborn Map, using an Elm Street address. Lot subdivided from 606 Washington, but then placed with 207 Elm. The same is shown on the 1939 Sanborn Map.

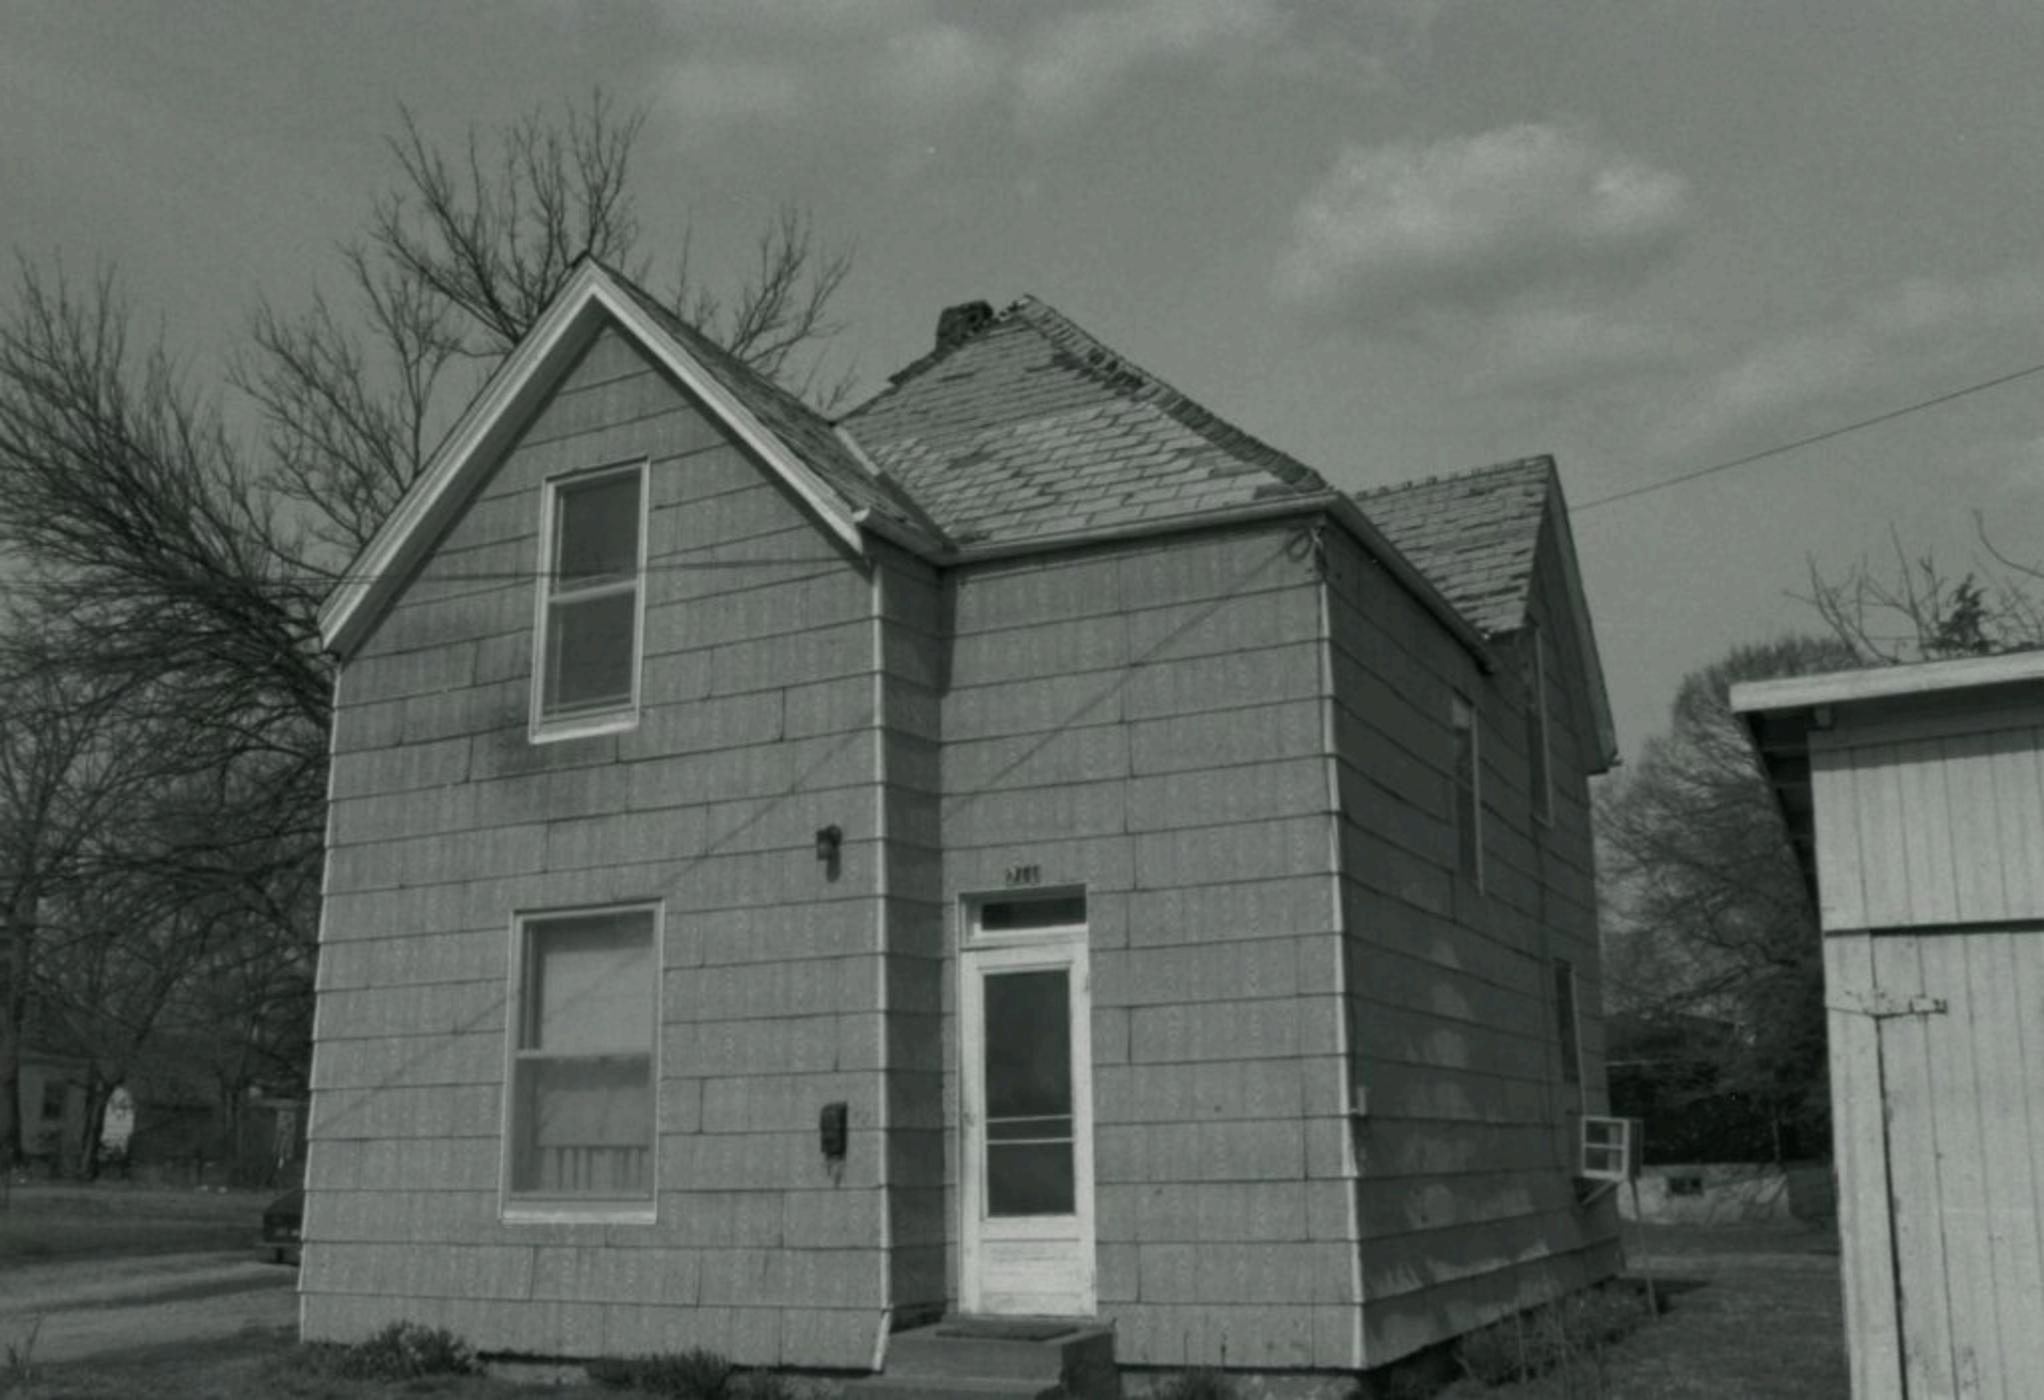
2 stories. no style or type. irregular plan, 2 bay asymmetrical, slight L-plan facade. concrete foundation, asphalt shingle covered walls. center hip with lower cross gables (asphalt shingle) roof. west bay as shallow projecting gable roof pavilion 1/1 window per story, molded rake boards; east bay with 1-light historic entry with narrow 1-light transom in re-entrant corner; concrete step/stoop. windows as 1/1 double hung. east elevation with wall gable to rear, 1/1 window in gable and directly below, 1/1 on 2nd-story to south. west elevation with projecting gable roof pavilion to rear, shed roof dormer to south on facade pavilion with slope chimney behind. rear with 1-story shed roof wing on west half.

This building appears in its current configuration on the 1908 Sanborn Map. The 1923 & 1939 maps are similar.

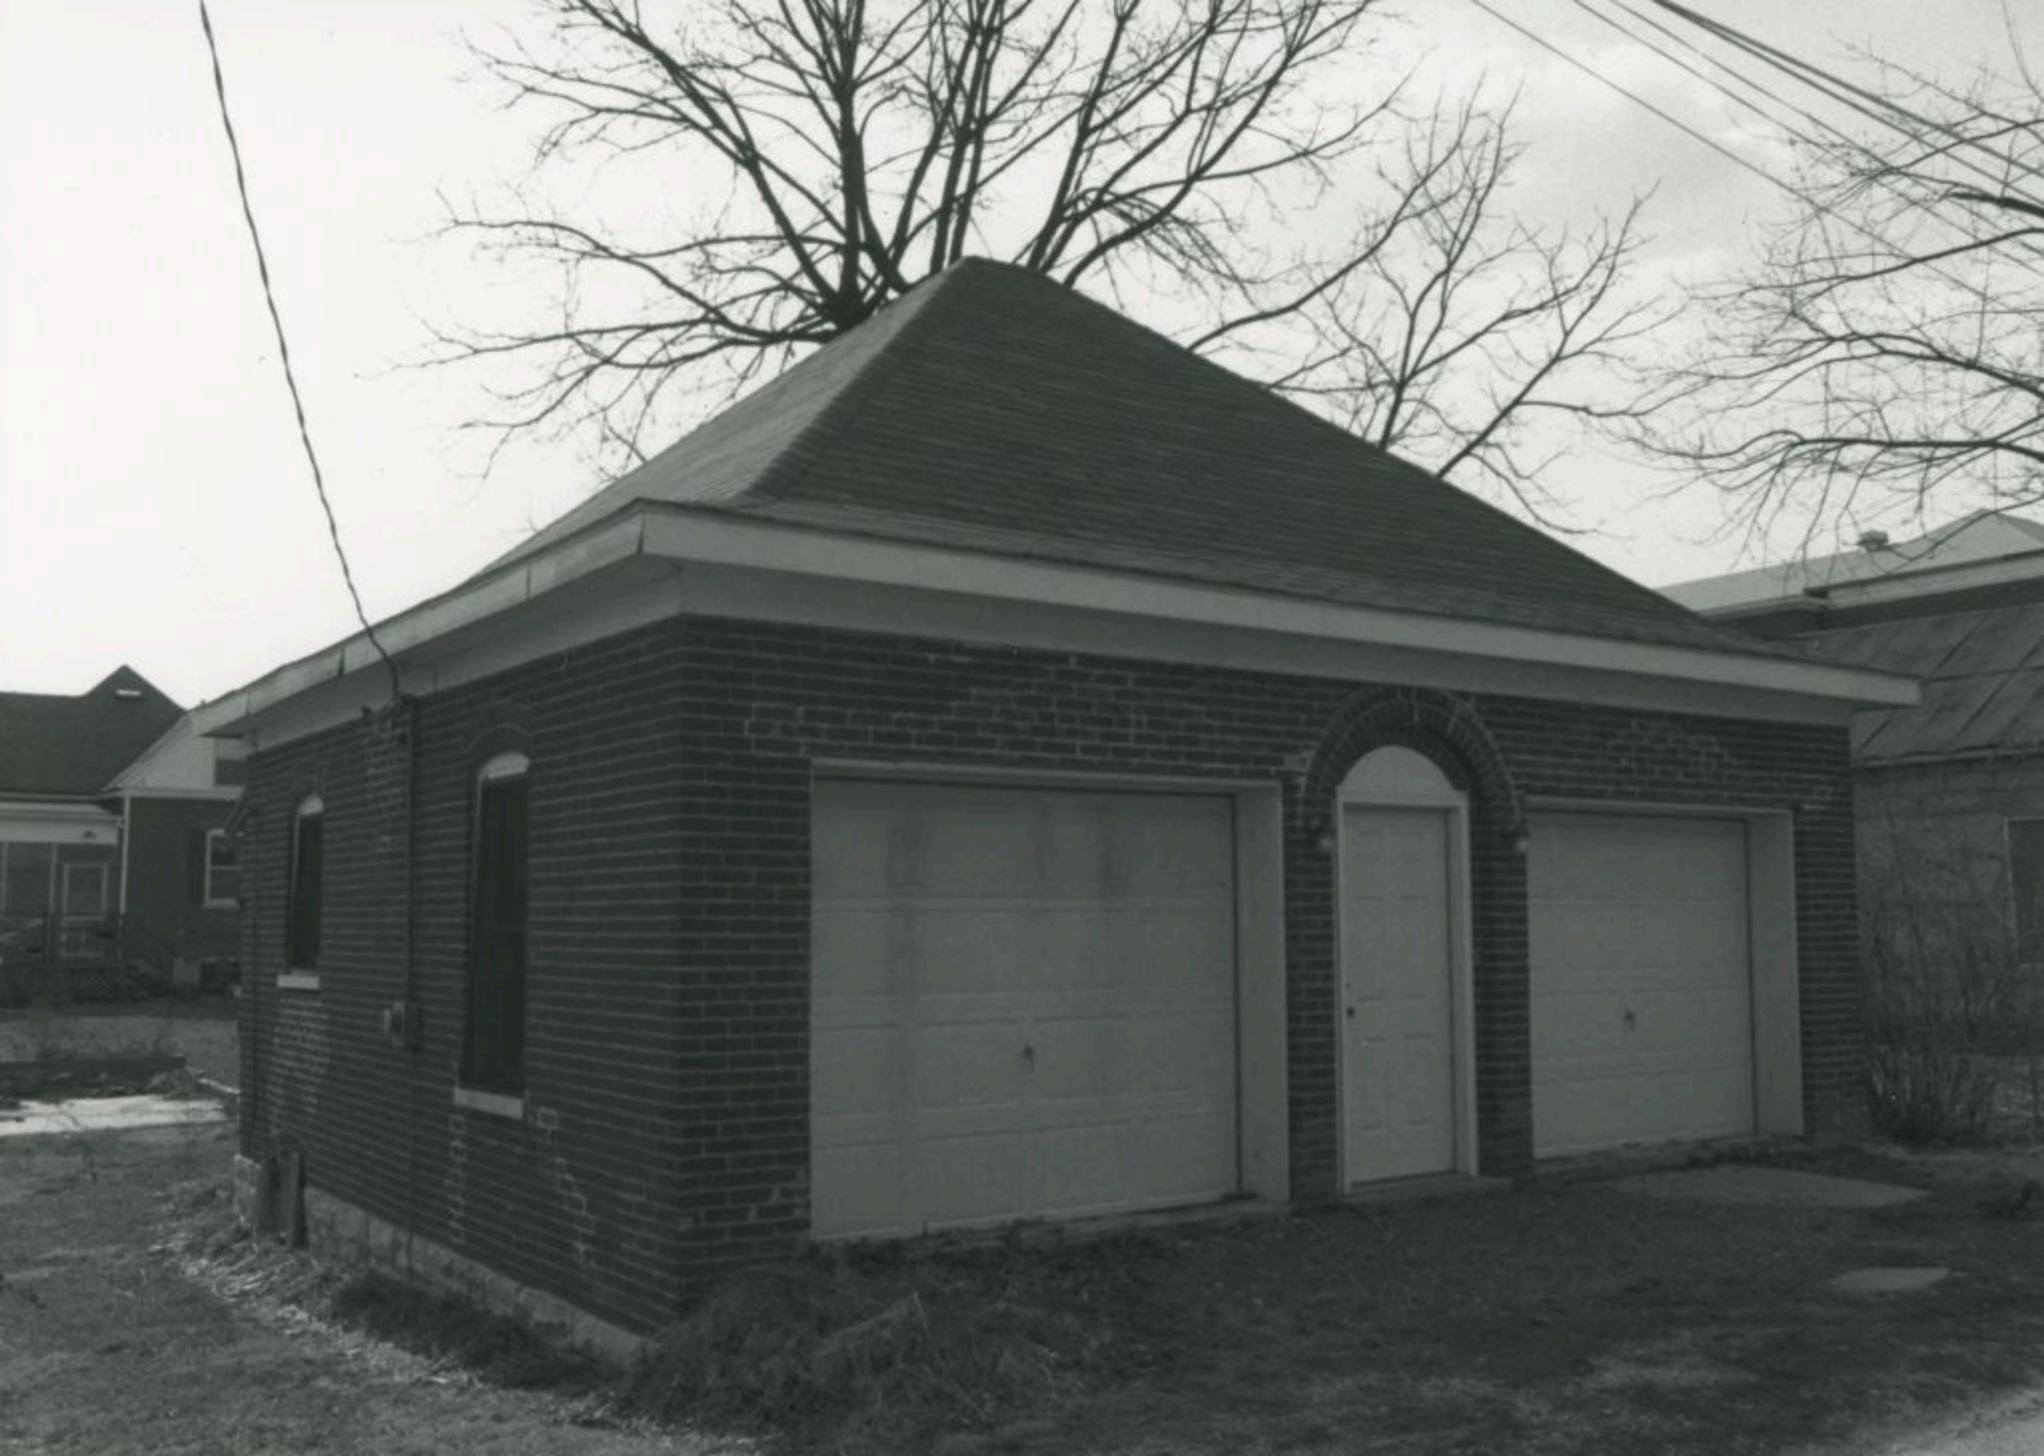
1 story. Pyramid Square Cottage vernacular type converted into garage. Square plan. Limestone foundation; brick walls (unpainted). Pyramidal belcast hip (asphalt shingle) roof. Two overhead (modern) garage doors flank a central modern pedestrian door which appears to be in a historic door or fenestration opening with a single rowlock brick arch inset from a double rowlock segmental brick arch. Double rowlock side (east/west) windows with stone lug sills. Two bays east with a shorter window south. Shed roof single bay wing toward house/south c. 1930 or earlier; Insul-brick siding and modern replacement windows.

Shown as 220 Cedar Street at the rear of 218 West Dunklin Street on the 1908 Sanborn Map, the first to show this section. One story central porches on the north and south. Still a dwelling on the 1939 Sanborn Map with 218-1/2 address. One story large garage mid-lot for West Dunklin-facing house; access not clear on this narrow lot.

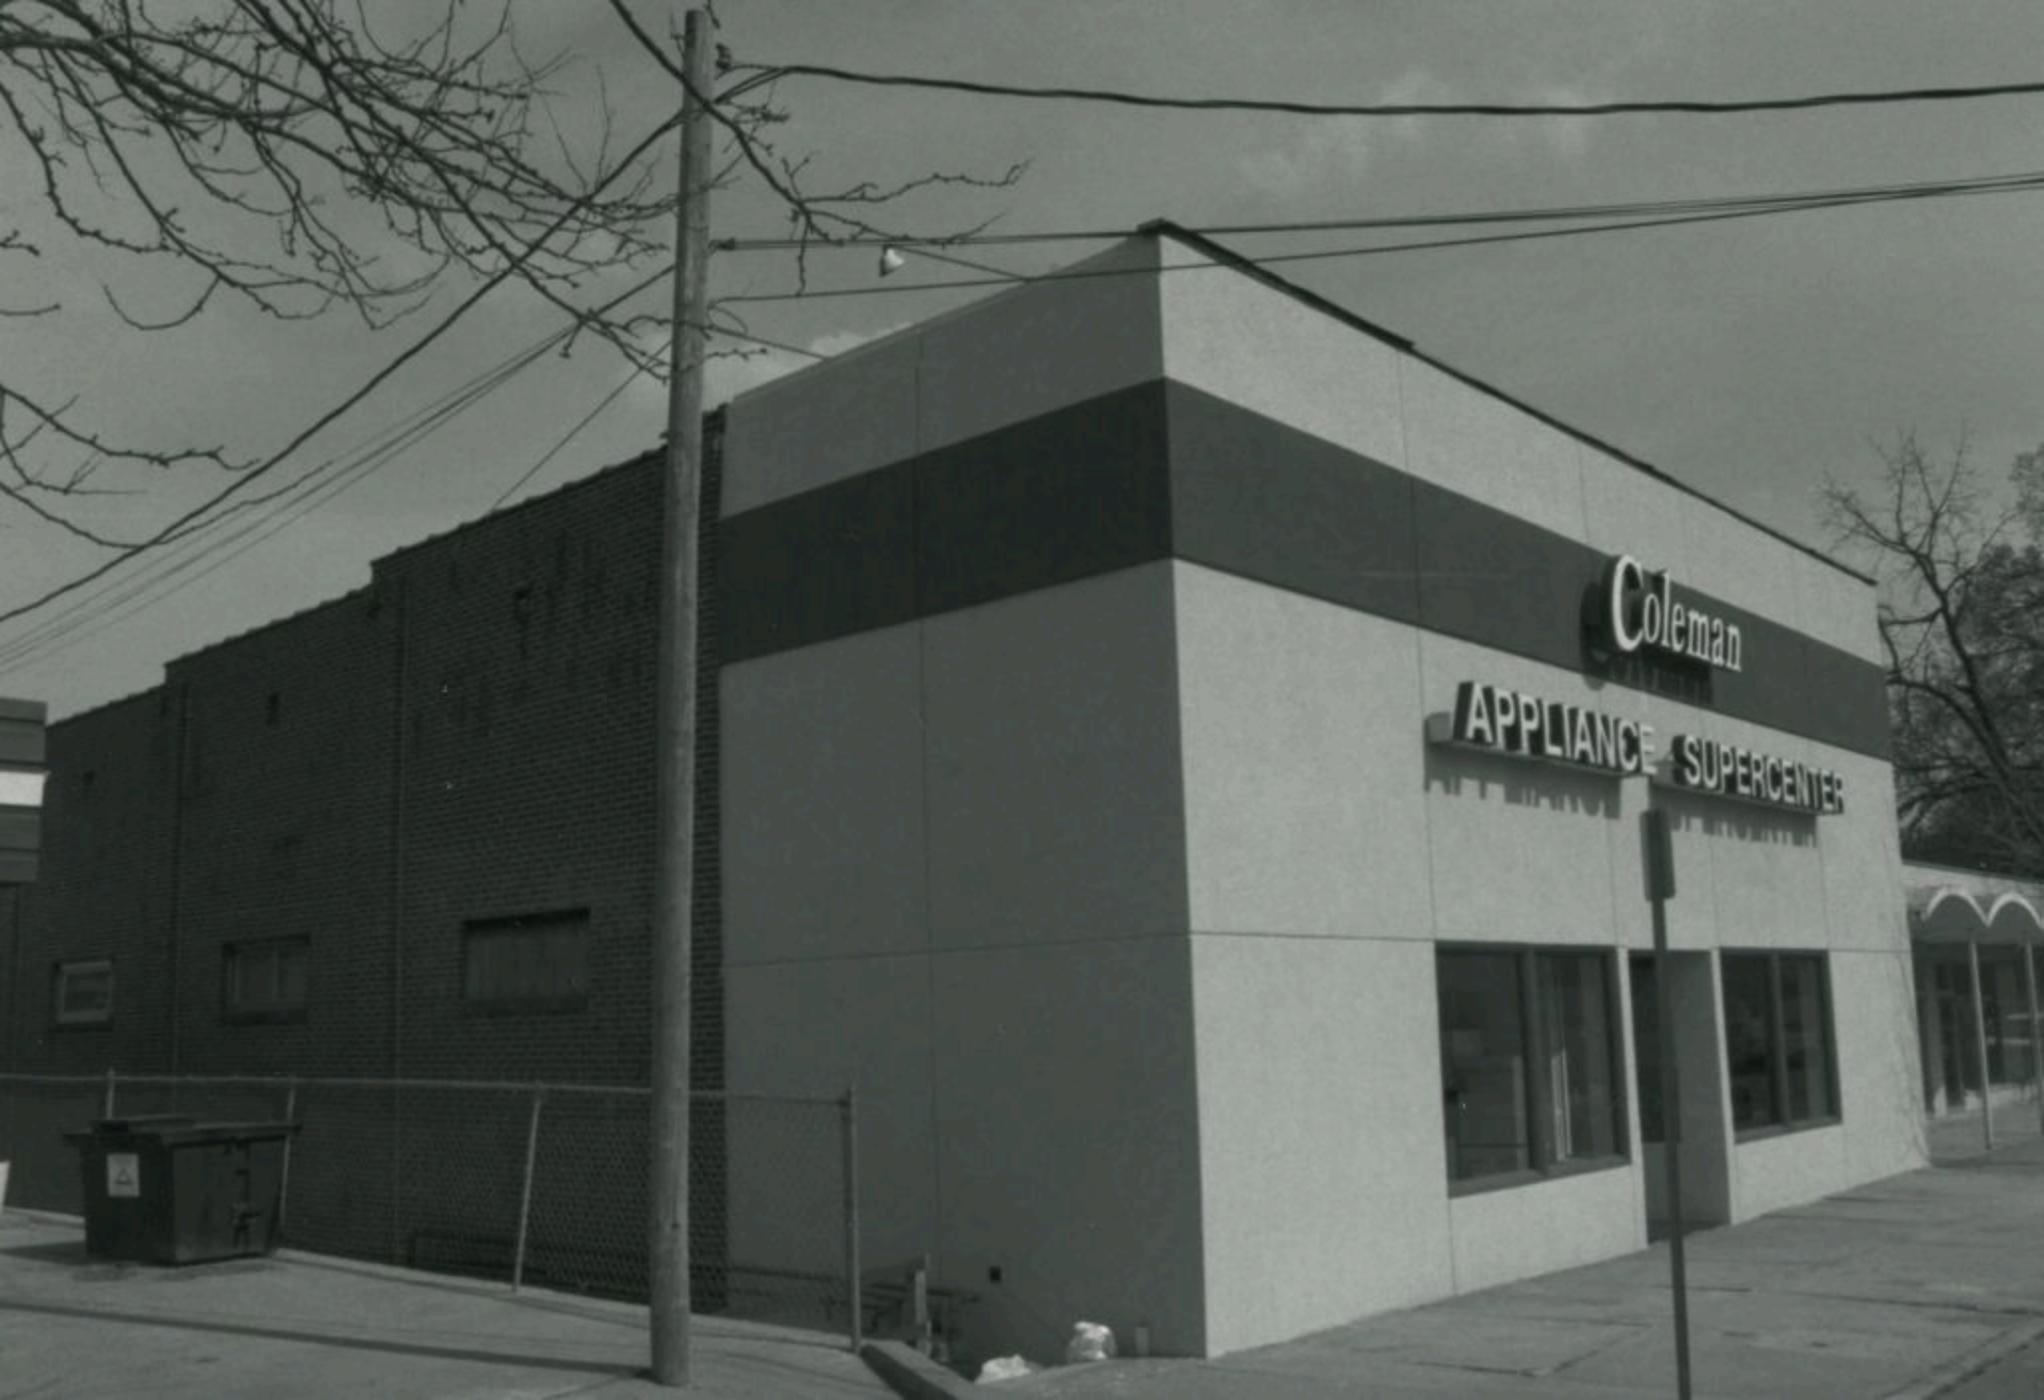
1 story. no commercial style or type. rectangular plan, 5 bay symmetrical facade. stone foundation. simulated stucco and brick (5 course Flemish header) walls. shed roof. simulated stucco paneled facade with deeply recessed center aluminum frame door, raised flanking paired 1-light modern display windows, end bays as blind stucco panels; contrasting colored simulated stucco strip below "parapet." brick west elevation with exposed stepped basement, seven bays divided by brick piers, simulated stucco returns one bay; single rectangular window openings in second through fifth bays, single pedestrian entry to south at basement level, 1/1 with double rowlock segmental arch opening in north end bay, tile coping; sidewalk along elevation. east elevation attached to 117 East Dunklin Street. brick 2-story rear elevation with concrete over stone foundation, center loading dock door in basement with flanking boarded openings with double rowlock segmental arch openings; 1st-story with oversized modern wood deck with exterior stairs, four windows and entry to east.

A dwelling is located in this area on the 1908 Sanborn Map. The 1923 maps shows a long rectangular building with three storefronts and a large vacant rear section. The 1939 map labels this building as a garage; the storefronts are gone.

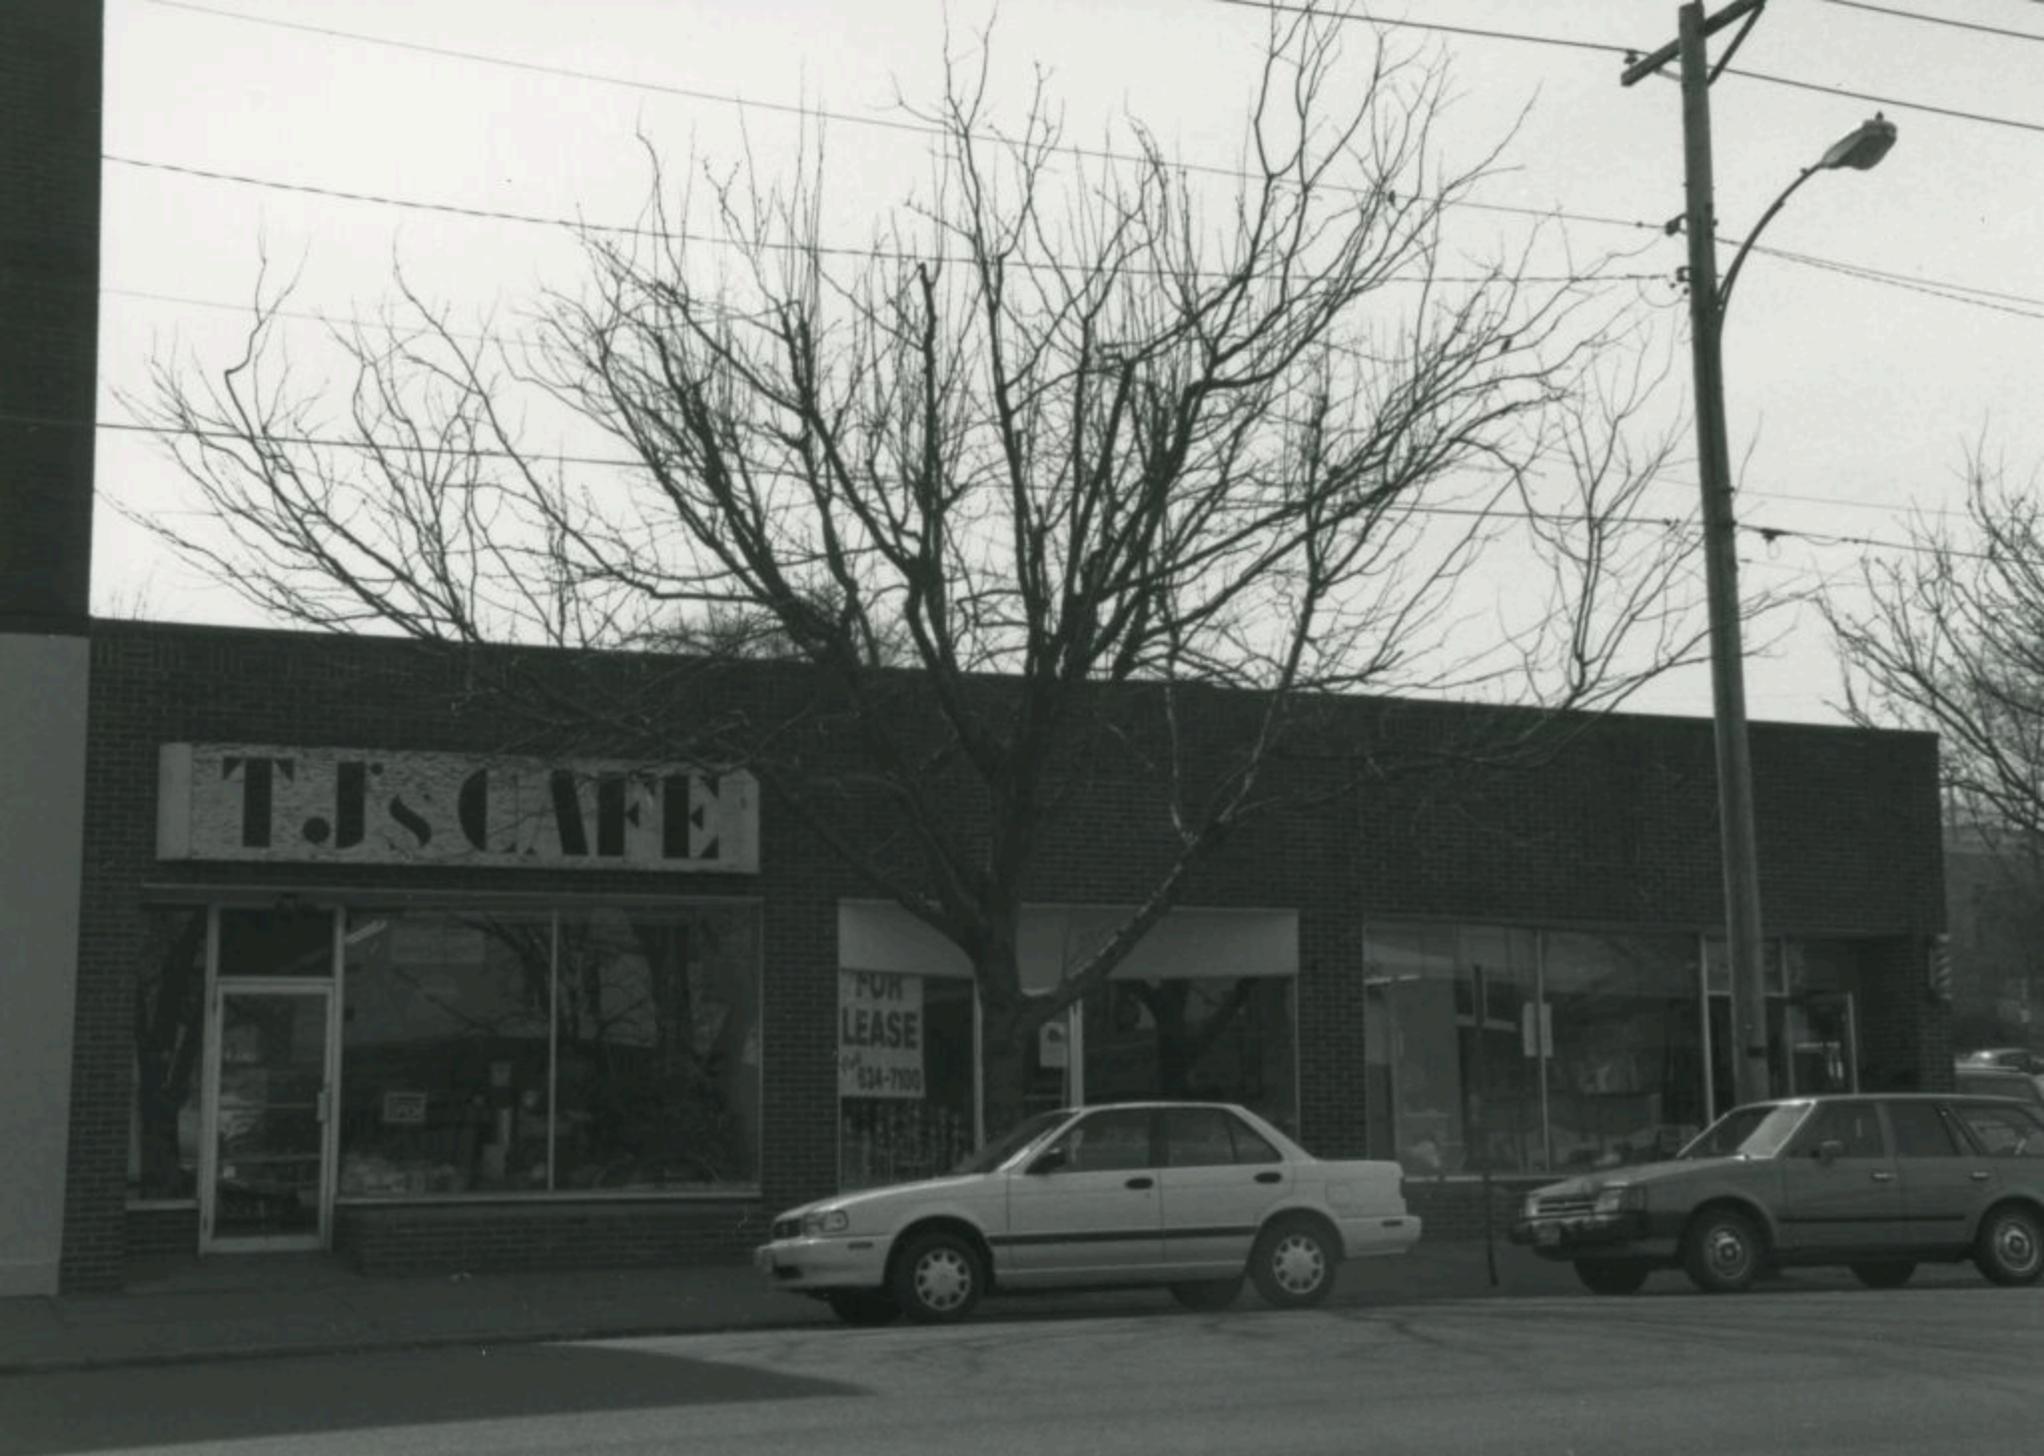
One story. No style or type. Three storefront mid-nineteenth century commercial building, altered c. 1950. Rectangular plan. Foundation not visible; brick walls with mottled color brick facade scattered into the west side elevation's smooth brick about four stretchers deep. Shed (composition) asphalt roof; some tile coping. Central storefront with center door and blocked transom flanked by single large scale angled storefront sash. End bay storefronts mirror images, with narrower tall fixed sash, door and transom recessed on the end, and two large scale storefront sash toward the central storefront, angled with brick planters at the bulkhead. Brick parapet with minimal decoration including brickwork at parapet top (altering three course stretcher and soldier brick). Left/east storefront with sign panel attached. Rear modern concrete block section (with tavern) doubles the size of the building. East elevation common/attached to 120. West elevation exposed, with mixed fenestration and doors.
