HISTORIC SOUTHSIDE COMMERCIAL AREA

MISSOURI HISTORIC PROPERTY INVENTORY FORM

REFERENCE NUMBER CO AS003-001		A. HISTORIC NAME					
B. COUNTY 054 Cole		C. OTHER NAME(S)					
D. ADDRESS 102 East Ashley Street			E. CITY Jefferson City		F. VICINITY <input type="checkbox"/>	G. RESTRICTED	H. ACREAGE

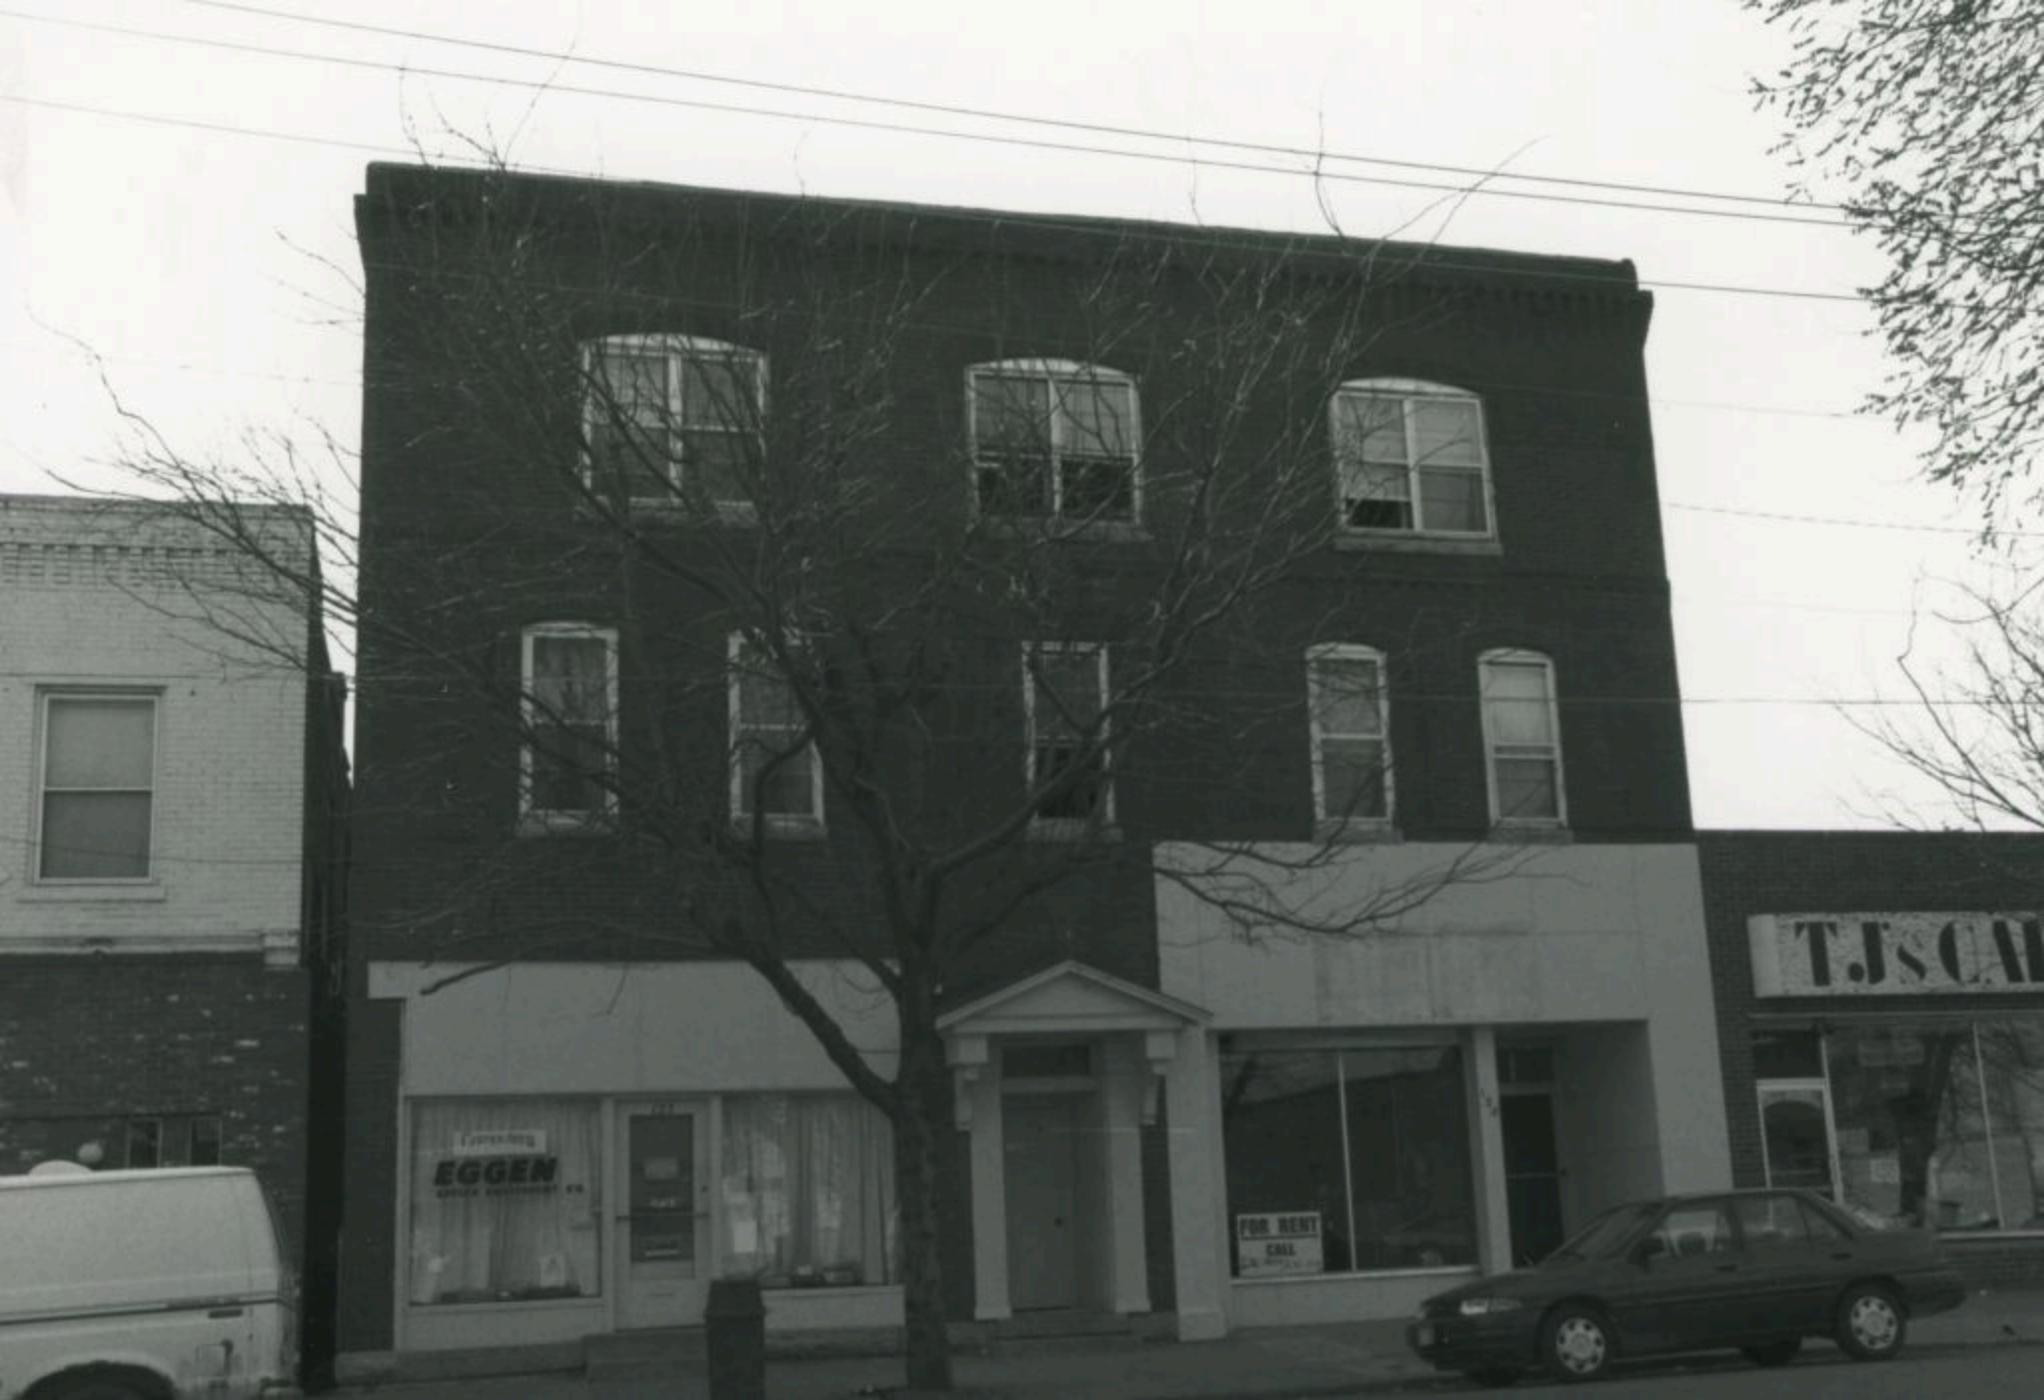
3 stories. walk-up apartment type. rectangular plan, 3 bay facade. coursed stone foundation. brick (running bond facade, 7-course side elevations) walls. shed roof. altered center recessed entry with modern door with 1-light transom, stone sill and step; fluted "pilaster" surround with stacked wood "capitals," gable hood set on square "beams" with brackets below, terrazzo foyer with "BASSMAN APARTMENTS" set in tile. flanking east and west end storefronts; west (#120, vacant): deeply recessed modern entry at west end with 2-light display window to east, oversized stucco/concrete paneled upper area; east (#122, Eggan's): historic configuration with center 1-light entry with flanking 1-light display windows, narrow wood bulkhead on stone sill plate, wood infilled transom area. 2nd-story with five windows, center window altered (larger opening infilled with brick, formerly triple window?); 3rd-story with three sets of paired windows; facade windows connected by subtle stone-faced stringcourse; brick corbelled stringcourse between stories, corbelled cornice with narrow parapet above. windows as 1/1 double hung with soldier segmental arch openings with drops and tooled stone sills, single and paired. west elevation adjacent to 114-118 East Dunklin on 1st-story, various sized 1/1 windows, some with double rowlock segmental arch openings on upper stories. east elevation similar, very narrow space between 120-122 and 124 East Dunklin Street. rear with center modern exterior wood staircase, exterior chimney; single windows on second story, paired windows on third story.

The 1908 Sanborn Map shows this 3-story building with a laundry on the east and a saloon on the west; lodgings are above and a 1-story steam laundry in the rear. The 1923 map labels this the "South Side Hotel" with two storefronts and 1-story rear wing. The 1939 map has a restaurant on the east, the rear wing is gone.

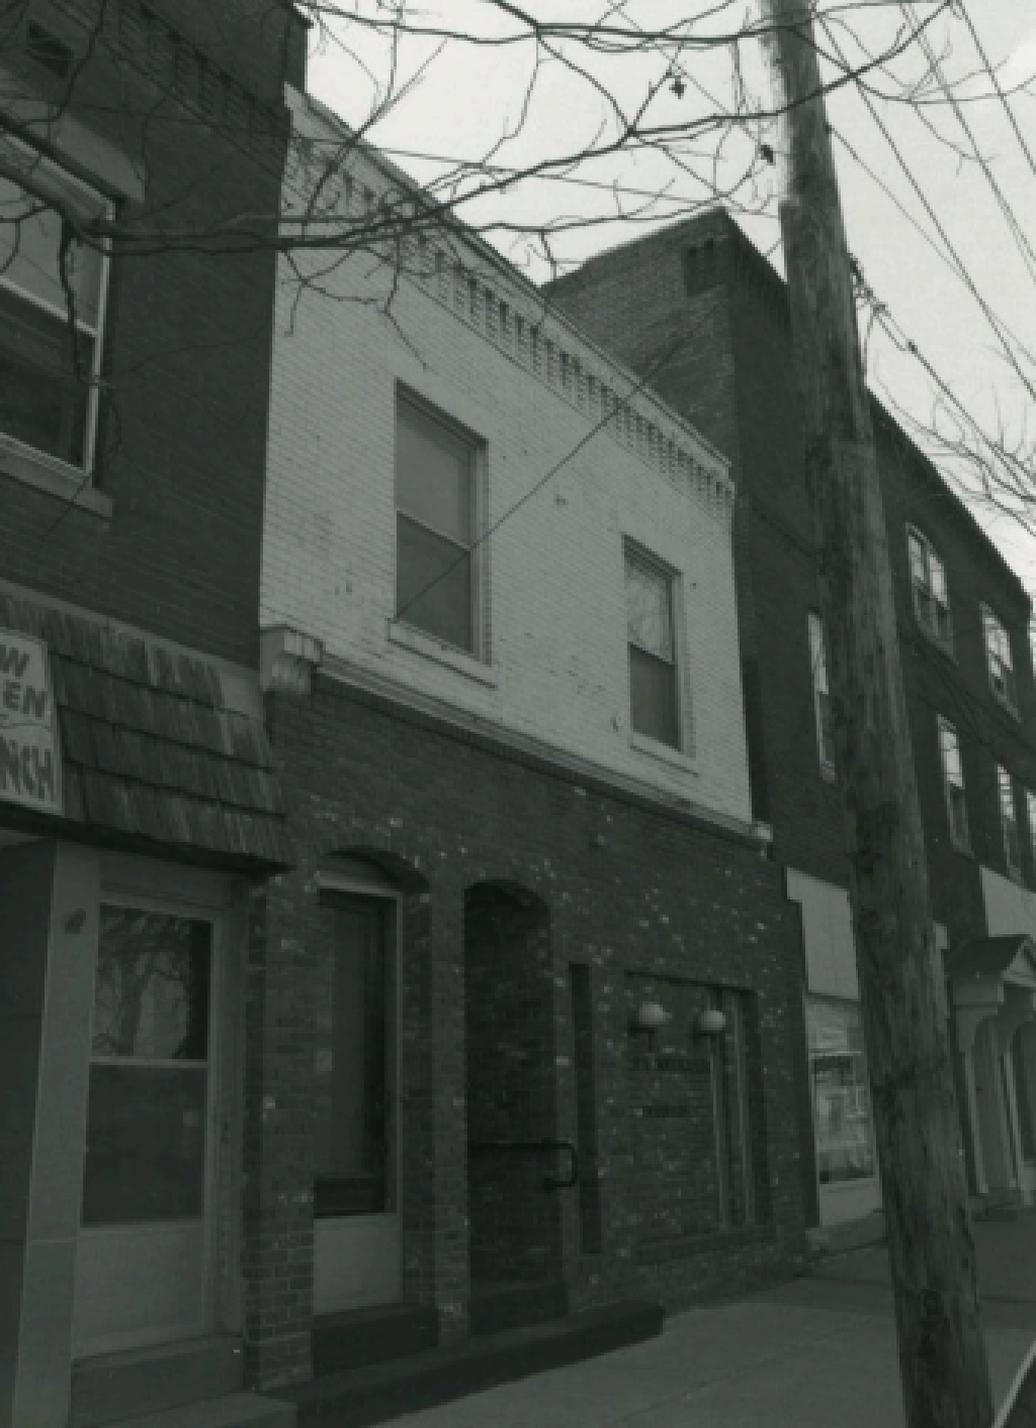
2 stories. no commercial style or type. rectangular plan. stone foundation, brick (face brick upper facade, painted; 6 course Flemish header side elevations) walls. shed roof. 1st-story with modern red brick veneer applied to facade; entry to 2nd-story (large historic 1-light door) at east end set in slight segmental arch recess (due to veneer), original transom extant behind facing; off-center (to east) recessed modern entry to 1st-story in segmental arch opening with single narrow rectangular modern 1-light to immediate west; west half with slightly recessed modern brick panel with two narrow modern 1-lights at west end of recess, rowlock sill under recess; rowlock brick course at top of applied veneer below original molded wood cornice with metal end brackets; 2nd-story with two large 1/1 windows with stone lintels and sills (painted), corbelled brick cornice with narrow brick parapet. windows as 1/1 double hung, narrow modern 1-light rectangular sash. west elevation set close to 120-122 East Dunklin, blind first story, four upper story windows, central end chimney. east elevation attached to 126 East Dunklin.

The 1908 Sanborn Map shows a 1-story building labeled "cobbler." The 1923 map shows the current 2-story building labeled a "store" with a shoe repair section in the rear and a 2-story rear porch. The 1939 map is similar.

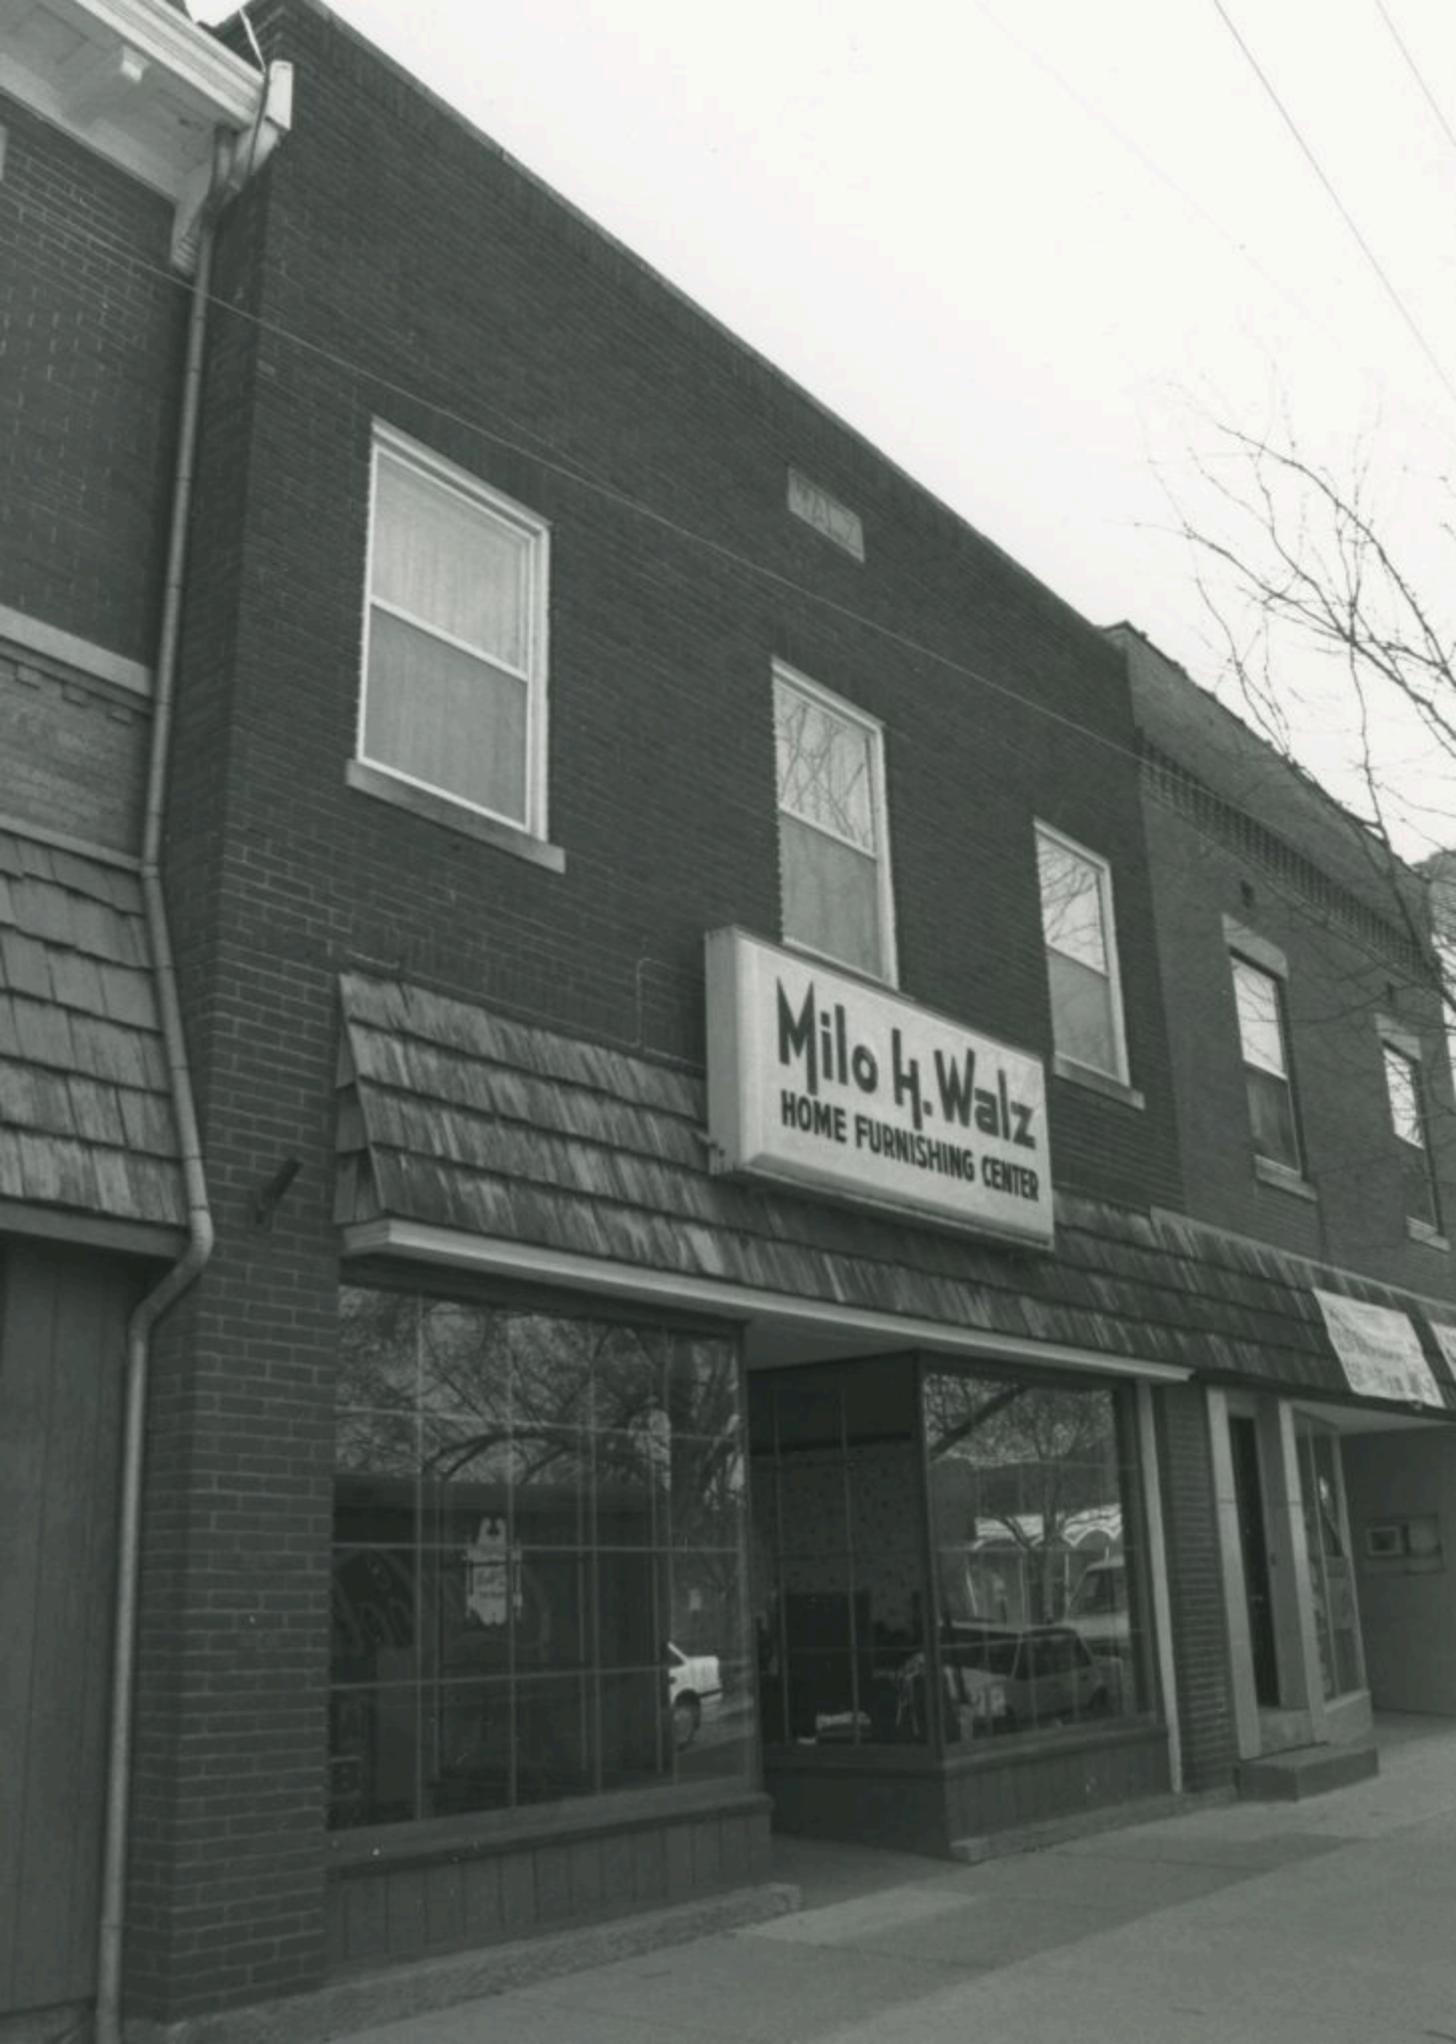
2 stories. single entry with display windows vernacular type. rectangular plan, 3 bay symmetrical facade. unknown foundation, brick (wire cut, running bond) walls. shed roof. deeply recessed modern paneled double-door center entry with flanking large 1-light display windows, windows with applied muntins, narrow modern wood bulkhead above concrete sill plate, wood shake-shingle pent roof in transom area below soldier course flat arch; 2nd-story with three large 1/1 windows, brick parapet with center stone panel inscribed "WALZ," soldier brick "cornice" below concrete coping. windows as 1/1 double hung with concrete sills and soldier course flat arches. west elevation attached to 126 East Dunklin Street; east elevation attached to slightly recessed 130 East Dunklin Street. rear with brick addition with lower south half open for alley access, bridge connection to 704 Madison Street; frame penthouse.

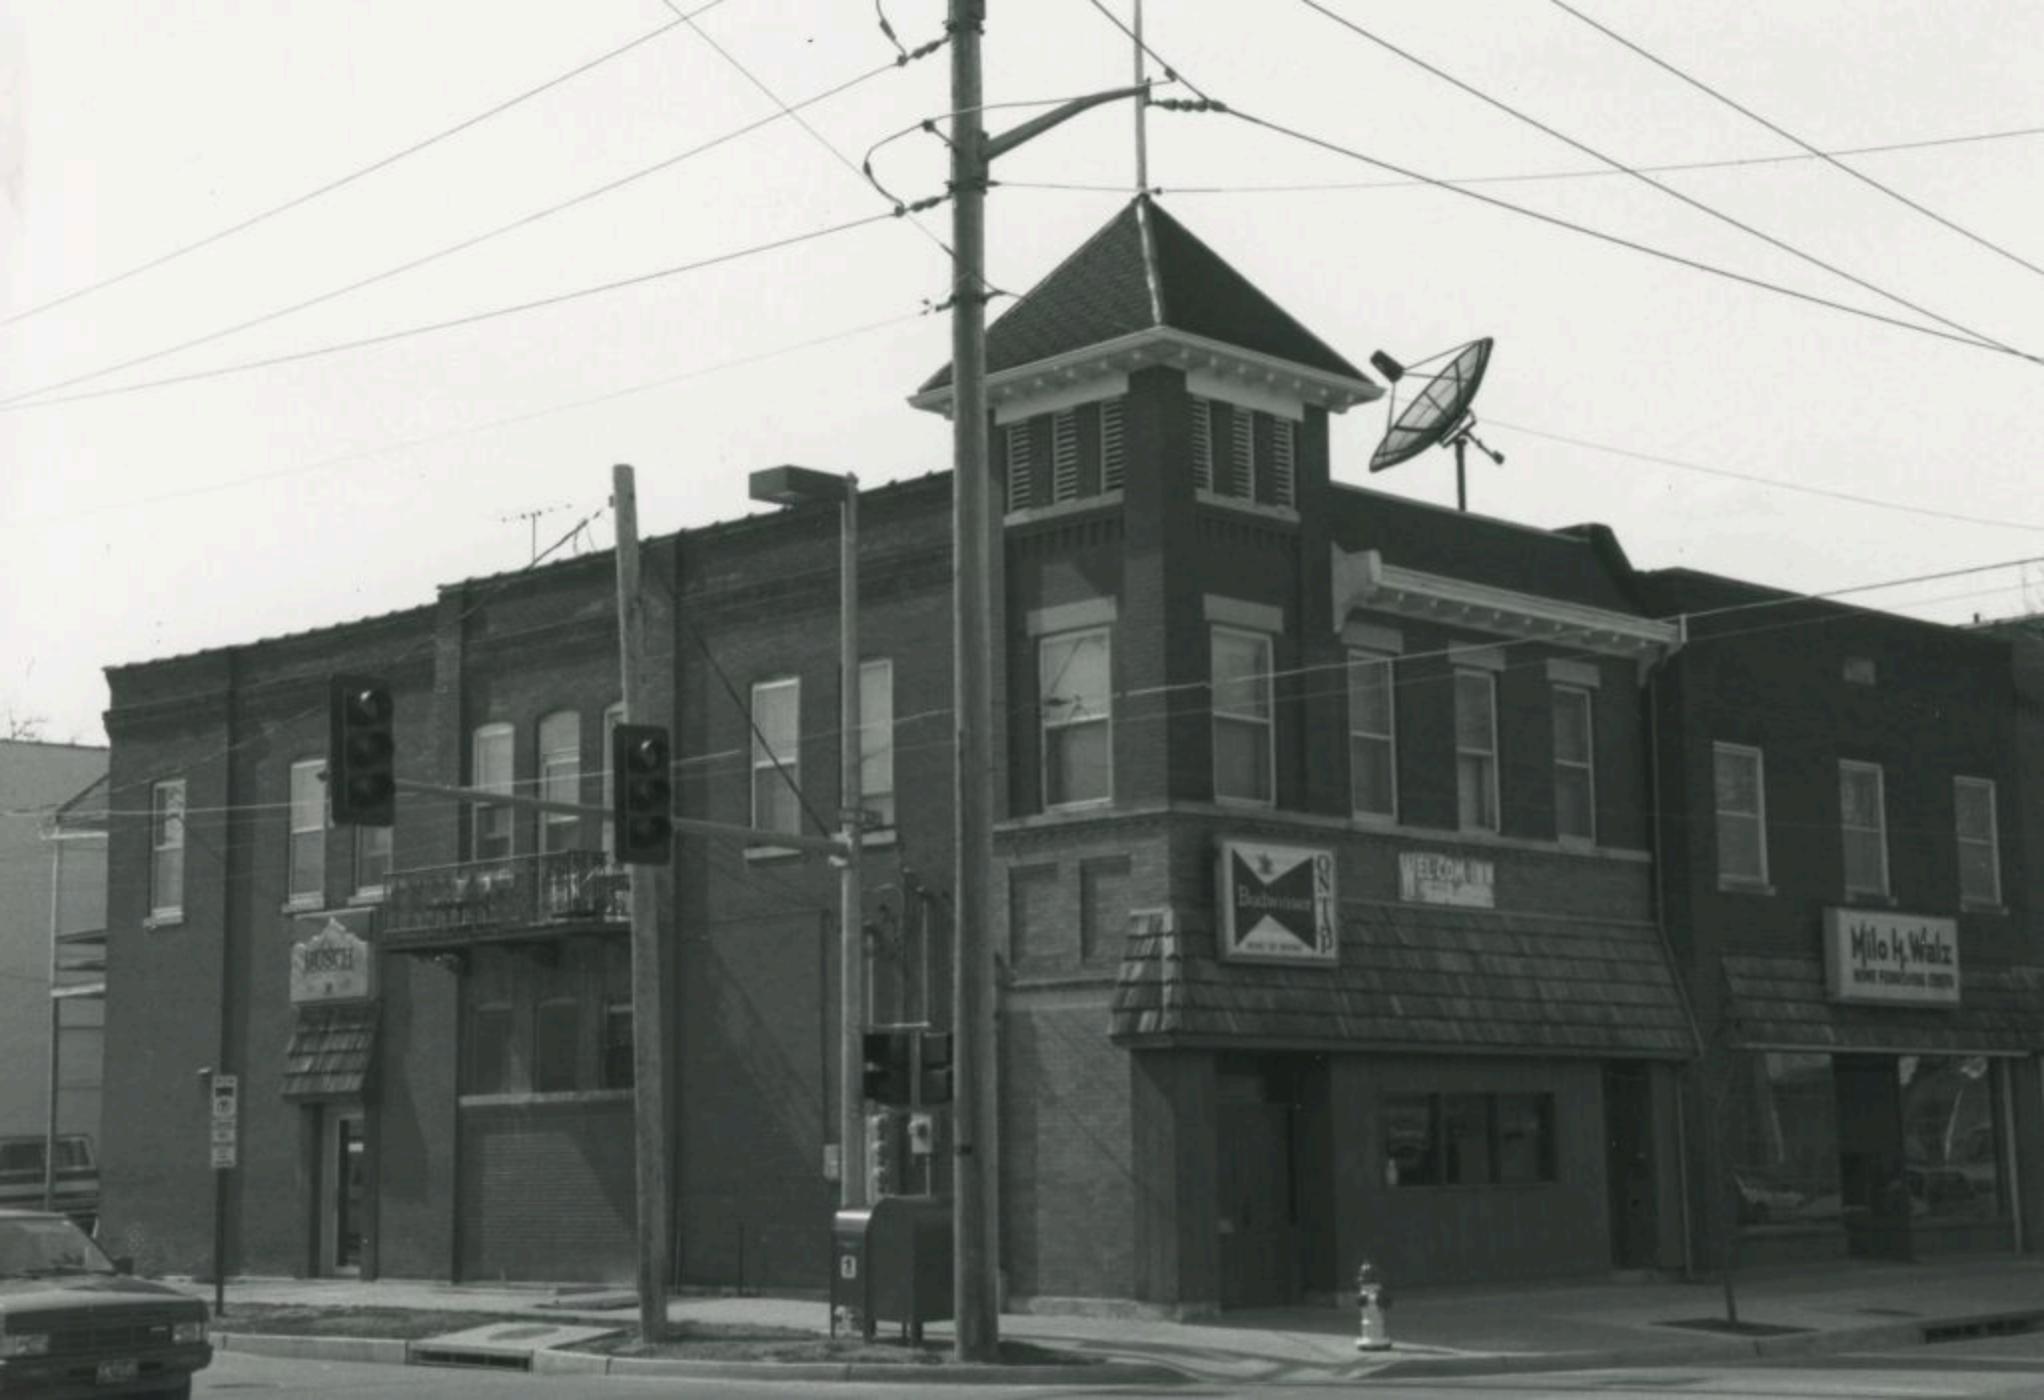
Two stories. Classical Revival style. Rectangular plan. Altered storefront. Foundation not visible; brick walls unpainted. Shed (composition asphalt) roof. Side with stepped parapet; tile coping. Main facade facing East Dunklin Street/north with historic (perhaps original) yellowish brown brick storefront which wraps a single bay east with end pier with stylized pre-cast stone cap; stone beltcourse. Recessed transom panels, dentils, and stone beltcourse above as continuous sill for front/north and one side/east window. Storefront altered with modern vertical wood, fixed modern sash, and shake pent roof. 2-1/2 story corner tower (northeast) with steeply pitched pyramidal roof. Triple rectangular vents face front and side/east with three course corbels below the continuous sill on each side. Wide eaves with modillions. Three second story bays front with one window in each, in addition to a fourth bay with tower. Three grouped with Mansard or steep shed roof above. Wide projecting cornice with end brackets and modillions. Long east elevation exposed to Madison Street with four section created by brick piers. Modern door and triple window set on first with, with paired and single windows on second story above. Front/north two sections with double rowlock segmental brick arches. Back/south two sections with soldier course segmental brick arches. Raised beltcourses at top and bottom of parapet; tile coping. Ornate iron balcony on second story east elevation above three window set high on the first story. Central door flanked by single windows. Rear with two story shed half elevation veranda; exterior staircase. Currently the Wel-Com-Inn tavern.

A one story grocery store is shown on the 1908 Sanborn Map. This building appears by the 1923 Sanborn Map, with a two story rear veranda, corner tower, and metal-clad ceilings.

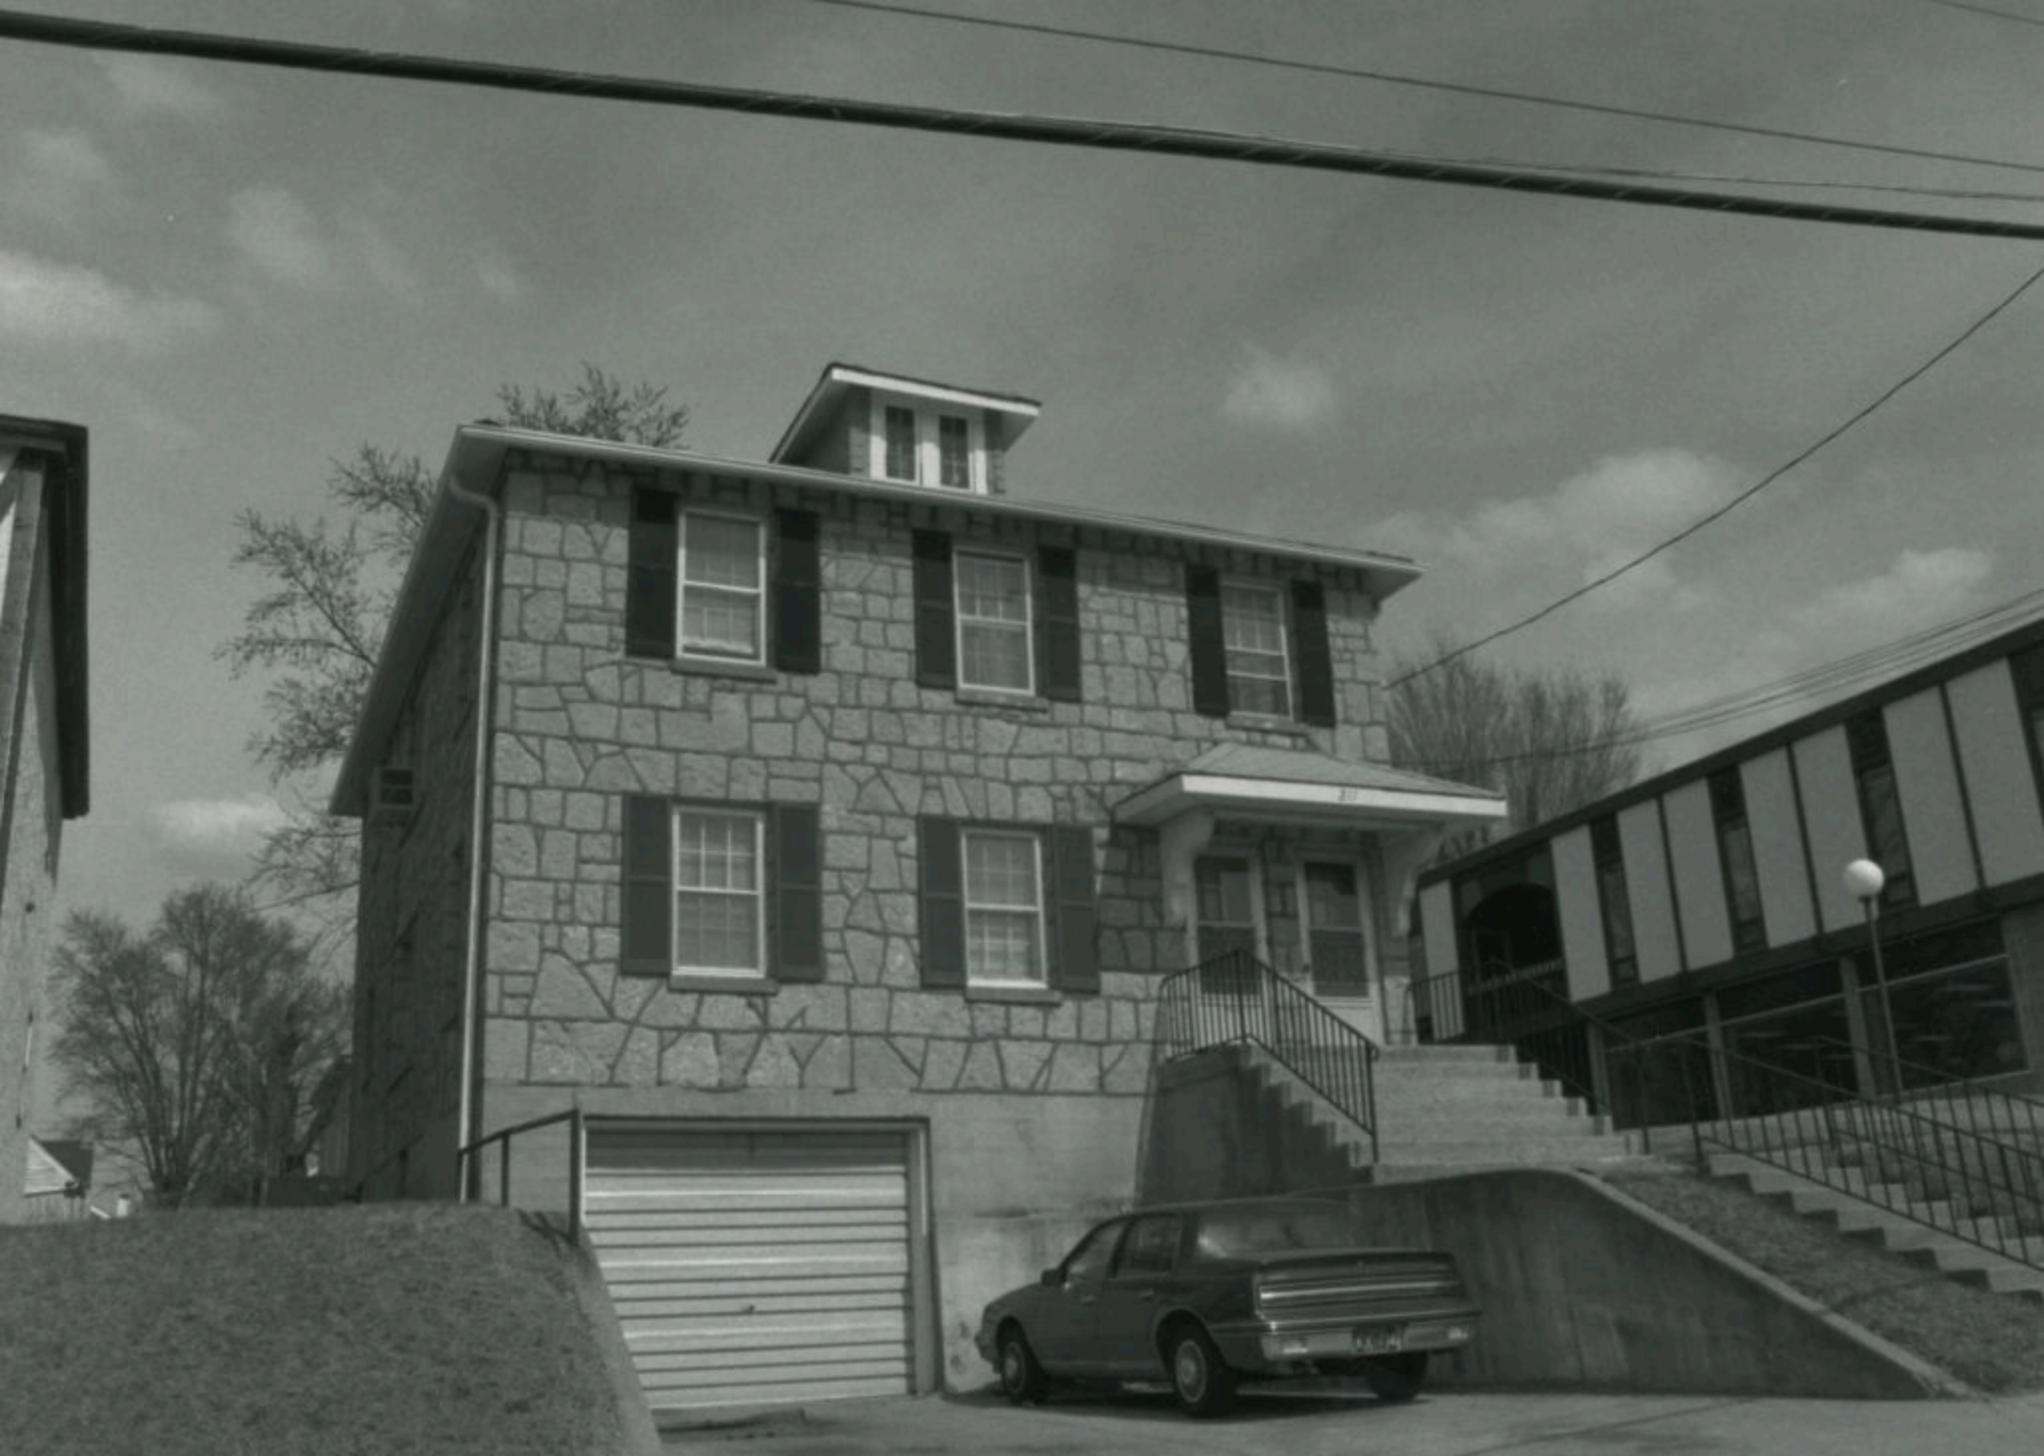
2-1/2 stories. 2-Family Flat type. rectangular plan, 3 bay symmetrical facade. concrete foundation, stone (rubble, coursed) walls. hip (asphalt shingle) roof. facade with exposed basement with modern overhead garage door at west end, wide concrete driveway cut into hillside with concrete retaining wall and two sets of wide concrete steps with metal railing to east. two 6-light/panel doors in east end bay below wide hip roof hood set on oversized shaped brackets with vinyl sided soffit; two 6/6 windows to west. 2nd-story with three windows, center hip roof dormer with paired 6-light casements; center ridge chimney. windows as 6/6 double hung with concrete sills, modern louvered blinds. both stories of west elevation with 6/6 window at south end, paired center 6/6, high sash at north end. east elevation with entry with stair sash above to south, two 6/6 windows to rear. rear with center dormer, west half with 2-story shed roof porch: 1st-story screen and lattice enclosed, 2nd-story vinyl sided enclosed.

The 1908 Sanborn Map does not cover this block. The 1923 map does not show this address; #209 & #213 are 1-1/2 story frame dwellings. The 1939 map is similar.

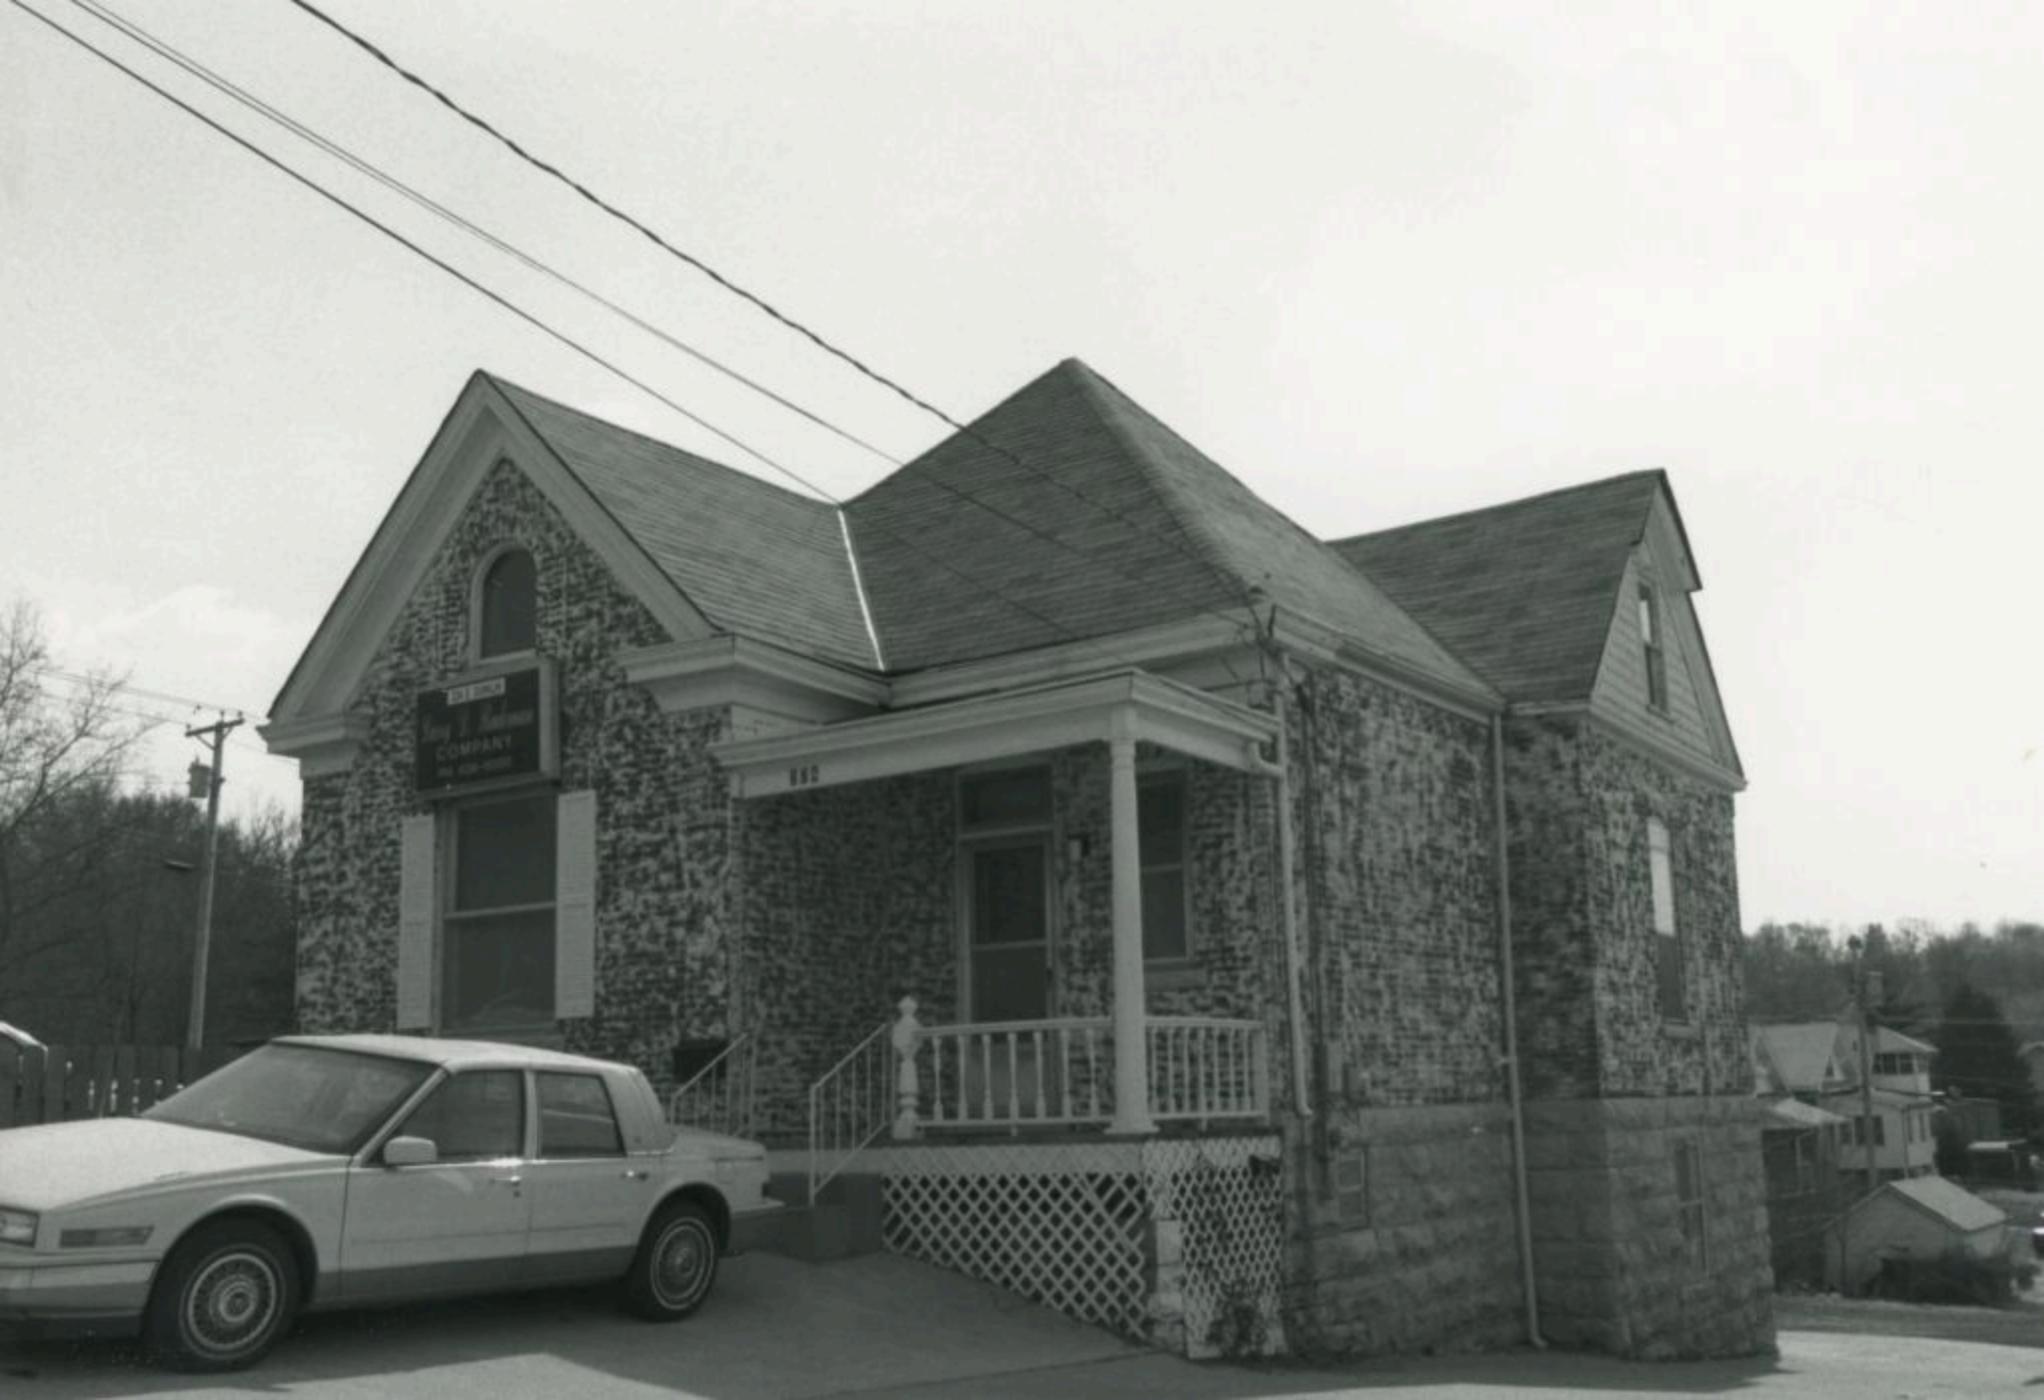
1-1/2 stories. Queen Anne cottage influence. Single family residence converted to office use. Irregular plan. Rock-faced limestone foundation; upper course of foundation stone with longer, thinner stones as to affect a watertable. Red brick walls painted white, with painted removed in parts, leaving a very speckled look. Fish scale shingled side gable. Gabled, steeply-pitched hip (asphalt shingle) roof. 1/1 double hung sash with soldier course segmental brick arches and stone lug sills. Left/east gable front pavilion with wide single 1/1, shutters applied, and sign panel attached above. Upper story with round arched sash with soldier course surround; wide molded cornice returns. Entrance with large light door with transom in reentrant angle to north of gable front with small 1/1 to right on end. Reentrant angle flat roof (half) porch with tapered Doric column (corner), replacement modern balustrade, and turned pedestal at stairs; raised wood deck. A wood cornice wraps the reentrant angle. East elevation with gable roof dormer with asphalt shingle sides; single window and fish scale shingles above. Small single bay rear wing with mixed asbestos shingle and clapboard walls. Rear shed roof dormer. Grade to west changes with basement fully exposed by rear. West side gable pavilion with fish scale shingles and single windows on first and upper stories; also at basement.

Appears on the 1923 Sanborn Map, the first to show this block; the lot was not sub-divided to the east, with 704 Monroe and 228 East Dunklin sharing the corner lot. No change is apparent on the 1939 Sanborn Map.

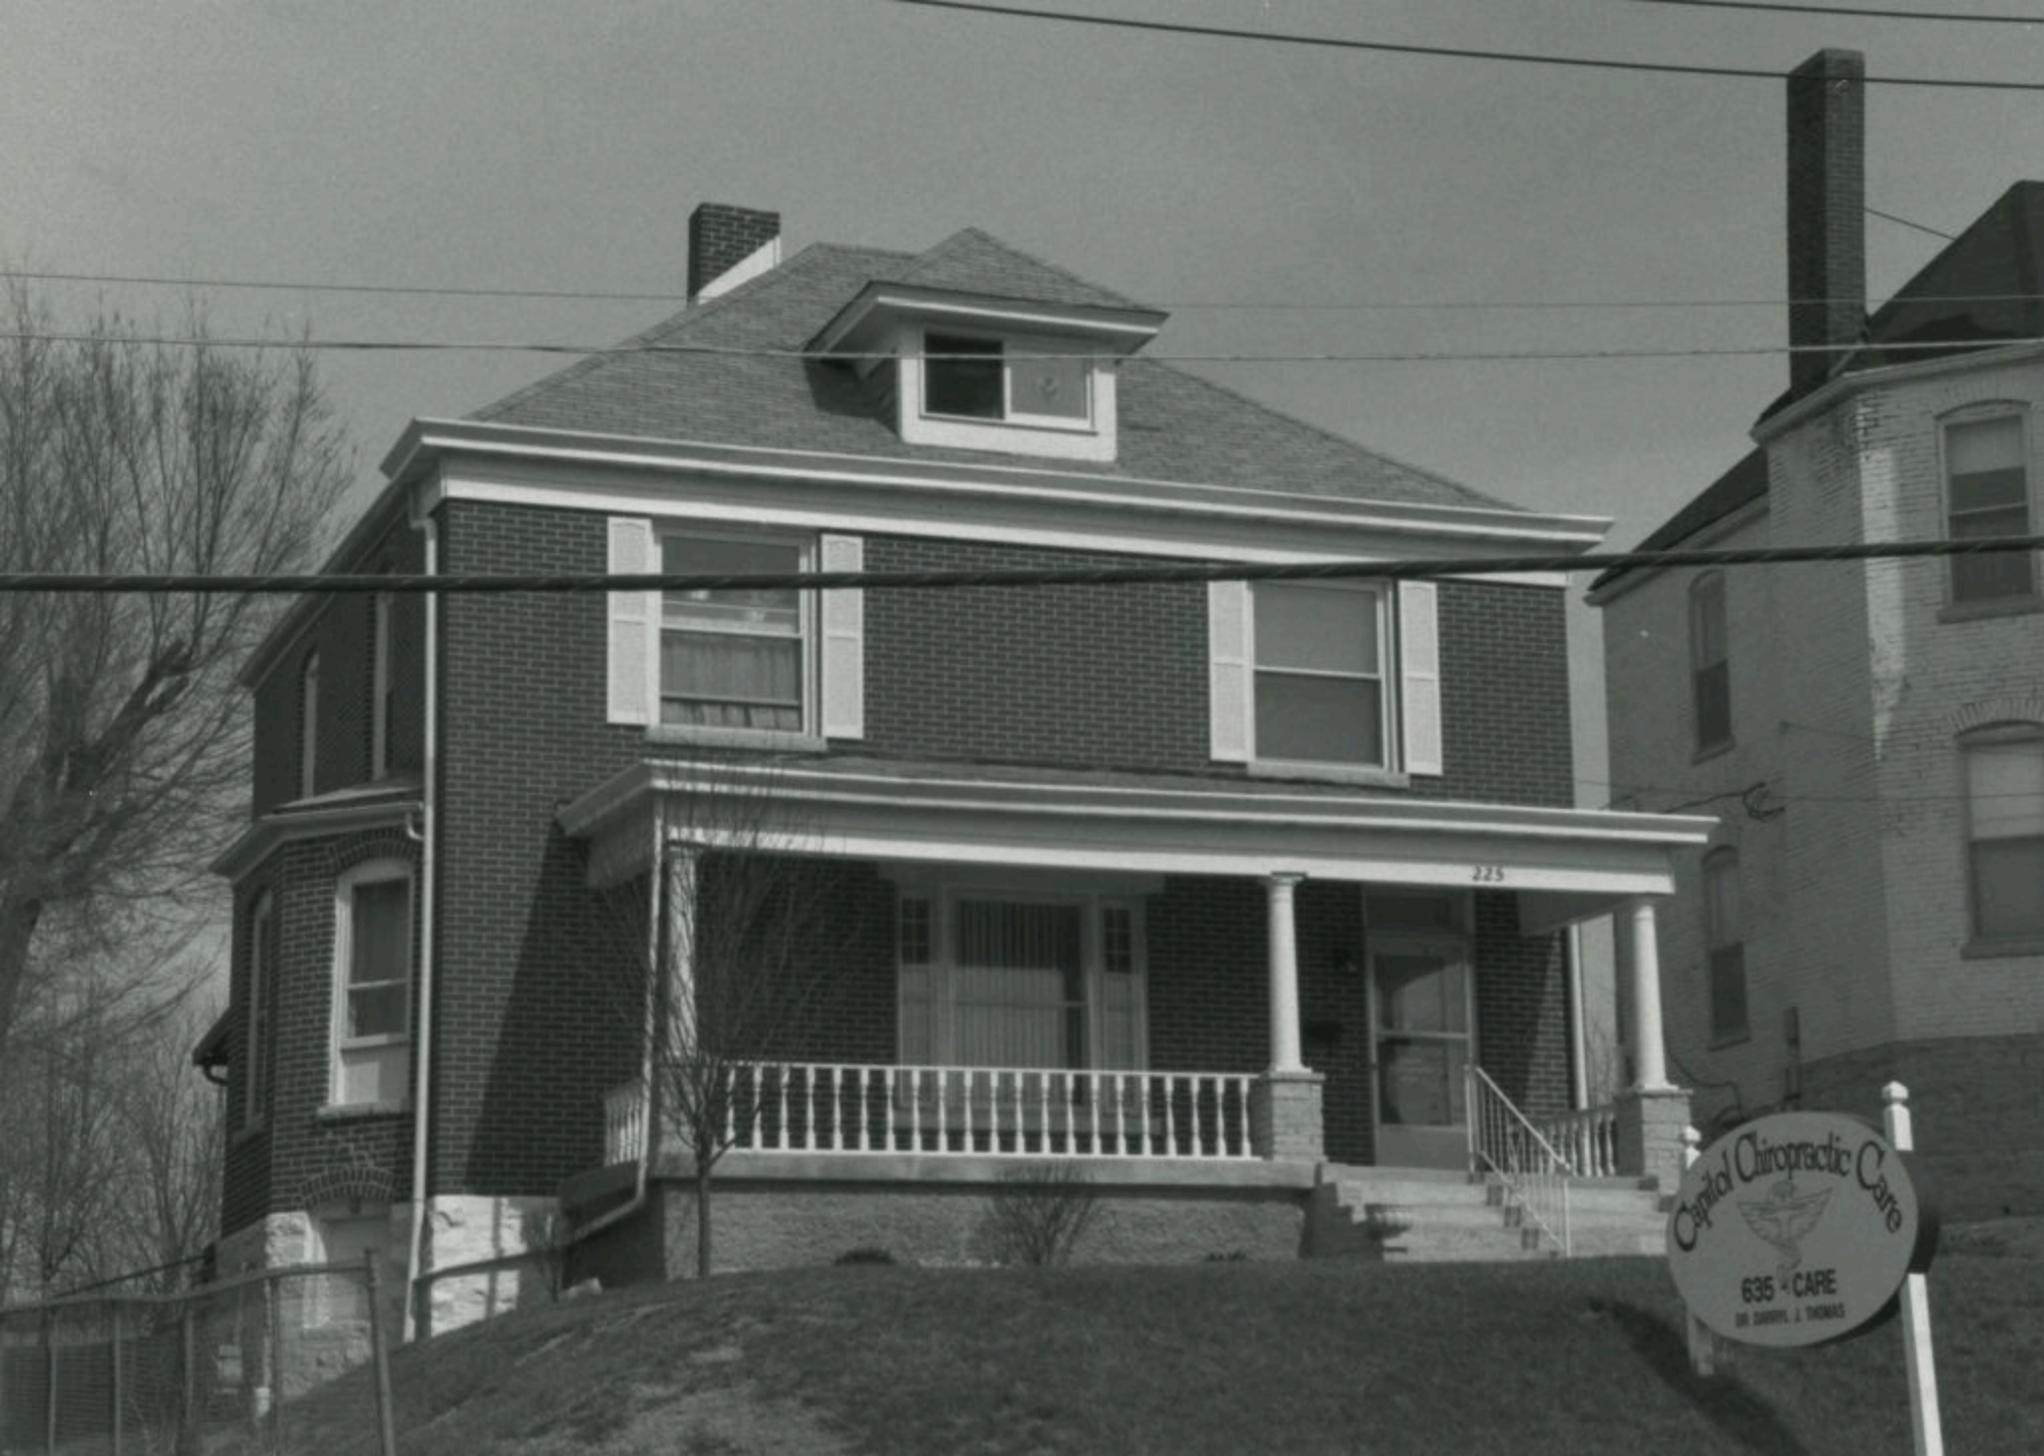
2-1/2 stories. Colonial Revival influence. rectangular plan. coursed stone (painted) foundation, brick (face, running bond facade; 7-course Flemish header side elevations). truncated hip (asphalt shingle) roof. 1-light door with transom to east, center large 1/1 with flanking 18-light sidelights with stone lintel and sill; three-quarter width hip roof porch with three Doric columns on ashlar pedestals, concrete deck and steps, modern turned wood balustrade, wide vinyl sided frieze and soffits. 2nd-story with two wide 1/1 that engage frieze, modern louvered blinds; narrow wood frieze and molded wood cornice, center 2-light hip roof dormer. windows as 1/1 double hung with stone sills, side elevations with double rowlock segmental arch openings. west elevation with exposed basement with openings, 1st-story with 1-story brick bay to south with 1/1 per face, 1/1 at north end, two 1/1 on 2nd-story, west slope chimney. east elevation with wide foyer window, two 1/1 on 2nd-story. frieze and cornice return only slightly on side elevations. rear with open porch on west, various windows.

This block does not appear on the 1908 Sanborn Map. This dwelling appears on the 1923 map with its west side bay and front porch. The 1939 map shows the rear porch.
