HISTORIC SOUTHSIDE COMMERCIAL AREA

MISSOURI HISTORIC PROPERTY INVENTORY FORM

REFERENCE NUMBER CO AS003-001		A. HISTORIC NAME					
B. COUNTY 054 Cole		C. OTHER NAME(S)					
D. ADDRESS 102 East Ashley Street			E. CITY Jefferson City		F. VICINITY <input type="checkbox"/>	G. RESTRICTED	H. ACREAGE

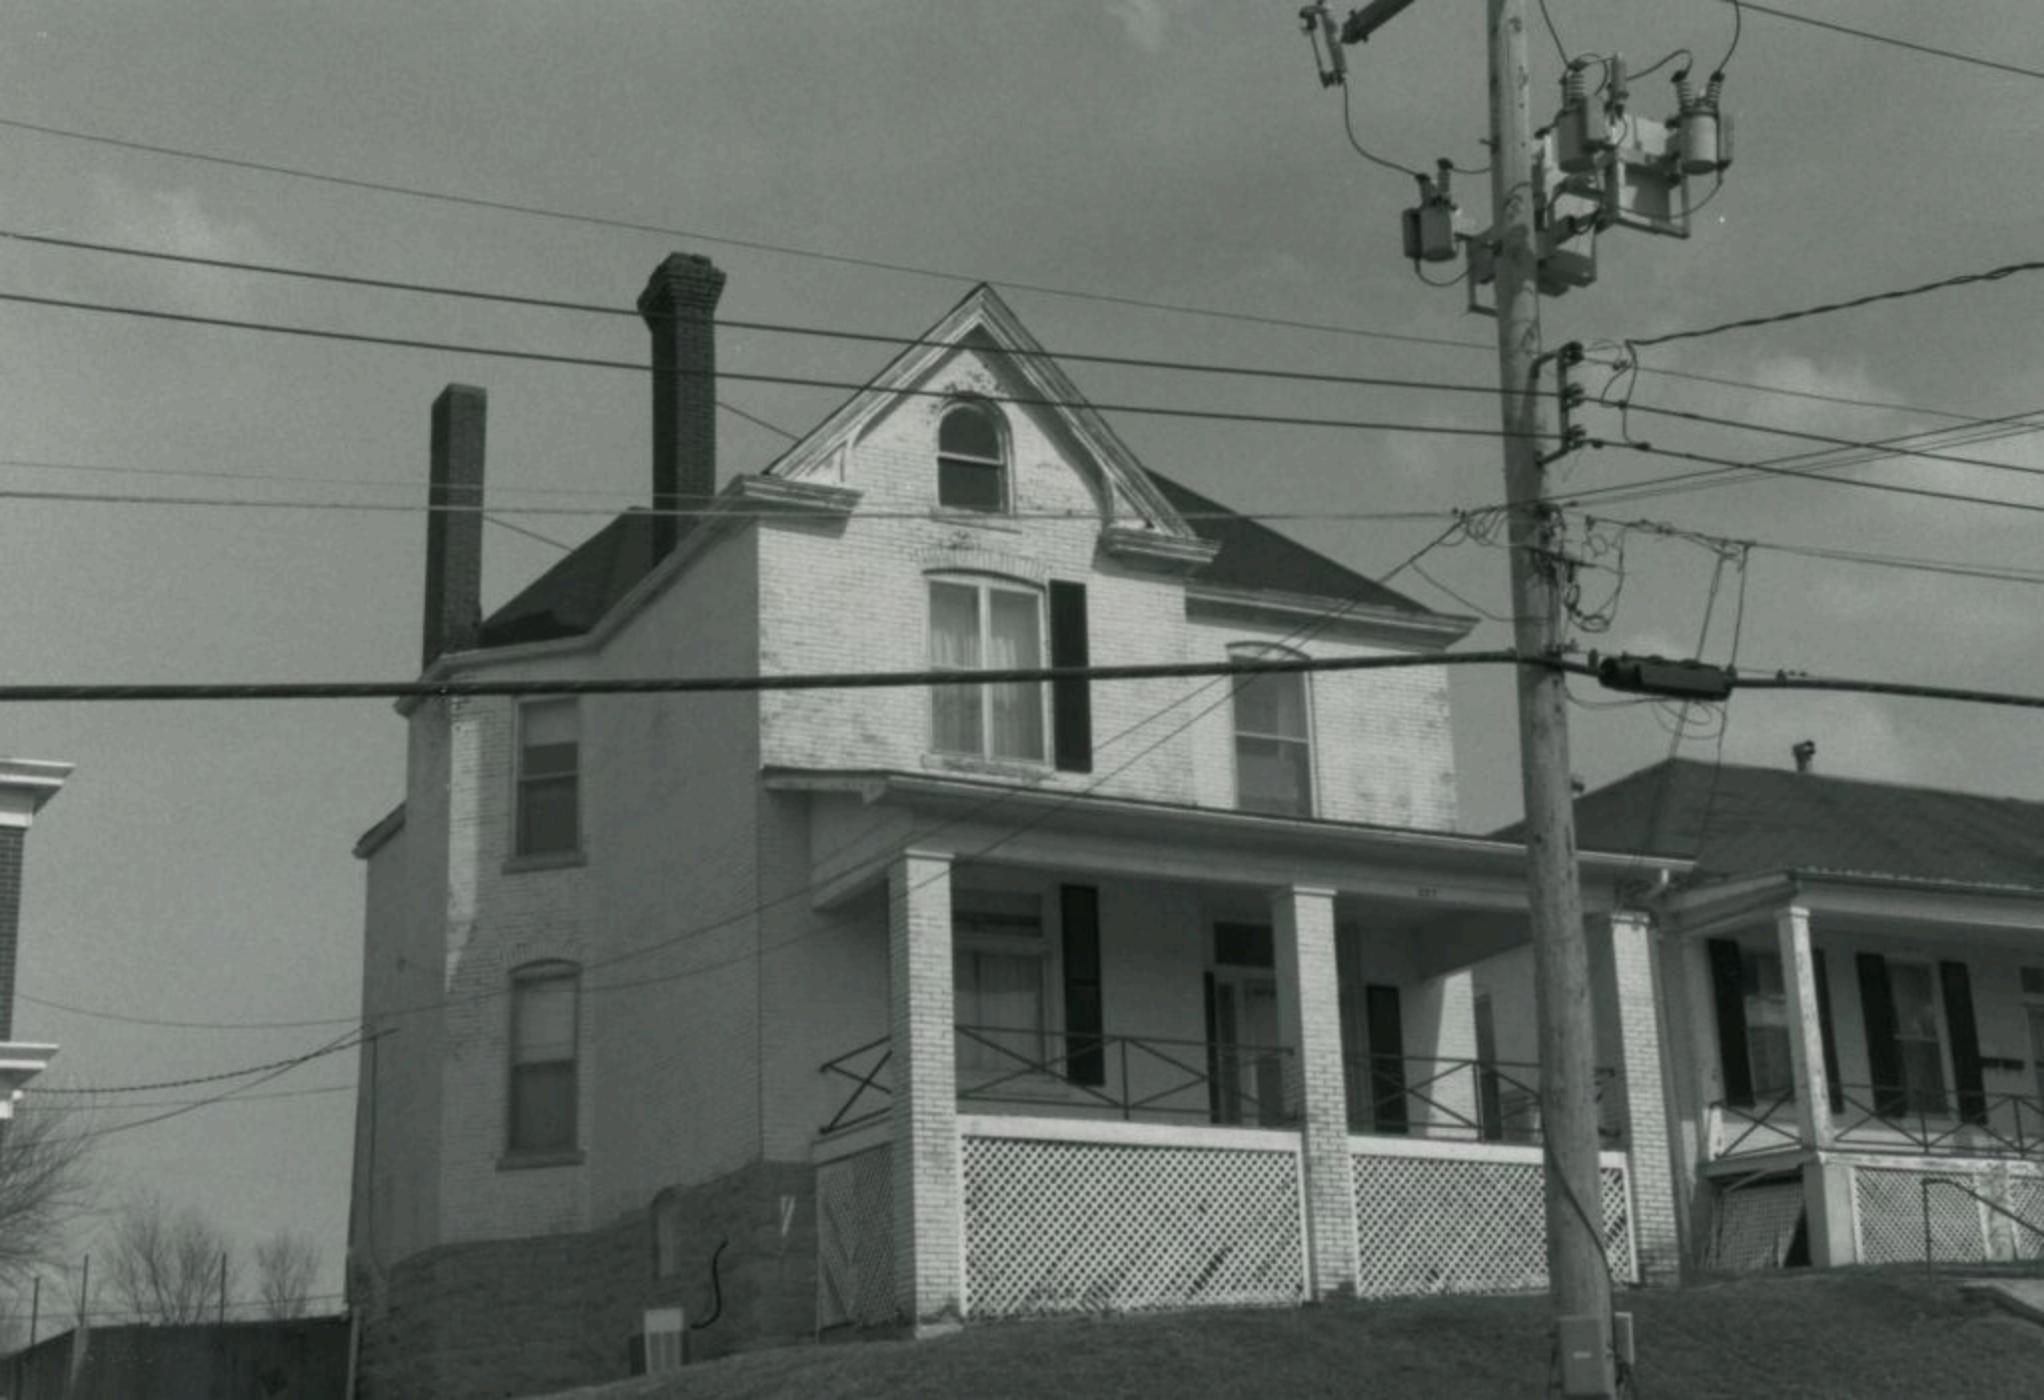
2-1/2 stories. no style or type. irregular plan, 2 bay asymmetrical facade. coursed stone foundation, brick (face, running bond, painted facade; 7-course side elevations) walls. hip and gable (asphalt shingle) roof. raised full-width shed roof porch with three brick piers, east side steps with brick step pedestal, lattice screening below wood deck and modern metal "X" railing, wide wood frieze and wide overhanging boxed eaves. west bay as projecting lower gable roof pavilion with large 1-light with transom and modern louvered blinds on 1st-story, 2nd-story with paired 1/1, round arch 1/1 in gable with molded wood rake boards and cornice returns with paneled angles, narrow overhanging boxed eaves; east bay with modern door with sidelights and 2-light transom, 1/1 window above. windows as 1/1 double hung with stone sills and soldier segmental arch openings. east elevation with beveled glass foyer sash to south, central entry now infilled with 1/1, 2-story projecting pavilion to north with narrow 1/1 per story facing south, east face with 1/1 then corbelled interior end chimney and 1/1; gable roof dormer with three sash and wood shingles to south. west elevation with exposed basement, south third blind with corbelled interior end chimney, center 2-story semi-hexagonal brick bay with blind west face with interior end chimney, 1/1 per story on side faces, north third with 1/1 per story. rear with 2-story open porch on east half, exterior steps, gable roof dormer.

This block does not appear on the 1908 Sanborn Map. This 2-story brick dwelling is shown on the 1923 map without the porches; the porches appear on the 1939 map.

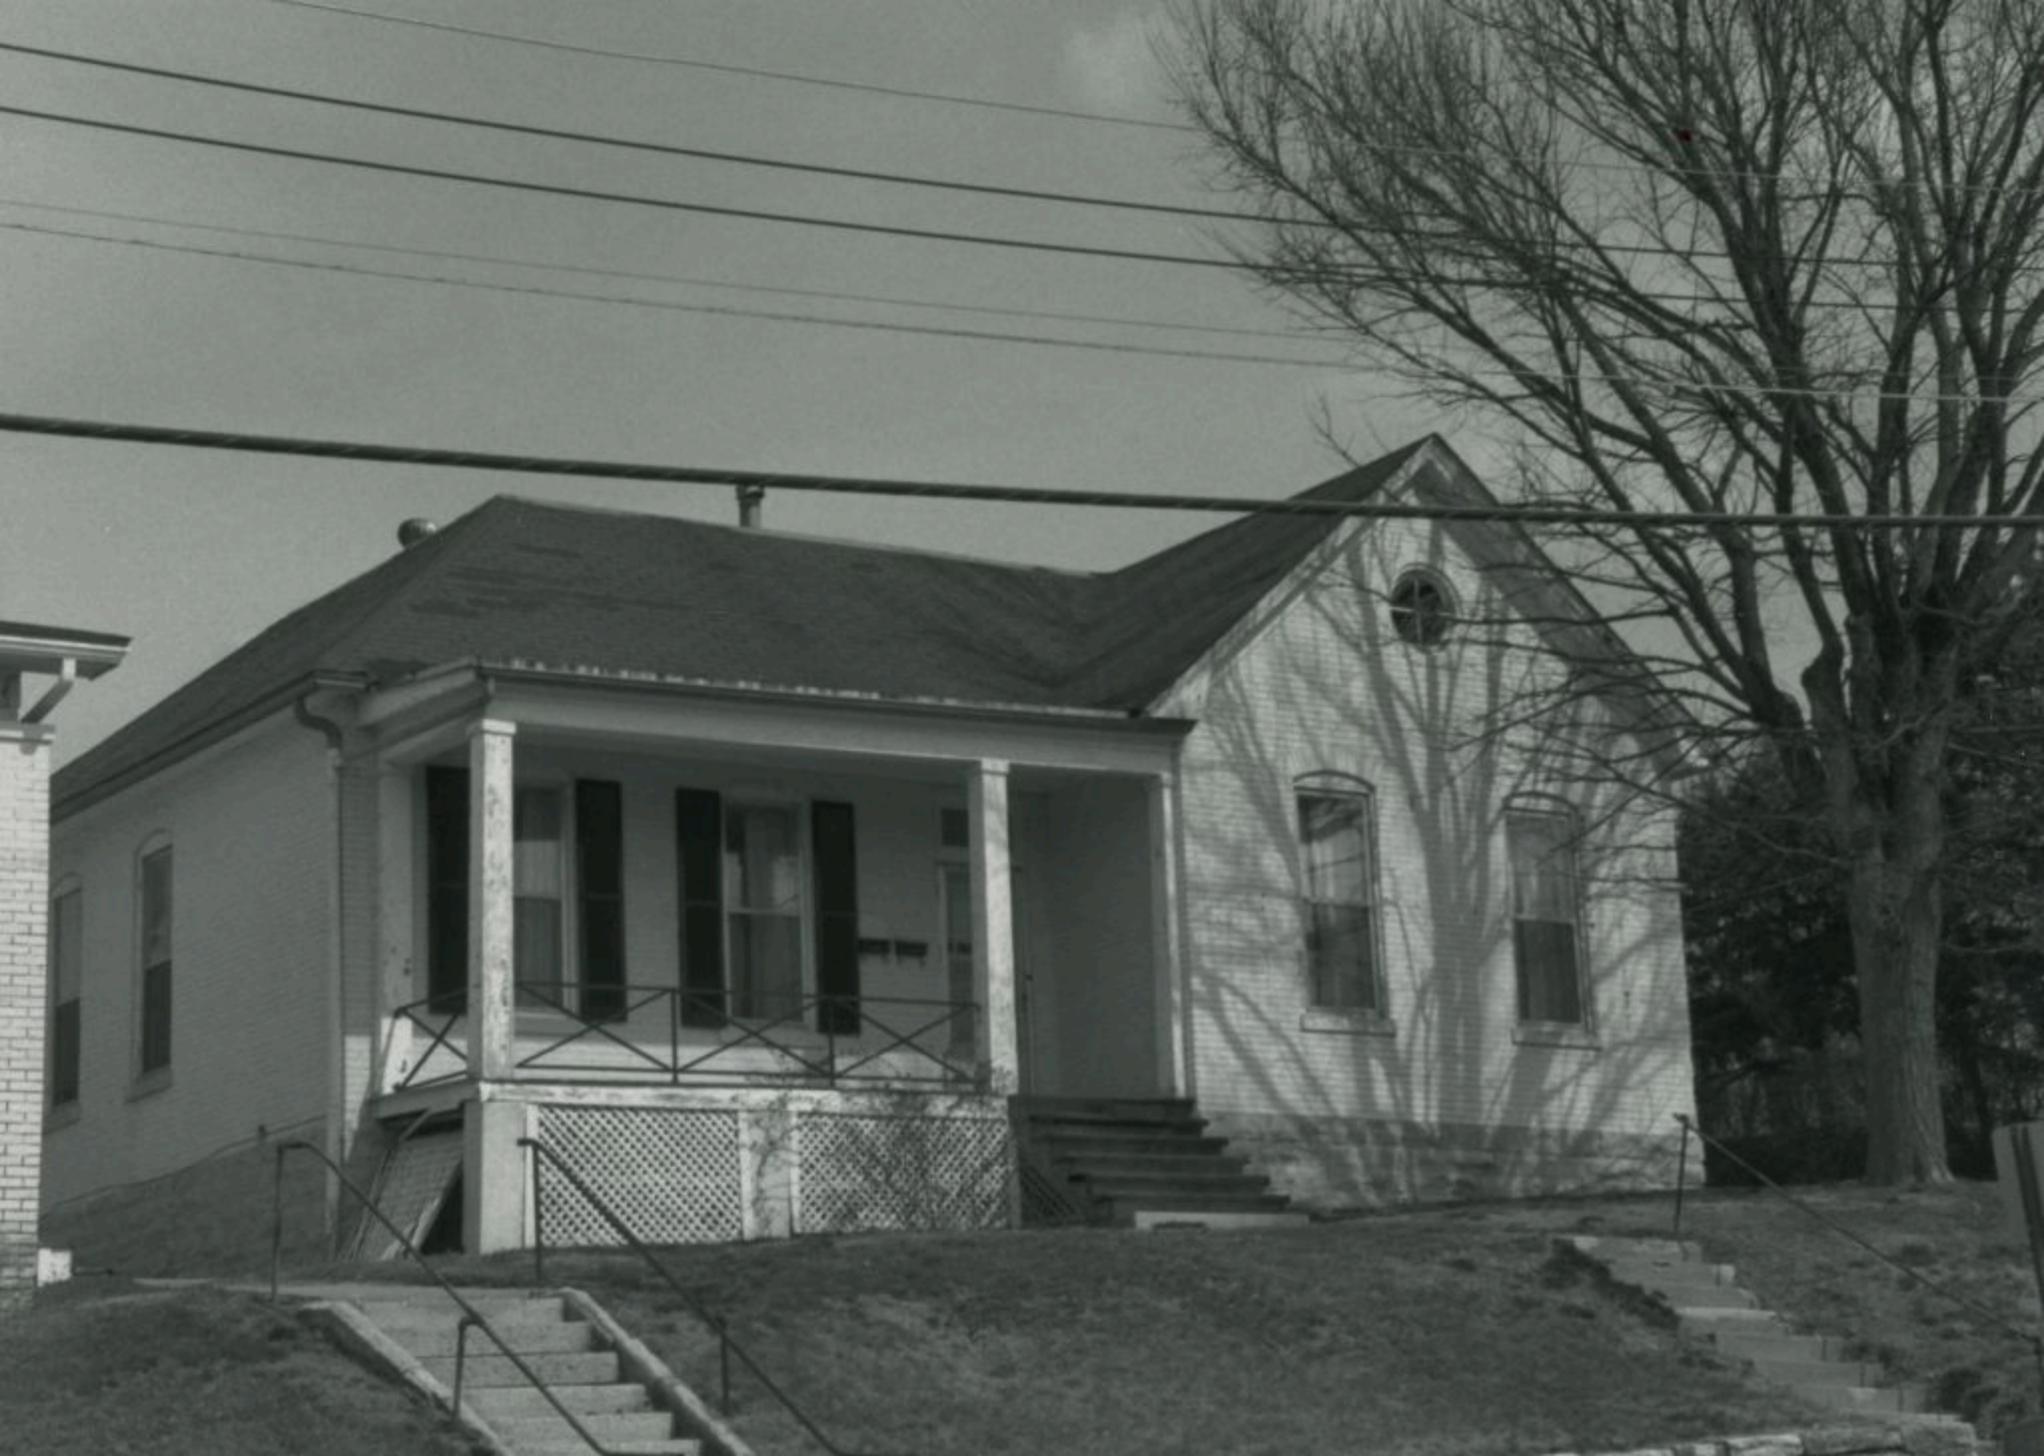
One story with attic. No style or vernacular type. L-plan, five bay asymmetrical facade. Rock-faced limestone foundation; brick walls (painted yellow). Gabled truncated hip (asphalt shingle) roof. 1/1 double hung sash with soldier course segmental brick arches and stone lug sills; incised pattern window heads. Right/east bay gable front pavilion with two window on first story; round four-light (quarter divided muntins) attic sash with header surround. Gable with boxed cornice returns. Left/west reentrant angle with two windows left and three-light door in third bay with two-light transom. Shed roof reentrant (half) porch with raised wood deck, tall lattice panel base, and wood posts. Modern iron "x" open rail added. Plain cornice. West elevation with two windows. Rear single bay hip roof historic wing toward west 2/3 of house. Small rear shed roof historic wing with tile coping to east with rear door.

The 1908 Sanborn Map does not cover this area. This house is shown on the 1923 Sanborn Map with a wing off the northeast corner. Two other dwellings are on the rear lot (#610 and #608 Monroe Street). The current side alley which parallels Monroe did not exist at that time; some reconfiguration of Wear's Creek evidently occurred on this block. No changes on the 1939 Sanborn.

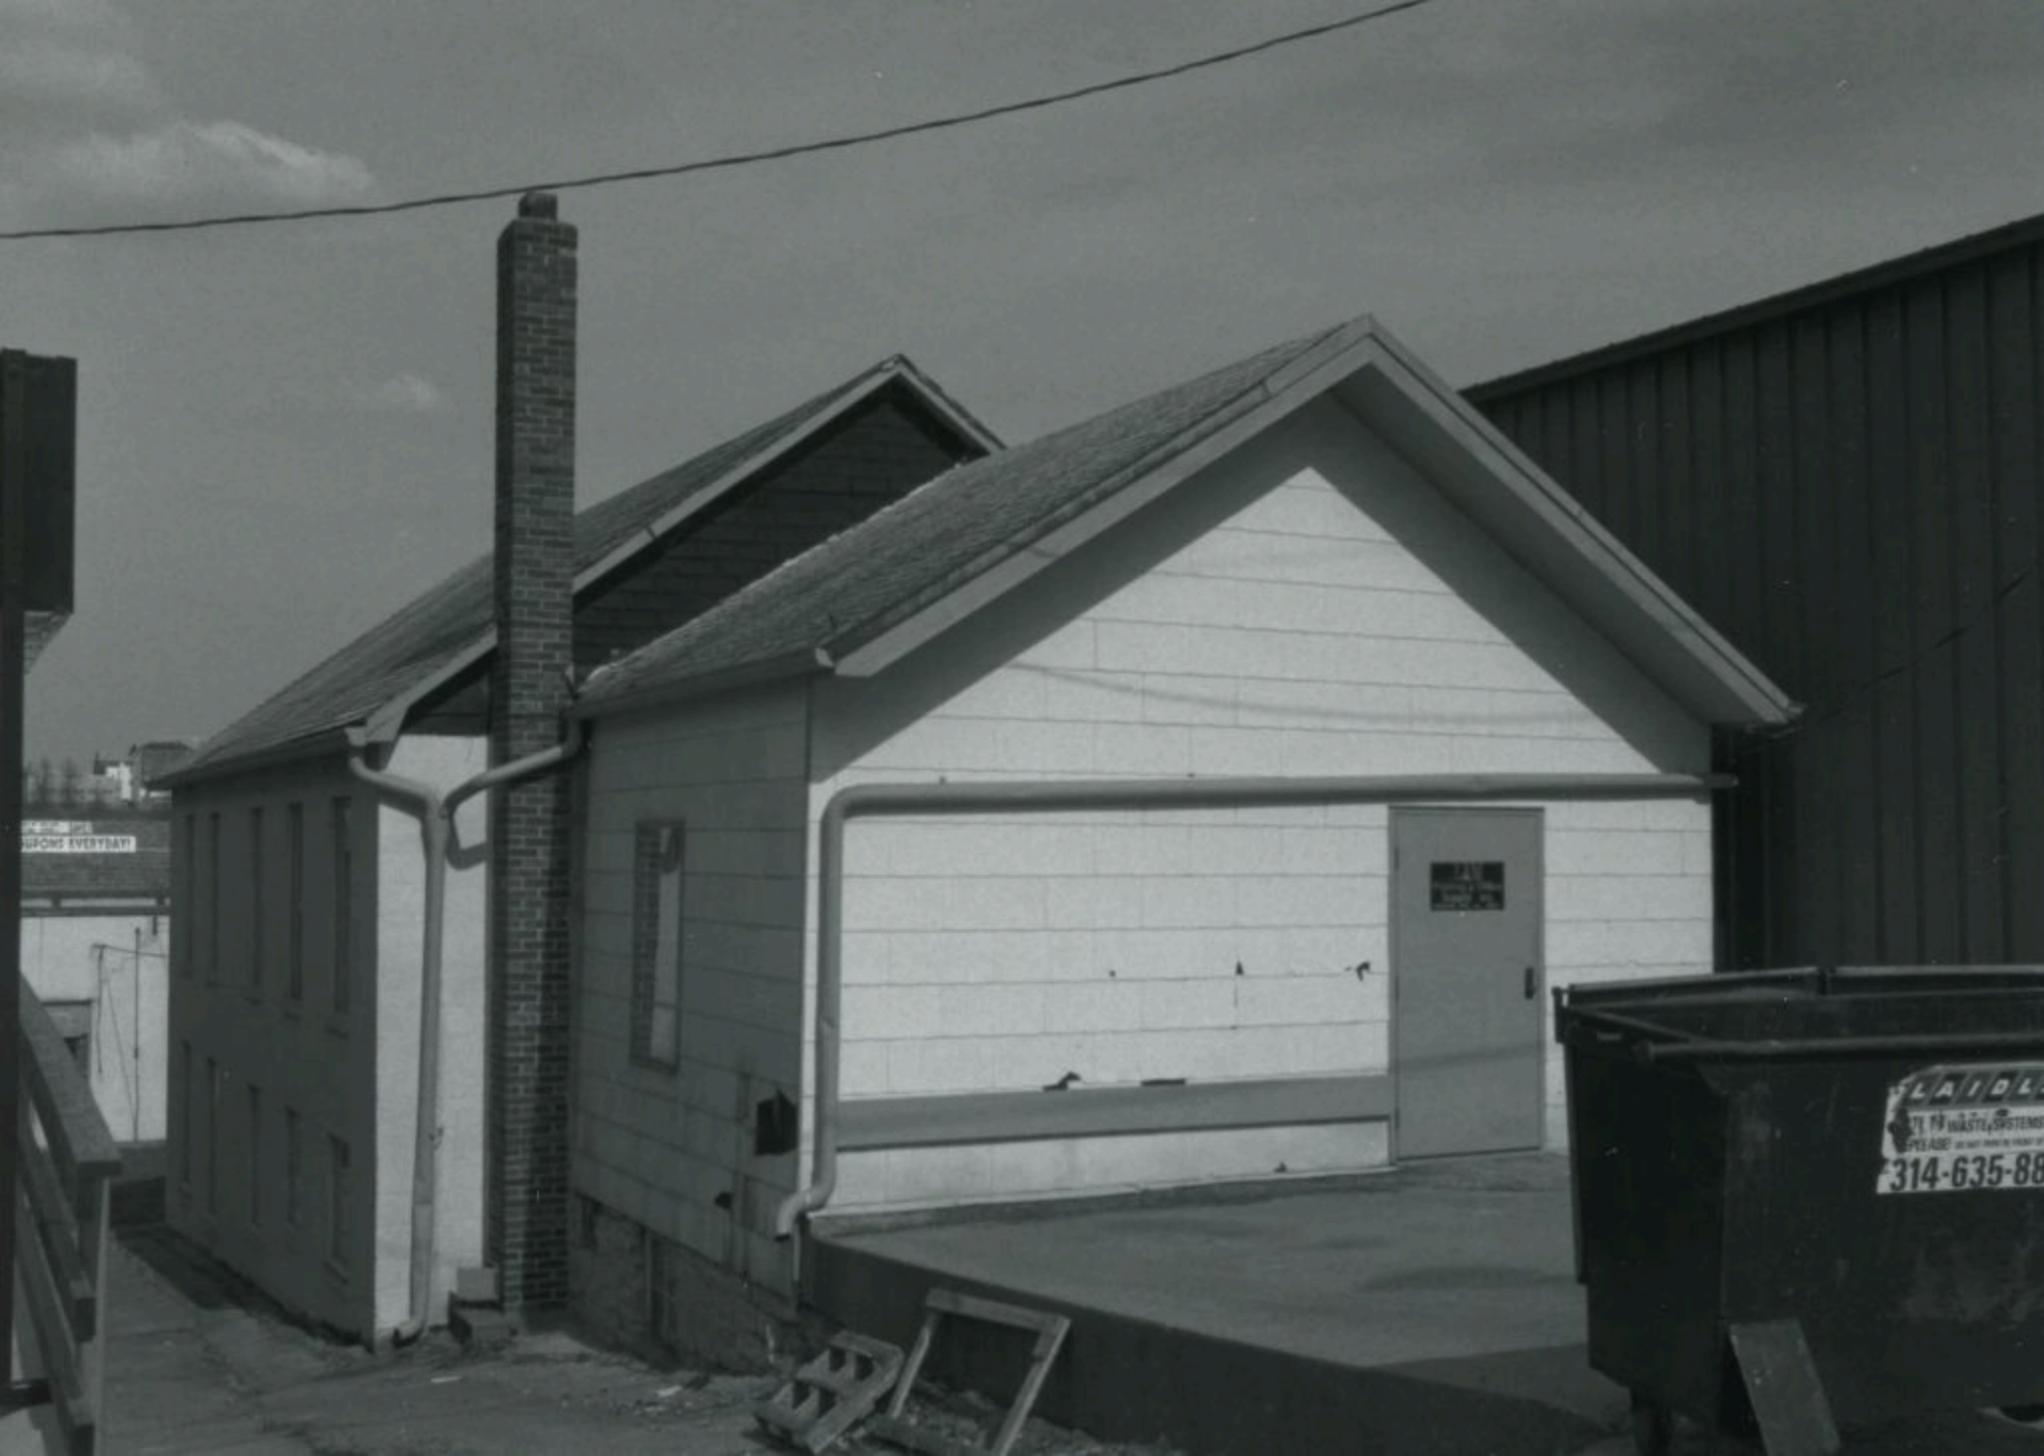
Appears to be same house shown as 119-1/2 as far back as the 1892 Sanborn Map. Set at rear alley, but nothing between house and West Dunklin Street. An adjacent 1-1/2 story carriage barn is shown to the west of the house on the 1892 and 1898 Sanborn Maps. The 1923 indicates the carriage barn was no longer extant. The 1939 Sanborn Map shows the same house listed previously listed as 119-1/2 also with a 115 address. The city directories had been listing the property as "115 rear" since at least 1908. (The 119-1/2 address really does not make since, with 119-117 adjacent to the west; 115 should be correct.) Porch faced West Dunklin Street. One story wing at west end toward rear. One story narrow outbuilding on narrow lot. (Only the rear-most bay of the current building appears to remain from this house.)

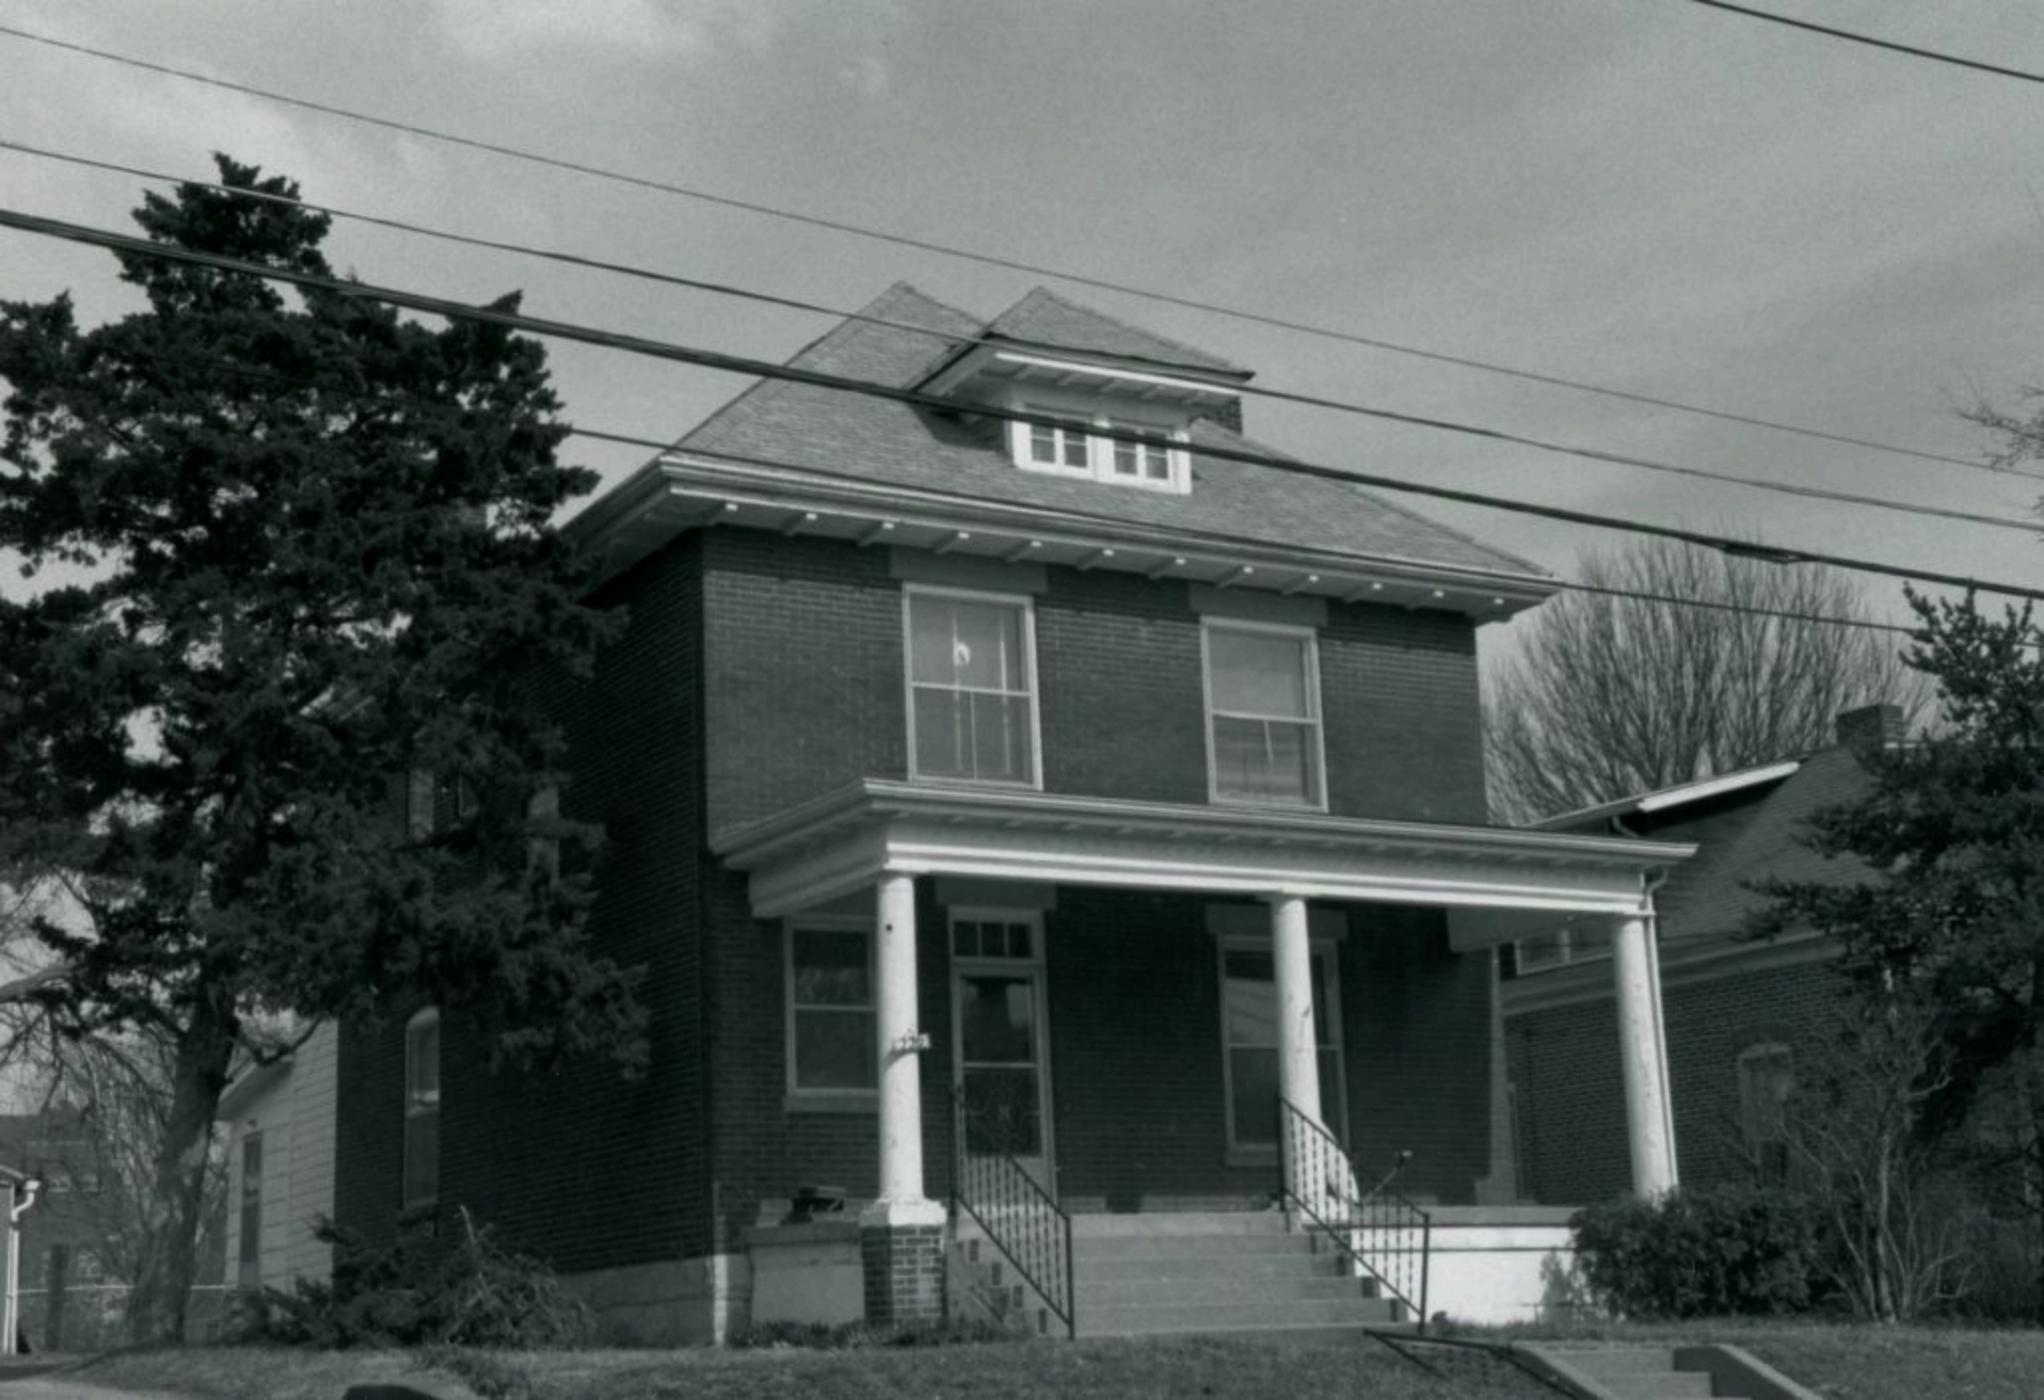
2-1/2 stories. American Four Square style. Rectangular plan. Limestone foundation, brick walls. Hip (asphalt shingle) roof. Asymmetrical first story facade with door with 3-light transom off-center (to west) and shorter 1/1 in west end bay, larger 1/1 in east end bay; full-width flat roof porch with poured concrete dec, three Doric columns, decorative patterned wide frieze and modillion cornice; second story with two large 1/1 windows, overhanging boxed eaves with plain modillioned cornice, hip roof dormer with paired 4-lights and similar eave treatment. Windows as 1/1 double hung with stone lintels and lug sills. West elevation with central stair window and 1/1 windows to rear on each story, 2-story frame (artificially sided) rear wing with single second story window, added shed roof 1-story frame addition beyond. East elevation with interior end chimney and semi-hexagonal 2-story bay. Small rear frame wing with second story wing on top. Appears as if a historic porch was removed.

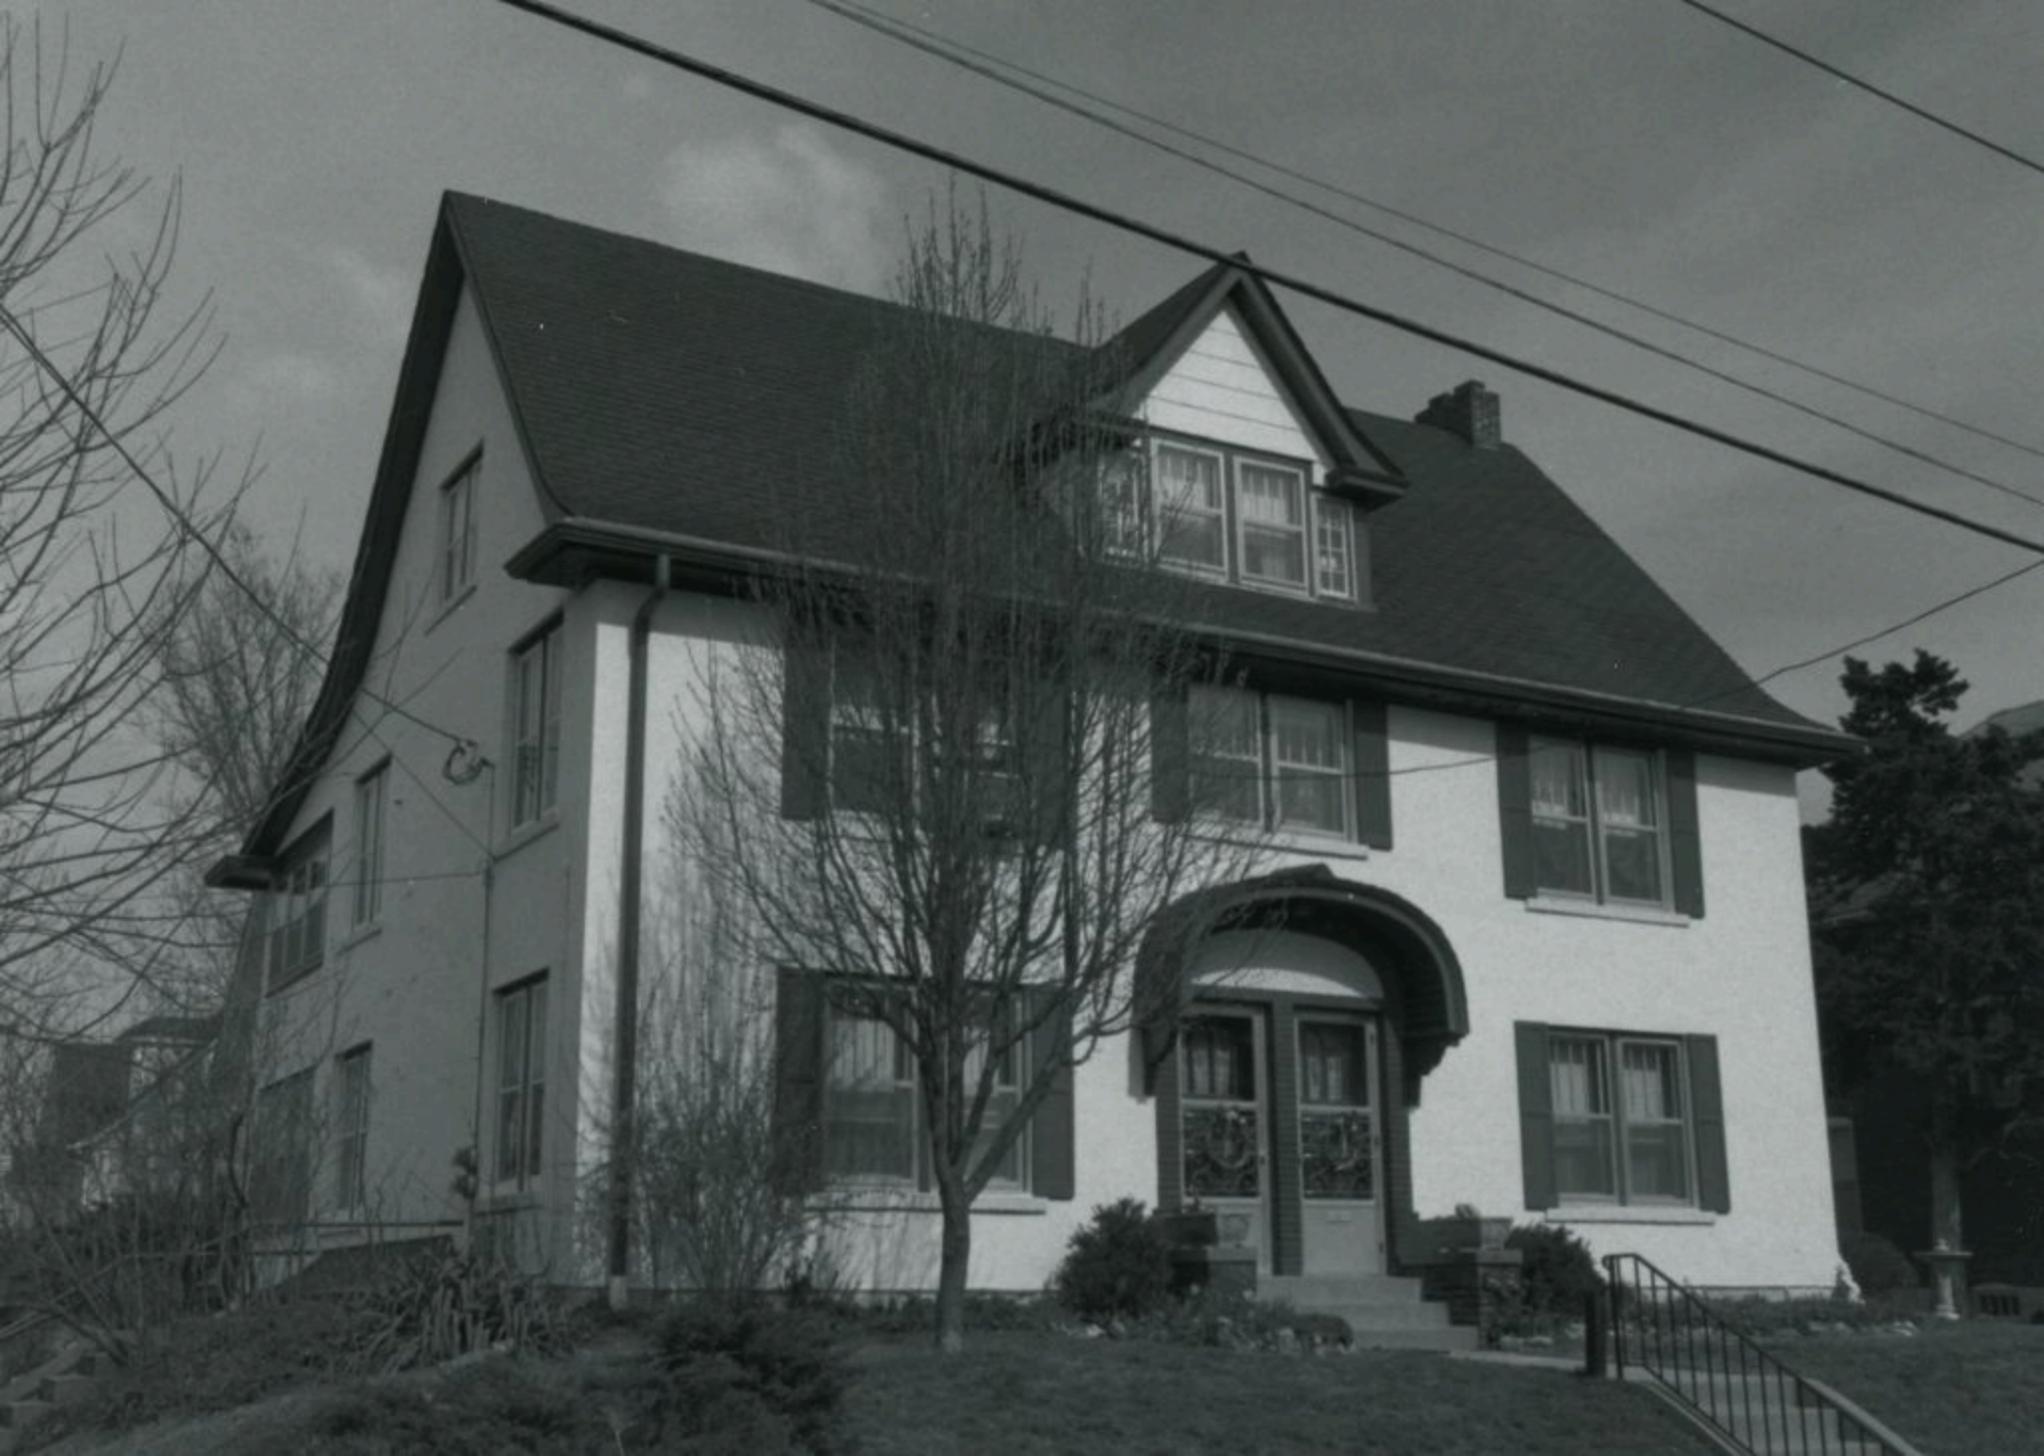
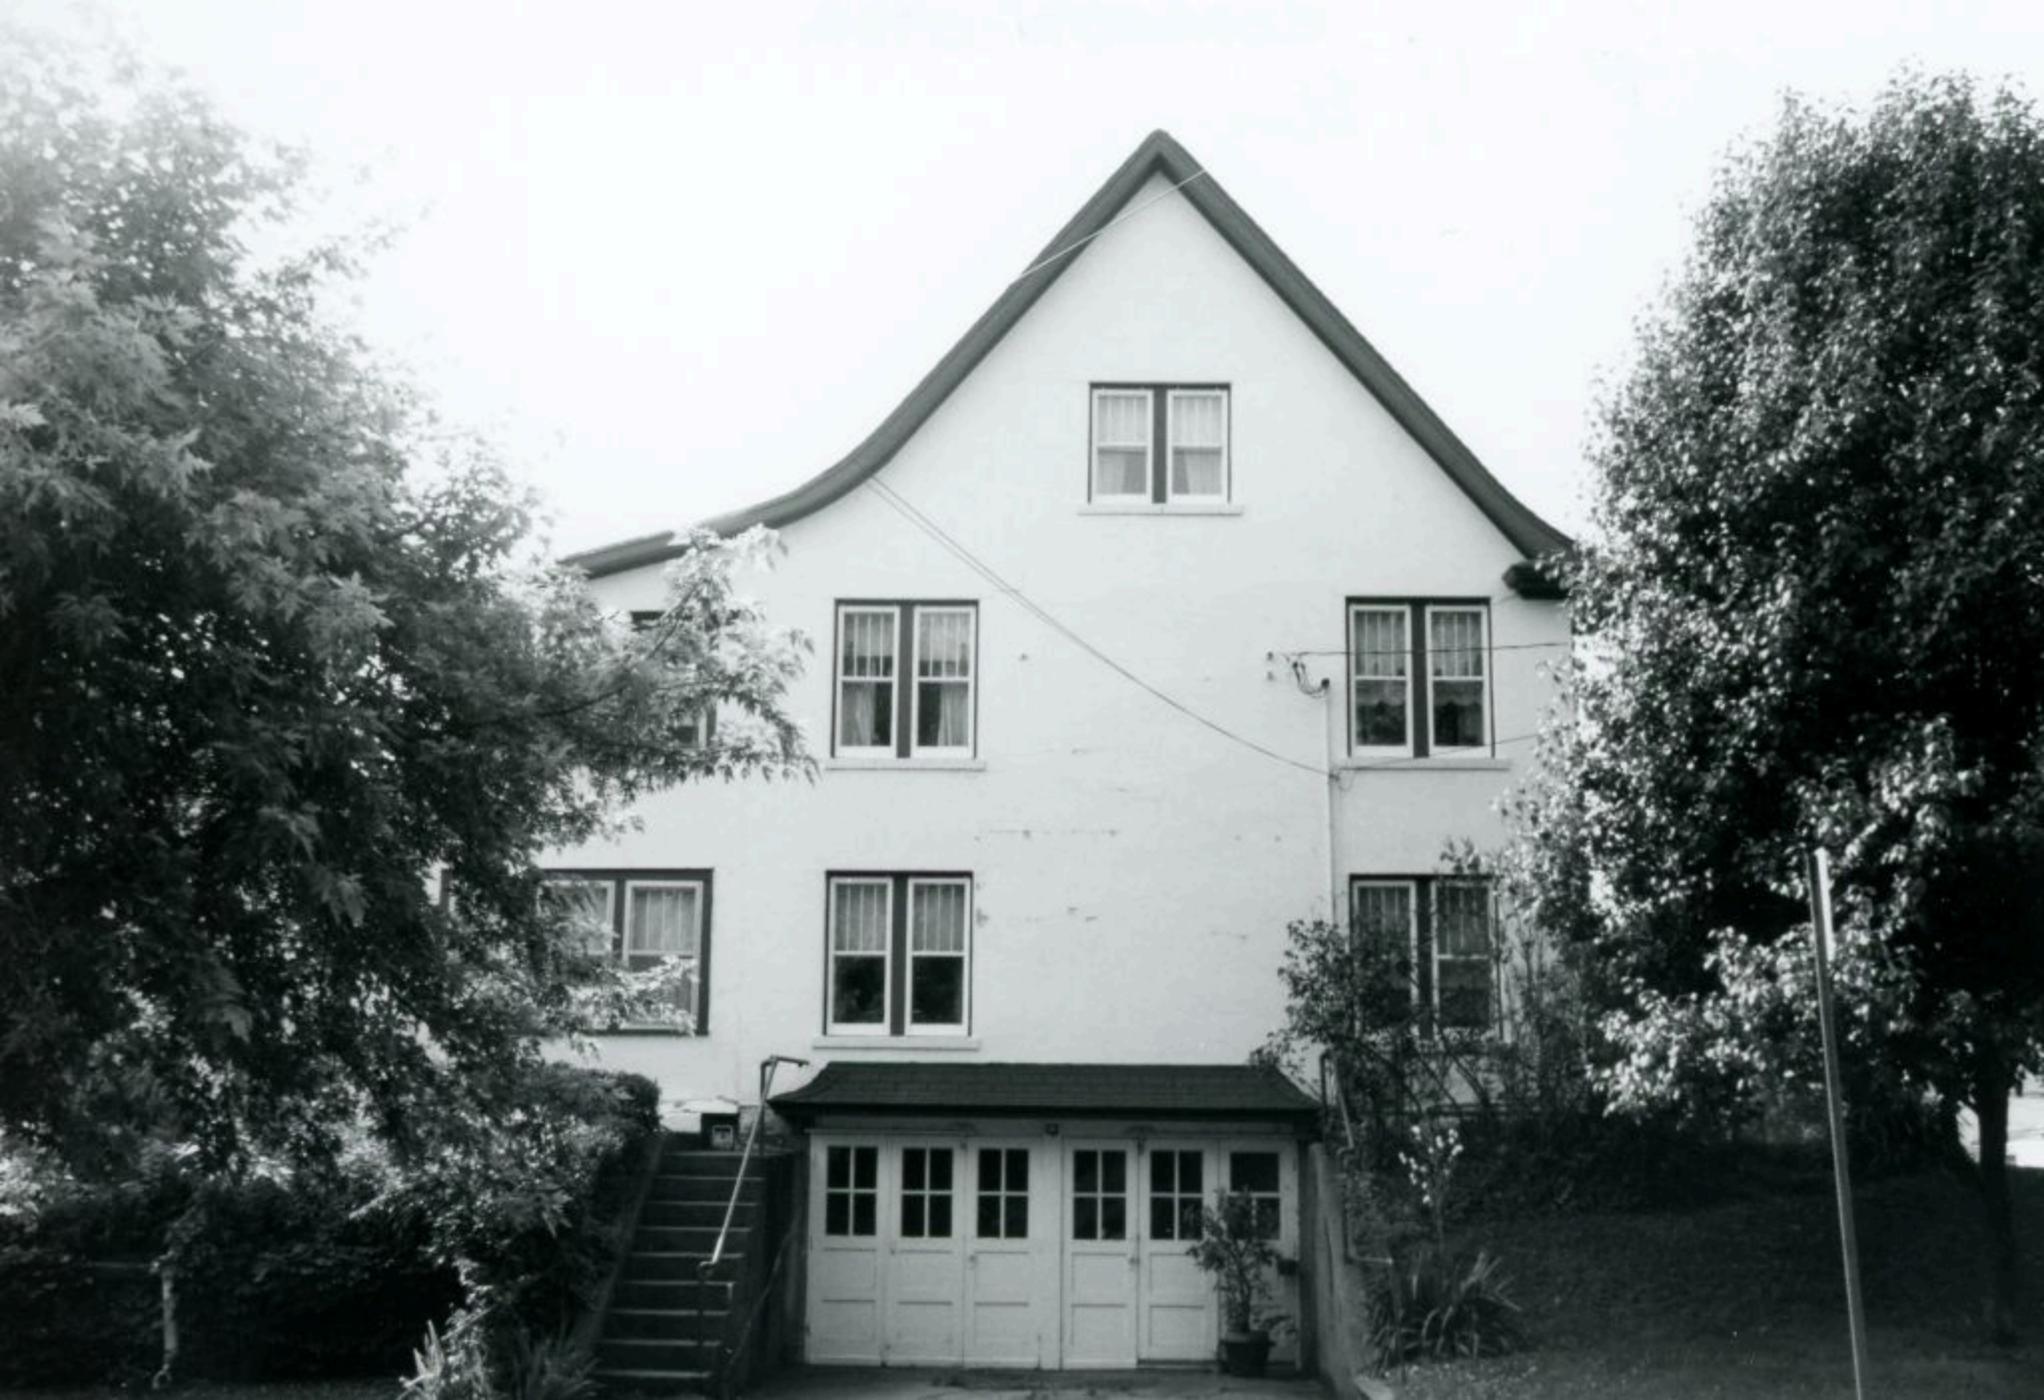
2-1/2 stories. Former German vernacular church altered historically to English Revival two-flat c. 1927. Rectangular plan. Limestone foundation, parged in parts. Stucco walls. 4 vertical/1 double hung sash with stone sills, occurring most always in pairs. Side gable (asphalt shingle) roof. Central double entrance with 3-light doors grouped with single stretcher "piers" and header top with patterned stucco blind transom and soldier segmental arch under curved entrance hood with curved open bed; asphalt shingle "finial." Three concrete stairs with brick cheek pieces and limestone caps. Three bay facade with paired windows in end bays, both stories; short pair above entrance bay. Belcast gable roof dormer central facade with cornice returns. Window pair with 8-light fixed sash or casements framing the pair. Side cornice returns on main gable. Narrower paired elevation windows. Exposed basement west/Broadway with double car basement garage, both with historic three-part, four-light garage doors. Flared pent roof over garage bay. Poured concrete exterior stairs lead to raised first story this elevation. (The side gable on the west is the original church entrance, as seen in a historic photograph.) Shed 3/4 rear enclosed sleeping porch with sets of three 4 vertical/1 side/west and rear/north. East interior end chimney. East elevation windows in singles, with smaller upper half story windows as on the west. Excellent condition; exceptionally well-maintained.

Recommended for potential local landmark designation. The building is historically significant within the development of this German neighborhood. While the Church is really only detectable with prior knowledge, the duplex "renovation" itself is now significant. The house remains occupied by a first generation German American whose parents settled in "Munichberg;" it has been in the Walter Schroeder family since the late 1920s.
