HISTORIC SOUTHSIDE COMMERCIAL AREA

MISSOURI HISTORIC PROPERTY INVENTORY FORM

REFERENCE NUMBER CO AS003-001		A. HISTORIC NAME					
B. COUNTY 054 Cole		C. OTHER NAME(S)					
D. ADDRESS 102 East Ashley Street			E. CITY Jefferson City		F. VICINITY <input type="checkbox"/>	G. RESTRICTED	H. ACREAGE

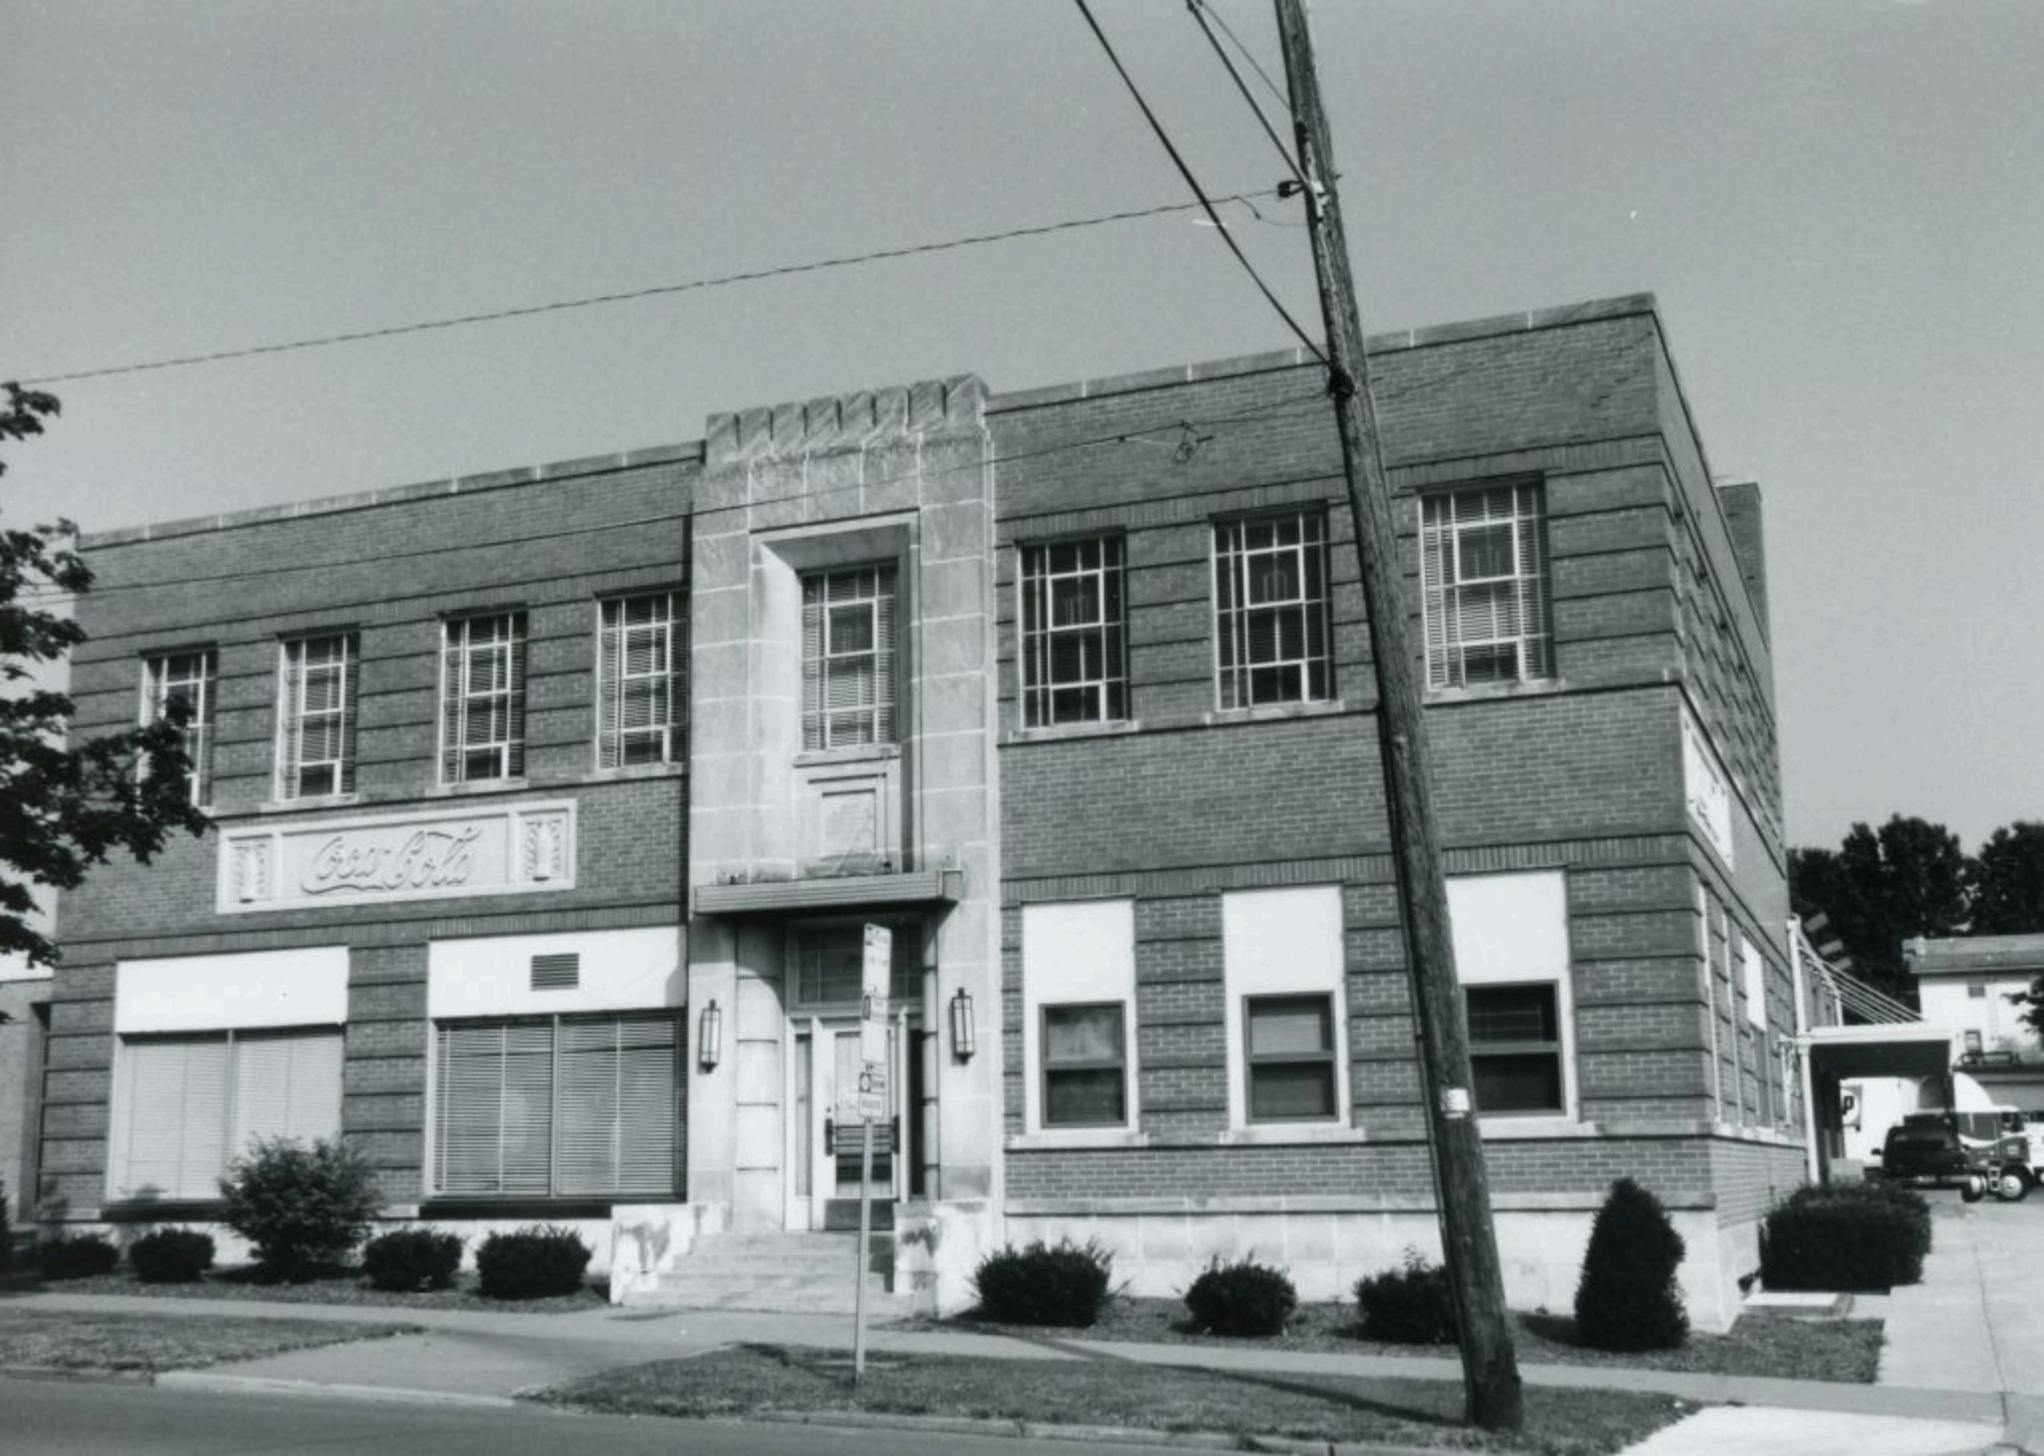
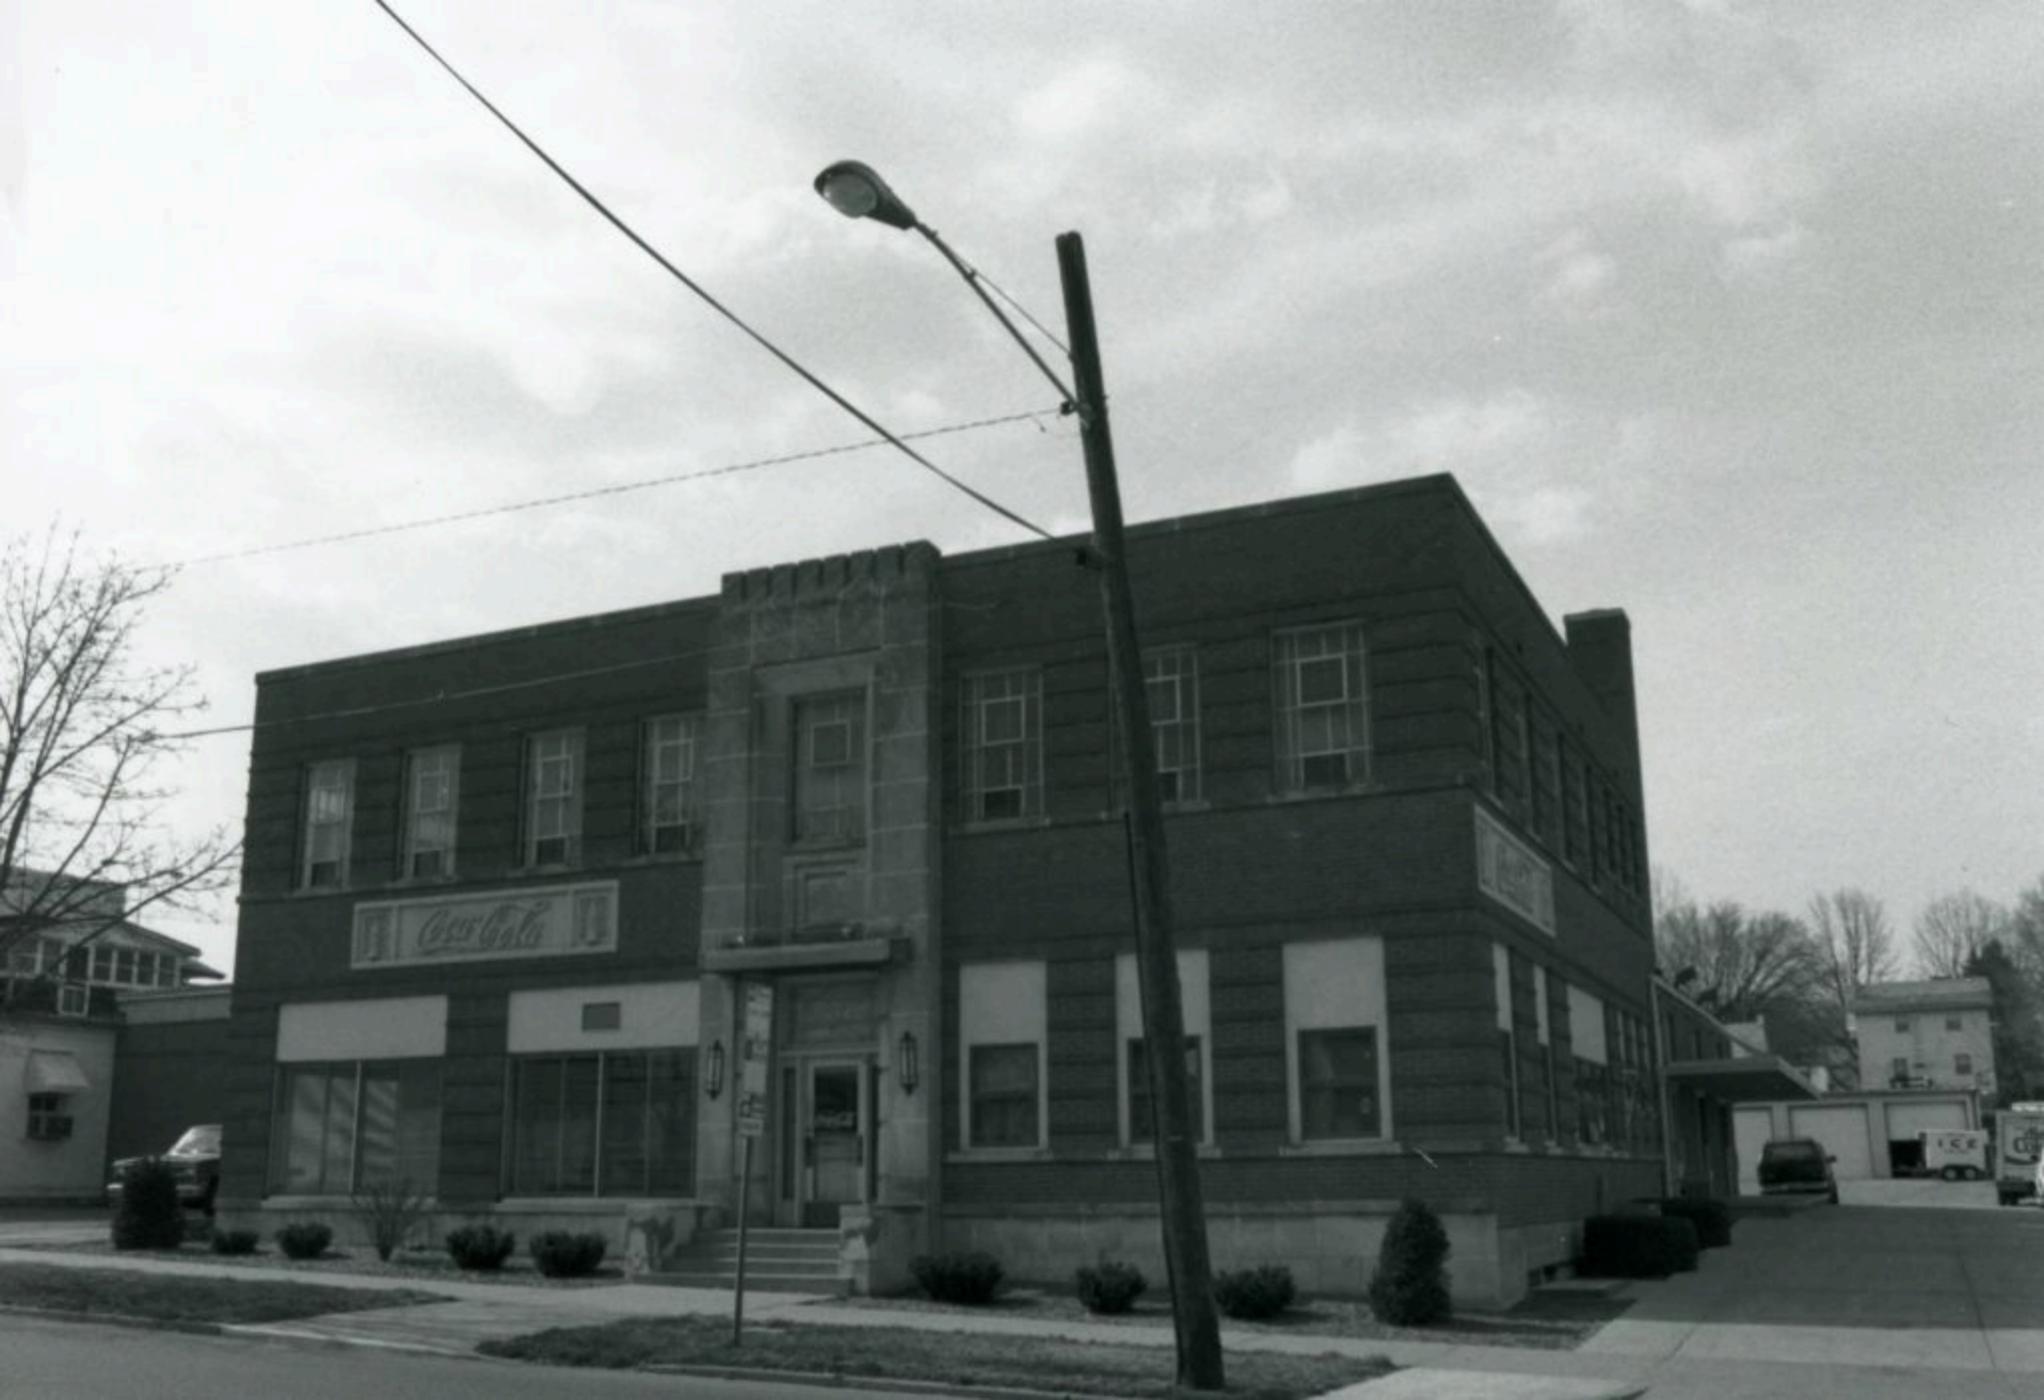
Two stories. Moderns Coca-Cola prototype building. Rectangular plan with additions. Six bay asymmetrical facade. Multi-light industrial sash with awning paneled, concrete continuous sills; some altered. Concrete foundation is limestone faced in the front; yellow brick walls. Projecting limestone watertable. Shed (composition asphalt) roof. Entrance off-center to right/north set in two story limestone shallow pavilion with battlement-like effect at parapet. Pavilion with curved walls to door with sidelights and multi-light transom. Flat metal canopy above with inset panel above reading "Erected in memory of Jacob Moerschel and Honor to Ernst C. Moerschel A.D. 1941." Triple inset panel frame with multi-light industrial sash above in beveled frame within two story entrance pavilion. First story (and second story) with raised stretcher courses (five) with sash topped by soldier course framed with additional raised stretcher course on top/bottom. Right/north with three sash symmetrically placed on both stories. Those windows on second story original; first story infilled with wood and smaller 1/1 double hung sash, but importantly the openings are evident. Longer section to left/south of entrance pavilion with four original second story windows intact. The bays below have been altered from four to two, with double storefront sash with blocked transom space with inset vent over the one on the right window (just left of the entrance pavilion). Between the two stories on this section is an inset limestone Coca-Cola panel with bottles at each end detailed even with "Trademark Registered in Contents 6 oz." (see photo 6-28) with fanned Deco background behind the bottle. The central section of the panel reads "Coca-Cola" in the trademark Coke script. The facade treatment continues on the south elevation with single storefront sash and an industrial sash above. A recessed wing of similar brick is to the south, presumed to be a later addition, but well done. Continuous soldier courses from first story of main building; corrugated metal "cornice." Large garage openings and pedestrian door face front/ east. North elevation with sign panel in the first (south) bay as on the front, for the benefit of the Whitton Expressway traffic. Again, the first story sash have been altered and those on the second story are intact; rear chimney. One story original rear wing flush with north elevation; some infill of fenestration, but original openings are clearly evident. Rear with two concrete block additions c. 1965 and c. 1975, not visible from Jefferson Street.

Setback from the Rex Whitton Expressway by drainage ditch/Wears Creek. Concrete driveway north accessed rear storage/warehouses. Billboard on roof aimed toward the expressway. Alley to south, off end of modern rear addition.

The first story replacement windows are unfortunately, but repairable, alterations to this good example of the Coca-Cola Company's prototype bottling works of the early 1940s. Overall, the building retains a good degree of integrity. It is the neighborhood's only example of the Moderns style, and is a visual landmark off the Rex Whitton Expressway and the Jefferson Street entrance into the neighborhood. The building's dedication and tribute to the Moerschel Brothers, who once held ownership in this establishment, is appropriate, as their Capitol Brewing Company once occupied much of the East Dunklin Street side of this block. The only remnant of that earlier era is the companion Western Bottling Works at 610 (and 608).

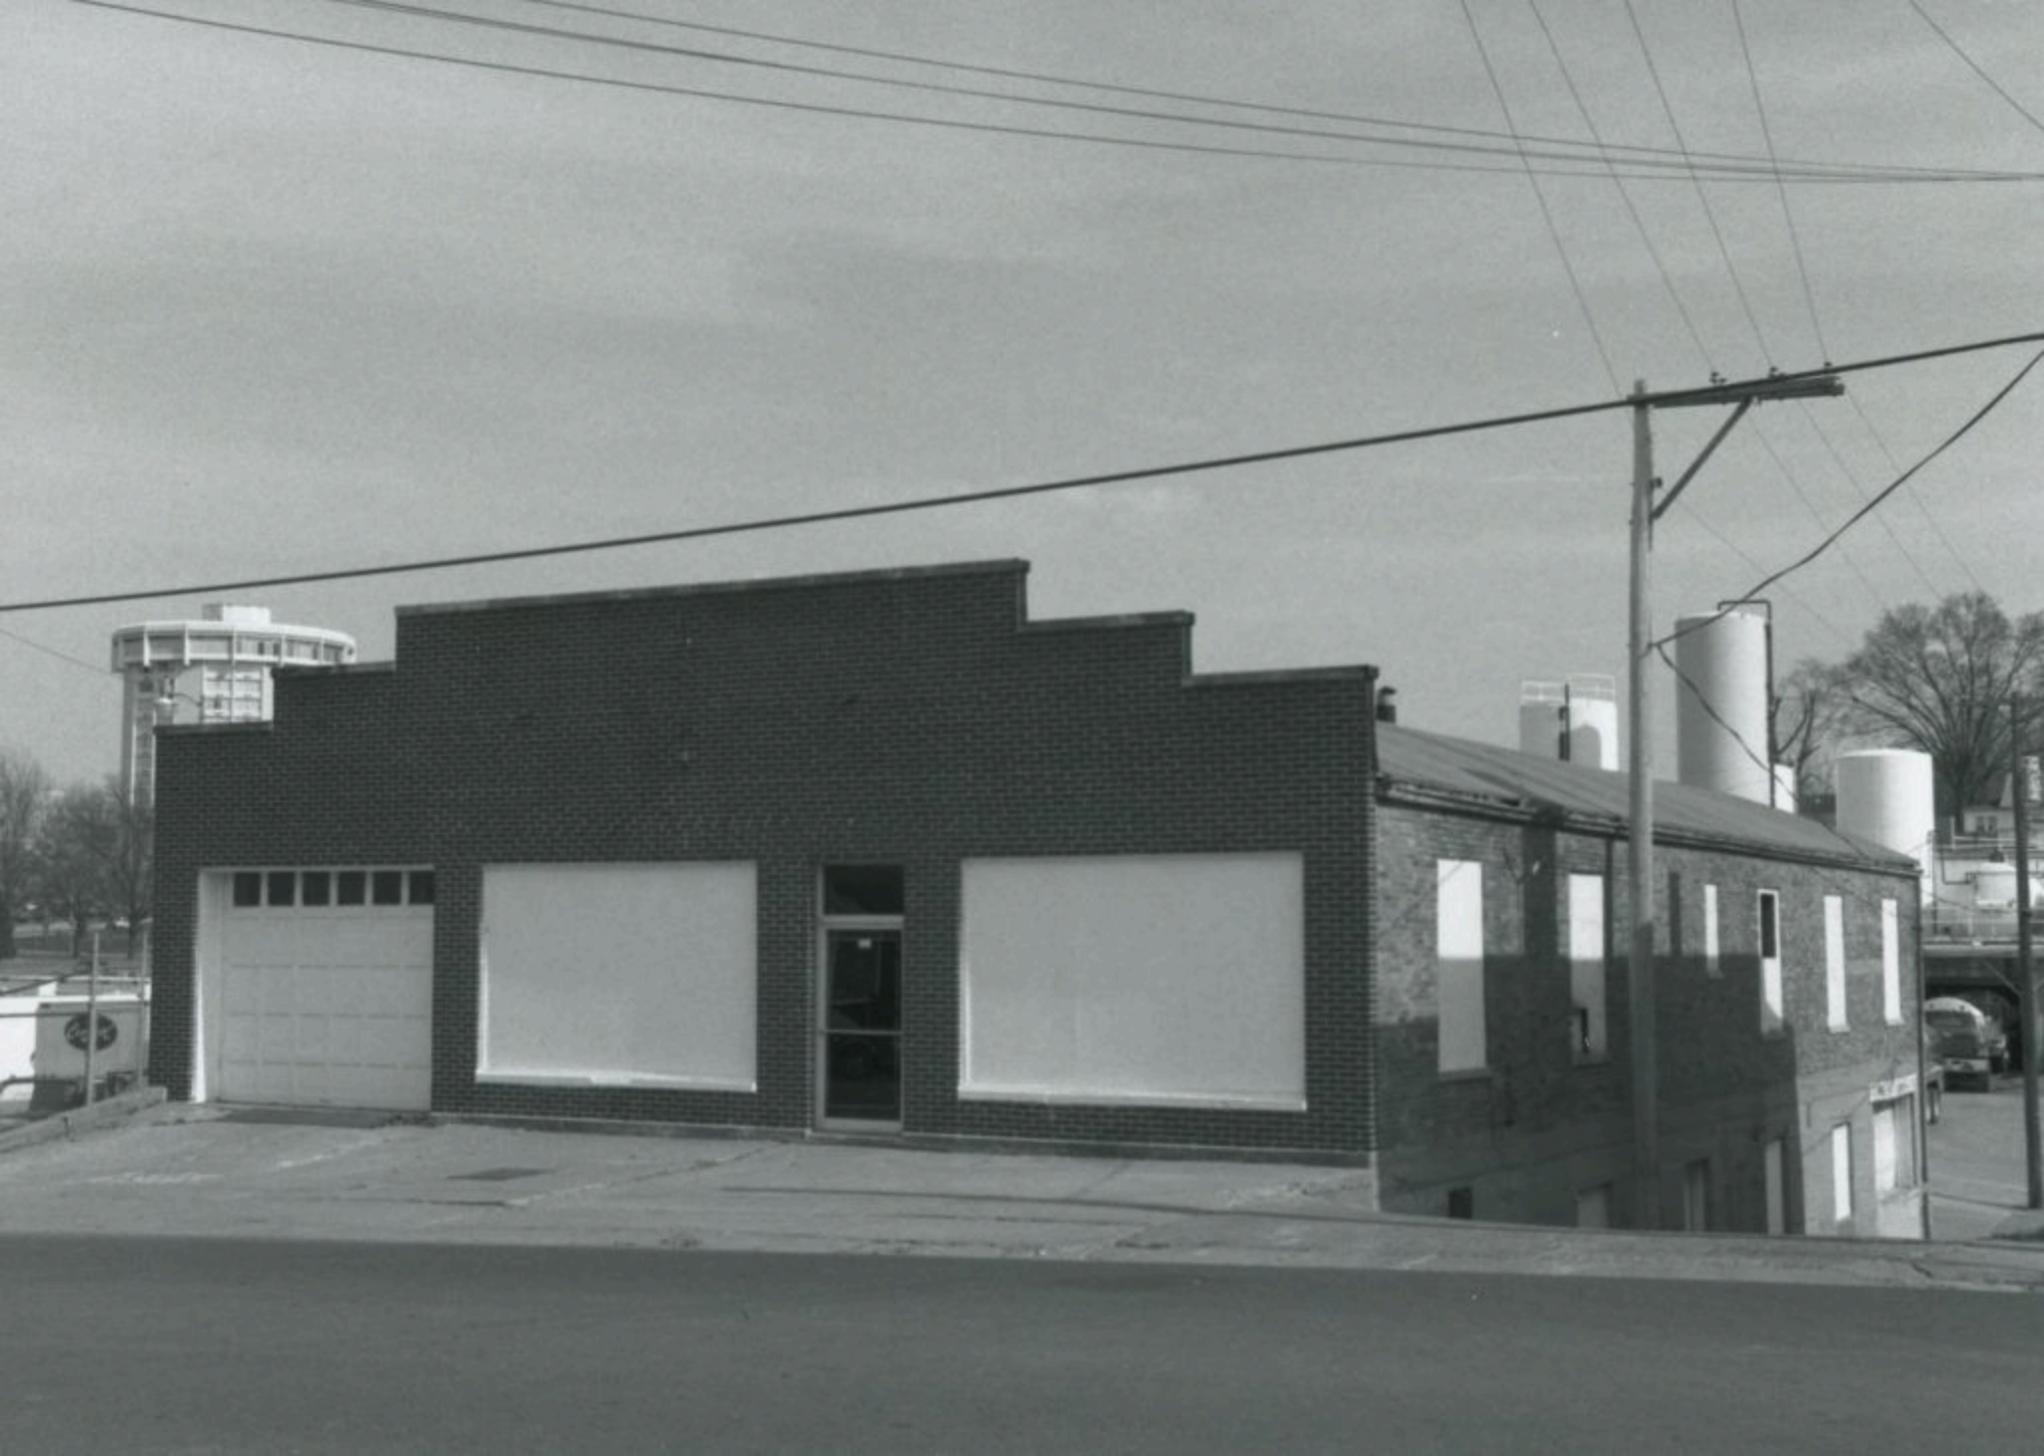
1 story. no style or type. rectangular plan, 4 bay asymmetrical facade. concrete foundation, brick (wire cut on facade, running bond) walls. curved (metal and tar) roof. off-center (to south) modern aluminum frame door with transom and flanking large boarded display windows, north bay with overhead garage door; stepped parapet with concrete coping. window openings all blocked; concrete sills. north elevation ground drops away to expose concrete basement with six at-grade square openings, 1st-story with six blocked openings. south elevation at alley, ground drops away to expose basement with four blocked square openings, raised loading dock at east end; 1st-story with six blocked openings.

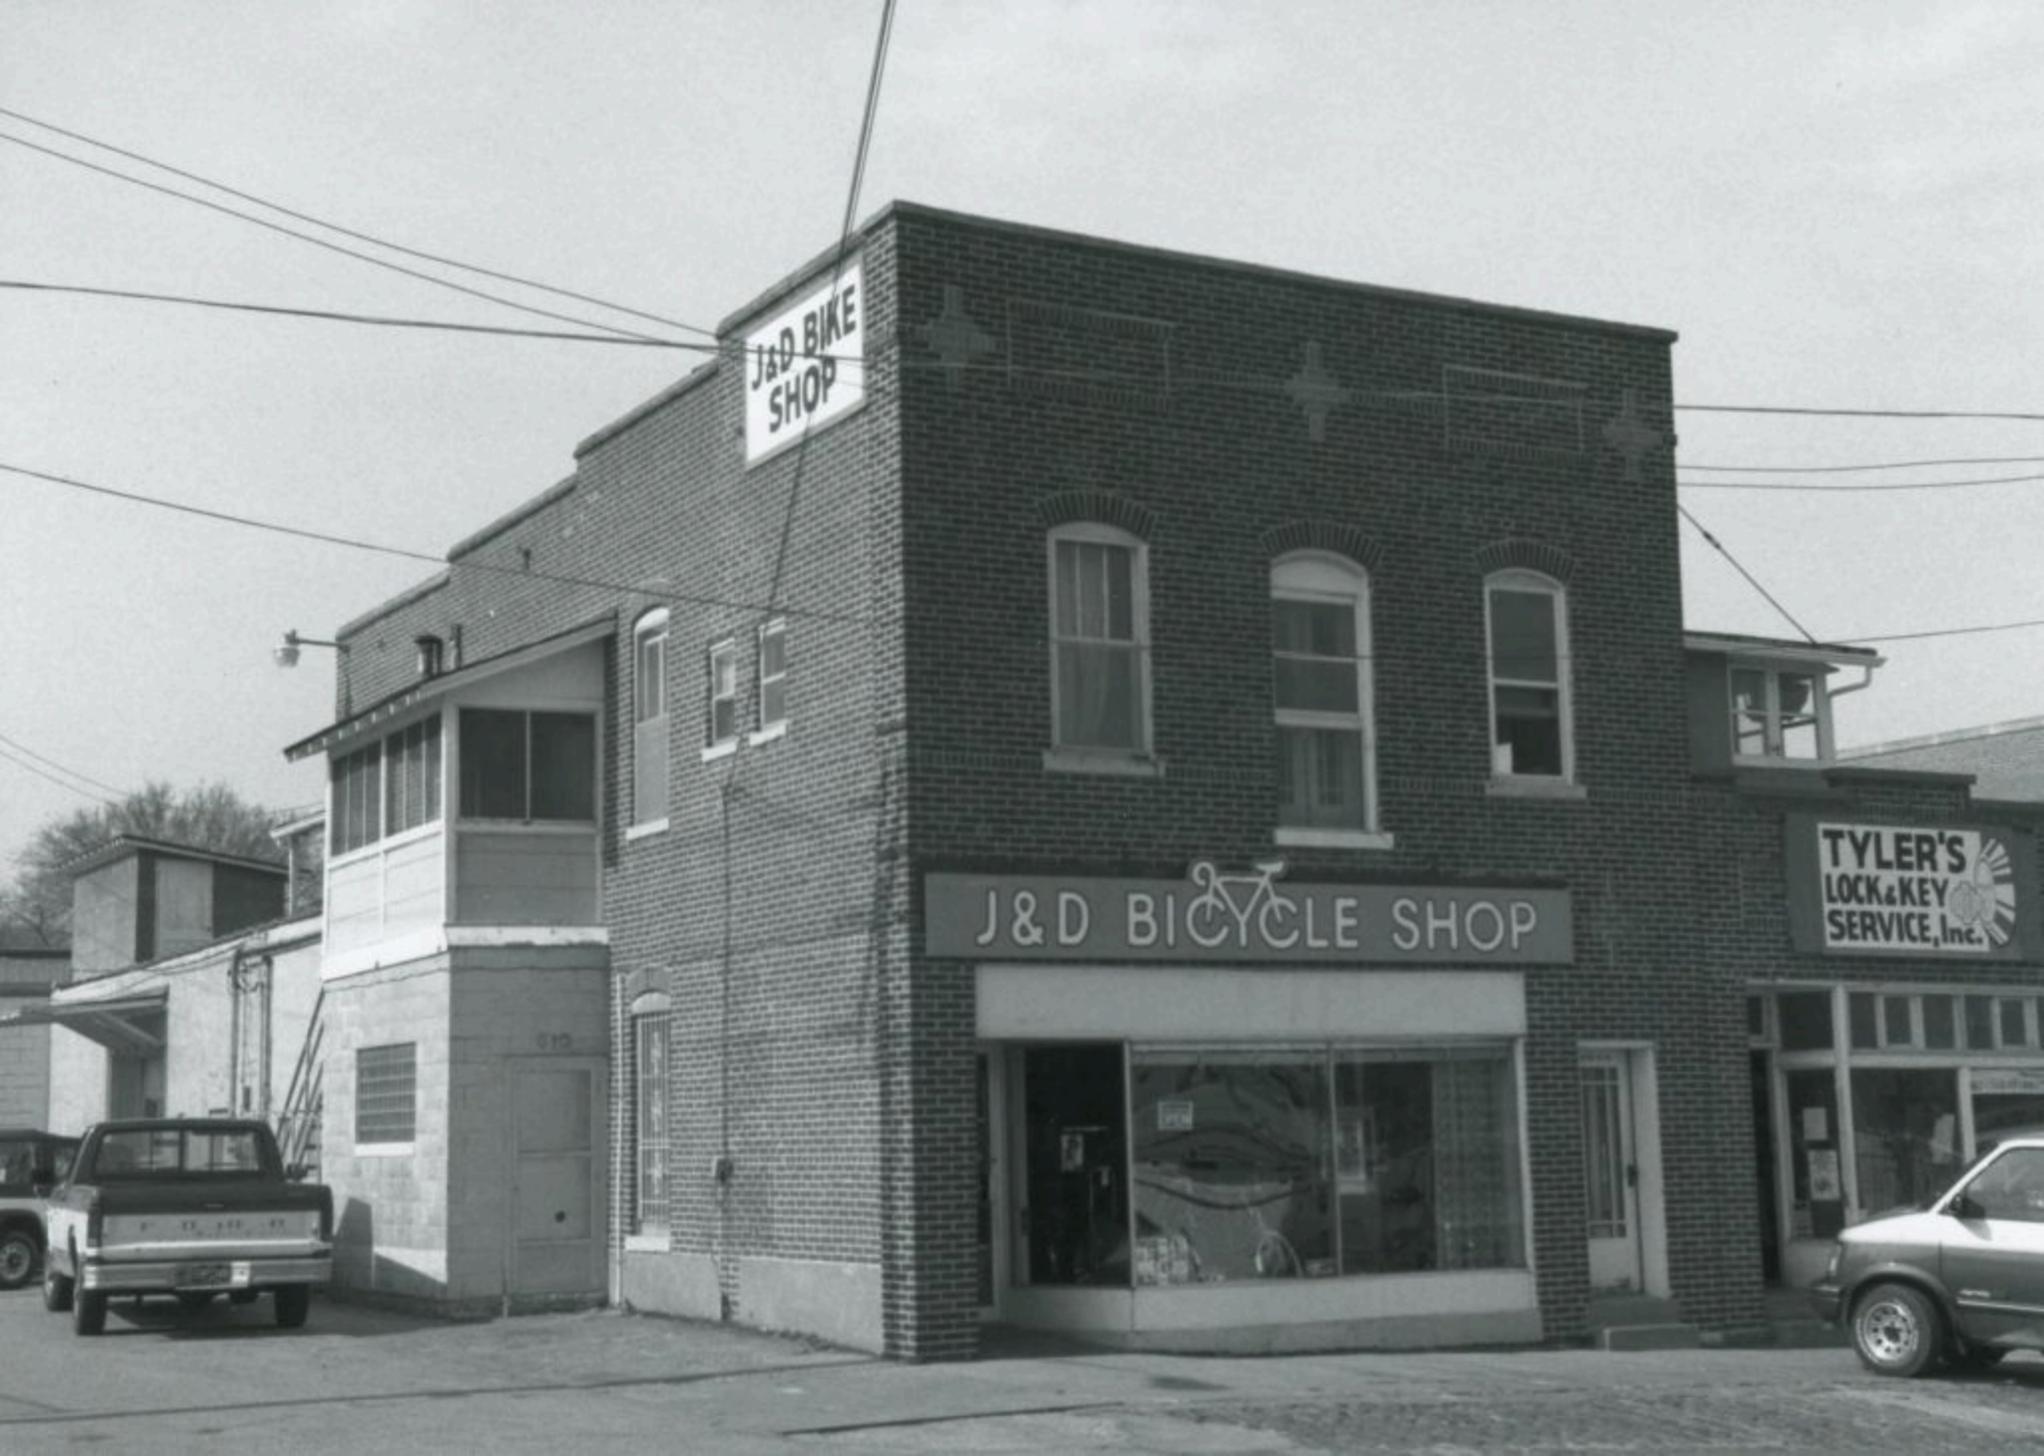
2 stories. Late nineteenth century commercial building with rectangular plan, two bay facade. Foundation not visible; brick walls (unpainted). Shed (composition asphalt) roof. Facade brick appears to be a c. 1925 brick applied to the older building; mottled wire-cut brick. Single storefront with deeply recessed left door, angled storefront sash, and two storefront sash, all with a blind transom; plain bulkhead. Sign panel attached to brick above. Right/north end bay with multi-light staircase door. Second story with three symmetrical bays: central multi-light French door pair with inset iron balconet concealed with modern storm/screen (see photo 2-26). 3 vertical/1 and 1/1 windows in end bays with stone lug sills and a continuous header beltcourse at the sill level. All three bays with soldier course segmental brick arches, plain window heads. Parapet with two header panels framed by yellow wire-cut cross patterns at center and ends. South elevation reveals earlier building with different brick, with some 2 vertical/2 vertical double hung sash; soldier course segmental brick arches. Stepped parapet, side elevation. Two story single bay added with concrete block (painted metallic silver) first story: frame second story (second story porch or apartment entrance, with exterior lot stairs from the rear); exposed rafter tails. Garage door (with flat roof canopy) opens to alley; pedestrian door and mixed fenestration on south elevation. North elevation with two low-pitched gable porch-like features off the second story onto 608's roof (appear to be c. 1925). Insul-brick clad; storm windows enclose.

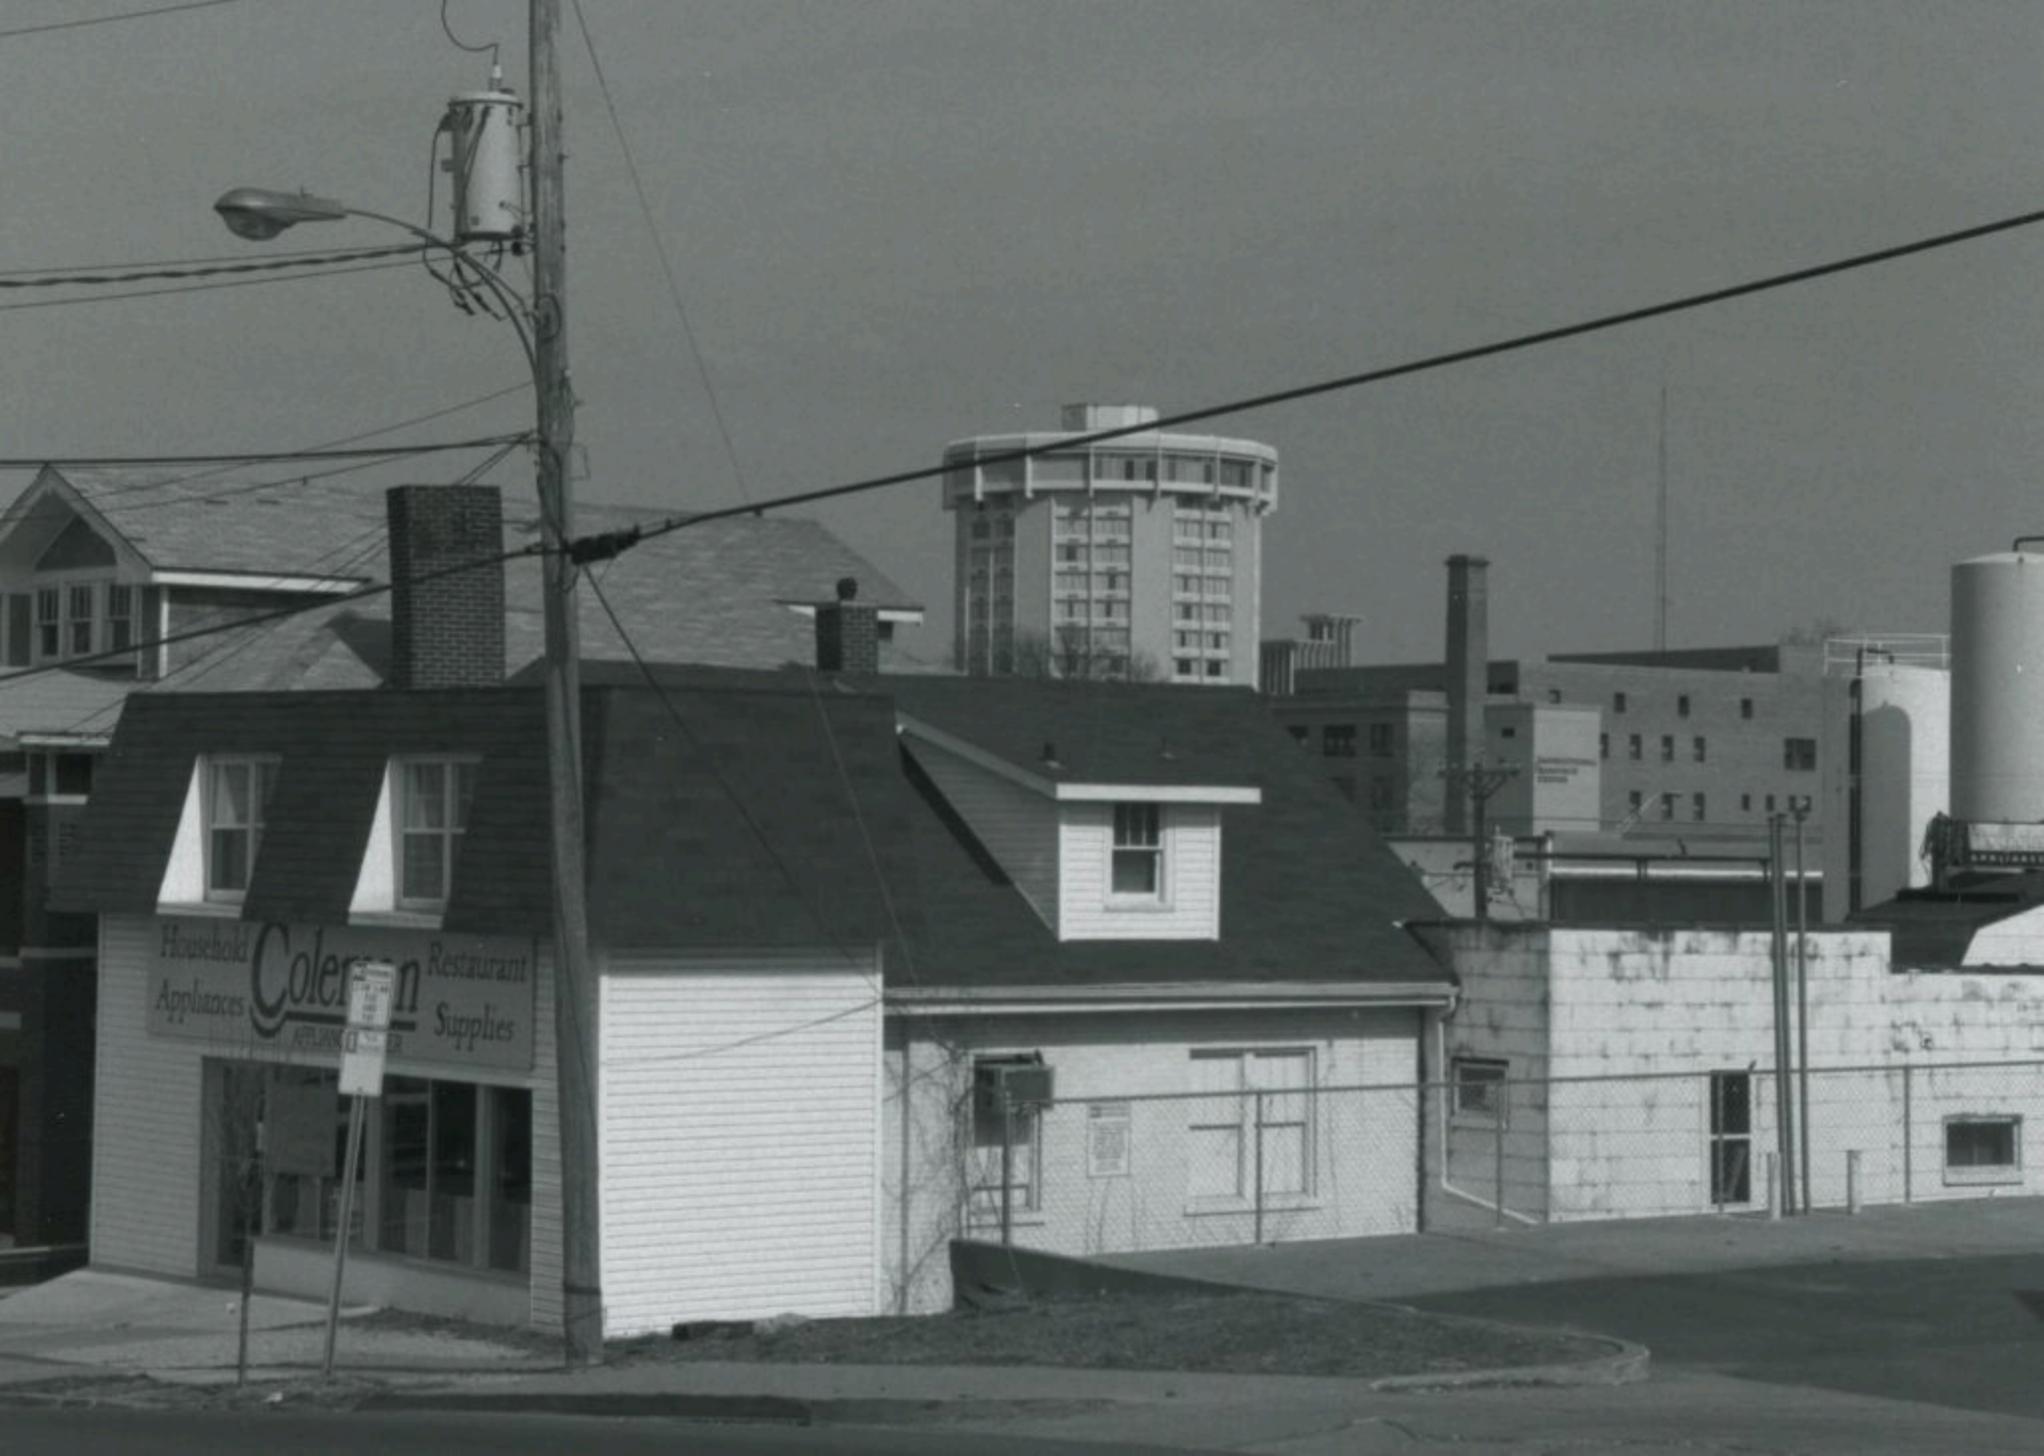
1-1/2 stories. no style or type (core was Bungalow vernacular type), irregular plan, asymmetrical facade. concrete and concrete block foundation, brick (wire cut, partially painted) and artificial sided walls. gable and "Mansard" (asphalt shingle) roof. artificially sided facade addition with modern entry to north and large 5-light modern display window to south, large sign above; upper story with modern "Mansard" roof with two sets of recessed paired modern (1/1, 6/6) windows, overhanging artificially sided eaves. windows as 3-vertical/1, modern 1/1 and 6/6 double hung; awning windows. south elevation with modern facade addition returning for one bay; historic brick Bungalow core recessed in center, exposed basement with two windows, truncated (no stack) exterior chimney to west, central blocked opening, paired windows to east, artificially sided shed roof dormer with single window; large concrete block and asbestos shingle 1-story with basement addition projecting to south on rear (east), basement with three multi-light industrial awning windows, 1st-story with 1/1 window to west, four 1-light awning windows to east. north elevation with modern facade addition returning for one bay; exposed concrete basement of red brick Bungalow core, two 1/1 windows on 1st-story, overhanging boxed eaves, similar shed roof dormer; concrete block and frame addition on rear with various sized and placed openings, tile coping. rear with 2-story (at-grade basement and 1st-story) frame (asbestos shingle) and concrete block shed roof addition; large overhead garage door to south, at-grade pedestrian door to north, 1st-story with off-center pedestrian door and flanking 2-light rectangular windows; frame penthouse roof access to east; residential core gable with paired openings, artificially covered.

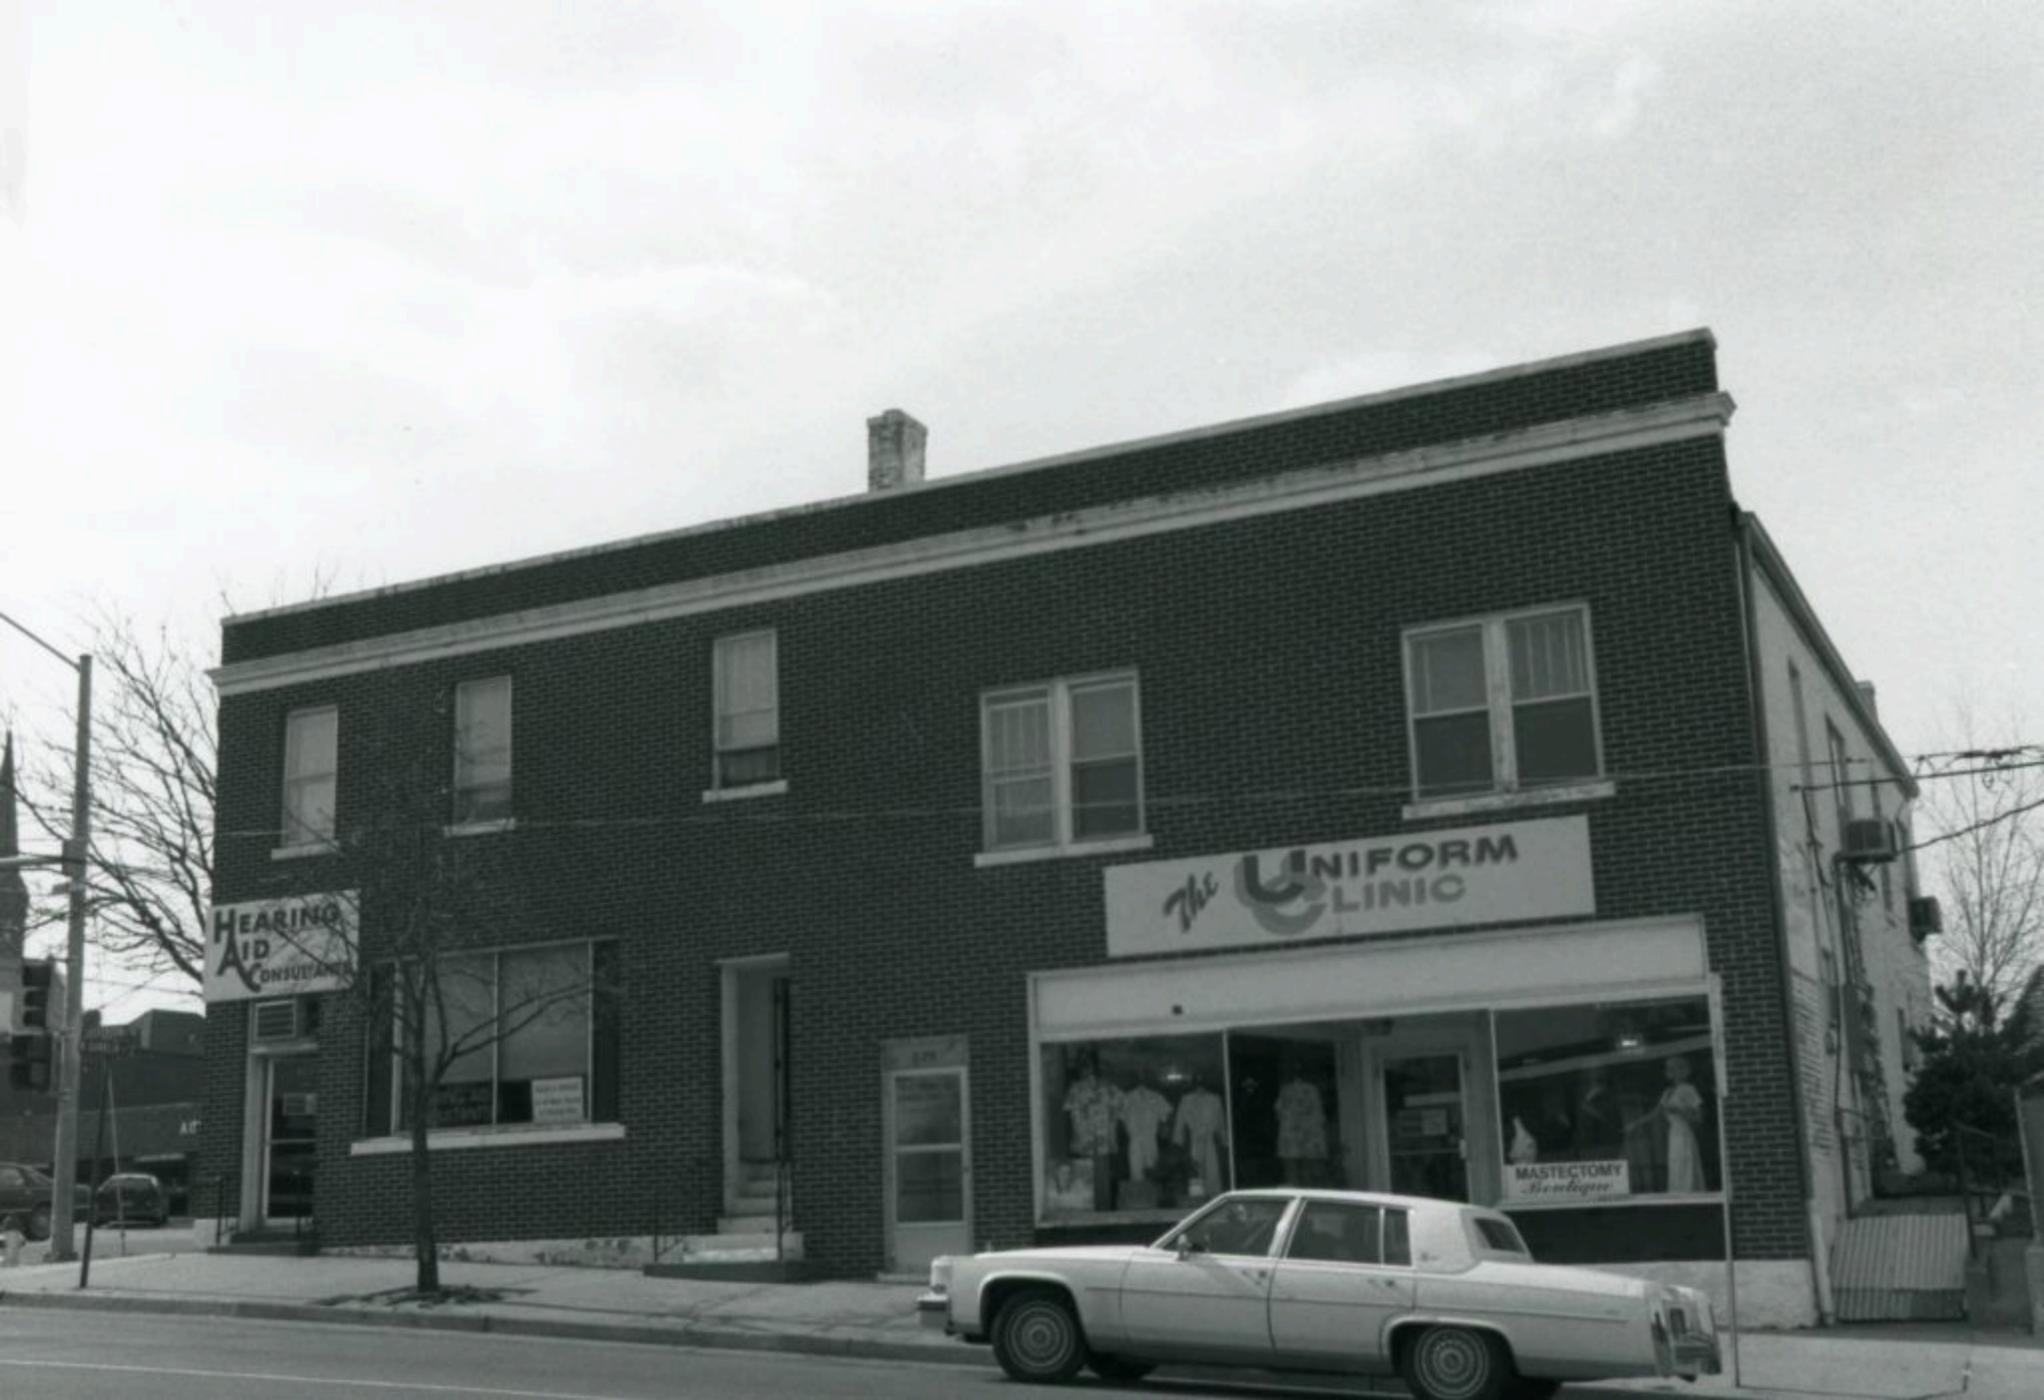
2 stories. rectangular plan, no commercial style or type, asymmetrical facade. coursed stone (painted) and concrete foundation, brick (wire cut, running bond) walls. shed roof. Jefferson Street facade steps down grade to north; south end (#628) with modern aluminum frame entry with transom and large 2-light display window framed by modern blinds with concrete sill to immediate north; two central entries, south: deeply recessed entry to hallway and staircase to 2nd story, exterior steps with curved metal railing, north: recessed 1-light with storm door at-grade entry; north end (#626) with center angled recess with modern entry and flanking large 1-light display windows, parged (painted) bulkhead, wood transom/blind sign panel above; 2nd story with three windows on south half, two sets of paired windows on north half (placed lower on facade); molded wood cornice, brick parapet with concrete coping, center interior end furnace chimney. windows as 4-vertical/1 and 1/1 double hung, concrete sills. Dunklin Street with central entry with transom, paired 1/1 to east, 1/1 and small 1/1 to west; 2nd story with five windows, triple windows at west end; parapet and cornice on east three-quarters only. north elevation painted brick with four blocked square openings on 1st story, 2nd story with single and paired windows, bulkhead to basement in northeast exterior corner. rear with smooth brick, raised concrete sidewalk along building, three blocked square openings on 1st story; 2nd story with raised concrete platform supported on three concrete columns, metal pipe railing, north side concrete steps; center entry with three sets of windows to south, entry toward north with flanking paired windows; south half with shed roof sloping to rear, north half with shed roof sloping to north.
