HISTORIC SOUTHSIDE COMMERCIAL AREA

MISSOURI HISTORIC PROPERTY INVENTORY FORM

REFERENCE NUMBER CO AS003-001		A. HISTORIC NAME					
B. COUNTY 054 Cole		C. OTHER NAME(S)					
D. ADDRESS 102 East Ashley Street			E. CITY Jefferson City		F. VICINITY <input type="checkbox"/>	G. RESTRICTED	H. ACREAGE

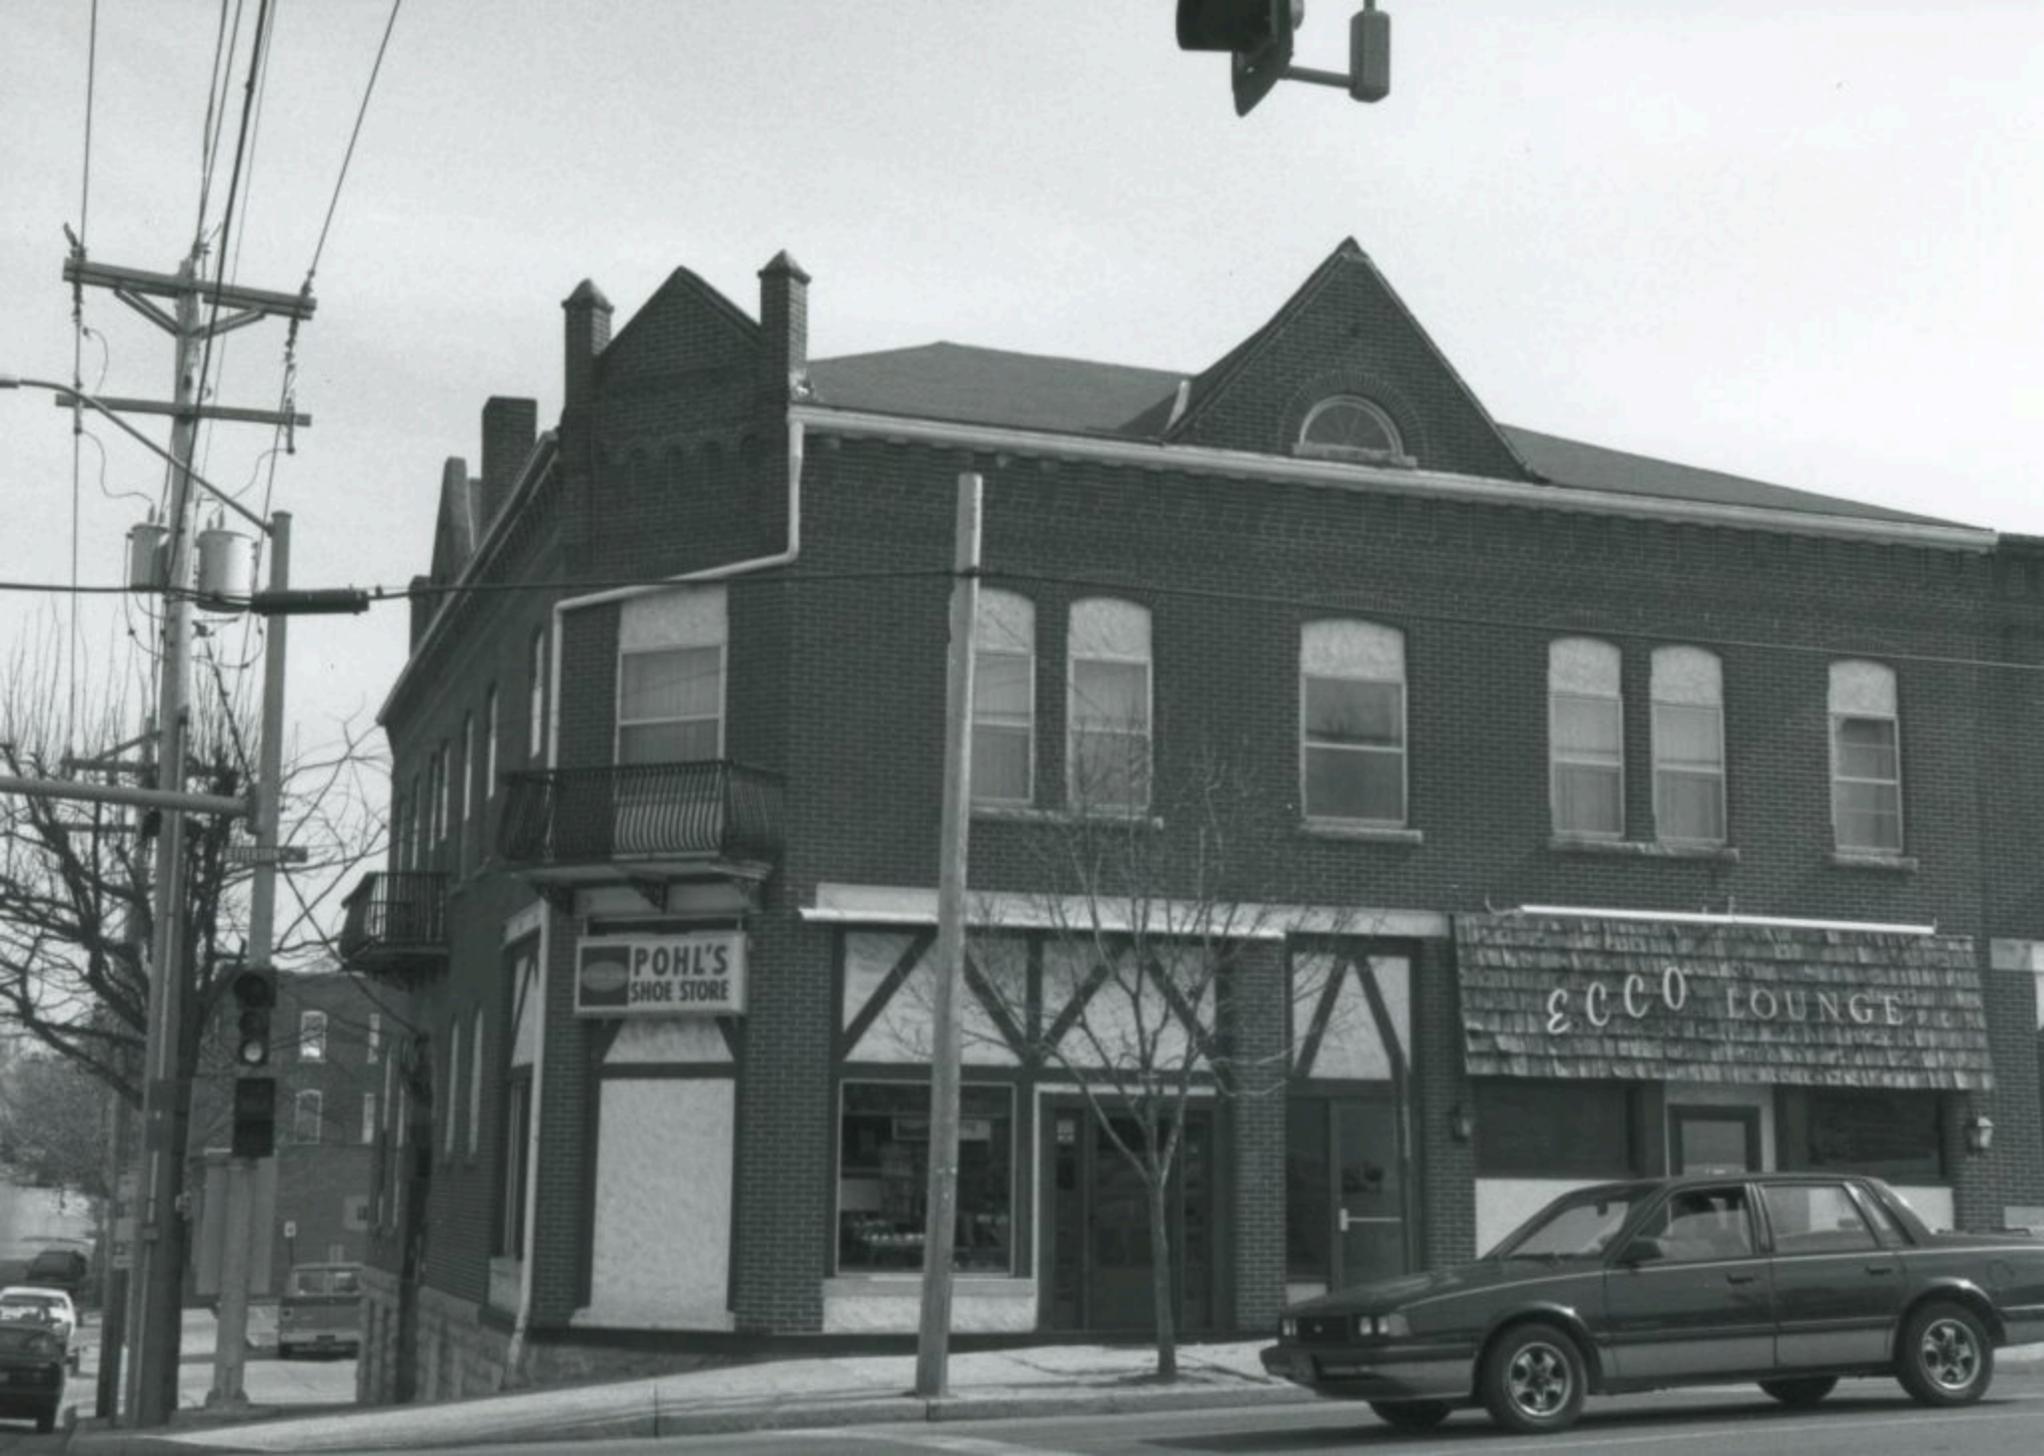
2 stories. L-plan, corner entrance type. coursed stone foundation with watertable, brick (running bond) walls. truncated hip (asphalt shingle) roof. angled corner with original entry infilled with rough cast stucco and applied "half-timbering," original metal sill plate and flanking brick piers, metal lintel; 2nd story with modern 1/1 window with stucco infilled upper and lower portions, iron balcony with wood deck supported on decorative metal brackets; corbelled cornice, pediment with triangular parapet between small square pinnacles. East Dunklin Street elevation slopes to east exposing stone basement with two 1-light square sash to east, three blocked openings to west; six bay 1st story with (from west) display opening with modern 2-light window, stucco and "half-timbering" infill, metal lintel; two small high round arch stucco infilled openings; large round arch entry opening (to grade) with stone voussoirs and keystone infilled with stucco and modern mechanical systems, triple rounded brick panels below impost; narrow round arch infilled opening; narrow round arch opening infilled with small modern 1/1 and stucco. 2nd story with seven modern 1/1 windows with infilled upper third; large iron balcony (same design) above central entry opening with paired entries converted to modern 1/1 windows; entablature with corbelled architrave, plain brick frieze, corbelled cornice; central brick gable roof dormer with half-round opening, flanking chimneys. Jefferson Street elevation with two bays. north: center modern entry with sidelights, modern display window to north, modern entry to 2nd story to south, large stucco and "half-timbering" transom areas, metal lintel and sill plate; south: center modern entry with modern high 1-light flanking windows with stucco below, large modern wood shingle pent roof; 2nd story with modern 1/1 windows with infilled upper third in paired, single, paired, single pattern; similar corbelled entablature, similar dormer over entry to 2nd story. windows as smaller modern 1/1 double hung with stone lug sills and soldier segmental arch openings. adjacent to 705 Jefferson on south. rear elevation as L-plan; north section with high exposed basement with center below grade entry with modern metal suspended canopy, flanking modern windows; 1st story with three infilled openings to north, added small 1/1 toward south; 2nd story with four 1/1 windows with infill; entablature continues. recessed south half with modern concrete and brick enclosed staircase from grade to 1st story on north, three 1/1 with infill openings, entablature continues; gable roof wood dormer to west as roof access, chimney.

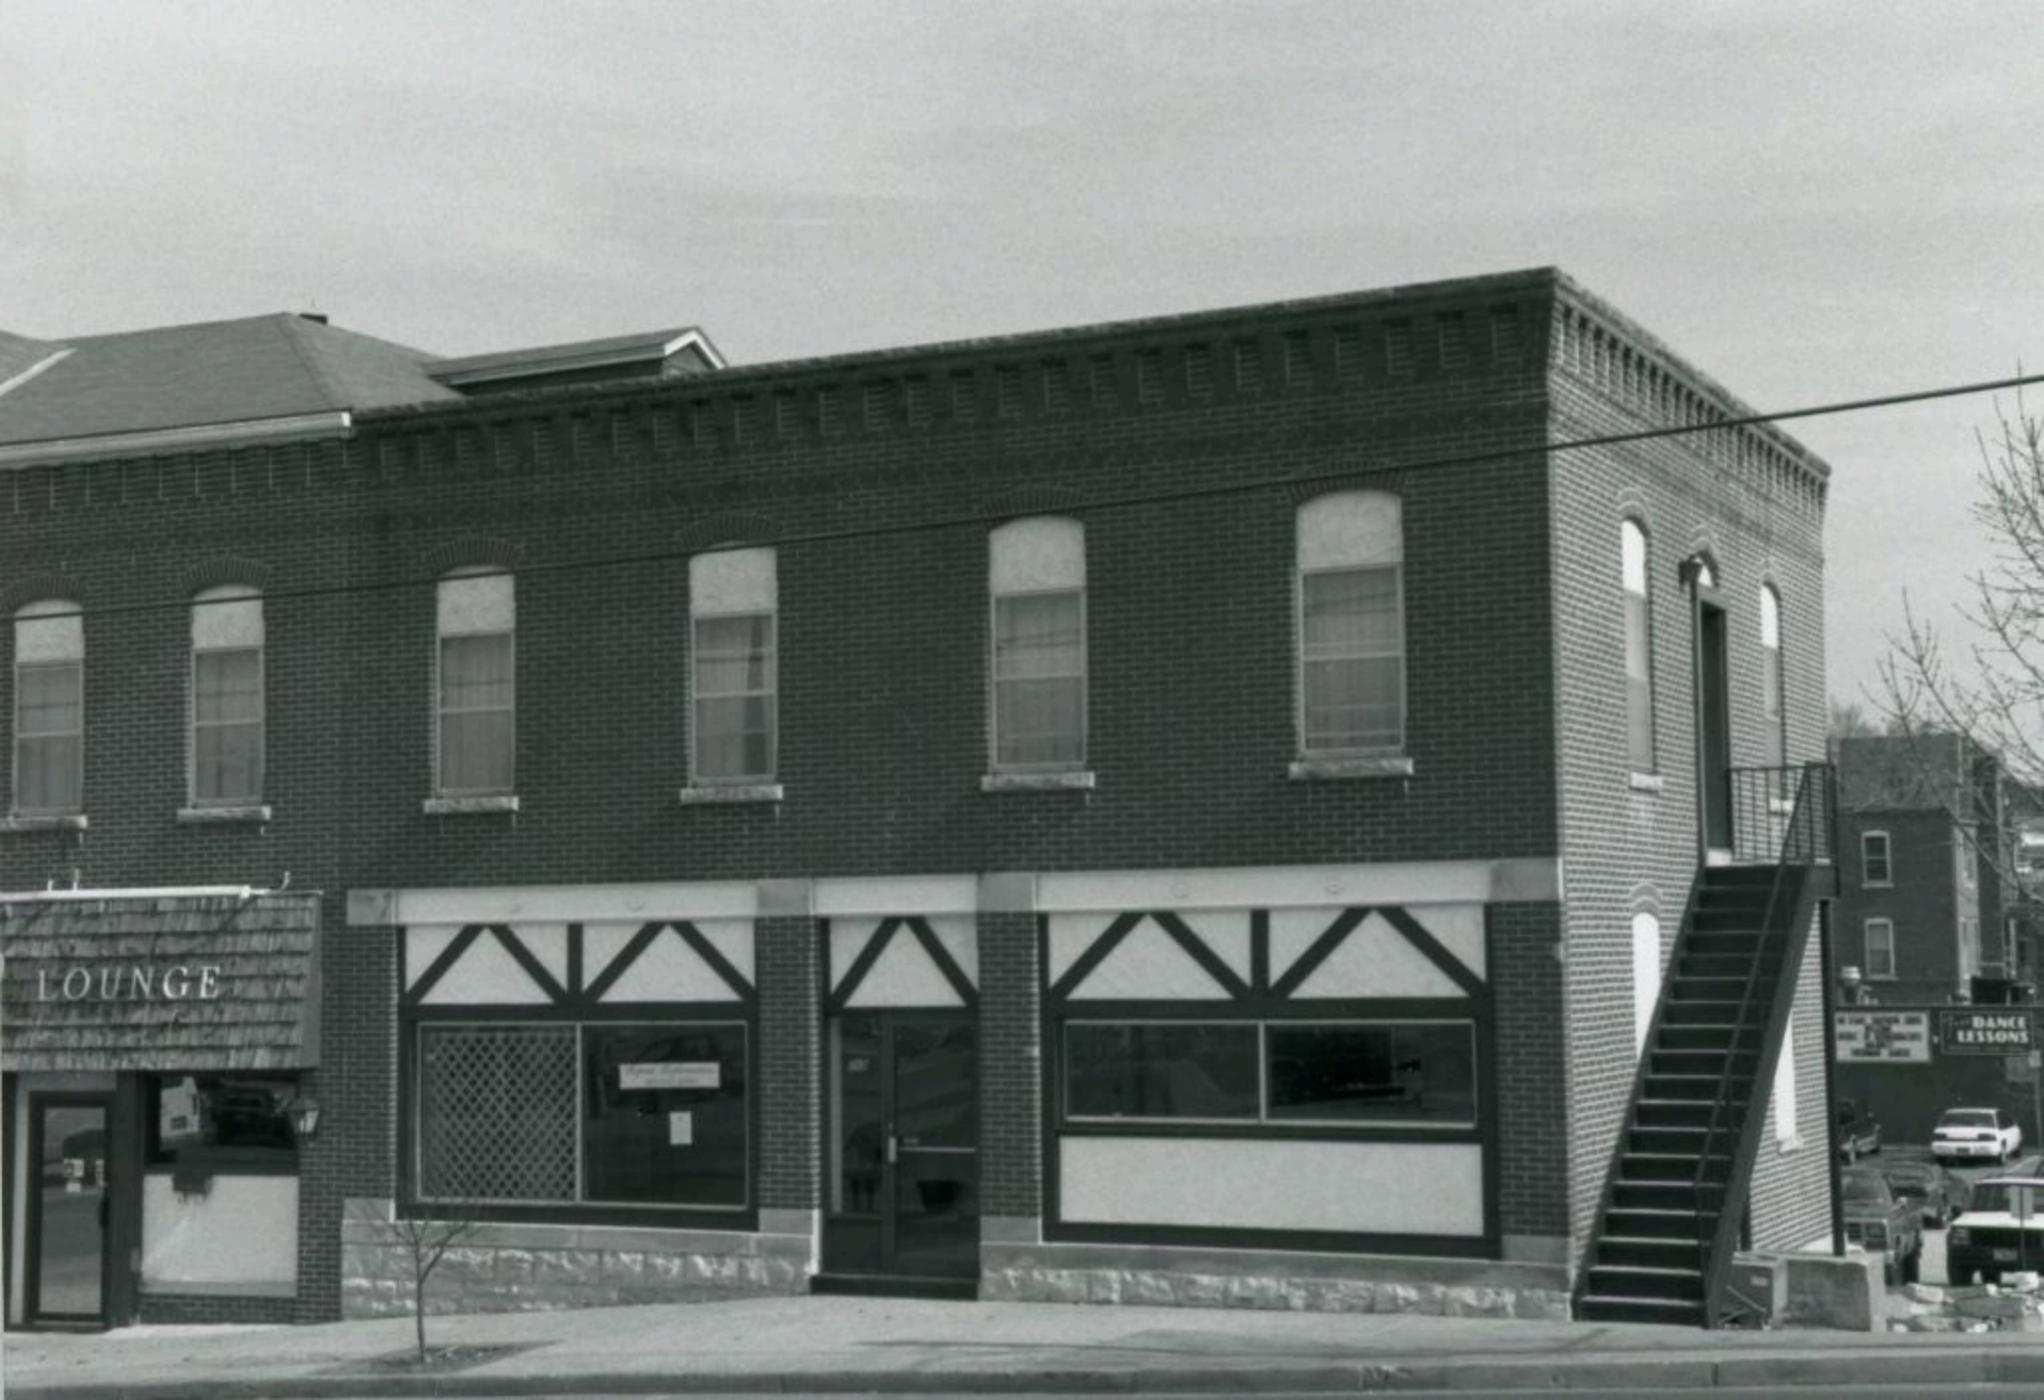
2 stories. single entry with display windows type, rectangular plan, 3 bay symmetrical facade. high coursed stone foundation with dressed stone watertable, brick (running bond) walls. north bay with modern 2-light display windows with stucco and applied "half-timbering" in transom area, center bay with modern aluminum frame door with sidelight and similar transom area, south bay infilled with 2-light horizontal sash with stucco below and stucco and "half-timbering" in transom area; metal lintel; bays divided by brick piers with stone bases and caps; 2nd story with four modern 1/1 infilled windows, entablature with corbelled architrave, plain frieze and corbelled cornice similar to 701-703 Jefferson. north elevation attached to 701-703 Jefferson. south elevation with 7-course Flemish header bond walls, 1st story with two infilled openings to east and west; 2nd story with center modern recessed door (originally window opening) and flanking modern infilled 1/1 windows, modern metal exterior staircase, entablature returns. windows as modern 1/1 double hung set in solder segmental arched openings with upper quarter stucco infilled. stone lug sills. rear elevation with exposed basement with infilled openings; 1st story with entry to north with modern concrete and wood deck/stairs, three infilled 1/1 windows to south; three infilled 1/1 windows on 2nd story, all with double rowlock segmental arches; no entablature.

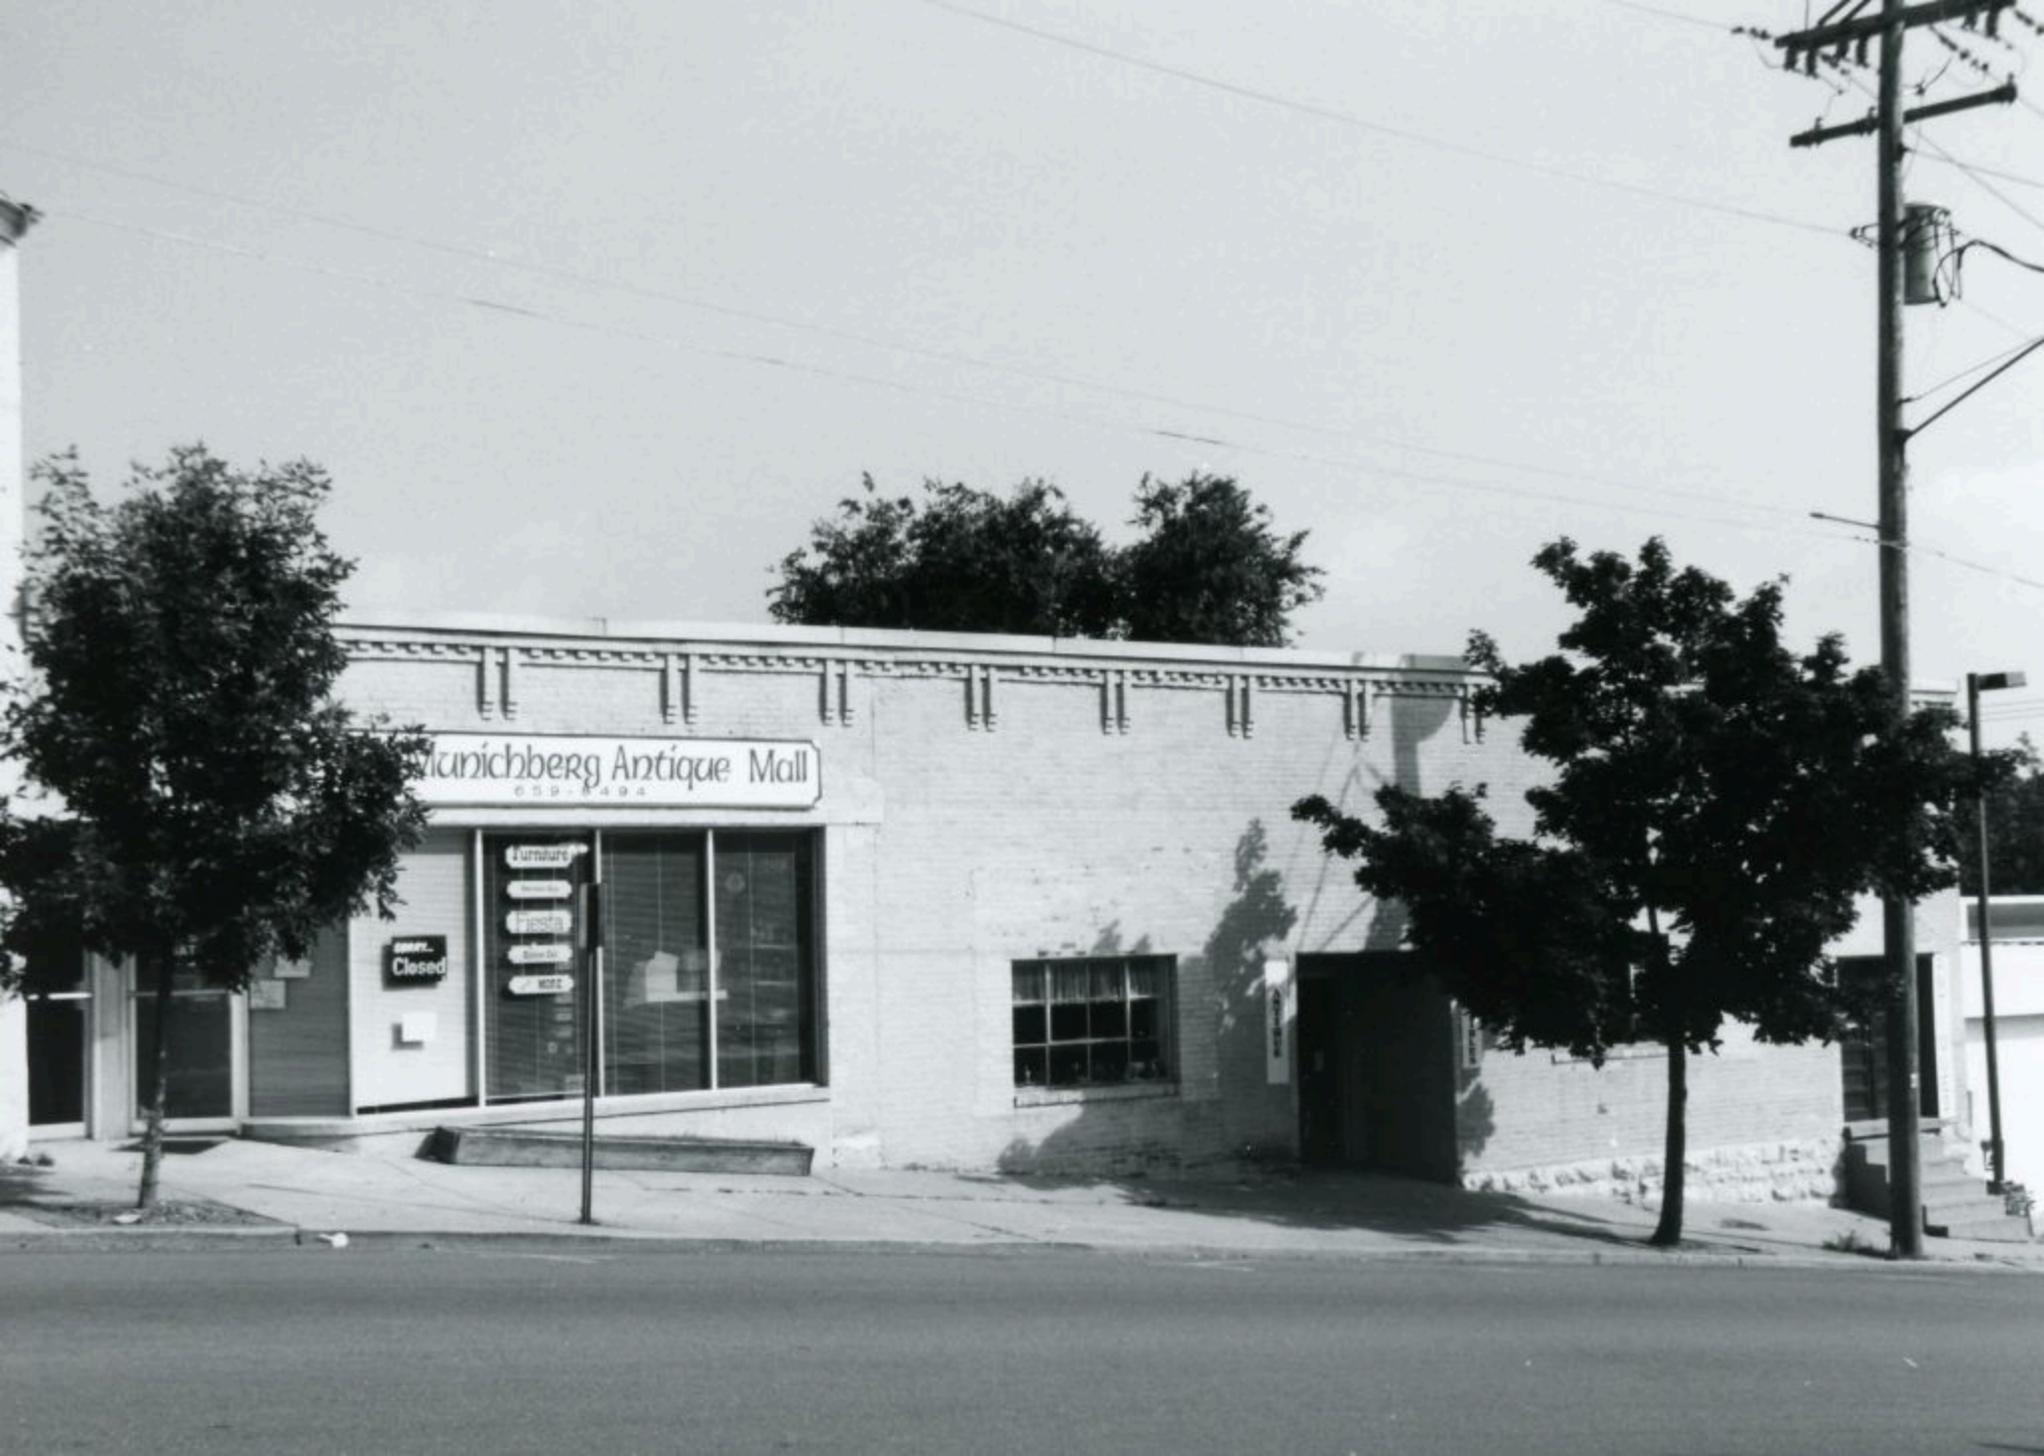
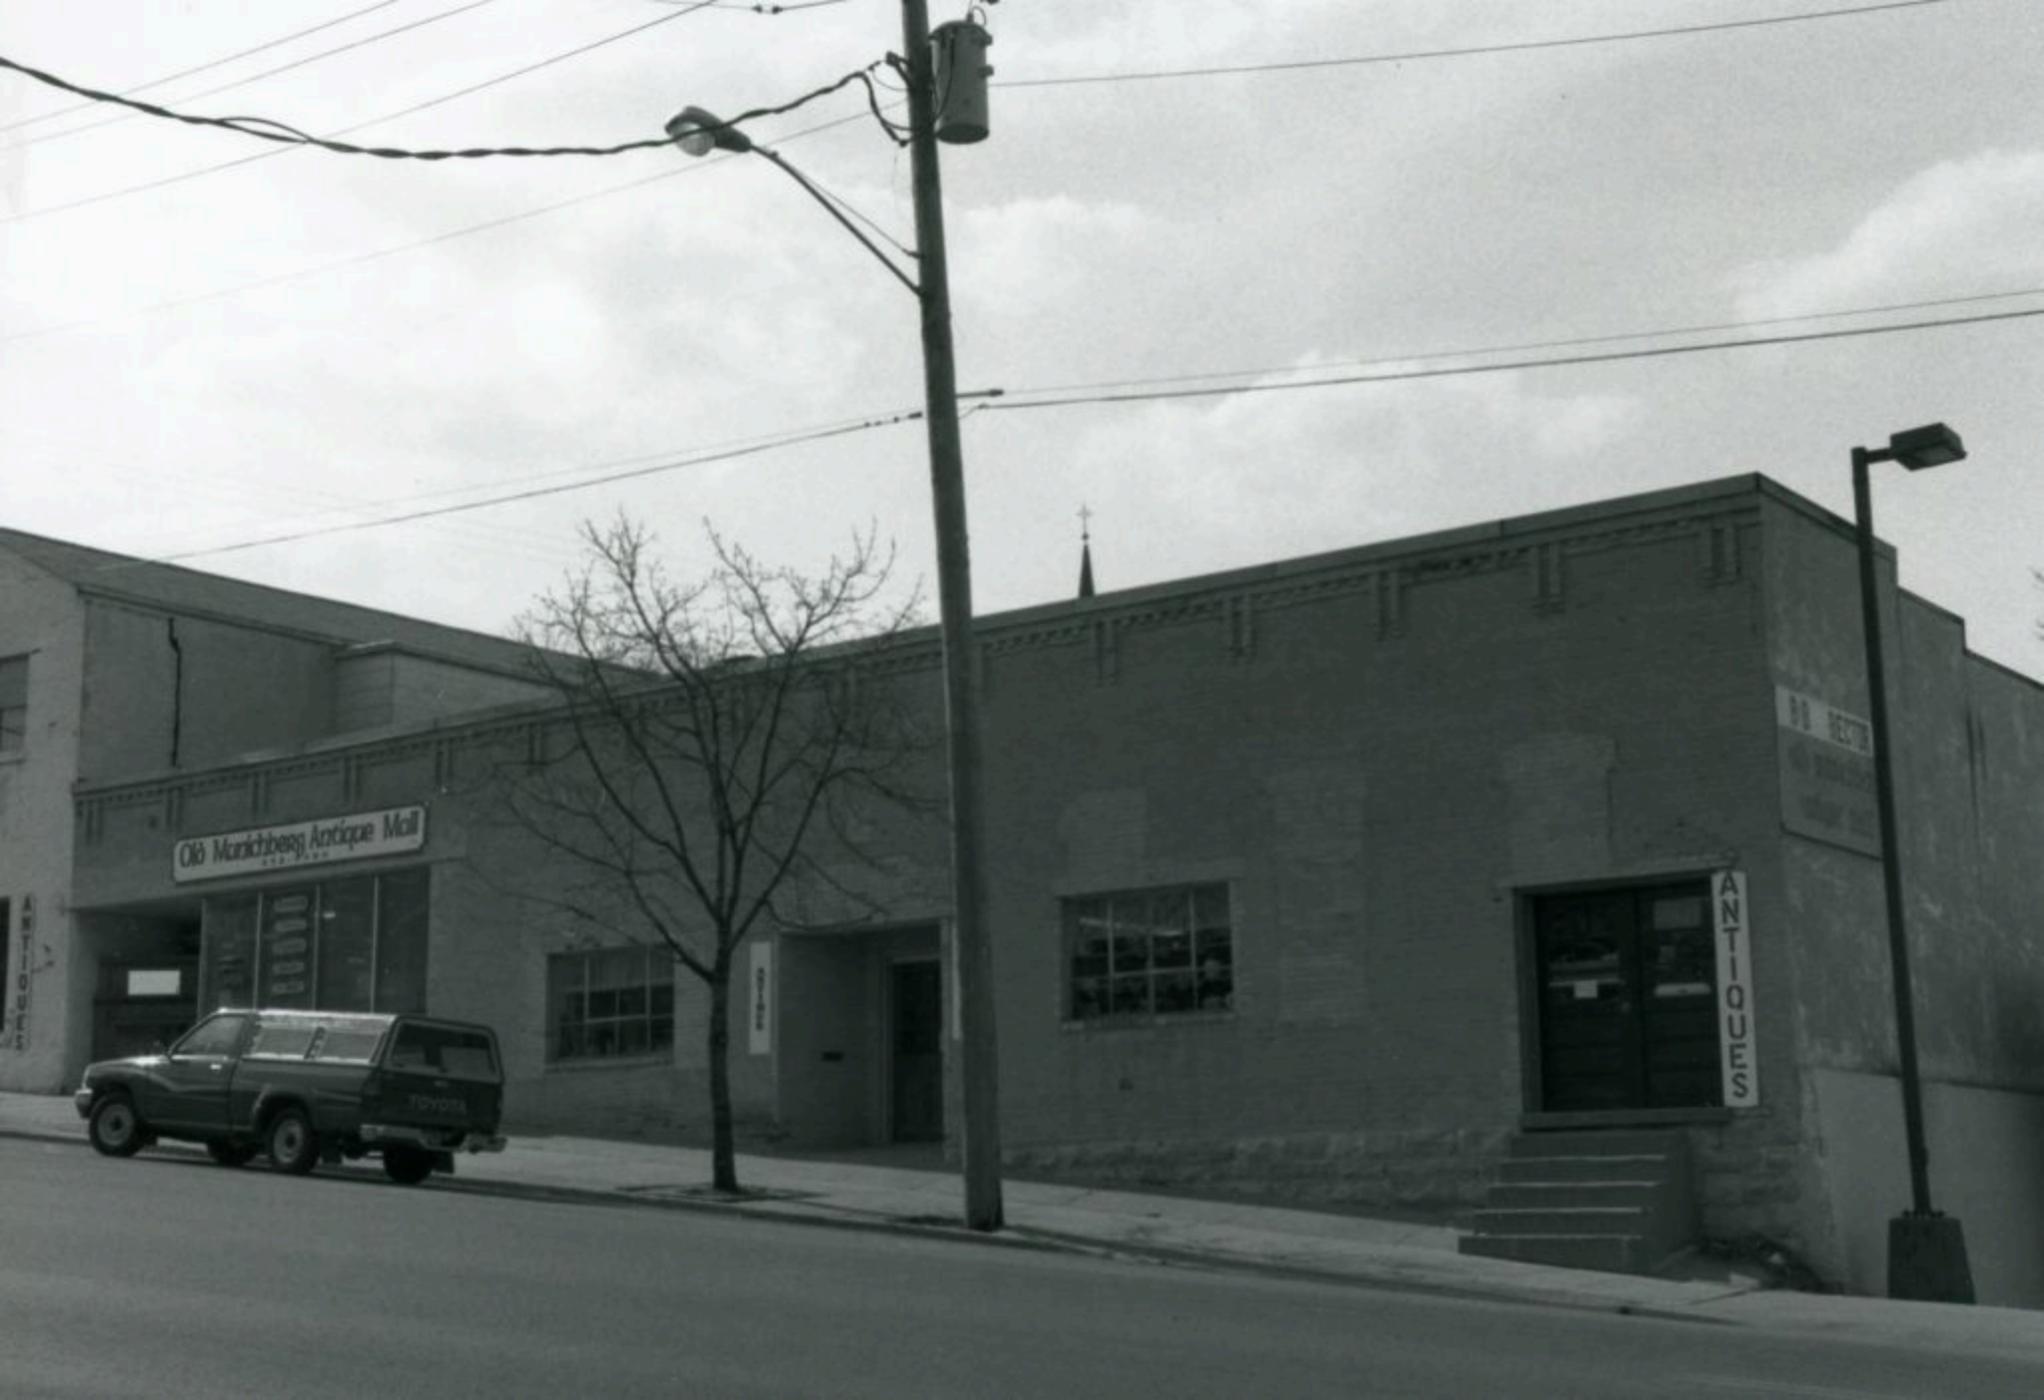
1 story. No style or vernacular type. Rectangular plan. Substantial elevation drop between the north and south ends of the building, with the north end entrances being at grade and those on the south requiring six stairs. Rock-faced coursed limestone foundation; brick (painted gray) walls. Shed (composition) roof. Mixed fenestration; many fenestration changes (sized altered and infilled). Decorative parapet intact, patterned with double corbels between spans of six dentils on raised stretcher course brick. Metal coping added above. Current facade configuration in three sections. Left/south section with two modern doors (adjacent), angled modern storefront sash, and four modern storefront sash at facade plane. Twelve-light industrial awning sash and recessed entrance in middle section. A door at this location appears to be original as indicated by brick infill. Between the second and third sections, a segmental arch is evident near a wall vent. End bay with the same industrial sash and an entrance with double doors accessed by carpeted stairs on the city sidewalk. Industrial sash c. 1940 with header sill. South wall flush/common with another historic commercial building (710) which was part of the Tanner Machine Shop also. Retaining wall added to north elevation's exposed basement level, with upper section having been stuccoed; blind except for three windows toward rear/west; stepped parapet. Rear elevation with various windows and double wood swing doors.

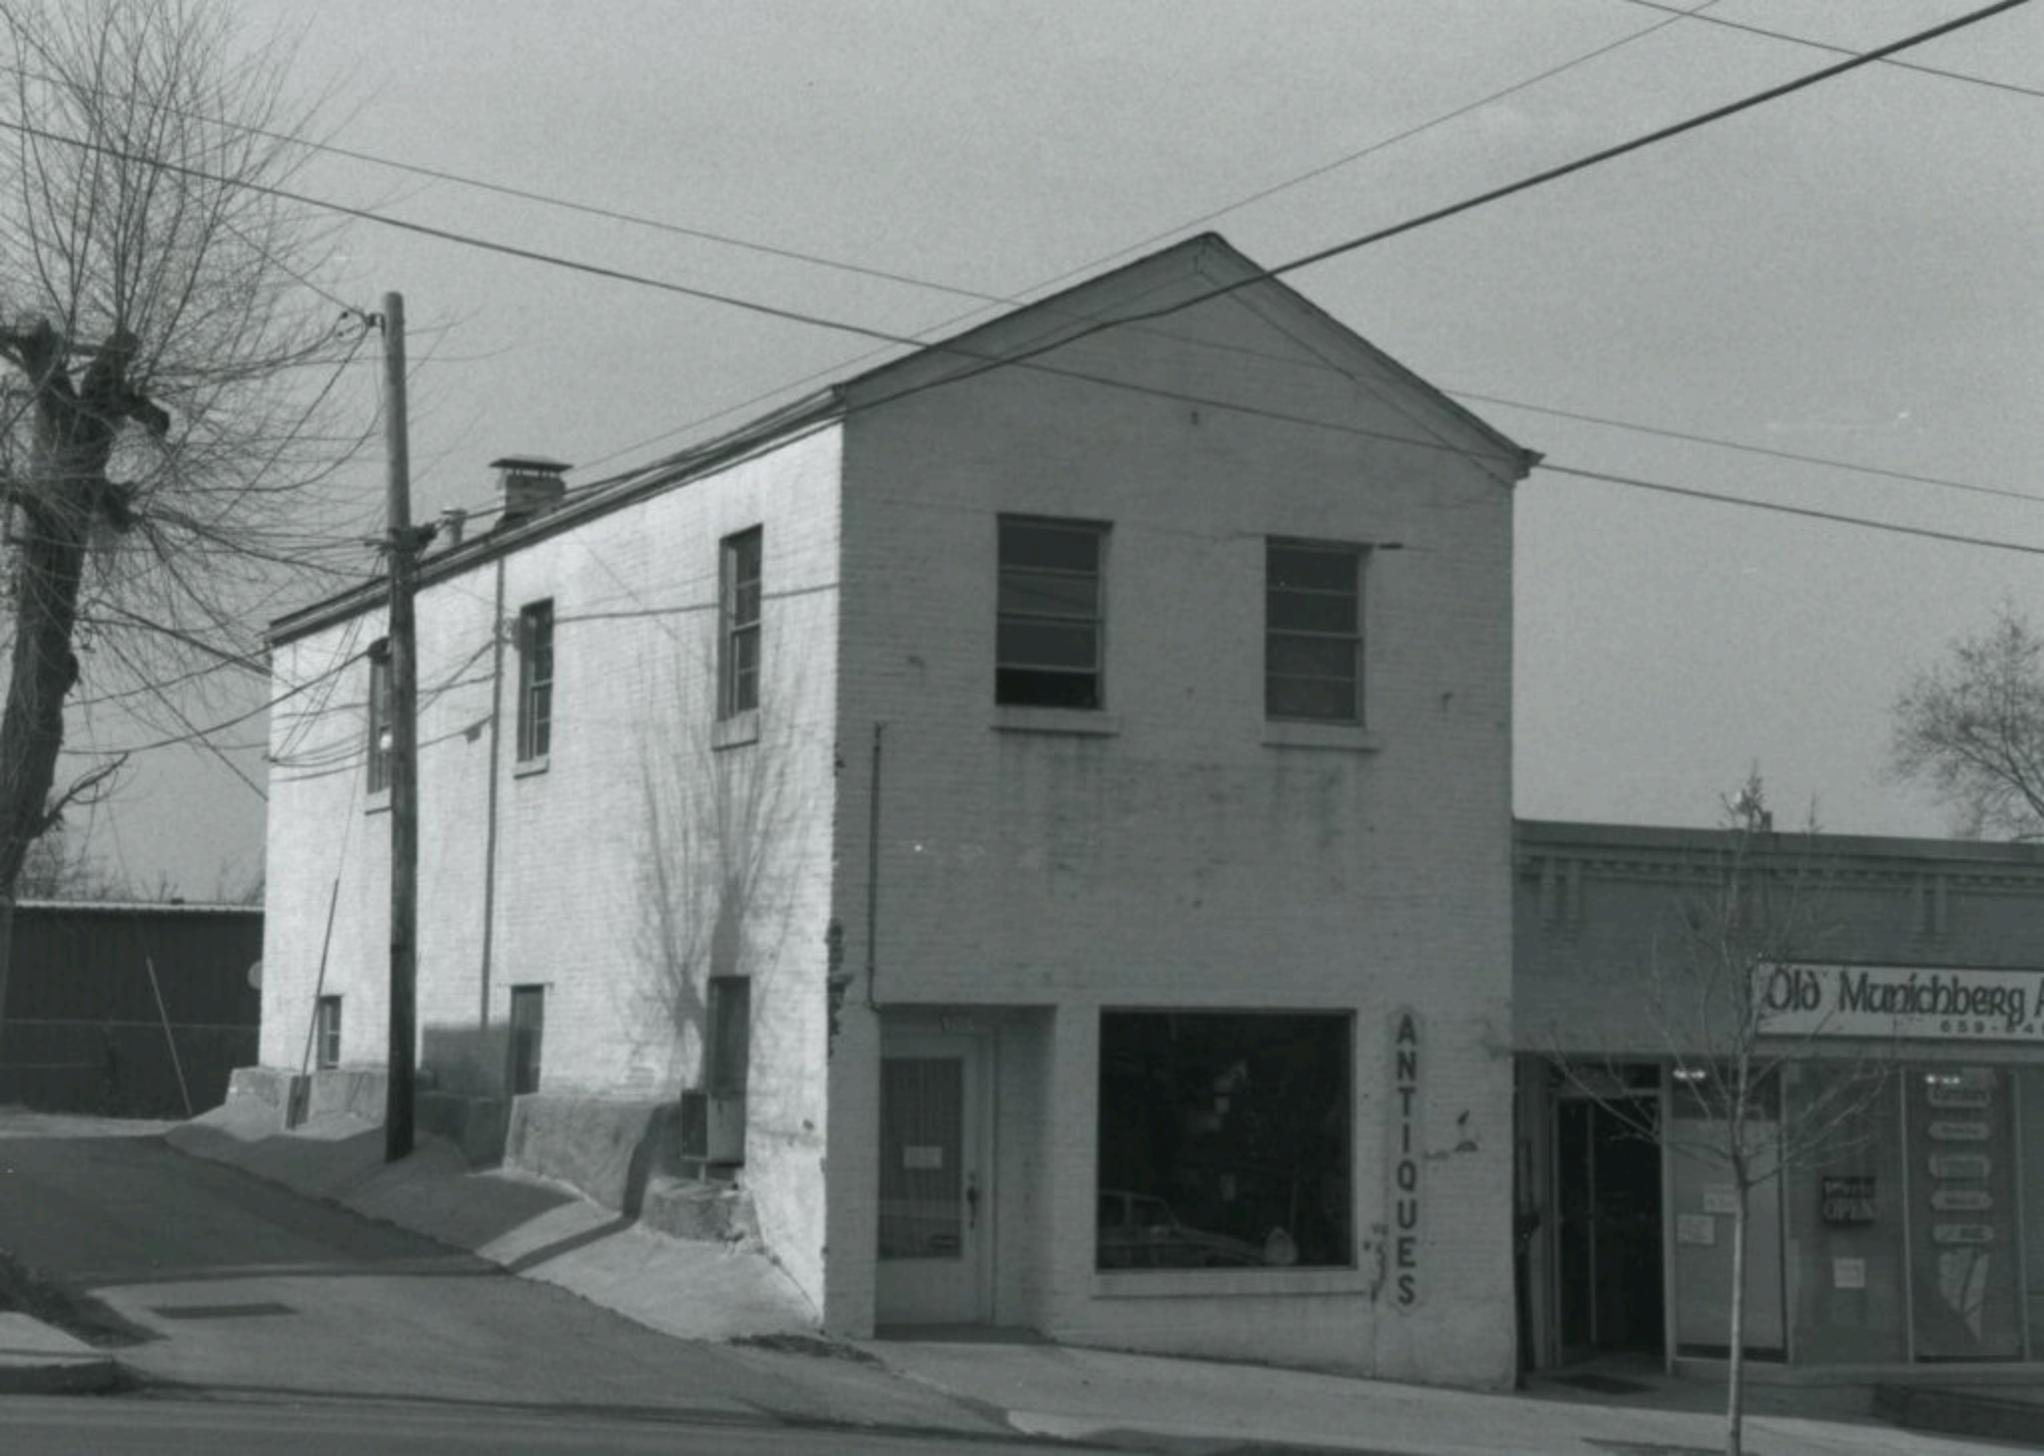
2 stories. no commercial style or type, rectangular plan, asymmetrical facade. parged concrete foundation, brick (heavily painted) walls. front gable roof. deeply recessed 1-light entry at south end, large 1-light display window with concrete sill toward north; 2nd story with two windows; plain gable with wood rake boards. windows as 2-horizontal/2-horizontal double hung, concrete sills. north elevation adjacent to 708 Jefferson on 1st story; blind 2nd story, narrow blind rectangular frame (asbestos shingle) addition to rear. south elevation 6-course common bond, concrete buttressing along 1st story with three windows; 2nd story with three windows and 2 brick infilled openings. rear with center interior end chimney, wood rake boards; off-center (to south) below grade entry, concrete buttressing; blind 2nd story.

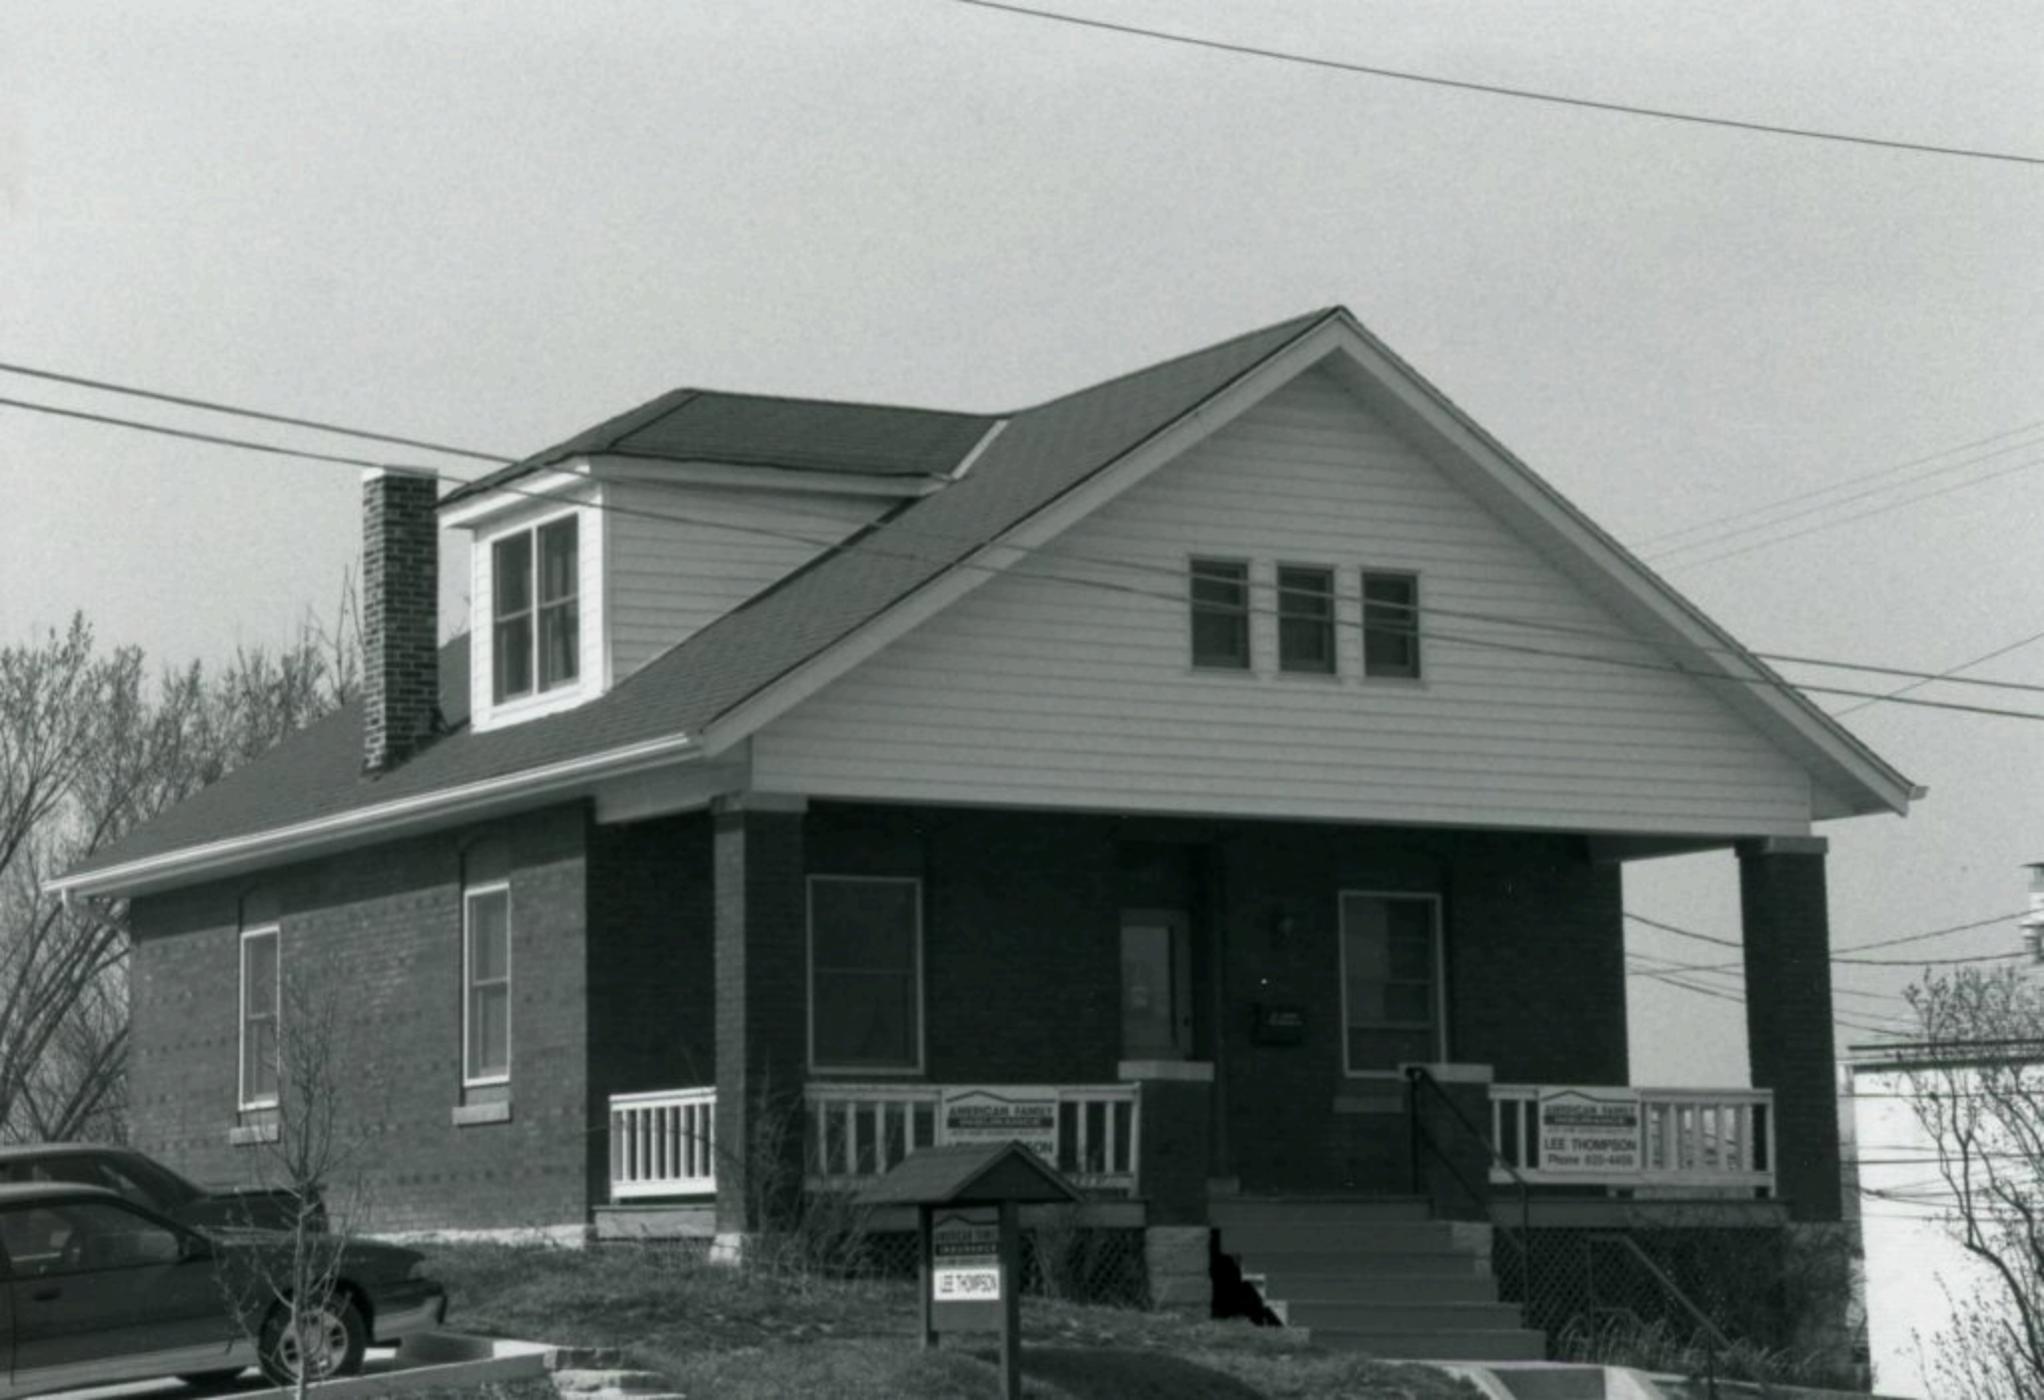
1-1/2 stories. Bungalow vernacular type, rectangular plan, 3 bay asymmetrical facade. coursed stone foundation, brick (5 course Flemish header) walls. front gable (asphalt shingle) roof. full-width porch set under main gable roof with brick corner piers, and step pedestals, concrete caps, open wood railing, deck and steps; off-center 1-light/panel entry (to north) with blocked transom and flanking replacement 1/1 windows in wood infilled openings; narrow artificially sided gable with three small modern 1/1 windows, overhanging boxed eaves. windows as smaller replacement 1/1 double hung set in wood infilled double rowlock segmental arched openings, concrete sills. north elevation with exposed basement with two windows and added (now infilled) center entry; 1st story with replacement 1/1 to east, modern 1-light casement to west, overhanging artificially covered eaves, large hip roof artificially sided dormer to east with paired 1/1 windows. south elevation with two replacement 1/1 windows, similar dormer with slope chimney to west. rear with modern entry to north, 2 small 1/1 windows to south, small wood deck.

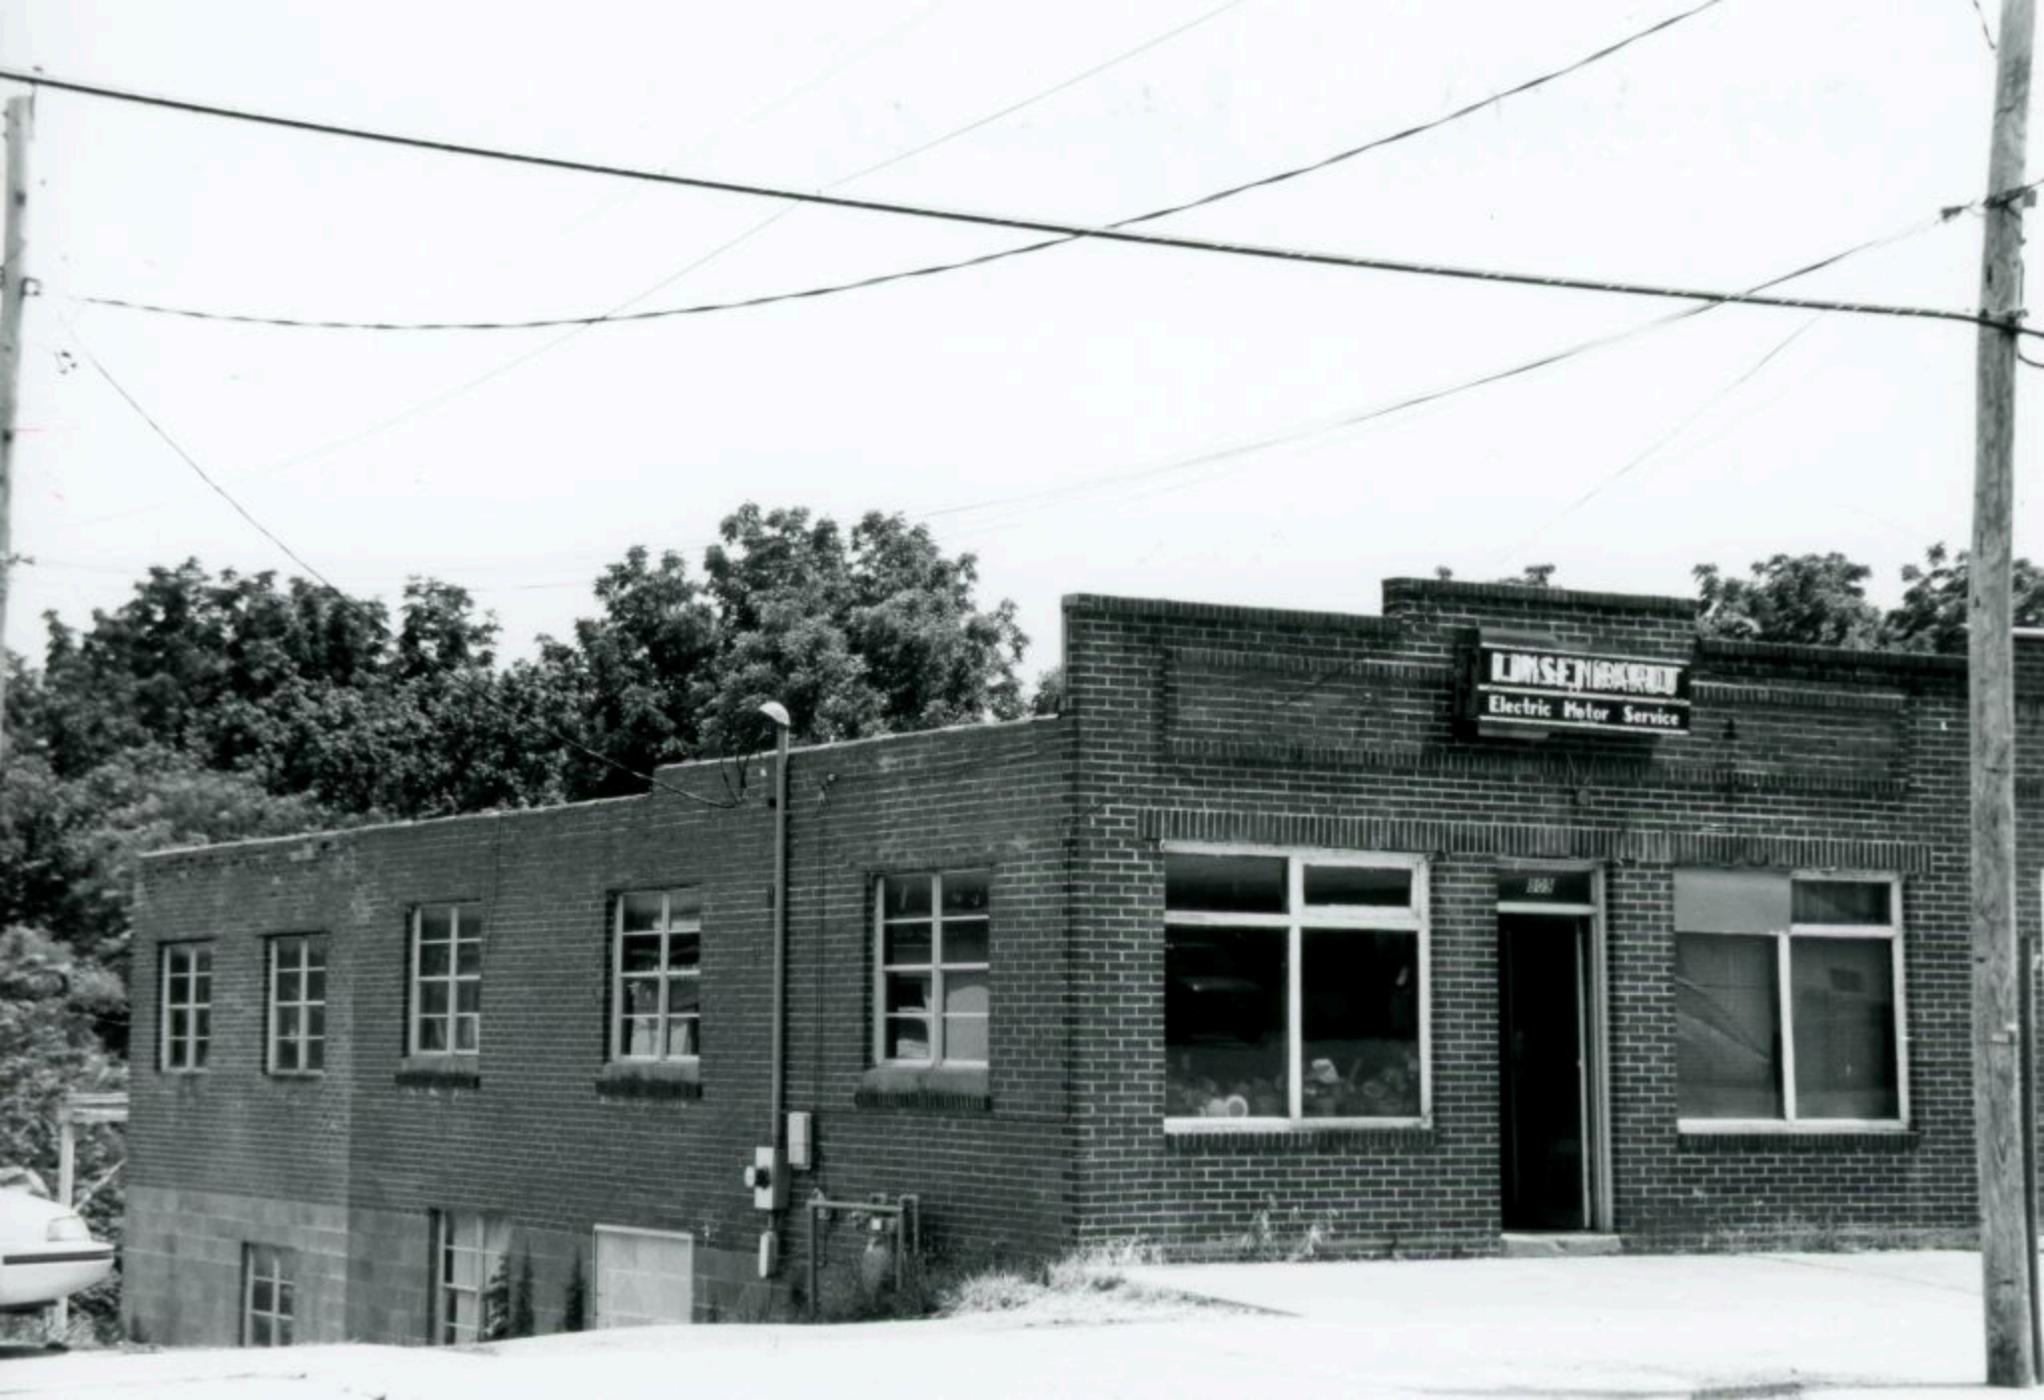
1 story. single entry with display windows commercial type. rectangular plan, 3 bay symmetrical facade. concrete block foundation, brick (wire cut) walls. shed roof. center modern aluminum frame door with narrow transom, historic 2-light wood display windows with 2-light transoms flanking entry, contrasting brick soldier course above door and windows; contrasting brick center sign panel outlined in header bricks, stepped parapet with dark header brick coping. windows as display windows with transoms and header brick sills; paired 2-horizontal/2-horizontal with header brick sills. north elevation with exposed concrete block basement with two sets of paired windows, addition on rear with single set of windows; 1st-story with three sets of paired windows with concrete added to original openings so modern windows fit, brick addition on rear with two sets of paired windows with concrete sills. south elevation connected to 811 Jefferson Street. concrete block rear with large at-grade opening with three-part wood folding door to north with steel framework and hoist in front; concrete block storage shed projects to east on south half; 1st-story with two sets of paired windows.
