HISTORIC SOUTHSIDE COMMERCIAL AREA

MISSOURI HISTORIC PROPERTY INVENTORY FORM

REFERENCE NUMBER CO AS003-001		A. HISTORIC NAME					
B. COUNTY 054 Cole		C. OTHER NAME(S)					
D. ADDRESS 102 East Ashley Street			E. CITY Jefferson City		F. VICINITY <input type="checkbox"/>	G. RESTRICTED	H. ACREAGE

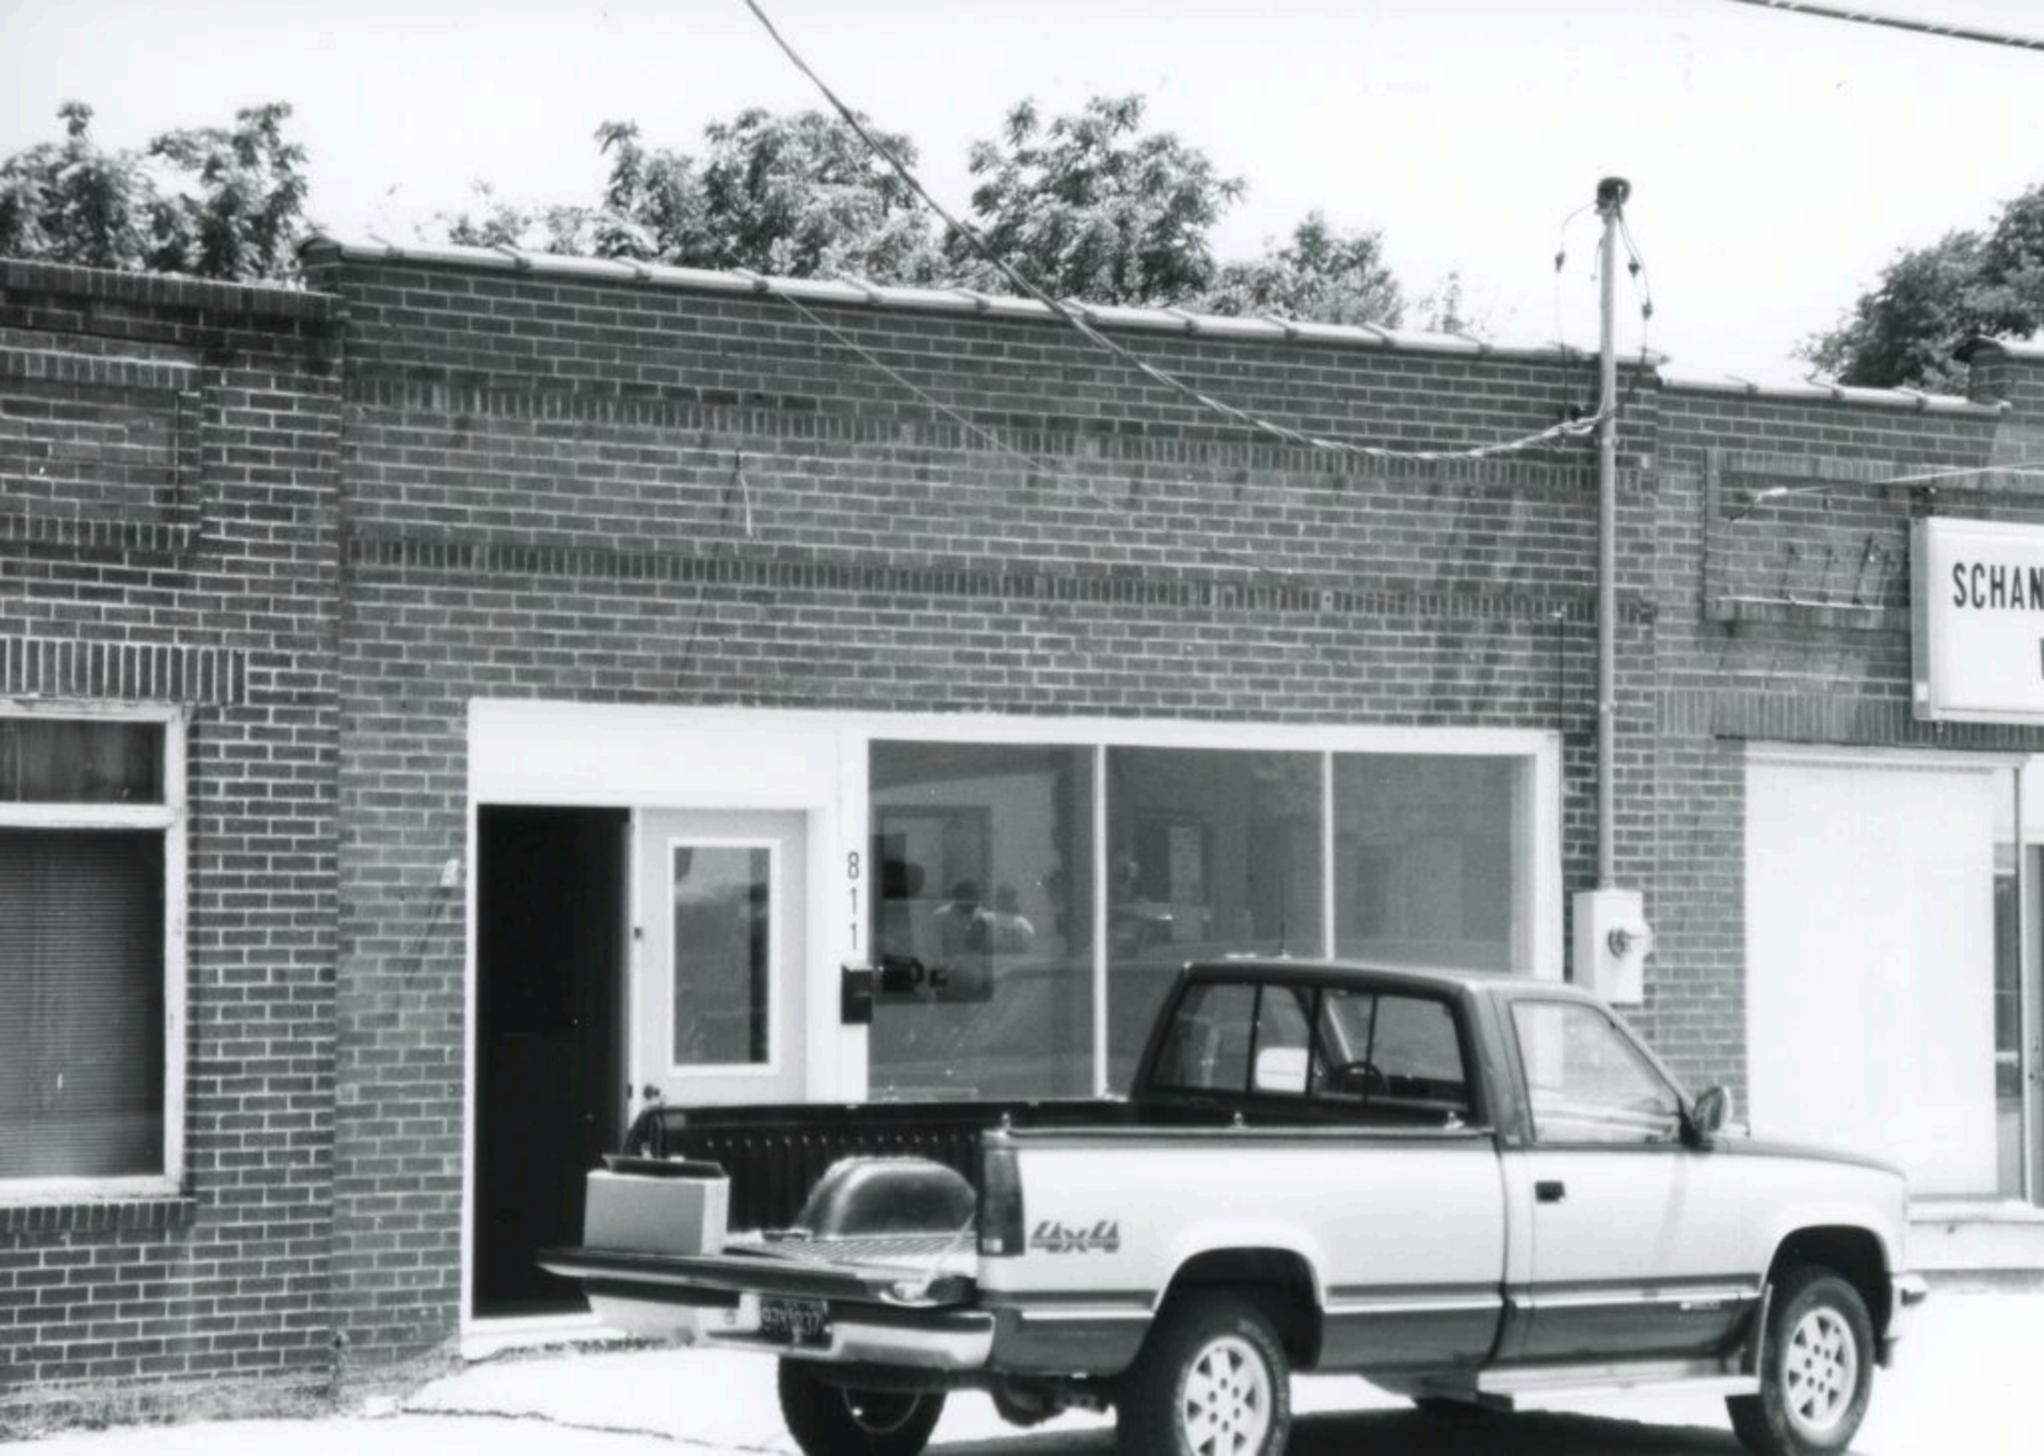
811

1 story. no commercial style or type. rectangular plan, asymmetrical facade. concrete block foundation, brick (wire cut) walls. shed roof. modern double 1-light doors to north with triple 1-light display windows to south with concrete sill, two recessed header brick stringcourses above, tile coping. north elevation attached to 809 Jefferson; south elevation attached to 813 Jefferson. rear with overhead garage door to north, multi-light industrial window to south in basement; 1st-story with three openings with projecting exterior fans, air conditioner in center.

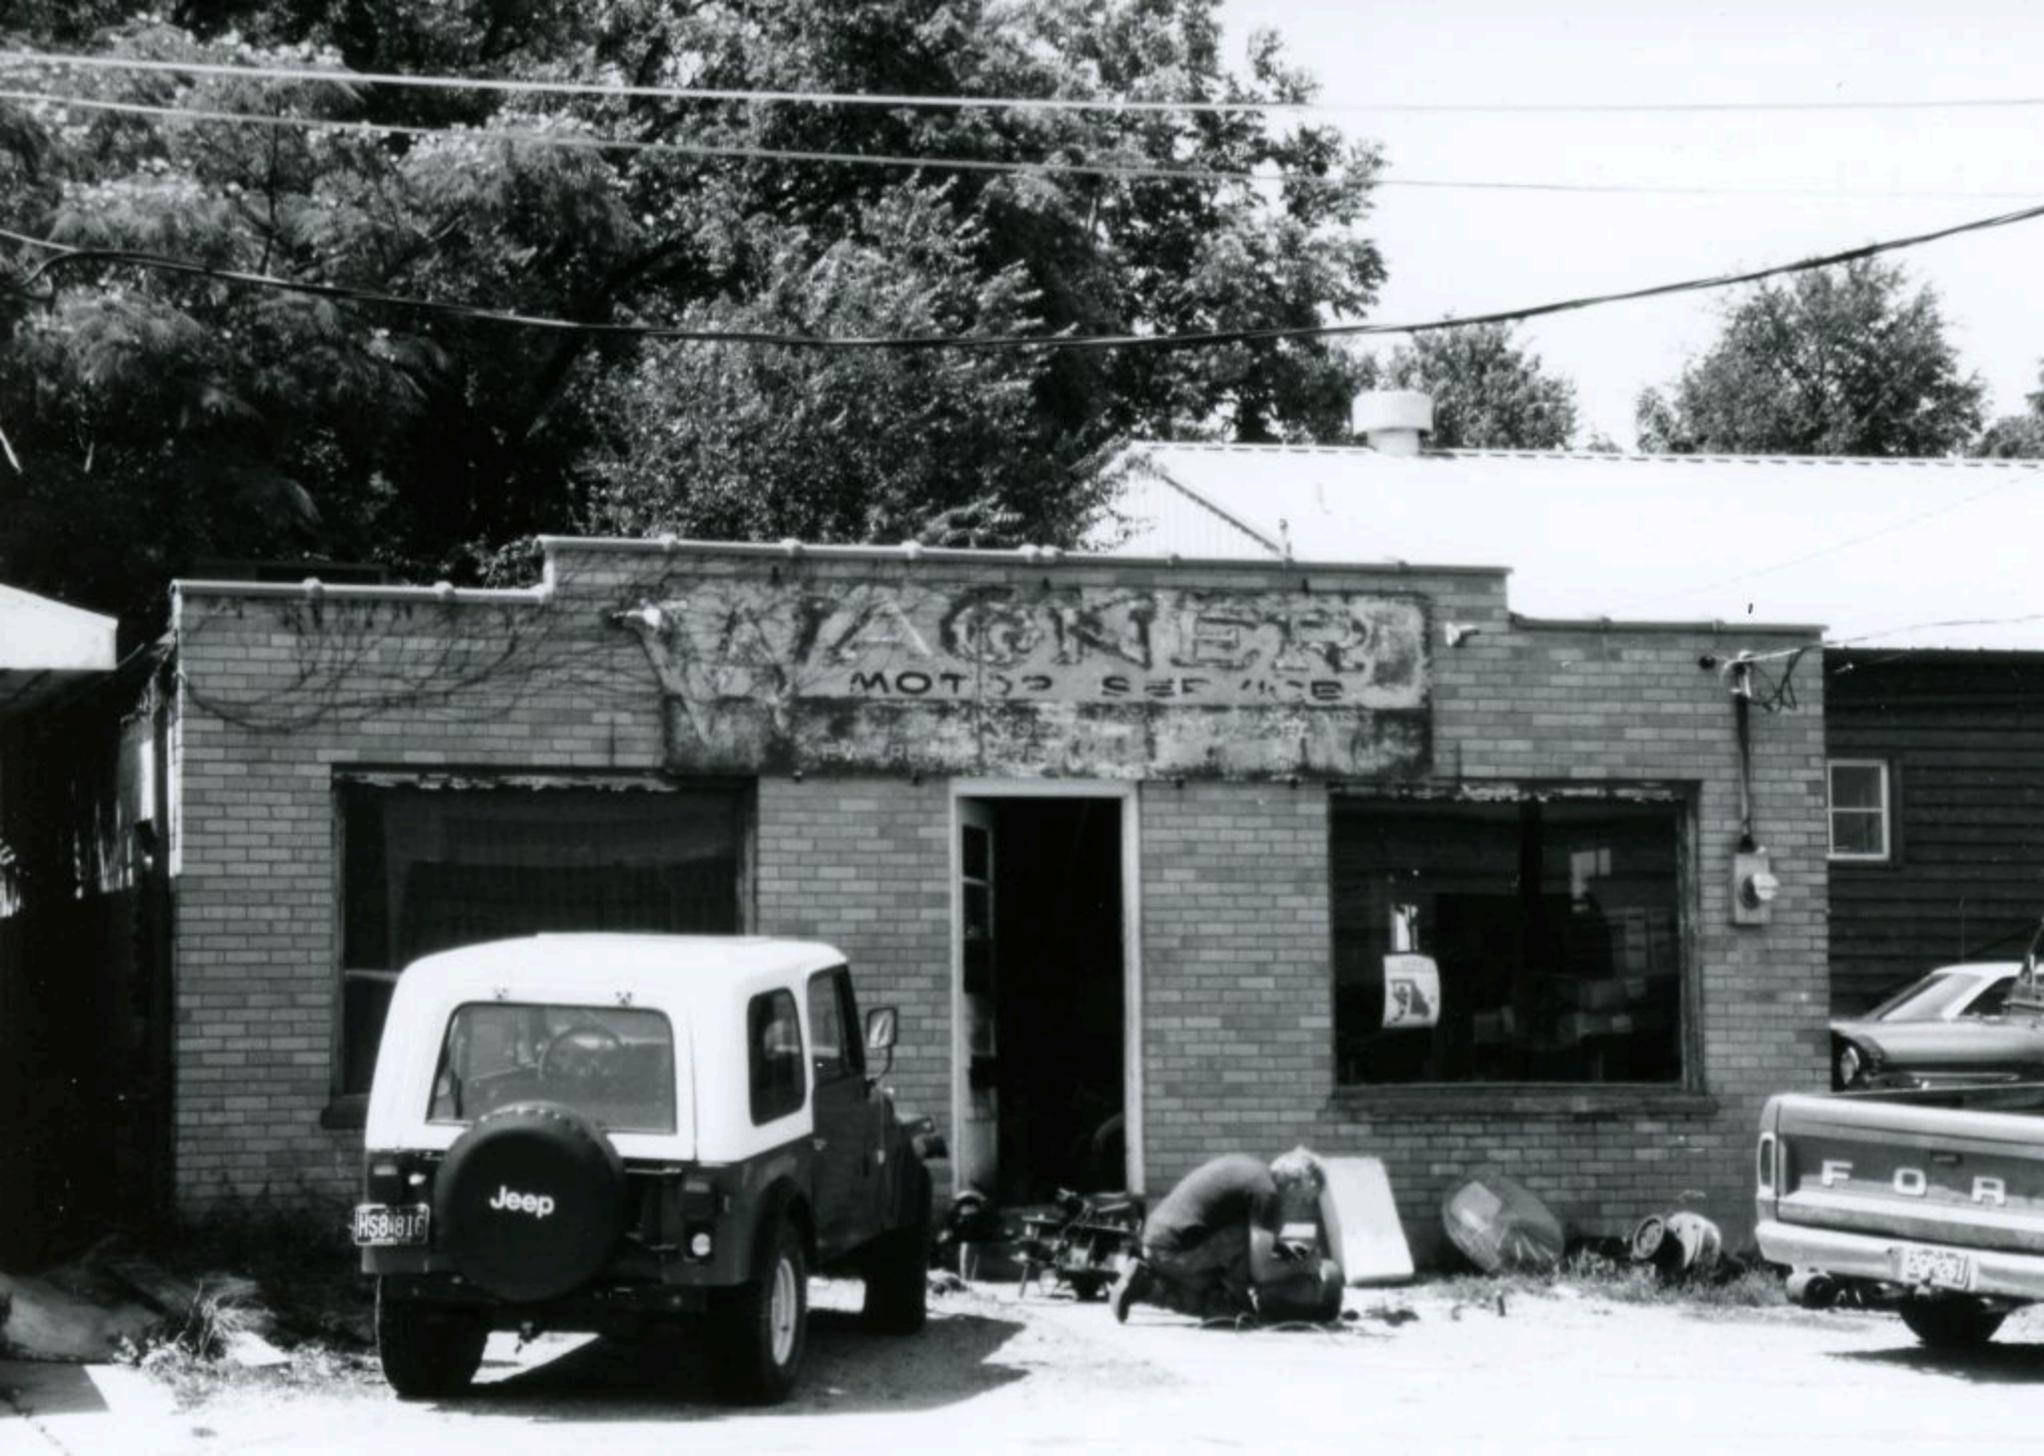
1 story commercial building. Single entry with display windows type. Rectangular plan; three bay symmetrical facade. Concrete block foundation. Yellow brick and concrete block walls; plain parapet. Composition roof with tile coping. Central entrance with three-light, paneled historic door flanked by large fixed sash in end bays. Central raised parapet with faded metal sign paneled attached; tile coping. Facade with wire-cut yellow brick wraps side elevation with quoin-like treatment onto concrete block (painted white) side elevations. Five bay north elevation with awning sash; wood cornice.

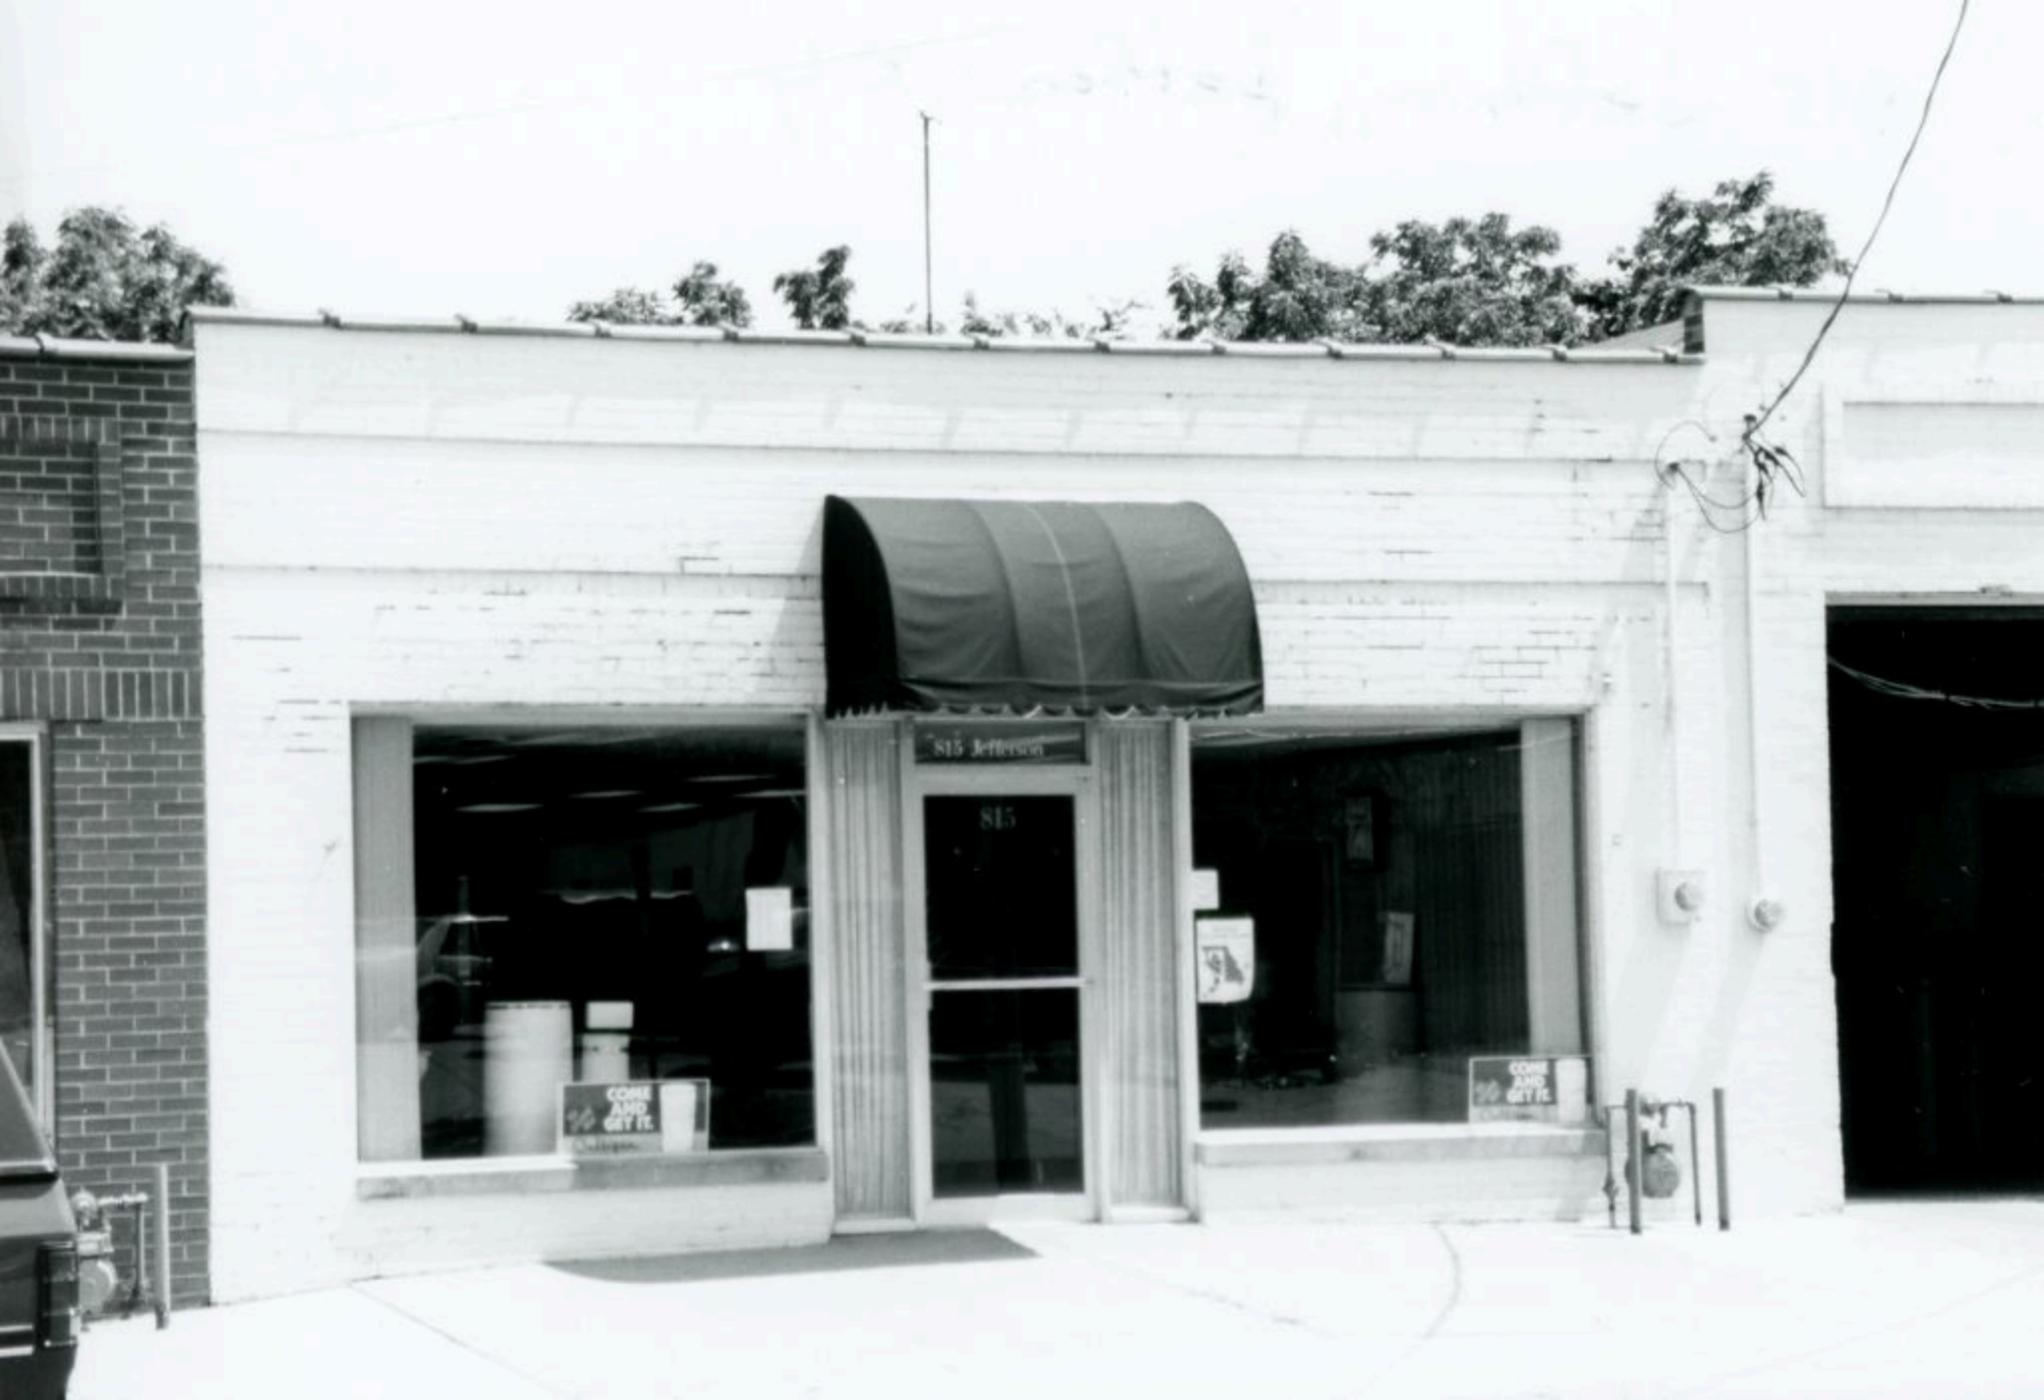
815 Jefferson

1 story. single entry with display windows commercial type. rectangular plan, 3 bay symmetrical facade. concrete block foundation, brick (wire cut, painted) walls. shed roof. center bay with modern aluminum frame door with 1-light sidelights and transom, canvass awning above; flanking large 1-light display windows with concrete sills; two recessed header brick stringcourses above, tile coping. north elevation attached to 813 Jefferson; south elevation attached to 817 Jefferson. concrete block rear elevation with multi-light industrial window to south, at-grade pedestrian door off-center (to south), large overhead door to north; 1st-story with 8-light industrial awning windows to north and south, central 1/1 window.

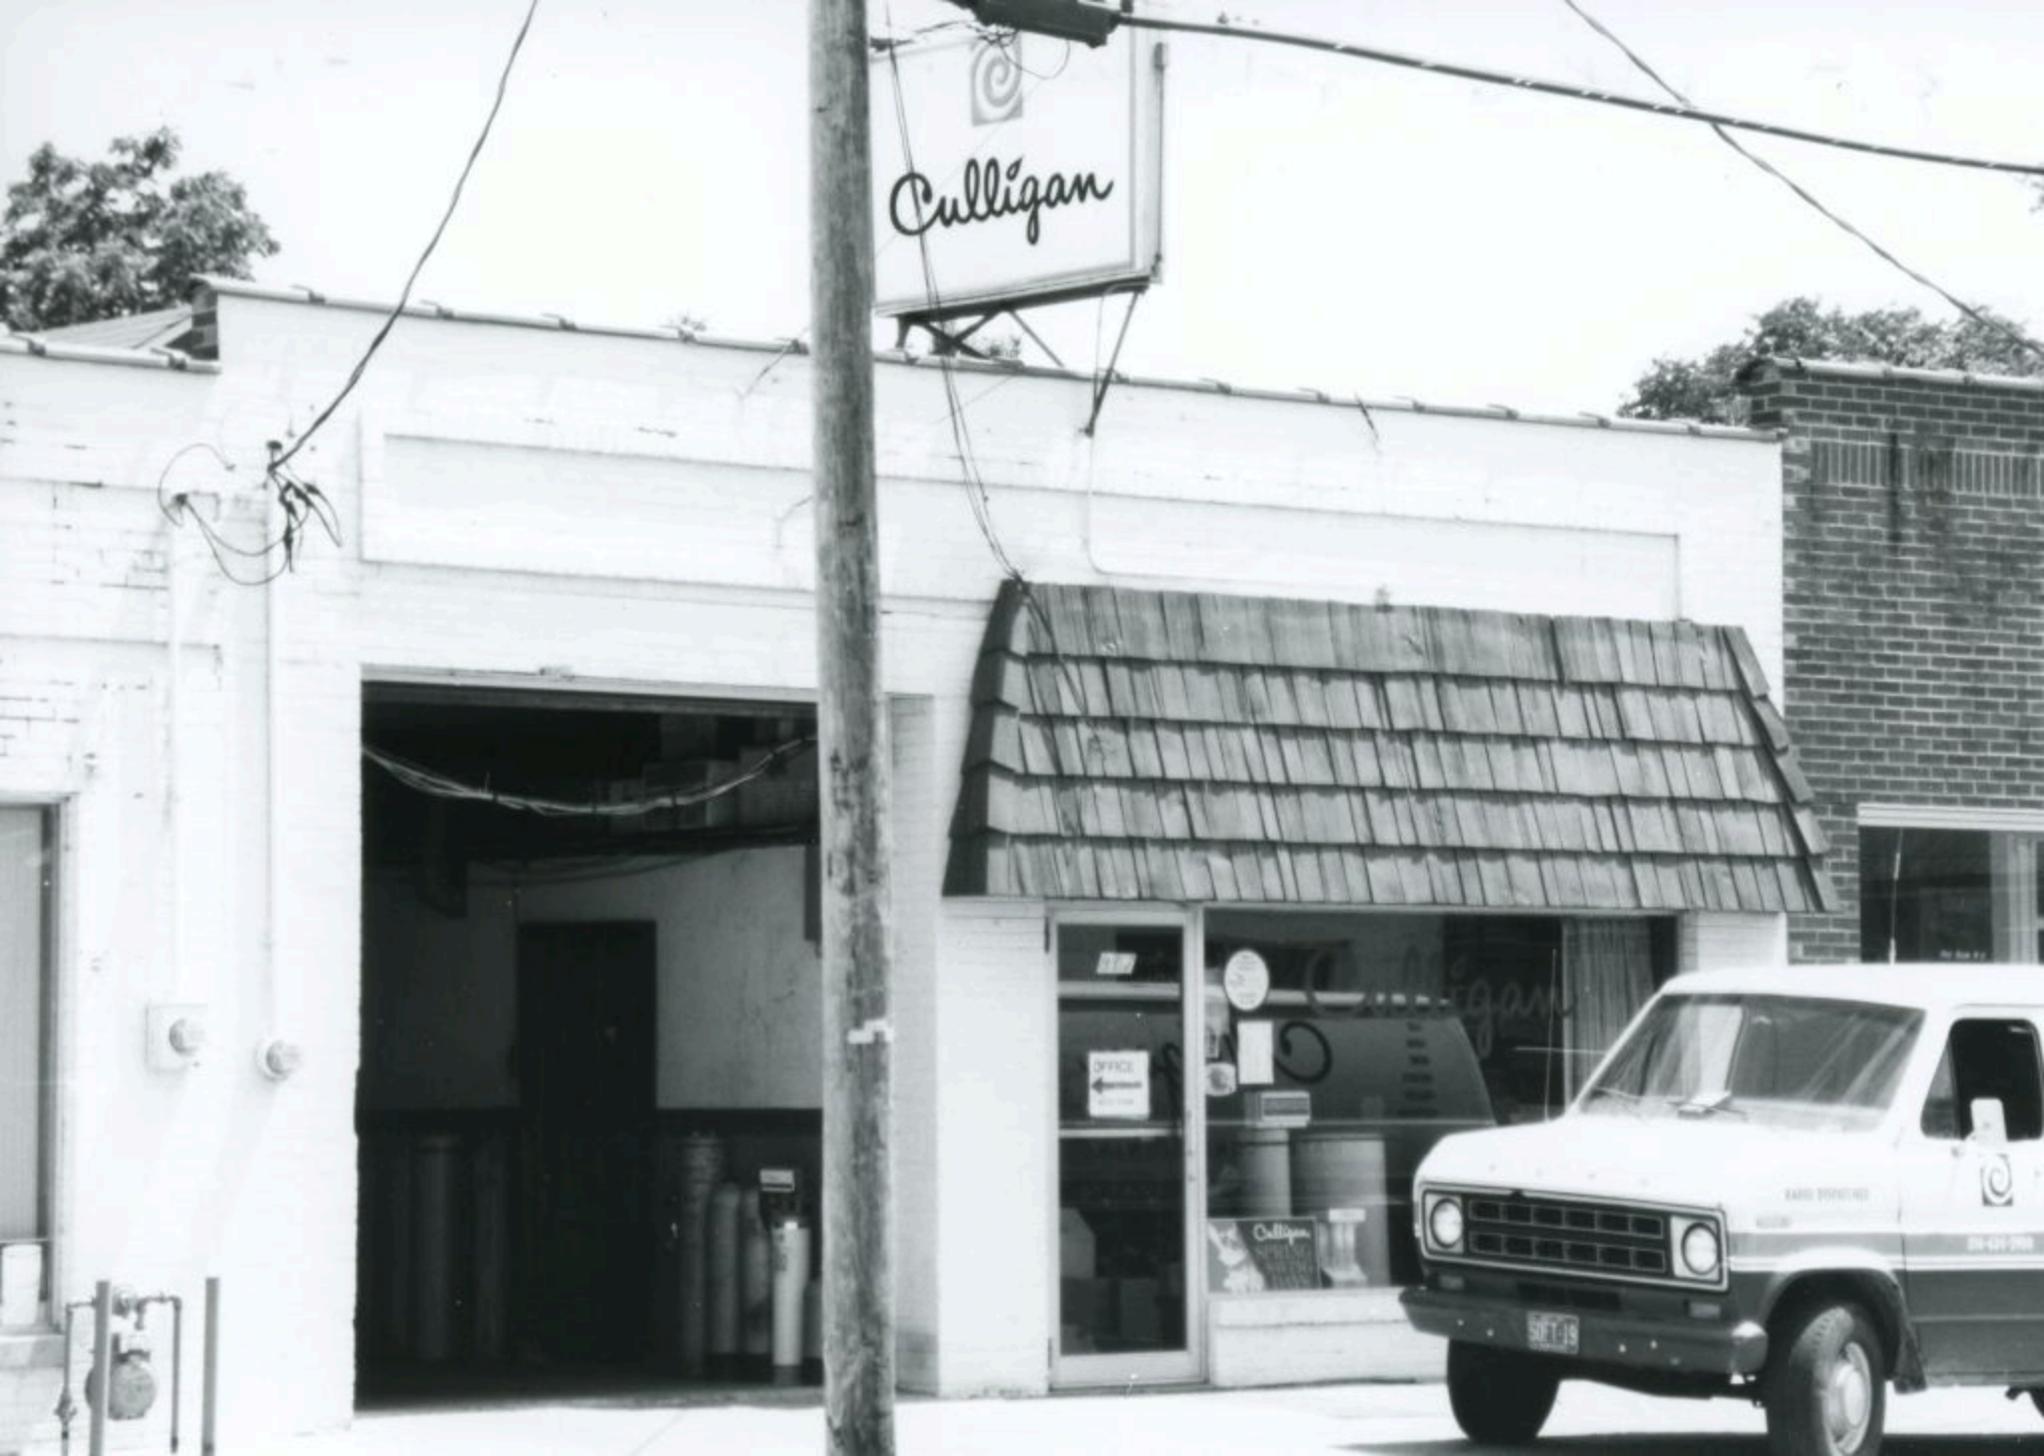
1 story. no commercial style or type. rectangular plan, 2 bay asymmetrical facade. concrete block foundation, brick (wire cut, painted) walls. shed roof. overhead garage door in north bay, south bay with modern aluminum frame door to north with large 1-light display window with header brick sill to south; modern pent (wood shake shingle) roof above door and window, center rectangular brick sign panel outlined in header bricks above, tile coping. north elevation attached to 815 Jefferson; south elevation attached to 819 Jefferson. concrete block rear elevation with two overhead garage doors in basement, two multi-light industrial windows on 1st-story.

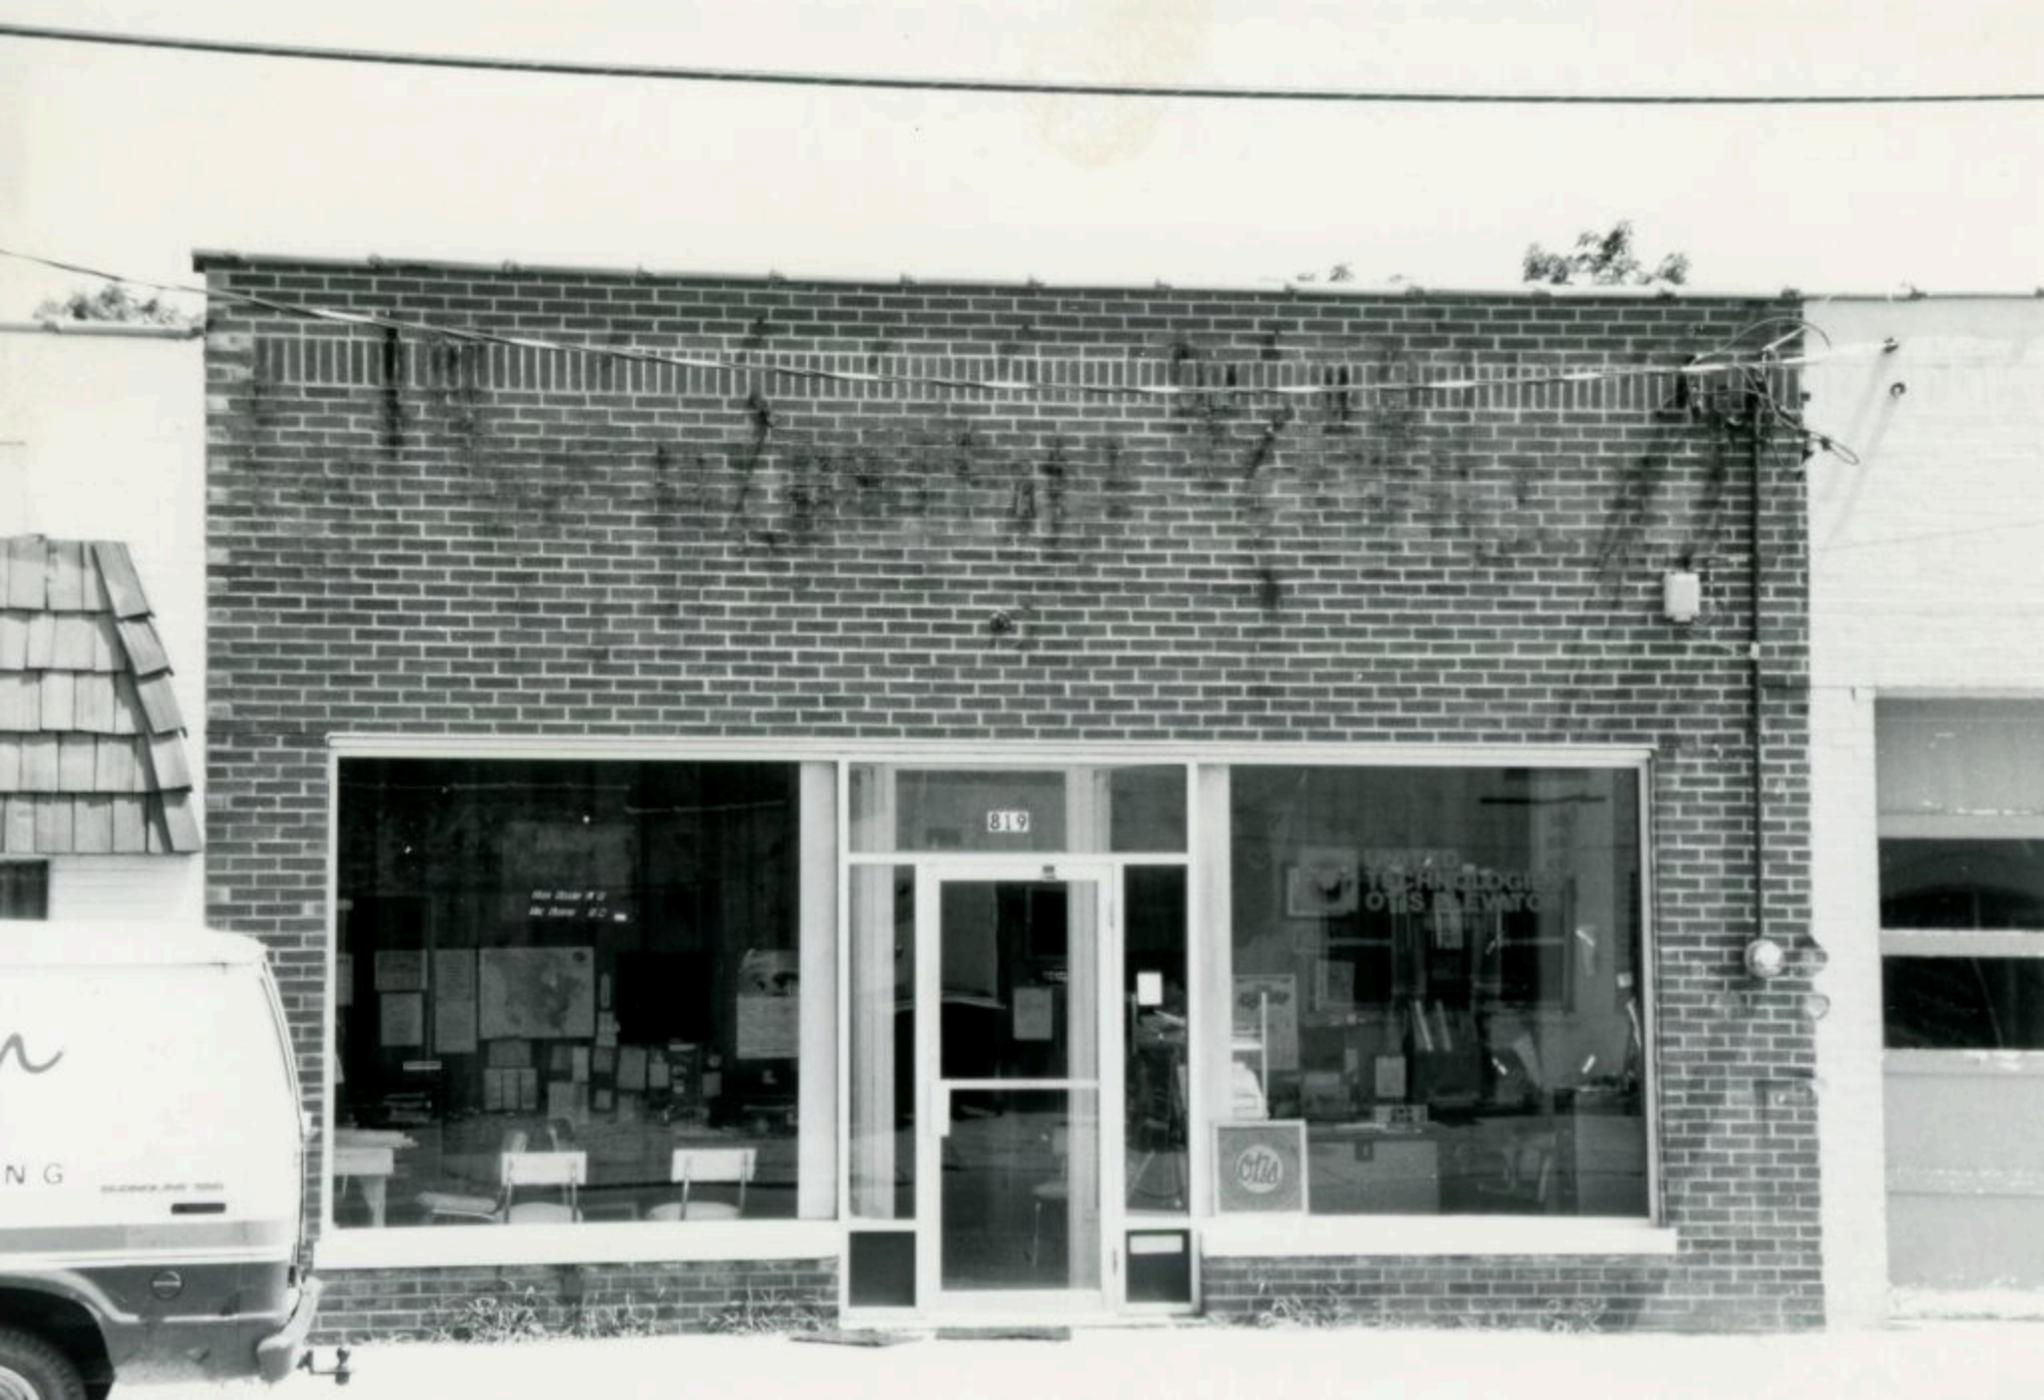
819

1 story. single entry with display windows commercial type. rectangular plan, 3 bay symmetrical facade. concrete block foundation, brick (wire cut) walls. shed roof. center aluminum frame modern door with sidelights and transom; flanking large 1-light display windows with concrete sills, plain upper section with soldier course below tile coping. north elevation attached to 817 Jefferson; south elevation attached to 821 Jefferson. concrete block rear elevation joined to rear of 821 Jefferson, see 821 form.

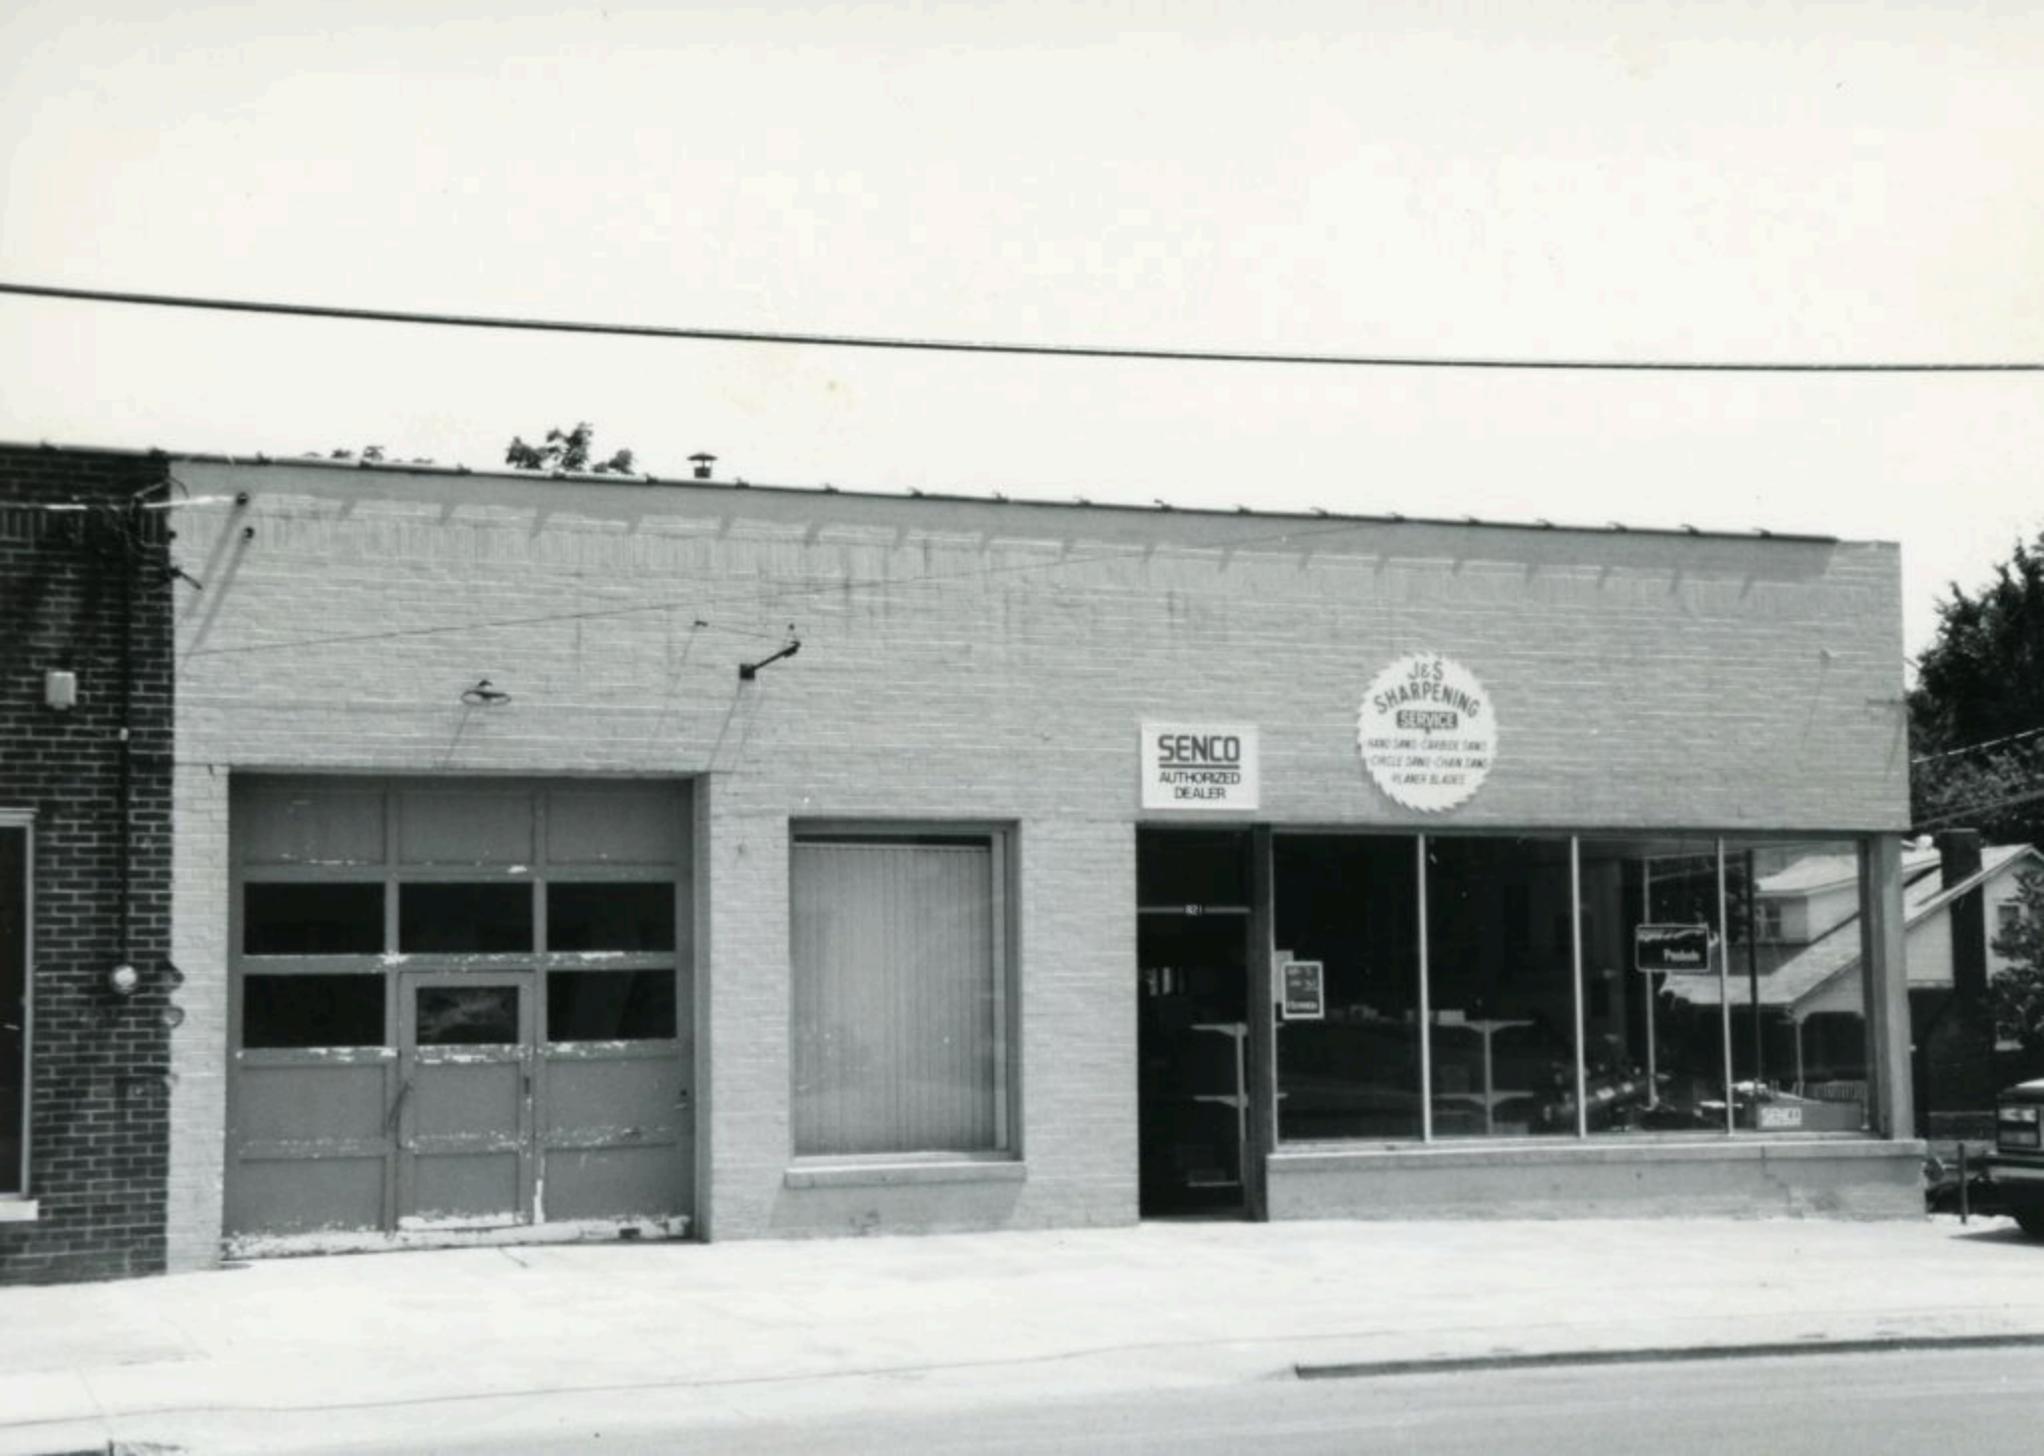
1 story. no commercial style or type. rectangular plan, asymmetrical facade. concrete block foundation, brick (wire cut, painted) walls. hip (metal) roof. overhead garage door at north end, large 1-light window off-center (north), modern aluminum frame door with transom off-center (to south) with adjacent band of four 1-light display windows to south corner and returning on south elevation; upper section plain with soldier course band below tile coping; concrete window sills. north elevation adjacent to 819 Jefferson. south elevation with two returning 1-light windows and infilled (vinyl sided) display opening; central garage door entry infilled with vinyl siding and pedestrian door with concrete steps, two modern 2-light windows to rear (east). exposed concrete block basement on rear joined with 819 Jefferson; basement with four modern overhead garage doors with industrial windows between south two doors; 1st-story with four modern 2-light windows to south, two industrial windows to north.

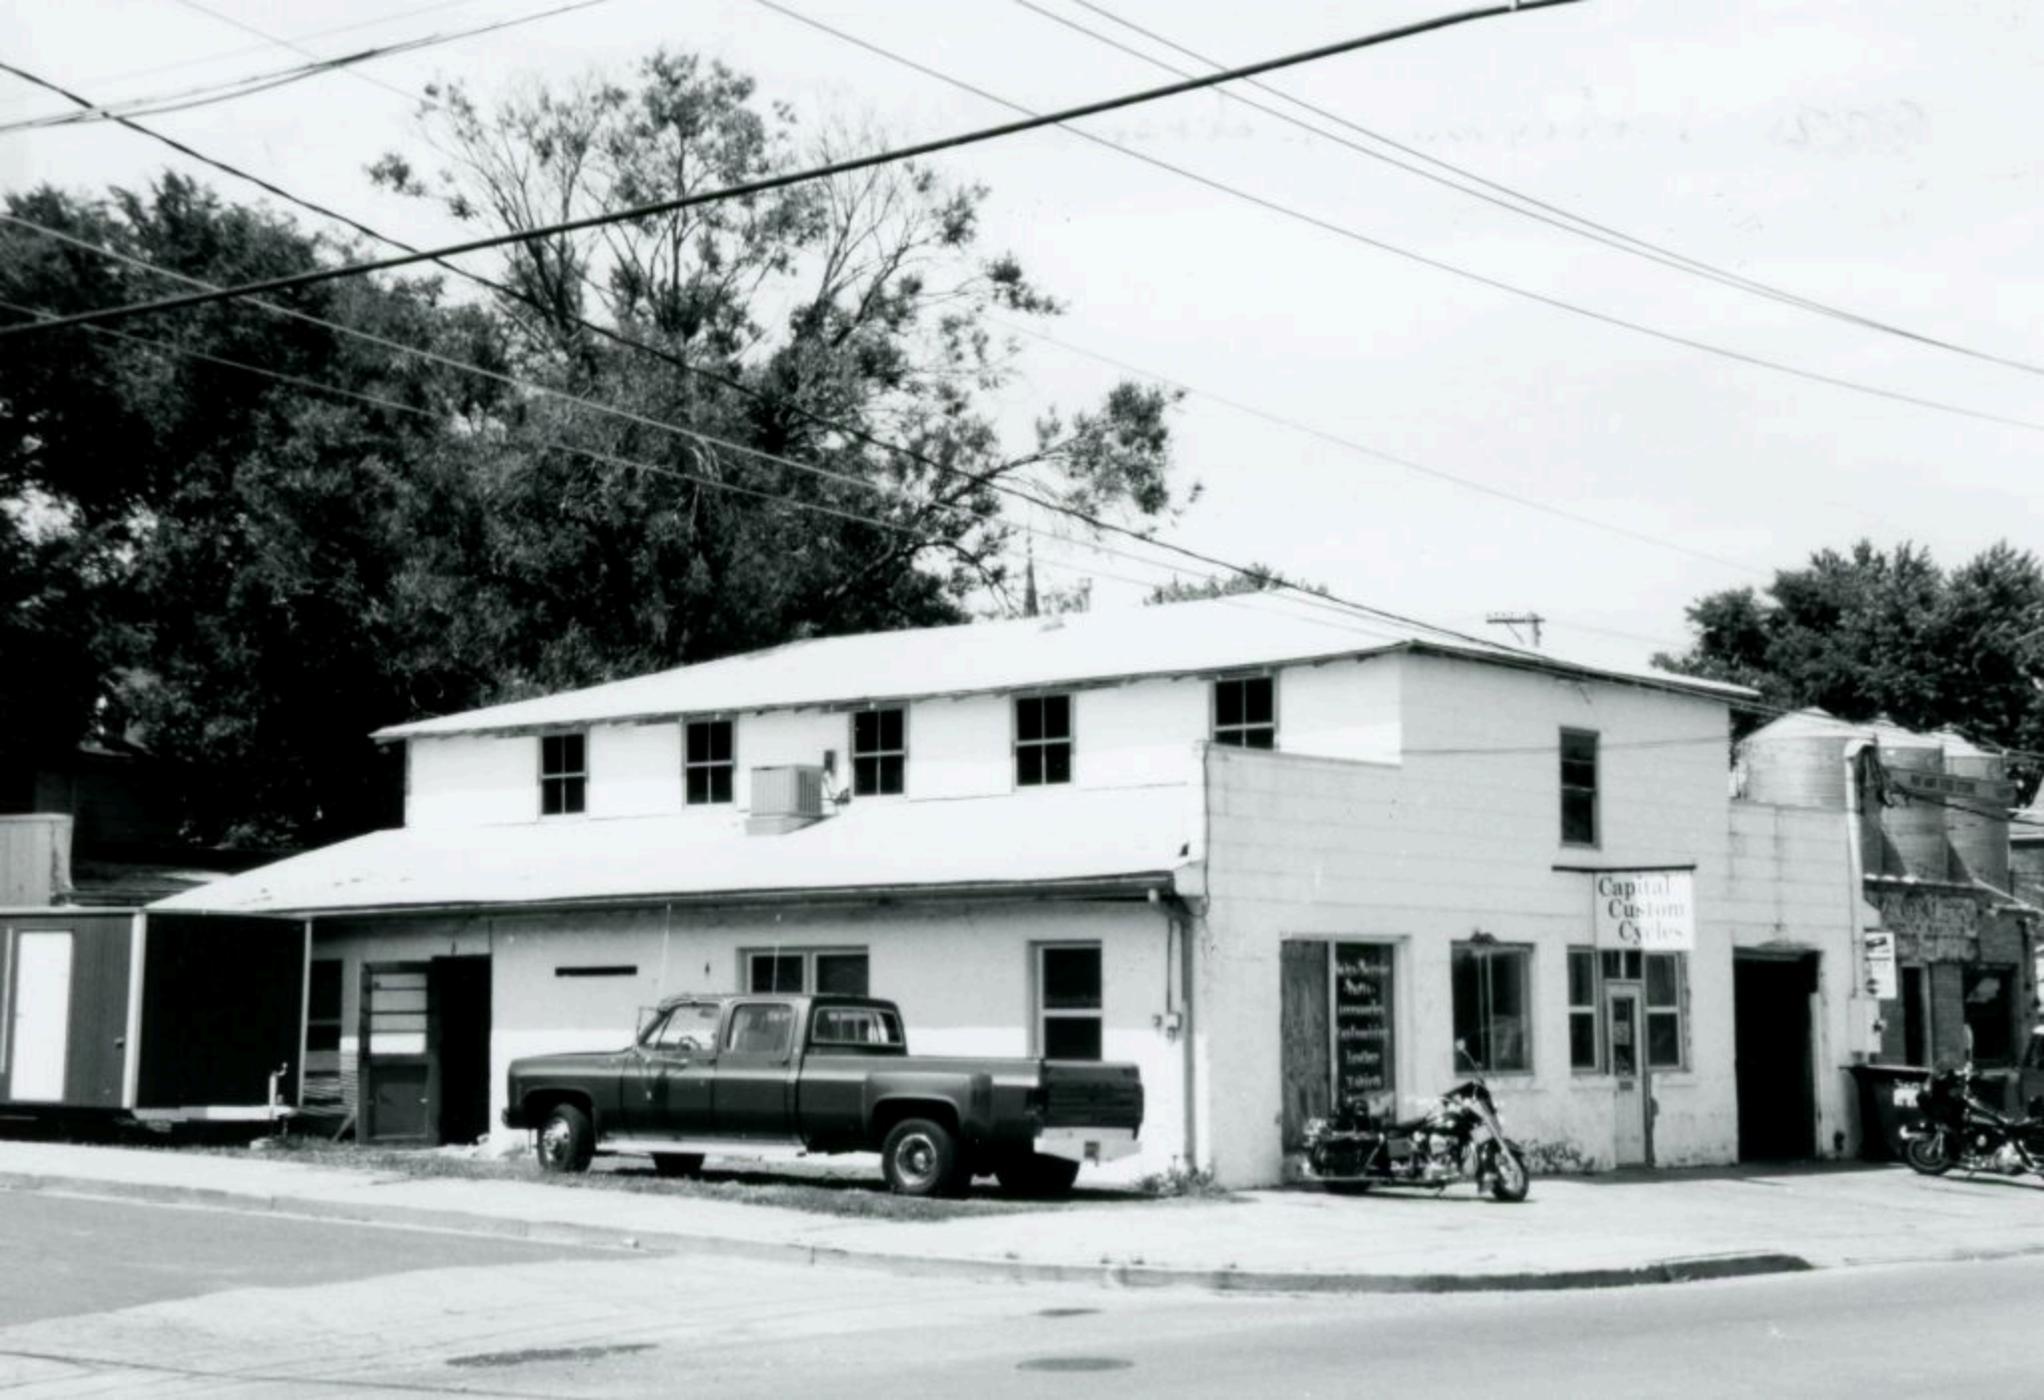
Two stories, with one story sections on either side. No style or vernacular building type. Rectangular plan. Foundation not visible; asbestos shingle (above first story windows) and stucco walls. Hip (asphalt shingle) roof with exposed rafter tails. One story side shed, false front south section with tall window pair; left/south window boarded; no front door this section. South elevation of this section with mixed fenestration and a pedestrian door toward the rear. Two story section on north with middle slider sash pair; door with boarded transom flanked by 1/1 windows; a single 1/1 is in the center of the second story facade. Third or southernmost section also with false front/side shed. The taller center hip block has five bays of 2 vertical/2 vertical double hung sash which are just above the side shed wings on either side elevation.
