HISTORIC SOUTHSIDE COMMERCIAL AREA

MISSOURI HISTORIC PROPERTY INVENTORY FORM

REFERENCE NUMBER CO AS003-001		A. HISTORIC NAME					
B. COUNTY 054 Cole		C. OTHER NAME(S)					
D. ADDRESS 102 East Ashley Street			E. CITY Jefferson City		F. VICINITY <input type="checkbox"/>	G. RESTRICTED	H. ACREAGE

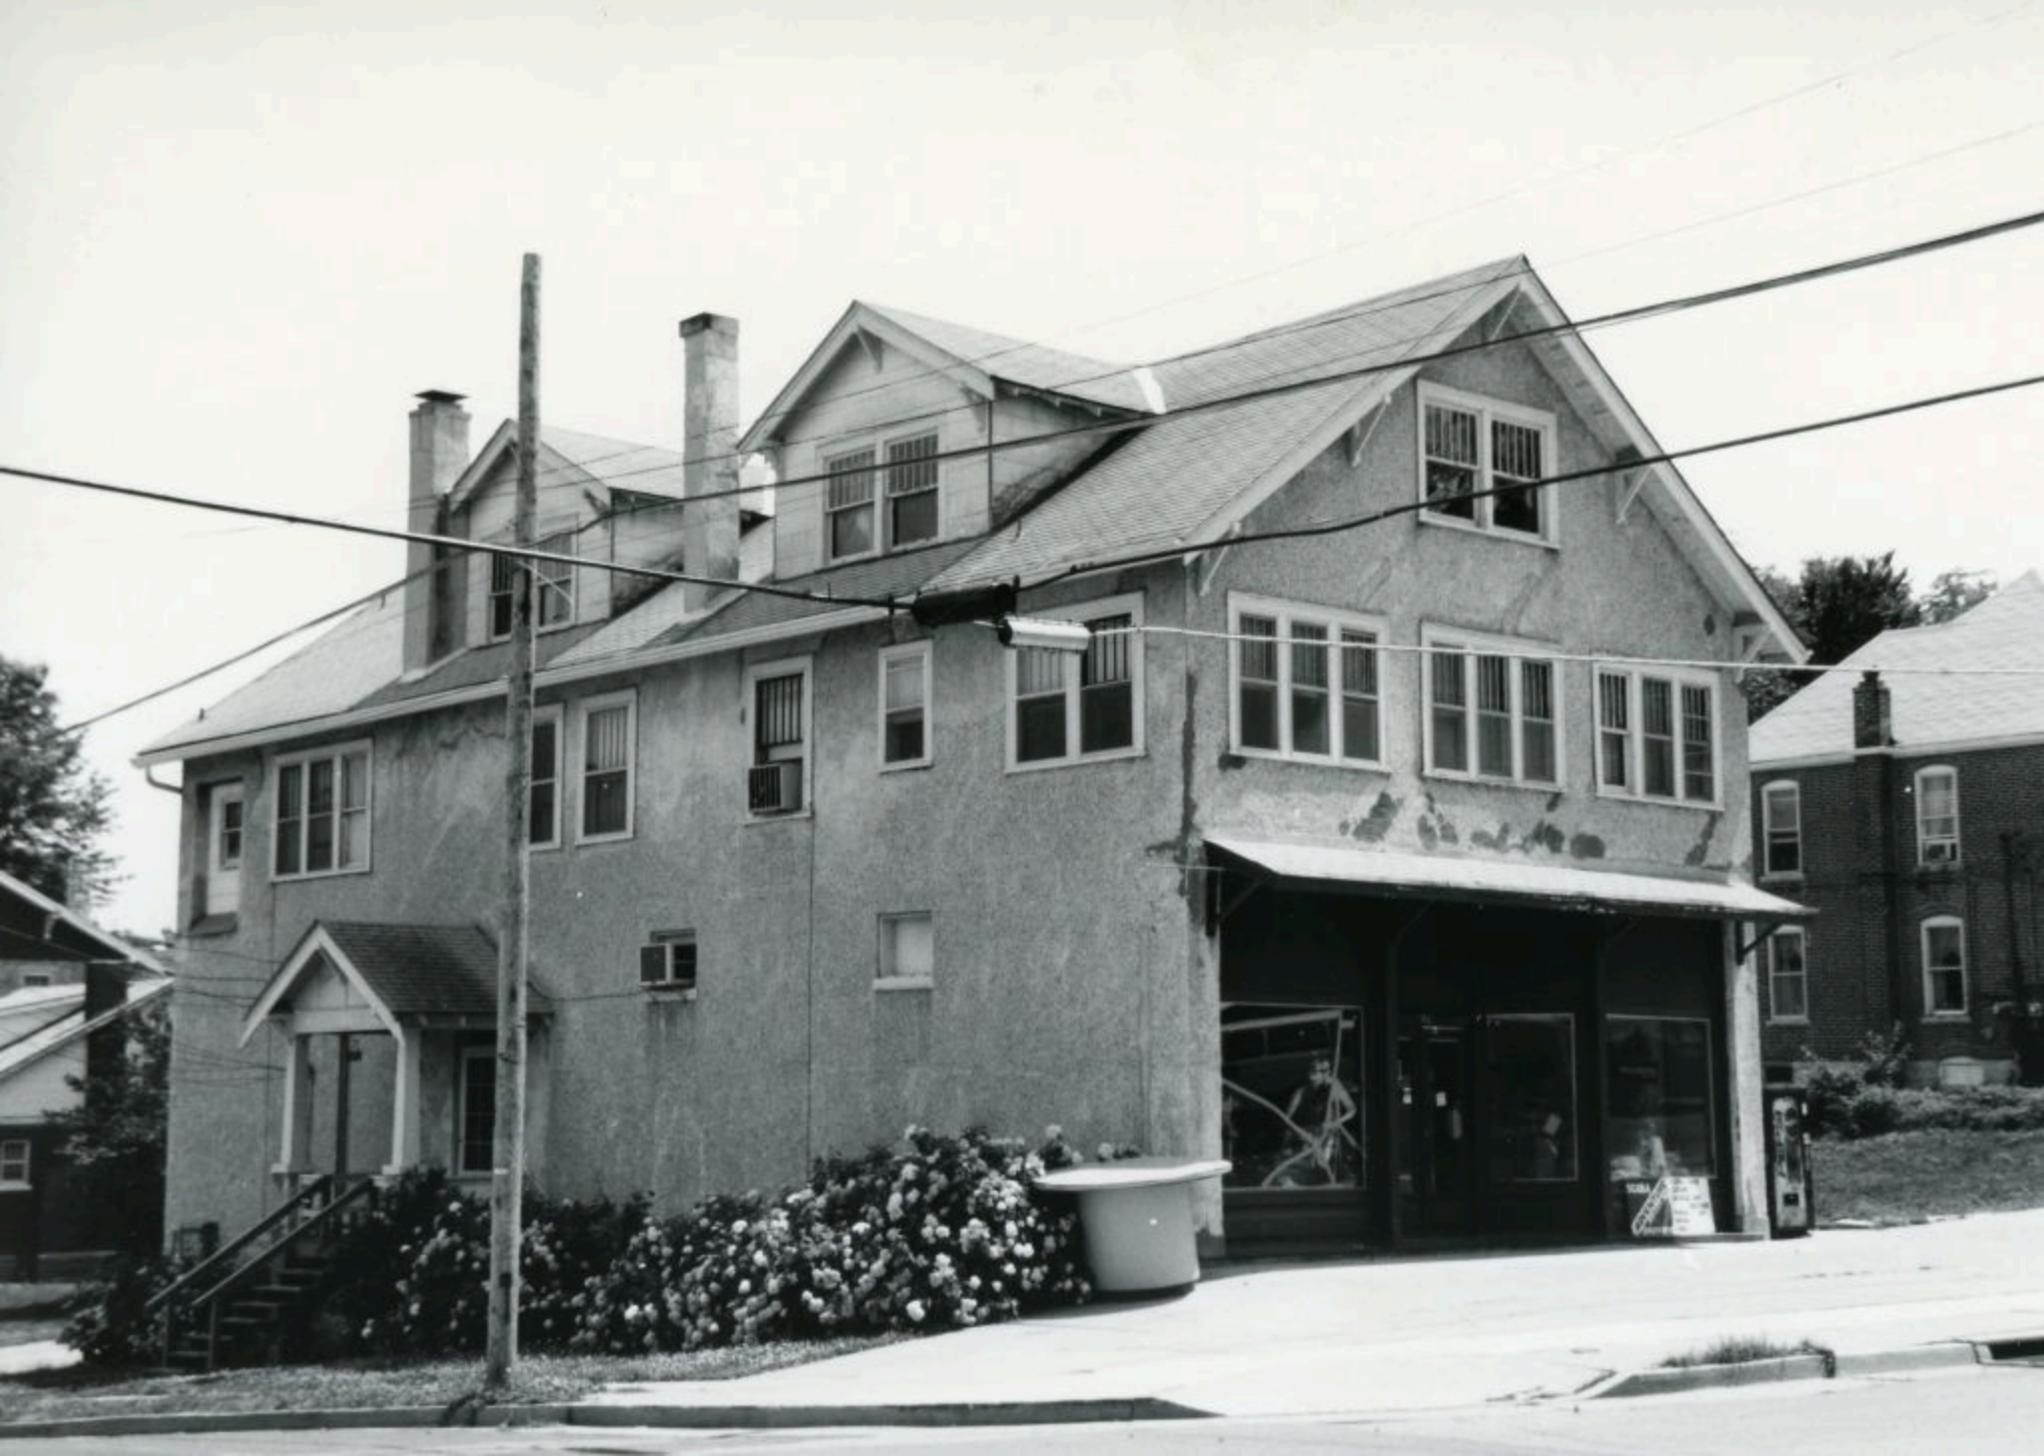
2-1/2 stories. Craftsman influenced corner commercial building. Rectangular plan. Limestone (coursed with "vined" mortar) foundation; stucco (rough aggregate, pigmented gray with black rock) walls. Gable front (asphalt shingle) roof with knee braces on gable ends and dormers; sides with exposed rafter tails. Multi-vertical-light/1 double hung sash with plain surrounds. Single storefront with double large light recessed doors with panels, angled windows, and large fixed single storefront sash on either side. Tall storefront transom area boarded. Shallow shed roof canopy with knee braces. Three sets of three 4 vertical/1 windows above with pair 6 vertical/1 in upper half story. North elevation with multi-light door with transom and multi-light storm door. Side entrance gable roof porch with raised wood deck accessed by wood replacement stairs, wood open rail, stucco pedestals with tapered Doric posts, knee braces and plain cornice. Gable with stucco and wood "half-timber" treatment; rake boards with extending pointed ends. Three fixed sash on first story set high; rock-faced stone lug sills; windows boarded or with air conditioner inserted. Basement windows exposed this side, with single rowlock segmental arches. Mixed second story windows with rear/easternmost bay infilled with a smaller historic 3 vertical/1 window and asbestos shingle where an open second story porch was. Various multi-light windows in singles, pairs, and sets. Two gable roof dormers with paired 6 vertical/1 windows. Interior end chimneys just left of each. Rear with exposed basement with solid replacement door and single window. Blocked transom left/south bay; 1/1 window to right of each door. Full elevation porch was originally open, but is now enclosed on the right two bays as east bay on second story of north elevation. Open bay with beadboard solid rail. Pair of windows second story as on facade. South elevation with exposed brick on first story; three fixed sash as on north elevation with a 6 vertical/1 window toward the rear. Second story mostly paired windows. Two gable roof dormers as other side, but no chimneys.

A very handsome corner commercial building with a high degree of integrity. Recommended for potential eligibility to the National Register of Historic Places for architectural significance, as a Craftsman influenced neighborhood corner commercial building.

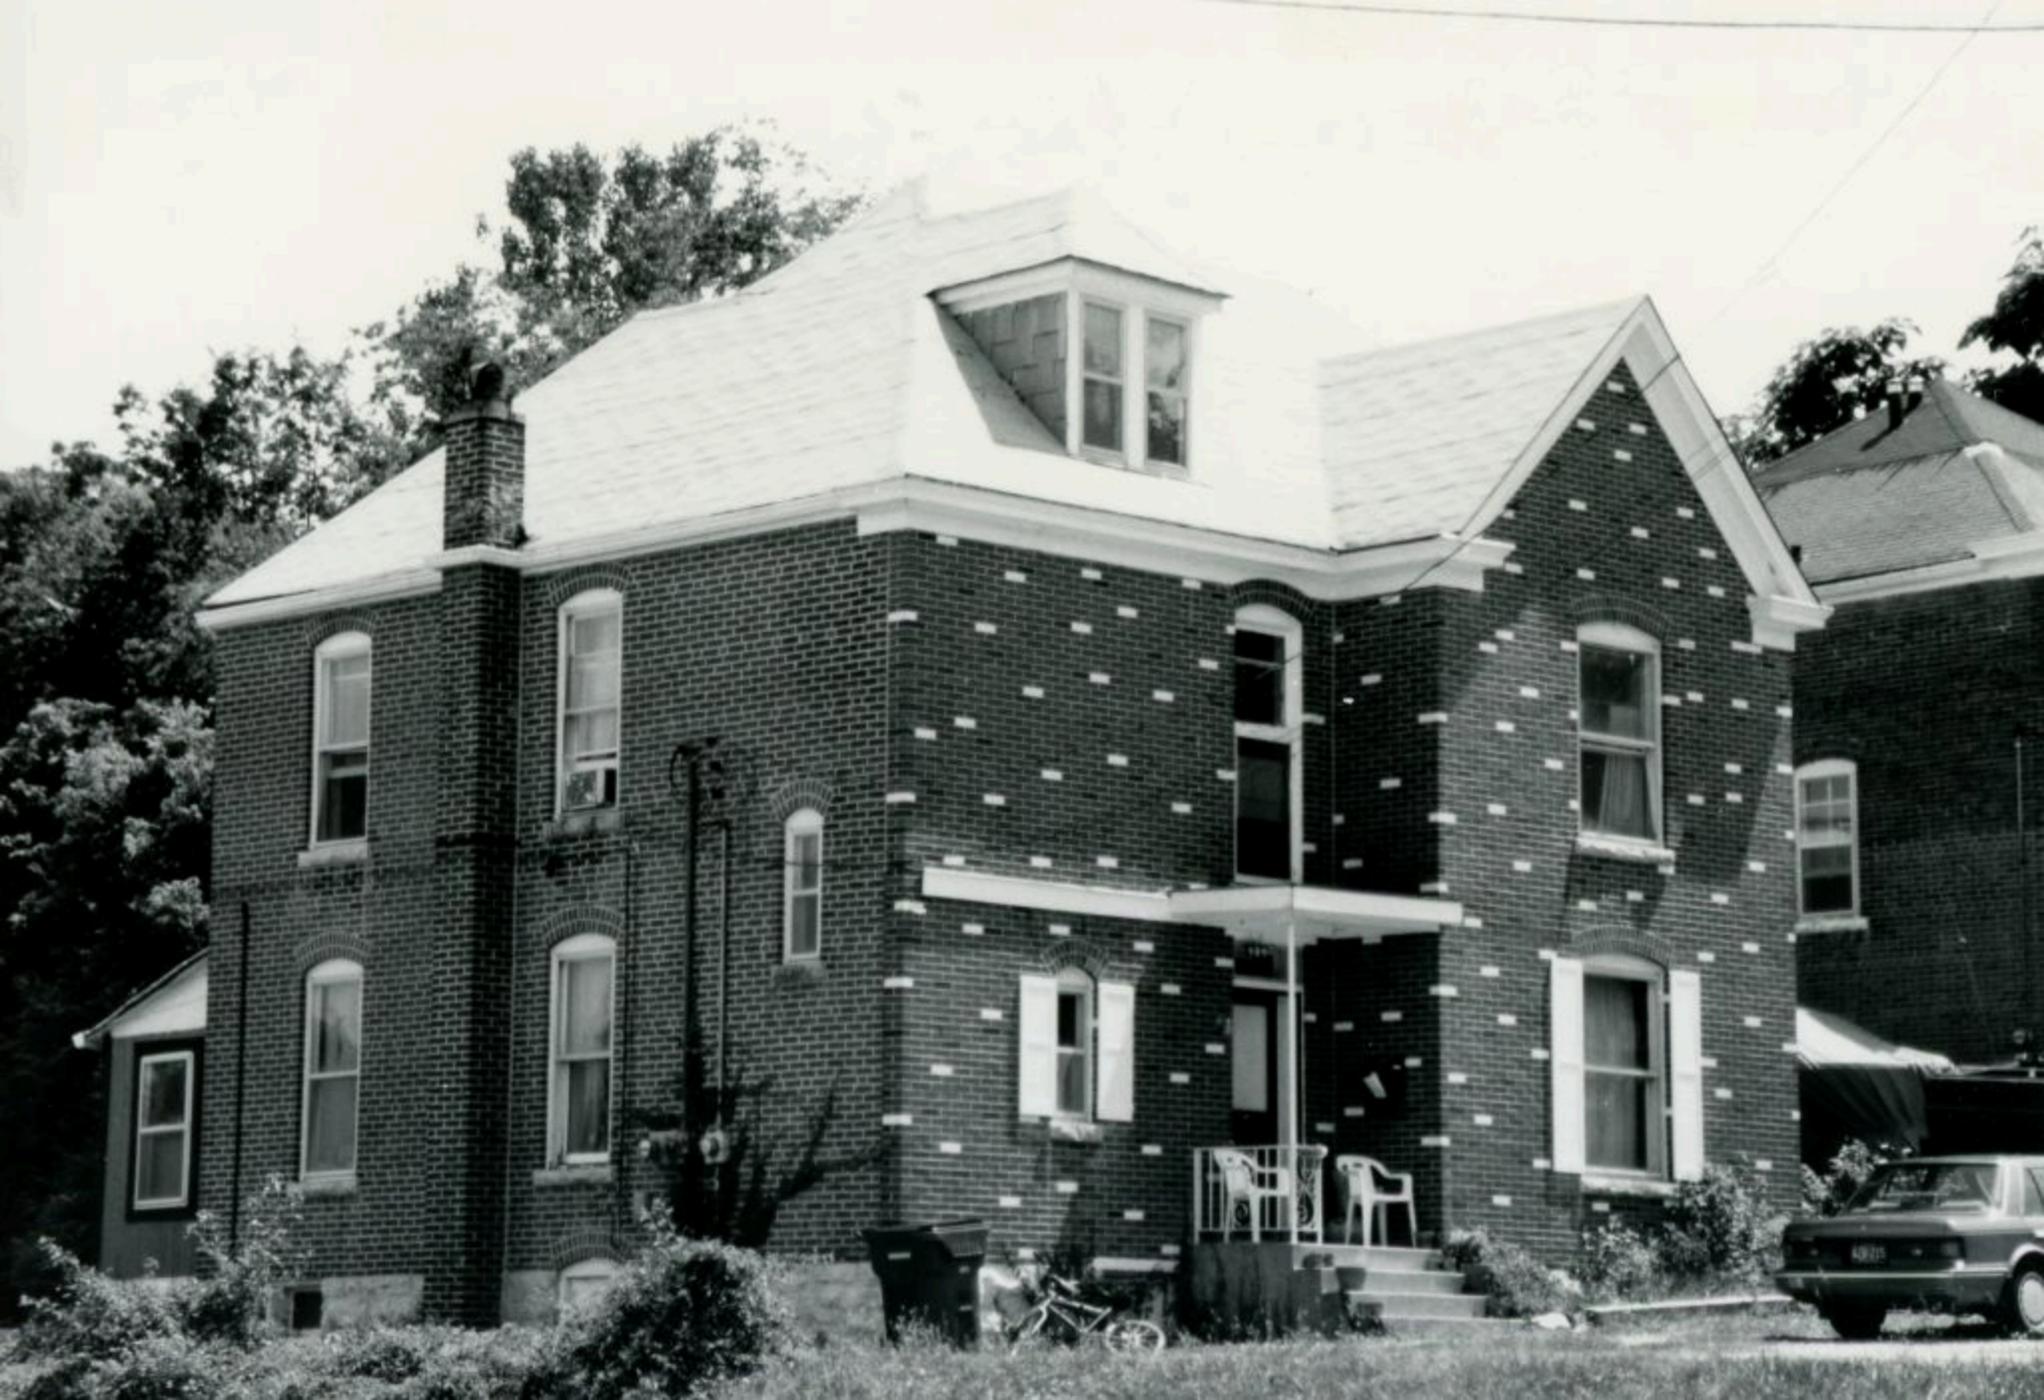
2-1/2 stories. Queen Anne influence, altered. Single family residence converted to apartments. L-plan, three bay facade. Limestone foundation; brick walls (facade brick appears more modern, perhaps a refacing); asphalt shingle dormer walls. Gabled hip (rolled asphalt) roof. 1/1 double hung sash with rock-faced stone lug sills, double rowlock segmental brick arches, and modern aluminum storm windows. Similar to 905 Jefferson Street, adjacent to the south. Facade with petite 1/1 left and entrance with large light door with transom in main hip block. Wide 1/1 window with paneled window head in gable front with same above; gable with cornice returns. Small modern entrance porch at reentrant angle with poured concrete raised stoop with small iron pole support for flat metal porch canopy; modern iron open rail. Second story facade above door has a full-height opening which appears to be a 1/1 double hung sash with a paneled bulkhead which raised as window, but as to affect a door. Hip roof dormer with asphalt shingle siding. Two 1/1 windows. Two bay symmetrical south elevation with shed two story wing extending full elevation. Hip roof dormer with interior end chimney dividing 1/1 windows. Straight run exterior wood staircase added from rear to attic, middle on south elevation. Rear with one story frame shed roof enclosed porch. Three bay north elevation with exterior end chimney; guttering cut out around and following chimney. Small 1/1 staircase landing window at front.

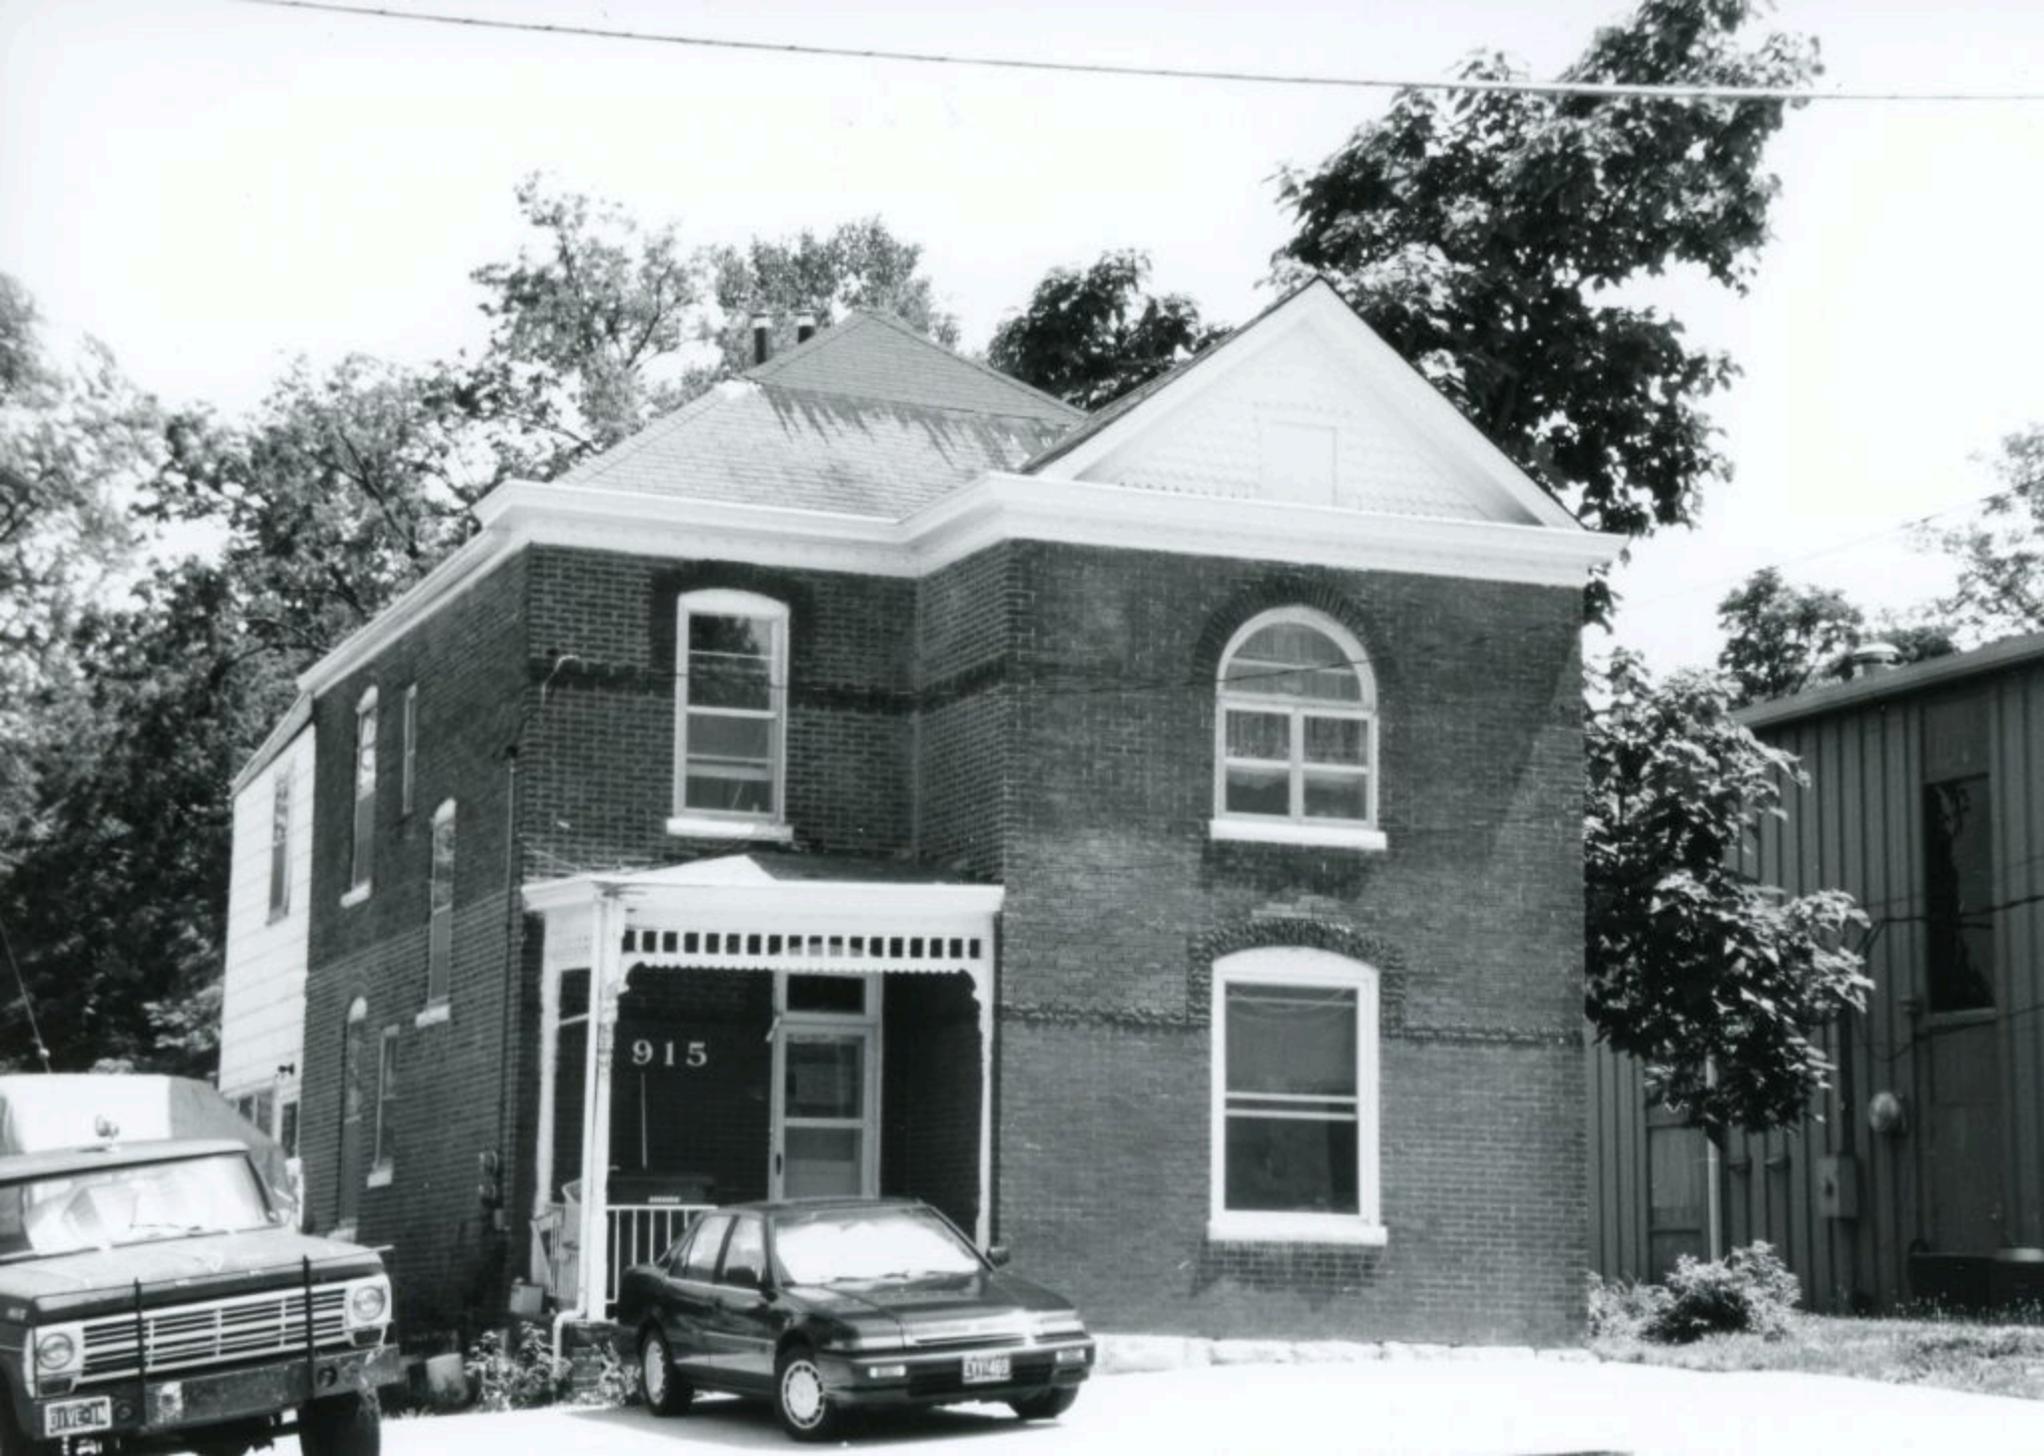
2 stories. Queen Anne. L-plan, 2 bay facade. Limestone foundation; brick walls. Fish scale shingle gable. Gabled hip (asphalt shingle) roof. 1/1 double hung sash with rock-faced soldier brick segmental arches with drops to mid-window height rock-faced two course brick belt course on both stories of facade; rock-faced stone lug sills painted white; side elevations with double rowlock segmental brick arches. Hip roof reentrant angle (half) porch with wood deck (clad with artificial turf), brick support piers, turned post, spindled and scalloped frieze, plain cornice, iron modern open rail; brackets at posts. Left/north entrance with large light door with transom in hip block. Right/south with two story gable roof pavilion. Wide 1/1 window first story; second story with round arched window group with storms concealing exact light pattern. Gable with fish scale shingles, full cornice return, and boarded attic fenestration with pedimented dripcap. Some repointing of brick with inappropriate mortar above porch and first story of north elevation (see mid-elevation height in photograph). Bulls eye cornice; boxed gutters. Mixed height windows on north elevation, including full-size window at staircase landing. Rear two story shed roof frame wing with asbestos shingle siding; may have originally been a sleeping porch. Three bay south elevation with at least one 2 vertical/2 vertical window intact; symmetrical fenestration placement between stories.

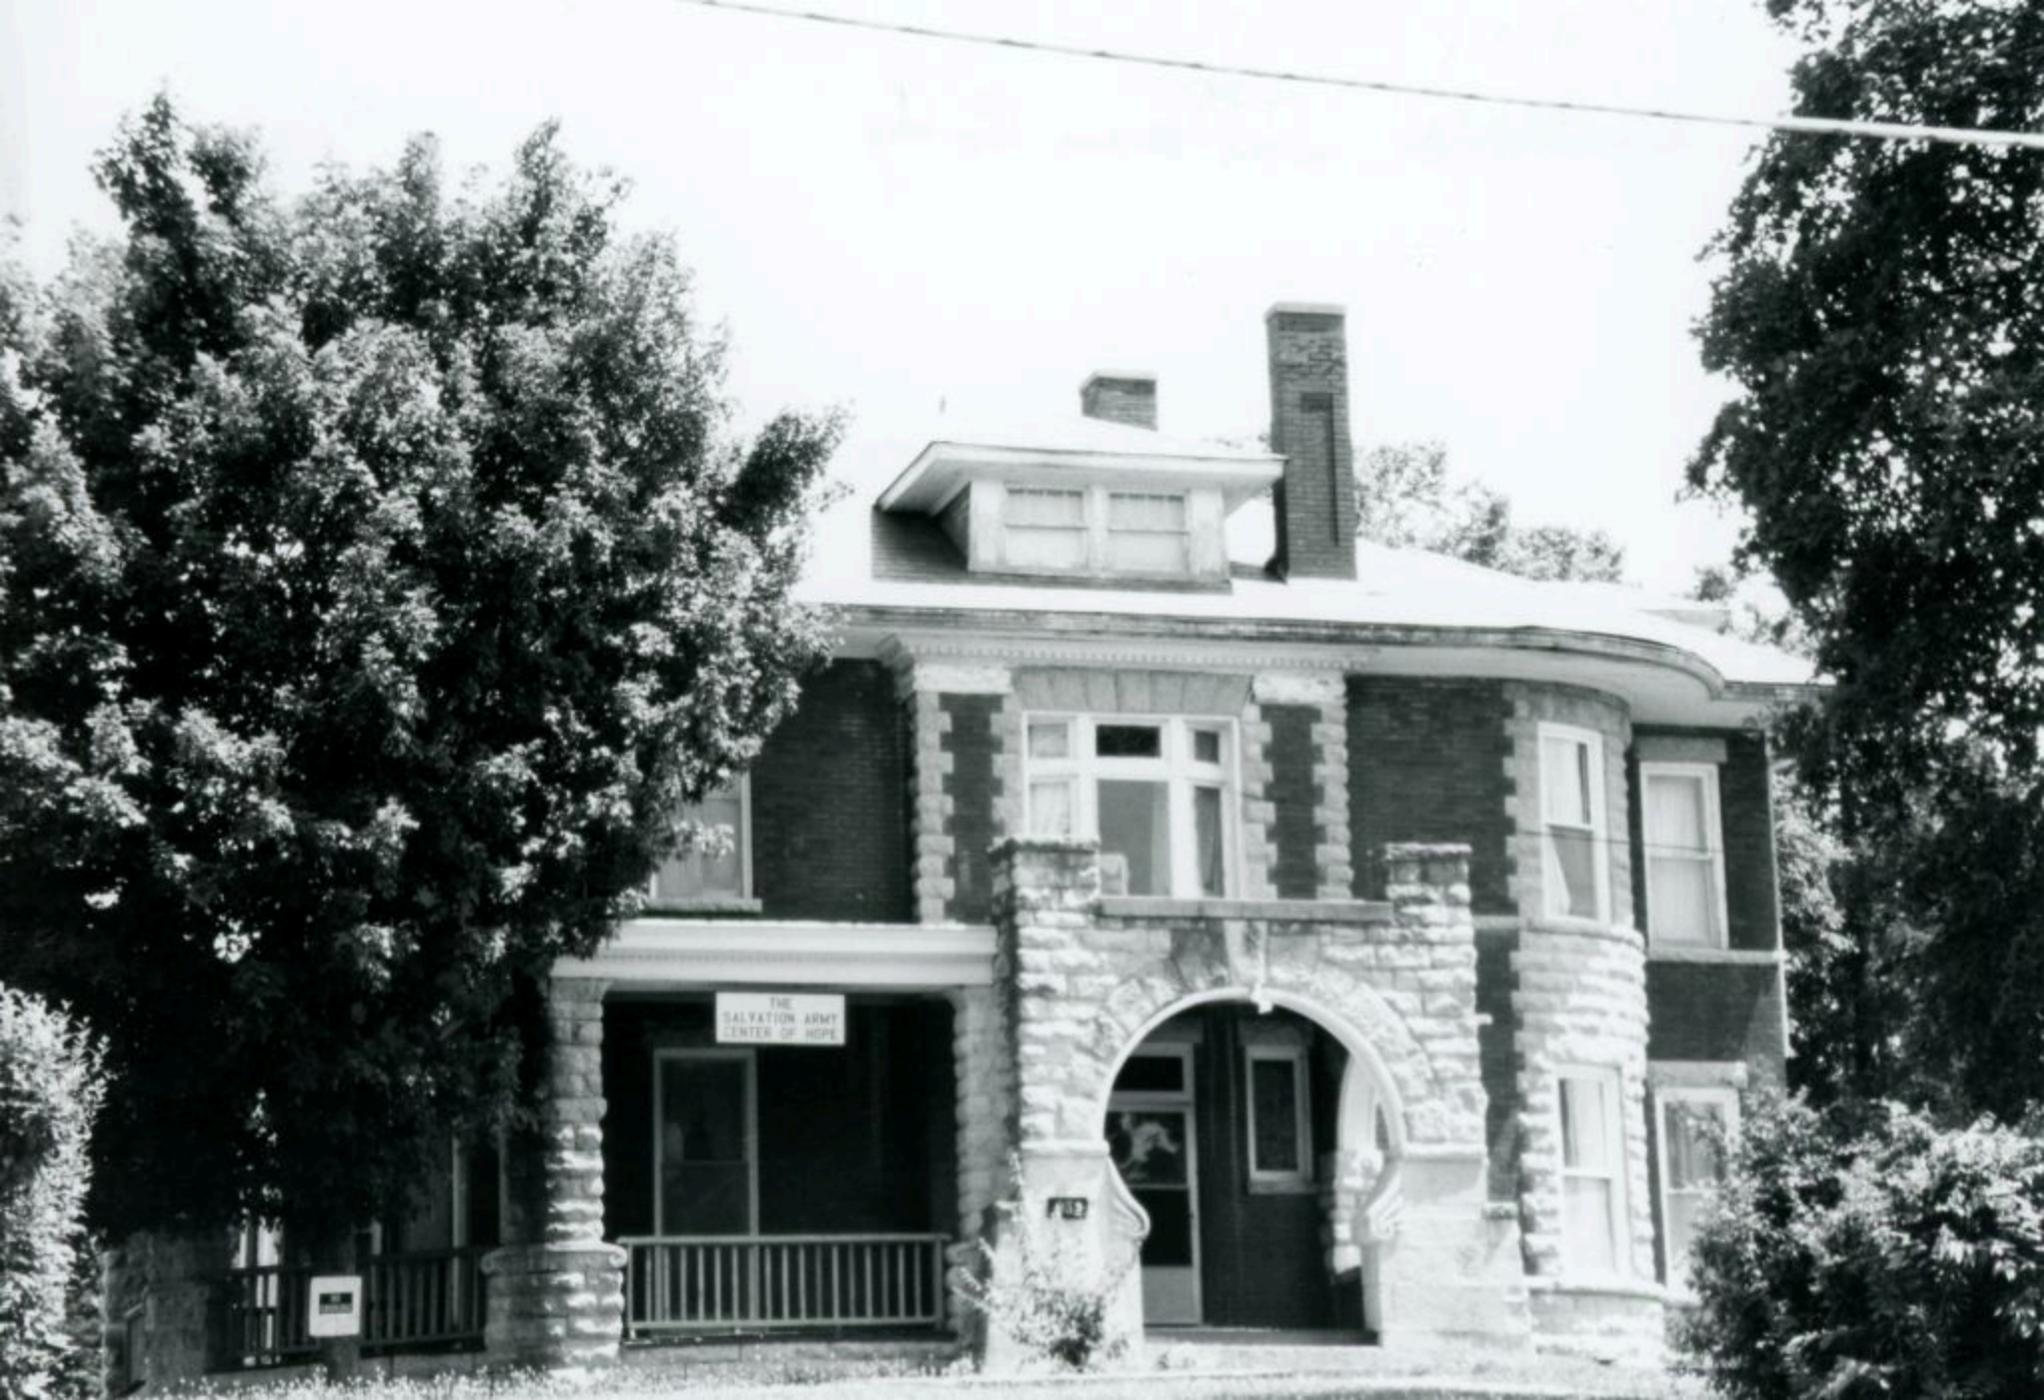
2-1/2 stories. Queen Anne style. irregular plan, 4 bay asymmetrical facade. coursed rock-faced stone foundation with watertable, brick (face, running bond) and stone walls. hip (slate) roof. flat roof porch across north two bays with angled north end that returns one bay on north elevation, four stone piers on stone pedestals, low stone foundation, wood deck and modern wood slat railing, wood frieze with dentils; elaborate stone round arch entryway with dressed stone base with scrolls at inner sides of impost blocks creating a horseshoe-type opening, rock-faced spandrel area and voussoirs, end piers flank center "parapet" with cap. north end bay with cut-away corner with 1/1 per face per story; 2nd bay as slightly projecting entry pavilion with door with transom and flanking high rectangular 1-lights, 2nd-story with stone quoins, center shallow semi-hexagonal wood three-part window with transoms inset in large opening with stone quoins/surround, stone flat arch with flanking wood cornice with dentil course above and across bay; 3rd bay with small rectangular frosted glass 1-light to south of entry bay with stone sill on corbells, brick flat arch with narrow wood lintel above with scrolled ends, stone string course below blind 2nd-story, rounded stone-faced corner with two curved 1/1 windows per story; square south end bay with 1/1 per story with watertable and string course as sills; very wide overhanging boxed eaves, center hip roof dormer with two wide windows, chimney with paneled stack to south. windows as 1/1, 4-vertical/1 double hung with stone lintels/sills; rear elevation windows with double rowlock segmental arch openings, stone sills. south elevation with rock-faced porch to west with square opening topped by round arch, stone "parapet"; rounded corner bay; low projecting hip roof pavilion with two 1/1 windows per story, 2nd-story window sills project from string course on two corbelled brick rows; wide overhanging eaves, hip roof dormer with two 1-light windows; rear section with triple 1/1 on 1st-story with soldier segmental arch opening, small 1/1 in corner of 2nd-story with blocked door at east end with added modern wood exterior stairs. north elevation with two bays: porch and cut-away corner with 1/1 windows returning on west bay, then blind section on both stories; east bay with projecting 1-story square bay with raised stone foundation (no watertable on this elevation), large elaborate window opening with three-part window divided by engaged columns with round arch three-part transoms, three corbelled brick round arches with wood extrados with scrolled ends and three oversized stone keystones, wood entablature around bay, brick parapet above with stone cap; 2nd-story as semi-hexagonal bay with three 1/1 windows with continuous stone sill, wide overhanging eaves, lower semi-hexagonal roof; center hip roof dormer with paired windows. rear as L-plan with lower projecting hip roof pavilion to south with modern door with transom to south, 2nd-story with 1/1 above door, small 1/1 to north; north re-entrant corner with large modern metal addition across 1st-story and projecting to east, 2nd-story with 1/1 in corner, high 1/1 and central 1/1 windows; hip roof dormer with paired windows, chimney to south.

Busy commercial street; very large lot, set on hill with deteriorating concrete yard slope steps, parking area and modern building to north, modern commercial buildings to south, gravel parking area in rear
No outbuildings

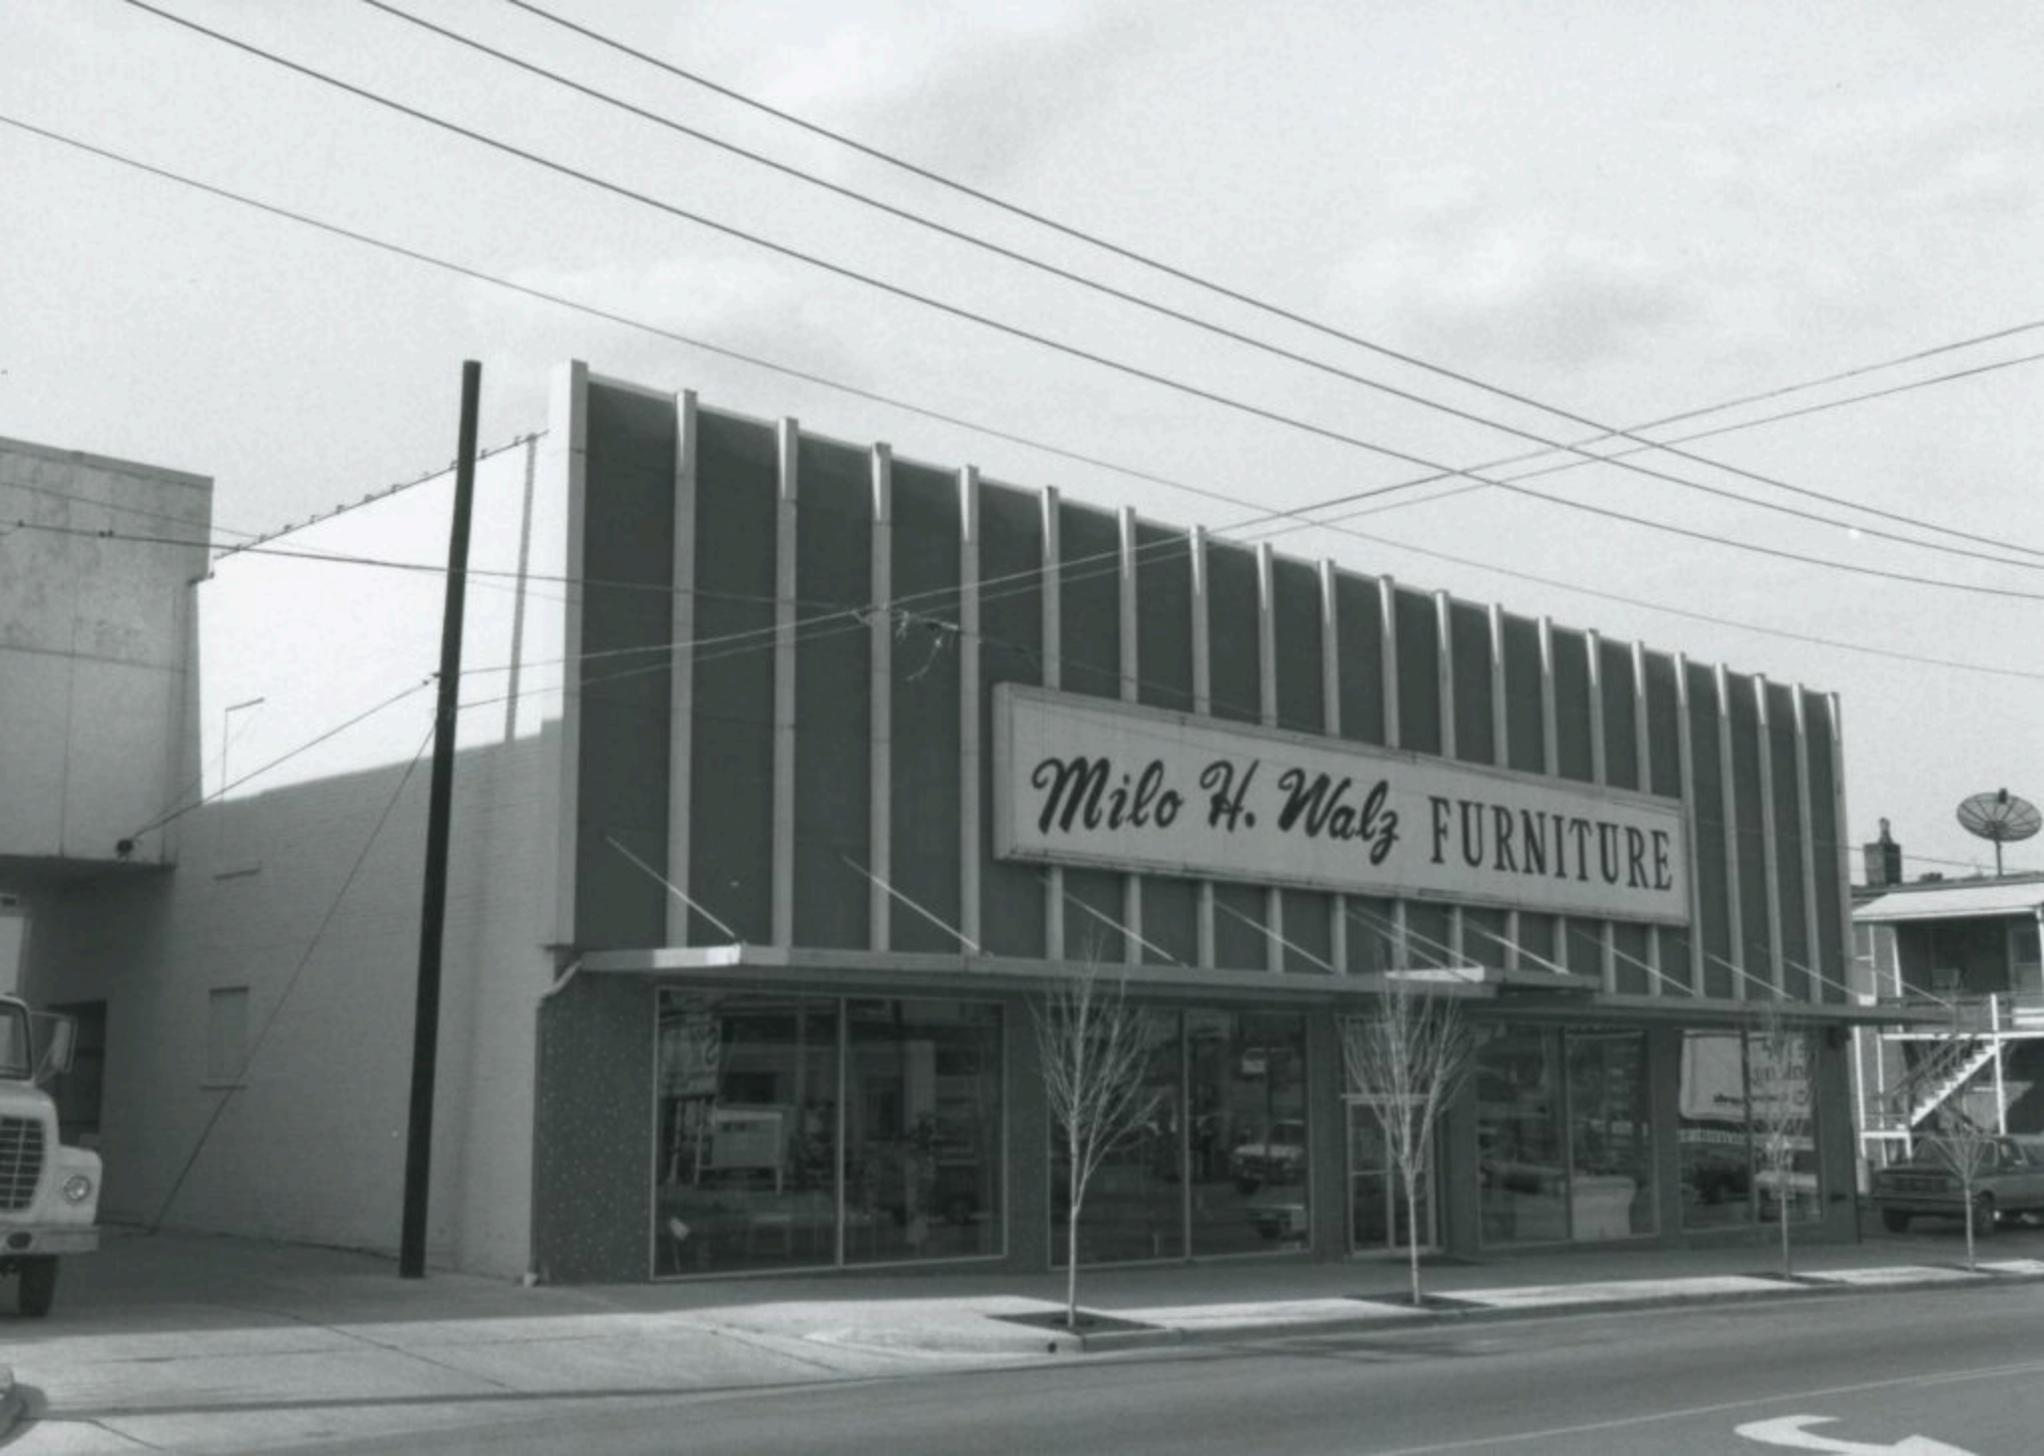
A black and white photograph of a two-story commercial building. The upper story features a series of vertical, dark-colored panels. A large, light-colored sign is mounted across the middle of the building, displaying the name 'Milo H. Walz' in a cursive script and 'FURNITURE' in a bold, sans-serif font. The ground floor consists of large glass windows and doors, reflecting the street scene. In front of the building, there are several small, bare trees planted in individual concrete pits. To the left, a utility pole with multiple power lines stands near the corner. On the far left, the front of a white truck is visible. To the right, another building with a satellite dish and a car is partially visible. The sky is overcast with light clouds.

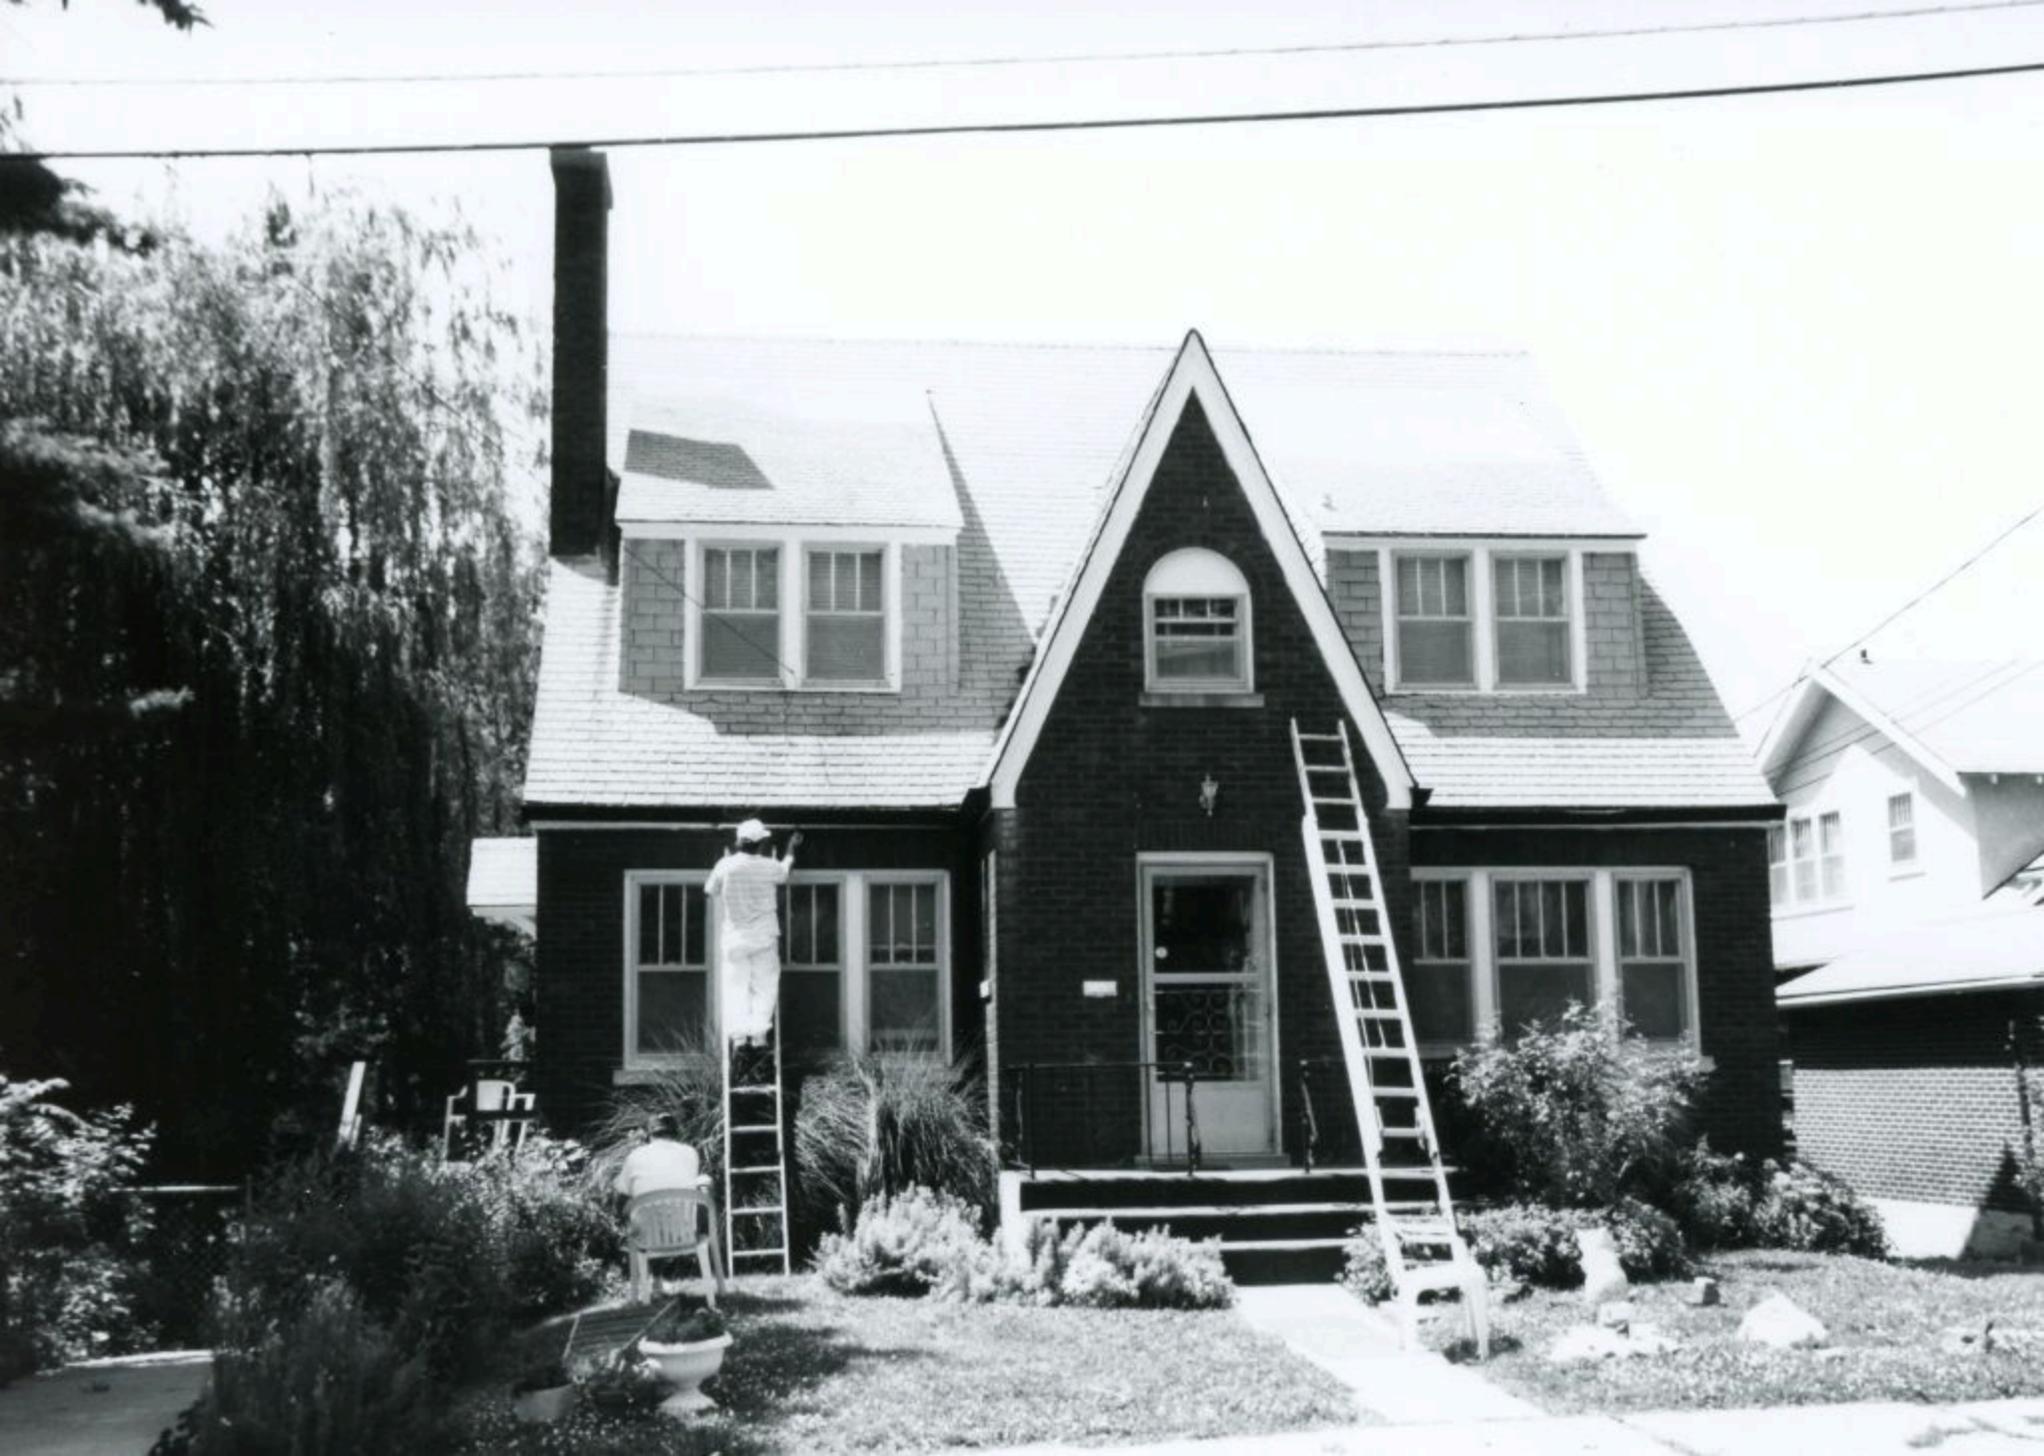
1 story with attic. Bungaloid type. Rectangular plan, 3 bay asymmetrical facade. Poured concrete foundation, brick walls. Gable (asphalt shingle) roof. Full-facade hip roof porch with three brick piers, open wood slat open rail with pedestal to right of entrance bay, low poured concrete deck, wood frieze. Off-center (to north) 6-light door with historic 8-light storm door, flanking 3-vertical/1 windows; brick main gable with single boarded opening & center brace, overhanging open eaves, rear brick ridge chimney. Windows as 3-vertical/1 double hung with soldier flat arches and rowlock sills. North elevation with three windows, center window smaller, exposed basement, overhanging open eaves with exposed rafter tails. Rear shed roof porch or wing recessed from north elevation. Three bay south elevation.

This area does not appear on the 1908 Sanborn Map. The 1923 map shows no buildings on this side of the 800 block of Monroe, except for #804. The 1939 map shows the current dwelling with its full-width front porch and rear porch.
