HISTORIC SOUTHSIDE COMMERCIAL AREA

MISSOURI HISTORIC PROPERTY INVENTORY FORM

REFERENCE NUMBER CO AS003-001		A. HISTORIC NAME					
B. COUNTY 054 Cole		C. OTHER NAME(S)					
D. ADDRESS 102 East Ashley Street			E. CITY Jefferson City		F. VICINITY <input type="checkbox"/>	G. RESTRICTED	H. ACREAGE

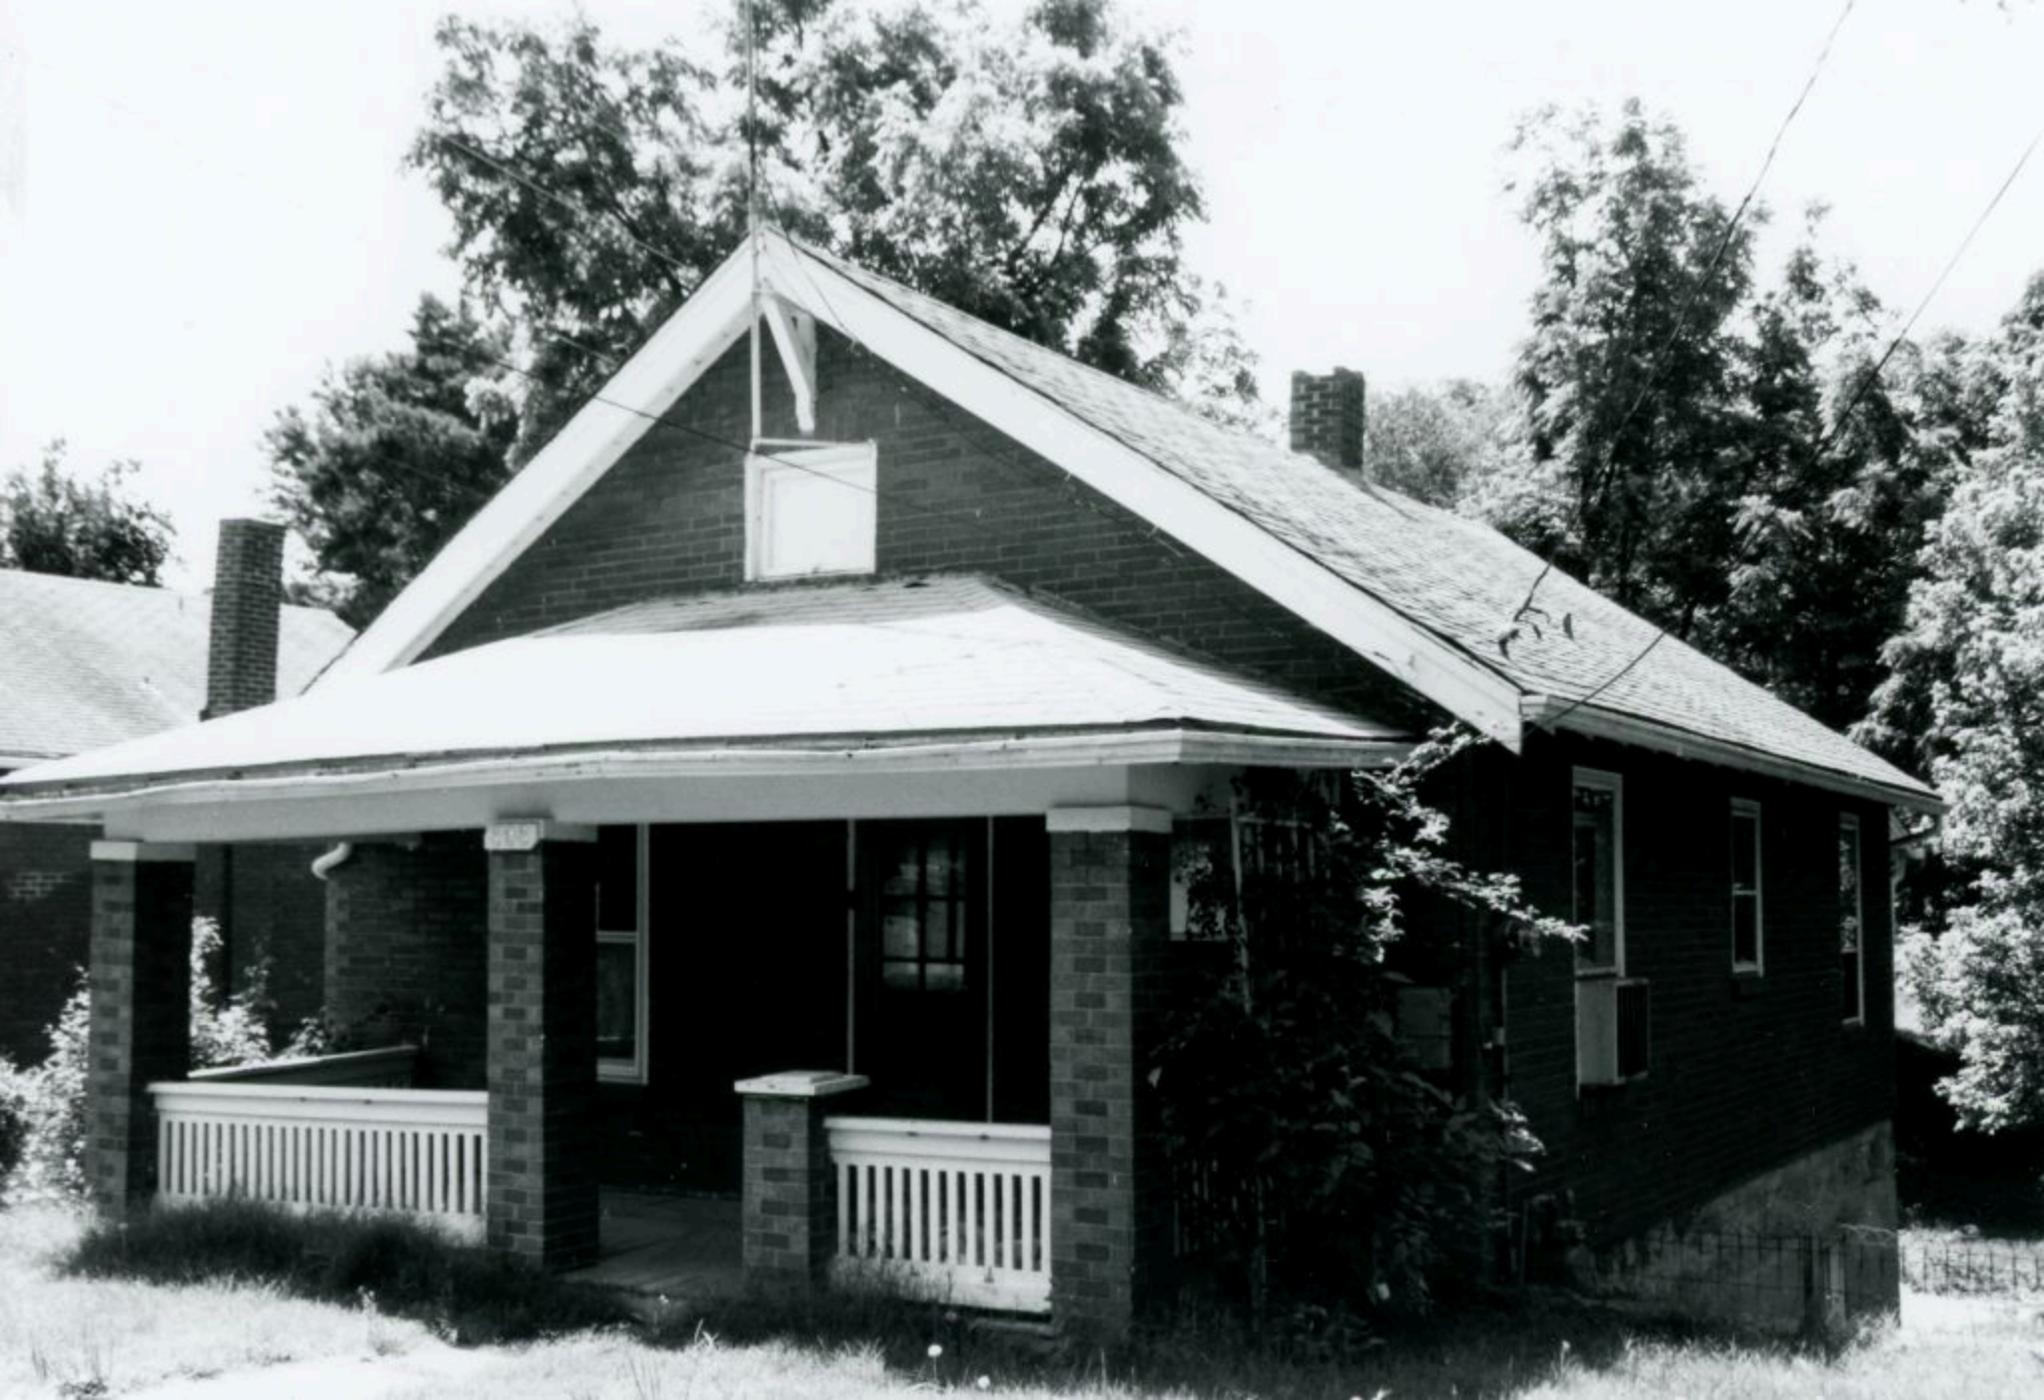
1 story with attic. Bungalow type. Rectangular plan, 3 bay asymmetrical facade. Poured concrete (painted) foundation, wire-cut brick walls. Gable (asphalt shingle) roof. Full-width gable roof porch with brick corner piers, brick solid rail with entry bay pedestals and painted concrete coping/caps, low poured concrete deck. Porch gable with asphalt shingles, wide wood frieze and wide overhanging open eaves with rafter tails, shaped rake board. Center 3-light/panel door with transom, flanking windows: single window to north and paired to south; brick main gable with paired vents, overhanging open eaves with rake board. Windows as 3-,4-vertical/1 double hung with concrete sills and double rowlock segmental arch openings. South elevation with single, paired, and single windows; overhanging open eaves with rafter tails. North elevation with single window, high smaller window, exterior brick furnace chimney and window to rear. Rear interior end brick chimney.

This area does not appear on the 1908 Sanborn Map. The 1923 map shows no buildings on this side of the 800 block of Monroe, except for #804. The 1939 map shows the current dwelling with its full-width front porch and rear porch.

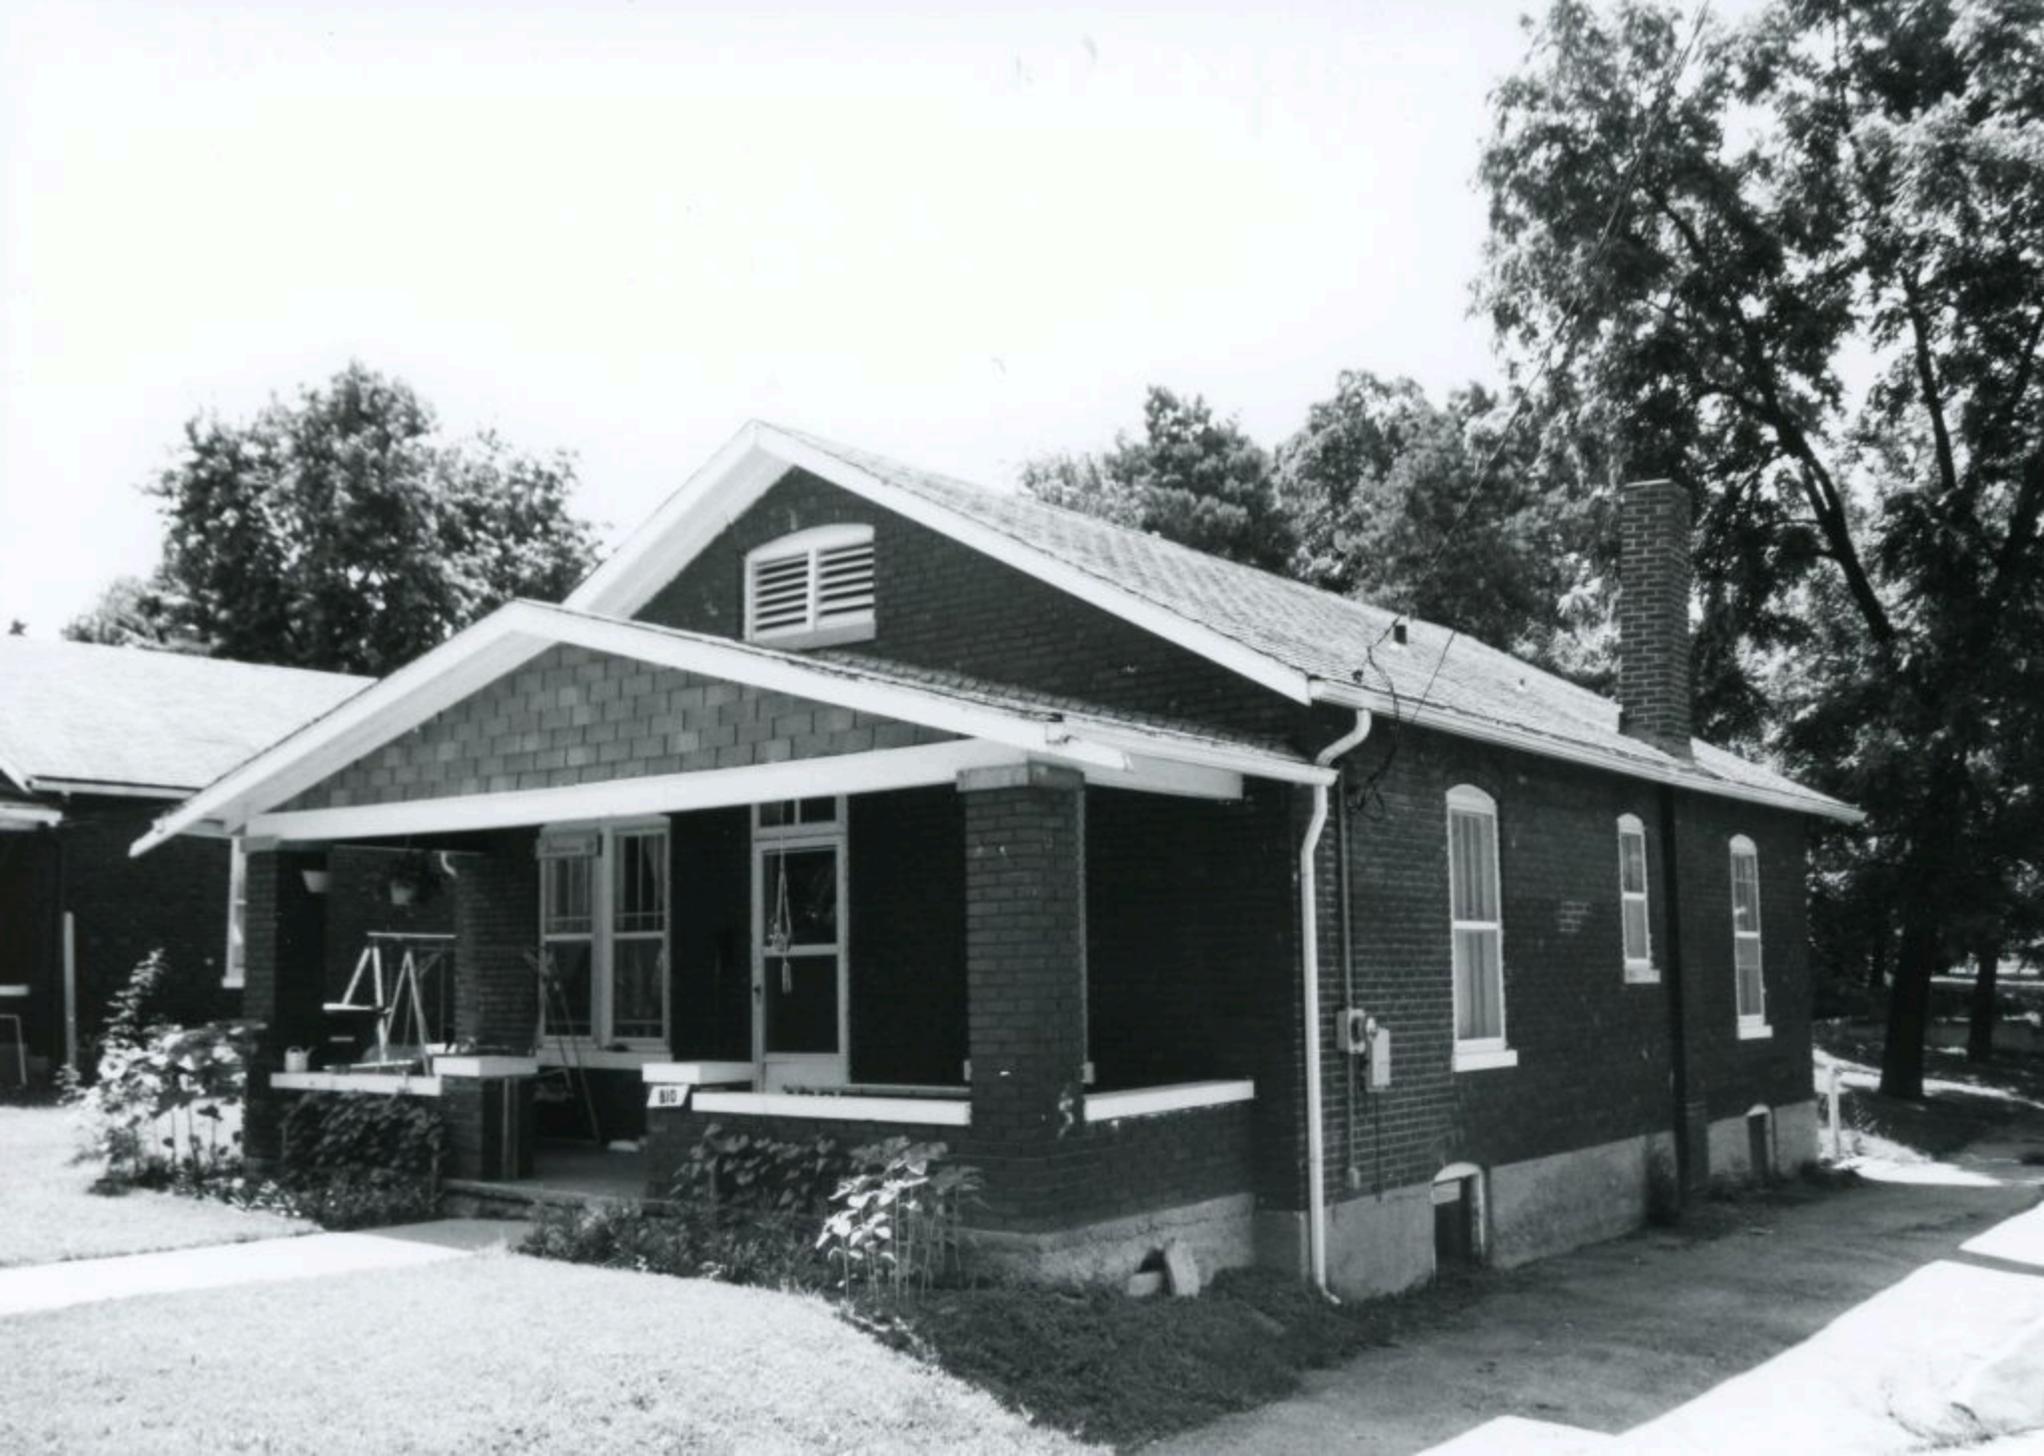
1 story with attic. Bungaloid type. Rectangular plan, 3 bay asymmetrical facade. Poured concrete foundation, wire-cut brick walls. gable (asphalt shingle) roof. Full-width gable roof porch with brick corner piers, brick solid rail with step pedestals and painted concrete coping/caps, low poured concrete deck, center concrete step, gable with asphalt shingles, wide wood frieze and wide overhanging open eaves with rafter tails, shaped rake board. Center 3-light/panel door with transom, flanking windows: single window to north and paired to south; brick main gable with paired 4-vertical light sash, overhanging open eaves with rake board. Windows as 3-, 4-vertical/1 double hung with concrete sills and double rowlock segmental arch openings. South elevation with single, paired, and single windows; overhanging open eaves with rafter tails. North elevation with single window, high smaller window, exterior brick furnace chimney and window to rear.

This area does not appear on the 1908 Sanborn Map. The 1923 map shows no buildings on this side of the 800 block of Monroe, except for #804. The 1939 map shows the current dwelling with its full-width front porch and rear porch.

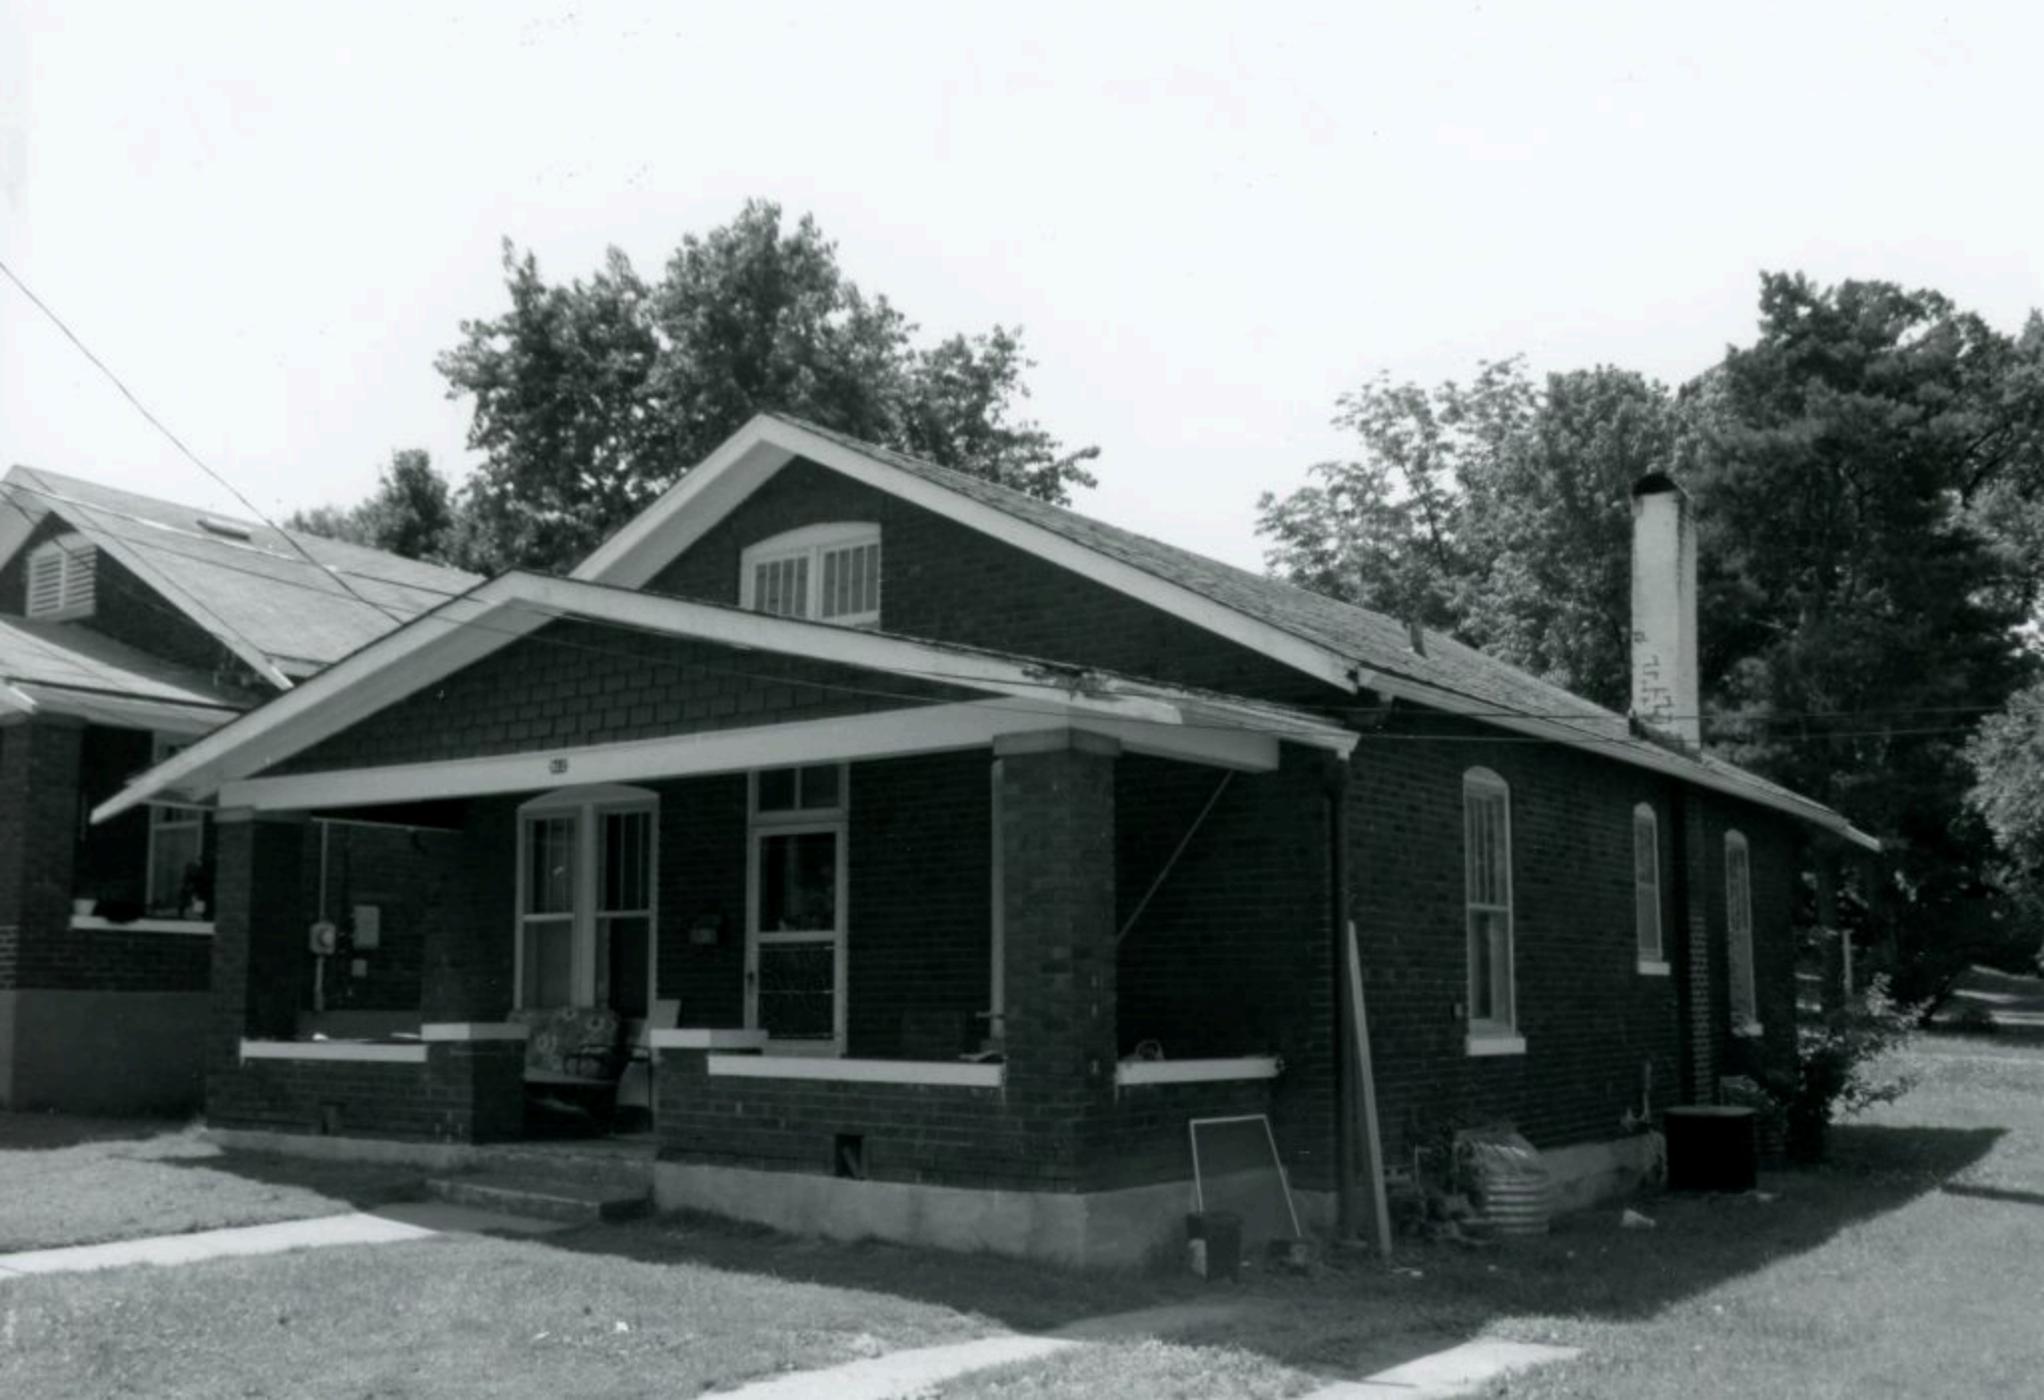
1 story with attic. Bungalow type. Rectangular plan, 3 bay asymmetrical facade. Poured concrete (painted) foundation, wire-cut brick walls. Gable (asphalt shingle) roof. Full-width gable roof porch with brick corner piers, solid brick balustrade with step pedestals and painted concrete coping/caps, poured concrete deck, center concrete steps with cheek pieces and metal railing, gable with asphalt shingles, wide wood frieze and wide overhanging open eaves with rafter tails, shaped rake board. Center 3-light/panel door with transom, flanking windows: single window to north and paired to south; brick main gable with paired louvered vents, overhanging open eaves with rake board. Windows as 3-,4-vertical/1 double hung with concrete sills and double rowlock segmental arch openings. South elevation with single, paired, and single windows (window to west partially infilled with smaller replacement window); overhanging open eaves with rafter tails. North elevation with single window, high smaller window, exterior brick furnace chimney and window to rear; basement partially exposed. Rear interior end brick chimney. Rear with single bay shed entrance porch; single window.

This area does not appear on the 1908 Sanborn Map. The 1923 map shows no buildings on this side of the 800 block of Monroe, except for #804. The 1939 map shows the current dwelling with its full-width front porch and rear entrance porch.

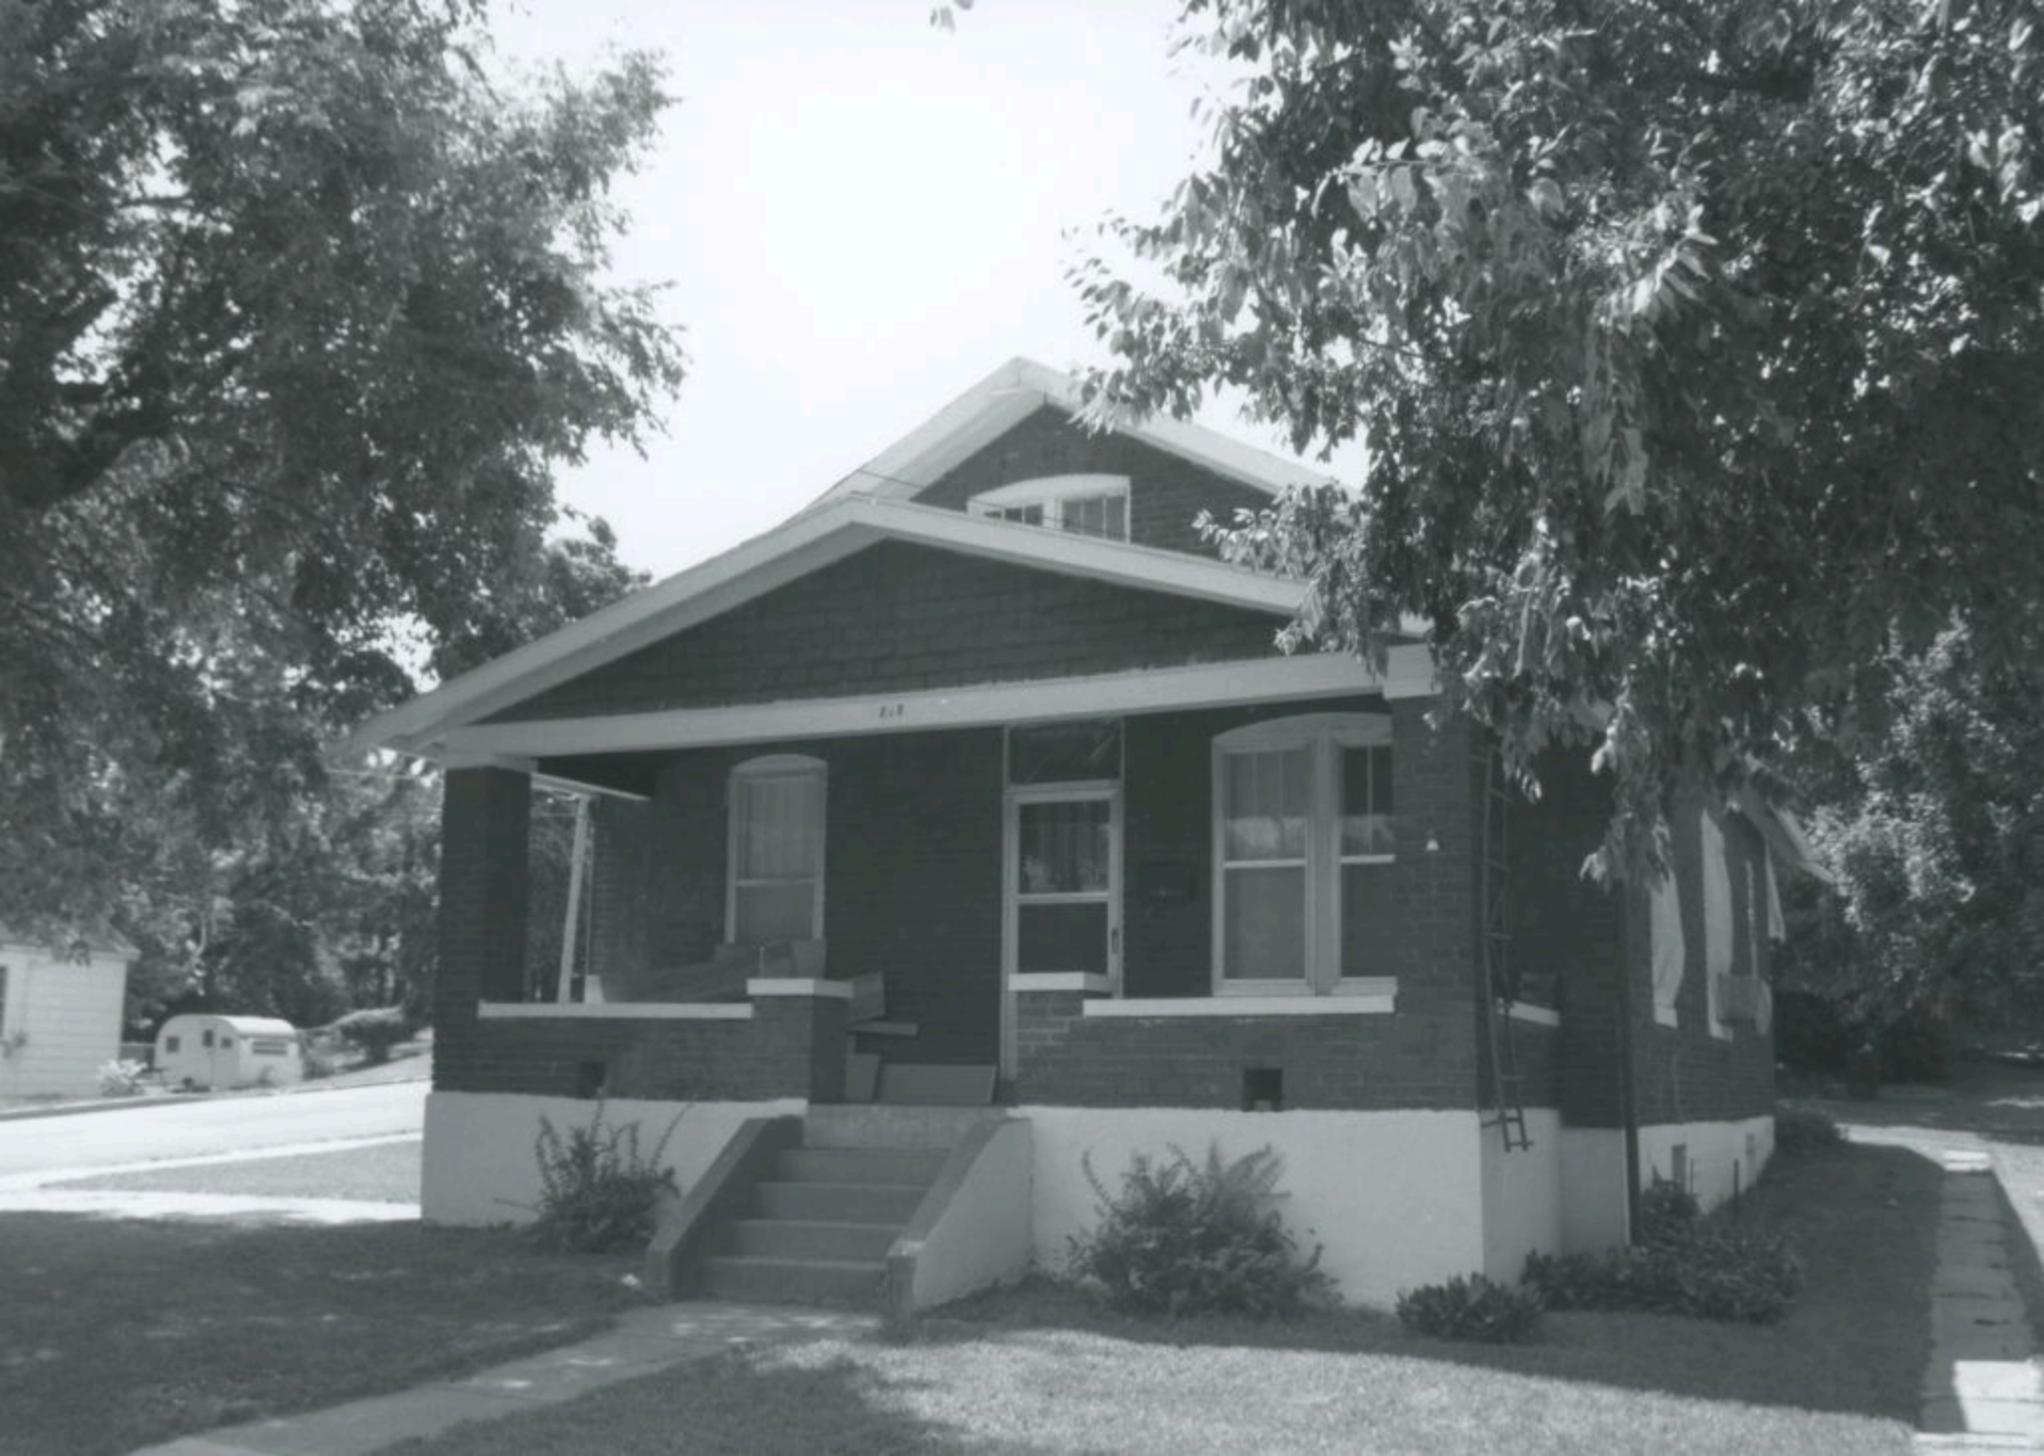
1-1/2 stories. Open Gable vernacular house type. Rectangular plan. Three bay facade. Concrete foundation; brick walls (unpainted.) Gable front (asphalt shingle) roof. 3 vertical/1 double hung sash with lug sills. Shed roof right 2/3 facade porch over entrance and adjacent window. Raised wood deck with ten wood stairs straight from front to deck; raised wide wood slate open rail. Full-height posts; plain cornice. Middle entrance flanked by single windows. Window pair in upper story. Basement garage left facade with 3-part garage door. Side of porch with vertical wood slats and wood slat door facing south for basement level storage. Two bay south elevation with window pair toward front. Aluminum awnings added to south window pair and south facade window. North elevation with three bays including a front window pair and a middle shorter window. Rear/west with 2/3 elevation shed roof porch; door and two short windows. Two windows in upper story, but not a pair as on the front. Interior end chimney.

First appears on the 1939 Sanborn Map; the basement garage is indicated and the front and rear porches are shown.

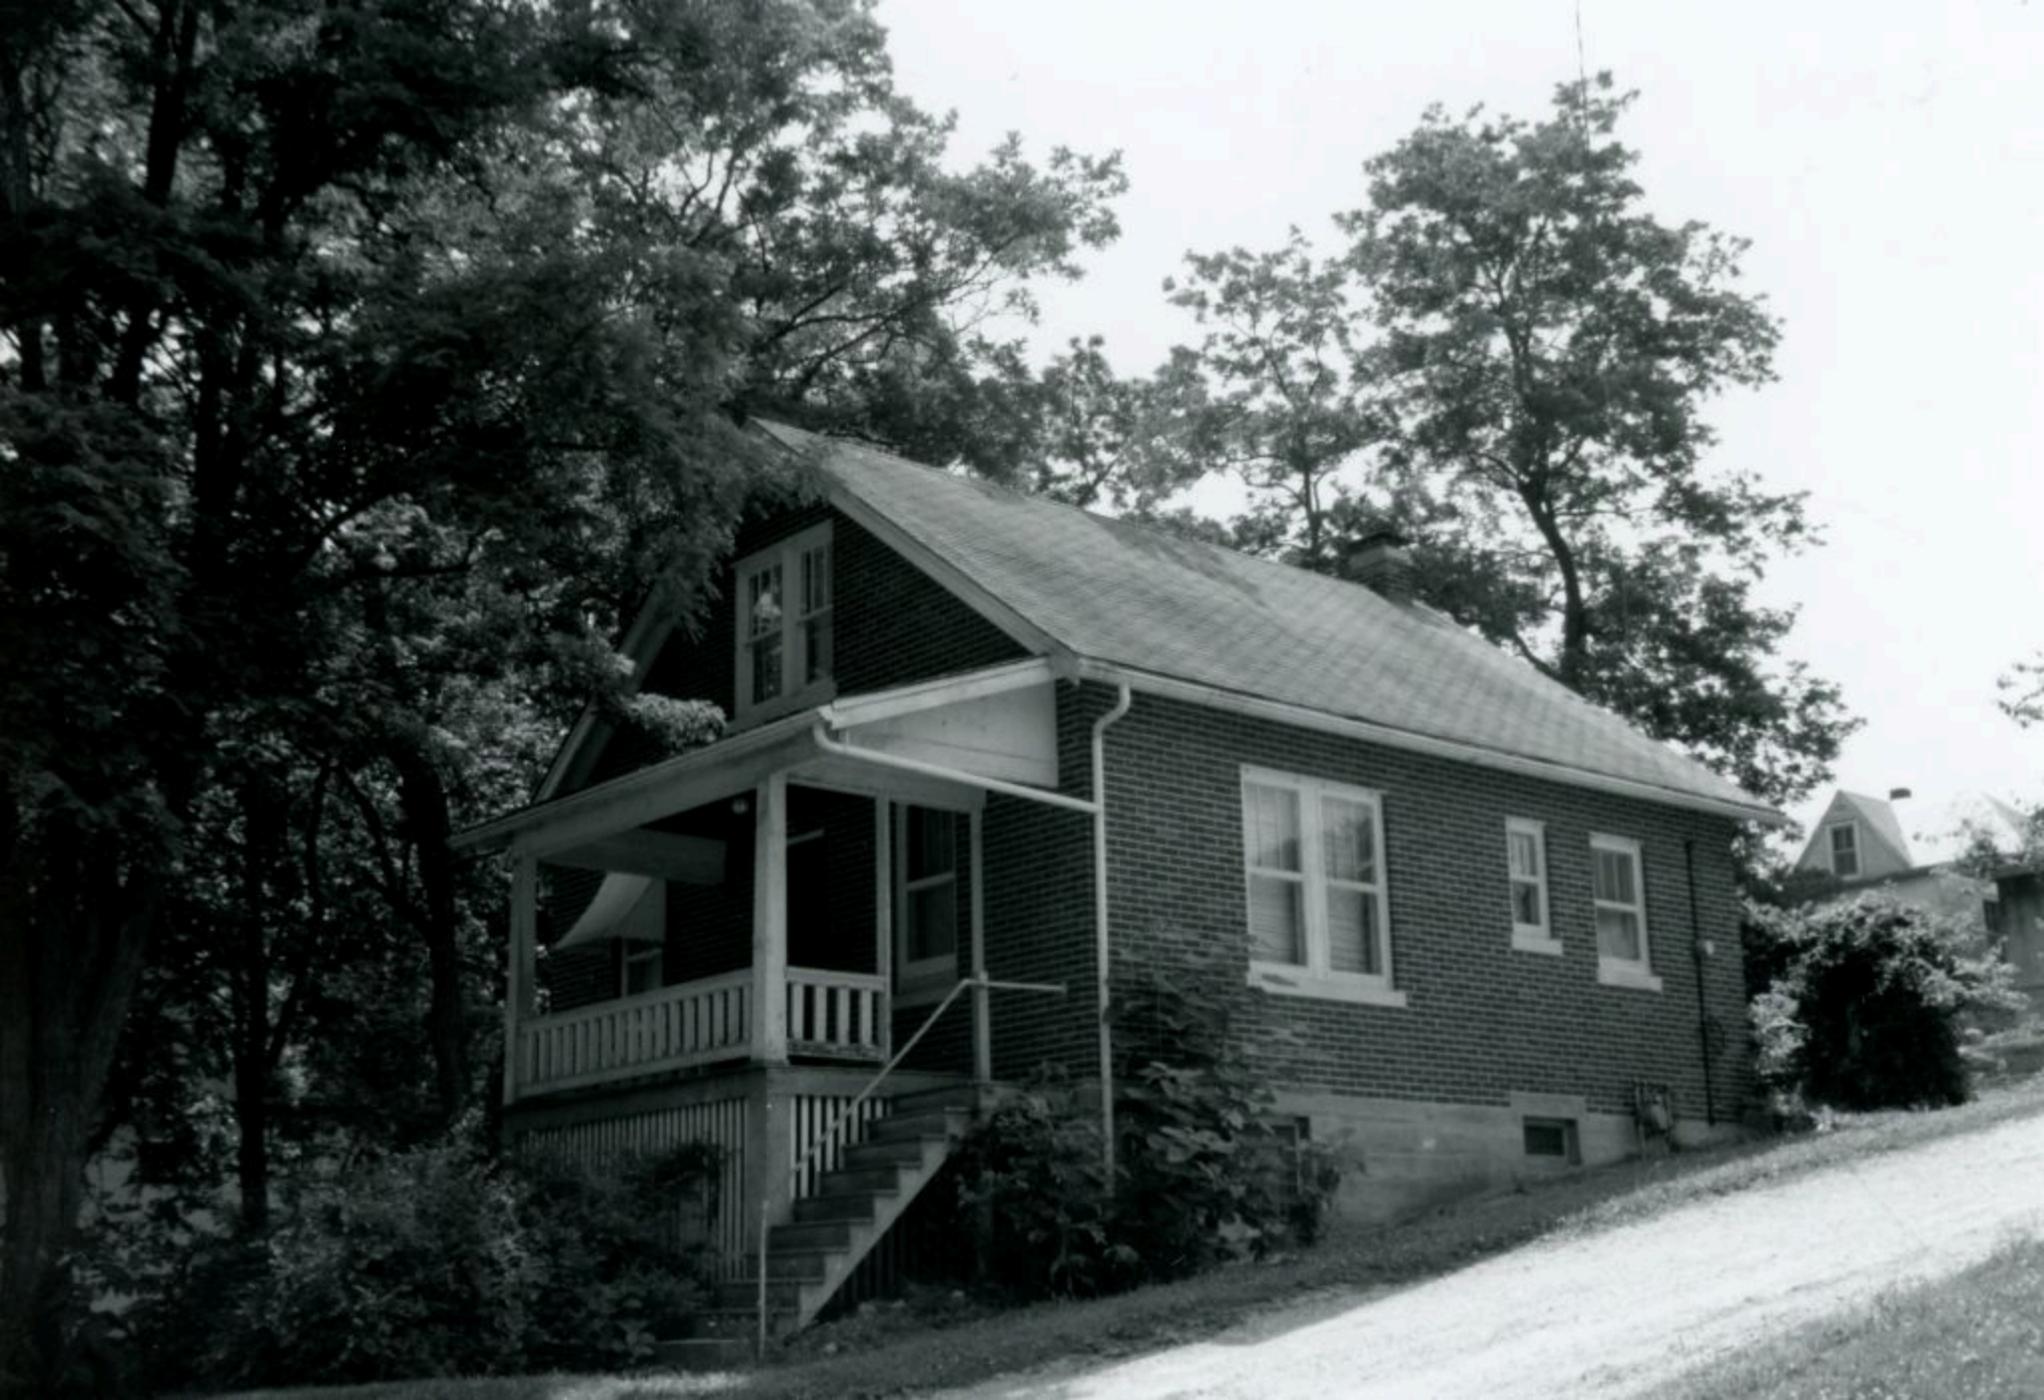
1-1/2 stories. open gable type. rectangular plan. high concrete (painted) foundation, brick (painted) walls. gable (asphalt shingle) roof. exposed at-grade basement on facade; projecting concrete block (painted) porch foundation to north, infilled garage access on south with at-grade door to south and window to north, large concrete driveway in front; hip roof porch on north two-thirds with three thin posts, open slat railing, no steps; off-center (to north) door with flanking paired 1/1; gable with paired 1/1. windows as 1/1 double hung with painted concrete sills; narrow overhanging eaves. north elevation with exposed basement, exterior furnace chimney to east with 1/1 to immediate west, 2-light window at west end; 1st-story with exterior chimney with flanking 1/1, two 1/1 to west. south elevation with two basement 1/1, two sets of paired 1/1 on 1st-story. rear with center shed roof enclosed porch, paired 1/1 in gable.

This area does not appear on the 1908 or 1923 Sanborn maps. This dwelling appears on the 1939 map with garage in basement.

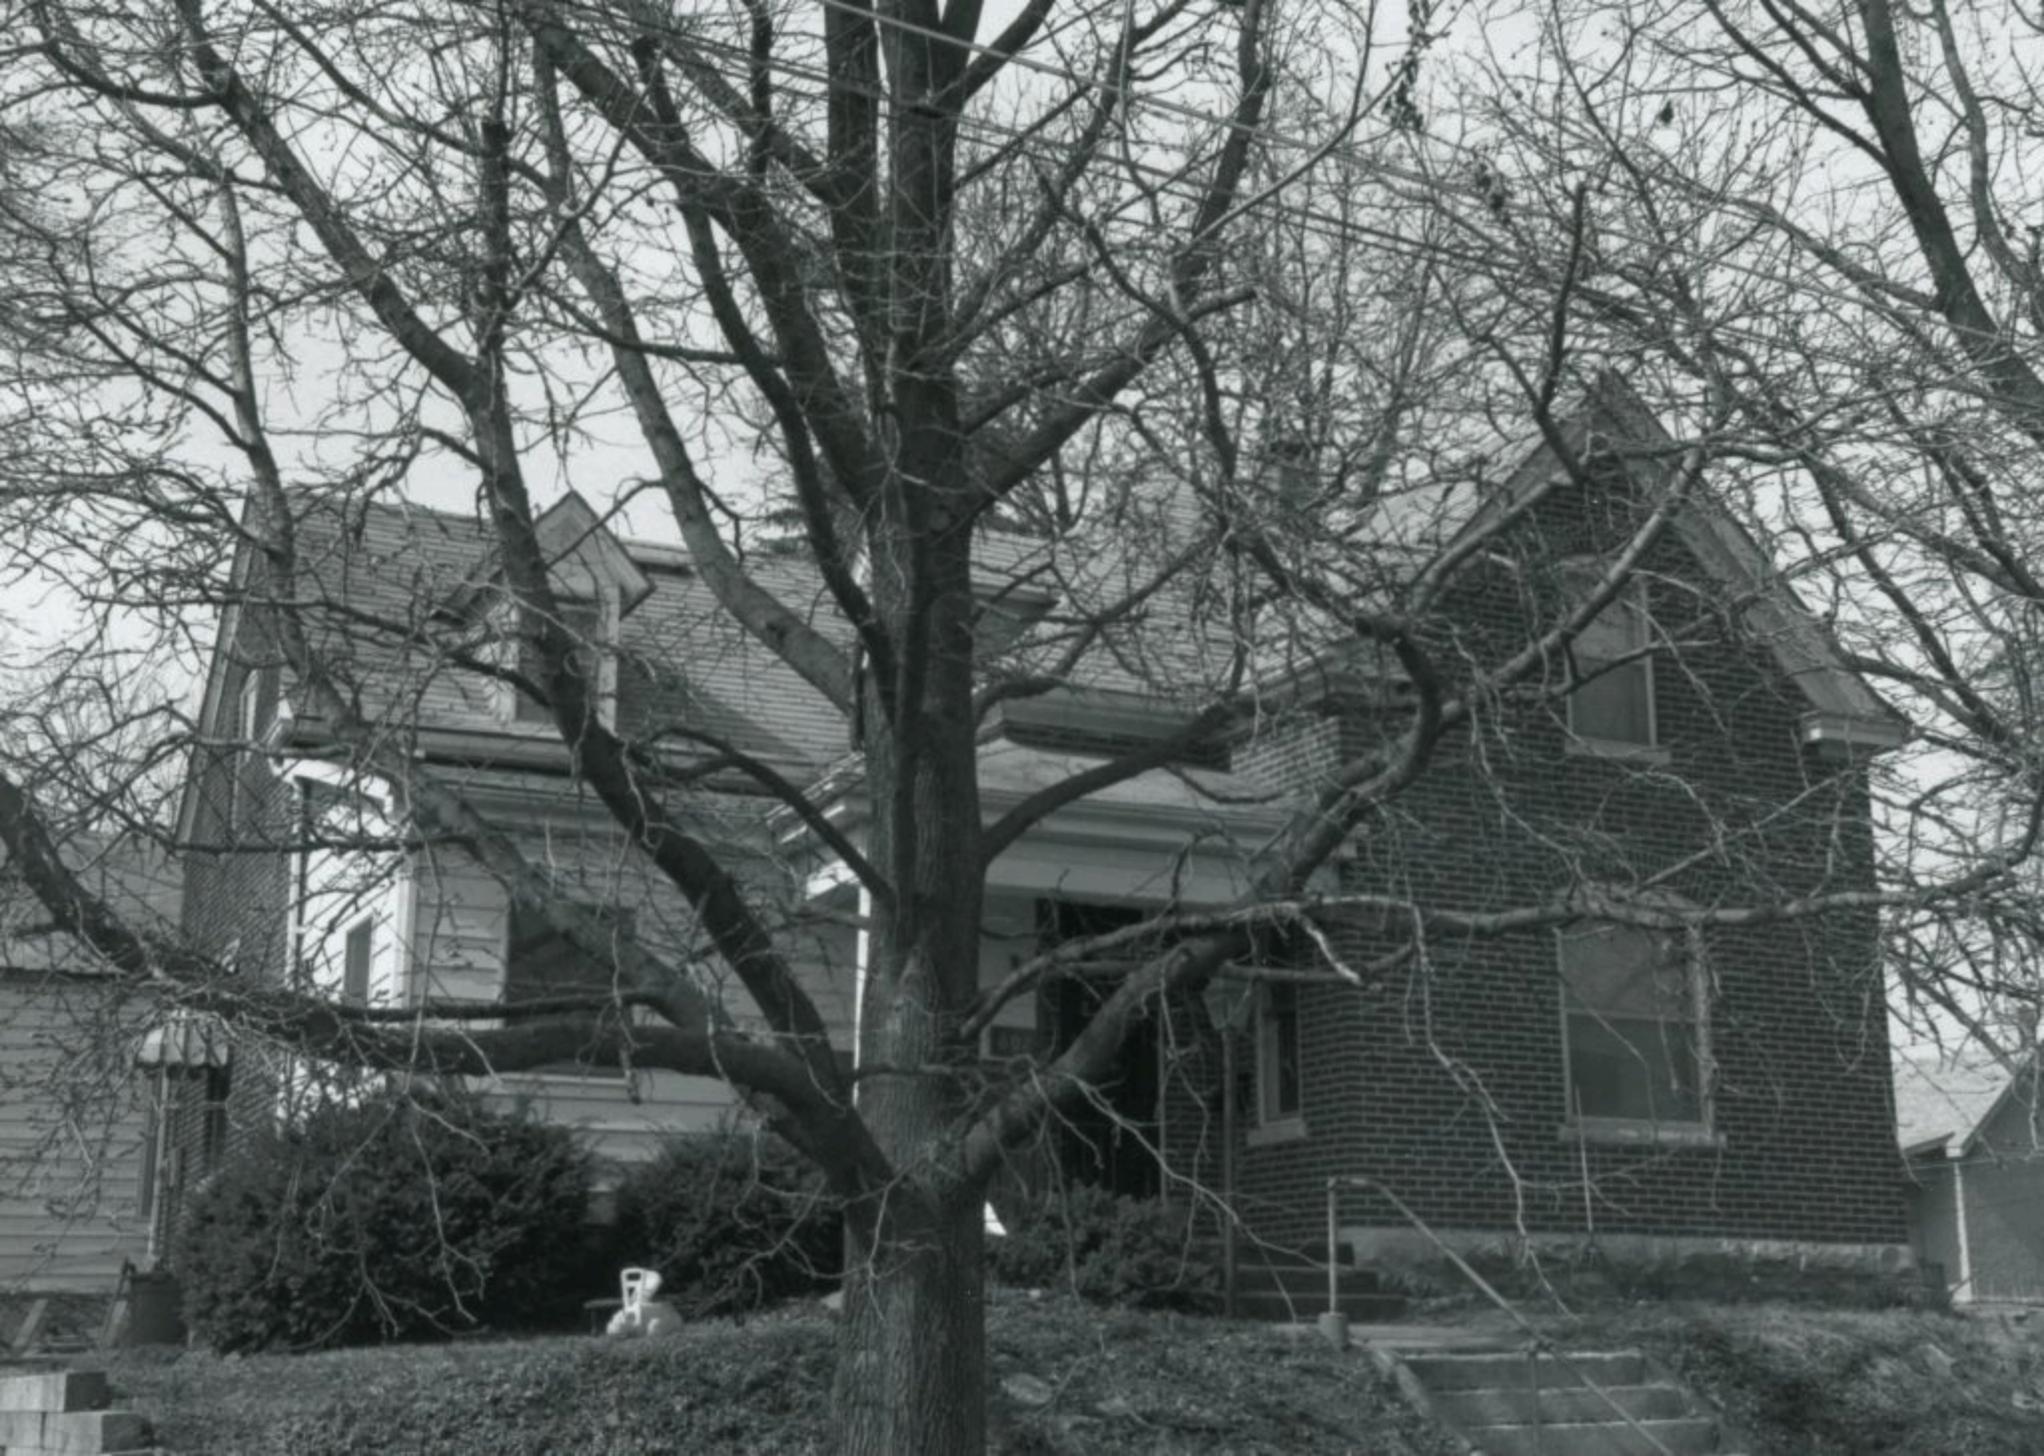
1-1/2 stories. no style or type. rectangular plan, asymmetrical facade. parged and stone (painted) foundation, stucco (over brick) walls. side gable (asphalt shingle) roof. stucco foundation projects slightly on facade, entry at south end with modern metal awning with corner poles, concrete stoop and steps with modern metal railing; four 1/1 windows across elevation (may have been five, center blank) with metal awnings, narrow wood frieze, north end with flat roof addition with modern picture window to north, entry to south with wood hood on braces, concrete stoop and steps with modern metal railing. windows as 1/1 double hung with stone sills (painted) and modern metal awnings. south elevation with exposed basement with windows, entry to rear (east); 1st story with window to west, interior end ridge chimney with small flanking attic windows, flush rake boards; stucco shed roof wing with window on rear over stone basement section, modern attached shed roof carport projects to south. 1-story flat roof addition along north elevation, interior end ridge chimney, single attic window, flush rake boards. rear with lower 1-1/2 story gable roof wing toward north with flat roof section on north corner, shed roof wing to south

This building appears on the 1908 Sanborn Map as a 1-1/2 story masonry structure with a small south corner front porch, a full-width 1-story rear wing, and 1-story wing with rear porch along the north side that projects out to the west. The 1923 map is similar without the northeast corner rear porch or front porch depicted. The 1939 map shows a similar 1-story rectangular plan dwelling with two 1-story wings along the north side.

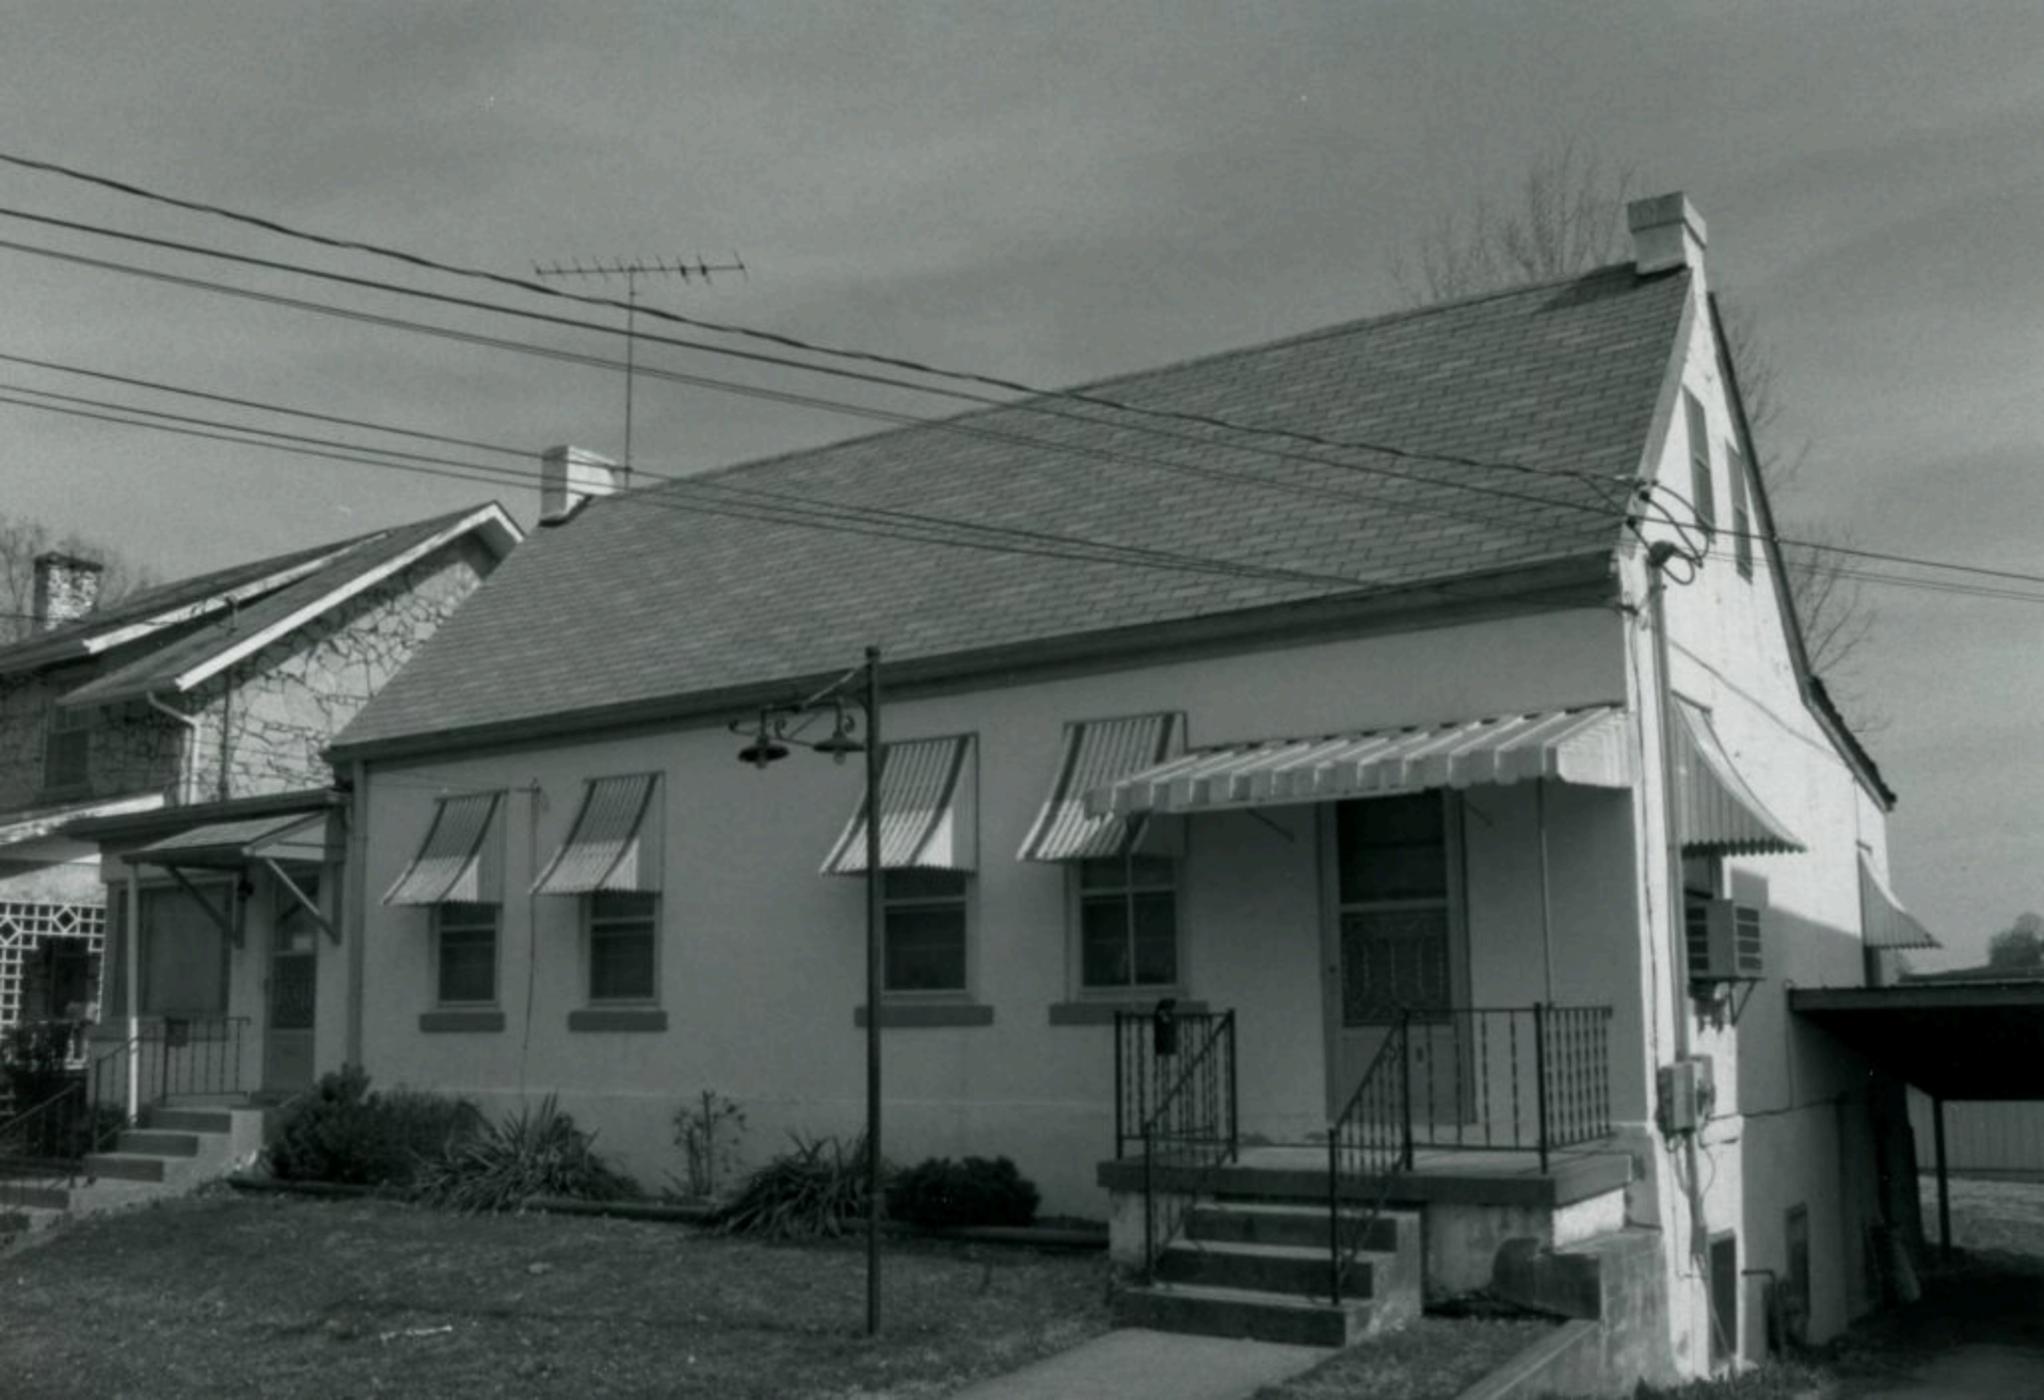
1-1/2 stories. Gabled Ell vernacular type. L-plan. Three bay asymmetrical facade. Stucco clad foundation and walls; gable (asphalt shingle) roof. Hip roof reentrant angle porch south with low deck clad with artificial turf, plain cornice, and replacement corner posts. 1/1 double hung sash; some 2 vertical/2 vertical double hung sash; sills only. Right/north bay gable front with single windows each story. Entrances face front/east and side/south from reentrant angle; single window to left of front-facing door. South side gable with single windows each story as on front. Lower one story rear gable wing off south side gable.

Appears on the 1908 Sanborn Map, the first to show this section. House shown also with rear L-plan and L-shaped rear porch. Front half porch in reentrant angle. One story outbuilding at north lot line. The front porch is not shown on the 1923 Sanborn Map, but that year's map did not consistently indicate porches. The porch is shown on the 1939 Sanborn Map. A garage is shown.
