HISTORIC SOUTHSIDE COMMERCIAL AREA

MISSOURI HISTORIC PROPERTY INVENTORY FORM

REFERENCE NUMBER CO AS003-001		A. HISTORIC NAME					
B. COUNTY 054 Cole		C. OTHER NAME(S)					
D. ADDRESS 102 East Ashley Street			E. CITY Jefferson City		F. VICINITY <input type="checkbox"/>	G. RESTRICTED	H. ACREAGE

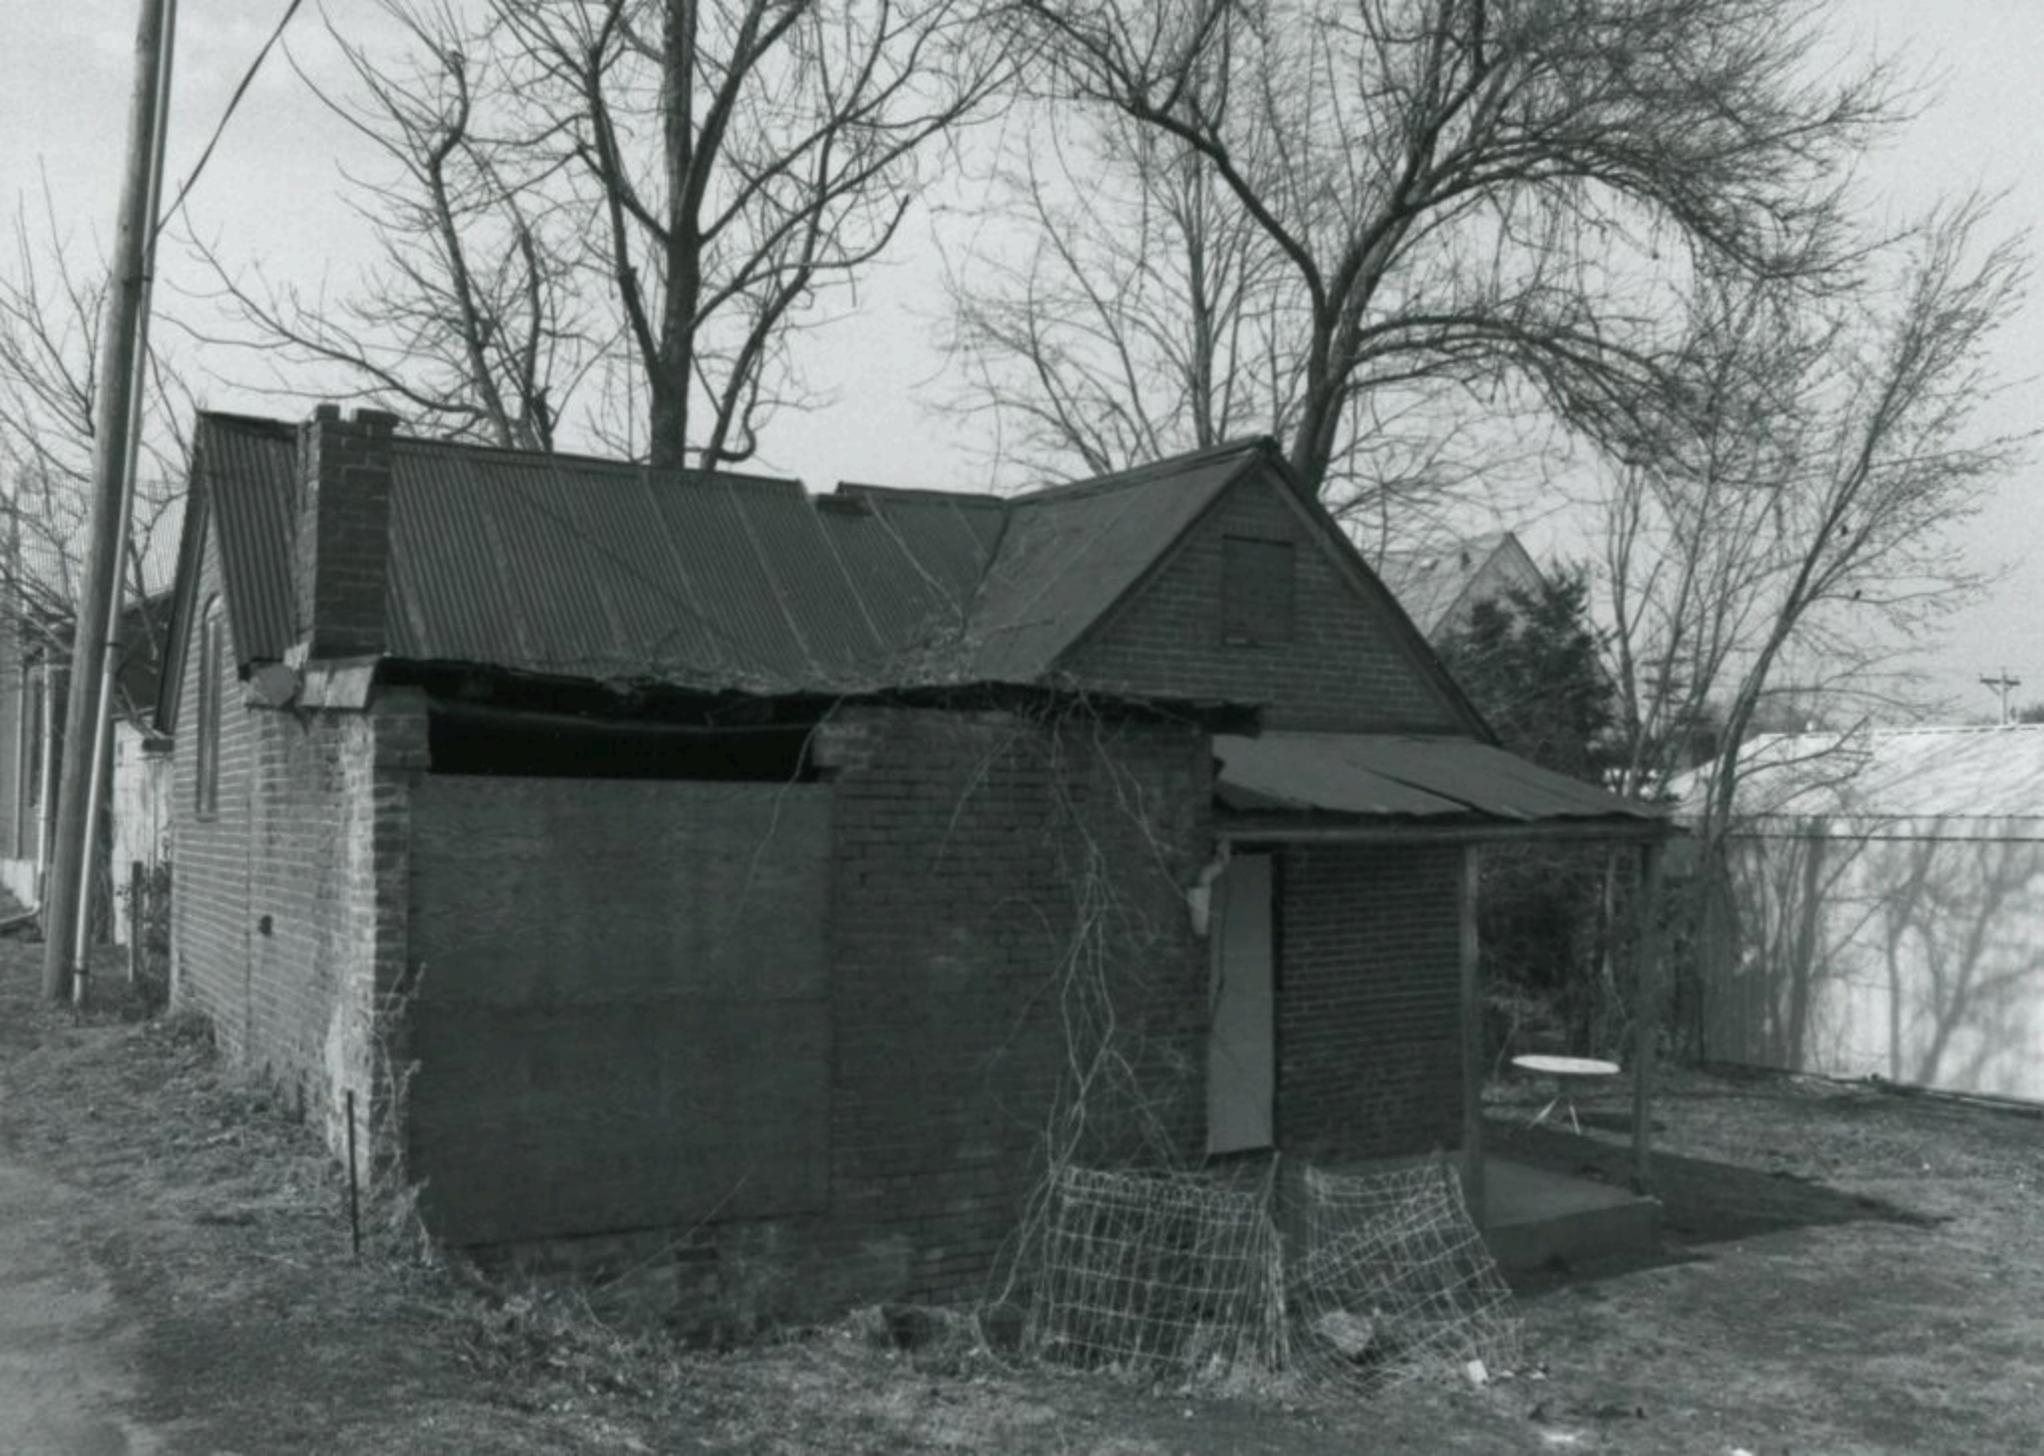
1 story. no style or type. irregular plan. brick foundation, brick walls. cross gable (corrugated metal panel) roof. east elevation originally L-plan now with projecting flat roof addition in south corner with large boarded opening at south corner, severe structural failure; cross gable roof section to north with shed roof (metal) porch, two wood posts, concrete deck; corner doors (blocked door in gable section, four panel door into flat roof section), small boarded gable opening. north elevation with single 2/2 window at east end. south elevation with cross gable section to west with large blocked opening, rake boards; flat roof addition to east with interior end chimney. west elevation with cross gable roof section to north, side gable section to south with change in brickwork between; blocked window openings. openings with single or double rowlock segmental arches, wood sills. central ridge chimney gone, opening remains.

The 1908 Sanborn Map shows this 1-story brick building with its current plan of a northeast porch and southeast wing; its labeled a dwelling. The 1923 and 1939 maps are similar.

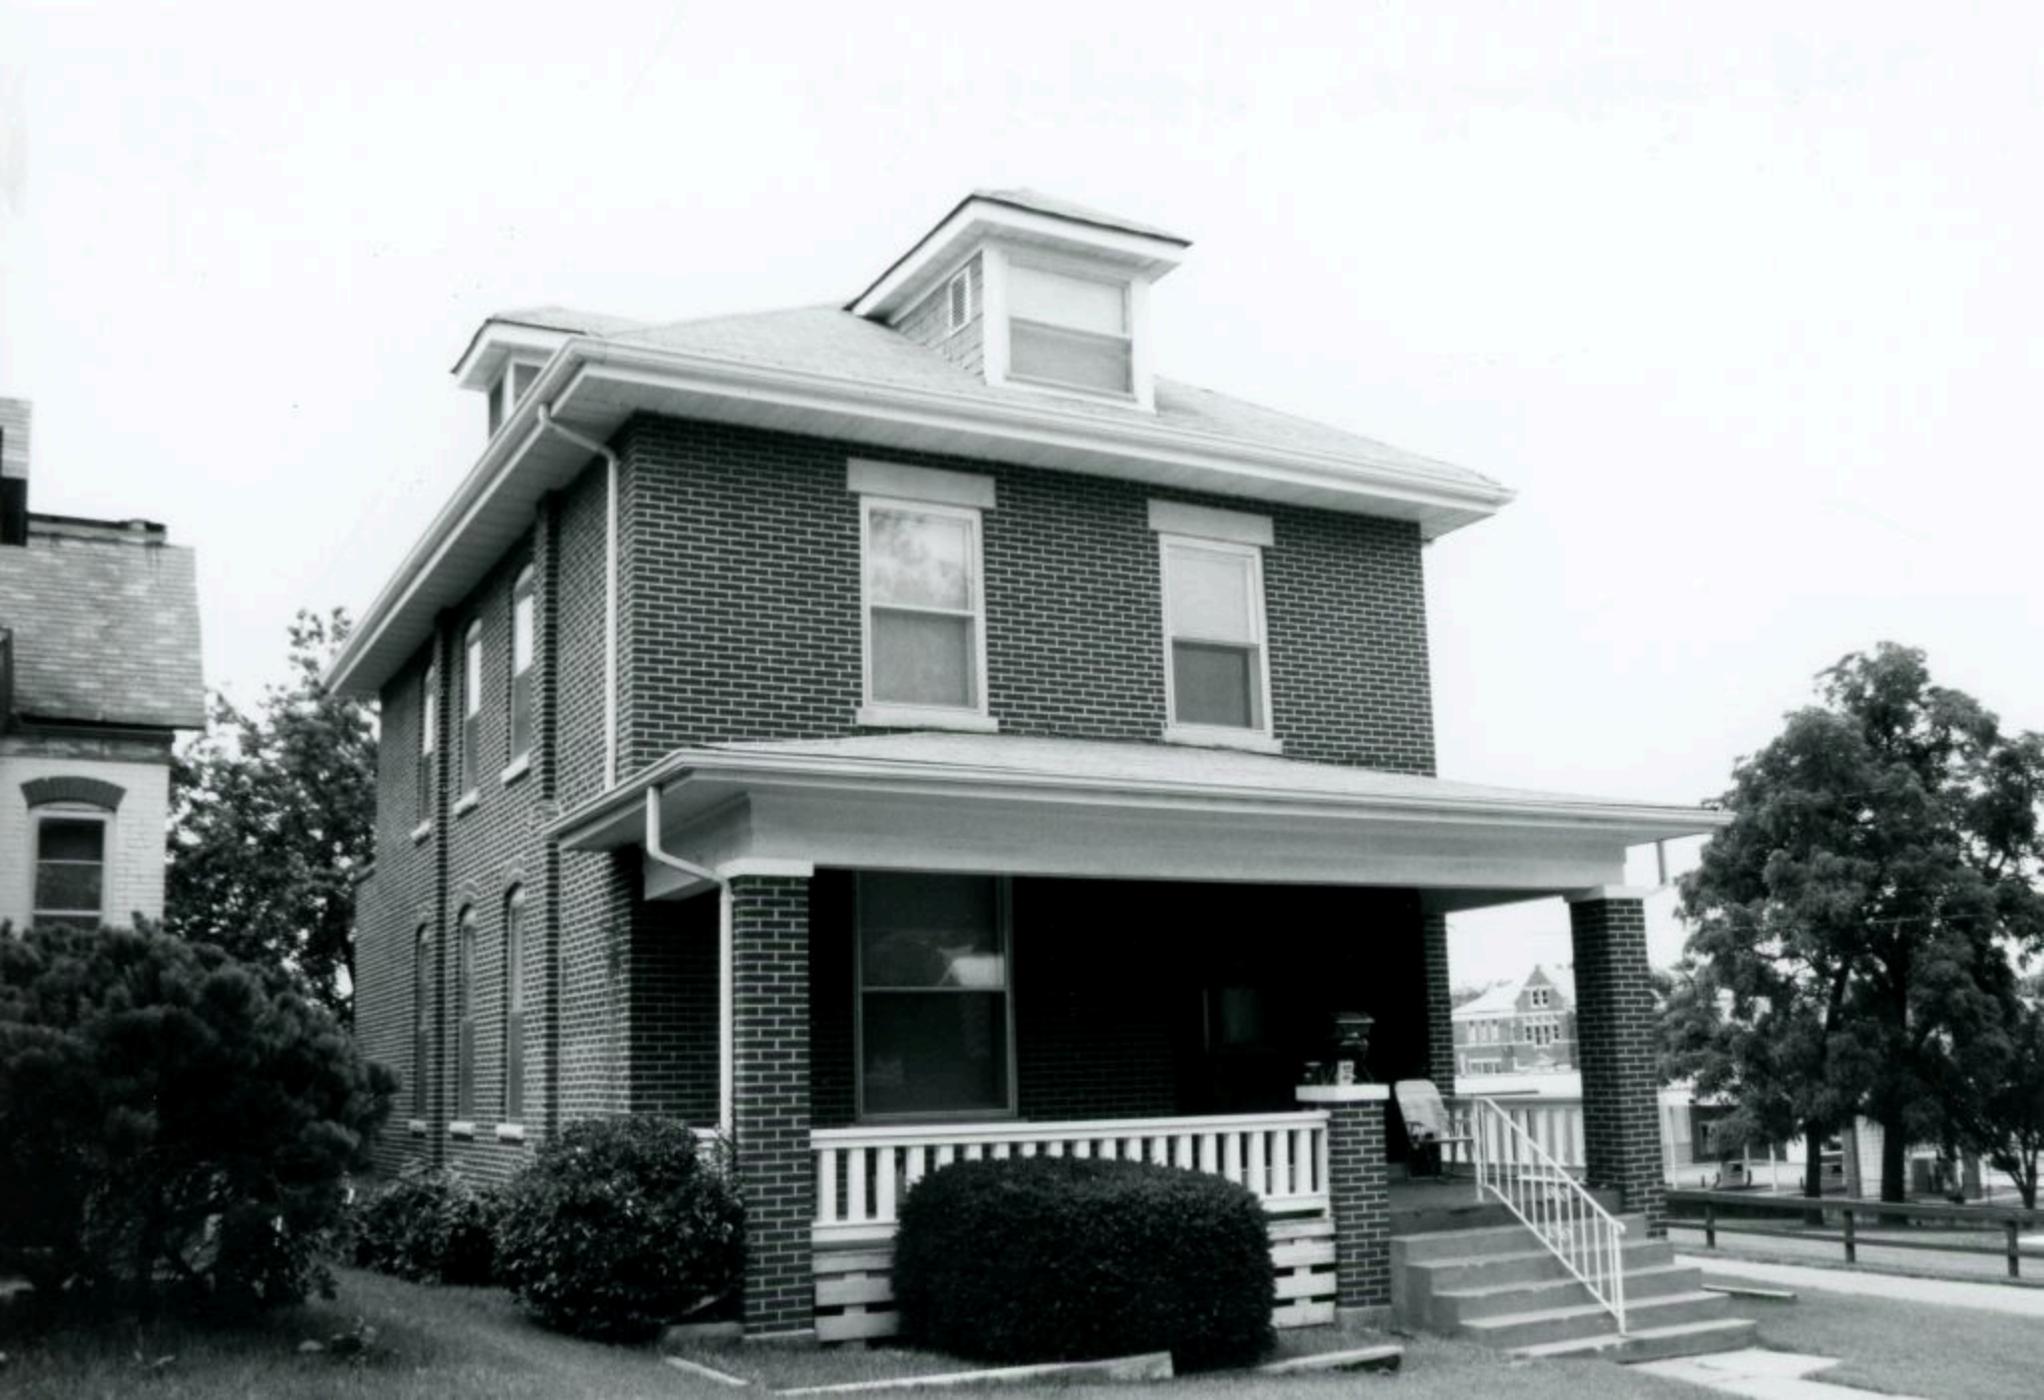
2 stories with attic. American Four Square. L-plan. 3 bay symmetrical facade. Limestone foundation; brick walls (unpainted). Hip (asphalt shingle) roof. 1/1 double hung sash with stone lintels and lug sills; side/rear elevation windows with double rowlock segmental brick arches. Full-facade hip roof porch with raised deck clad with artificial turf; full-height brick piers rise from ground at corners; pedestal to left/south of entrance; wood slat balustrade; plain cornice. Main section with two bay facade; right door (6-light original) with modern storm door and modern wood surround. Left bay with side 1/1 window; two regular size windows above each bay on the second story. Third facade bay created by side hip pavilion to the north. A single window each story faces front from this section. Hip roof dormer central of hip front section with wide 1/1 window. Symmetrical south elevation with three 1/1 windows. Two brick pilaster-like features appear too small to be exterior end chimneys. Hip roof dormer this elevation narrower than the one facing front. North elevation with multi-light leaded window with segmental soldier course brick arch and keystone at staircase; a second stair landing window is a small 1/1 with a lintel. The other north-facing windows have double rowlock segmental brick arches. Basement windows with rock-faced stone lintels. Hip roof dormer as on the south. Exterior end chimney cropped below dormer. One story single bay rear brick original wing with side parapets. Shed porch with entrance off this wing. Porch with rear open shed for storage. Second story enclosure built out over this porch (hardboard sided) with access to roof of porch for small open deck. Good condition. Converted from single to multi-family.

Appears on the 1923 Sanborn Map, the first to show this area. The rear wing is shown. No outbuildings. No porch shown, but the 1923 map usually did not show porches. A second rear wing is toward the alley. Appears on the 1939 Sanborn Map; a front porch is shown, and "2 flat" is indicated. Garage at rear/side alley junction.

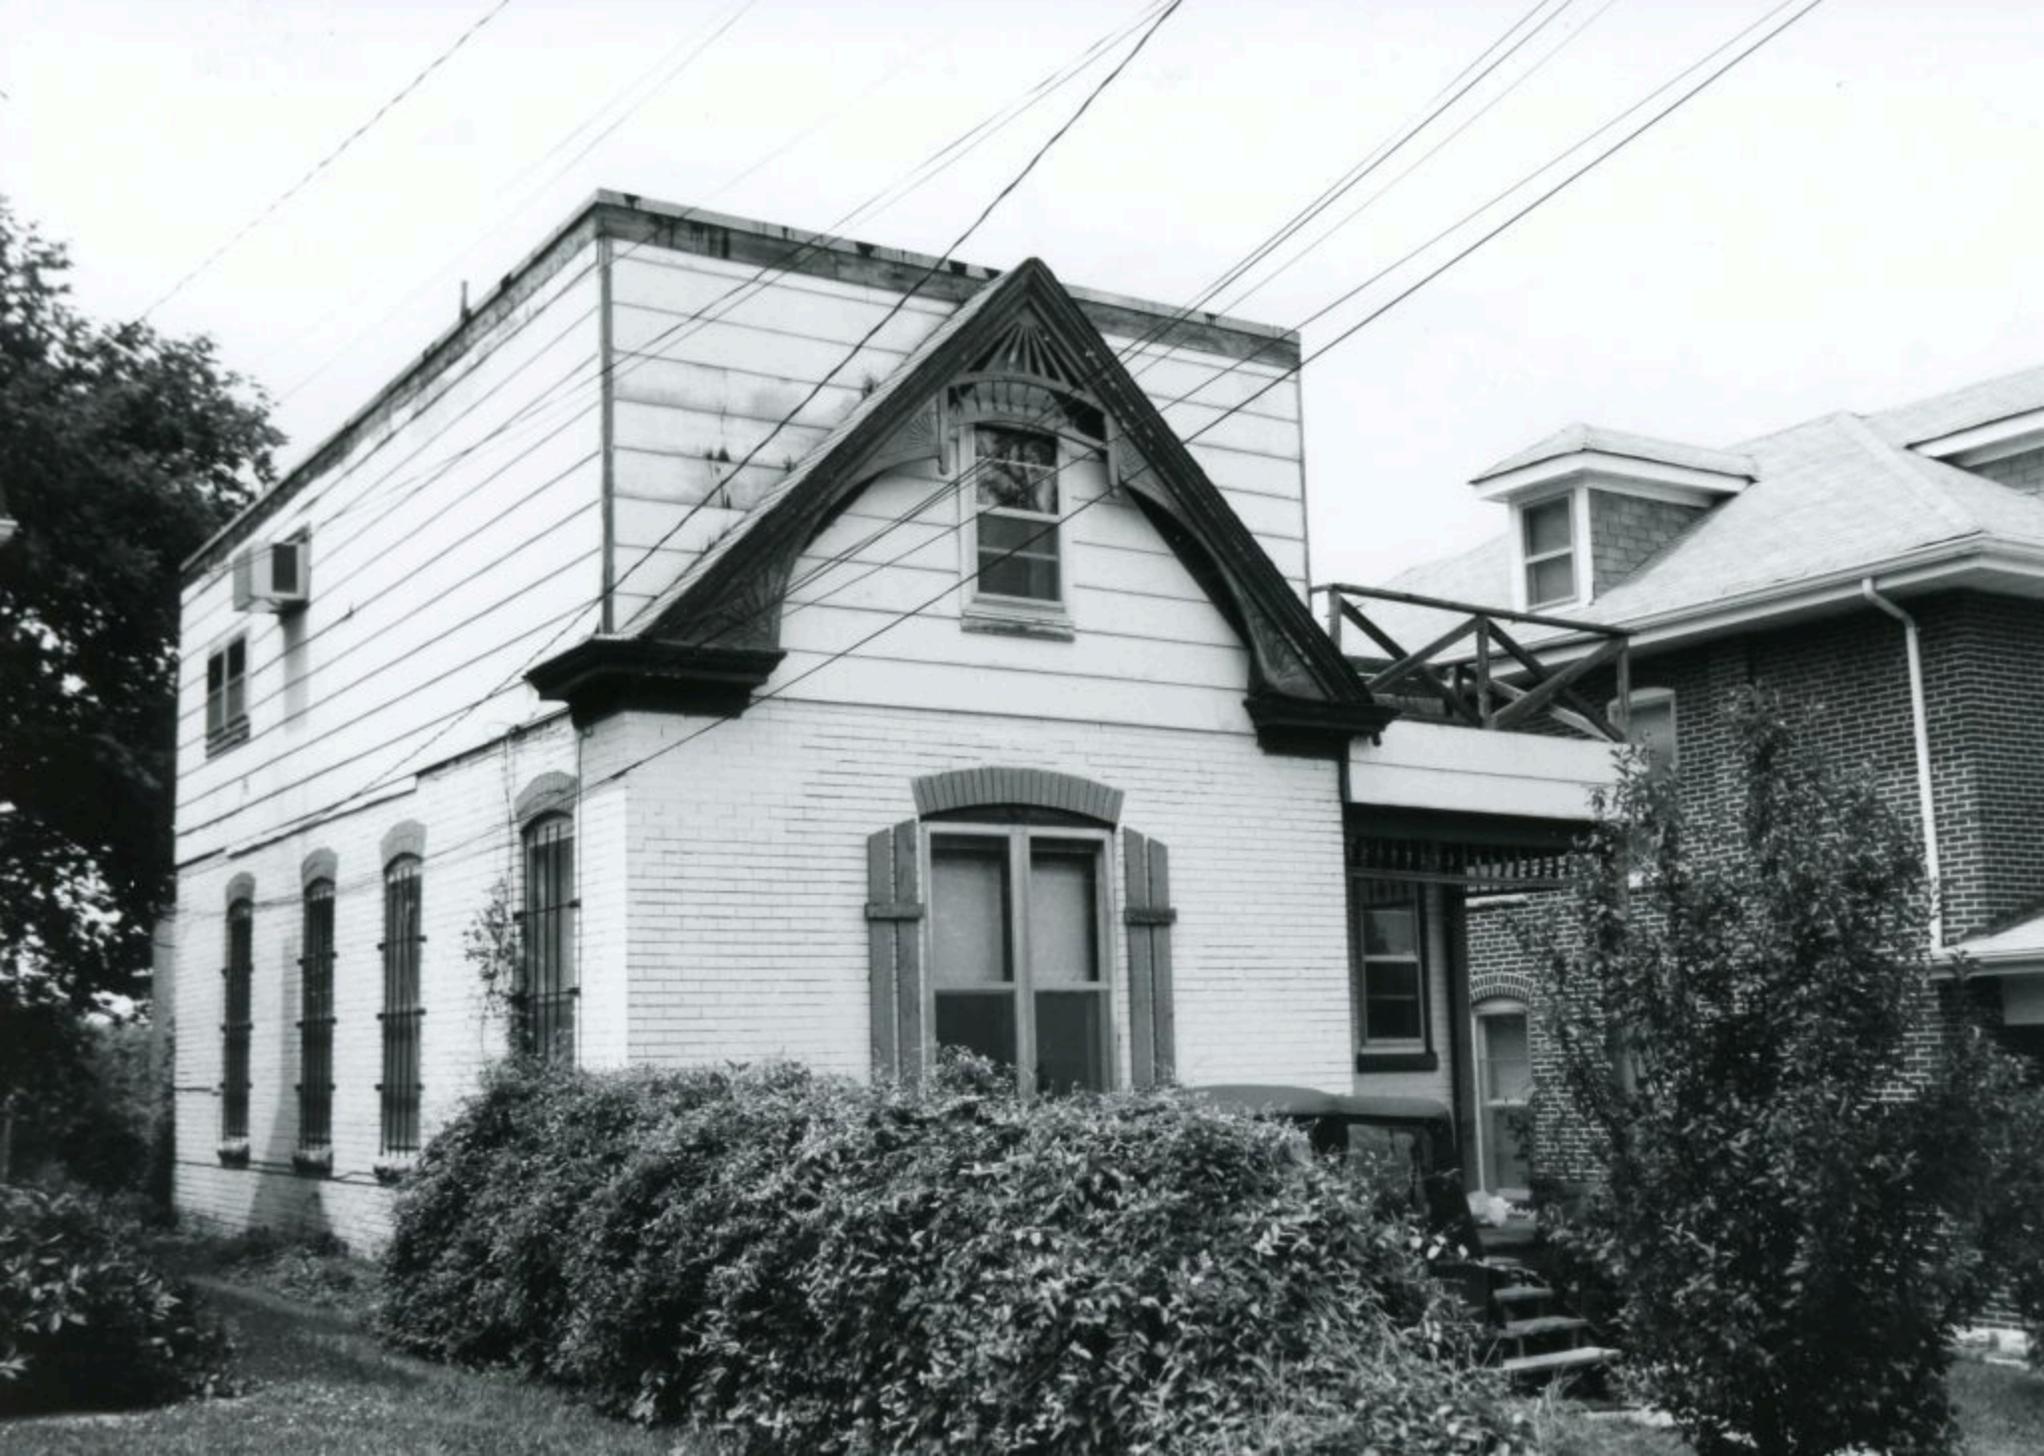
1-1/2 stories. Irregular plan; altered Queen Anne cottage. Limestone foundation painted bluish gray; brick walls painted white. Hip, gable and flat (asphalt, asphalt shingle) roofs. 1/1 double hung sash with soldier course segmental brick arches facing front; double rowlock segmental brick arches facing sides; stone lug sills. Trim painted blue/gray. Left gable front wing with pair narrow 1/1 double hung sash, panel and bulls-eye window head, and soldier course segmental arch. Modern hardboard sided gable with flat roof addition "squaring" the gable on either side to the main hip block. Upper story with single modern window. Boxed cornice and extensive bargeboard consisting of upside down sun rays, spindle work below with side quarter sunbursts framing the upper story/boxed cornice. Entrance with blocked transom and smaller 1/1 window in reentrant angle into main hip roof section. Flat roof reentrant angle porch with spindled frieze, raised wood deck (replacement). Modern deck added above for second story entrance into addition onto gable front. North elevation with gable roof dormer clad with hardboard on its sides, but fishscale shingles north; pair 1/1 windows. North side gable with single 1/1 window front/east. Rear elevation appears to have another upper story addition on the side gable with a historic/original brick one story wing beyond appearing to be full-elevation (visible on south elevation as well, but recessed from south elevation plane). Four windows south elevation. Iron security grates added. Flat roof addition to gable full-elevation south; pair modern windows and air conditioner inserted, but blind otherwise.

Appears on the 1923 Sanborn Map, the first to show this area. No porch is shown, but few porches were shown on that year's map. The north elevation has a U-shape toward the rear. A single car garage was located on the south lot line near the rear alley. The 1939 Sanborn Map shows the north elevation U-shape infilled, and a small front reentrant angle porch; a rear porch was shown/added.

Exceptional bargeboard intact despite extremely insensitive addition(s).

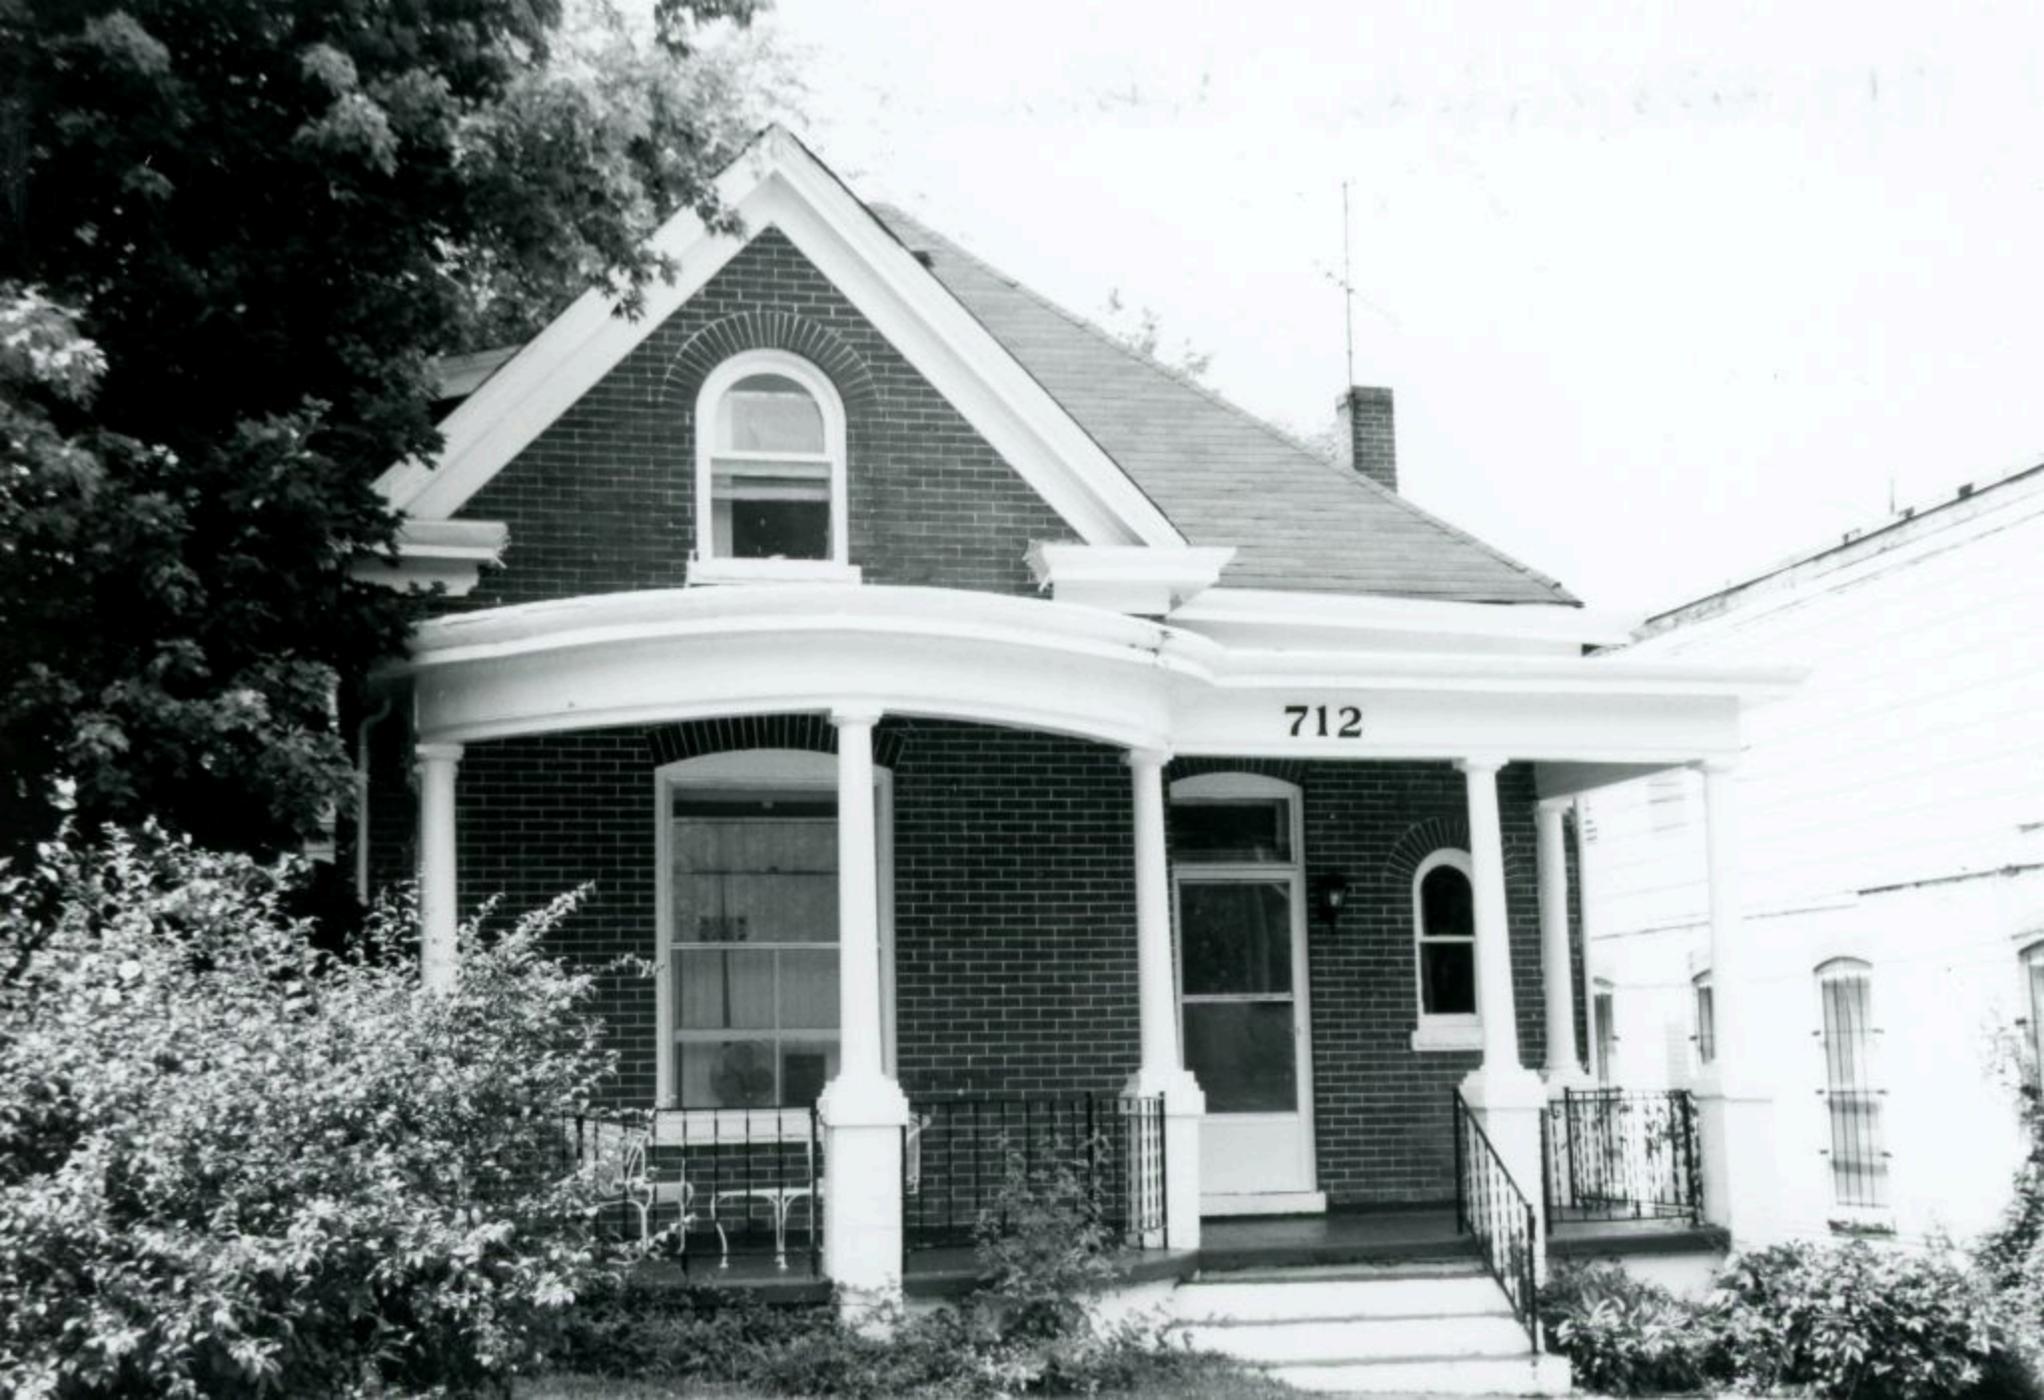
712

1-1/2 stories. Queen Anne influence. L-plan. Three bay asymmetrical facade. Limestone foundation; brick walls (unpainted). Hip and gable (asphalt shingle) roofs. 1/1 double hung sash with soldier course segmental or round arches; smooth stone lug sills with rock-faced stone panels; painted white. Left/south gable pavilion with wide 1/1 double hung sash on first story with segmental arch and plain window head. Small round arched 1/1 in upper story; cornice returns. Recessed hip roof block with second and third bays. Entrance in second bay; small round arched 1/1 window in third right/north end bay. Flat roof porch nearly full-facade, curved at gable front; brick pedestals painted white with Doric columns; low concrete deck; broad plain cornice; modern iron open rail added. South elevation mostly blocked by trees. Exterior end chimney. Interior end chimney through shed dormer cropped at dormer roof. Three shed dormers on this side. Angled south side entrance bay ornamented with a quarter sunburst, knob and spindle corner brackets, and knob pendil. North elevation with gable bay projection cut-away with knob and spindle side brackets as on south side entrance. Exterior end chimney in middle through eave. Modern deck on rear elevation.

Appears to be a student rental, but well-maintained; good condition.
No outbuildings; no driveway.

Appears on the 1923 Sanborn Map, the first to show this area. The porch is shown; a single car garage was at the rear alley. The 1939 Sanborn Map shows a rear side porch added on the north.

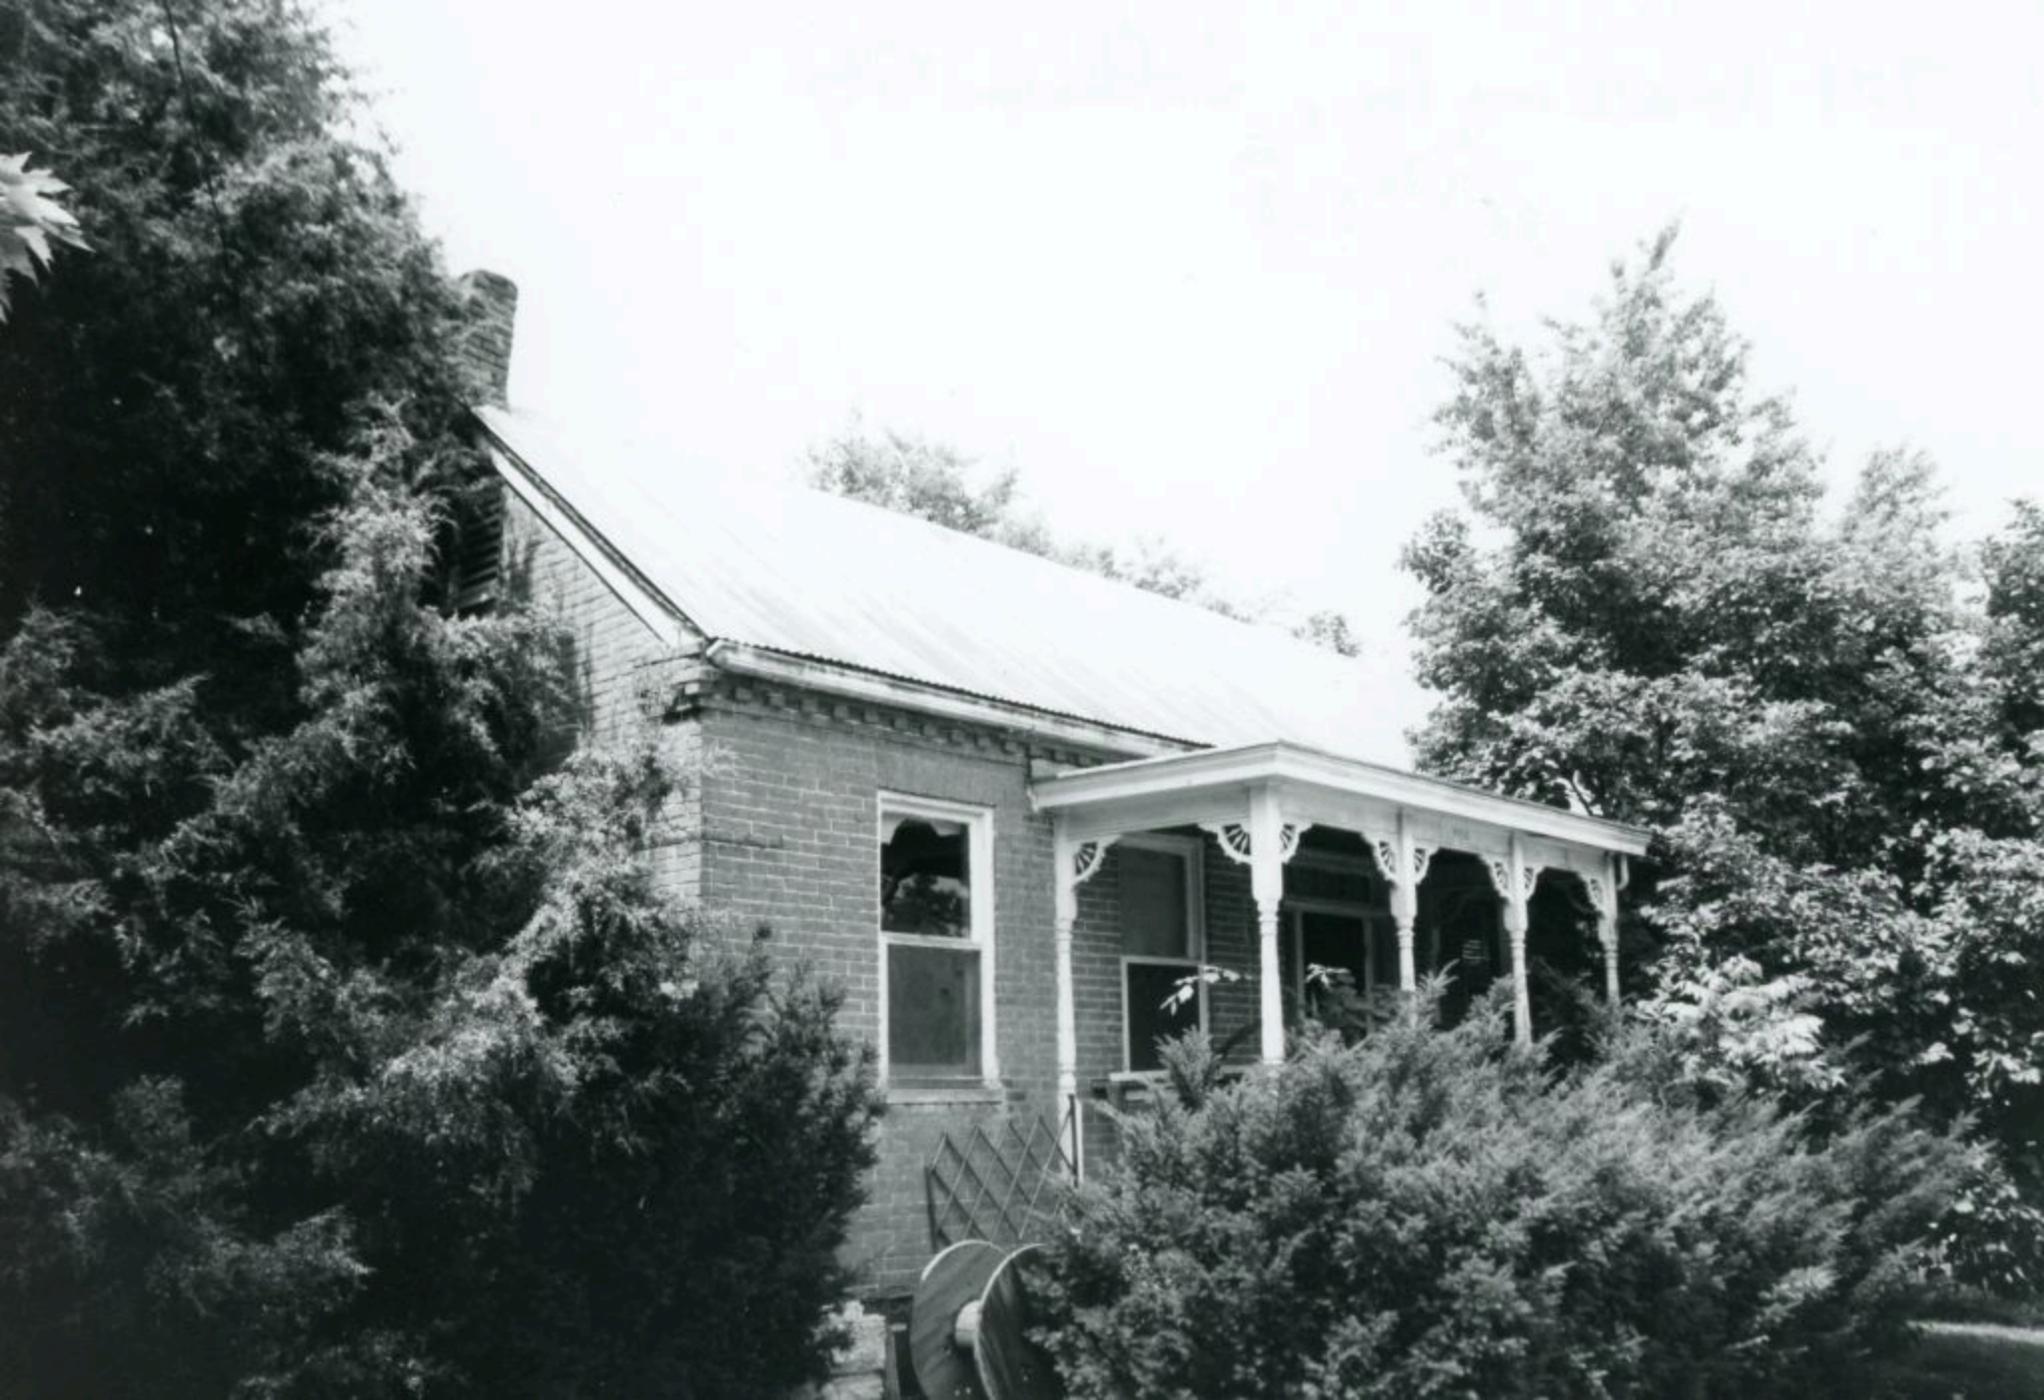
1 story with attic. Central Passage, single pile vernacular type. L-plan altered historically to rectangular plan. Five bay symmetrical facade. Limestone foundation; brick walls. Side gable (corrugated metal) roof. 1/1 double hung sash with soldier course jack arches; wood sills. Exceptional central entrance composed of door with thin multi-light sidelights and 4-light transom showing influence of the Greek Revival style. Two 1/1 windows on either side. Flat roof porch over entrance and left adjacent window (second and third bays) only. South side access to porch appears to be blocked by large industrial cable reel. Porch with turned posts (4 front and two engaged posts at facade plane). "Paddle wheel" corner brackets off each post; plain cornice. Facade with header dentils and raised stretcher beltcourse for cornice, wraps slightly either side elevation. Interior end chimneys either gable end; orth chimney cropped. Elevation drops to north with more of basement exposed. Rear gable wing on south end; exterior end apex chimney. Nearly all of south elevation is block by evergreens and overgrown volunteer trees. Rear reentrant angle appears to be infilled with one story wing. Shed porch enclosed with fiberglass off half of rear gable and part of reentrant infill wing. Rear gable with interior end chimney. Attic vent south of center. From north elevation, brick shed roof rear wing appears historic infill of rear reentrant angle; windows here with double rowlock segmental brick arches. North elevation with basement entrance; mailbox located here. Mortar missing from much of upper gable, north elevation. Some structural failure with wall slanting in.

Potentially eligible to the National Register of Historic Places for architectural significance as an excellent example of the mid-nineteenth German vernacular architecture (and craftsmanship) which once dominated this neighborhood. The house is also symbolic historically of the German immigration/migration into this neighborhood, and the businesses which were once a vital part of the neighborhood (in this case, a basement grocery store.) Recommended for local landmark status also.

The house is in immediate need of proper maintenance to ensure its preservation.

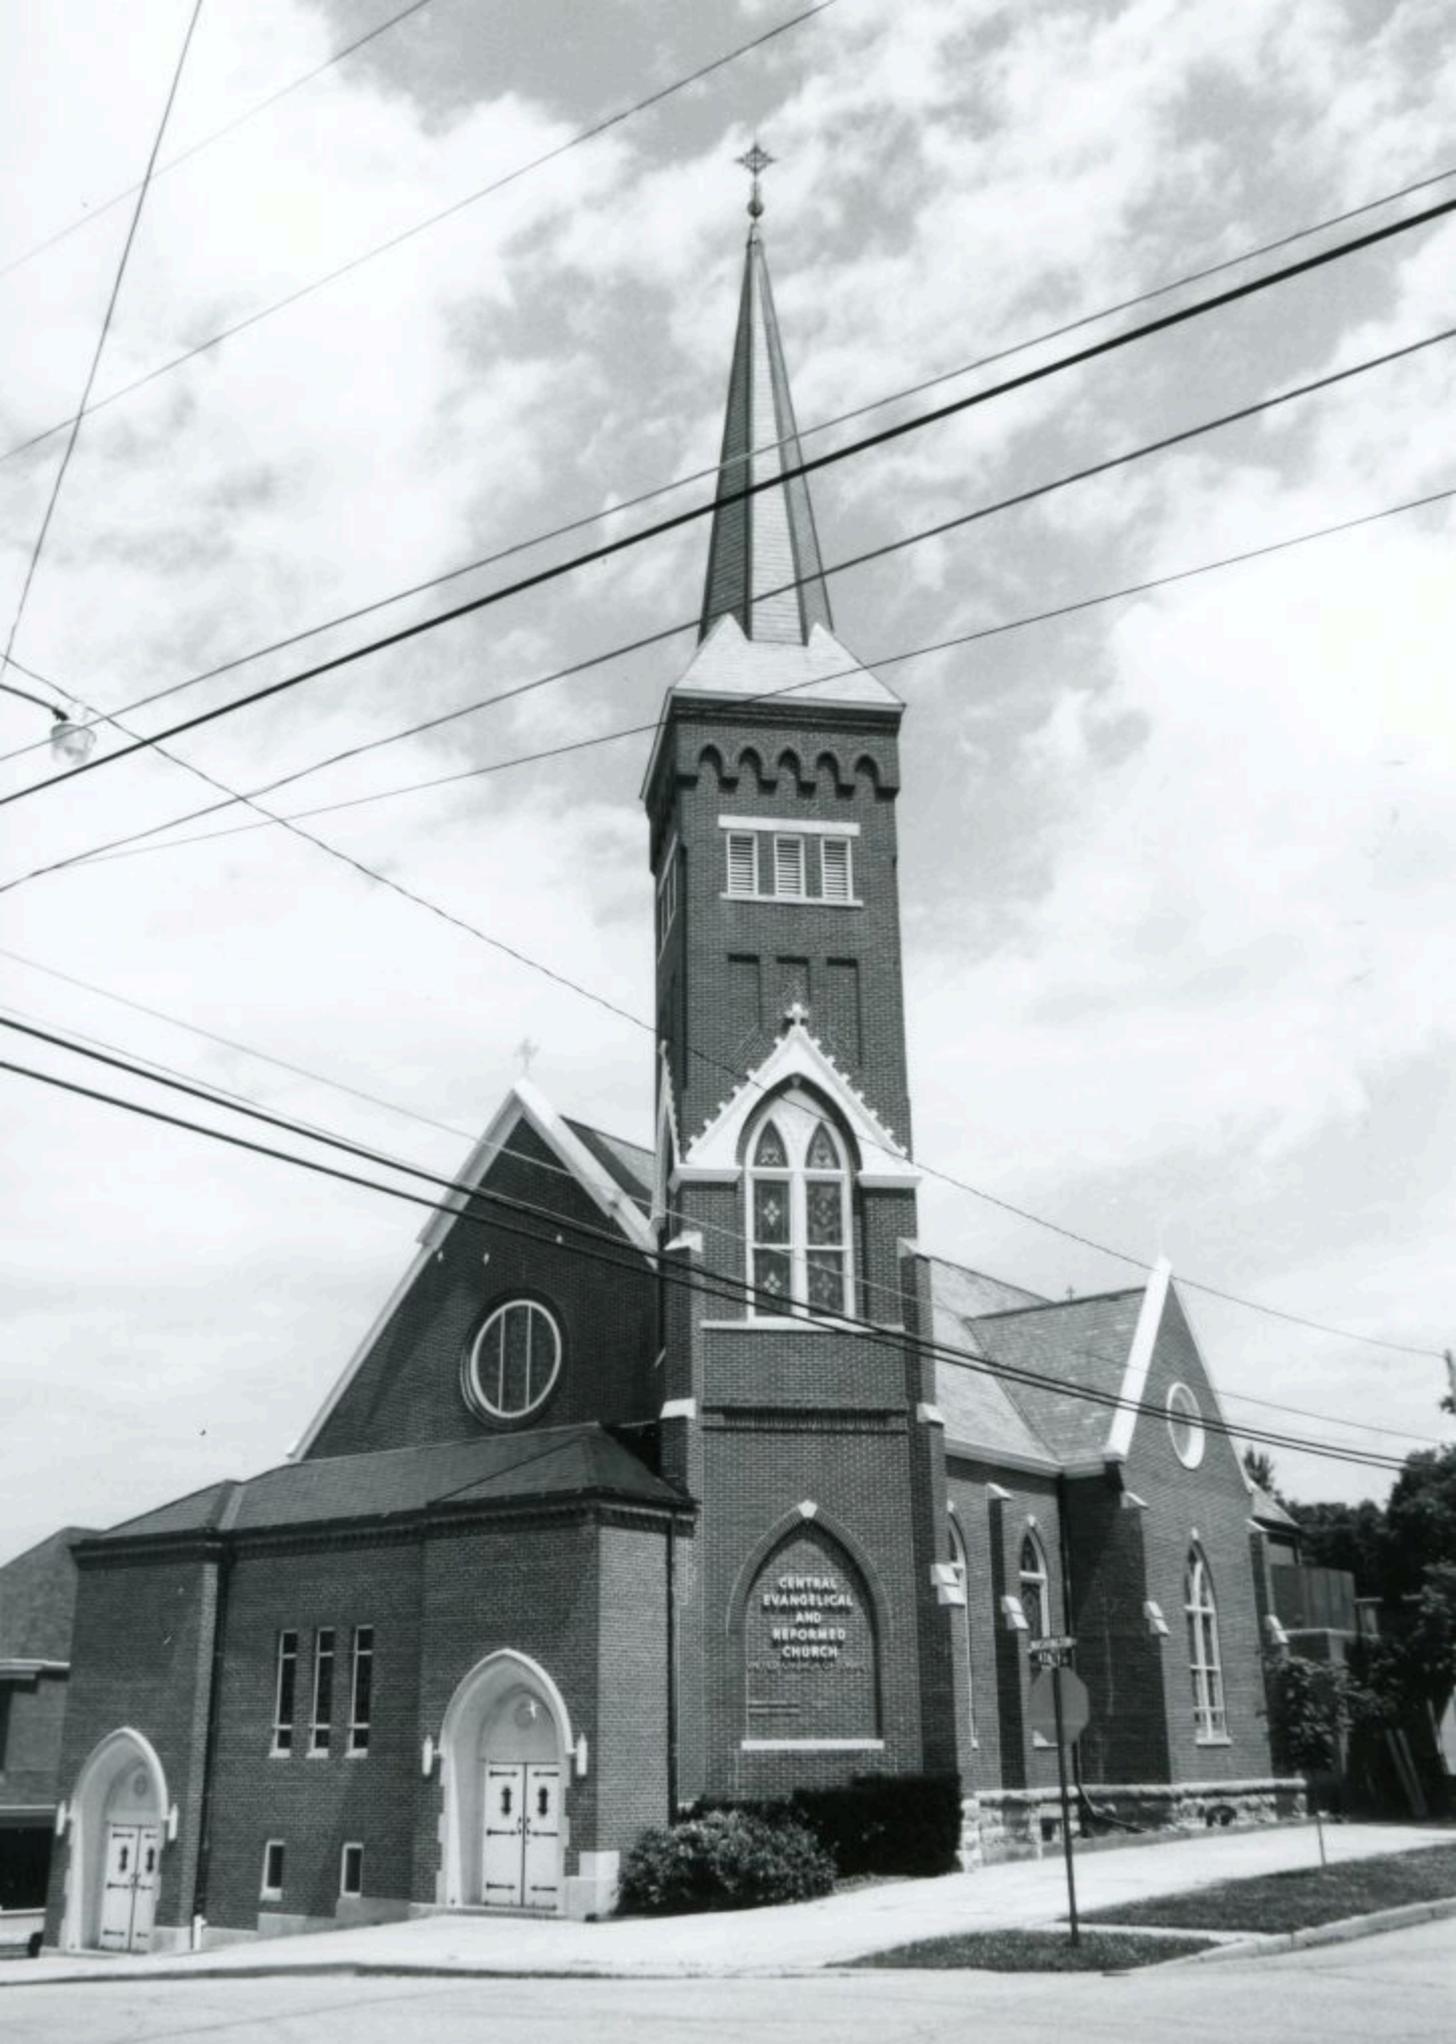
CENTRAL
EVANGELICAL
AND
REFORMED
CHURCH

Oversized 1 story with tower. Late Gothic Revival style. irregular plan. coursed stone with watertable and concrete foundation, brick (5-,7-course common bond) walls. gable and hip (slate) roof. Washington Street elevation: 3 bay modern (c. 1957) entryway with concrete foundation that steps down to north. north and south slightly projecting end bays with recessed wood double doors with strap hinges and small 1-light grilles set in stone pointed arch surround with blind stone tympanum/transom area with inset circle with cross; center with two square 1-light windows with brick flat arches above foundation, three narrow modern stain glass windows above (casements with fixed top/bottom) with flat arches; corbelled brick cornice below hip roof. historic brick main gable behind entryway with large round stain glass window with three row rowlock brick surround, stepped rake boards, metal finial/cross. 3-level corner tower on angle with stepped buttressed corners with stone shoulders; 1st-level with brick pointed arch opening with stone keystone (original double door entry) infilled with brick and attached signage, diagonal soldier course stringcourse above; 2nd-level with paired stain glass 1/1 windows per face with pointed arch transom area with two pointed arch stain glass transoms and center wood tracery, wood pointed arch surround with scroll rake board and edge and apex finials, brick relieving arch over surround with three blind brick panels above; 3rd-level with three vertical louvered openings with continuous stone sill and lintel below blind pointed arch corbelled arcade band, corbelled cornice; hip base to steeple with metal cross finial. Ashley Street elevation: coursed stone below-grade basement with rock-faced watertable and large window well, parged lower half; 4 bays; west bay as tower with two modern paired 1-light basement casements, central triangular stain glass window then tower as above; 2nd bay with central buttress with flanking windows (basement with ground level openings infilled with smaller modern 1/1 with lintel, 1st-story with tall 1/1 double hung stain glass windows with pointed arch transoms); 3rd bay as projecting lower gable roof pavilion with corner buttresses, basement with center paired modern 1/1 windows with segmental arch openings, 1st-story with center paired stain glass 1/1 with pointed arch transoms and tracery, gable with round stain glass window, smaller finial; east end bay as modern (c. 1957) brick entry addition to historic church, projects to sidewalk, wood double door entry with strap hinges and 3-light doors to east with transom, three central high narrow modern stain glass windows, historic church rear section with corbelled brick cornice; 1-story modern (c. 1979) addition to east (Evangelical Center). east elevation with modern addition across lower section, historic church gable with group of three pointed arch stain glass windows in center with brick surrounds. north elevation with 4 bays. west end bay as side of modern entry addition with three modern stepped stair stain glass 1-light casements. corbelled cornice returns; 2nd bay in three parts divided by three stepped buttresses (one in corner). exposed stone basement with at-grade modern door to west, center glass block infilled opening, 1/1 to east, 1st-story with three tall 1/1 pointed arch stain glass windows with transoms; 3rd bay as projecting lower gable roof pavilion with corner buttresses, basement with center at-grade opening infilled with glass block, flanking modern 1/1 windows, 1st-story with center paired stain glass 1/1 with pointed arch transoms and tracery, gable with round stain glass window; east bay with 2-story projecting addition to north with at-grade entry, four windows on 1st-story, lower basement addition projects to north in corner, large addition behind to east, historic church behind to south.
