RURAL CHURCHES OF CALLAWAY  
COUNTY, MISSOURI  
T: 44 N R: 9 W  
August 2010

**ARCHITECTURAL/HISTORIC INVENTORY FORM**

1. Survey No. CYAS002-001		2. Survey name: Rural Churches of Callaway County, Missouri	
3. County: Callaway		4. Address (Street No.)	Street (name) N. side CR 4011, W. of CR 485
5. City: Tebbetts	Vicinity: <input type="checkbox"/>	6. UTM: 15/590380/4275120	7. Township/Range/Section: T: 44N R: 9W S: 5
8. Historic name (if known): Tebbetts United Methodist Church		9. Present/other name (if known): Tebbetts Methodist Episcopal Church	
10. Ownership: <input checked="" type="checkbox"/> Private <input type="checkbox"/> Public		11a. Historic use (if known): RELIGION/Religious facility/church	11b. Current use: RELIGION/Religious facility/church

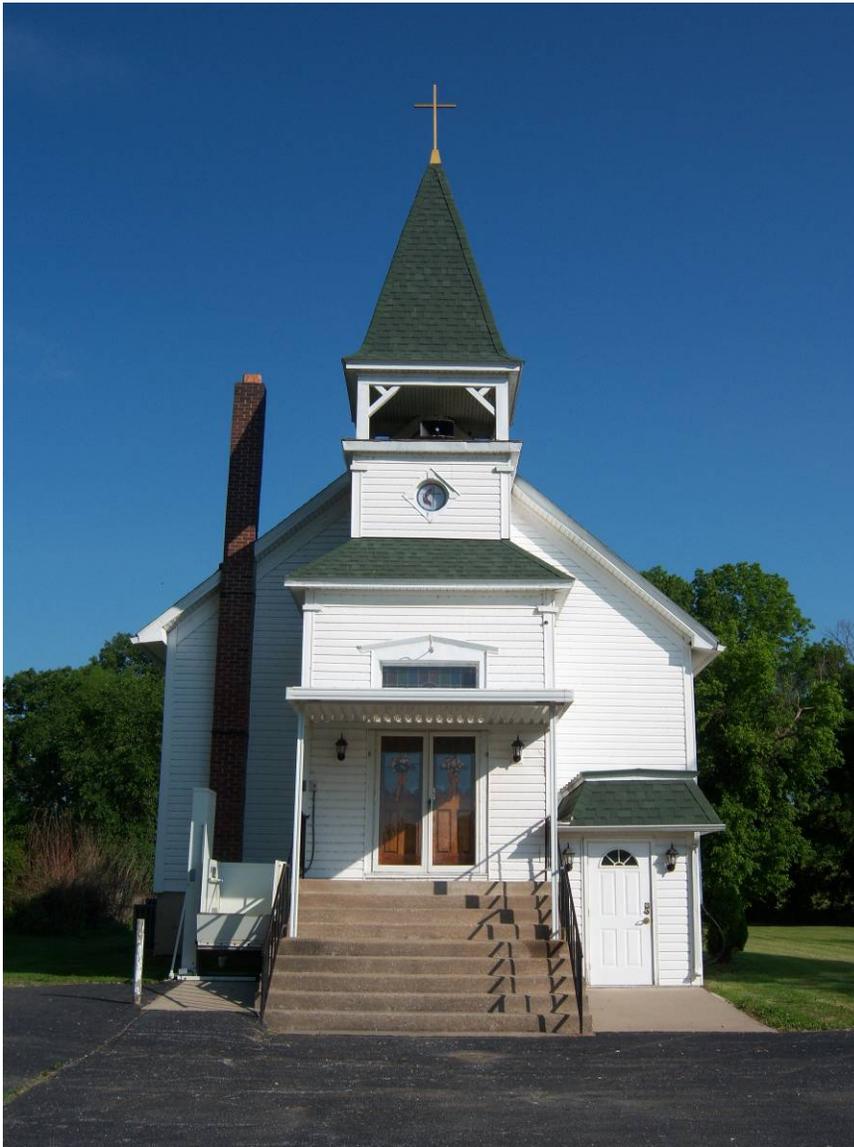
CYAS002-001  
Rural Churches of Callaway County, Missouri  
Tebbetts United Methodist Church, N. side CR 4011, W. of CR 485, Tebbetts

South elevation, looking north.

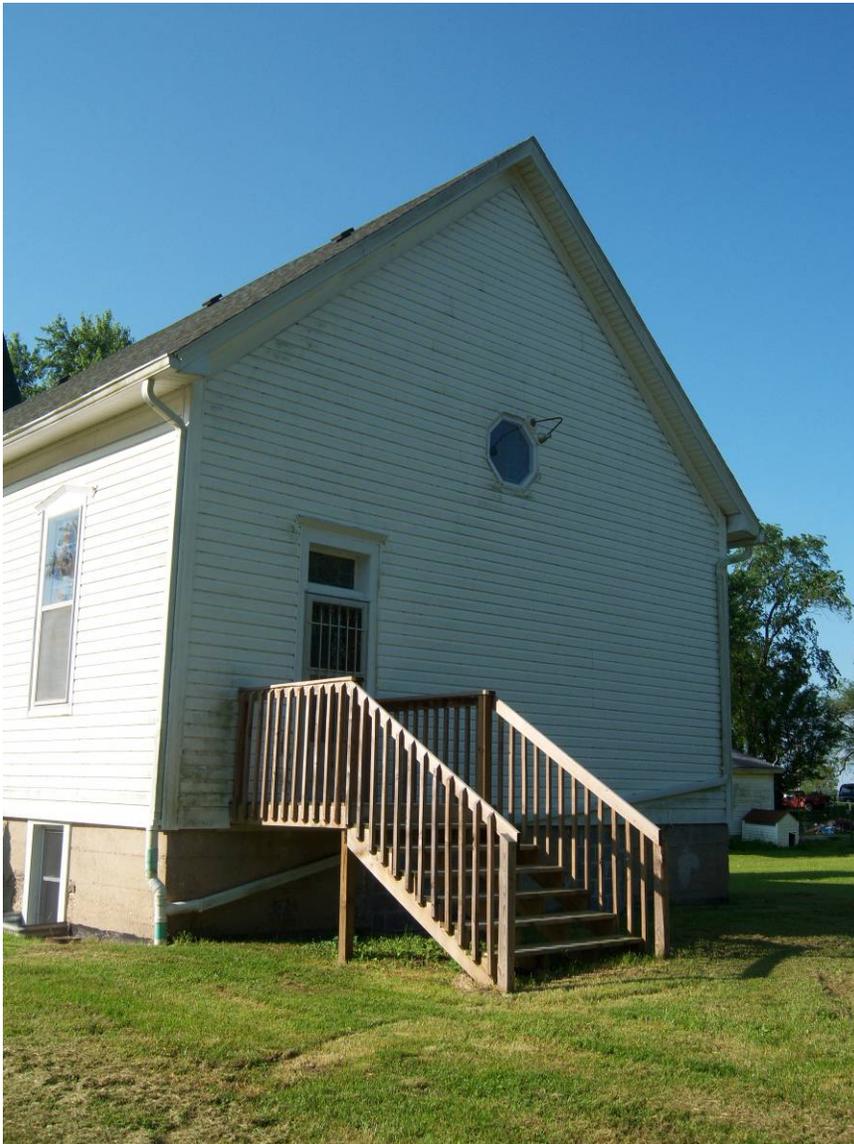
CYAS002-001  
Rural Churches of Callaway County, Missouri  
Tebbetts United Methodist Church, N. side CR 4011, W. of CR 485, Tebbetts

North elevation, looking southwest.

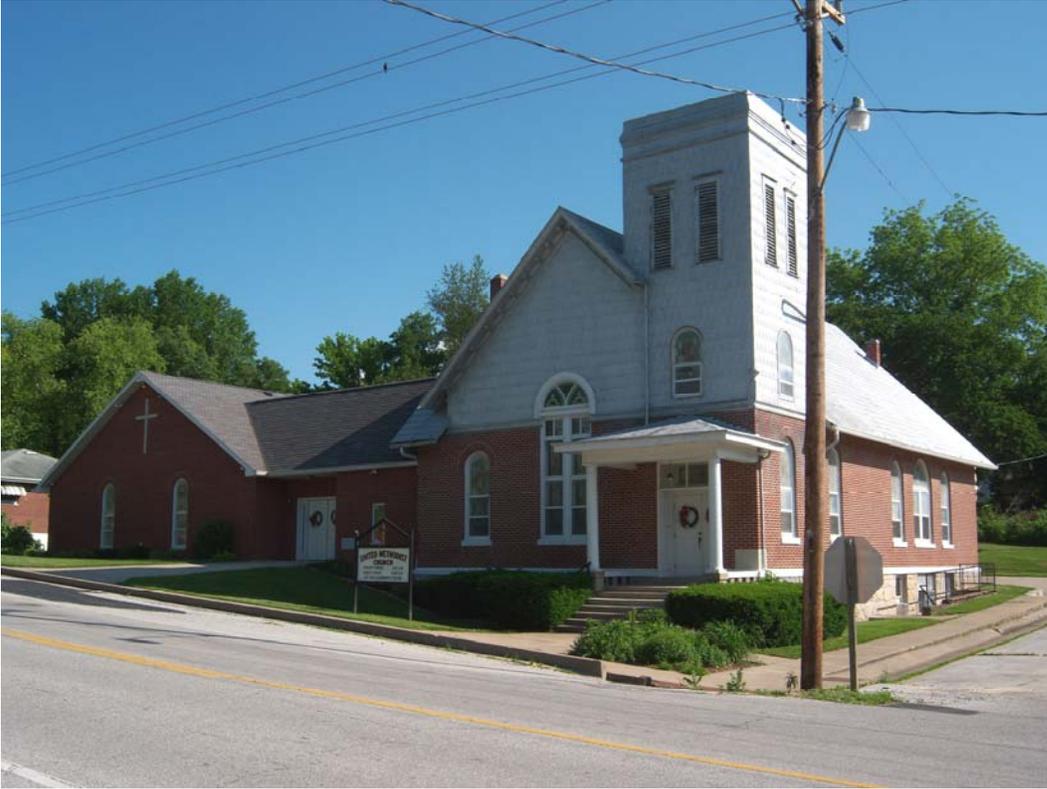
CYAS002-003  
Rural Churches of Callaway County, Missouri  
Mokane United Methodist Church, 401 Fulton, Mokane

This side steeple church retains much of its original materials and configuration, though a very large addition was added to the northern (side) elevation in c. 2005. The original block sits on a concrete foundation, has brick walls, and pressed metal siding in the gable and the upper stories of the corner tower. The original block of the church also retains its pressed metal shingles. The primary (west) elevation has a centered, tall round arched window, flanked on the north by a smaller round arch window and on the south by the tower which contains the entrance. The entrance is sheltered by a hipped roof porch supported by simple columns. The second and third tiers of the tower are clad in pressed metal siding. The second tier contains round arched windows and the top has square topped vented openings, possibly marking the historic belfry. The addition has a cross gable roof, with a shorter front gable portion with round arch windows balancing the larger gable of the original building.

West and south elevations, looking northeast.

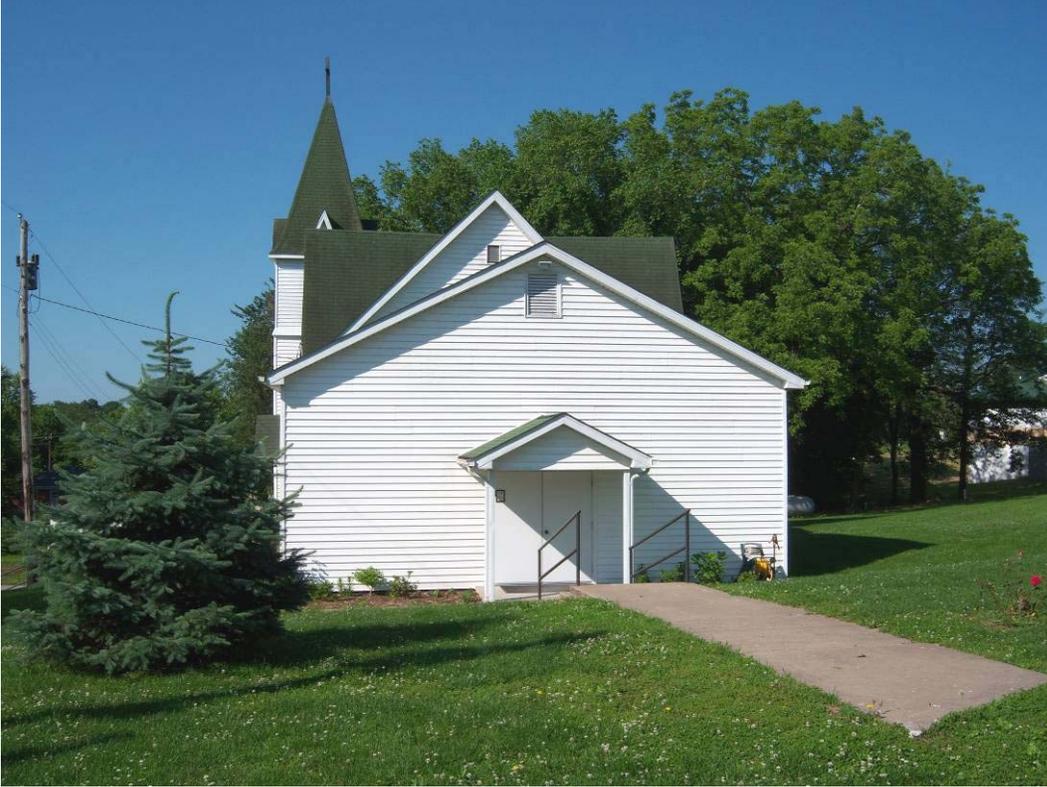
CYAS002-004  
Rural Churches of Callaway County, Missouri  
St. Jude Thaddeus, SW Corner Collier & Adams Sts., Mokane

Originally a frame side steeple church with cross gable roof and stone foundation, the building has been reoriented with a rear addition now acting as the front of the building. The original portion of the building faced west southwest overlooking a slope leading to Fulton Street, Mokane's main street. The original entrance may have been located in the large corner tower, but modern vinyl siding obscures original features of the tower and original (west) elevation of the building. The west elevation likely contained an entrance or large window, but is now a blank wall due to the installation of modern siding. The eastern elevation (now the "front") consists of a gable front addition, the gable shorter and at a lower pitch that the original building block. Centered in the elevation are paired doors sheltered beneath a gable front porch roof.

Northeast elevation, now "front" of building, looking southwest.

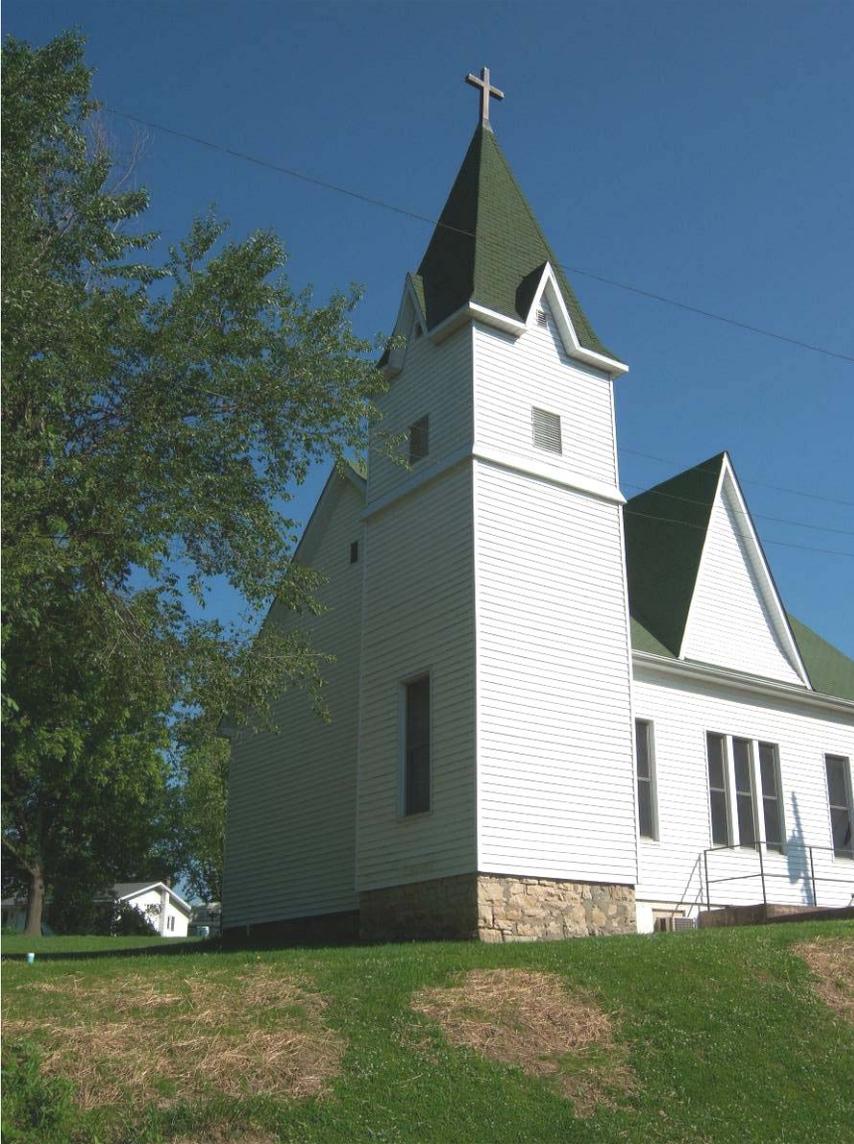
CYAS002-004  
Rural Churches of Callaway County, Missouri  
St. Jude Thaddeus, SW Corner Collier & Adams Sts., Mokane

West elevation, looking north.

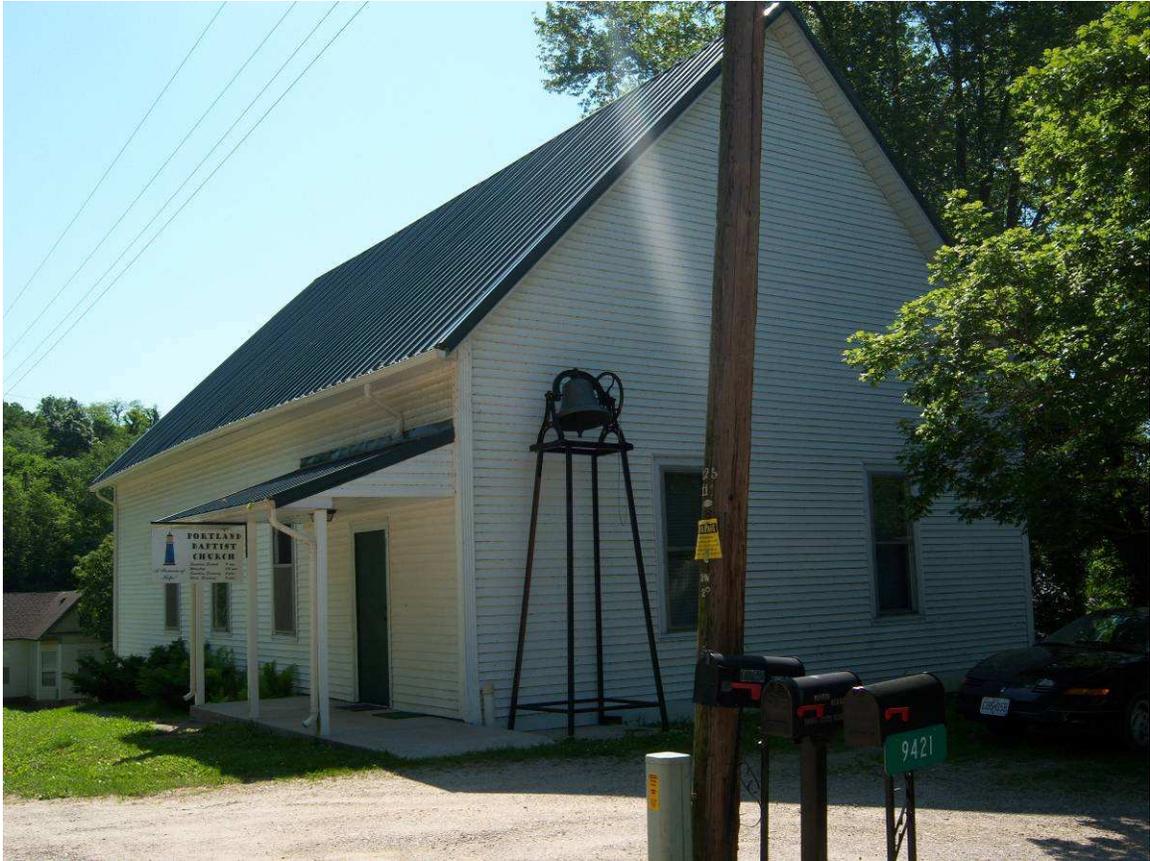
CYAS002-018  
Rural Churches of Callaway County, Missouri  
Portland Baptist Church, Hwy 94 and Market St., Portland

West and north elevations, looking east southeast.

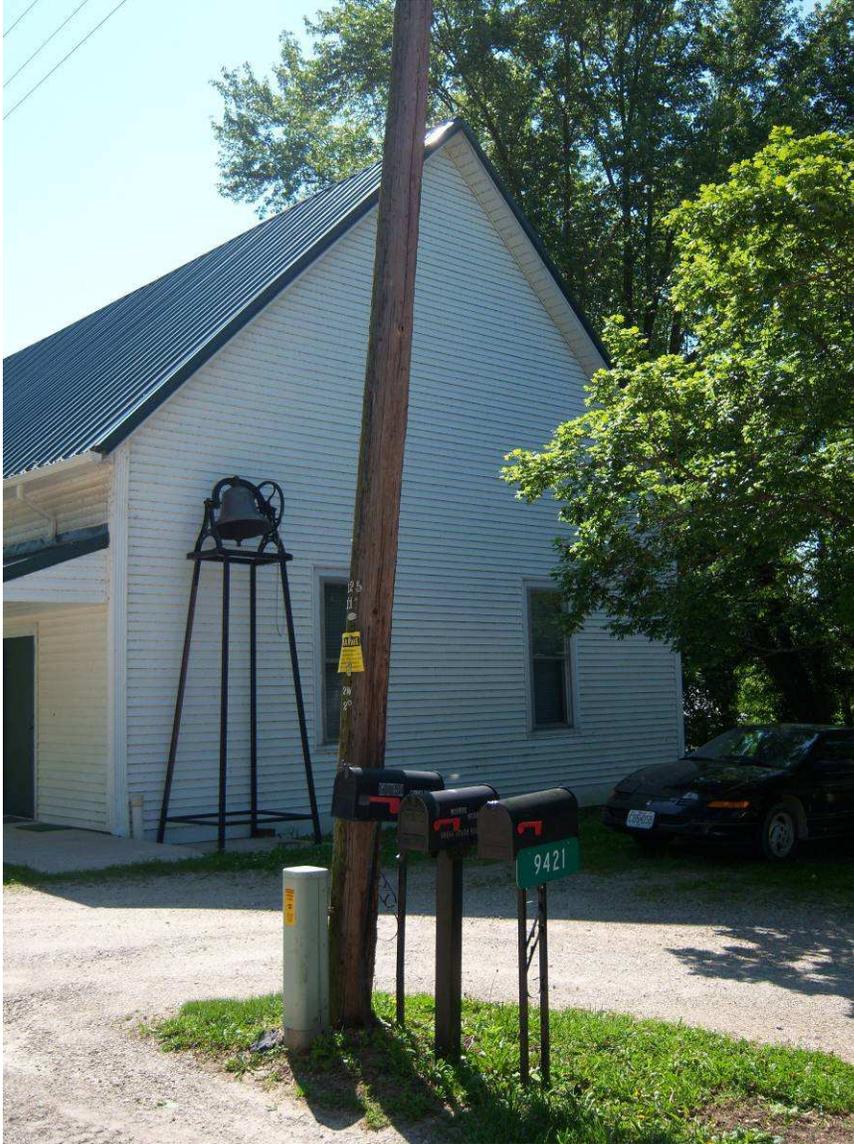
CYAS002-018  
Rural Churches of Callaway County, Missouri  
Portland Baptist Church, Hwy 94 and Market St., Portland

West elevation, looking southeast.

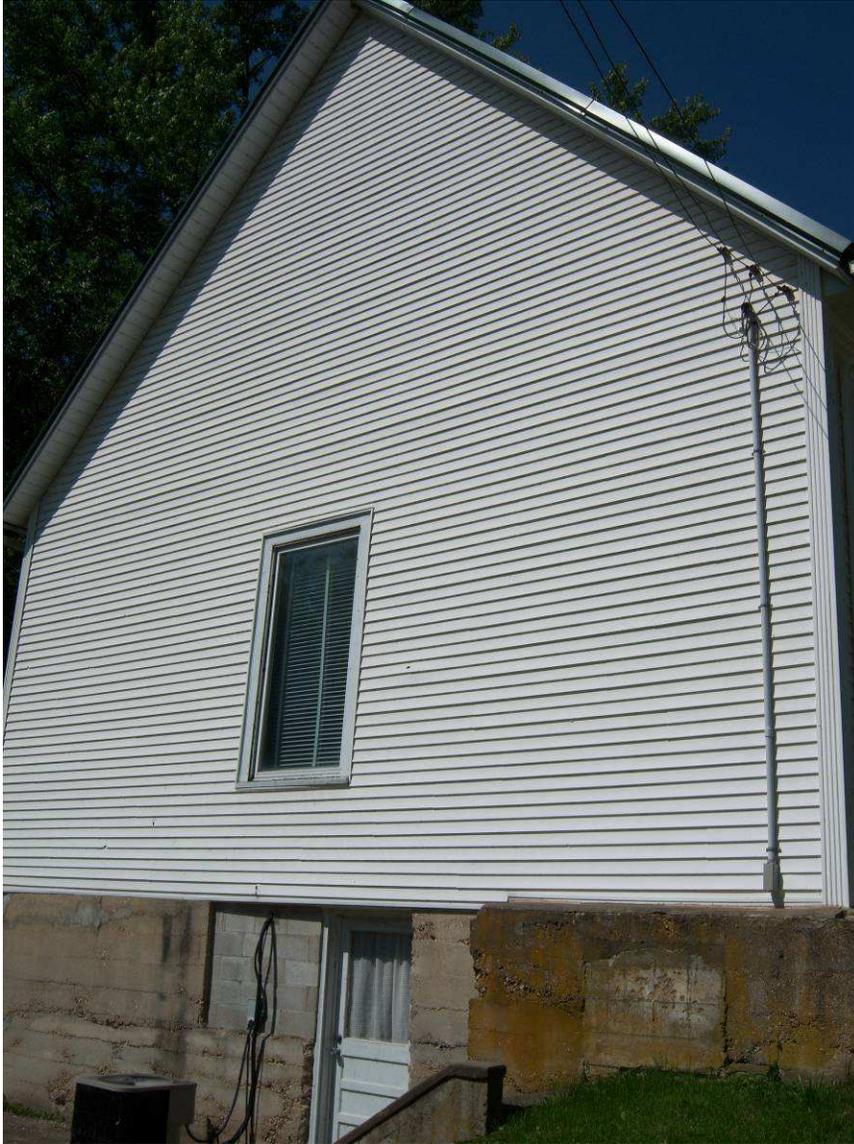
CYAS002-018  
Rural Churches of Callaway County, Missouri  
Portland Baptist Church, Hwy 94 and Market St., Portland

East elevation, looking southwest.

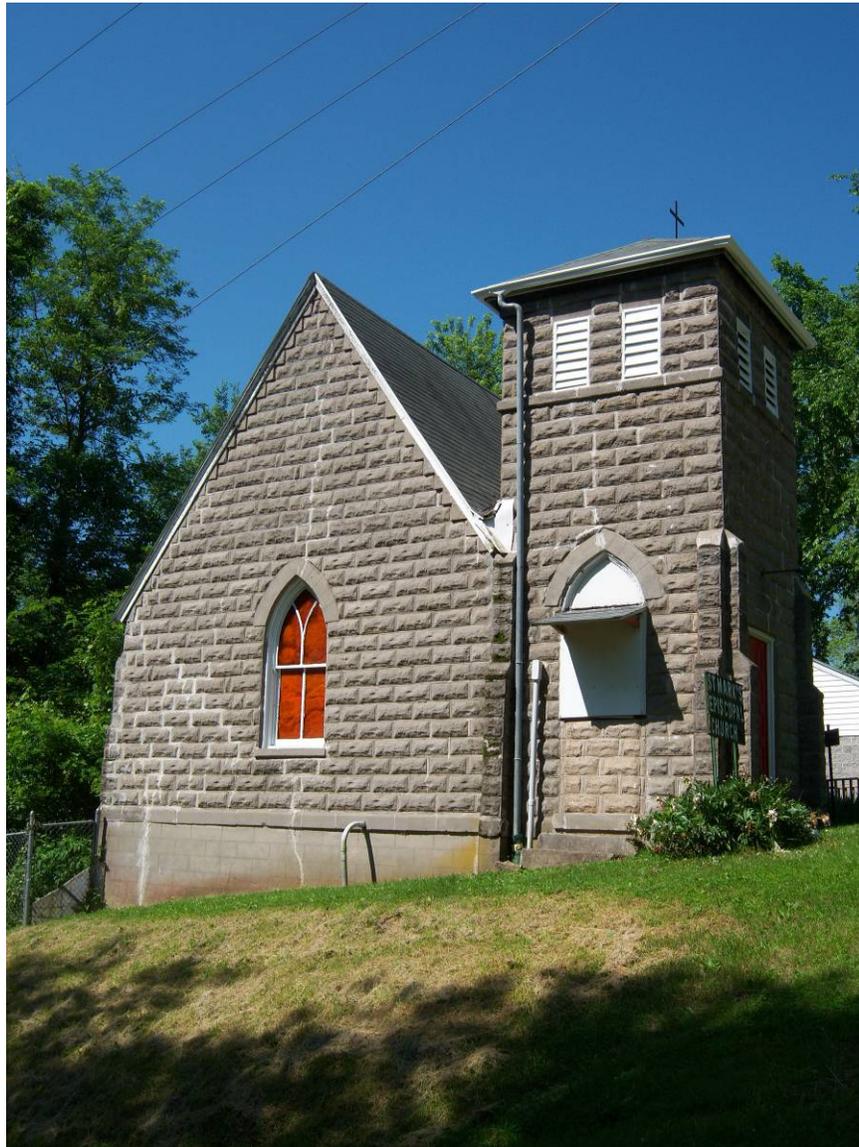
CYAS002-019  
Rural Churches of Callaway County, Missouri  
St. Mark's Episcopal Church, 8645 County Road 466, Portland

East elevation, looking southwest.

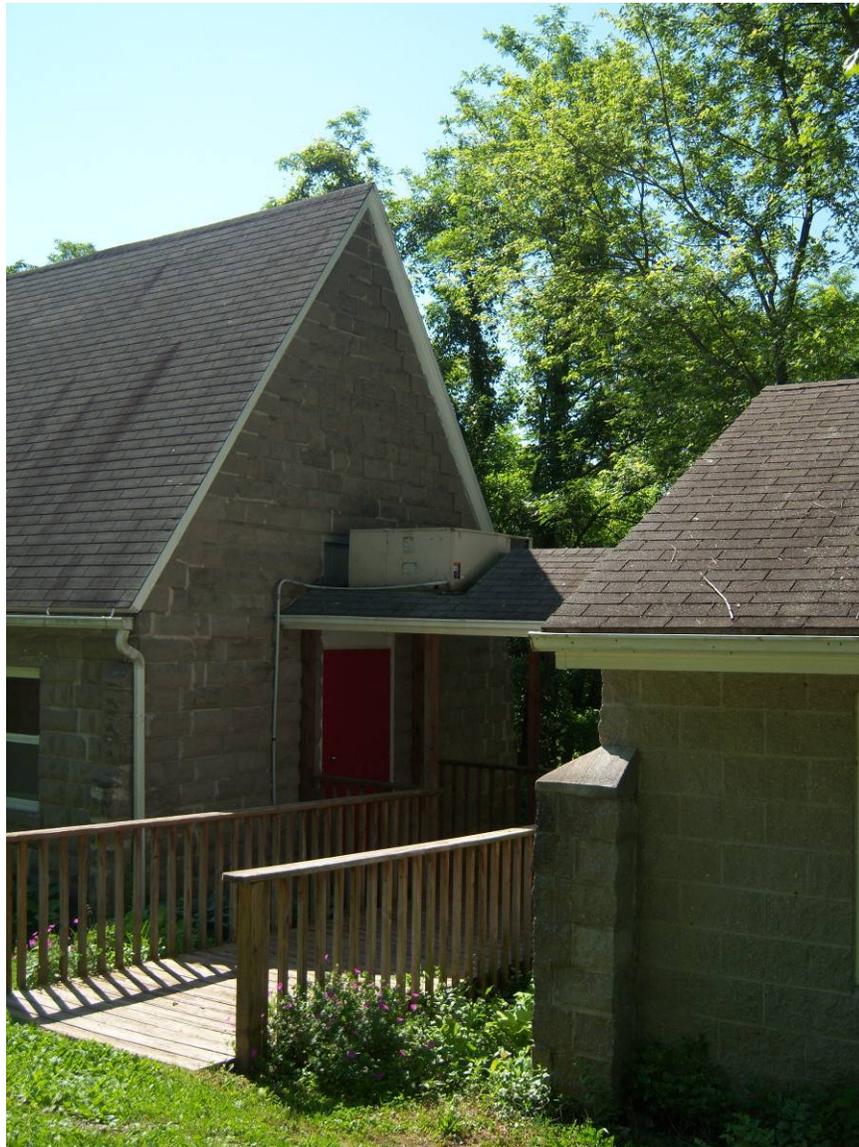
CYAS002-019  
Rural Churches of Callaway County, Missouri  
St. Mark's Episcopal Church, 8645 County Road 466, Portland

West elevation and connection, looking southeast.

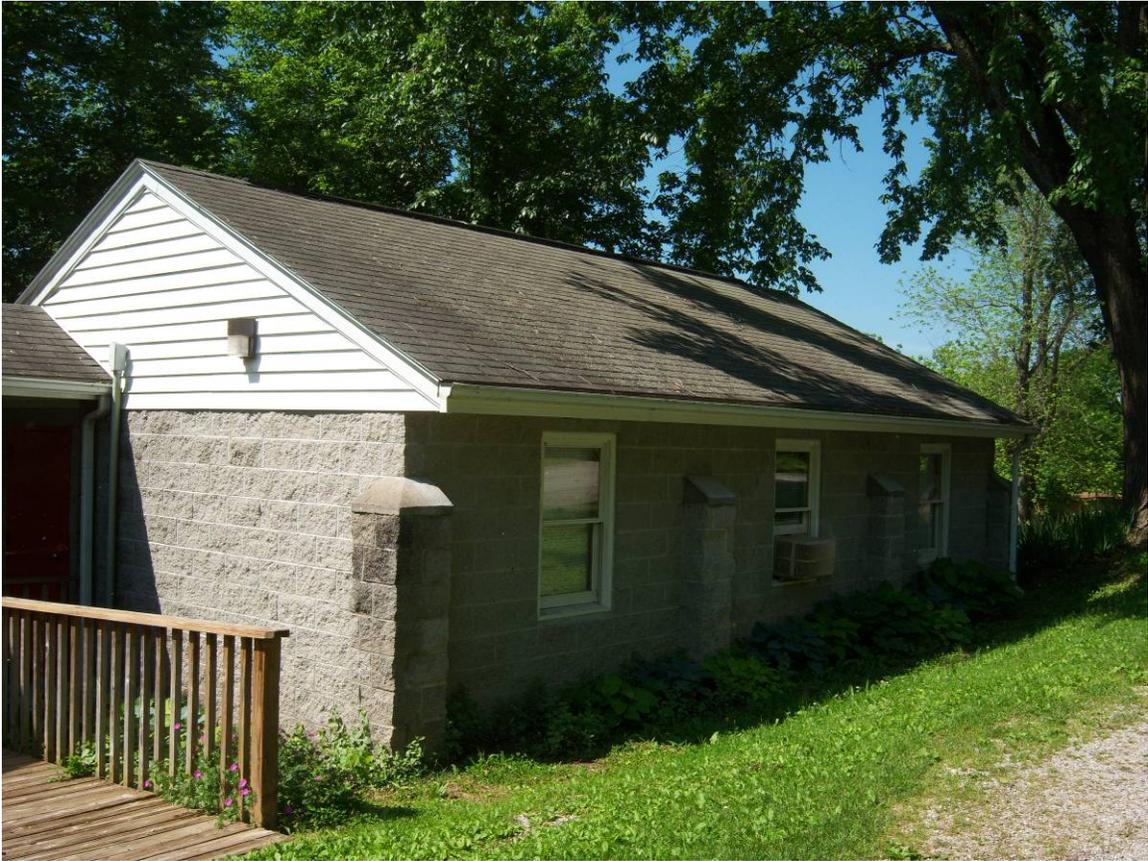
CYAS002-019  
Rural Churches of Callaway County, Missouri  
St. Mark's Episcopal Church, 8645 County Road 466, Portland

North and east elevation, social hall building, looking southwest.

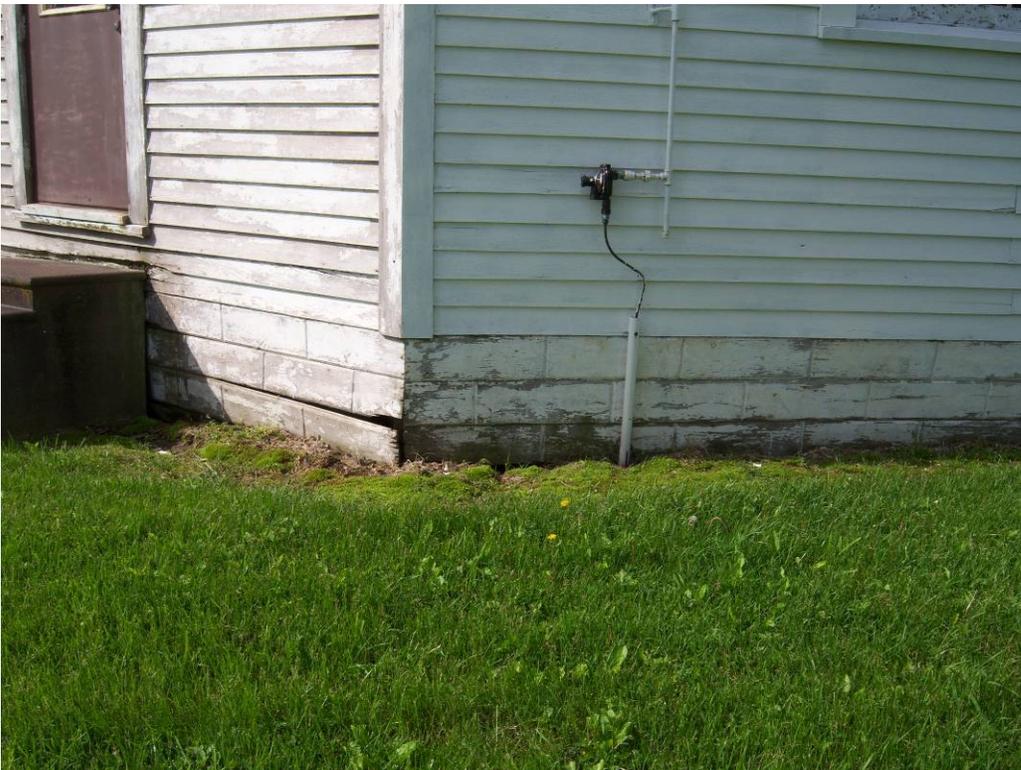
Detail of foundation boards, looking southwest.
