1. Survey No. MC-AS-001-001		2. Survey name: Downtown Macon Commercial Historic District	
3. County: Macon		4. Address (Street No.) Lots 11-13 block 93	Street (name) East Bourke Street (100 block)
5. City: Macon	Vicinity: <input type="checkbox"/>	6. Geographical Reference:	7. Township/Range/Section: T: R: S:
8. Historic name (if known):		9. Present/other name (if known): City of Macon Parking Lot #3	
10. Ownership: <input checked="" type="checkbox"/> Private <input type="checkbox"/> Public		11a. Historic use (if known): Commercial	11b. Current use: vacant

42. Current owner/address: City of Macon Macon, MO 63552	43. Form prepared by (name and org.): Kristi Chase MO SHPO	44. Survey date: 9/24/2014
		45. Date of revisions:

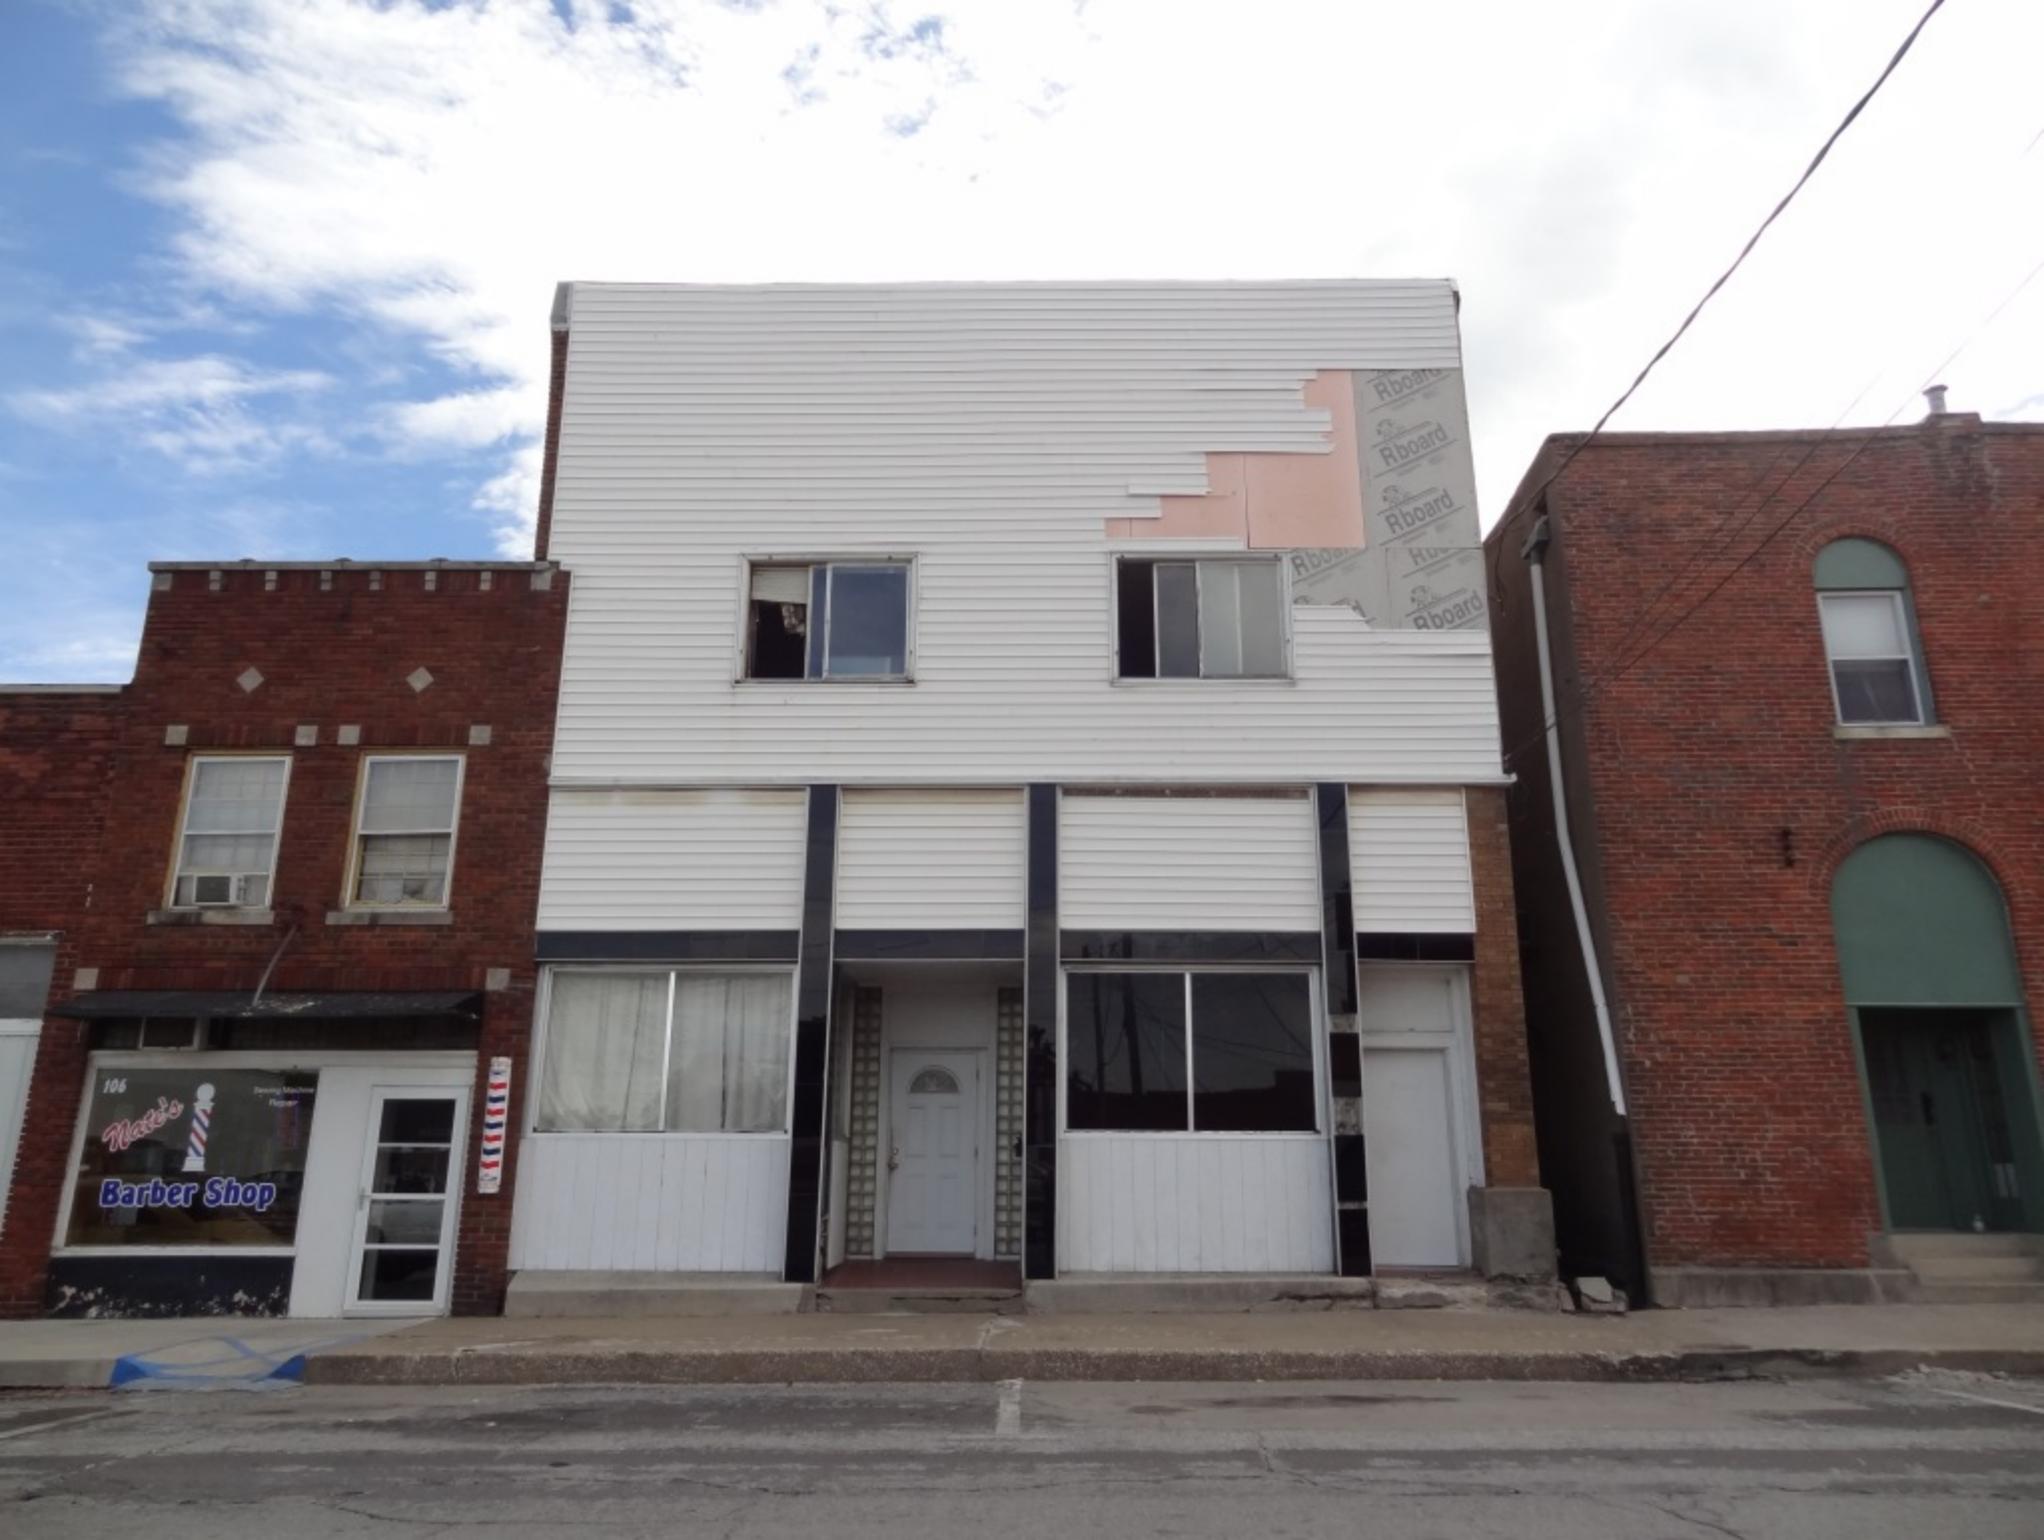
This two-part commercial block building has been heavily modified. The first story contains four bays. From west to east, the first and third bays contain a non-historic metal window with two lights and tall bulkheads clad with vertical wood boards. The second bay is recessed and contains a non-historic aluminum door with glass block sidelights. The fourth bay contains a non-historic wood door with a boarded up transom. Historic brick cladding and a stone foundation is visible at the eastern corner of the building. Three thin columns of black structural glass, flanking the centermost bays, rise to the second story. A thin row of black structural glass is applied to the wall directly above the first story bays. The remainder of the building is clad in vinyl. The second story contains two window openings, each filled with non-historic metal windows with two horizontally sliding sash. Some of the vinyl has been removed from the second story, revealing Rboard and insulation underneath.

Due to loss of historic building materials, the building would not contribute to a potential National Register historic district.

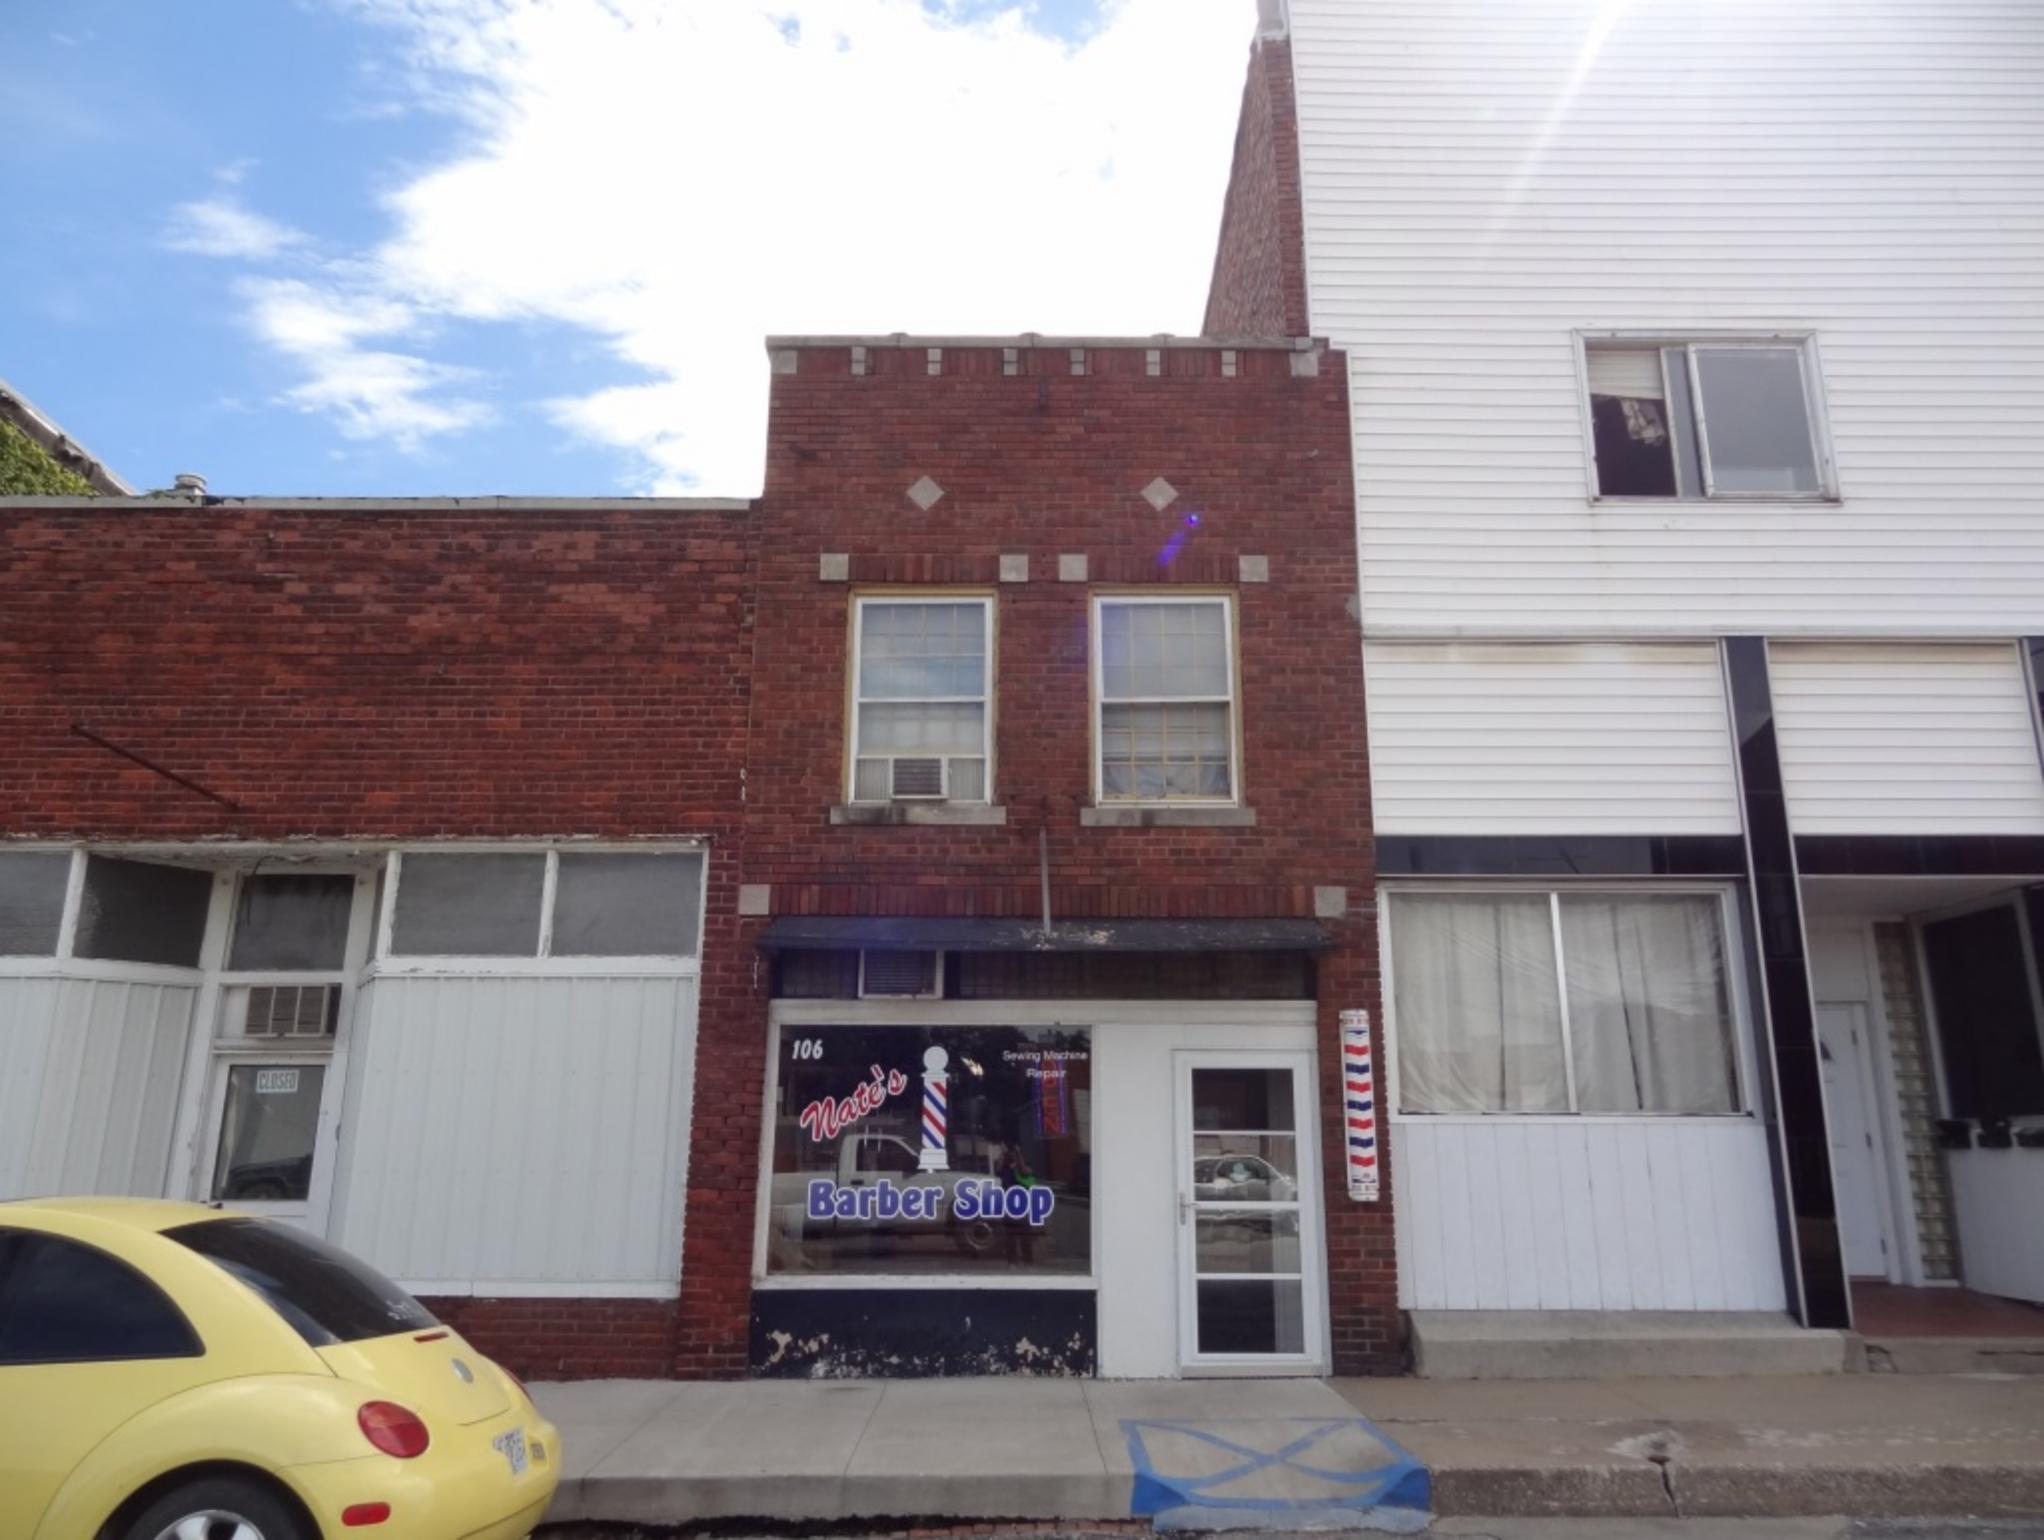
This building retains architectural integrity and would likely contribute to a potential National Register historic district.

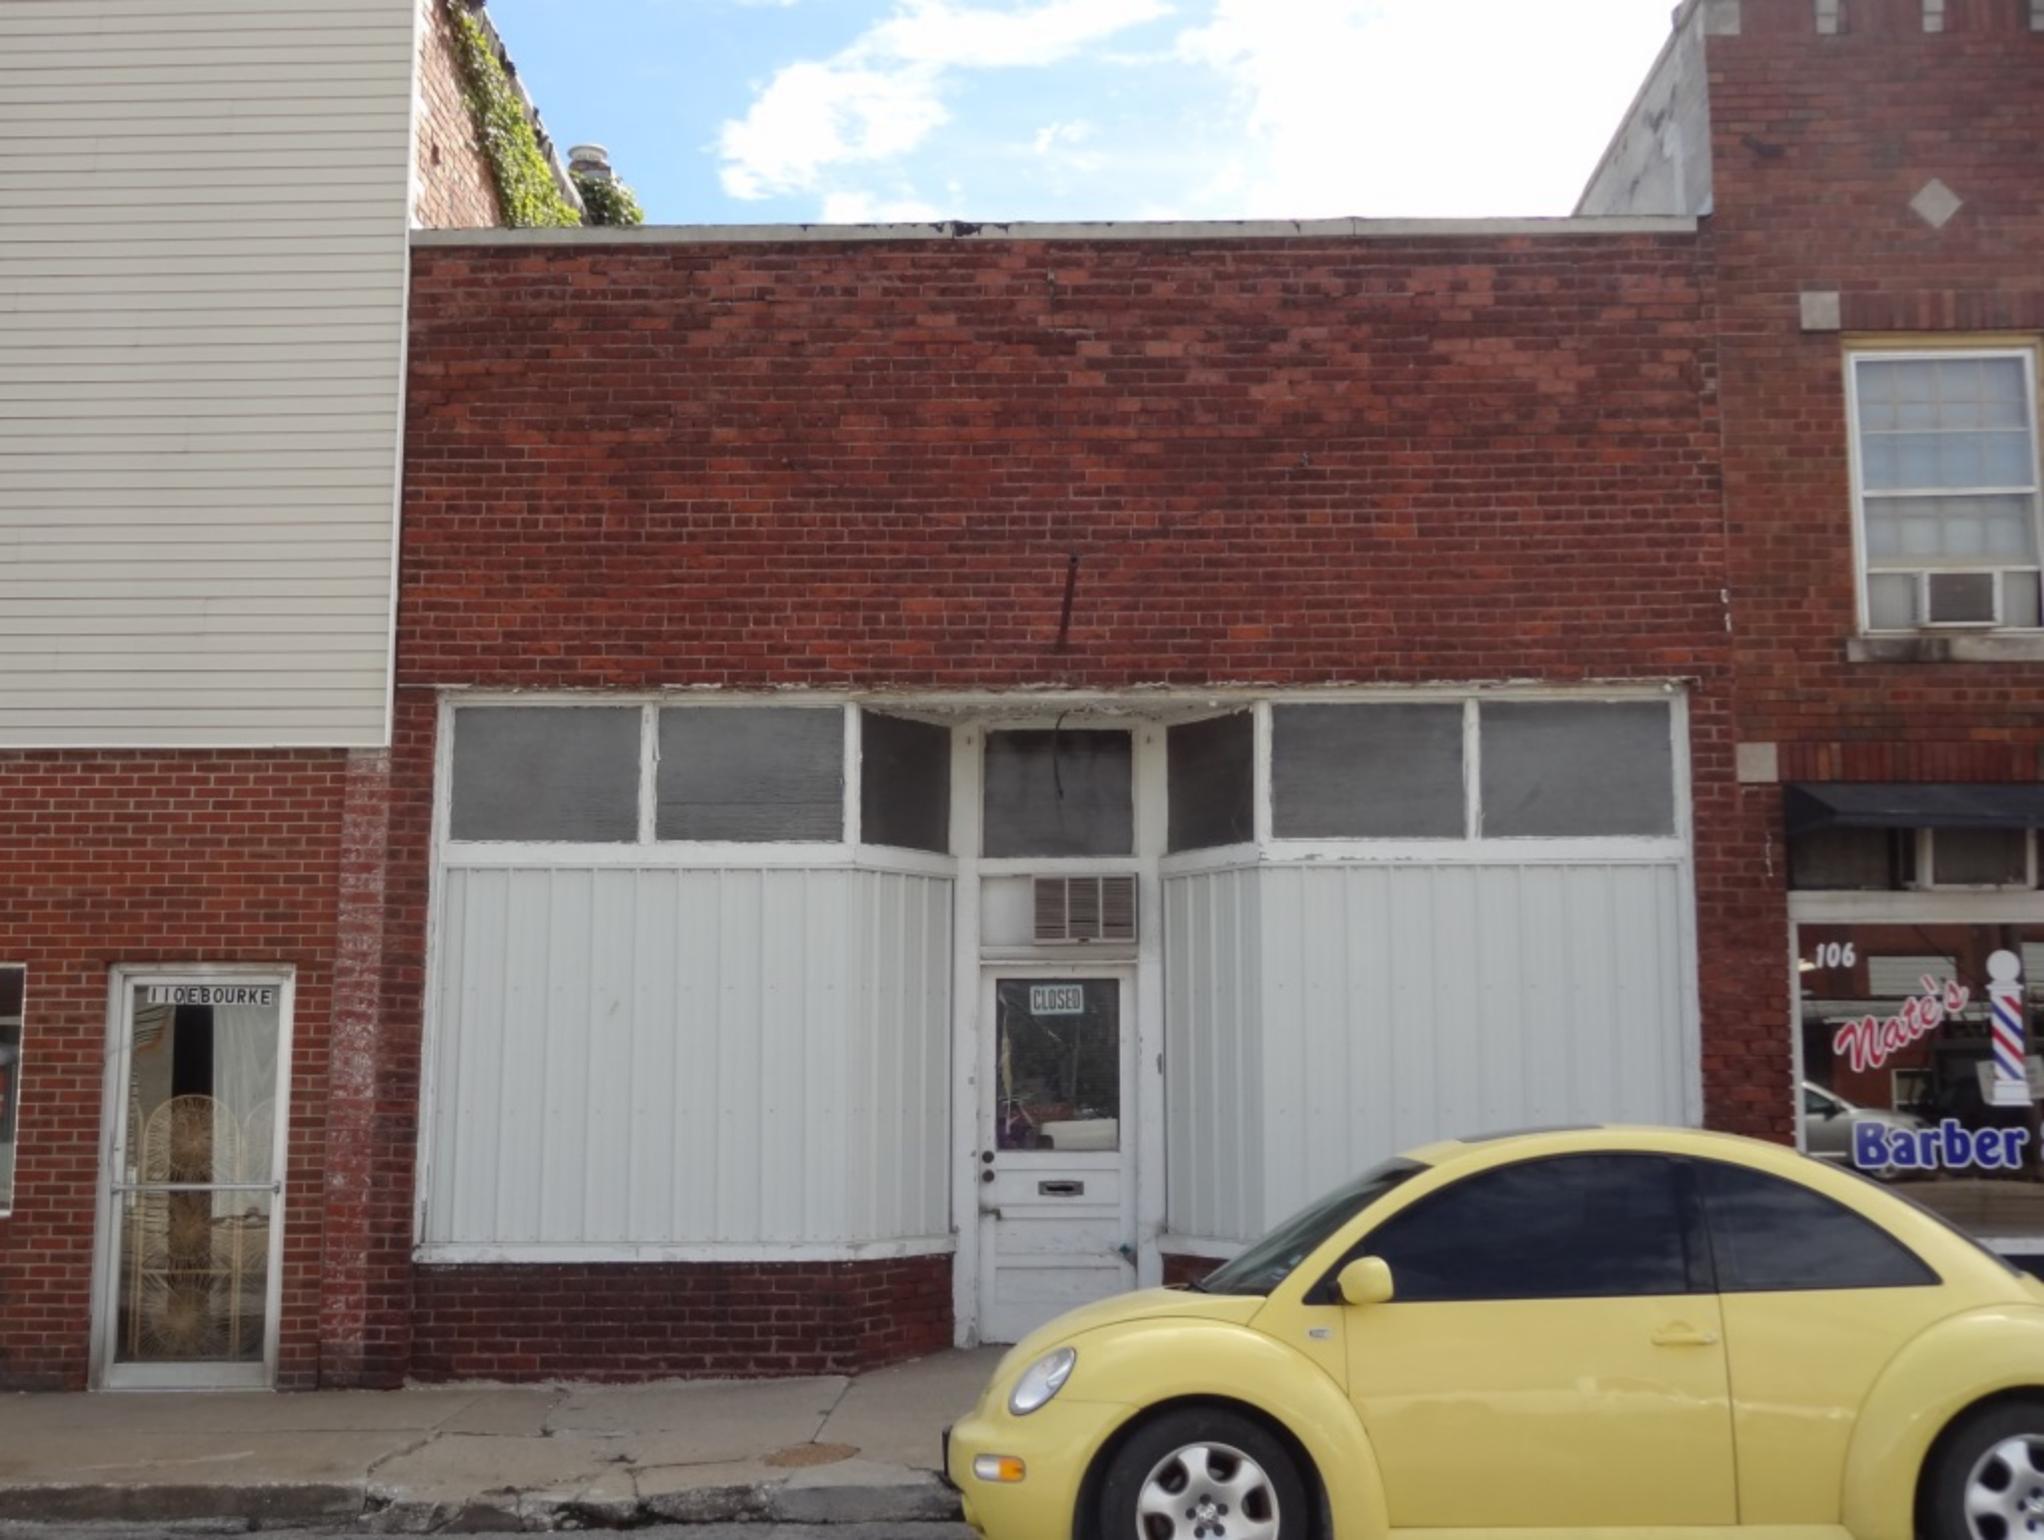
This brick one-part commercial block building retains a single storefront with a centered historic entry door. The area for display windows on each side of the door have been boarded up with corrugated metal. A transom directly above the door has been filled in with an air conditioning unit. Historic transom windows are located above the storefront. The exterior cladding, brick laid in a seven-course common bond, is evident above the storefront and the cornice is capped with limestone. The condition of the brick indicates that a large sign or other external cladding was removed.

This building retains architectural integrity and would likely contribute to a potential National Register district.

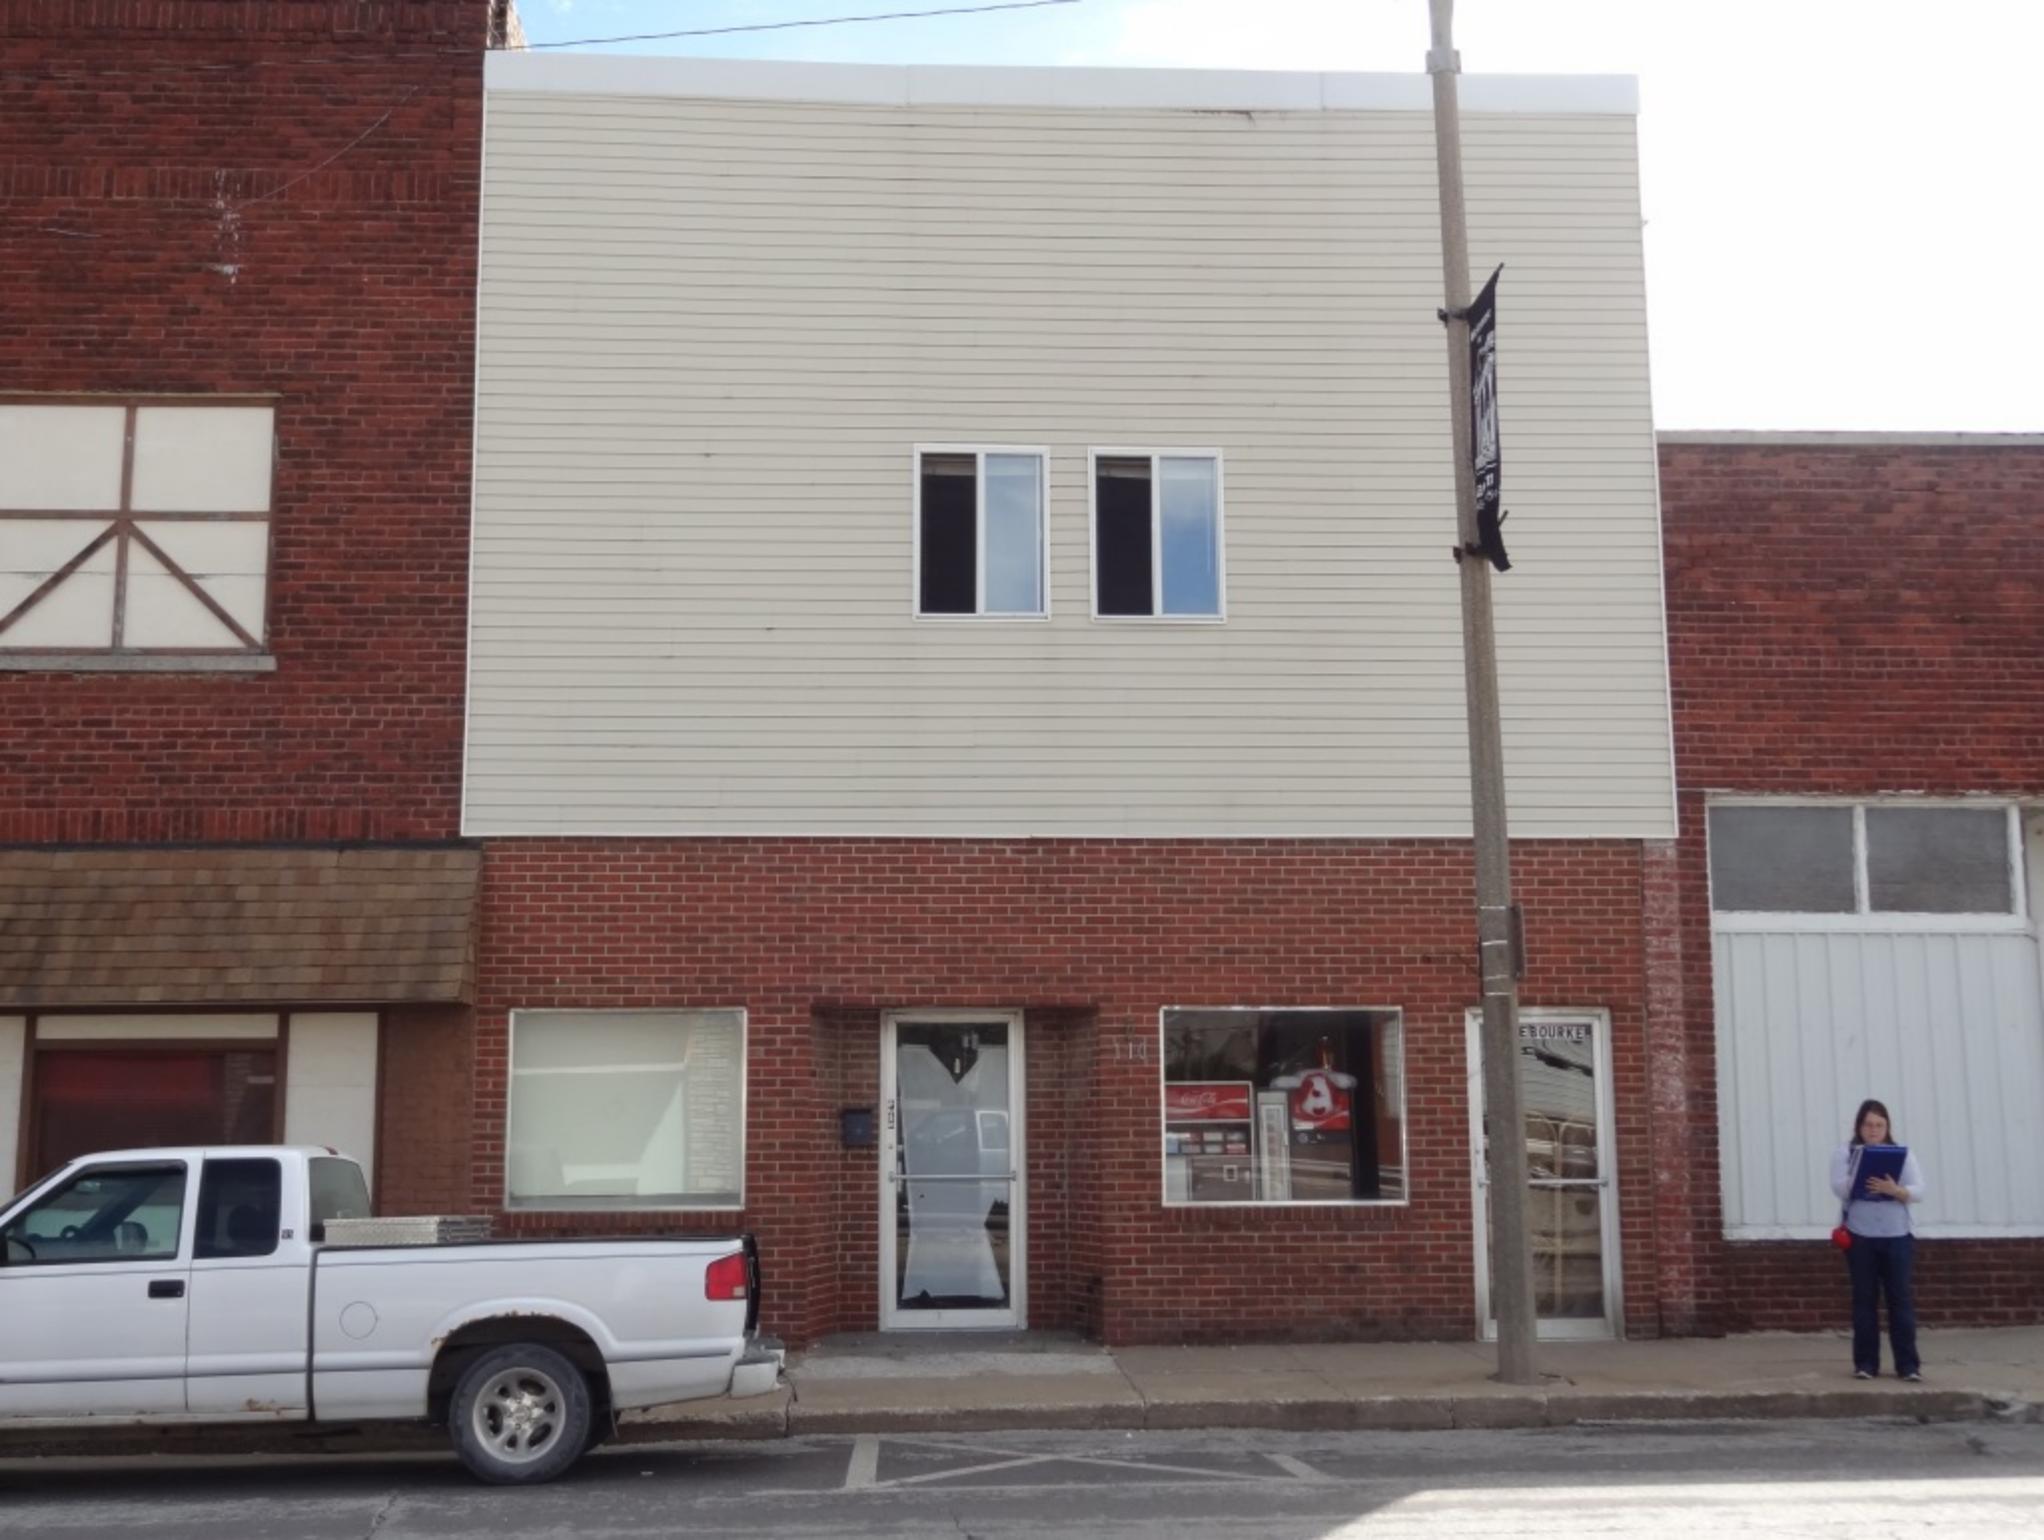
Due to the loss of historic building materials, this building would likely not contribute to a potential National Register historic district.

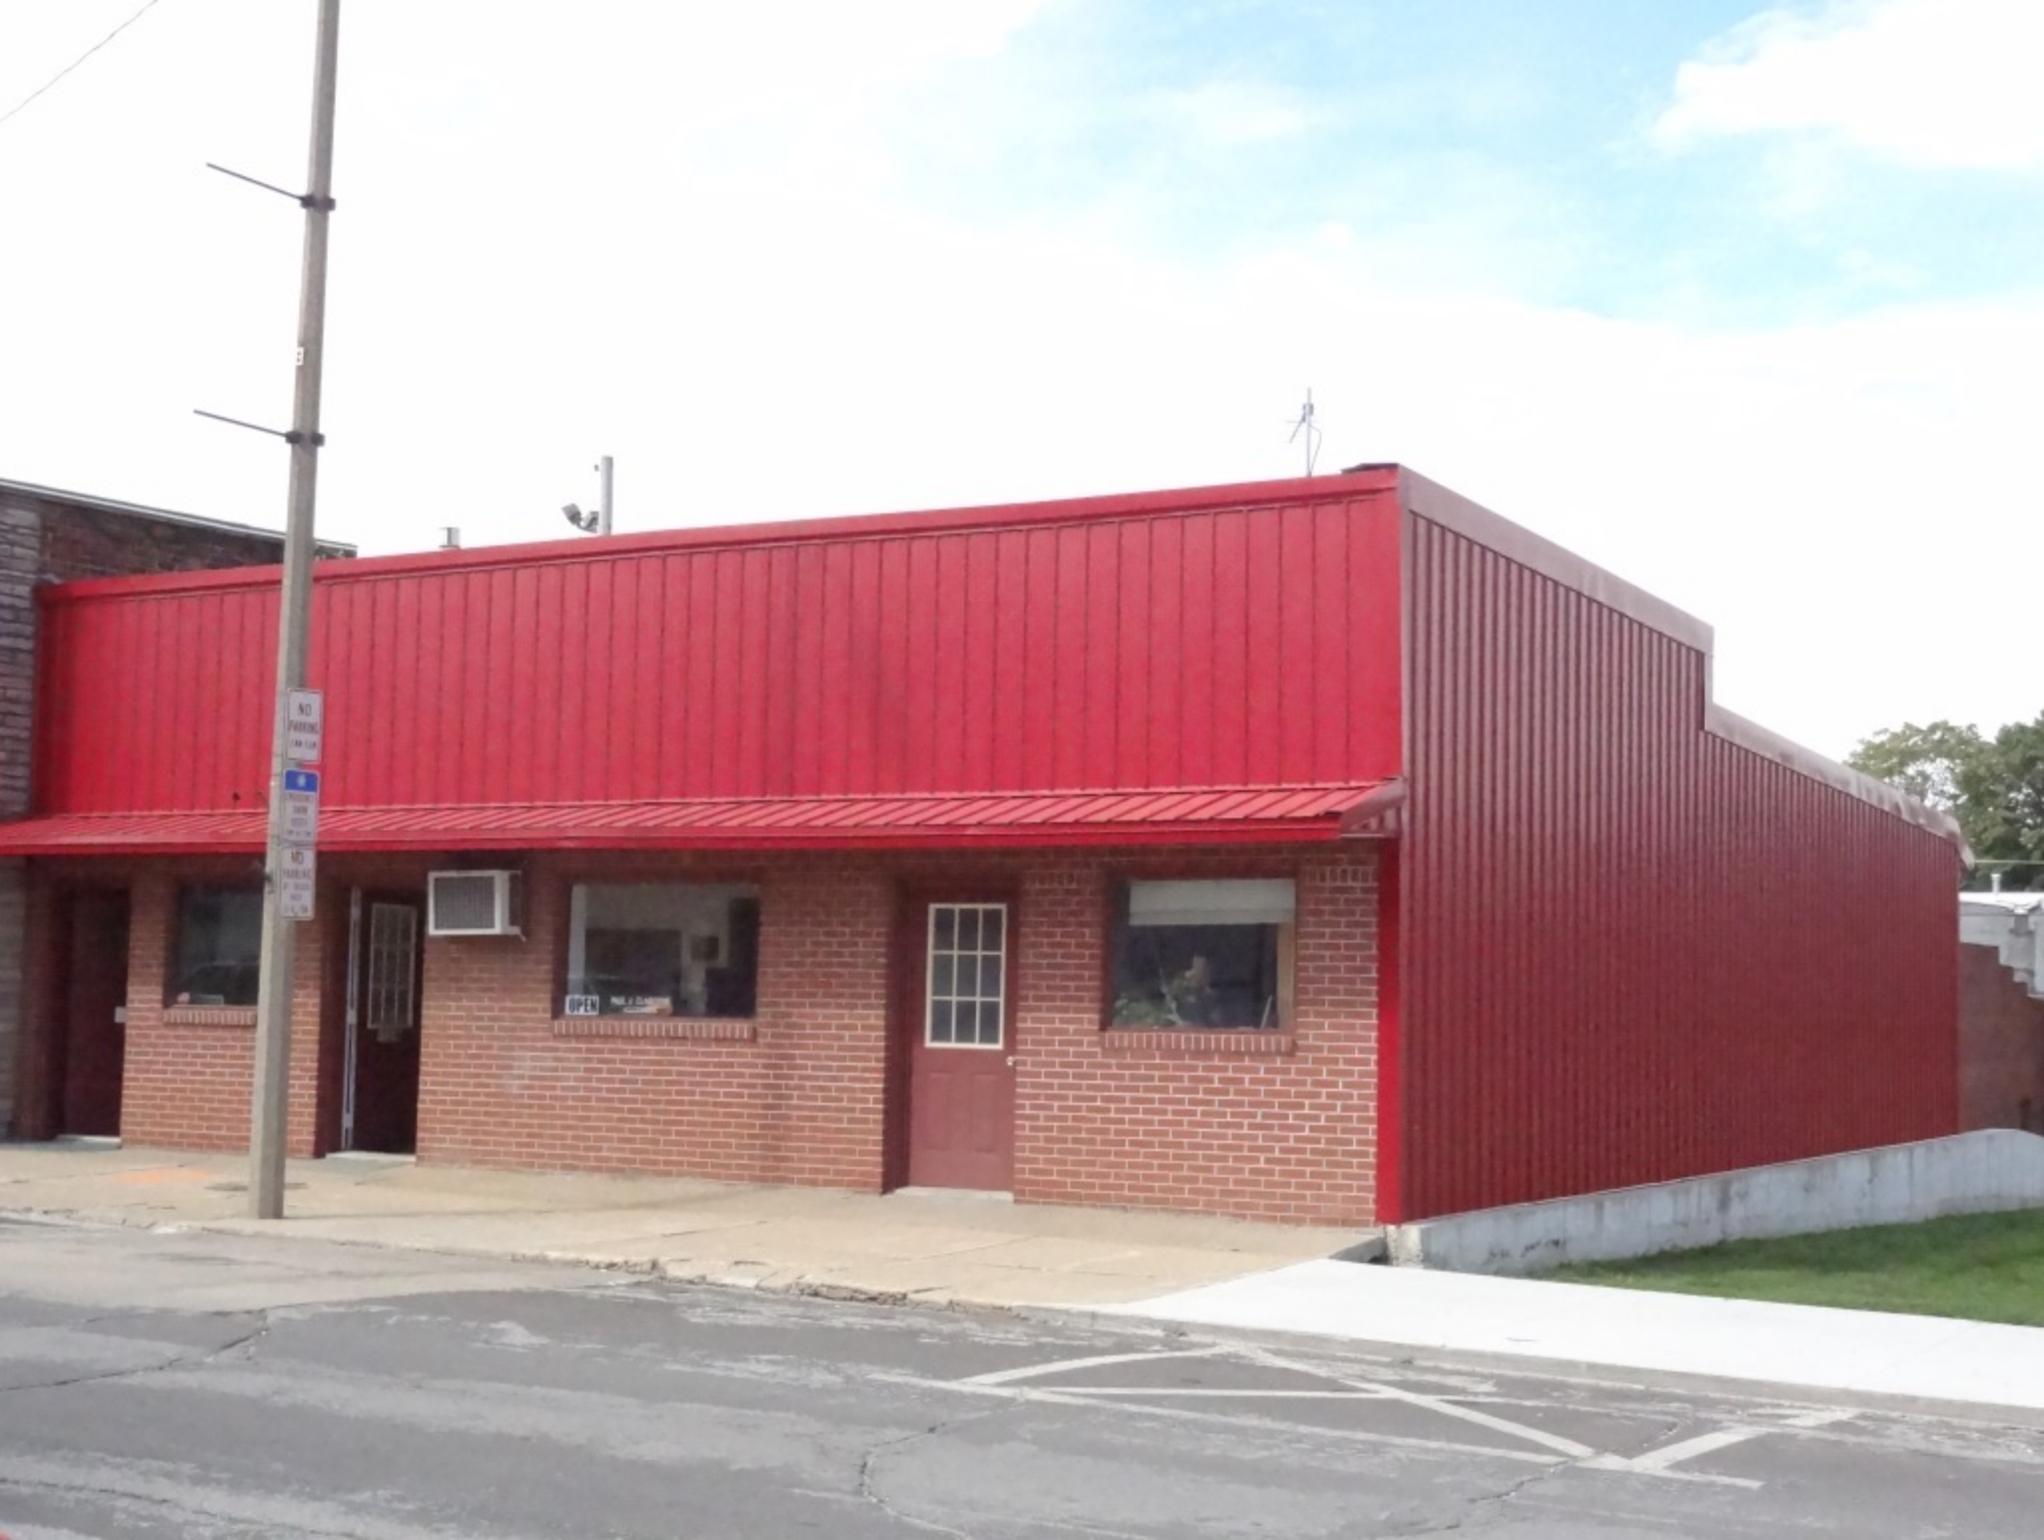
The one-part commercial block brick building contains six bays along its facade. The foundation is covered with concrete. The façade appears to have a modern brick veneer and bays 1, 3, and 5 include metal doors with nine lights. Bays 2, 4, and 6 include rectangular fixed display windows with header brick sills and stretcher brick lintels. Above the bays is a corrugate metal awning and the upper cornice is covered with corrugated metal. The east elevation is covered with corrugated metal siding.

These alterations have resulted in a loss of architectural integrity, rendering the property not eligible.

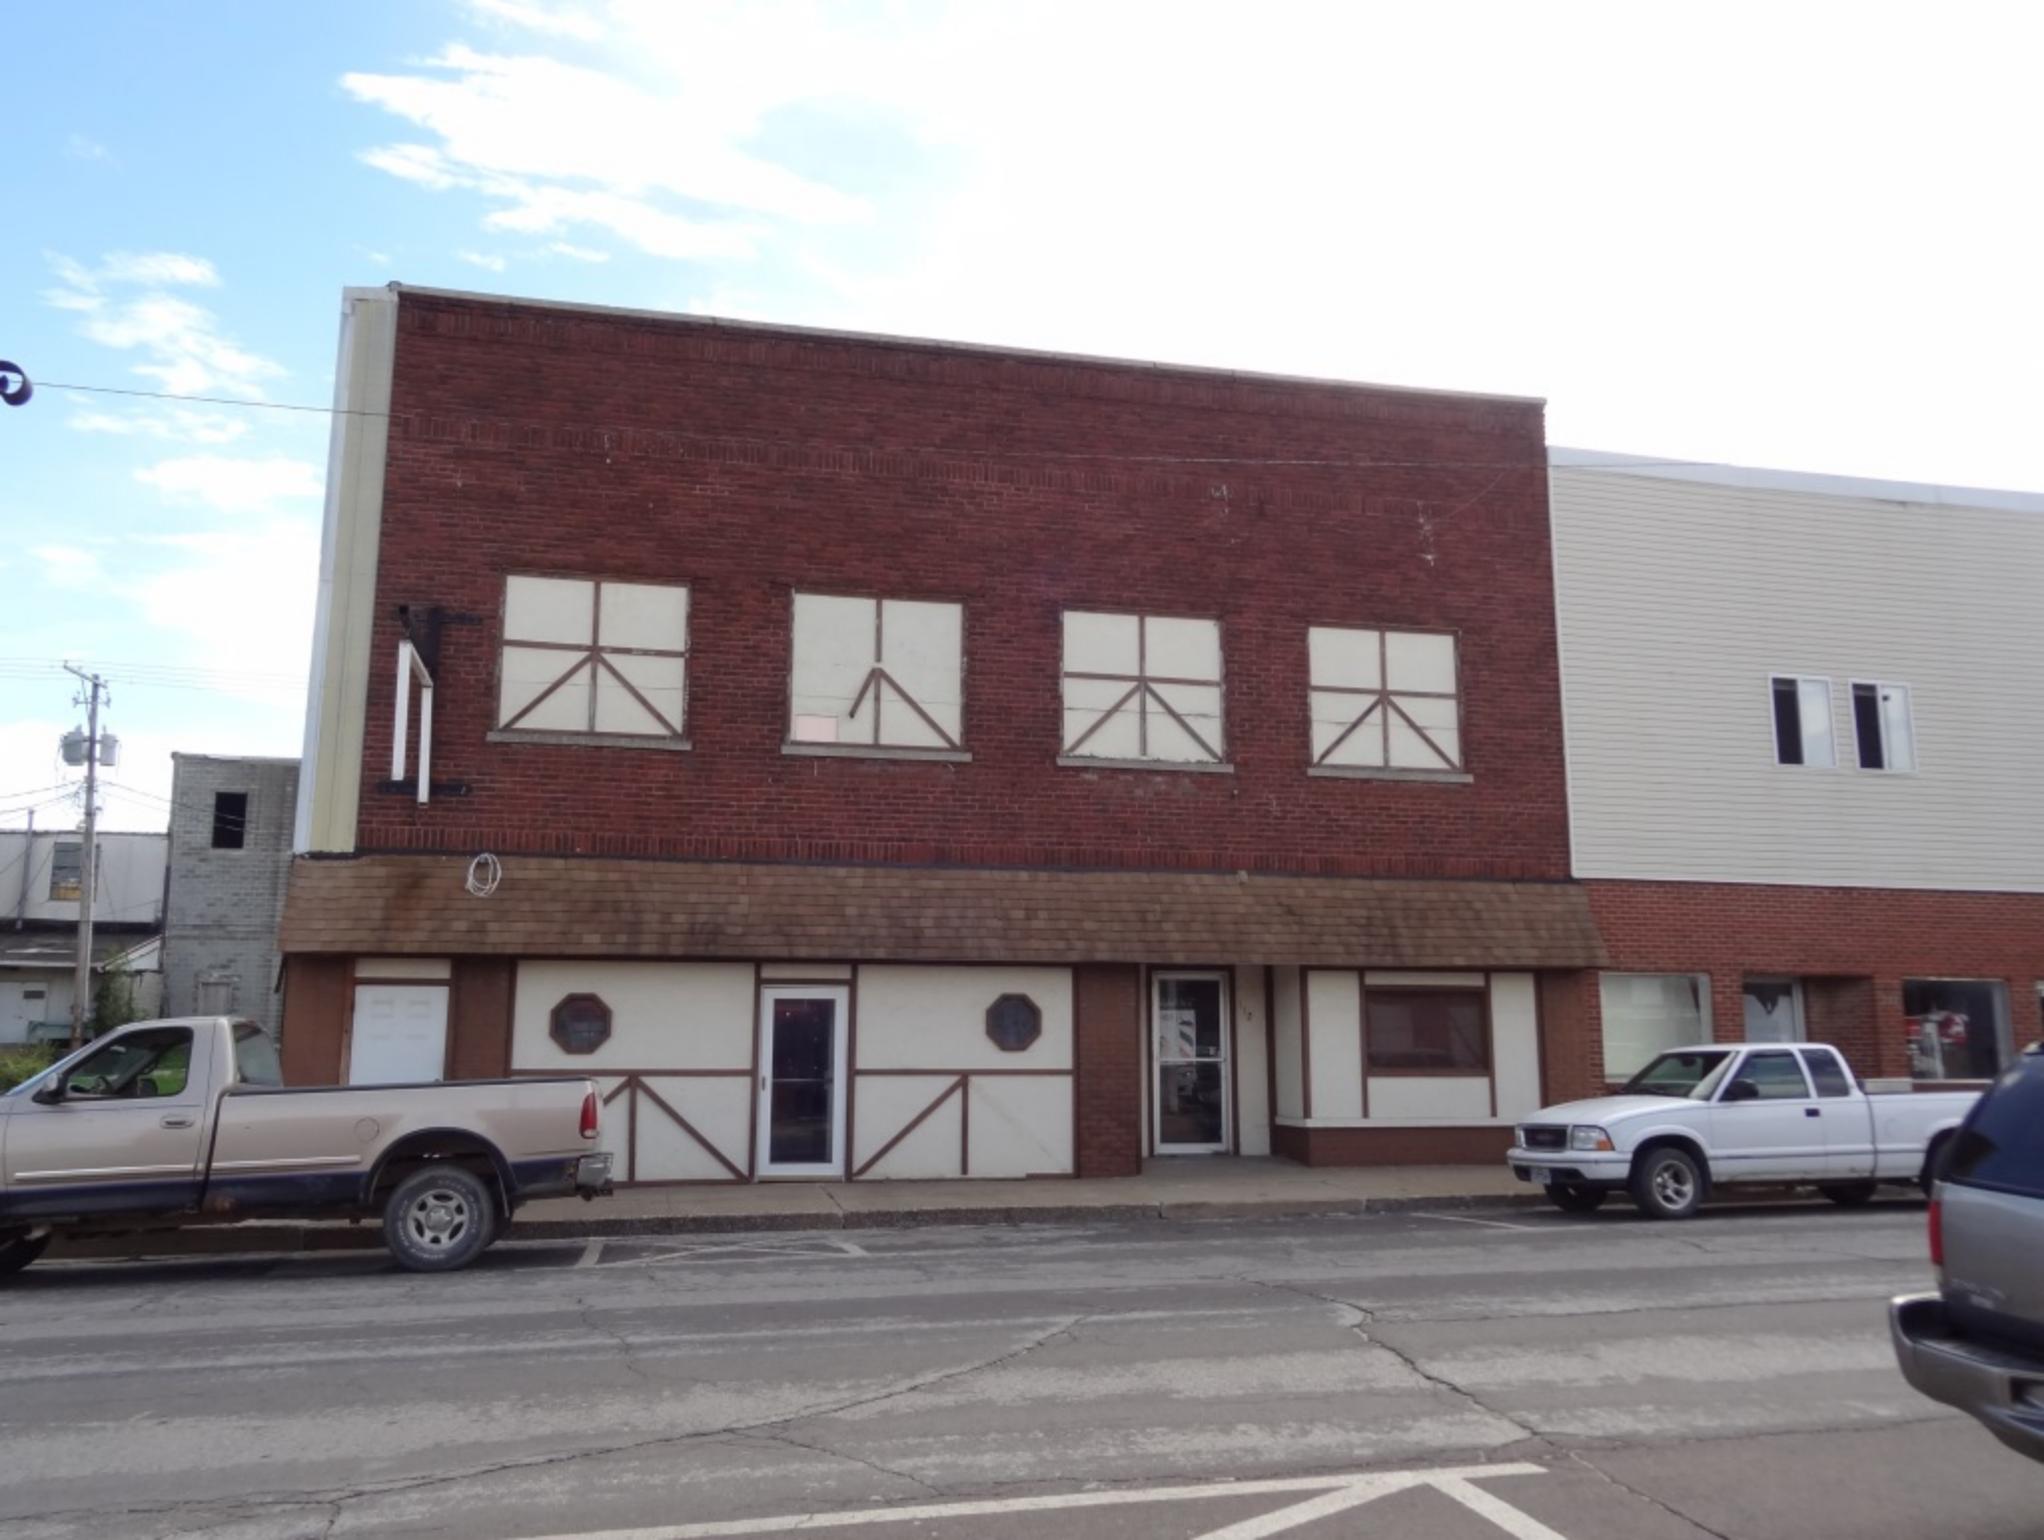
While the windows have been infilled, the overall massing of the building is intact. A 1942 photograph on page 107 of Franke's book shows the building with a plain upper façade at that time. This building would likely contribute to a potential National Register historic district.
