1. Survey No. MC-AS-001-001		2. Survey name: Downtown Macon Commercial Historic District	
3. County: Macon		4. Address (Street No.) Lots 11-13 block 93	Street (name) East Bourke Street (100 block)
5. City: Macon	Vicinity: <input type="checkbox"/>	6. Geographical Reference:	7. Township/Range/Section: T: R: S:
8. Historic name (if known):		9. Present/other name (if known): City of Macon Parking Lot #3	
10. Ownership: <input checked="" type="checkbox"/> Private <input type="checkbox"/> Public		11a. Historic use (if known): Commercial	11b. Current use: vacant

42. Current owner/address: City of Macon Macon, MO 63552	43. Form prepared by (name and org.): Kristi Chase MO SHPO	44. Survey date: 9/24/2014
		45. Date of revisions:

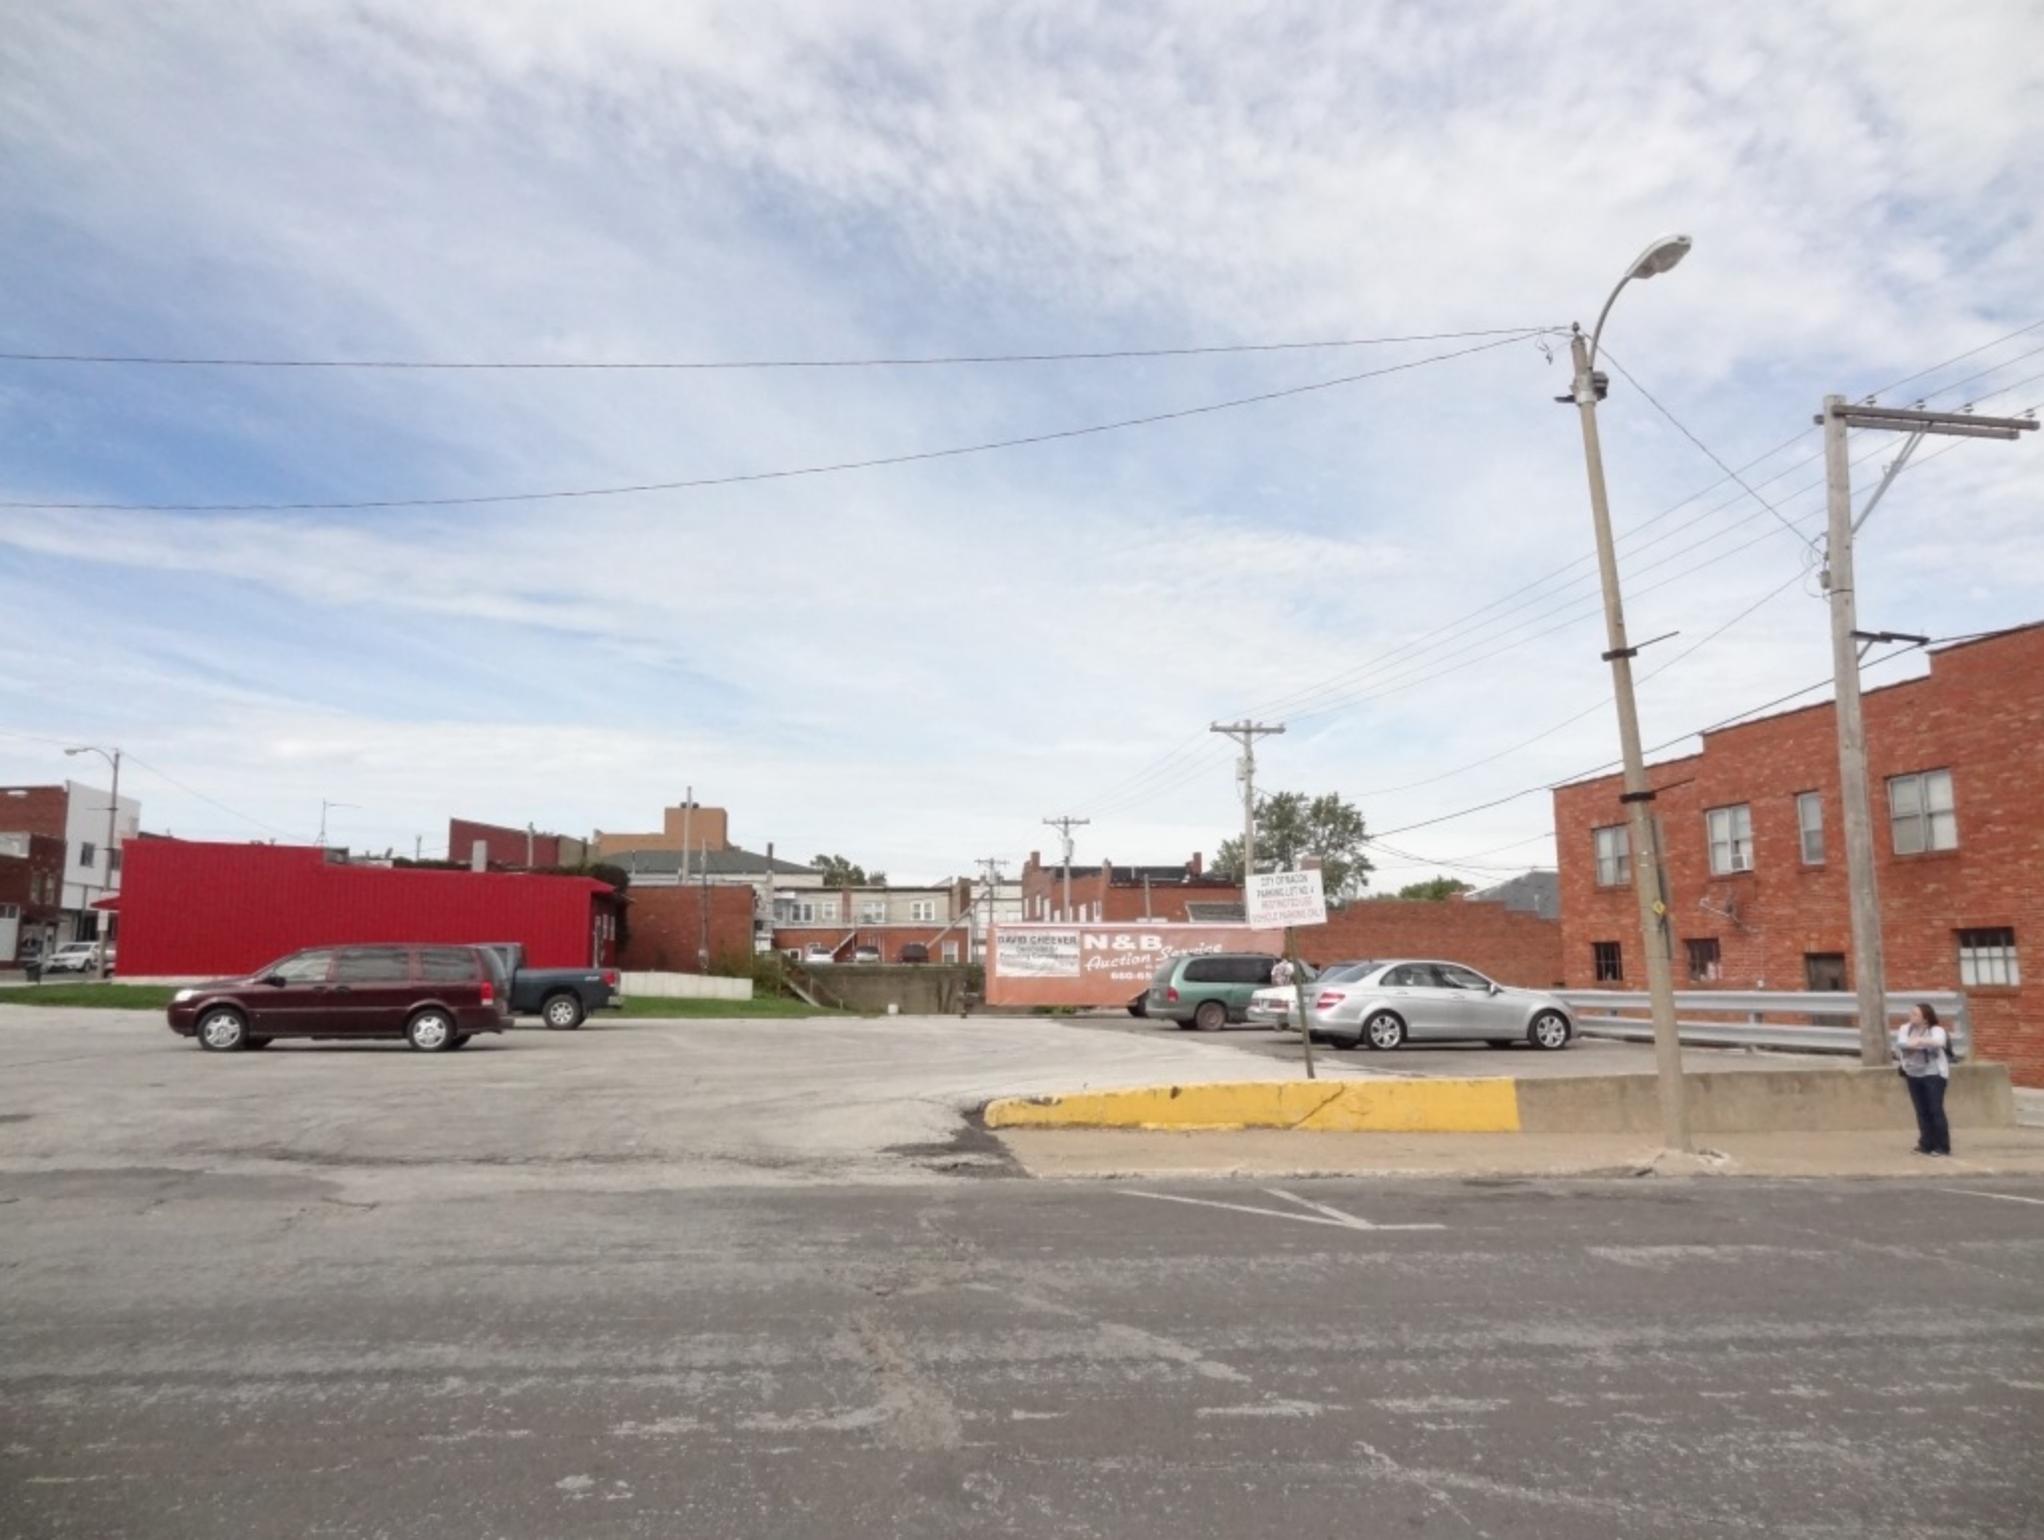
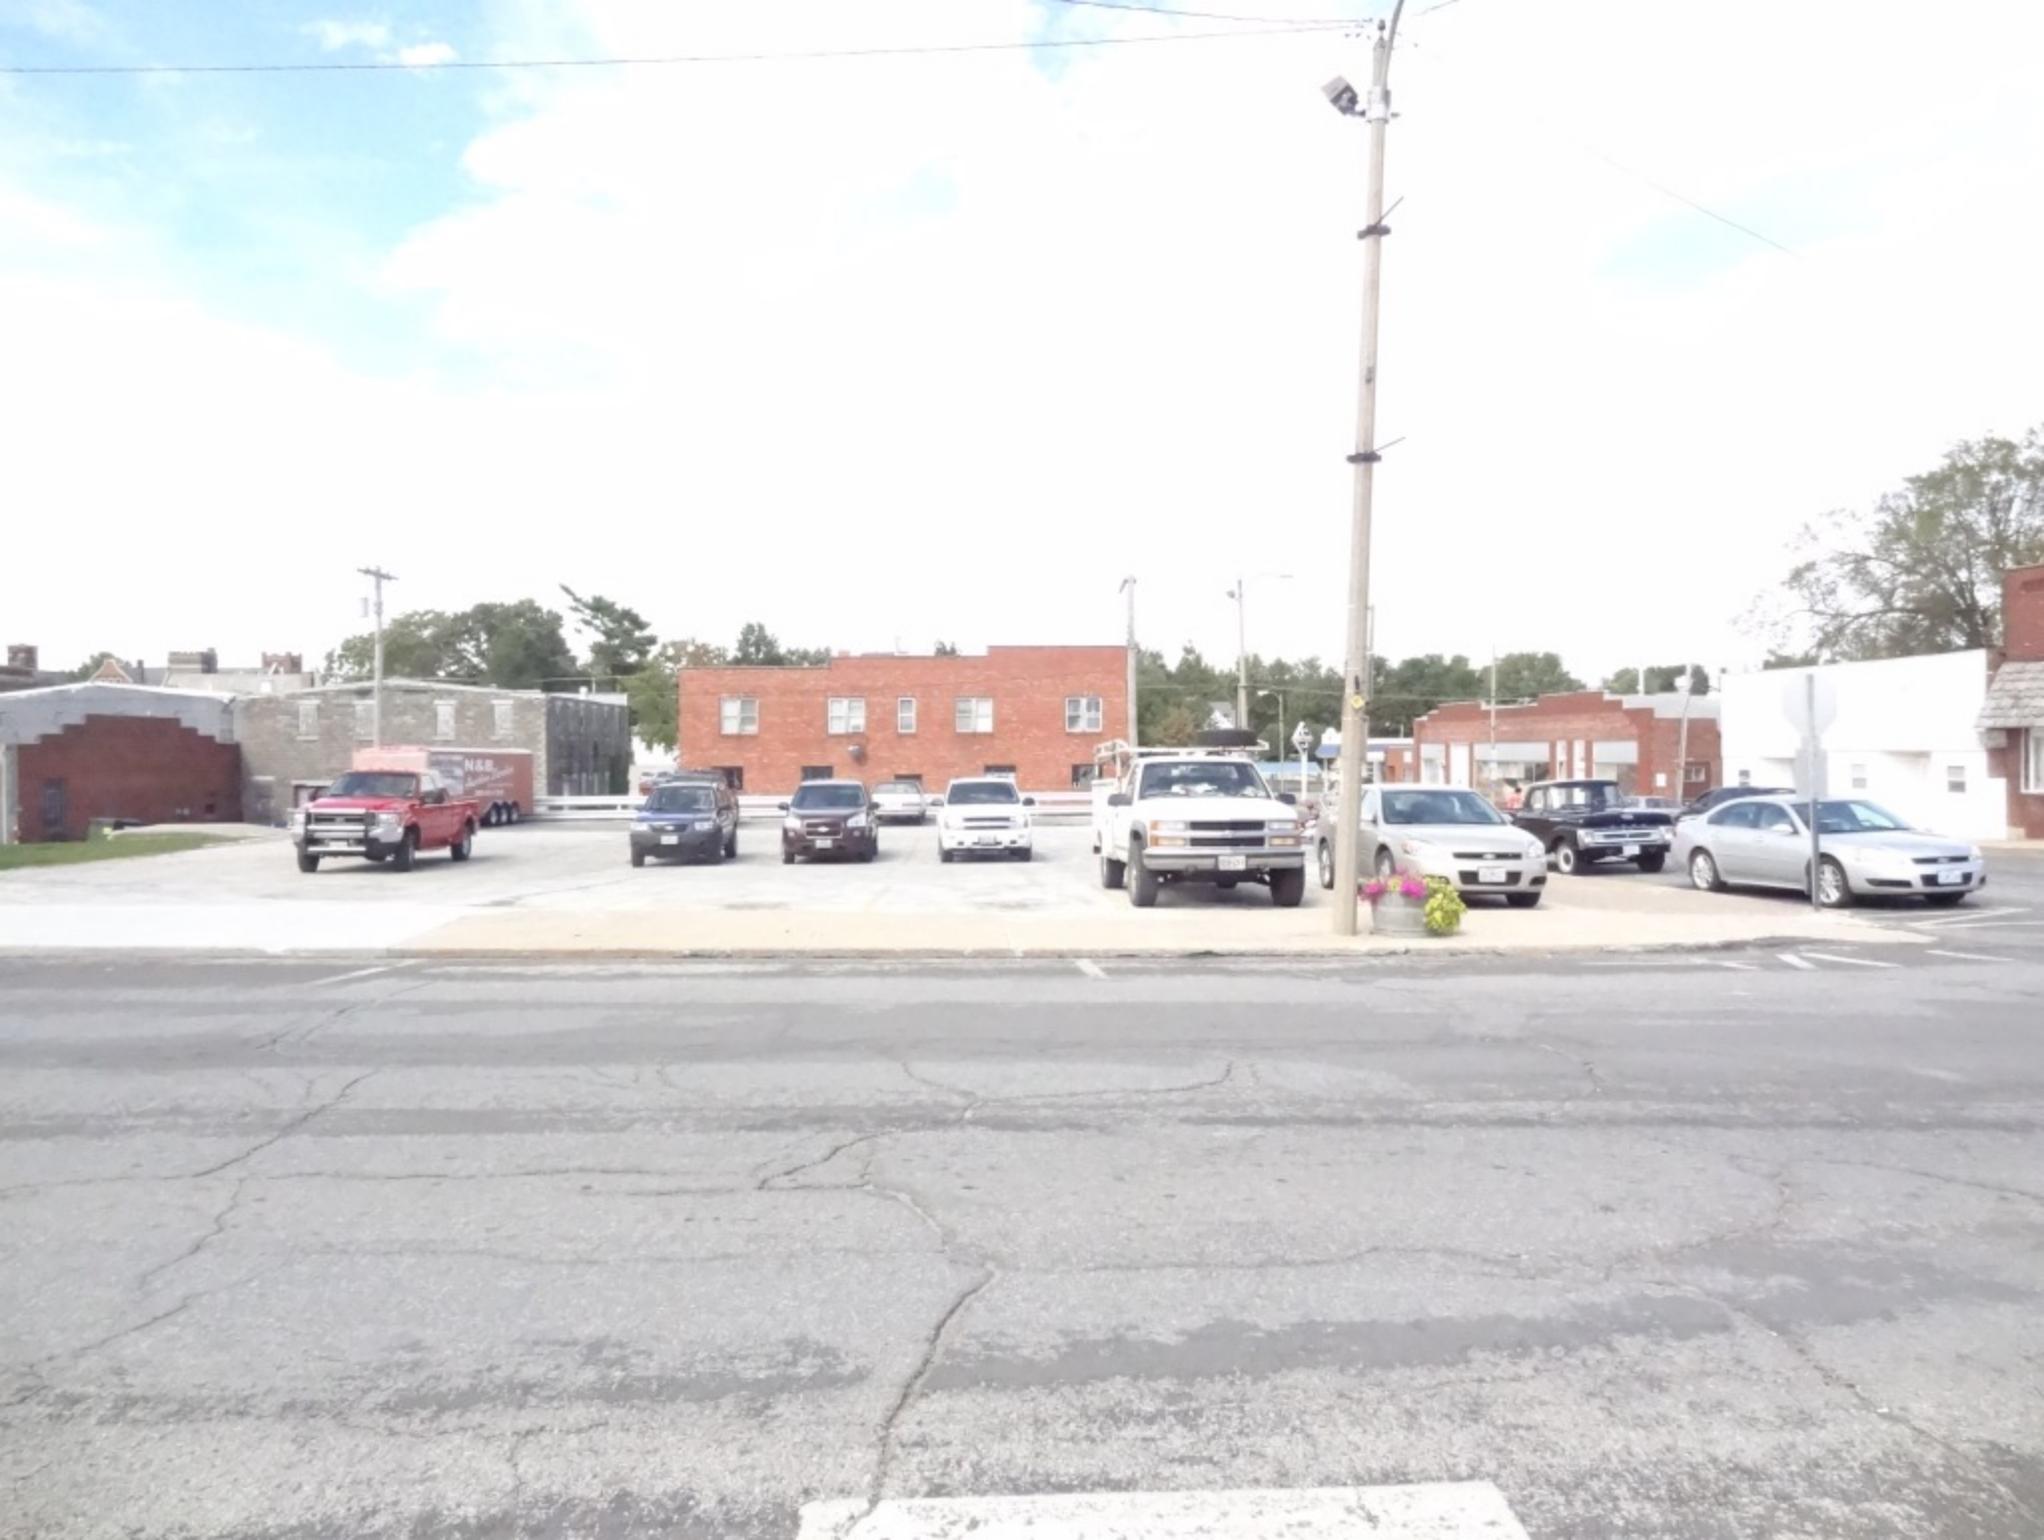
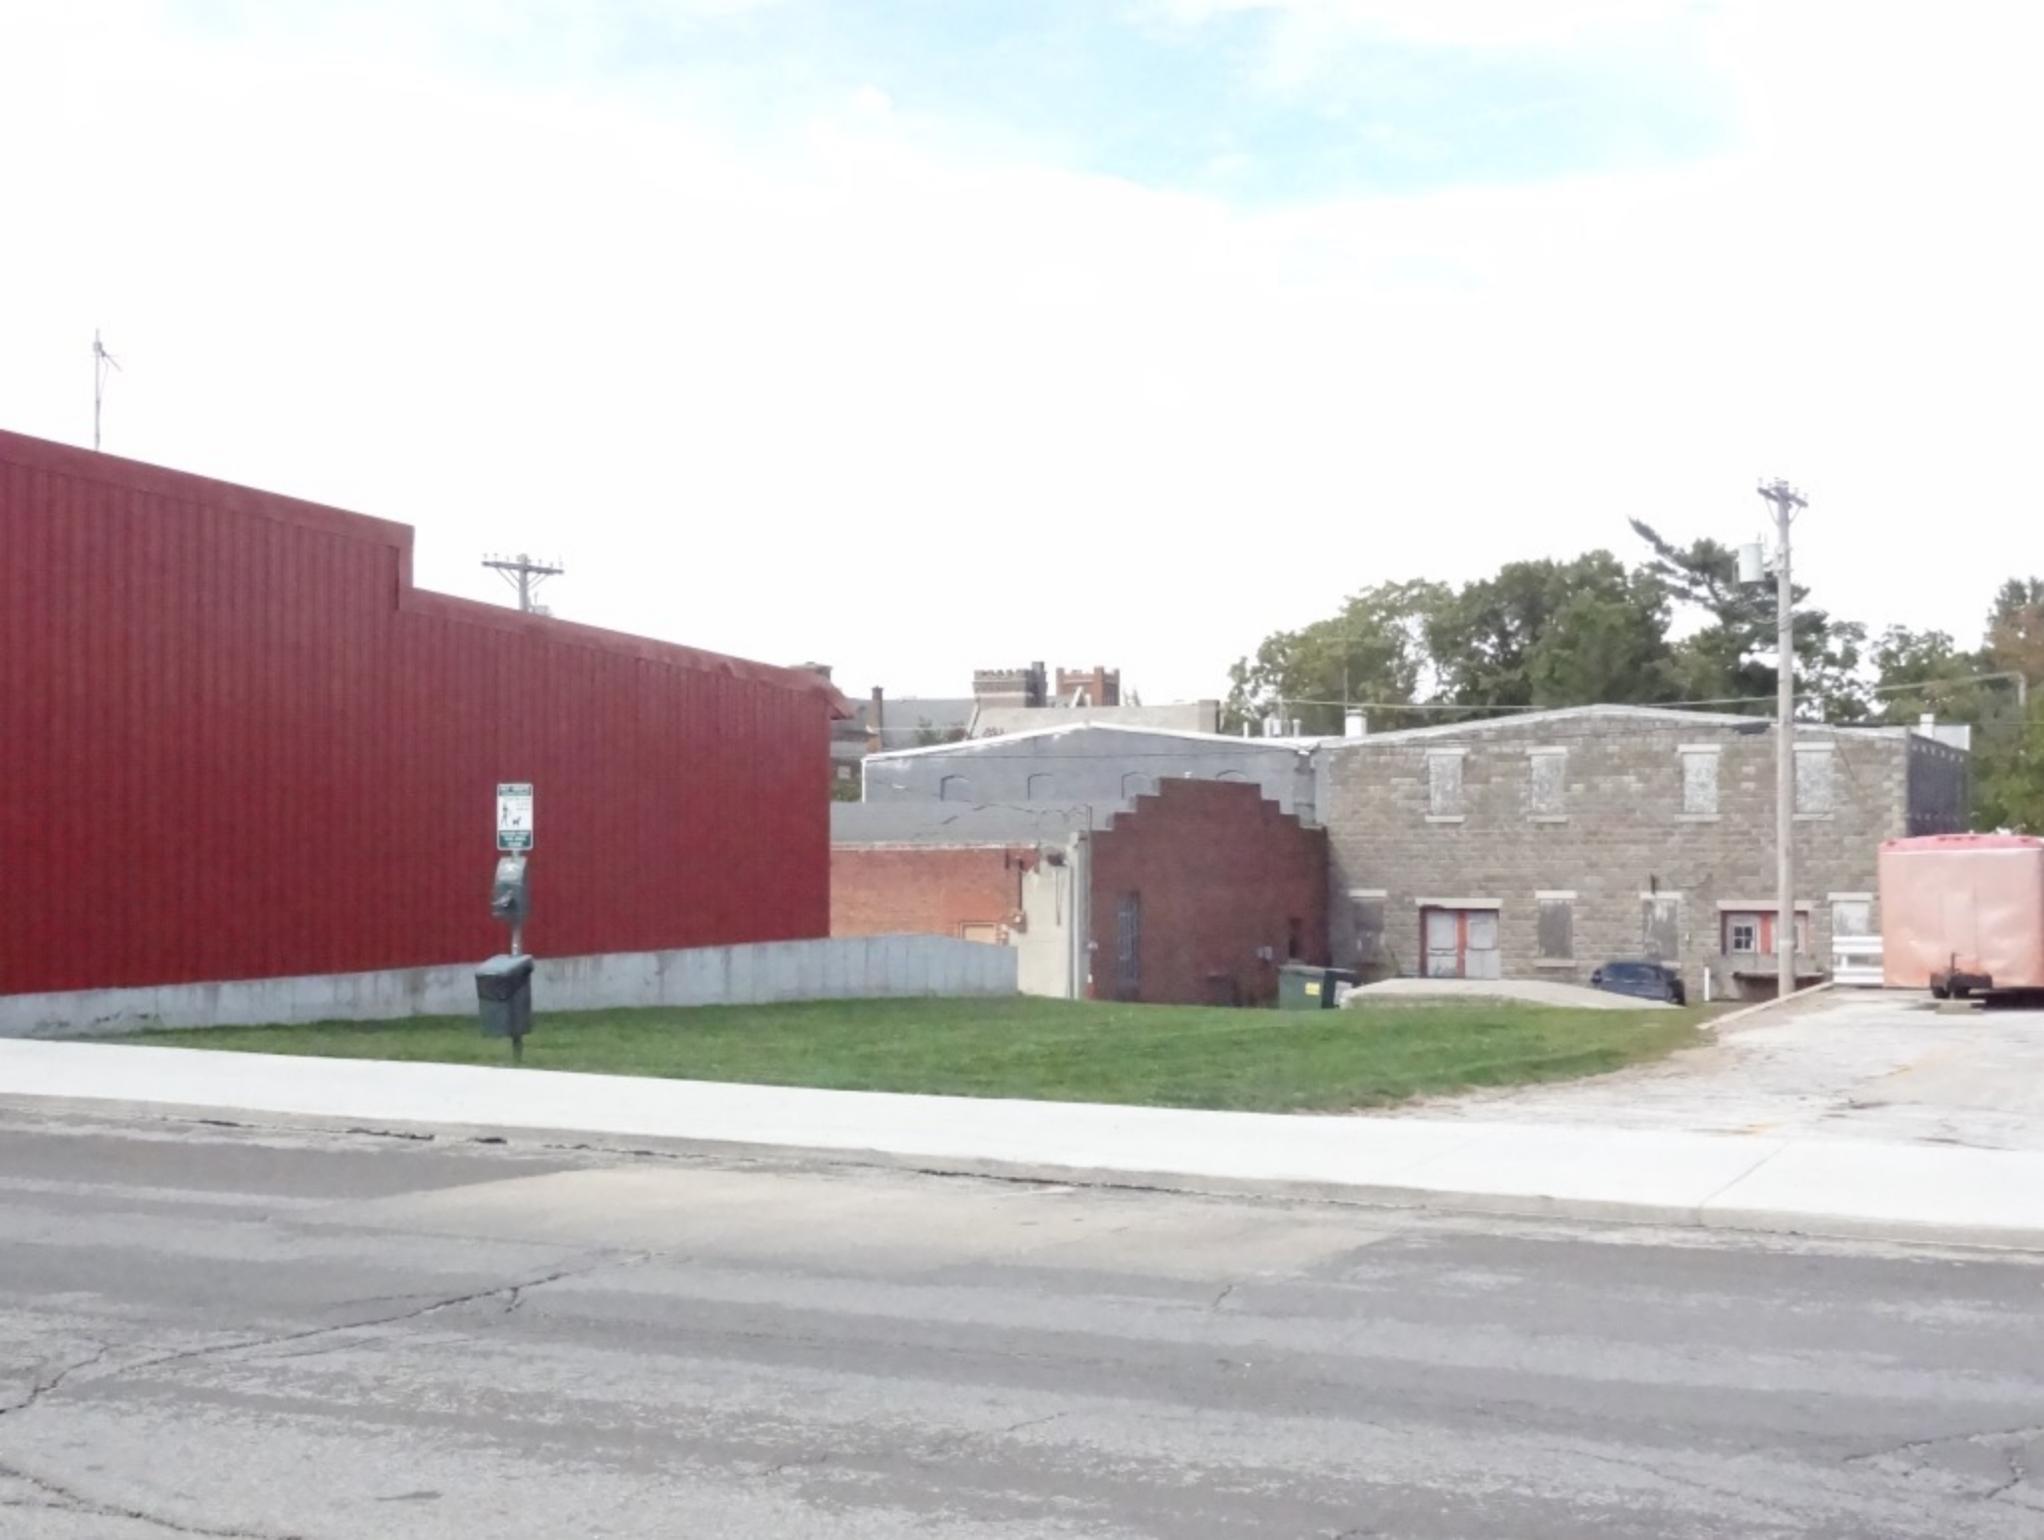
Historically, the property contained commercial brick buildings but according to the Recorder of Deeds, these were removed c. 2010. The property currently contains a concrete and asphalt covered parking lot.

These alterations have resulted in a loss of integrity, rendering the property not eligible.

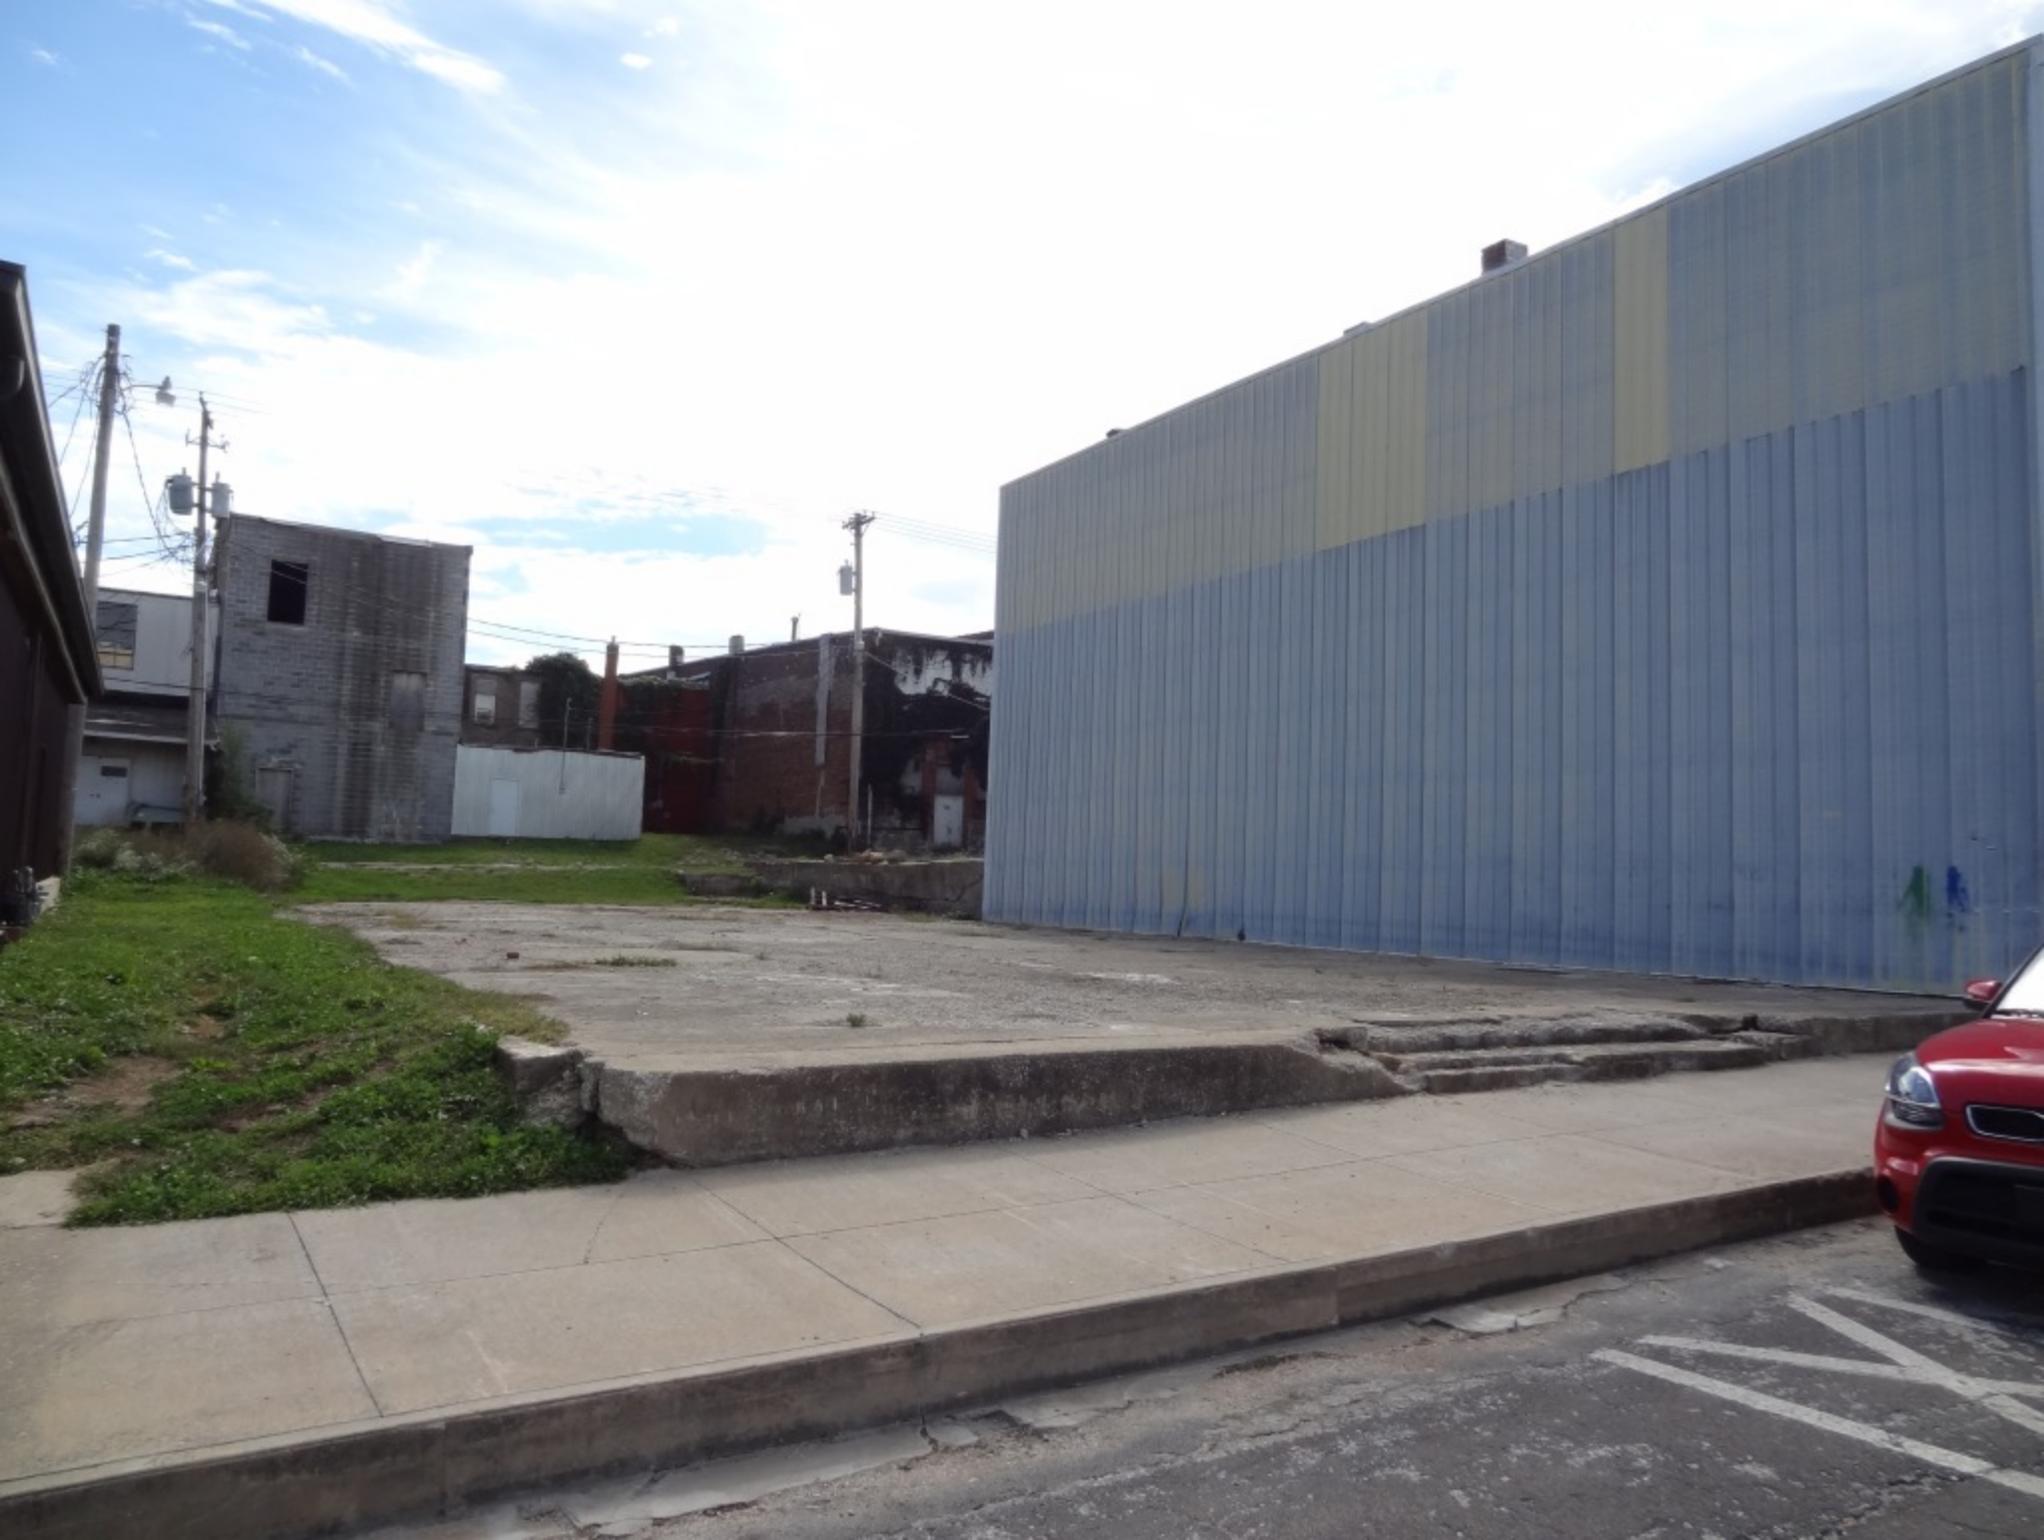
The lot is primarily identified by the existing concrete foundation of a previous building. The building historically on the lot was removed within the modern era, and the lot is not eligible for listing.

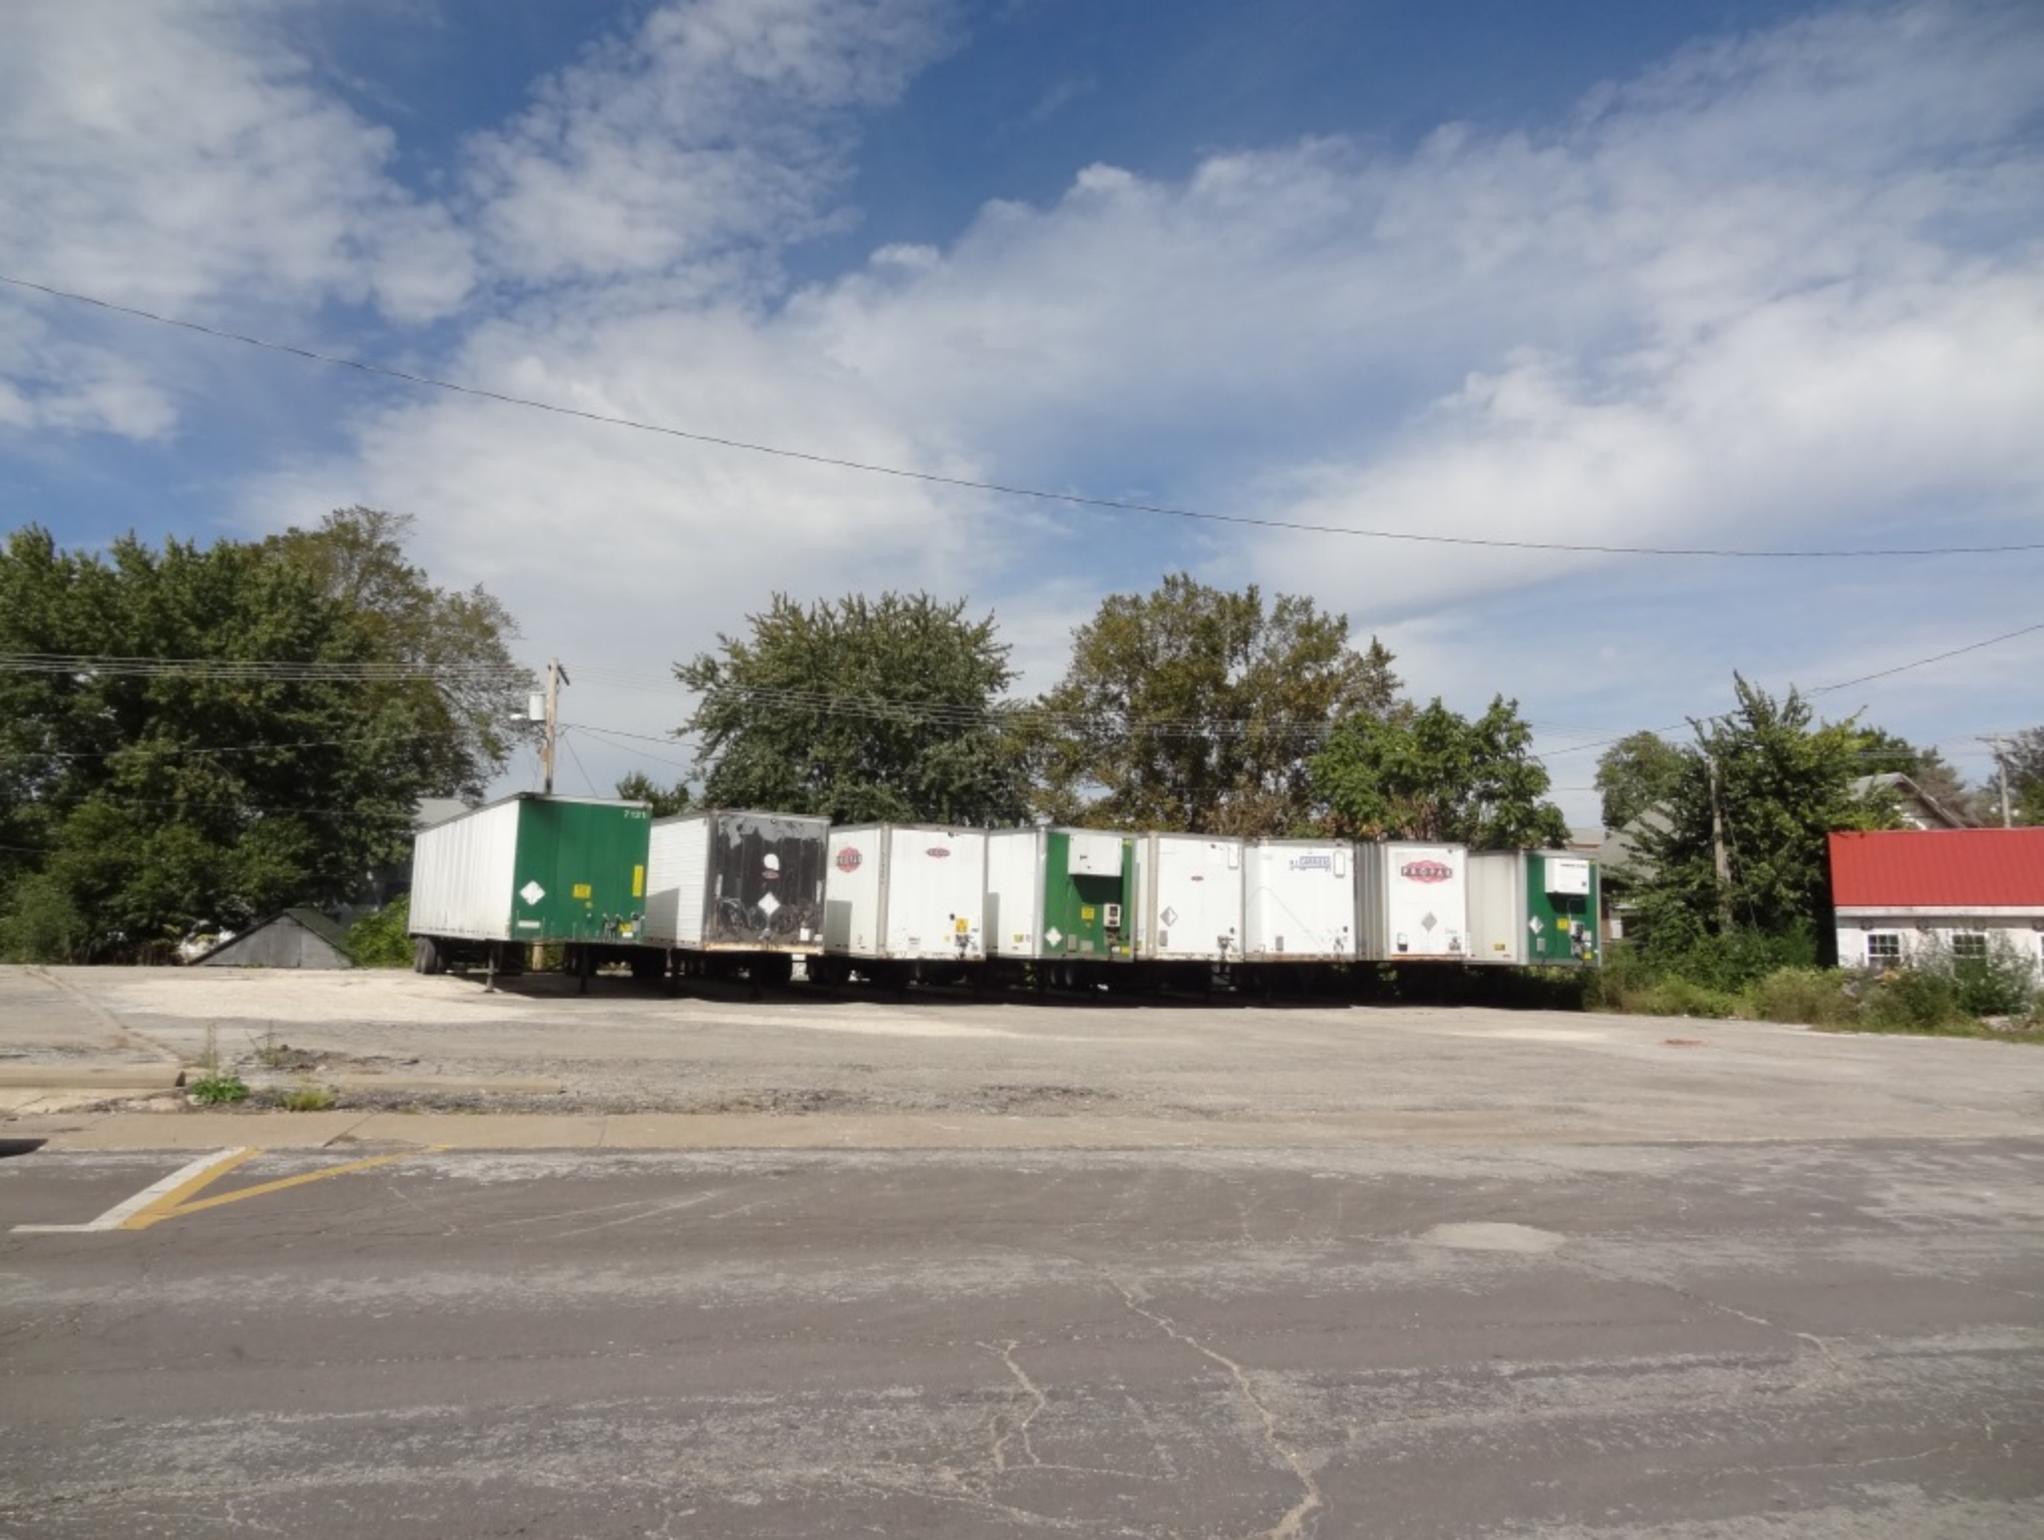
Although this property has never had much development, it did historically have a dwelling and a small auto garage which have since been removed at an unknown date. The parking lot contains lots 11-13 and portions of lot 14. It is asphalt covered

These alterations have resulted in a loss of architectural integrity, rendering the property not eligible.
