1. Survey No. MC-AS-001-001		2. Survey name: Downtown Macon Commercial Historic District	
3. County: Macon		4. Address (Street No.) Lots 11-13 block 93	Street (name) East Bourke Street (100 block)
5. City: Macon	Vicinity: <input type="checkbox"/>	6. Geographical Reference:	7. Township/Range/Section: T: R: S:
8. Historic name (if known):		9. Present/other name (if known): City of Macon Parking Lot #3	
10. Ownership: <input checked="" type="checkbox"/> Private <input type="checkbox"/> Public		11a. Historic use (if known): Commercial	11b. Current use: vacant

42. Current owner/address: City of Macon Macon, MO 63552	43. Form prepared by (name and org.): Kristi Chase MO SHPO	44. Survey date: 9/24/2014
		45. Date of revisions:

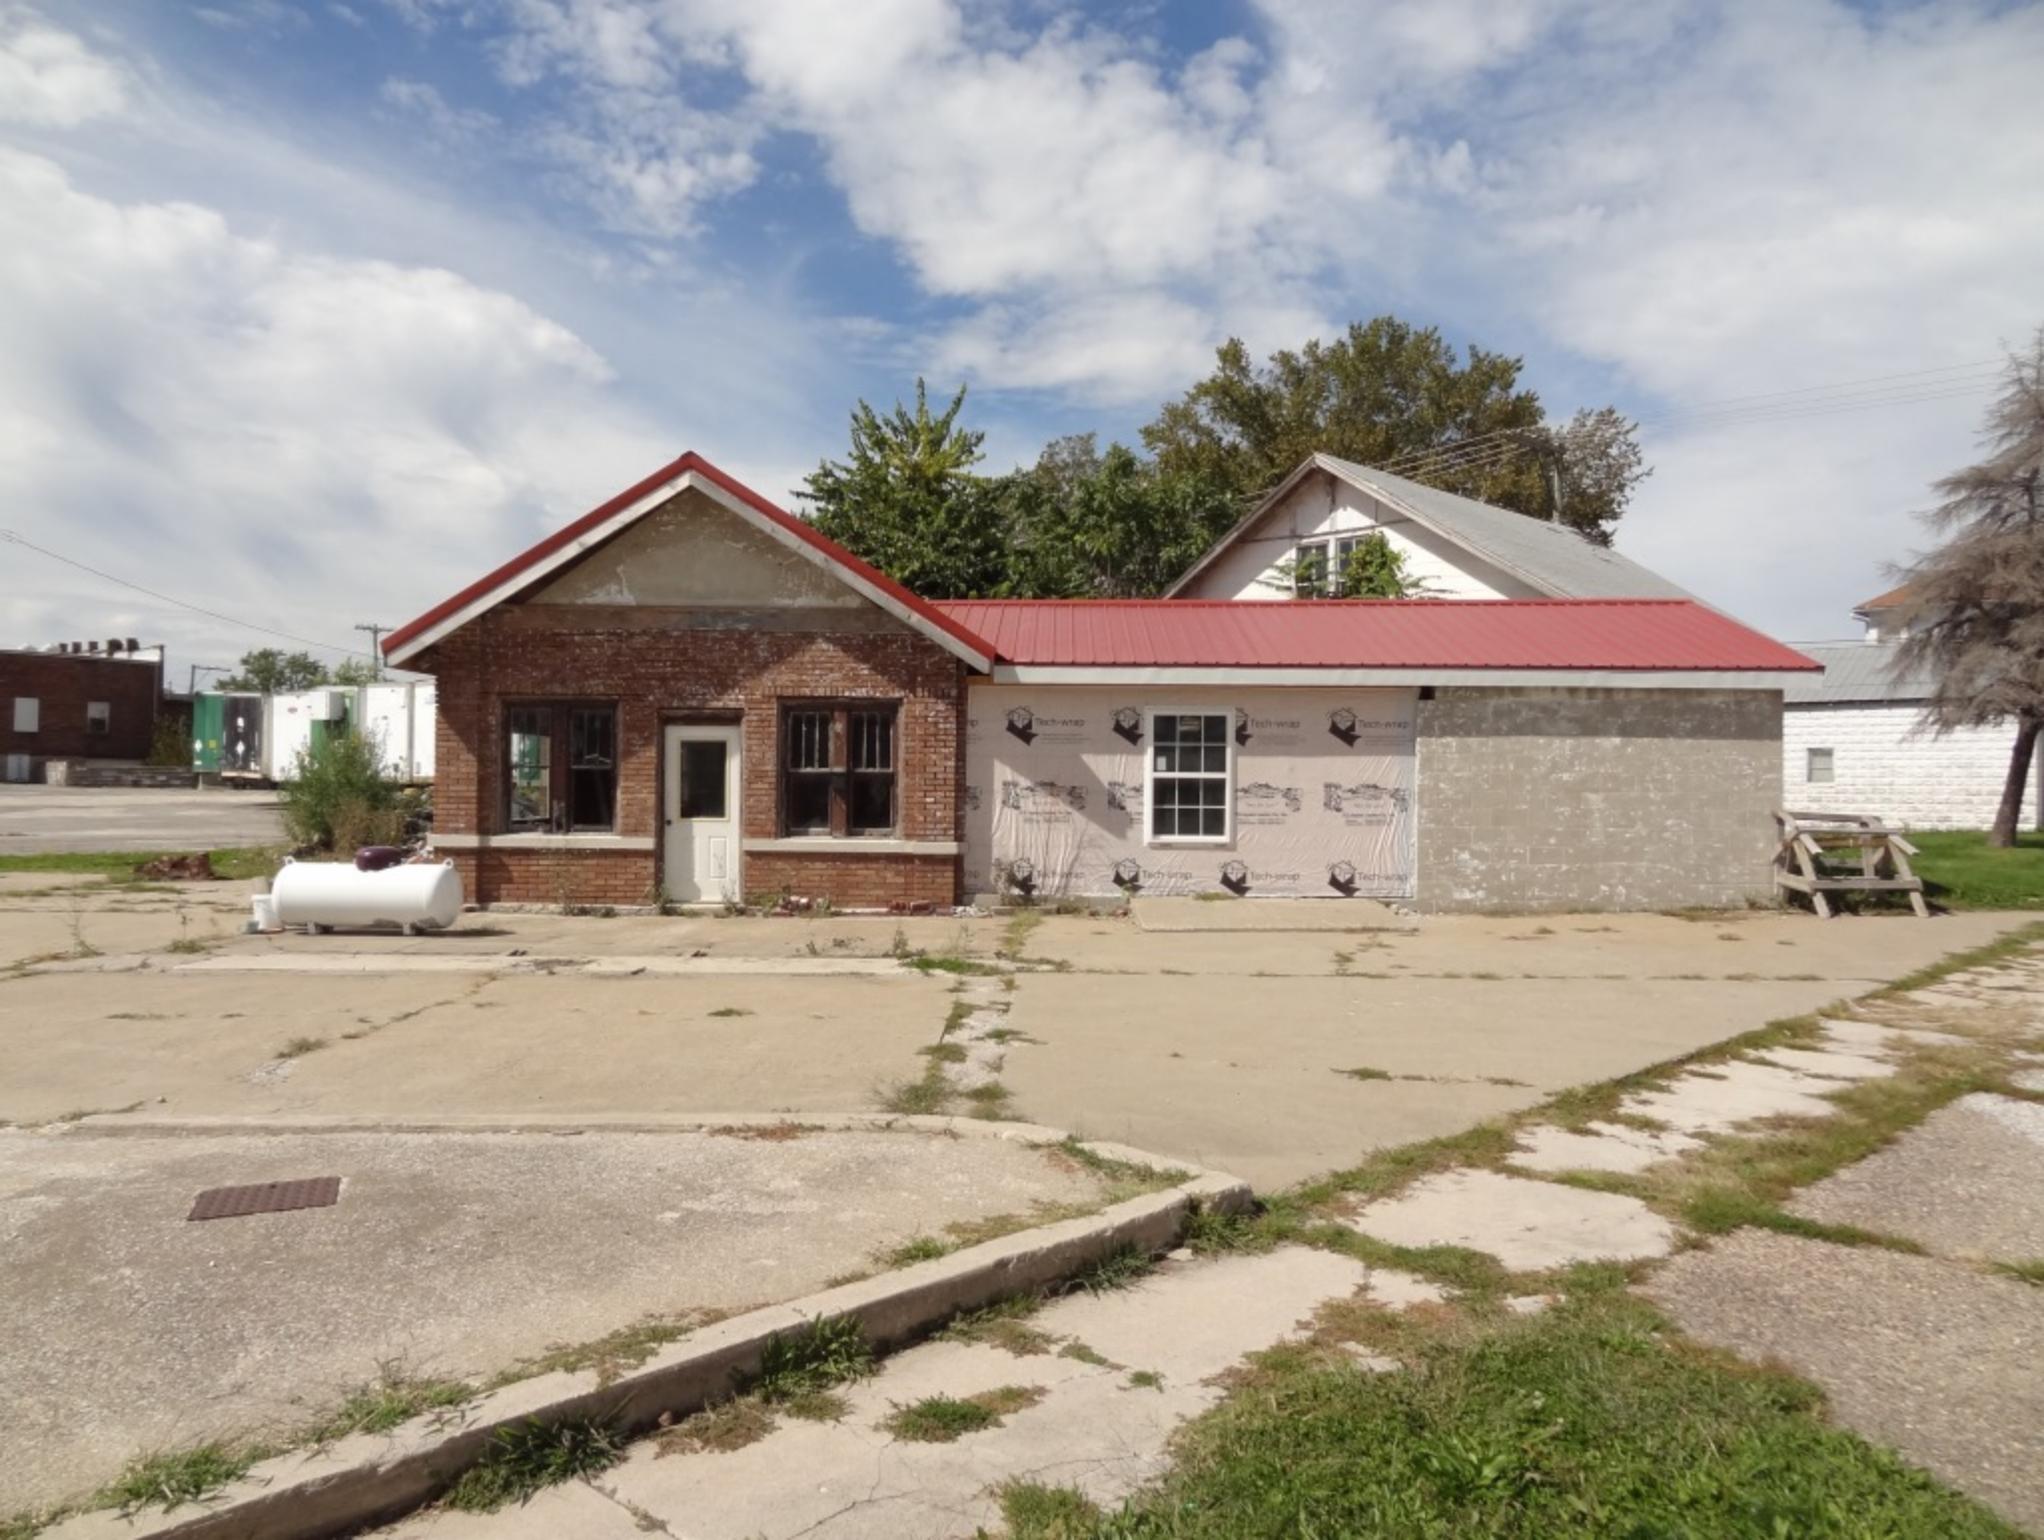
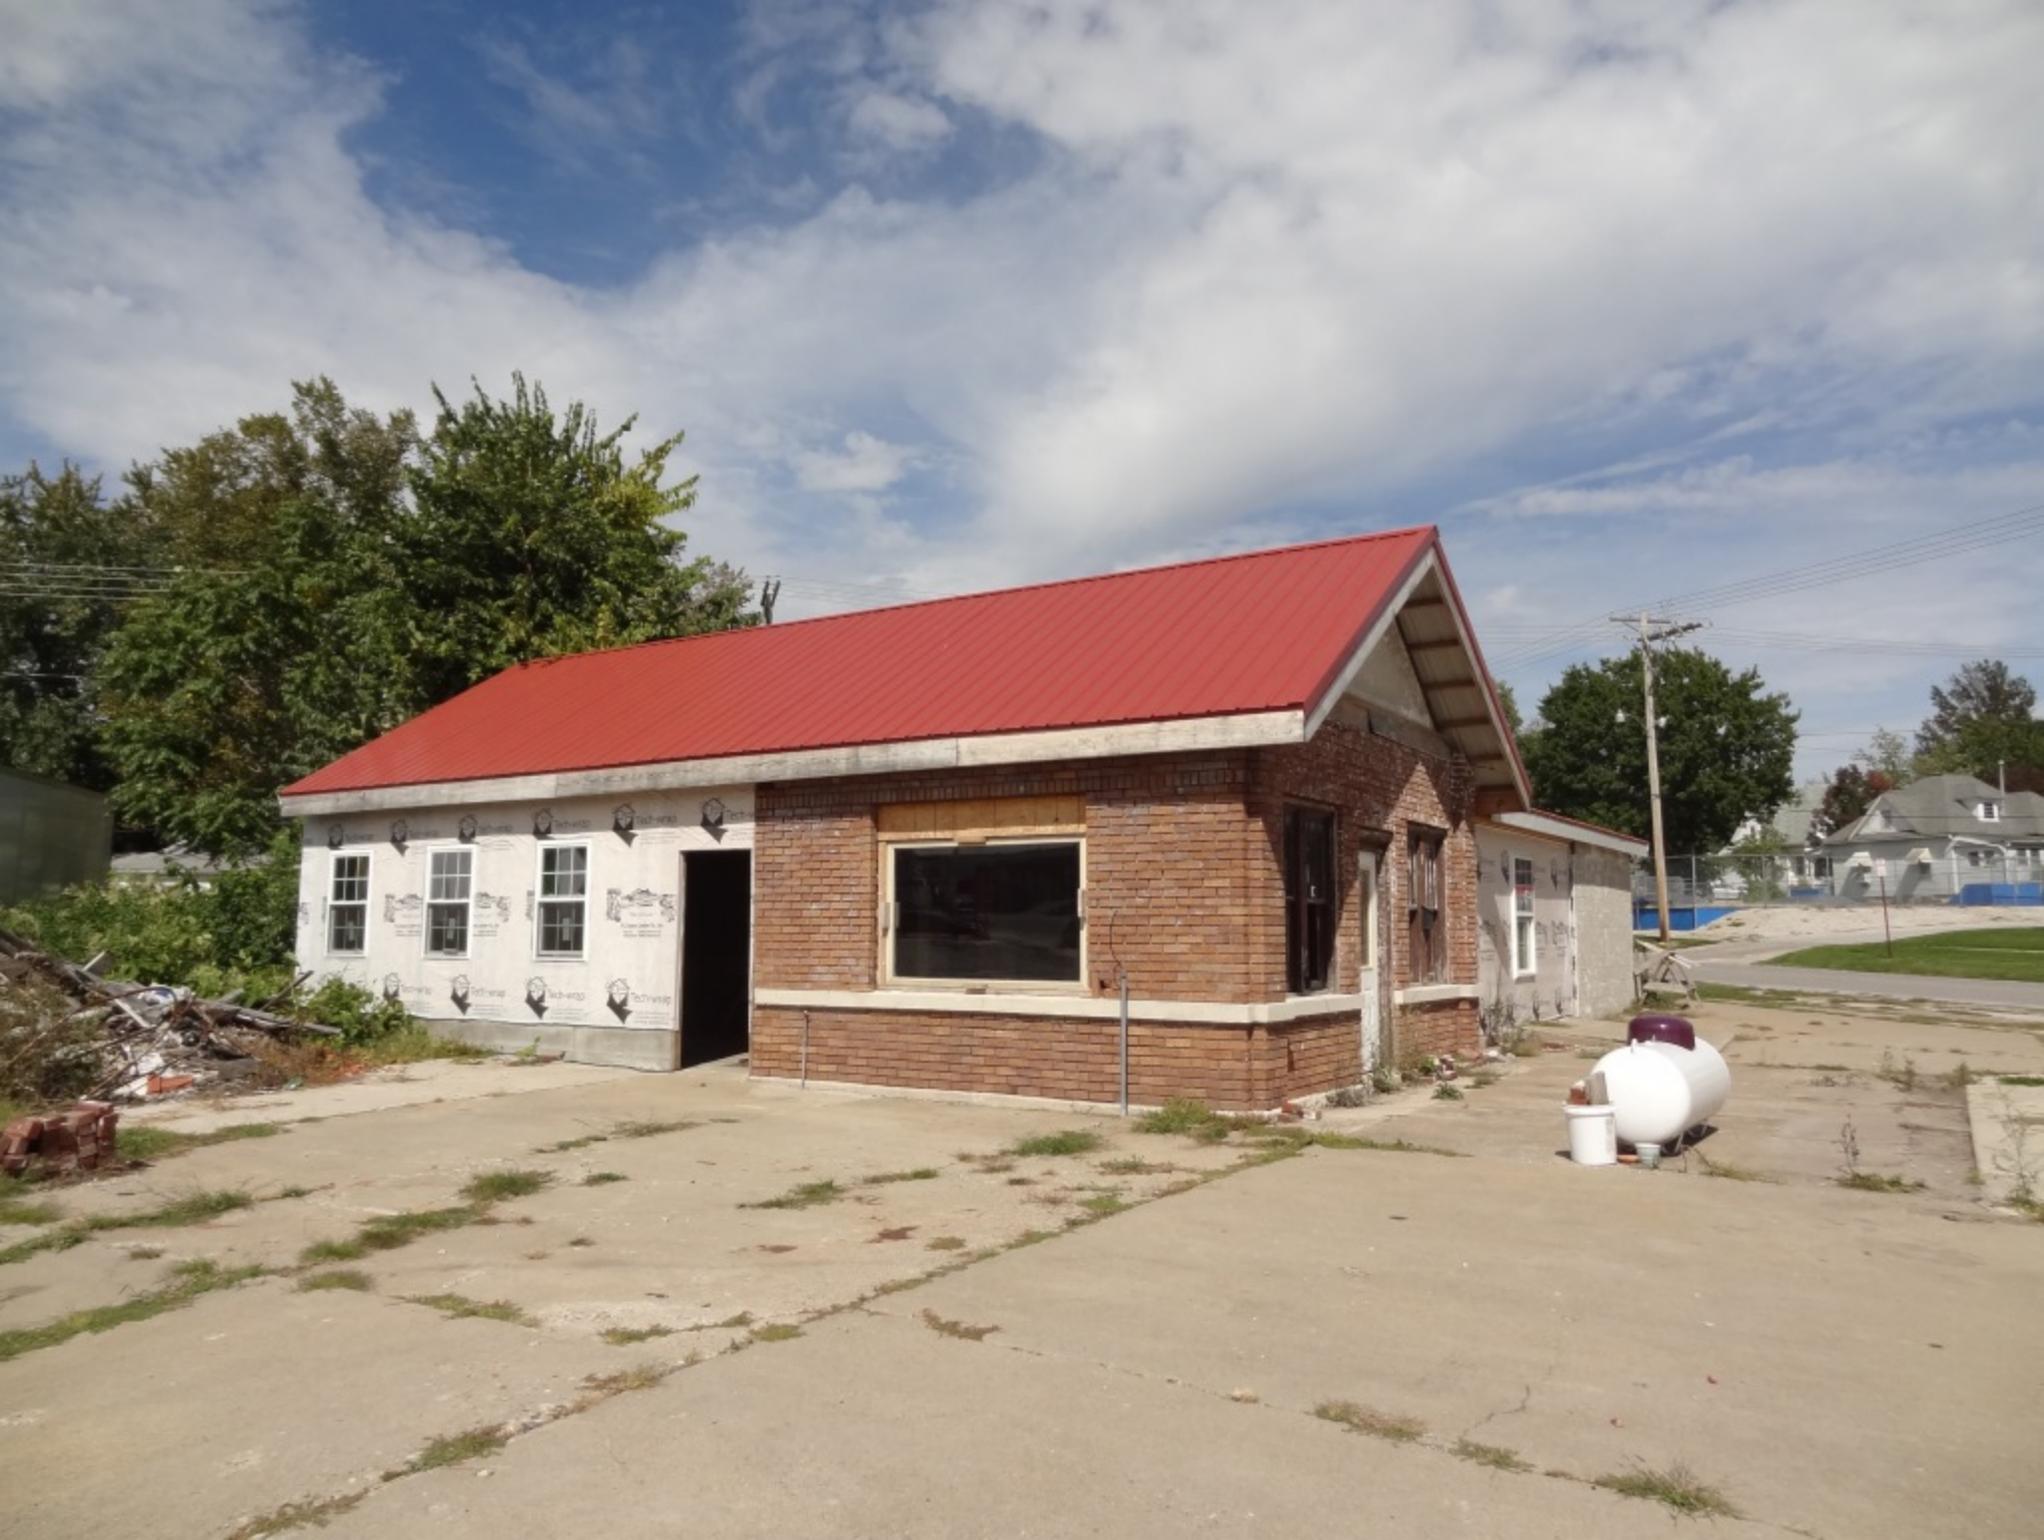
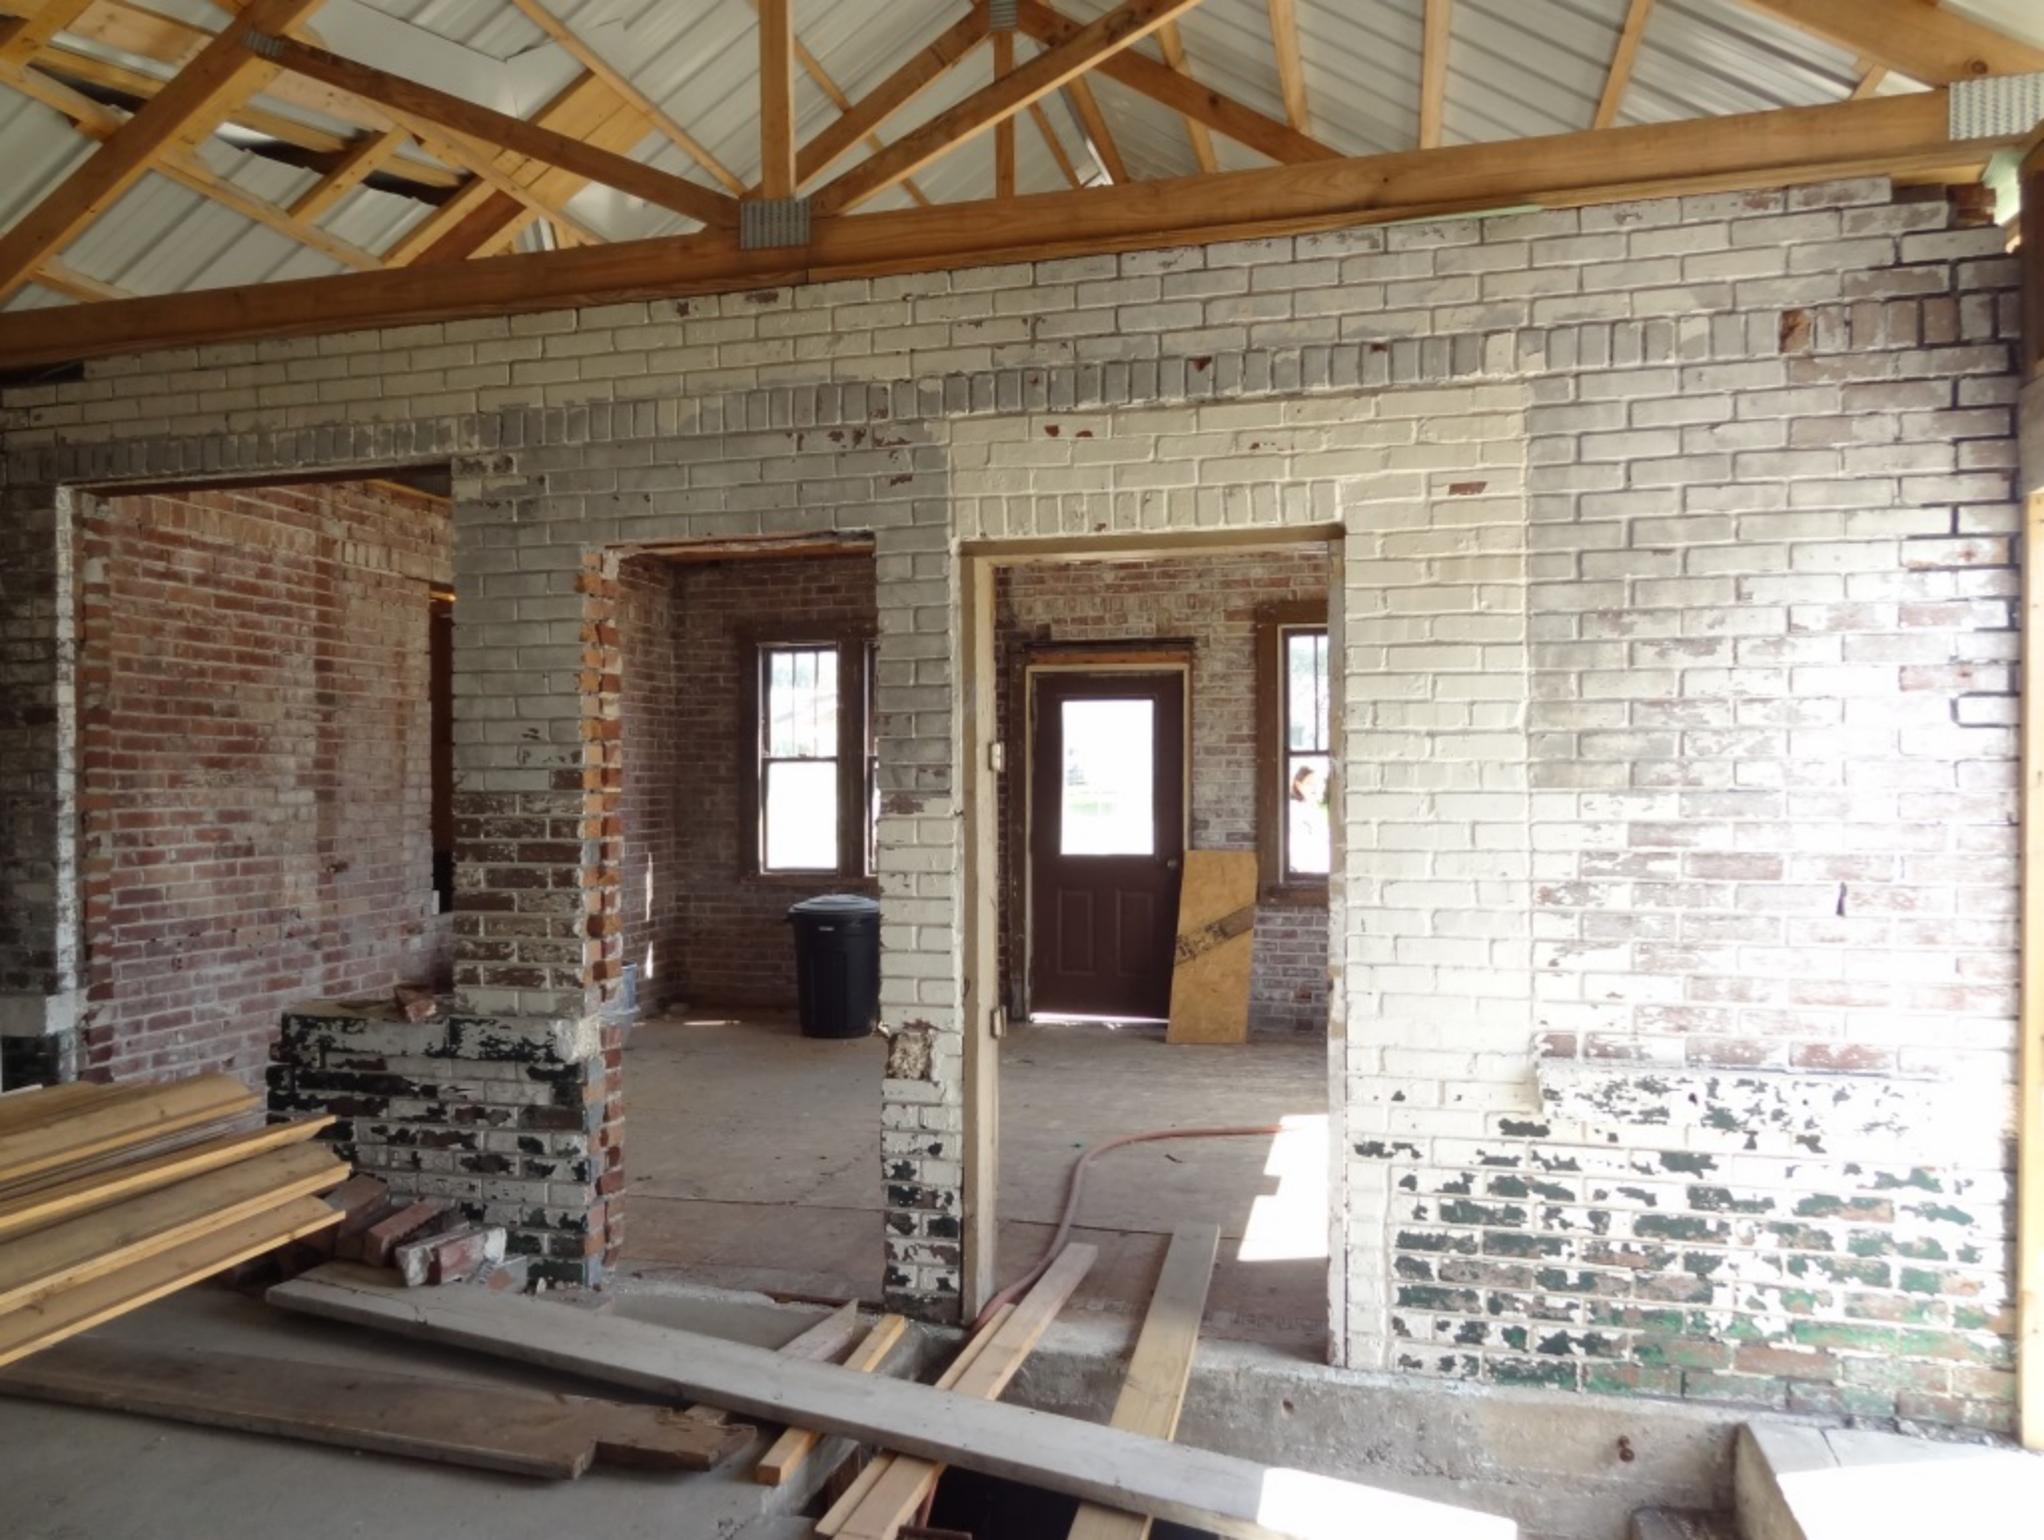
The 1935 service station has undergone significant modern alterations: a modified roof alignment and sizeable additions to its rear and northeast elevation.

These alterations have resulted in a loss of integrity, rendering the property not eligible.

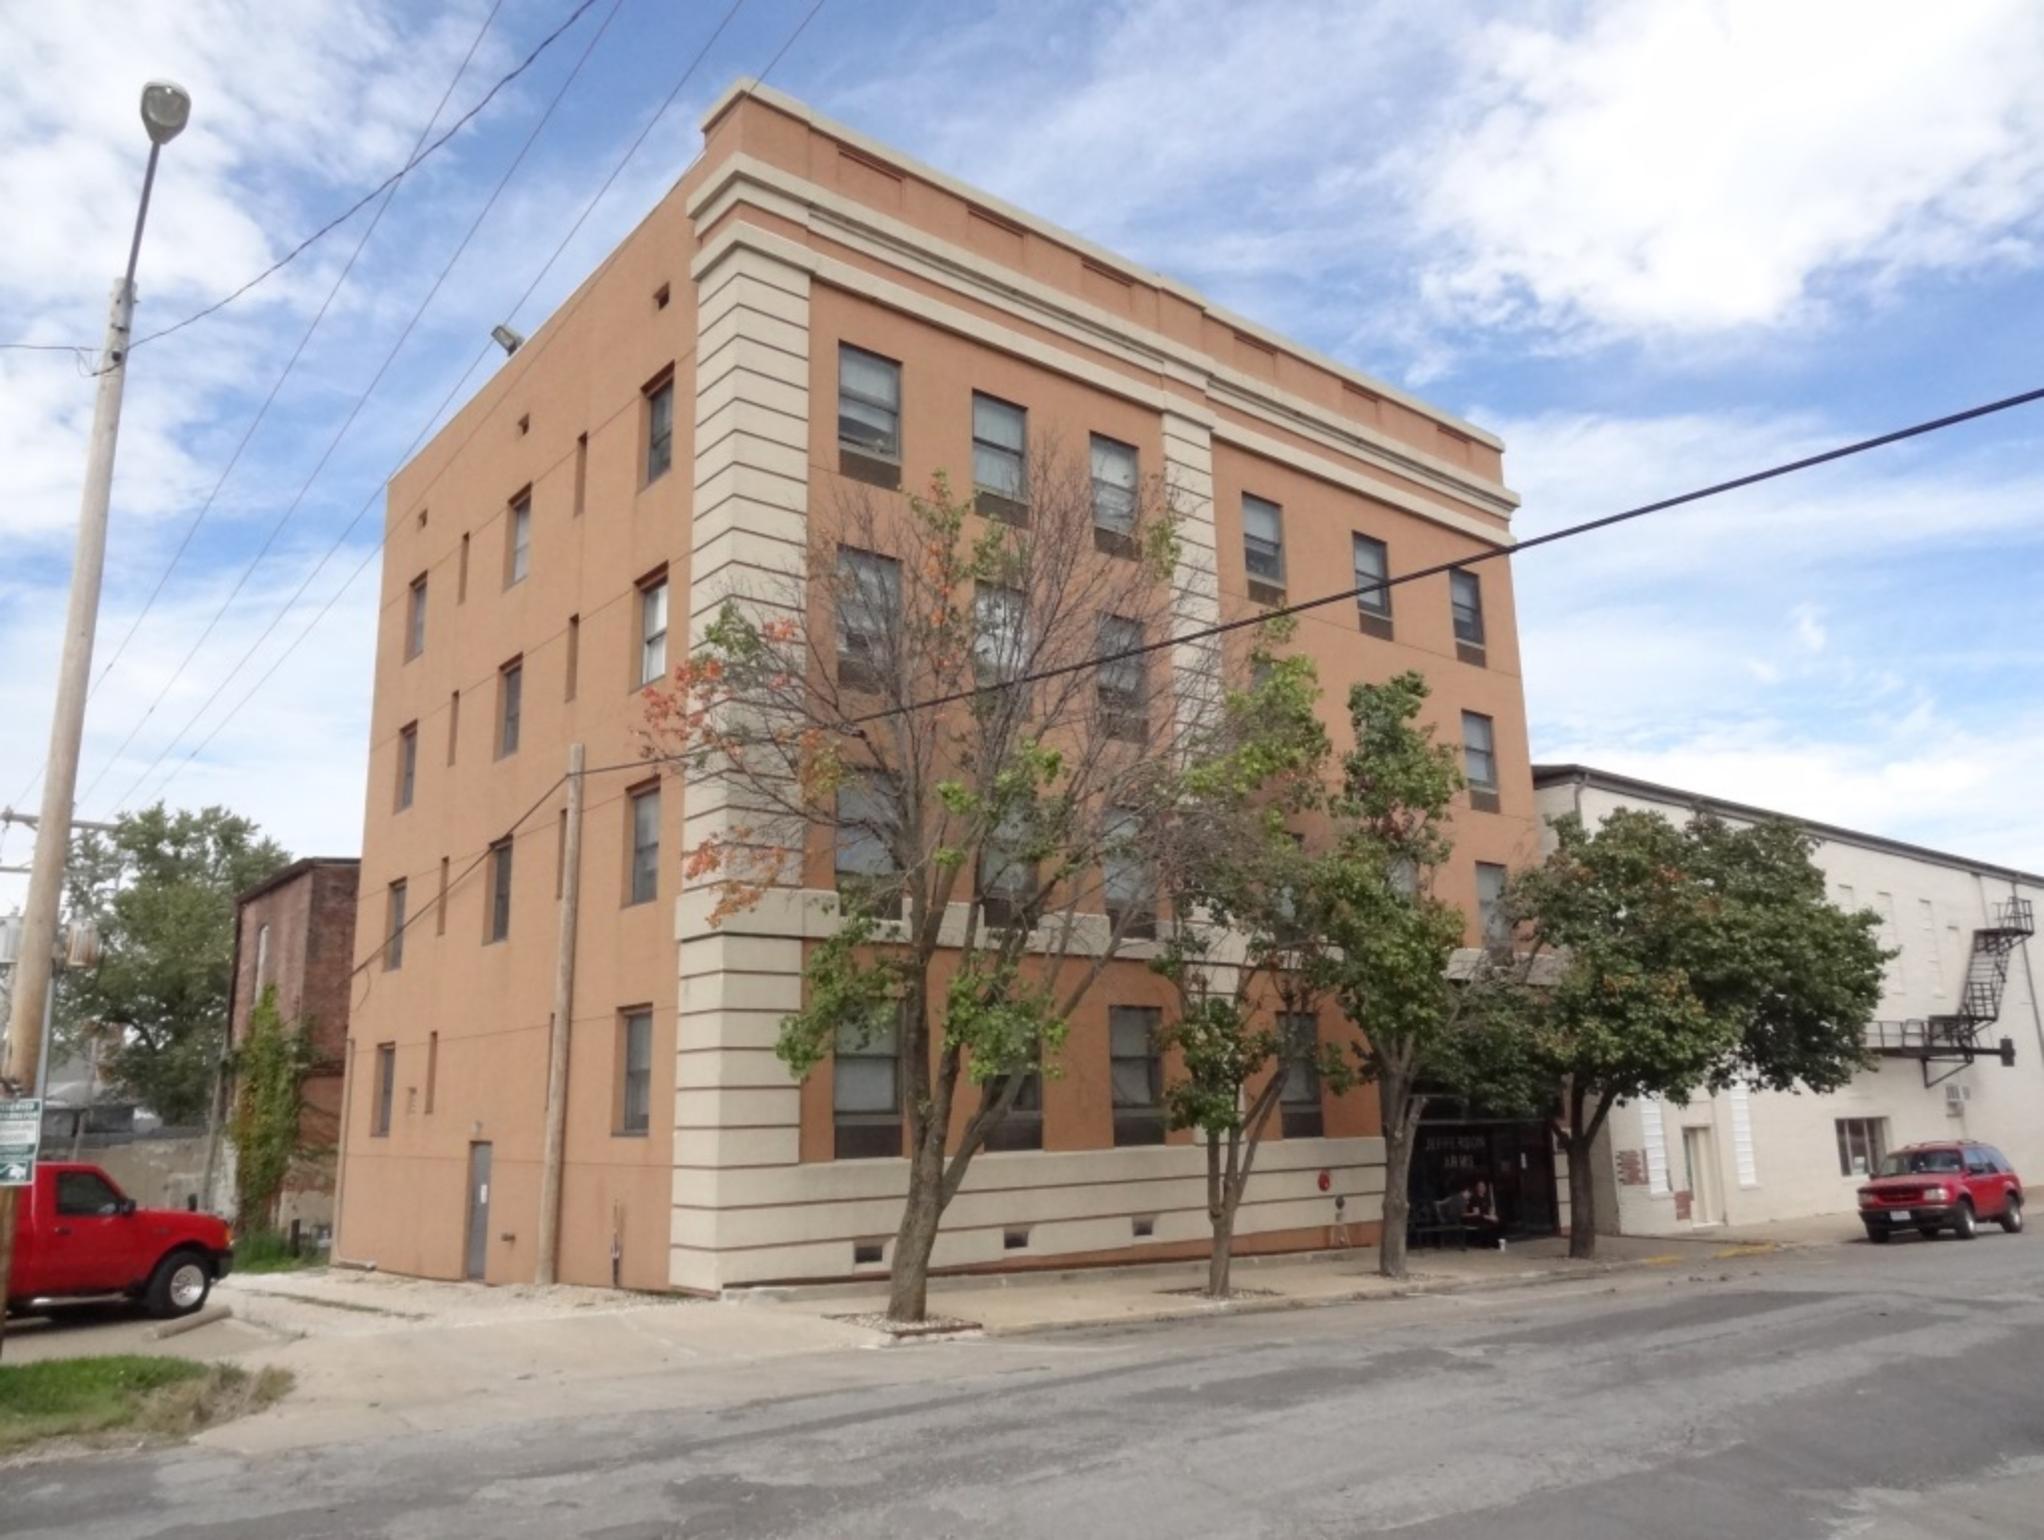
The west elevation contains five bays: bays one and four include a window on each floor, bays two and three include small windows on each floor parallel to bays 1 and 4, bay three includes a metal door at the basement level and windows one the second to fourth floors. Three vents are located above the one-over-one double-hung windows along the fourth floor. All windows are metal one-over-one double-hung sash windows with bottom air conditioning units.

The building received alterations in 1982 and most likely included the concrete stucco siding and replacement windows. According to the Macon County Historical Society, the building obtained its fourth story at this time. These alterations have resulted in a loss of architectural integrity, rendering the property non-contributing to a potential National Register historic commercial district.

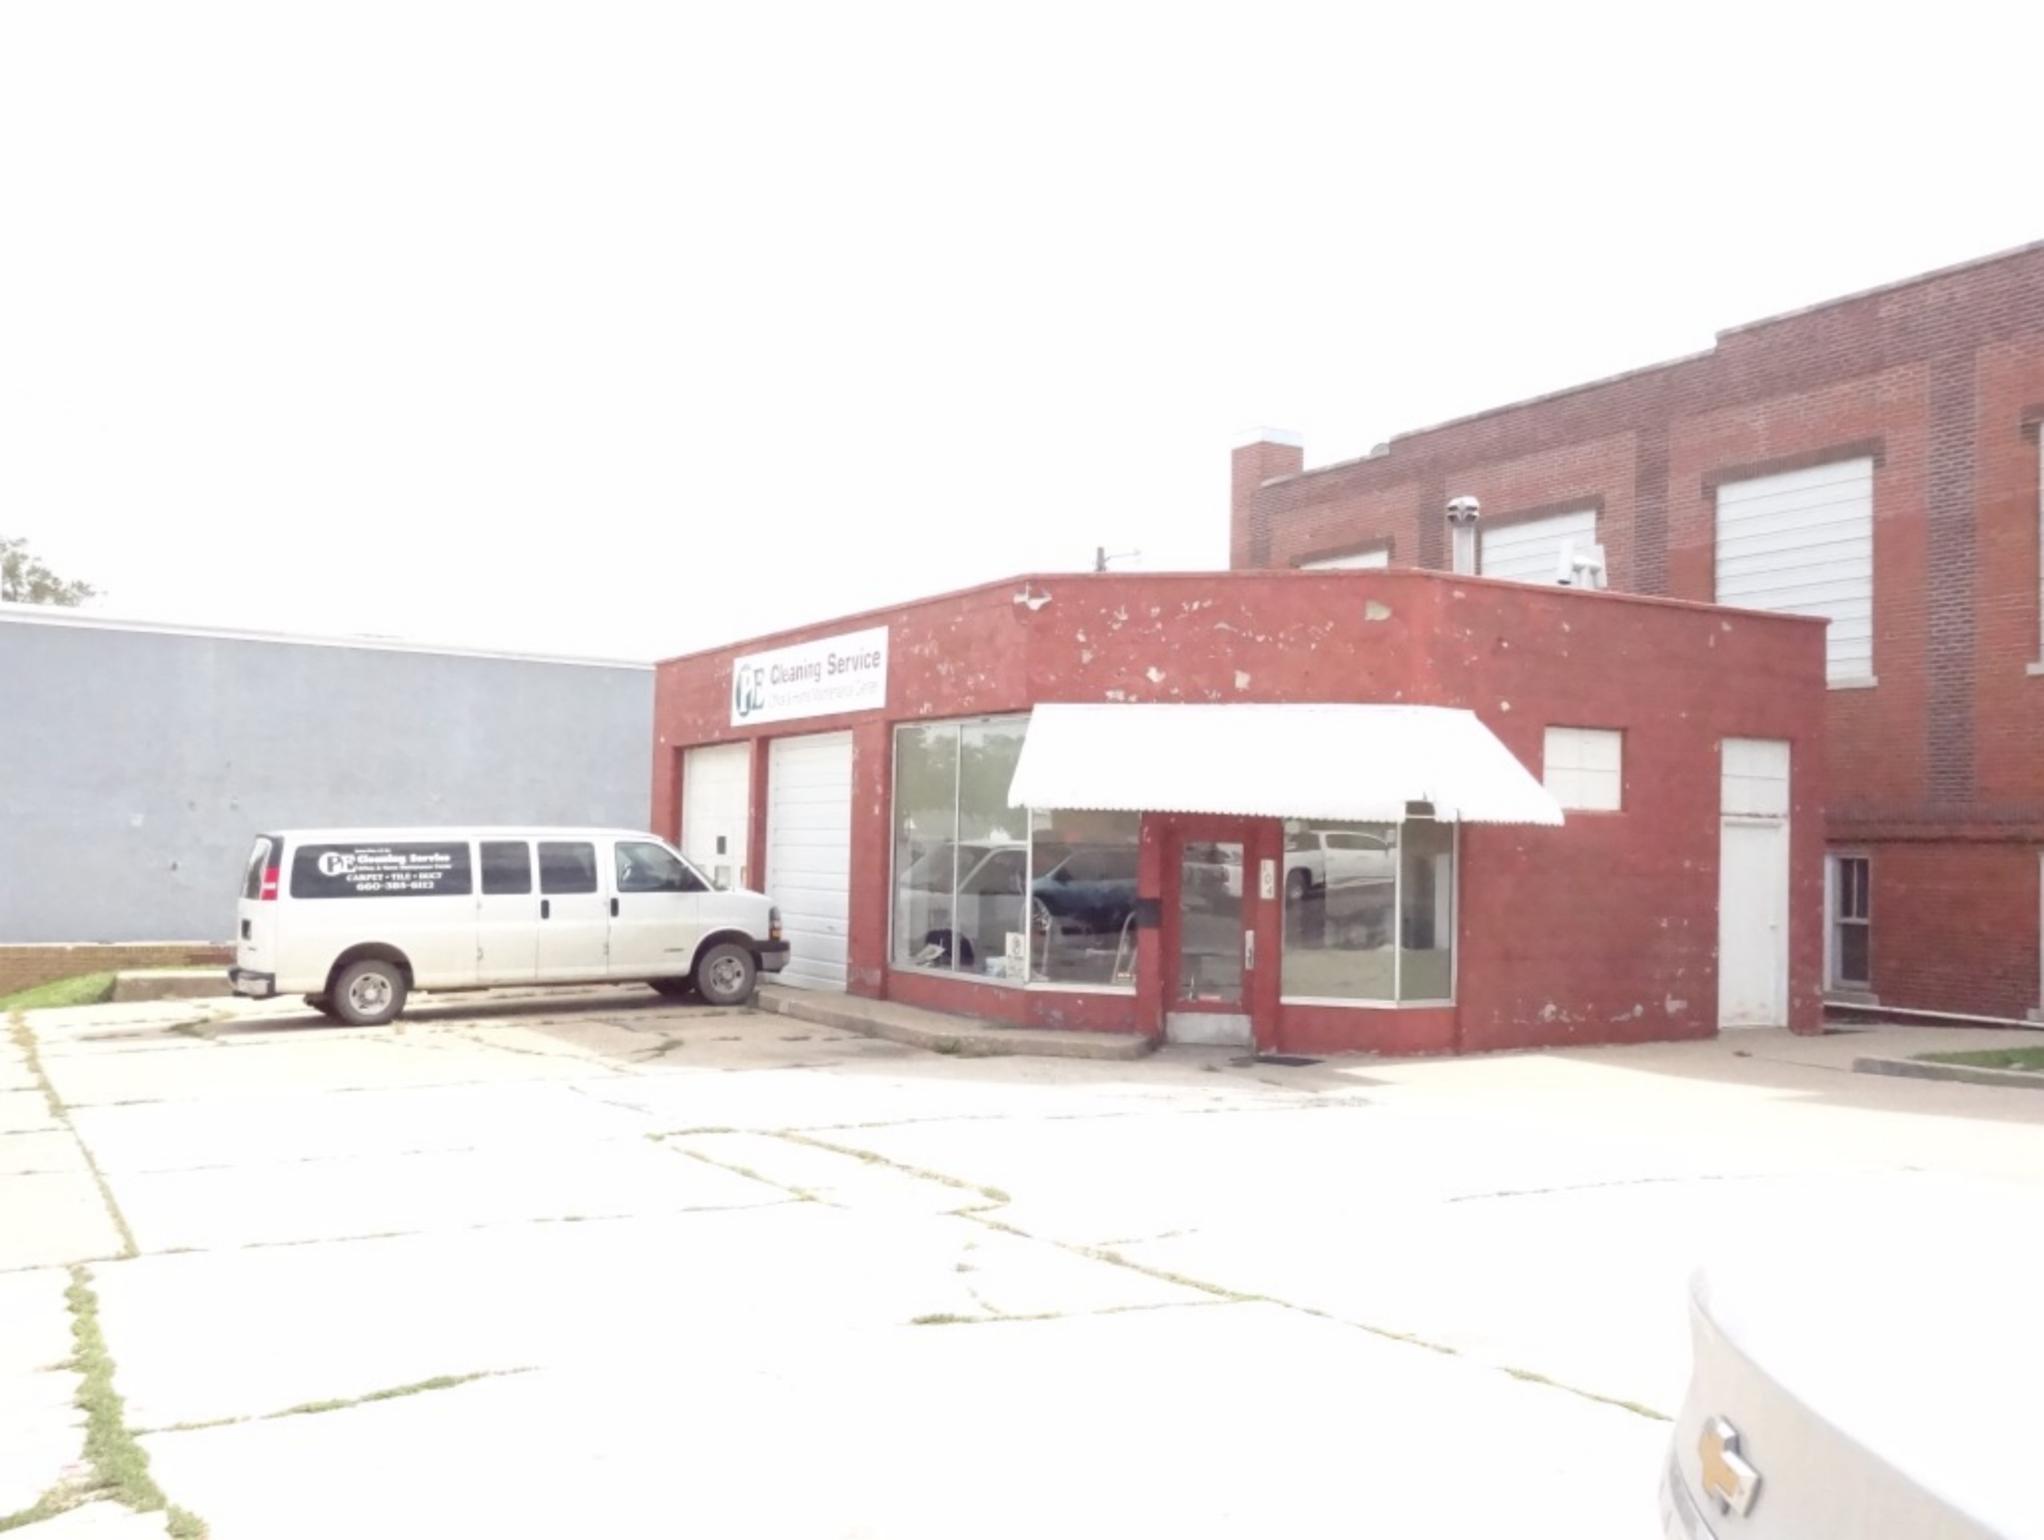
The one-story concrete block oblong box service station is rectangular in shape and includes a flat roof with a clipped corner storefront facing northwest. The building includes three bays along its façade: two vinyl garage door openings and the corner storefront. The storefront includes three large glass display windows, a metal and glass door and two large glass display windows returning onto the west elevation. The west elevation includes a small enclosed four pane window opening and a wood side entry with enclosed four pane transom. The east elevation also includes two multi-pane metal sash windows. A fiberglass awning spans half of the corner storefront.

Due to its age and retention of its historic fabric the property retains architectural integrity but its status to a district has not been determined due to its location outside the potential historic commercial district.

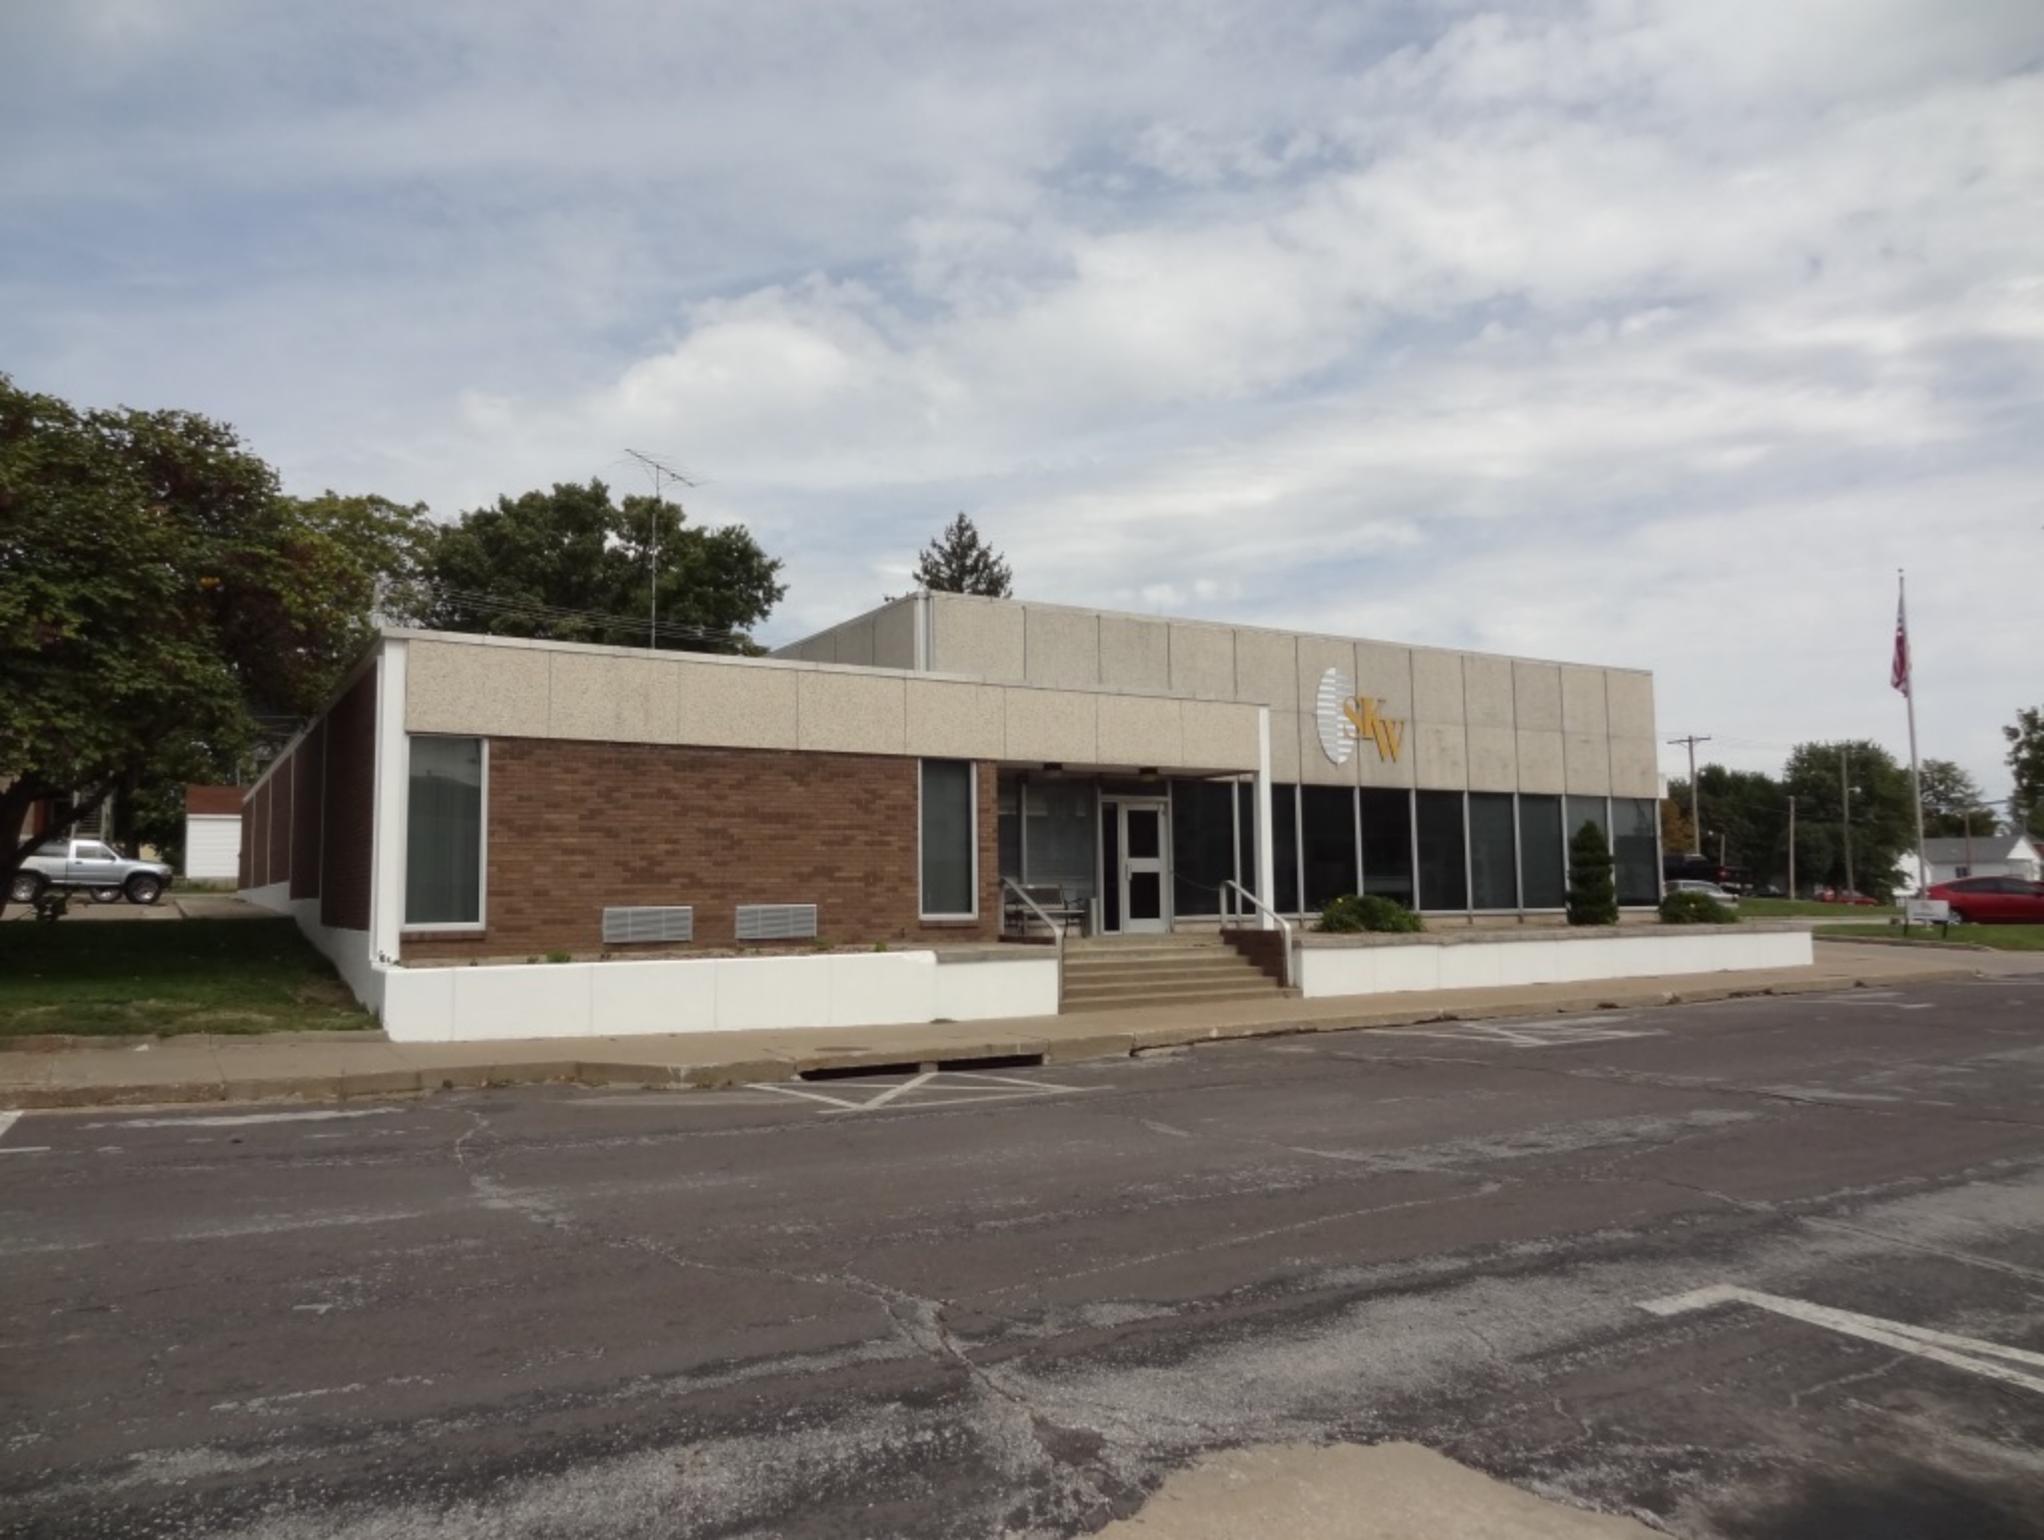
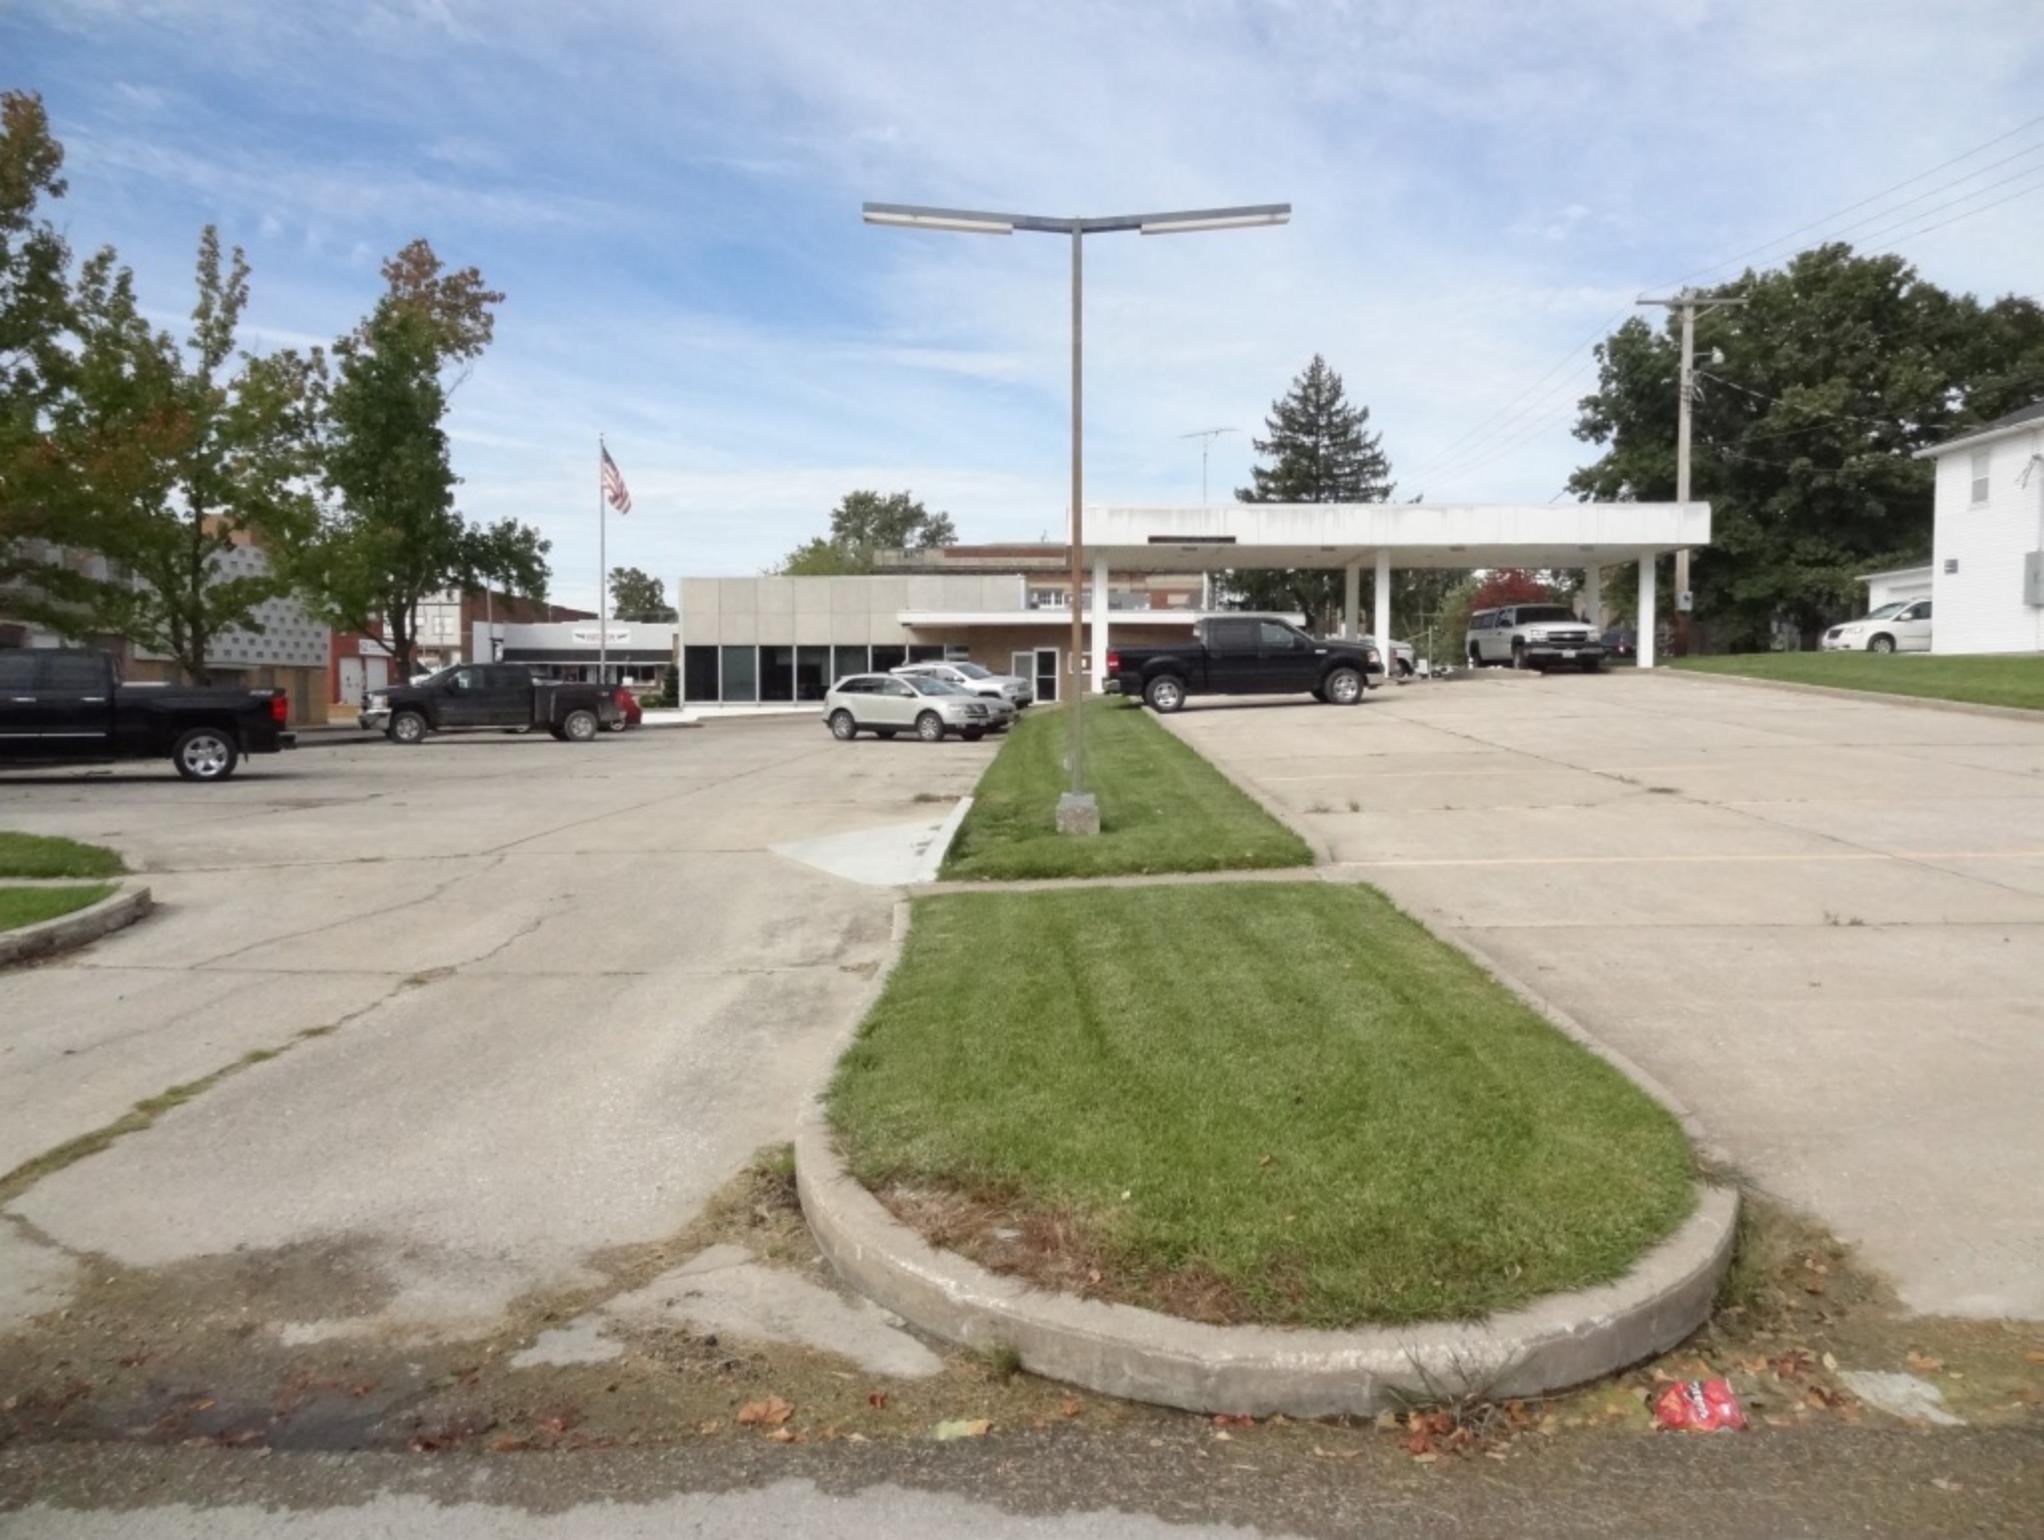
This one-level building constructed in the Modern Movement style is primarily square in plan with a one-story L-shaped wing that hugs the northern and western elevations. It was originally constructed as a bank. The wing is lower in height than the primary mass of the building. It is clad with brick and, at the roofline, large cut stone panels. A tall single-light vertical window pierces western and eastern edges of the elevation. The roofline of the wing extends to the east in front of the primary mass of the building, creating a partial width porch that shelters the entrance to the building. Approximately six concrete steps lead from the sidewalk to the porch. The entrance is comprised of an aluminum and glass door with one sidelight and two fixed pane windows to the left. A ribbon of tinted fixed-pane windows wrap around the remainder of the southern elevation. They are topped with two rows of cut stone.

This building appears to retain architectural integrity. Since it was built in 1965, it has just reached 50 years of age at the time of this survey. Depending on the period and area of significance, this building may or may not contribute to a potential National Register historic district.
