1. Survey No. MC-AS-001-001		2. Survey name: Downtown Macon Commercial Historic District	
3. County: Macon		4. Address (Street No.) Lots 11-13 block 93	Street (name) East Bourke Street (100 block)
5. City: Macon	Vicinity: <input type="checkbox"/>	6. Geographical Reference:	7. Township/Range/Section: T: R: S:
8. Historic name (if known):		9. Present/other name (if known): City of Macon Parking Lot #3	
10. Ownership: <input checked="" type="checkbox"/> Private <input type="checkbox"/> Public		11a. Historic use (if known): Commercial	11b. Current use: vacant

42. Current owner/address: City of Macon Macon, MO 63552	43. Form prepared by (name and org.): Kristi Chase MO SHPO	44. Survey date: 9/24/2014
		45. Date of revisions:

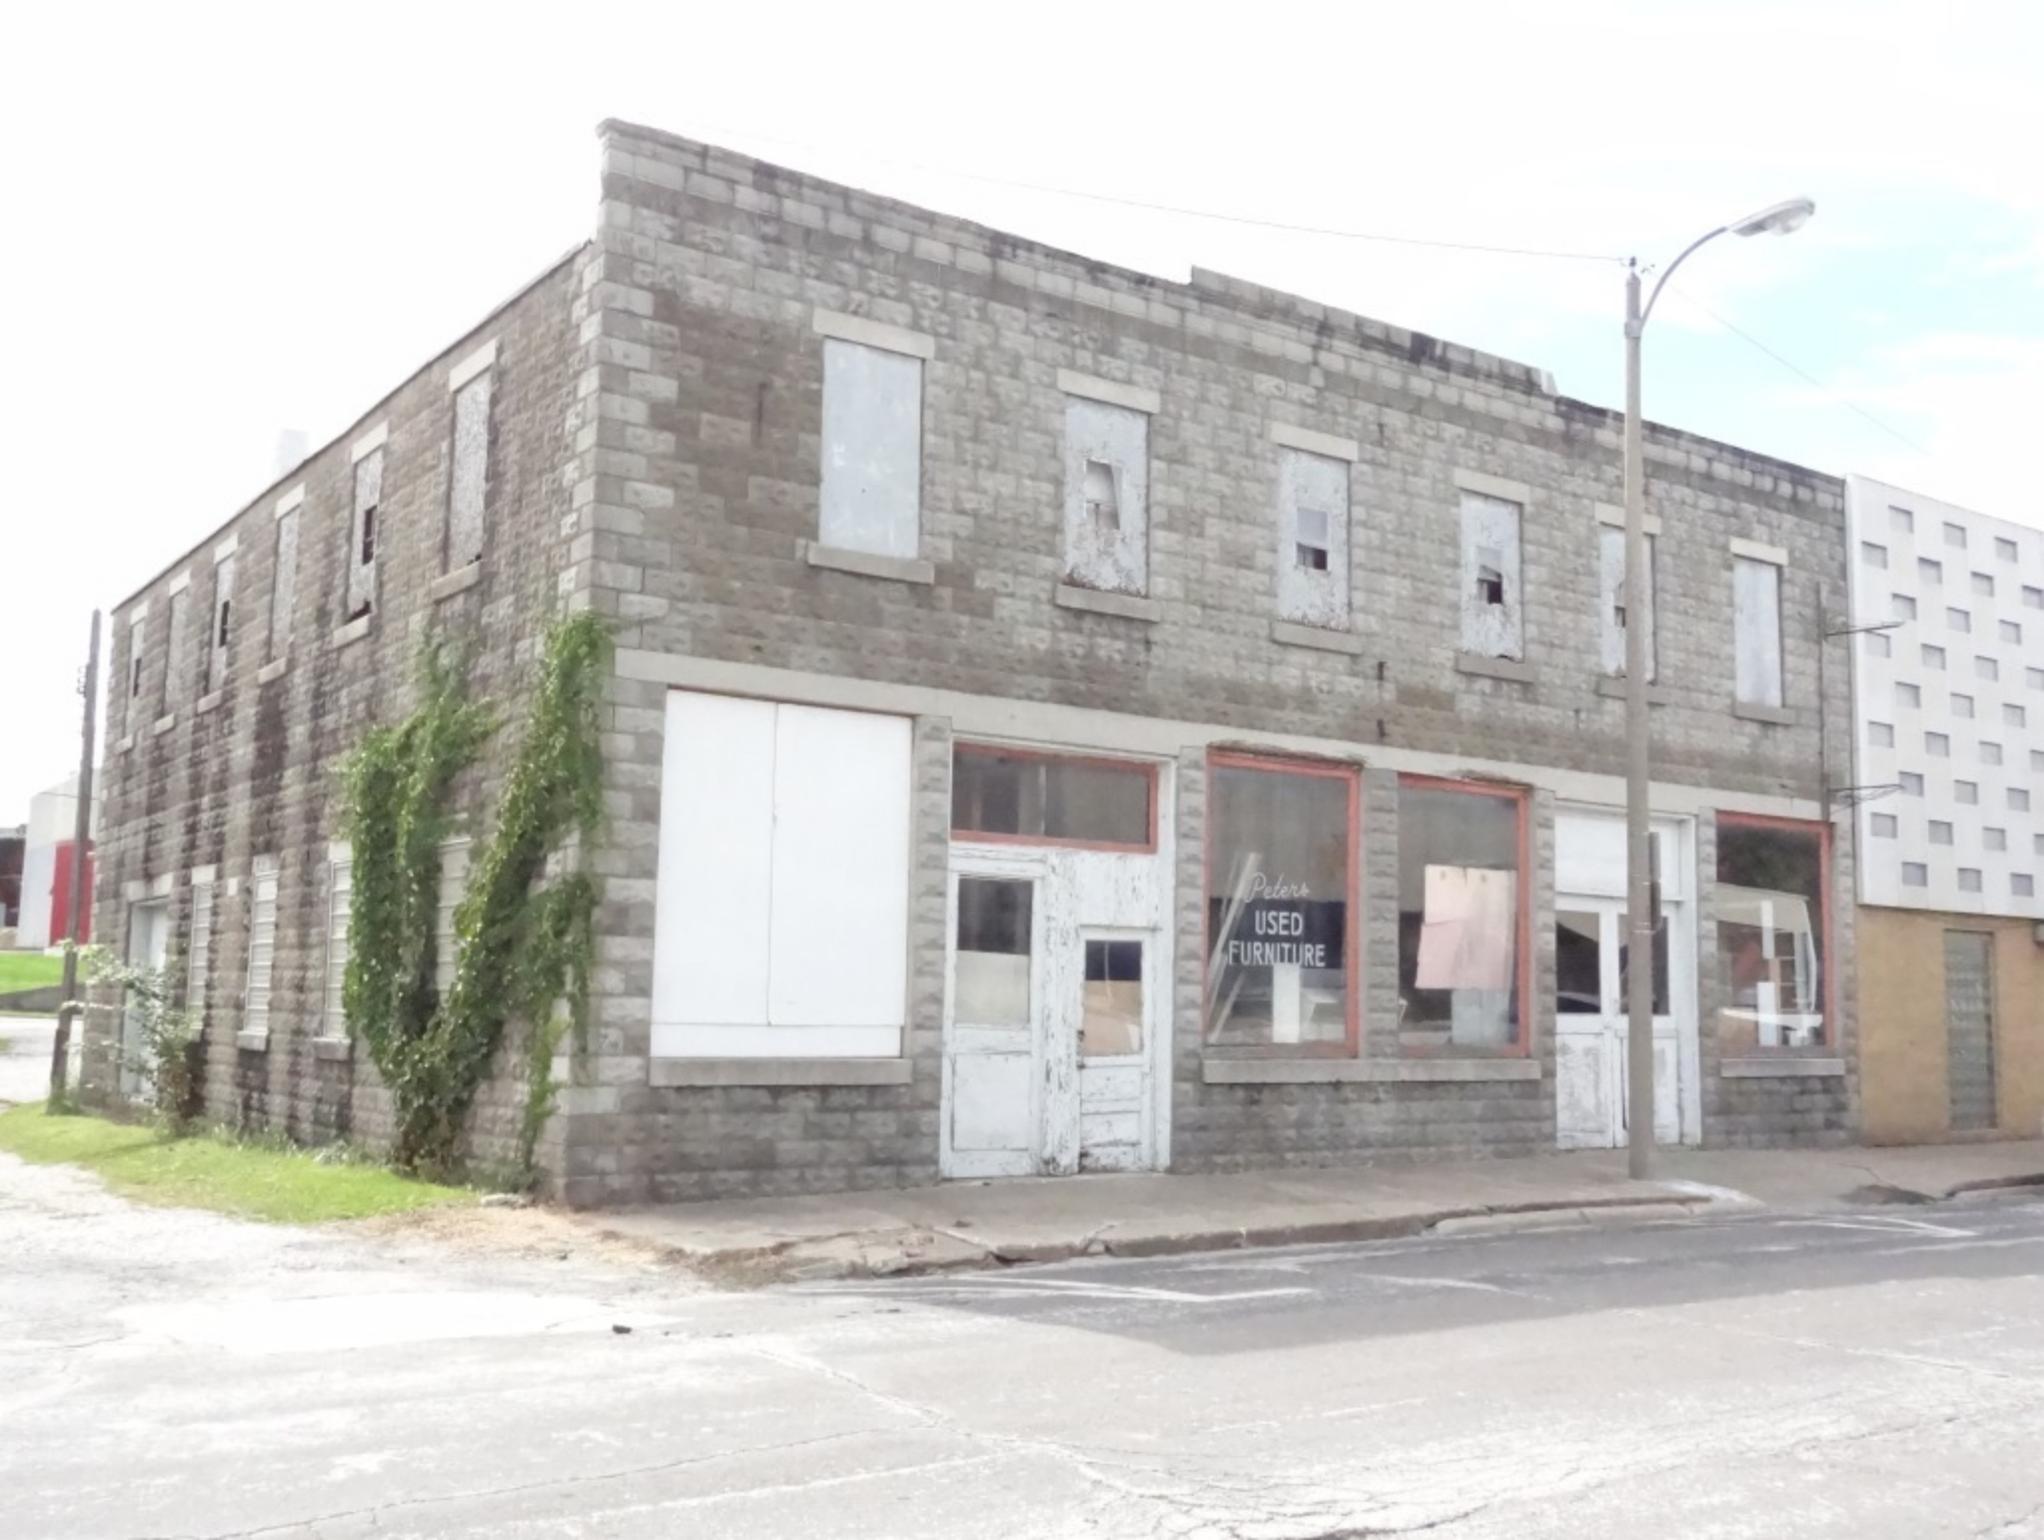
The two-part commercial block building is rectangular in shape and contains an ashlar block surface. The façade contains three bays along the first floor storefront. The first bay includes a plywood enclosed window opening and a wood two-door entry with transom. The wood doors appear to have been replaced at one time as they are irregular shaped to one another. The second bay includes two large single pane display windows with wood sash and the third bay includes a wood double door entry with a plywood enclosed transom and a large single pane display window with wood sash. A concrete band separates the two floors. The second floor contains six plywood enclosed window openings. The east elevation includes five bays along the first floor: one garage door at the southeast corner and four fiberglass boarded window openings. The second floor includes six plywood enclosed window openings. The lintels and sills are concrete lug design.

Due to its age and retention of its historic fabric the property retains architectural integrity but its status to a district has not been determined due to its location outside the potential historic commercial district.

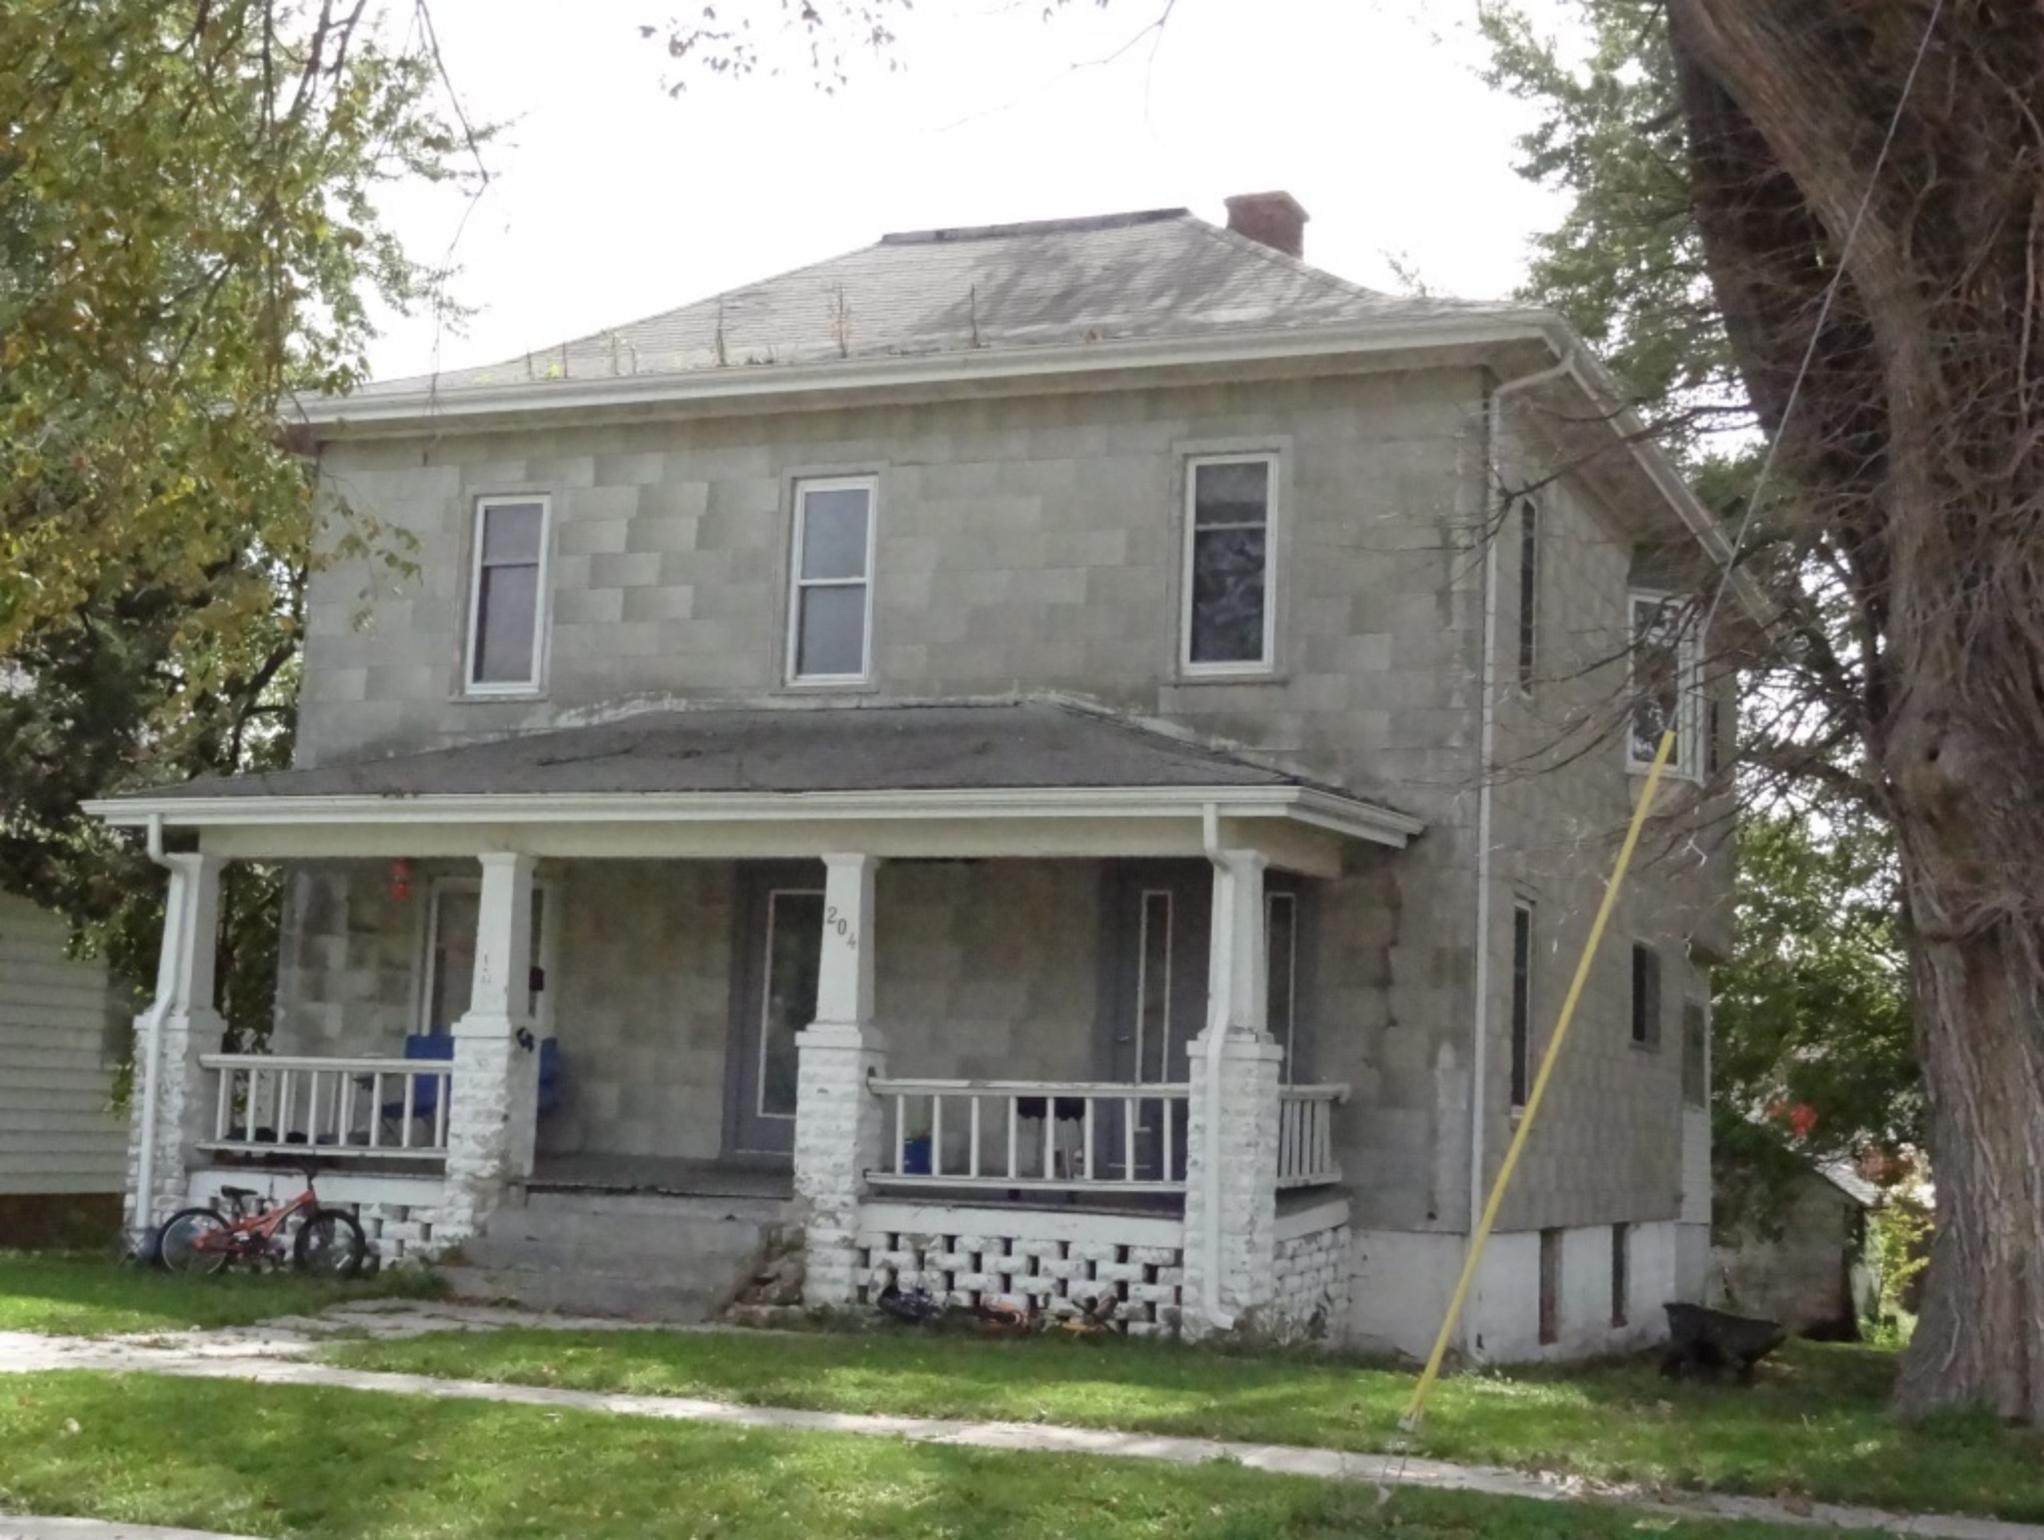
The dwelling at 204 Butler Street is a three bay American Foursquare with a hipped asphalt roof and asbestos shingle siding. The dwelling sits on a concrete foundation with raised basement. The façade's first floor includes a picture window (left), a center entry with a modern door with a glass pane, and a side entry with a modern door with a glass pane and sidelight. These bays open onto a partial center hipped roof one-story wood deck porch with tapered square columns on battered brick pedestals and wood balustrade. The deck has concrete steps leading to the sidewalk and a brick lattice design supports the wood deck. The second floor contains three one-over-one vinyl windows. The west elevation includes two visible basement windows. The first floor includes two replacement windows a one-over-one double hung vinyl and a sliding vinyl and an enclosed first floor porch at the rear. The second floor includes a one-over-one double-hung vinyl sash window, a vinyl oriel window and a smaller window. An interior brick chimney with concrete capping is located on the western slope of the roof.

This building may be contributing to a potential National Register historic residential district due to its age and retention of its historic fabric, but not applicable for a potential National Register commercial district.

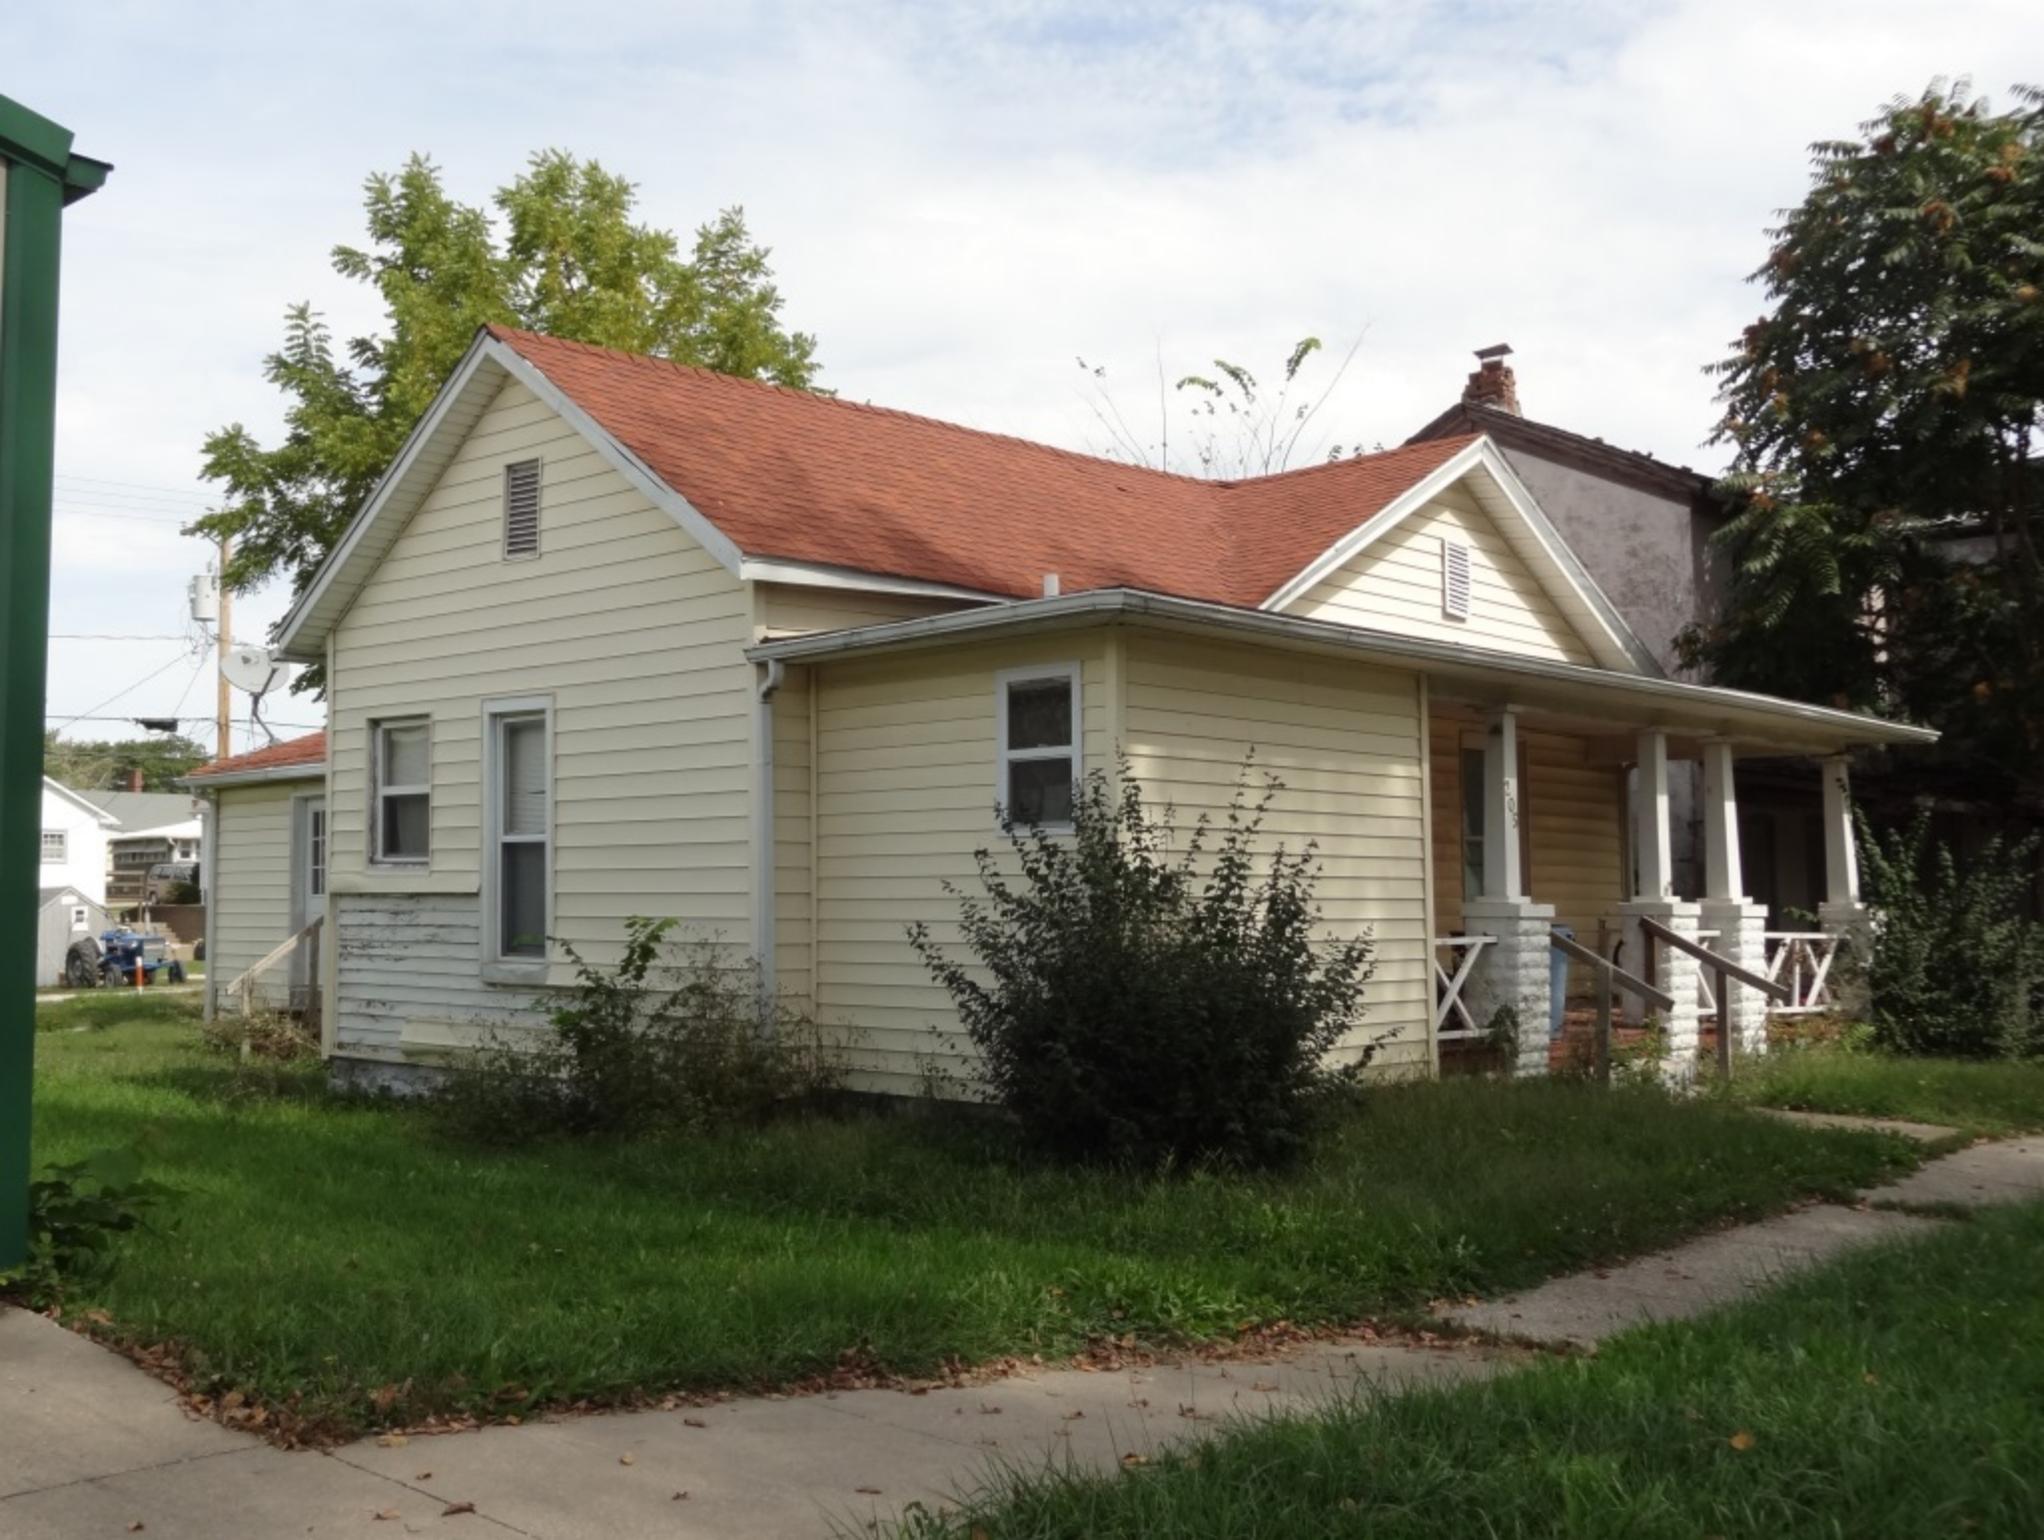
This one-story gabled ell cottage has a cross-gabled roof, vinyl siding covering wood lap siding, and a shed-roof full-width porch. The left (west) side of the porch is enclosed. The remainder of the porch is supported by four wood posts on concrete block bases. Crossed wood posts are used as porch railings. The porch floor is plank wood. The front (south) façade of the residence has two bays. The west bay contains a non-historic door with a nine-light window and the east bay contains a replacement 1/1 double-hung window. The front-facing gable of the roof contains an attic vent in the eave.

The house's historic wood siding has been covered with vinyl siding, and the historic windows have been replaced. Due to a loss of architectural integrity, the house is likely not eligible for listing.

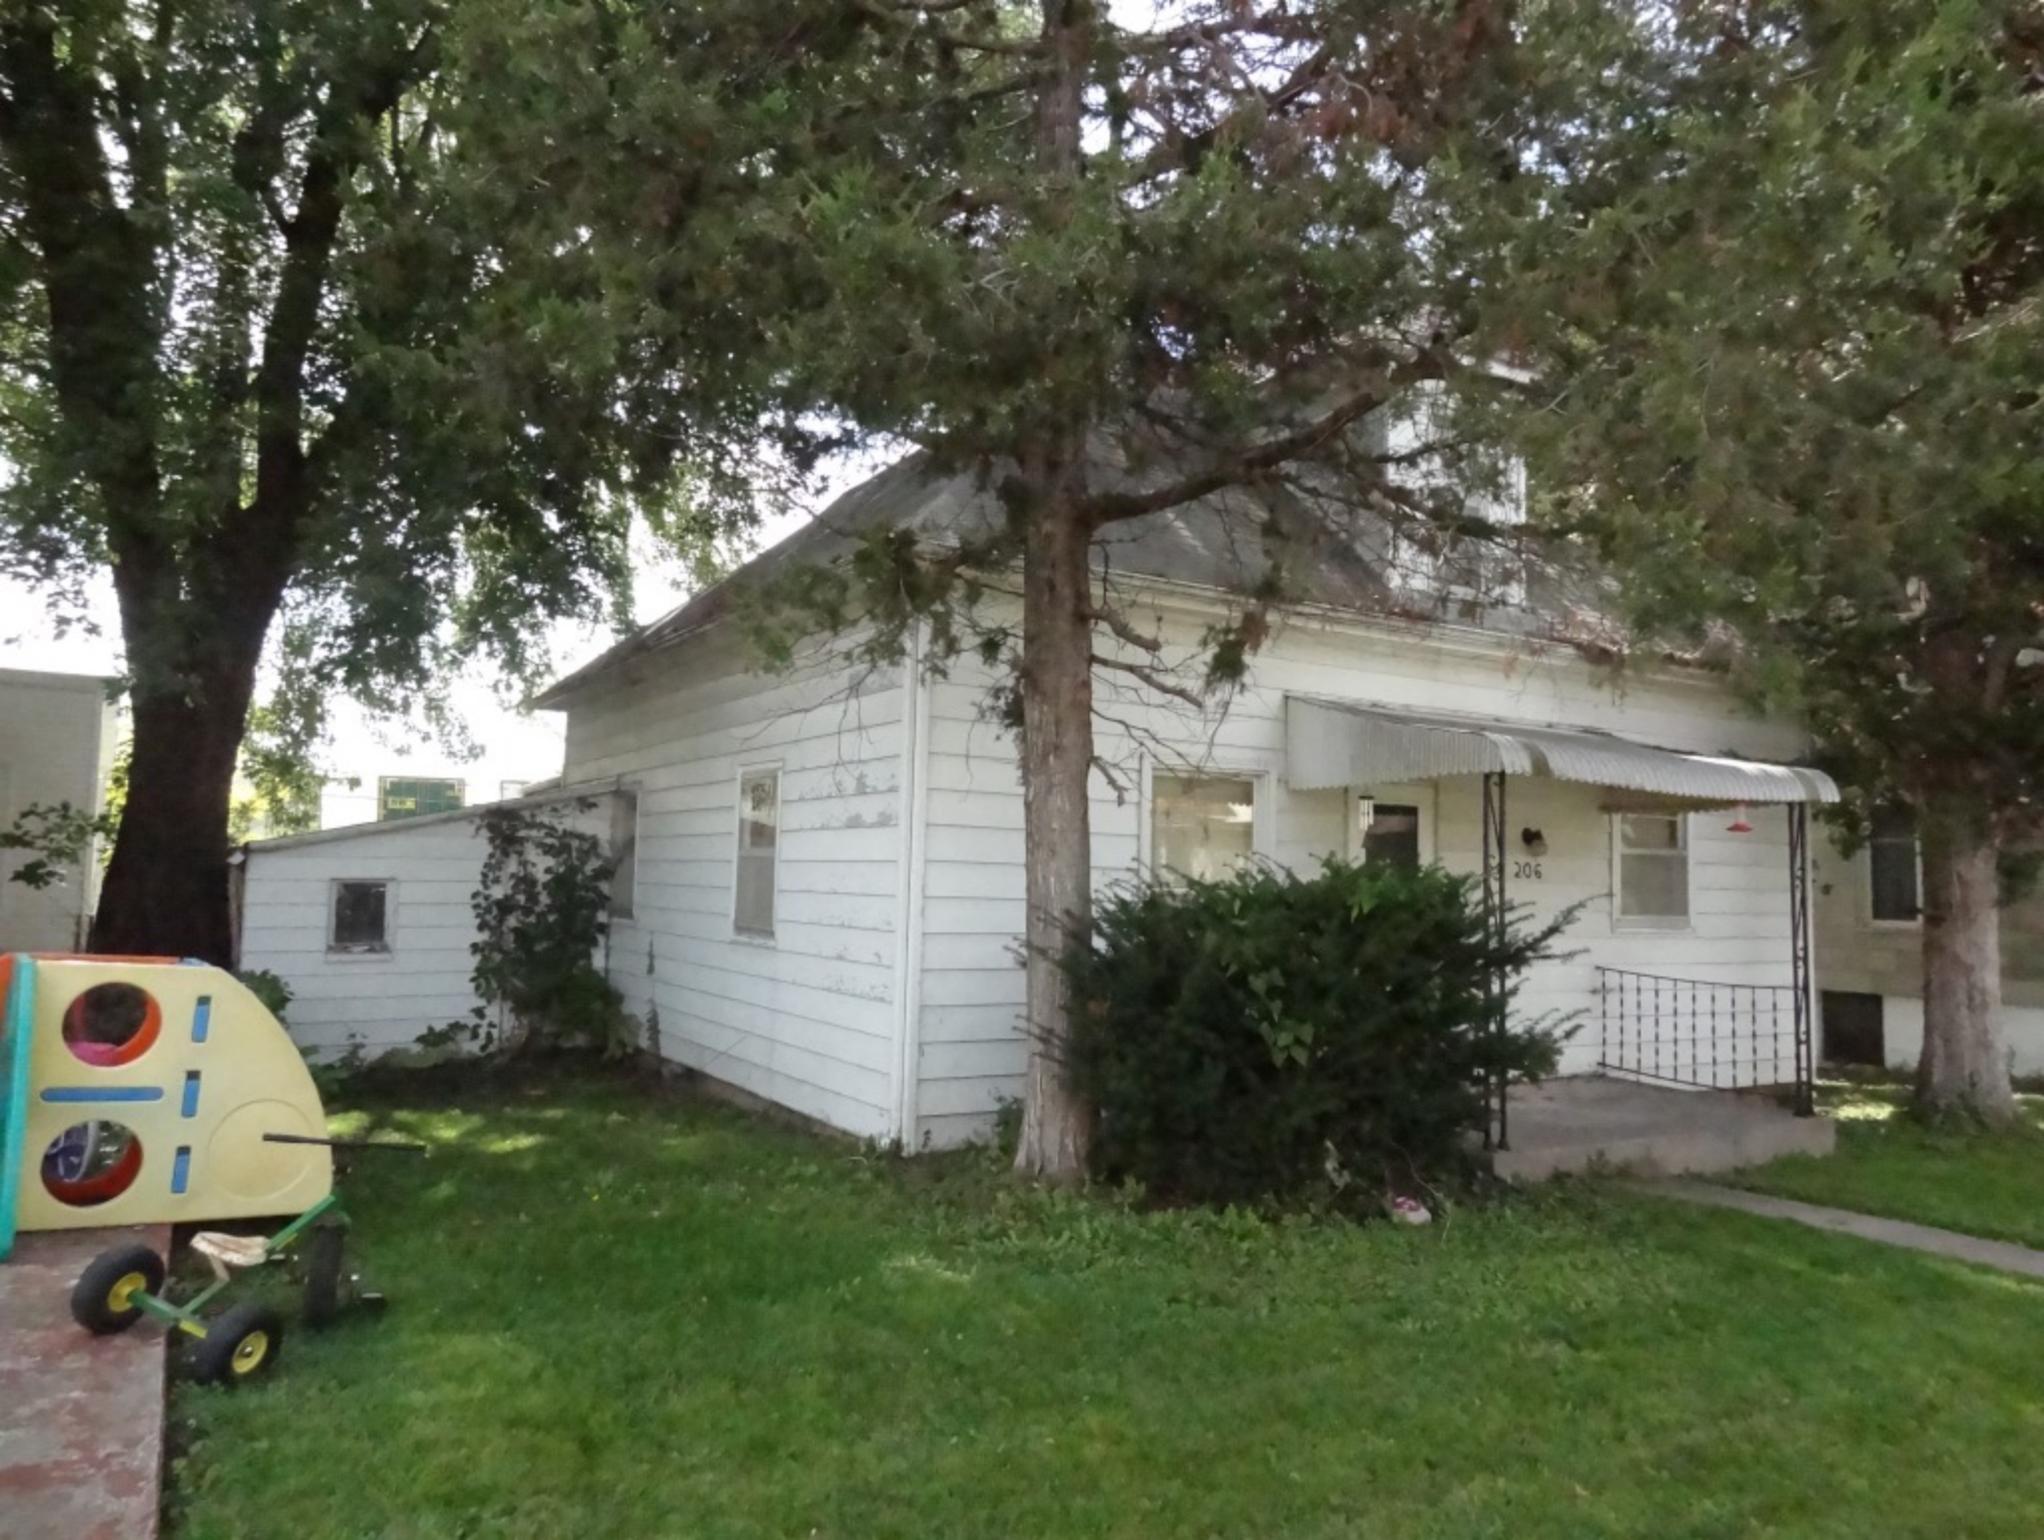
This aluminum-sided bungalow includes a hipped asphalt roof with a hipped dormer with a one-over-one double-hung wood window along its three-bay façade. The front elevation includes a one-over-one double-hung wood window, an off-center entry with a storm door, and a one-over-one double-hung wood window. The entry opens onto a metal awning covered portico with wrought iron supports and balustrade resting on a concrete deck. The east elevation of the dwelling includes two one-over-one double-hung wood windows and a shed roof one-story rear addition that appears to attach at the southeast corner of the building.

This building may be contributing to a potential National Register historic residential district due to its age and retention of its historic fabric, but not applicable for a potential National Register commercial district.

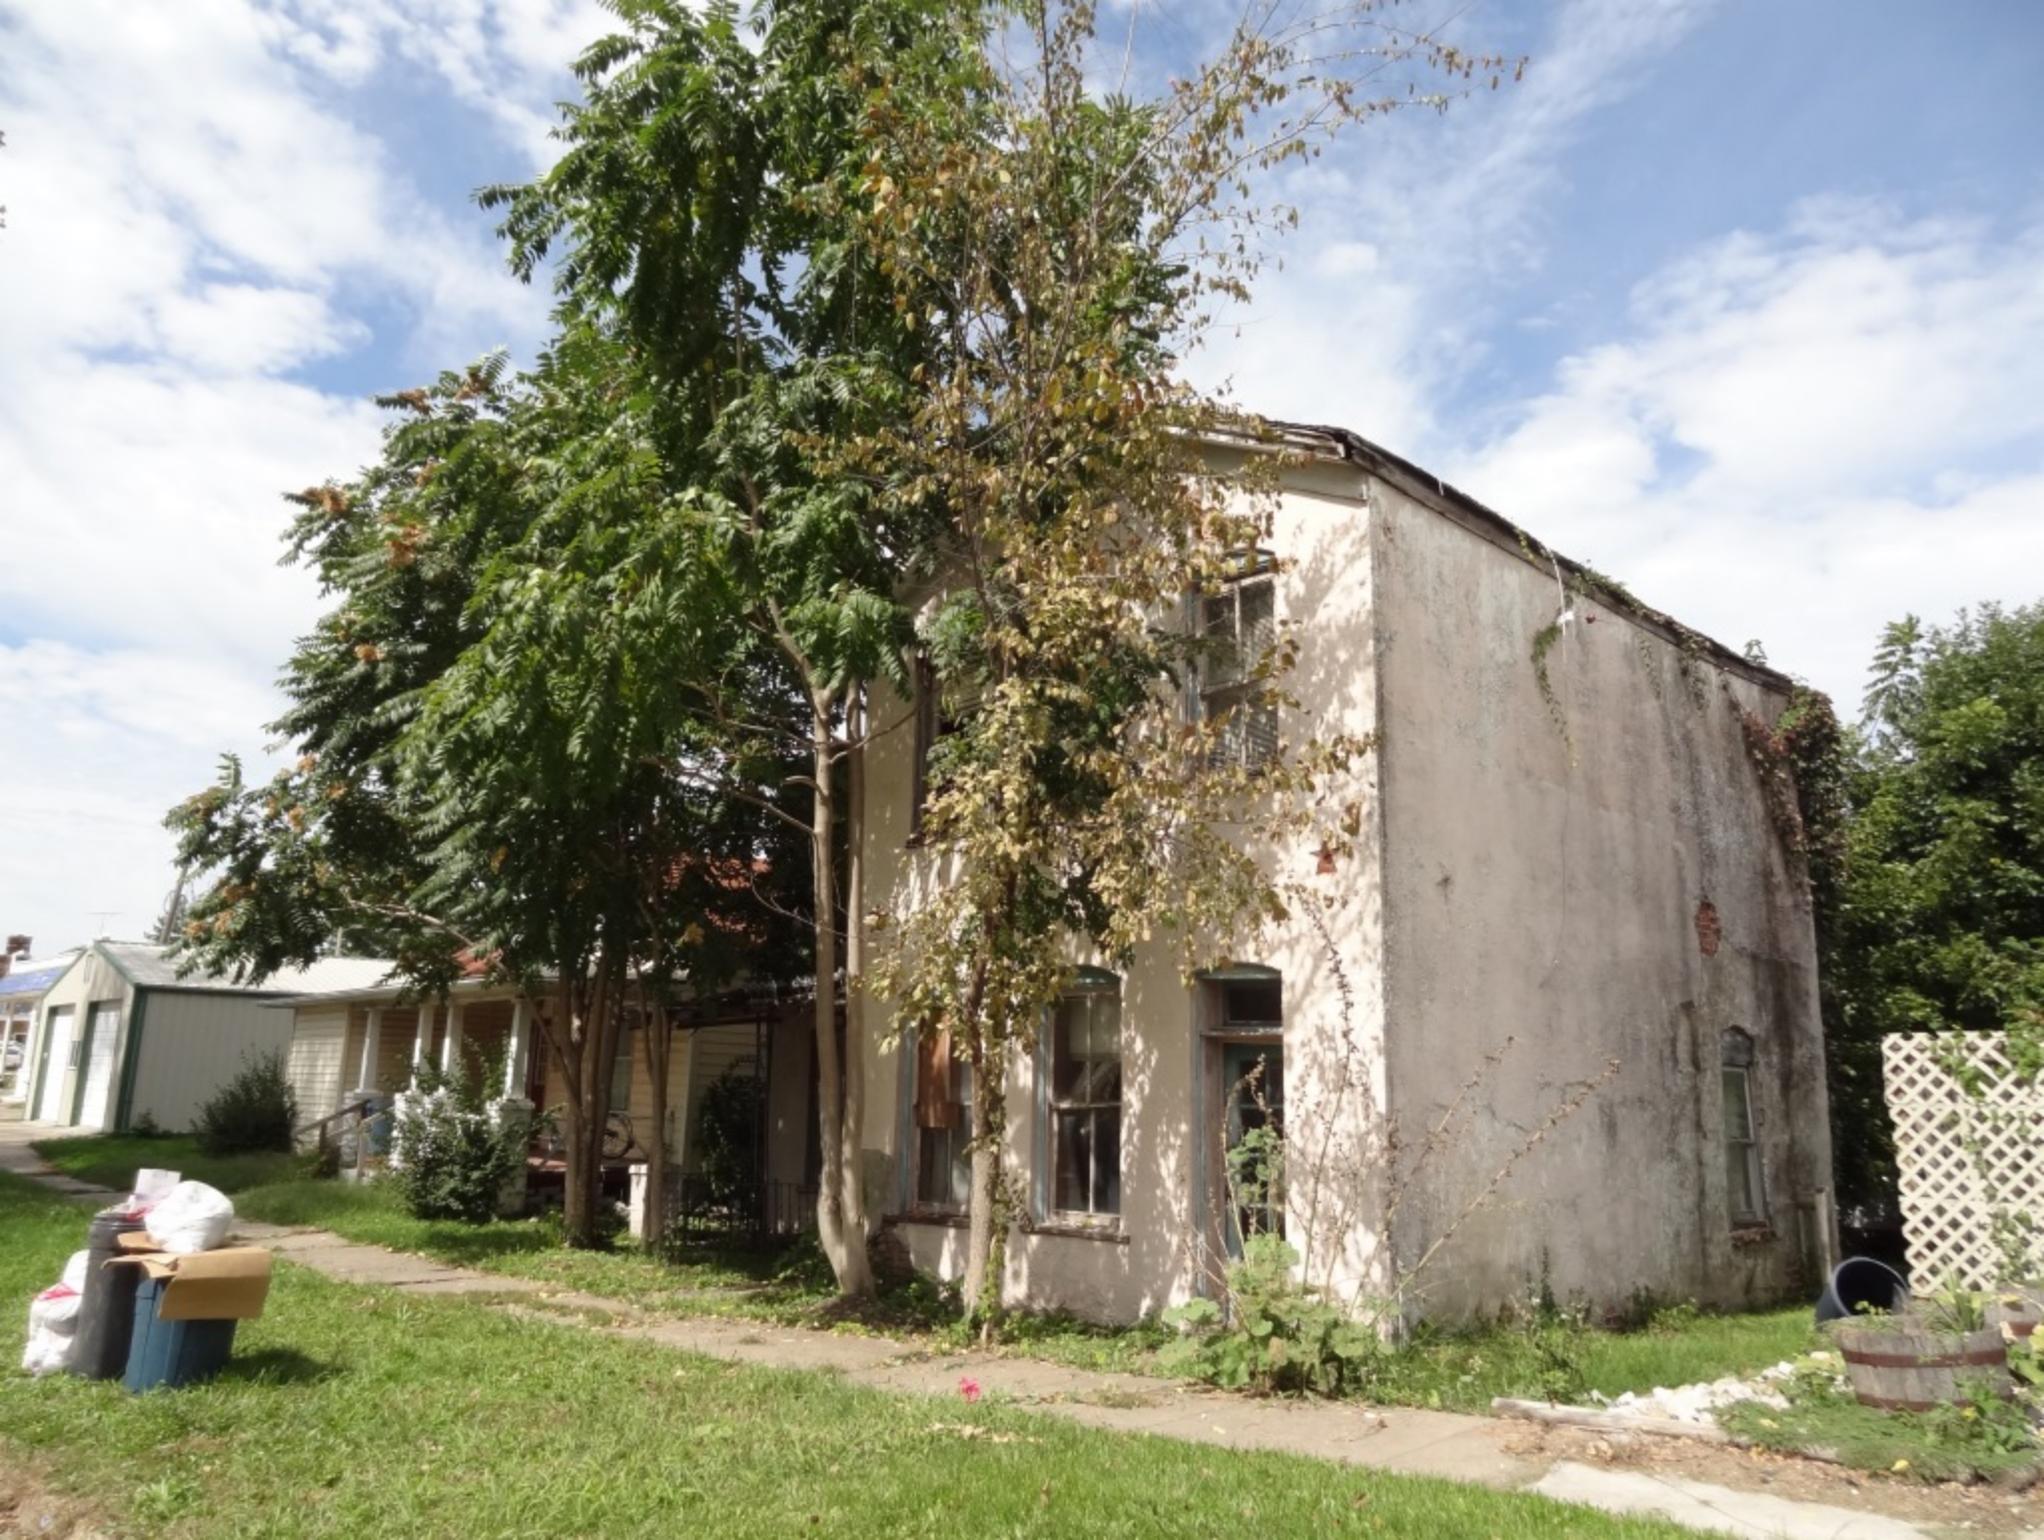
This two-story gabled-ell house is covered with deteriorating stucco, revealing historic brick underneath. The side-gabled western mass of the house has three bays on each story. A deteriorating porch with a flat roof supported by wrought iron rails on brick piers covers the first story. A short iron balustrade lines the roof of the porch. The two western bays on both floors contain historic 2/2 wood double-hung windows with wood sills. The eastern bay on the first floor contains a historic multi-light wood door concealed by a modern aluminum storm door. A transom window is above the door. The eastern bay of the second story contains a historic 1/1 wood double hung window. A front-gabled wing with three bays in both floors projects forward from the eastern side of the residence. The first floor of the wing contains two historic 2/2 wood double-hung windows and one historic multi-light wood door with transom. The second floor contains three historic 2/2 wood double-hung windows. All windows and doors are set within segmented arch openings.

The residence retains architectural integrity and would likely contribute to a potential residential National Register historic district.

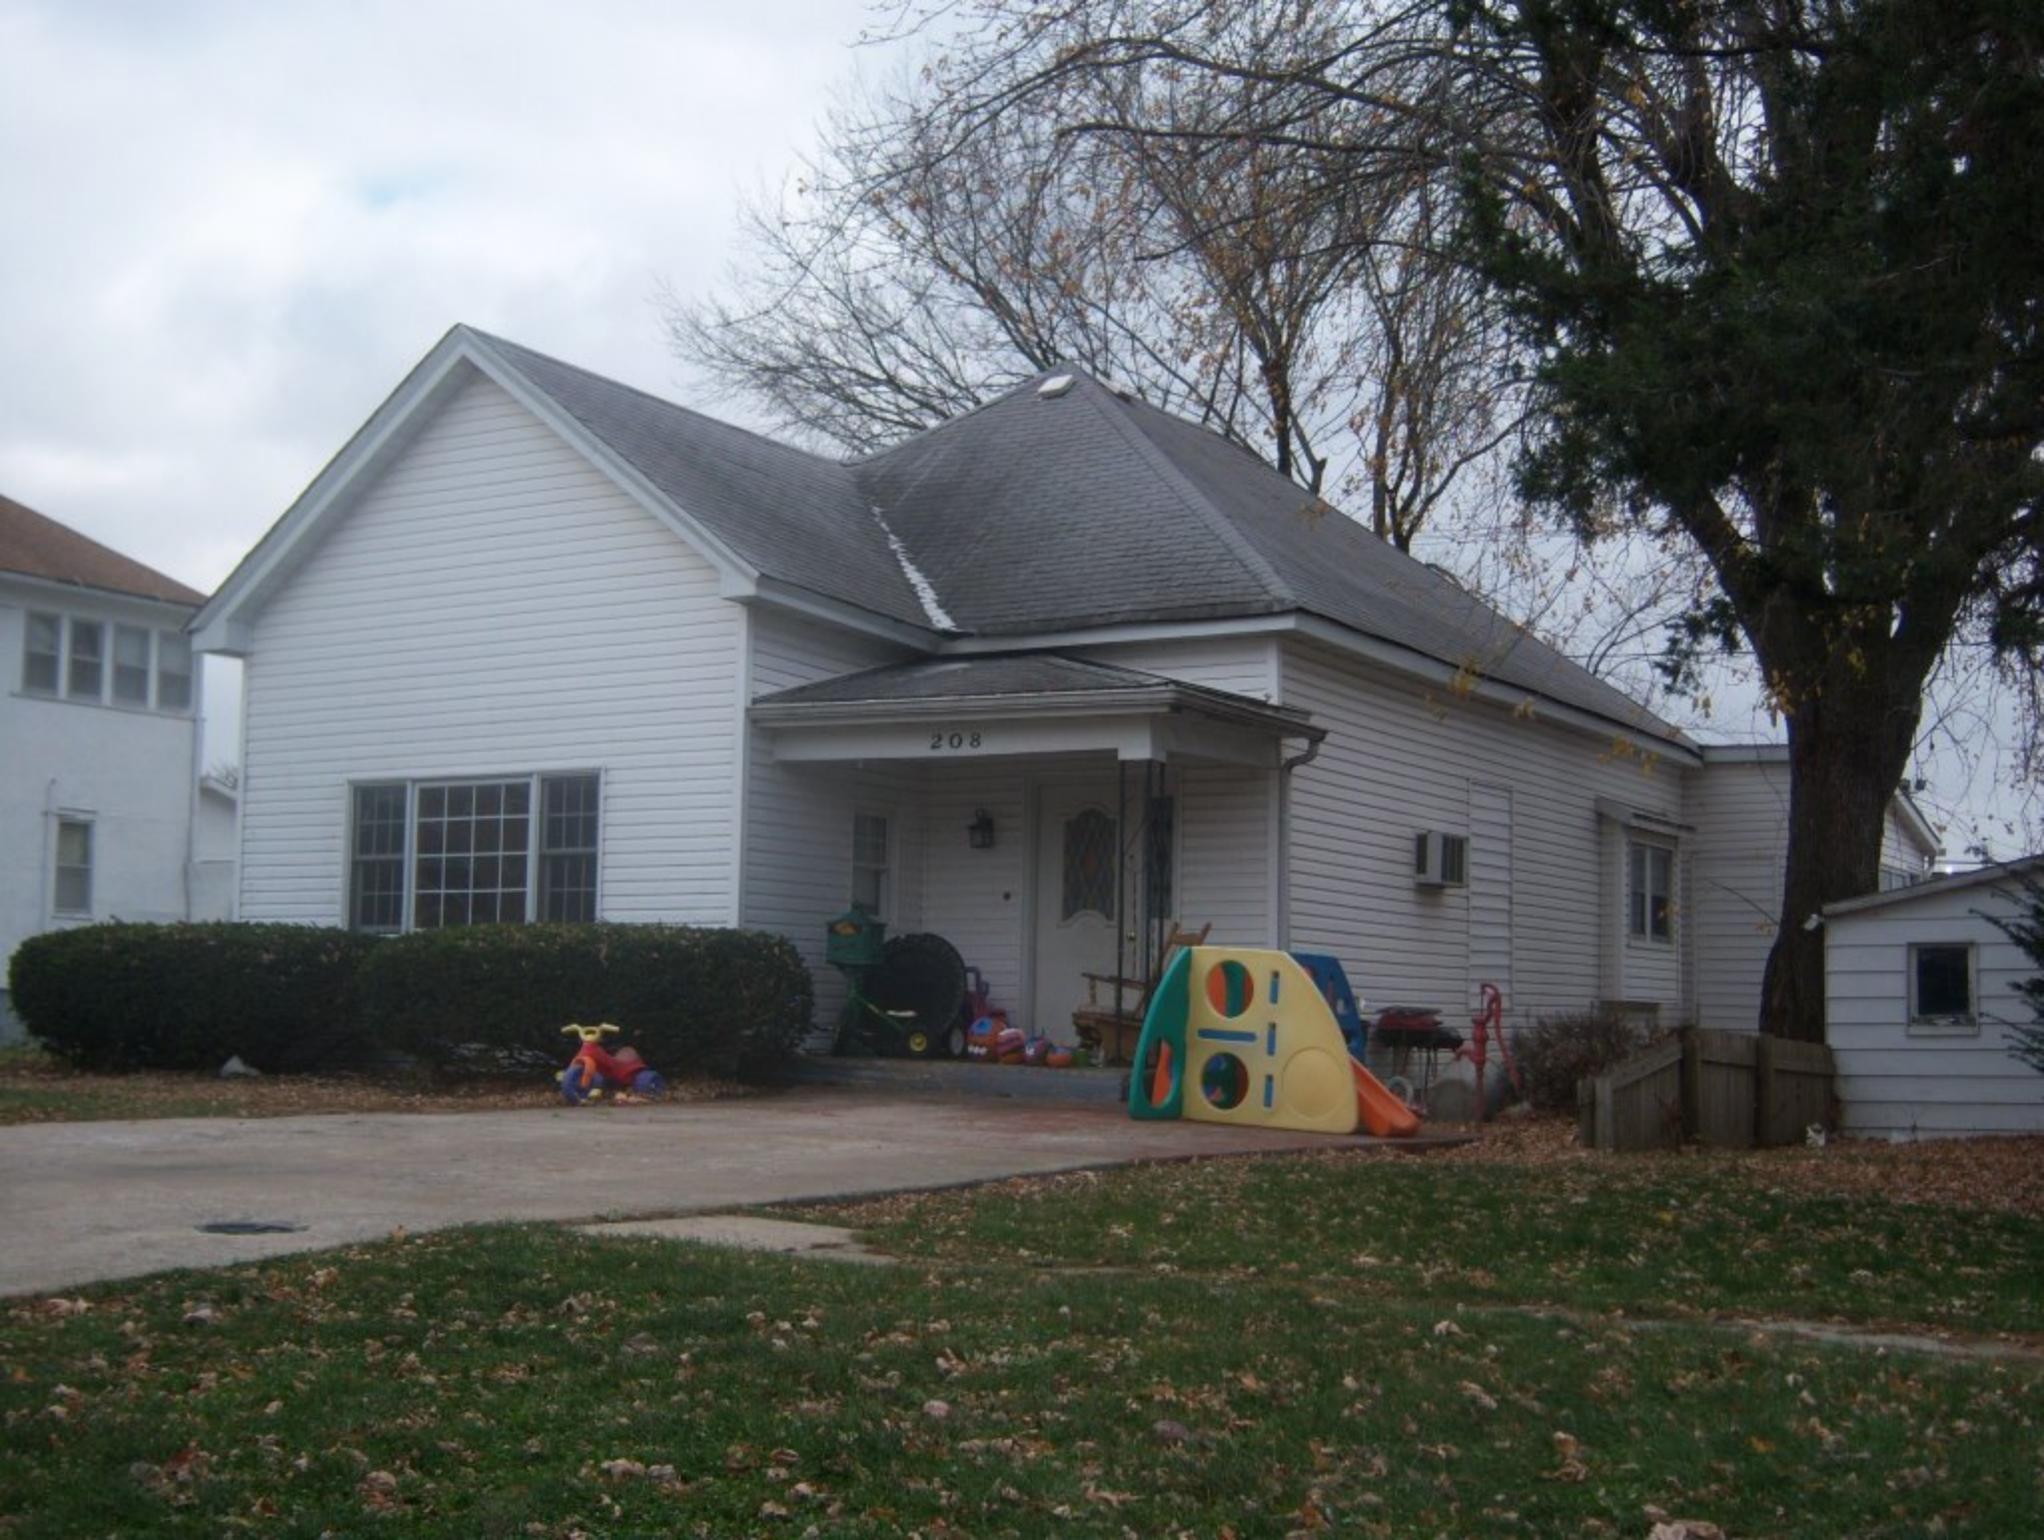
The dwelling is irregular shaped with a square footprint with an asphalt covered pyramidal roof with a front gable projection and a shed rear addition. The dwelling contains vinyl siding supported by a concrete foundation. The façade is two bays: a modern vinyl picture window framed by a one-over-one double-hung window and a modern vinyl paneled door with faux stained glass and a faux stained glass side light. The front entry steps out onto a partial porch with a concrete deck and a low hipped asphalt roof supported by a wrought iron column. The east façade includes three bays of one-over-one double-hung wood sash with storm windows and a brick exterior end chimney. One-story and one and half story shed additions are visible from the side walk. The west elevation is three bays wide with a vinyl siding enclosed window bay, a projecting bay window, and the one and a half story rear shed addition.

The vinyl windows, vinyl siding and additions were added at an unknown date. These alterations have resulted in a loss of integrity, rendering the property not eligible.
