1. Survey No. MC-AS-001-001		2. Survey name: Downtown Macon Commercial Historic District	
3. County: Macon		4. Address (Street No.) Lots 11-13 block 93	Street (name) East Bourke Street (100 block)
5. City: Macon	Vicinity: <input type="checkbox"/>	6. Geographical Reference:	7. Township/Range/Section: T: R: S:
8. Historic name (if known):		9. Present/other name (if known): City of Macon Parking Lot #3	
10. Ownership: <input checked="" type="checkbox"/> Private <input type="checkbox"/> Public		11a. Historic use (if known): Commercial	11b. Current use: vacant

42. Current owner/address: City of Macon Macon, MO 63552	43. Form prepared by (name and org.): Kristi Chase MO SHPO	44. Survey date: 9/24/2014
		45. Date of revisions:

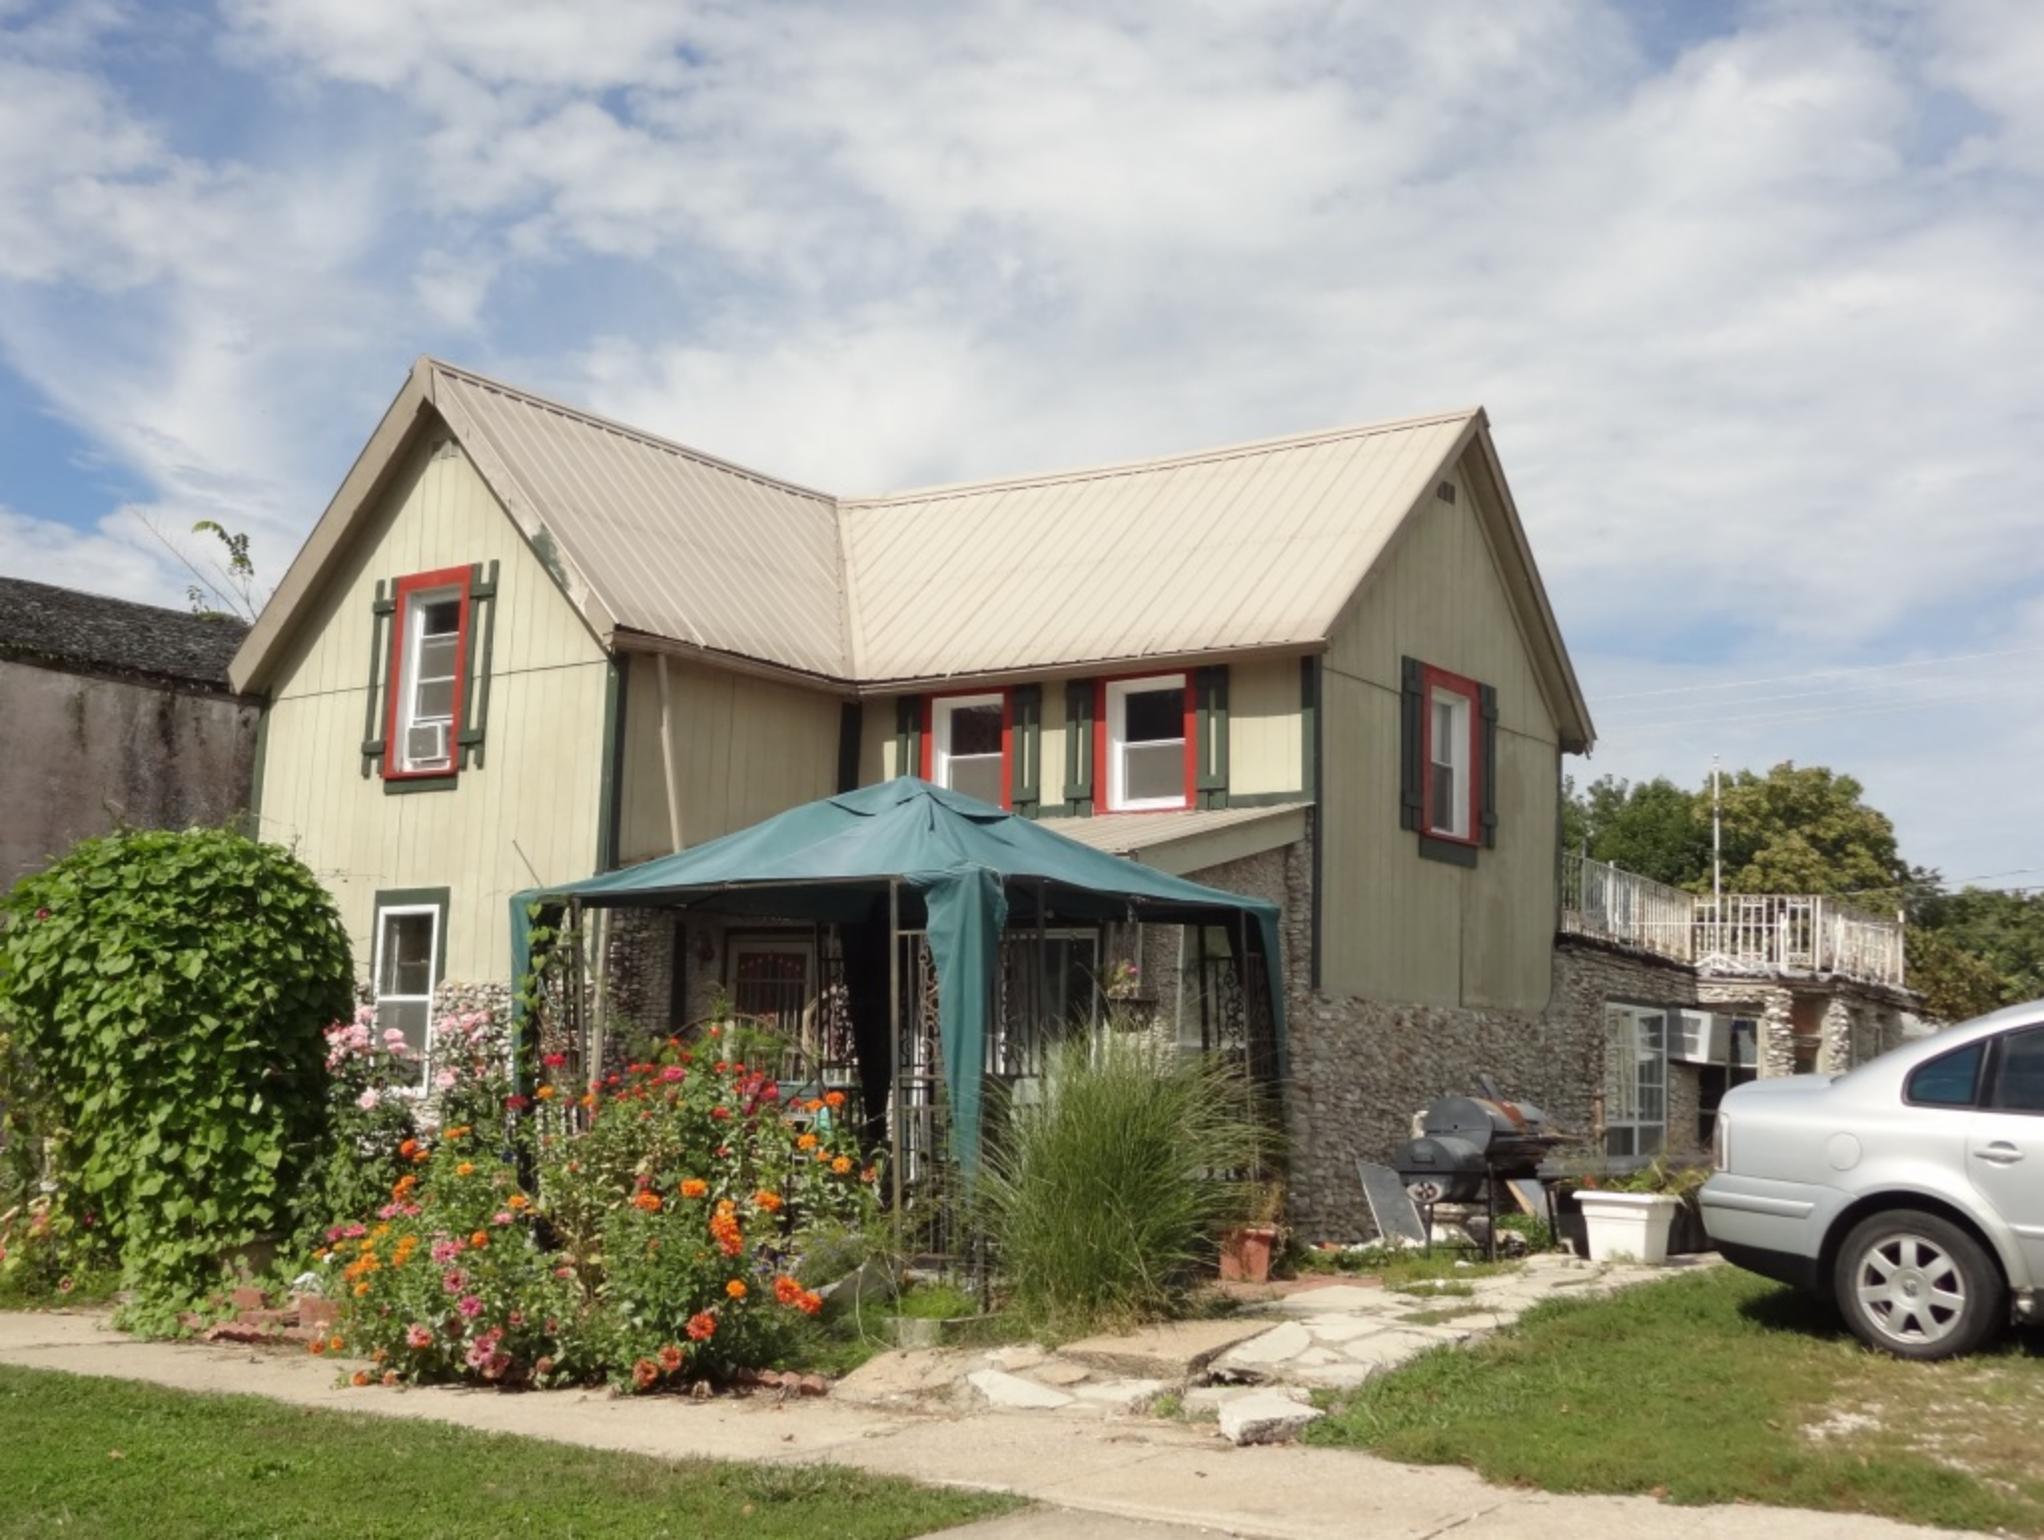
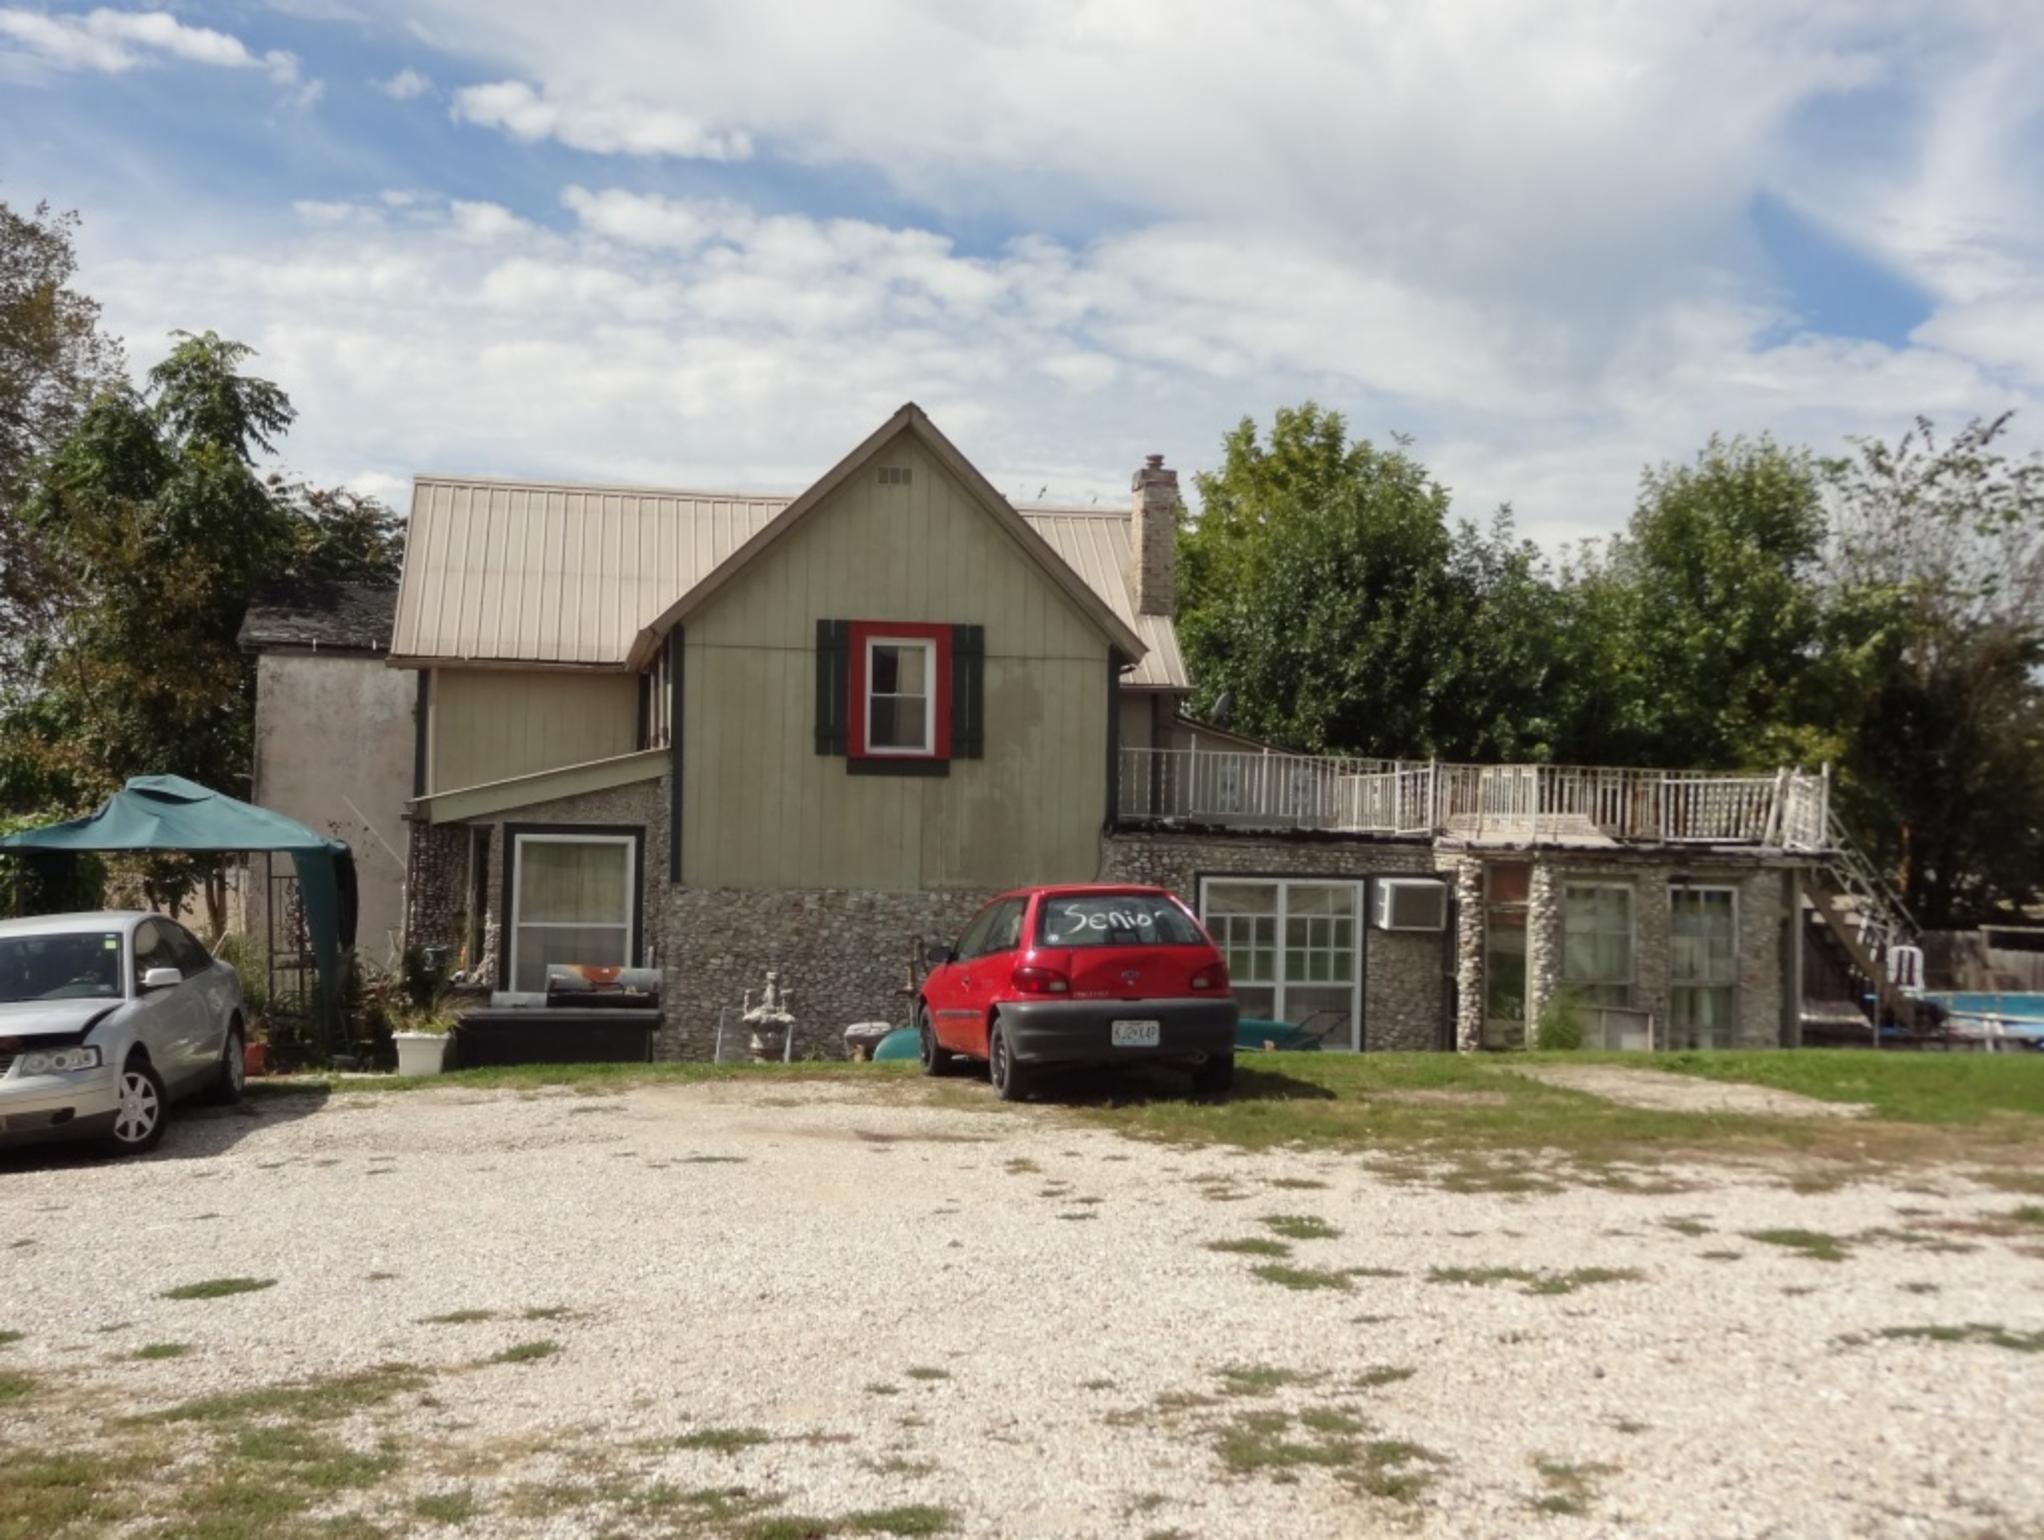
This two-story gabled ell house is clad with random rubble stonework and vertical wood plank siding. It has been heavily modified from its historic form. The front-gabled ell projects forward from the west side of the house and has one bay in each story. Both bays contain a non-historic 1/1 window. The second story window is flanked with thin wood planks applied as decorative shutters. The side-gabled eastern mass of the house has two bays on the first floor; the left bay contains a single non-historic entry door and the right contains two modern sliding glass doors. The first floor is covered by a shed roof porch with wrought iron railings. The second story contains two replacement 1/1 vinyl windows with wood plank decorative shutters. A one-story addition with a flat roof extends from the rear of the house. The addition is clad with random rubble stonework and a tall wrought iron railing lines the roofline.

The siding and windows have been replaced and the design of the house has been altered, rendering it ineligible for listing.

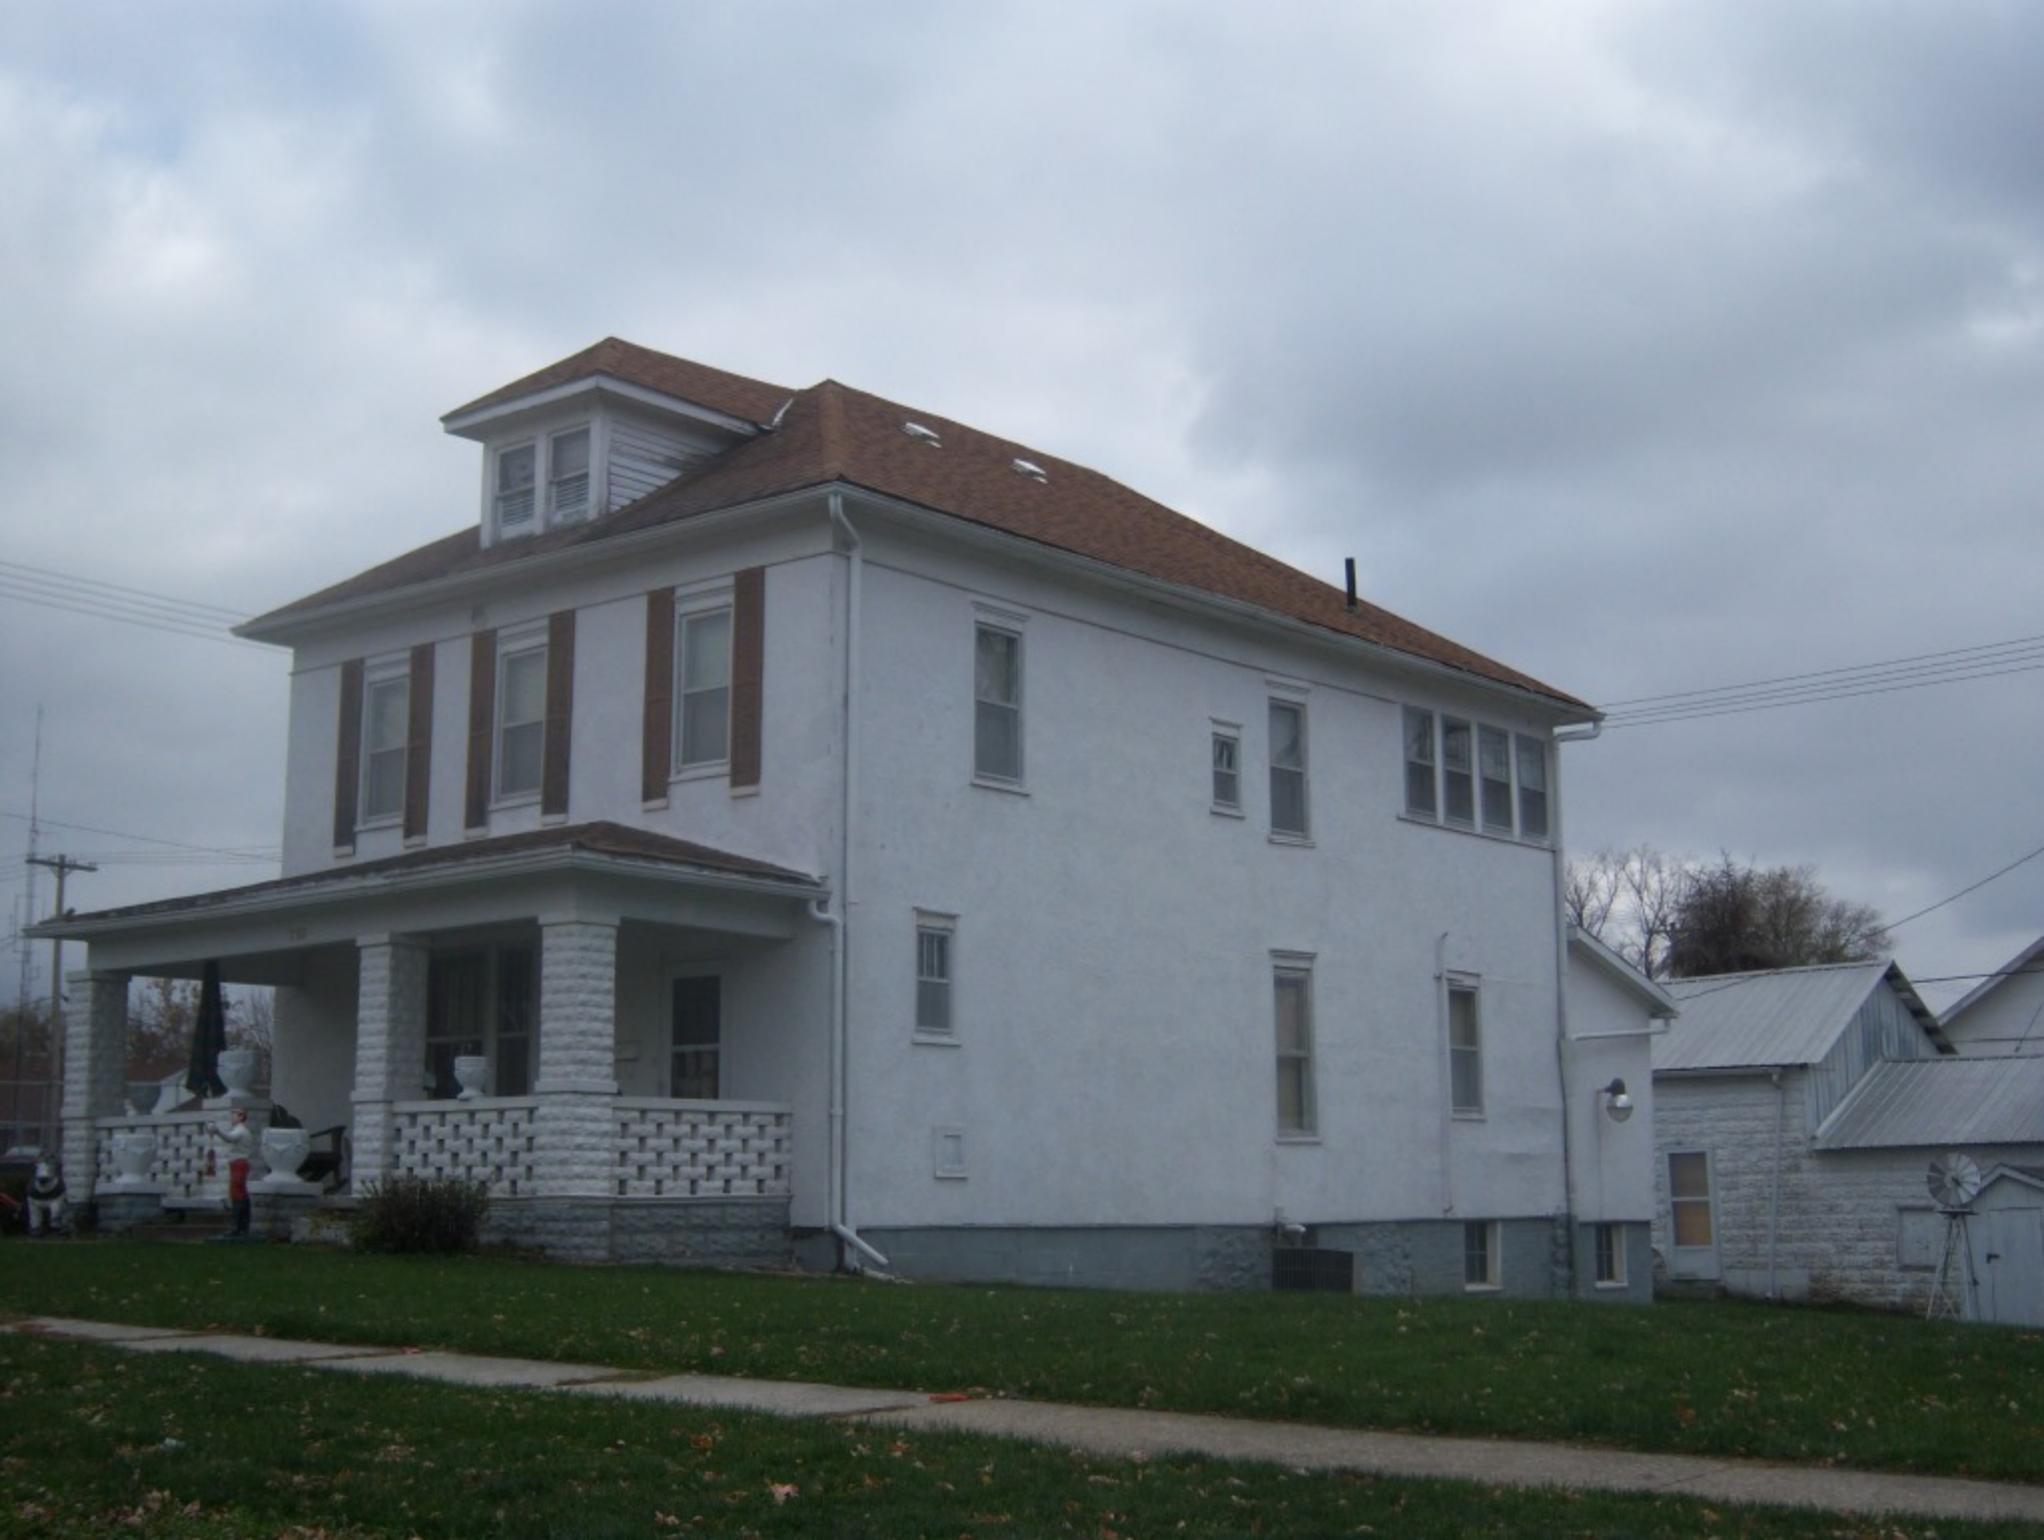
The two and a half story bungalow includes an asphalt hipped roof with a hipped front dormer composed of two one-over-one double-hung wood sash windows. The first floor contains two bays: a tripartite window composed of a center four-over-one double-hung wood sash window flanked on either side by a smaller three-over-one double-hung wood sash window and a wood and glass door obstructed by a vinyl storm door. The door opens onto a center partial width one-story porch with a low hipped asphalt roof supported by ashlar block square columns and balustrade set on a concrete deck. Urns are set on either side of the porch's entry. The second story includes three one-over-one double-hung wood sash with storm windows flanked by fixed vinyl shutters. From the west elevation, it appears that the dwelling may have been an American Foursquare which typically has a narrow depth. Two additions were added on, first the one-bay wide stone foundation addition and then the one-bay wide brick foundation addition which may have enclosed an early sleeping porch as indicated by the windows on the second floor. A rear one-story hipped addition was added c. 1902. The windows on the side elevations are irregular: one-over-one, four-over-one, and three-over-one double-hung wood sash windows. The foundation on the east is obstructed by bushes. The alterations appear to be historic.

This building may be contributing to a potential National Register historic residential district due to its age and retention of its historic fabric, but not applicable for a potential National Register commercial district.

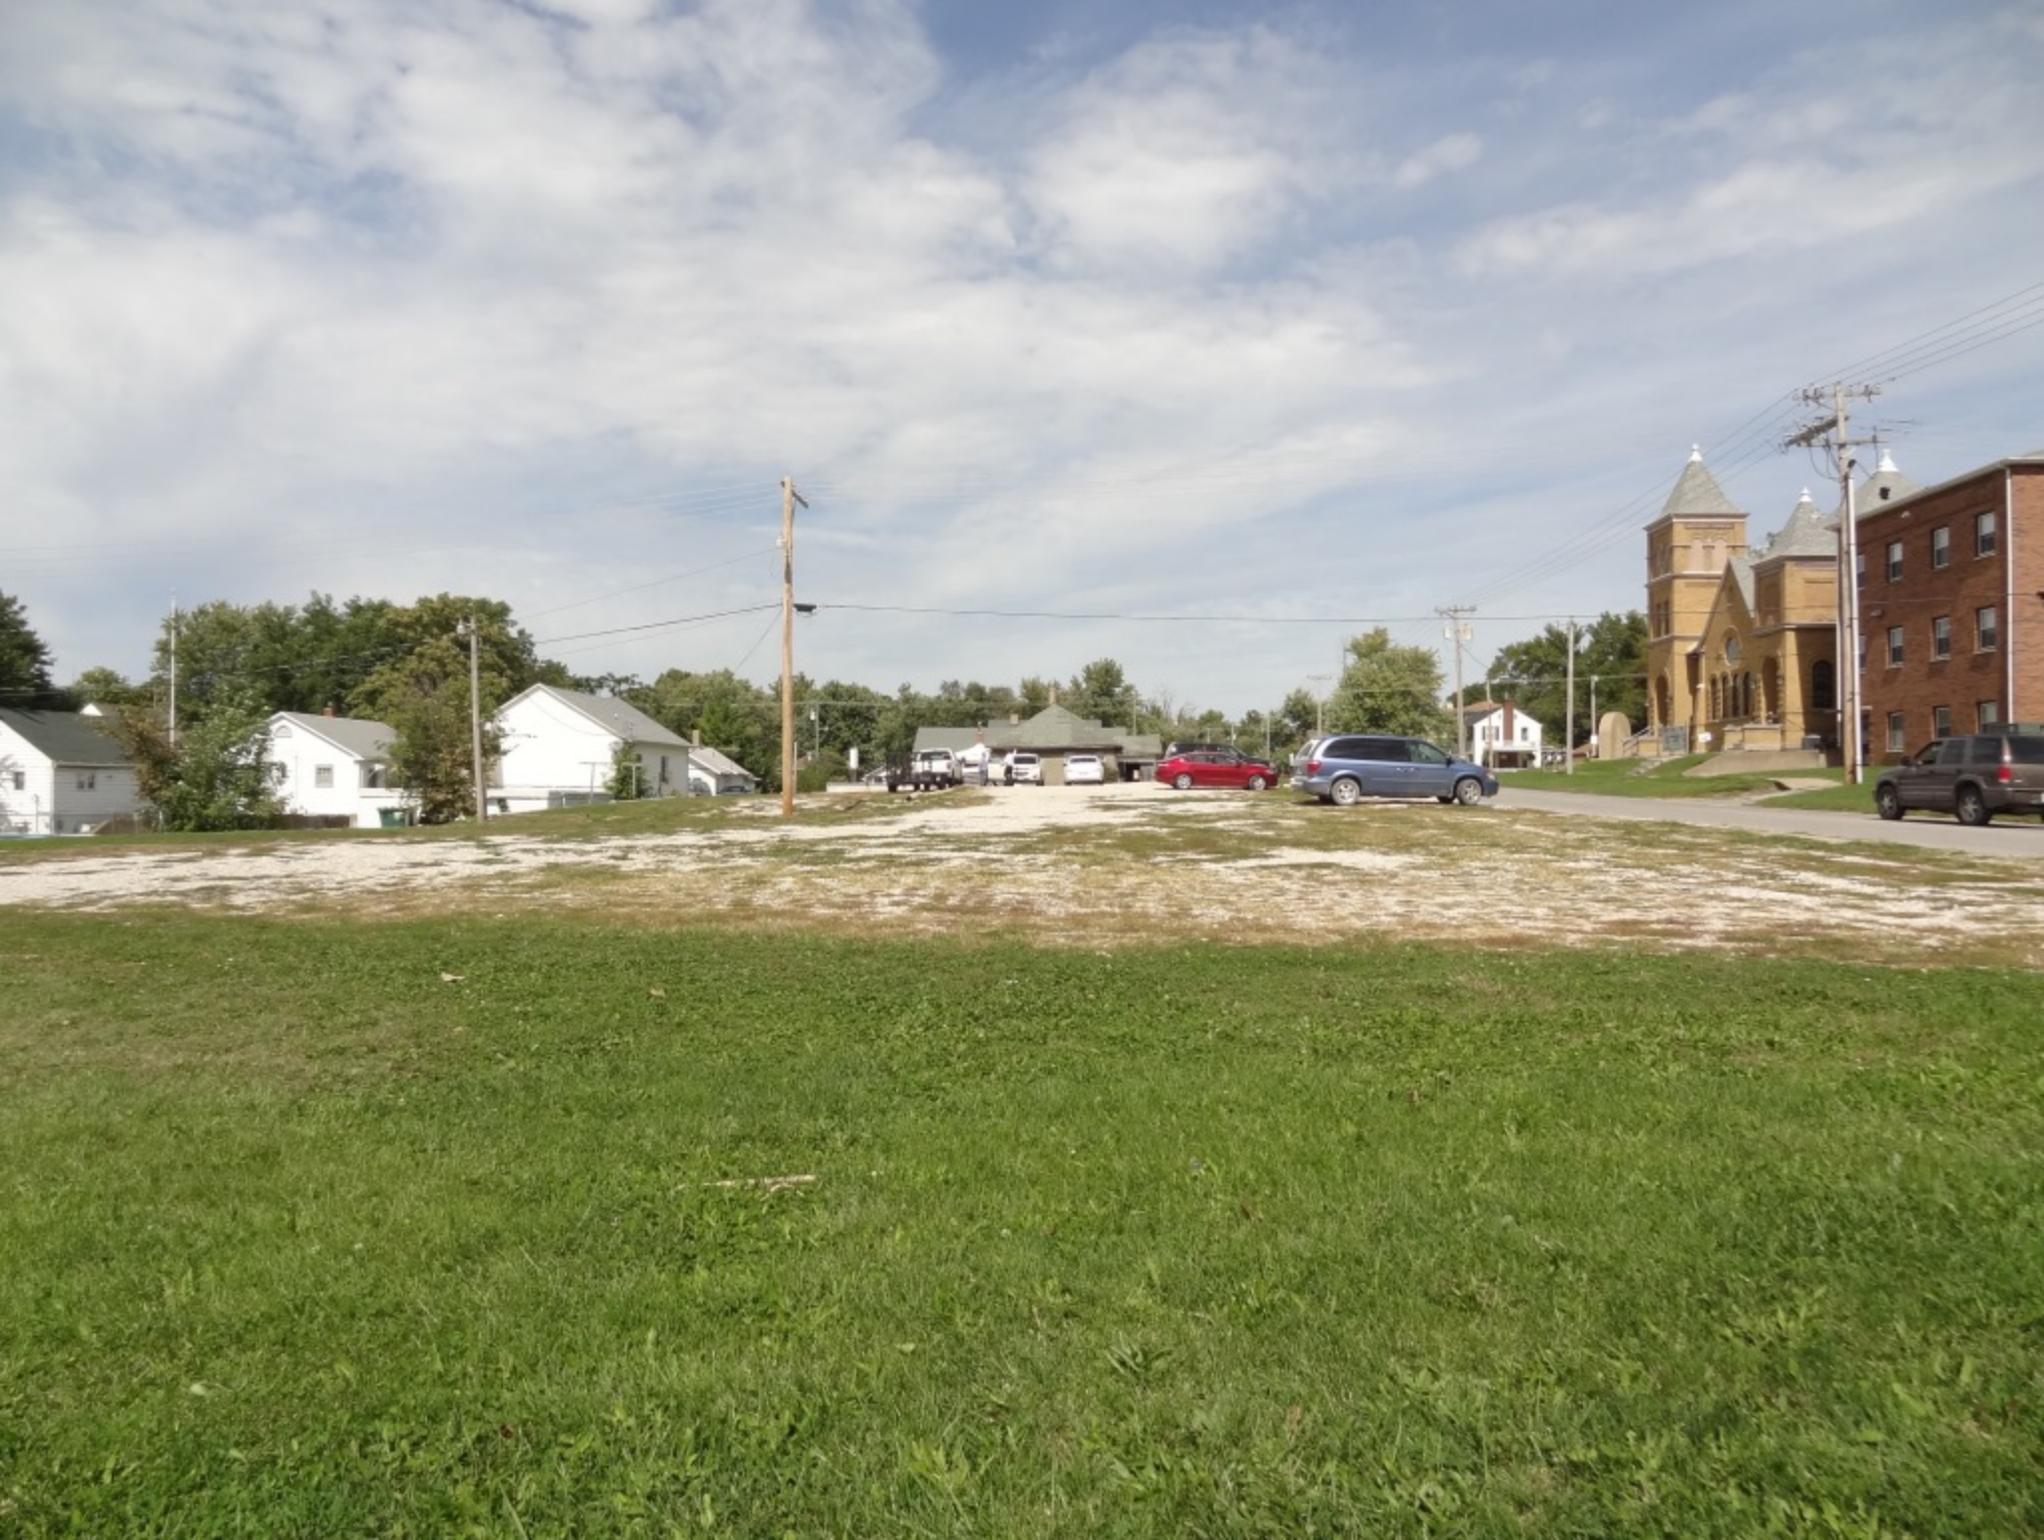
The parking lot is comprised of gravel and grass and has concrete curbing. The parcel's conversion to a parking lot is likely less than 50 years old; the lot is likely not eligible for listing.

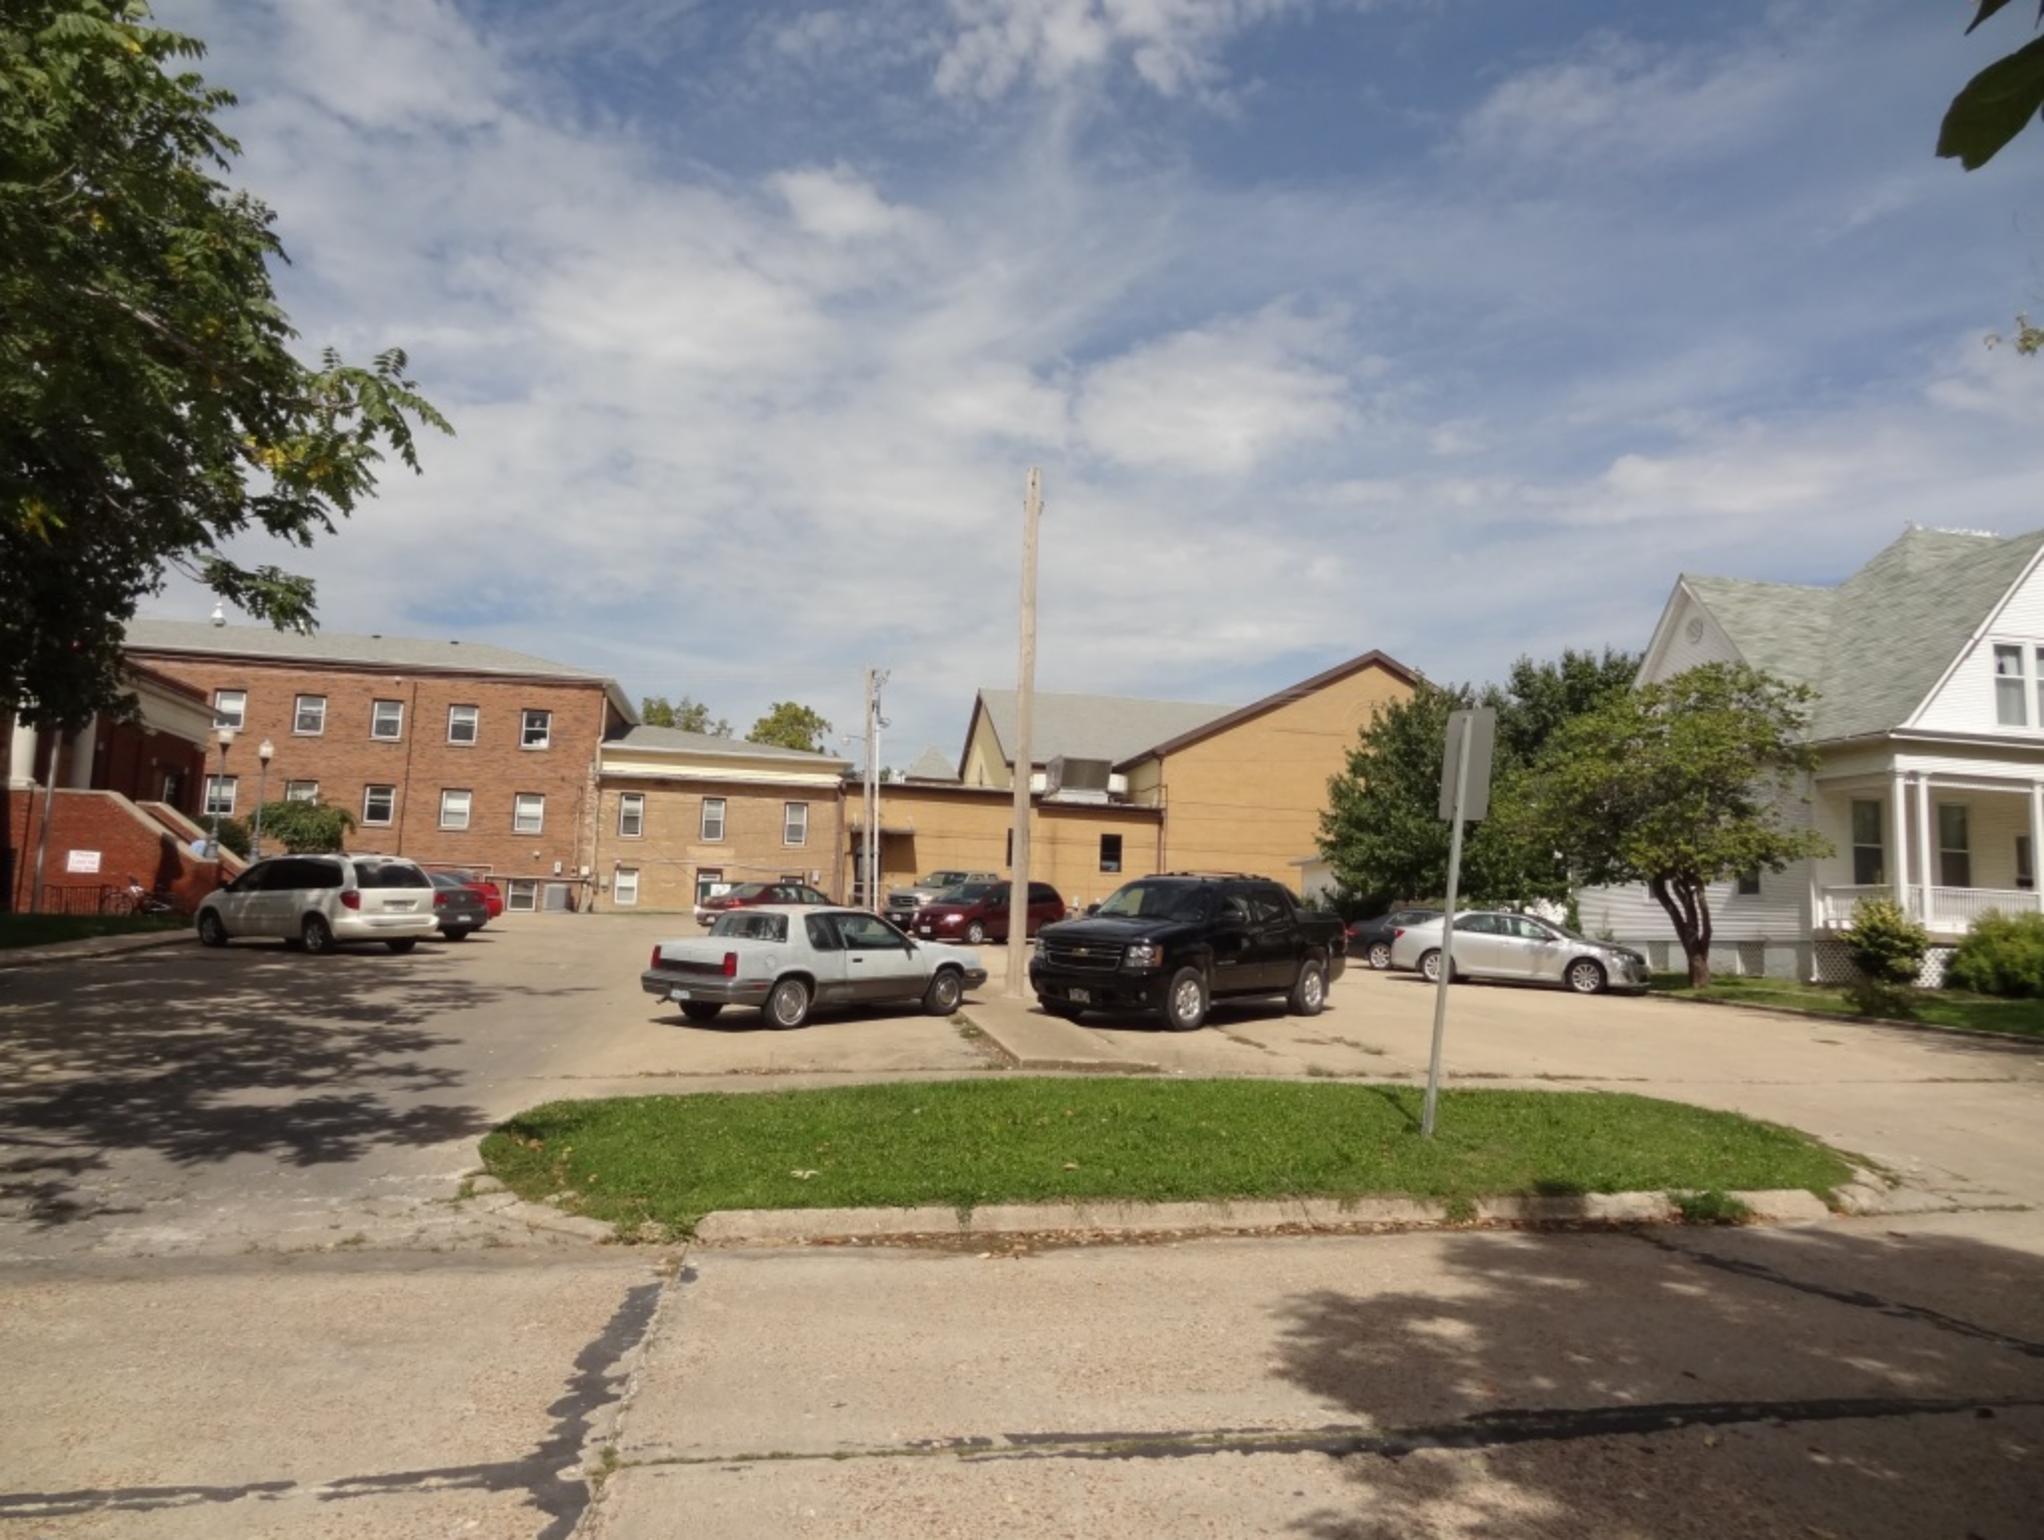
This paved parking lot features diagonally painted parking spaces and is used primarily by patrons of the Macon Public Library. It has two entrances from Butler Street and can also be accessed via the east-west alley to the north. It is owned by the First Baptist Church of Macon.

The lot historically contained a residence and is currently not eligible for listing.

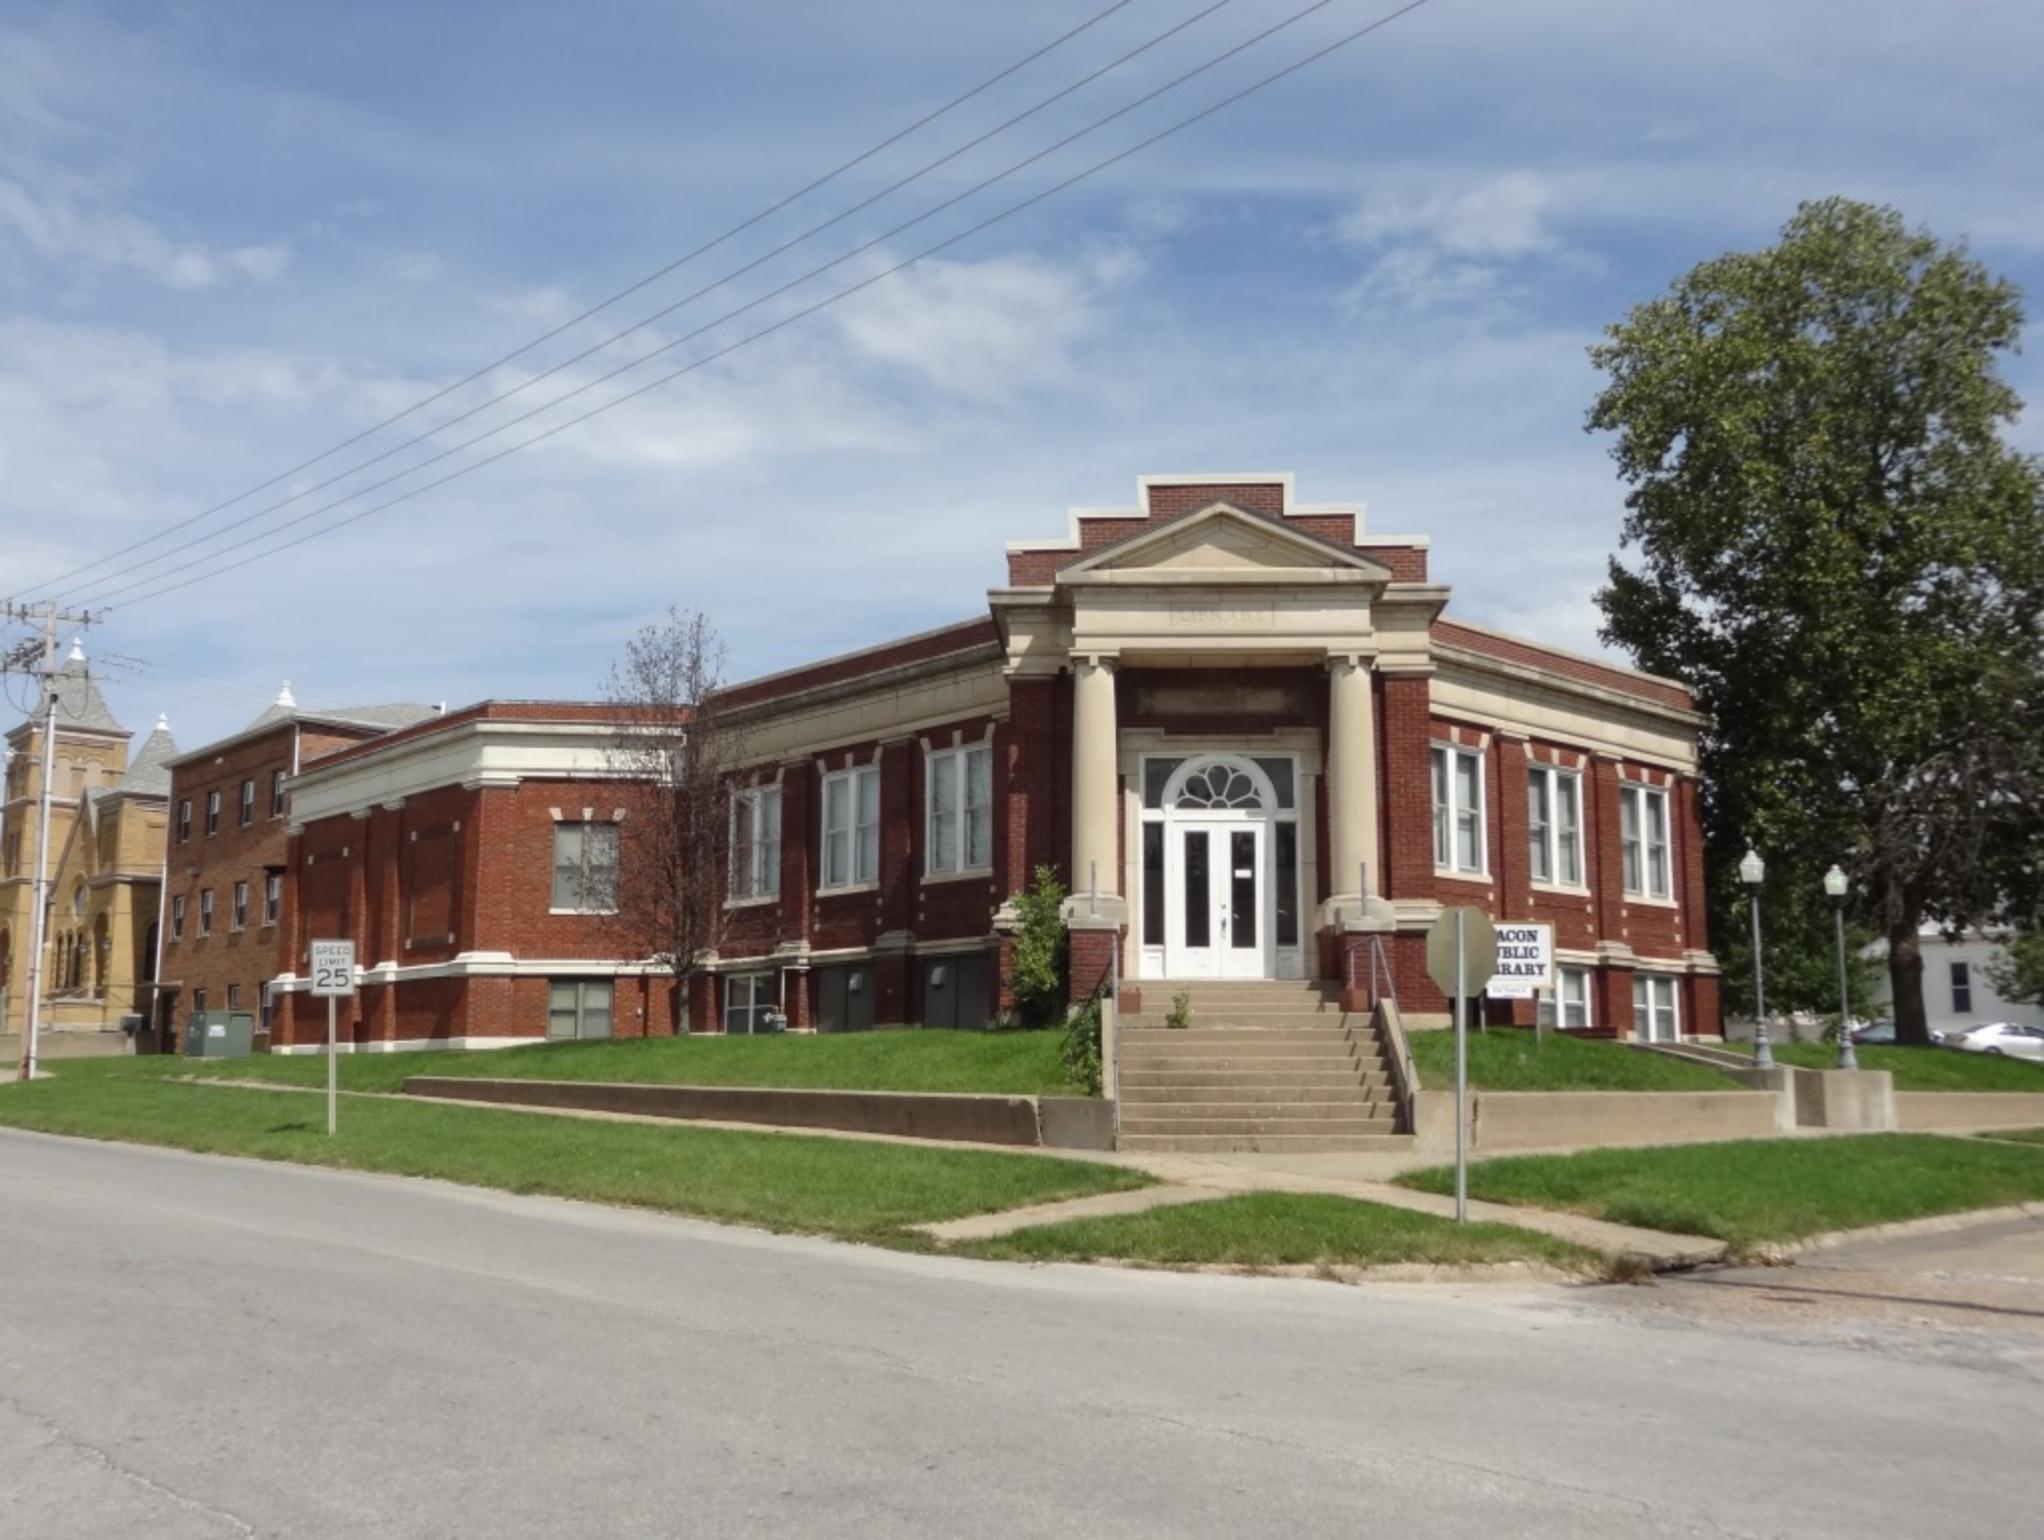
This one story Neoclassical Revival style library features a full basement and brick cladding with limestone foundation and architectural details. The historic mass of the building that dates to 1916 is generally square in shape with the primary entrance oriented to the southwest towards the intersection of Butler and N. Rutherford Streets. The historic west elevation contains three bays at the basement and main levels. The bays are separated by brick piers with limestone bases and capitals. The southernmost basement windows are infilled; the northern basement window contains paired replacement 1/1 windows. A limestone stringcourse delineates the basement and the main level. The main level windows feature paired double-hung 1/1 wooden sash with limestone sills and flat arch lintels articulated with soldier bricks and limestone keystones. Rowlock brick rectangles with limestone corners decorate the space below the windows. The building features a heavy limestone entablature topped by a low brick parapet with limestone coping. The southwest entrance is sheltered by a portico supported by two Tuscan limestone columns set on brick piers. The heavy entablature continues across the entrance and is inscribed with the word "LIBRARY". A limestone pediment backed by a stepped brick parapet with limestone coping further defines the primary entrance. The entrance is comprised of double leaf historic wood and glass doors flanked by single light sidelights. A large multi-light fanlight tops the doors. The entrance has a limestone surround, and the year in Roman numerals is inscribed into a limestone panel above the doors. The entrance projects forward, creating one bay on each side that contains paired 1/1 windows at the basement and main levels. The main level of the south elevation is identical to that of the north. The basement level contains, from west to east, a modern glass and aluminum entry door sheltered by a metal awning, and paired 1/1 windows in the other two bays. An addition, sympathetic in design, materials, and scale, was attached to the northern elevation of the historic building in 1995.

This building retains architectural integrity and may contribute to a potential National Register historic district. The property may be individually eligible for listing for Social History (the building has served as Macon's library since 1916); the non-historic two-story addition would need to be evaluated when assessing integrity under Criterion A.
