1. Survey No. MC-AS-001-001		2. Survey name: Downtown Macon Commercial Historic District	
3. County: Macon		4. Address (Street No.) Lots 11-13 block 93	Street (name) East Bourke Street (100 block)
5. City: Macon	Vicinity: <input type="checkbox"/>	6. Geographical Reference:	7. Township/Range/Section: T: R: S:
8. Historic name (if known):		9. Present/other name (if known): City of Macon Parking Lot #3	
10. Ownership: <input checked="" type="checkbox"/> Private <input type="checkbox"/> Public		11a. Historic use (if known): Commercial	11b. Current use: vacant

42. Current owner/address: City of Macon Macon, MO 63552	43. Form prepared by (name and org.): Kristi Chase MO SHPO	44. Survey date: 9/24/2014
		45. Date of revisions:

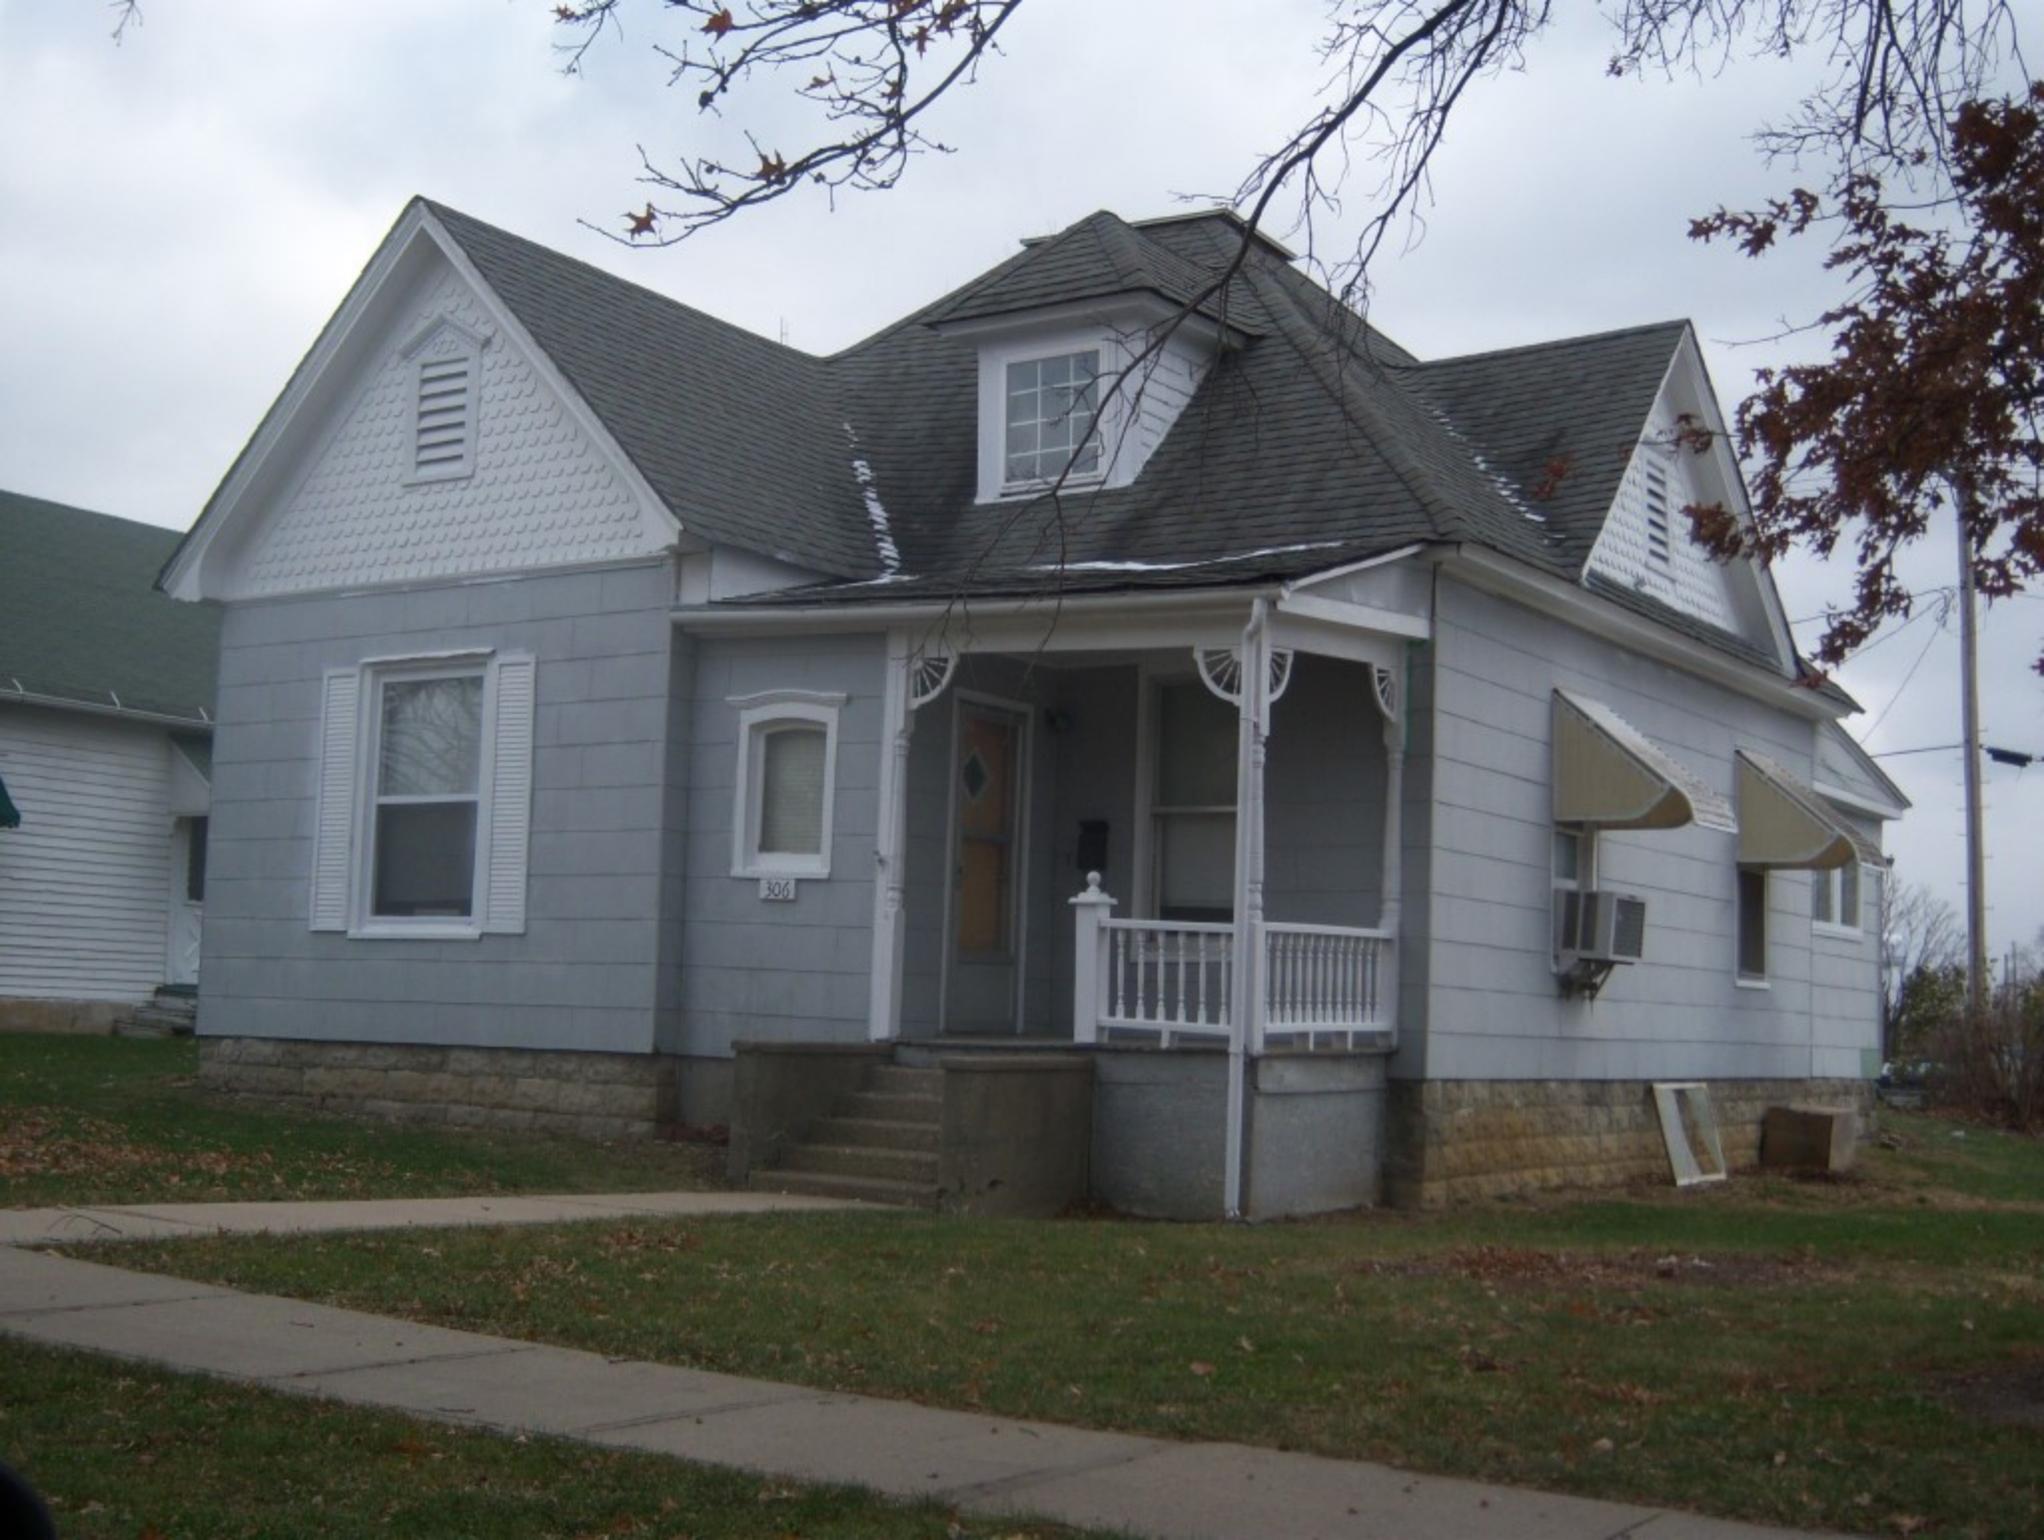
This one and a half story dwelling contains an asphalt pyramidal hipped roof with a projecting front gable, a side gable dormer, and a rear one-story shed addition. The dwelling contains a full basement with an ashlar block foundation. The first floor contains three bays: a one-over-one double-hung window in the projecting gable, a small fixed wood window, and a one-over-one double-hung wood sash window. The fixed window includes a slightly curved sash with molding and is located on the partially enclosed porch that provides a side entry into the dwelling. The front entry includes a wood door with diamond-shaped light and opens onto a partial porch on the right side of the façade. The shed roof porch includes a wood deck and plywood walls and modern turned columns and balustrade and spindle work along the cornice. Concrete steps lead up to the porch. On the half story, the projecting gable includes scalloped shingles and a decorative vent, and on the main roof line is a hipped dormer with a fixed vinyl window.

Along the west elevation includes two one-over-one double-hung wood sash windows with Plexiglas awnings on the first floor and a cross gable with scalloped shingles and a vent are on the half story. The rear shed addition with a vinyl window is visible. The west elevation contains three bays: two one-over-one double-hung wood sash windows and a projecting one-story hipped bay with a window opening (not visible). The majority of the historic wood sash windows contain storm coverings.

This building may be contributing to a potential National Register historic residential district due to its age and retention of its historic fabric, but not applicable for a potential National Register commercial district.

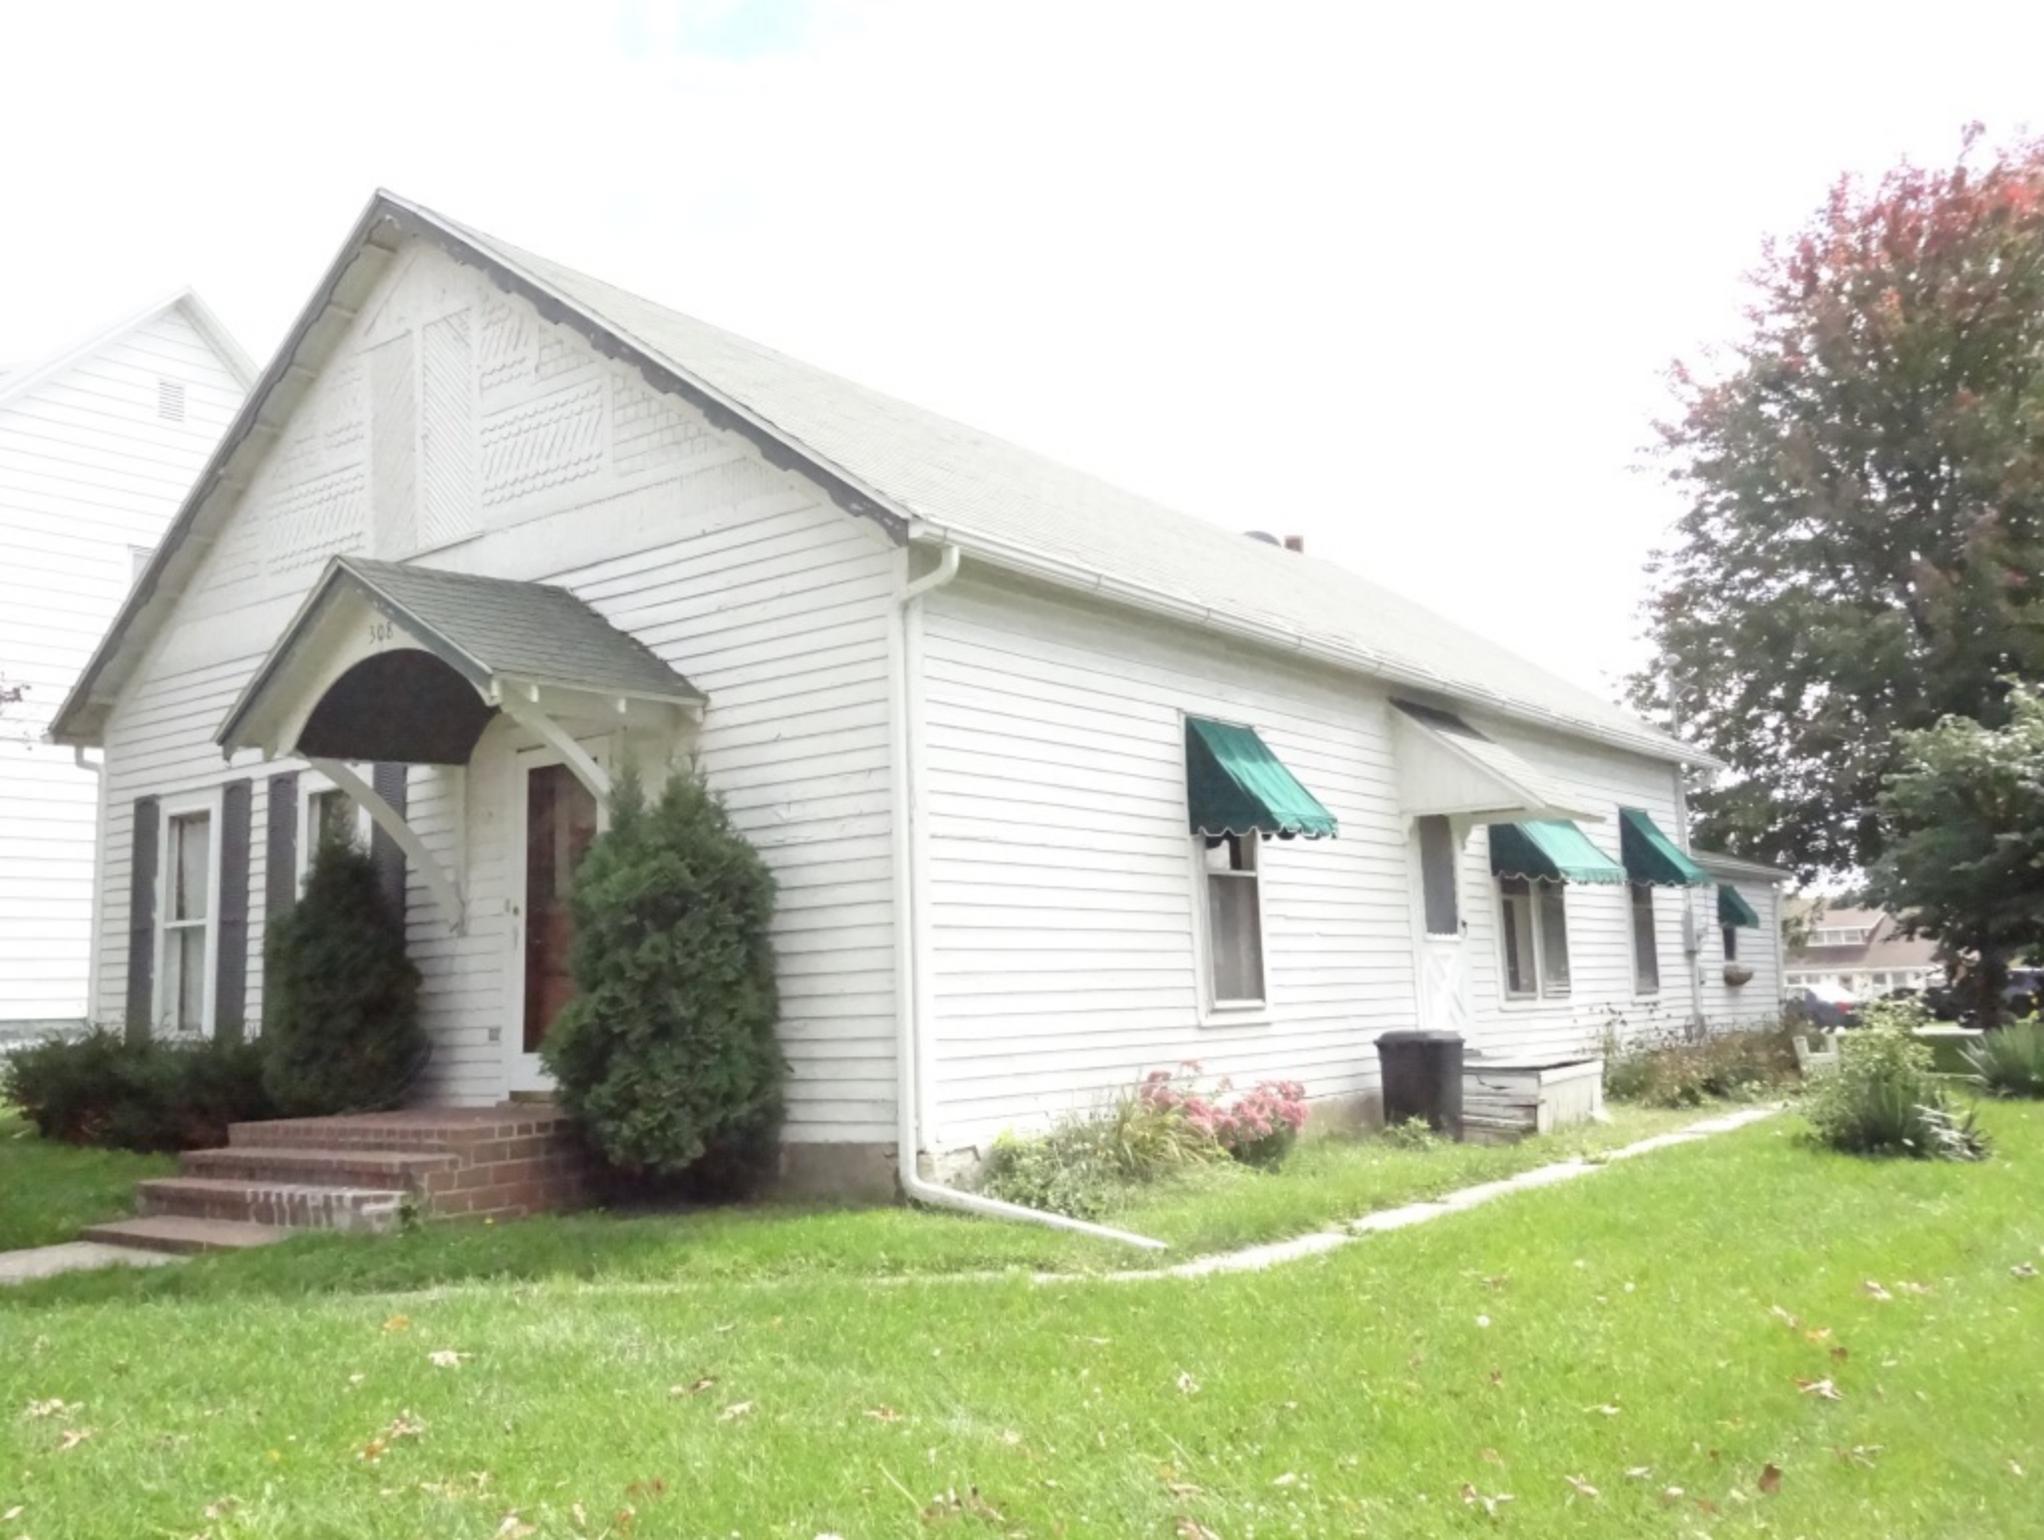
The front gable one-story frame dwelling contains clapboard siding with various decoratively shaped shingles on the gable end with carved cornice trim. It sits on a concrete parged foundation. The façade includes three bays: two one-over-one double-hung wood sash windows with fixed vinyl shutters and a front entry. The entry includes a wood paneled door with a rectangular light covered by a storm door. Above the door is a gable hood with visible rafters and curved brackets. The door opens out onto a brick stoop with four steps that connects to the concrete sidewalk that leads to the street sidewalk. In the gable end are decorative shingles in various designs: shakes, octagon, ball, and sawtooth.

This building may be contributing to a potential National Register historic residential district due to its age and retention of its historic fabric, but not applicable for a potential National Register commercial district.

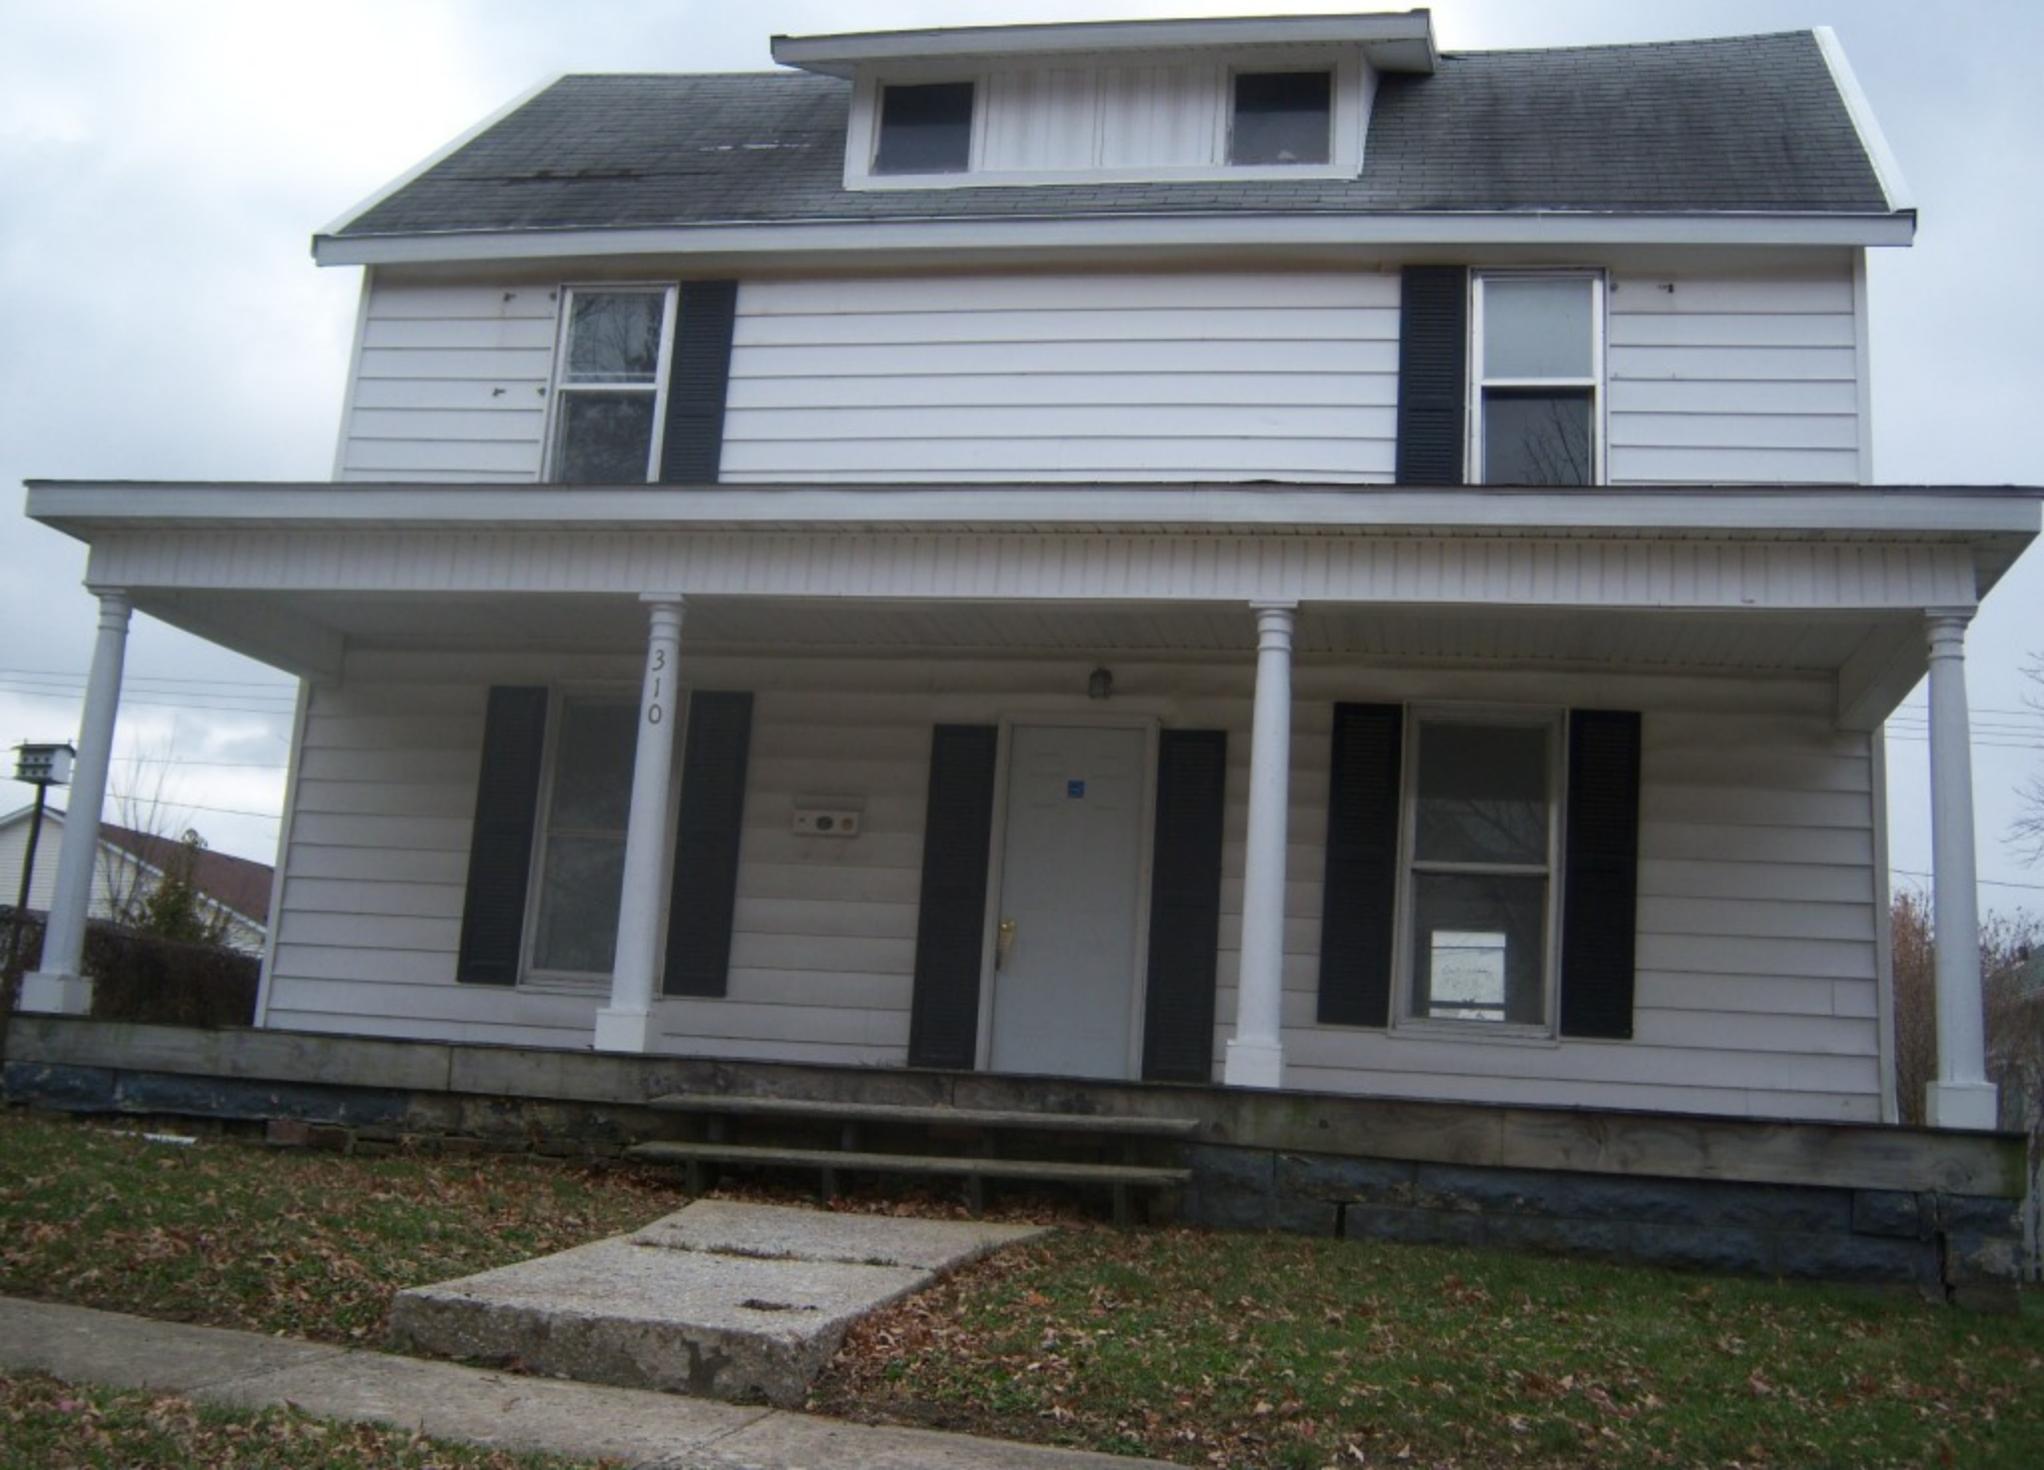
The two-and-half story asphalt side gable dwelling contains vinyl siding and sits on a concrete foundation. The dwelling contains three bays on the façade: a center entry with a vinyl door and fixed vinyl shutters flanked on either side by one-over one double-hung wood sash windows with fixed vinyl shutters. The entry opens onto a full width asphalt roof porch with an ashlar block base and wood deck. The cornice contains vinyl siding and is supported by four tapered Tuscan columns on square bases. The upper story includes two one-over-one double-hung wood sash windows with single fixed vinyl shutter on each. At the roof line, is a shed dormer with four bays: two center openings have been enclosed and the outer openings contain a single fixed window.

The east elevation is one bay wide: with a one-over-one double-hung wood sash window on the first and second floor. A small metal one-over-one double-hung window is located at the southeast corner of the dwelling. The rear of the building contains a one-story addition and a two-story ell. The windows contain storm coverings.

The modern alteration has resulted in a loss of integrity, rendering the property non-contributing to a potential National Register historic residential district, and is not applicable to a commercial district.

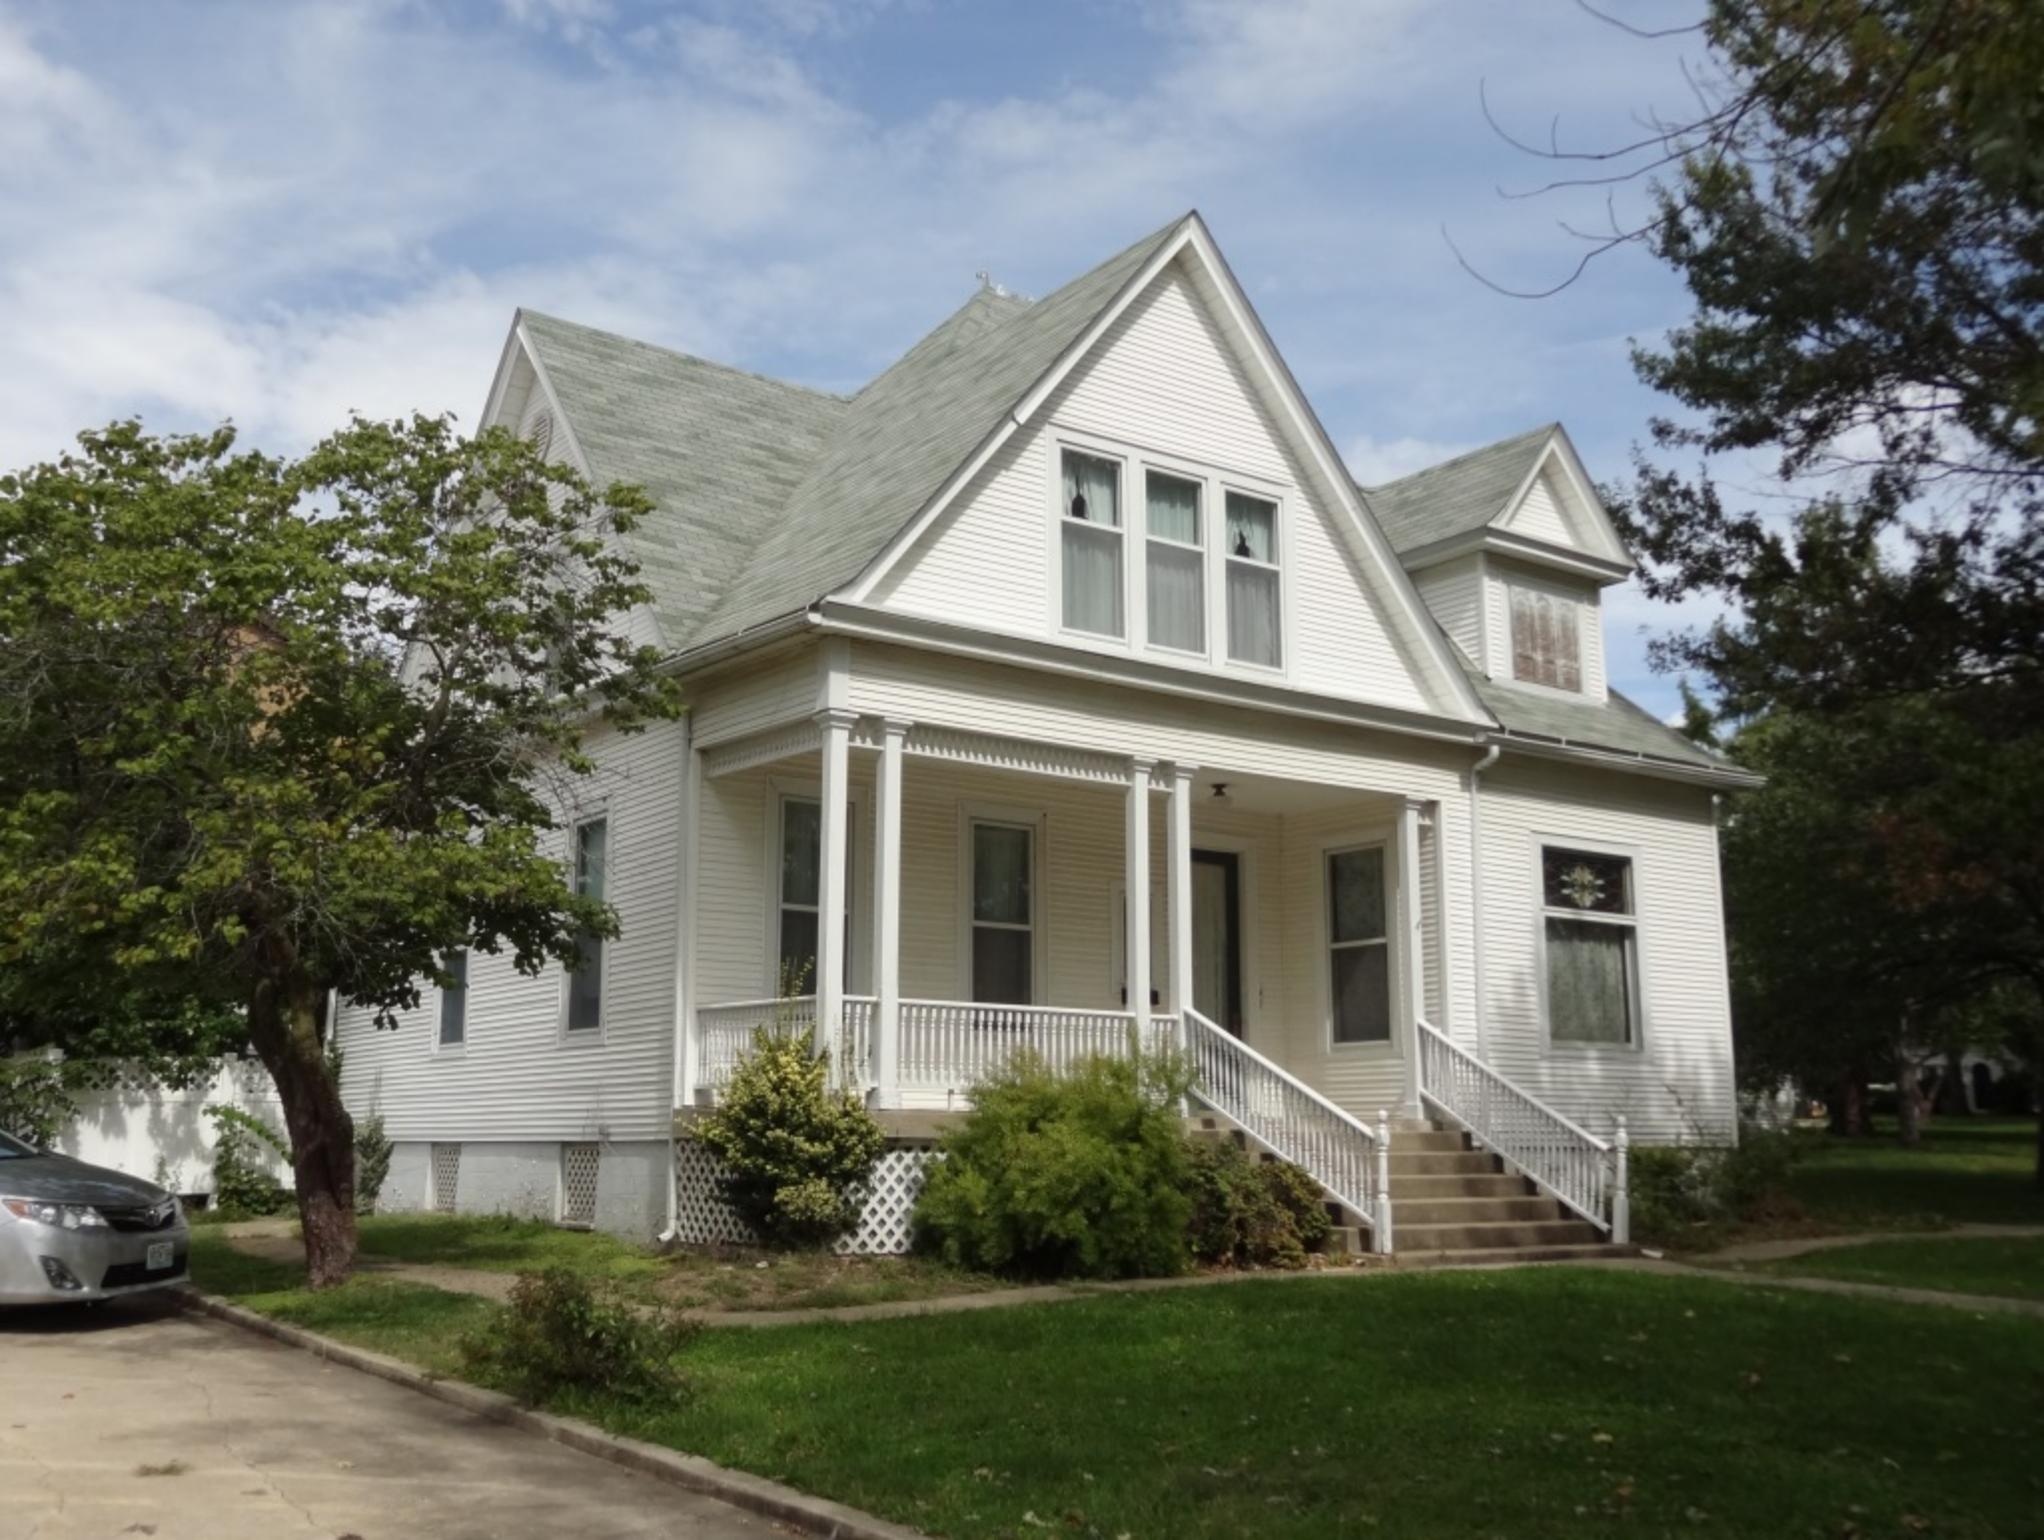
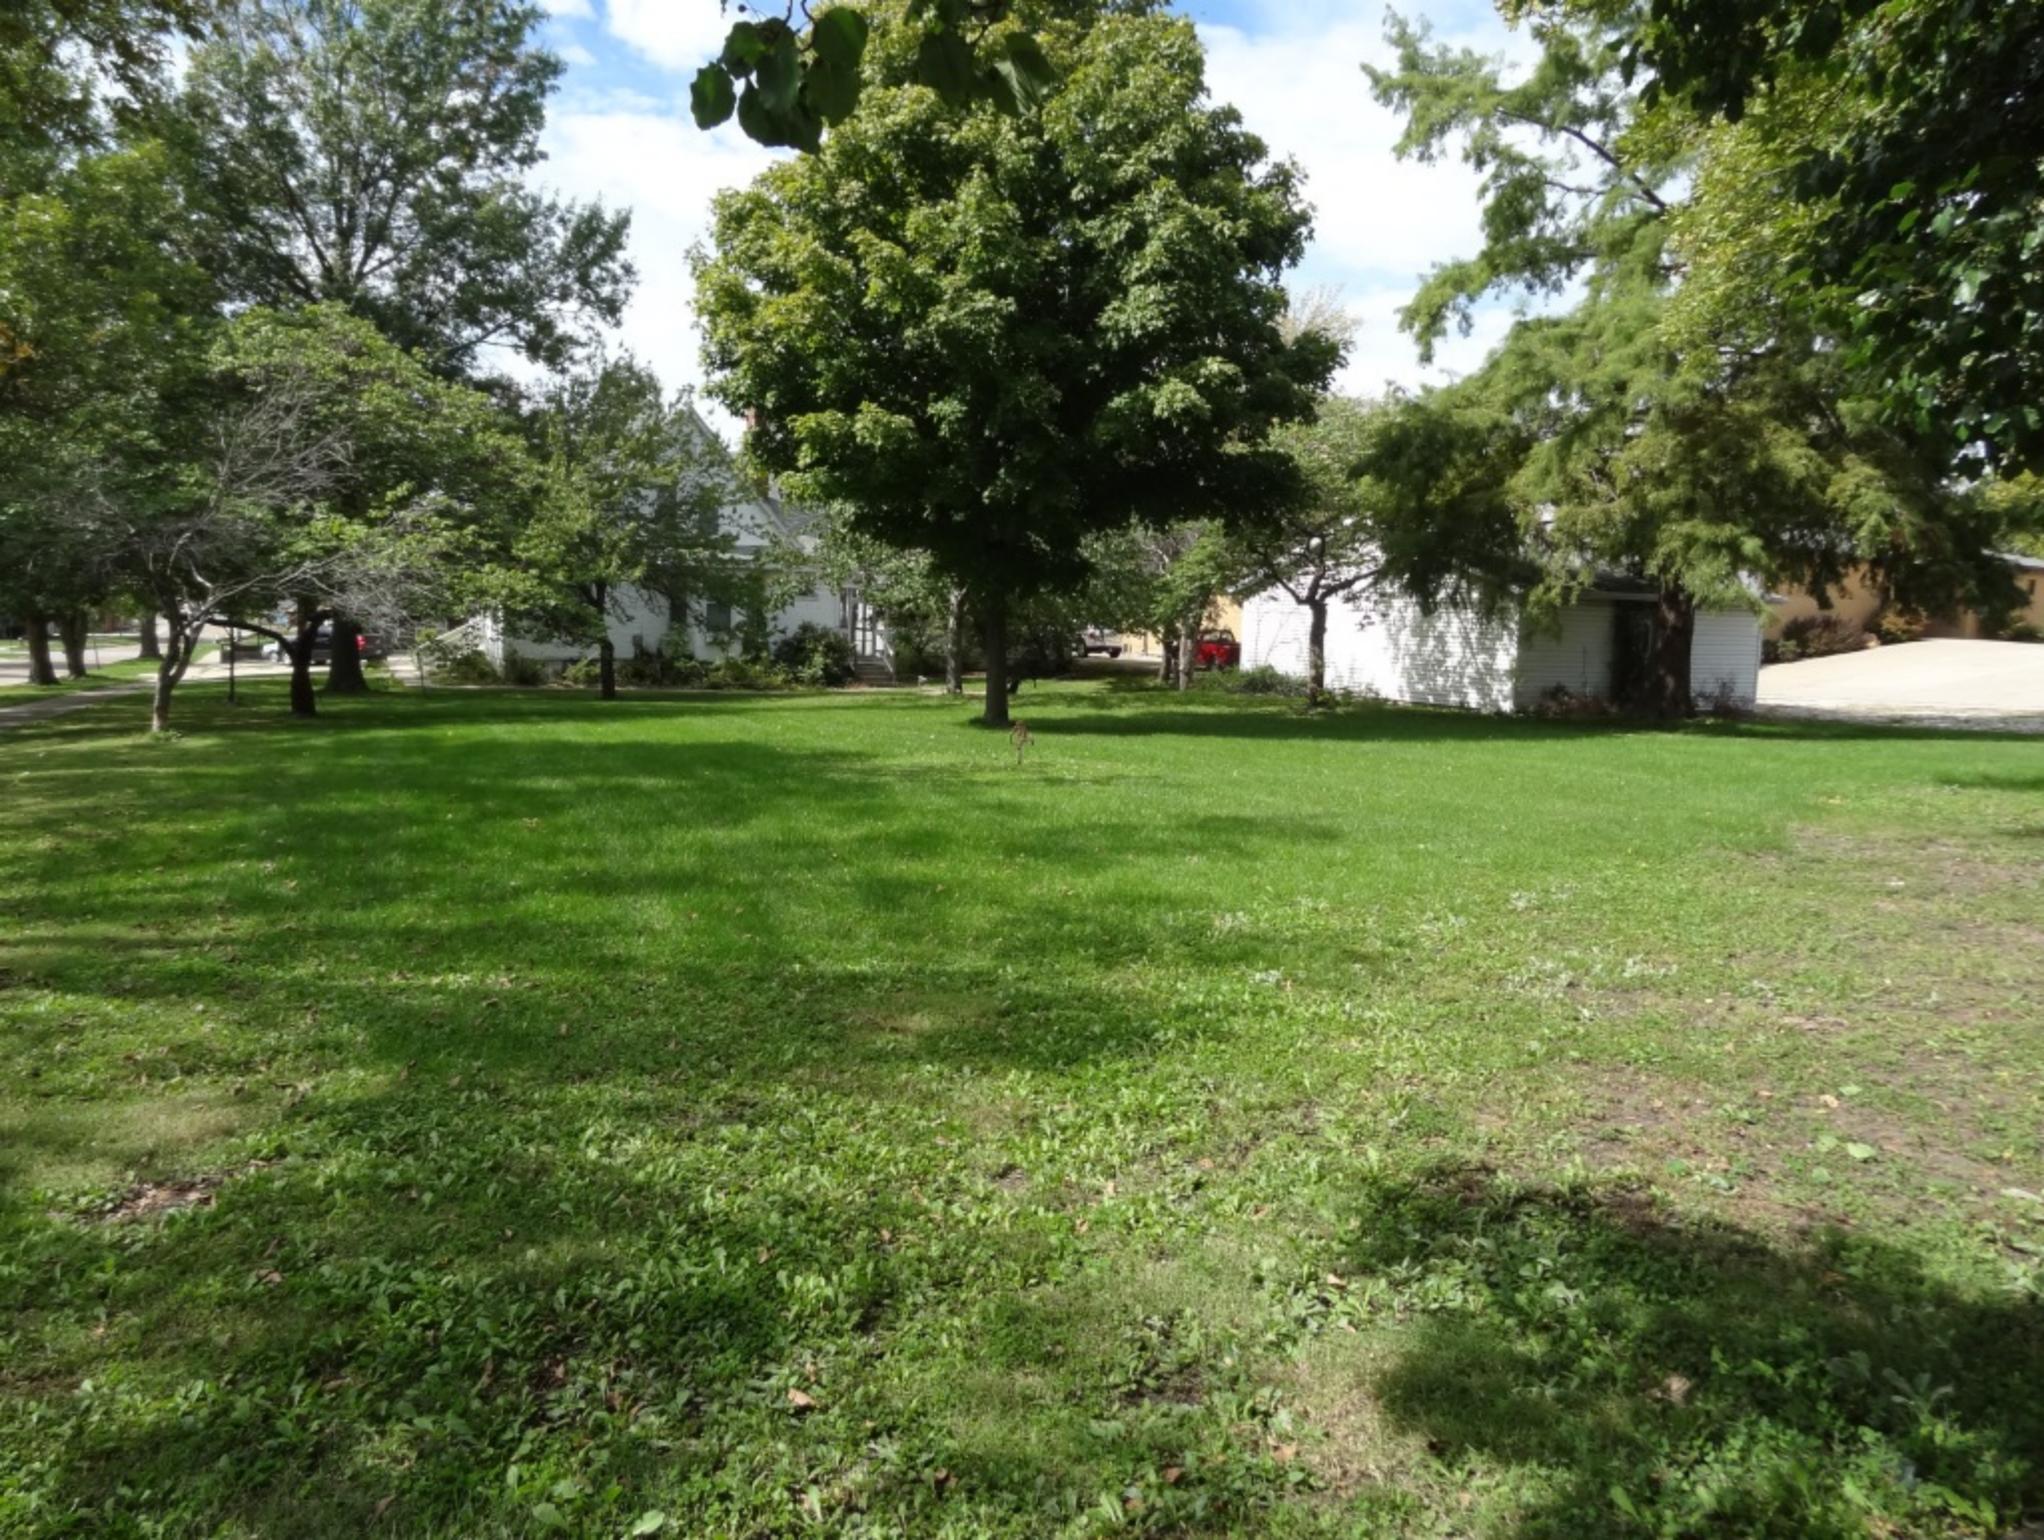
This 1½ story Queen Anne cottage has an asphalt shingle high hipped roof with cross gables and is clad with vinyl siding. The primary façade has five bays. From west to east, the first two bays contain replacement 1/1 windows. The third bay contains a historic wood door with a large glass light. To the left of the door is a small stained glass window. The fourth bay faces west and contains a replacement 1/1 window. The fifth bay contains a 1/1 window, with the upper sash containing a stained glass panel. The first three bays are sheltered under a recessed porch. The porch is supported by five thin wood posts spanned with a balustrade with turned wood spindles. Seven concrete steps flanked with wood railing lead up to the porch. The upper ½ story contains a cross gable with three paired 1/1 windows. A small dormer projects from the roof above the fifth bay. It is filled in with three small wood shutters.

The historic wood siding has been covered or replaced with vinyl siding, but the overall massing and design of the house is intact. The house may contribute to a potential residential historic district, but likely would not contribute to a commercial National Register historic district.

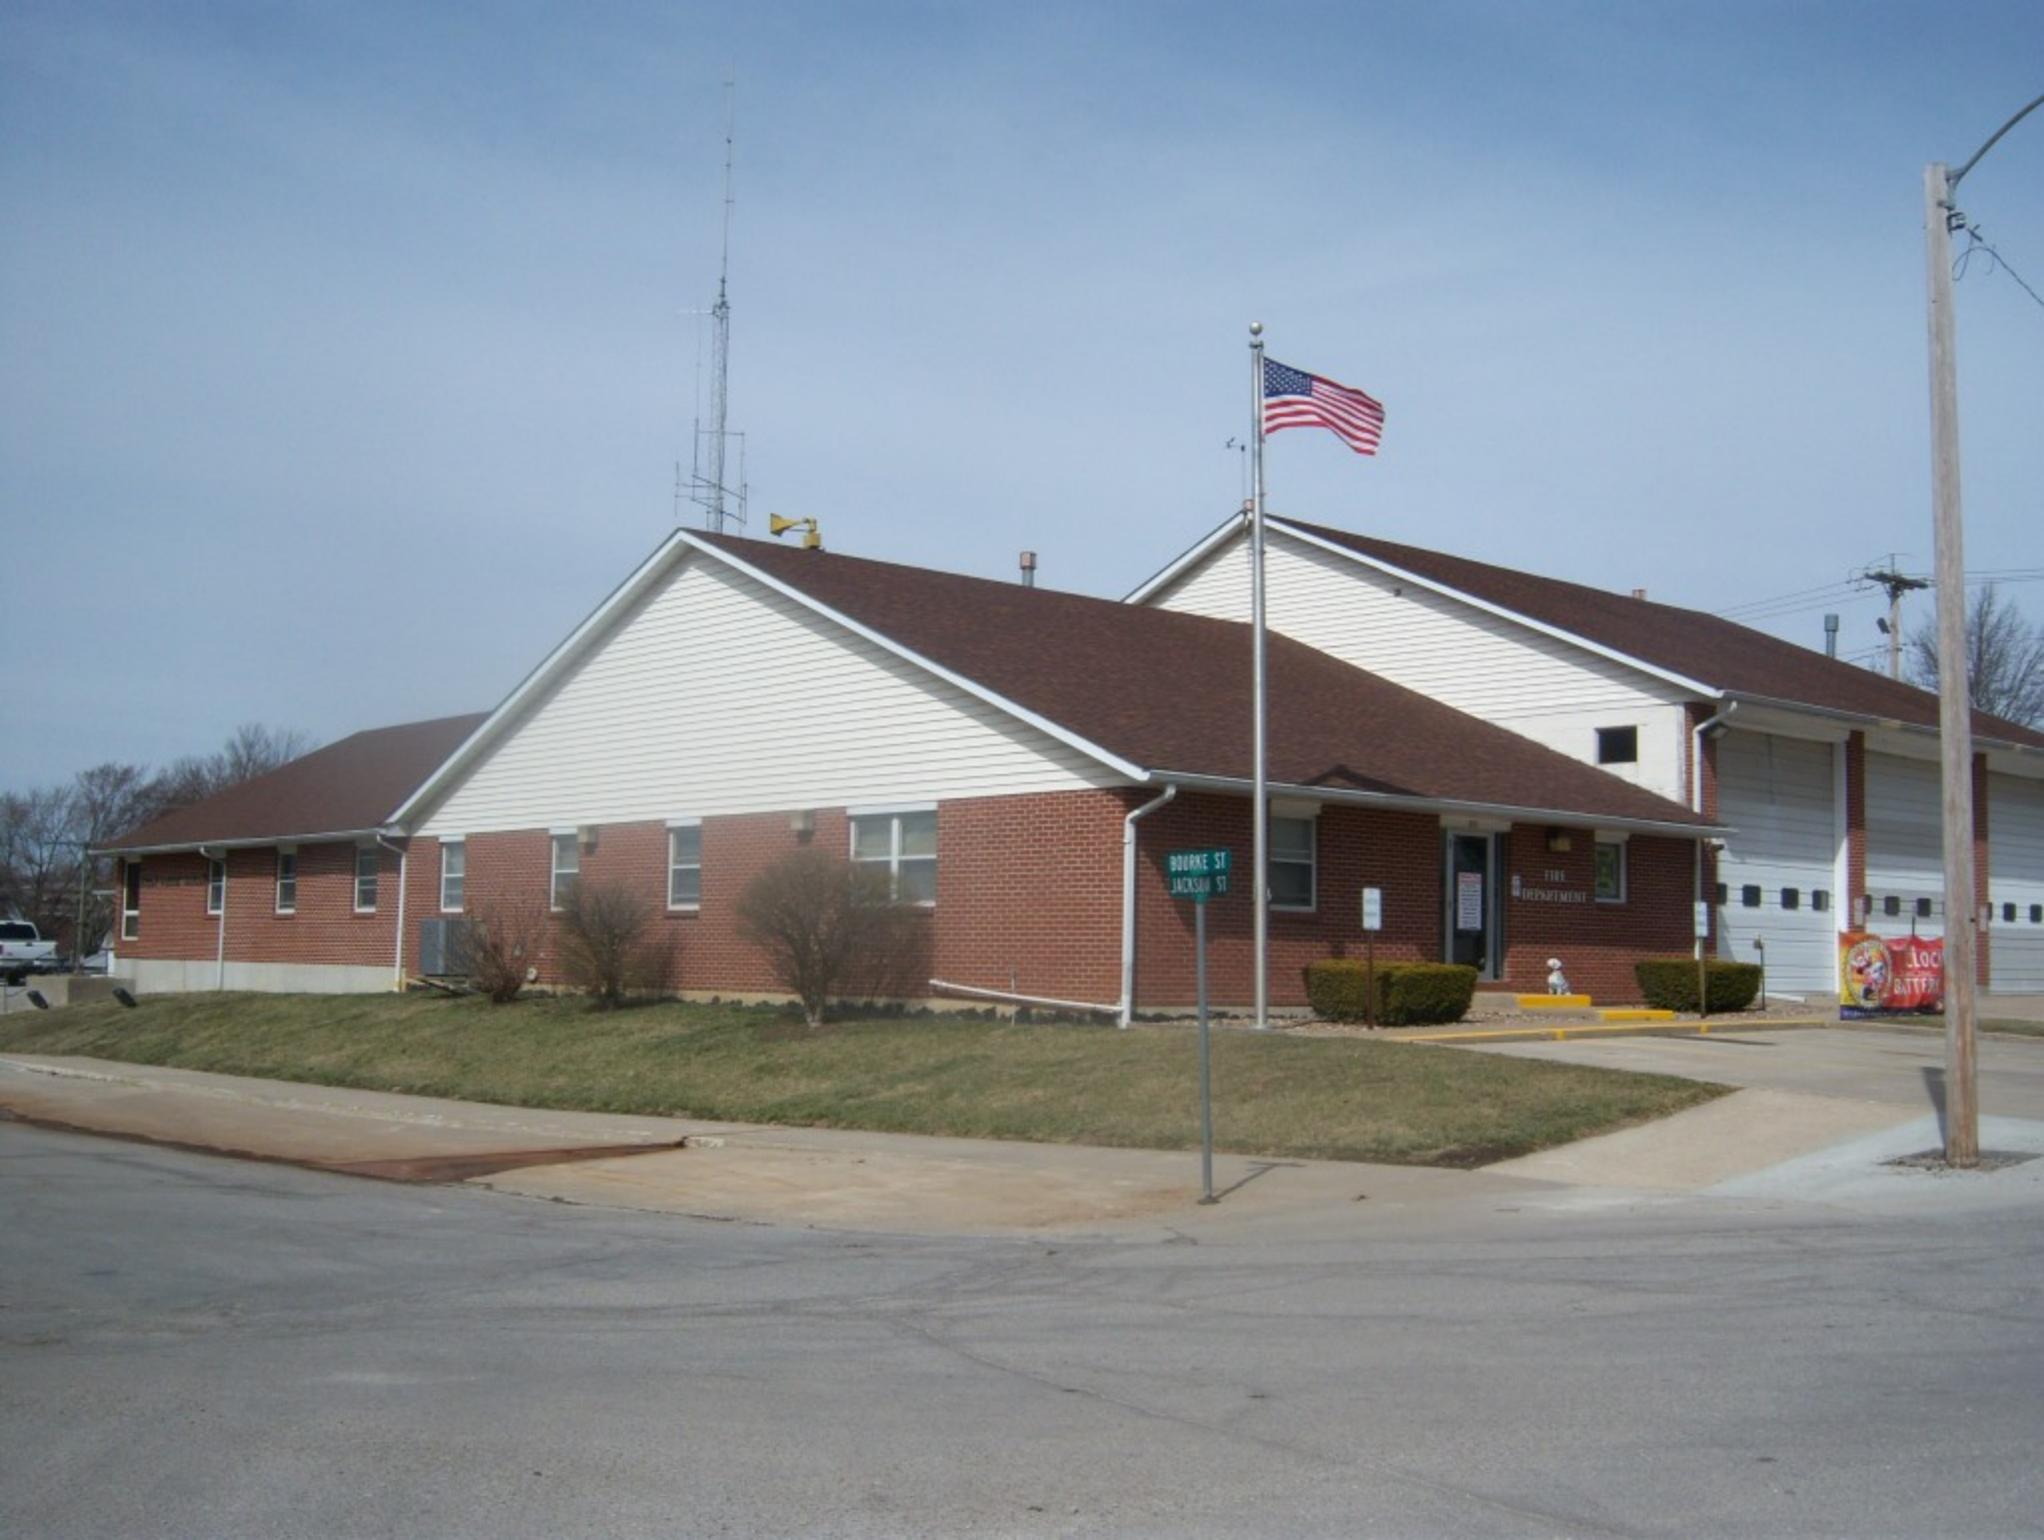
The Macon Central School building was removed from this block at an unknown date and was replaced with a gravel parking lot, asphalt and concrete parking lot, and a modern brick police/fire station with concrete foundation. The station includes an asphalt cross gable office building and attached side gable three bay fire truck garage.

These alterations to the property have resulted in a loss of integrity, rendering the recently constructed property not eligible.
