1. Survey No. MC-AS-001-001		2. Survey name: Downtown Macon Commercial Historic District	
3. County: Macon		4. Address (Street No.) Lots 11-13 block 93	Street (name) East Bourke Street (100 block)
5. City: Macon	Vicinity: <input type="checkbox"/>	6. Geographical Reference:	7. Township/Range/Section: T: R: S:
8. Historic name (if known):		9. Present/other name (if known): City of Macon Parking Lot #3	
10. Ownership: <input checked="" type="checkbox"/> Private <input type="checkbox"/> Public		11a. Historic use (if known): Commercial	11b. Current use: vacant

42. Current owner/address: City of Macon Macon, MO 63552	43. Form prepared by (name and org.): Kristi Chase MO SHPO	44. Survey date: 9/24/2014
		45. Date of revisions:

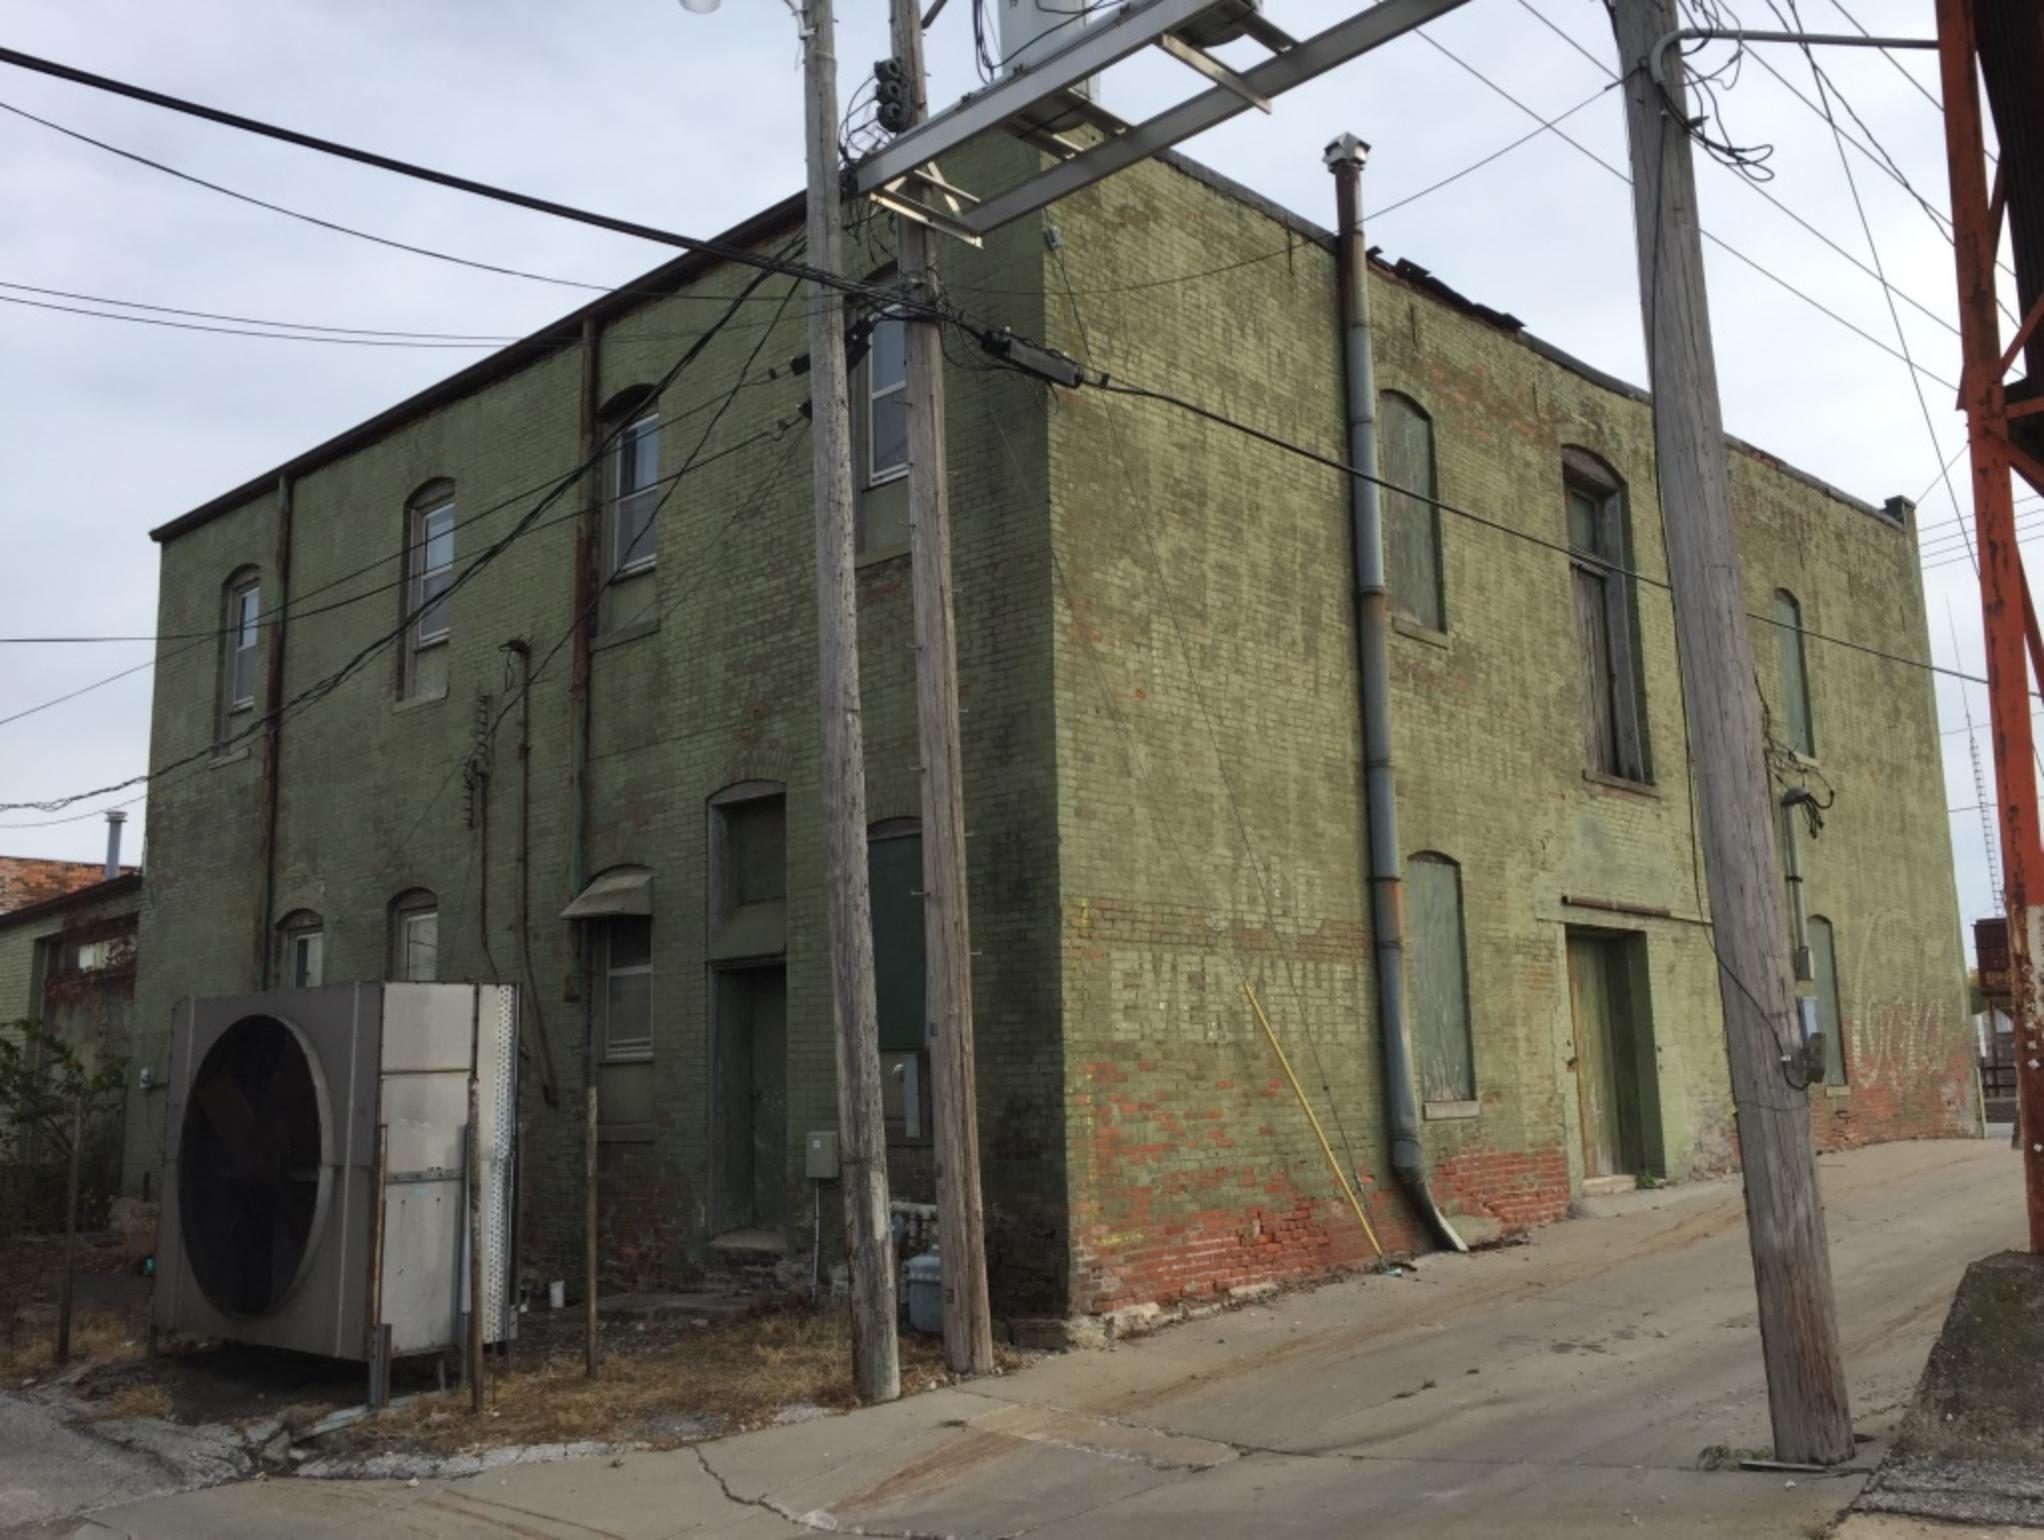
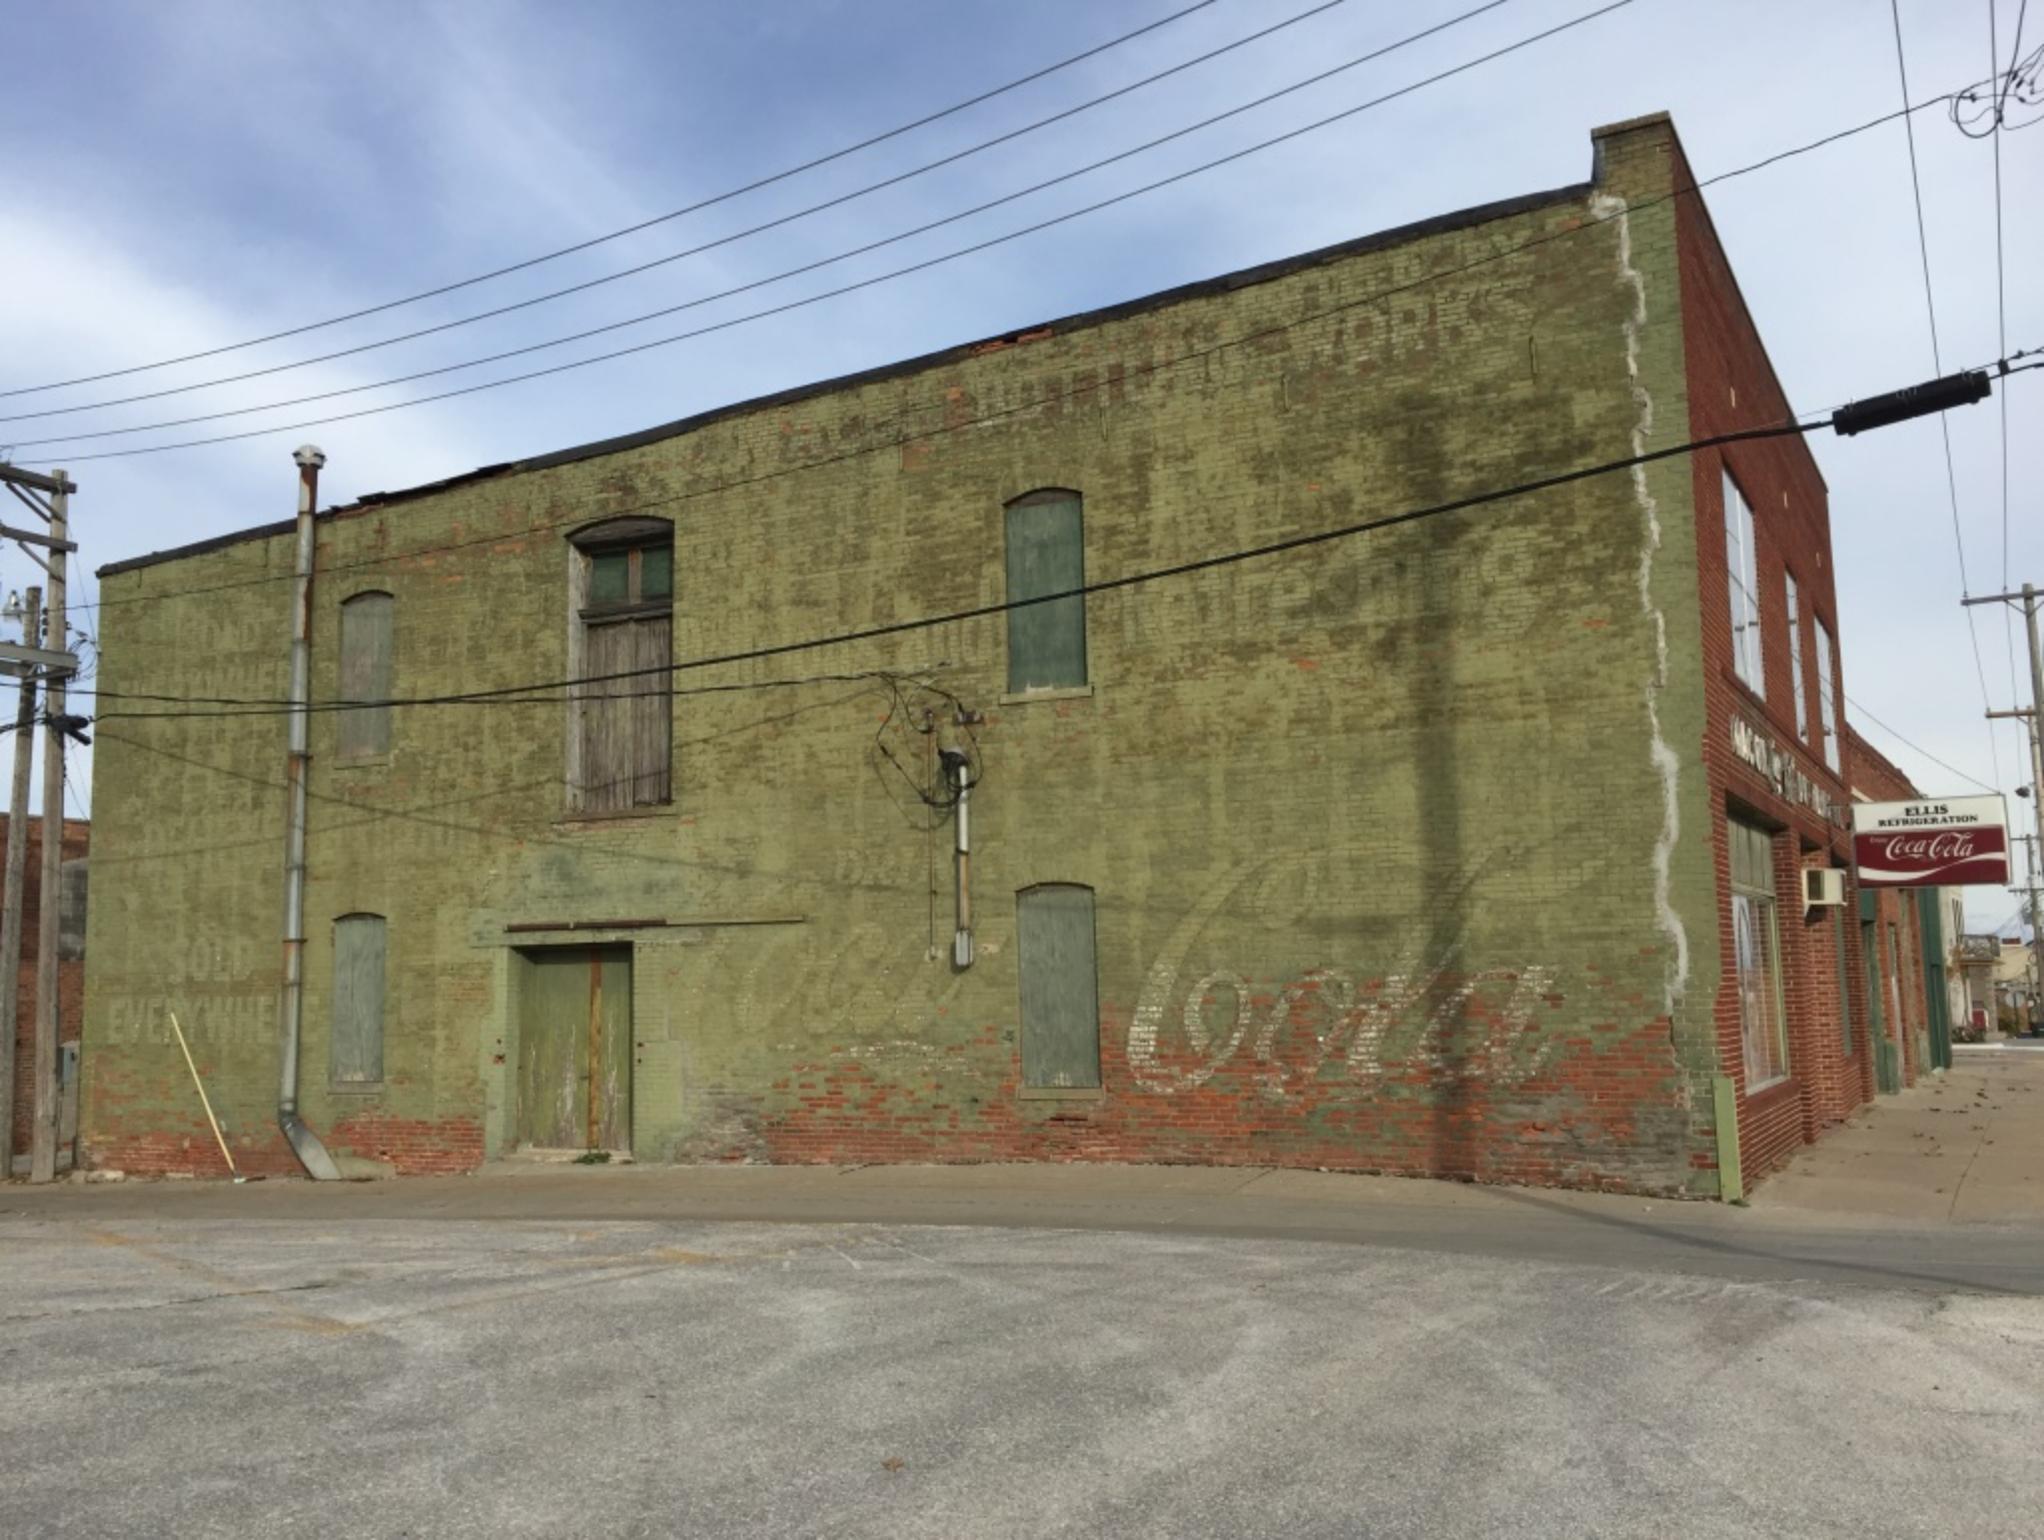
A single-bay painted brick garage is attached to the east wall of the three-bay garage. A single-vehicle metal overhead garage door is situated on the right side of the bay, and the remainder is boarded with metal siding. The cornice features brick corbelling.

Despite alterations, the building retains integrity and would contribute to a potential National Register district. Further research may also reveal if the building is individually eligible for listing under Commerce or Industry.

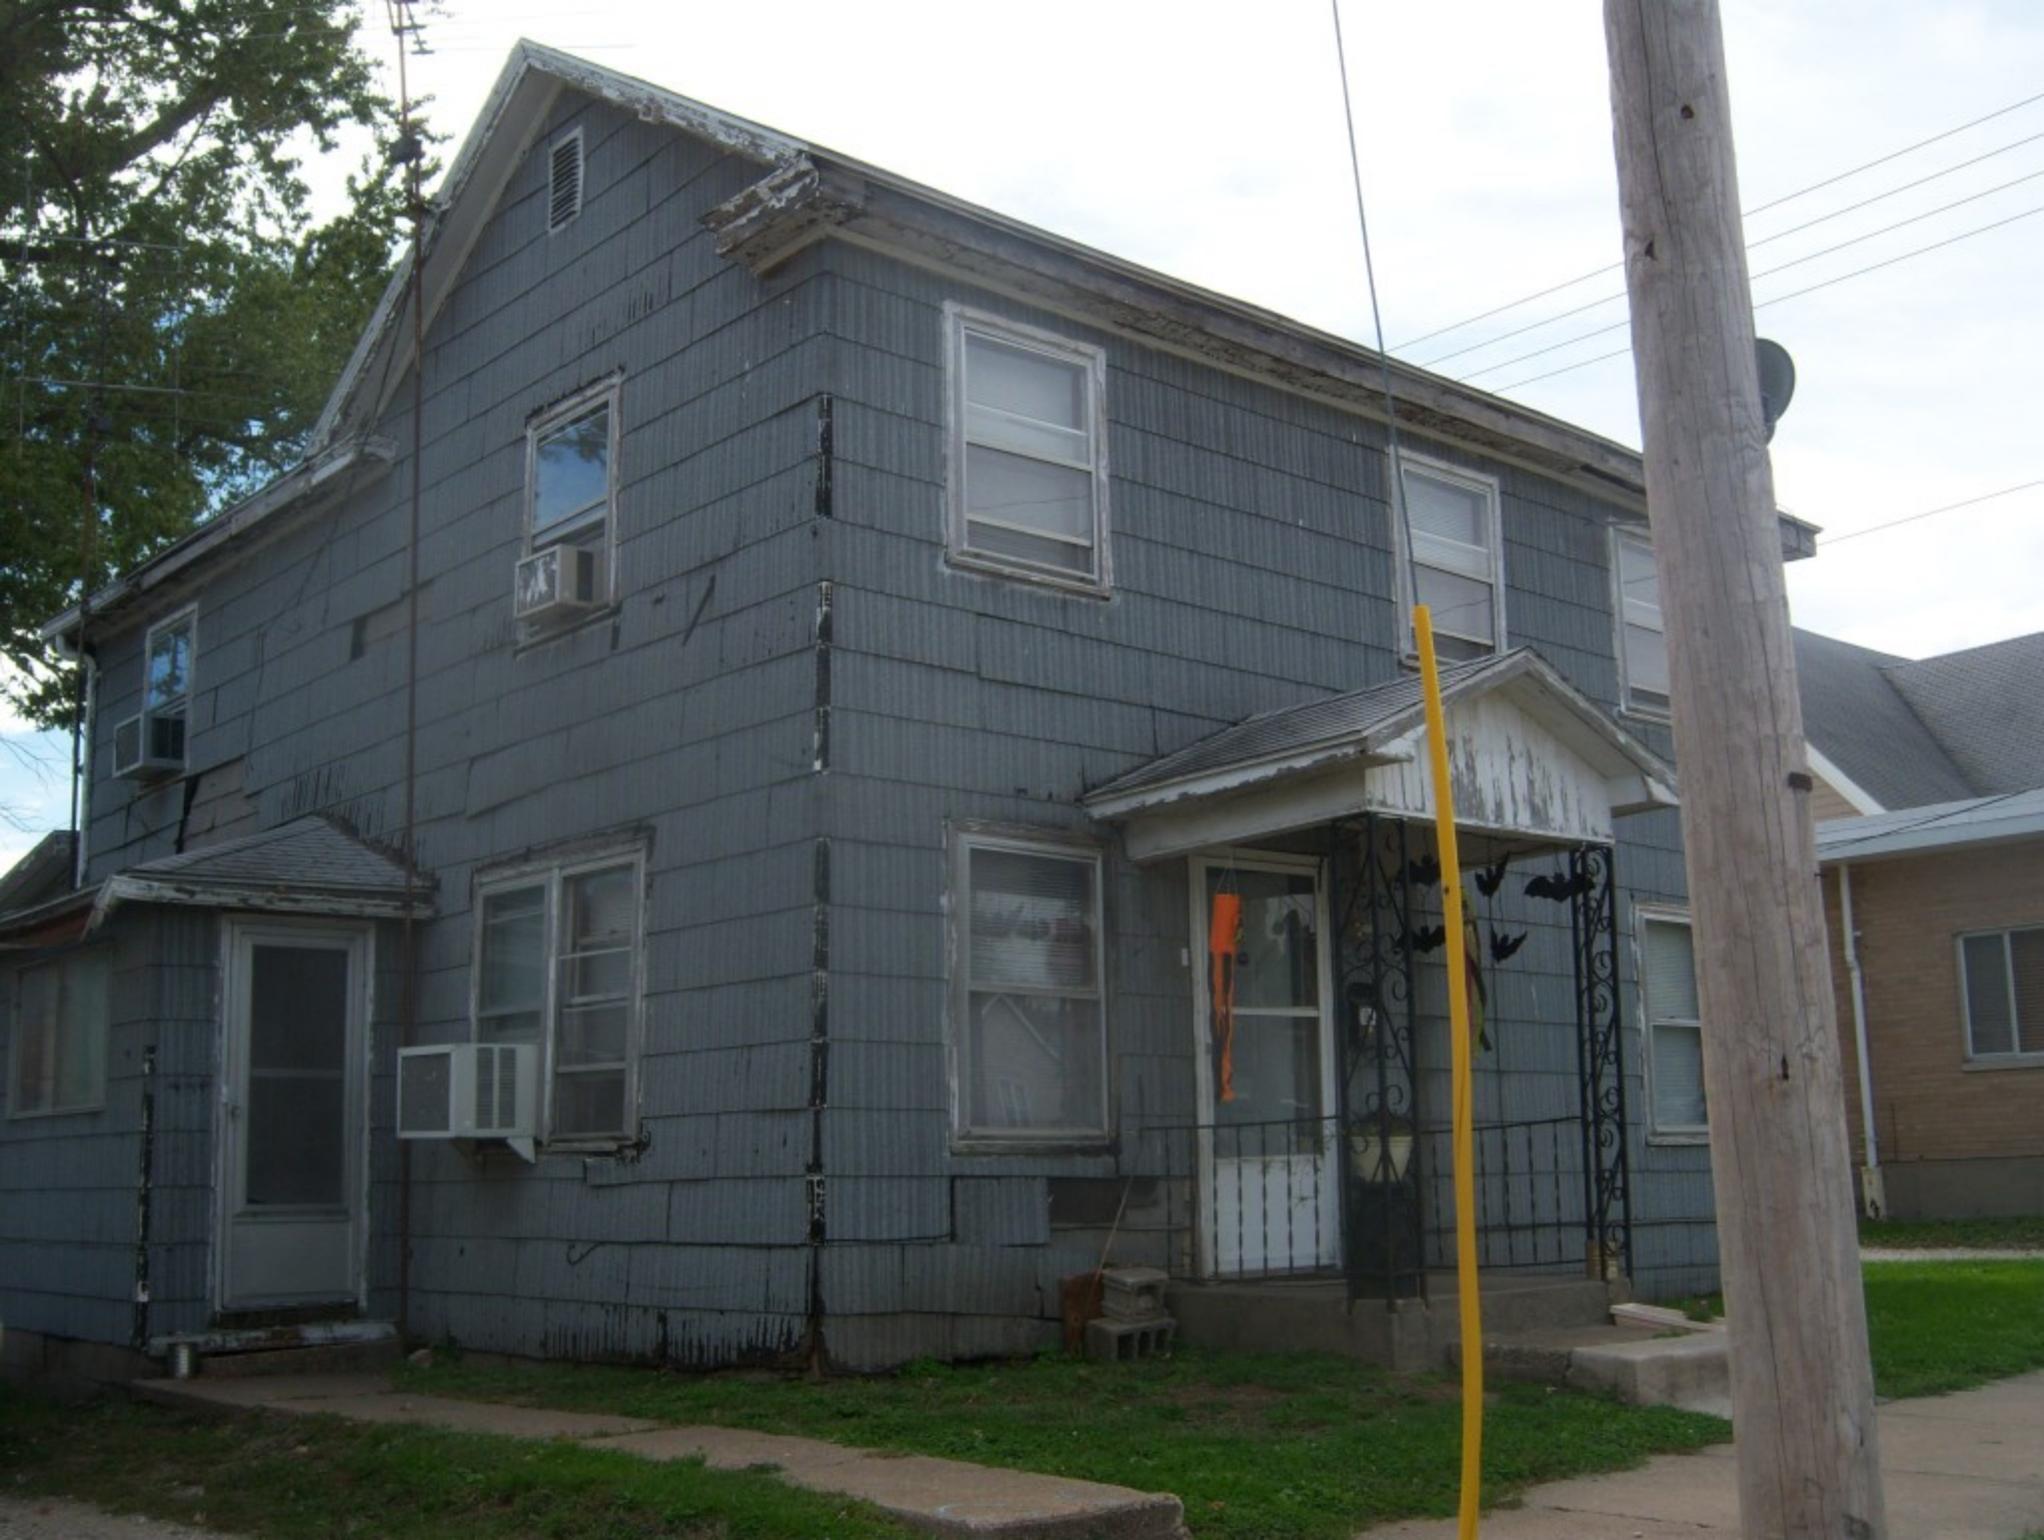
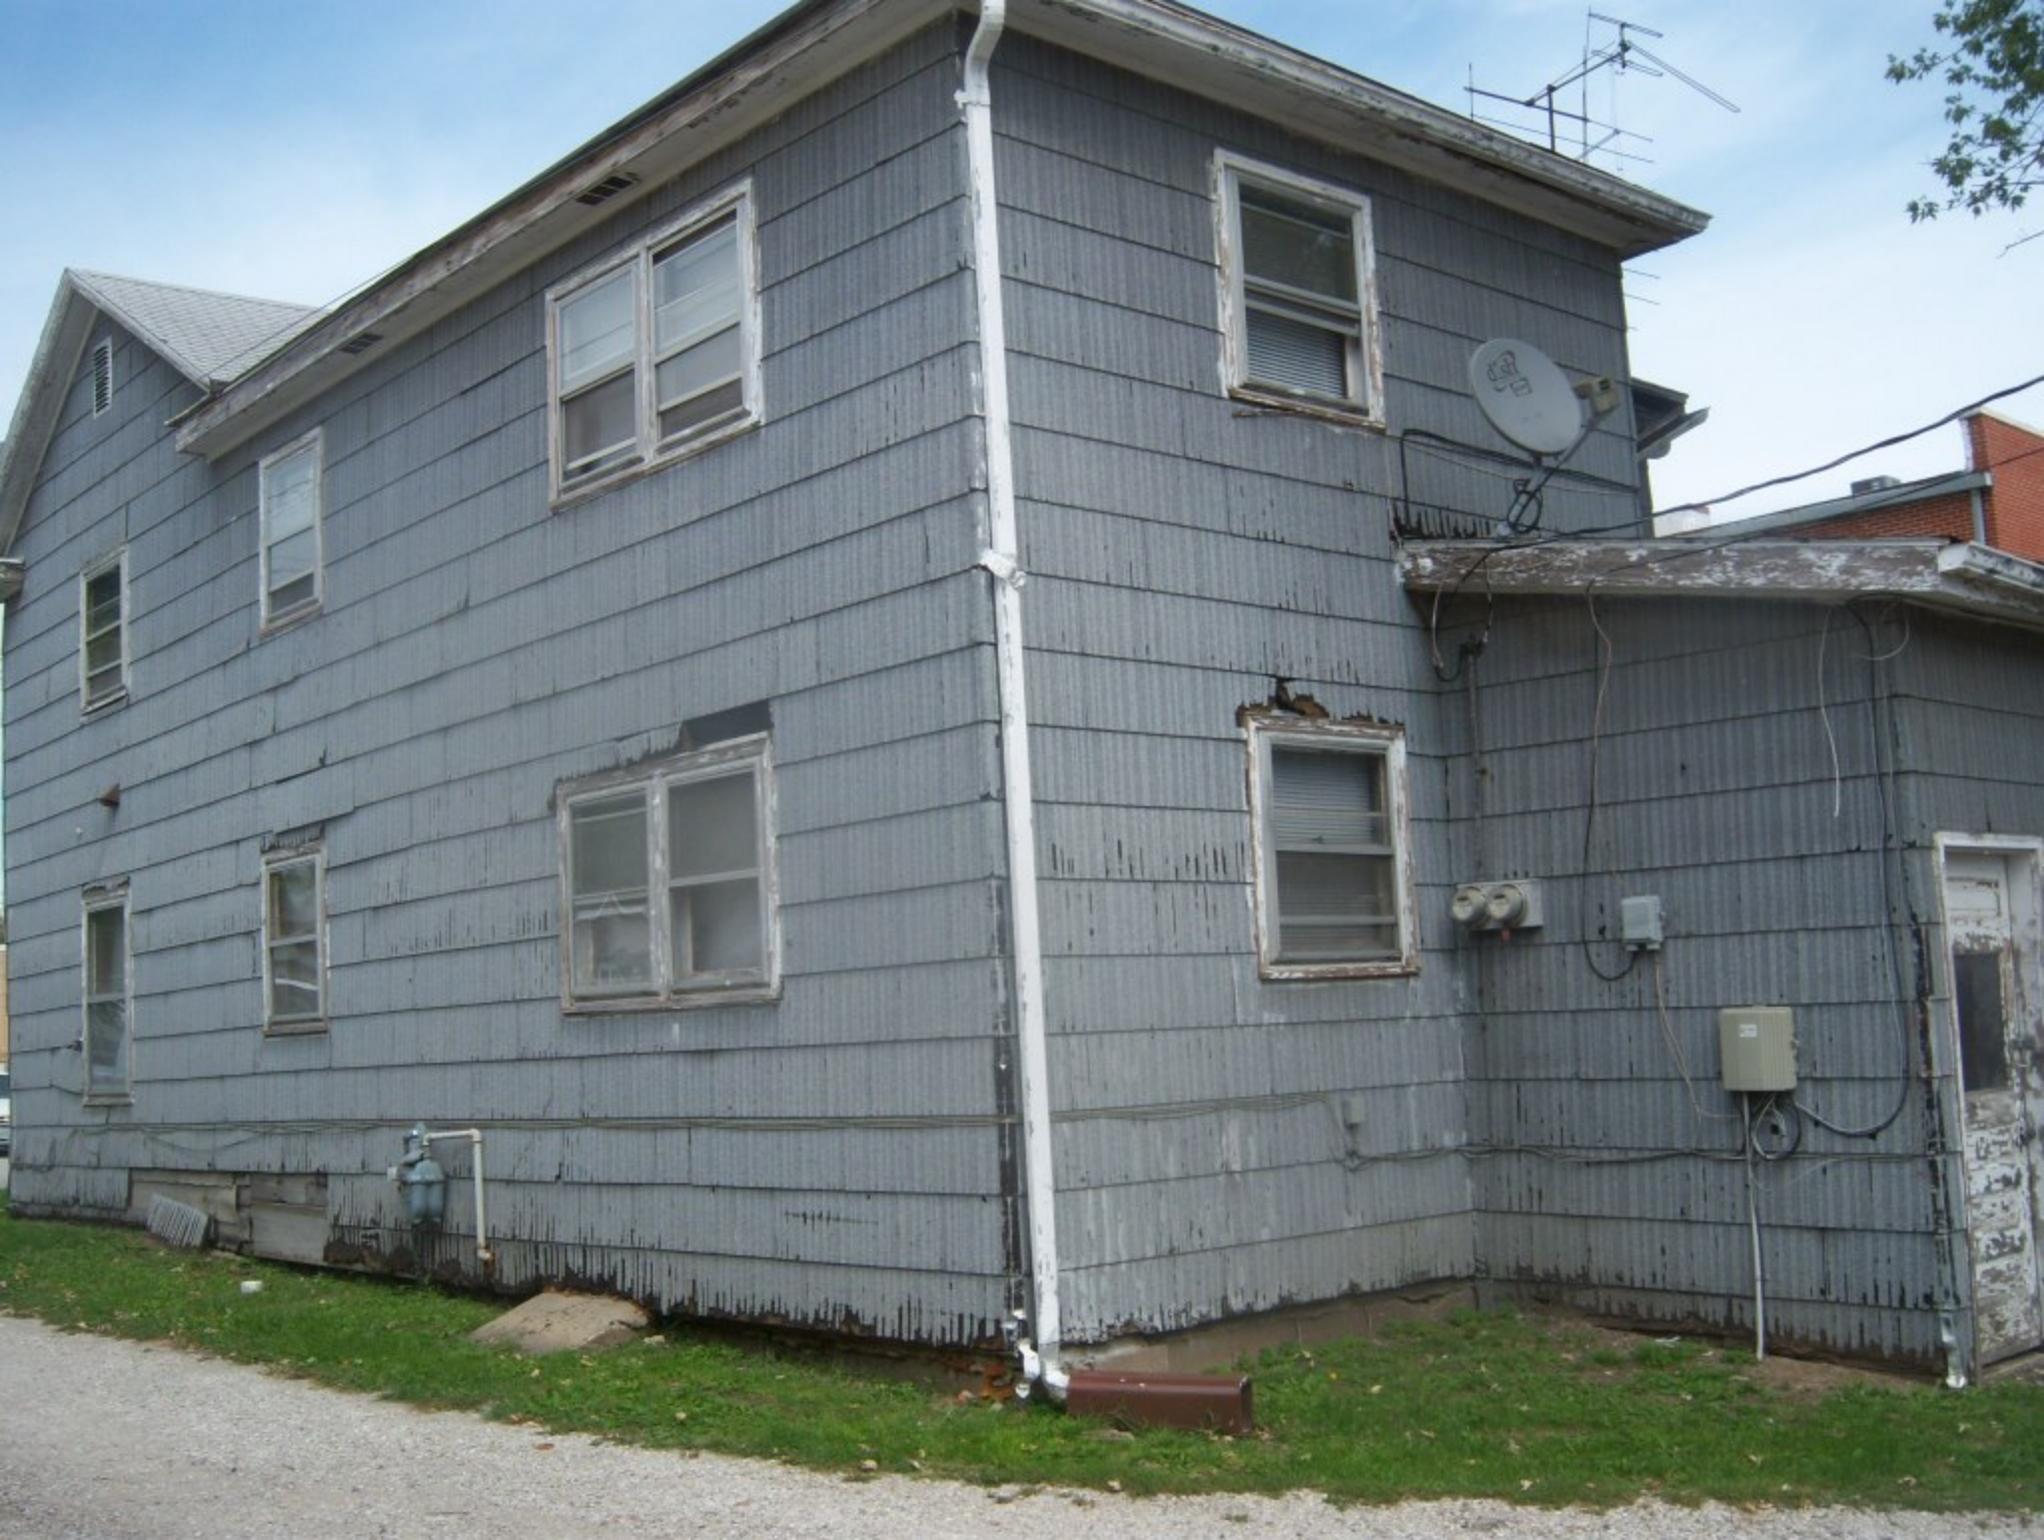
The Colonial Revival influence two-story dwelling has a rectangular shaped with a side gable asphalt roof and a low hipped asphalt rear ell with a rear one-story shed addition that surrounds the southeast corner of the dwelling. Asphalt siding on asbestos shingles on top of wood siding serves as the dwelling's wall cladding. The three-bay façade includes an off-center door entry flanked by windows on the first floor. Windows are 1/1 wood double-hung sash covered by metal storm windows. The entry opens onto a front gable wood portico with an asphalt roof, wrought iron supports and balustrade and a concrete stoop. The second floor façade includes three windows with the center window off-center. A wood cornice marks the roof line and has returns. The western elevation contains three bays of windows: one window on each floor in the side gable and one single window and paired windows in the rear wing. The south elevation is one bay wide with a window on each floor. The rear one-story shed addition includes a rear wood paneled door entry with a fixed pane.

The building retains its historic fabric and its fenestration layout but due to it being a residence, is not contributing to a potential National Register historic commercial district.

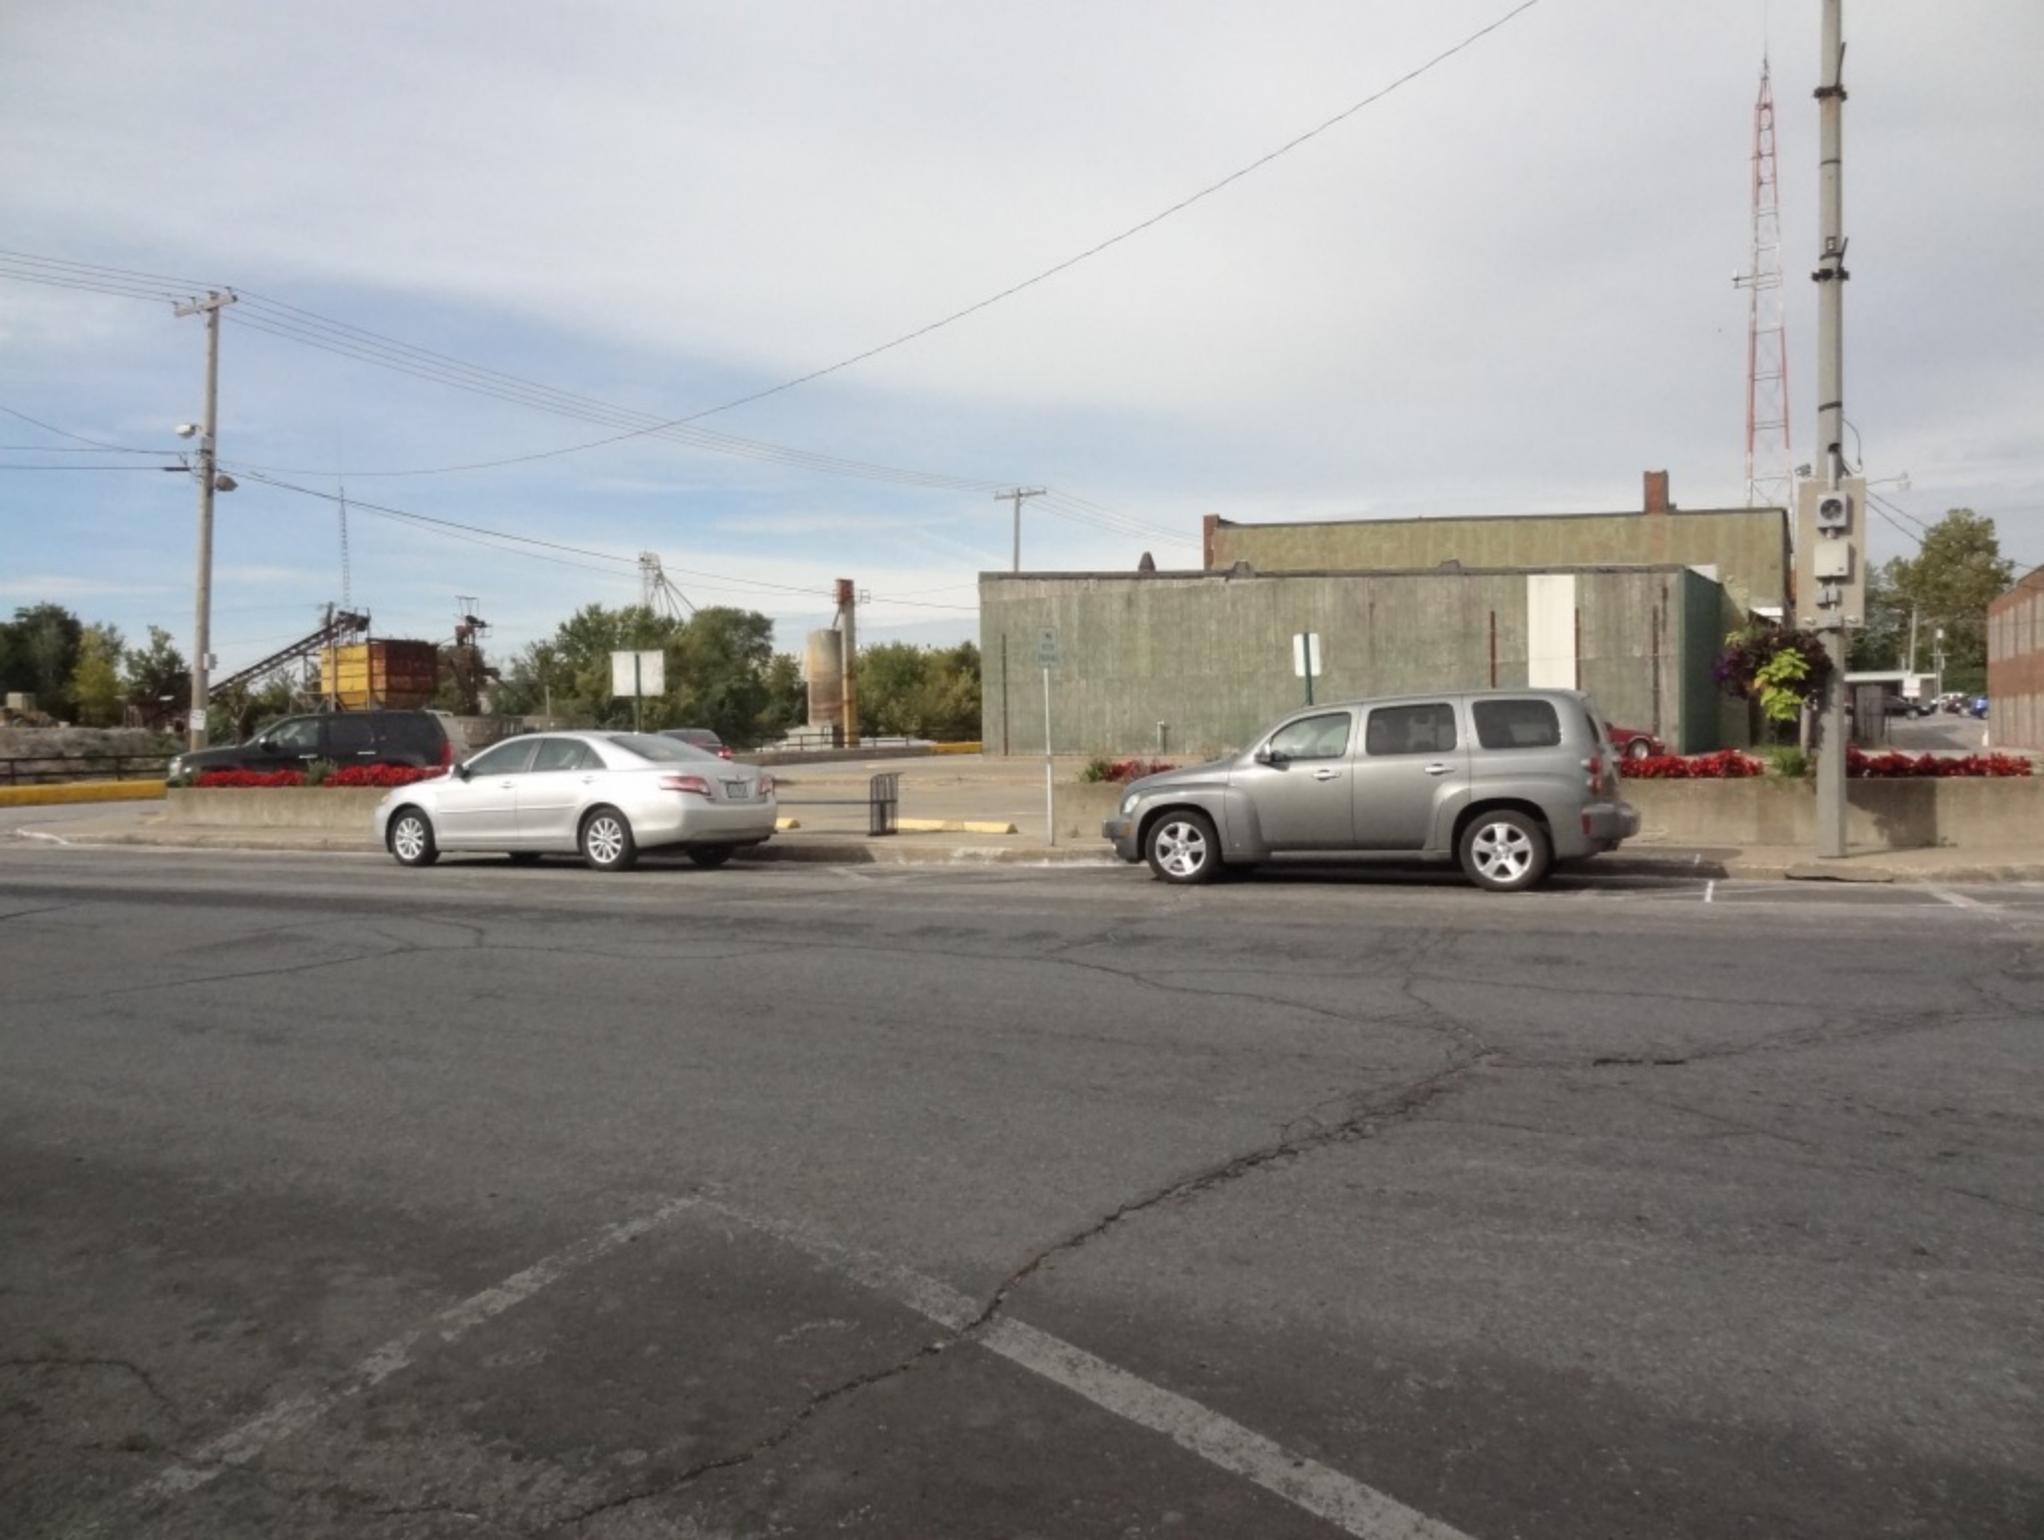
The property historically had commercial buildings on the lot but is currently vacant. These undated alterations have resulted in a loss of architectural integrity, rendering the property non-contributing to a potential National Register Historic District.

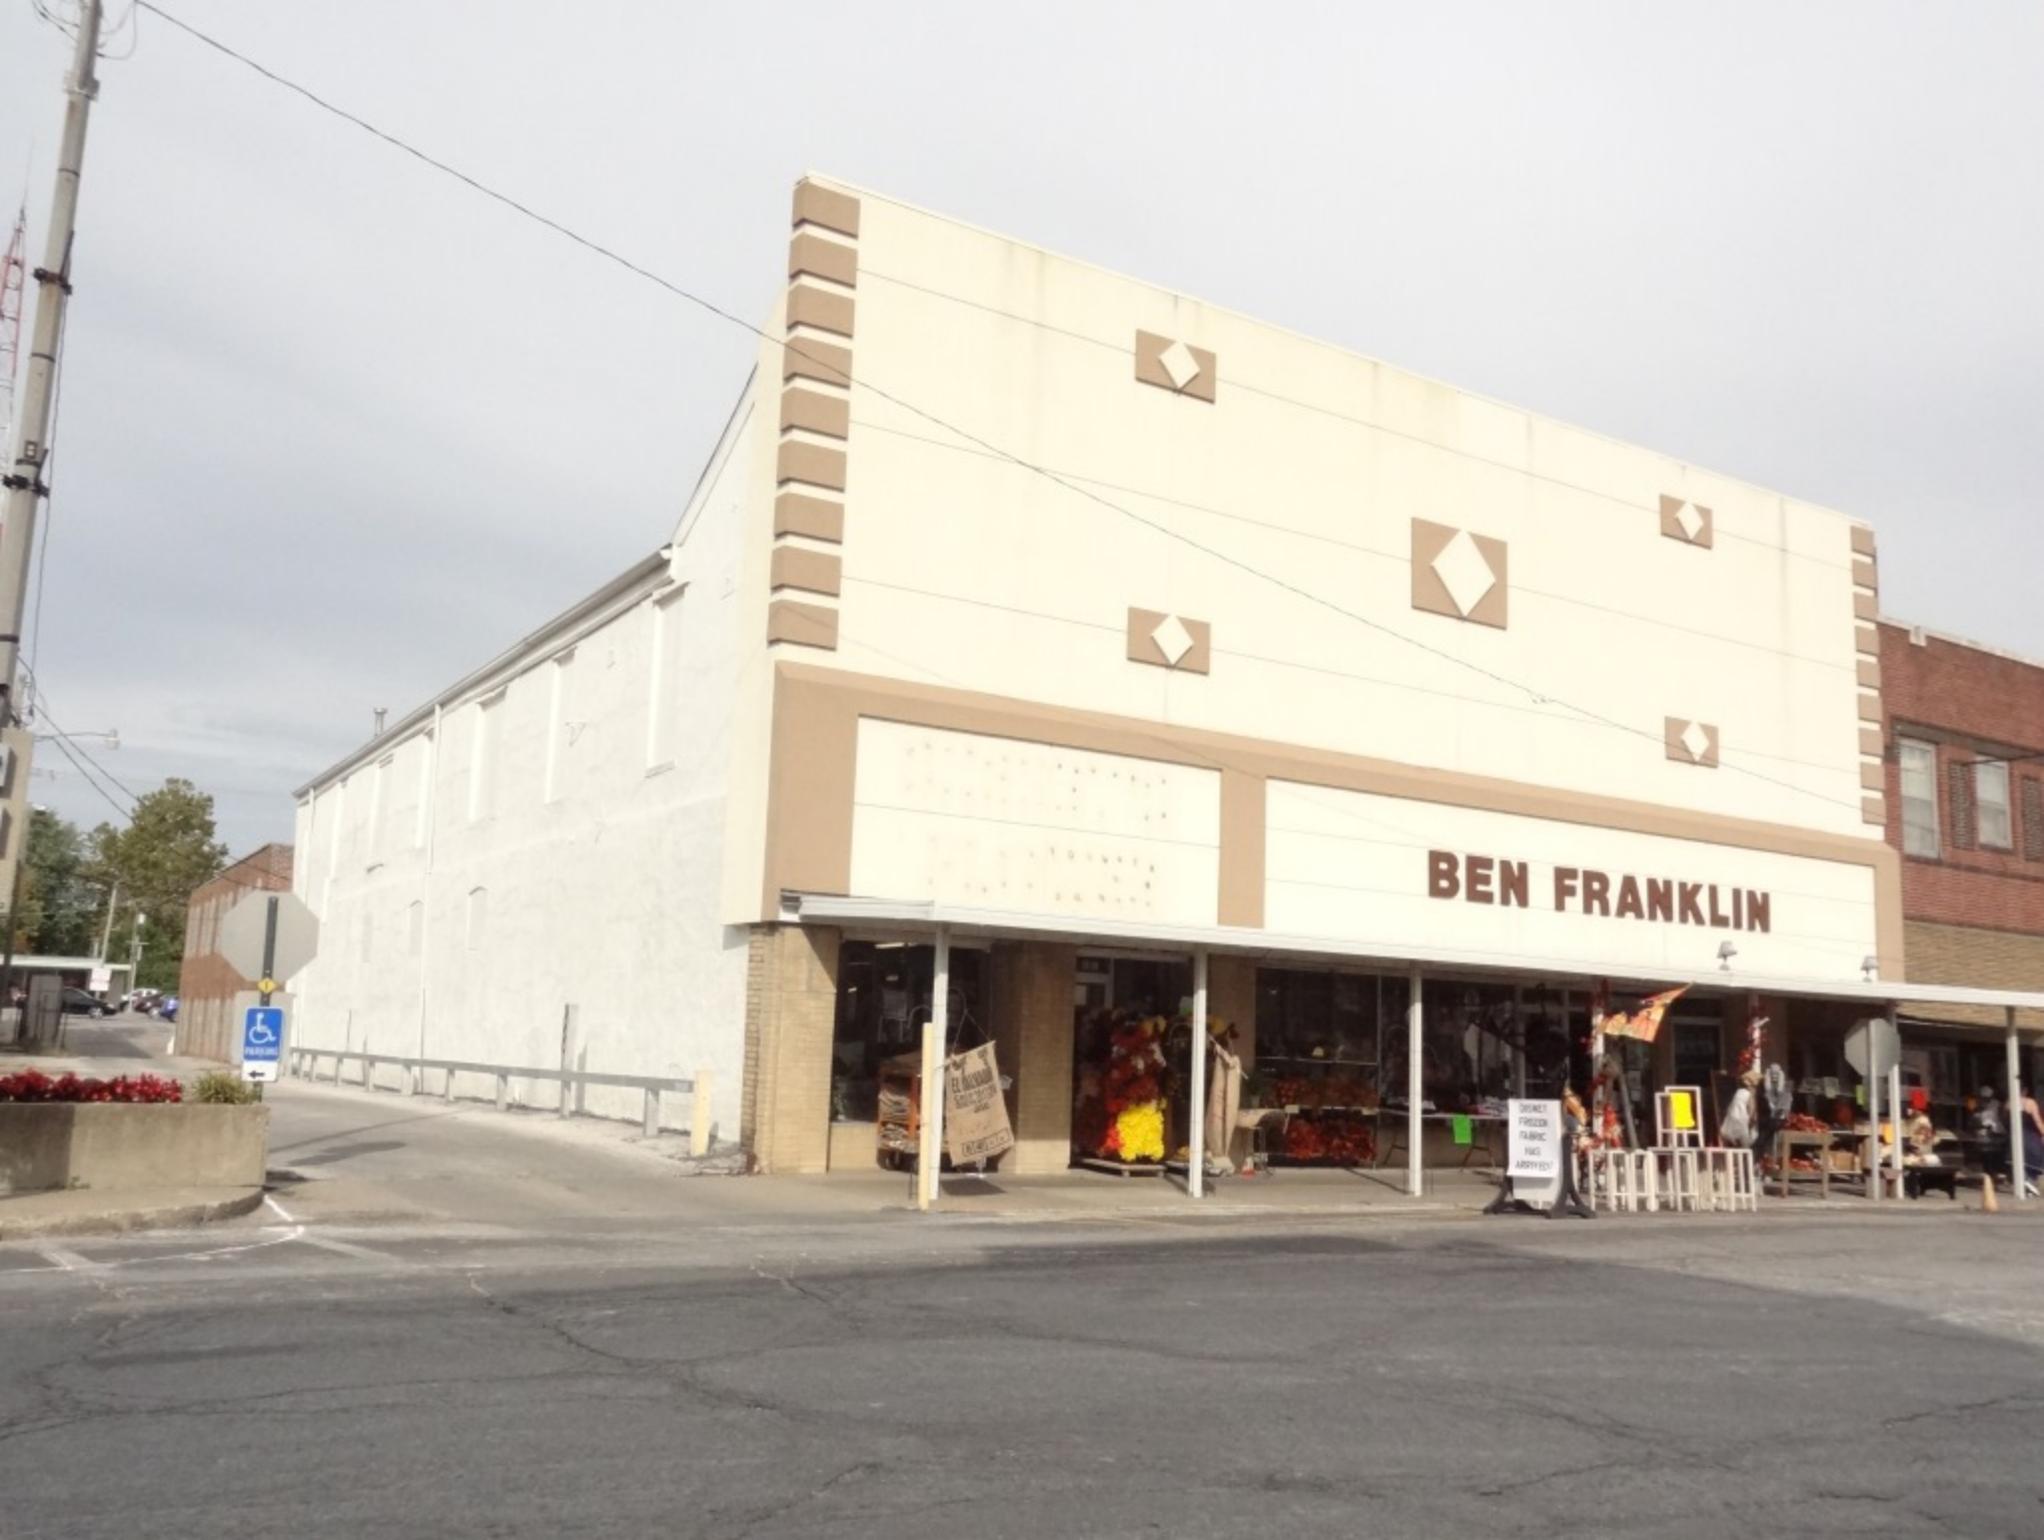
The two-part commercial block brick building located at 103-105 North Rollins Street is rectangular and consists of six bays along the front façade and is six bays deep. The roof is flat with a hipped roof system at the northern portion of the building abutting the parapet wall. The hipped roofing may enclose the HVAC system for the building. The secondary elevations consist of Dry-vit stuccoed brick and a more elaborate concrete stucco finish on the second floor and parapet wall of the front facade. The concrete stucco finish includes diamond and linear details with quoins. Tan brick is visible from the first story store-front and includes a full-width flat metal awning with plain metal support posts that covers the three recessed entries framed by large fixed glass panes that run the length of the façade. Starting at the southeast corner, bays 1, 3 and 4 consist of a large fixed single metal sash window. Bay 2 consists of a glass entry with transom and a large side fixed single metal sash window. Bay 5 includes a double glass entry with transom and a large fixed single metal sash window. Bay 6 includes a modern wood frame that sits in front an original entry and fixed sash window. The wood alteration gives the appearance of three arched windows. The stucco covered south elevation includes three enclosed windows on the first floor and six bays of enclosed windows on the second story.

Alterations were completed c. 1955 according to the Recorder of Deeds and the stucco occurred more recently. The upper story windows have been enclosed. These alterations have resulted in a loss of architectural integrity, rendering 103-105 North Rollins Street non-contributing to a potential National Register Historic District.
