1. Survey No. MC-AS-001-001		2. Survey name: Downtown Macon Commercial Historic District	
3. County: Macon		4. Address (Street No.) Lots 11-13 block 93	Street (name) East Bourke Street (100 block)
5. City: Macon	Vicinity: <input type="checkbox"/>	6. Geographical Reference:	7. Township/Range/Section: T: R: S:
8. Historic name (if known):		9. Present/other name (if known): City of Macon Parking Lot #3	
10. Ownership: <input checked="" type="checkbox"/> Private <input type="checkbox"/> Public		11a. Historic use (if known): Commercial	11b. Current use: vacant

42. Current owner/address: City of Macon Macon, MO 63552	43. Form prepared by (name and org.): Kristi Chase MO SHPO	44. Survey date: 9/24/2014
		45. Date of revisions:

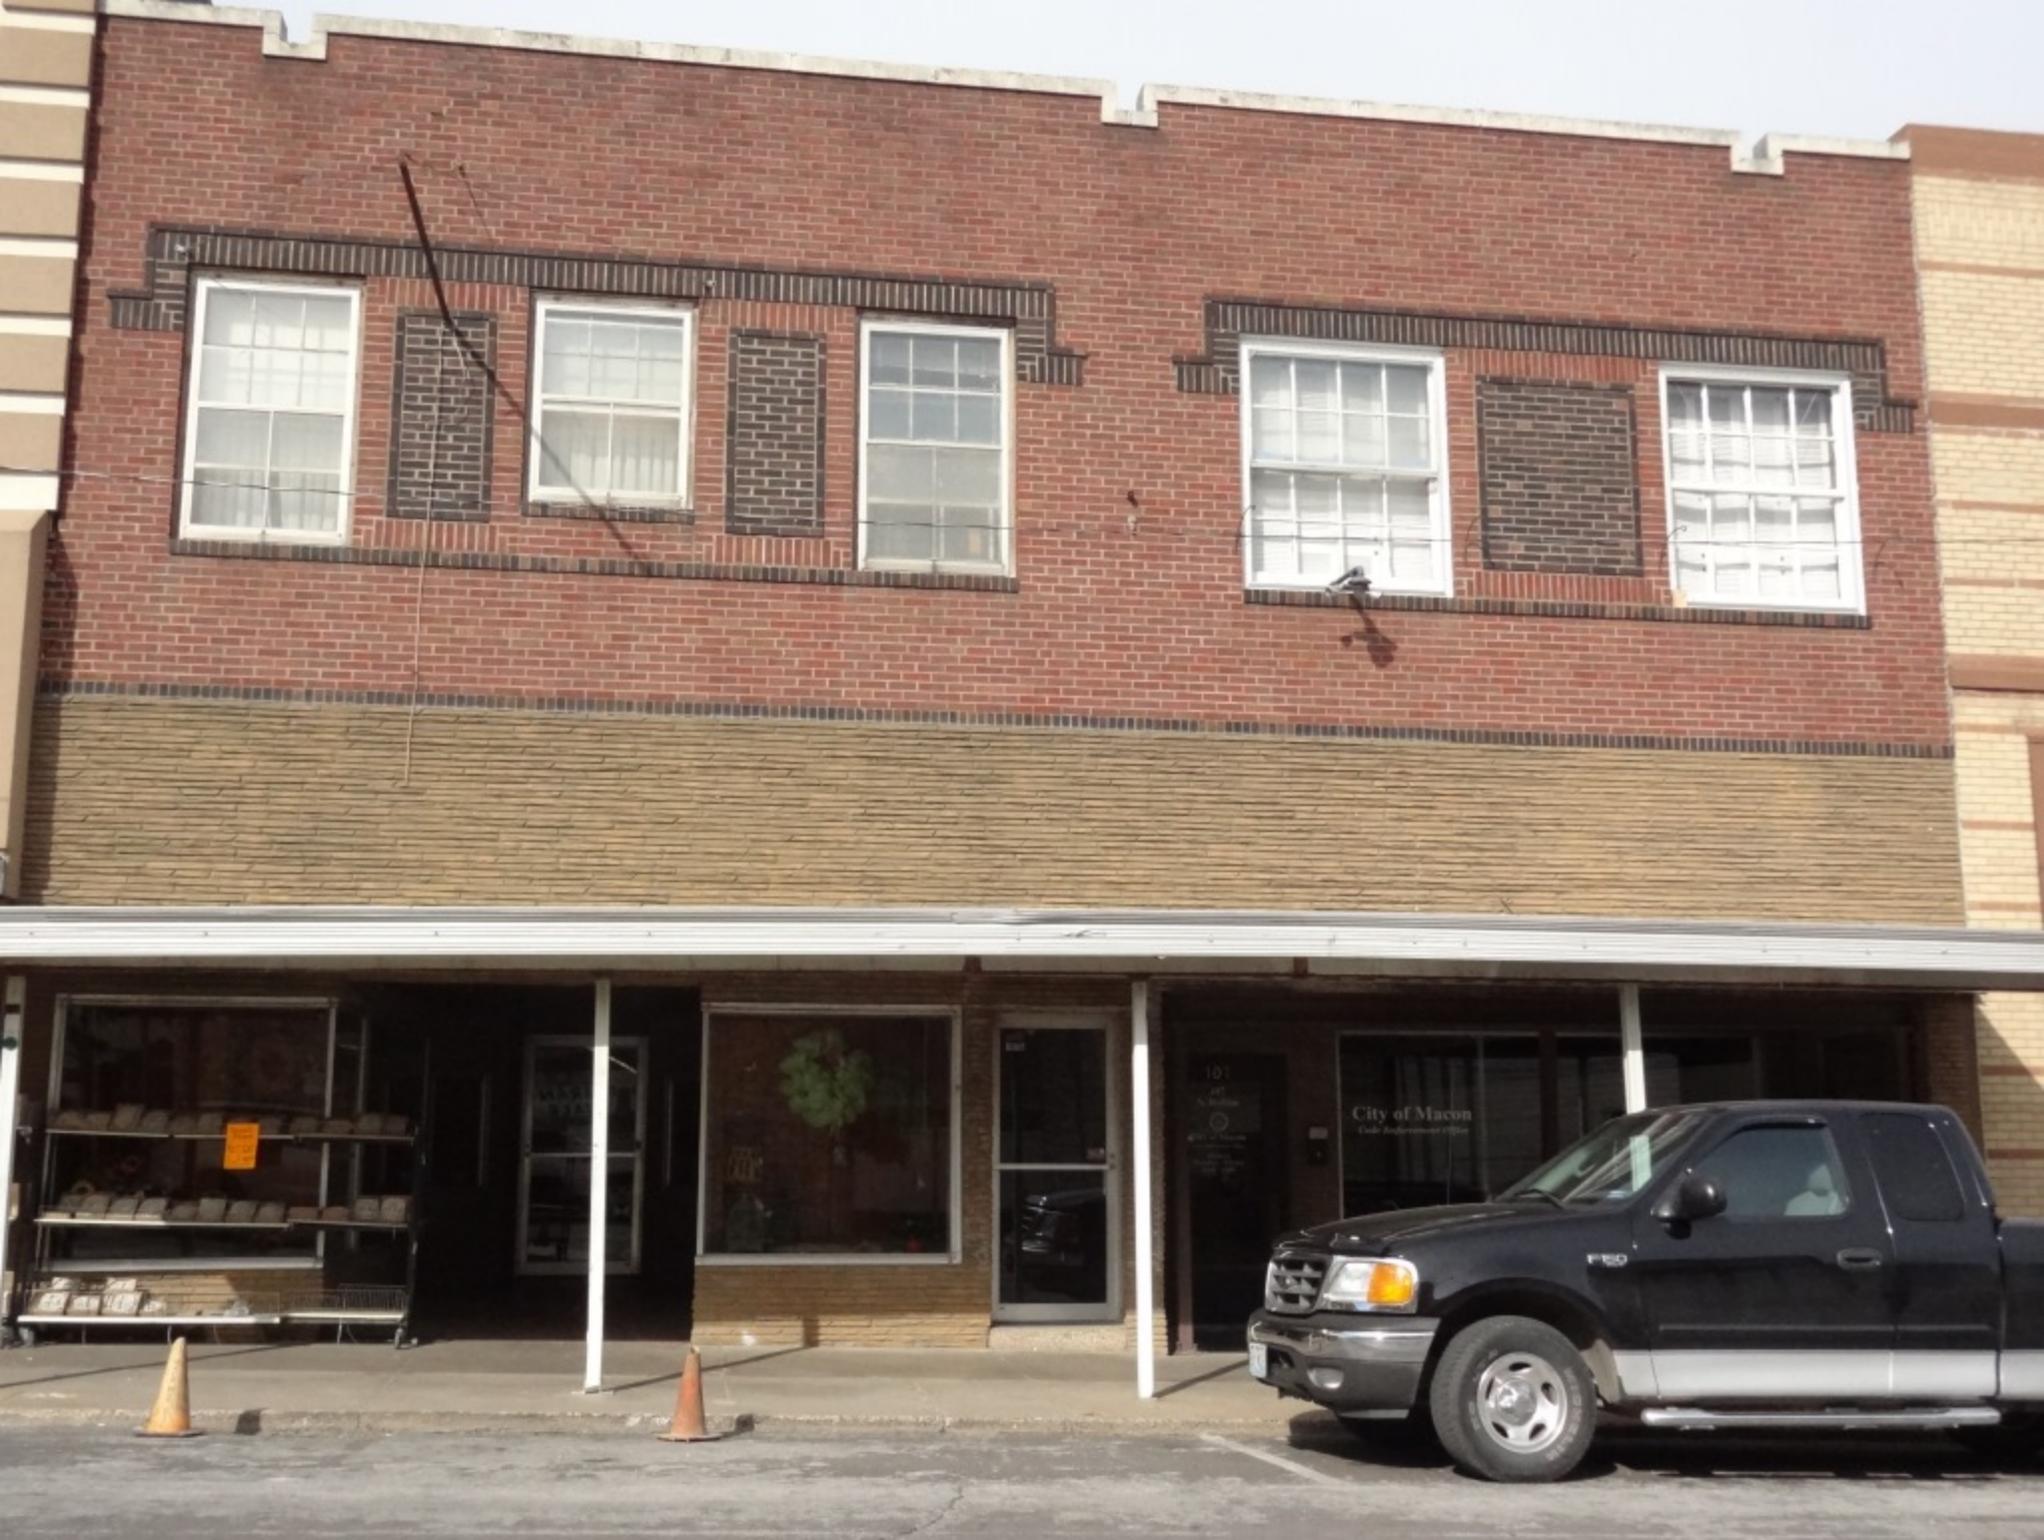
The two-part commercial block brick building located at 107 North Rollins Street is rectangular with a flat roof and consists of six bays along the front façade. The façade includes red brick with dark brick detailing on the second floor and permastone on the first floor store-front. Dark brick details delineate the soldier brick header of the upper windows, sills, and band separating the first and second stories. The first story store front includes a full-width flat metal awning with plain metal support posts. A protruding central entry is flanked on either side by recessed entries with large fixed single metal sash windows. Bays 1, 3, and 6 include a large fixed single metal sash window. Bay 2 includes a recessed glass entry door with flanked by a large fixed single metal sash window on either side. Bay 4 consists of a protruding glass central entry and bay 5 consists of a recessed glass entry.

Alterations were completed c. 1963. Despite alterations, the building retains enough historic fabric and its fenestration to be contributing to a potential National Register commercial district.

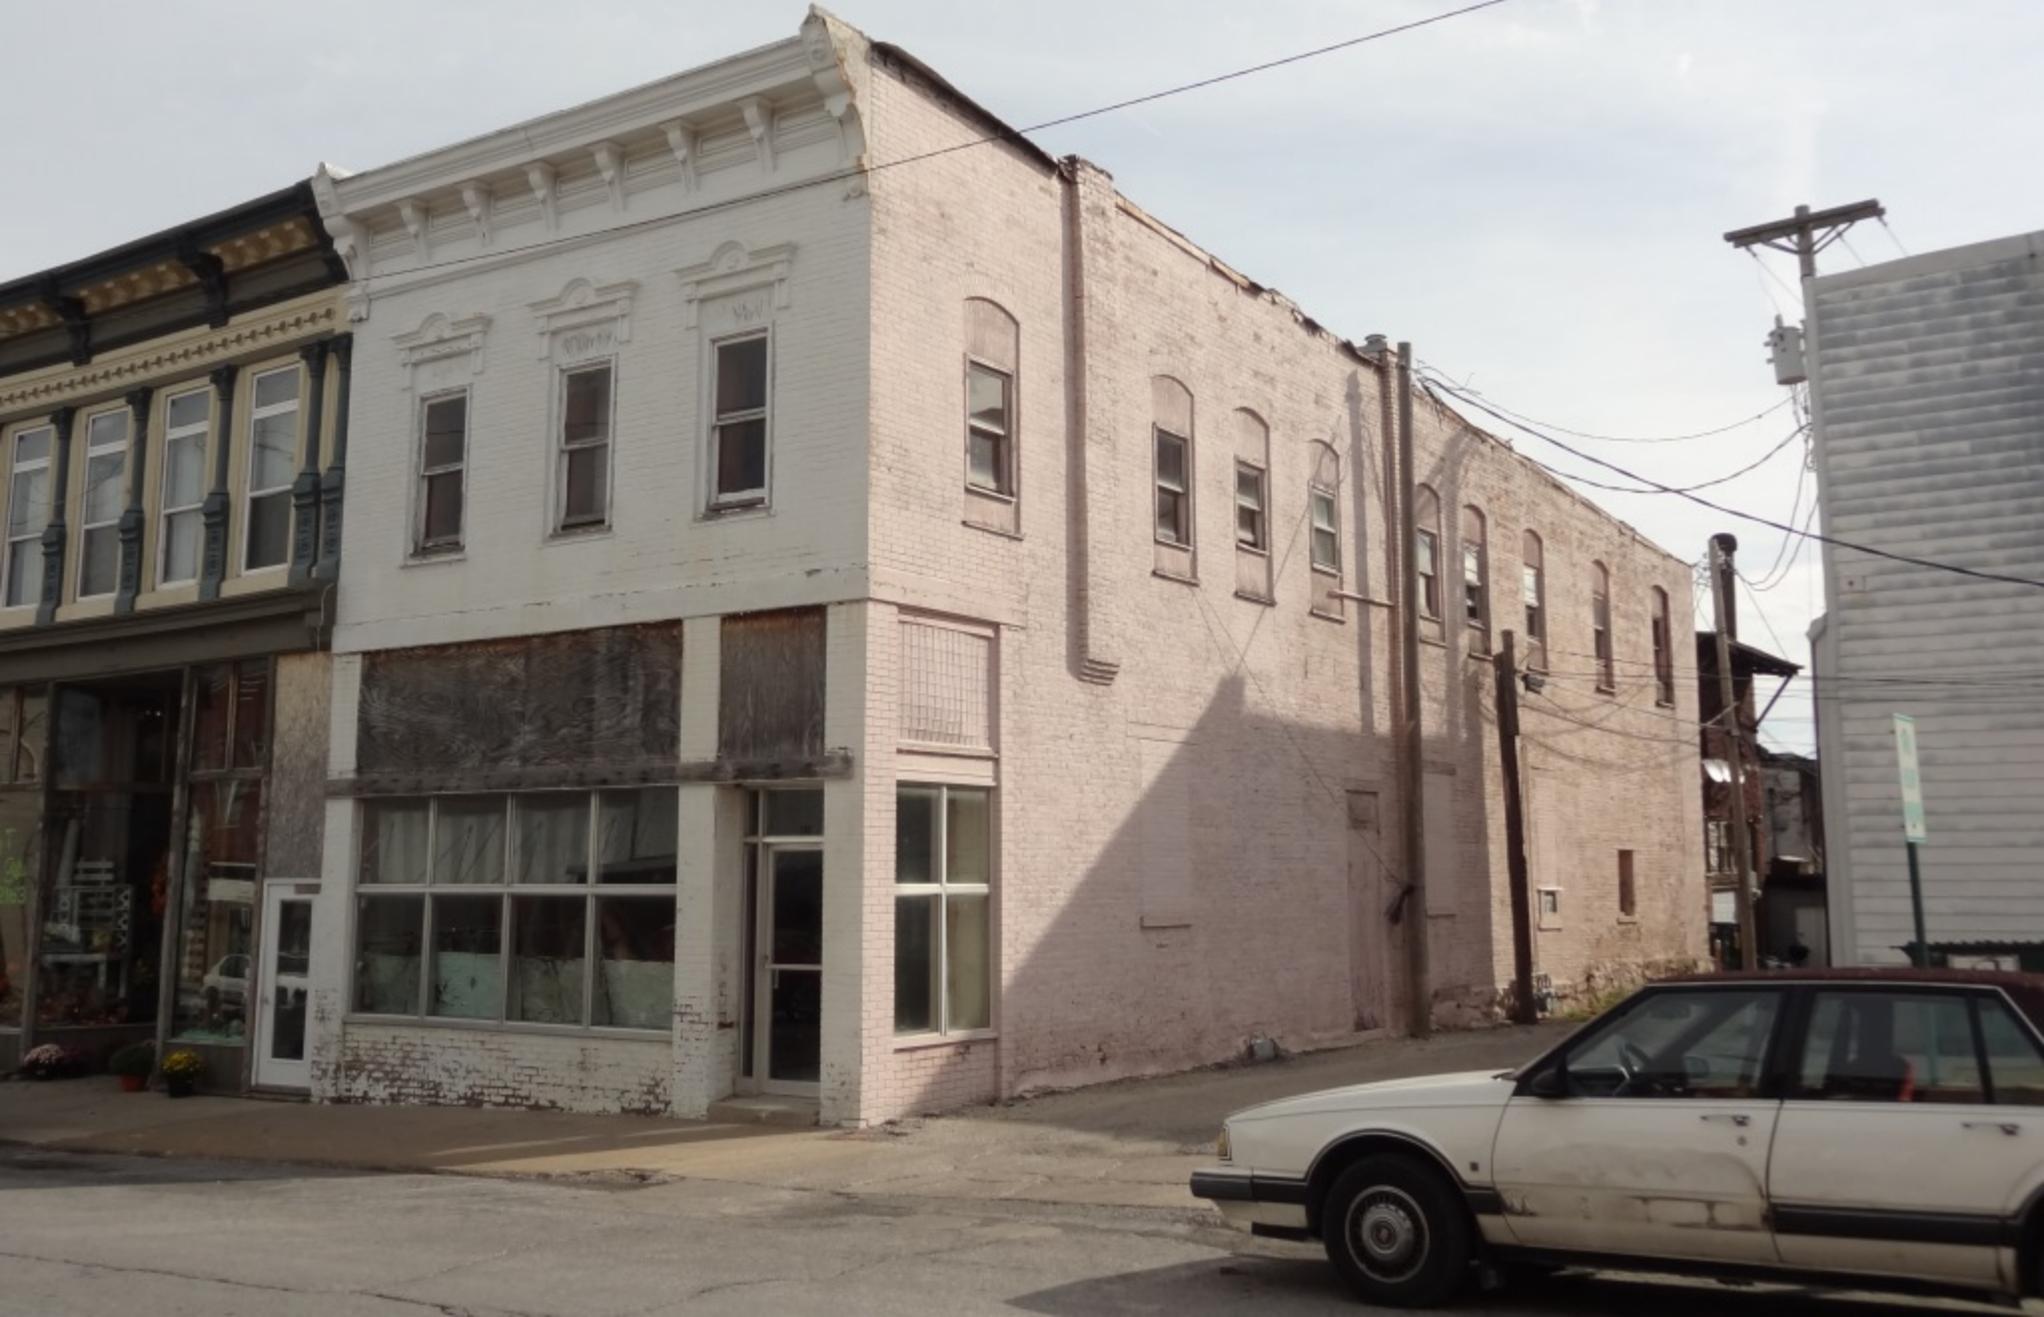
This painted brick two-part commercial block building has two bays on its first story. The northern bay contains a large aluminum and glass window with eight lights. The southern bay contains an aluminum and glass entry door. Plywood boards cover the transom area above the windows and door, which is topped with a painted wood lintel. The second story contains three bays, each filled with a historic 1/1 wood window with wood sill and decorative window hood. The cornice is elaborated with prominent brackets. The end brackets feature a pressed metal panel ornamented with a face. The windows along the upper story of the south elevation have been infilled with modern 1/1 windows; the historic segmented arch openings are still intact.

While the storefront has been altered, the upper story is remarkably intact and retains historic details such as window hoods and cornice brackets. Despite alterations, the building retains integrity and would contribute to a potential National Register district.

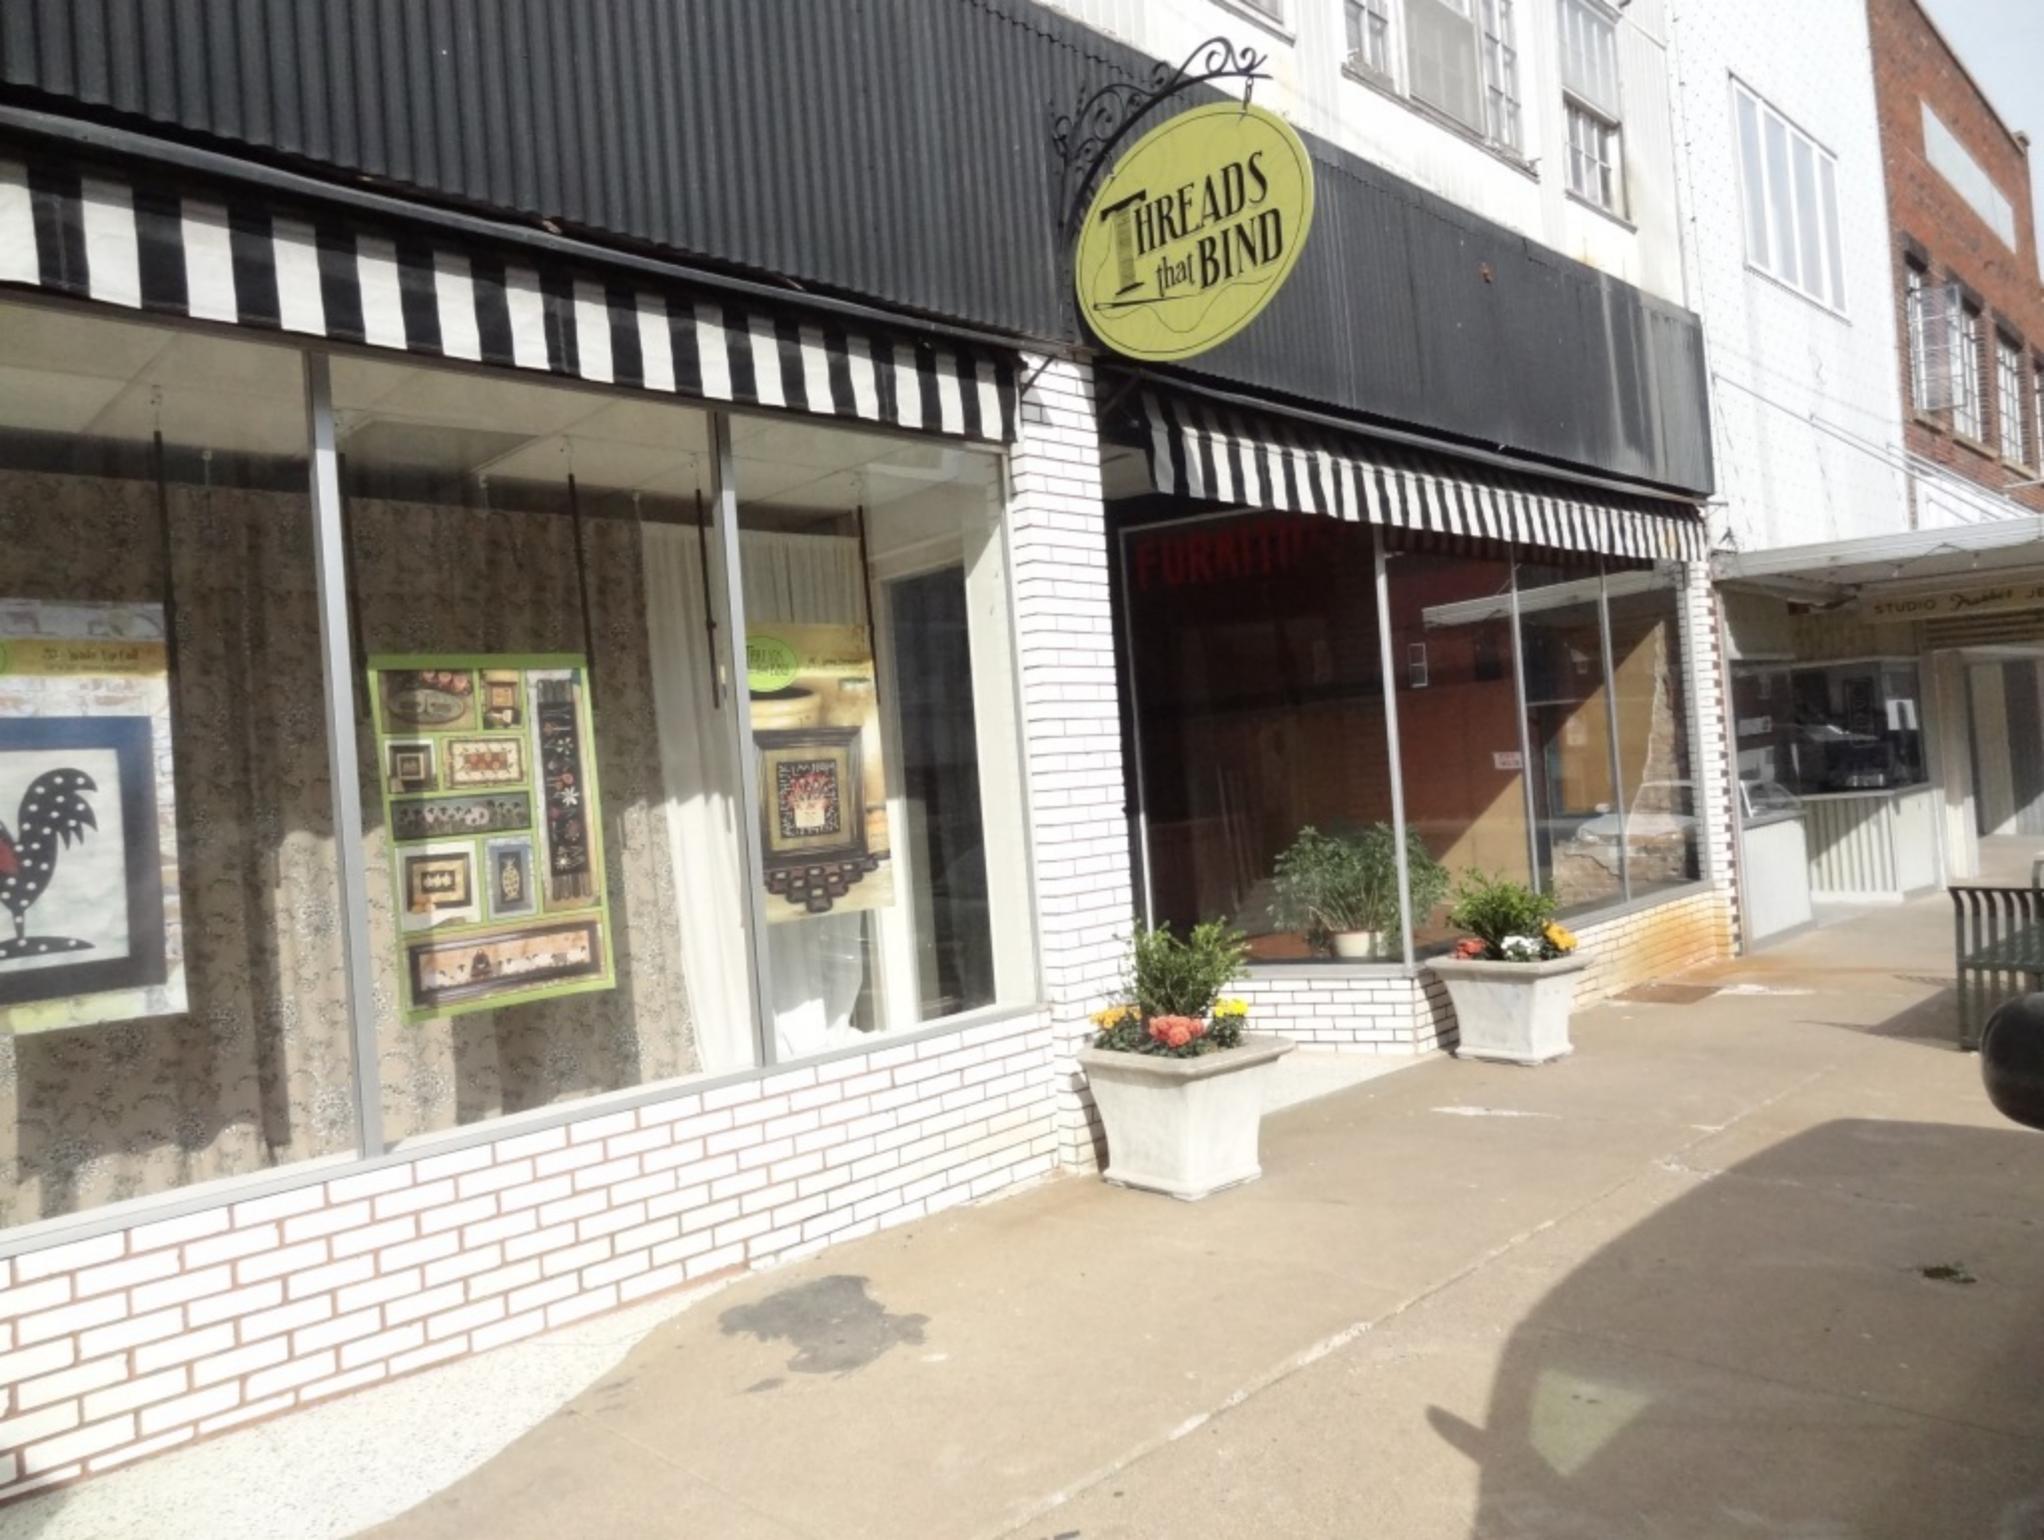
Alterations were completed at an unknown date, but appear to be from the 1960s. Despite alterations, the building retains enough historic fabric to be contributing to a potential National Register historic commercial district.

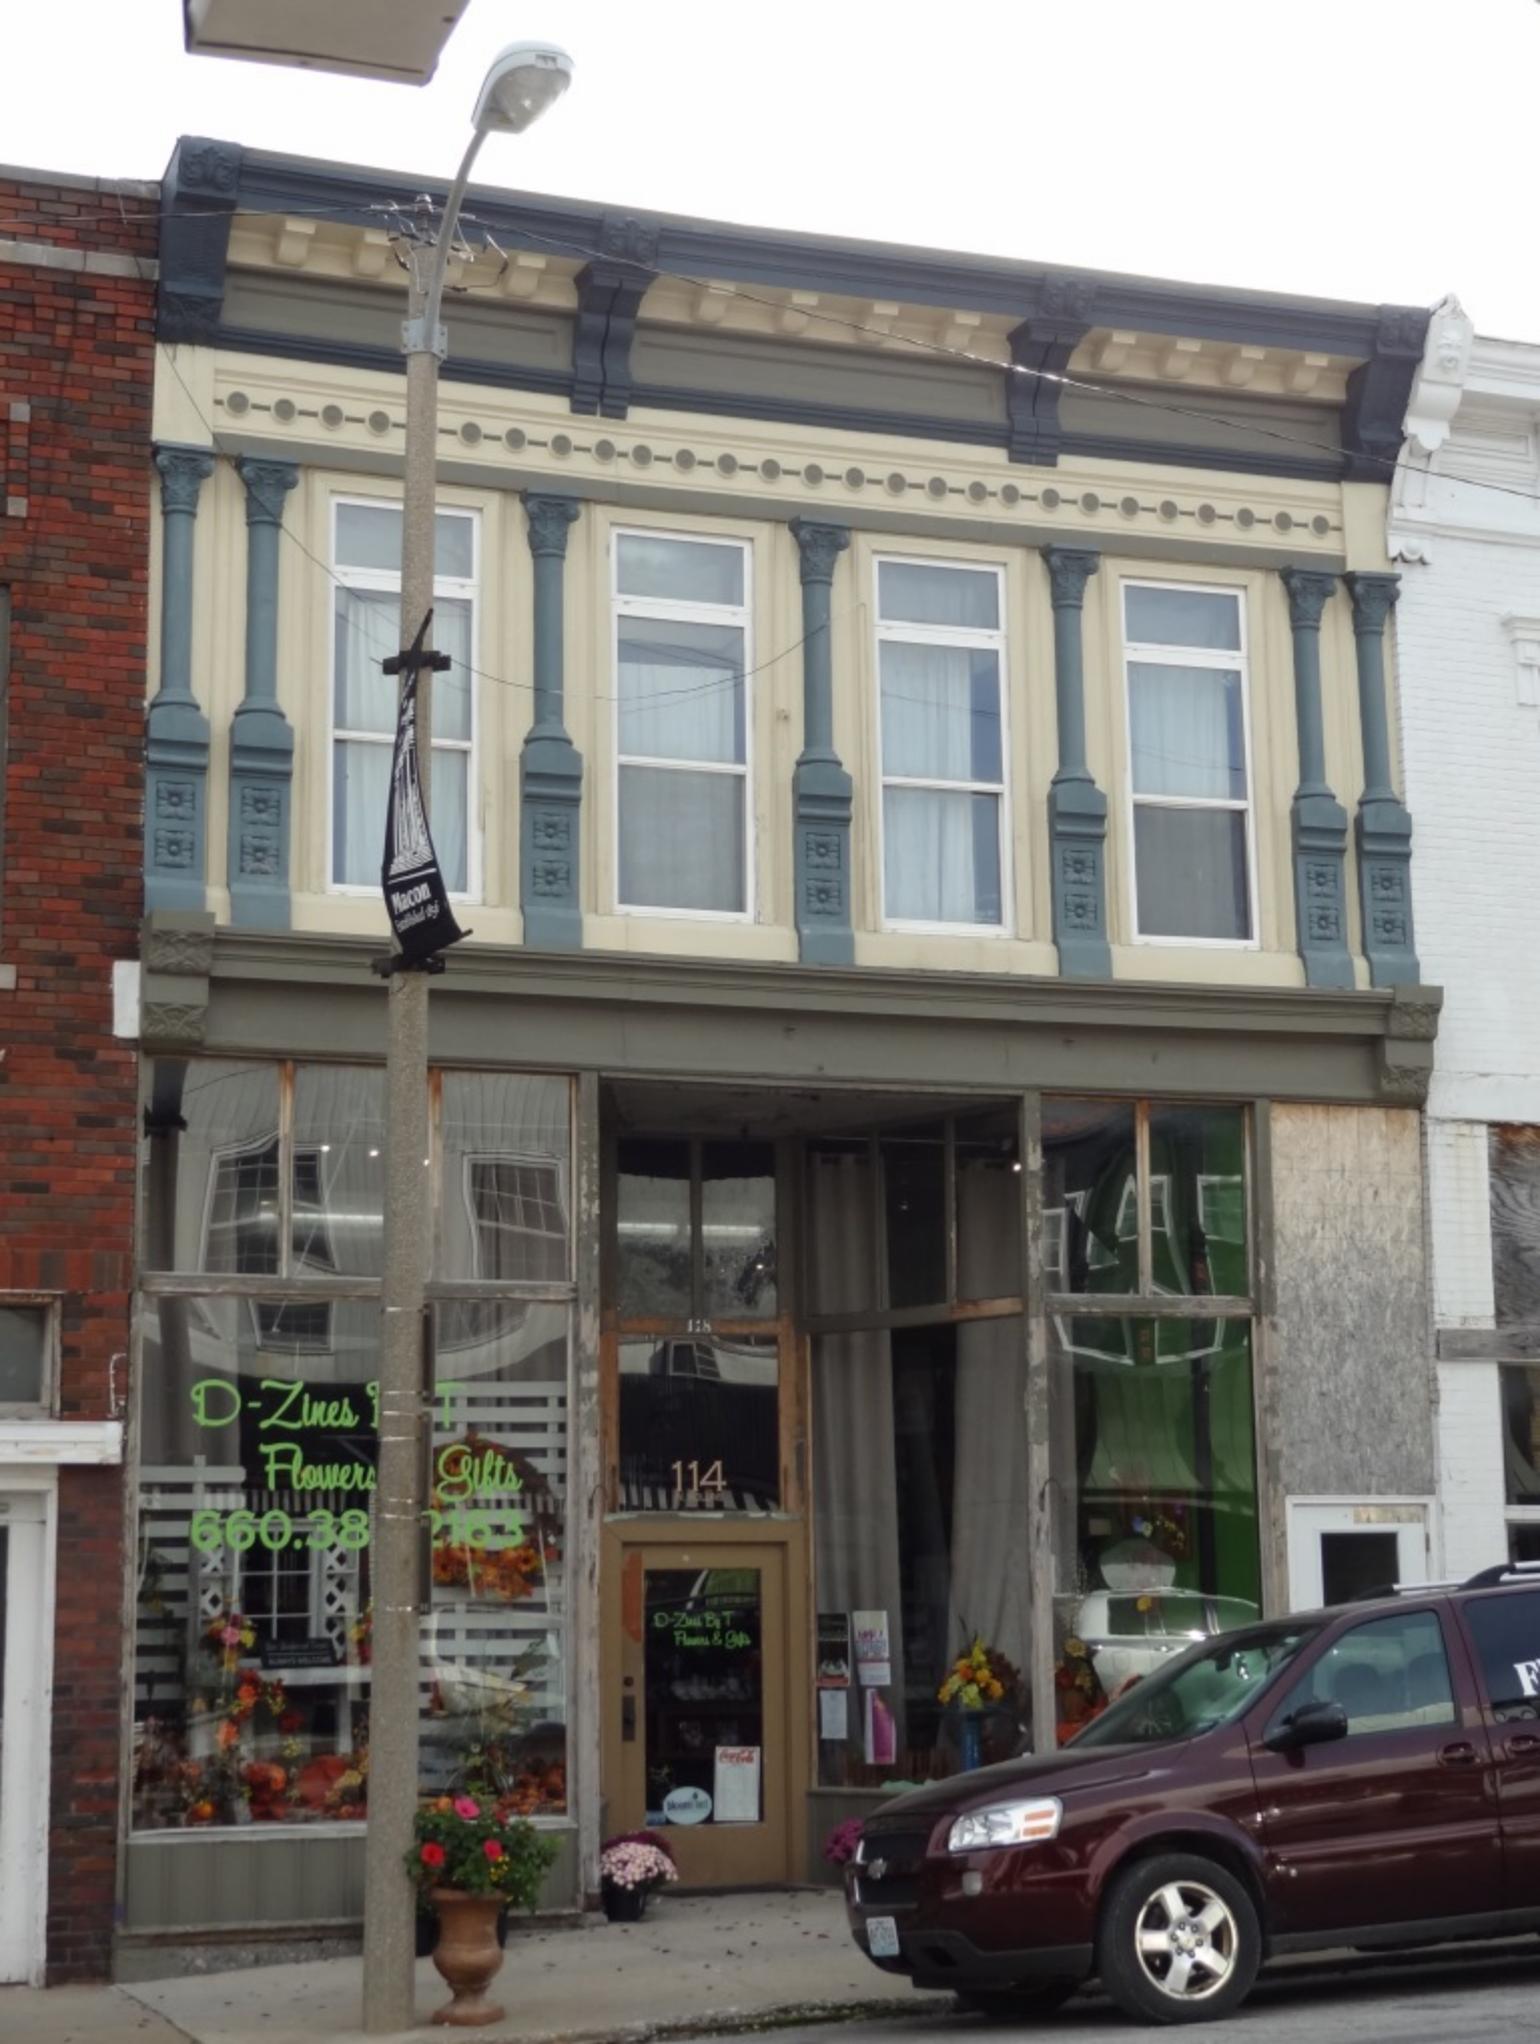
This two-part commercial block building contains four bays on the first story. From north to south, the first three bays comprise the storefront entrance. The central storefront bay contains a recessed wood and glass entry door with a tall transom window. The outer storefront bays contain tall plate glass display windows with wood muntins that extend outward to align with the plane of the façade. Multi-light transom windows with wood muntins are above. The fourth bay at the far right contains a non-historic door leading to the second floor. The transom above the door is covered with plywood. A metal lintel course with a bracket decorated with a stamped metal floral motif at each end delineates the first and second stories. The second story retains historic metal cladding and has four bays. Each bay contains a window with replacement 1/1 sash and single-light transom. The bays are flanked by slender metal columns with decorative capitals and bases stamped with two rosette medallions. The columns terminate at a lintel course with a circular medallion motif. The cornice features heavy paired brackets and modillions. The end brackets are decorated with stamped metal floral designs.

Despite alterations, the building retains integrity and would contribute to a potential National Register district.

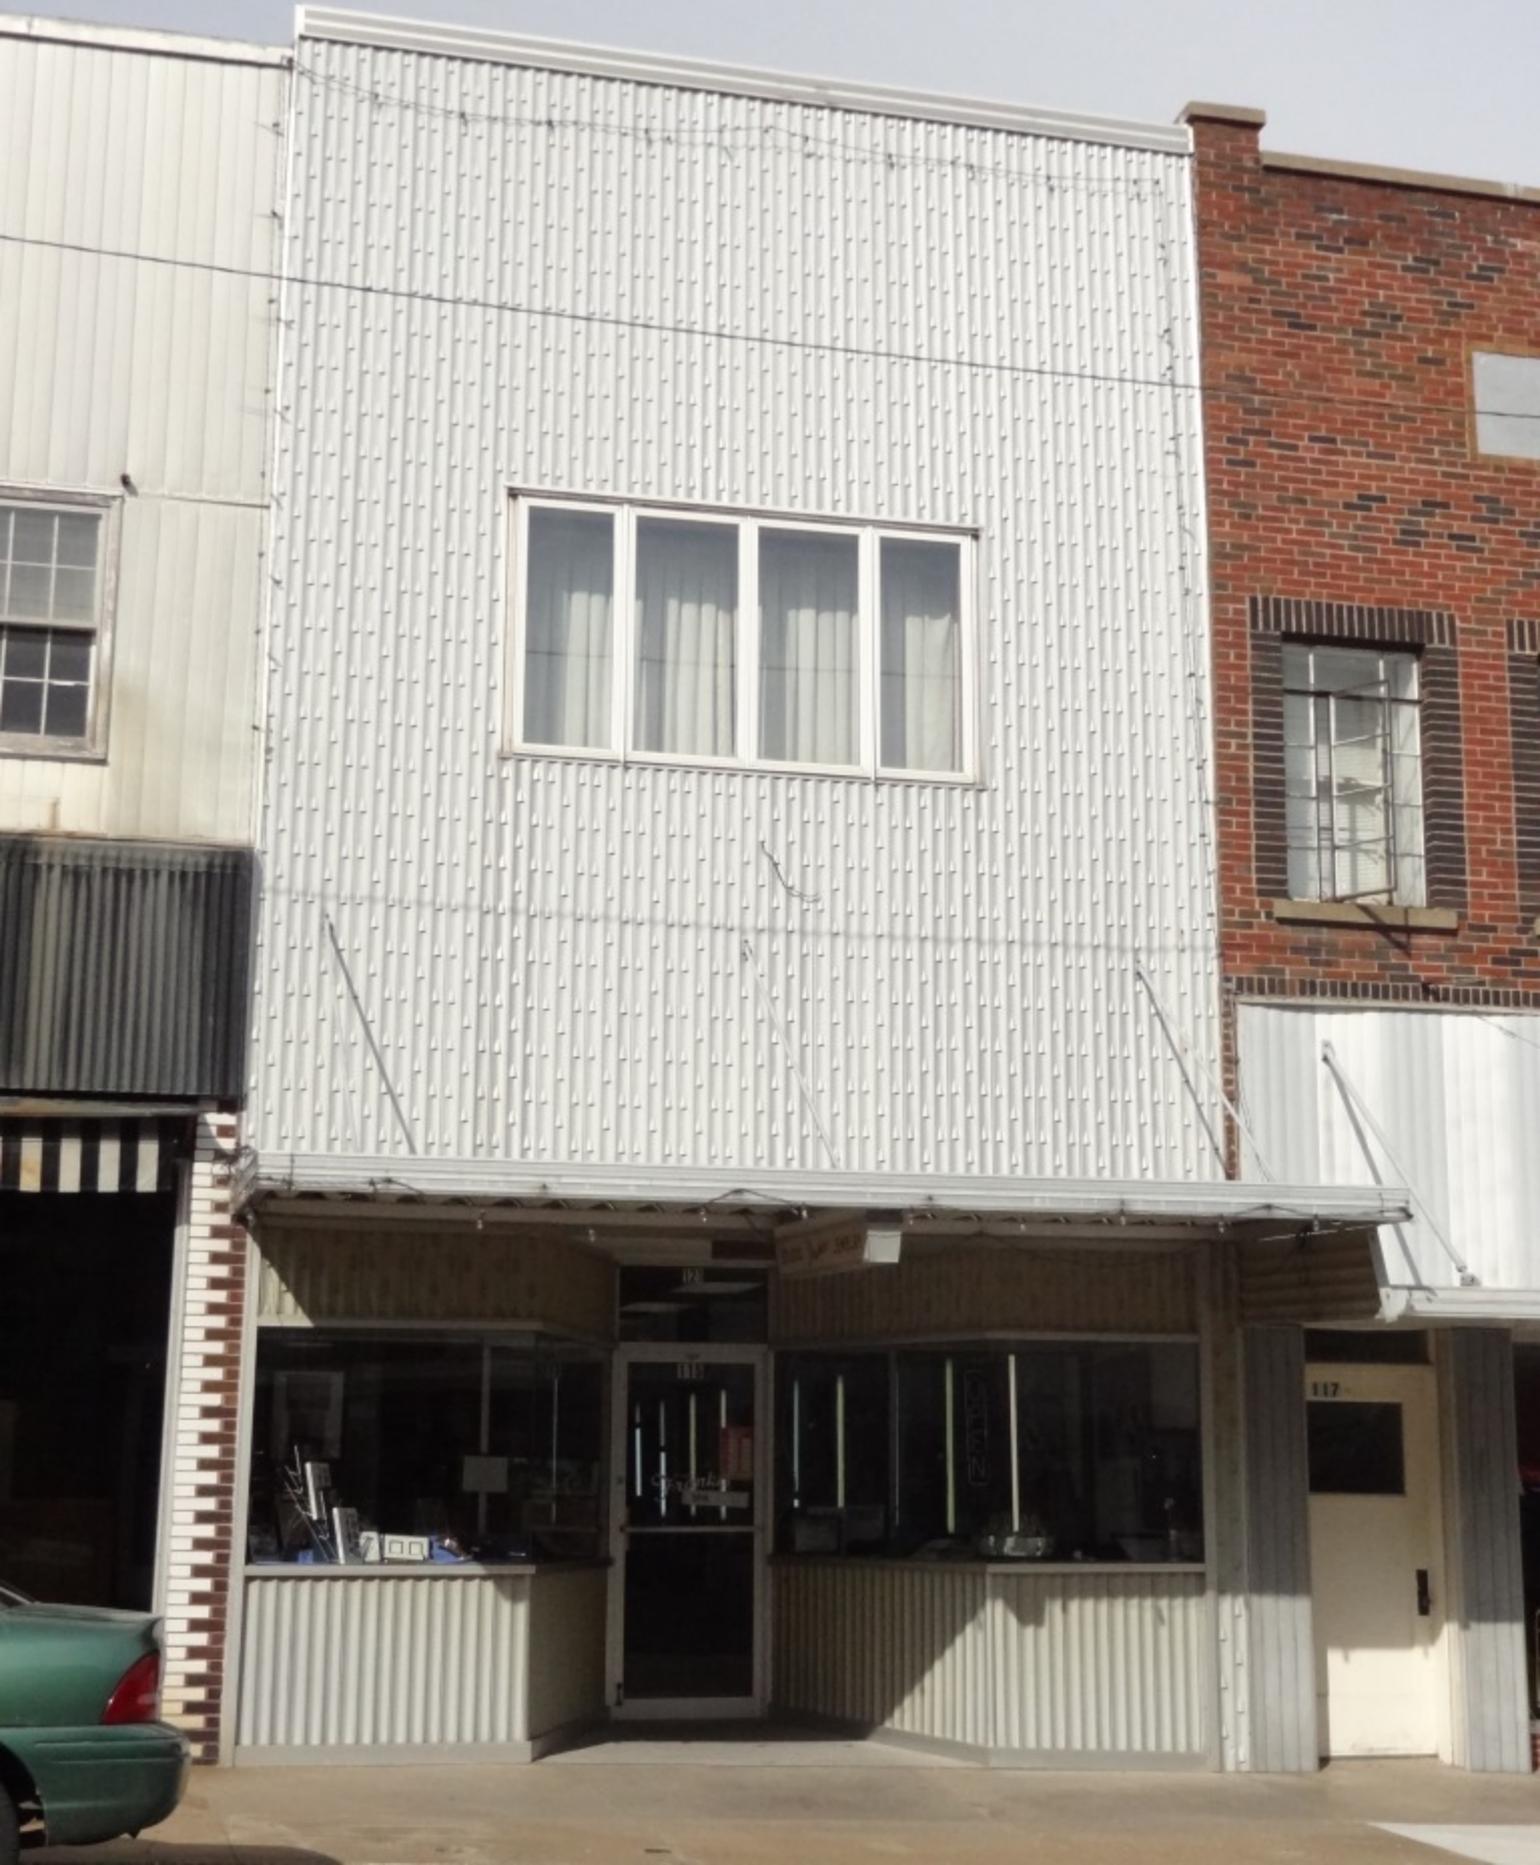
The two-part commercial block brick building located at 115 and 121 North Rollins Street is rectangular with a flat roof and consists of three bays along the first floor of the front façade. The façade includes vertical fiberglass paneling at the storefront bulkhead and transom framing the fixed glass display windows along the first floor. The windows flank a recessed center aluminum and glass entry door and a flat metal awning supported by metal suspension cords separates the two floors. Triangular punctured corrugated metal sheathing covers the upper floor which has a center band of four vinyl fixed single pane windows. Aluminum caps the building's parapet.

Alterations were done c. 1965 according to the Recorder of Deeds and most likely consisted of the metal sheathing and windows, altering the whole facade. The building at 115 and 121 North Rollins Street is noncontributing to a potential National Register historic commercial district.

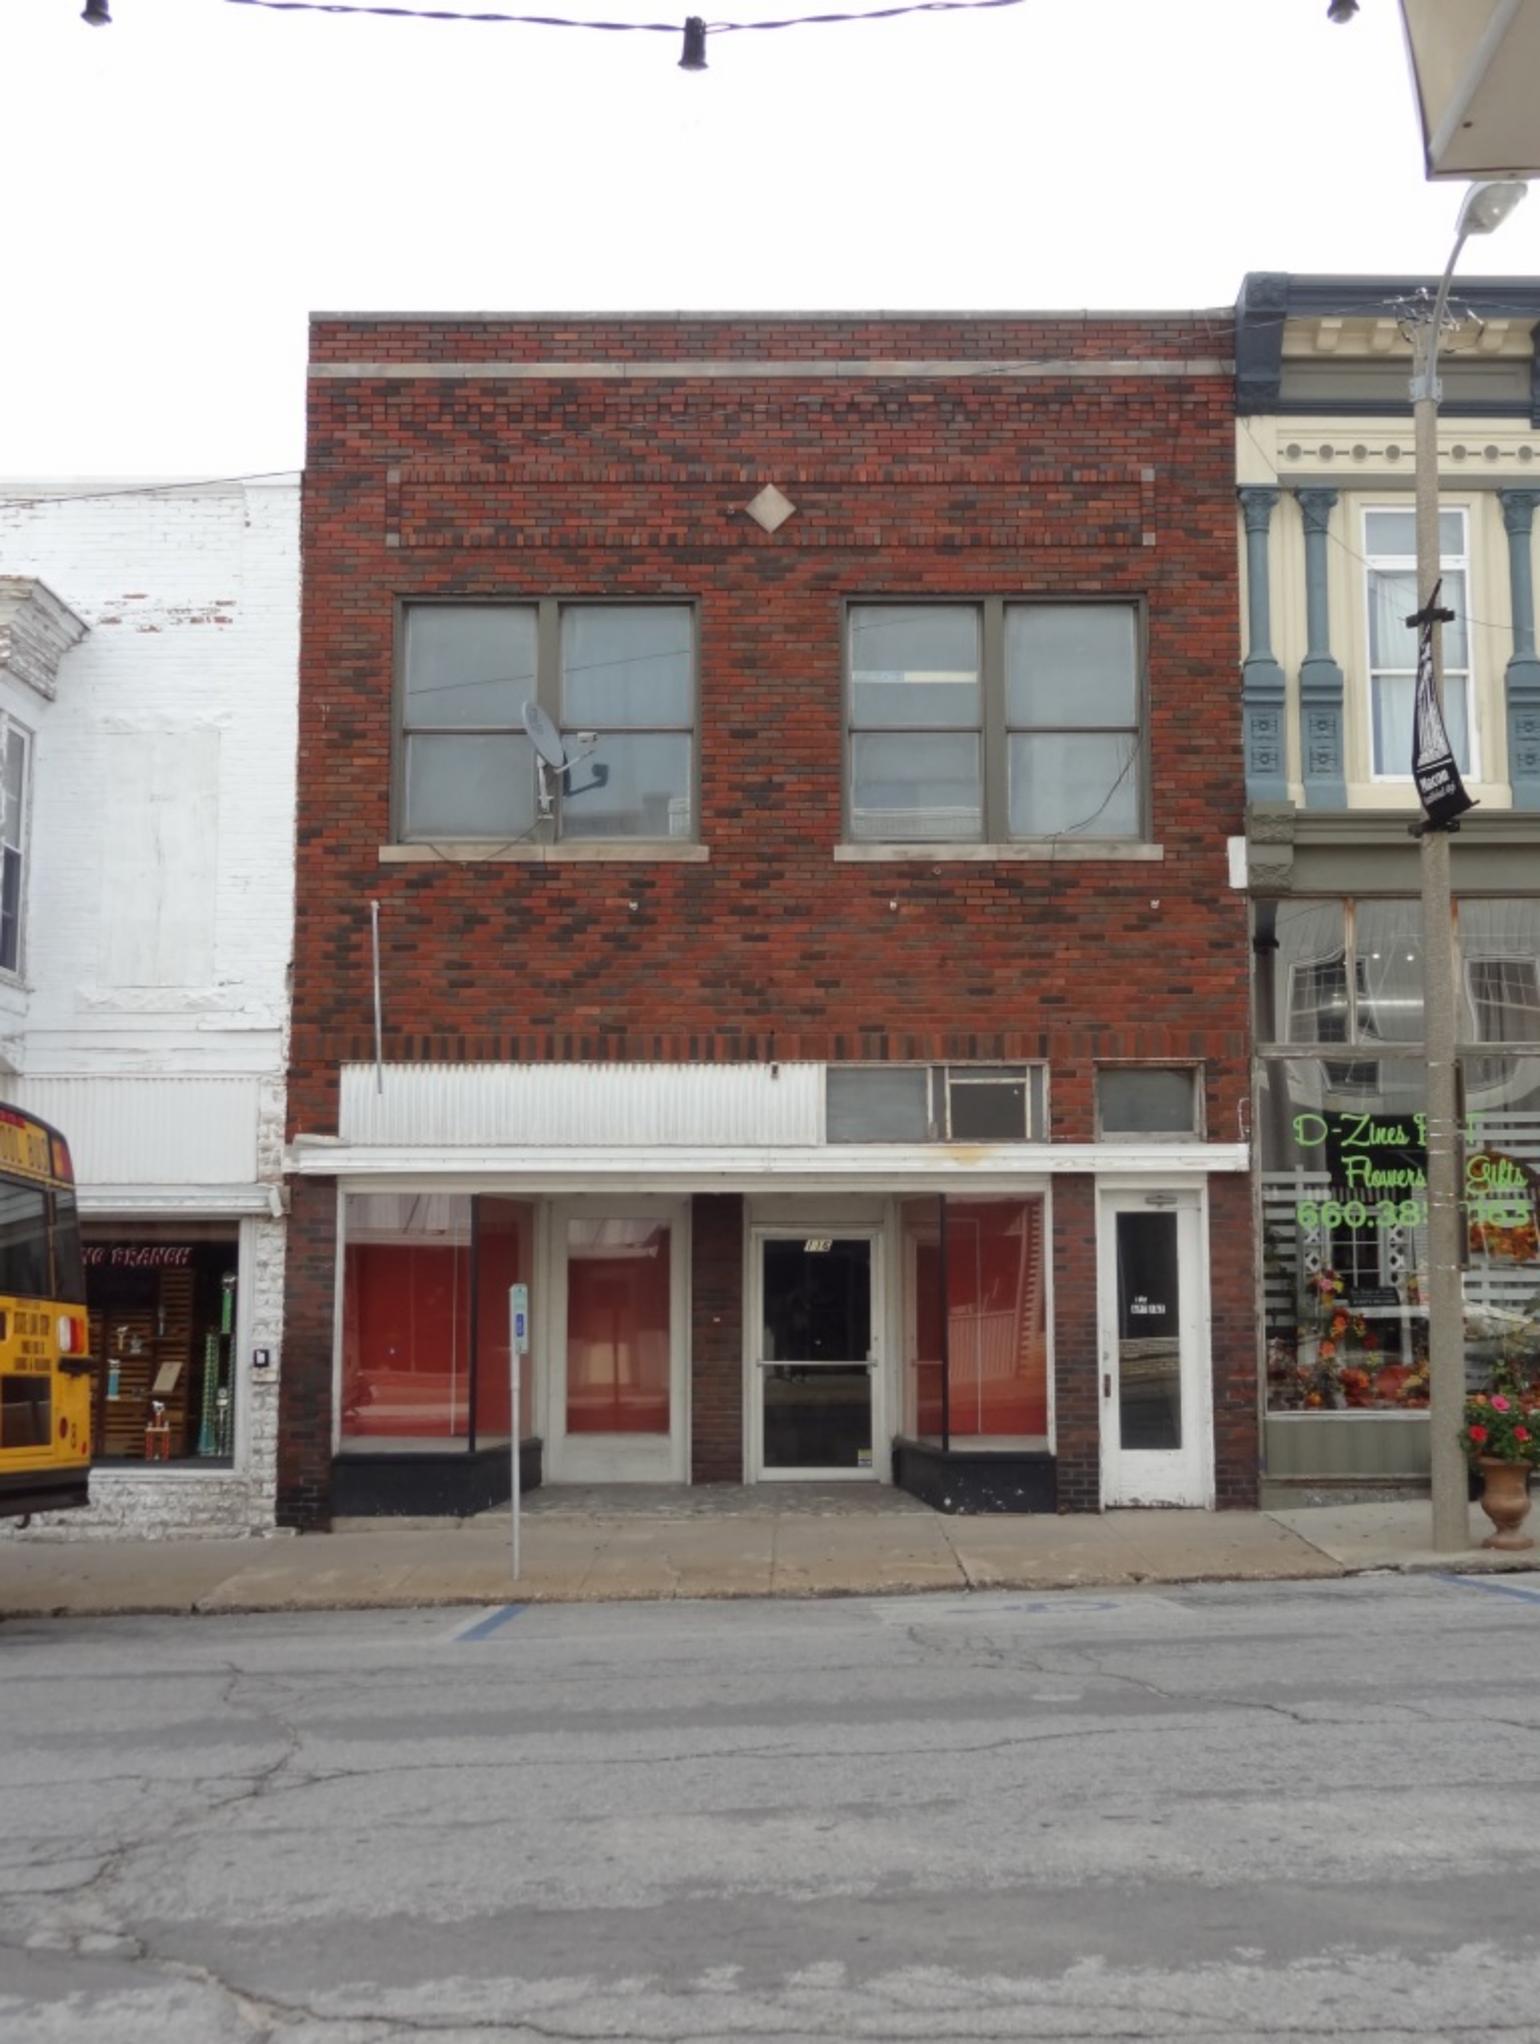
This two-part commercial block brick building has five bays on the first story. From north to south, the first and fourth bays contain plate glass display windows with concrete bulkheads. The second bay contains a wood door with a single light, and the third bay contains a non-historic aluminum and glass entry door. The fifth bay contains a wood and glass door that leads to the upper story residential space. A metal beam from an awning is applied to the façade above. Above that, a line of transom windows is partially boarded with corrugated metal. A soldier brick stringcourse delineates the first and second stories. The second story contains two bays; each has a set of paired 1/1 wood windows with stone sills. A rectangle of rowlock bricks with a limestone diamond-shaped block decorates the wall above the windows. The cornice is lightly corbeled and features a stone stringcourse.

While the building no longer has its iron storefront, the brick veneer cladding is likely historic. Despite alterations, the building would contribute to a potential National Register district.
