1. Survey No. MC-AS-001-001		2. Survey name: Downtown Macon Commercial Historic District	
3. County: Macon		4. Address (Street No.) Lots 11-13 block 93	Street (name) East Bourke Street (100 block)
5. City: Macon	Vicinity: <input type="checkbox"/>	6. Geographical Reference:	7. Township/Range/Section: T: R: S:
8. Historic name (if known):		9. Present/other name (if known): City of Macon Parking Lot #3	
10. Ownership: <input checked="" type="checkbox"/> Private <input type="checkbox"/> Public		11a. Historic use (if known): Commercial	11b. Current use: vacant

42. Current owner/address: City of Macon Macon, MO 63552	43. Form prepared by (name and org.): Kristi Chase MO SHPO	44. Survey date: 9/24/2014
		45. Date of revisions:

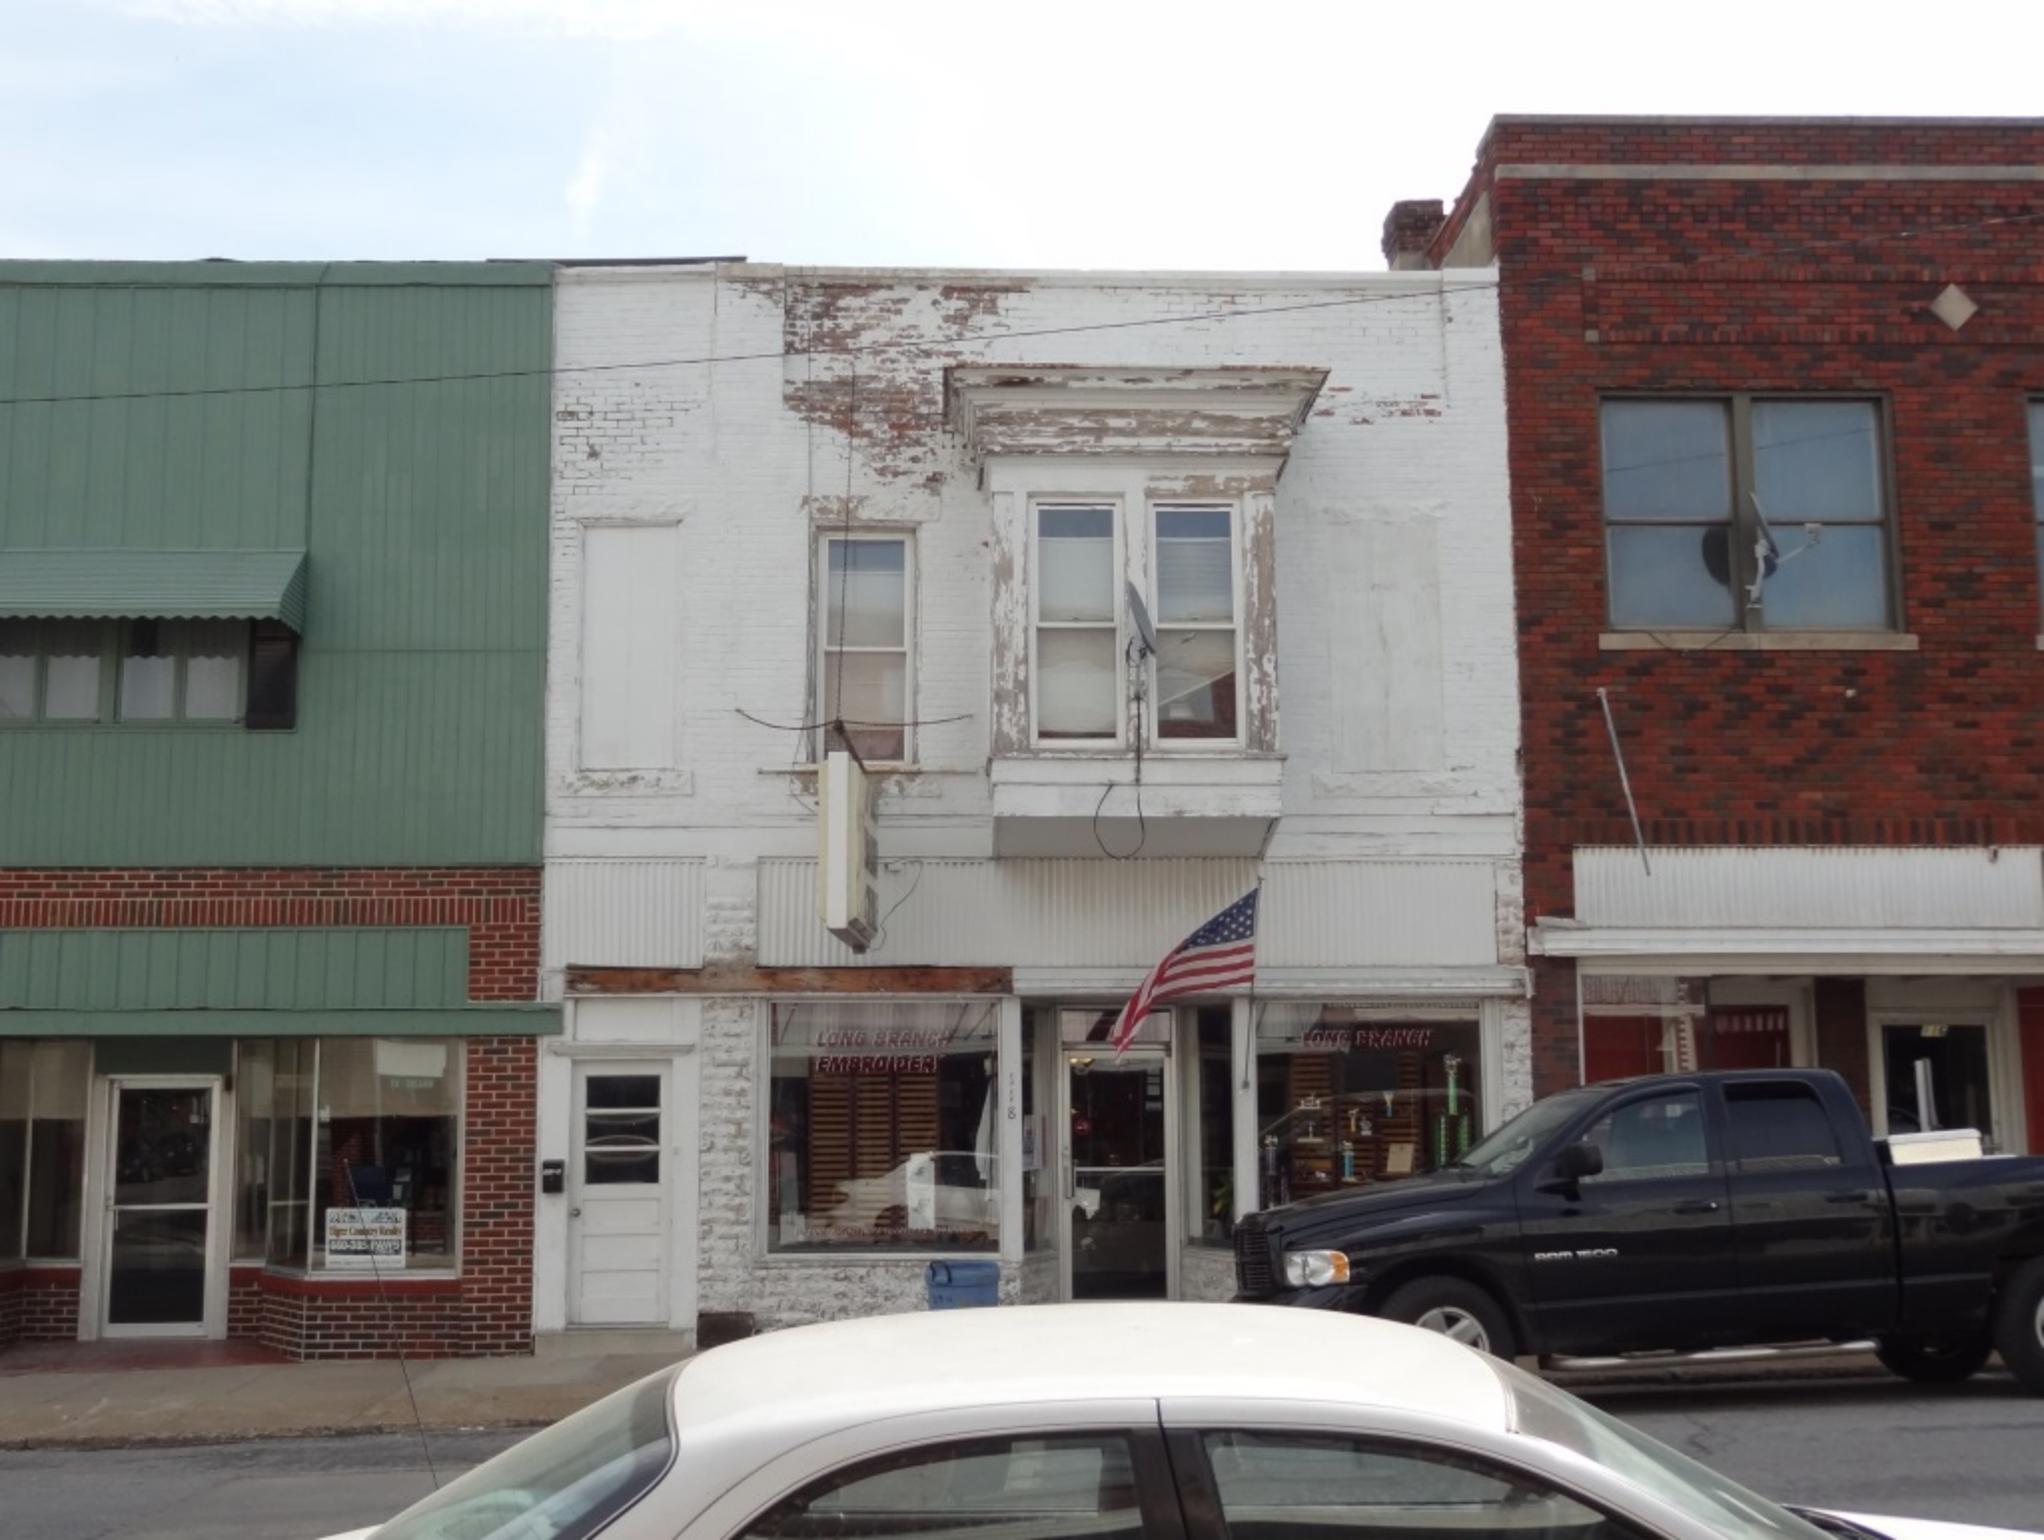
This two-part commercial block painted brick building has four bays on the first story. From north to south, the first bay contains a wood and glass door that leads to the second floor. A transom above the door has been boarded up. The other three bays comprise the storefront. The central storefront bay contains a recessed modern aluminum and glass entry door with a glass transom. The flanking bays contain plate glass display windows that extend back out to align with the façade. Masonry veneer clads the exterior on the first story. The transom space above the four bays has been covered with corrugated metal. The second story exterior is clad with brick. From north to south, the first and fourth bays have boarded up window openings with rough cut stone sills and lintels. The second bay contains a replacement 1/1 window. The third bay has a square-shaped wood bay window with four replacement 1/1 windows and a prominent wood entablature.

An upper floor bay window is not shown on the Sanborn maps but is seen in a 1933 and a 1959 photograph in Franke's book. Despite alterations, the building may contribute to a potential National Register district.

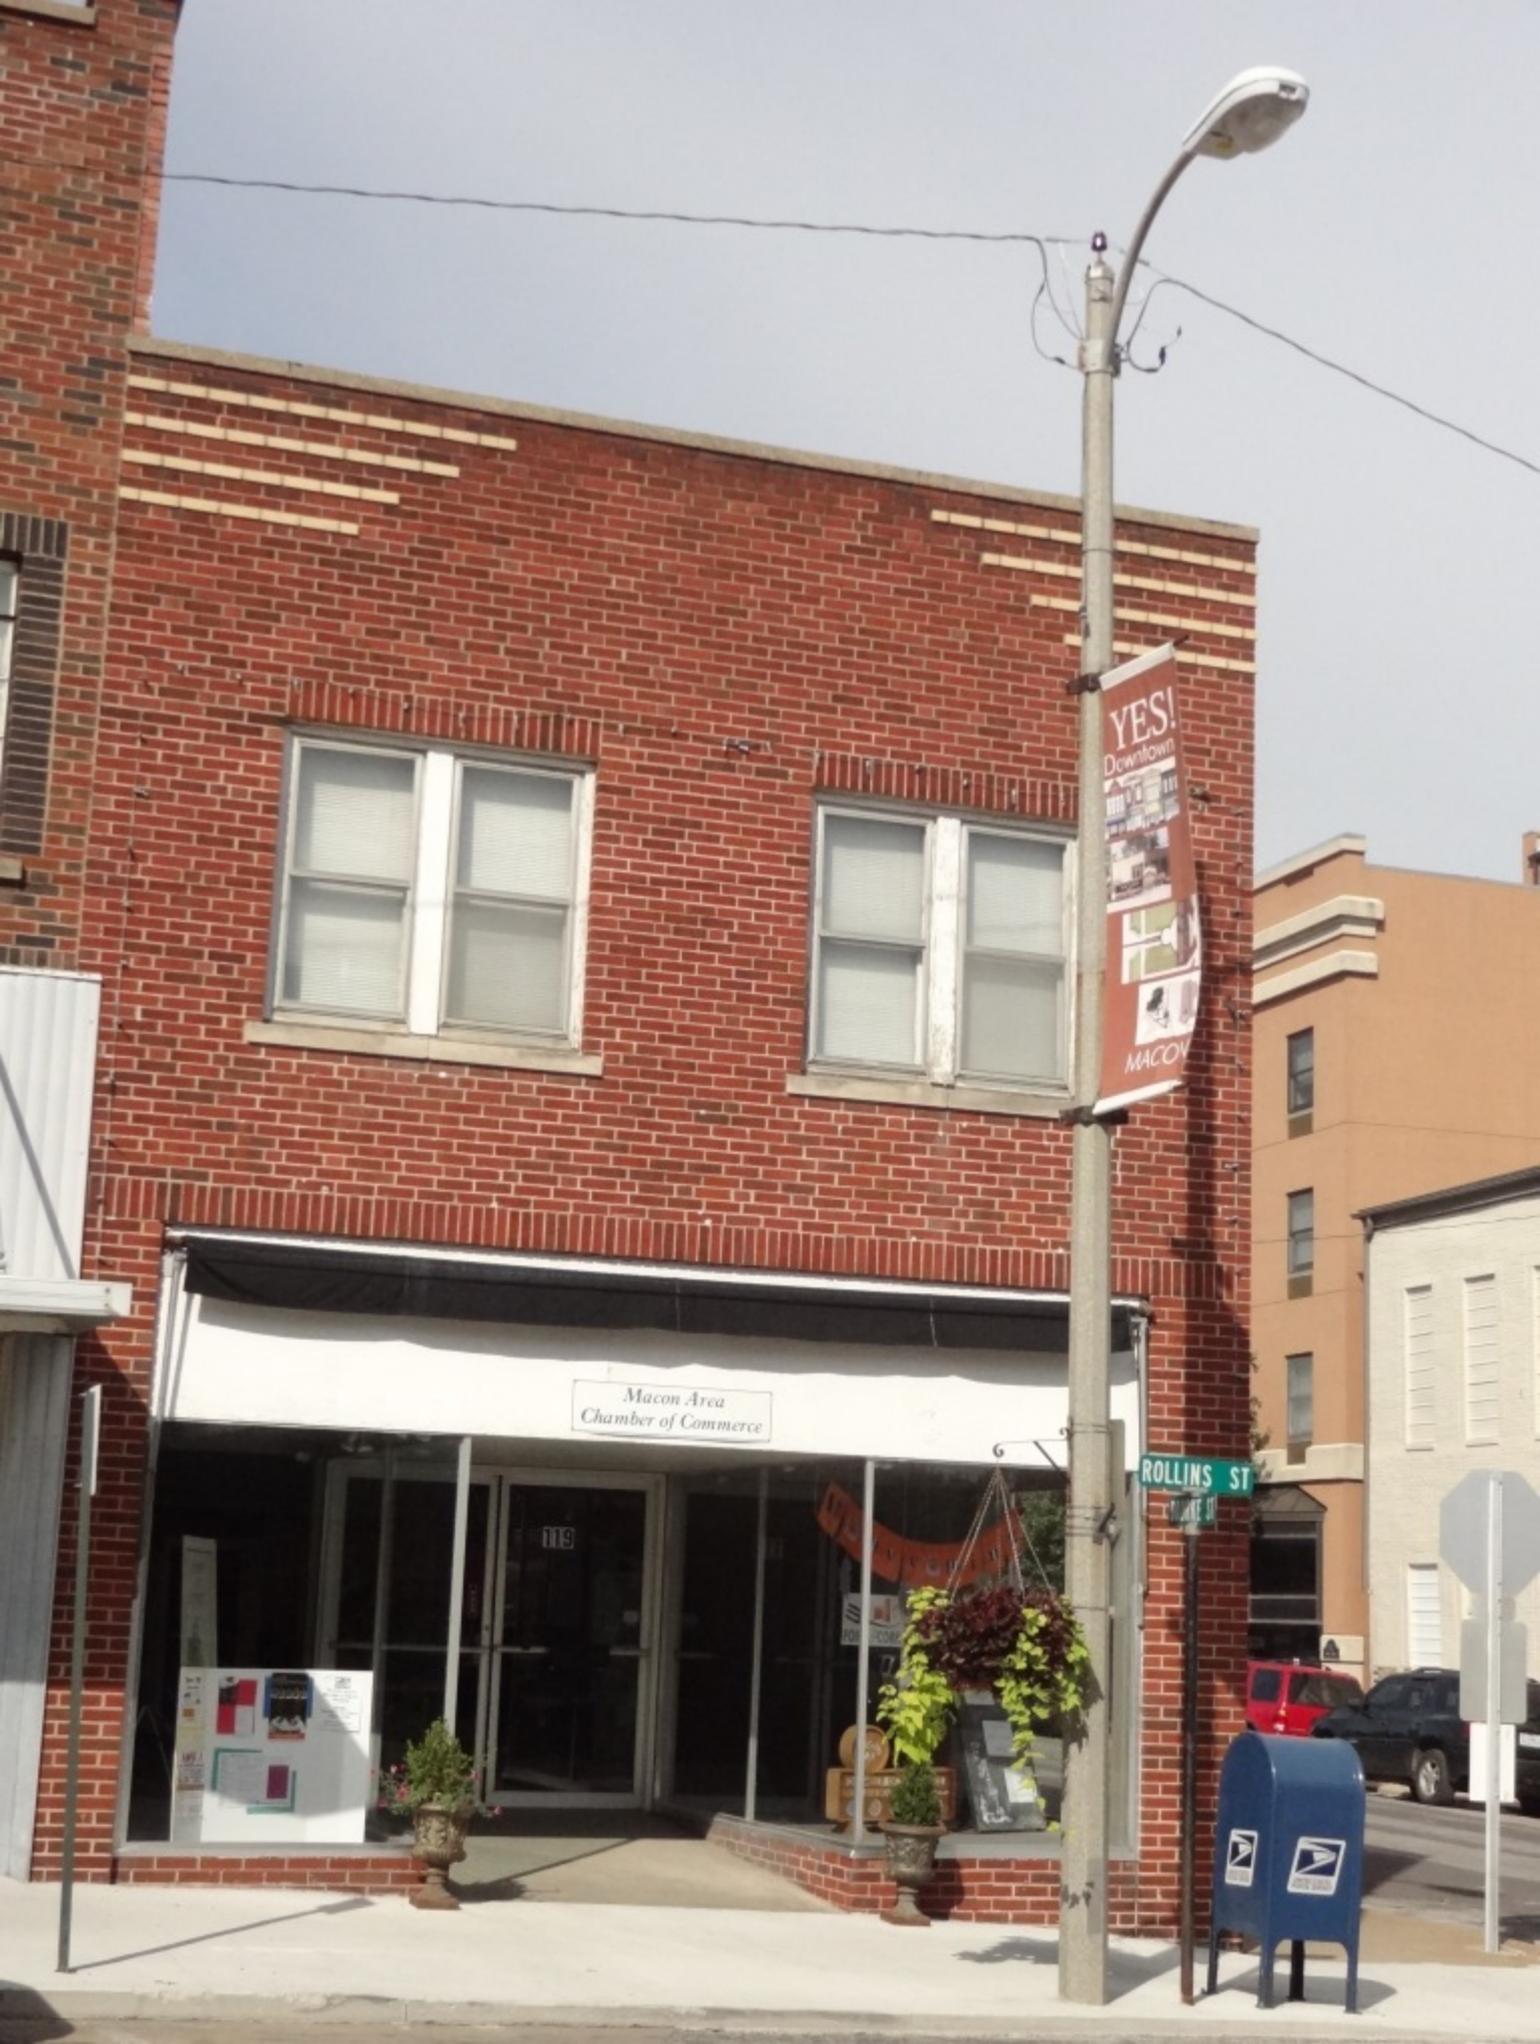
The two-part commercial block brick building located at 119 North Rollins Street is rectangular with a flat roof and consists of three bays along the first floor of the front façade. The first floor façade includes a large fixed glass storefront with a plywood enclosed transom and a recessed center side entry. A soldier brick course separates the floors. The second floor includes two paired 1/1 double-hung wood sash windows with soldier brick lintels and limestone sills. The brick parapet with concrete capping includes Art Moderne influenced terra cotta horizontal lines from each corner. The detailing of the front façade wraps around to the north elevation for one bay. The building is eight bays deep with a side entry. Windows include 1/1 double-hung wood sash. A brick chimney on the rear elevation includes similar terra cotta bands from the façade.

Alterations were done c. 1967 according to the Recorder of Deeds and appear to be at the storefront. The building is contributing to a potential National Register historic commercial district.

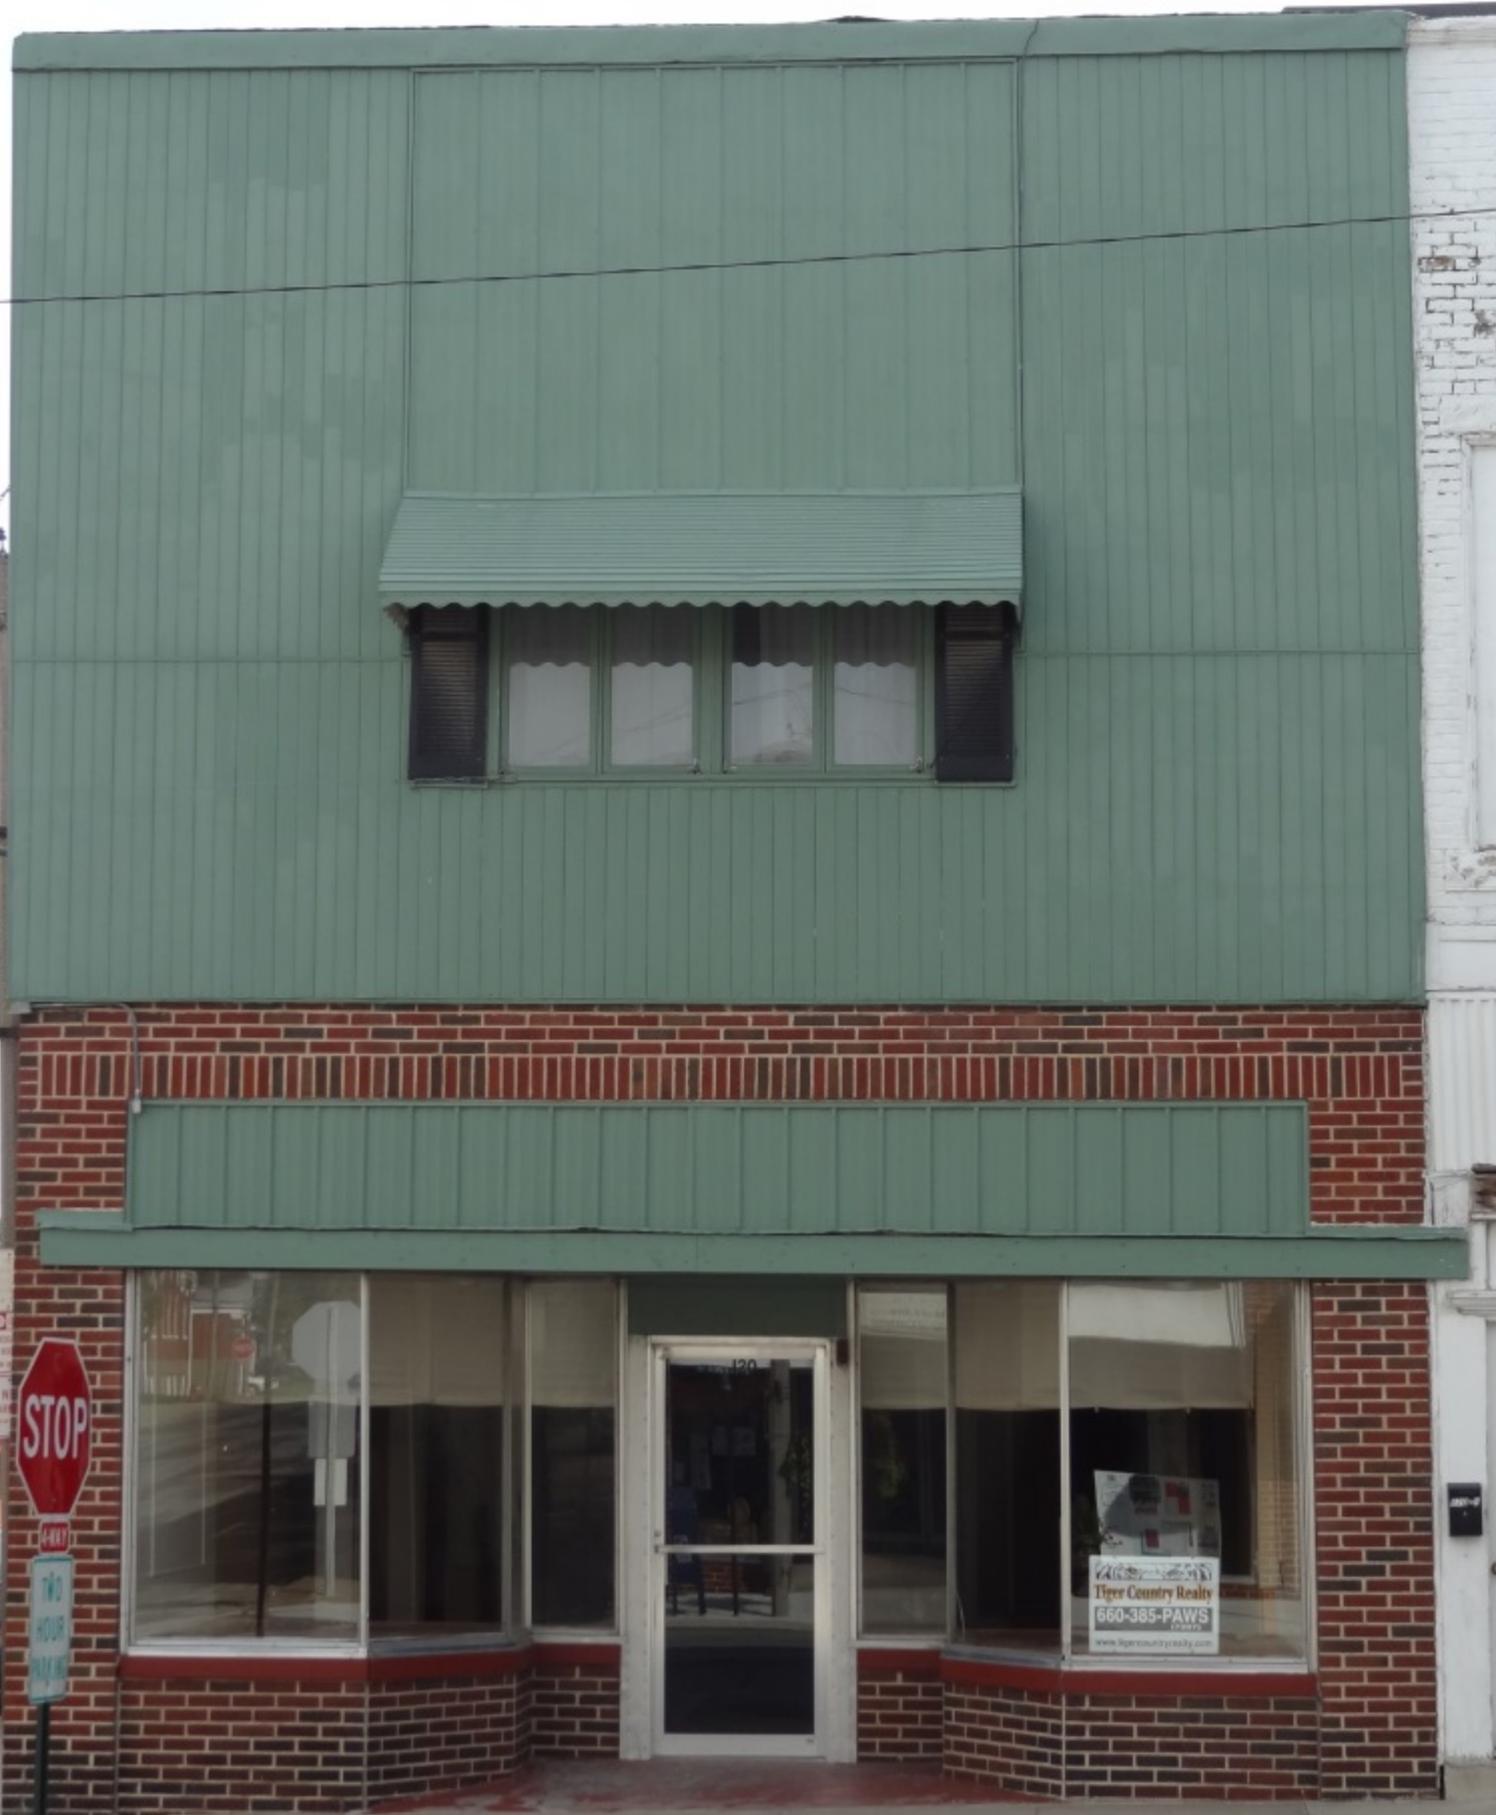
At some point after 1959, the upper story was altered, resulting in the loss of the central oriel window and the Italianate iron cladding, which was replaced with metal panels. These alterations likely render the building non-contributing to a potential National Register district.

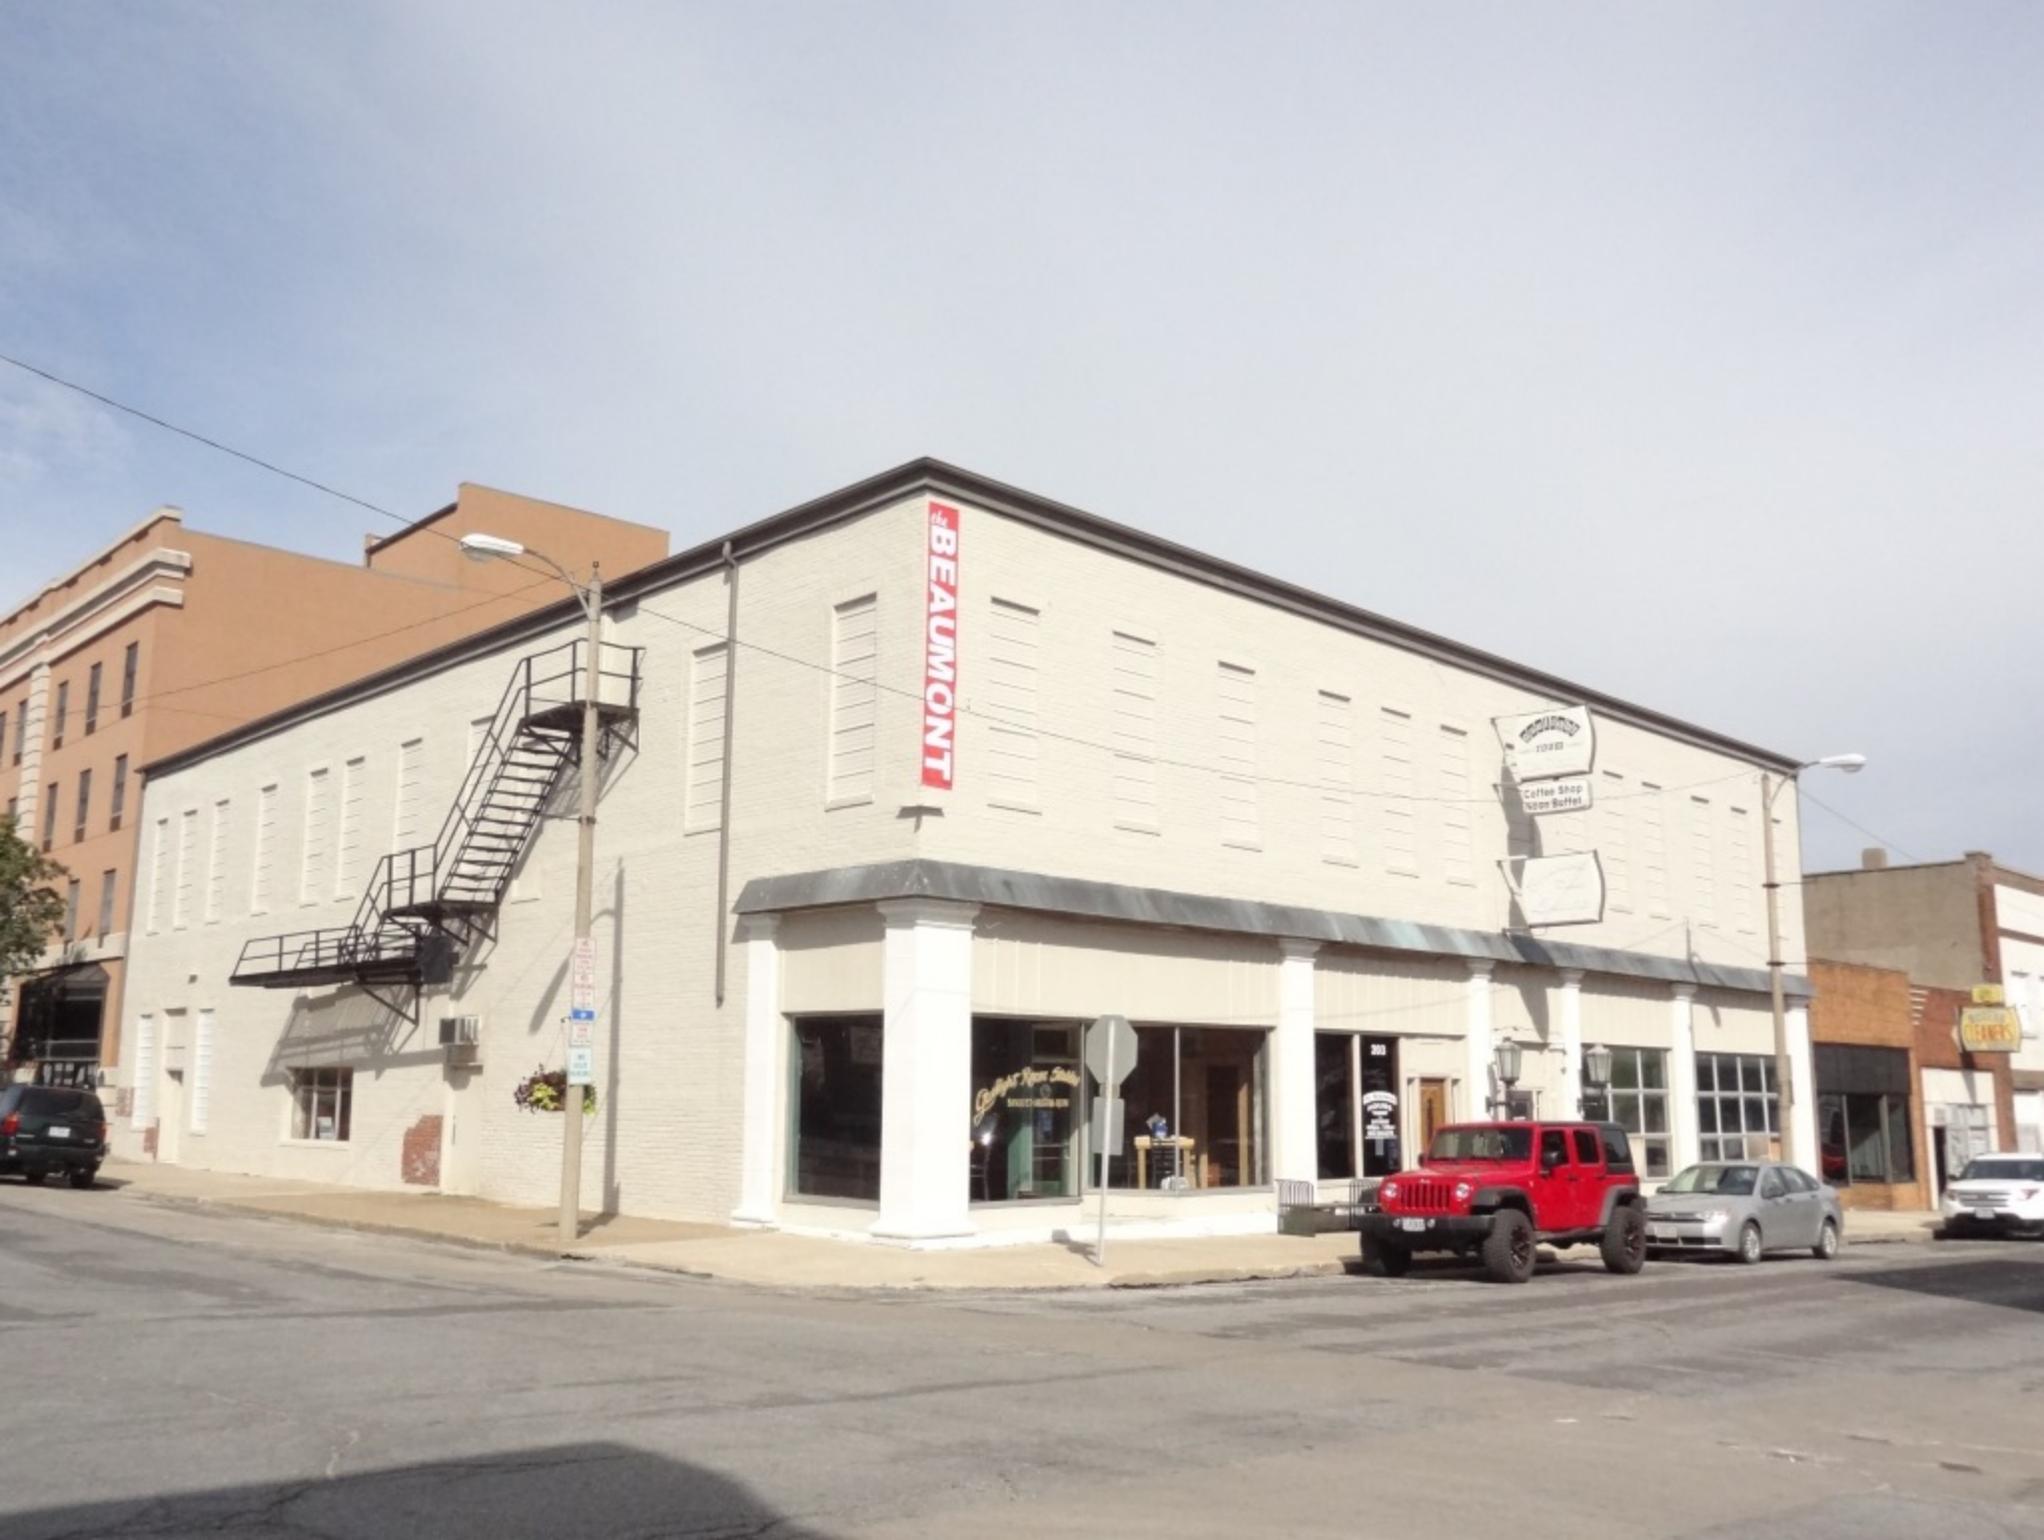
Alterations were completed c.1969 according to the Recorder of Deeds. According to a City of Macon street maintenance employee during survey, the owner recently replaced the flat roof with an asphalt hipped roof and enclosed the upper floor windows with corrugated metal. The brick façade has also been enclosed with Dryvit stucco. The second floor is currently used for storage and is uninhabitable according to the city street maintenance employee.

These alterations have resulted in a loss of architectural integrity, rendering 203-205 North Rollins Street non-contributing to a potential National Register historic district.

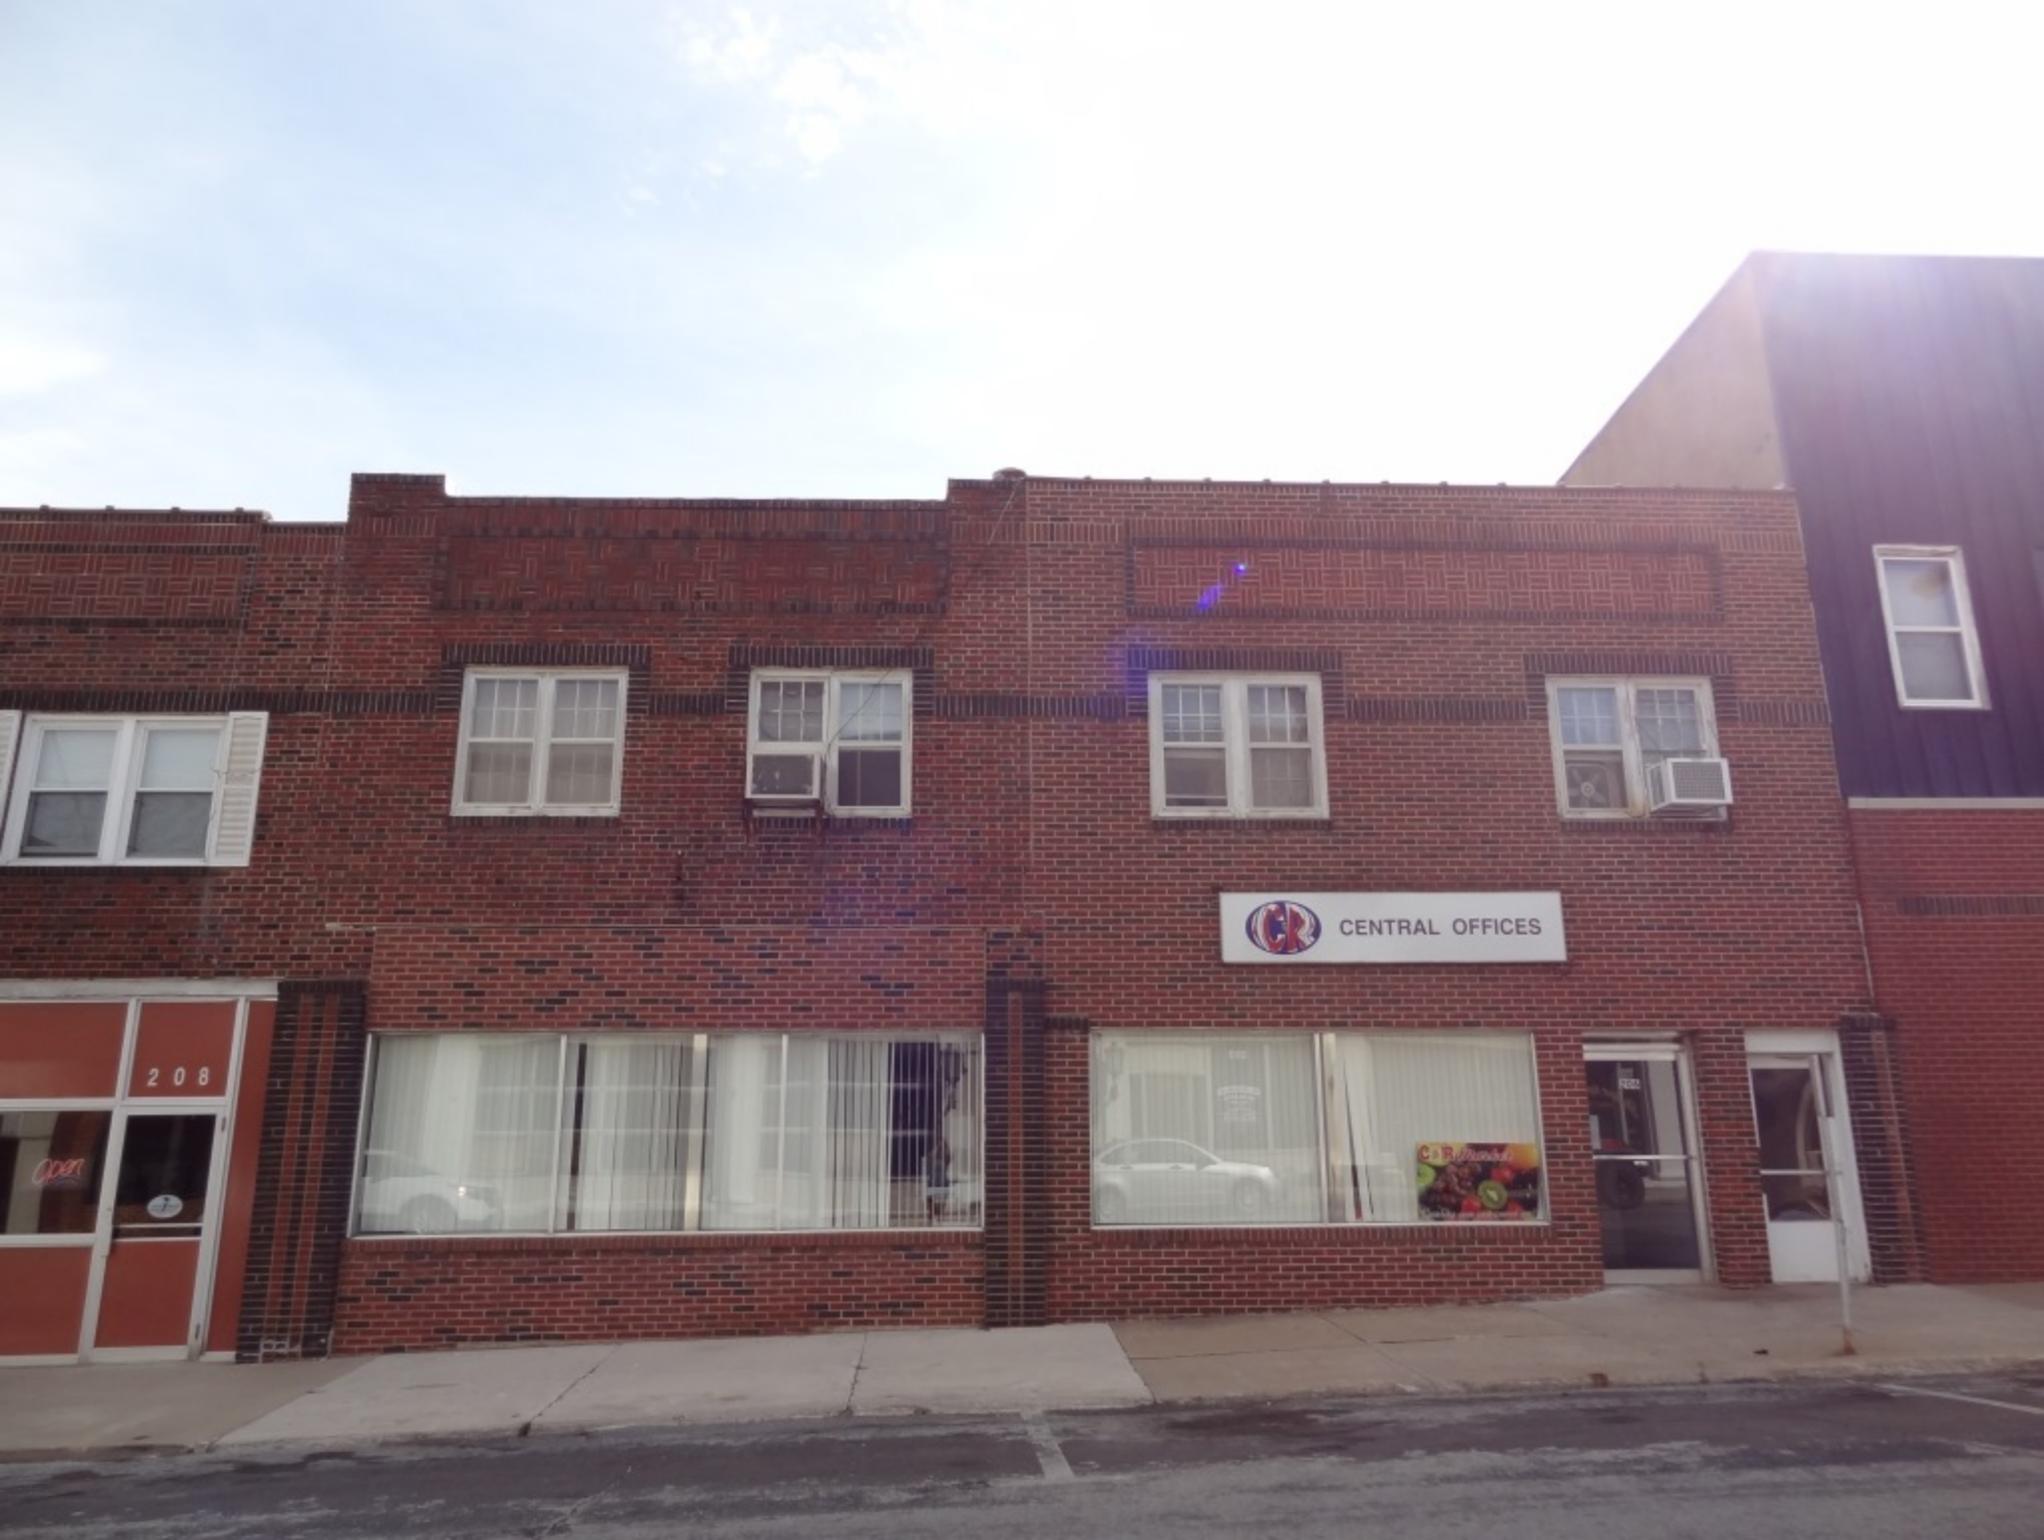
This brown and red brick two-part commercial block building was once two separate buildings; sometime after 1959 they were internally connected and now function as one building. The first story has four bays. From north to south, the first bay contains a large replacement window with three fixed lights and a rowlock brick sill. This bay was once a recessed storefront. The window is flanked on each side by a brown and red brick decorative pilaster. The second bay contains a similar window with two fixed lights. The third bay has a non-historic aluminum and glass door that leads to the office space. The fourth bay has a non-historic door that leads to the second floor. A brown and red brick pilaster abuts the door to the south. The second story contains four bays. The northern half of the building features historic brick laid in a Flemish bond. Each upper story bay contains paired historic 6/6 wood windows with rowlock brick sills. A soldier brick lintel course runs above and between the window bays. Two projecting rowlock brick rectangles filled with decorative brick bonding are on the wall above the windows.

Extensive alterations that occurred after 1959 have resulted in a loss of integrity. This building likely would not contribute to a National Register district.

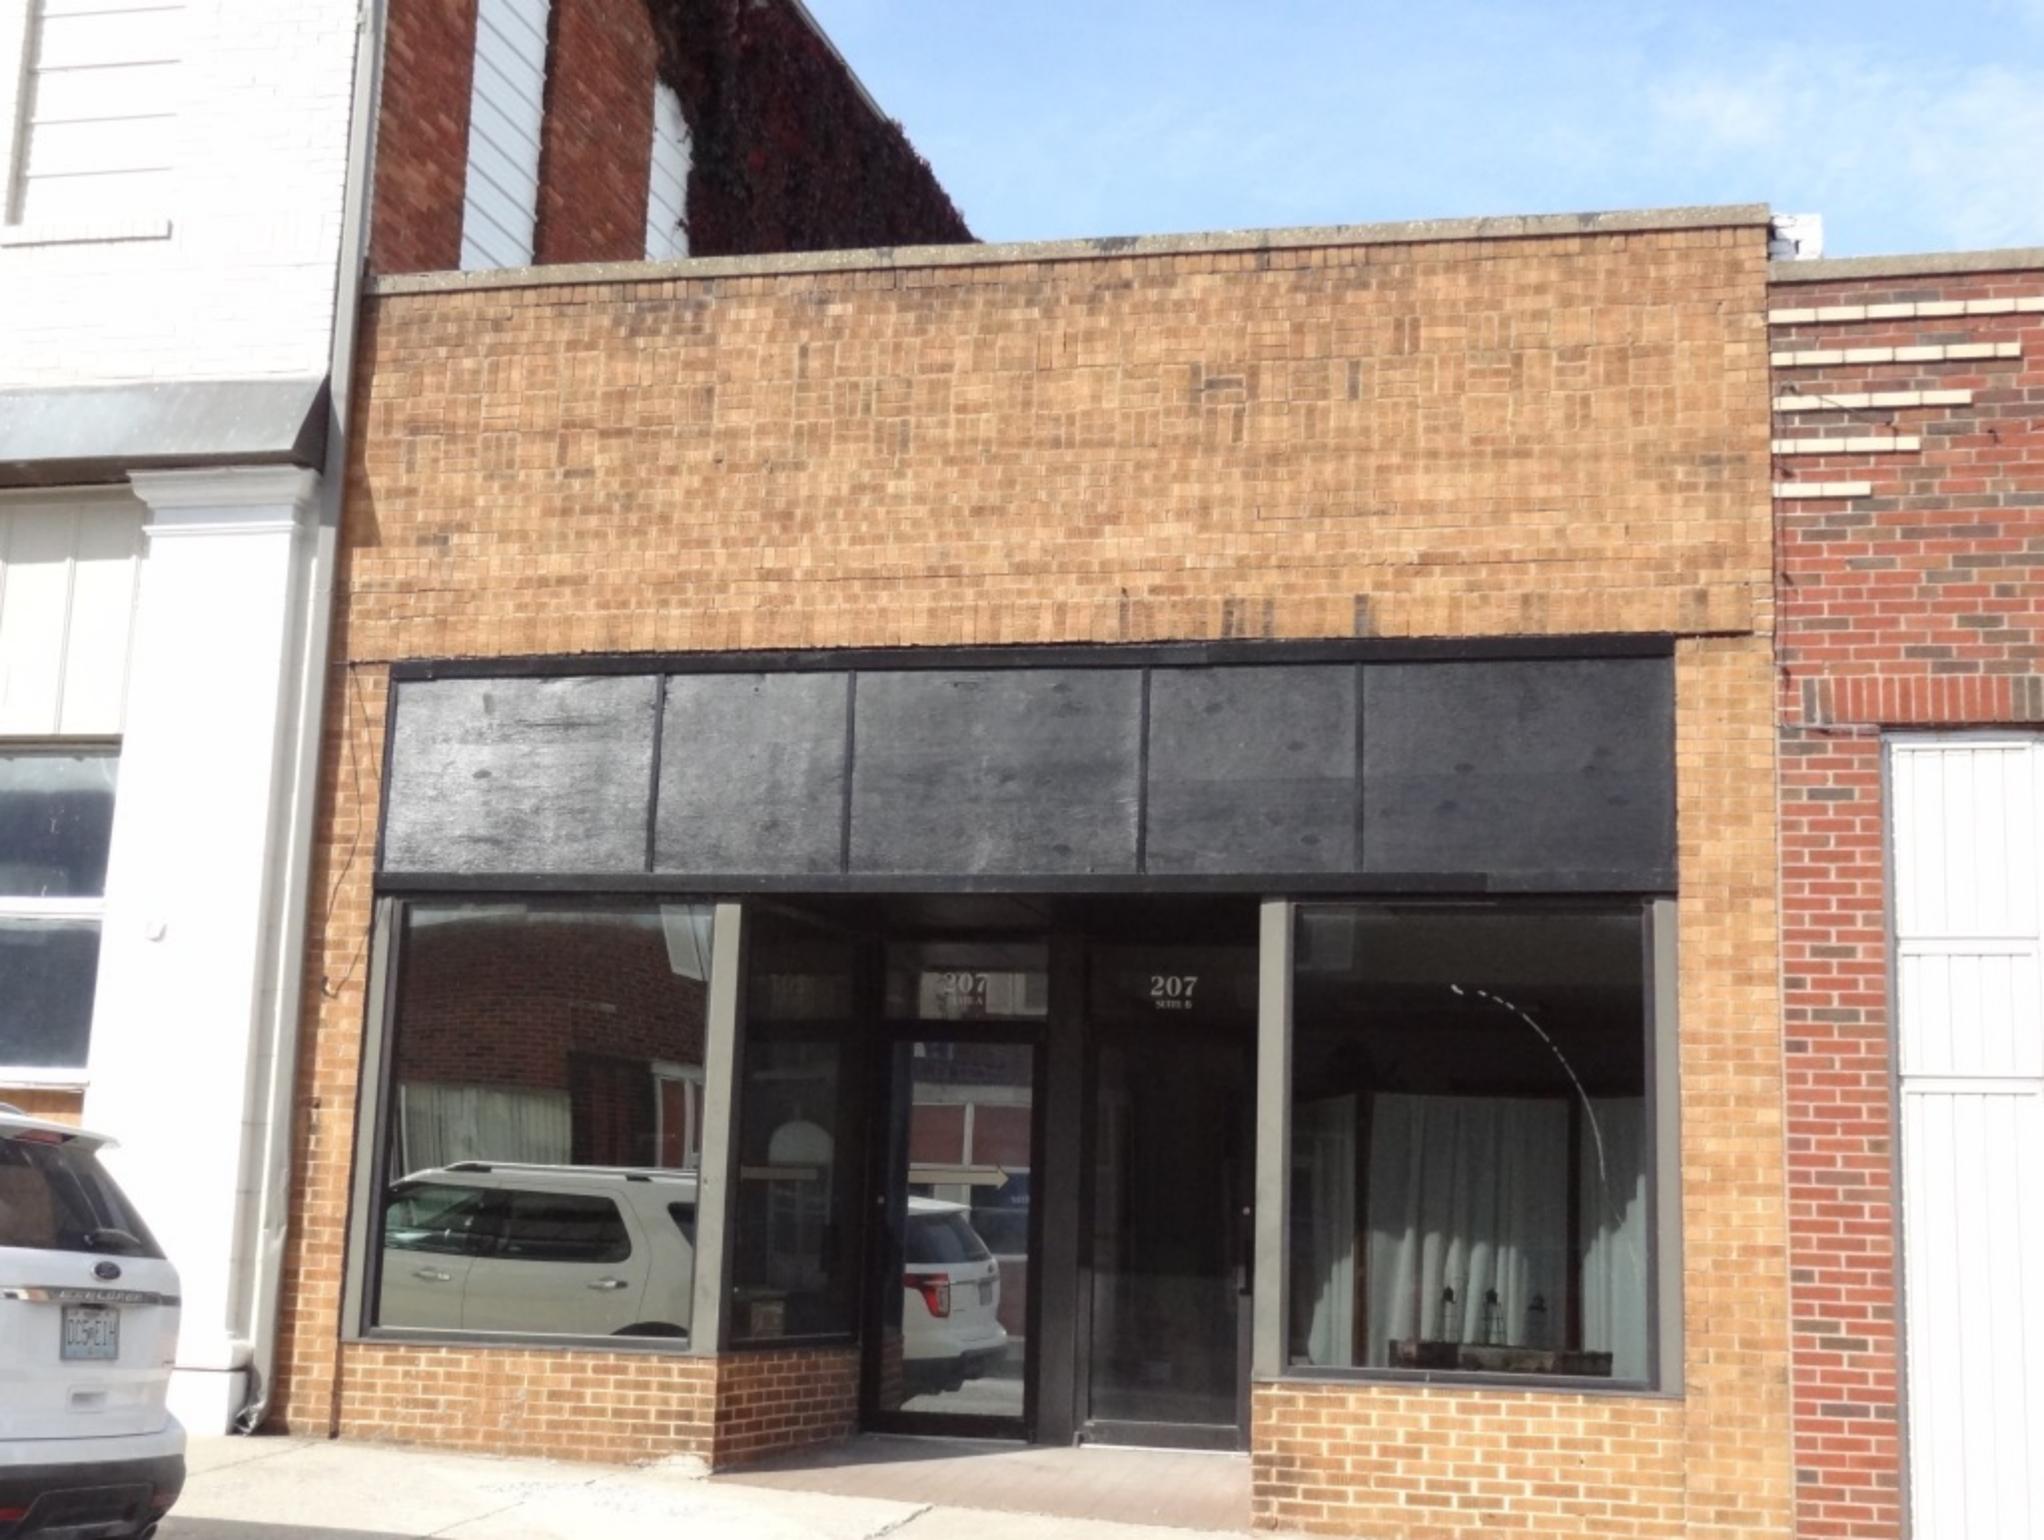
According to the Macon County Department of Economic Development, the building is of concrete construction.

Alterations were done c. 1969 according to the Recorder of Deeds and appear to be related to the storefront. Despite alterations, the building retains enough historic fabric to be contributing to a potential National Register historic commercial district.
