1. Survey No. MC-AS-001-001		2. Survey name: Downtown Macon Commercial Historic District	
3. County: Macon		4. Address (Street No.) Lots 11-13 block 93	Street (name) East Bourke Street (100 block)
5. City: Macon	Vicinity: <input type="checkbox"/>	6. Geographical Reference:	7. Township/Range/Section: T: R: S:
8. Historic name (if known):		9. Present/other name (if known): City of Macon Parking Lot #3	
10. Ownership: <input checked="" type="checkbox"/> Private <input type="checkbox"/> Public		11a. Historic use (if known): Commercial	11b. Current use: vacant

42. Current owner/address: City of Macon Macon, MO 63552	43. Form prepared by (name and org.): Kristi Chase MO SHPO	44. Survey date: 9/24/2014
		45. Date of revisions:

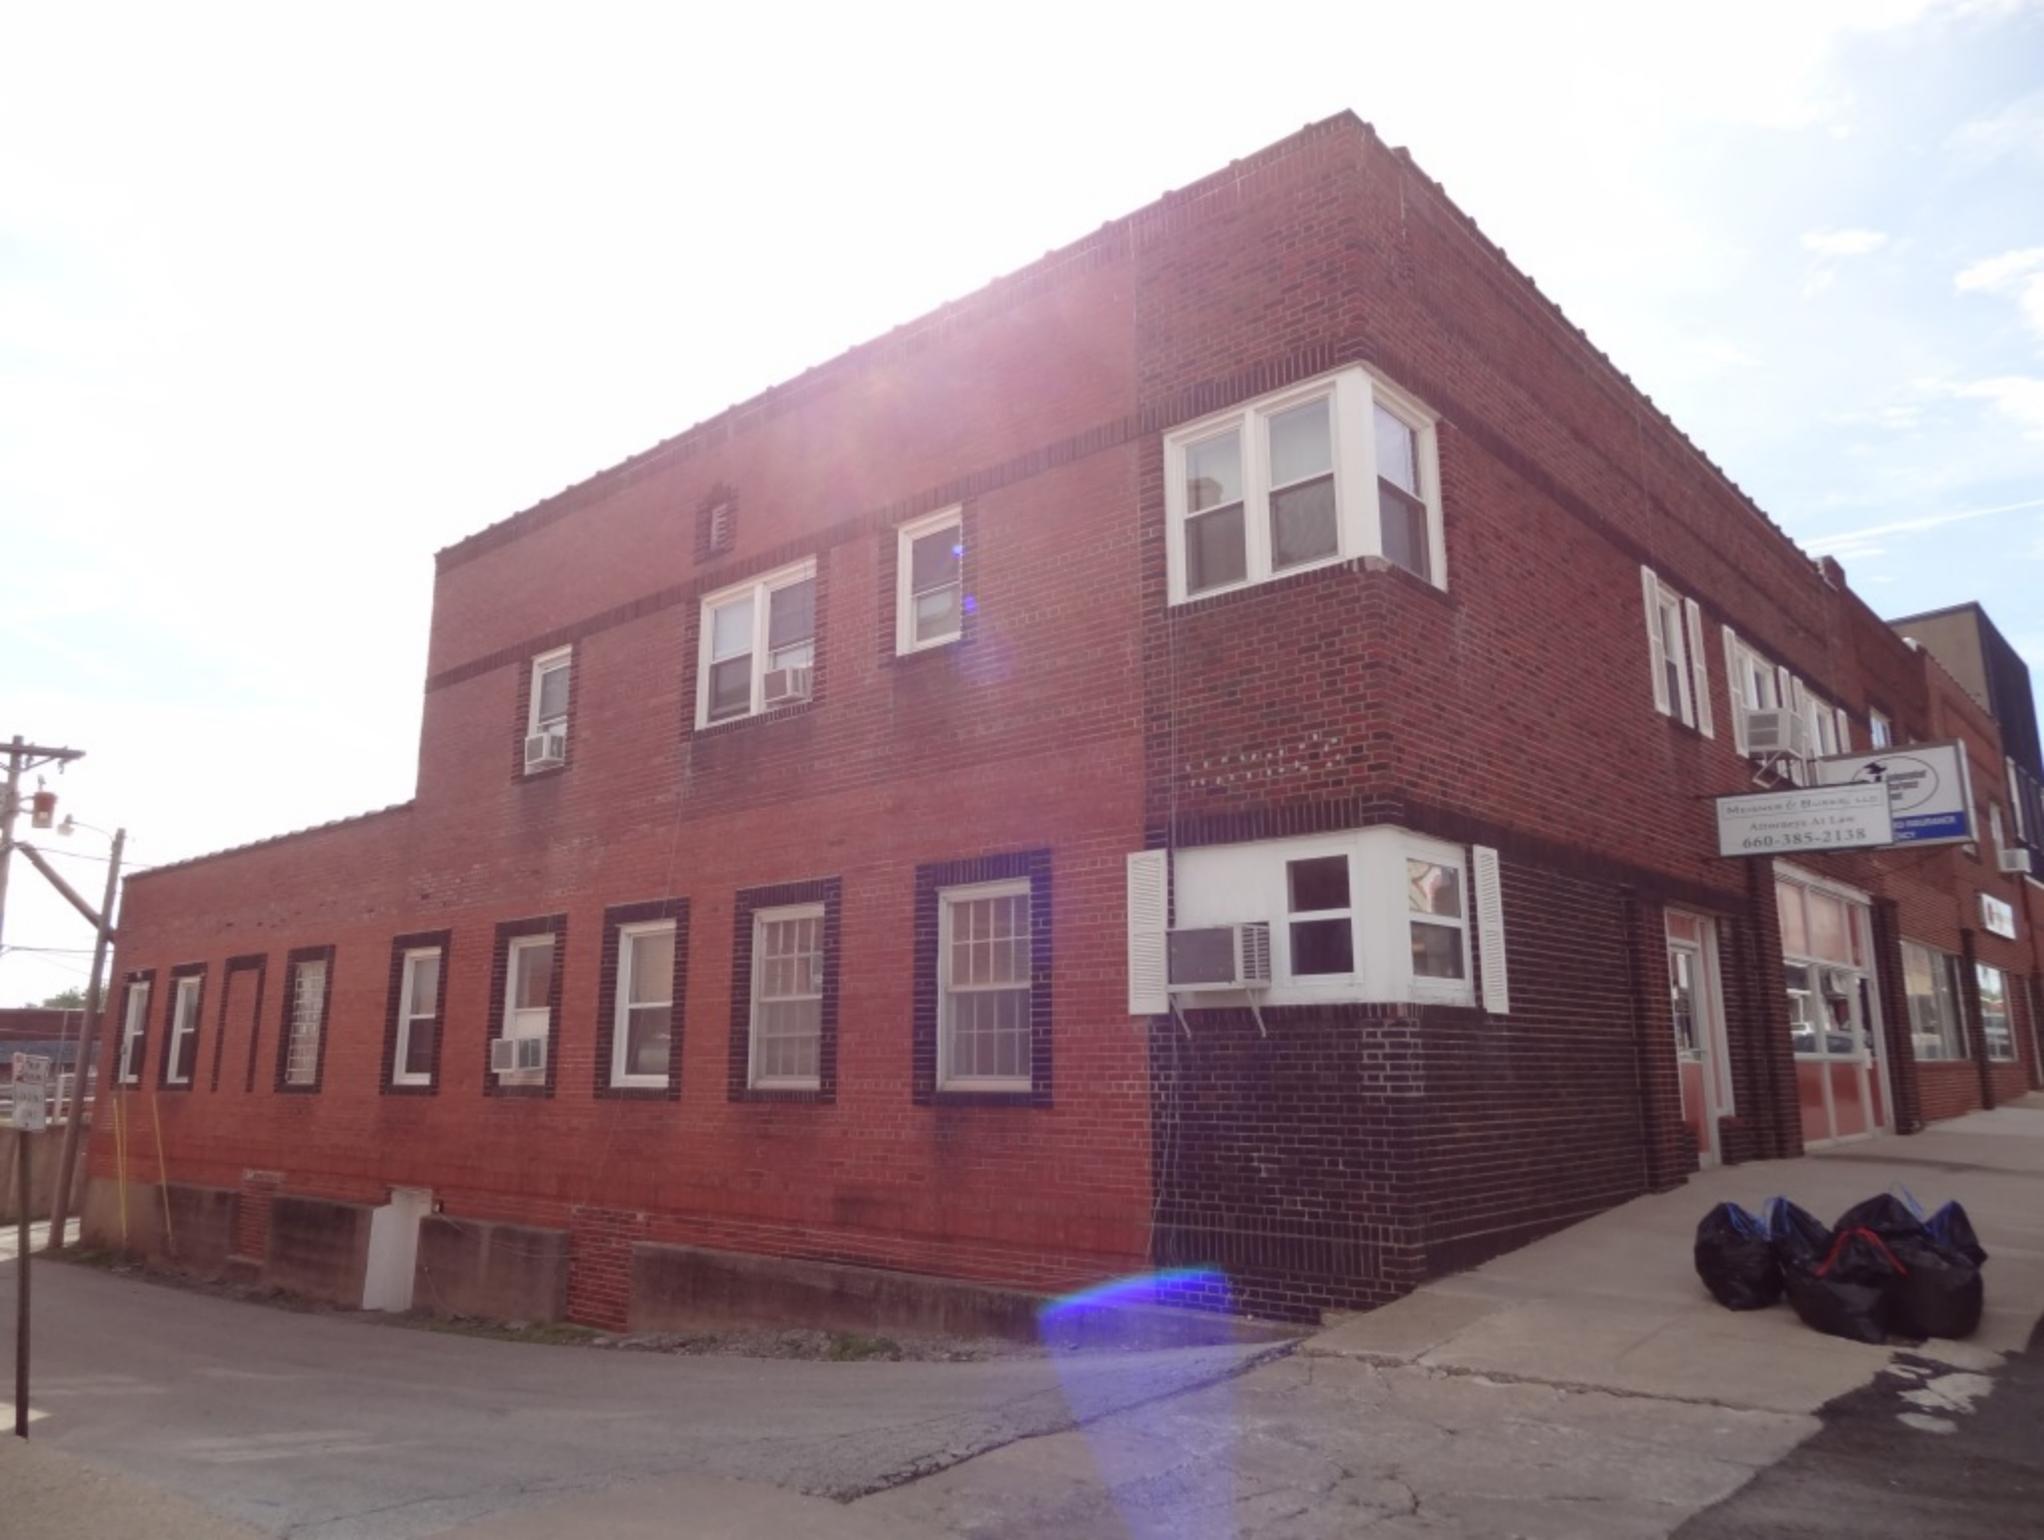
This red and brown brick two-part commercial block building has three bays on the first story. From north to south, the first bay wraps around the northwest corner of the building and contains two replacement 1/1 vinyl windows flanked by white shutters. The remaining two bays are clustered at the south end of the building. The second bay contains an aluminum and glass door with transom flanked by ¾ length sidelights. The bottom half of the door and the transom and sidelights have opaque glass. This bay comprises the storefront entry for the lawyer's office. The third bay is the widest and contains a multi-light aluminum and glass curtain wall with two fixed pane windows and an entry door. Opaque glass is used except in the upper door light and the central window lights. This bay comprises the storefront entry for the insurance company. Brown and red brick pilasters flank the second and third bays. The second story has four bays. From north to south, the first bay wraps around the northwest corner and contains three replacement 1/1 vinyl windows. The second bay is centered over the second bay on the first floor and contains a replacement 1/1 vinyl window with white shutters. The third and fourth bays are centered over the third bay on the first floor. They contain paired replacement 1/1 vinyl windows with white shutters. A soldier brick lintel course runs the length of the façade. The cornice is decorated with a rowlock brick rectangle filled with decorative brick bonding.

The storefronts and upper story windows have been altered at an unknown date. Depending on the area and period of significance, the building may or may not contribute to a potential National Register district.

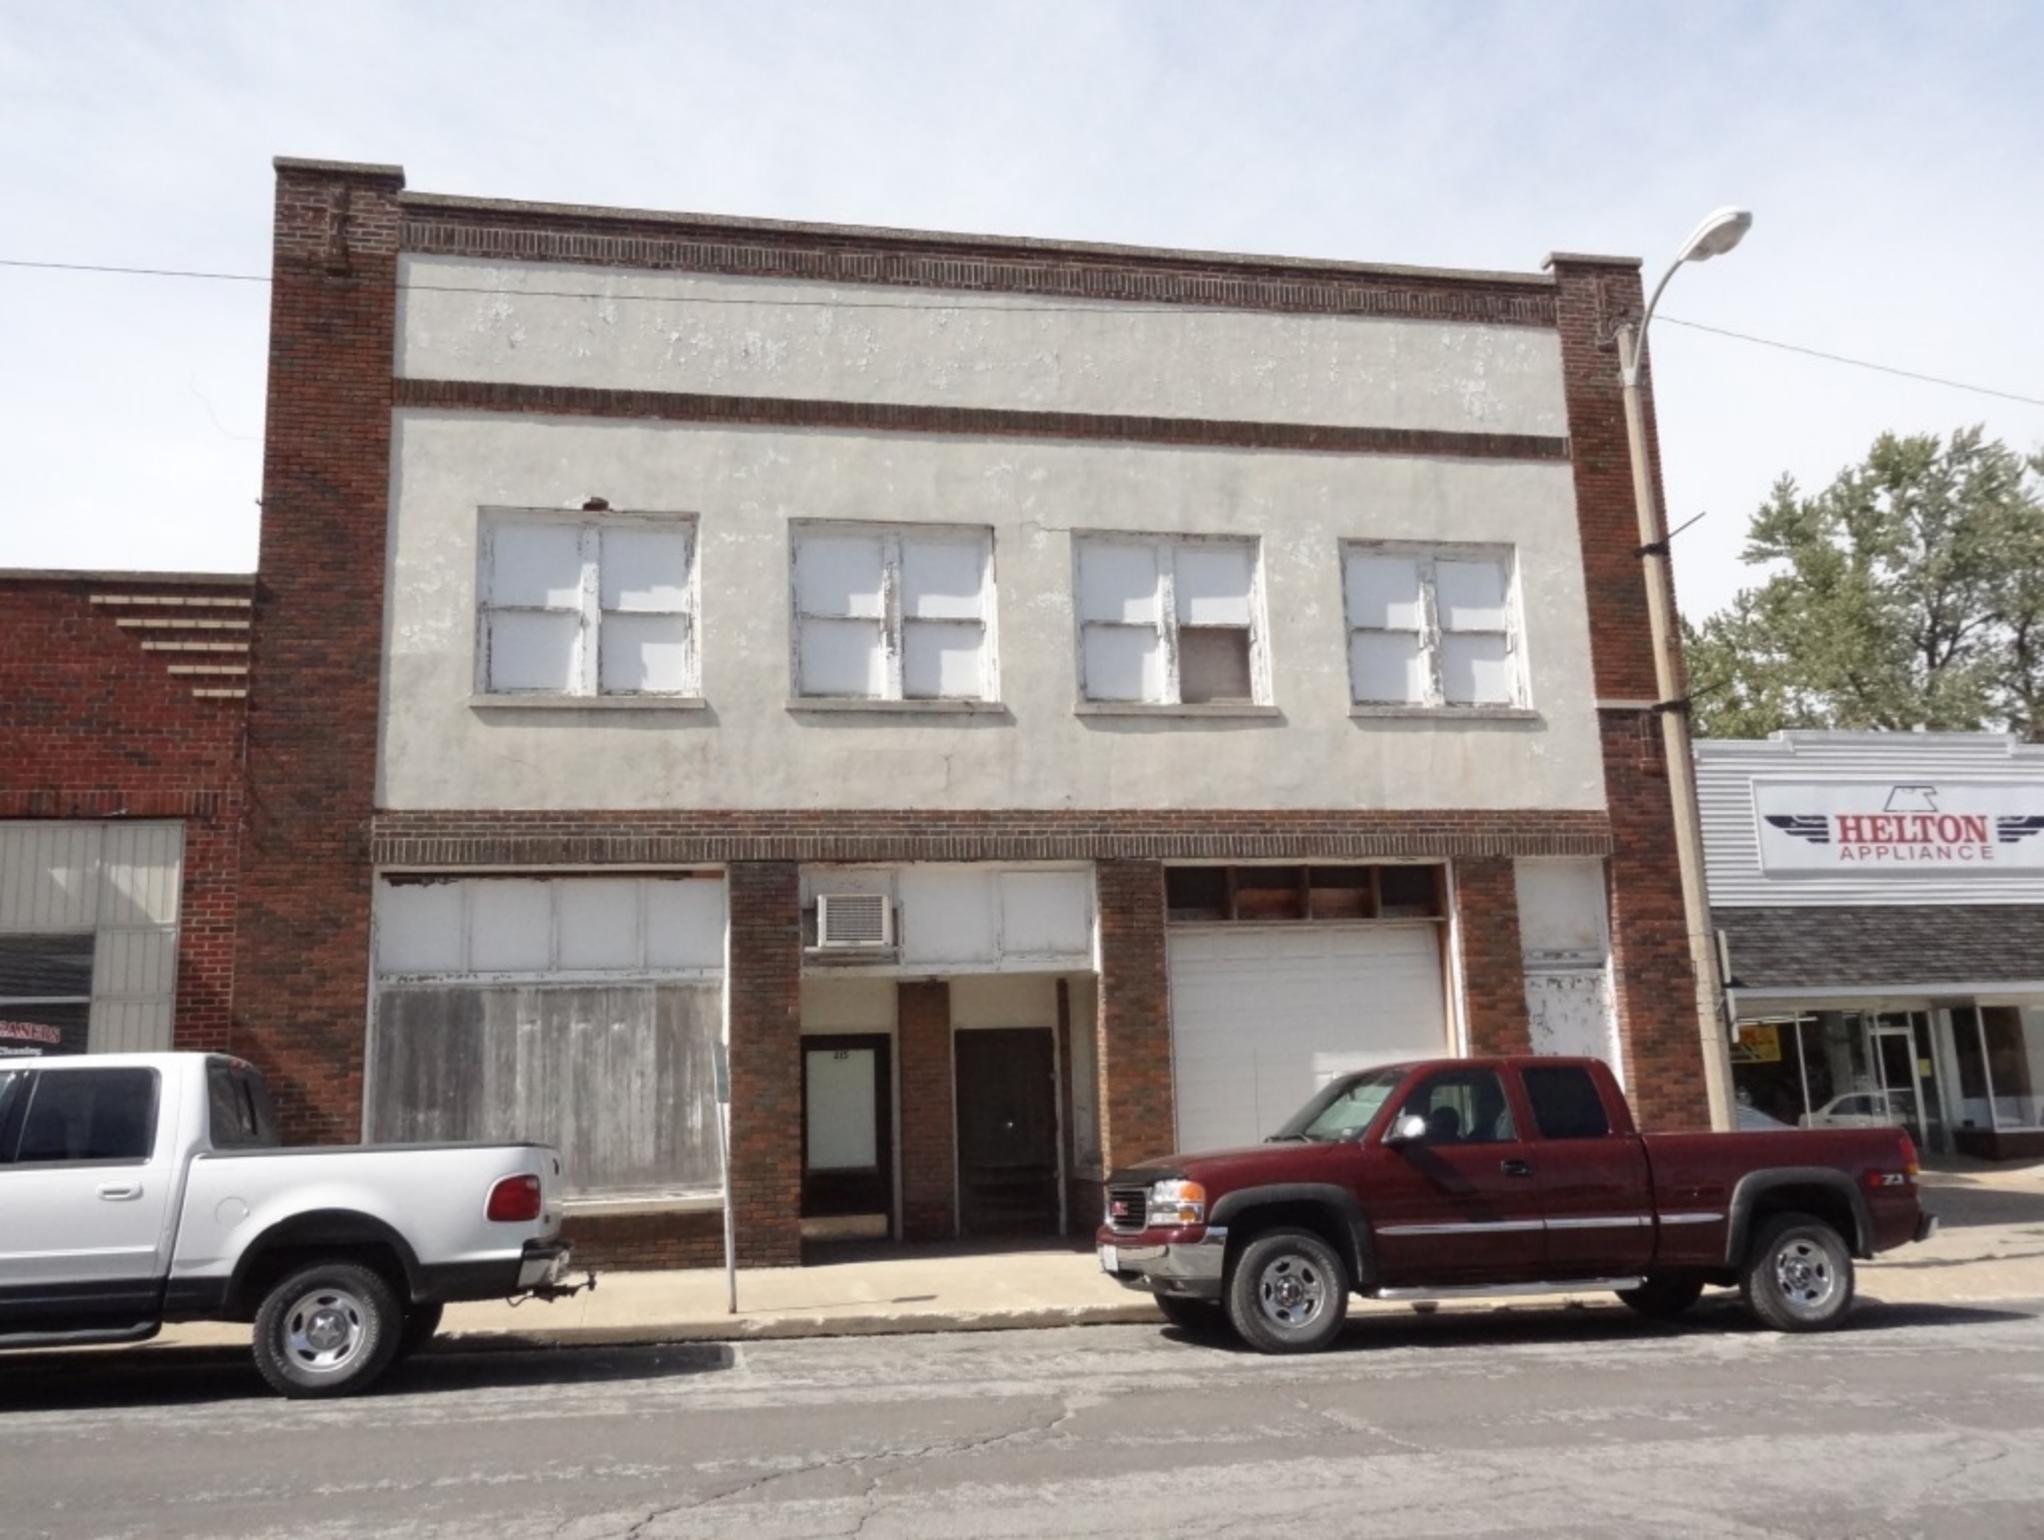
According to the Macon County Economic Development, the property includes 3800 square feet, 1999 remodeling with new roof line, and storage area plumbed for kitchen or bath space.

Alterations were completed at an unknown date. The buildings bays have been altered and the façade includes stucco. These alterations have resulted in a loss of integrity, rendering 211 North Rollins Street non-contributing to a potential National Register historic district.

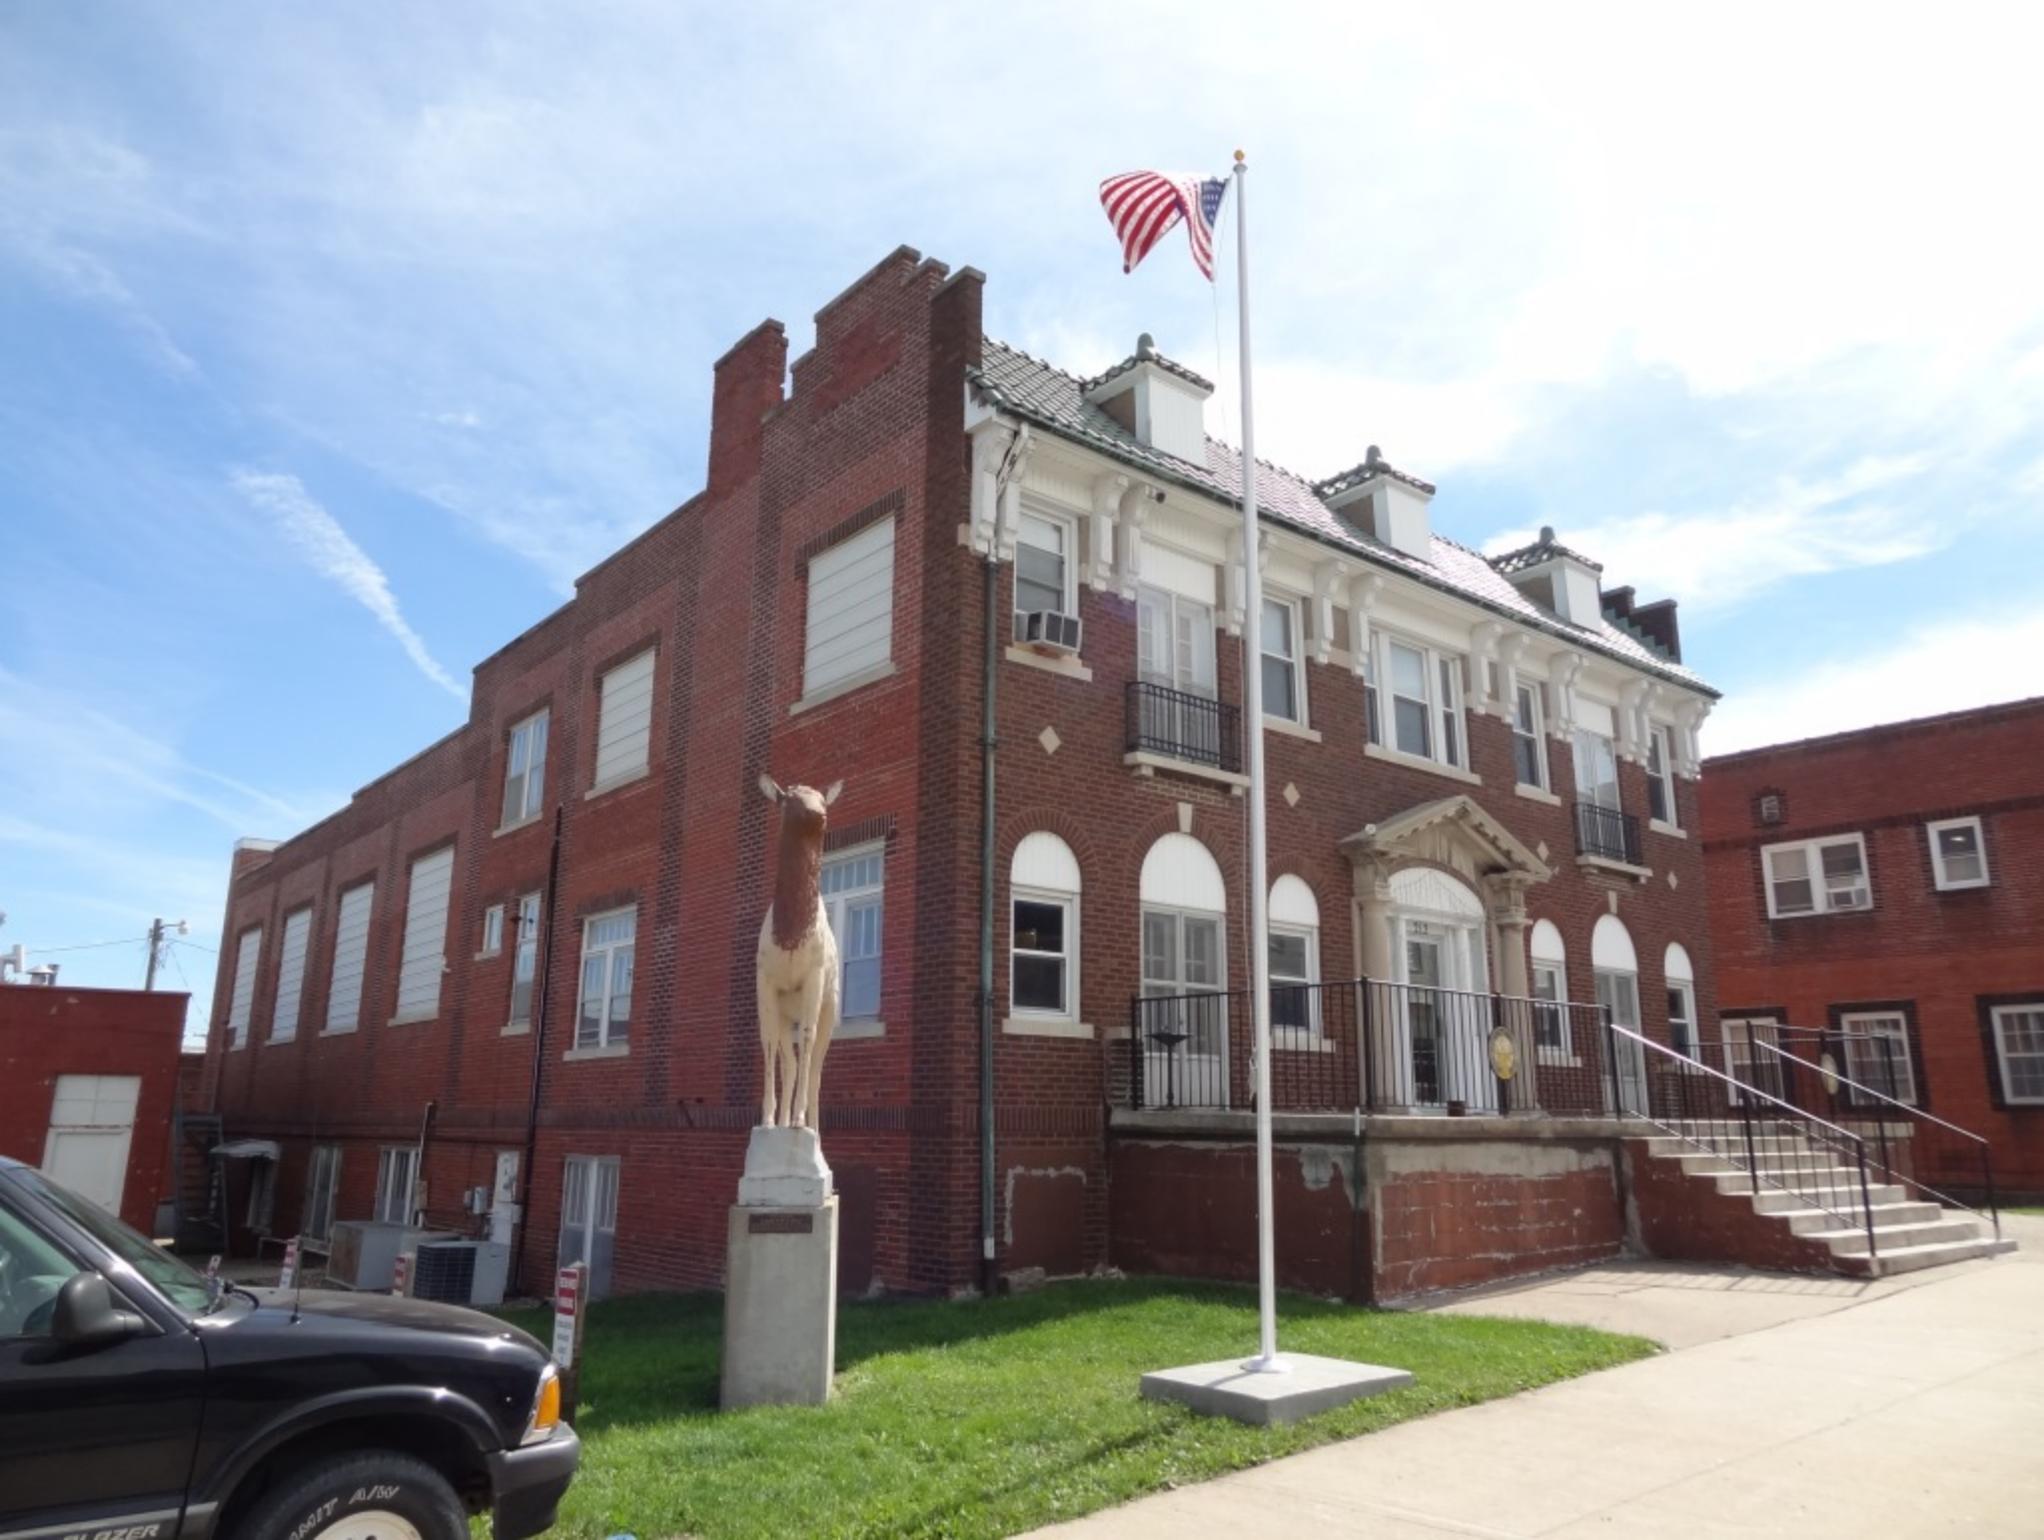
This rectangular, symmetrical two-story brick building has a wide concrete stoop with eight steps and iron handrail leading to the front entrance. The first story has seven bays, with the concrete stoop fronting the central five bays. From north to south, the first three bays are comprised of multi-paned French doors flanked by replacement 1/1 vinyl windows. All are set within Roman arch openings, and vinyl siding is used to fill the space between the windows and doors and the arch. The windows have limestone sills. The fourth bay contains the building entrance, a door set between engaged columns and ¾ length sidelights. An elliptical fanlight has been infilled with vinyl. The door is surrounded by a limestone Neo-Classical Revival style broken pediment with dentils and Tuscan columns. The remaining three bays are identical to the first three. The second story contains seven bays. From north to south, the first three bays are comprised of multi-paned French doors with iron railing flanked by replacement 1/1 vinyl windows. All have limestone sills and are flanked by tall wood brackets ornamenting the slightly overhanging eaves. The fourth bay contains a 1/1 vinyl window flanked by thinner 1/1 vinyl windows. The remaining three bays are identical to the first three. The mansard roof covers the upper ½ story and is clad with green ceramic barrel tiles and has three hipped tiled dormers. The dormer openings have been filled in with vinyl. The north and south eaves of the roof are concealed by a raised stepped parapet.

A photograph in Franke's book shows the historic porch (comprised of brick with curved brick knee walls) and historic windows retained as late as 1959. At some point afterwards, the windows and porch were replaced. The building likely does not retain sufficient integrity to individually convey architectural significance, but it may be individually eligible under Criterion A for Social History. The building retains integrity for a potential National Register district.

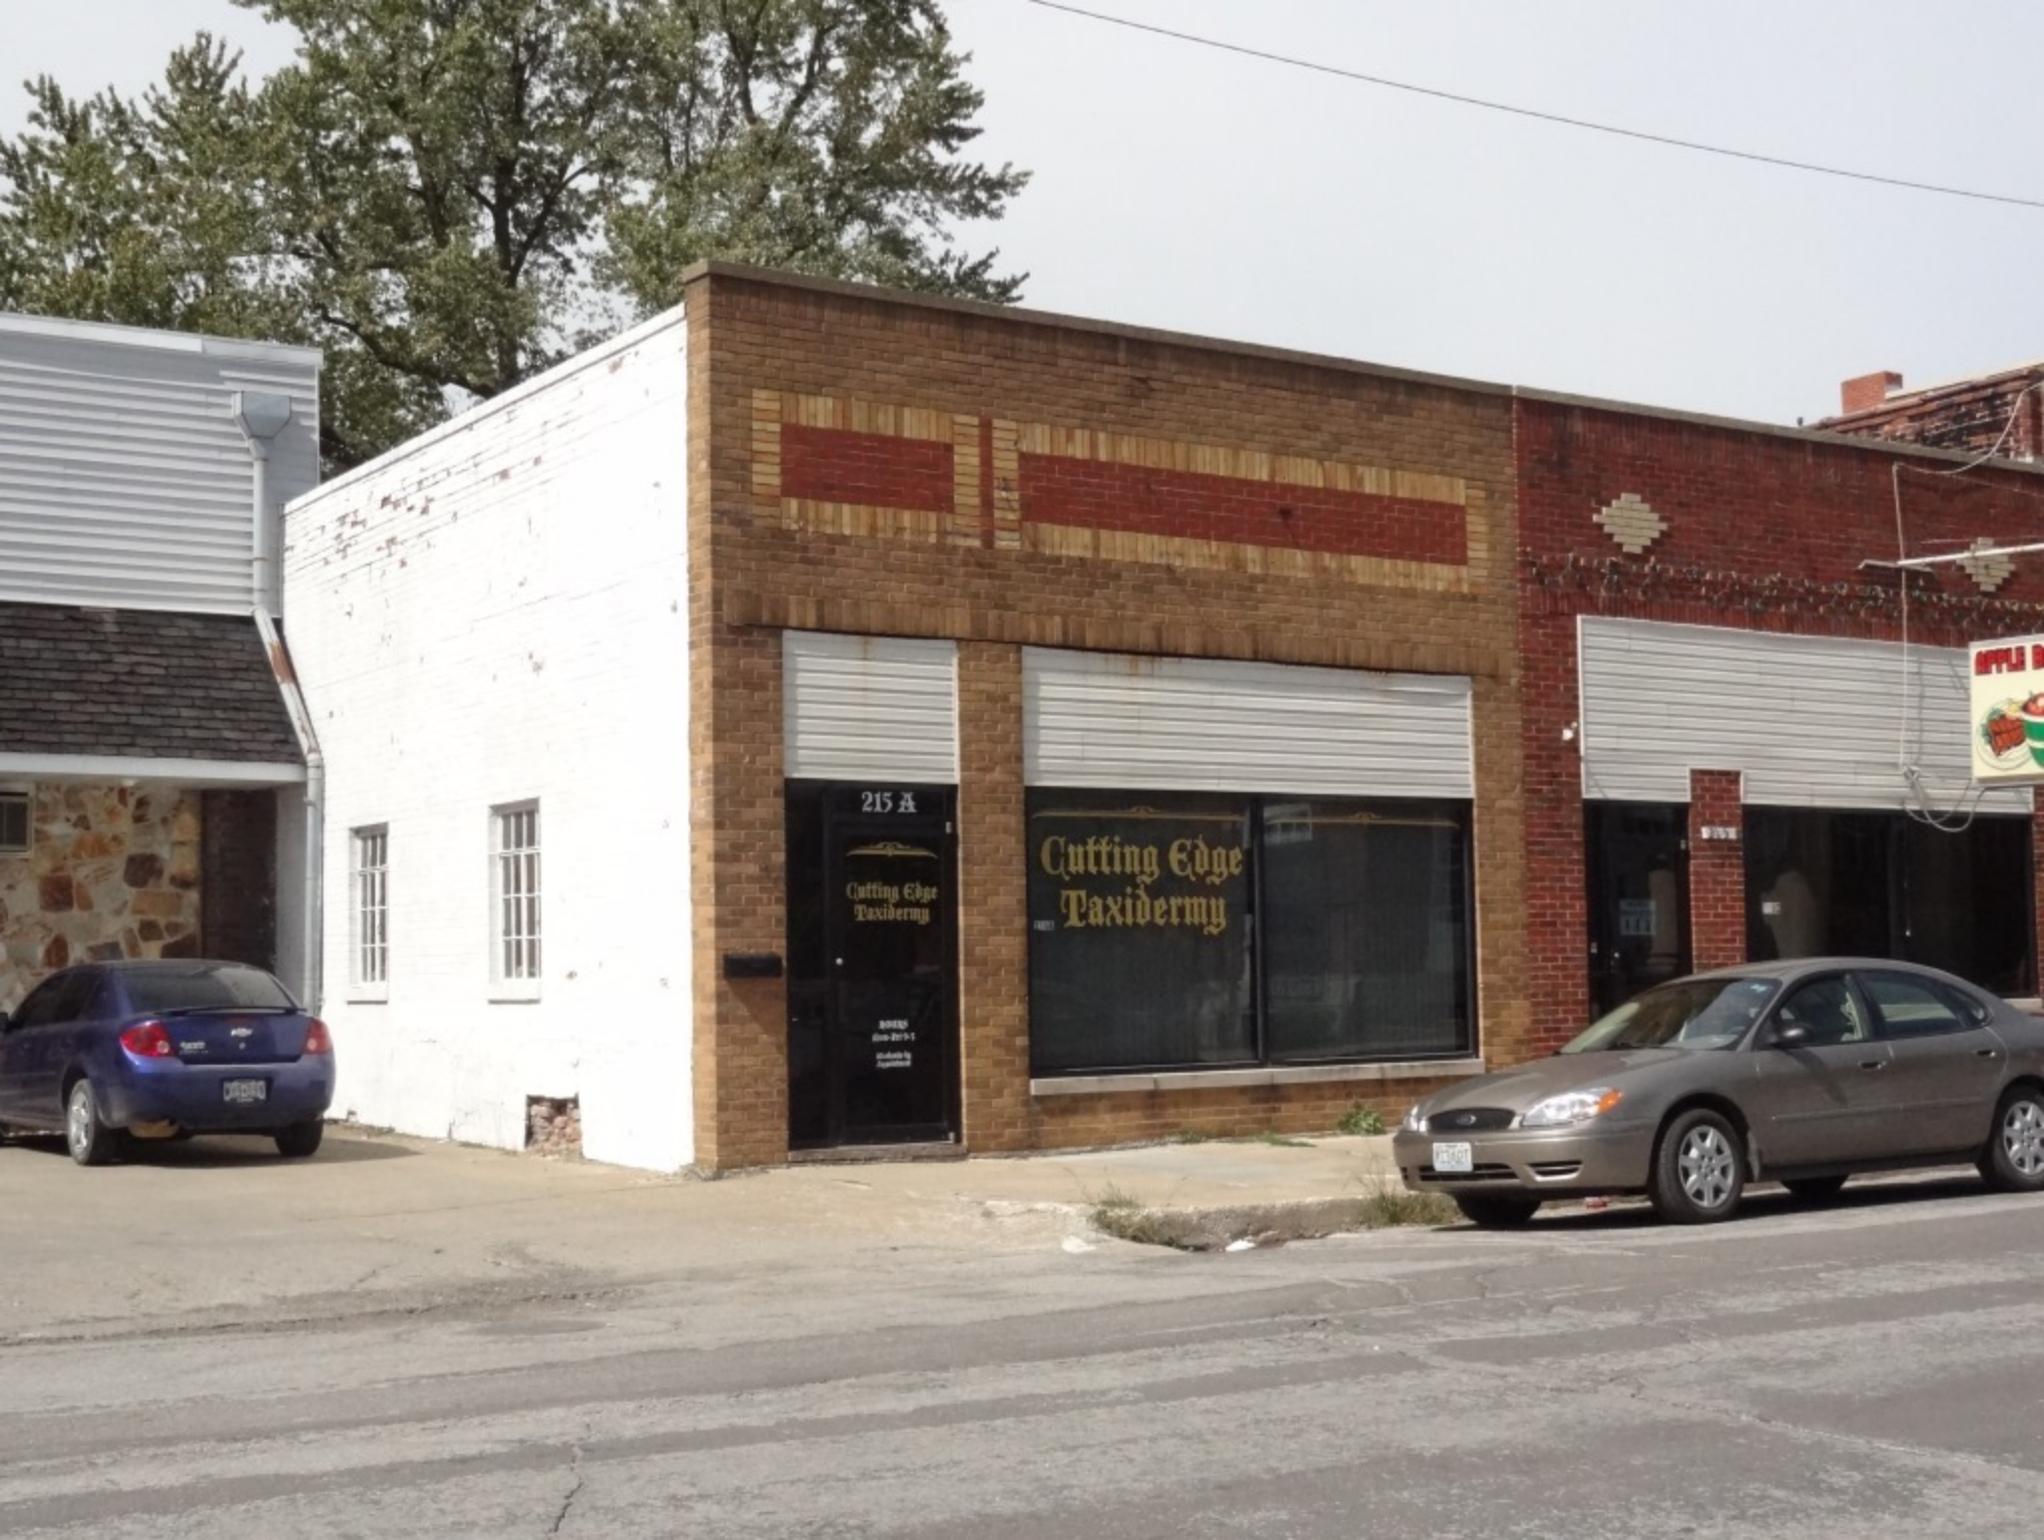
According to the Macon County Department of Economic Development, the building has 3,800 square feet of space and is of masonry construction. The building contains a back entry with ramp and the interior includes a front show room and an area plumbed for a kitchenette and half bath.

Alterations were completed in 1999 according to the Recorder of Deeds and included a new roof and some remodeling. Despite alterations, the building retains enough historic fabric to be contributing to a potential National Register historic commercial district.

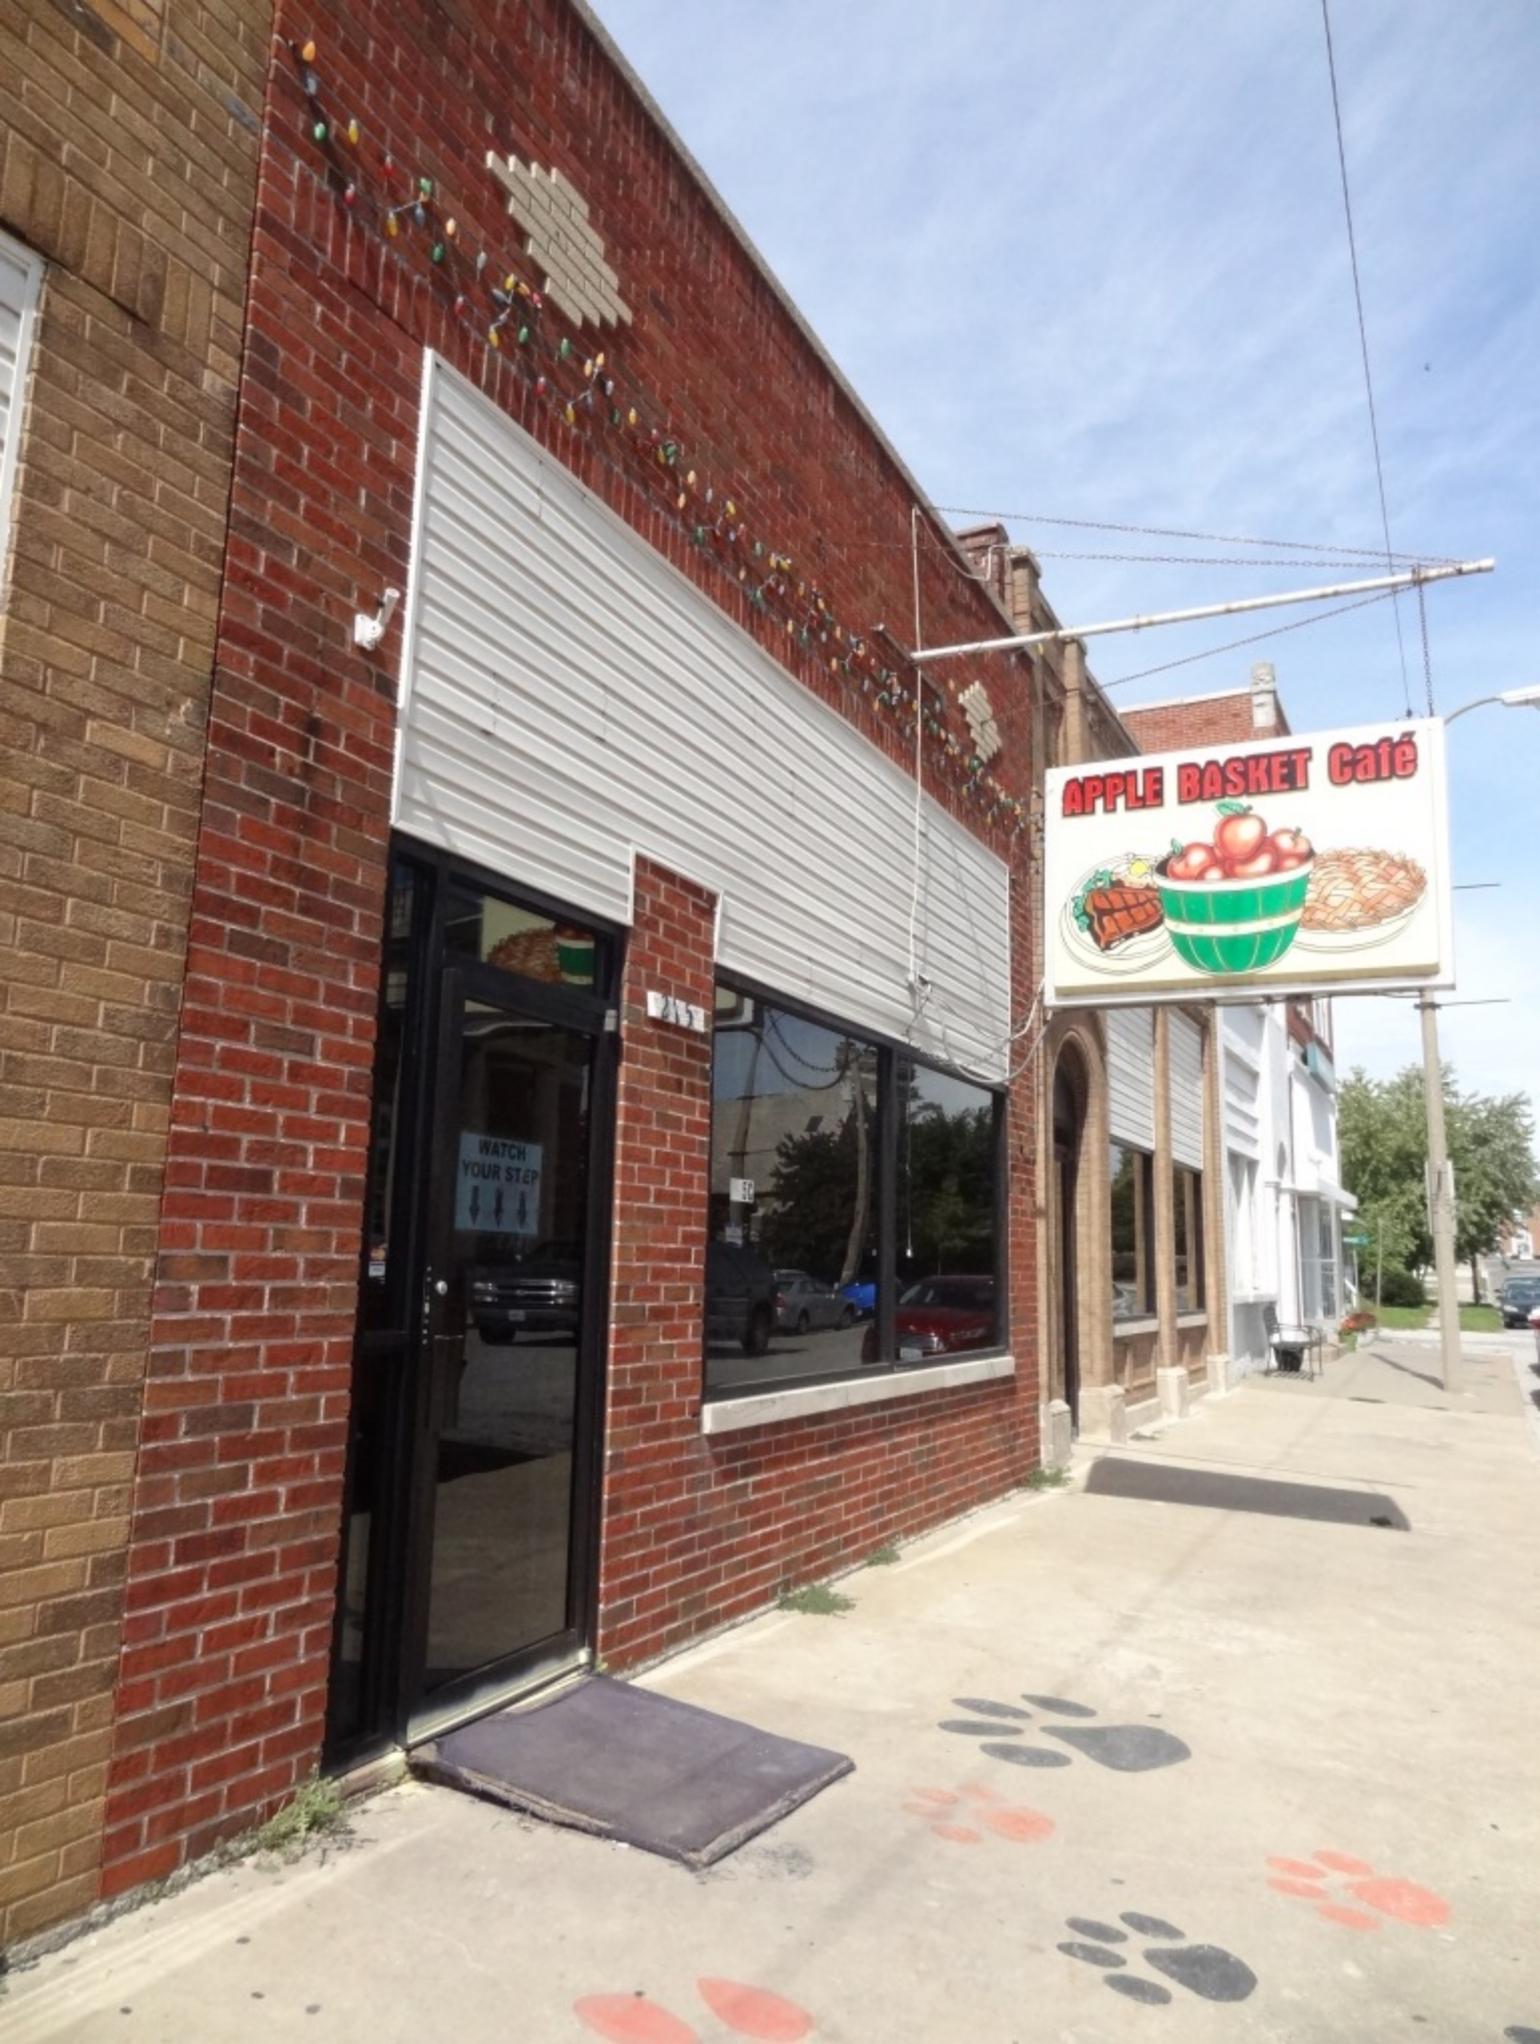
The one-part commercial block brick building located at 215 North Rollins Street is rectangular shaped, has a flat roof, and consists of two bays along the first floor façade. The first floor (from left to right) contains a non-historic side glass entry with a left side light and an enclosed transom with vinyl siding. The second bay includes two non-historic large fixed glass panes with enclosed transoms of vinyl siding. The flat roof building contains variegated brick on the façade with tan terra cotta chevron details along the entablature. A soldier brick course runs above the bays and along the cornice capped with concrete. The window bay sills are concrete. A fiberglass sign projects from above the soldier brick course.

Alterations were completed at an unknown date. Despite alterations, the building retains enough historic fabric to be contributing to a potential National Register historic commercial district.

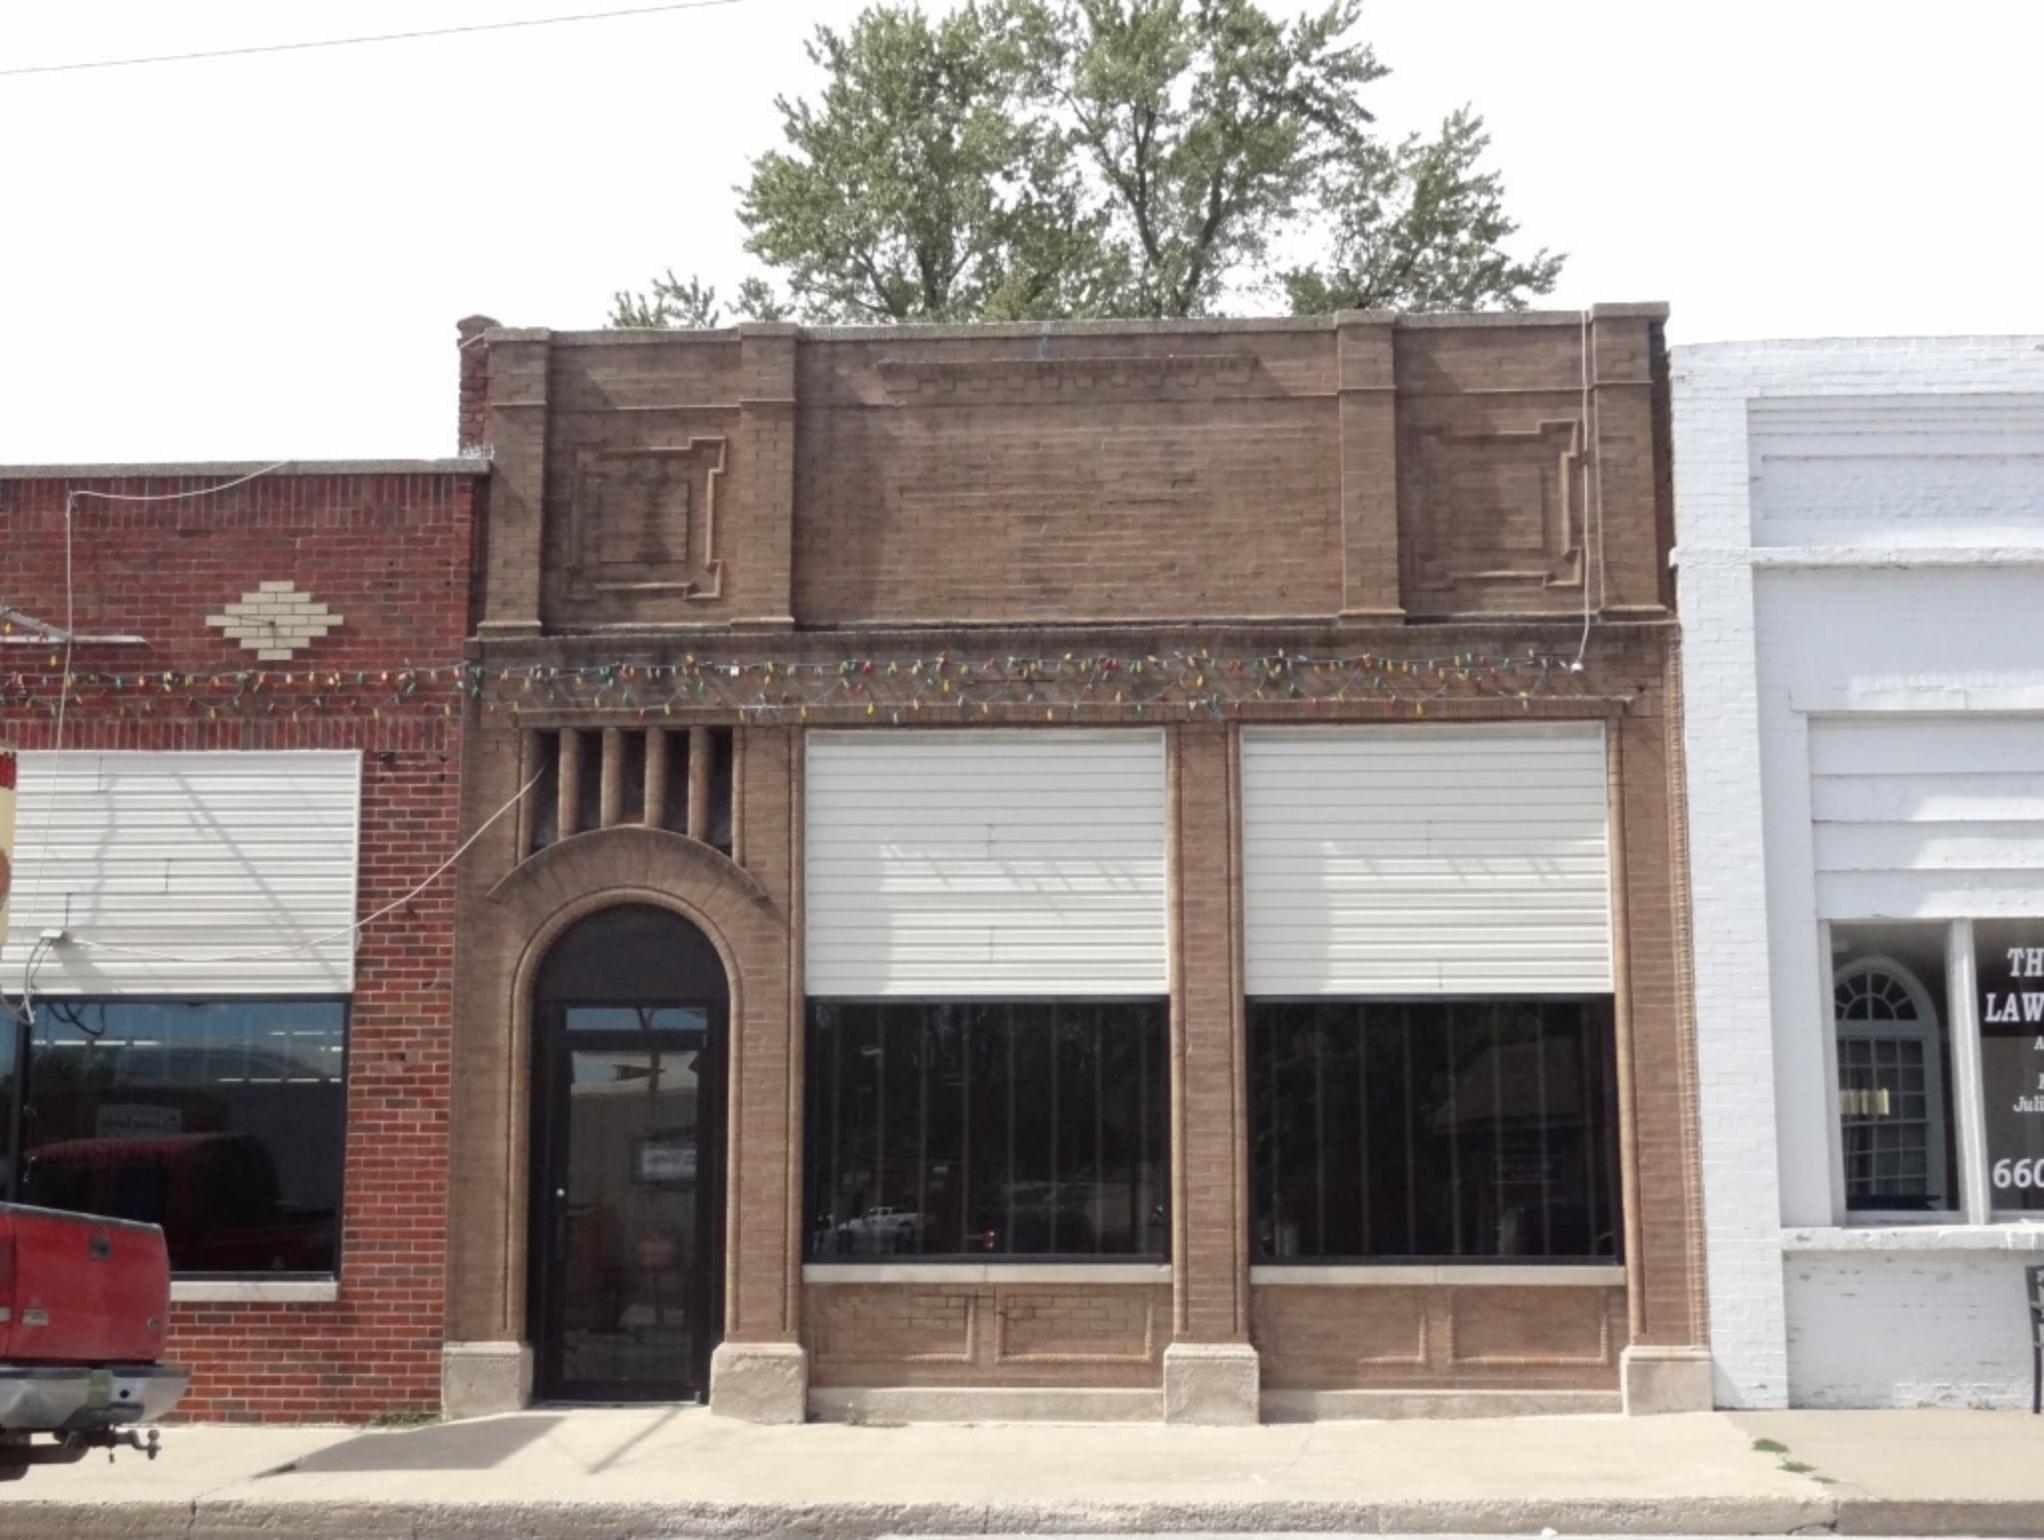
The one-part commercial block tan brick building located at 215 C North Rollins Street is rectangular shaped with a flat roof and consists of three bays along the first floor façade. The first floor (from left to right) contains an arched side entry bay with a modern glass door and terra cotta recessed and projecting vertical engaged balustrade framing the arch and entablature. Two large fixed single metal sash windows with enclosed vinyl transoms are adjacent. Square pilasters with carved rounded edges frame each bay. Terra cotta egg and dart details line vertically along the storefront corners and additional egg and dart details frame paired rectangles along each window bay's bulkhead. The entablature includes an architrave of brick headers and a cornice of thin projecting terra cotta. The parapet includes four square shaped pilasters with two concave belt courses along the façade (lower and upper portions). A terra cotta geometric design is located at each corner end of the parapet and corbelling is located along the center bay of the parapet. Limestone is located along the building's base, forming plinths for the pilasters and caps the building's parapet.

Alterations were completed at an unknown date. Despite alterations, the building retains enough historic fabric to be contributing to a potential National Register historic commercial district.
