1. Survey No. MC-AS-001-001		2. Survey name: Downtown Macon Commercial Historic District	
3. County: Macon		4. Address (Street No.) Lots 11-13 block 93	Street (name) East Bourke Street (100 block)
5. City: Macon	Vicinity: <input type="checkbox"/>	6. Geographical Reference:	7. Township/Range/Section: T: R: S:
8. Historic name (if known):		9. Present/other name (if known): City of Macon Parking Lot #3	
10. Ownership: <input checked="" type="checkbox"/> Private <input type="checkbox"/> Public		11a. Historic use (if known): Commercial	11b. Current use: vacant

42. Current owner/address: City of Macon Macon, MO 63552	43. Form prepared by (name and org.): Kristi Chase MO SHPO	44. Survey date: 9/24/2014
		45. Date of revisions:

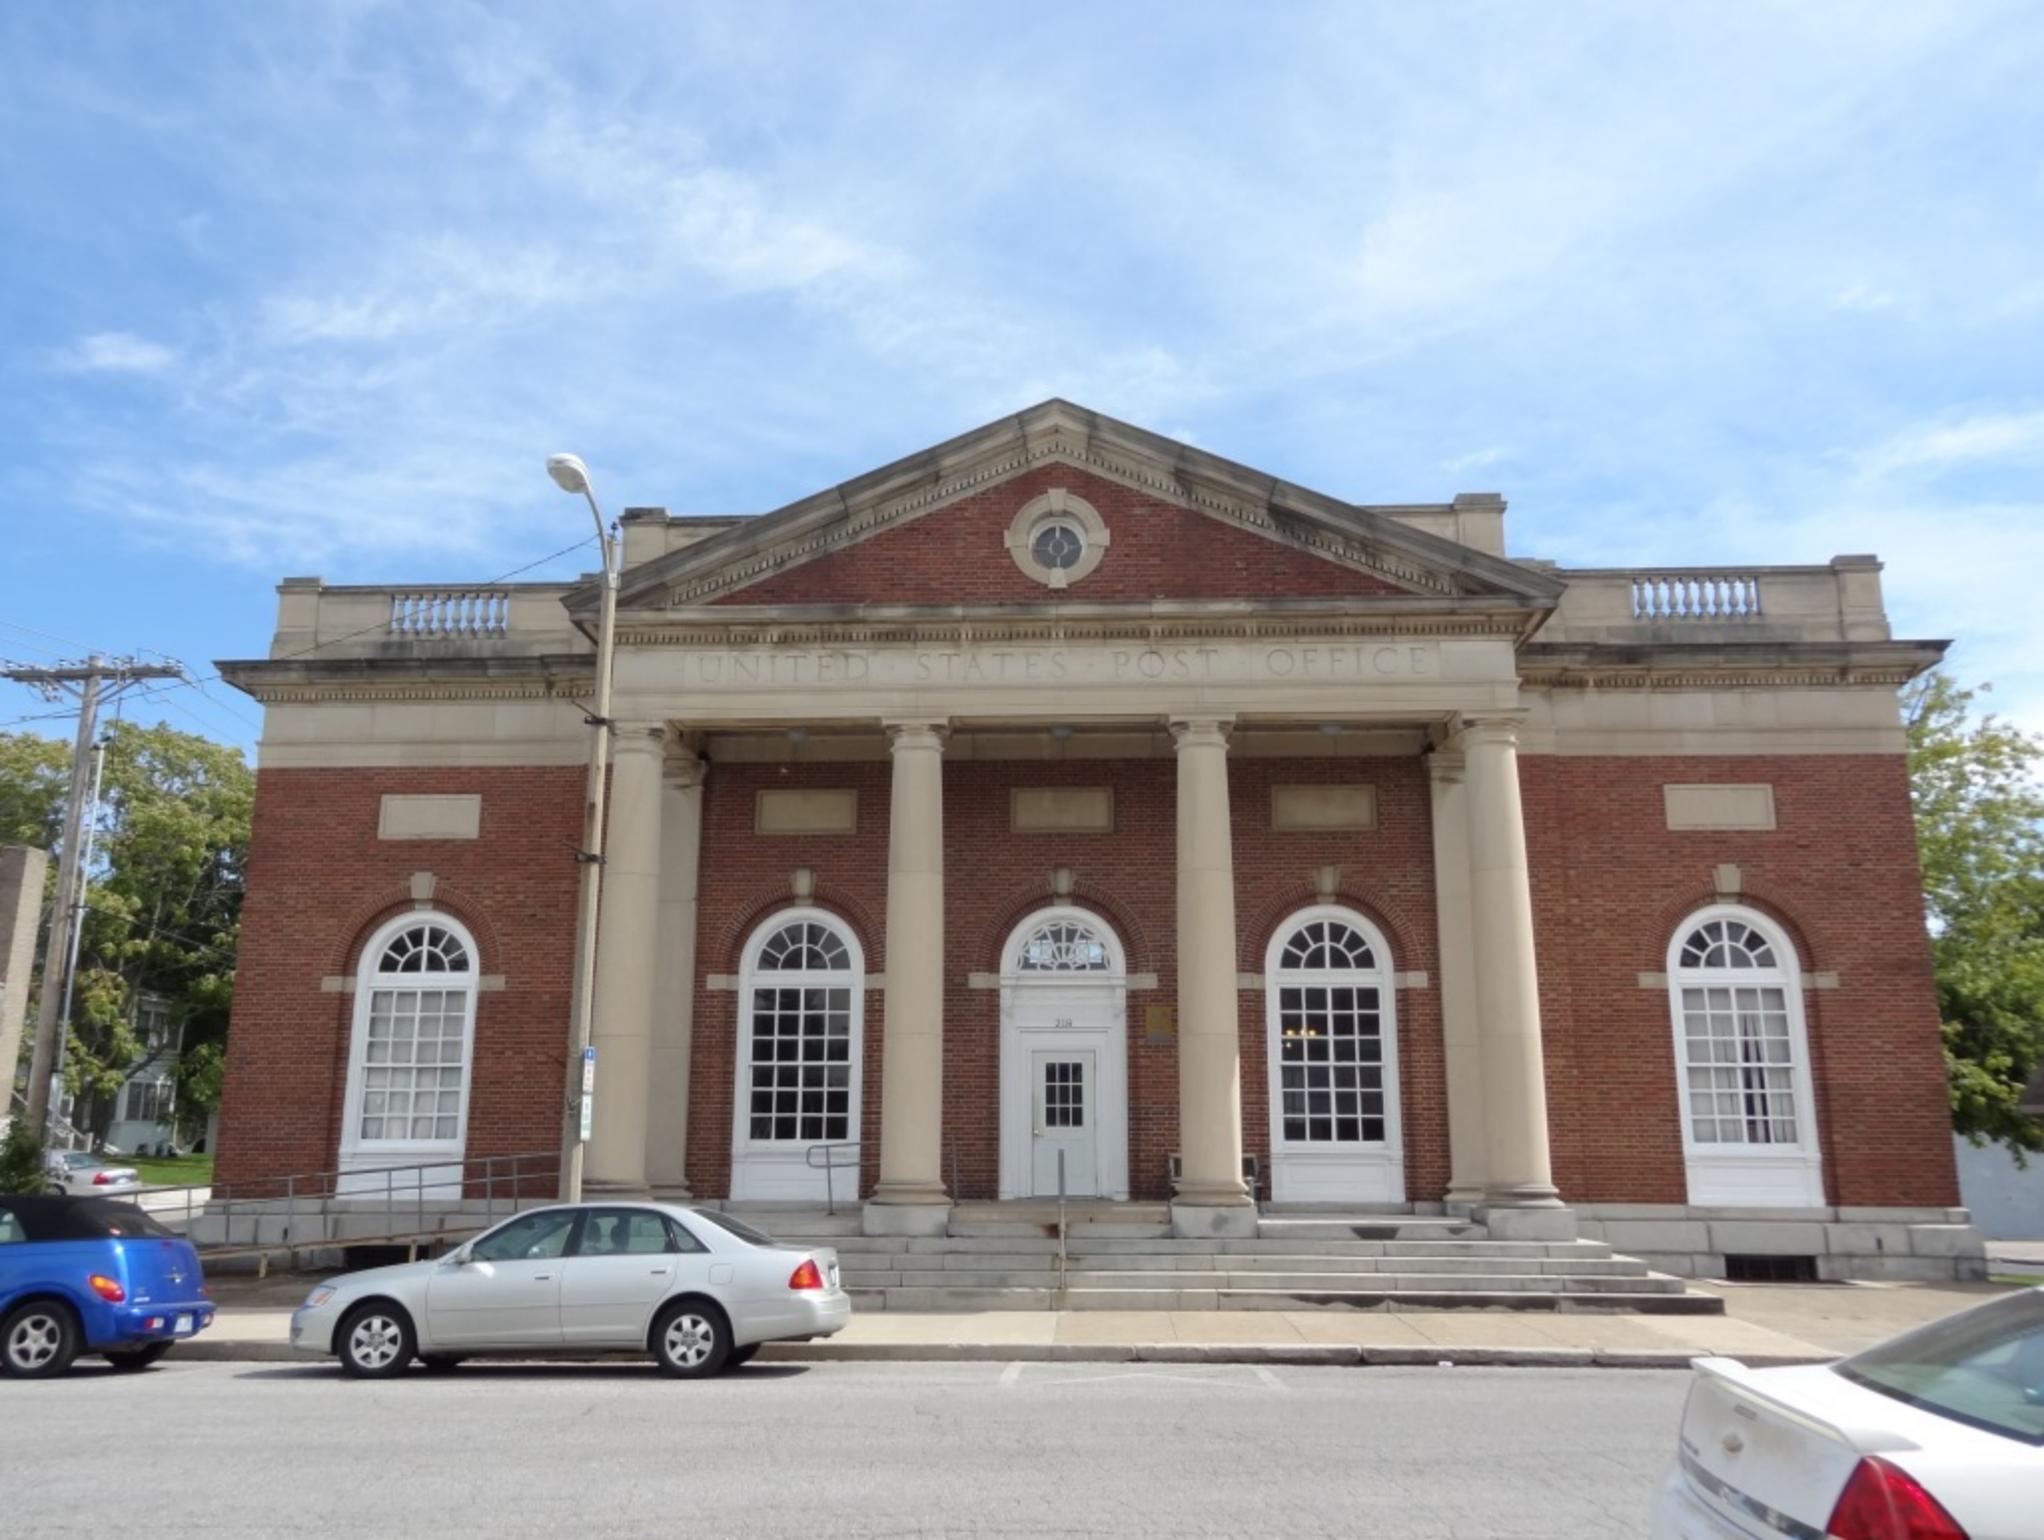
This rectangular, symmetrical Neo-Classical Revival style one-story brick building has five bays on the west façade and a stone clad foundation. From north to south, bays 1-2 and 4-5 are identical and contain one historic 12/12 wood window with an arched multi-light transom set within a Roman arch opening with stone keystones. The central bay contains a non-historic entry door with a historic wood door surround with engaged columns and a multi-light Roman arch fanlight with stone keystones. Rectangular stones are set in the brick wall above each bay. The three central bays are flanked by stone pilasters and sheltered by a large pediment supported with four stone Tuscan columns. Granite steps lead up to the porch. The frieze on the pediment is engraved with "United States Post Office." There is a porthole window and brick cladding in the tympanum and the pediment is outlined with stone dentils. The cornice of the building is also lined with stone dentils. The flat roof has a stone balustrade with curved stone balusters.

The building retains the majority of its historic building material and may be individually eligible for architecture as well as its significance as a United States Post Office. The building would likely contribute to a potential National Register district.

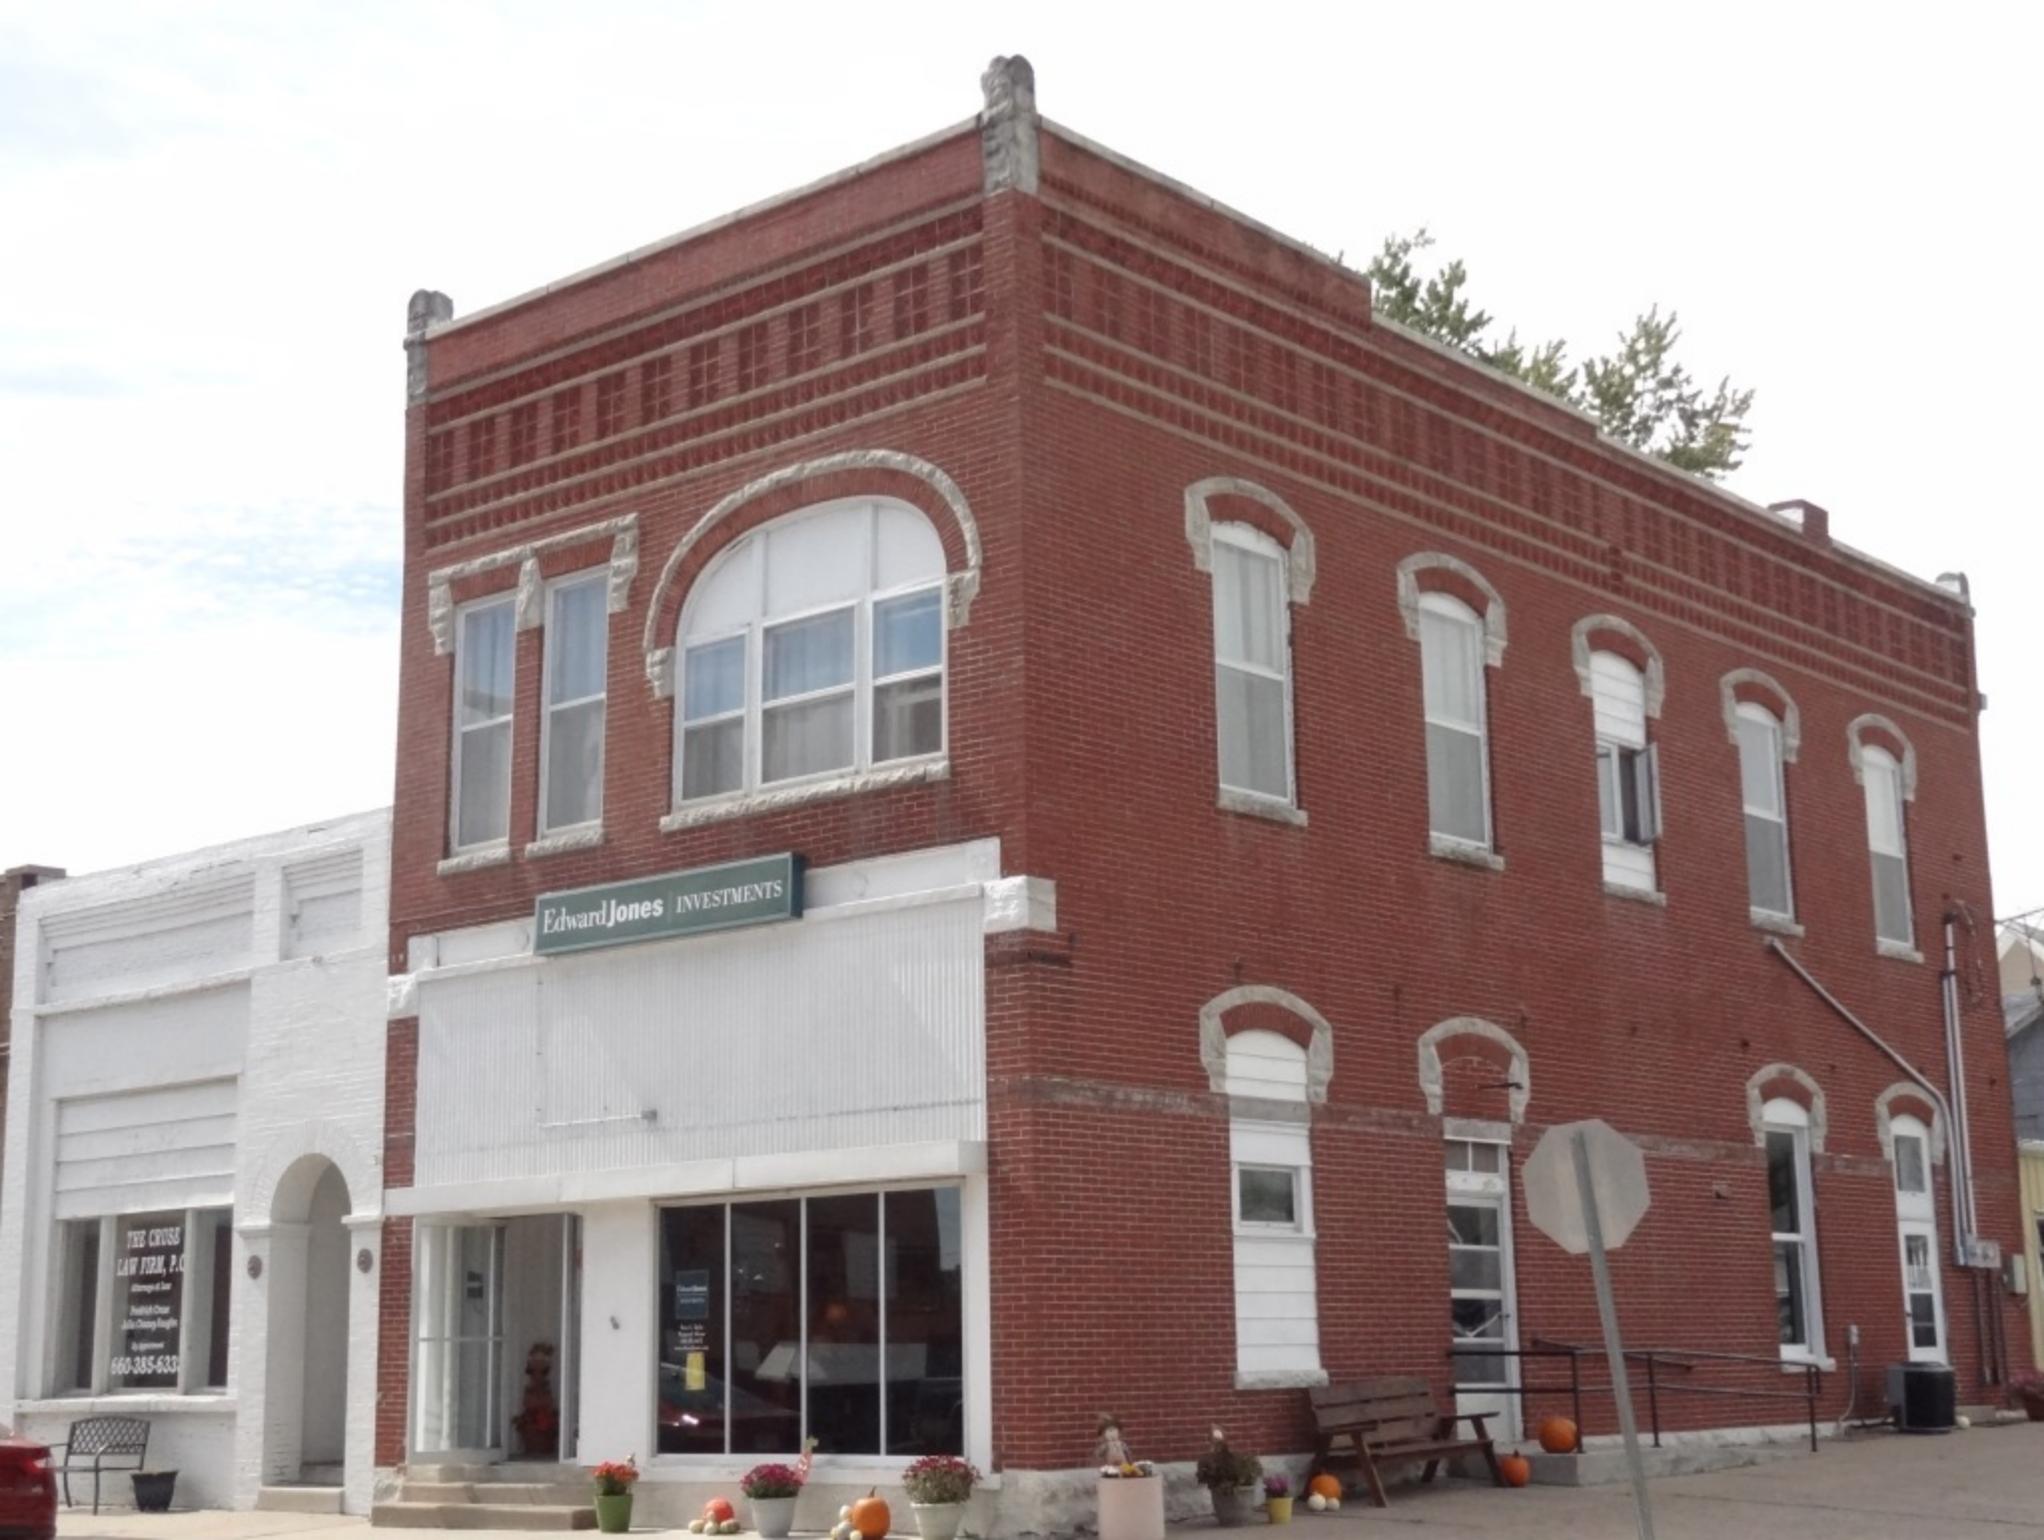
A 1976 one-story board and batten two-bay addition is located to the rear of the building and has a poured concrete foundation. The bays include a side glass entry with metal surround and a two-door fiberglass garage door.

Alterations were completed c. 1975 according to the Recorder of Deeds and may have included the modified storefront and window openings. Despite alterations, the building retains enough historic fabric to be contributing to a potential National Register historic commercial district.

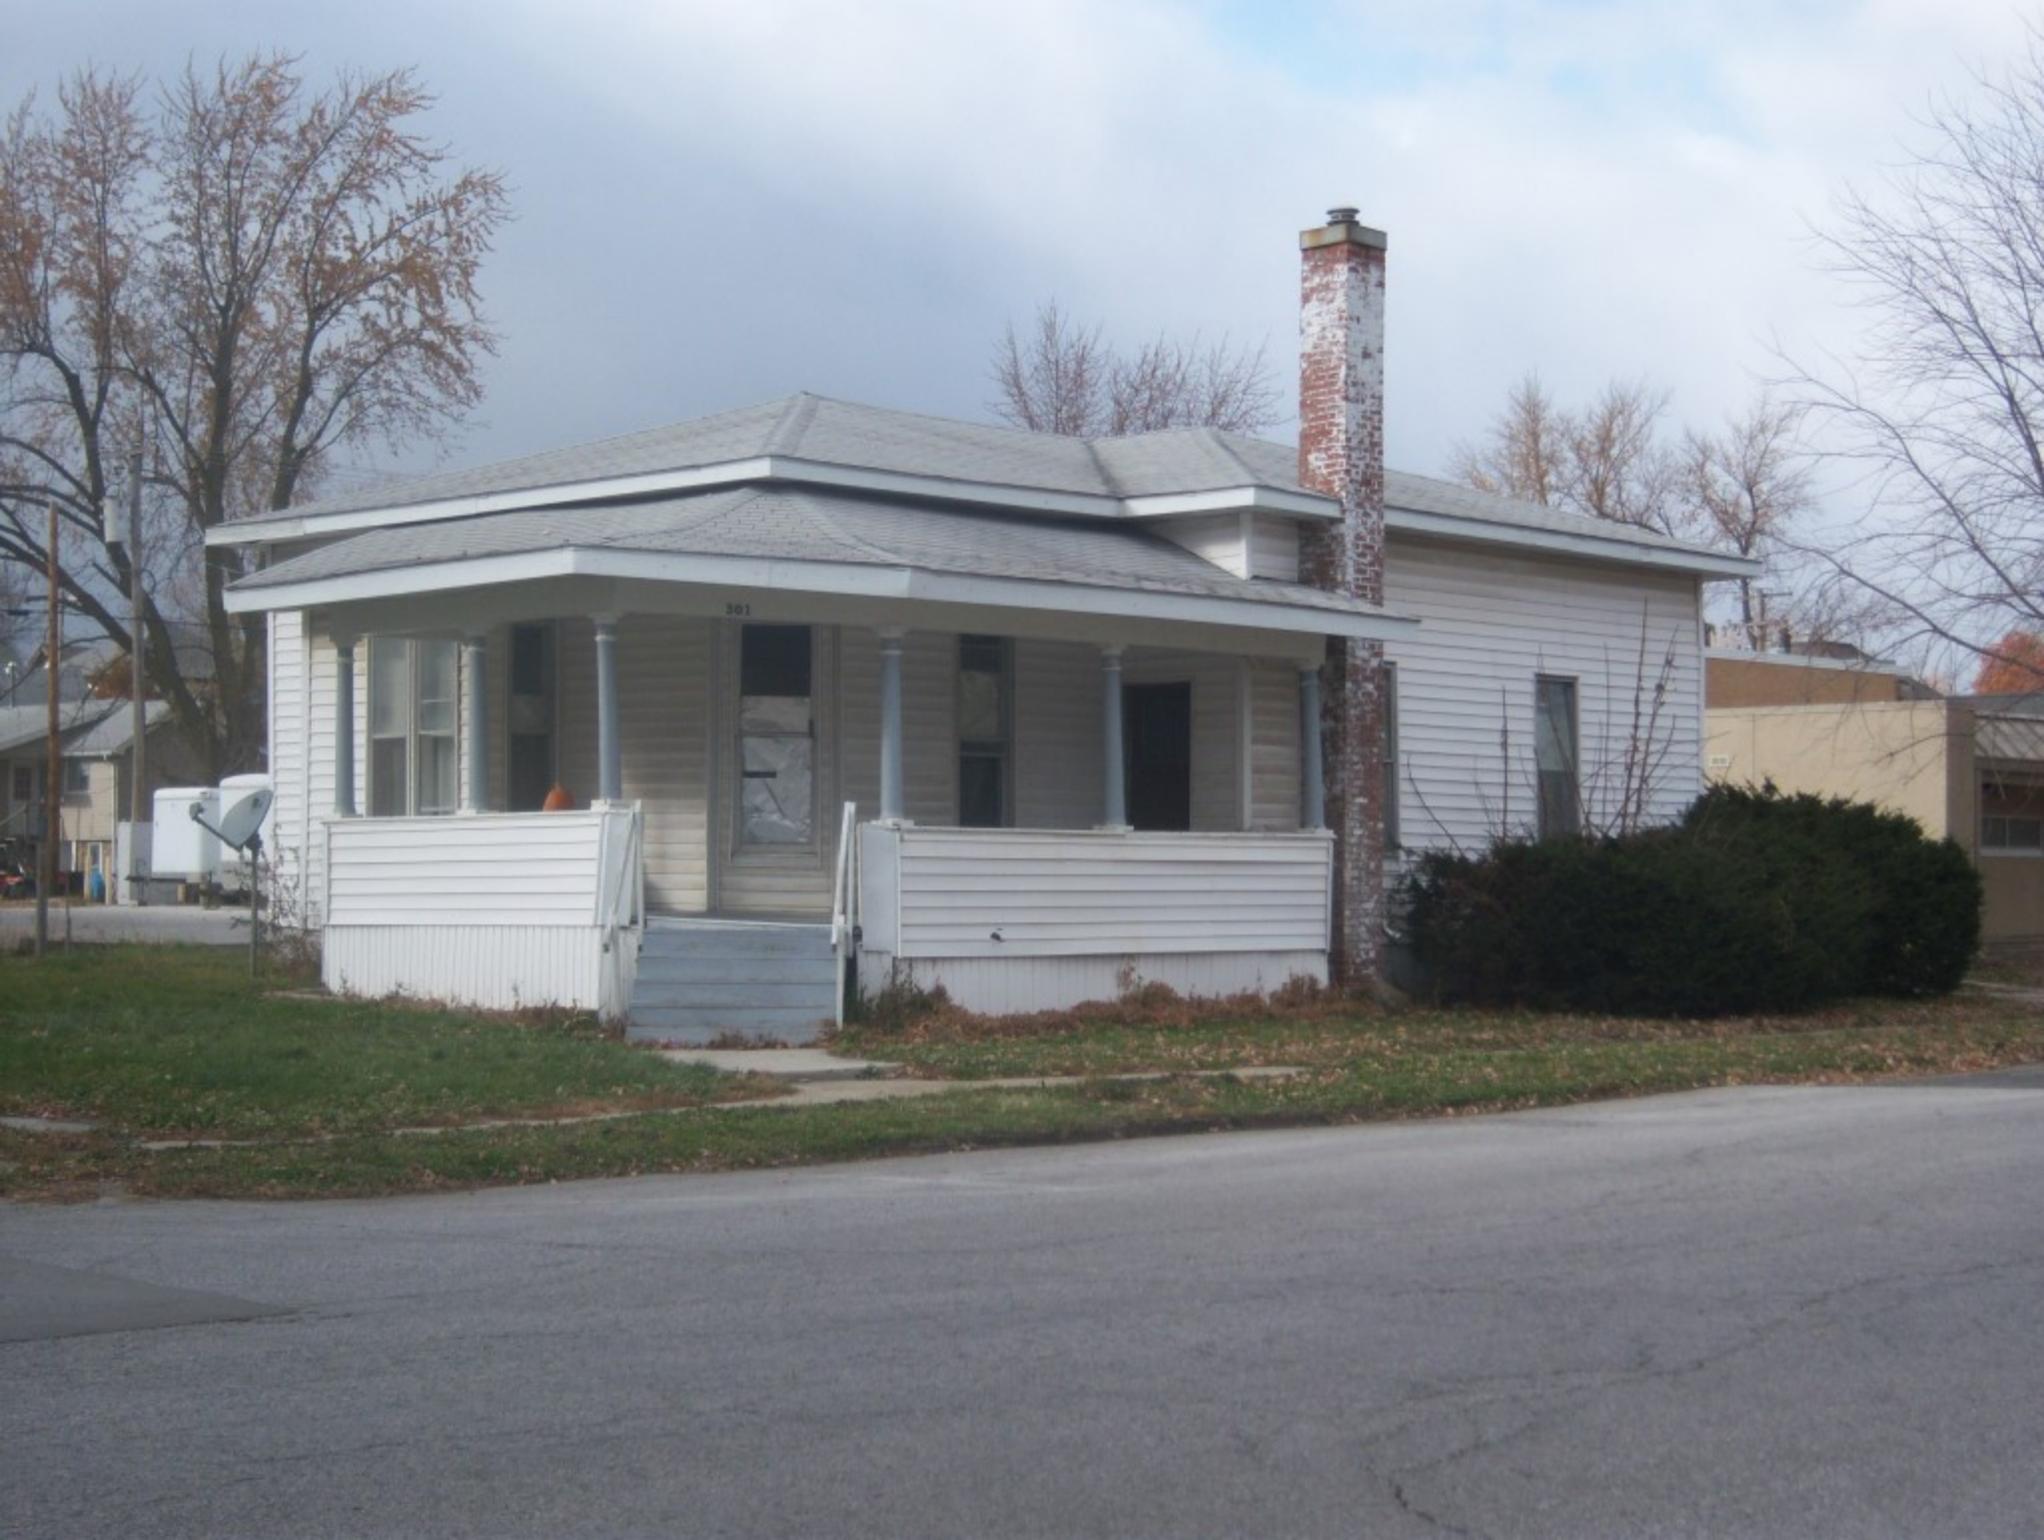
The one-story frame dwelling at 301 North Rollins Street is irregular shaped with a low cross hipped asphalt roof with small one bay projecting wings on the north and south elevations. Covered in vinyl siding, the dwelling has a full brick cellar with concrete parging. A front centre exterior brick chimney capped with concrete cuts into the northern hipped roof gable wing. The dwelling consists of four bays across its façade. The south wing of the façade includes a southeast corner entry, a 1/1 wood double-hung window, a side entry into the north wing and two 1/1 wood double-hung windows. The two entries look out onto the wraparound one-story porch which contains a wood deck, wood Tuscan columns. Vinyl siding covers the balustrade and crawl space under the porch deck.

Alterations were completed in 2004 according to the Recorder of Deeds and may have included the vinyl siding. These alterations have resulted in a loss of integrity, rendering the property not eligible to a potential National Register residential historic district.

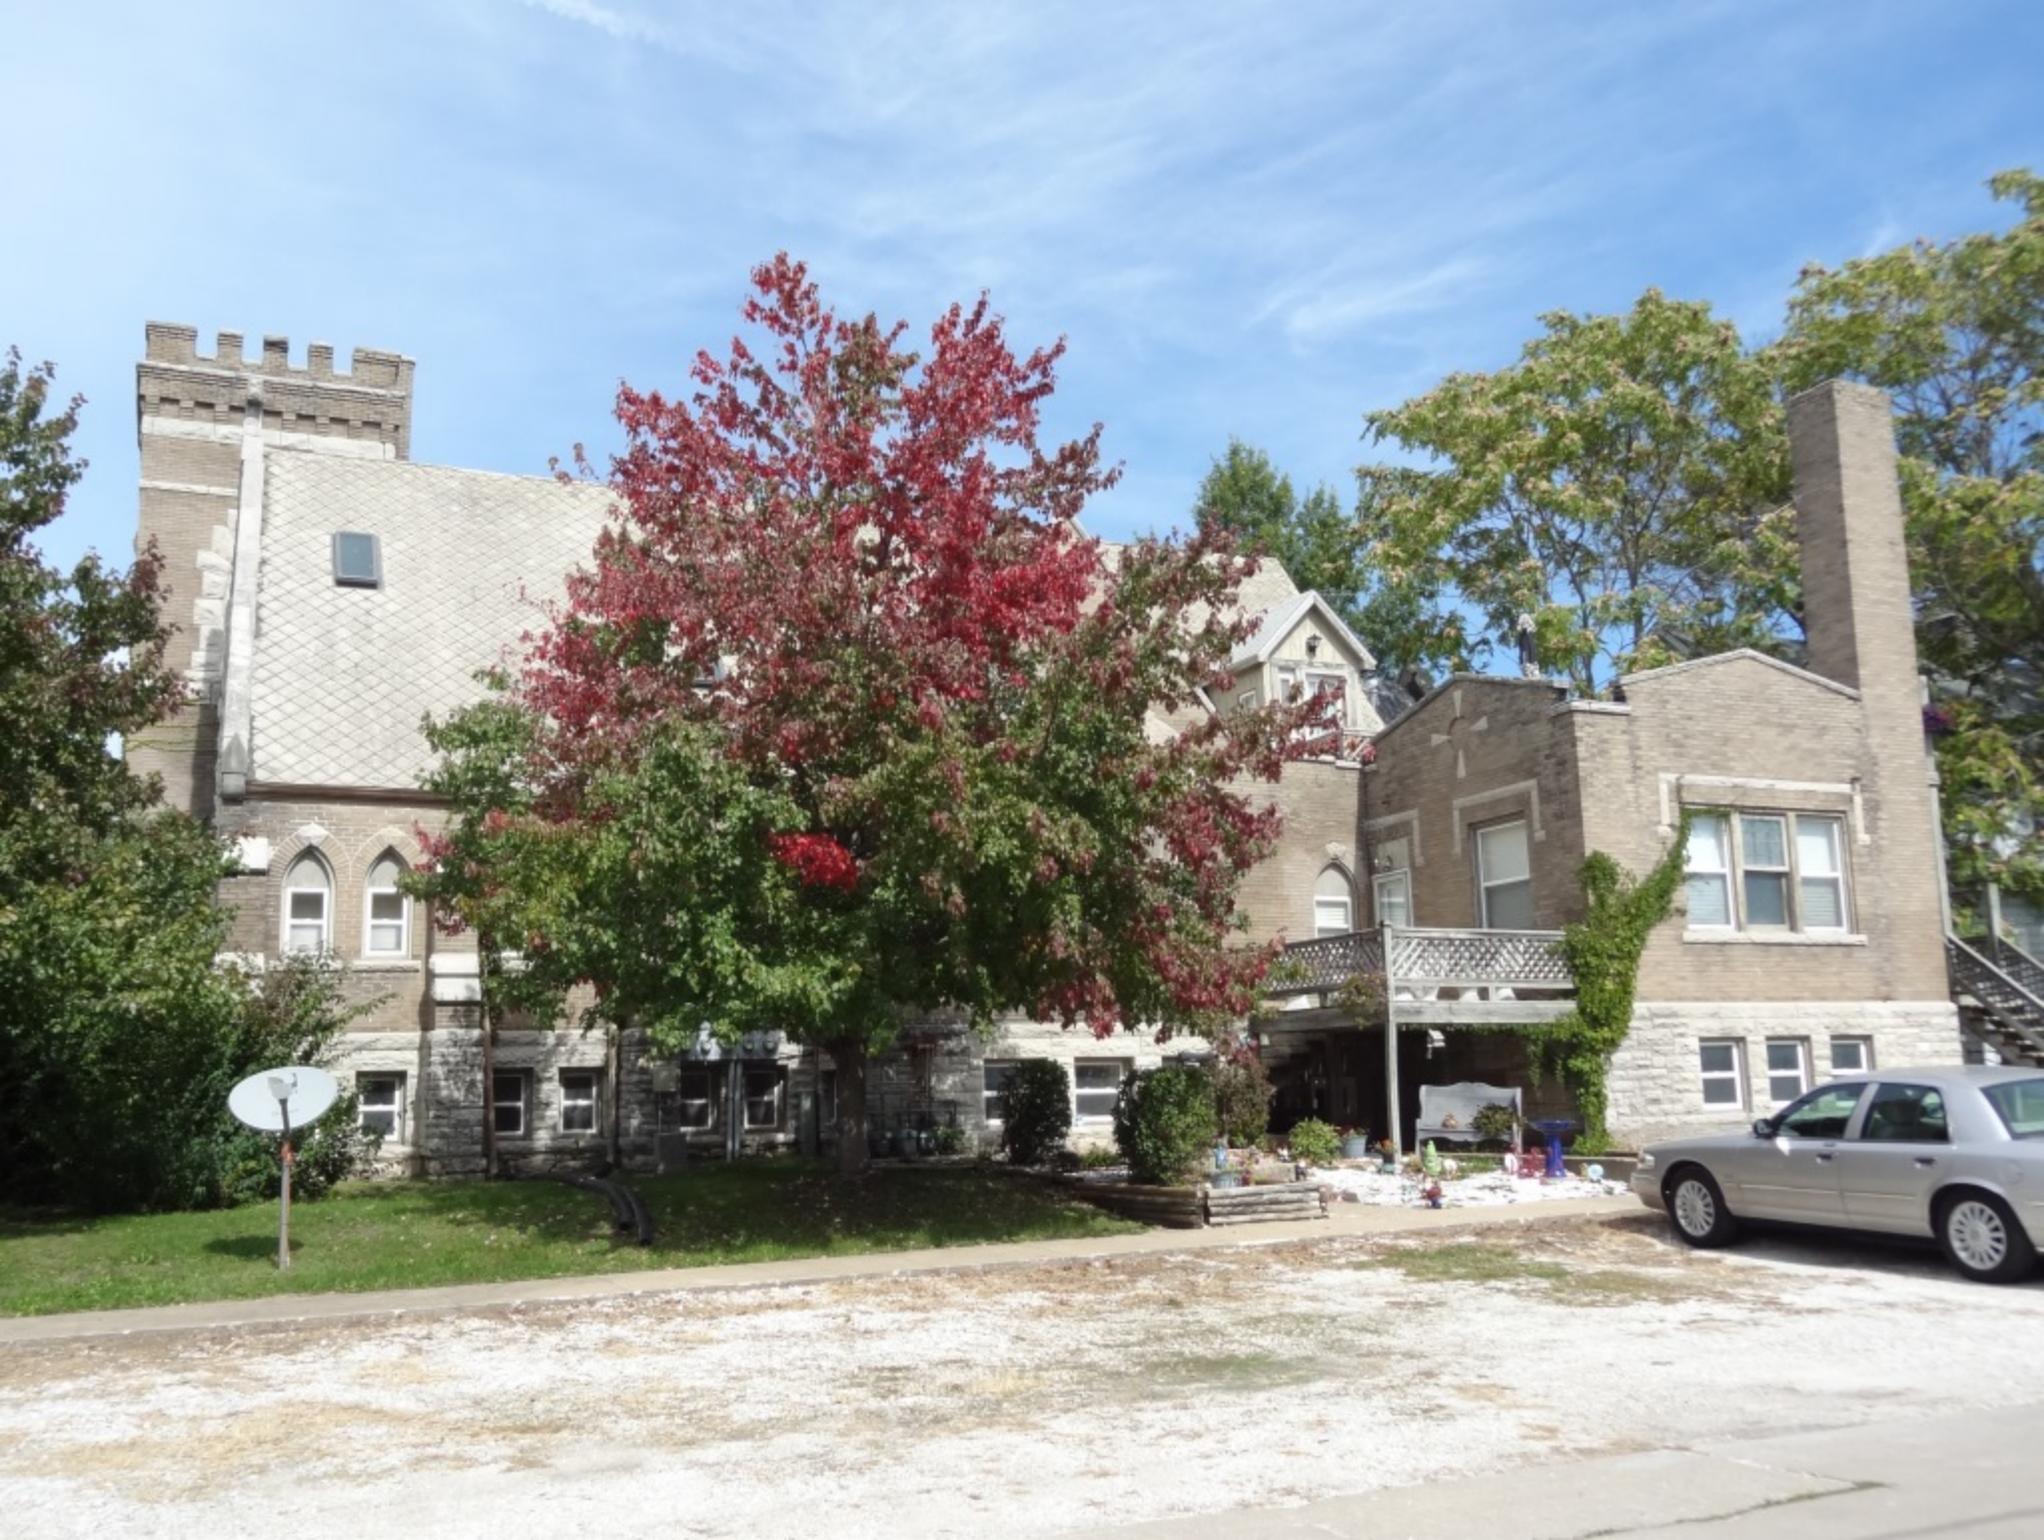
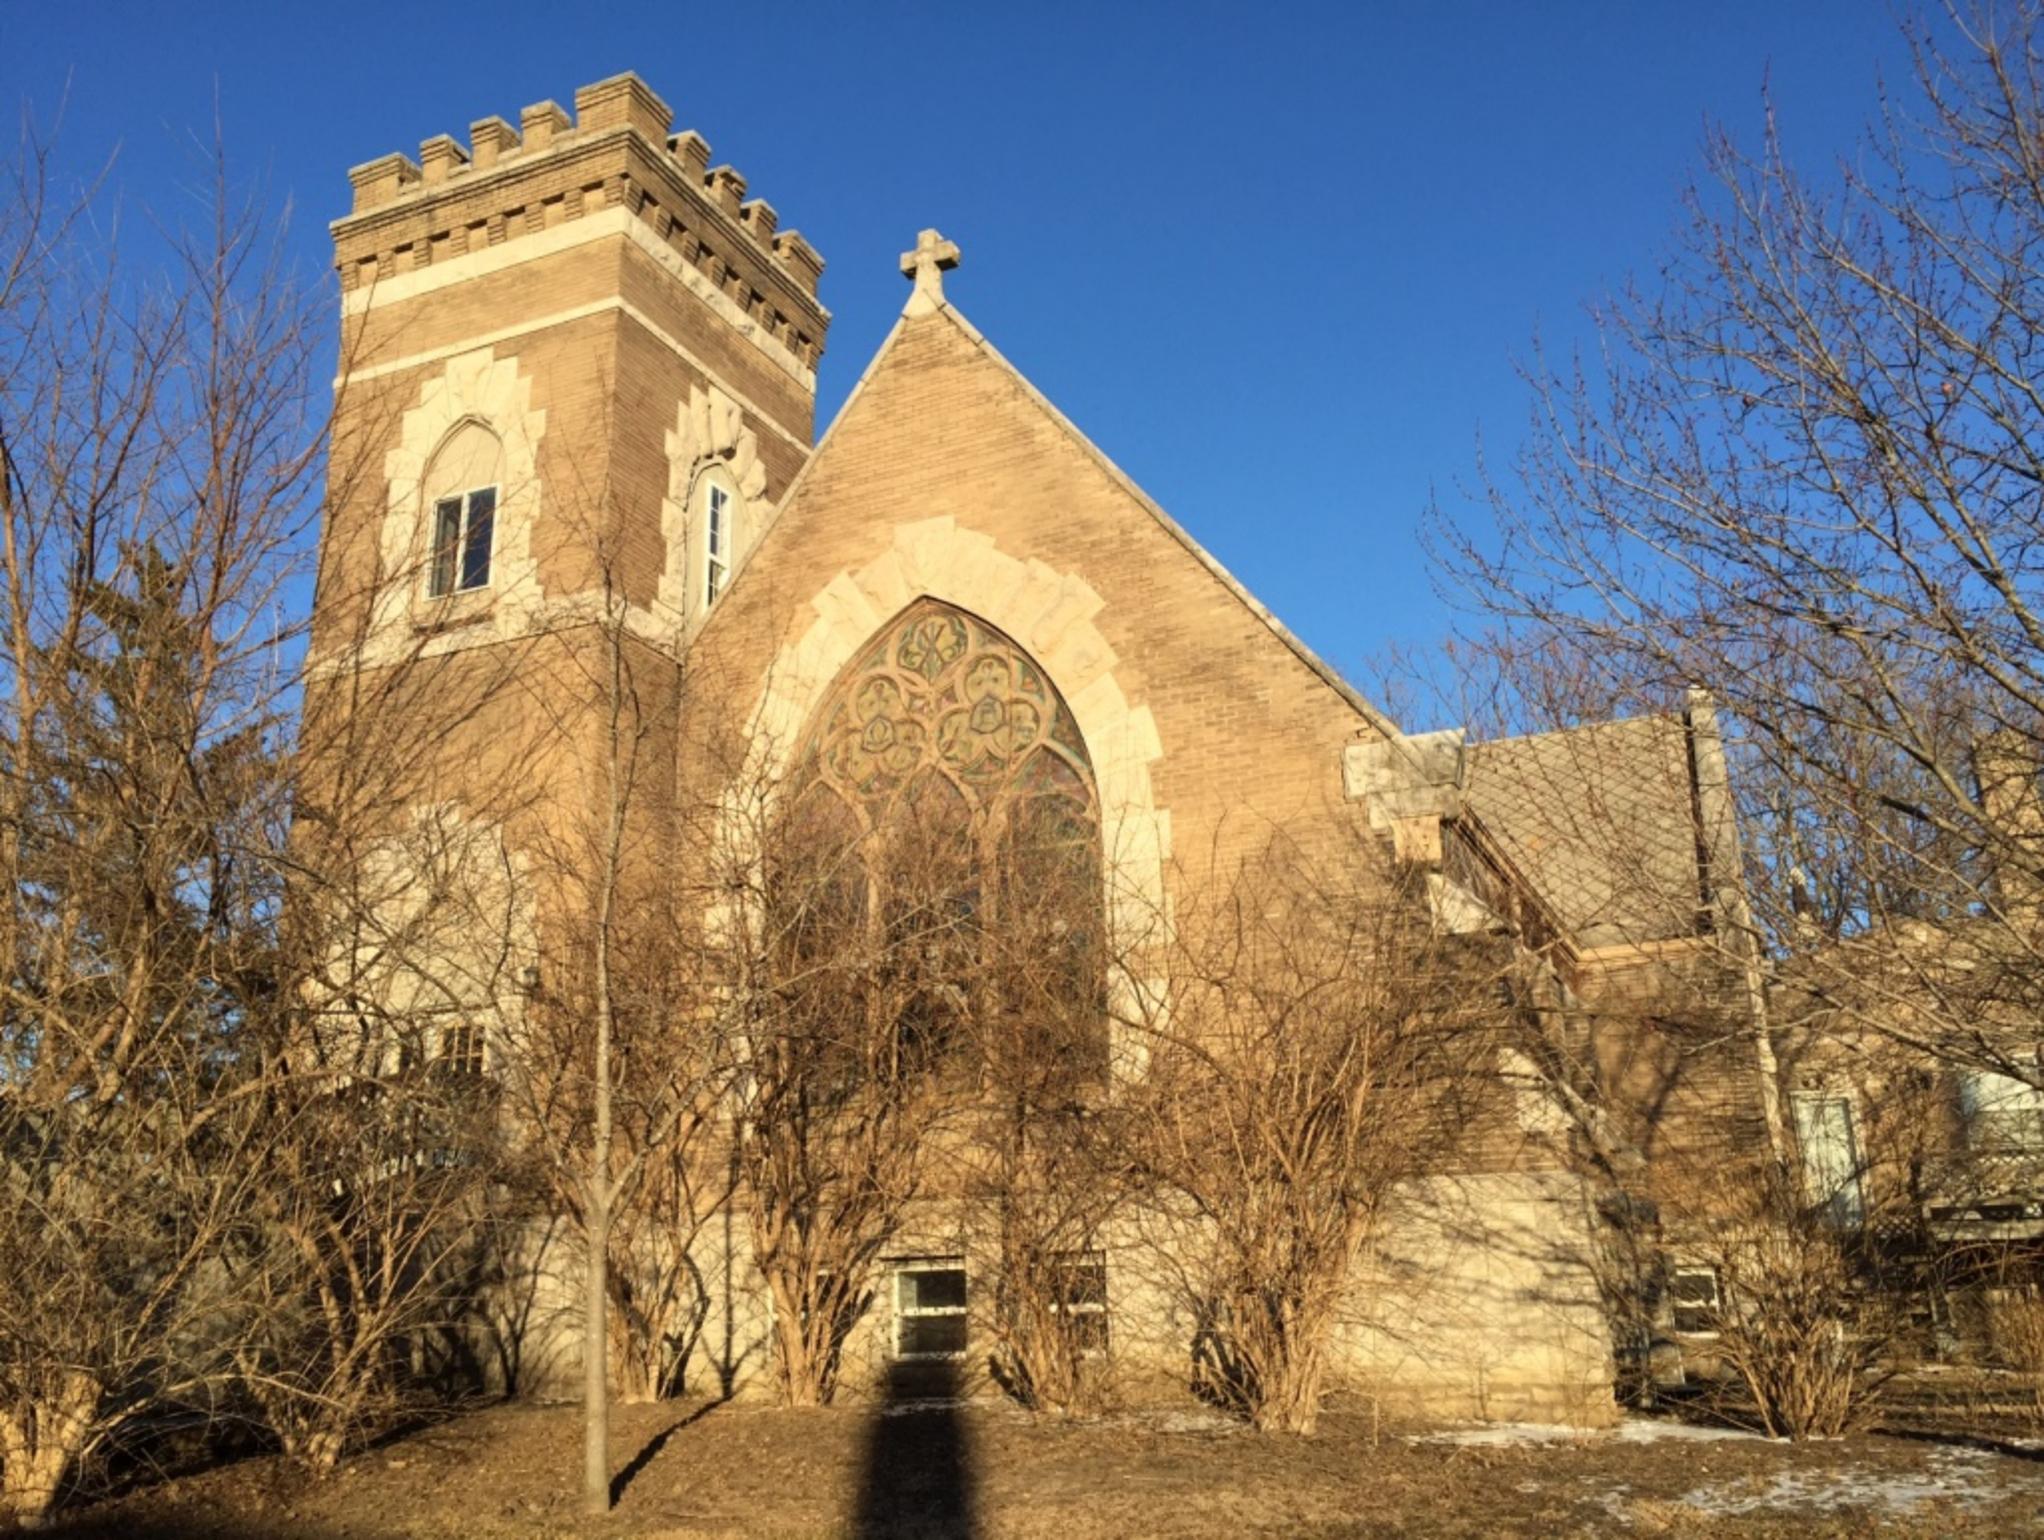
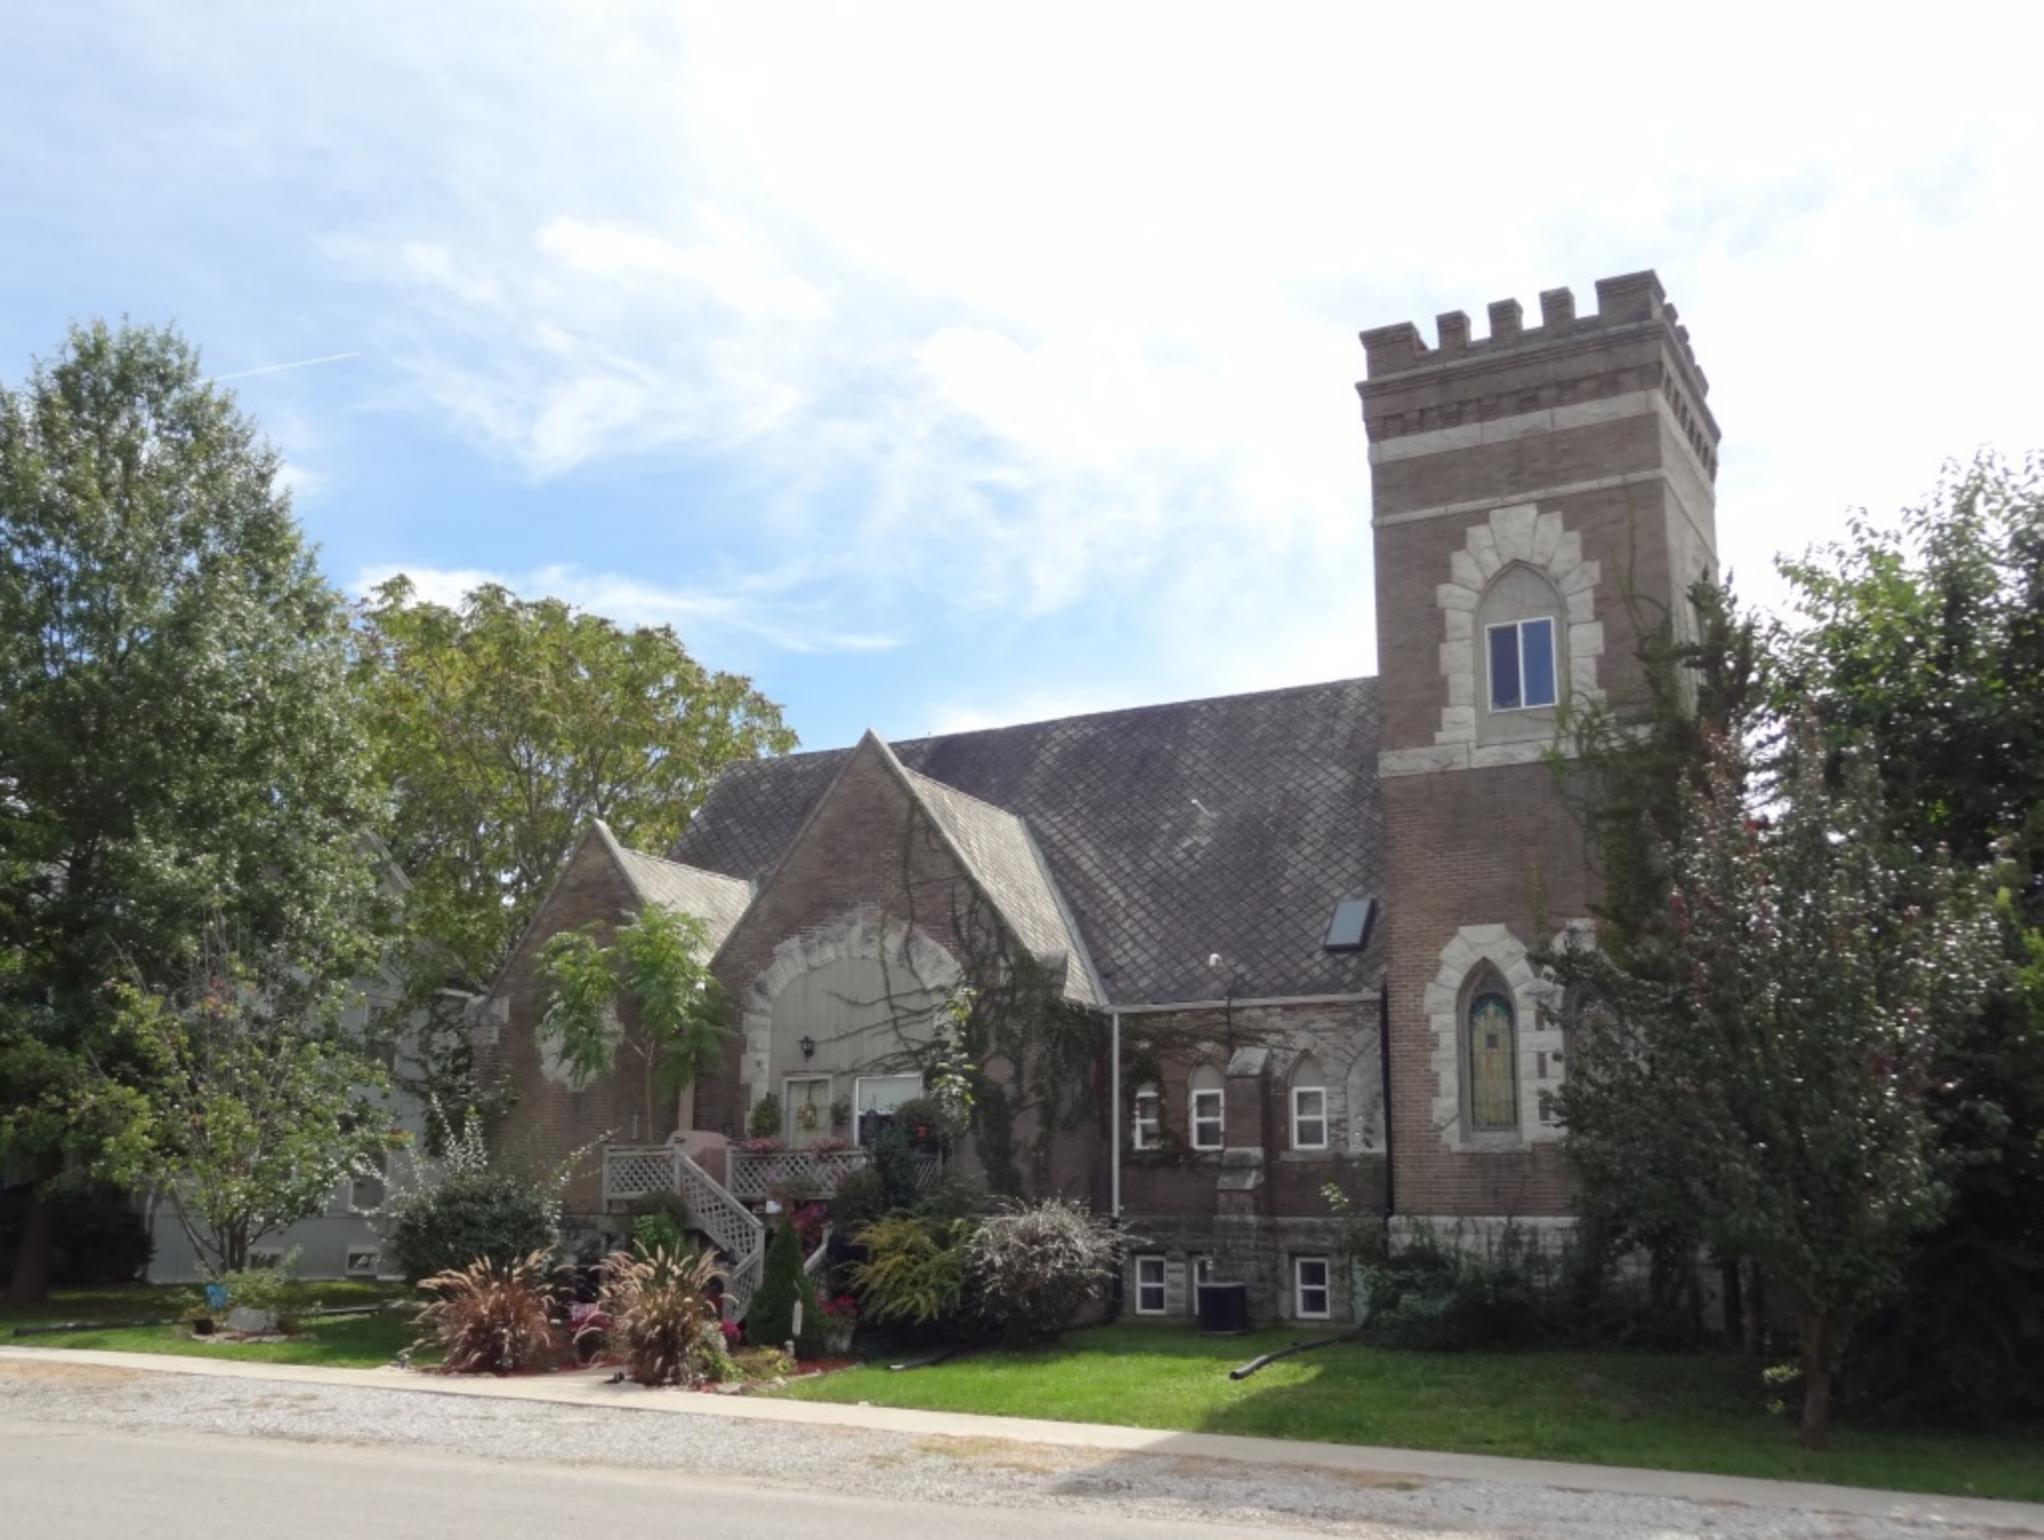
This Gothic Revival style brick and stone church has been subdivided into apartments. Its primary entry on the west elevation is obscured by trees and fencing. The roof is front gabled and a prominent castellated square tower rises from the northwest corner of the building. The tower retains rusticated limestone stringcourses and Gothic arched window openings with rusticated limestone voussoirs. Most of the stained glass windows in the tower have been replaced with under-sized vinyl windows with the remaining space infilled with wood planks. A large Gothic arched tracery window with stained glass is located on the west elevation of the primary mass of the church. A limestone cross is affixed to the peak of the gable. The rusticated stone foundation is visible on the north and south elevations. Basement-level windows have all been replaced with 1/1 double hung windows. The first floor window openings feature Gothic arches with stone keystones and sills. The windows have been replaced with vinyl 1/1 sash and the arches infilled with wood planks.

The building was altered in 1995 and subdivided into apartments. From the exterior, the building still reads as a church, but due to exterior alterations to accommodate its new residential function, the building does not retain integrity to individually convey architectural significance. It is unknown how much of the historic church interior remains. The building might contribute to a potential National Register district depending on the period and area of significance.
