1. Survey No. MC-AS-001-001		2. Survey name: Downtown Macon Commercial Historic District	
3. County: Macon		4. Address (Street No.) Lots 11-13 block 93	Street (name) East Bourke Street (100 block)
5. City: Macon	Vicinity: <input type="checkbox"/>	6. Geographical Reference:	7. Township/Range/Section: T: R: S:
8. Historic name (if known):		9. Present/other name (if known): City of Macon Parking Lot #3	
10. Ownership: <input checked="" type="checkbox"/> Private <input type="checkbox"/> Public		11a. Historic use (if known): Commercial	11b. Current use: vacant

42. Current owner/address: City of Macon Macon, MO 63552	43. Form prepared by (name and org.): Kristi Chase MO SHPO	44. Survey date: 9/24/2014
		45. Date of revisions:

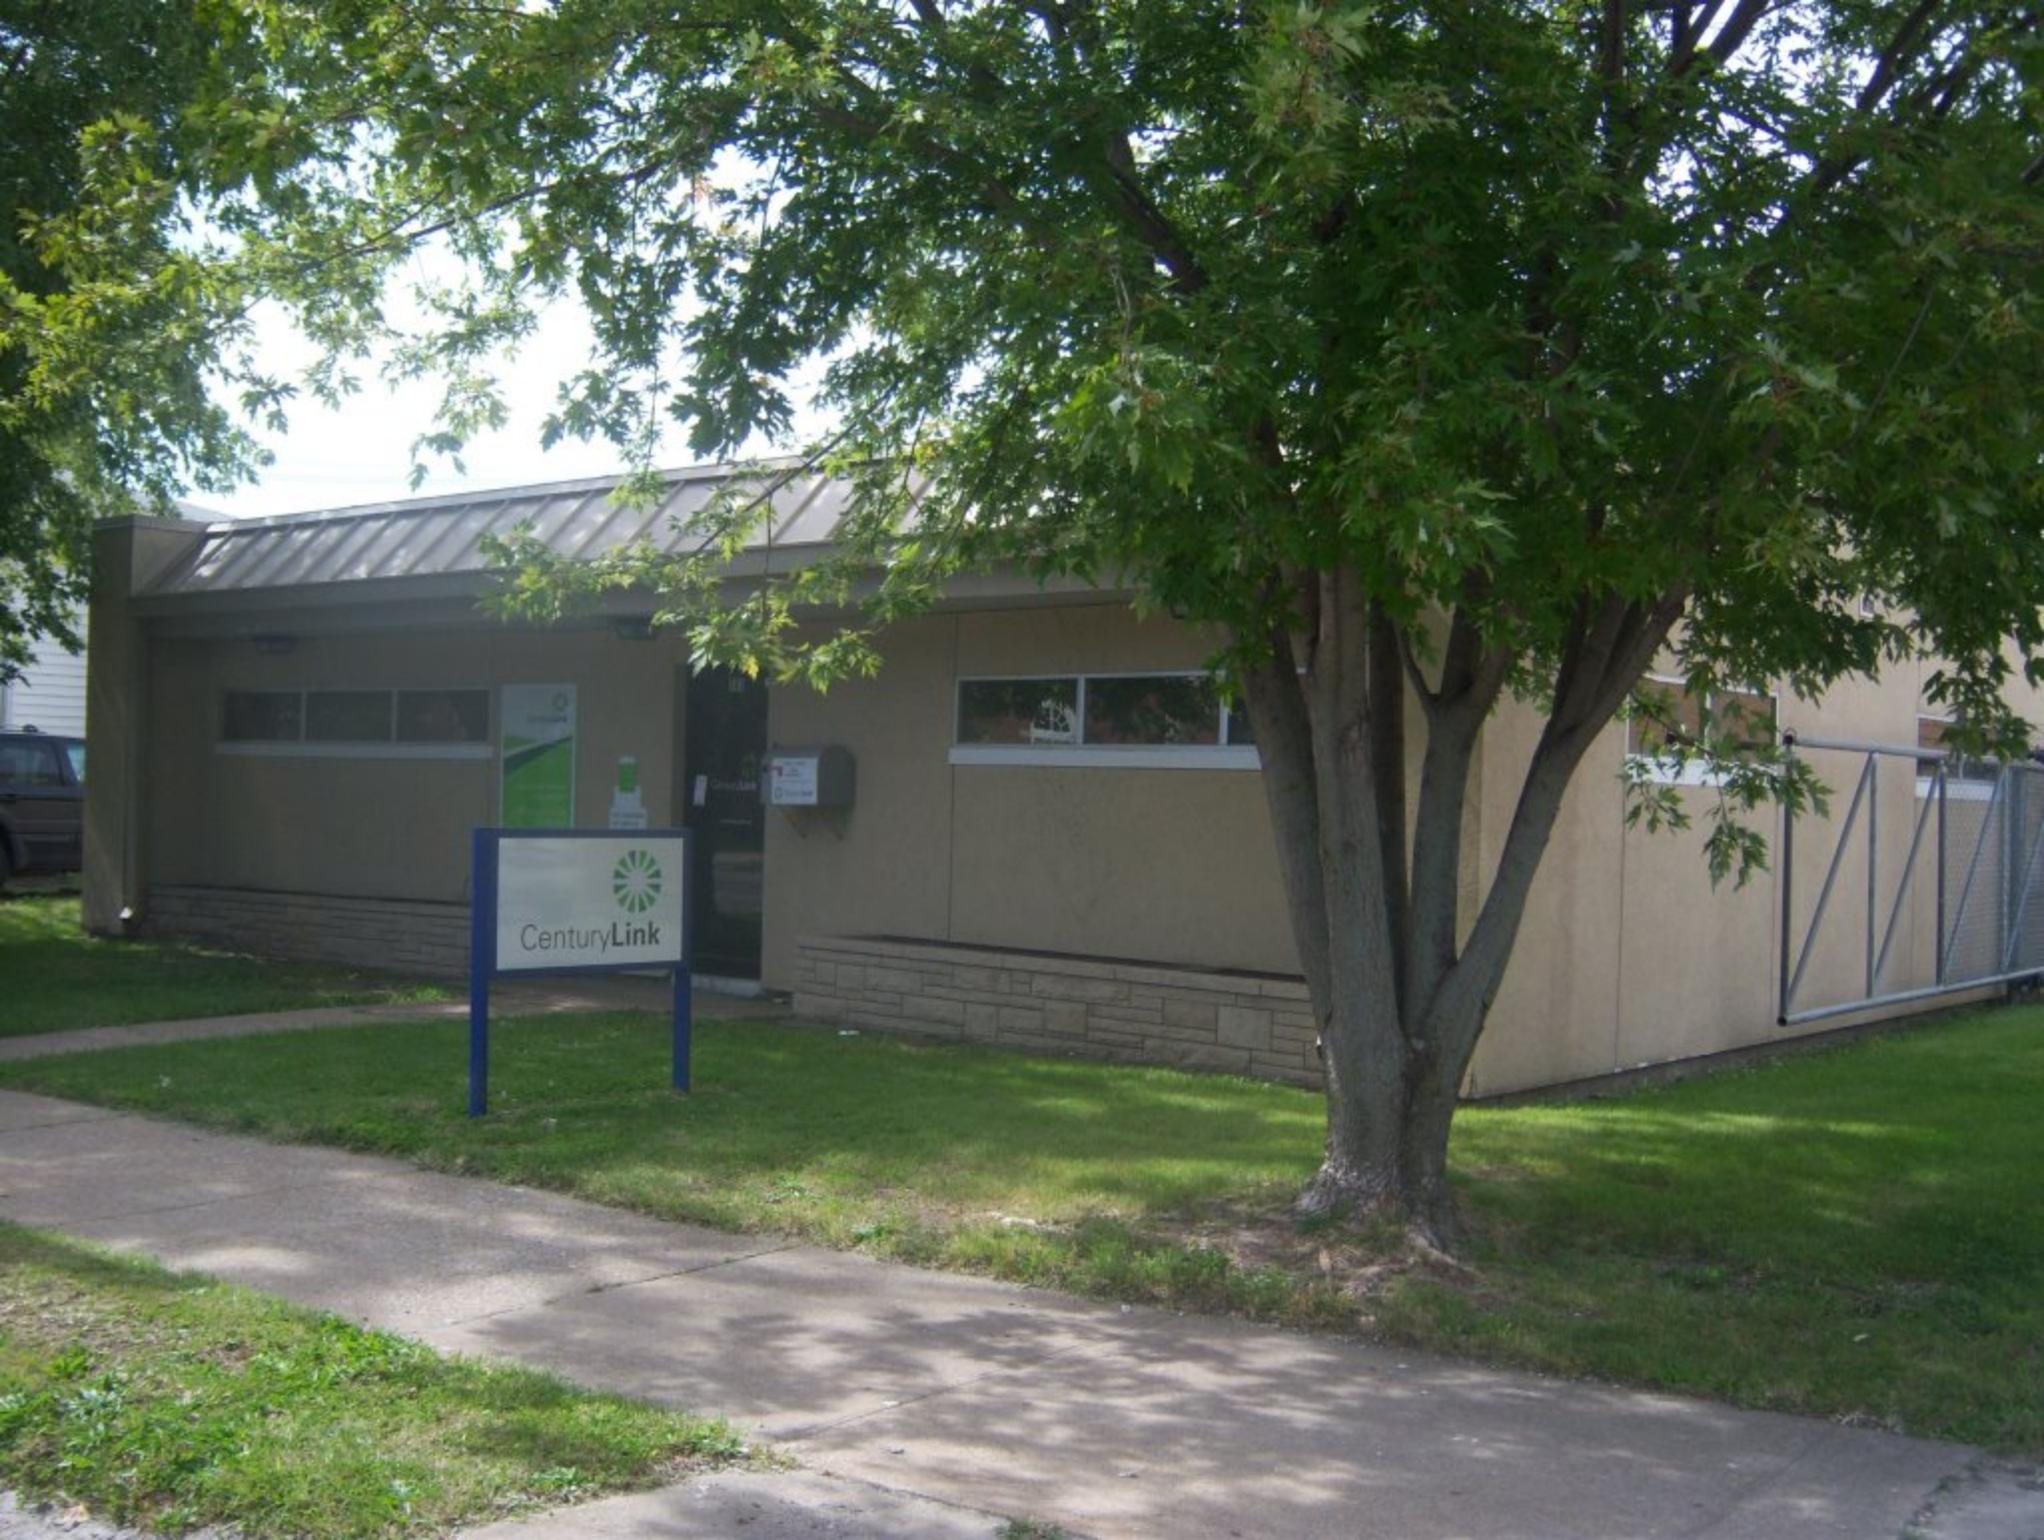
The one-part commercial block building is rectangular in shape with a flat roof and a faux metal mansard awning along the façade. The building is three bays wide with a concrete foundation and has concrete stucco siding. The façade includes a center glass door entry, flanked by tripartite fixed single metal window sashes. PermaStone hedged walls frame the foundation on either side of the entry. Two sets of paired fixed single metal sash windows are located on the north and south elevations.

The property is not eligible due to its age, modern alterations and location outside of a potential historic commercial district. It is high unlikely it would contribute to a residential historic district.

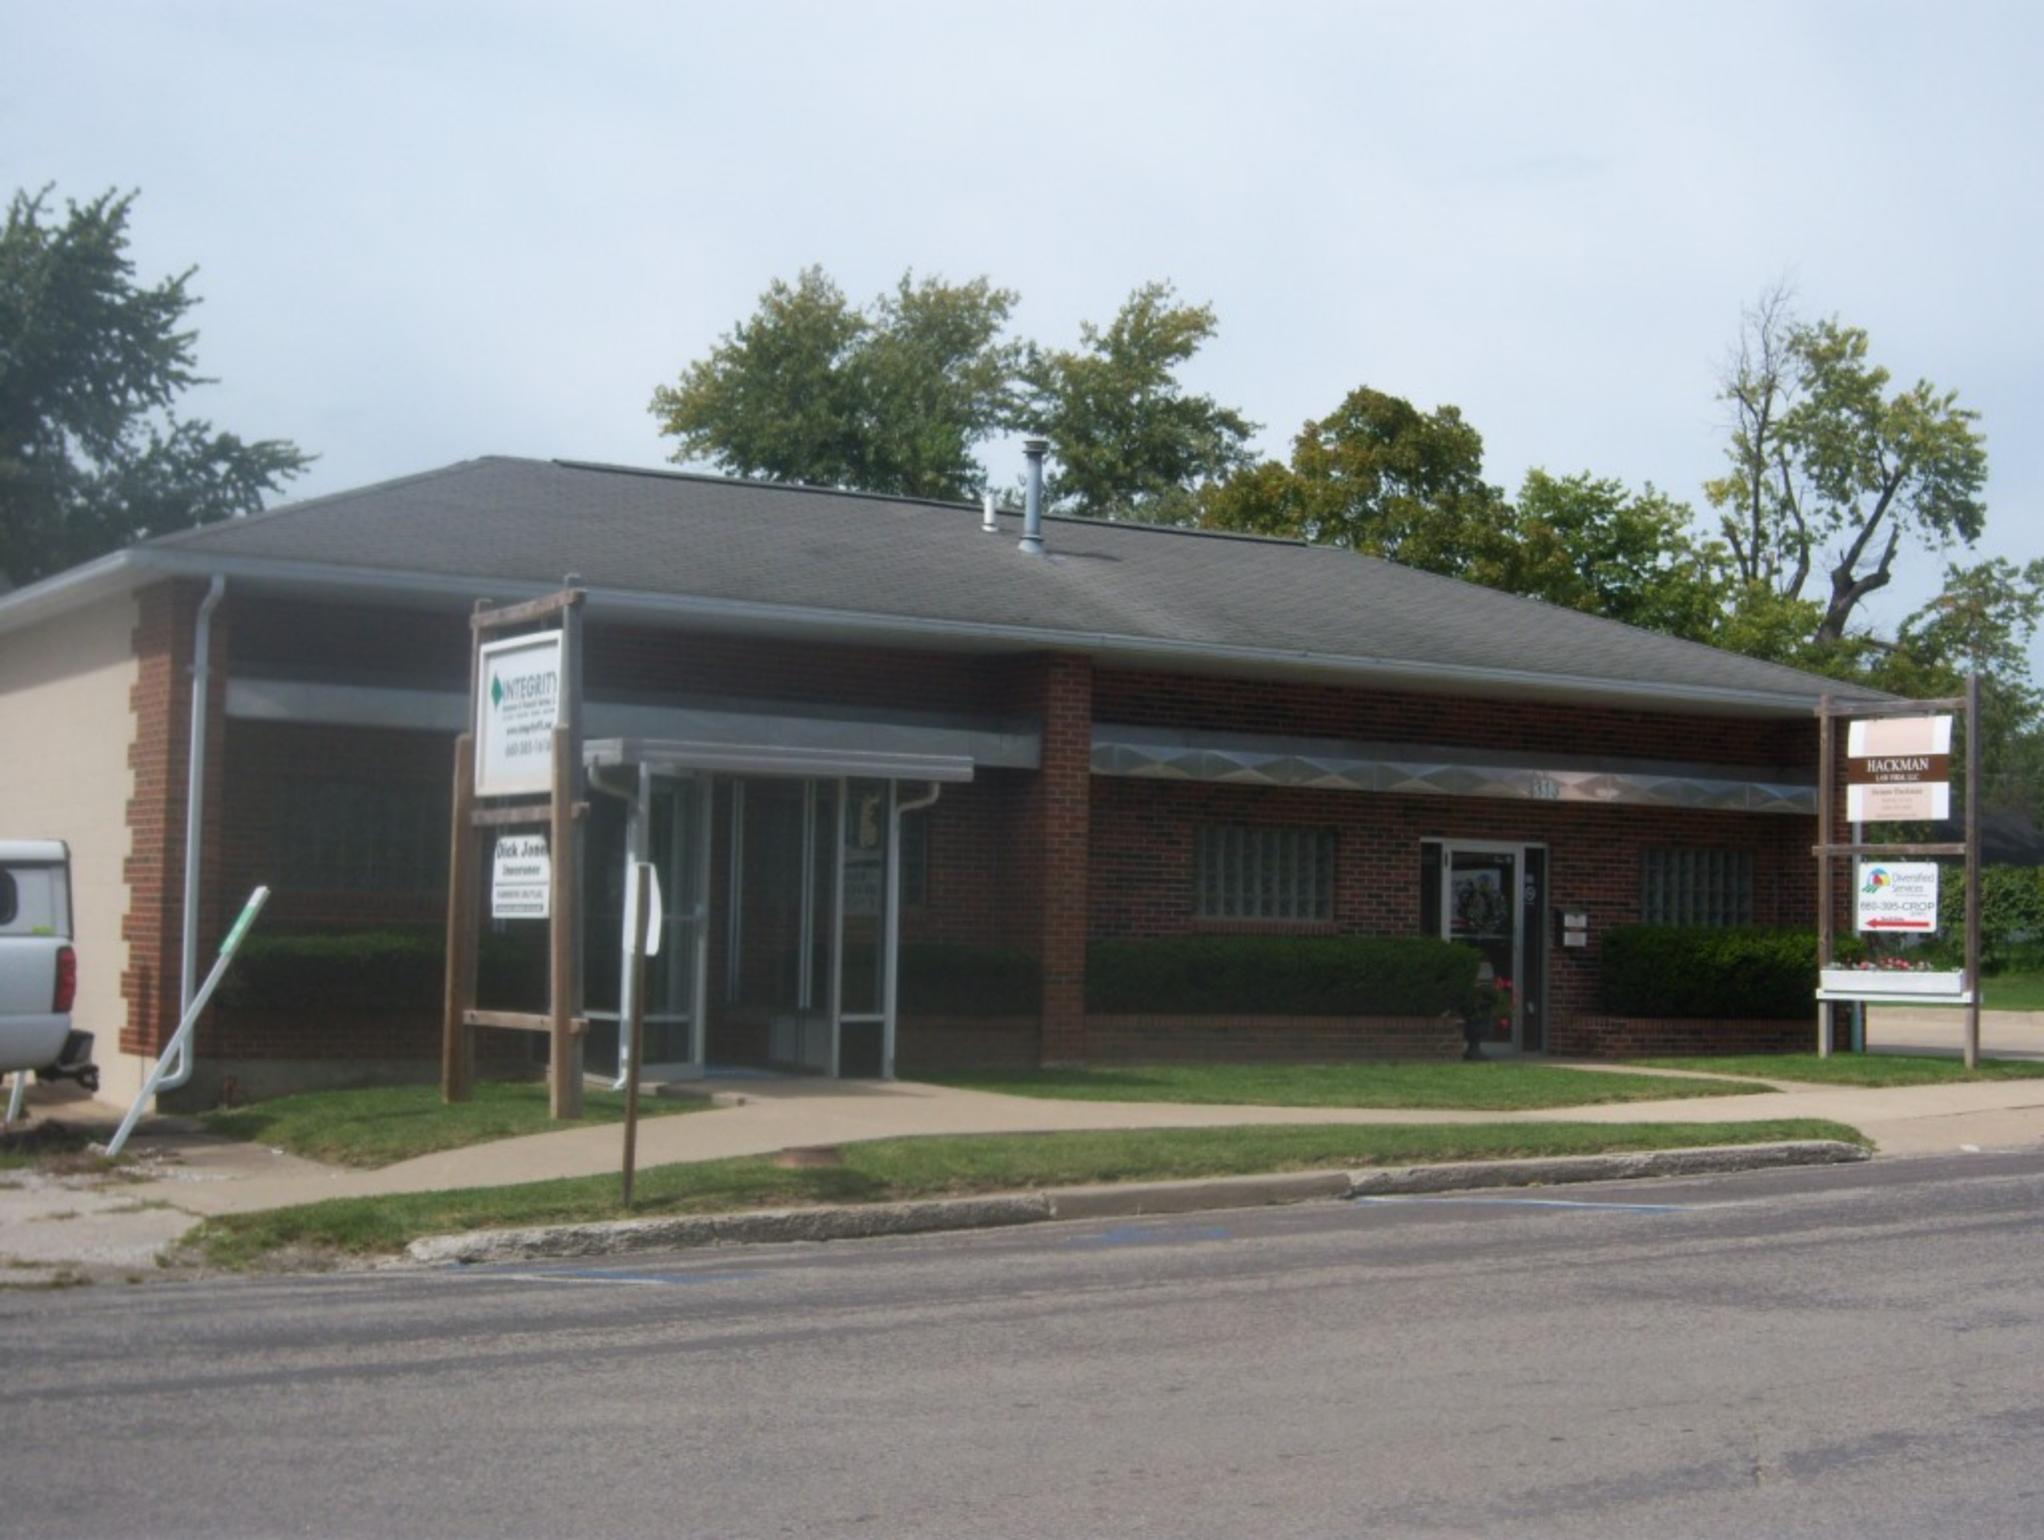
The one-part commercial block building is rectangular in shape with an asphalt hipped roof and a geometric metal awning along the façade. The building is two bays wide with a projecting center brick wall breaking up the façade. A concrete foundation supports the brick façade building and concrete stucco covers the side elevations. The first bay includes a center glass entry door with metal surround and is flanked by a horizontal band of glass block windows. A metal and glass portico projects from this bay's entry. The second bay includes a center glass entry door with side lights and metal surround flanked by a horizontal band of glass block windows. Brick walls along the façade create hedging that surround bushes. The north elevation consists of one bay composed of side entry and a vinyl sliding window and a smaller rear addition with a vinyl sliding window.

The property is not eligible due to its age, modern alterations and location outside of a potential historic commercial district. It is high unlikely it would contribute to a residential historic district.

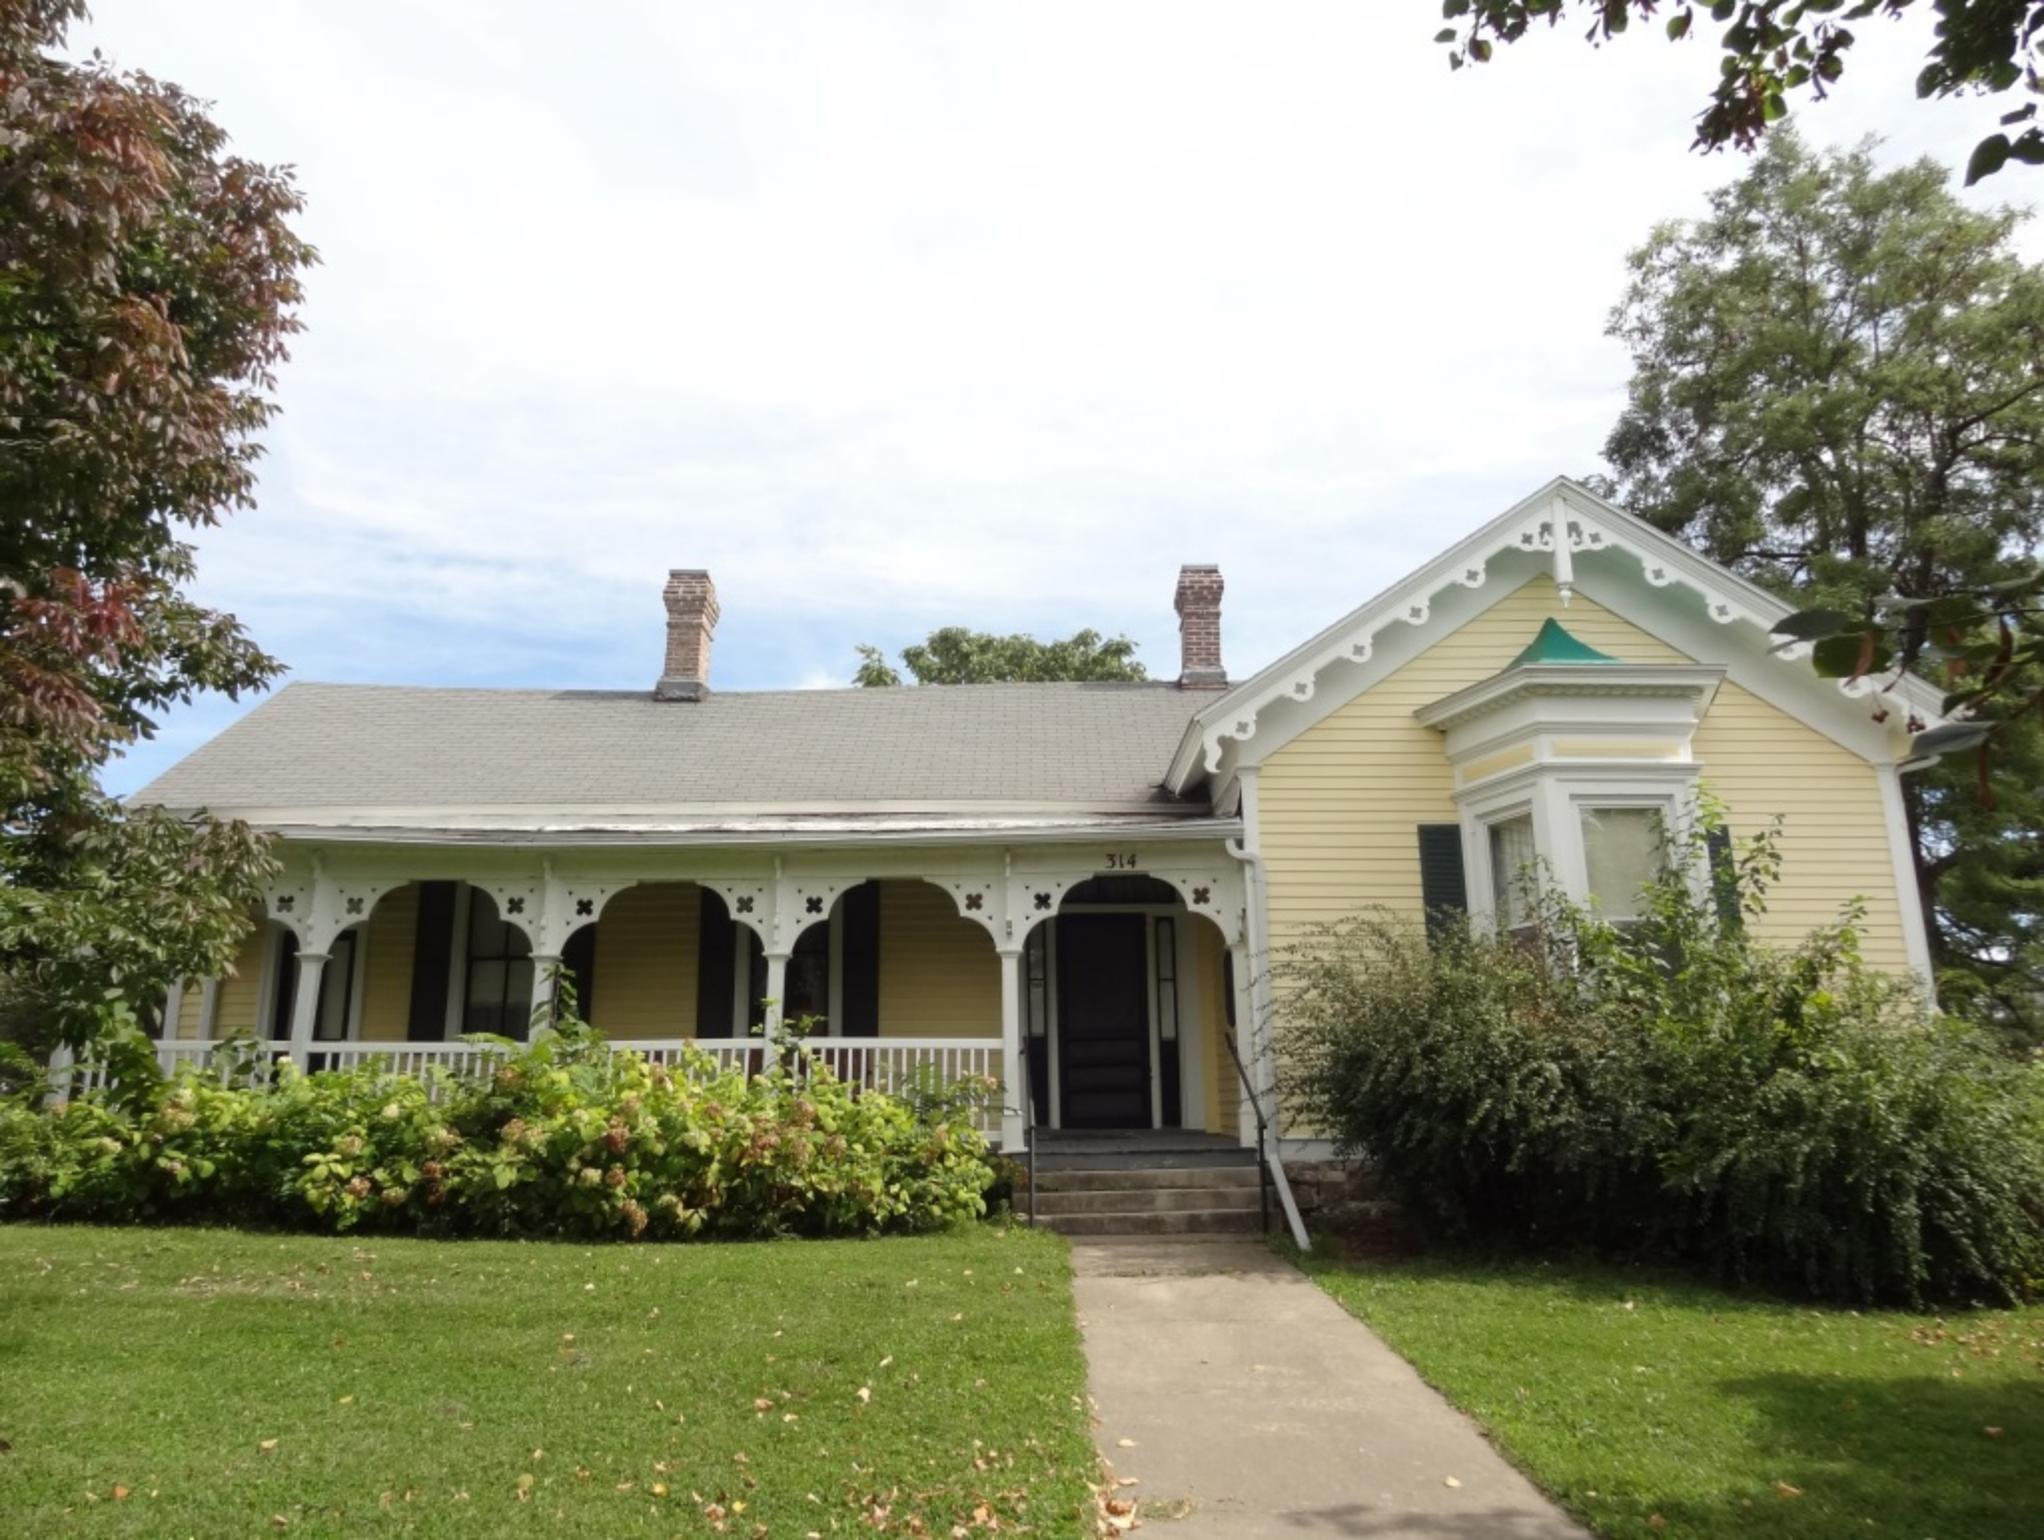
This one-story gabled ell house exhibits Gothic Revival style architectural ornamentation. It is clad in painted yellow weatherboard and has a stone foundation. The primary mass of the house is side-gabled, and two corbeled brick chimneys are visible at the ridgeline. The front (west) façade has five bays. From north to south, the first bay contains a historic wood door with two vertical lights and a wood door surround with simple entablature. The second and third bays contain historic 2/2 wood windows with shutters. The fourth bay contains a historic wood entrance door with sidelights, transom, and wood door surround with pilasters. A shed roofed porch with wood plank flooring shelters these four bays. The porch is accessed via three concrete steps and features a wood balustrade with square posts articulated with bargeboards decorated with quatrefoil cutouts. The fifth bay is within a projecting front gabled ell. It contains a three-sided bay window with a prominent entablature and replacement 1/1 double hung windows and shutters. The eaves of the ell contain bargeboards with quatrefoil cutouts.

The house retains integrity and may contribute to a potential National Register district depending on the period and area of significance. The building was determined individually eligible for the National Register in a 1995 eligibility assessment submitted to the Missouri State Historic Preservation Office.

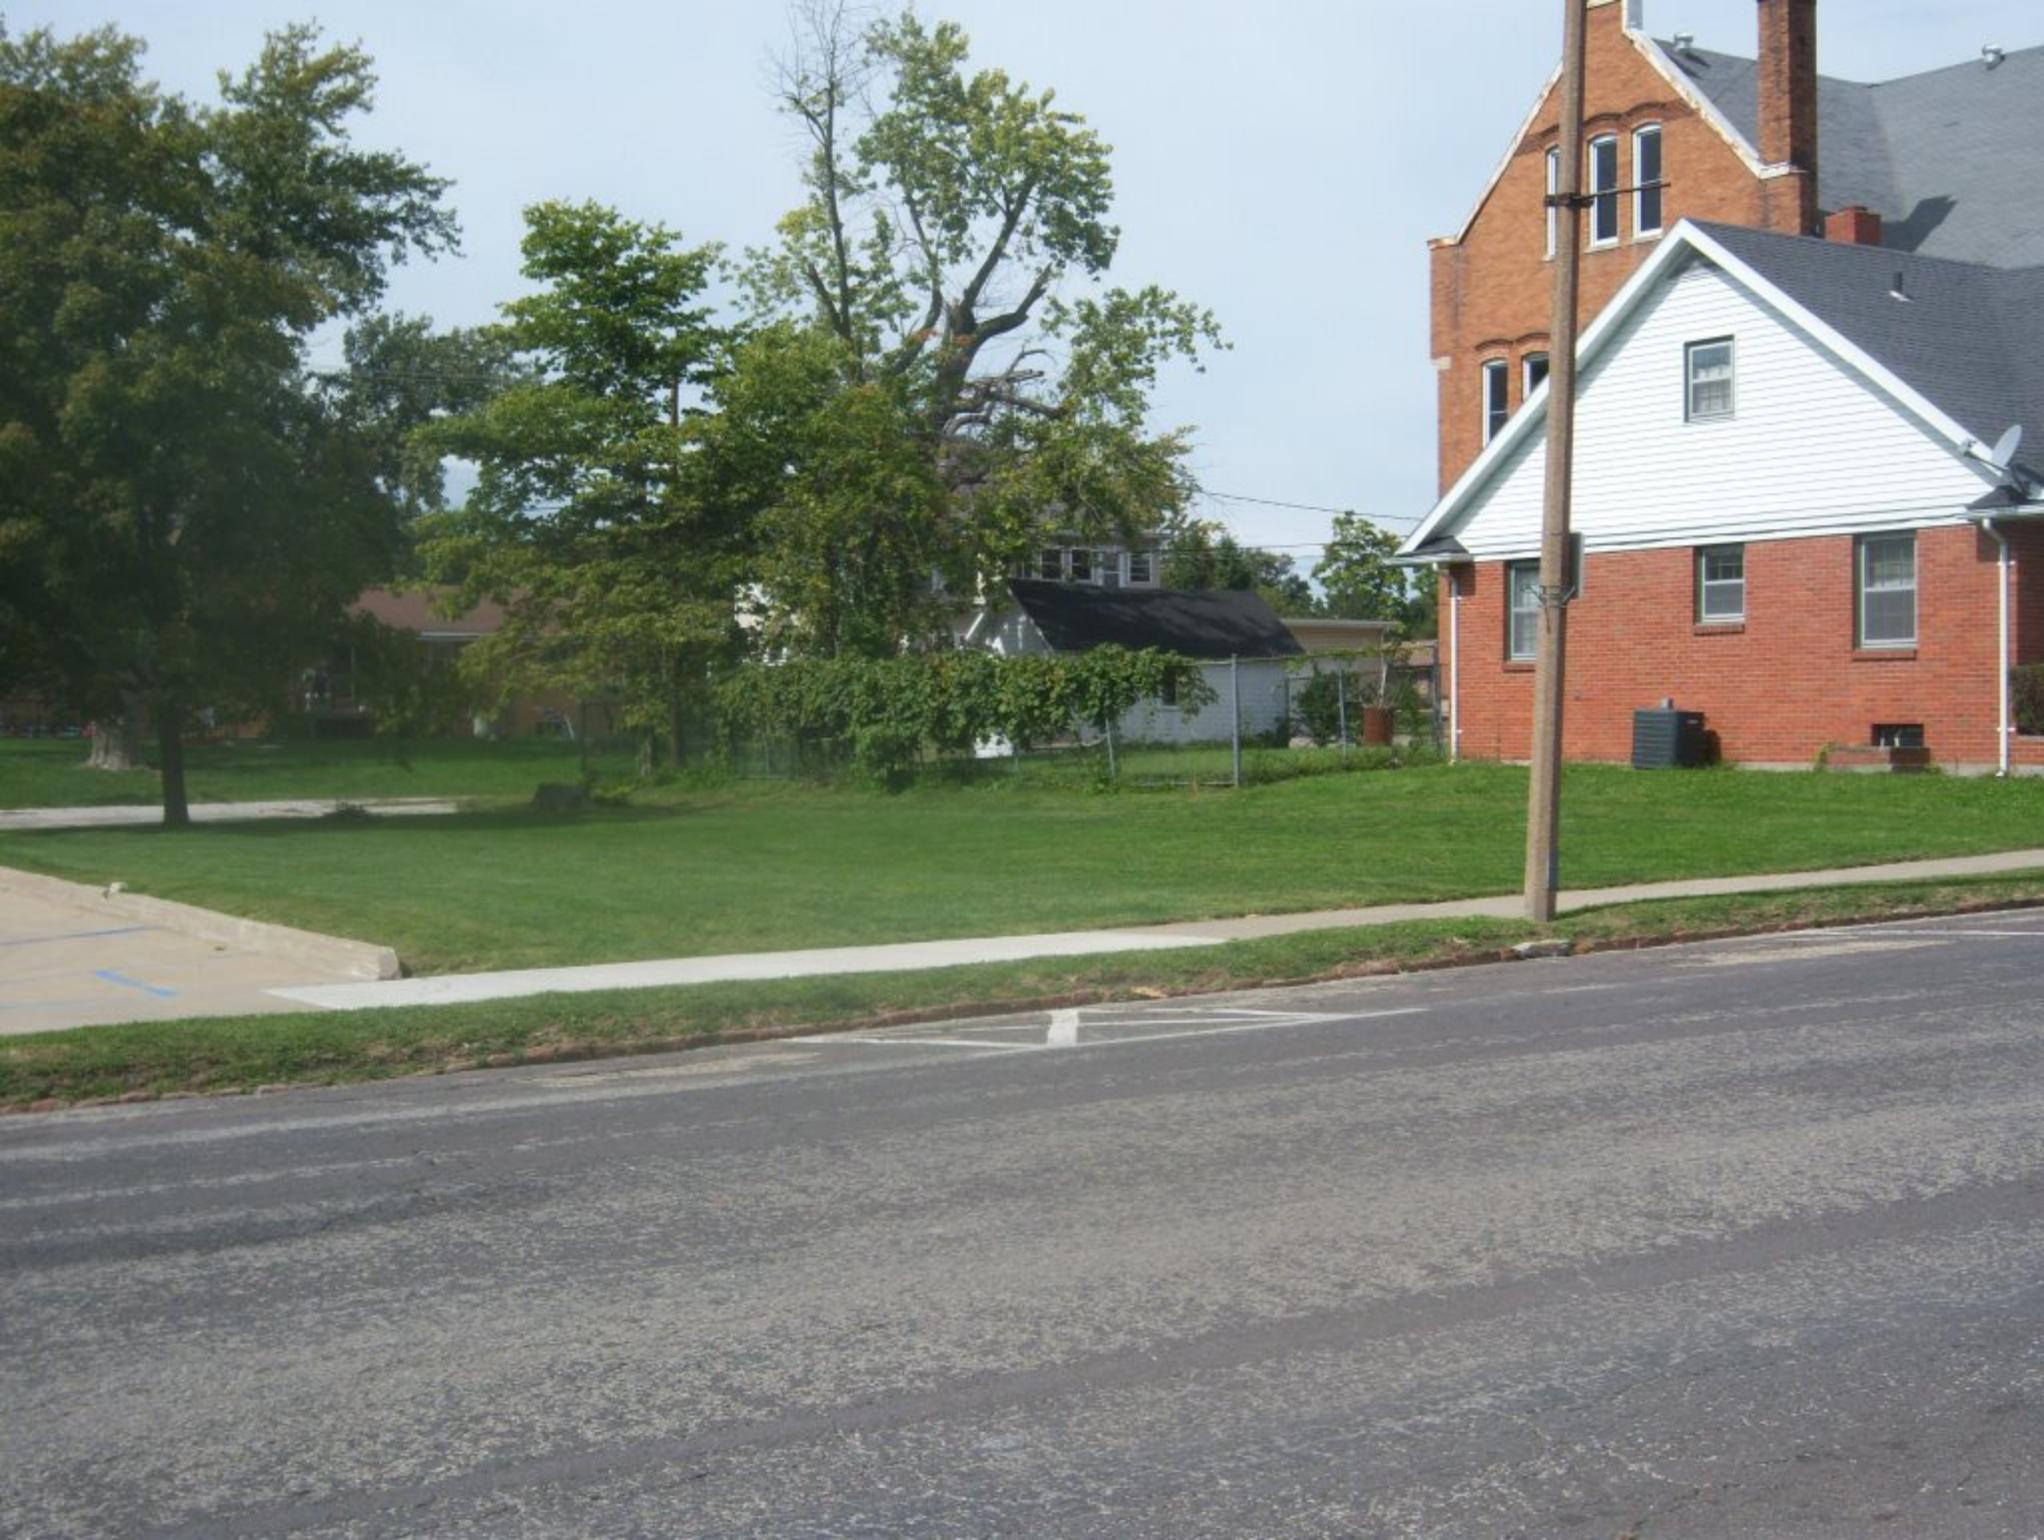
The lot is currently vacant and consists of a grassy setting. The removal of the building has resulted in a loss of integrity, rendering the lot non-contributing to a potential National Register historic district.

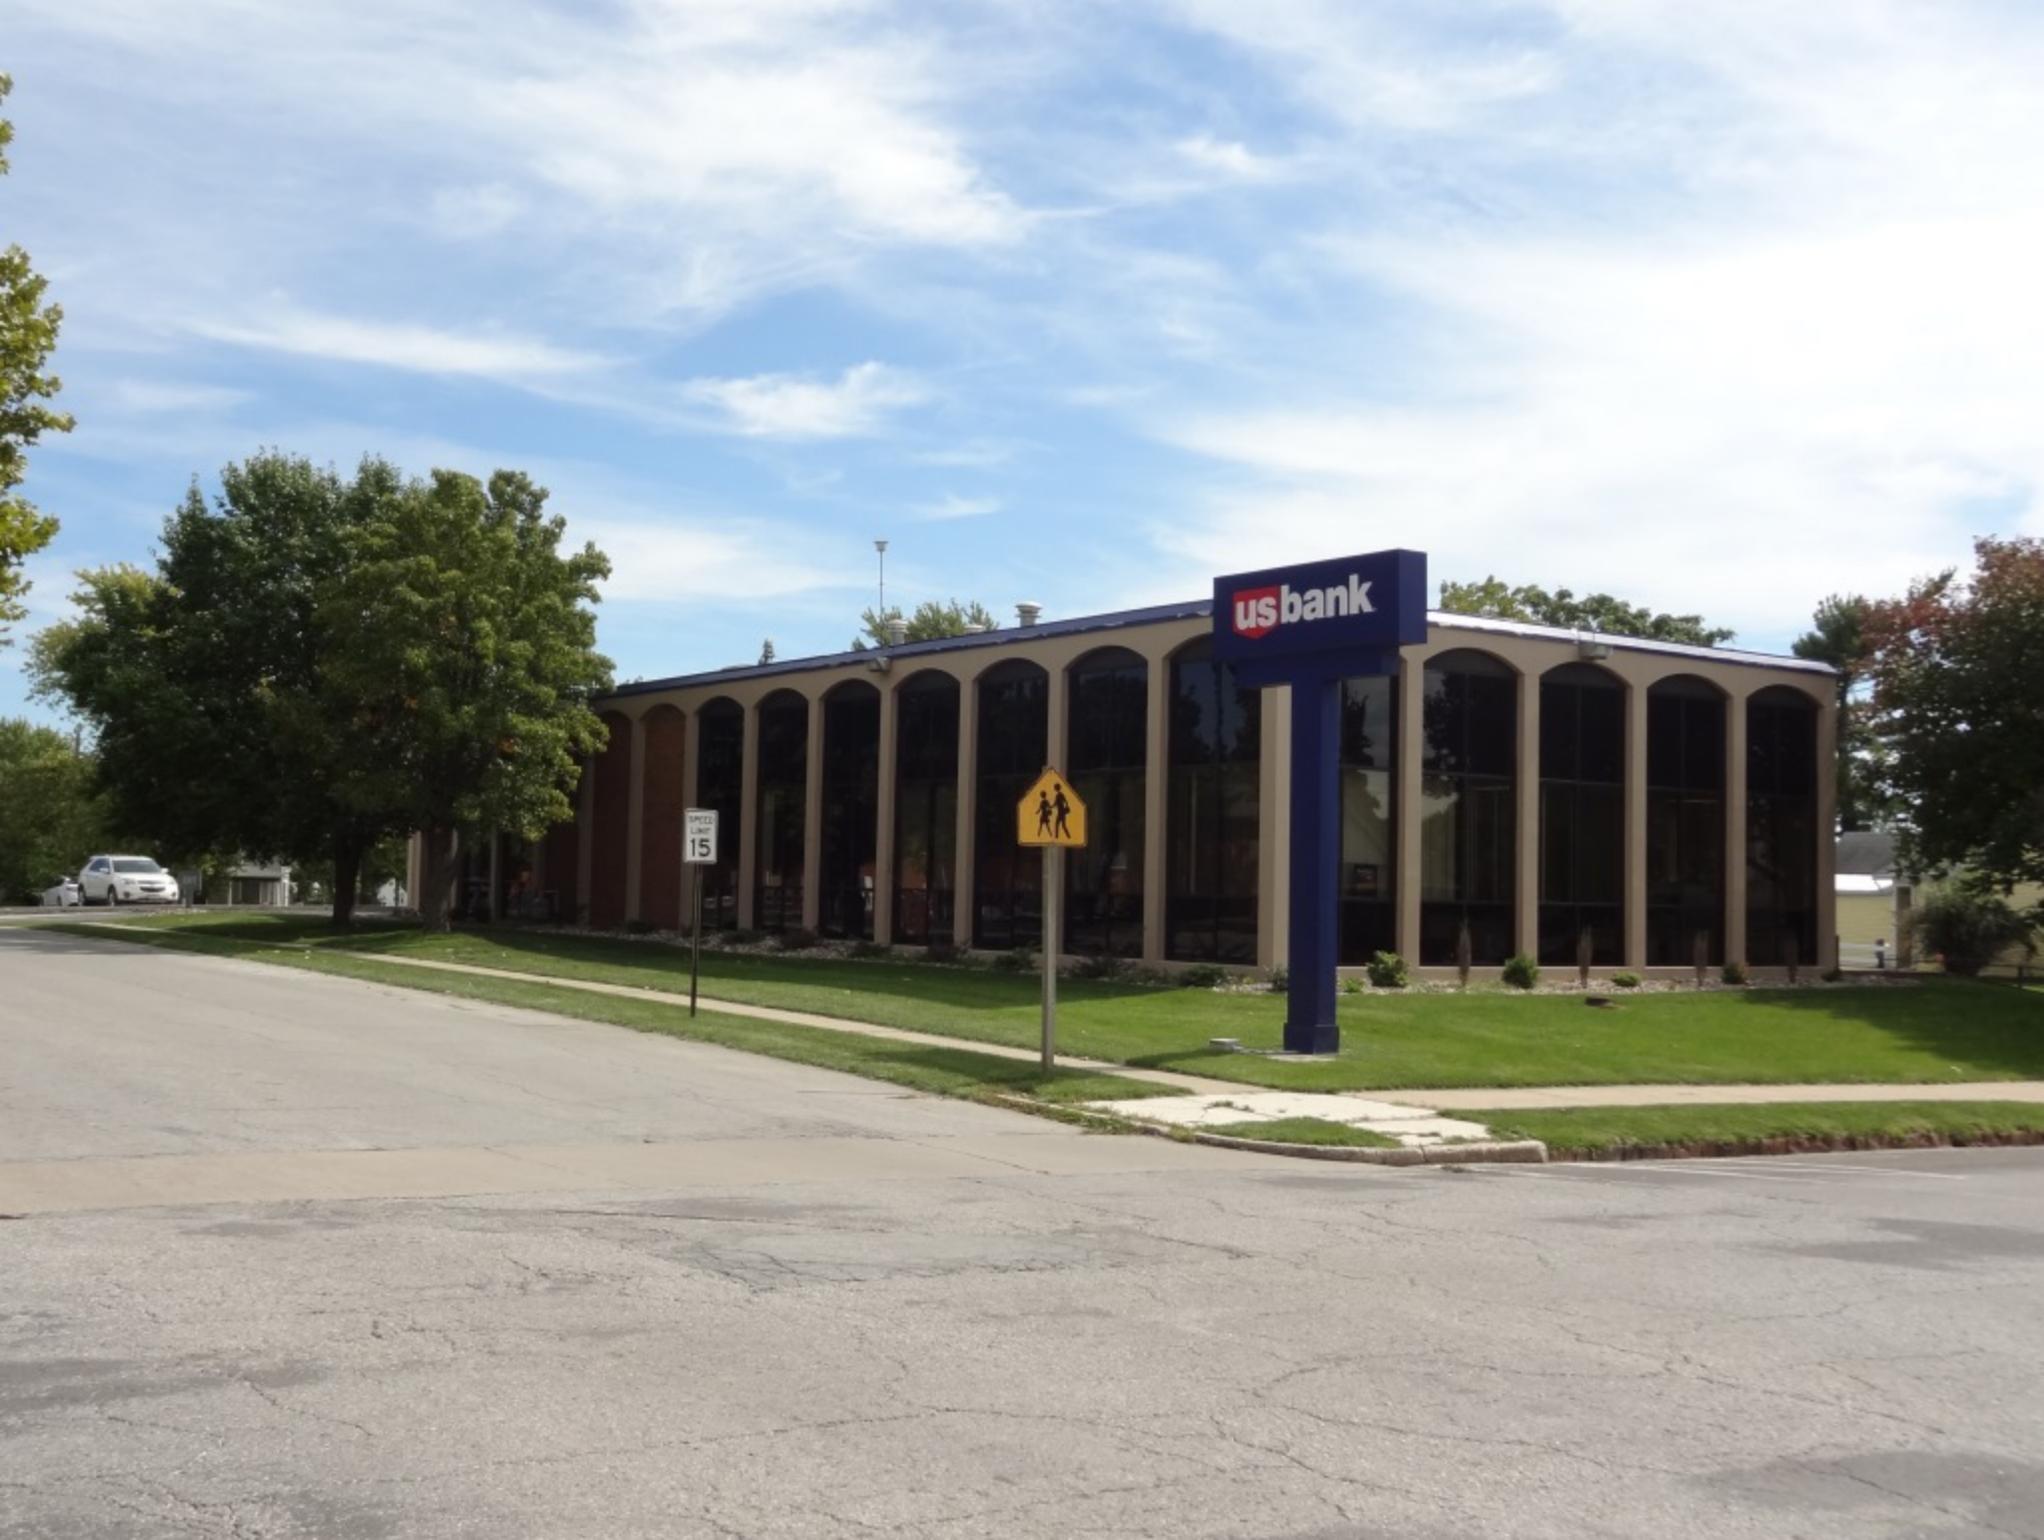
This long rectangular one-story modern movement building has a flat roof and a continuous rhythm of tall glass and metal window walls separated by thin piers along its north, west, and south elevations. The south elevation contains the primary entrance and has 13 bays, which are all the same height and width. The bays are flanked by thin stuccoed piers joined above the bays with segmented arches. From west to east, bays 1-4 feature tall glass and metal window walls with six lights. The fifth bay contains the entrance, comprised of double glass and metal entrance doors set below a window wall. Bays 6-7 are identical to bays 1-4. Bays 8-10 are clad with brick. Bays 11-12 are identical to bays 1-4 and 6-7. The 13th bay features brick cladding with an inset ATM and affixed plastic US Bank sign. The west façade features five bays of window walls, and the north façade is nearly identical to the south, but lacks a customer entrance.

Tax assessor records indicate the building was altered in 1989; this may have resulted in replacement windows. Pre-1989 photographs of the building will need to be viewed to ascertain integrity, but due to age, the building would likely not be eligible for listing.

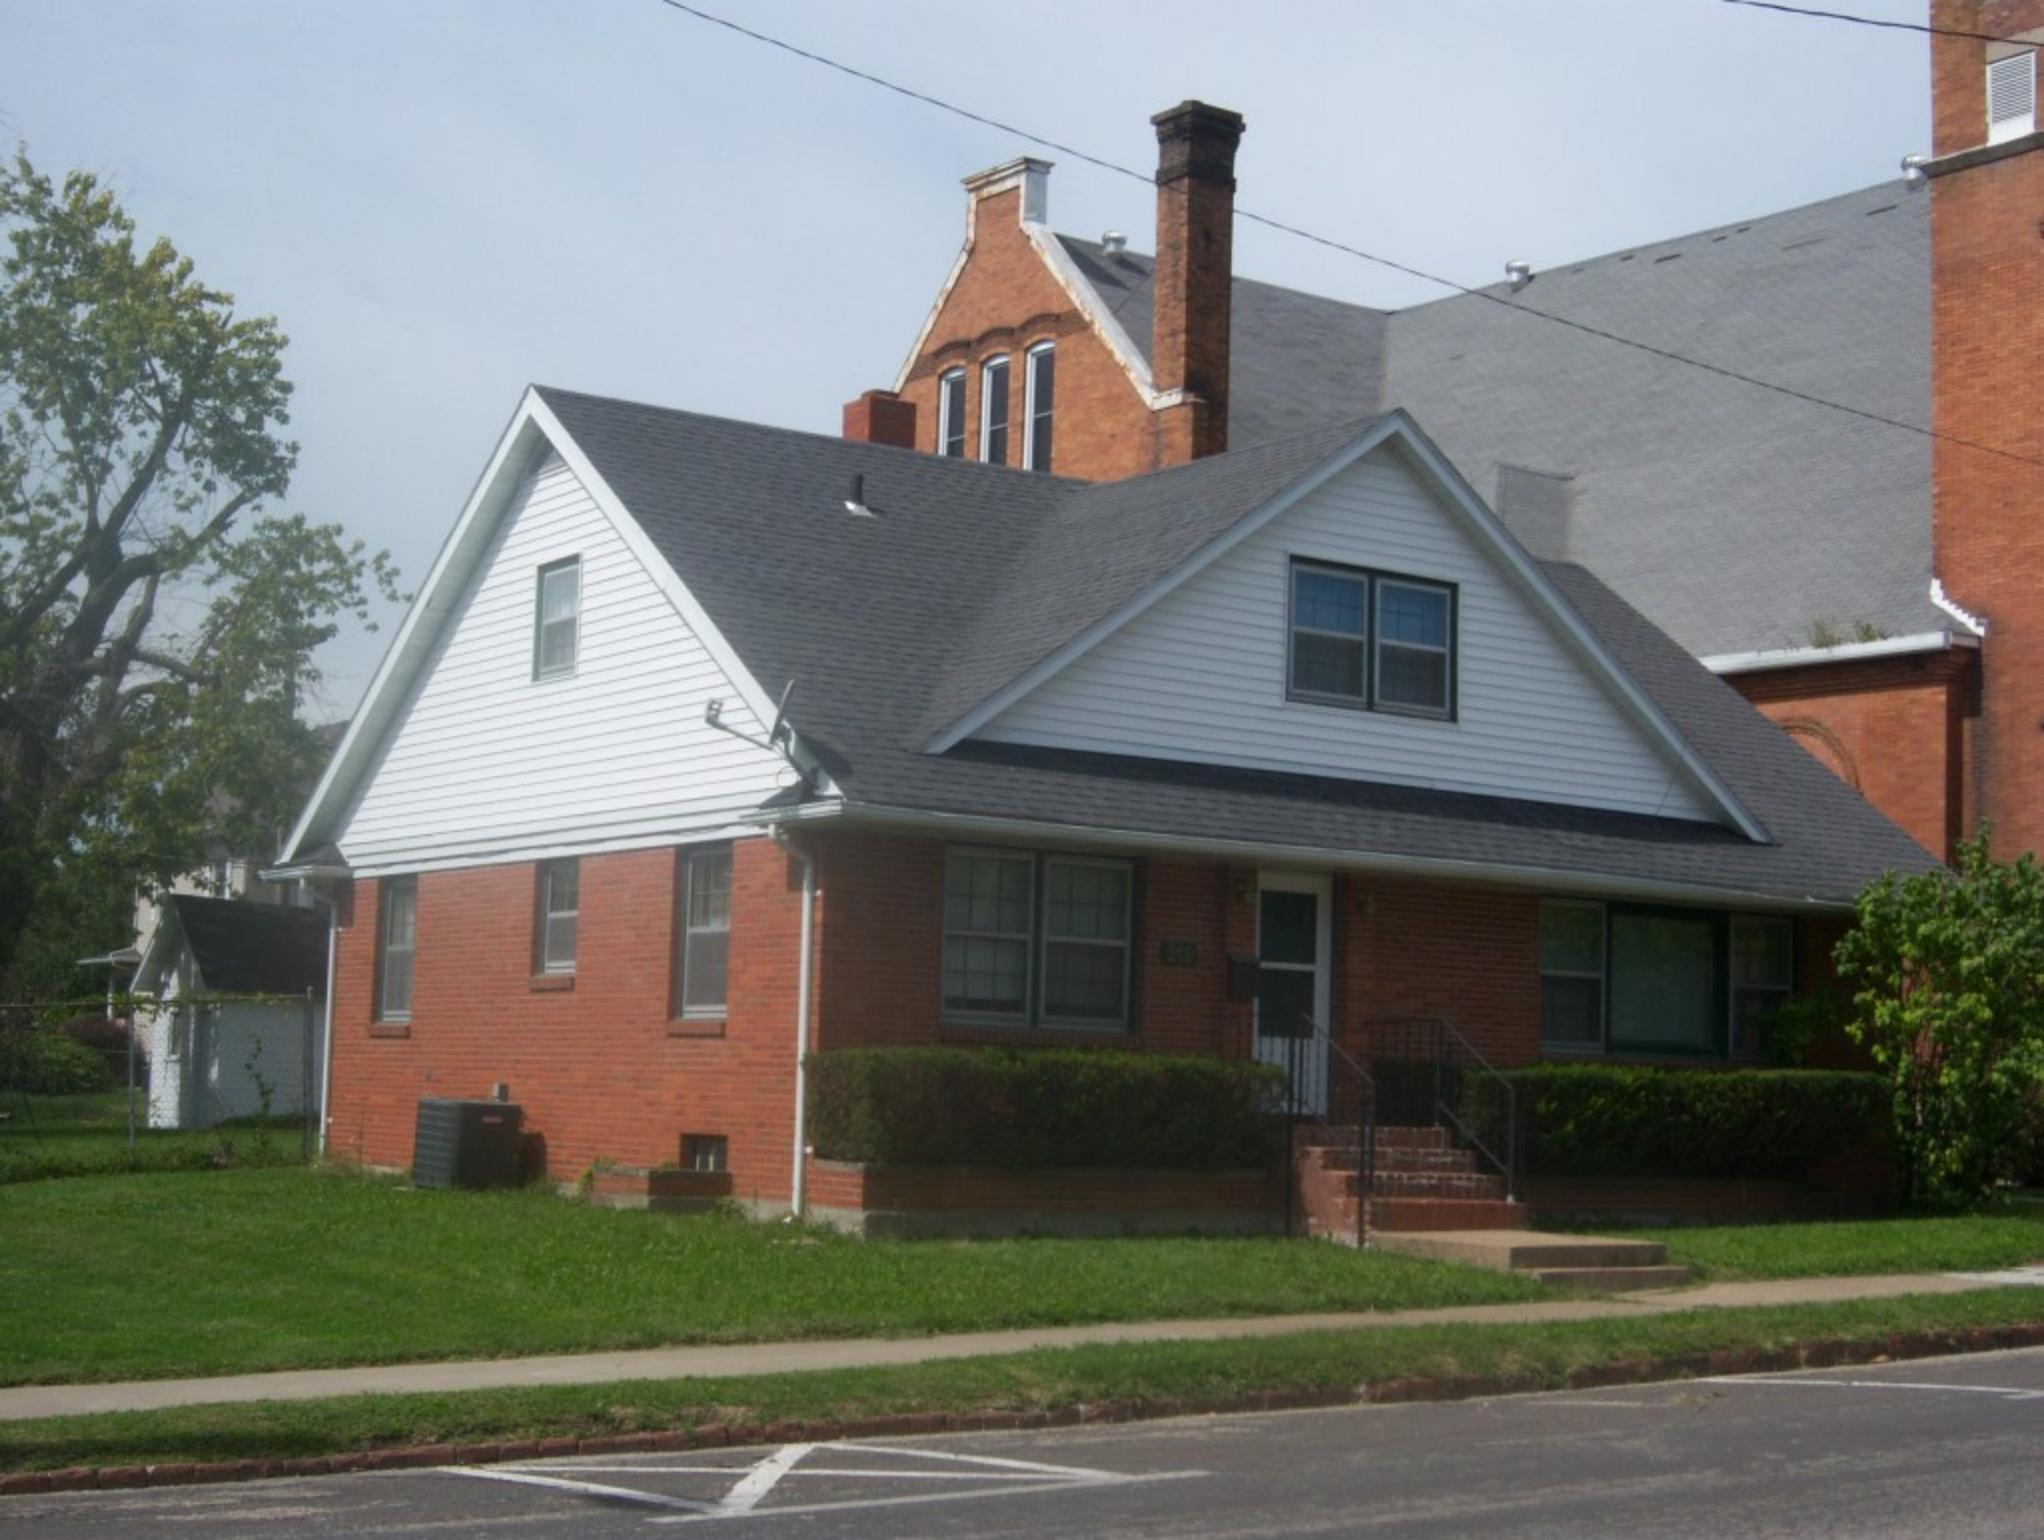
The brick side gable 1 ½ story dwelling consists of rectangular plan, an asphalt roof, and a front gable dormer with paired six-over-six double-hung wood sash windows and sits on a full concrete basement. The façade contains three bays: paired six-over-six double-hung wood sash windows, a front entry projecting out onto a brick stoop with wrought iron balustrade, and a tripartite window with a picture window framed by six-over-six double-hung wood sash windows. Brick walls frame the façade creating space from vegetation. The gable ends contain vinyl siding. The south elevation contains three bays on the first floor and contains a smaller six-over-six double-hung wood sash window flanked by larger six-over-six double-hung wood sash windows. A small six-over-six double-hung wood sash window sits within the side gable. The windows are covered with metal storm windows. A window well sits at the southeastern corner of the dwelling's basement level. A brick interior chimney is located along the rear slope of the dwelling.

The property's status has not been determined due to it being a residence outside a potential commercial historic district. It may be contributing to a residential district, having retained architectural integrity.
