1. Survey No. MC-AS-001-001		2. Survey name: Downtown Macon Commercial Historic District	
3. County: Macon		4. Address (Street No.) Lots 11-13 block 93	Street (name) East Bourke Street (100 block)
5. City: Macon	Vicinity: <input type="checkbox"/>	6. Geographical Reference:	7. Township/Range/Section: T: R: S:
8. Historic name (if known):		9. Present/other name (if known): City of Macon Parking Lot #3	
10. Ownership: <input checked="" type="checkbox"/> Private <input type="checkbox"/> Public		11a. Historic use (if known): Commercial	11b. Current use: vacant

42. Current owner/address: City of Macon Macon, MO 63552	43. Form prepared by (name and org.): Kristi Chase MO SHPO	44. Survey date: 9/24/2014
		45. Date of revisions:

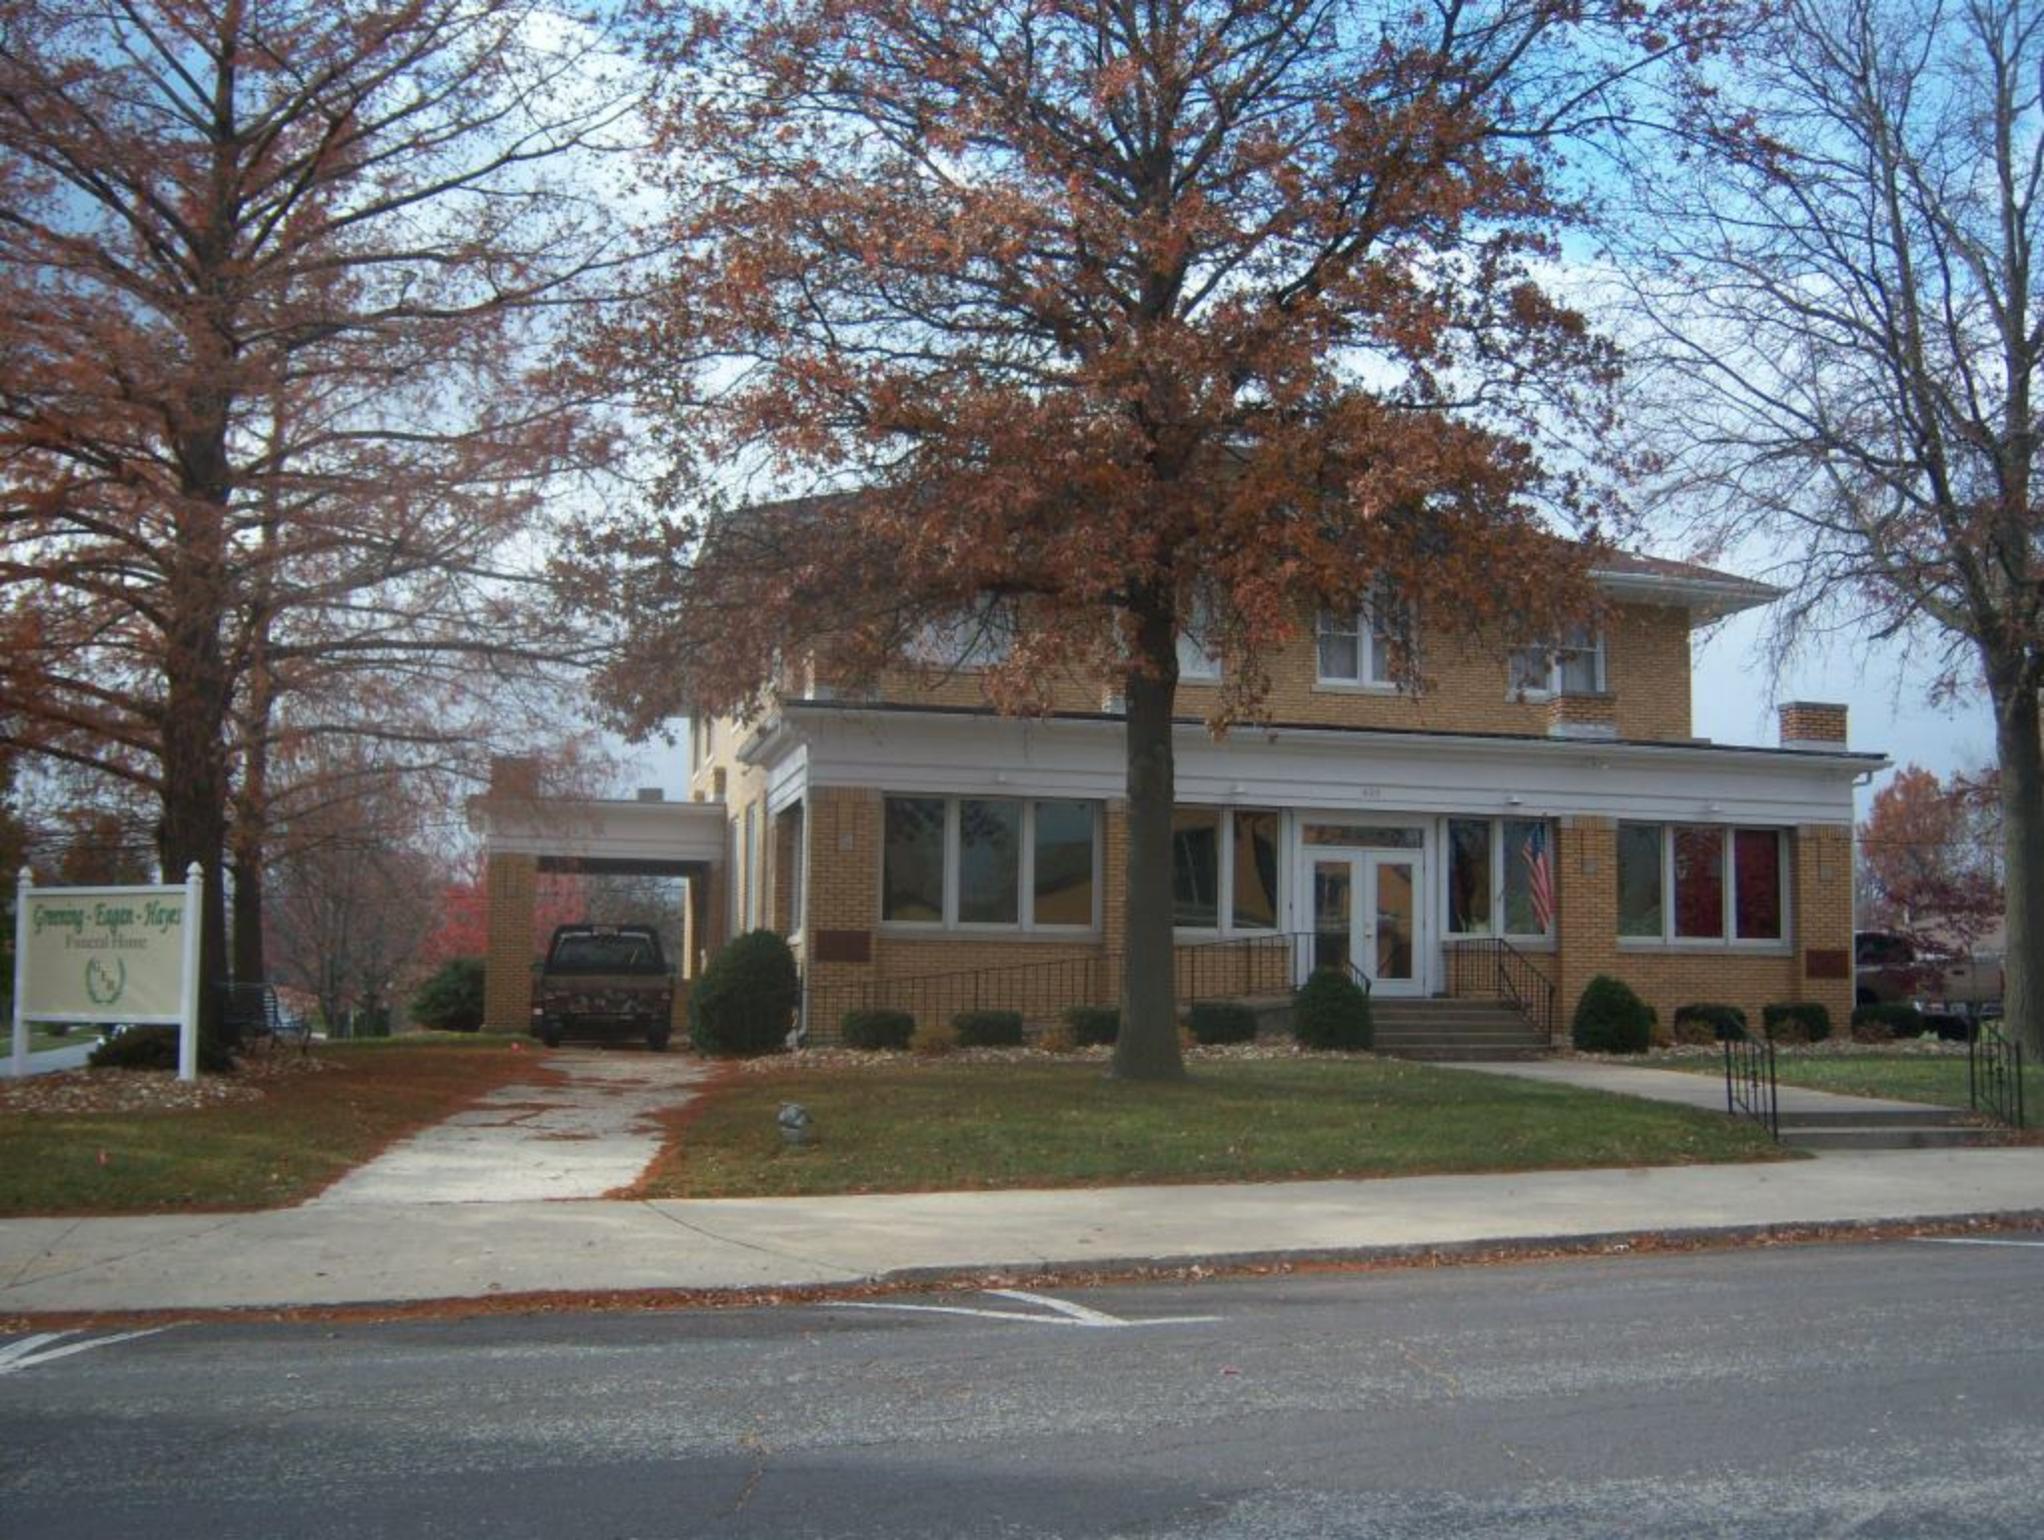
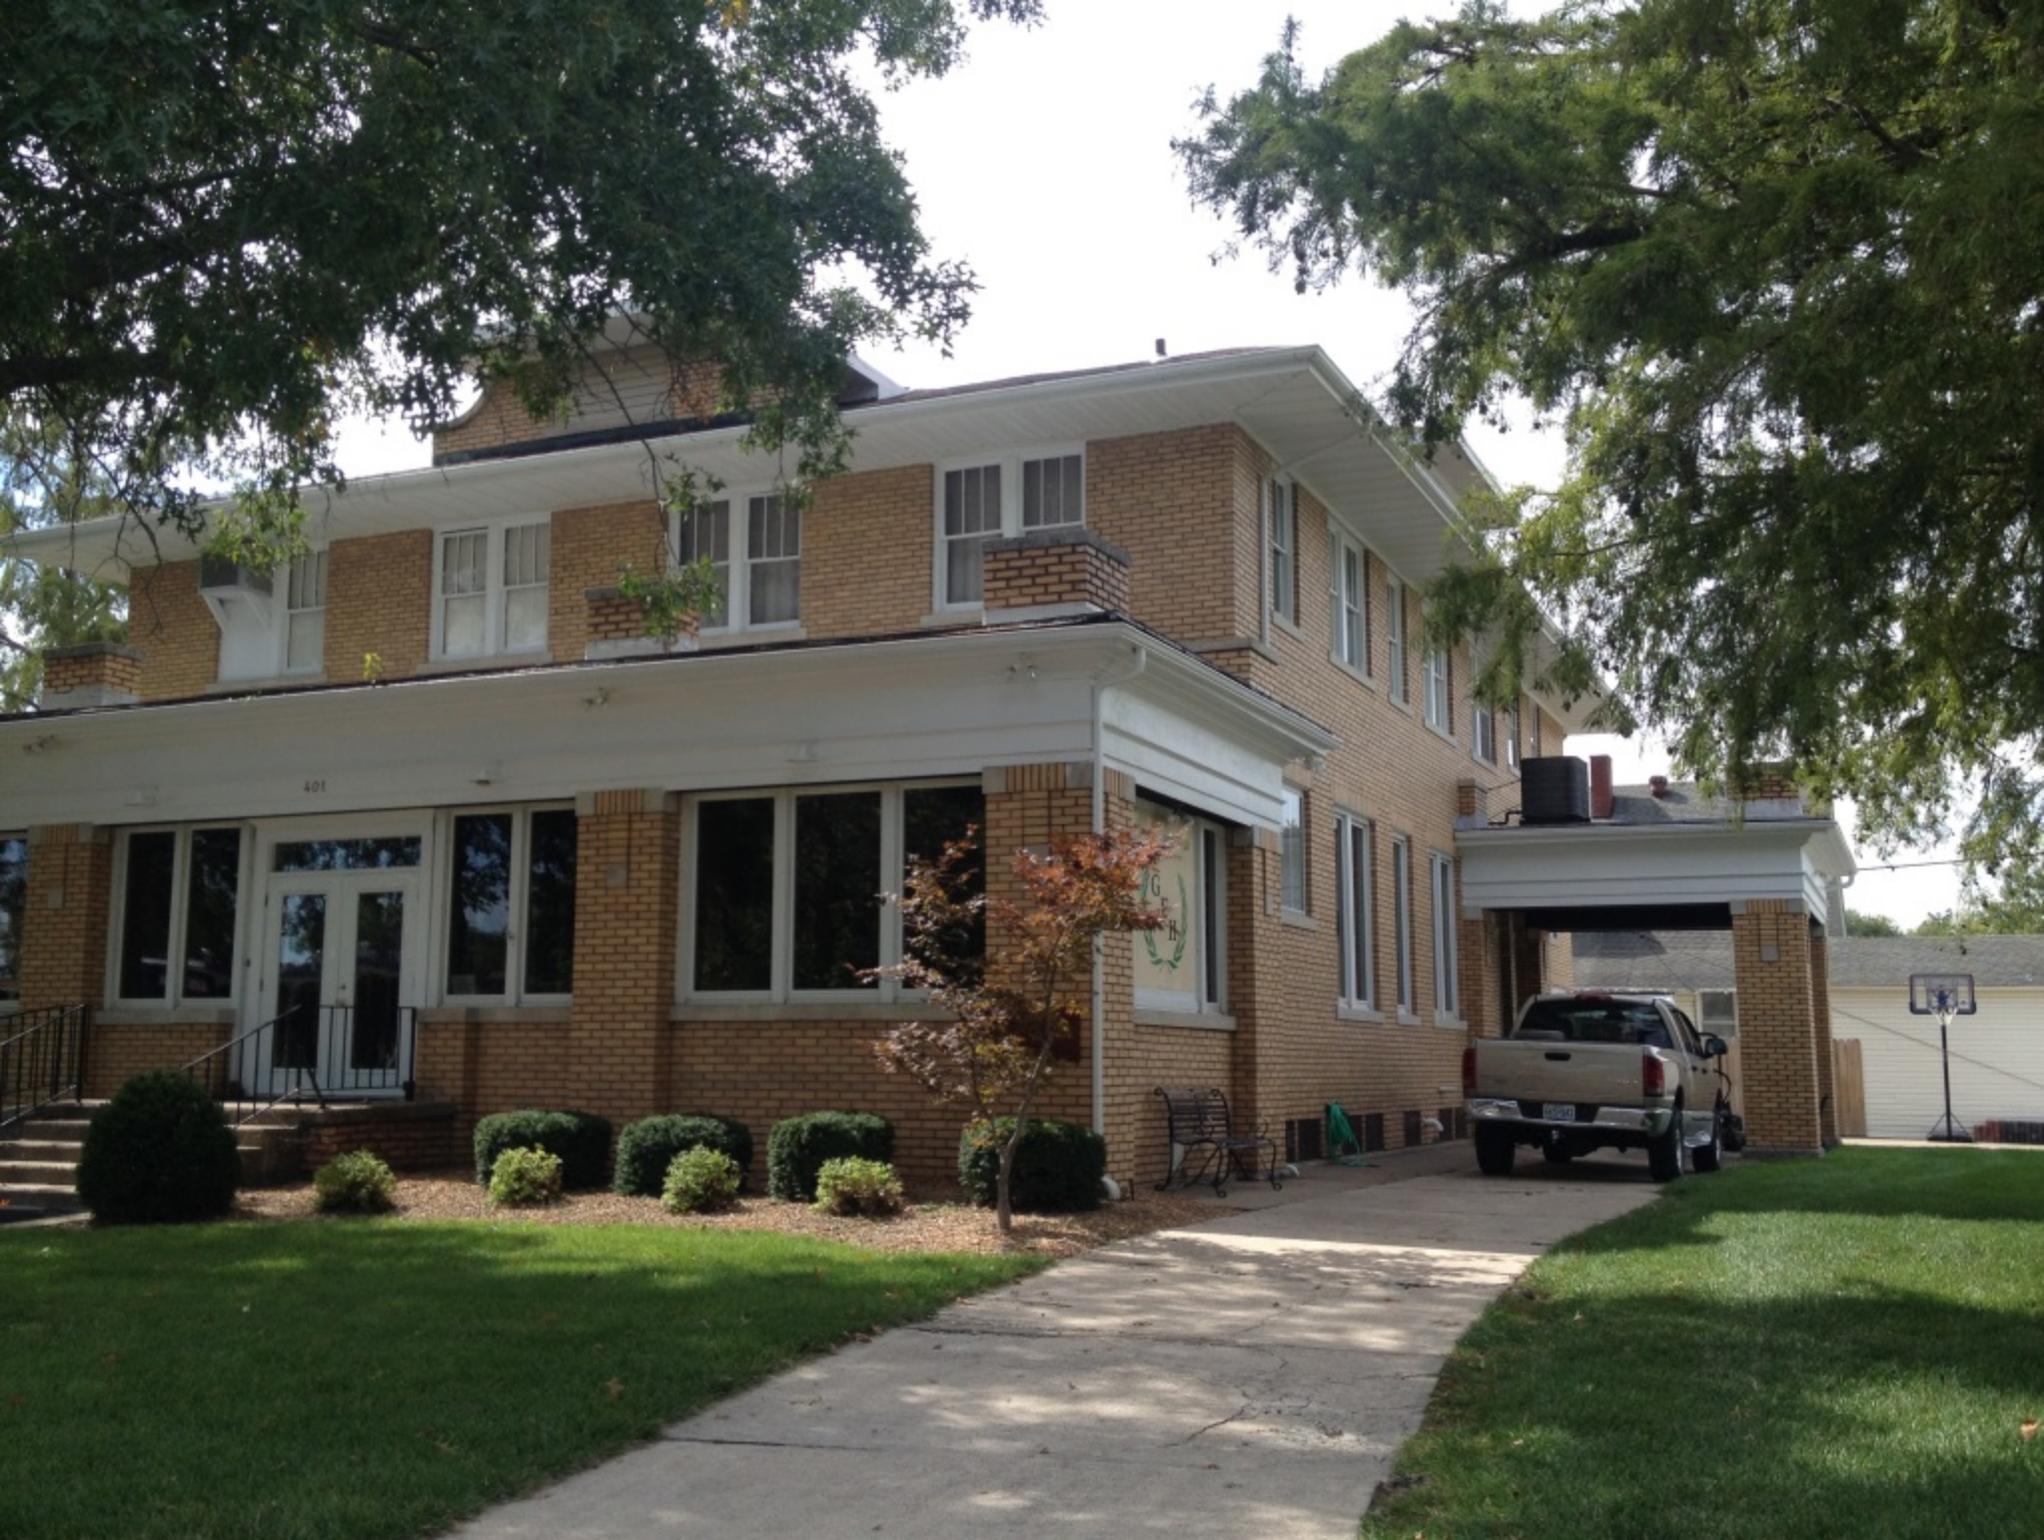
Greening - Egan - Hayes
Funeral Home

The Prairie styled tan brick 2 ½ story building is rectangular in shape and contains a low-hipped asphalt roof with a bell-shaped hipped dormer. The first floor includes a full-width enclosed porch with three bays and wide plain architrave. The first bay (left) includes three fixed panes bounded by brick columns. The second bay includes a center entry of double vinyl and glass doors below a transom and is flanked on either side by two fixed panes bounded by brick columns. Concrete steps with an ADA ramp and metal rail project eastward from the entry. The third bay is identical to the first bay. Metal signs are located at the corner columns of the façade

The building appears to have largely remained intact according to a 1963 photograph. The first floor windows have been changed and the porch roof had Chinese railing between the balusters. The property may be individually eligible as a funeral home under Criterion A. Due to its location, the property is not applicable to a potential historic commercial district.

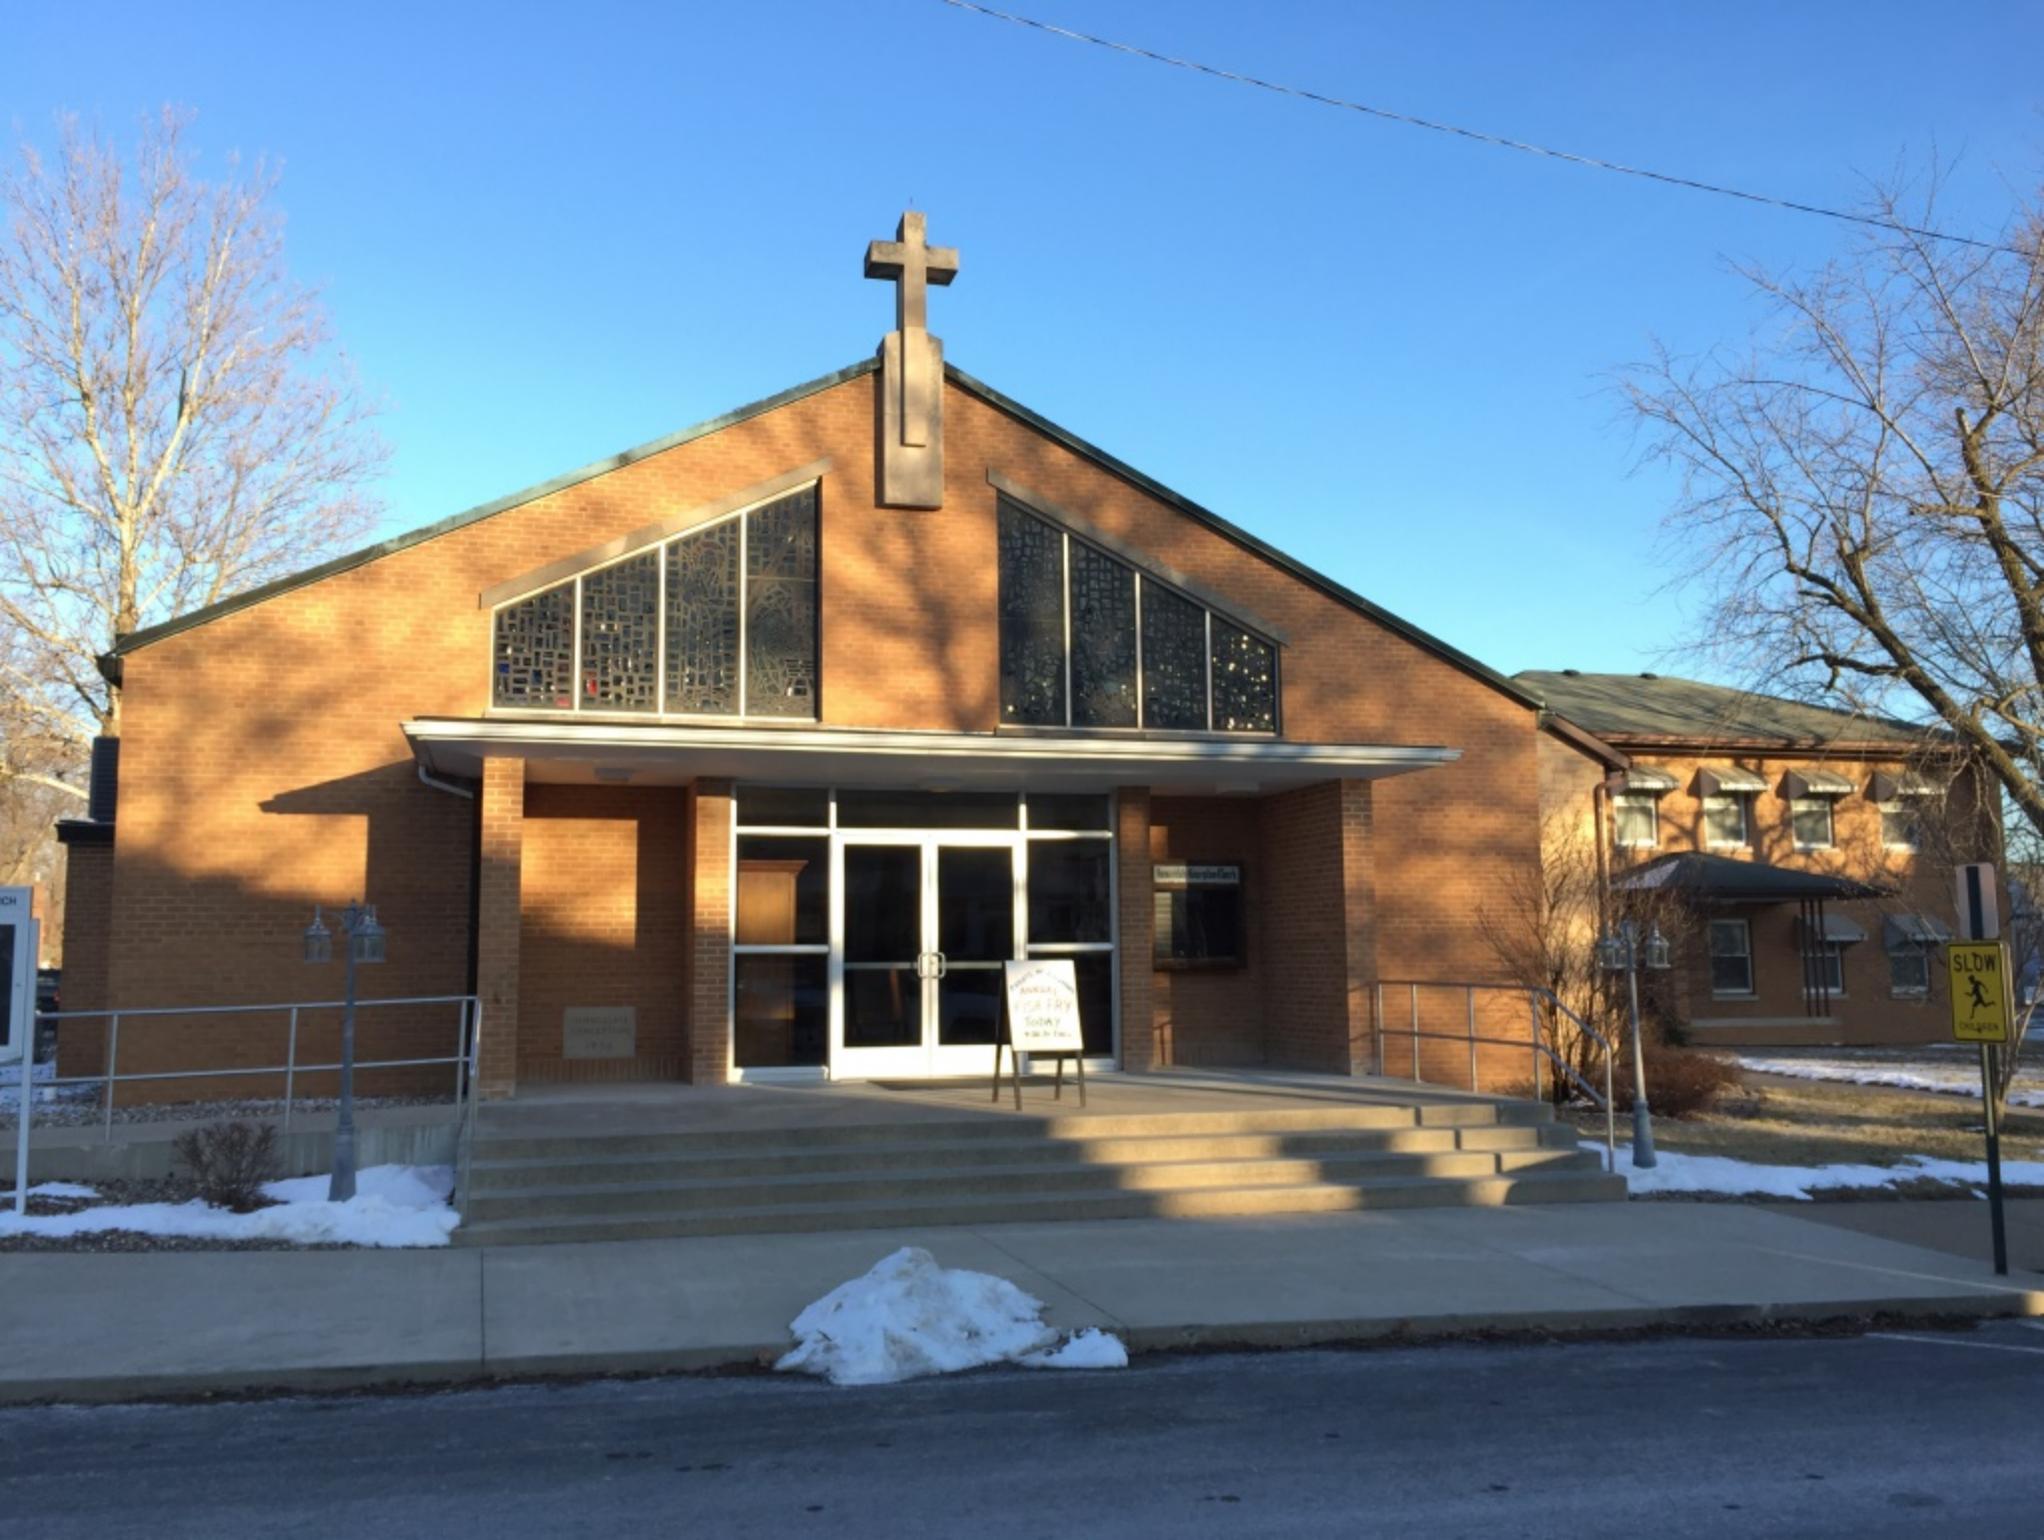
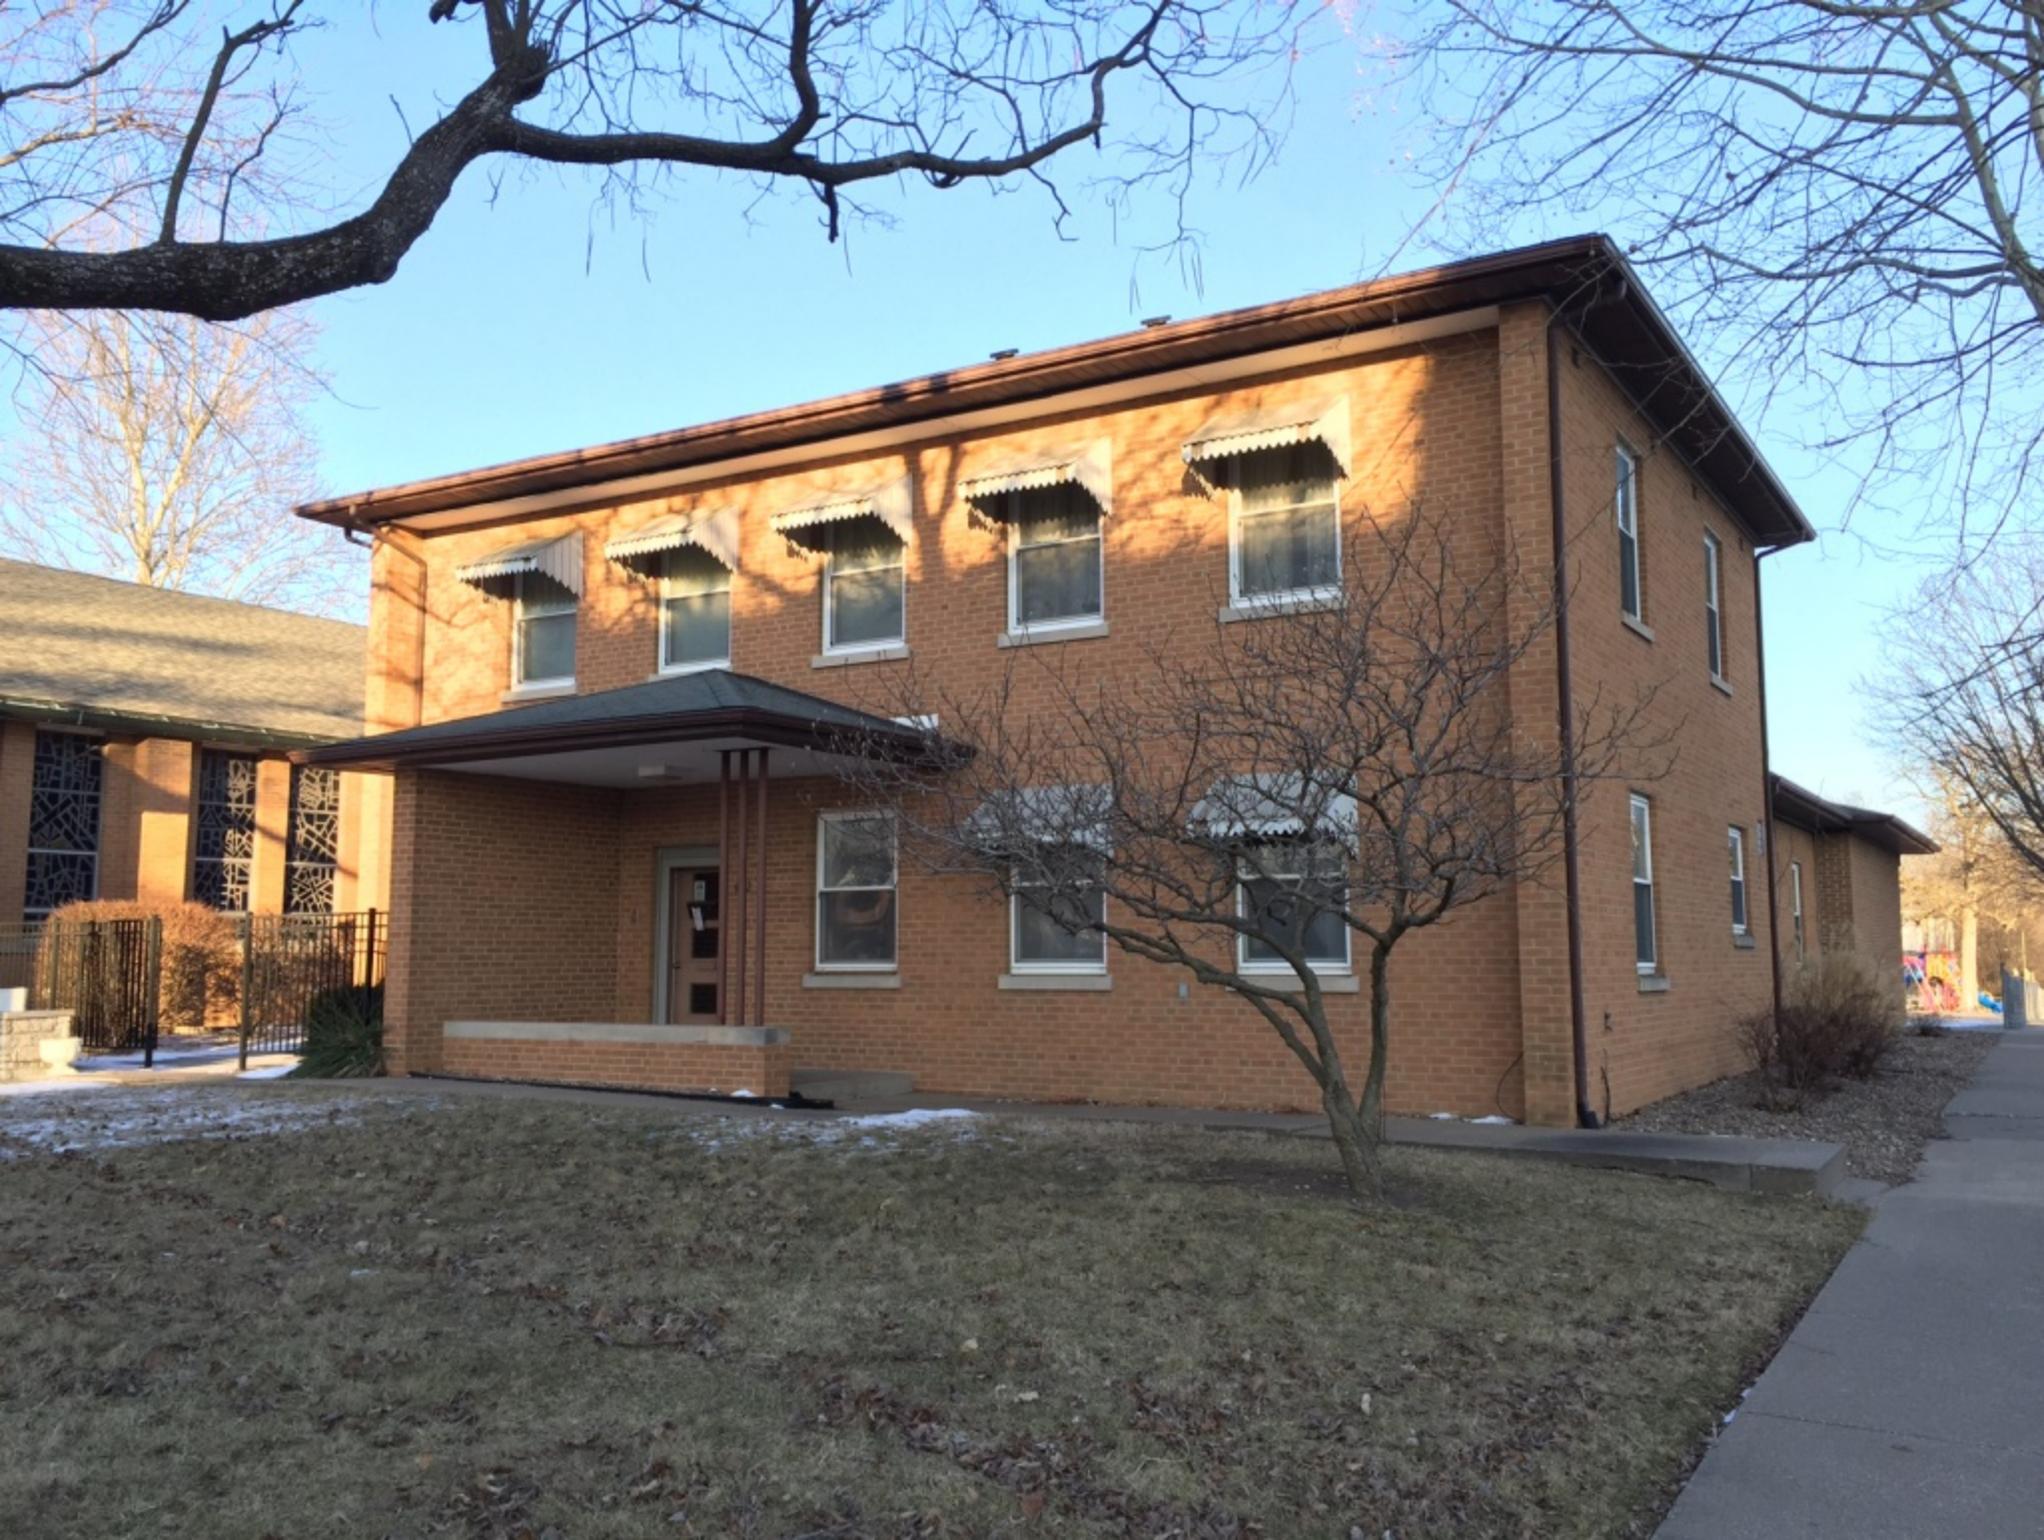
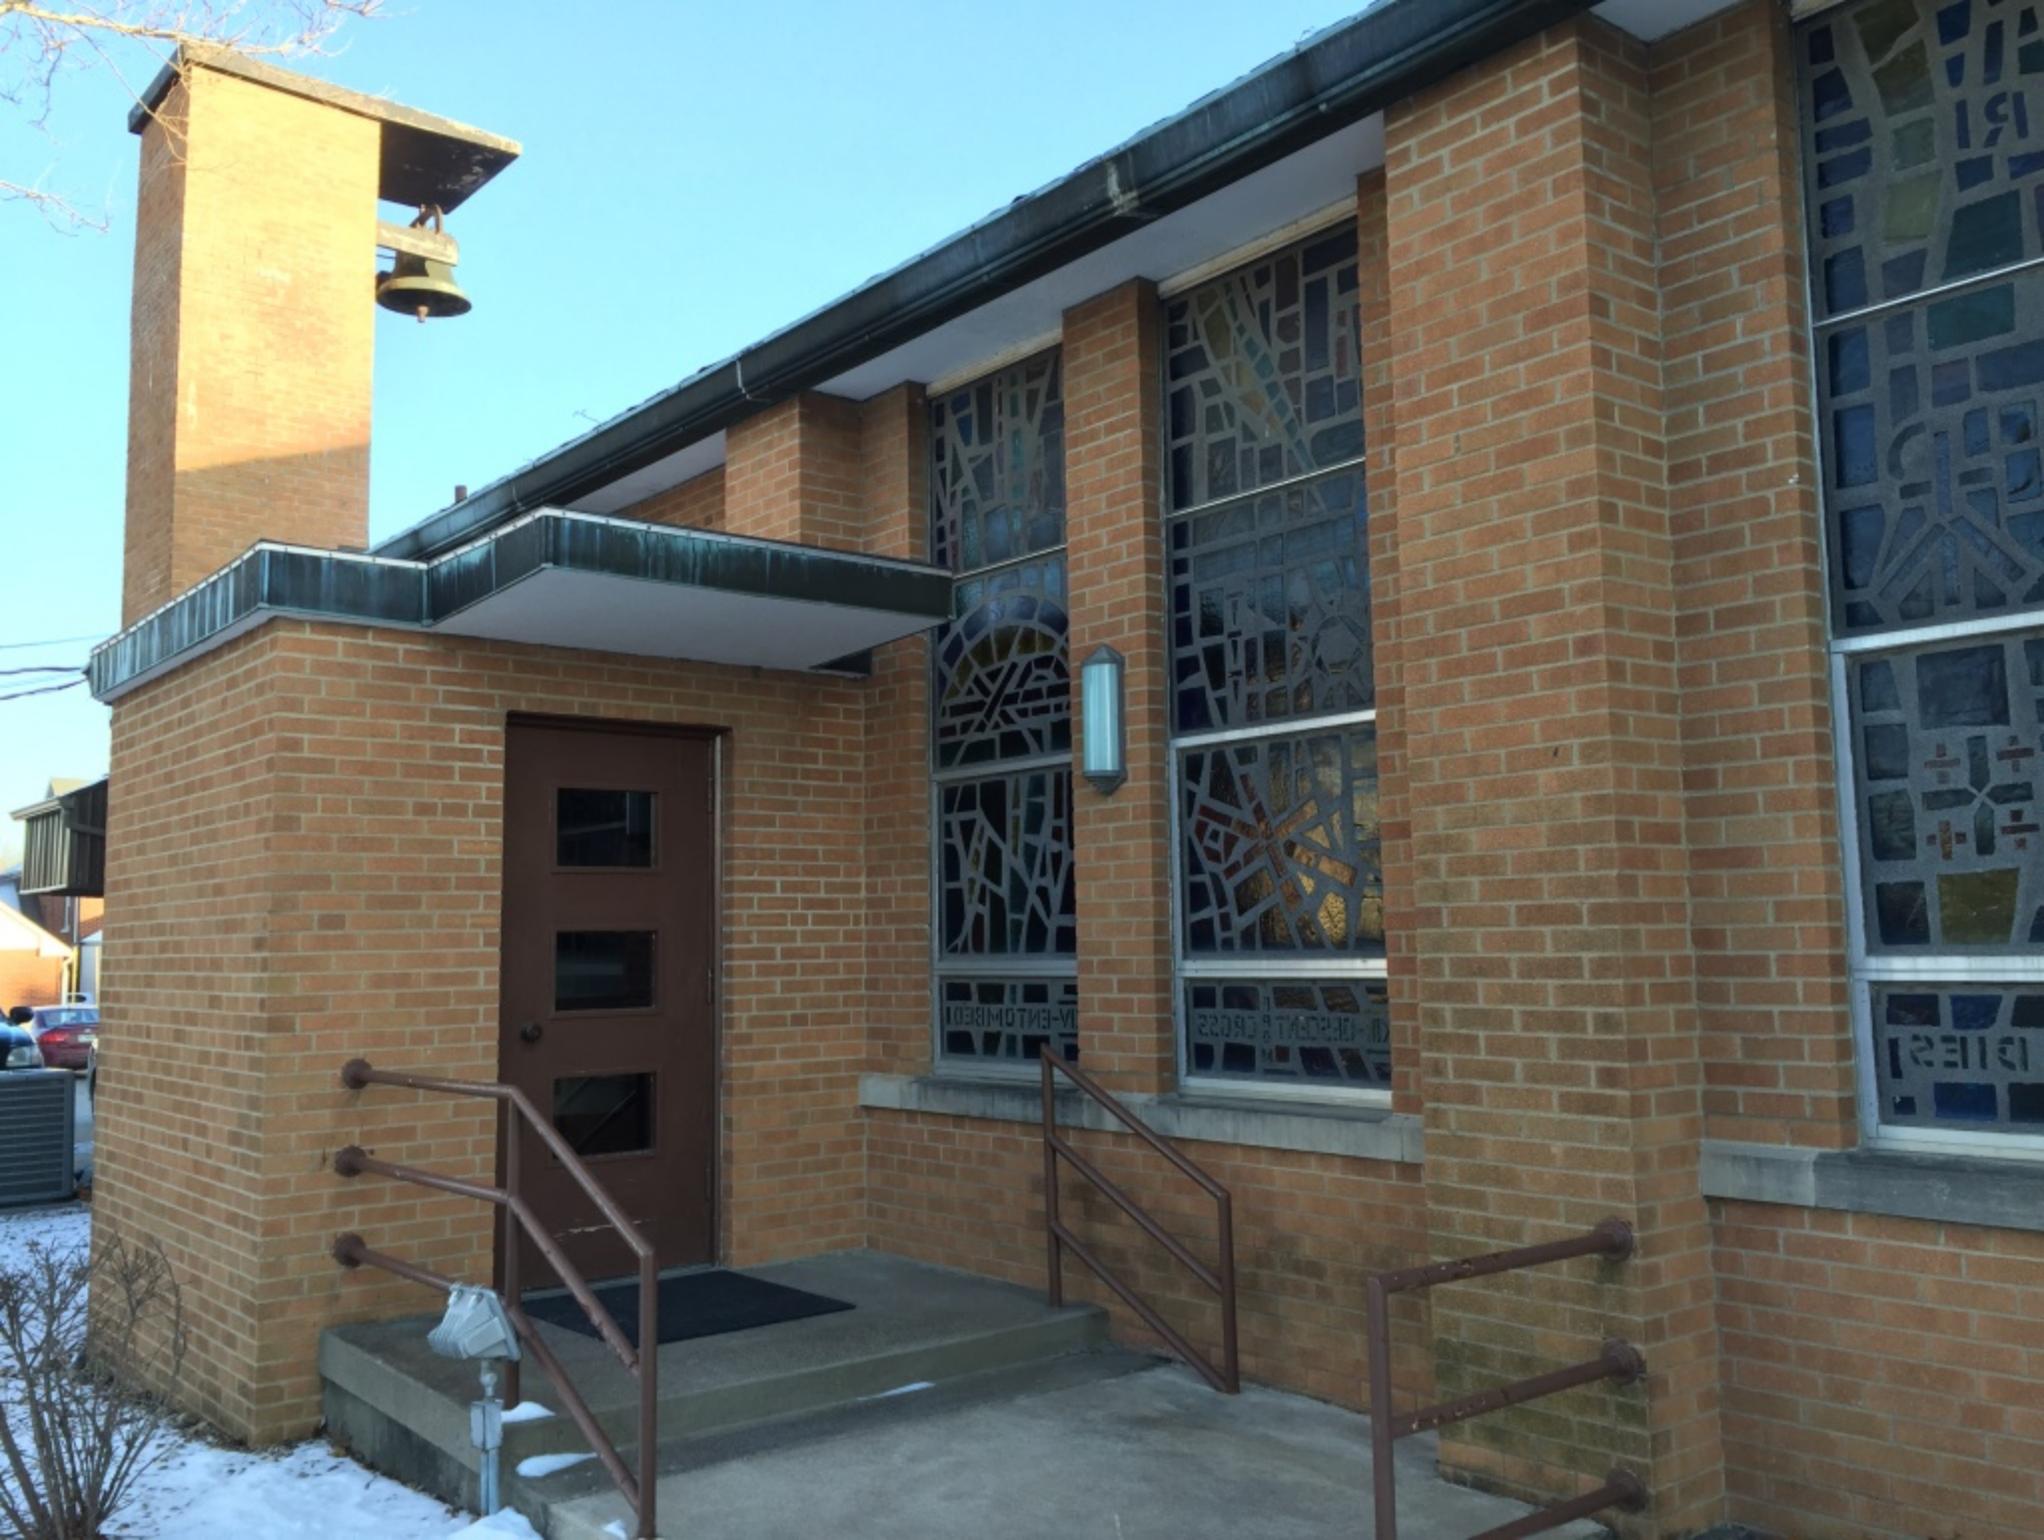
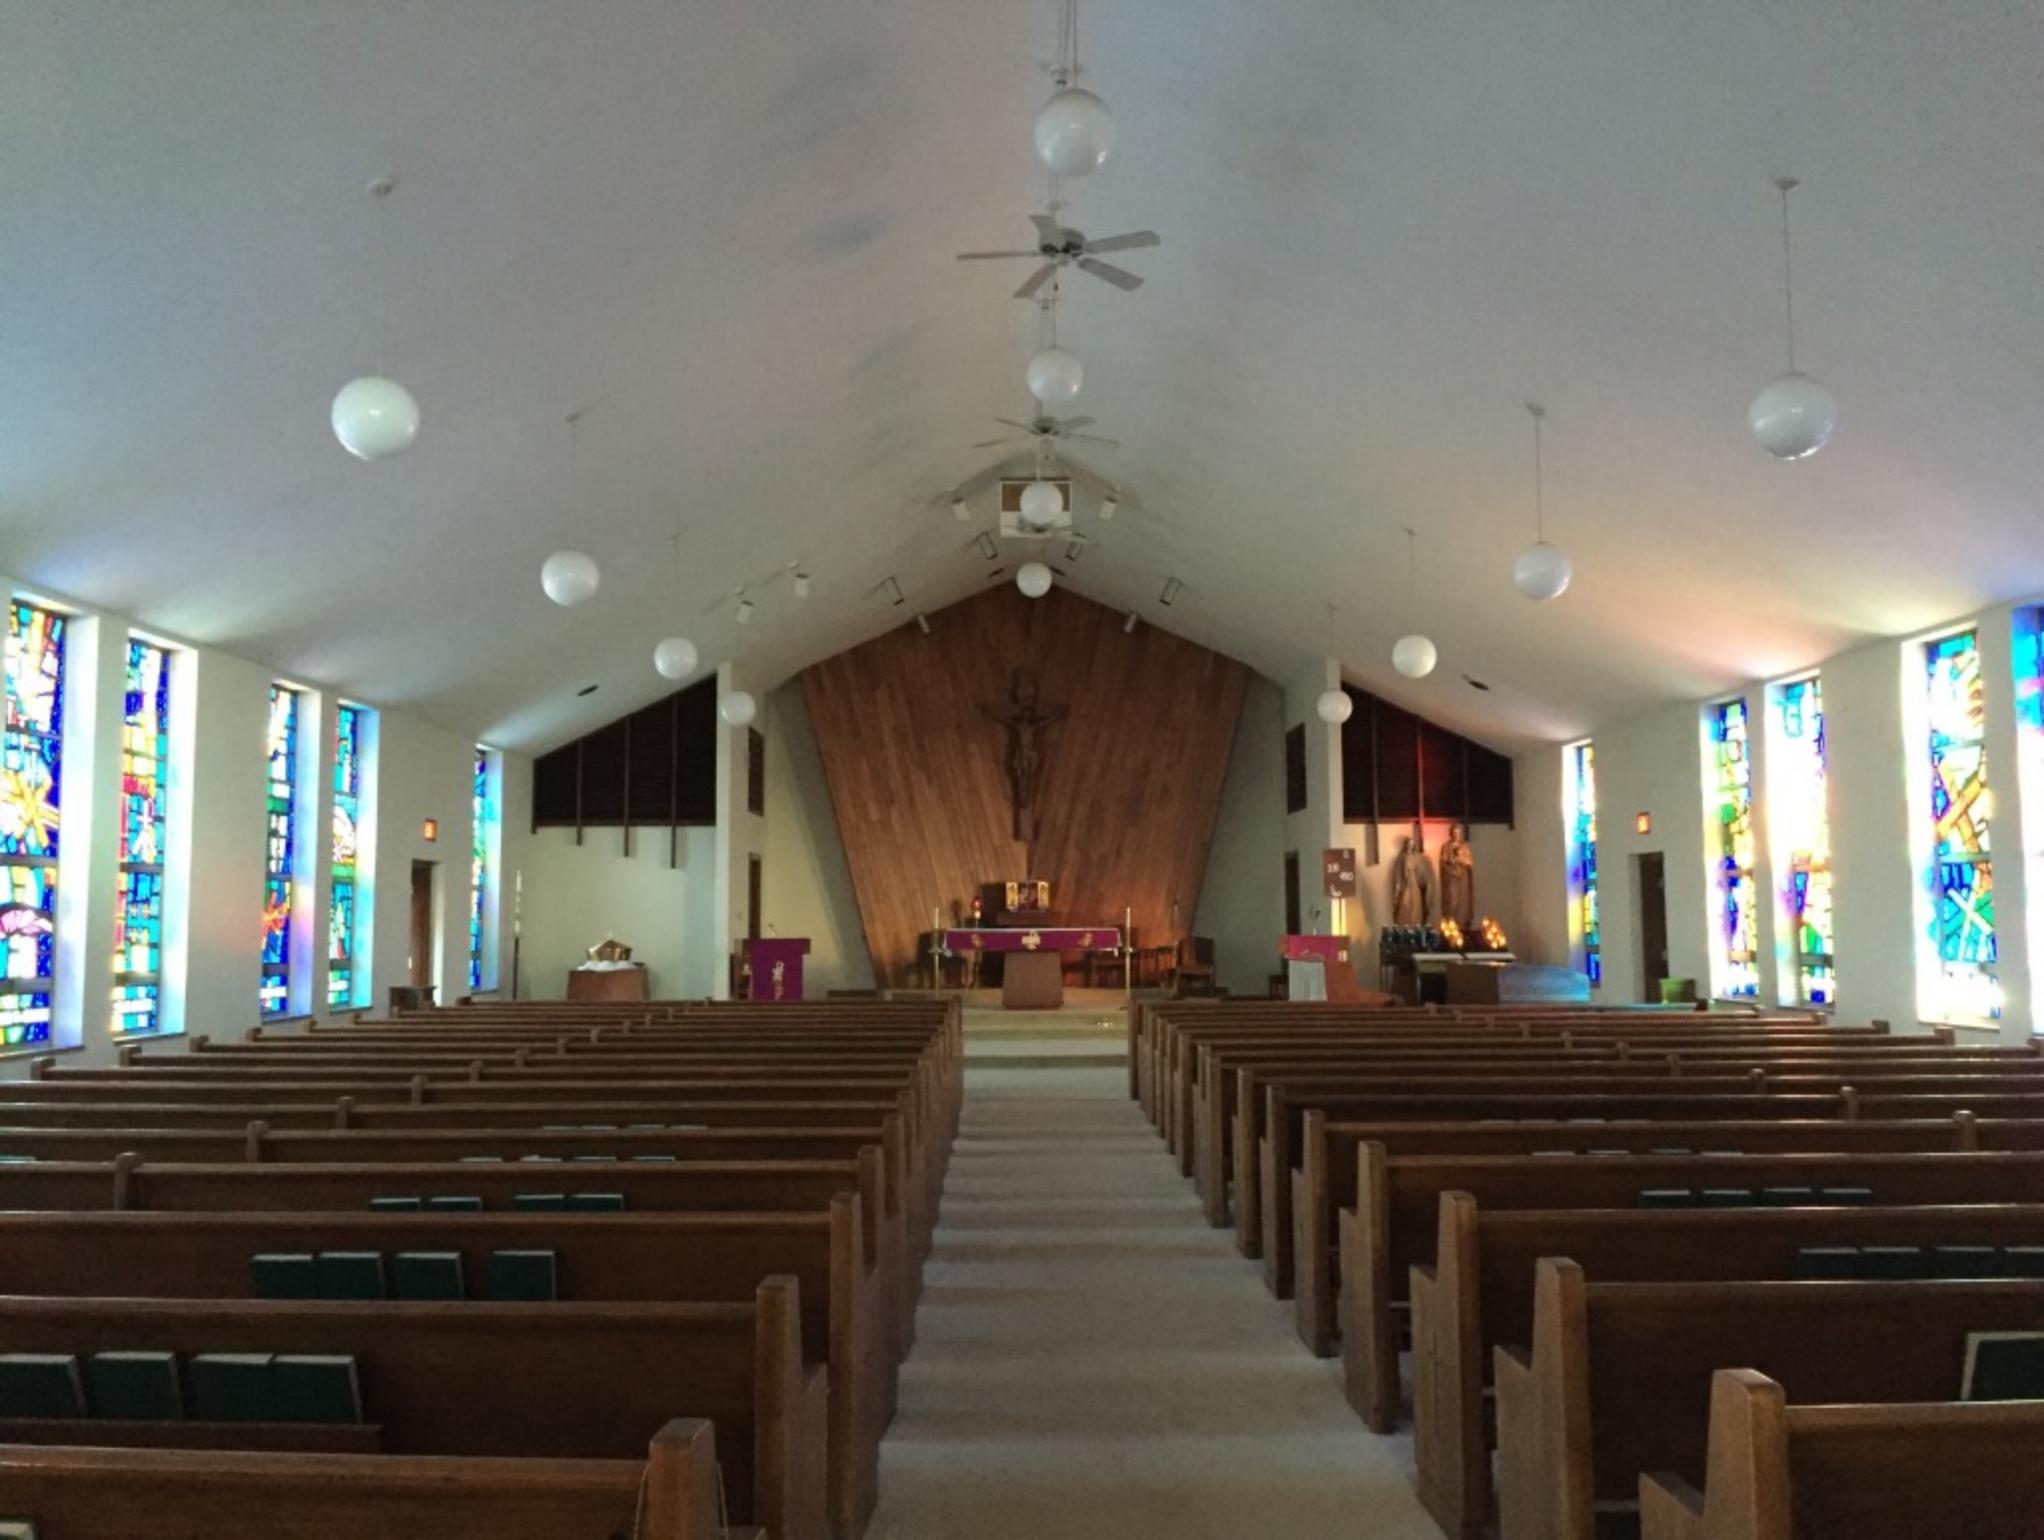
This rectangular Modern Movement church has its short end, and primary façade, facing N. Rollins Street. The church is front gabled with a concrete cross at the peak. Three bays organize the entrance; the central bay is comprised of aluminum and glass entry doors with sidelights and transoms. The entrance is accessed via a concrete stoop with an accessibility ramp and brick kneewalls. A flat awning shelters the entrance. Two trapezoidal stained glass windows, each with four lights, are located above the entrance. Pairs of stained glass windows are also visible on the north elevation.

Tax assessor records and a newspaper article indicate that the church and parsonage were constructed in 1956. The church and parsonage retain architectural integrity and may or may not contribute to a National Register historic district depending on the period and area of significance. The church could potentially be individually eligible as an excellent local example of a Modern Movement church.

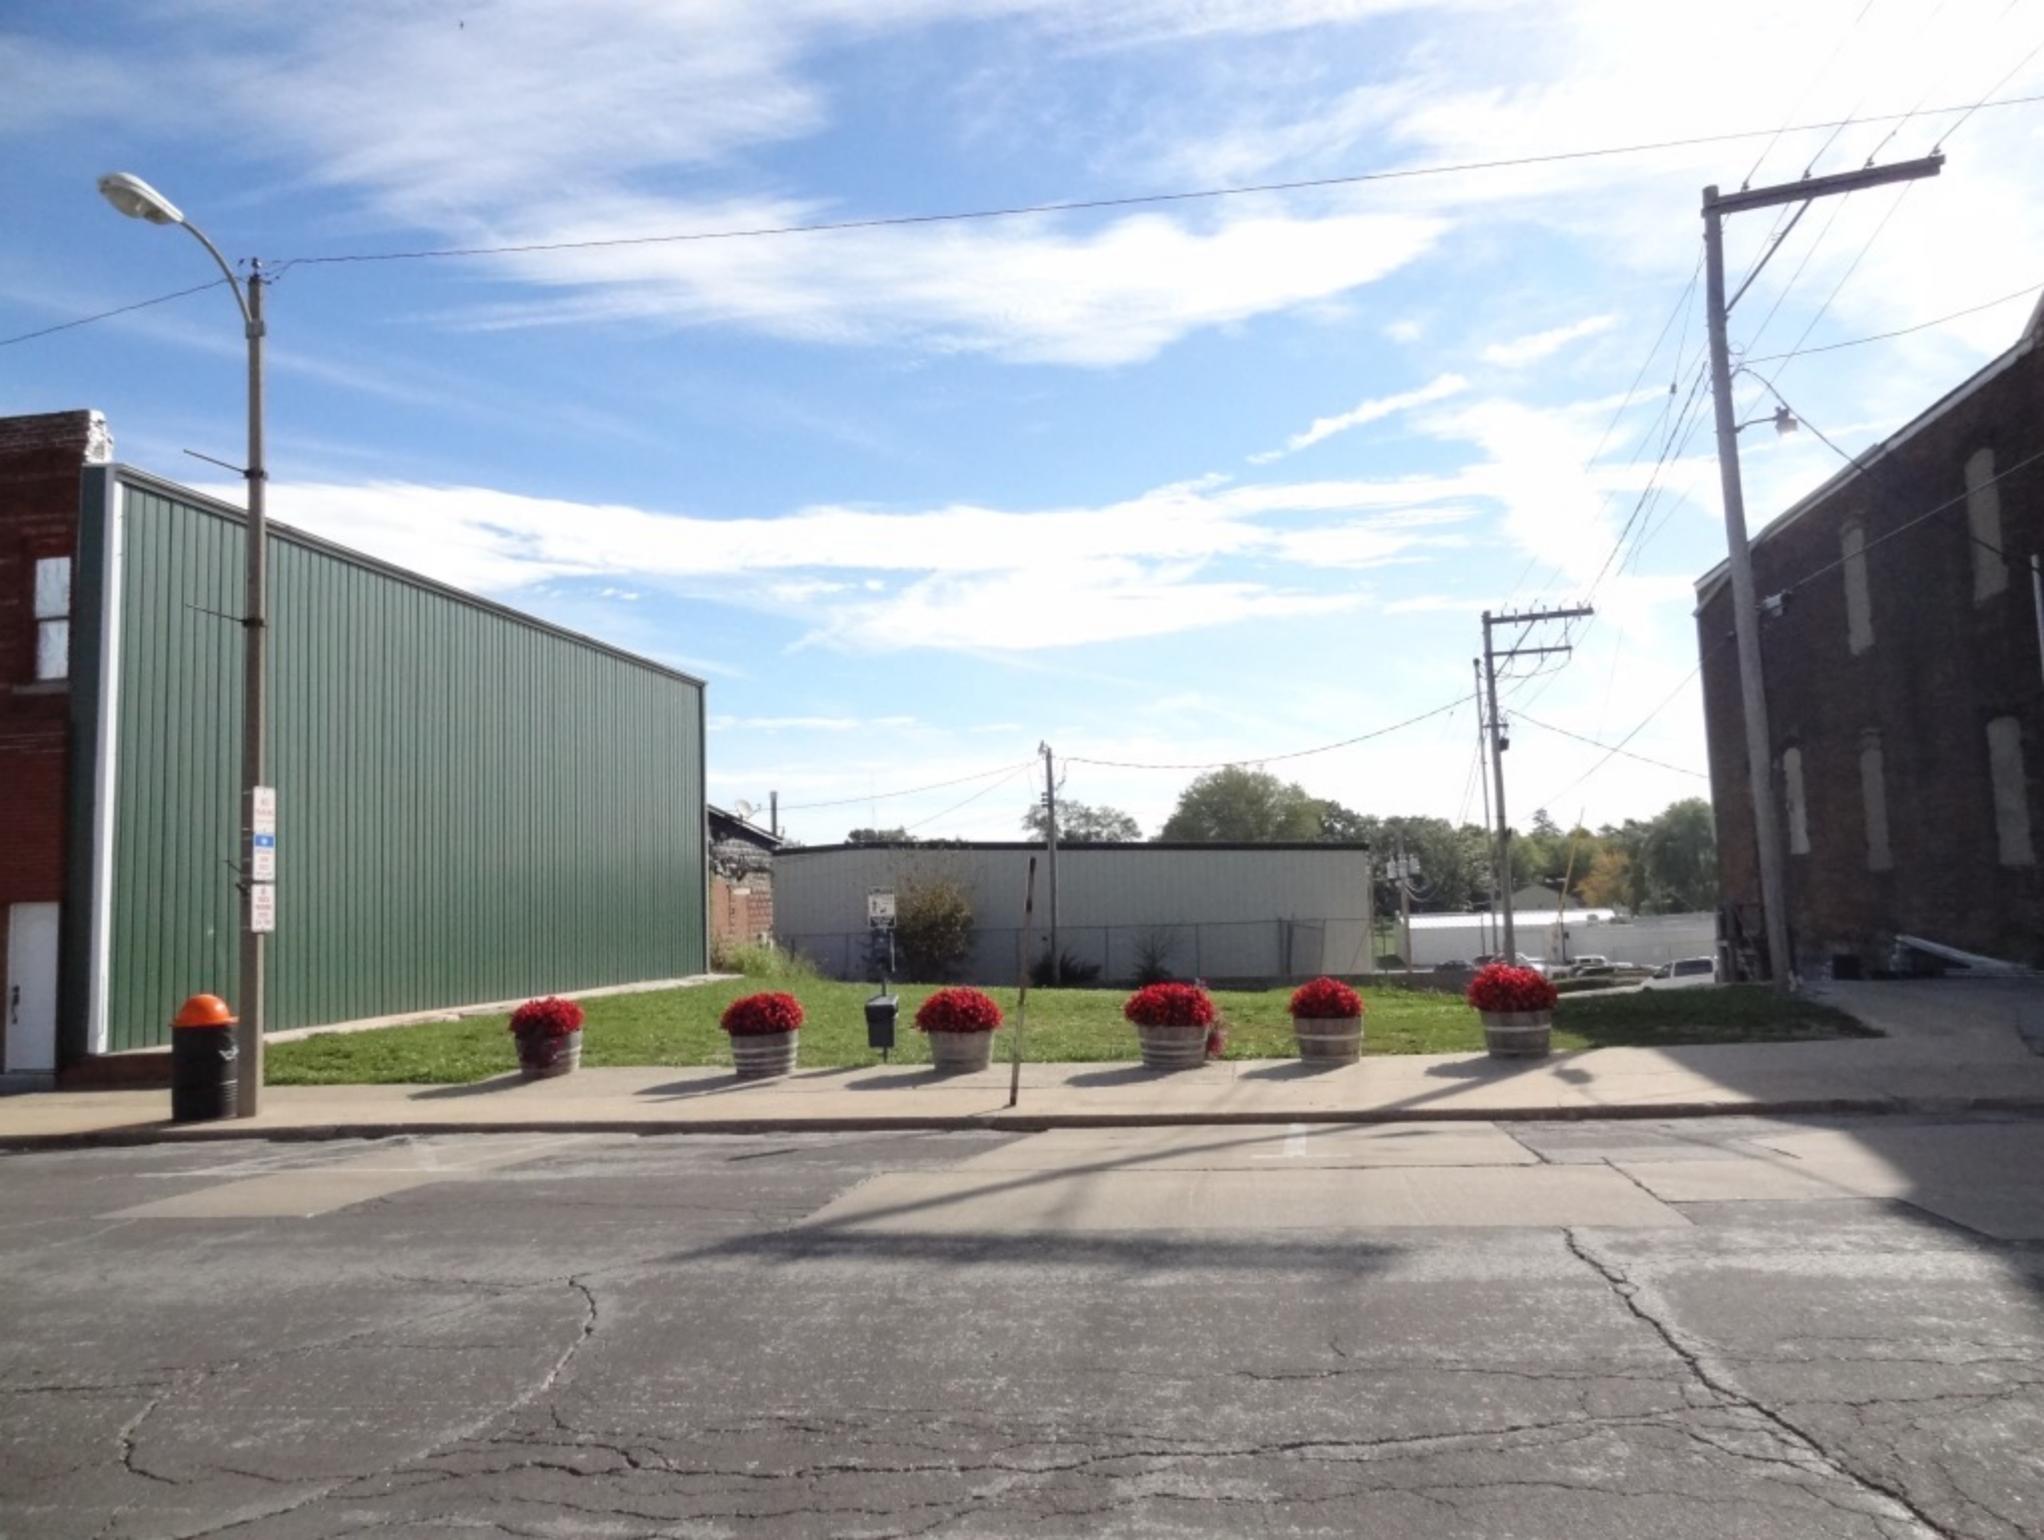
The lot is currently vacant and appears to have had a one-story brick building constructed c. 1916 to hold a marble shop.

The lot has lost its integrity and is located outside a potential historic commercial district, rendering it not eligible.
