1. Survey No. MC-AS-001-001		2. Survey name: Downtown Macon Commercial Historic District	
3. County: Macon		4. Address (Street No.) Lots 11-13 block 93	Street (name) East Bourke Street (100 block)
5. City: Macon	Vicinity: <input type="checkbox"/>	6. Geographical Reference:	7. Township/Range/Section: T: R: S:
8. Historic name (if known):		9. Present/other name (if known): City of Macon Parking Lot #3	
10. Ownership: <input checked="" type="checkbox"/> Private <input type="checkbox"/> Public		11a. Historic use (if known): Commercial	11b. Current use: vacant

42. Current owner/address: City of Macon Macon, MO 63552	43. Form prepared by (name and org.): Kristi Chase MO SHPO	44. Survey date: 9/24/2014
		45. Date of revisions:

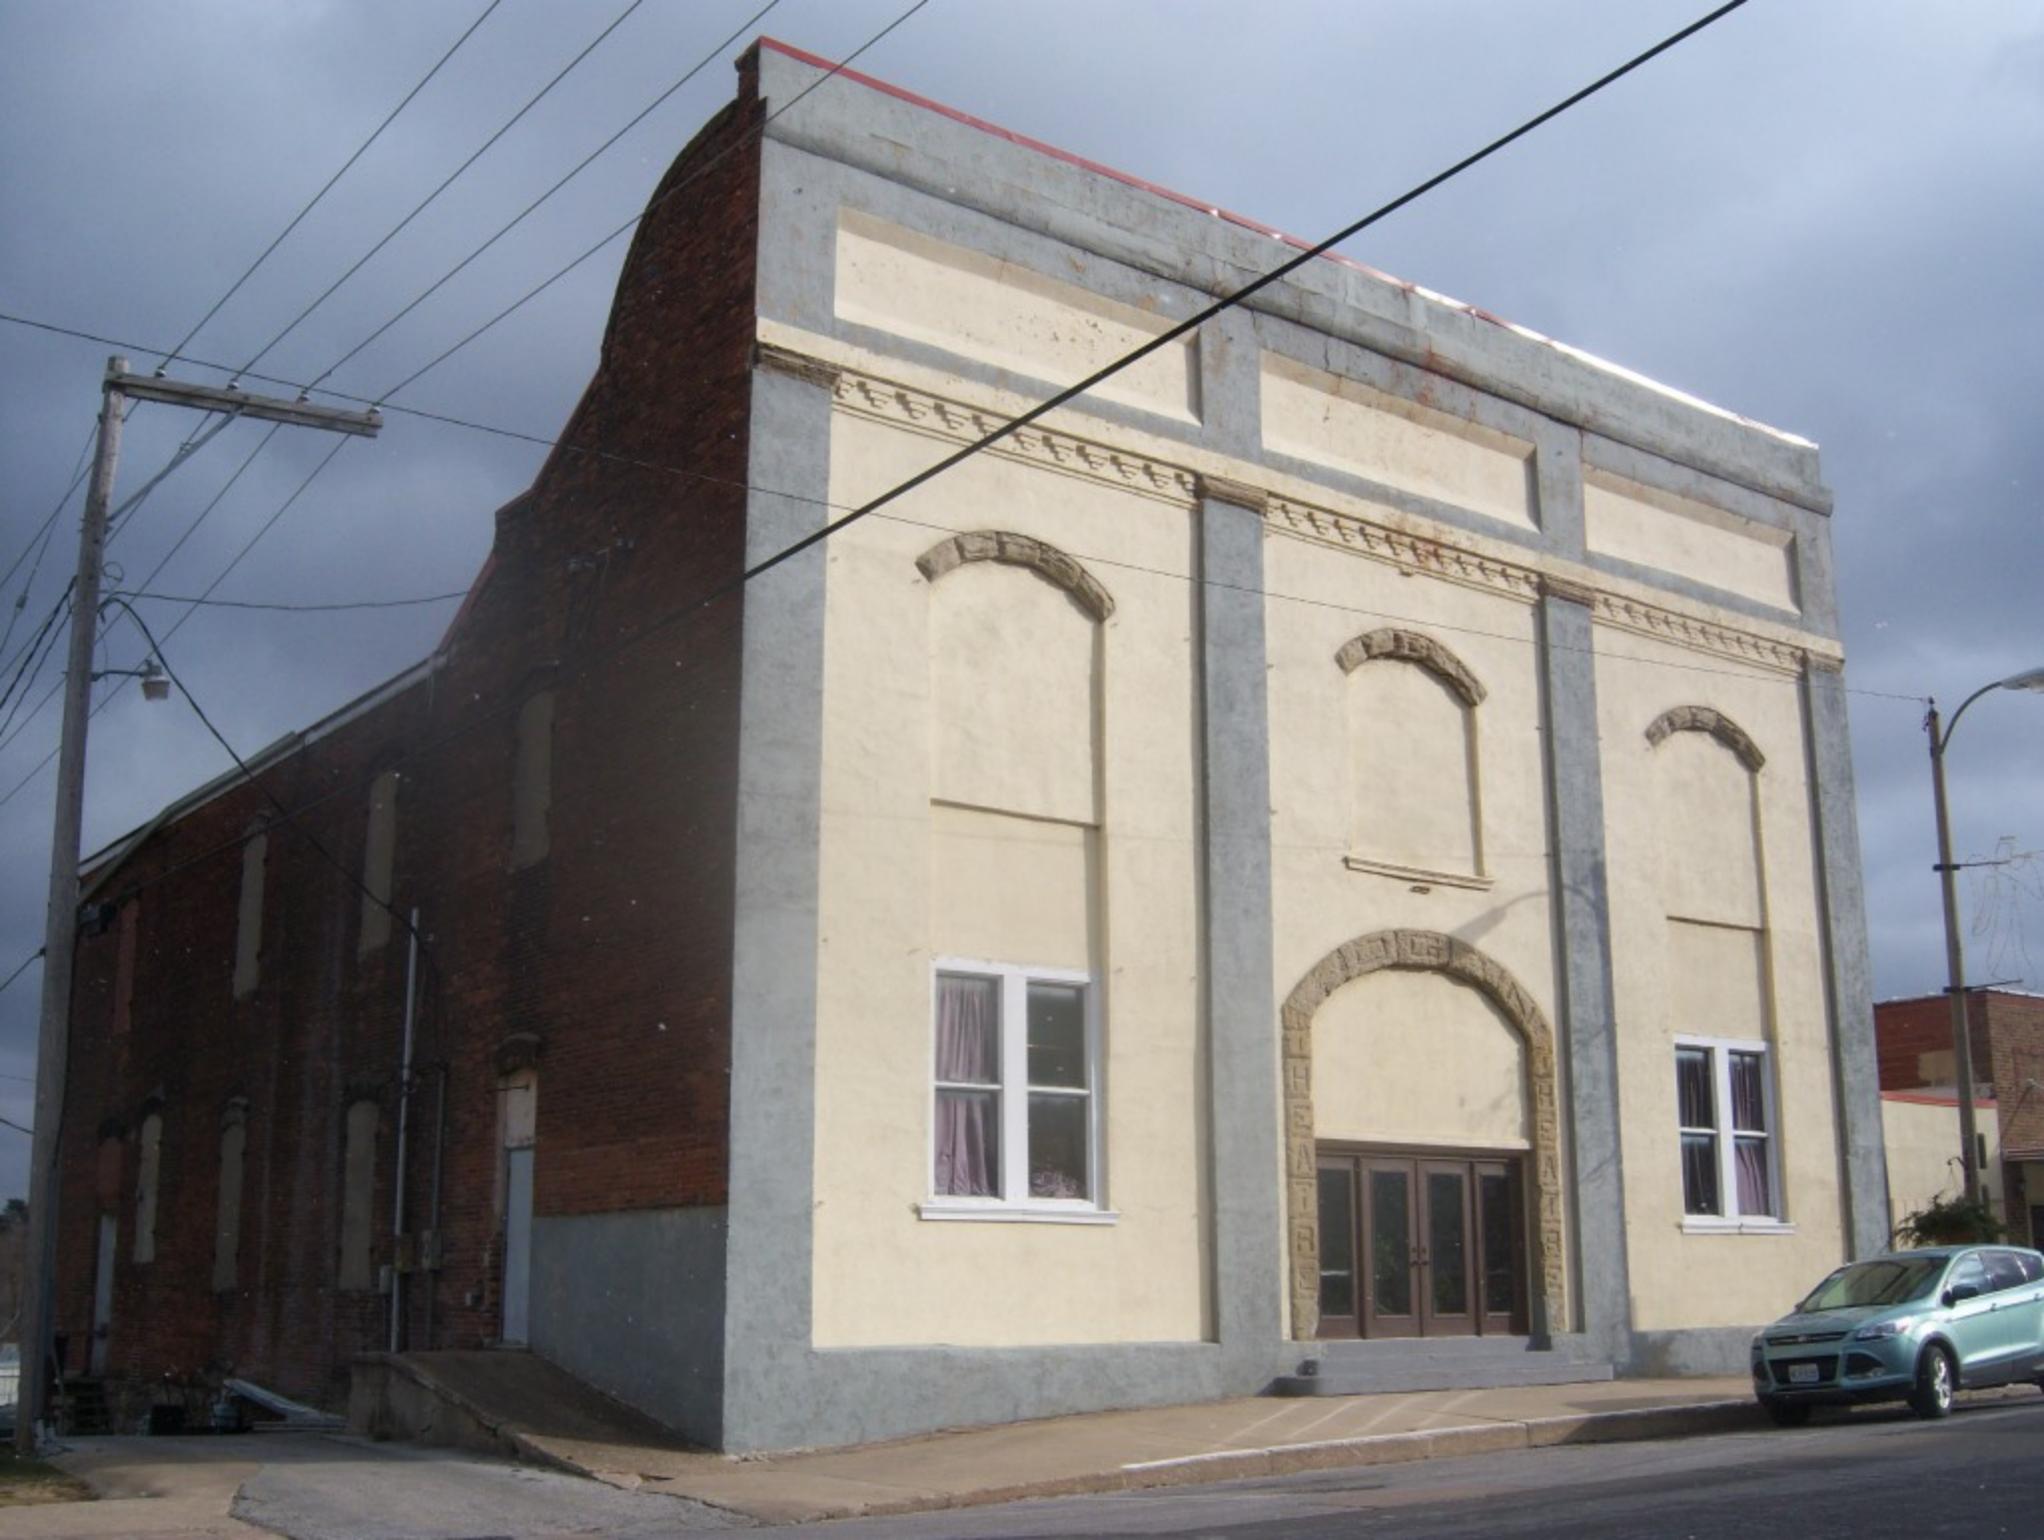
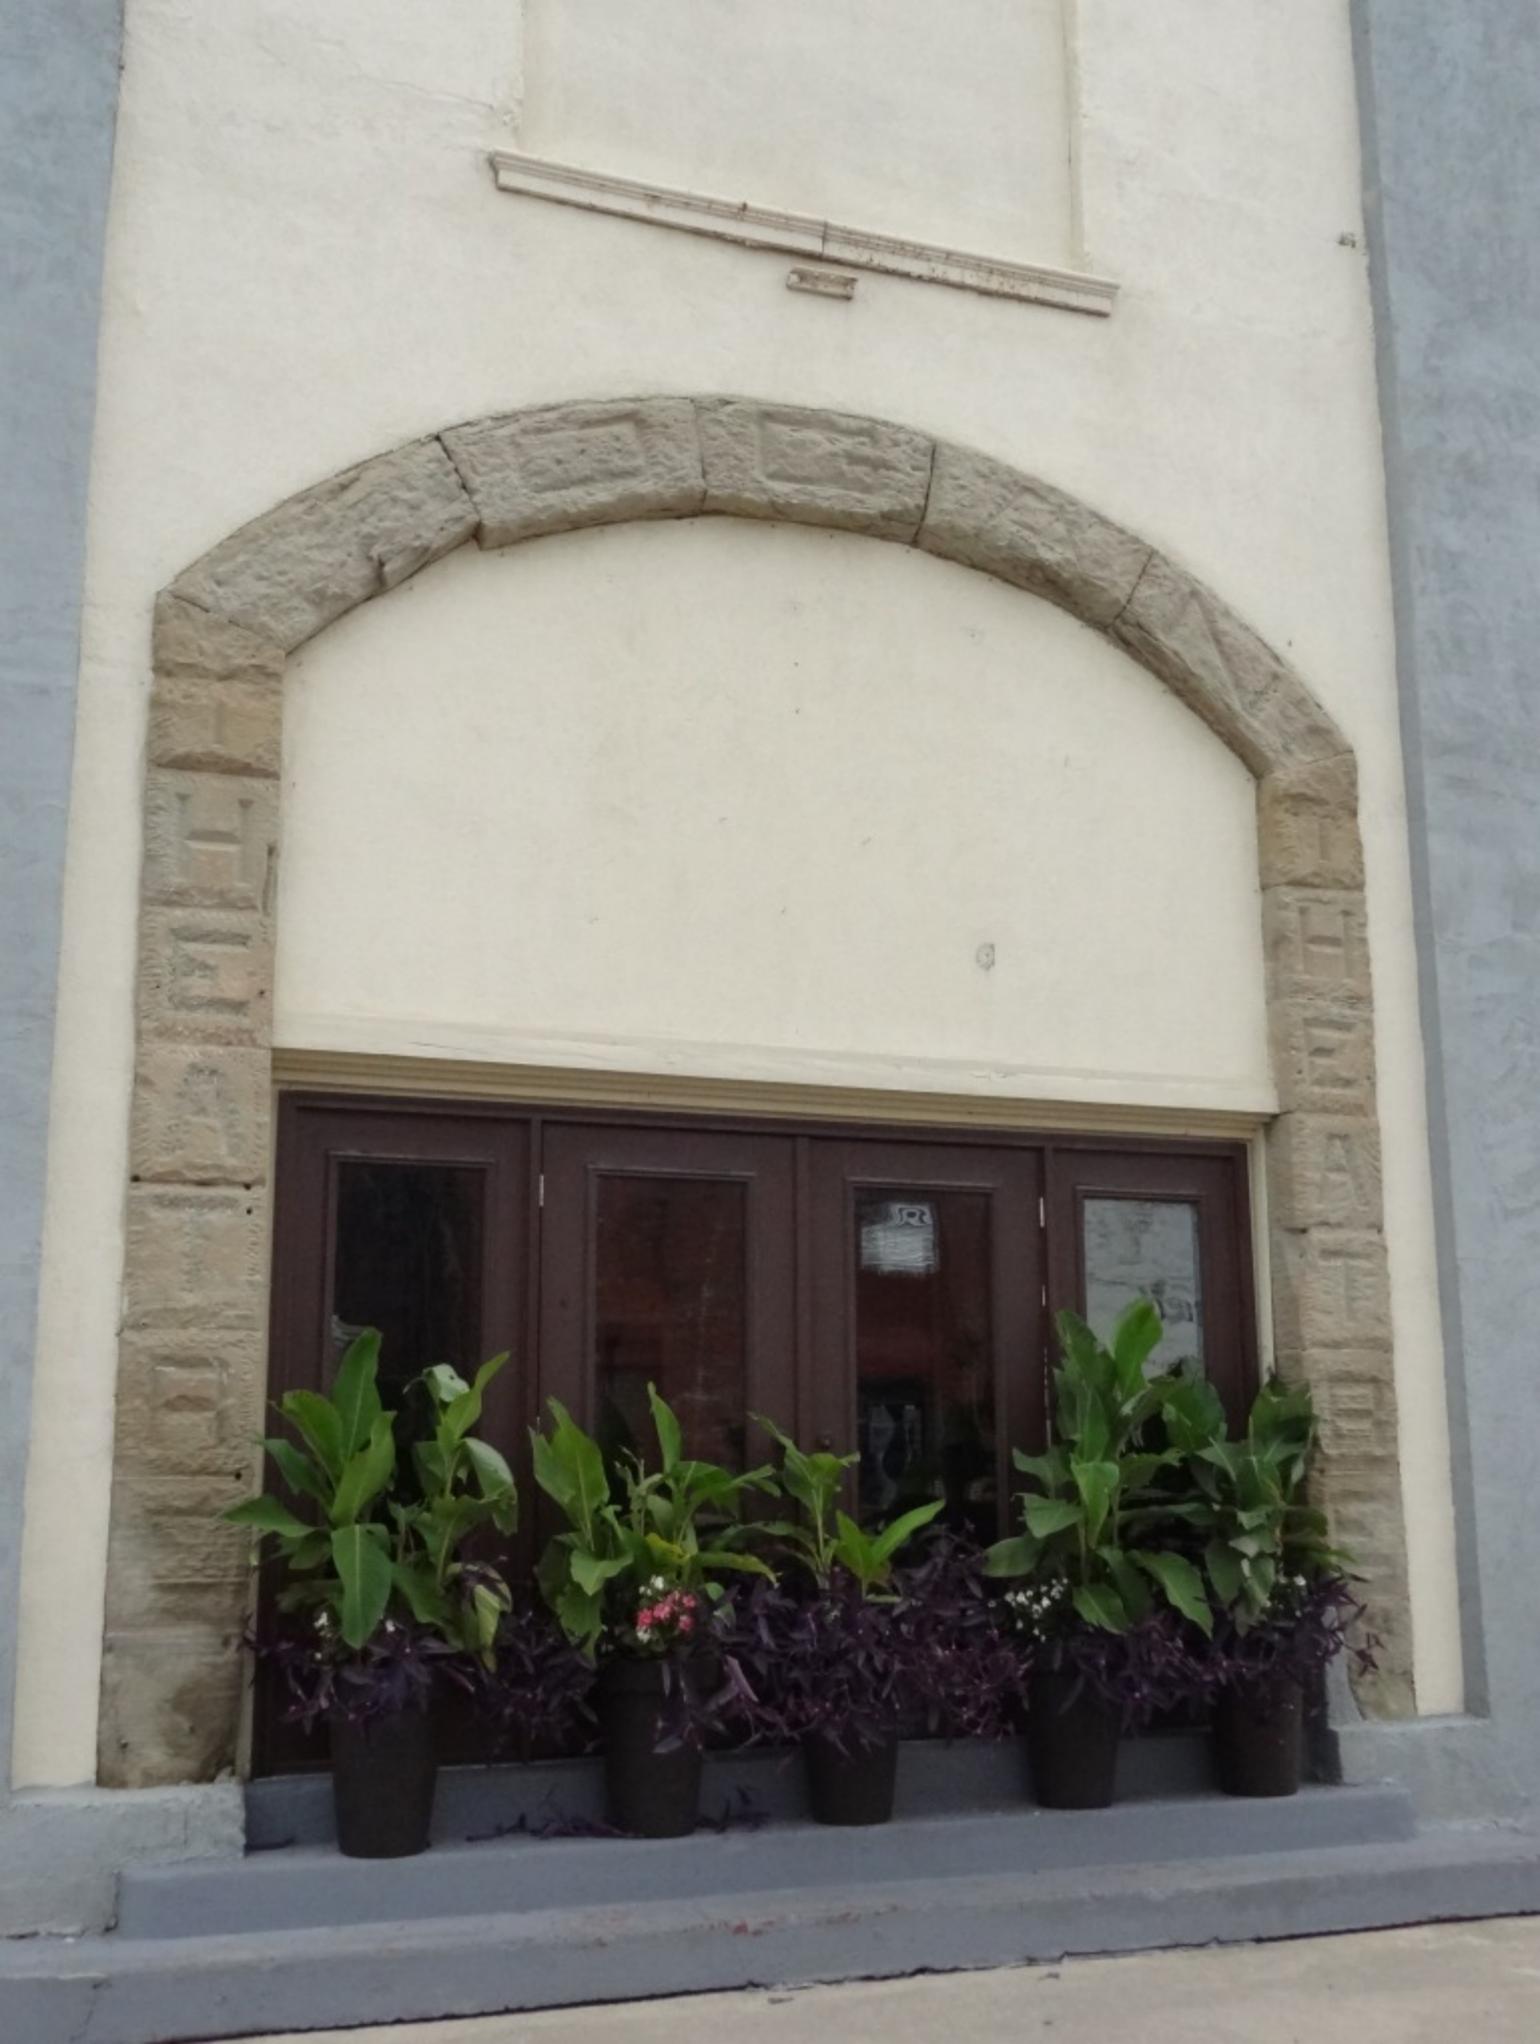
The Royal Theatre consists of a theatre building and a connecting addition attached to 102 North Rubey Street. The c. 1889 theatre building is a two-story boom-town front brick building. The building has a slight front gambrel metal seam roof hidden by the front parapet. The front façade contains stucco and is three bays wide with a central paired double entry with an enclosed arched window bay above, flanked by replaced paired wood 1/1 double-hung window bay openings. The original bays were tall multi-paned windows. Plain pilasters also break up the façade's bays and run up to the cornice. The bays have arched stone lintels and the entry arch has faded carved "Logan Theatre." Along the upper second story is a terra cotta corbeled course. At the cornice is a half concave band running the length of the façade. The side elevations are five bays deep with enclosed windows and modified rear door entrances at the northeast and west corners. The south elevation includes a painted advertisement "Royal Theater Distinctive Attractions."

The c. 1909 one-story one-bay addition has a flat roof and is composed of plywood paneling and stucco on the upper portion of the façade. An off-center modern door labeled "stage door" serves the theatre building. The addition connects the theatre and the ticket office building (at 102 North Rubey Street).

The property is located outside a potential National Register historic commercial district. The alterations have resulted in a loss of architectural integrity, rendering 104 North Rubey Street non eligible.

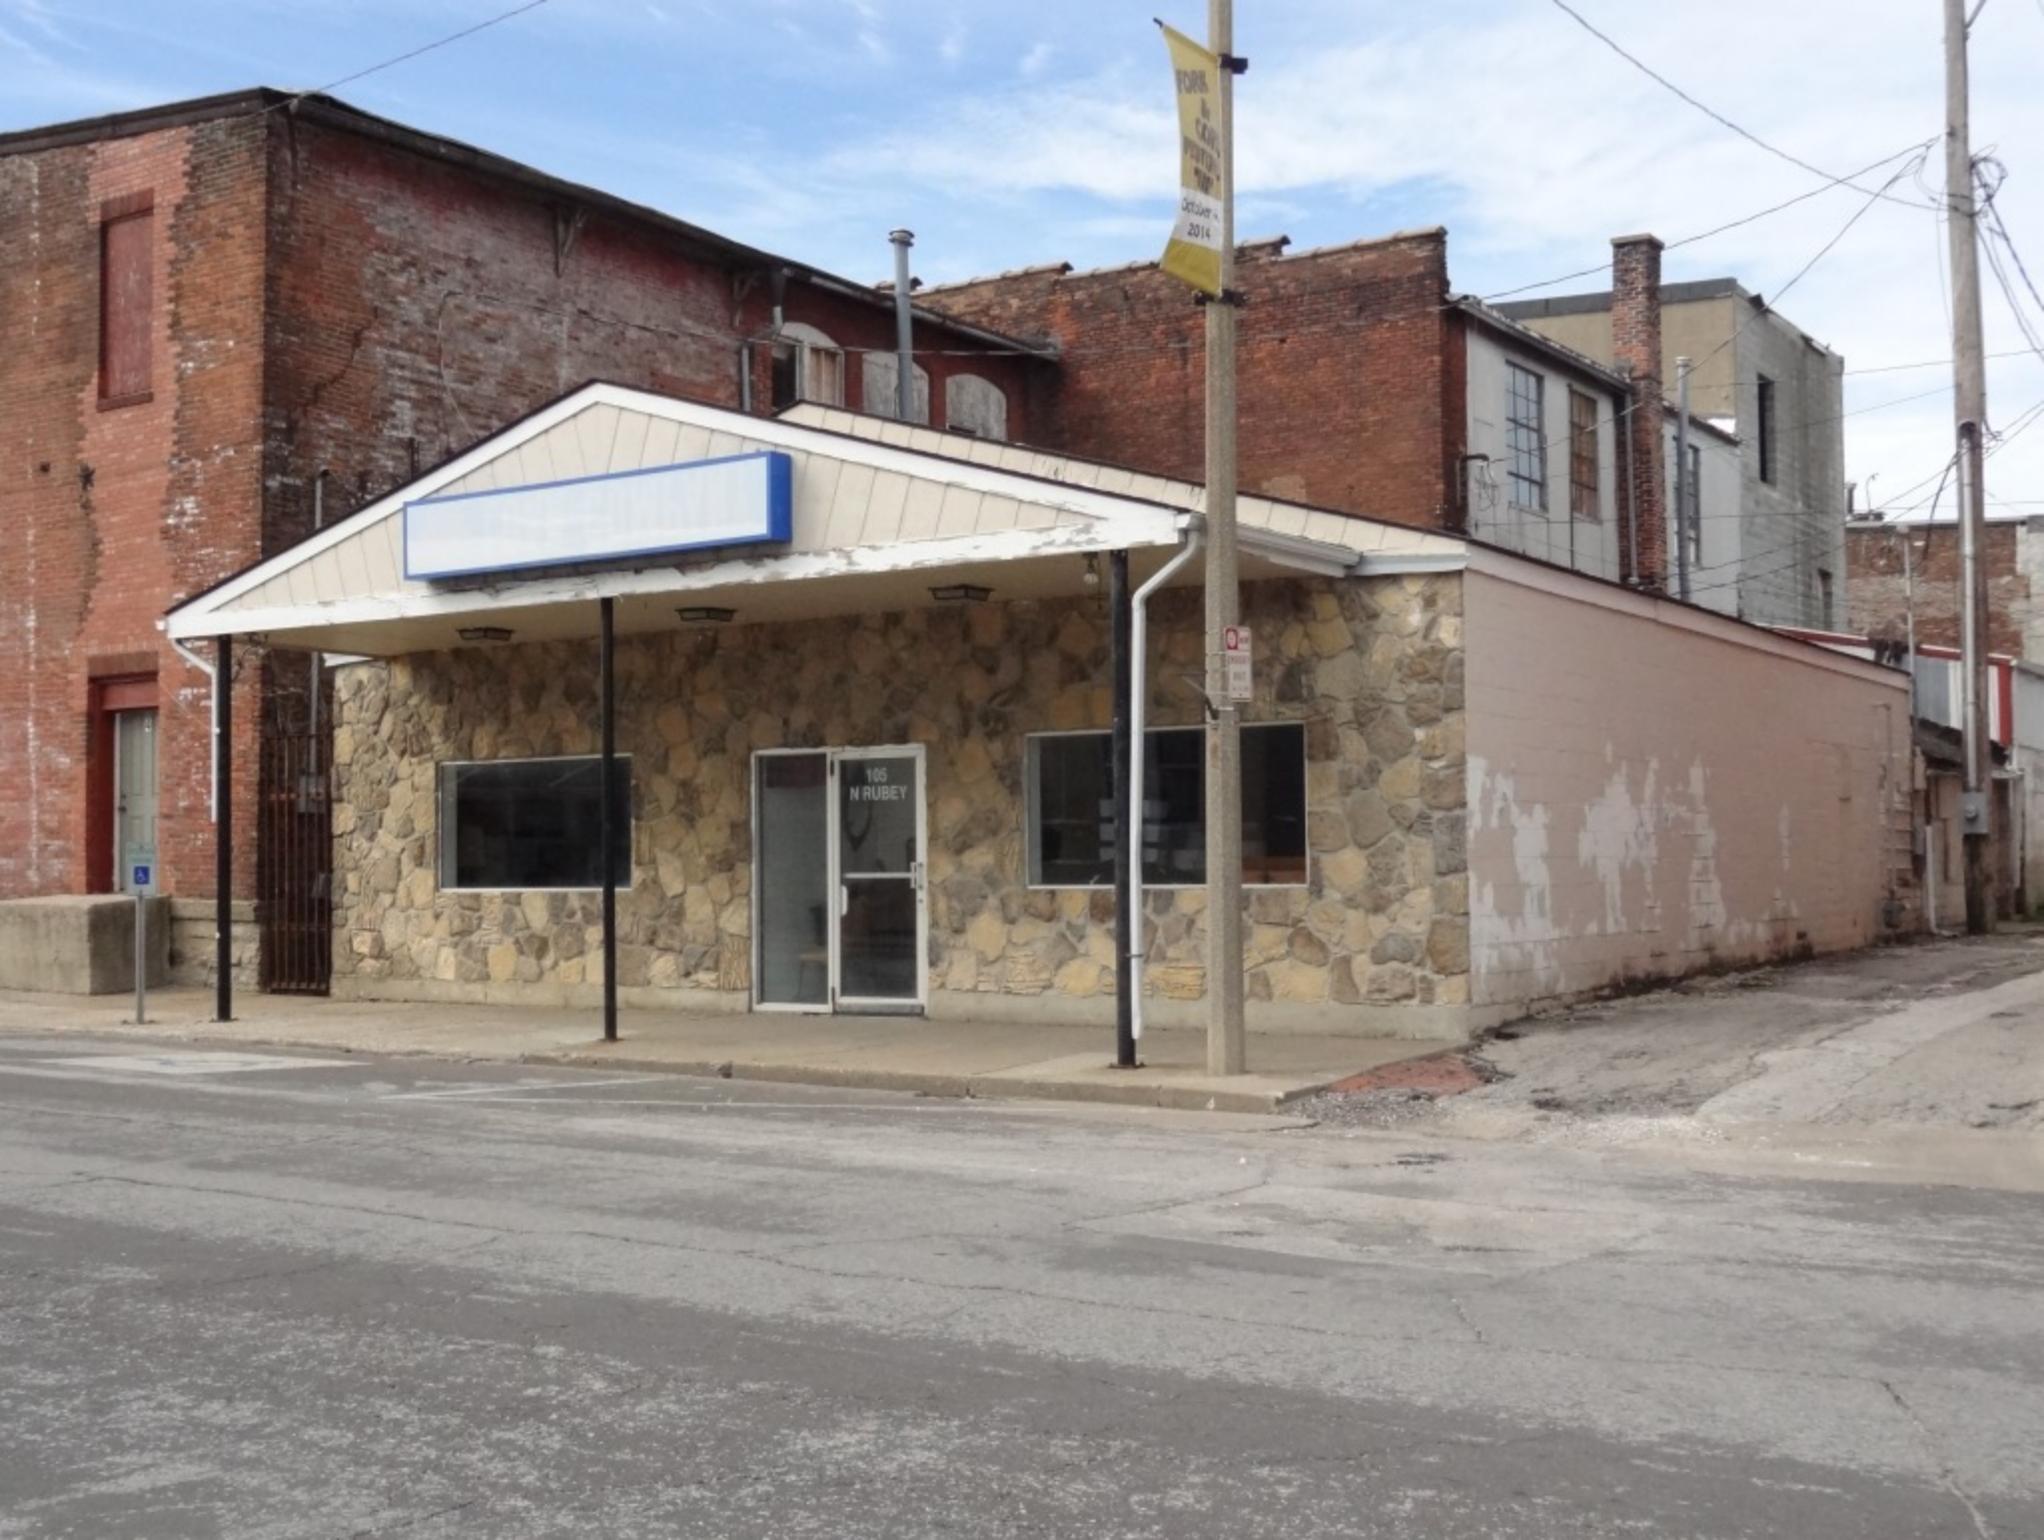
105
N RUBEY

According to the Macon County Economic Development, the property includes 3,500 square feet of concrete construction.

The property is non-contributing to a potential National Register historic district due to its 1974 construction, outside the period of significance.

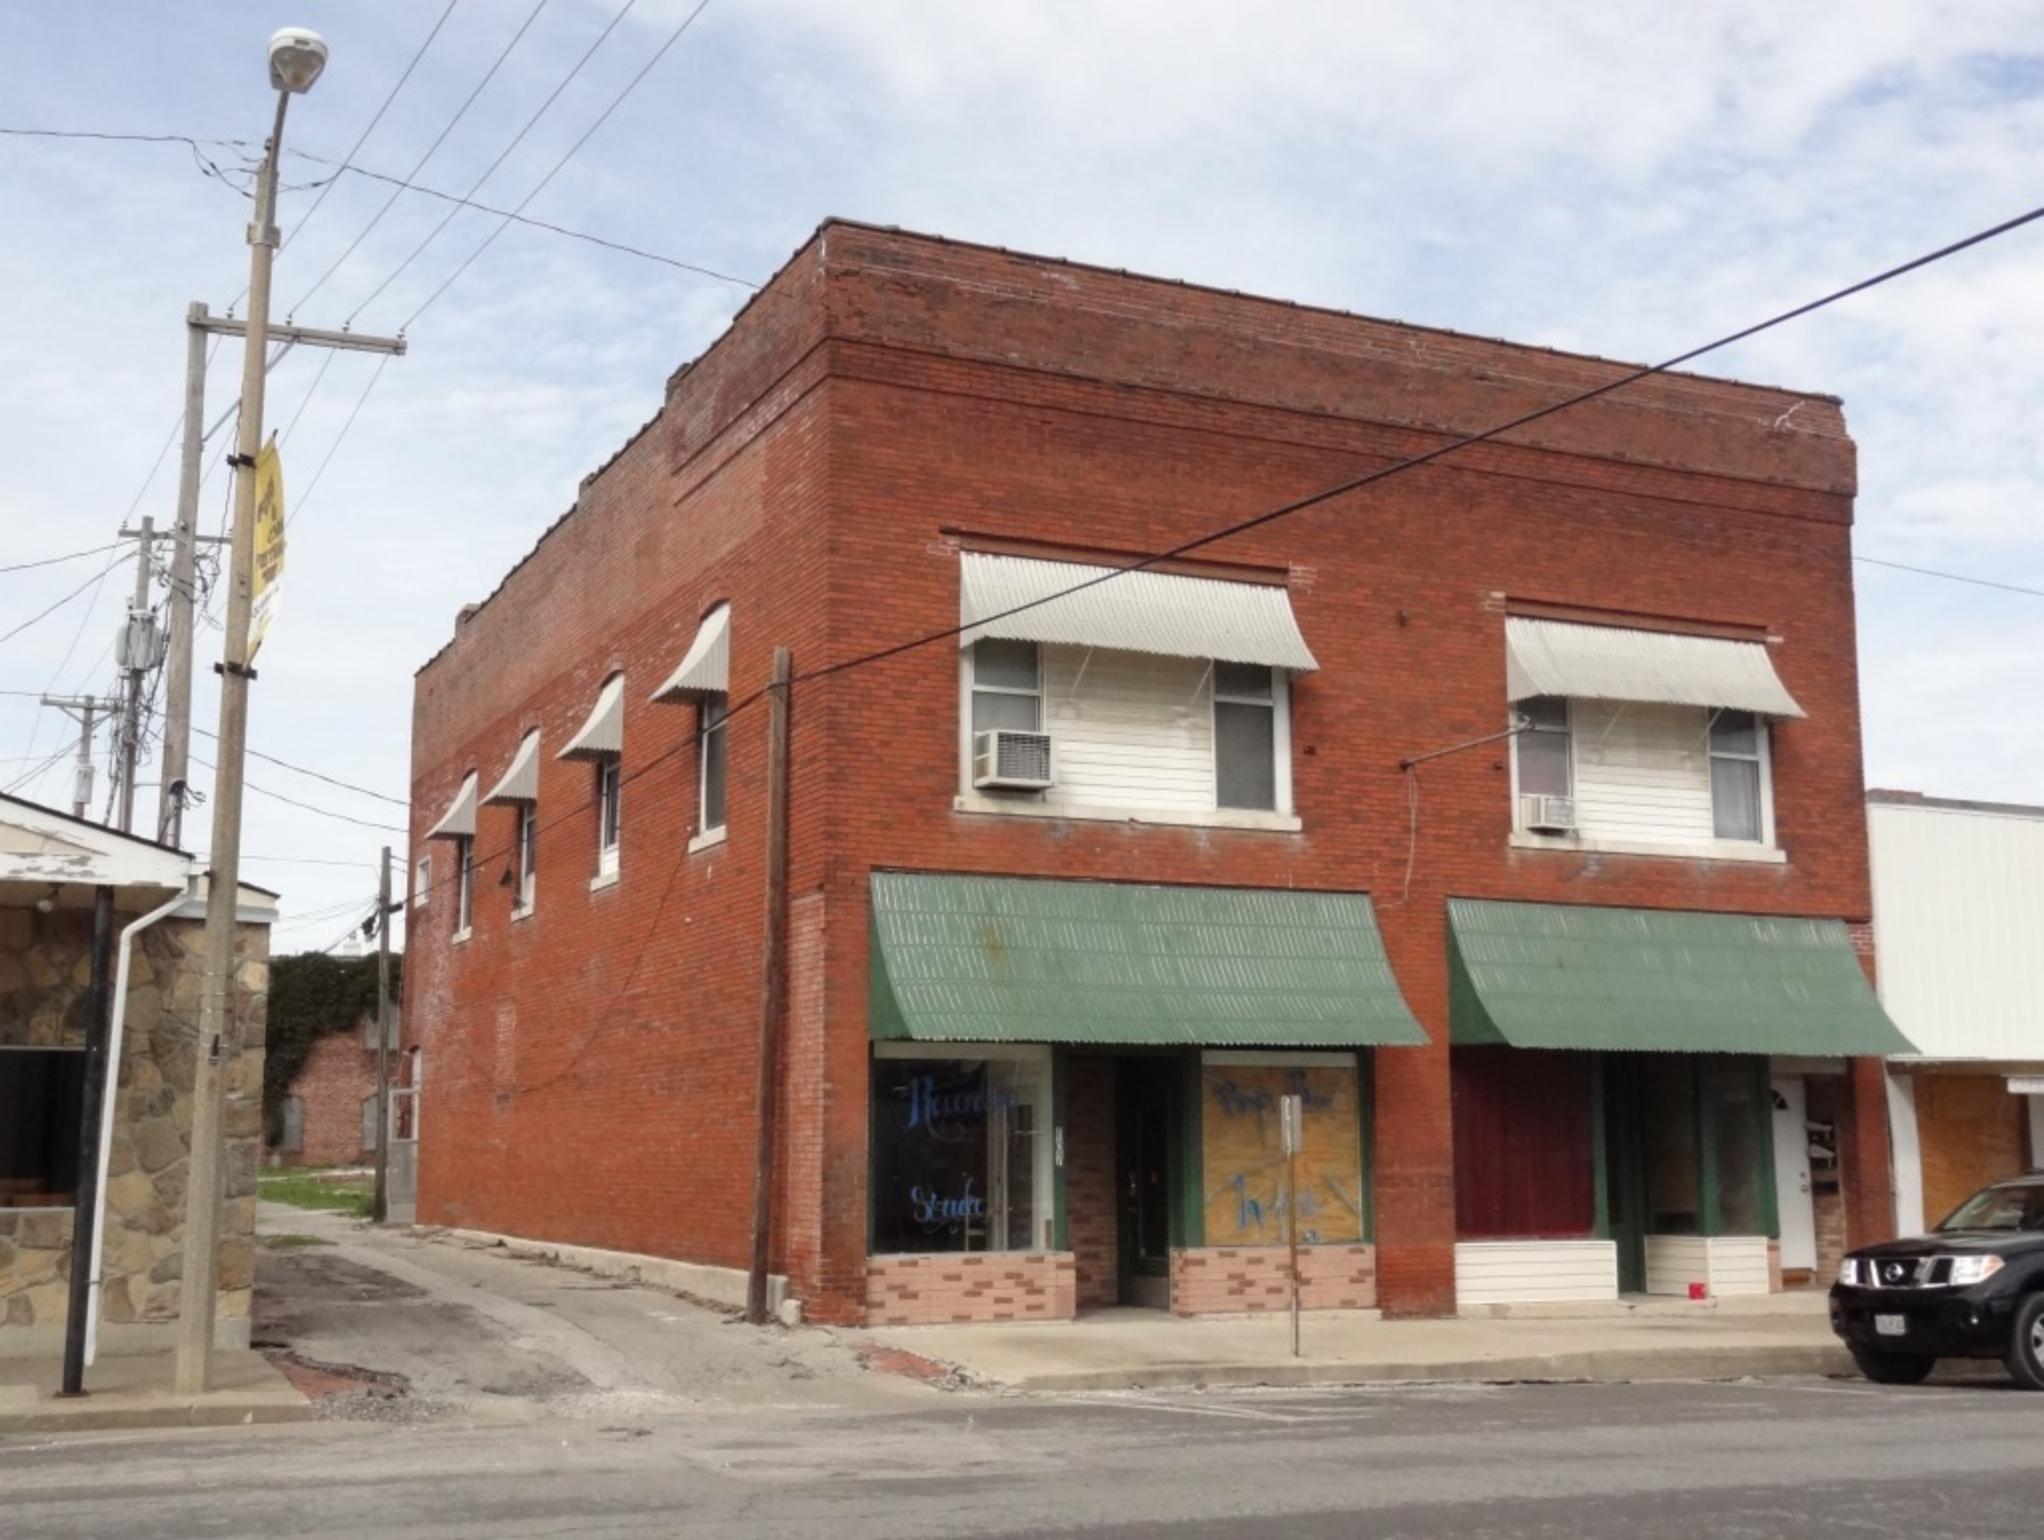
According to the Macon County Economic Development, the building includes 4400 square feet, is of concrete construction with commercial or office space on the first floor and apartments on the second floor. The building's utilities have been separated and includes a FA gas furnace and central air.

According to the Recorder of Deeds, alterations were completed in 1964 and may have included the altered second floor window bays and on the first floor storefront, the awnings and bulkheads. The building retains enough historic fabric and is contributing to a potential National Register historic commercial district.

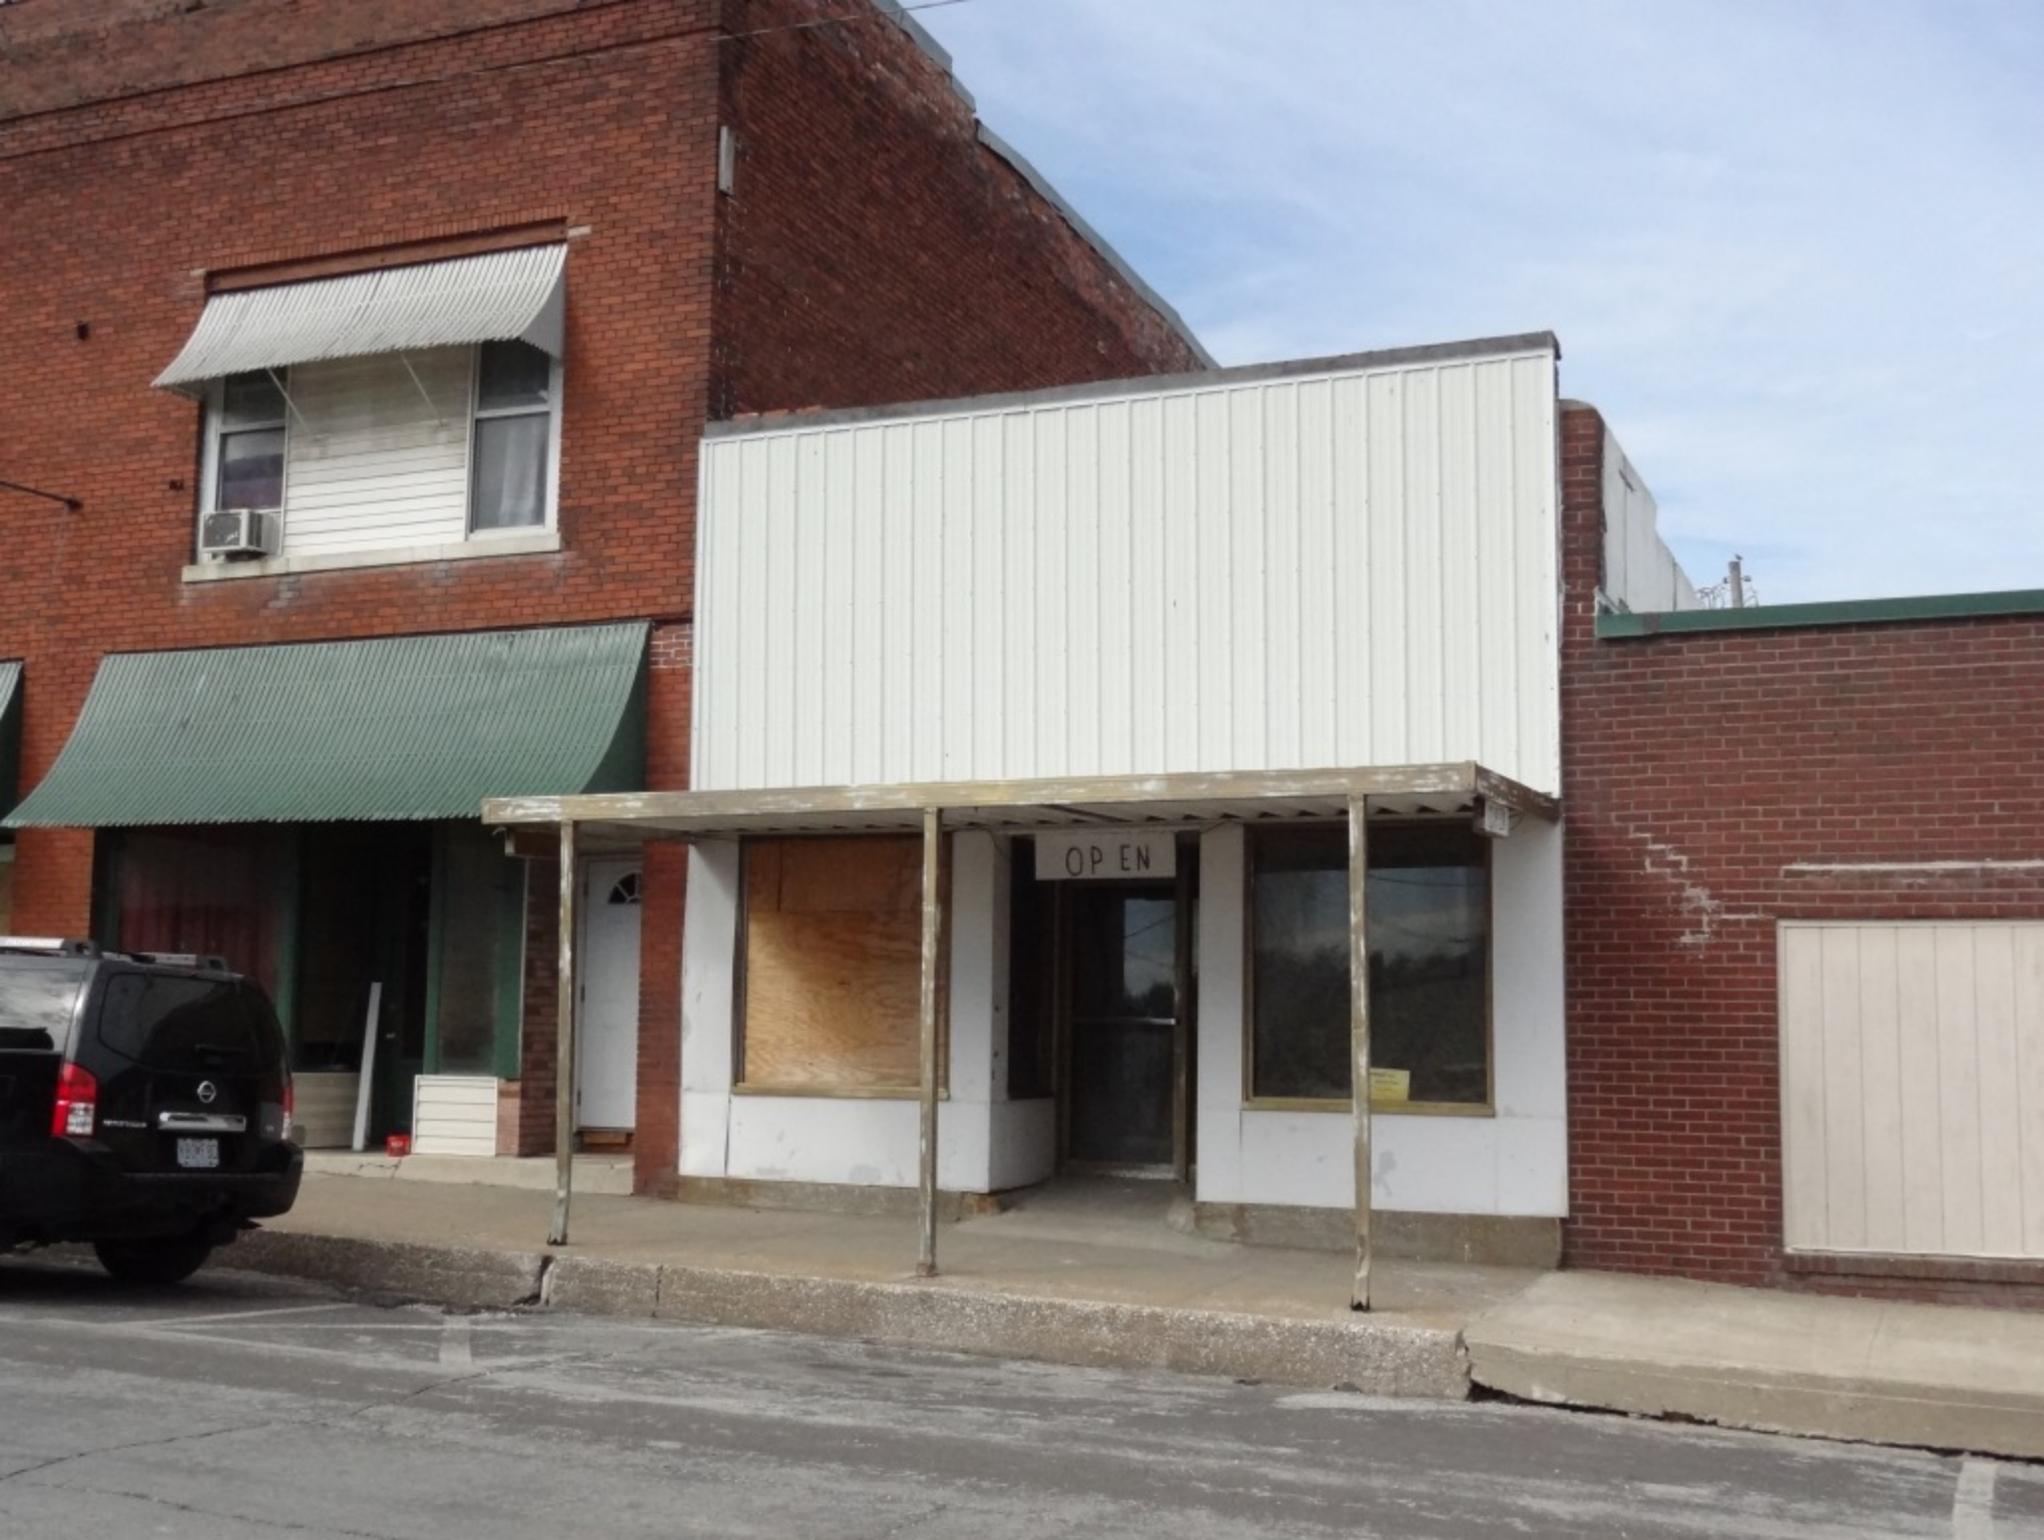
The brick one-part commercial block building is rectangular and consists of three bays. The storefront consists of a recessed glass entry door flanked by two narrow single fixed wood panes and projecting large square single fixed wood panes (the southernmost bay has been replaced with plywood). The lower façade includes aluminum paneling and the upper portion contains corrugate metal sheathing. A flat metal awning with plain square metal supports projects out and divides the two portions. Concrete covers the building's foundation. It appears that the upper portion of the northern elevation has concrete parging.

According to the Recorder of Deeds, alterations were completed in 1965. The addition of corrugated metal sheathing and aluminum paneling on the storefront façade appears to be more recent. These alterations have resulted in a loss of integrity, rendering 111 North Rubey Street non-contributing to a potential National Register historic district.

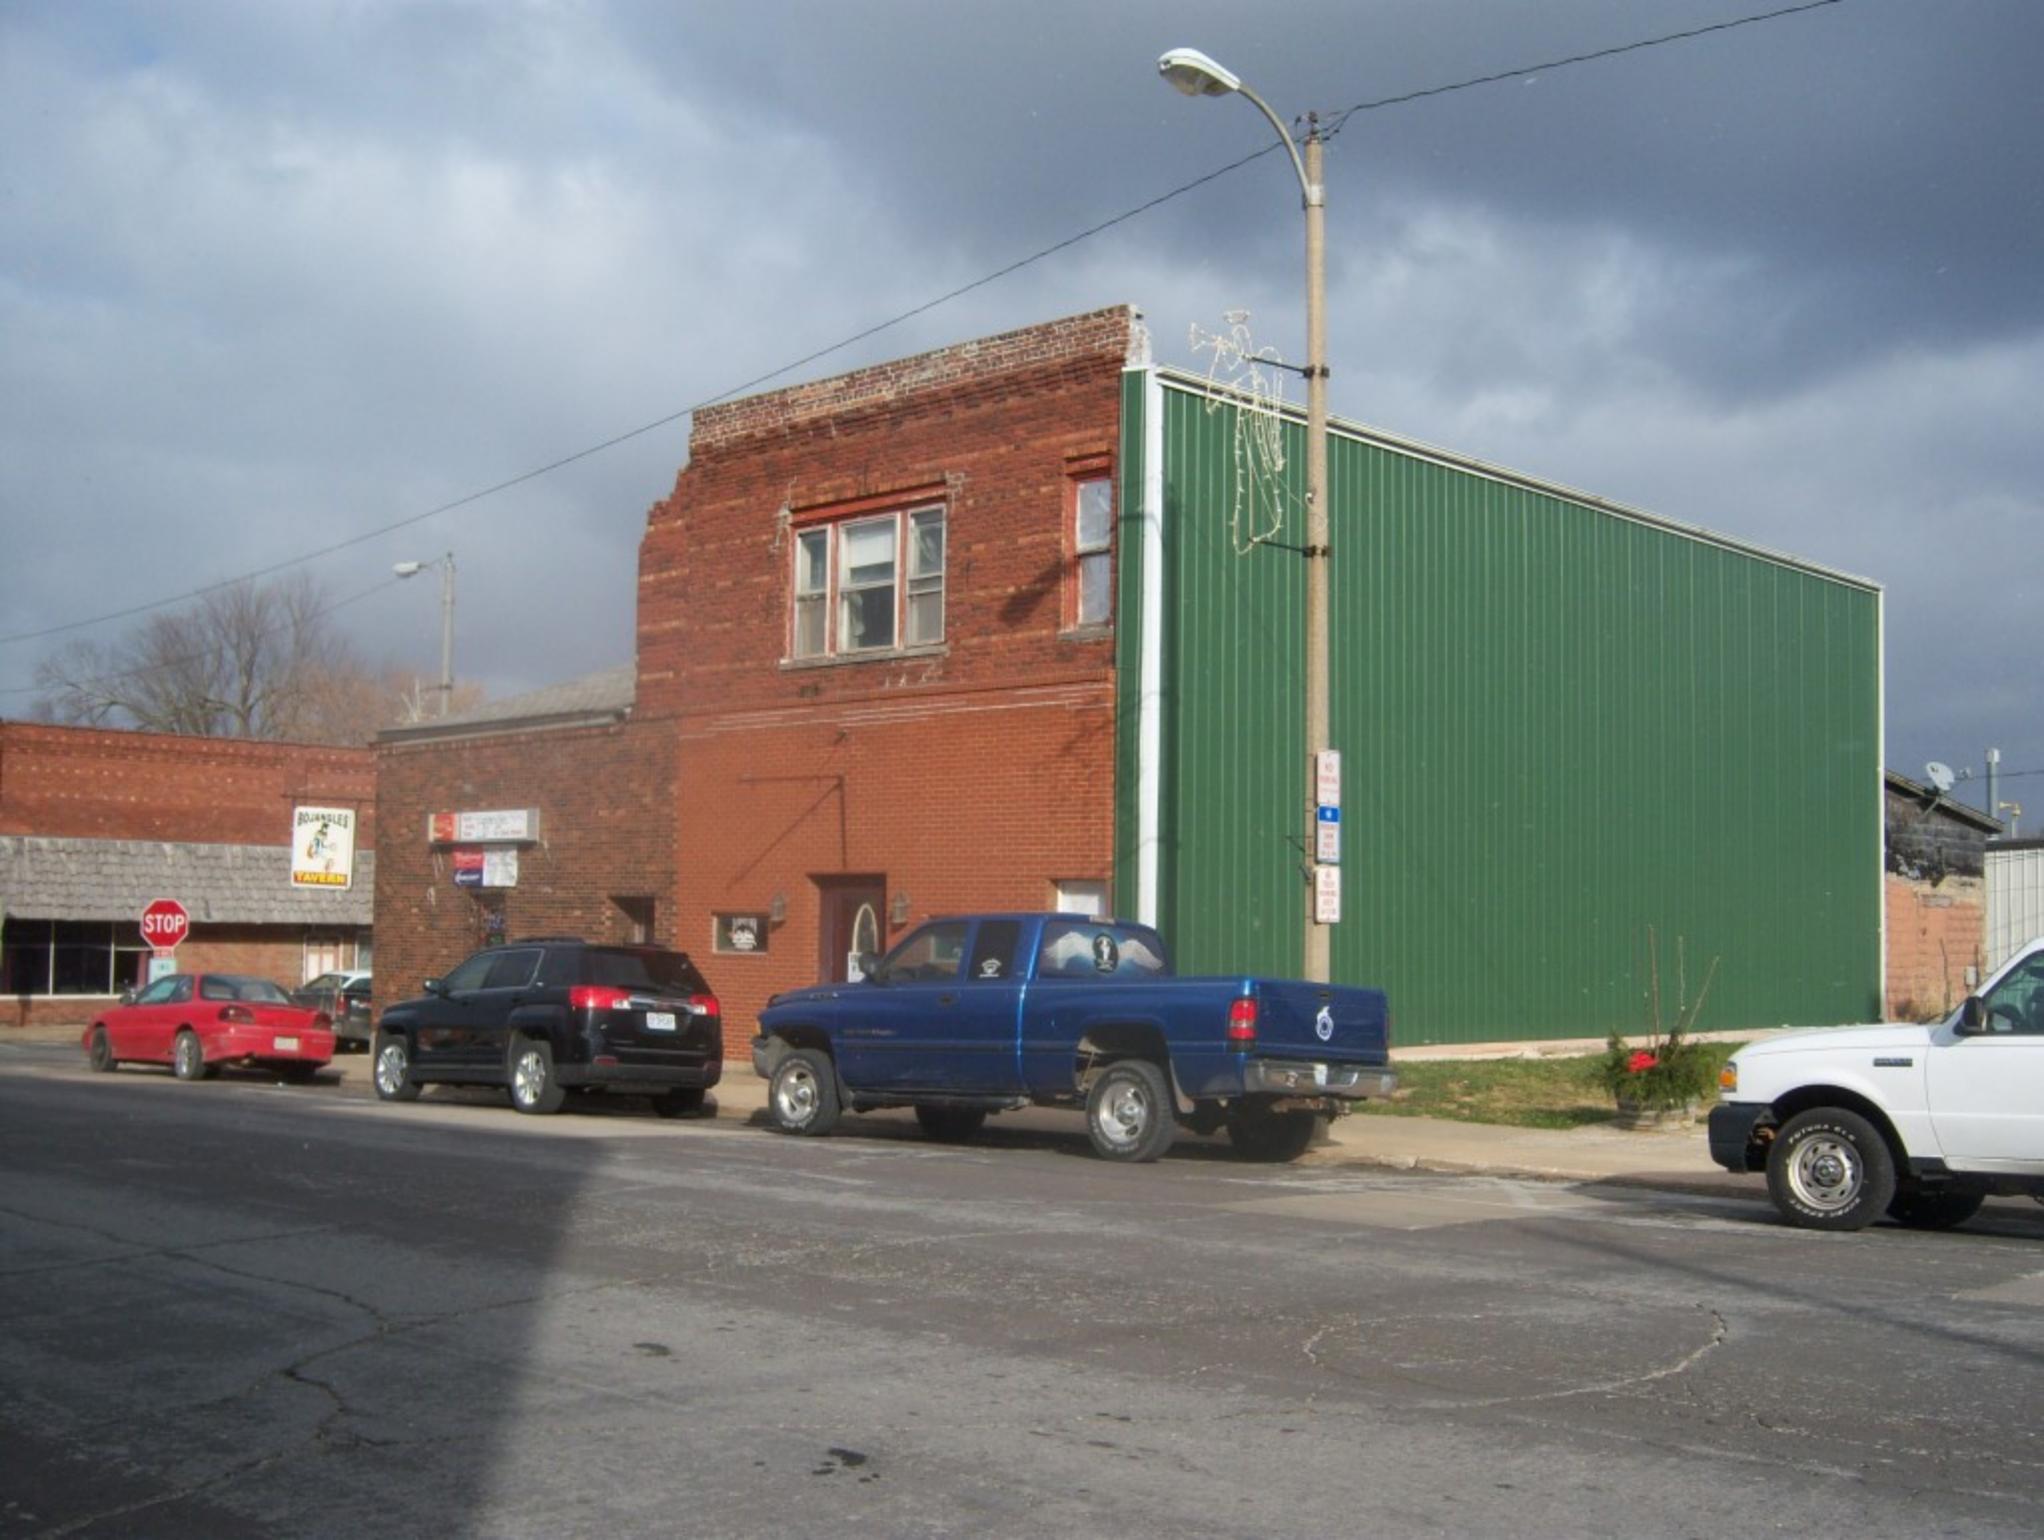
The brick two-part commercial building is rectangular and contains three bays along its facade. The first floor storefront has been modified with a contemporary brick front and bays. The bays consist of a center vinyl door with an oval shaped pane flanked on each side by a small horizontal single pane and a side vinyl panel door leading to dwelling space on the second floor. The bays include stretcher lintels and header soldier course sills. A header brick course frames the upper portion of the first floor. The second floor contains variegated common brick bond and contains two bays. The bays include a tripartite bay with a larger 1/1 double-hung wood sash window flanked by smaller 1/1 double-hung wood sash windows. Metal storm windows cover the tripartite bay. A small 1/1 double-hung wood sash window is located at the southwest corner of the façade. The bays are framed with l-beams and header soldier lintels and concrete lug sills. The cornice contains brick corbelling and the upper portion has been modified with additional brick courses creating a parapet. The southern elevation has been modified and contains green corrugated metal siding.

According to the Recorder of Deeds, the building underwent alterations c. 1960, and may be associated with the modification of the first floor storefront and the addition of corrugated metal siding to the building's southern elevation. Due to its location outside a potential National Register historic commercial district and its alterations to its elevations having resulted in a loss of integrity, the property is not eligible.
