1. Survey No. MC-AS-001-001		2. Survey name: Downtown Macon Commercial Historic District	
3. County: Macon		4. Address (Street No.) Lots 11-13 block 93	Street (name) East Bourke Street (100 block)
5. City: Macon	Vicinity: <input type="checkbox"/>	6. Geographical Reference:	7. Township/Range/Section: T: R: S:
8. Historic name (if known):		9. Present/other name (if known): City of Macon Parking Lot #3	
10. Ownership: <input checked="" type="checkbox"/> Private <input type="checkbox"/> Public		11a. Historic use (if known): Commercial	11b. Current use: vacant

42. Current owner/address: City of Macon Macon, MO 63552	43. Form prepared by (name and org.): Kristi Chase MO SHPO	44. Survey date: 9/24/2014
		45. Date of revisions:

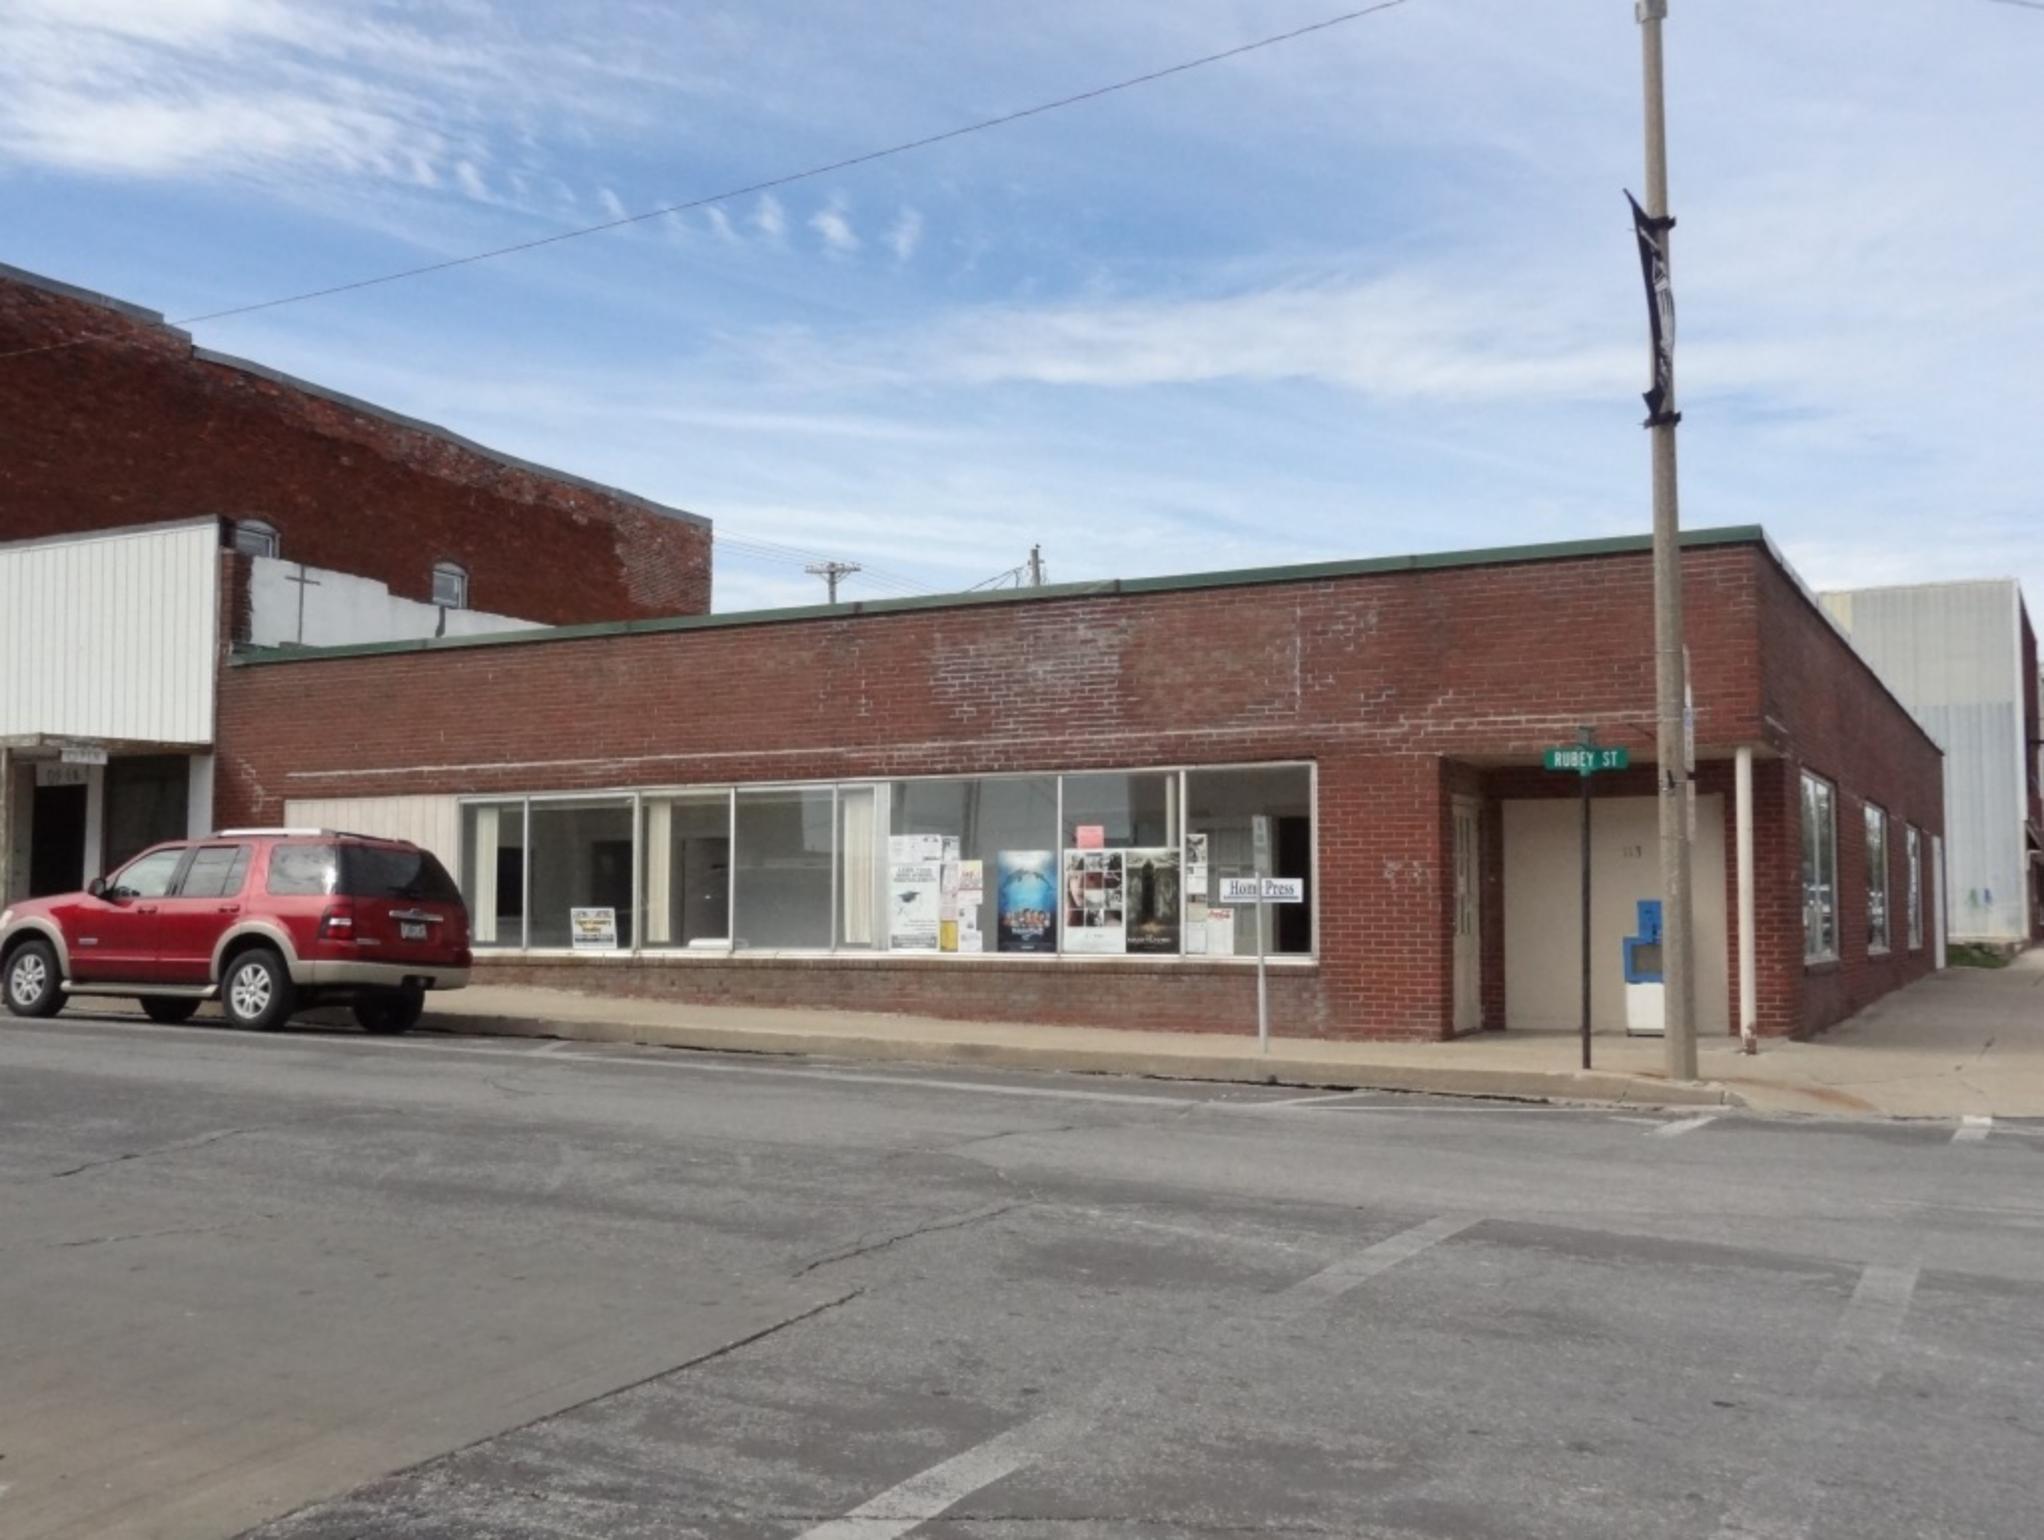
The brick one-part commercial block building is rectangular with a corner store type entry at the northeast corner. The building consists of two bays. The bays consist of a running set of 7 large square and rectangular fixed panes with metal sash. Vinyl siding encloses the southeast portion of the windows and a concrete support beam located between the fourth and window pane supports the space. The second bay includes the corner entry which is recessed and supported by a metal cylindrical pole. A vinyl paneled door with 9 panes looks out toward the north. Along the eastern portion of the corner entry, a larger plywood enclosed opening may have existed, possibly for an automobile. The top of the building is topped with metal coping. The north elevation contains four bays: three paired large single metal sash panes and a contemporary vinyl paneled entry door and surround. The building's windows include a stretcher lintel and a header sill.

Alterations were done in 1994 and may have included the altered window bay and entry on the facade. Due to its location outside a potential National Register historic commercial district, the property's status has not been determined.

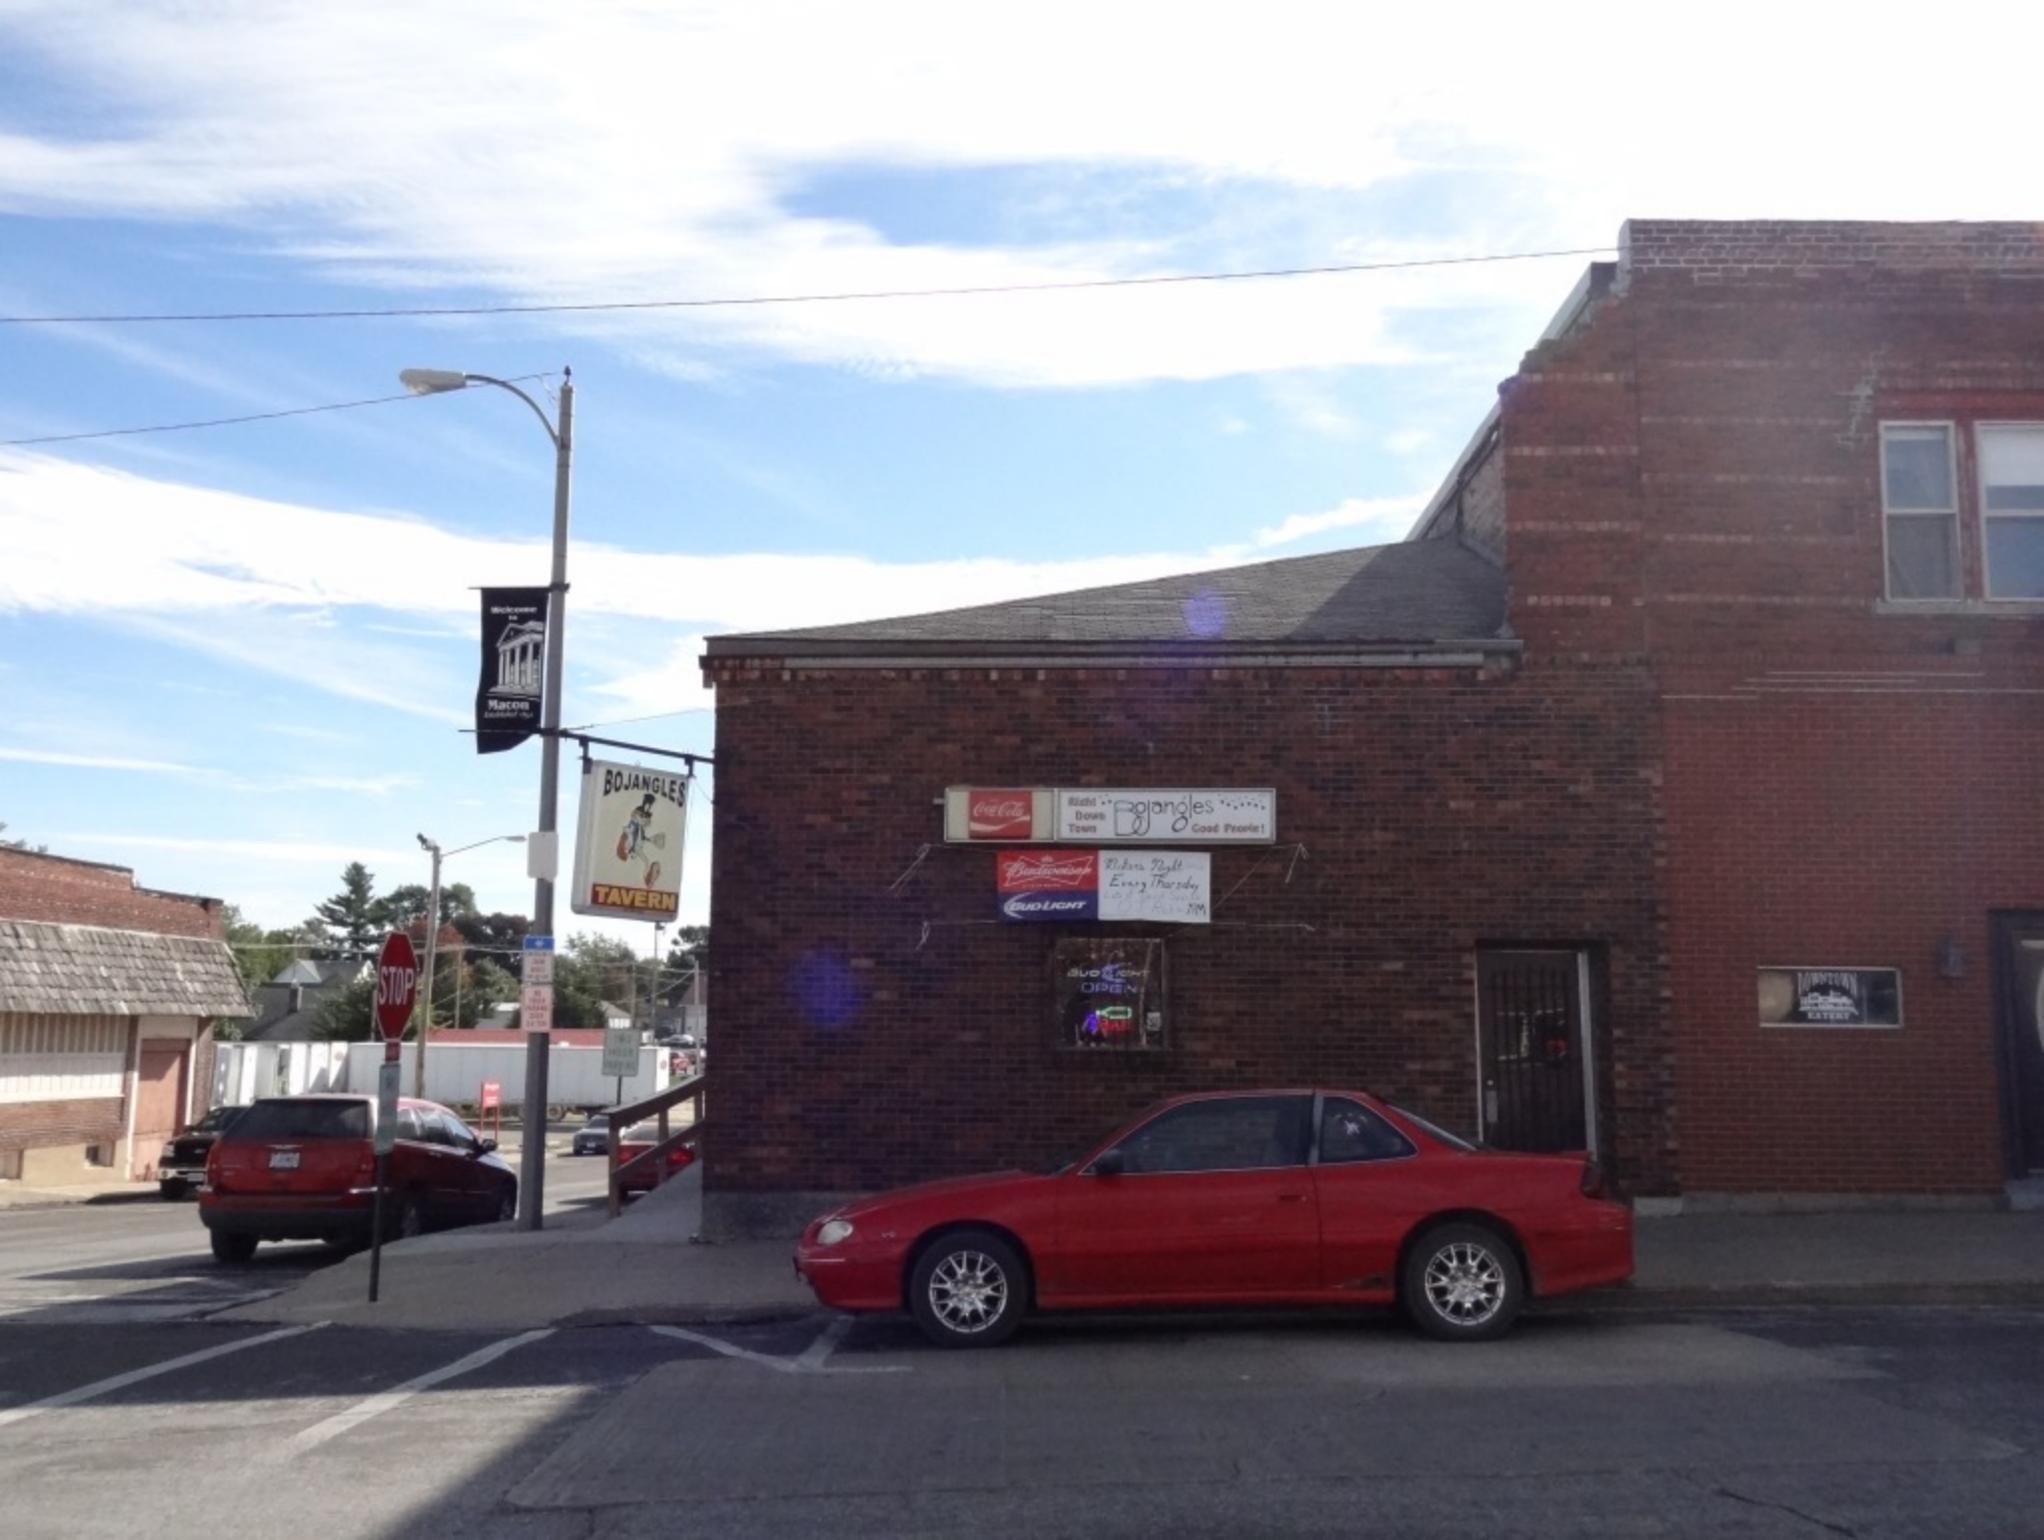
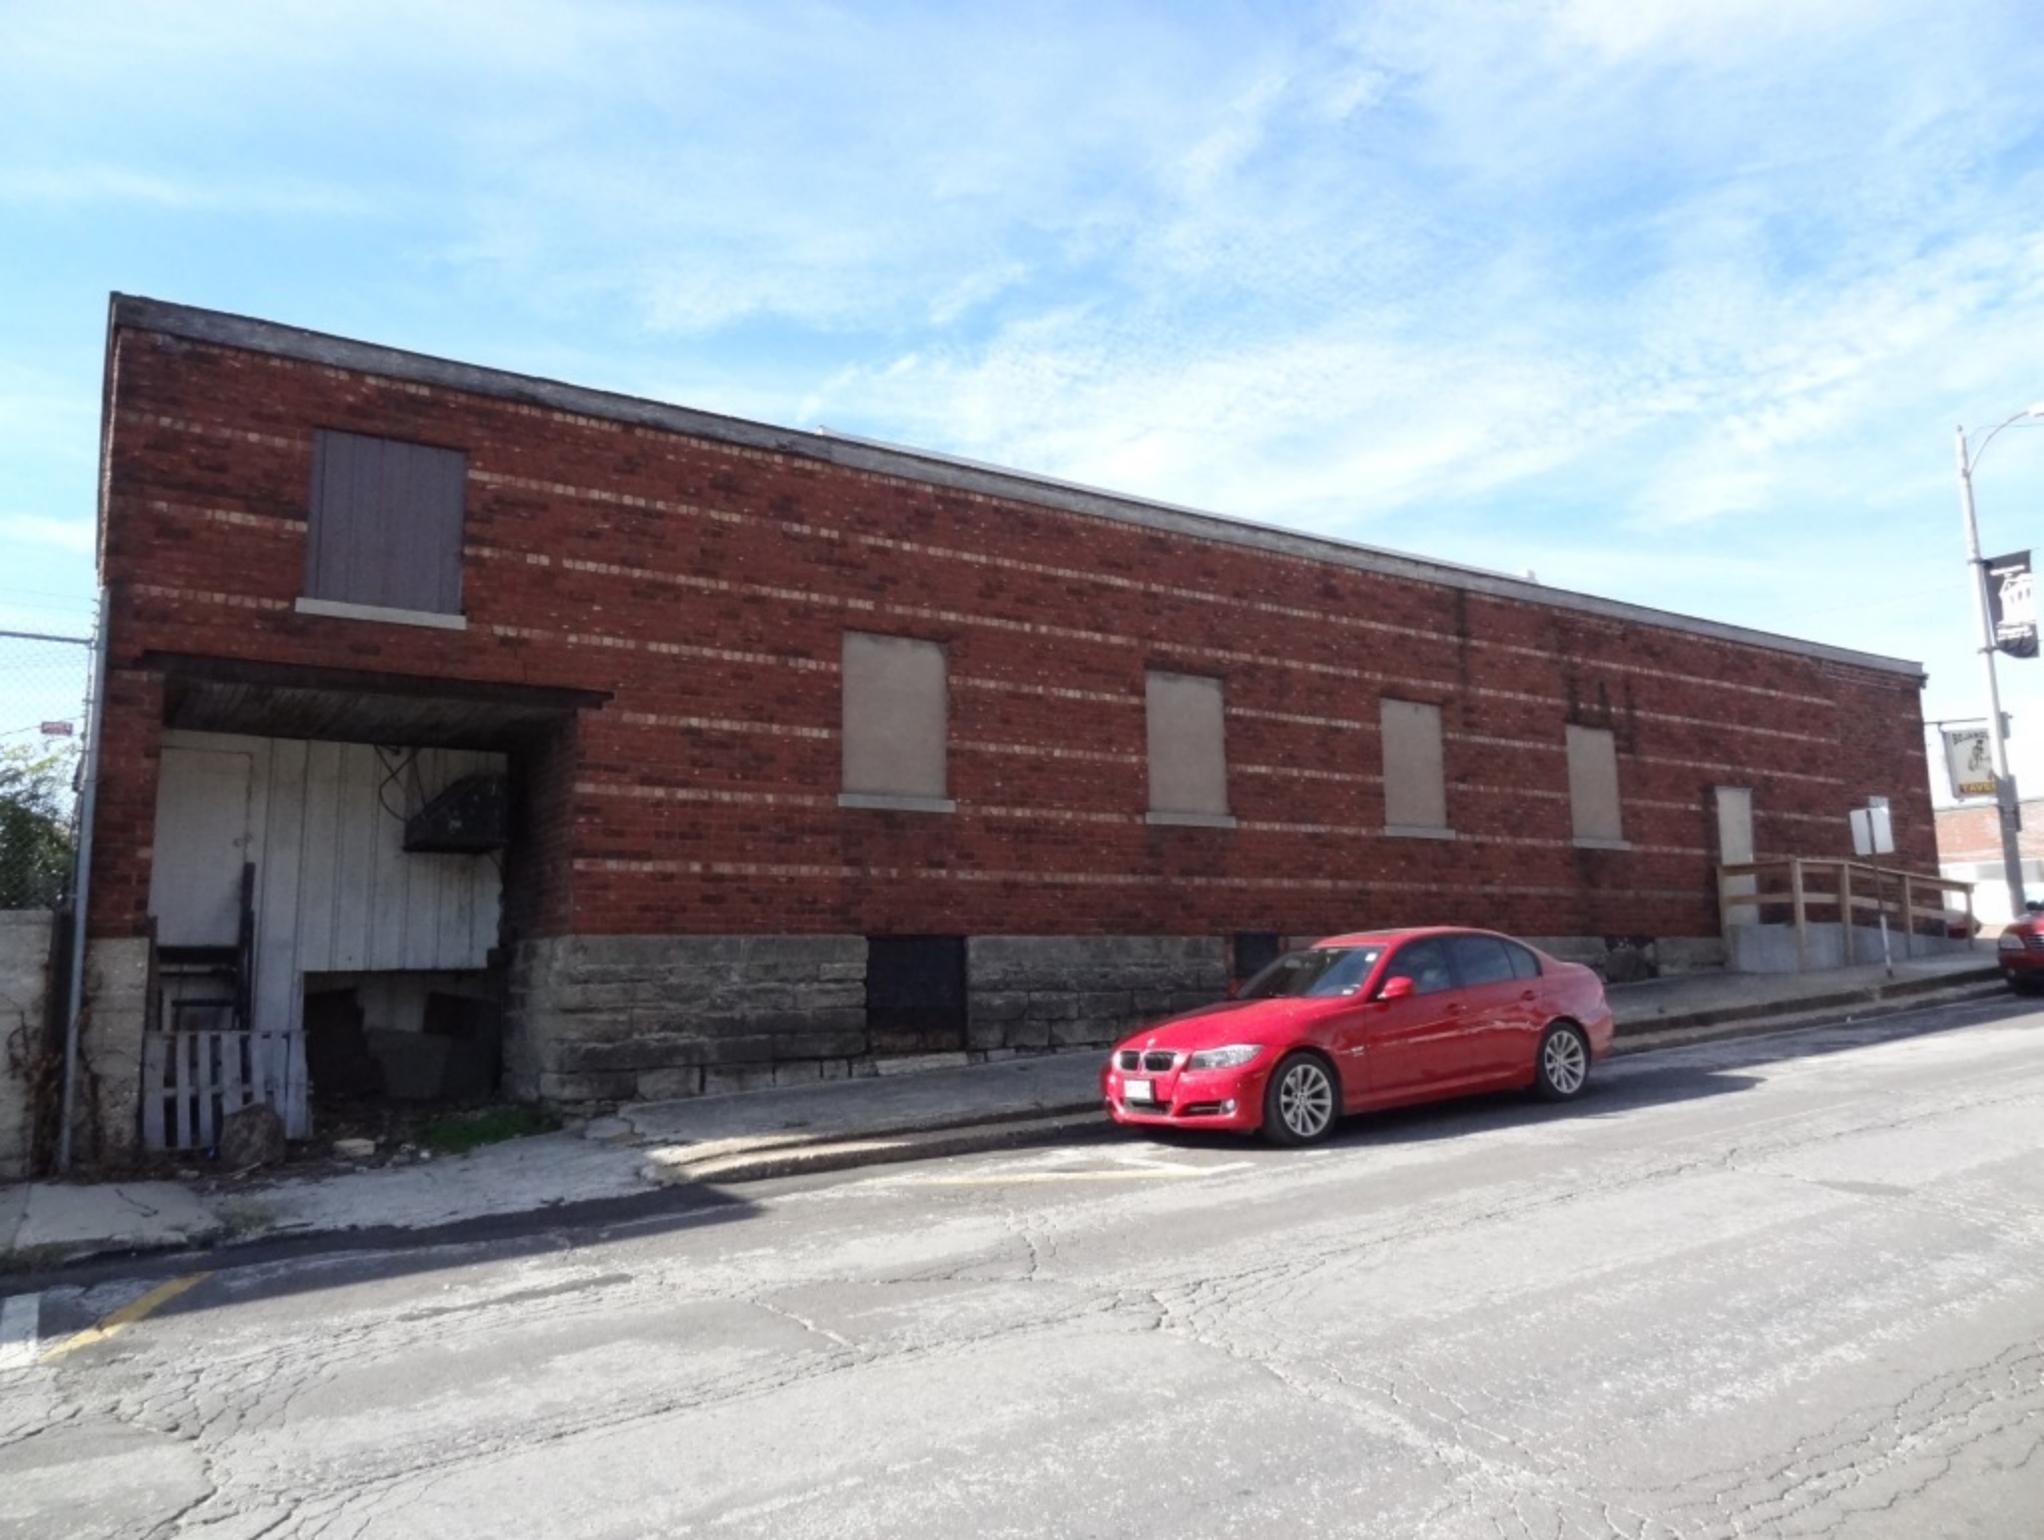
The variegated brick one-part commercial block building is narrowly rectangular, has an asphalt hipped roof and contains two bays along its façade. The bays consist of a small square fixed pane and a side main entry metal door with a rectangular pane. The panes are protected by metal security bars. A thin rectangular fiberglass sign runs along the façade above the window bay. A header course runs along the cornice and a brick wall with the same coursework of its north elevation and 112 North Rubey Street projects vertically. This may be a remnant of the building's upper stories. The north elevation contains six bays and the ground inclines toward the northeast corner, displaying the limestone foundation and basement. The basement has enclosed window bays matching the first floor fenestration. The elevation contains a variegated common brick bond with tan header brick courses. The northeast corner contains an automobile entry that has since been enclosed with board and batten siding. A frame stoop leads to a small wood door cut into the wood siding. The bay is supported by a small I-beam and the wood ceiling is visible. A small opening above the automobile bay has been enclosed with board and batten and contains a stretcher lintel and concrete lug sill. Adjacent to the automobile bay are four plywood enclosed window bays with stretcher lintels and concrete lug sills. A contemporary vinyl door is located west of the windows and contains a concrete ADA ramp with a plain 2x4 wood balustrade. A tall opening appears to have been bricked up at the northwest corner of the building north elevation.

According to the Recorder of Deeds, the building underwent alterations c. 1975, and may be associated with the modification of the storefront and the apparent damage to the upper portion of the building along the roof line. The brick work along the façade differs from the upper portion along the roof line and north elevation. The property is located outside a potential National Register historic commercial district. The alterations have resulted in a loss of integrity, rendering the property not eligible.

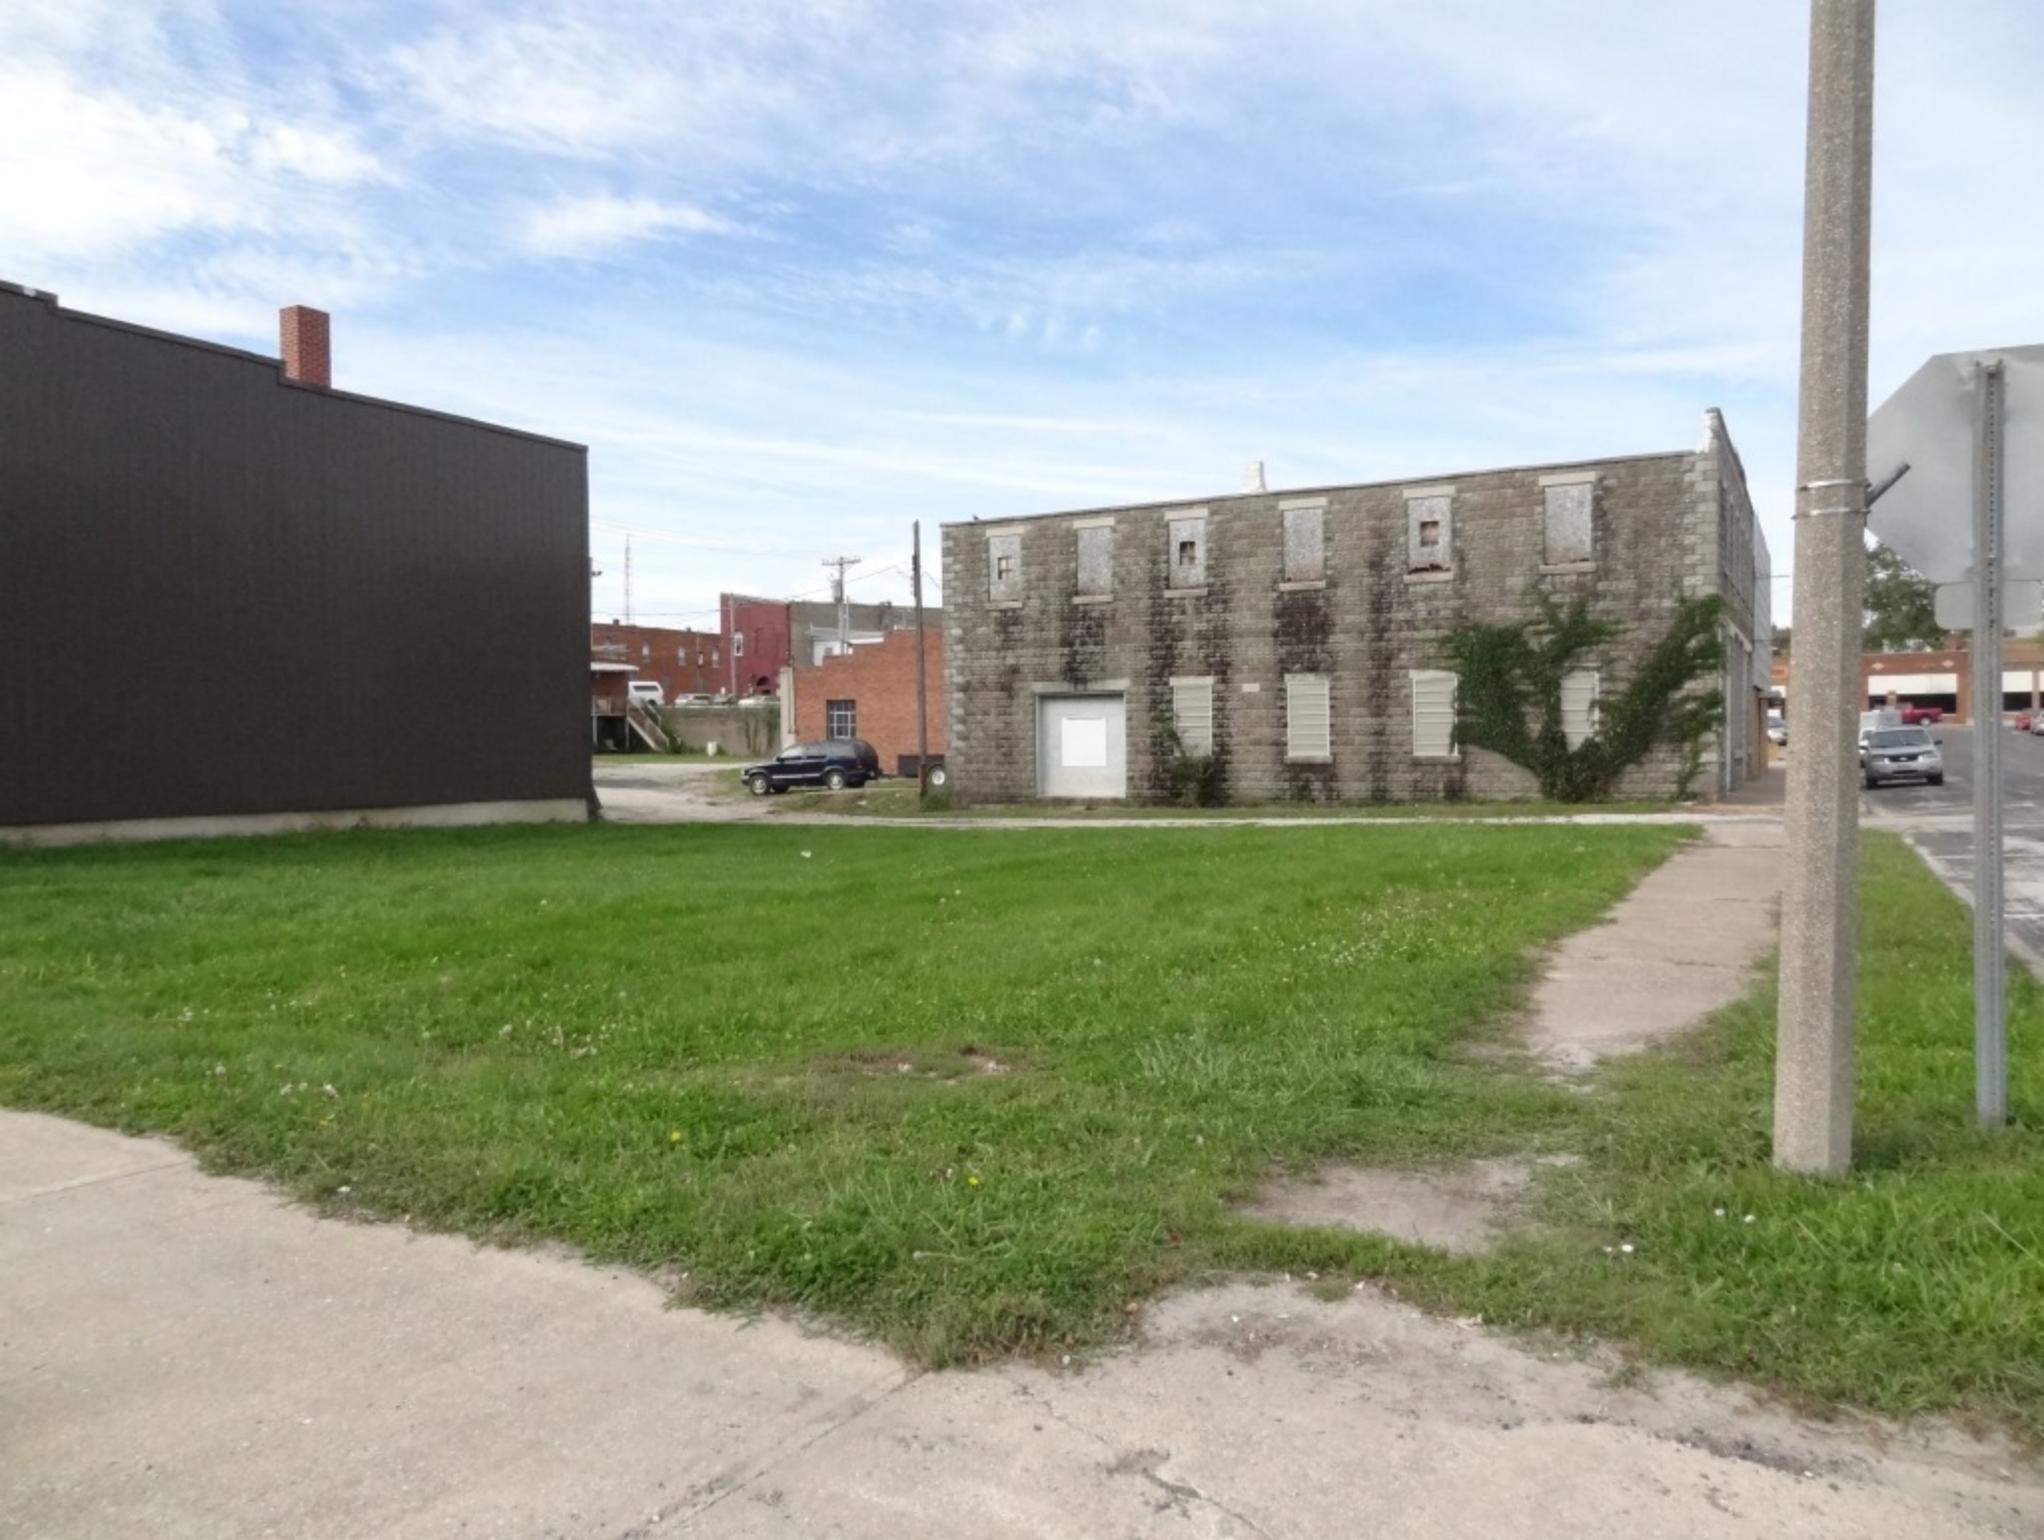
The property current consists of a grassy lot.

It appears that the buildings that were located on this current vacant lot were removed c. 1963 resulting in the adjacent building 211 North Rubey Street receiving metal sheathing on its north elevation. The lot is located outside a potential National Register historic commercial district. The alterations have resulted in a loss of integrity, rendering the lot not eligible.
