1. Survey No. MC-AS-001-001		2. Survey name: Downtown Macon Commercial Historic District	
3. County: Macon		4. Address (Street No.) Lots 11-13 block 93	Street (name) East Bourke Street (100 block)
5. City: Macon	Vicinity: <input type="checkbox"/>	6. Geographical Reference:	7. Township/Range/Section: T: R: S:
8. Historic name (if known):		9. Present/other name (if known): City of Macon Parking Lot #3	
10. Ownership: <input checked="" type="checkbox"/> Private <input type="checkbox"/> Public		11a. Historic use (if known): Commercial	11b. Current use: vacant

42. Current owner/address: City of Macon Macon, MO 63552	43. Form prepared by (name and org.): Kristi Chase MO SHPO	44. Survey date: 9/24/2014
		45. Date of revisions:

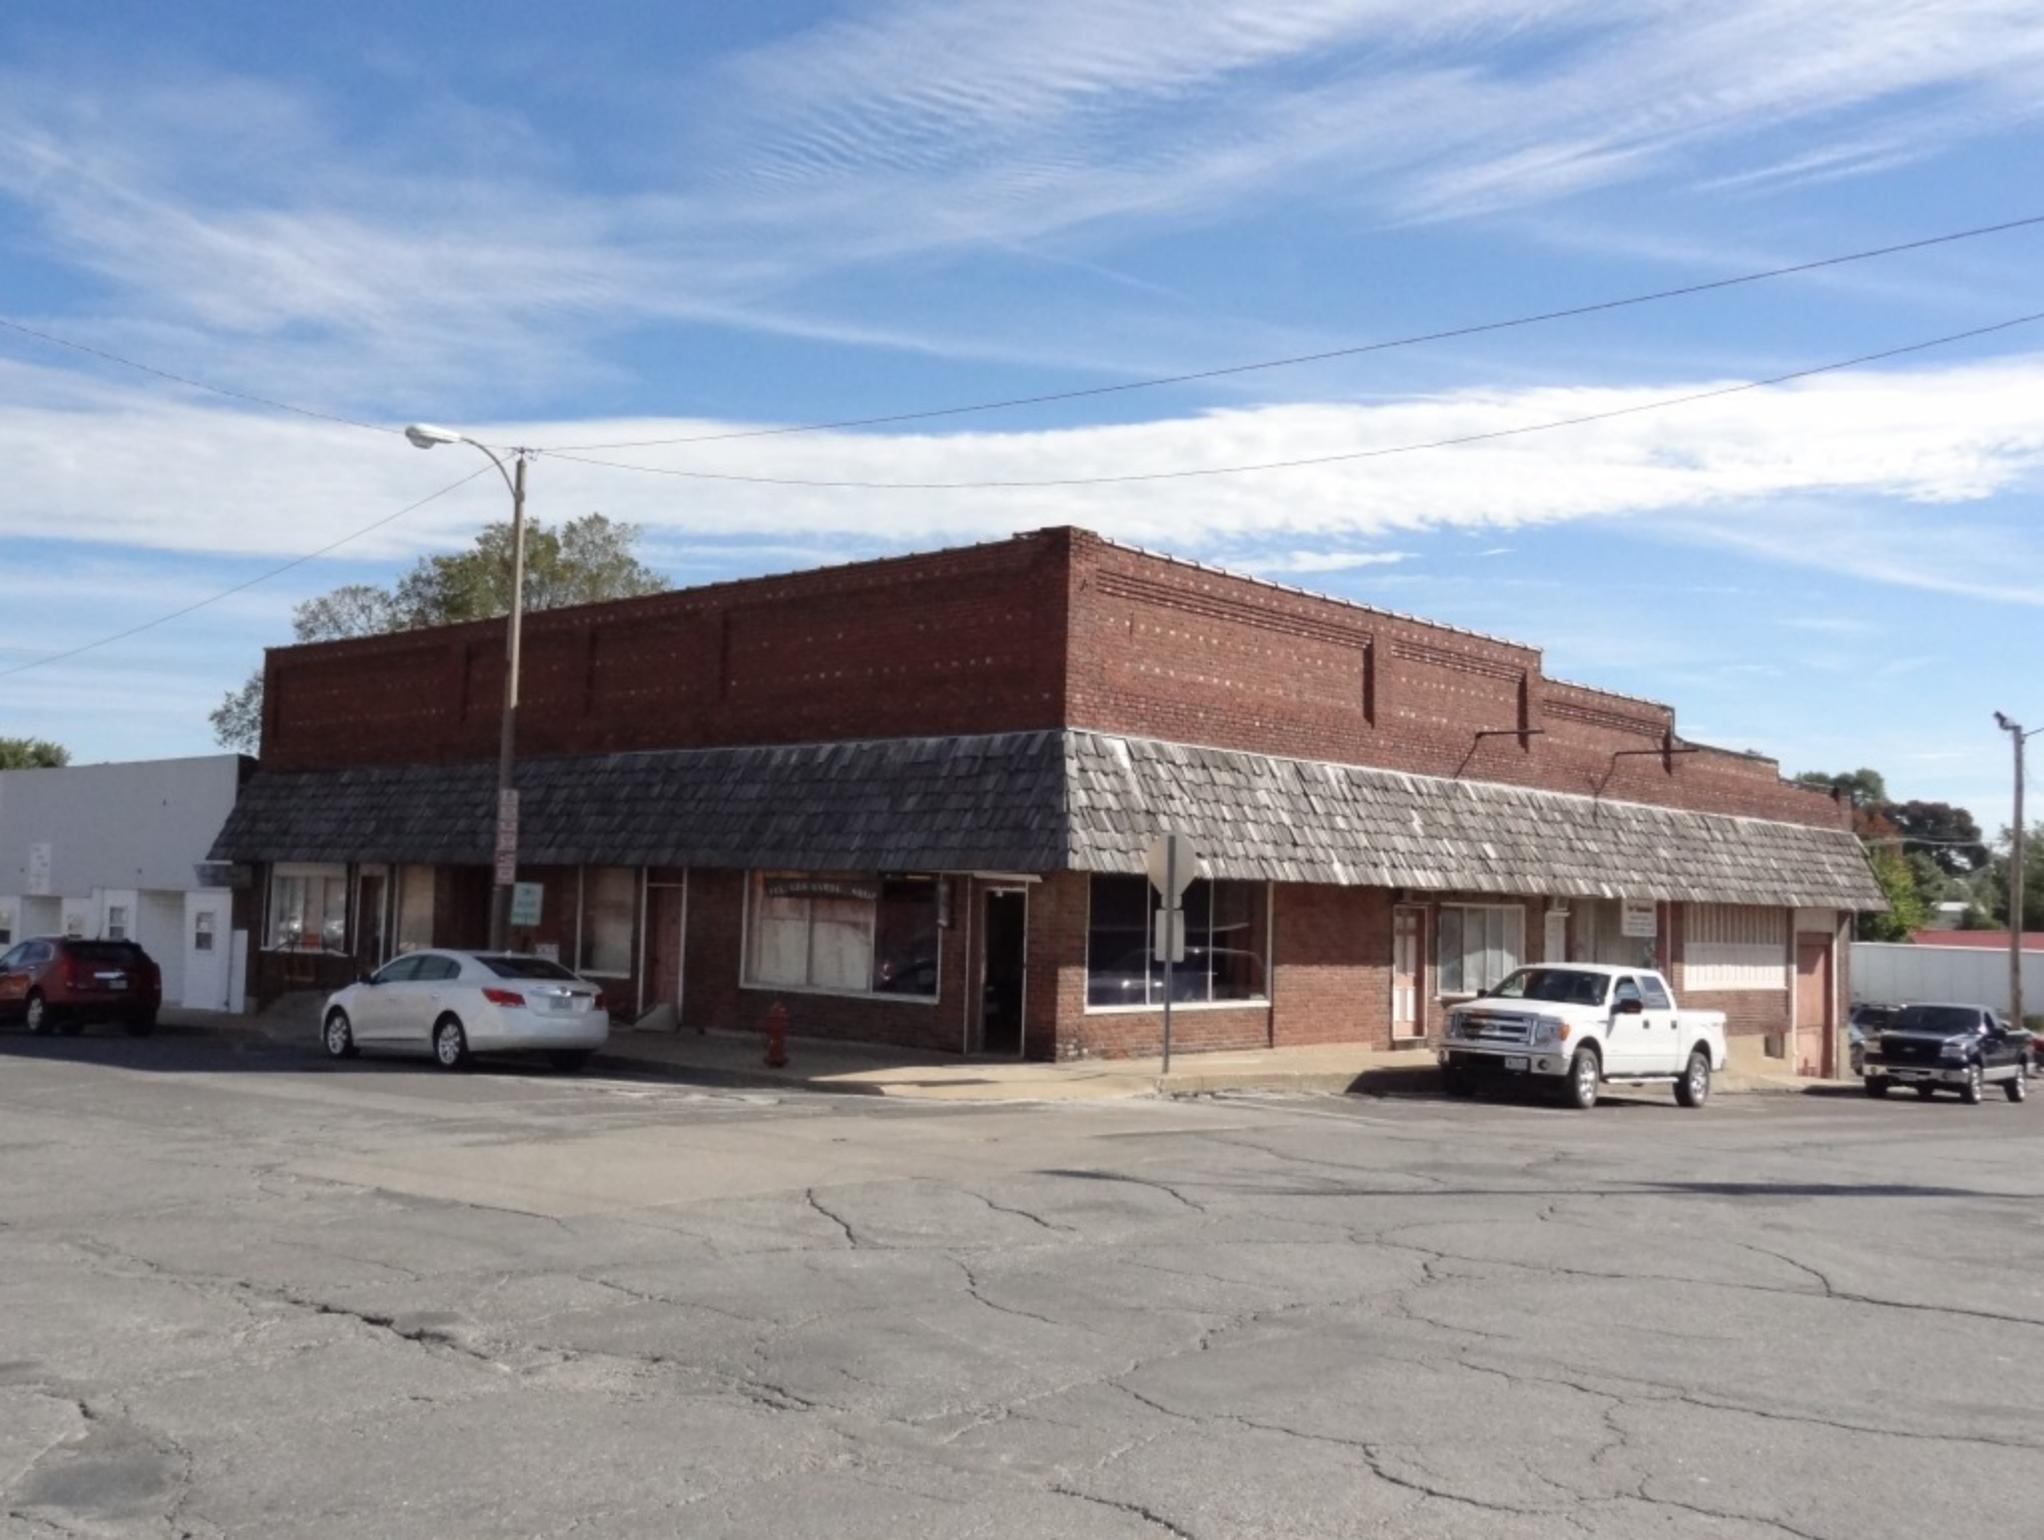
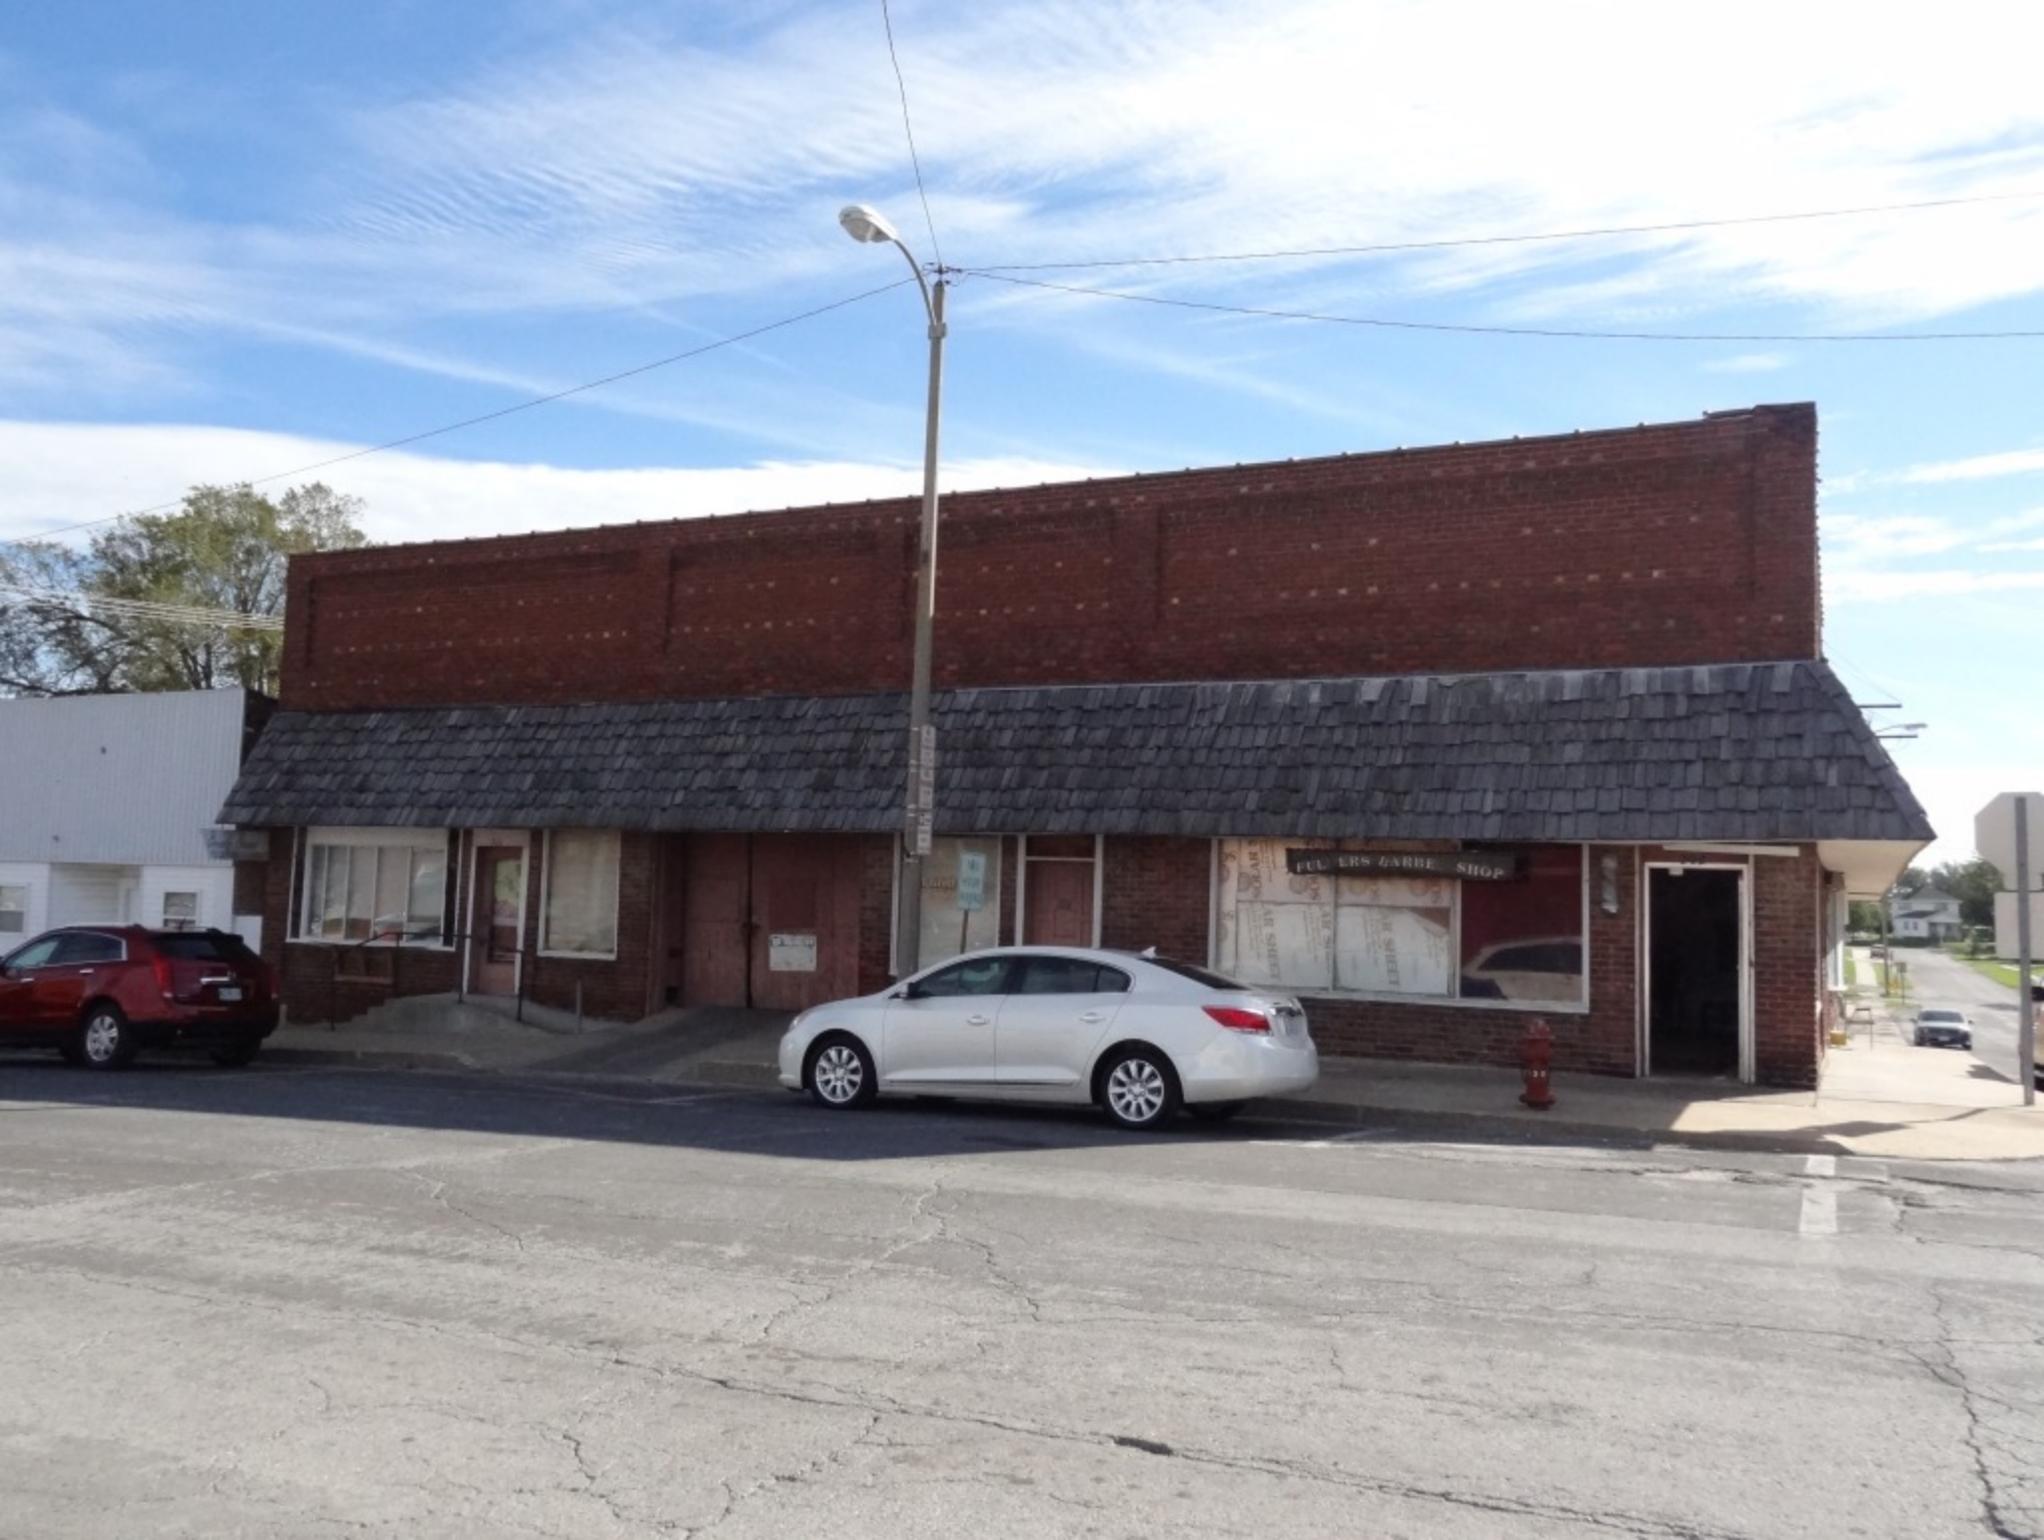
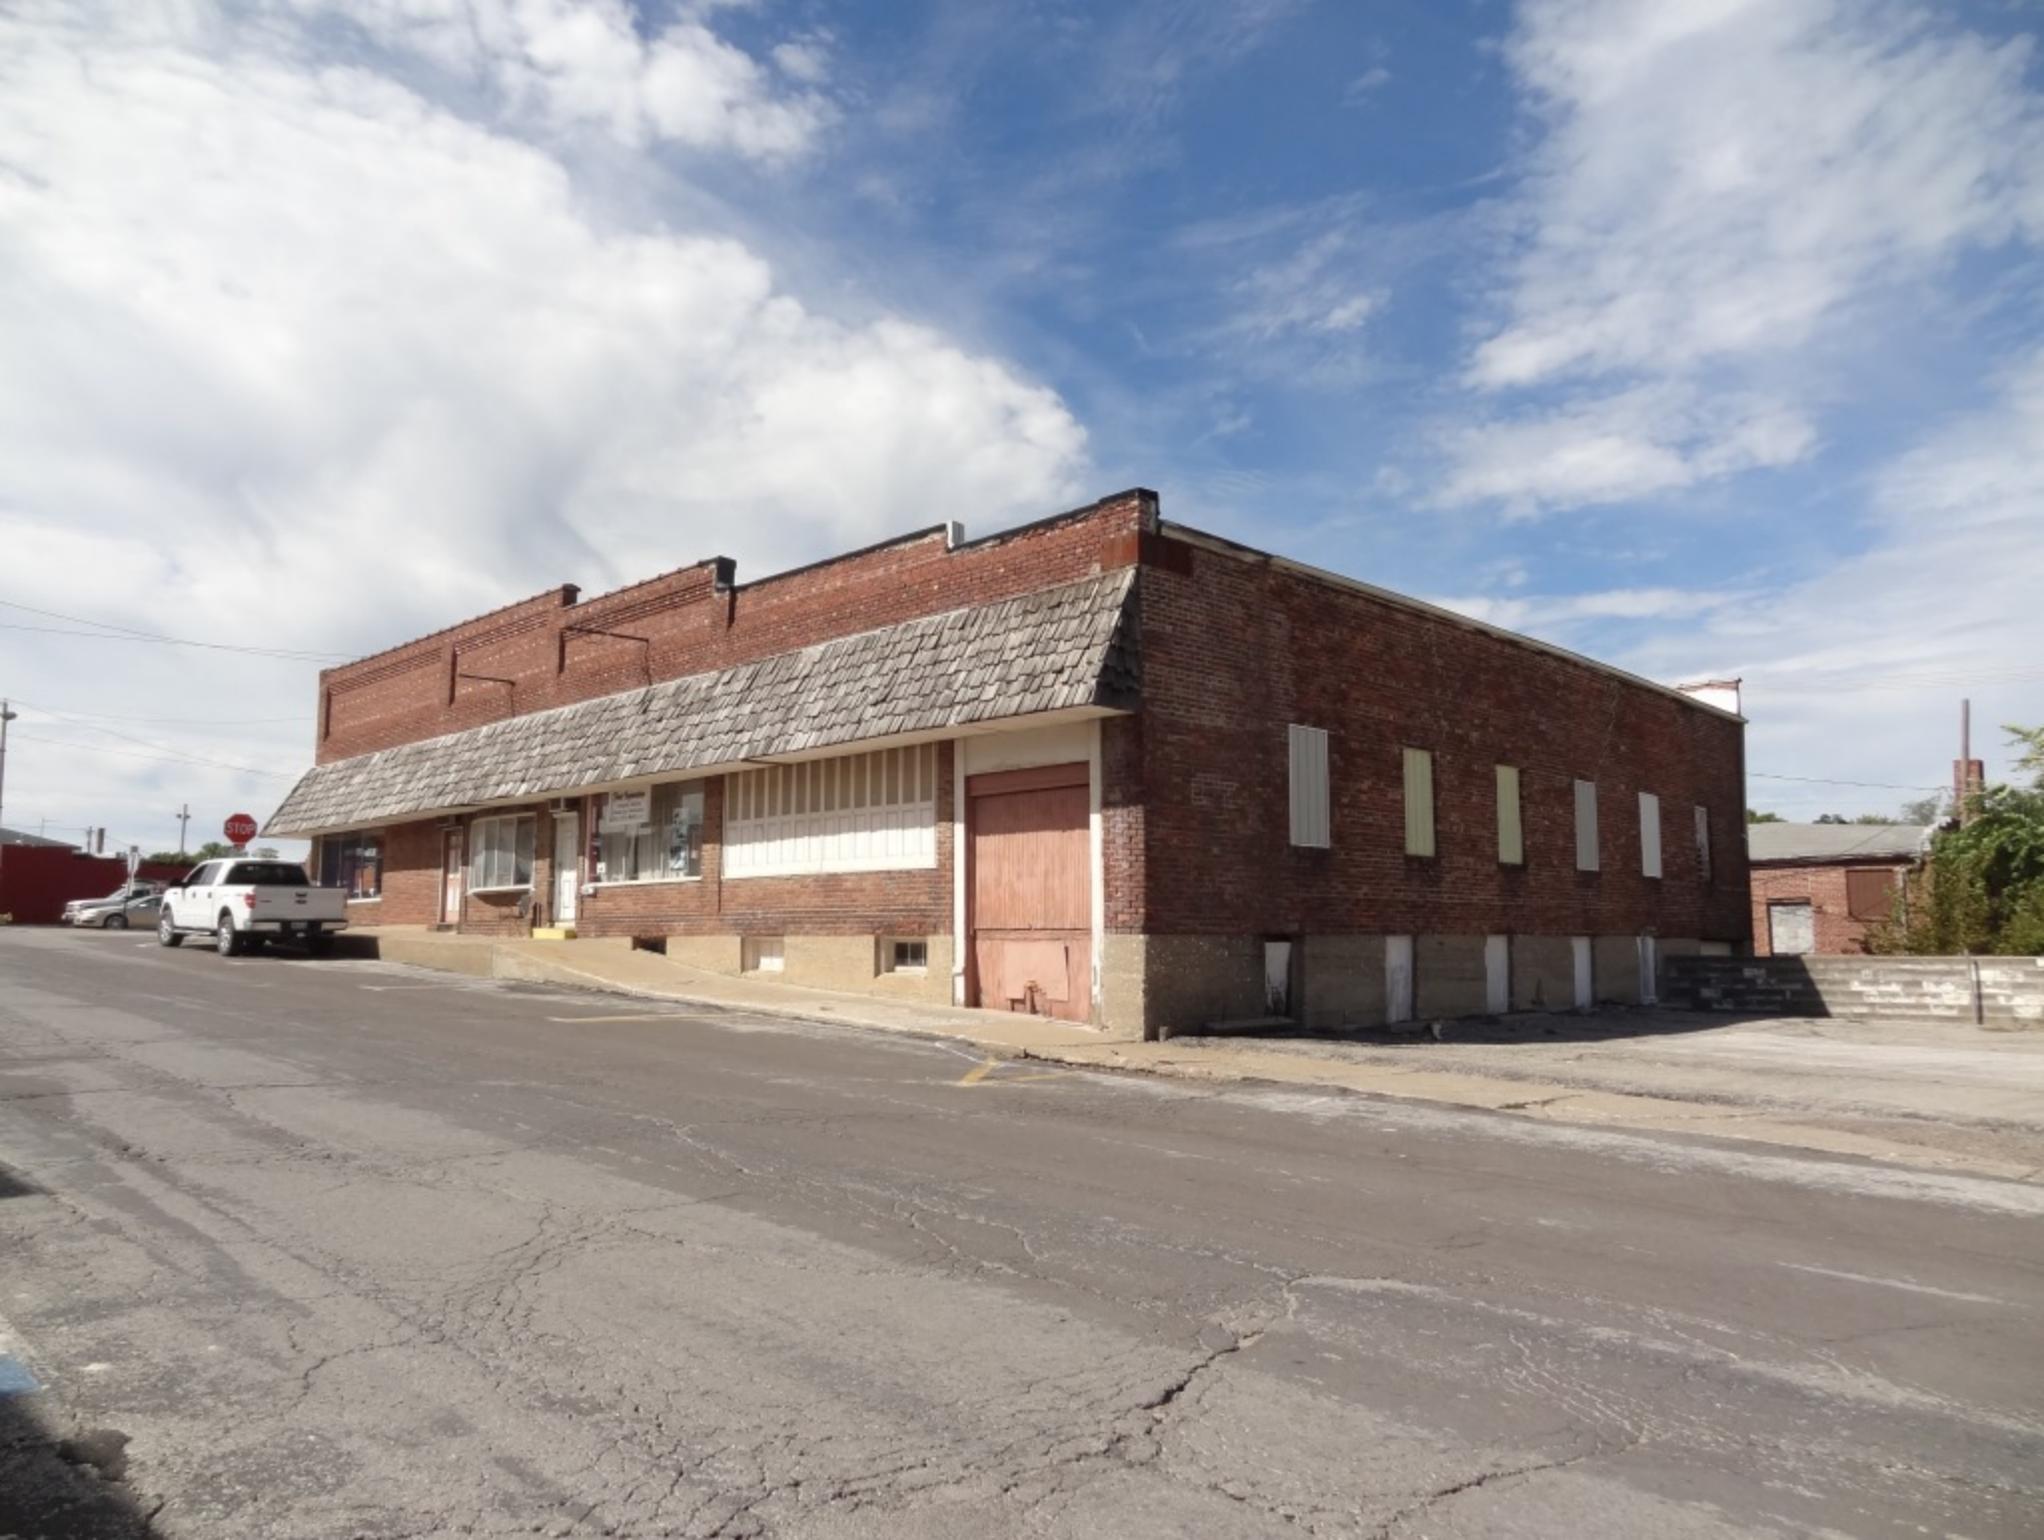
The southern façade which faces East Bourke Street has a stepped parapet roof line and the elevation declines eastward. The façade also contains four bays following the four main openings and brick parapet panels. At the west end of the façade is a set of three large rectangular fixed wood sash panes allowing the 202 North Rubey Street business to view East Bourke Street. Right of this bay is the second bay which includes a vinyl paneled door and a contemporary five fixed pane wood bay window with an inset brick bulkhead. Right is the third bay (203 East Bourke Street), which includes a vinyl paneled door and a set of three large rectangular fixed wood sash panes. The entry has a concrete step stoop. At this bay a partial concrete basement is visible with three 3-pane wood sash windows across the rest of the façade. The fourth bay includes a large opening that is enclosed with wood paneling and a plywood panel covered automobile entry. A metal brace supports the cornice at the southeast corner of the building. The east elevation includes six bay composed of fiberglass enclosed windows except for the northernmost opening along its main floor which contains a single fixed wood sash pane. The basement level includes six plywood enclosed windows openings. A concrete block wall intersects the building between the fifth and sixth opening (northern end). An approximately four foot tall concrete block wall blocks the space between 208-210 and 202-206 North Rubey Streets. A brick exterior end chimney is located along the north façade.

The alterations appear to be the enclosure of the windows along the east elevation, modification of some of the windows on the facades, and the addition of the awning. Despite these alterations, the building retains enough historic fabric and its fenestration layout. Due to its location outside a potential National Register historic commercial district, the property's status has not been determined.

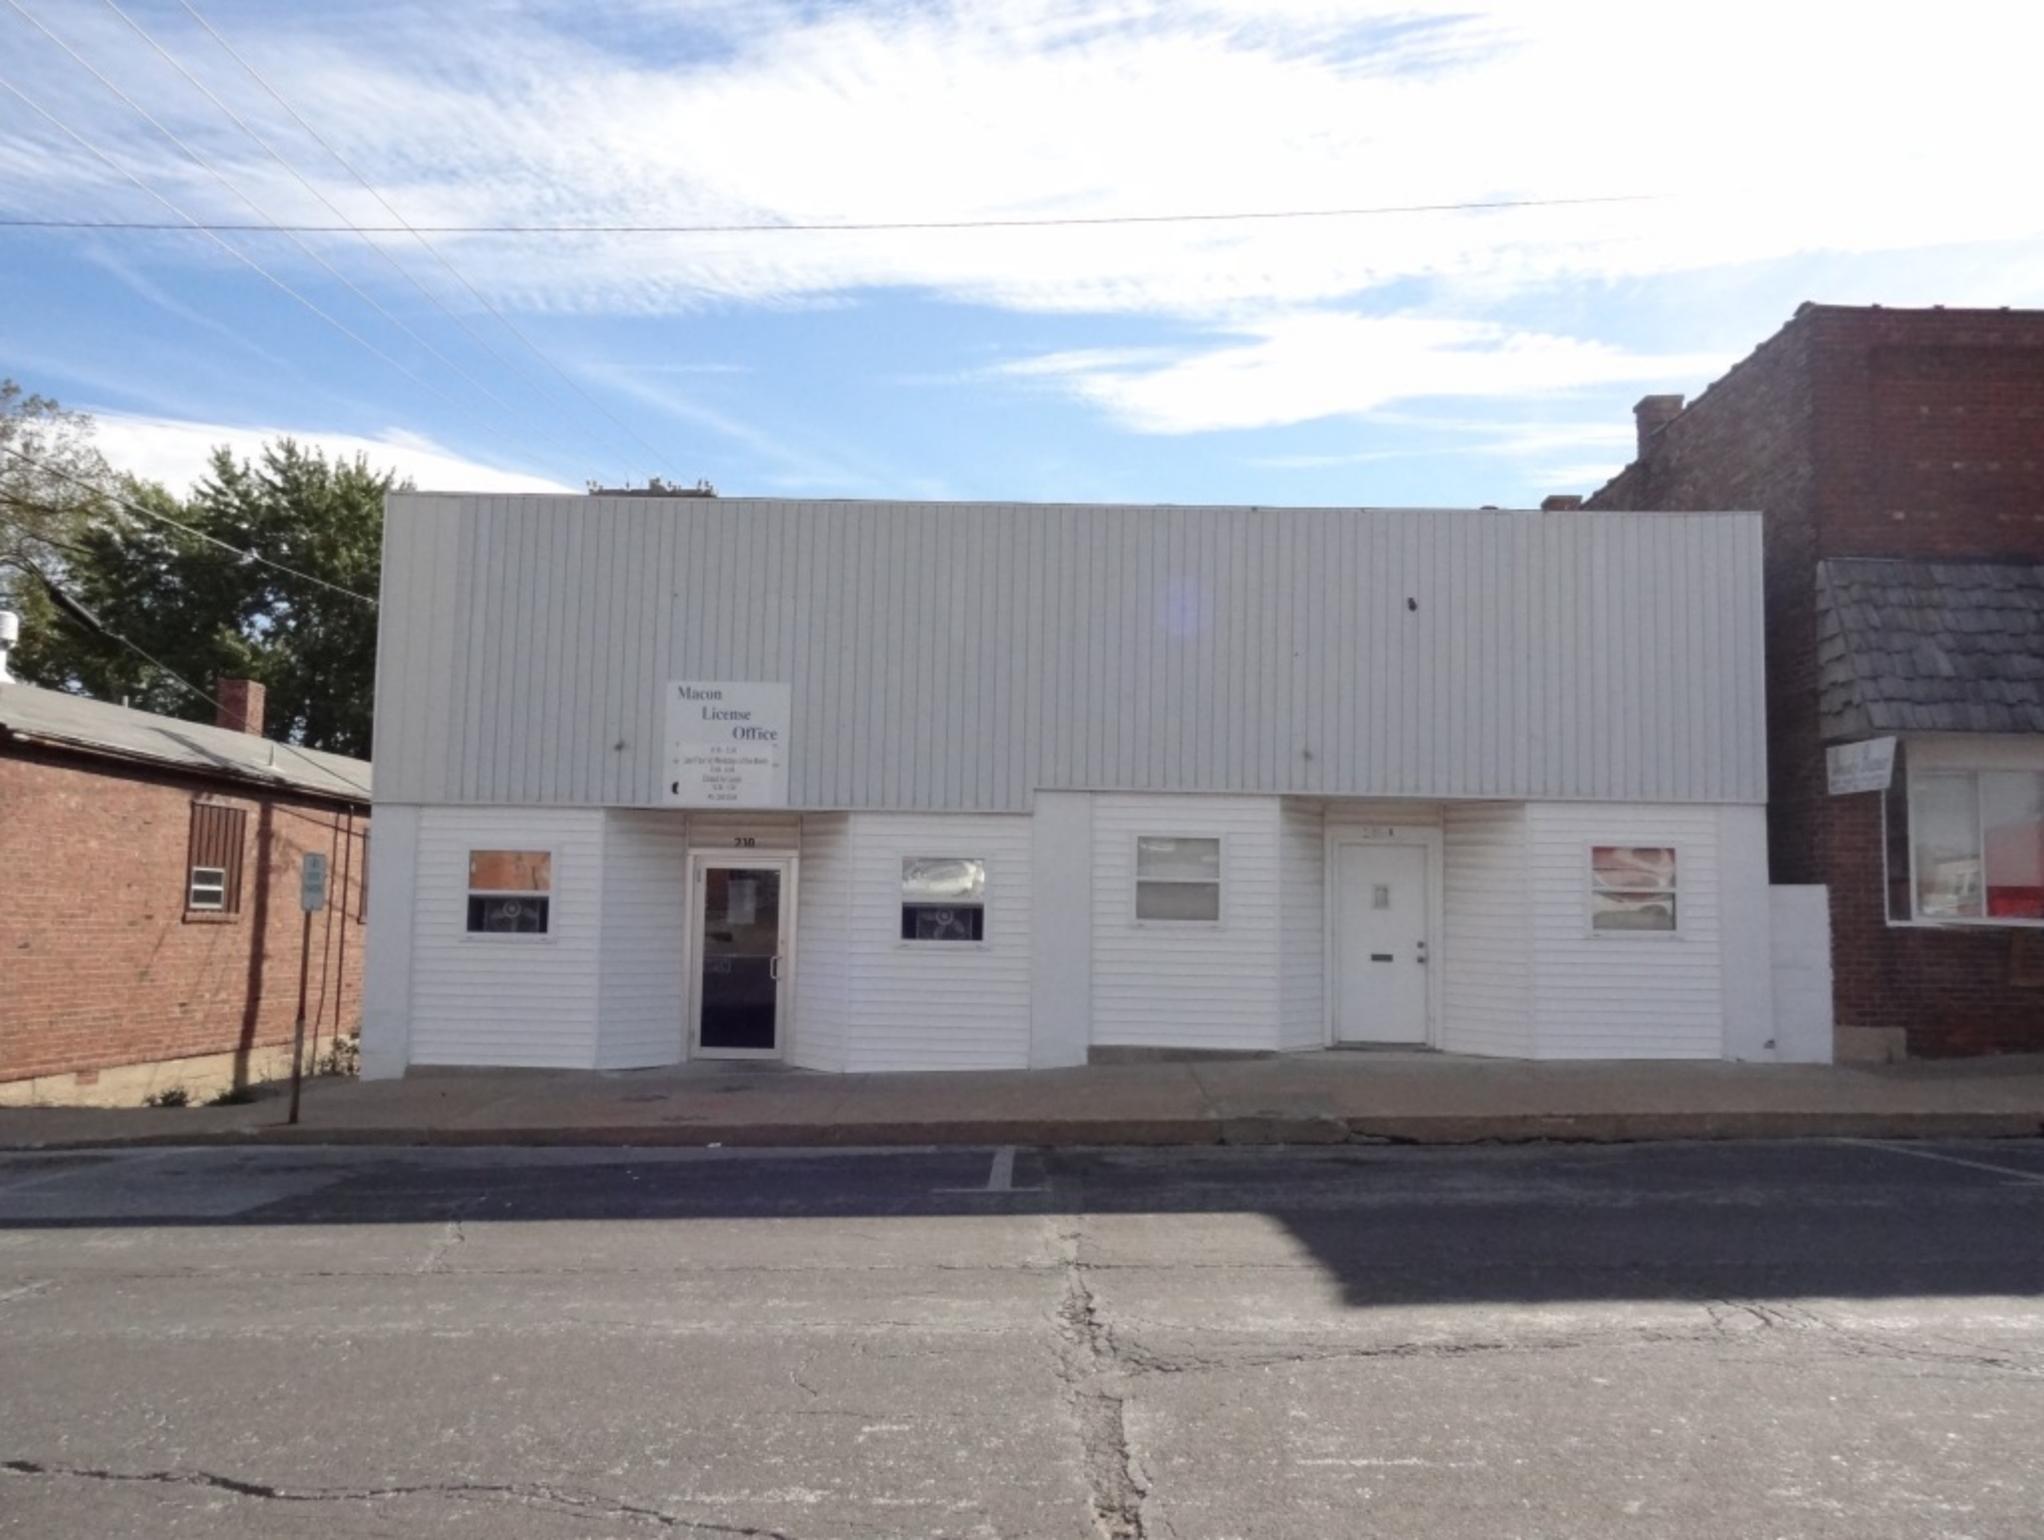
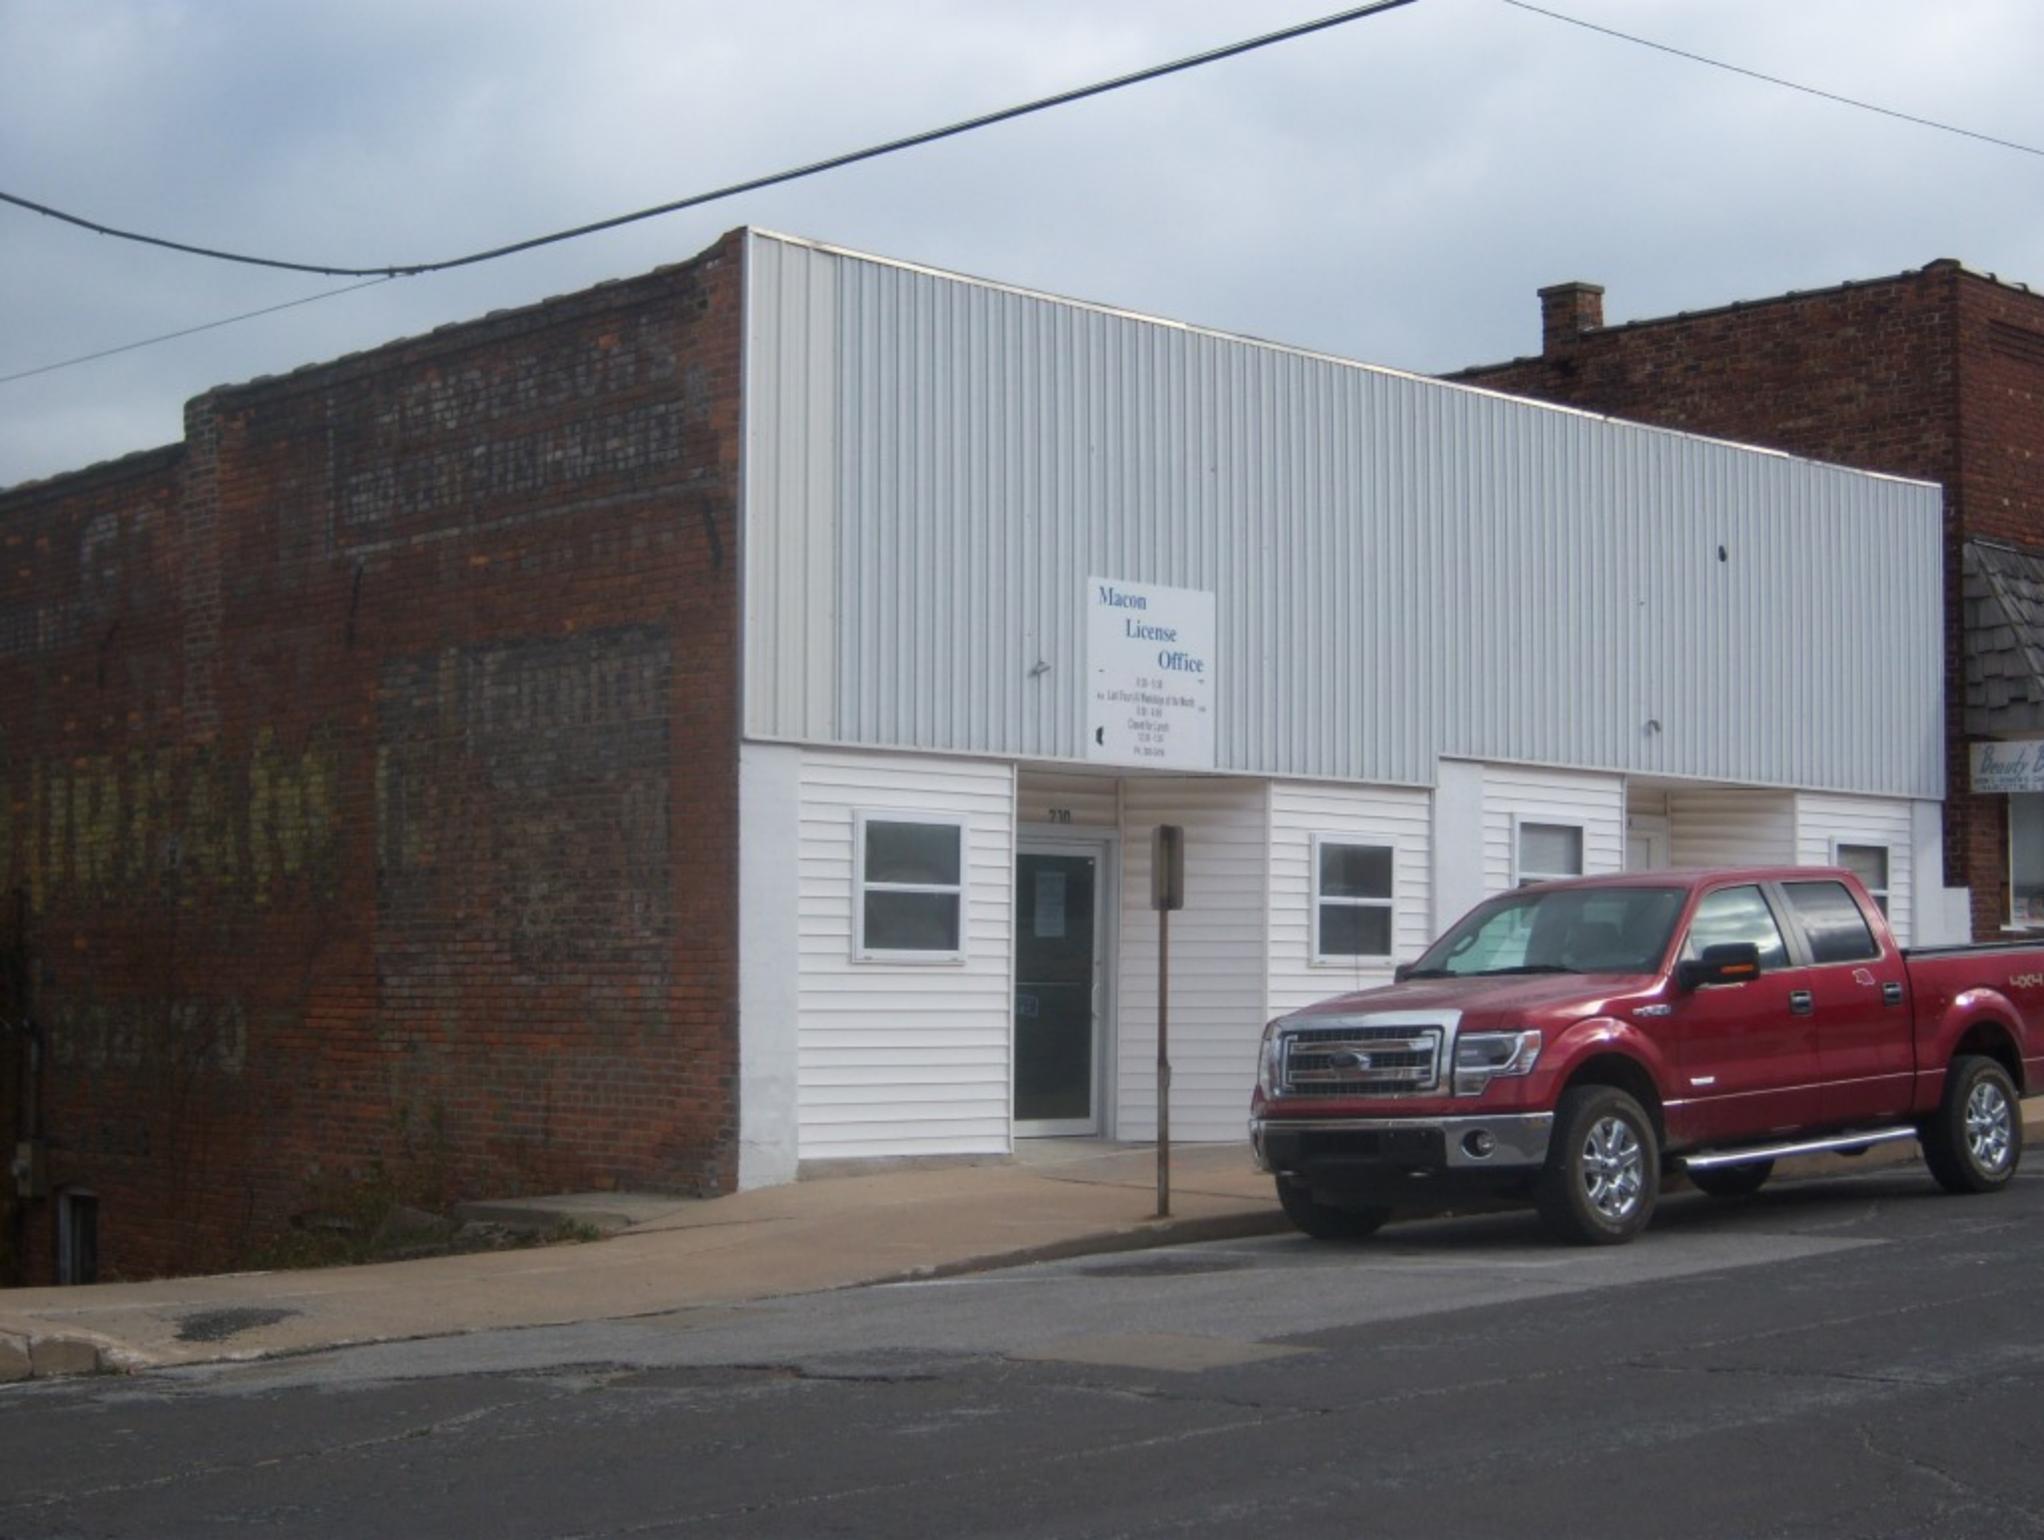
The one-part commercial block brick building is rectangular and contains a modified storefront façade. Vinyl siding is located on the lower half of the façade and corrugated metal siding covers the upper portion of the façade or parapet wall. The façade contains two bays or two storefronts. Each storefront consists of a central recessed entry flanked on either side by 1/1 vinyl windows. The door at 210 North Rubey Street is glass with metal surround. The door at 208 North Rubey Street contains a wood door with a small single fixed pane. An approximately four foot tall concrete block wall blocks the space between 208-210 and 202-206 North Rubey Streets. The brick structural material is visible along the building's north elevation. Remnants of painted advertisements are visible along the elevation including Henderson's Grocery & Fish market and a furniture ad. The elevation contains at least one window along the basement level. Visibility was difficult due to vegetation.

According to the Recorder of Deeds, the building received alterations in 1979, which may have included the modification of the storefront to include the vinyl and corrugated metal siding and vinyl windows. The property is located outside a potential National Register historic commercial district. These alterations have resulted in a loss of integrity, rendering the property not eligible.

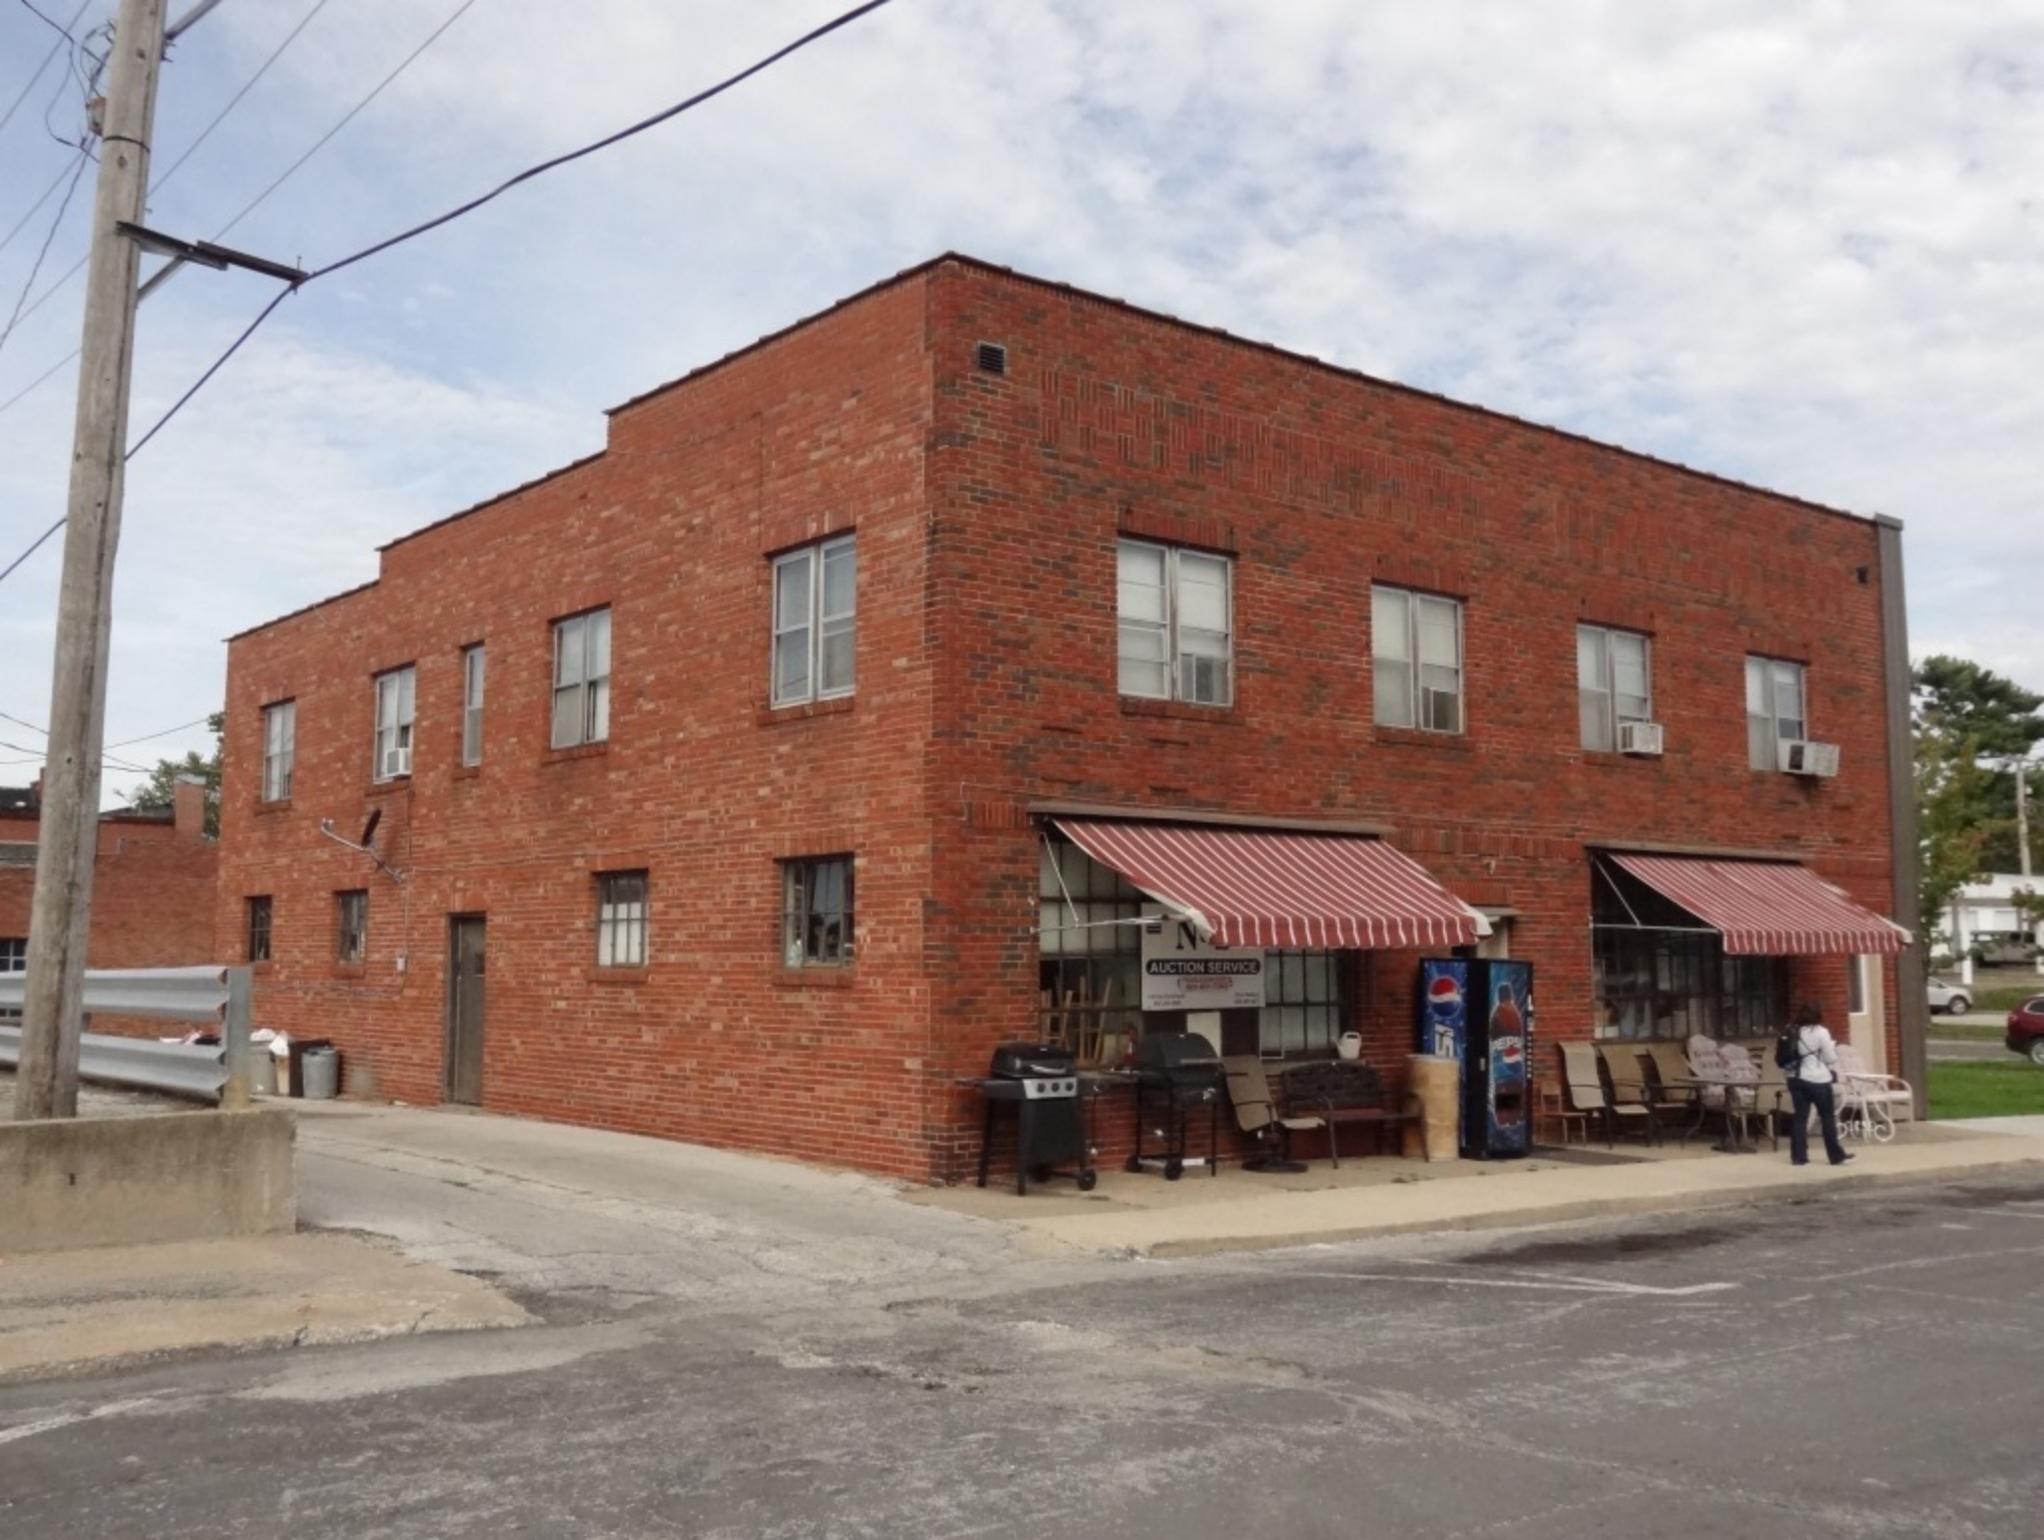
The variegated brick two-part commercial block building is rectangular and contains two bays or two storefronts. A darker brick composes the façade with the other elevations using lighter brick. Each storefront contains a large multi-pane metal sash window and a side entry door with concrete step. Fabric awnings top each window. The first door (left) contains a wood door with a large fixed pane. The second door (right) includes vinyl door with a fixed pane. Stretcher jack arch lintels and header sills frame the window openings. A stretcher course divides the floors. The second floor contains four paired one-over-one double-hung wood sashes with storm windows. Two long rectangular brick geometric patterns line the upper façade. A string of headers top the façade with metal coping. A brick interior chimney is located in the center of the building. The south elevation includes five bay openings; a center wood door flanked on each side by two multi-pane metal windows on the first floor. The second floor contains a center one-over-one double hung wood window flanked on each side by two paired one-over-one double-hung sash windows. This elevation includes a stepped parapet topped with metal coping. The north elevation includes metal siding across both stories with concrete along the foundation.

Alterations were completed in 1982 according to the Recorder of Deeds and may have involved the addition of metal siding to the building's north elevation, possibly when the buildings on lots 1 and 2, north of the property were removed. Despite alterations, the building retains enough historic fabric to have retained its integrity. Due to its location outside a potential National Register historic commercial district, the property status has not been determined.
