1. Survey No. MC-AS-001-001		2. Survey name: Downtown Macon Commercial Historic District	
3. County: Macon		4. Address (Street No.) Lots 11-13 block 93	Street (name) East Bourke Street (100 block)
5. City: Macon	Vicinity: <input type="checkbox"/>	6. Geographical Reference:	7. Township/Range/Section: T: R: S:
8. Historic name (if known):		9. Present/other name (if known): City of Macon Parking Lot #3	
10. Ownership: <input checked="" type="checkbox"/> Private <input type="checkbox"/> Public		11a. Historic use (if known): Commercial	11b. Current use: vacant

42. Current owner/address: City of Macon Macon, MO 63552	43. Form prepared by (name and org.): Kristi Chase MO SHPO	44. Survey date: 9/24/2014
		45. Date of revisions:

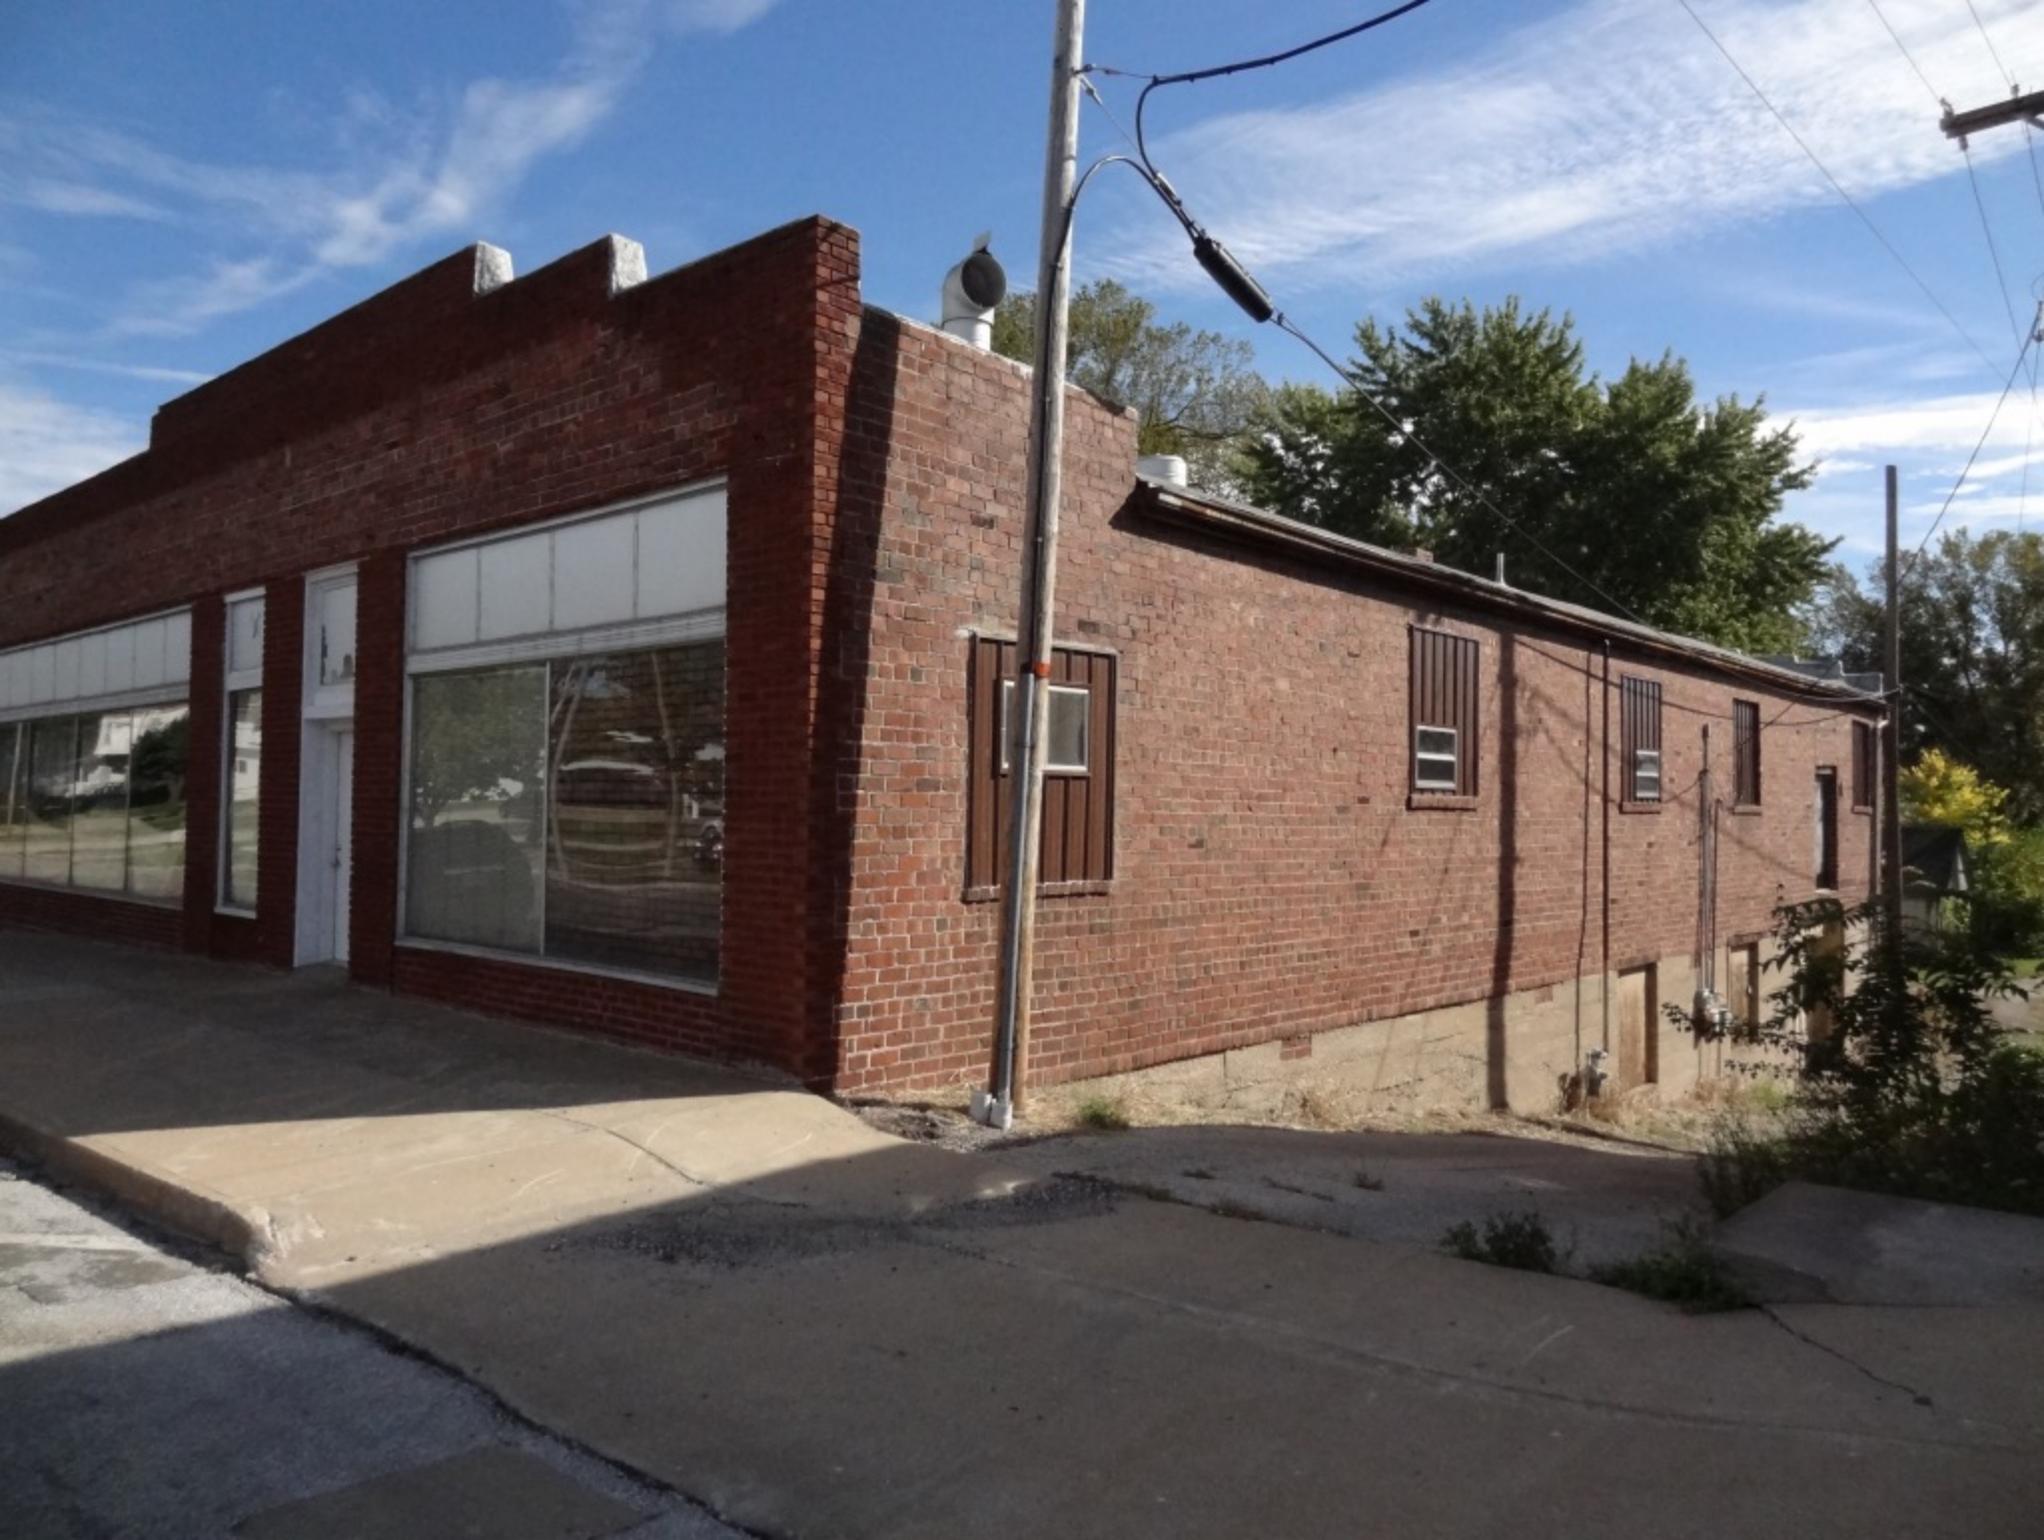
This common brick bonded Boomtown Front building is rectangular with a small wing on its north elevation that includes two garage door bays facing Butler Street. The building has a concrete foundation and basement which is visible along the side elevations as the ground slopes away from Rubey Street. The façade includes four bays and from left to right is composed of a two window storefront with a side entry (1), a vinyl garage door opening (2), a five window storefront with small single window (3), and a side entry with a two window storefront (4). The first bay includes a set of two large rectangular fixed pane opening with one of the panes replaced with plywood. Above the opening is an enclosed transom. A vinyl door with a fixed pane and a concrete stoop steps down onto the street. The third bay includes a series of five large rectangular fixed window panes below an enclosed transom and a small rectangular fixed pane window below an enclosed transom. The fourth bay includes a wood door with enclosed transom and a set of two large rectangular fixed window panes below an enclosed transom. It appears some repointing may have occurred above the transoms within the brick (ghost) and the stepped parapet gives the building its boomtown appearance.

The rear elevation (east) includes ten multiple pane metal windows along the first floor and nine window openings along the basement level. The majority of these basement windows have been bricked up or enclosed with vinyl siding. Only the two end windows contain their multiple metal panes. A rear interior chimney is along the rear elevation between the third and fourth bay. The elevation's parapet gives a stepped appearance. The north elevation includes the two garage door openings, a flat roof capped with metal coping. A brick chimney is located at the interior end of the north elevation and the building at 214 North Rubey Street covers the remaining of the elevation of 212 North Rubey Street.

According to the Recorder of Deeds, the building received alterations in 1981 and may consist of the enclosed transoms and vinyl garage door on the facade. Despite alterations, the building retains enough historic fabric to have retained its integrity. Due to its location outside a potential National Register historic commercial district, the property's status has not been determined.

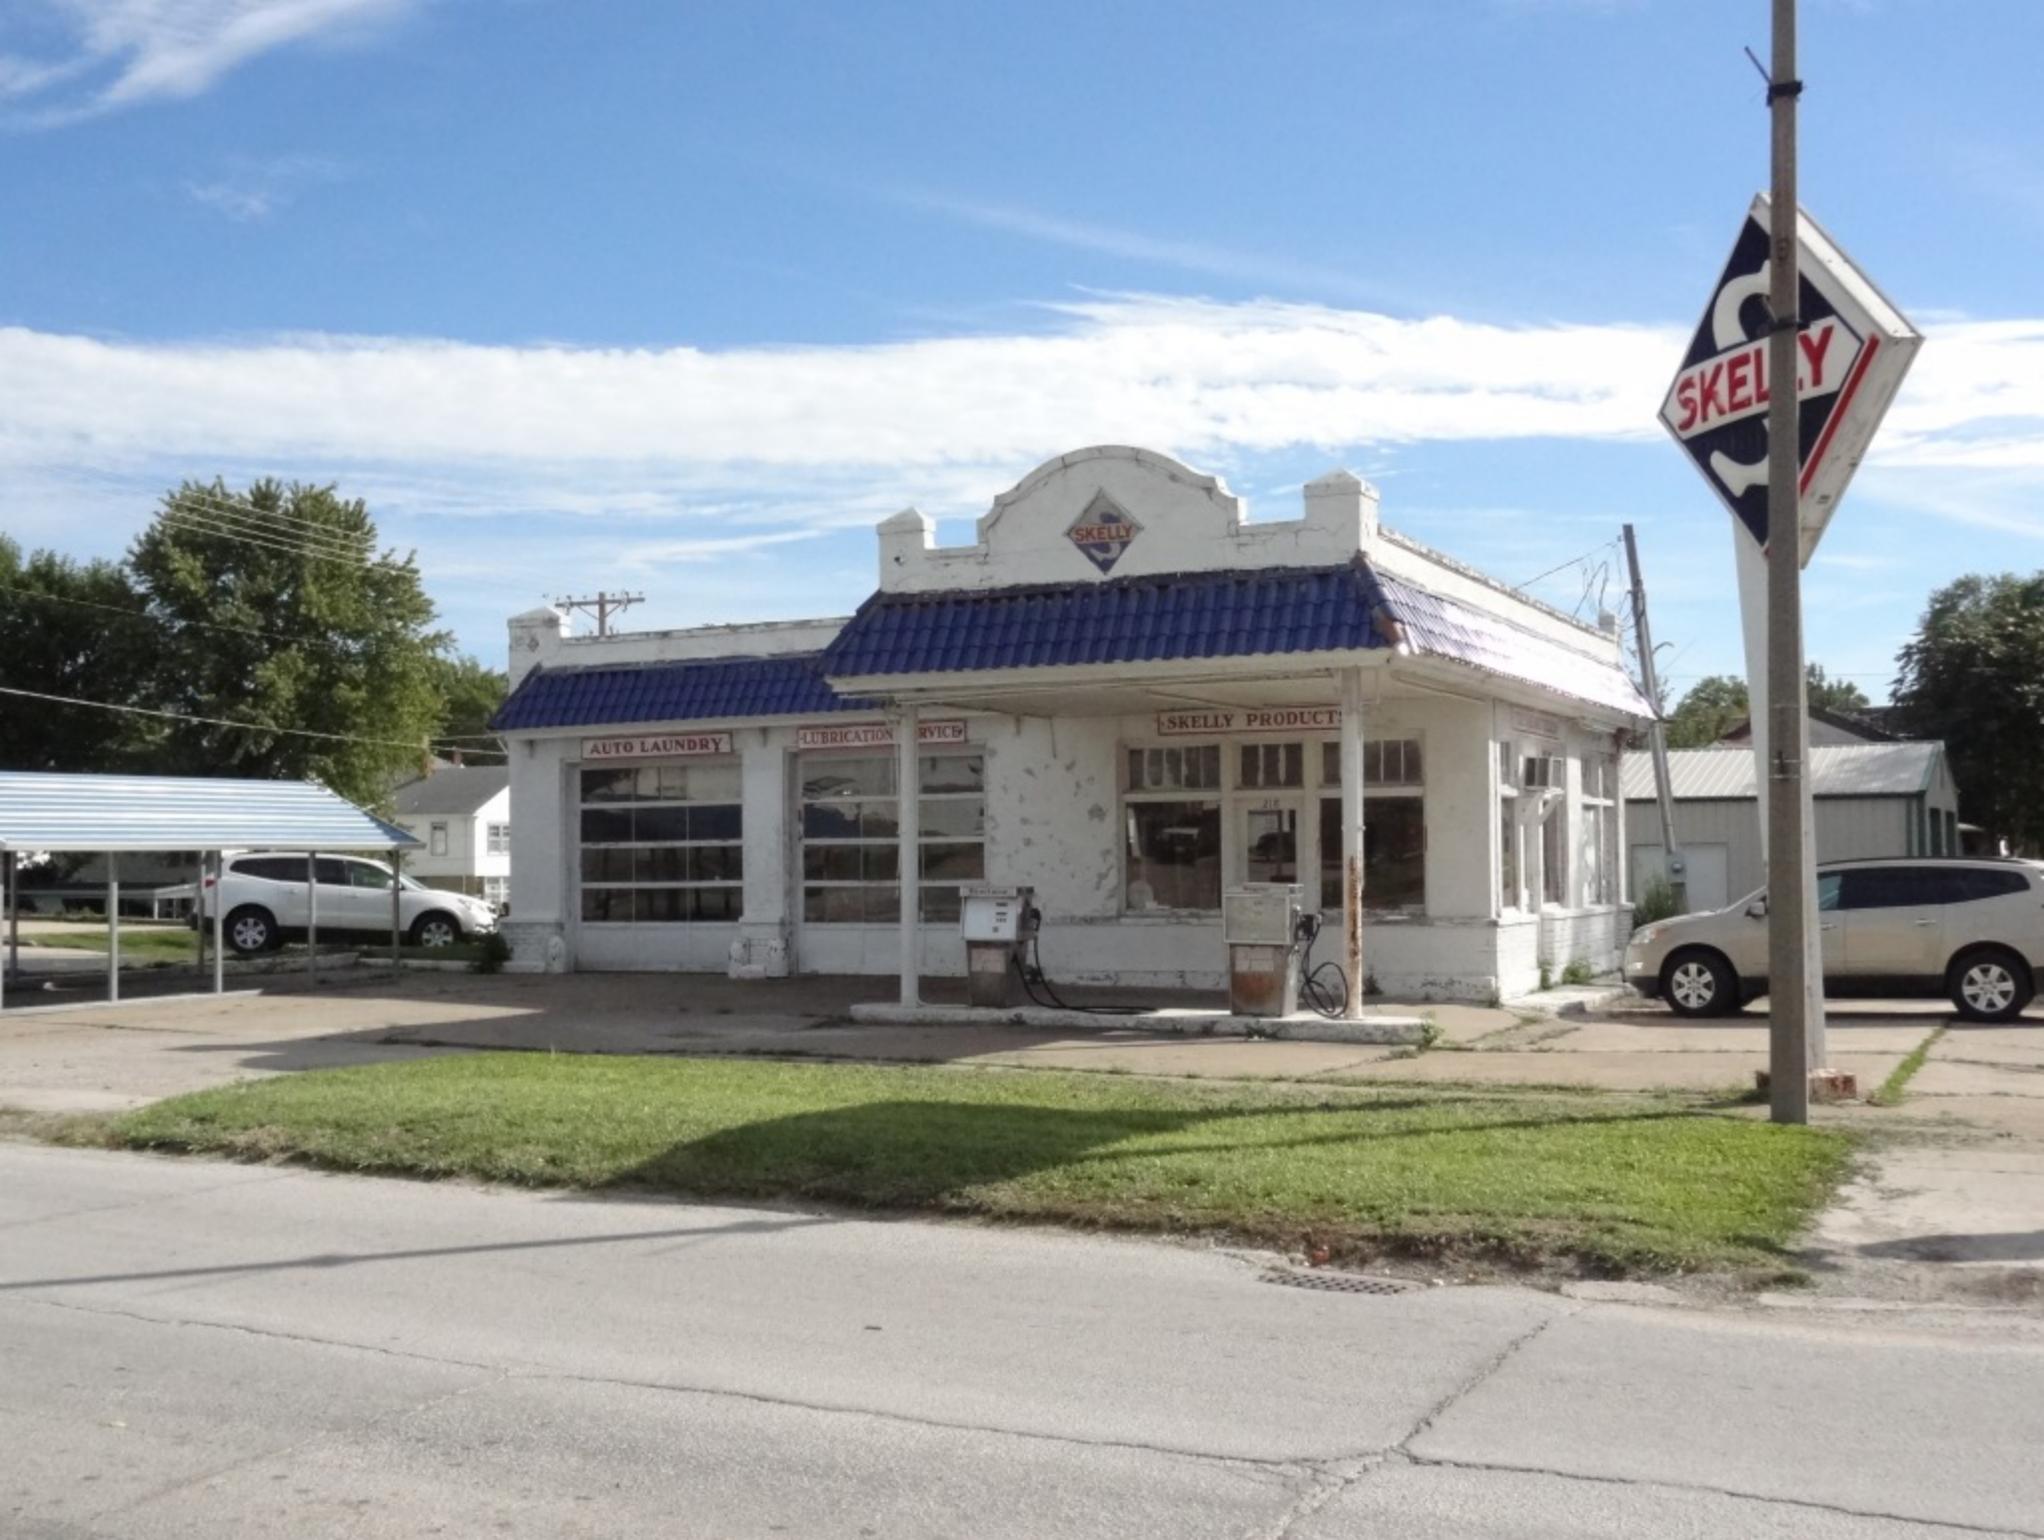
The service station building is rectangular with a projecting canopy at the southwest portion of the façade. Composed of a brick water table and concrete block walls, the building contains a concrete foundation. The façade includes five bays. The left side of the façade includes two glass and wood garage doors. Concrete buffers are located at the base of each garage door opening. The rest of the façade includes a large fixed display window with a five light transom at bays 3 and 4 and a wood panel door with fixed light and a three light transom. Above bays 4-6, the canopy projects from the building's cornice and is supported by two cylindrical metal posts that sit on the concrete median that contain two fuel pumps. Along the west and south elevations, a tiled faux mansard awning projects from above the storefront and the parapet is castellated at the building's corners. A rounded projection from the parapet includes the Skelly logo. Signs "AUTO LAUNDRY," "LUBRICATION SERVICE," and "SKELLY PRODUCTS" are above the garage doors and office entry. The north elevation depicts the brick water table and concrete wall with a small six light window at the northeast corner of the elevation. It appears the upper portion of the elevation has been stuccoed and there is damage along the upper parapet.

The south elevation includes five bays and a concrete curb at its base. Bays 1 and 3 each consist of a large display window with a four light transom. Bay 2 contains a wood paneled door with a fixed light and an enclosed transom occupied by an air conditioning unit. Bay 4 contains a slightly larger fixed display window and a six light transom and bay 5 contains a wood paneled door with a fixed light and a three light transom. A sign "TIRES & BATTERIES" is located above bays 1-3.

Due to this property having retained much of its historic materials and appearance, the building may be individually eligible.

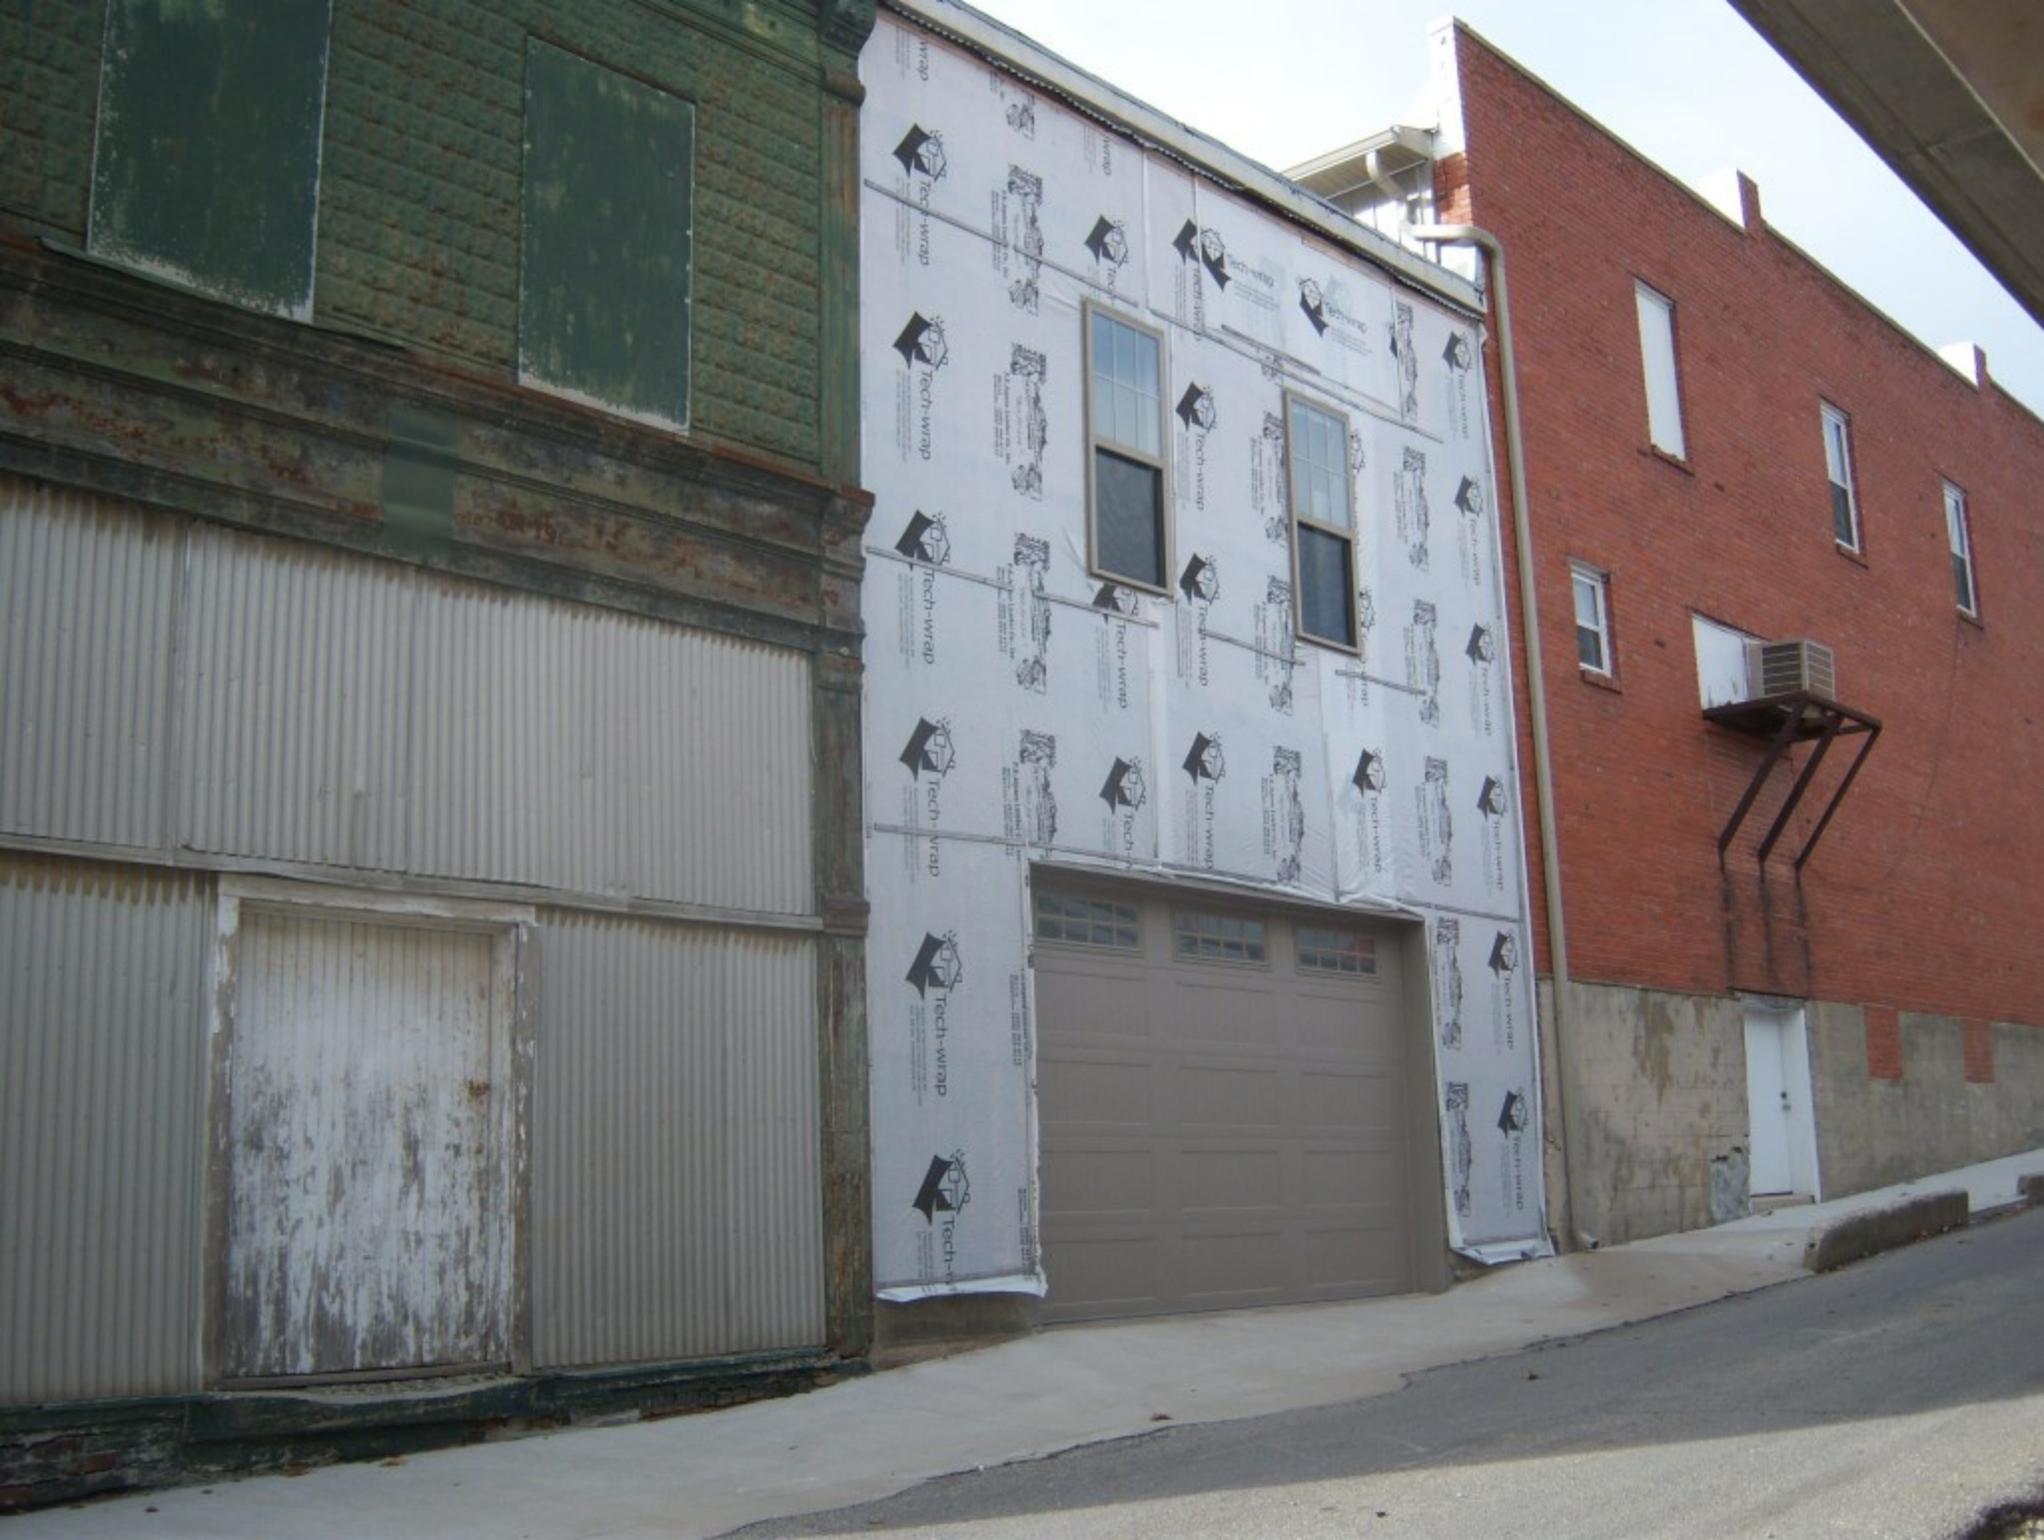
The two-part commercial block brick building at 8 South Rubey Street is a rectangular shaped building one bay wide with a flat roof. The façade is covered with tech-wrap and the first floor consists of a single bay of a modern two-car vinyl garage door. The second floor consists of two modern 1/1 double-hung vinyl sash windows.

Alterations may have occurred c.1955 according to the Recorder Deeds. Recent alterations appear to have included tech-wrap siding and a vinyl garage door and windows. These alterations have resulted in a loss of architectural integrity, rendering 8 South Rubey Street non-contributing to a potential National Register historic district.

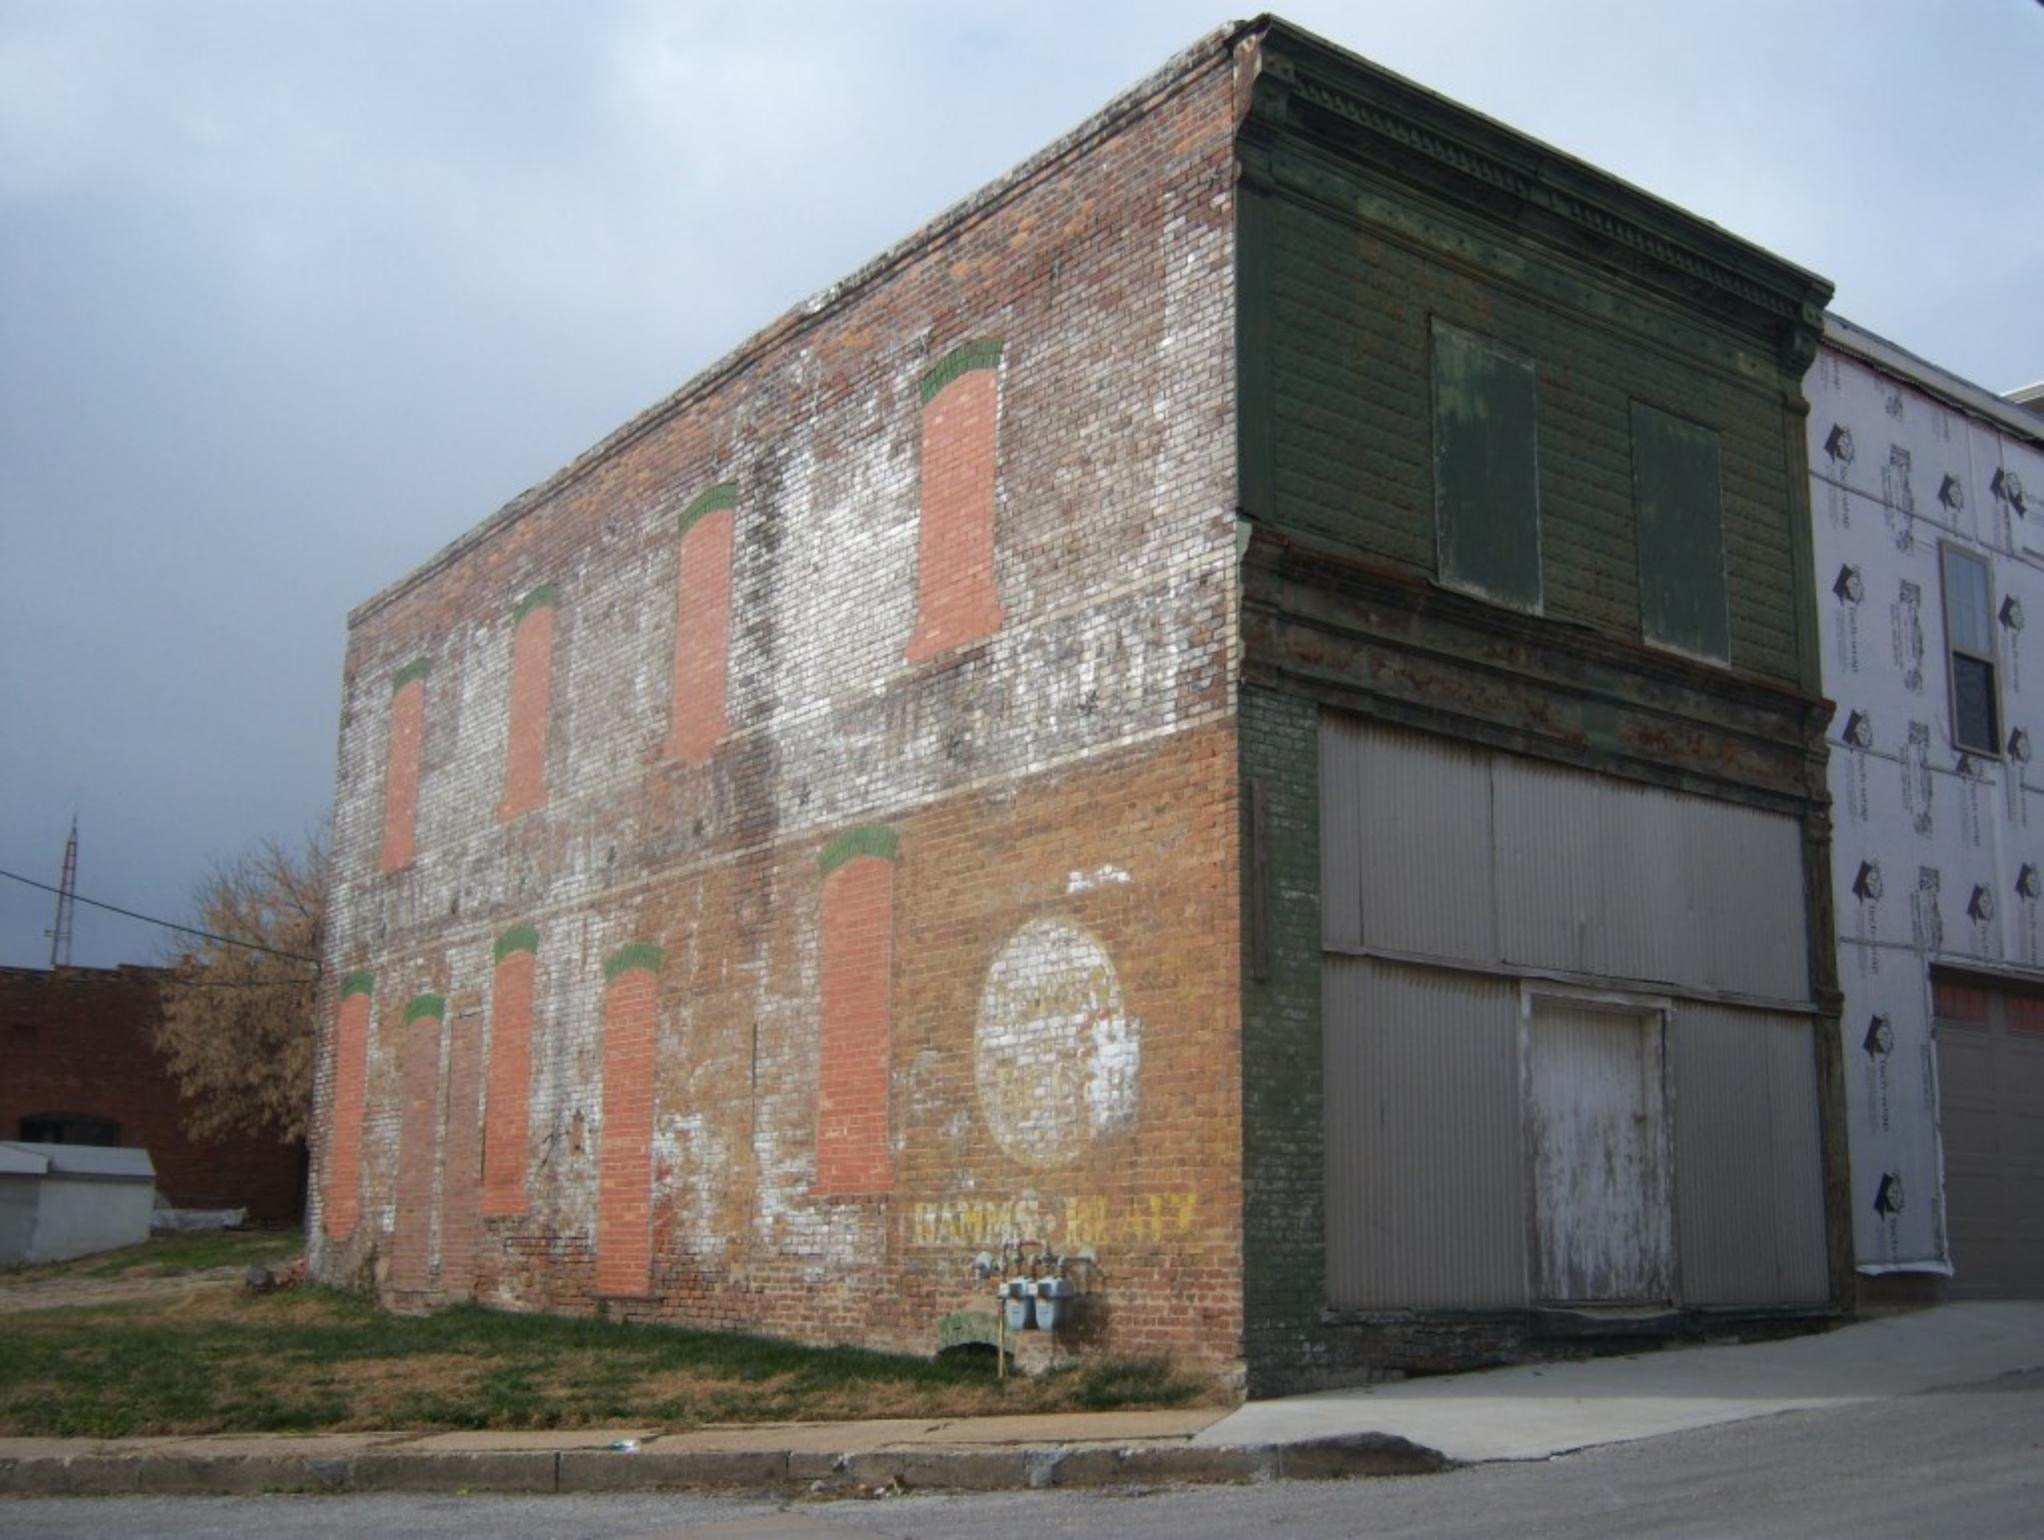
The two-part commercial block brick building at 10 South Rubey Street is a corner rectangular building three bays wide with a flat roof. The first floor consists of a boarded up store front: corrugated metal bays flank a plywood center entry. Corrugated metal covers up what may have been transom lights on the first floor. The second floor is two bays wide of enclosed windows and metal façade. The metal façade includes a plain entablature at the storefront cornice, imitated stone tiles and decorative building cornice with dentils and scrollwork. On the south elevation the common brick bond is visible. The elevation's first floor includes four enclosed window bays with arched brick lintels except for the third bay (from the left). Remains of painted advertising about "BARBQ & BEER" along with "HAMM'S MAIZ (sp.)" survive. The second floor includes four enclosed window bays with arched brick lintels.

Alterations were done c.1955 according to the Recorder of Deeds. Despite the building being boarded up along the store front and second floor windows, 10 South Rubey Street is contributing to a potential National Register historic commercial district.

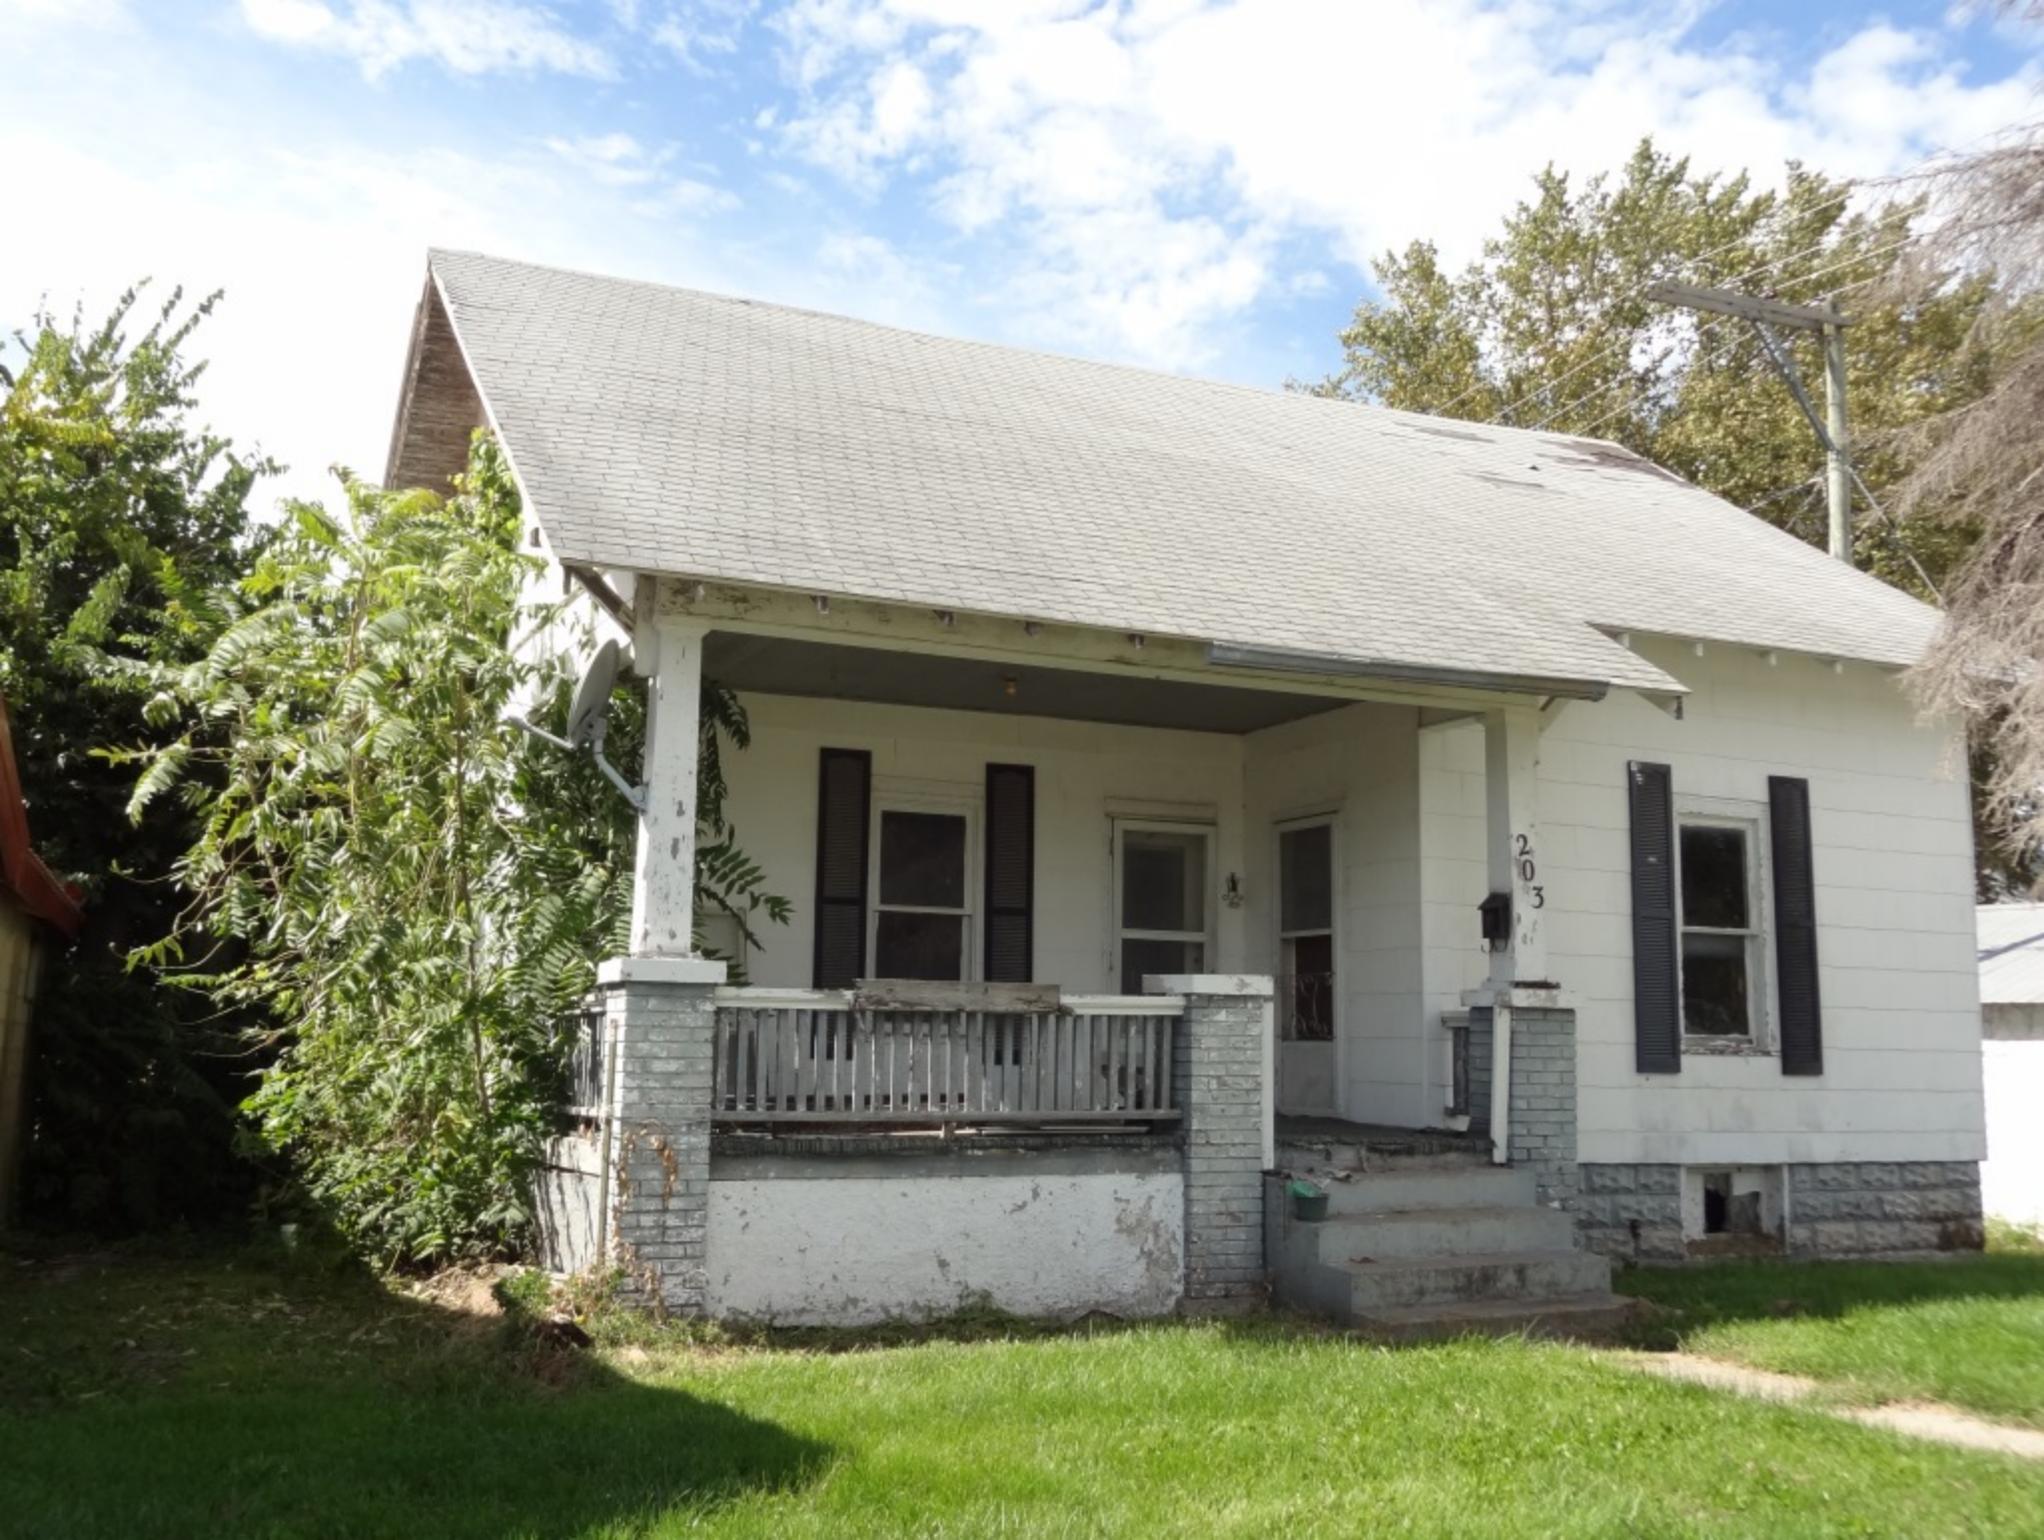
The one-and-half story asphalt side gable dwelling is L-shaped and contains three bays along its façade. Rafter tails are visible and the eaves contain knee braces. That dwelling sits on a full basement and the foundation is composed of ashlar block. Along the first floor façade, bays one and two are inset and include a window and an entry with a storm door. These bays open onto a partial shed roof porch with a wood deck. The roof and plain entablature are supported by slightly tapered square columns that rest on raised brick piers. The porch is wrapped with a plain square post balustrade. Concrete has filled in the space under the deck and concrete steps lead to the sidewalk. The third bay includes a slight projection with a window facing east on the first floor and a broken window opening along the basement level. On the west elevation of the wing, another door opens onto the porch.

Windows are one-over-one double-hung wood sash windows flanked by vinyl fixed shutters, except for the gable end which is mentioned above.

The property has retained its historic fabric, but due to its location outside a potential historic district, the property's status has not been determined.

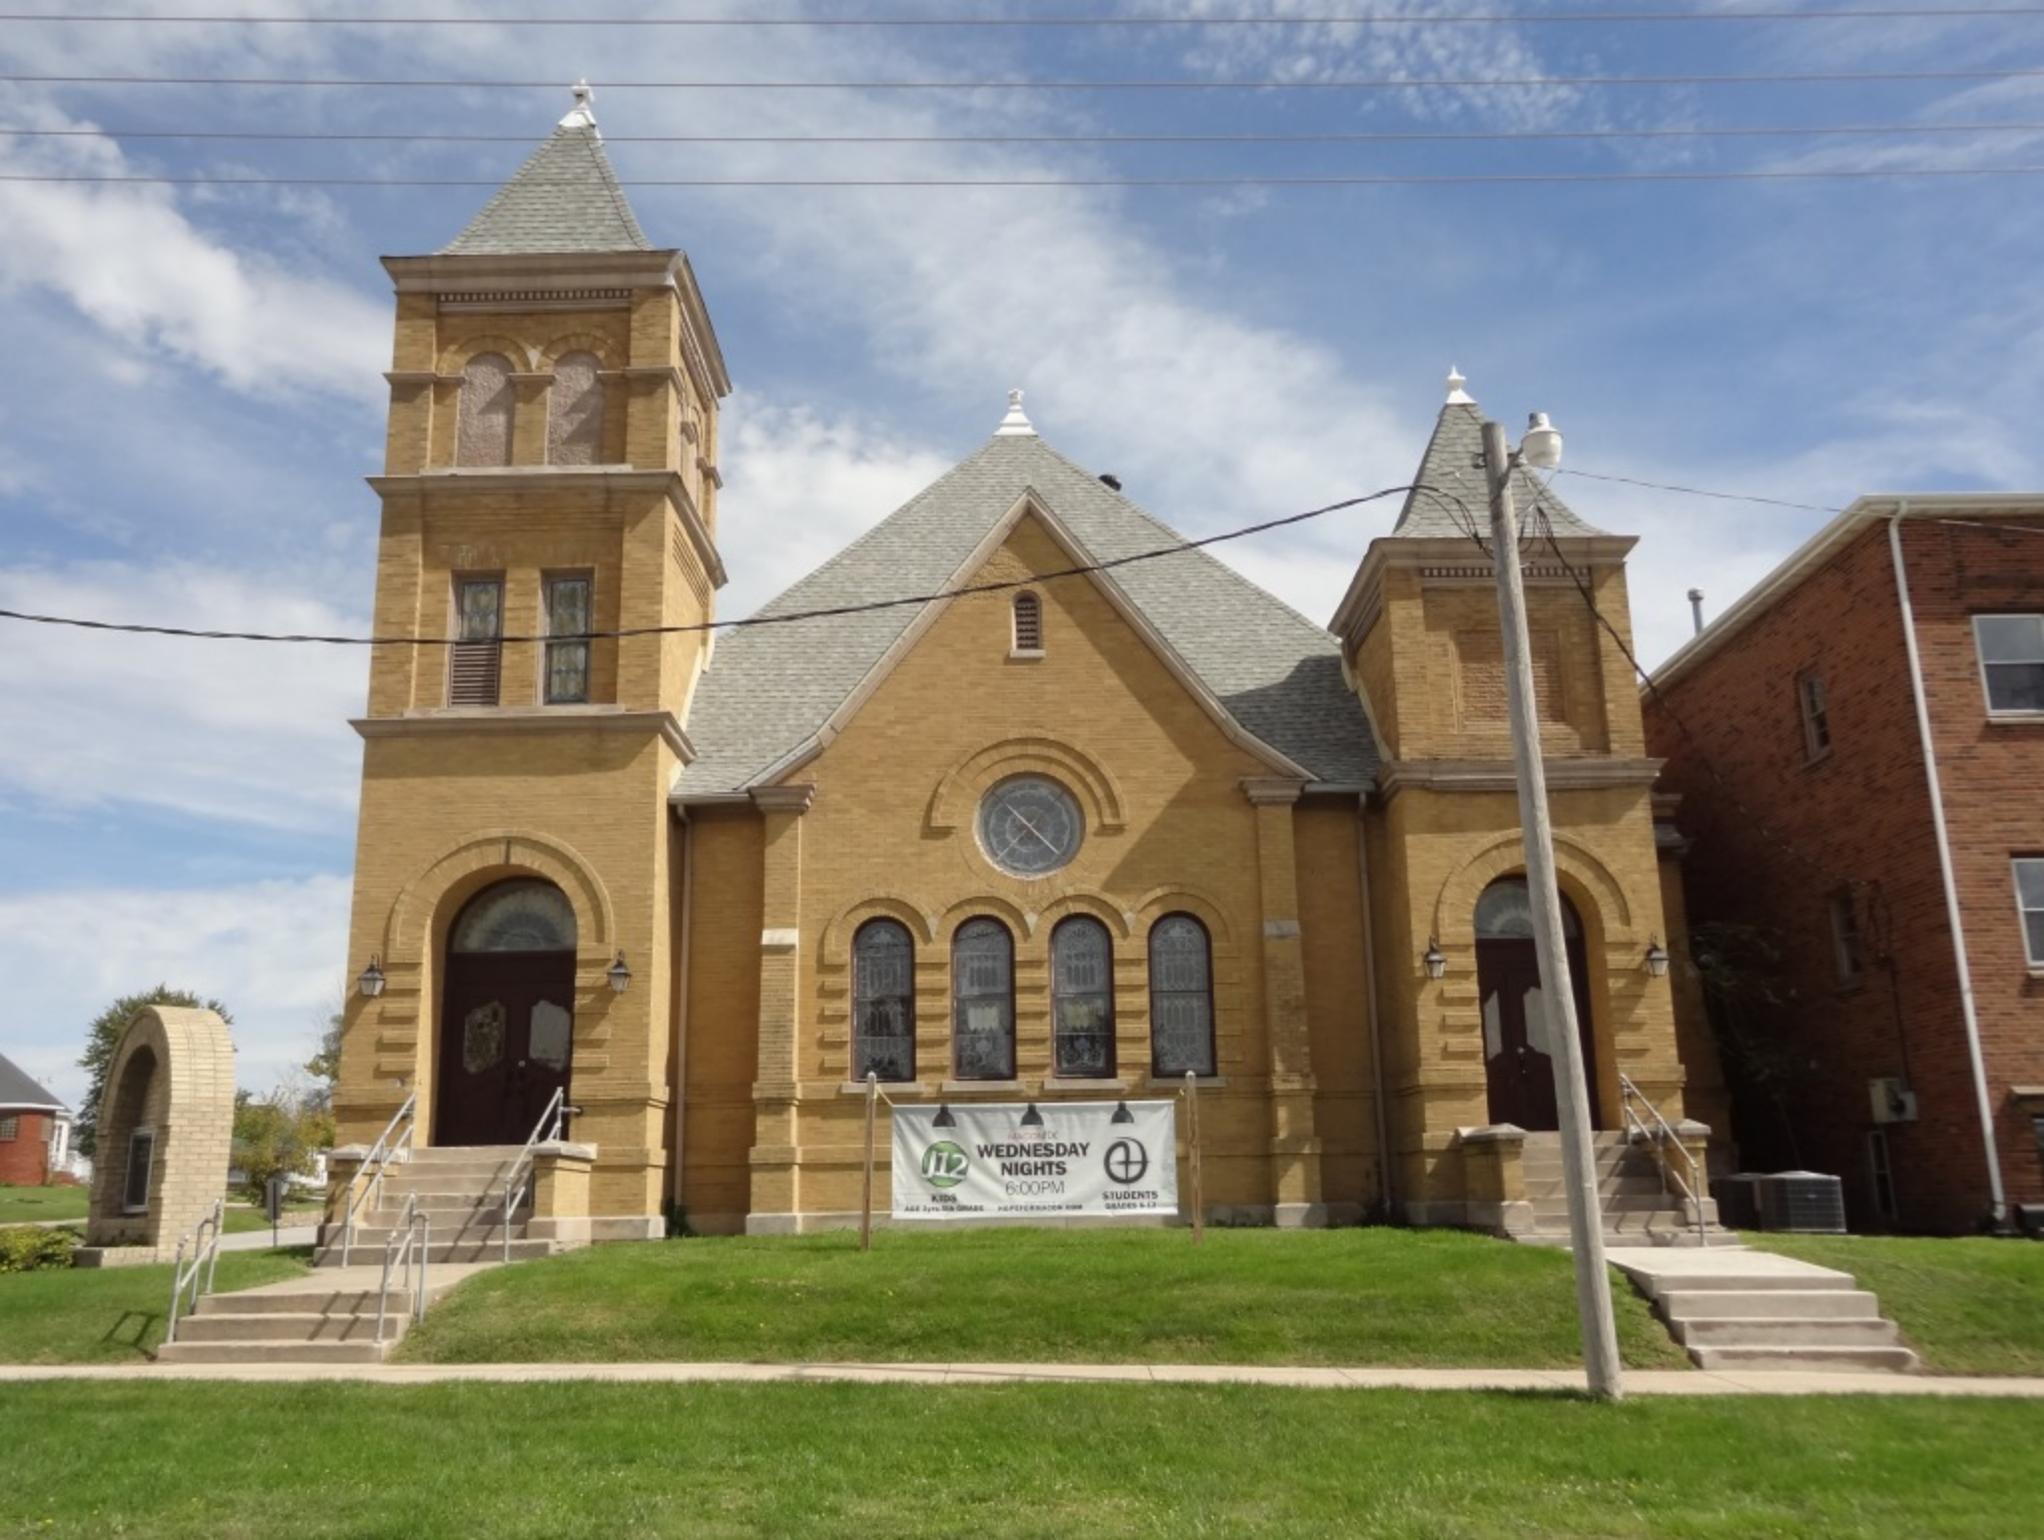
The 2 ½ story tan brick building contains three bays along its façade; a central front gable flanked on each side by a tower of a varying height. The building has a limestone basement capped with a tan brick band water table. The façade's first bay includes the northern tower, taller than the southern tower and includes a recessed entry composed of a double wood paneled door with leaded glass and elliptical stained glass transom. The entry bay includes a rounded arch with delineated brick details. Concrete steps with brick knee walls with stone capping and metal railing step down to the side walk. Above the entry is a stone projecting band and two one-over-one double-hung wood sash stained glass windows with flat arch lintels. The lower pane of the window on the left has been replaced with a vent. Above is linear brick corbeling and another stone project band and two stuccoed over window bays. These bays include rounded arch lintels of brick and stone banding. Above at the tower's cornice is dentil work and a delineated entablature. The tower includes a bell-shaped pyramidal roof topped with a finial.

window with brick arch lintels and stone lug sills. A stone course divides the second story and upper tower with the castellated top. Three vents are located on each side of the tower's top. Concrete steps with a simple metal rail lead up to each entryway. The door is inset from the rounded arch opening ...The second bay includes a large stained glass rounded arch window that extends to the second story. The lower portion of the window opening includes a set of four one-over-one double-hung wood sash windows separated by thin Tuscan pilasters and a Norman cross design fills the architrave between the two levels of windows. The window includes a stone lug sill. Two small paired one-over-one stained glass wood sash windows are located at the gable end with a brick lintel and stone lug sill.

The third bay includes the taller tower and has identical fenestration on its first and second stories as the southern tower. The upper portion of the tower includes stone coursework and three arcaded vent space on each side of the castellated tower. The tower's peaks are topped with concrete.

Due to its location the property is outside the potential National Register historic commercial district. The church has undergone significant changes with its rear addition. Because of this the property appears to be not individually eligible.
