1. Survey No. MC-AS-001-001		2. Survey name: Downtown Macon Commercial Historic District	
3. County: Macon		4. Address (Street No.) Lots 11-13 block 93	Street (name) East Bourke Street (100 block)
5. City: Macon	Vicinity: <input type="checkbox"/>	6. Geographical Reference:	7. Township/Range/Section: T: R: S:
8. Historic name (if known):		9. Present/other name (if known): City of Macon Parking Lot #3	
10. Ownership: <input checked="" type="checkbox"/> Private <input type="checkbox"/> Public		11a. Historic use (if known): Commercial	11b. Current use: vacant

42. Current owner/address: City of Macon Macon, MO 63552	43. Form prepared by (name and org.): Kristi Chase MO SHPO	44. Survey date: 9/24/2014
		45. Date of revisions:

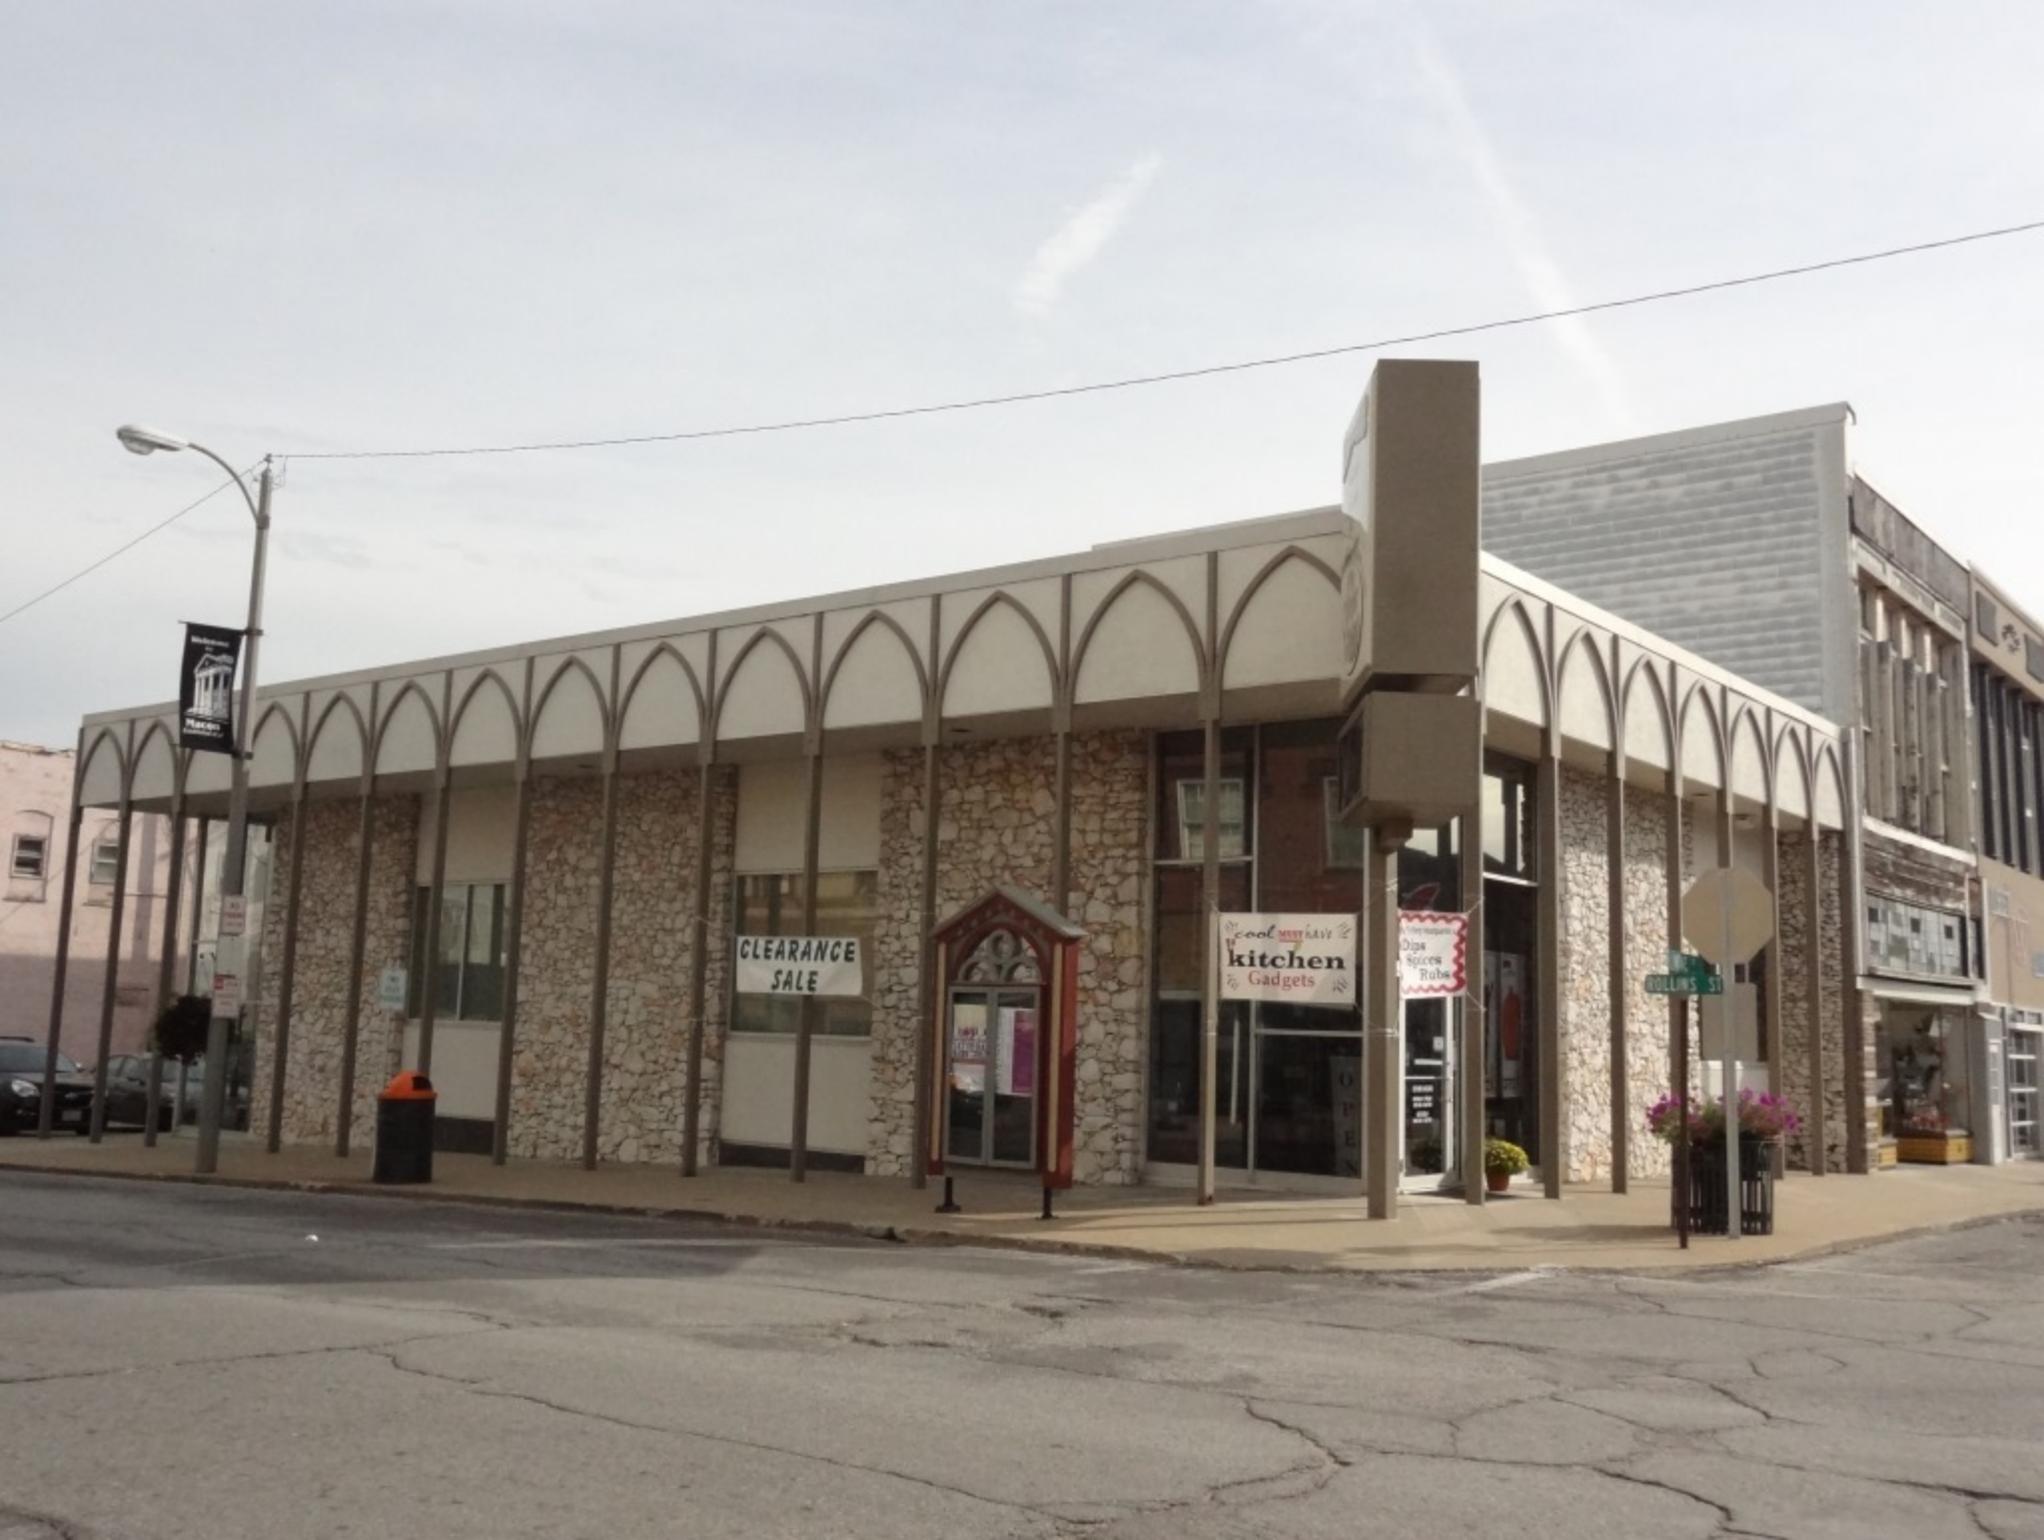
The south façade has three bays. The far left bay is comprised of a wall of glass and aluminum, with an entrance door with two sidelights. The central bay is clad with rubble stone in shades of white, grey, and cream. The far right bay contains a centered three-light fixed window with stuccoed wall surfacing. The west façade has seven bays. The far right bay adjoins with the south façade and features an aluminum and glass window wall. The remaining bays alternate with large expanses of rubble stone and two-light fixed windows centered in a stuccoed wall surface. The far left bay is another aluminum and glass window wall that wraps around to the north elevation.

Constructed in 1967, the building will be considered historic in 2017. At the time of this survey, it would likely not contribute to a potential National Register historic district due to age. In the future, it may be individually eligible as a good local example of the New Formalism style.

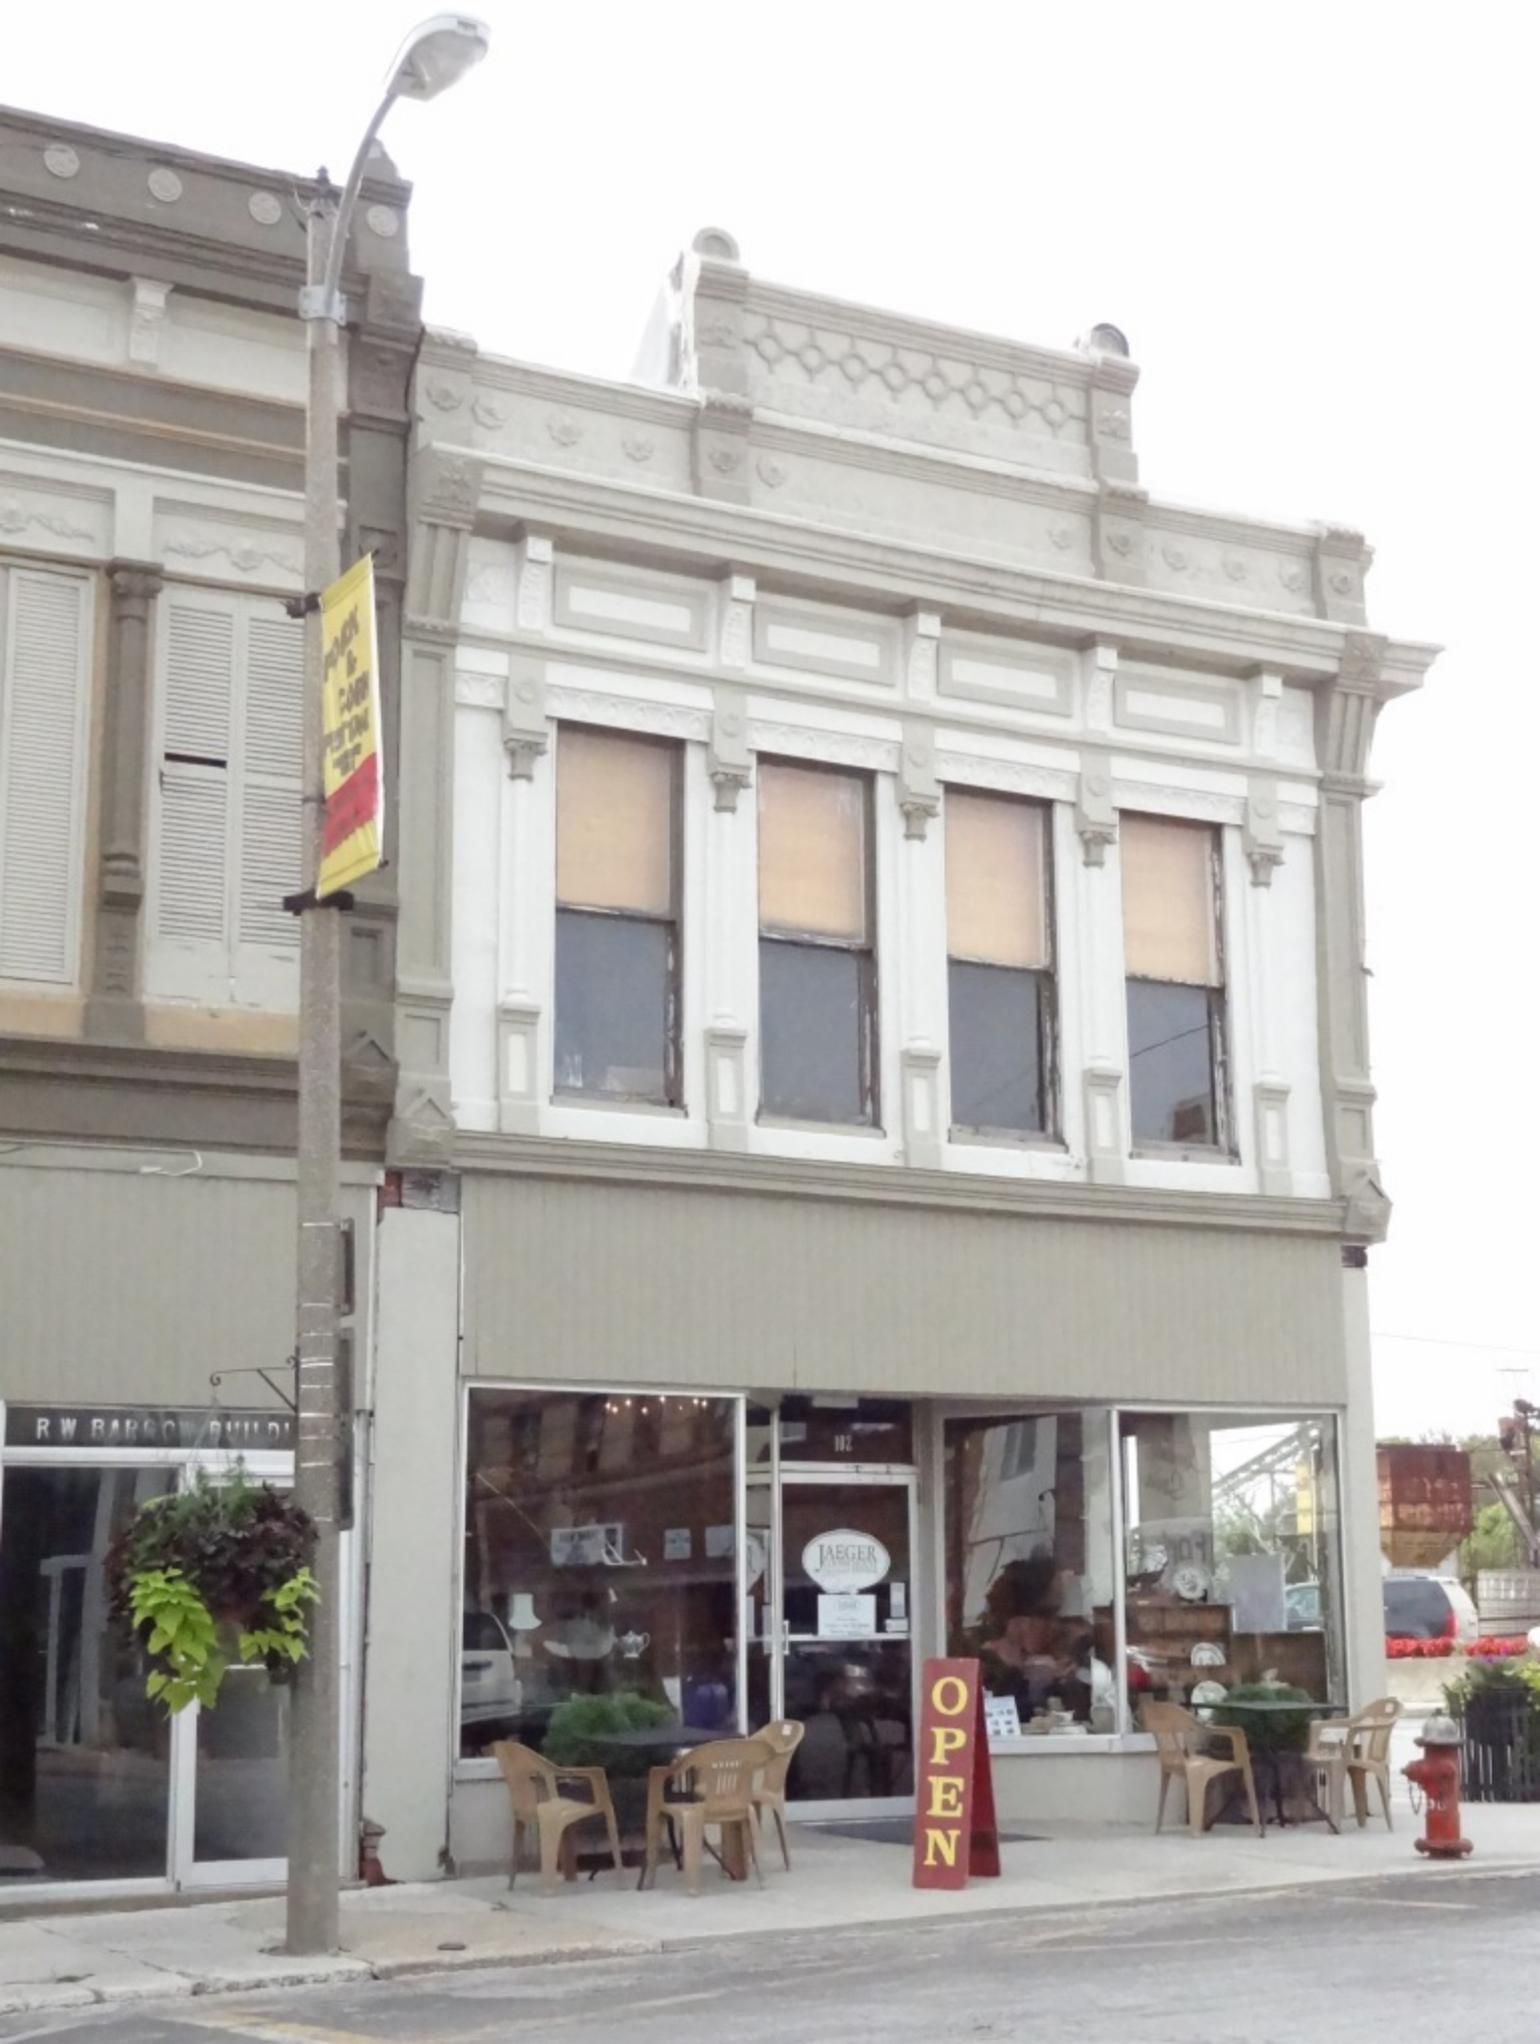
This rectangular, two-part commercial block building retains elements of its once-grand Italianate style, including upper-story cast metal columns and an elaborate cornice. The first story of the façade consists of a three-bay storefront. The central bay contains a recessed glass and aluminum entry door with a transom flanked by plate glass display windows with stuccoed brick bulkheads. Vertical wood boards cover the transom area above the storefront. Another bay of the storefront is located on the west elevation. This bay contains a plate glass display window with a two-light transom. The second story features four bays, each with an historic one-over-one double-hung wood window. The windows are framed by five slender cast metal engaged columns and are topped with an embossed metal lintel course. Cast metal engaged columns rise at the edges of the upper story to the cornice and terminate as oversized brackets with a stamped metal floral design. Five additional decorative brackets with a stamped metal floral motif support the cornice. A parapet wall rises above the roofline and features stamped metal round floral medallions. A rectangular cornice pediment rises from the center of the parapet wall. It features a circular geometric motif. An additional bay with the same metal stylized detail wraps the corner to the west elevation.

Tax assessor records indicate the building received alterations in 1980. While there are a few alterations to the storefront, the building retains a majority of historic building material and would contribute to a potential National Register district.

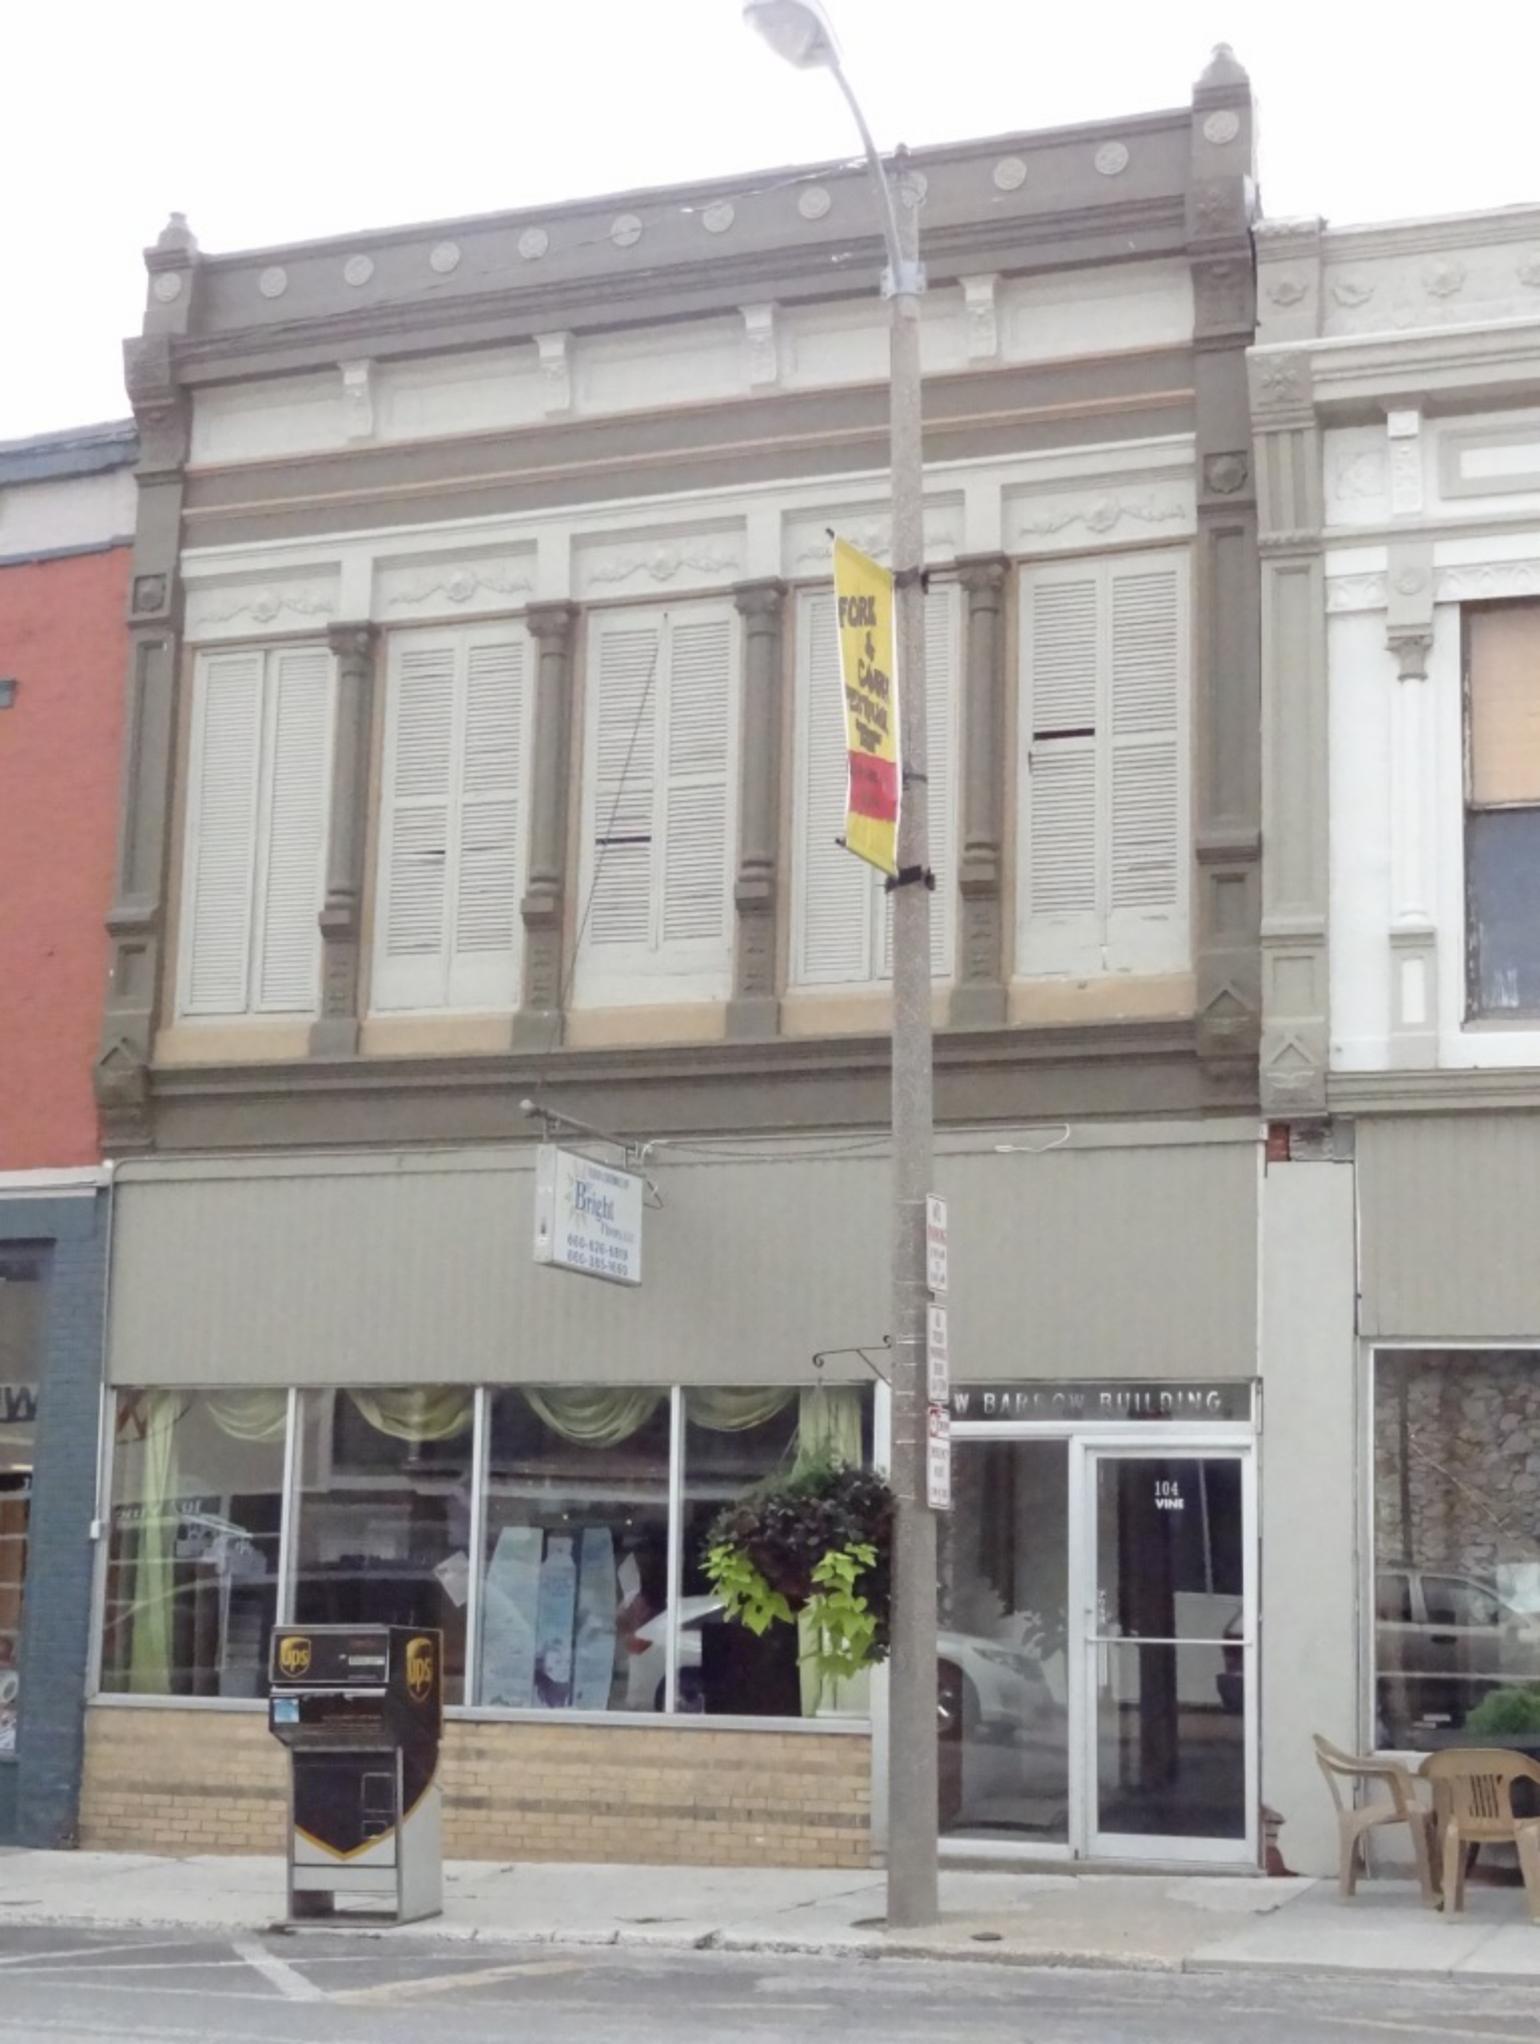
This rectangular, two-part commercial block building retains elements of its once-grand Italianate style, including cast iron columns on the second story. The first story consists of a two-bay storefront. The western bay has a non-historic aluminum and glass entrance door with a large glass sidelight to the east. A thin transom window over the bay retains historic painted lettering that reads "RW BARROW BUILDING". The eastern bay contains a plate glass display window with four lights and a blonde brick bulkhead. The transom area above the store is boarded up with vertical wood panels. A small, backlight plastic advertising sign extends out from this area. The second story features five bays. Within each bay, a pair of wooden shutters of unknown origin fills the historic window openings, obscuring the windows. Four slender, engaged cast metal columns fill the spaces between the window openings. Each column is set on a base with a stamped double rosette. A metal panel embossed with a floral design adorns the façade above each window opening. Cast metal columns rise at the edges of the upper story to the cornice and terminate as prominent brackets with a floral motif. Four additional decorative brackets are integrated in the building's cornice. A level parapet wall rises above the roofline and features round metal ornamental medallions.

The building's storefront has been altered, resulting in replacement display windows and door. Despite alterations, the building retains integrity and would contribute to a potential National Register district.

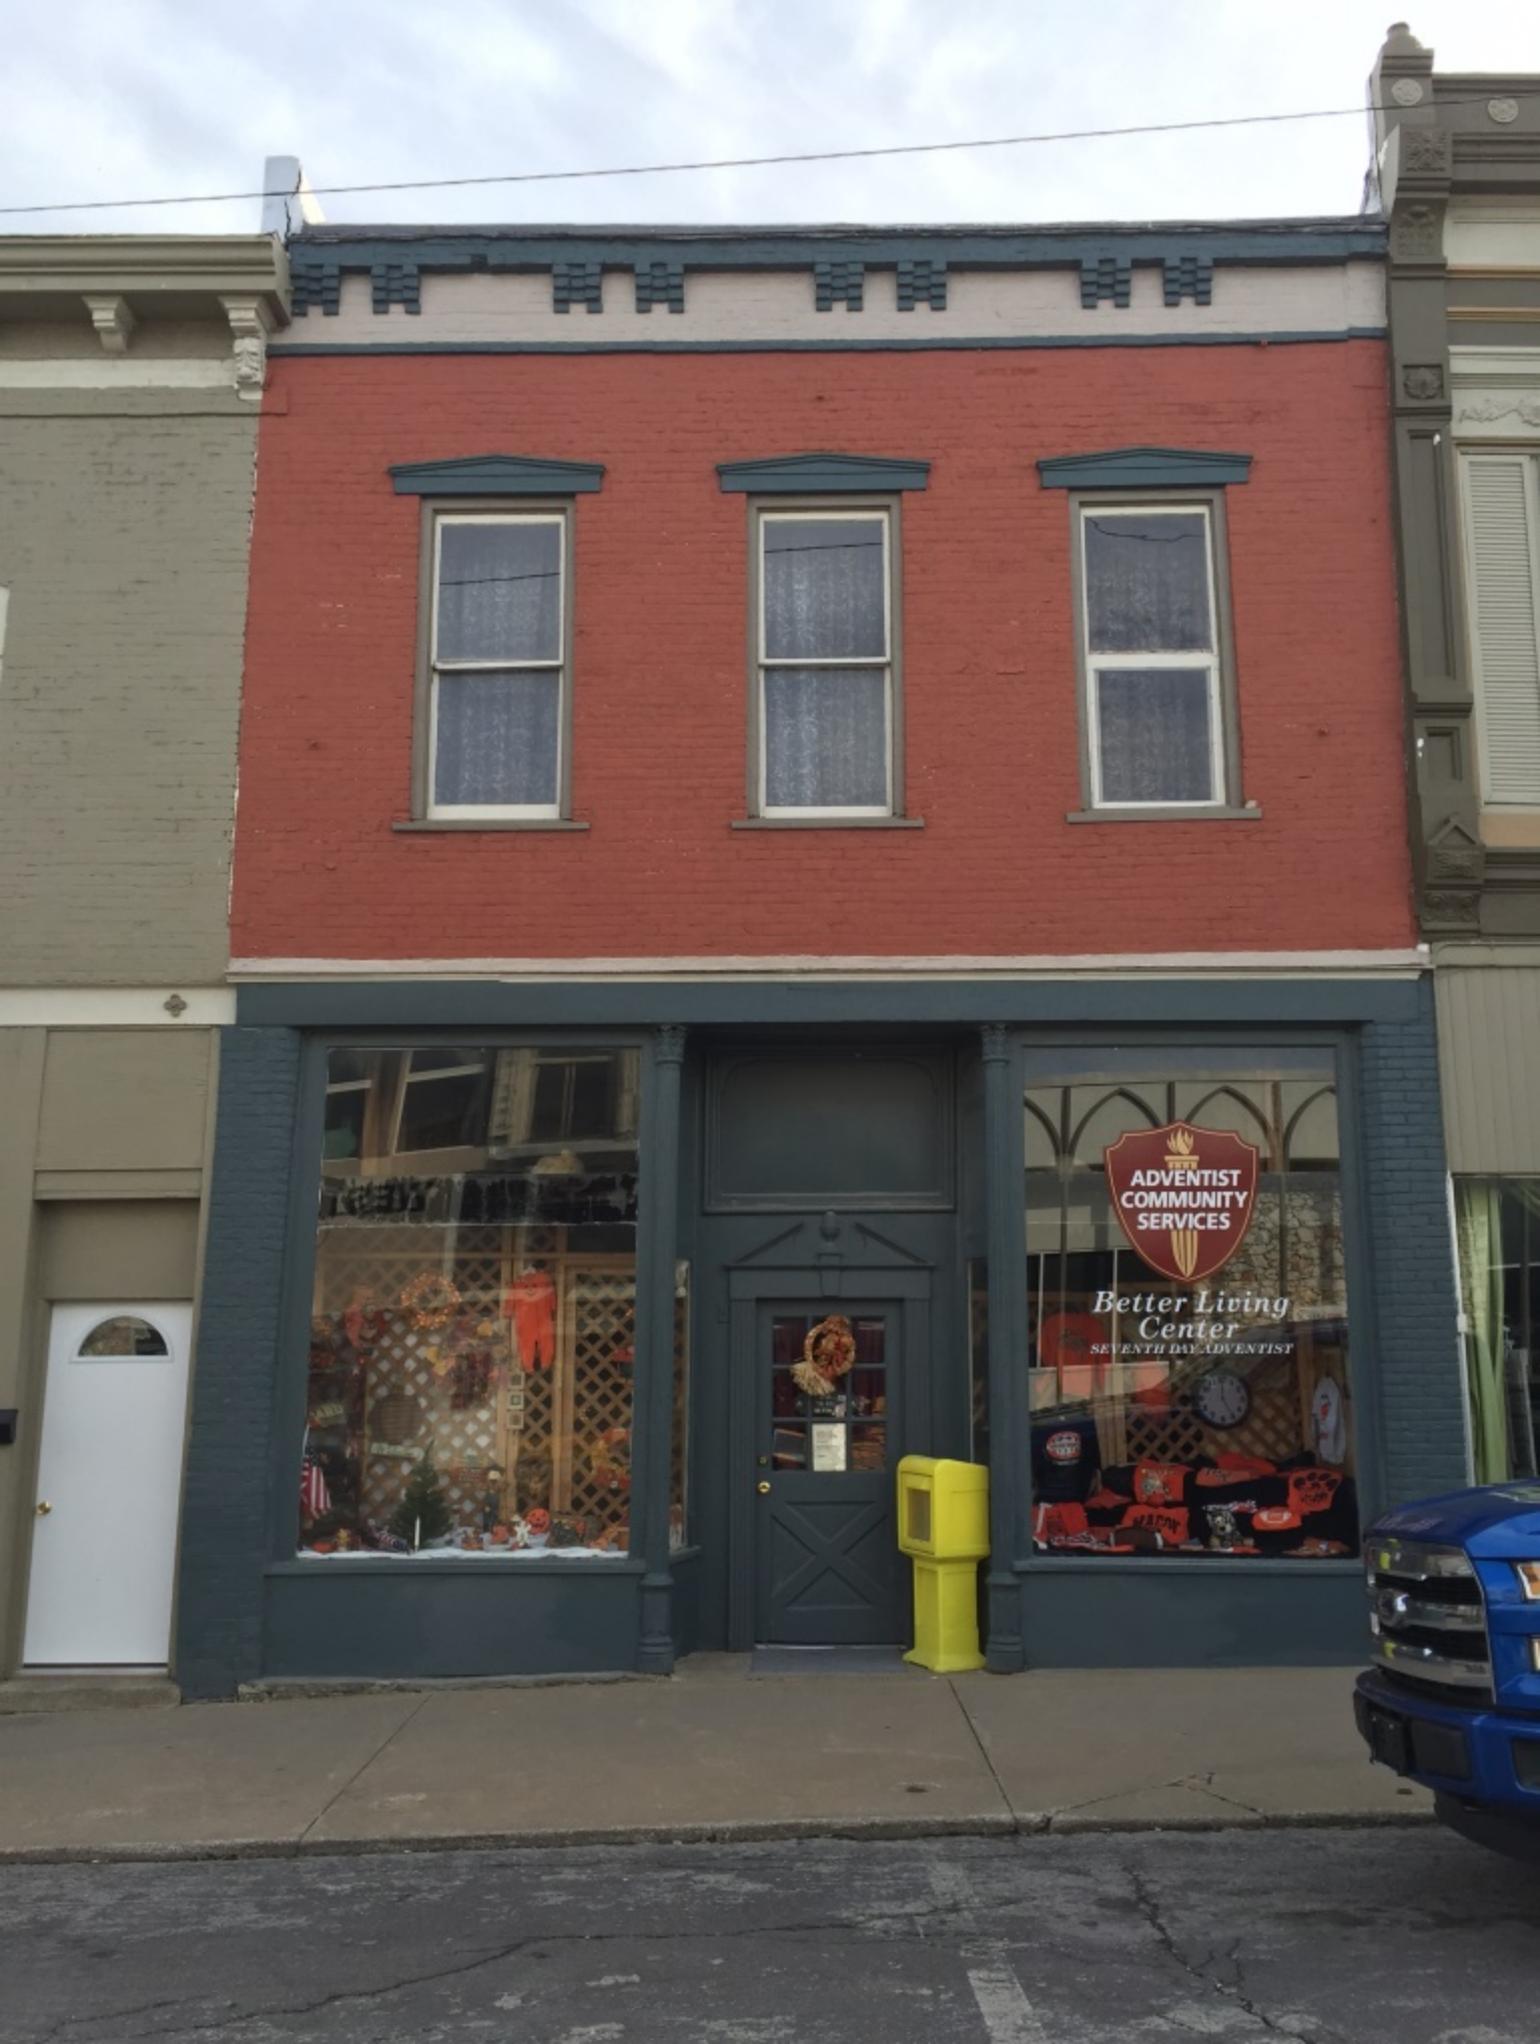
This rectangular, two-part commercial block brick building has a three-bay storefront in its first story with a recessed multi-light wood entrance door in the central bay. The entrance door has a modern wood surround with fluted pilasters and a broken scroll pediment. A transom opening above the entrance door is boarded up with wood. The outer bays contain tall plate glass display windows that extend out to align with the plane of the façade. Cast metal columns spanning the height of the first story are located at the corner of each window where they meet the recessed entrance. Wood bulkheads are located below the windows, and painted brick is visible at the outer edges of these bays. The second story has painted brick and features three bays with one-over-one wood windows topped with non-historic pediment-shaped wood window hoods. Four sets of paired corbelled brick brackets form the building's cornice.

Tax assessor records indicate the building was altered in 1977, likely resulting in the remodeled storefront. Despite alterations, the building retains a sufficient amount of historic building material to contribute to a potential National Register district.

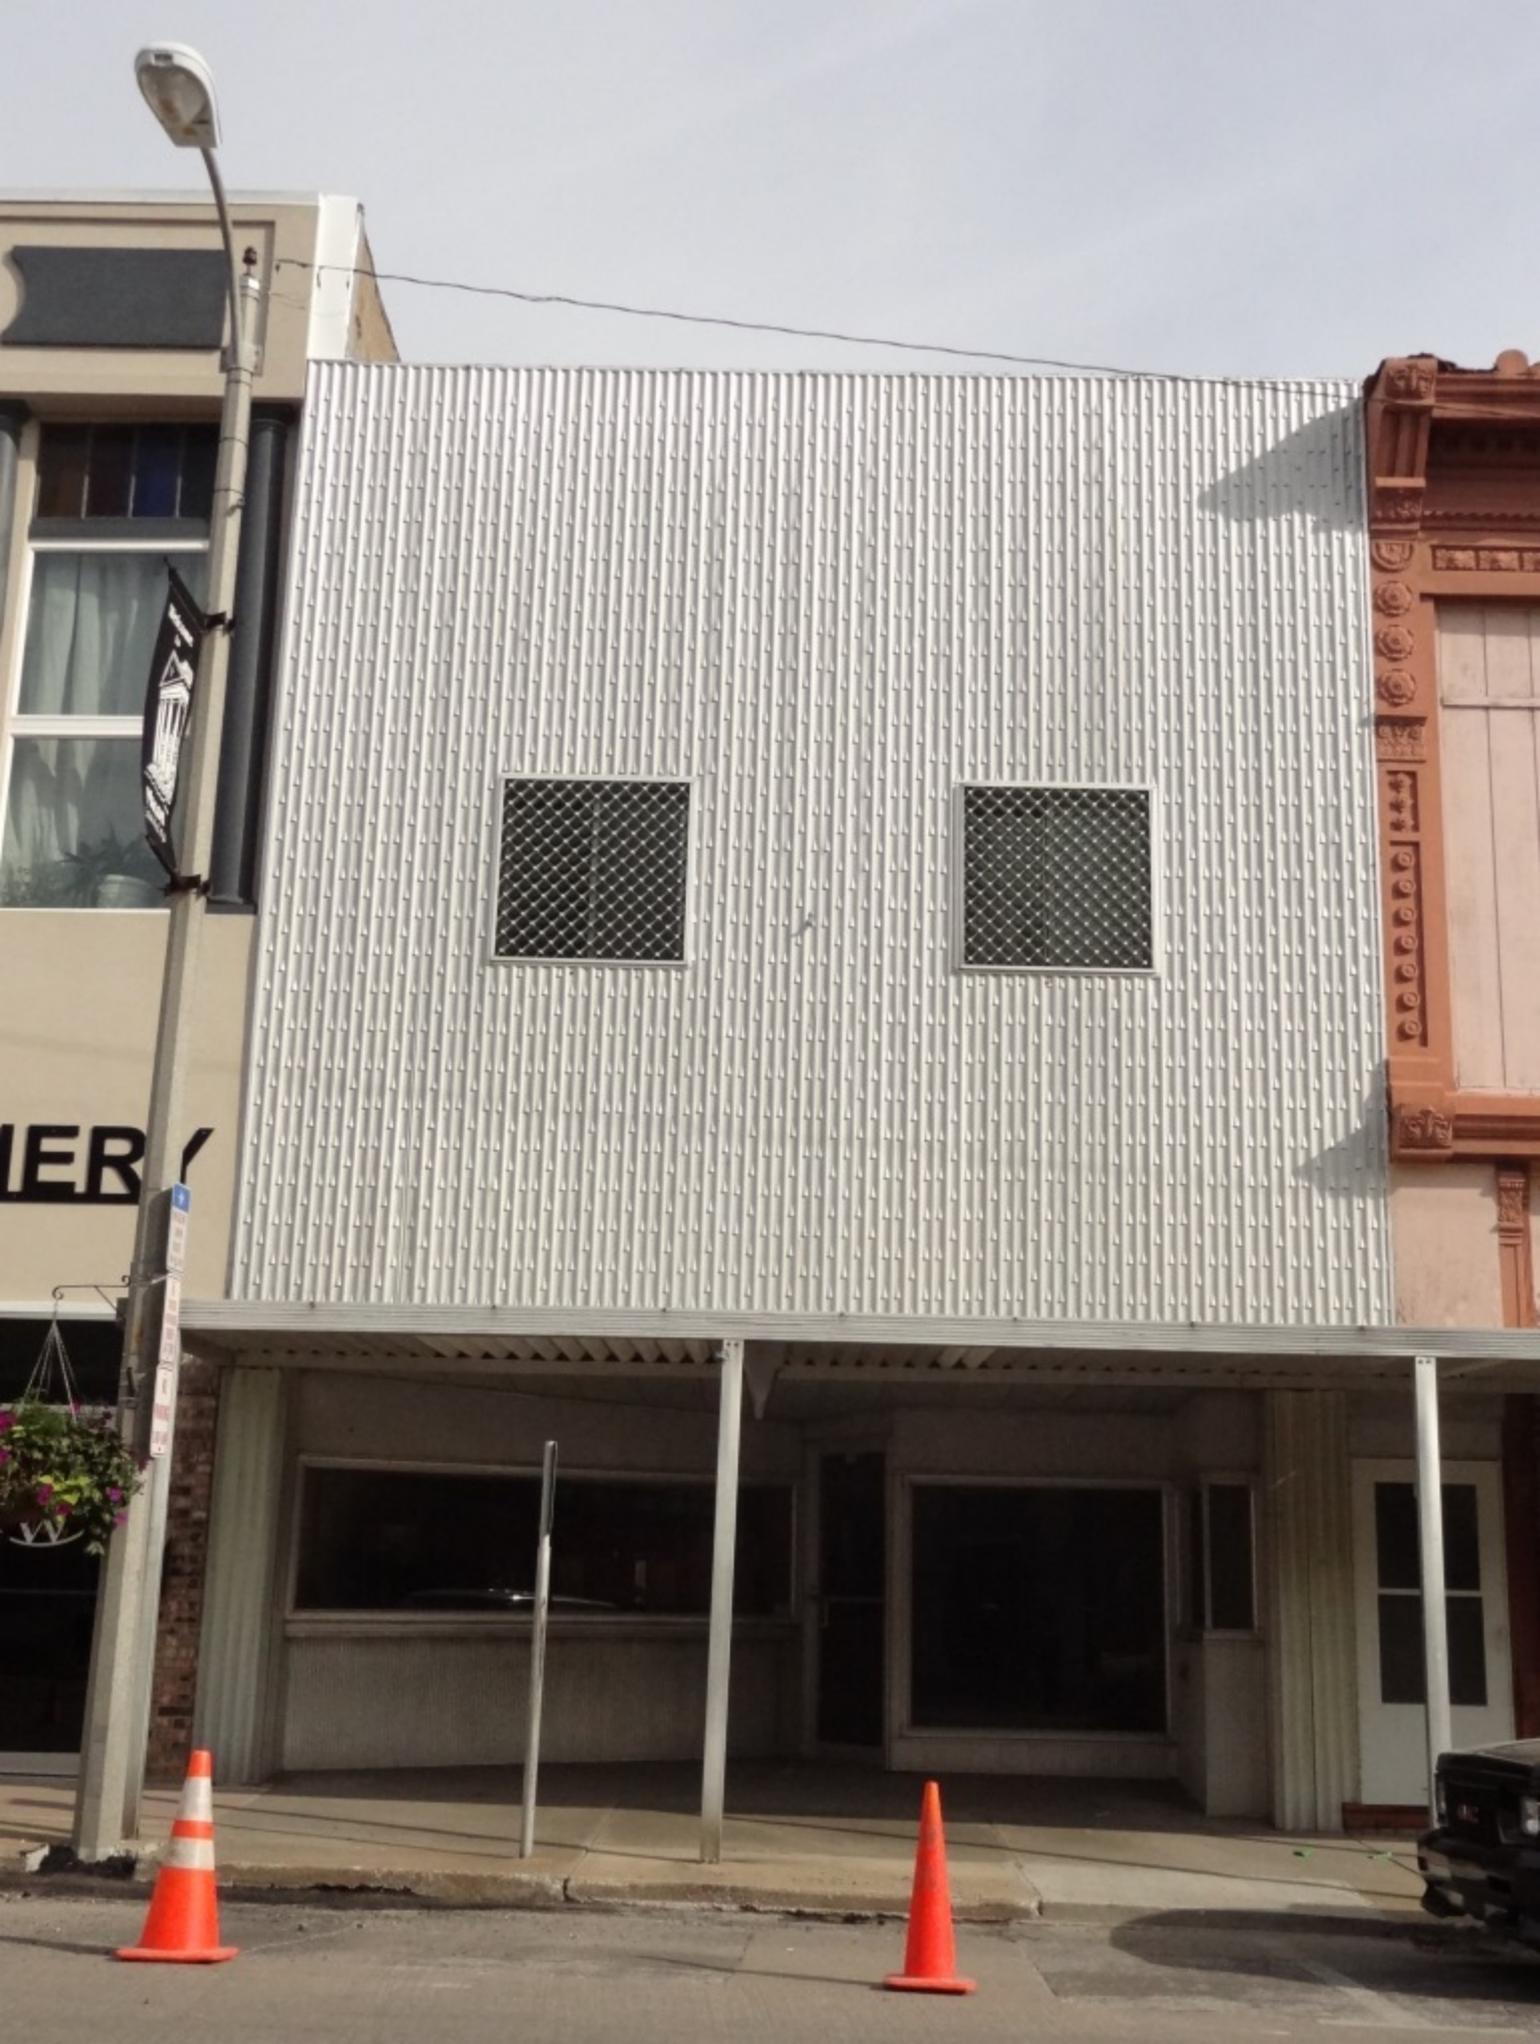
This rectangular, two-part commercial block building has five bays on its first floor. The far left bay slants inward at a diagonal line and contains a ribbon window with metal cladding above and below. The next bay contains a modern entrance door, also tilted inward. To the right of the door is a recessed square display window that is parallel with the sidewalk. To the right of this window, an extremely thin fixed window extends outward and aligns with the plane of the façade. Metal clads the walls above and below. The far right bay contains a modern aluminum storm door. A flat, full-width metal awning extends out over the sidewalk. The upper story is clad entirely with metal stamped with a "raindrop" motif. It has two bays, each containing a small, square window concealed by a metal screen. The roof is flat.

Tax assessor records indicate the building was altered in 1962. This may have resulted in the application of the metal siding. If so, the metal siding would be considered "historic" today. Depending upon the period of significance of a proposed National Register district, this building may or may not be contributing.

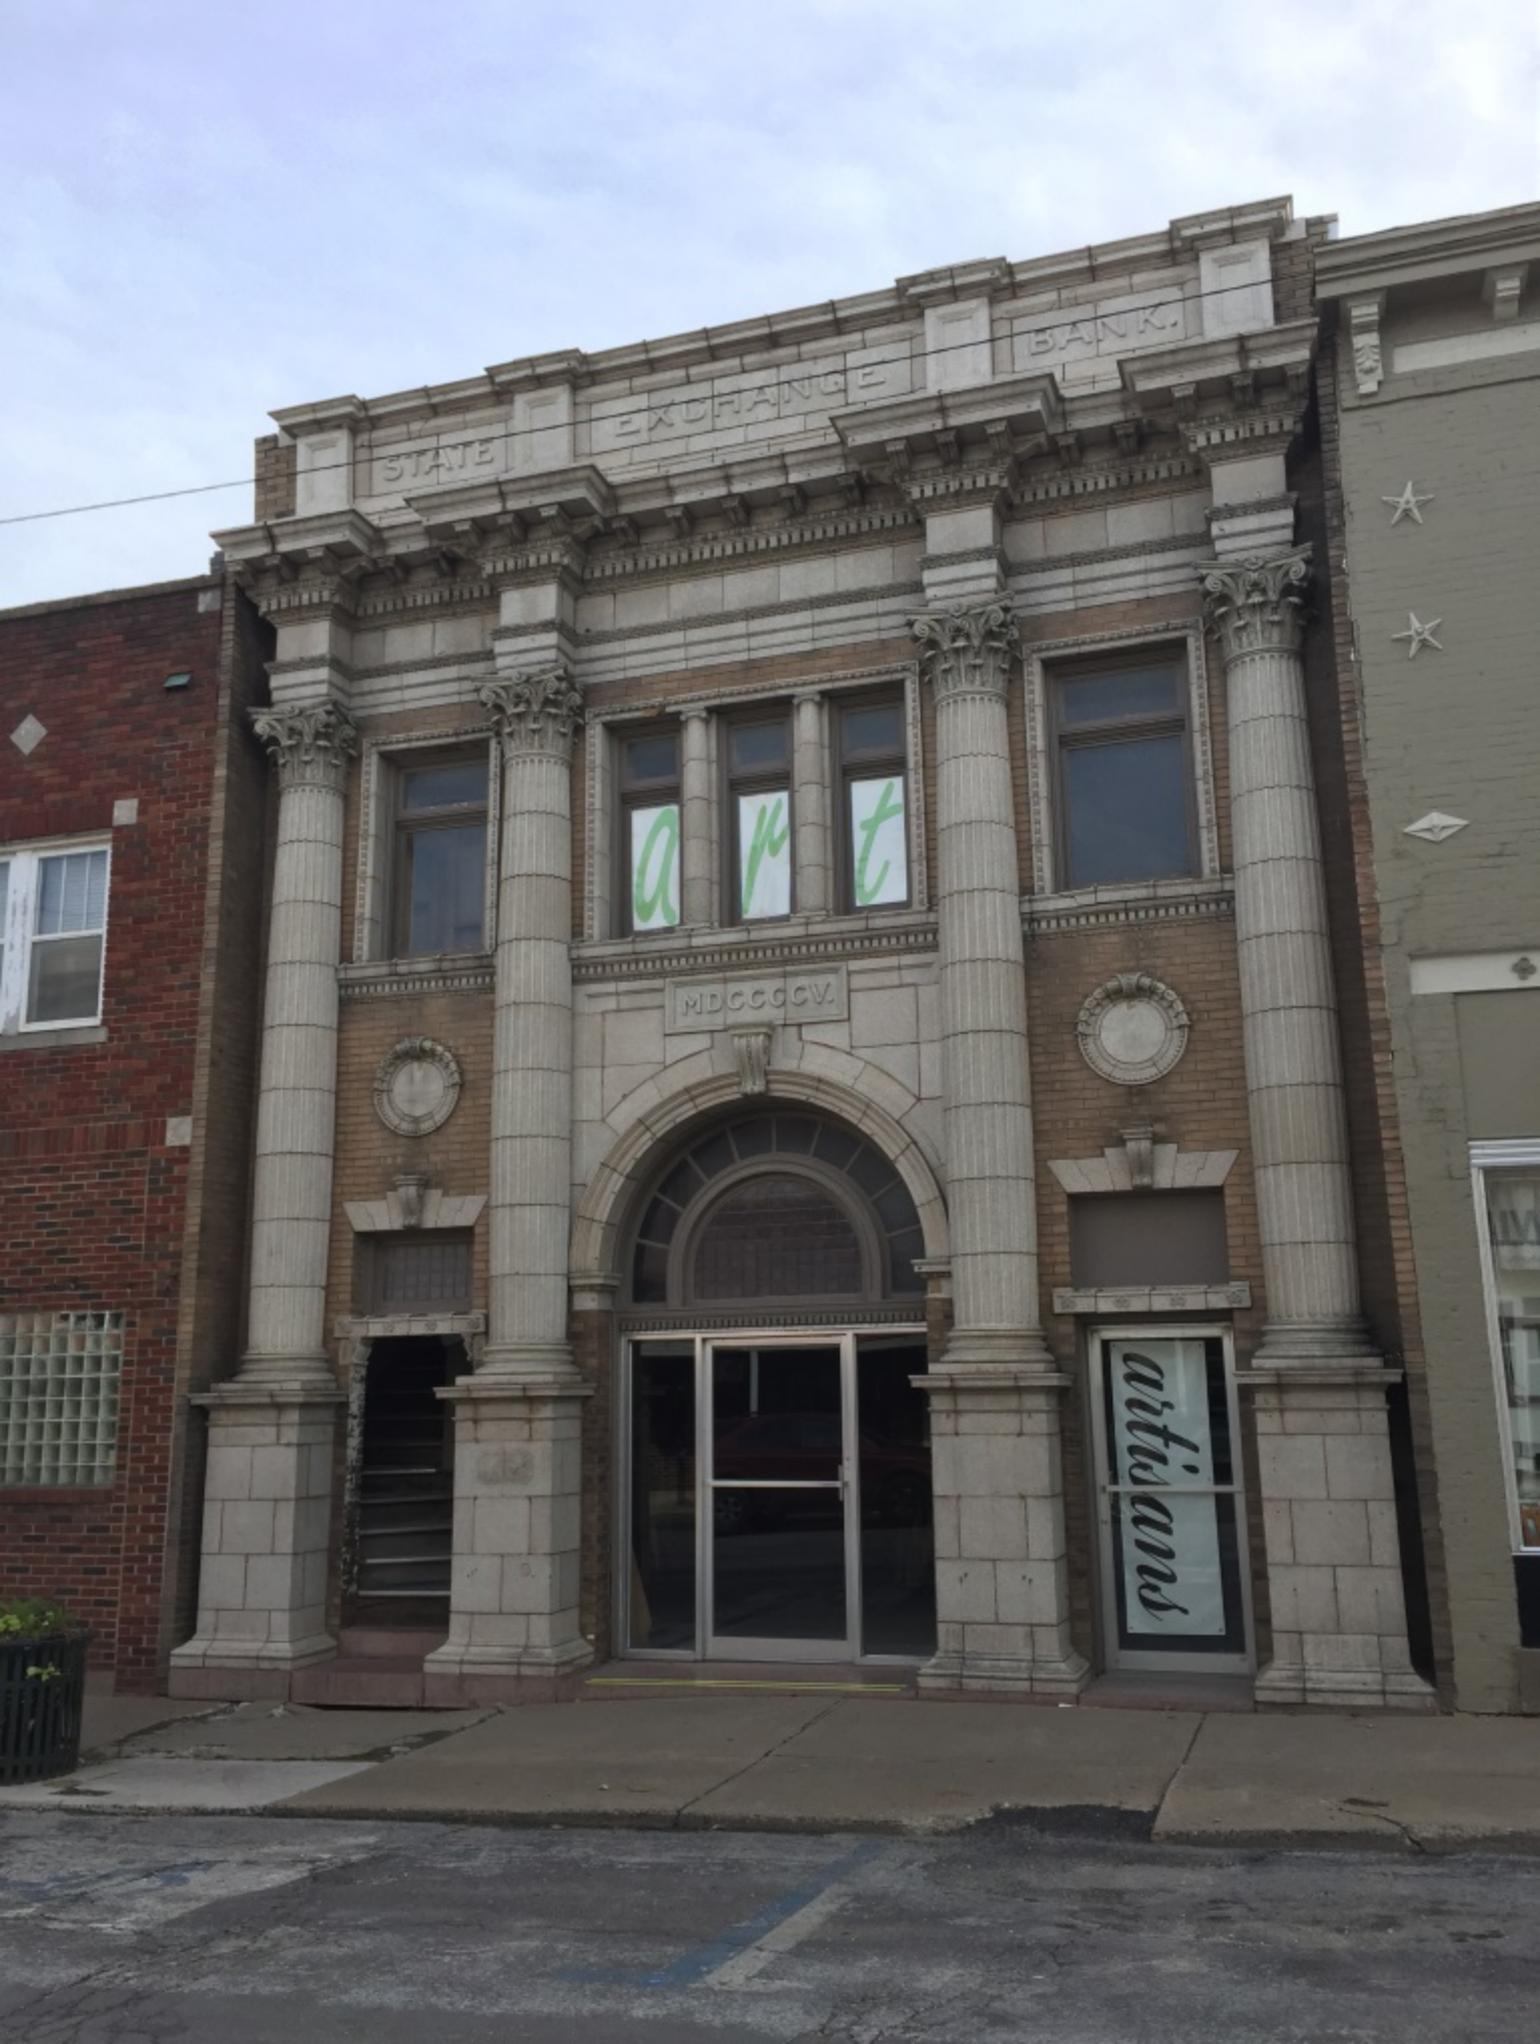
This rectangular, two-part commercial block building has three bays on its first and second stories. The façade is slightly recessed from the plane of the unified commercial block. Four stone fluted engaged columns on stone bases with Corinthian capitals span the first and second stories and extend out slightly from the primary façade's plane, aligning with that of the adjacent buildings. A stone foundation is visible on the first story, with a red granite threshold to the entrances. The westernmost bay on the first story has a glass and aluminum door. The door is flanked by two of the aforementioned Corinthian columns, with the stone bases of the columns being just slightly lower in height than the door. The door has a stone lintel with four round ornamental medallions. Immediately above the door is a fixed window with a stone flat arch lintel featuring a scrolled keystone. A blind oculus is centered above the window, and both the oculus and window are framed by a light beige brick and the engaged columns. The central bay of the first story is the most elaborate and has a glass and aluminum entrance door flanked by fixed sidelights. Wood dentils line the wall above the door underneath a multiple-light fanlight with wood muntins. The fanlight's lintel is a stone Roman arch with scrolled keystone. The engaged columns flank the sidelights, and stone clads the remaining space of the exterior in this bay. Above the keystone, the carved stone Roman numerals "MDCCCCV" (1905) indicate the year the building was constructed. The easternmost bay of the first story features a masonry door-sized opening leading to a curved flight of stairs. Like the westernmost bay, this opening is flanked by two of the engaged columns, with the stone bases of the columns being just slightly lower in height than the opening. The area above the opening up to the second floor is identical to that described in the westernmost bay. The second story of the building has three bays, with the western and eastern bays containing identical one-over-one fixed-light windows with decorative stone surrounds. The center bay contains a three-part window, with each part having identical one-over-one fixed lights. The three-part window has a decorative stone surround, and the central one-over-one fixed lights are flanked by Ionic pilasters. A dentiled stone sill course, broken by the engaged columns, runs below the windows of the second story. The Corinthian capitals of the engaged columns align with the upper third of these windows. The elaborate stone cornice steps out over the plane of the building where it aligns with each engaged column. Dentils and modillions are integrated into the cornice. Above the cornice, a stone parapet rises above the flat roofline and features the words "State Exchange Bank" in carved stone.

Tax assessor records indicate the building received alterations in 1966; this likely resulted in the replacement of the entrance doors. The building has also received a small rear addition. The building retains the majority of its historic buildings materials and design and would contribute to a potential National Register district.
