1. Survey No. MC-AS-001-001		2. Survey name: Downtown Macon Commercial Historic District	
3. County: Macon		4. Address (Street No.) Lots 11-13 block 93	Street (name) East Bourke Street (100 block)
5. City: Macon	Vicinity: <input type="checkbox"/>	6. Geographical Reference:	7. Township/Range/Section: T: R: S:
8. Historic name (if known):		9. Present/other name (if known): City of Macon Parking Lot #3	
10. Ownership: <input checked="" type="checkbox"/> Private <input type="checkbox"/> Public		11a. Historic use (if known): Commercial	11b. Current use: vacant

42. Current owner/address: City of Macon Macon, MO 63552	43. Form prepared by (name and org.): Kristi Chase MO SHPO	44. Survey date: 9/24/2014
		45. Date of revisions:

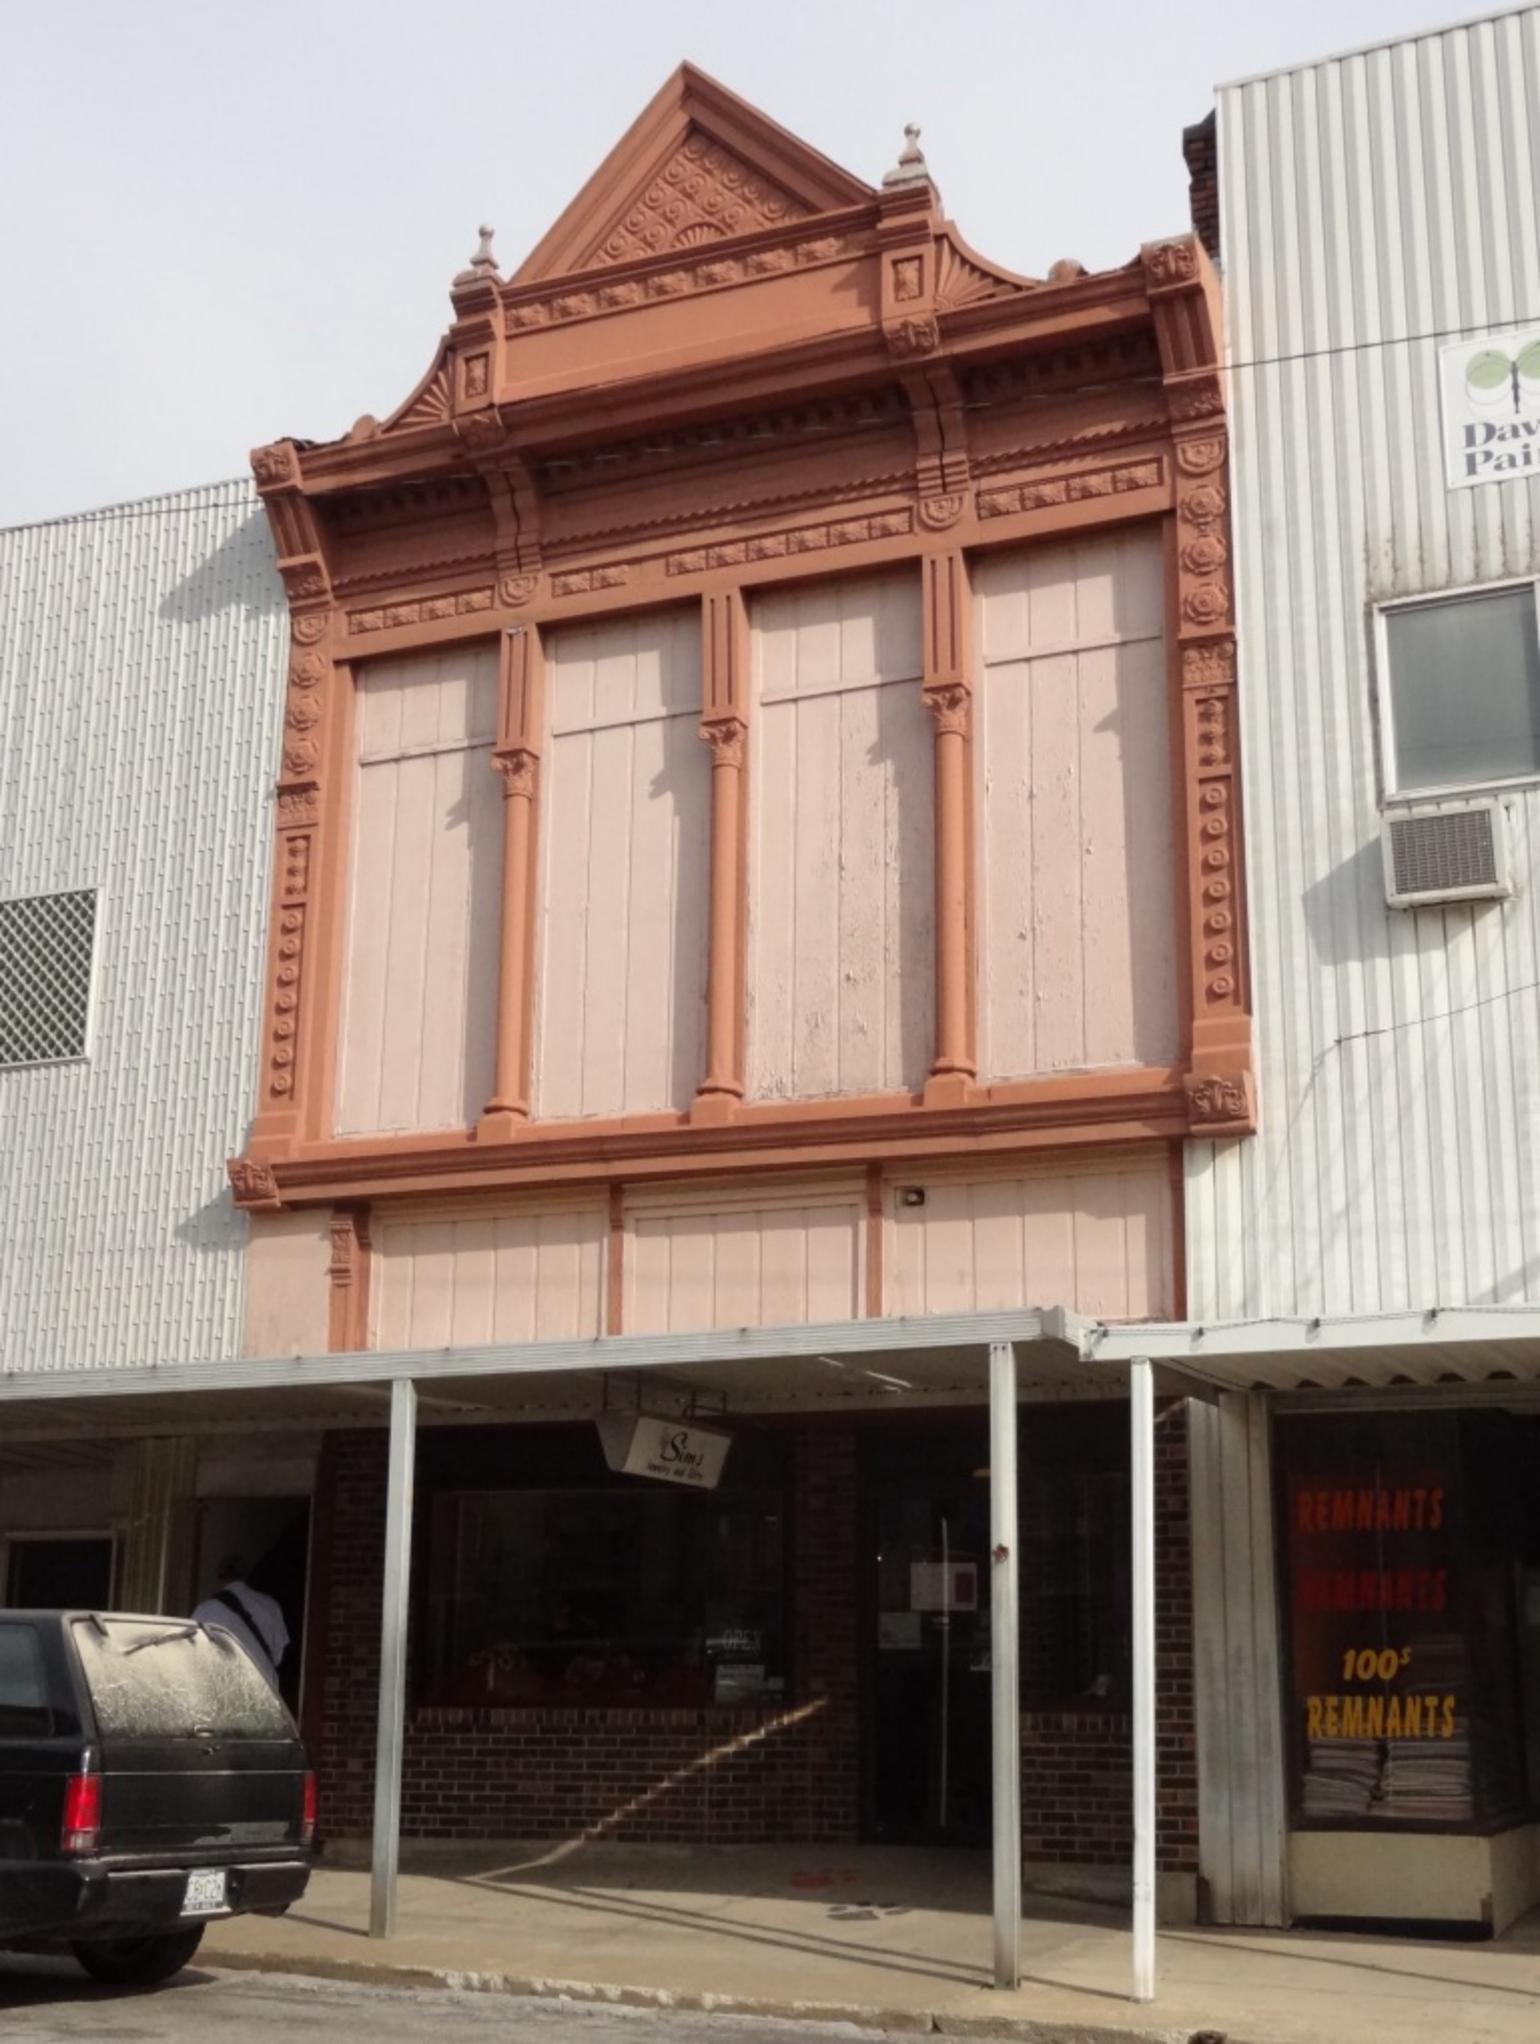
This rectangular, two-part commercial block building retains historic cast iron cladding infilled with modern vertical wood planks on the upper story. It has a flat roof, and the first floor contains three bays which comprise a storefront entrance. The western bay is the largest, with a fixed plate glass display window with three vertical lights that gently steps inward towards the modern entrance door. The eastern bay steps back out towards the sidewalk, is smallest in width, and contains a fixed plate glass display window with two vertical lights. The exterior of the first story is clad in a variegated brick veneer. To the far left, a metal iron column is extant. A flat, full-width metal awning extends out over the sidewalk. The second story is clad in historic decorative cast iron with Italianate-style detailing. Three wide transom openings directly above the first story are filled in with vertical wood planks and flanked by metal pilasters. Above this, the cast iron façade is divided into four tall, thin openings by three slender Ionic columns. The openings are filled in with vertical wood planks. The edges of the buildings are dotted with medallions in spiral and floral motifs. The heavily embellished cornice frieze features paired brackets, rectangular floral medallions, and sawtooth and dentil bands. A prominent triangular cornice pediment rises above the roofline. The eaves of the triangle contain decorative tiles with spirals and a fan motif. A rectangular stoop projects forward from the pediment over the roofline and is ornamented with floral tiles and capped at each end with two finials.

Tax assessor records indicate the building was altered in 1978. Despite alterations, this is one of the few remaining commercial buildings that retain its historic cast iron storefront façade. These cast iron storefronts dominated the Vine Street commercial row in the late 1800s. The building retains integrity and would likely contribute to a potential National Register district.

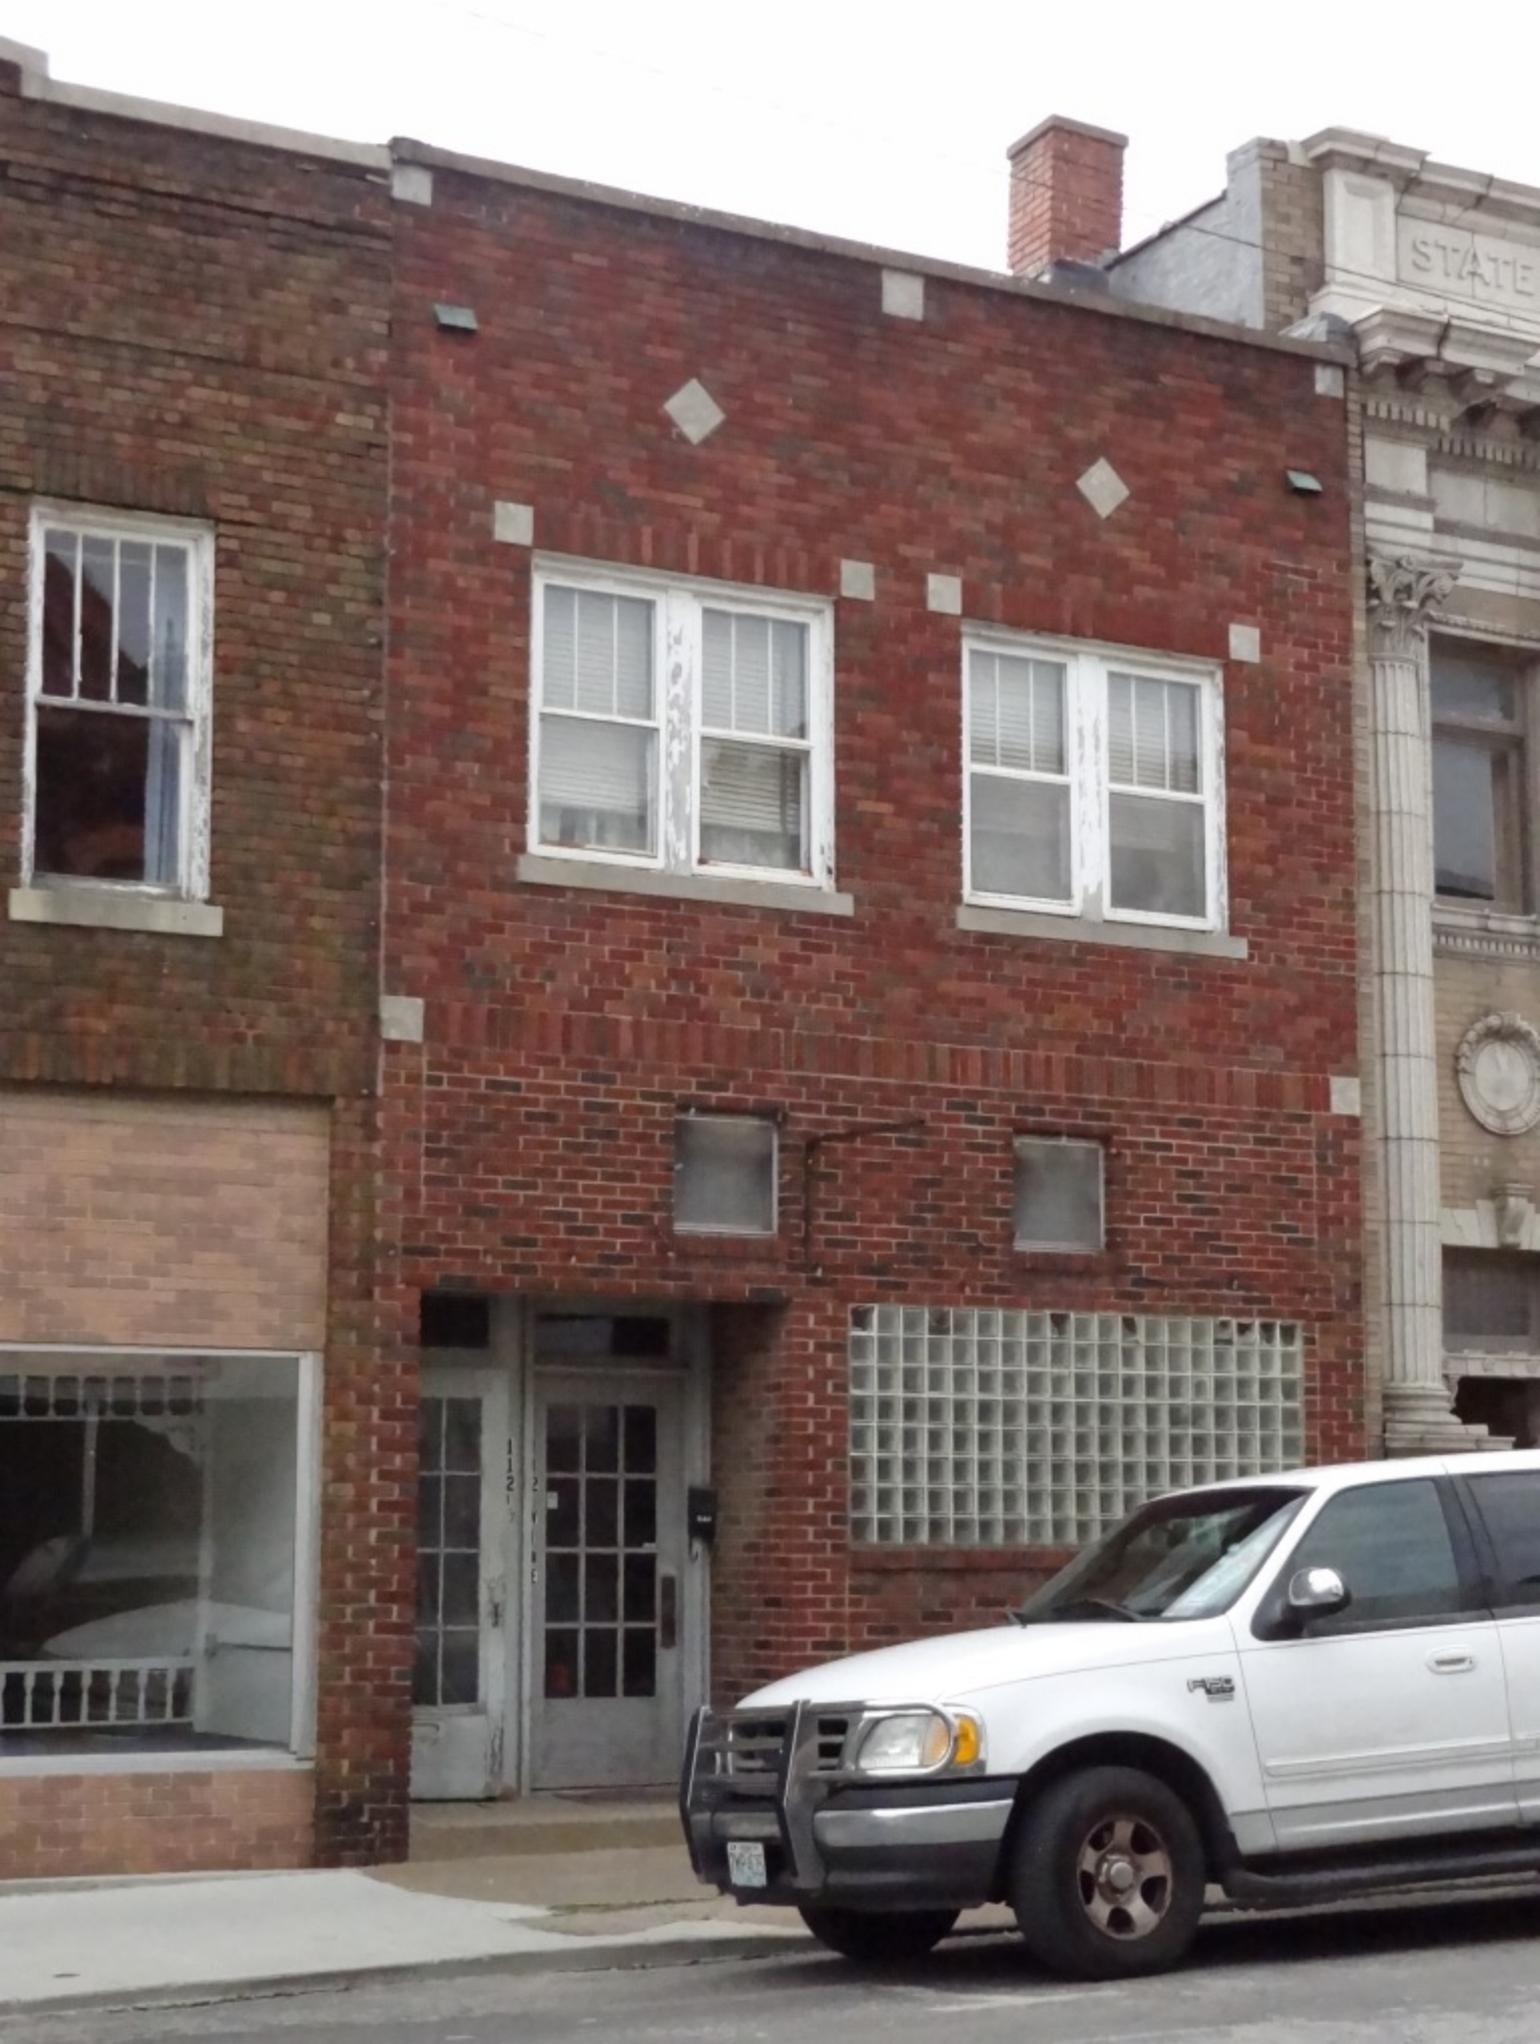
This rectangular, two-part commercial block brick building has two bays on its first floor with a recessed entry in the easternmost bay. One concrete step leads up to the entrance, comprised of two wood doors with twelve lights and a transom window. The easternmost door leads to the second floor while the other door leads to the first floor. The western bay contains a window comprised of multiple glass blocks. Two centered window openings, each filled with a square fixed light, pierce the wall above these bays. A soldier brick beltcourse creates a visual dividing line between the first and second floors. The second story has two identical bays filled with paired 3/1 double-hung historic wood windows with stone sills. Both pairs of windows have a soldier brick lintel flanked by square stone blocks. The wall above is ornamented with two diamond-shaped stone blocks. Square stone blocks, three in total, are placed at both ends and in the center of the capped parapet.

The storefront was altered c. 1955. Despite alterations, the building retains historic brick cladding and upper story windows, rendering it contributing to a potential National Register district.

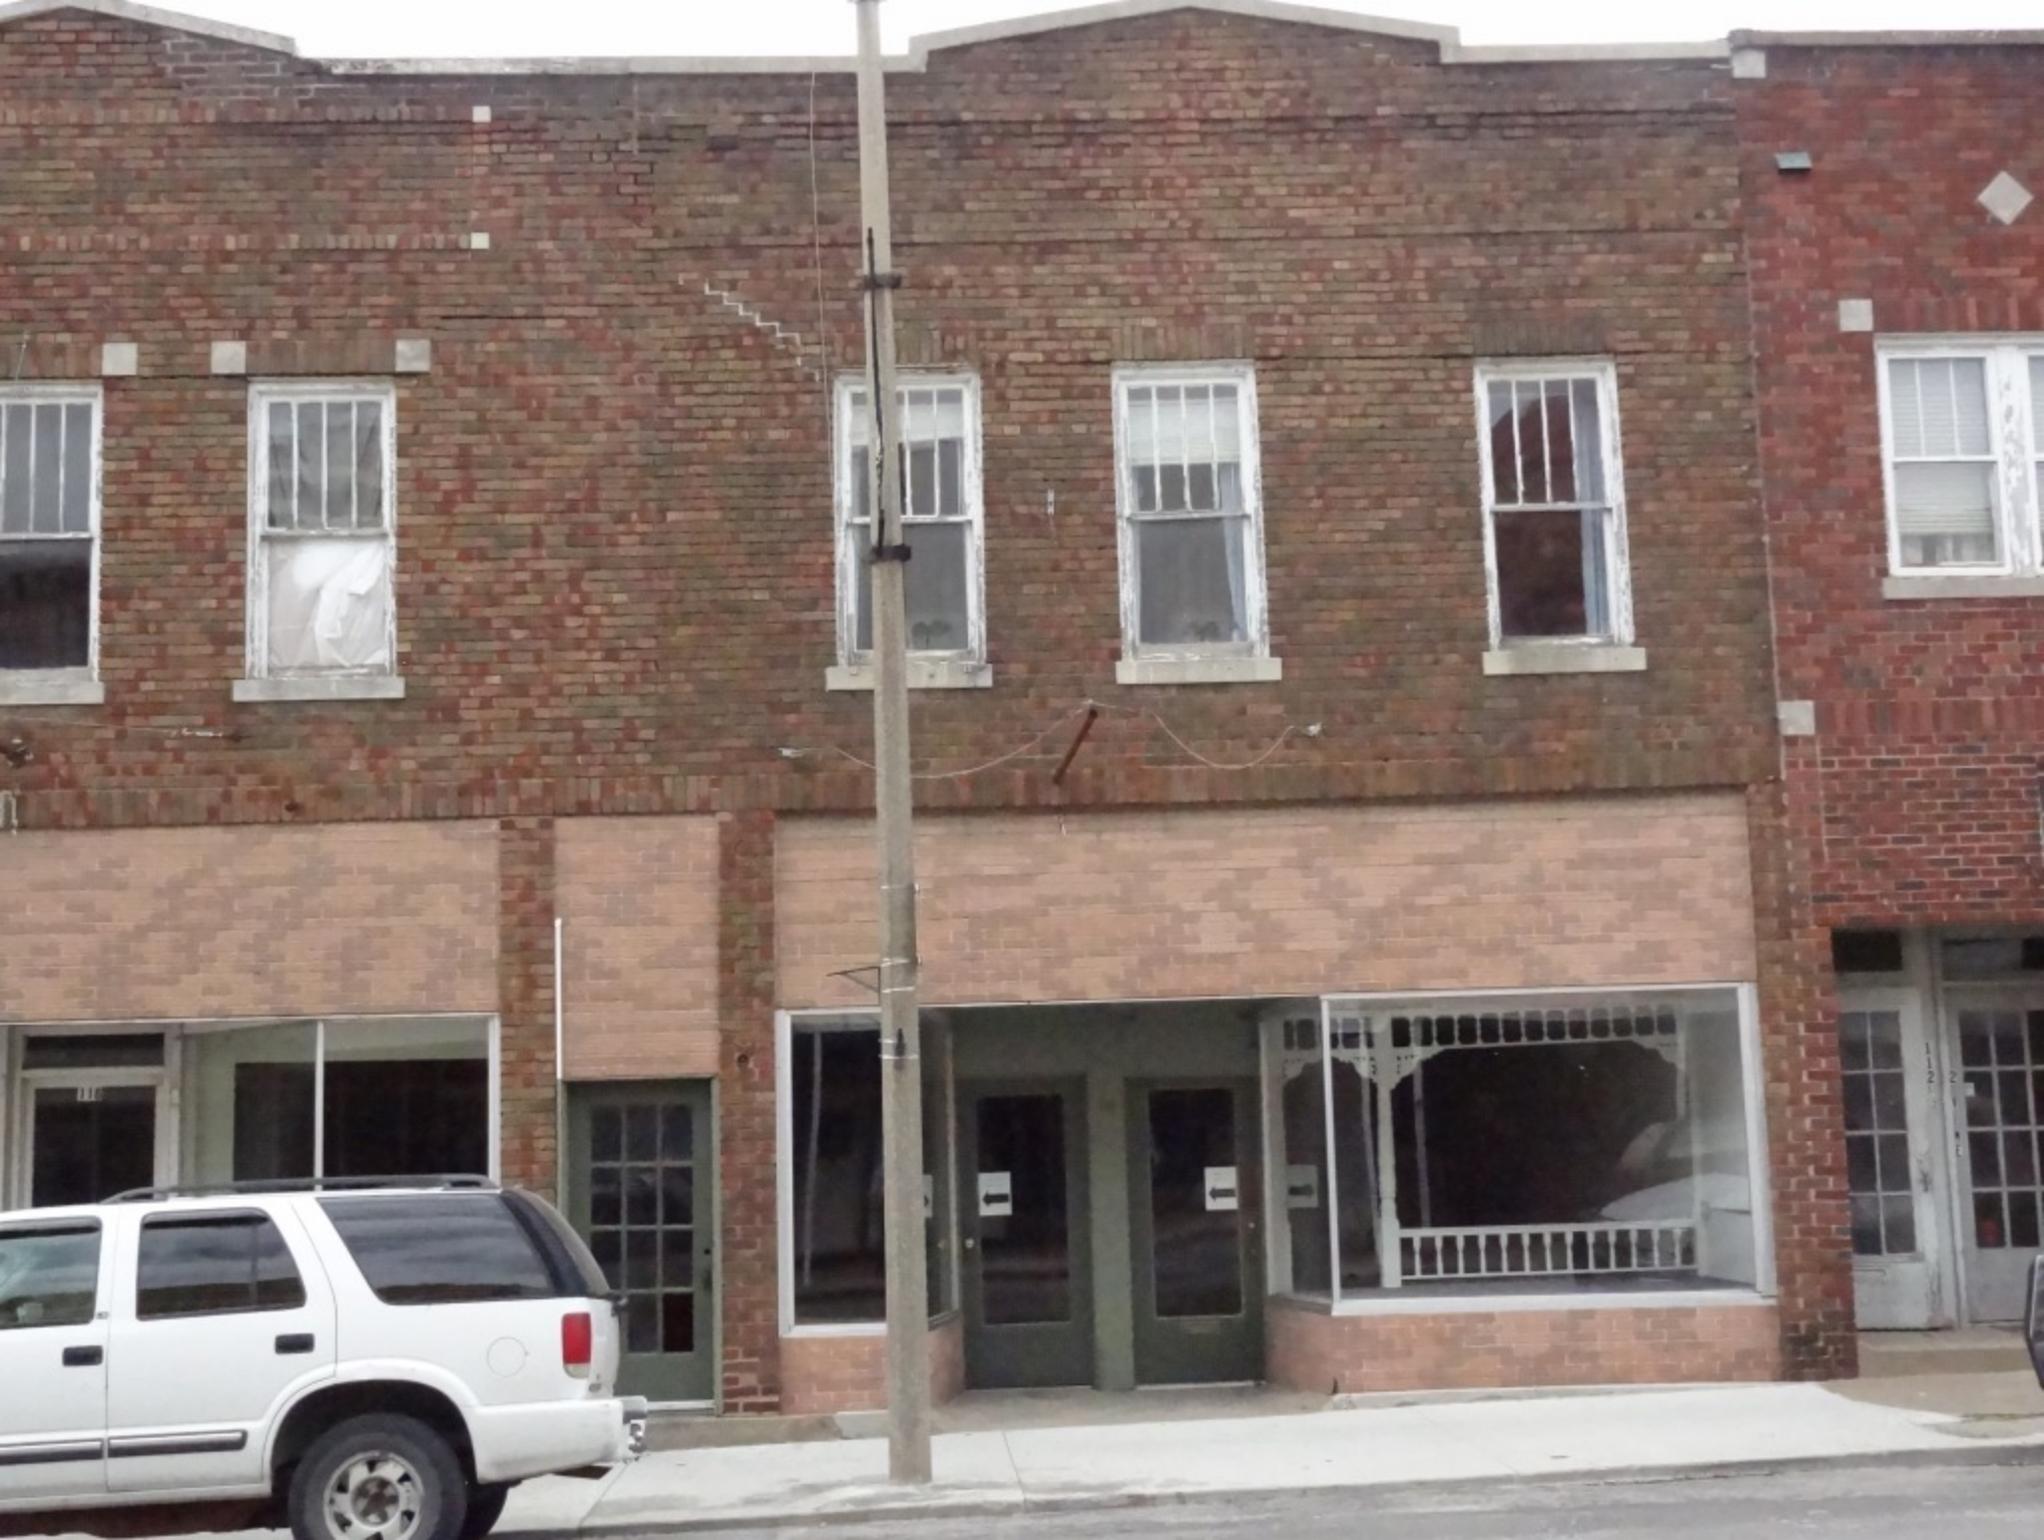
Surveyors were given access to the interior of the building and viewed moderate water damage. There appears to be two mid-twentieth century additions to the rear of the building.

The storefront was altered in the mid-twentieth century, likely covering historic transoms with brick. Despite alterations, the building retains enough historic fabric to be contributing to a potential National Register district.

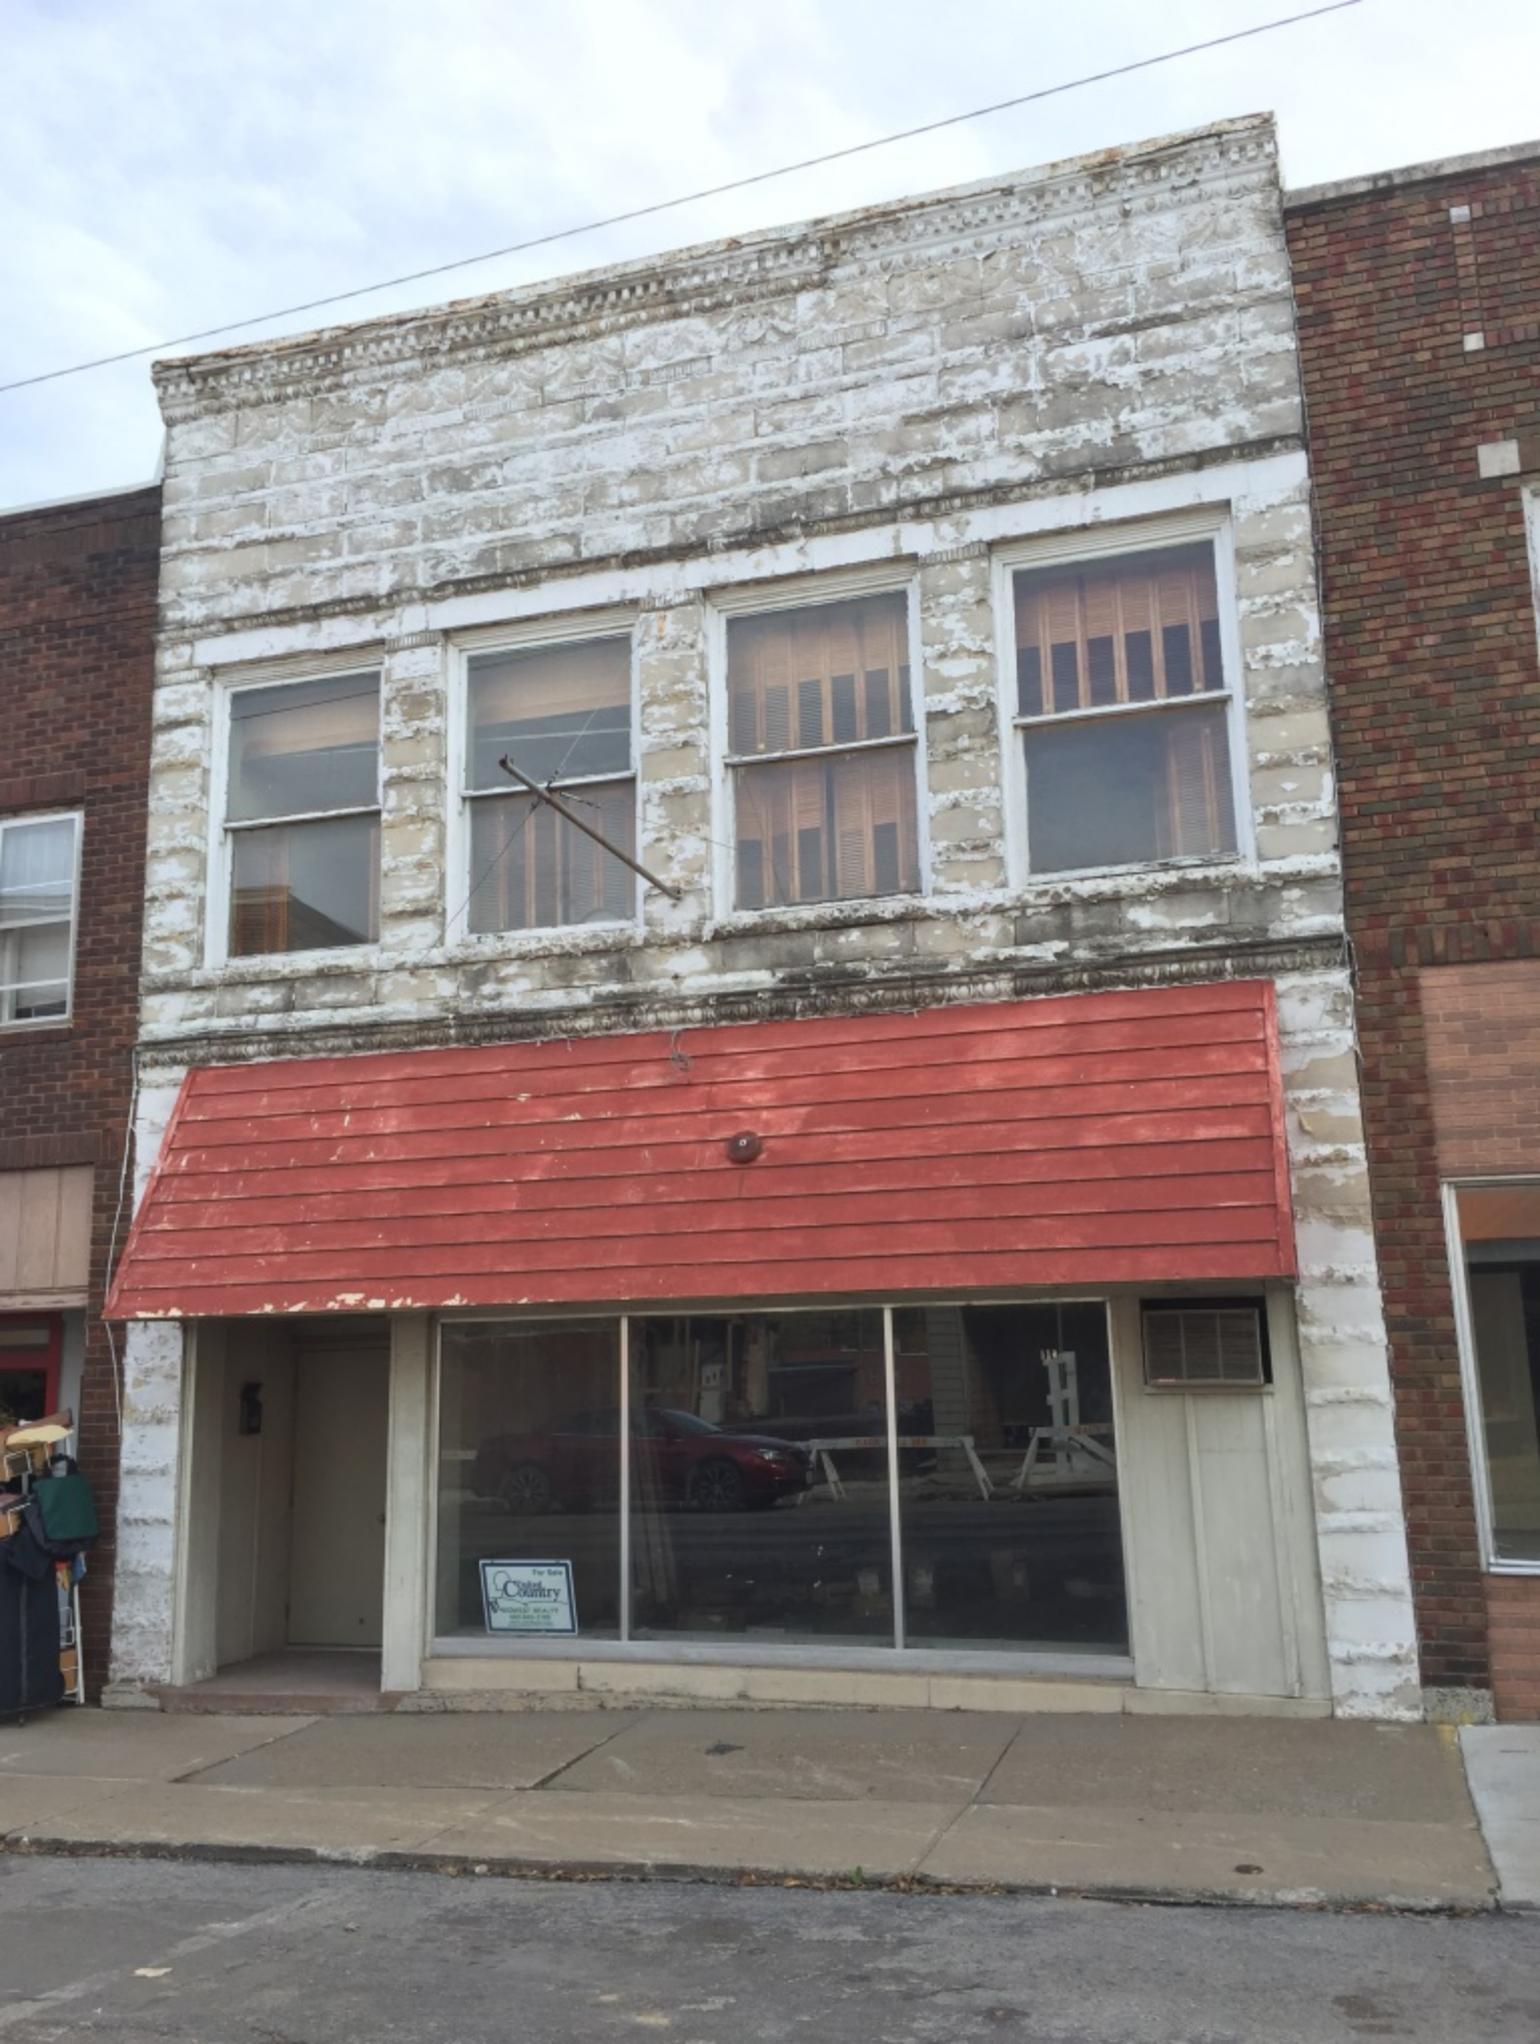
This rectangular, two-part commercial block building is clad in stone. A different exterior cladding material may have been recently removed as the stone appears to have some damage. The first story has three bays. The large western bay contains a plate glass display window with three lights and a small section of wood vertical siding with an inset air conditioning unit. The next bay contains a canted wood door with a glass light that leads to the storefront. The eastern bay contains a wood door that leads to the second floor. Both doors are recessed and accessed via a concrete step. A wood mansard awning extends over the bays, which are flanked by stone pilasters that rise up to a beltcourse featuring egg and dart molding. The upper story, also clad in stone, features four historic wood 1/1 windows with a raised stone sill course and an egg and dart lintel course. The cornice features decorative floral scrollwork, egg and dart molding, and dentils.

Tax assessor records indicate the storefront was altered c. 1960. Despite alterations, the building retains enough historic materials to be contributing to a potential National Register district.

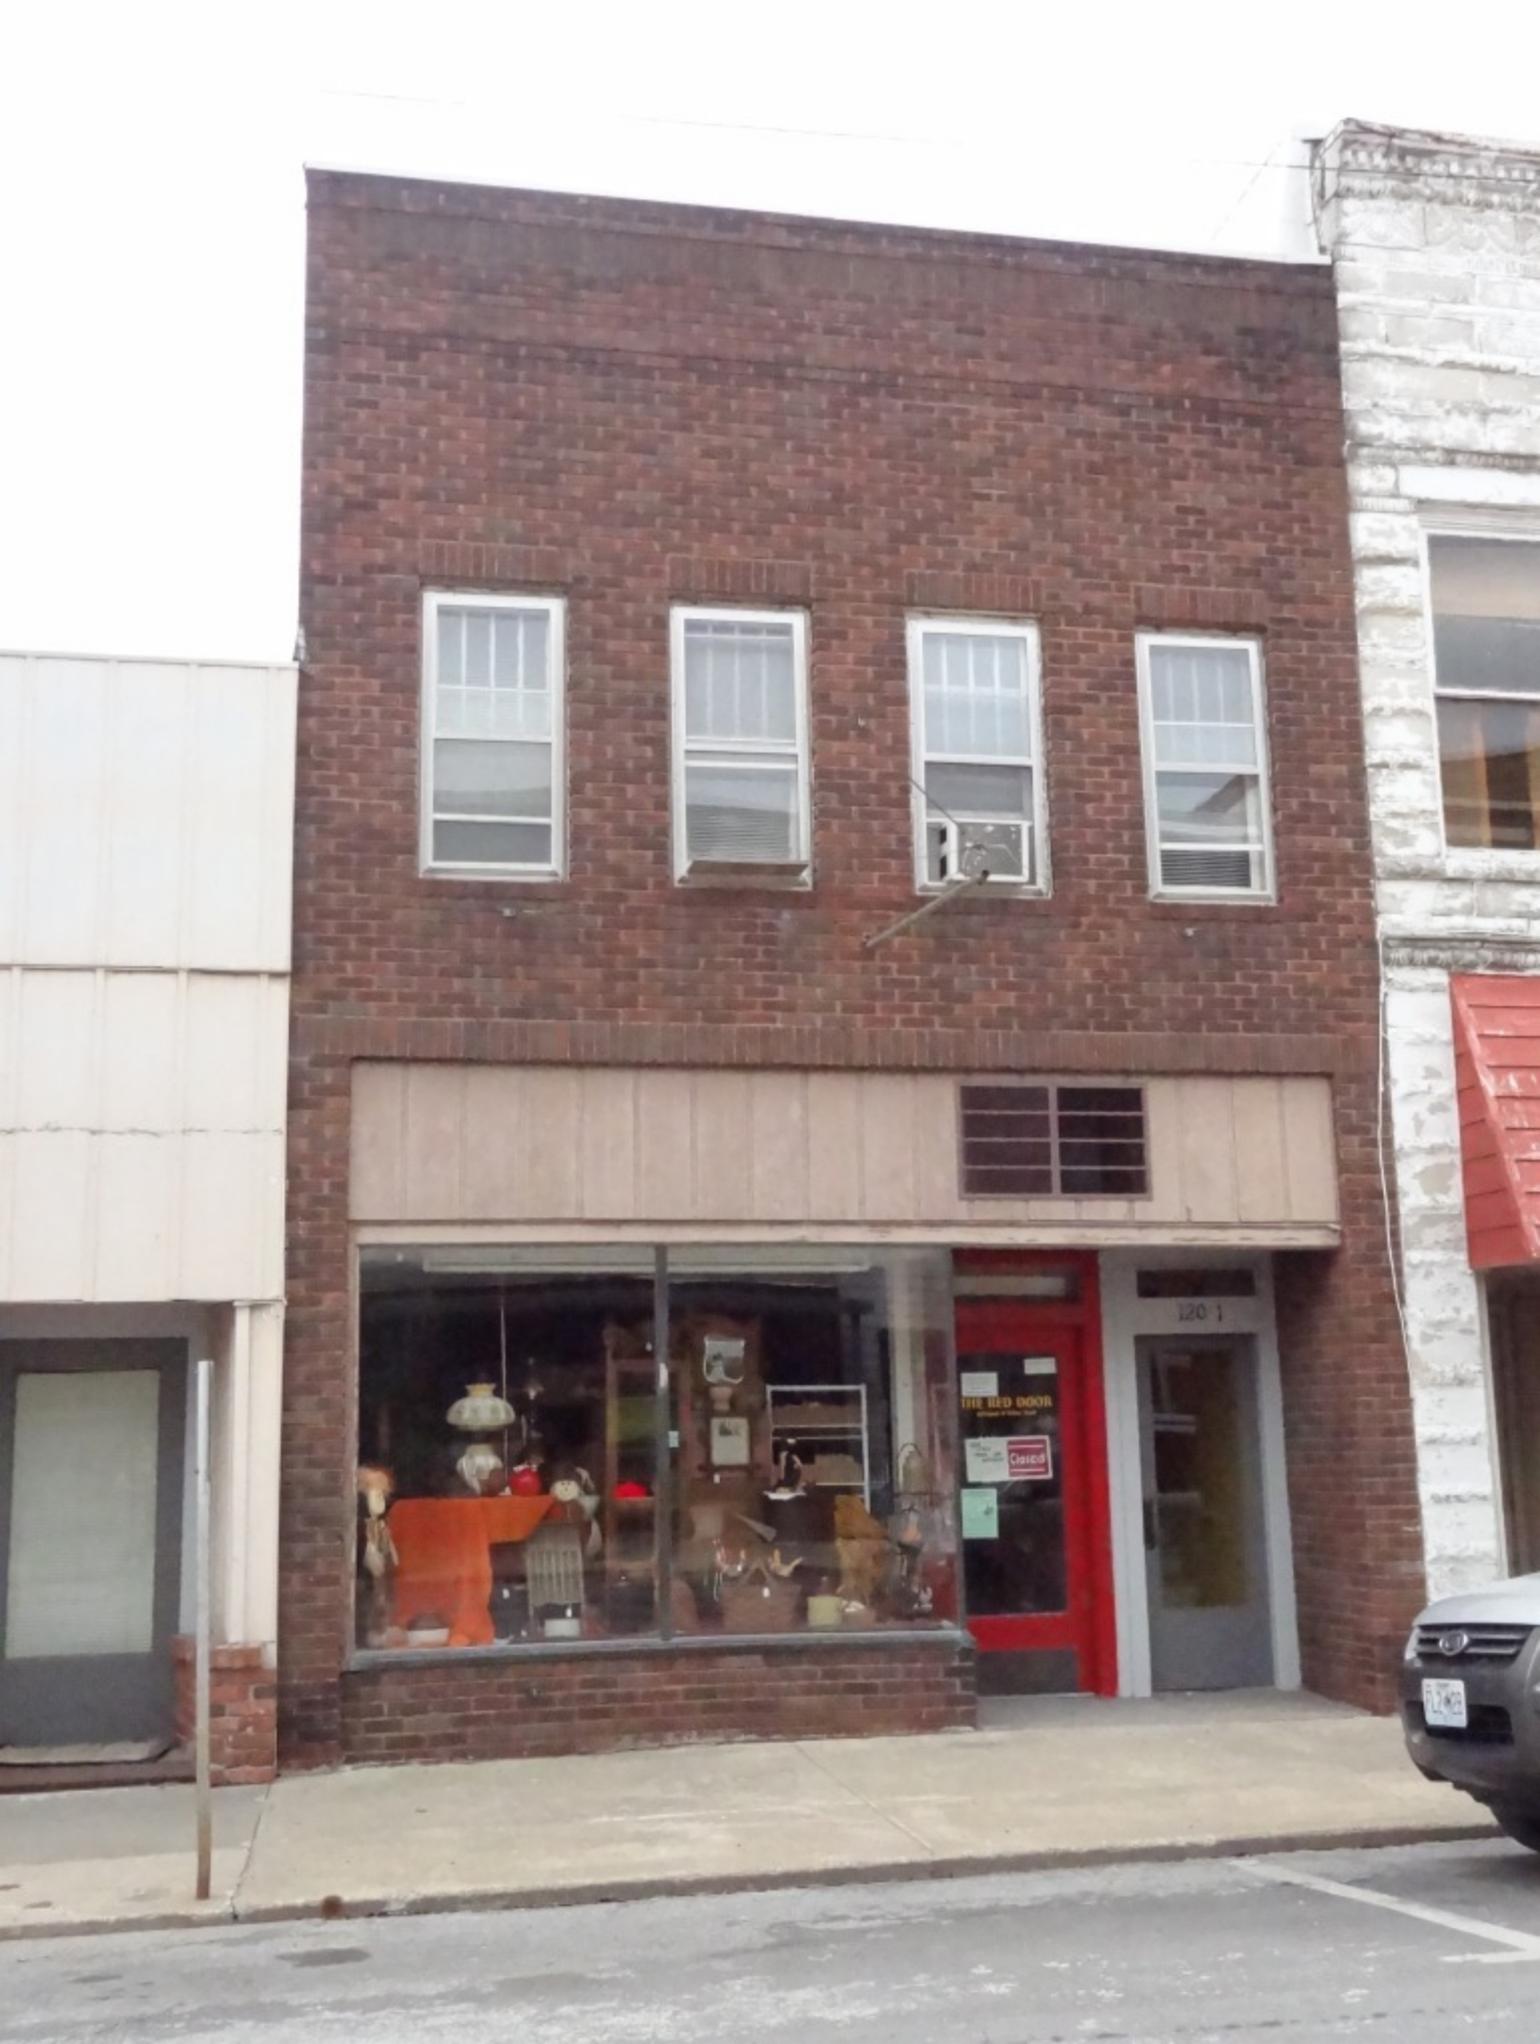
This rectangular, two-part commercial block brick building has three bays on its first story. The two recessed west bays have wood doors with glazing and transoms. The westernmost door leads to the second story and the other door serves as the storefront entrance. The eastern bay extends back out to align with the primary façade and contains a plate glass display window with three lights. Brown brick clads the bulkheads and the exterior wall area flanking the bays. Wood paneling clads the transom area above the bays. A metal vent is set within the wood paneling. A belt course of soldier bricks forms a visual dividing line between the first and second stories. Brown brick clads the exterior of the second story, which has four bays. All four bays contain a historic 4/1 wood double-hung window covered with an aluminum storm window. The western central bay contains an air conditioning unit. All windows have brick sills and straight arch brick lintels. A row of soldier bricks marks the cornice.

While the storefront has some alterations, the building retains enough historic fabric to be contributing to a potential National Register district.

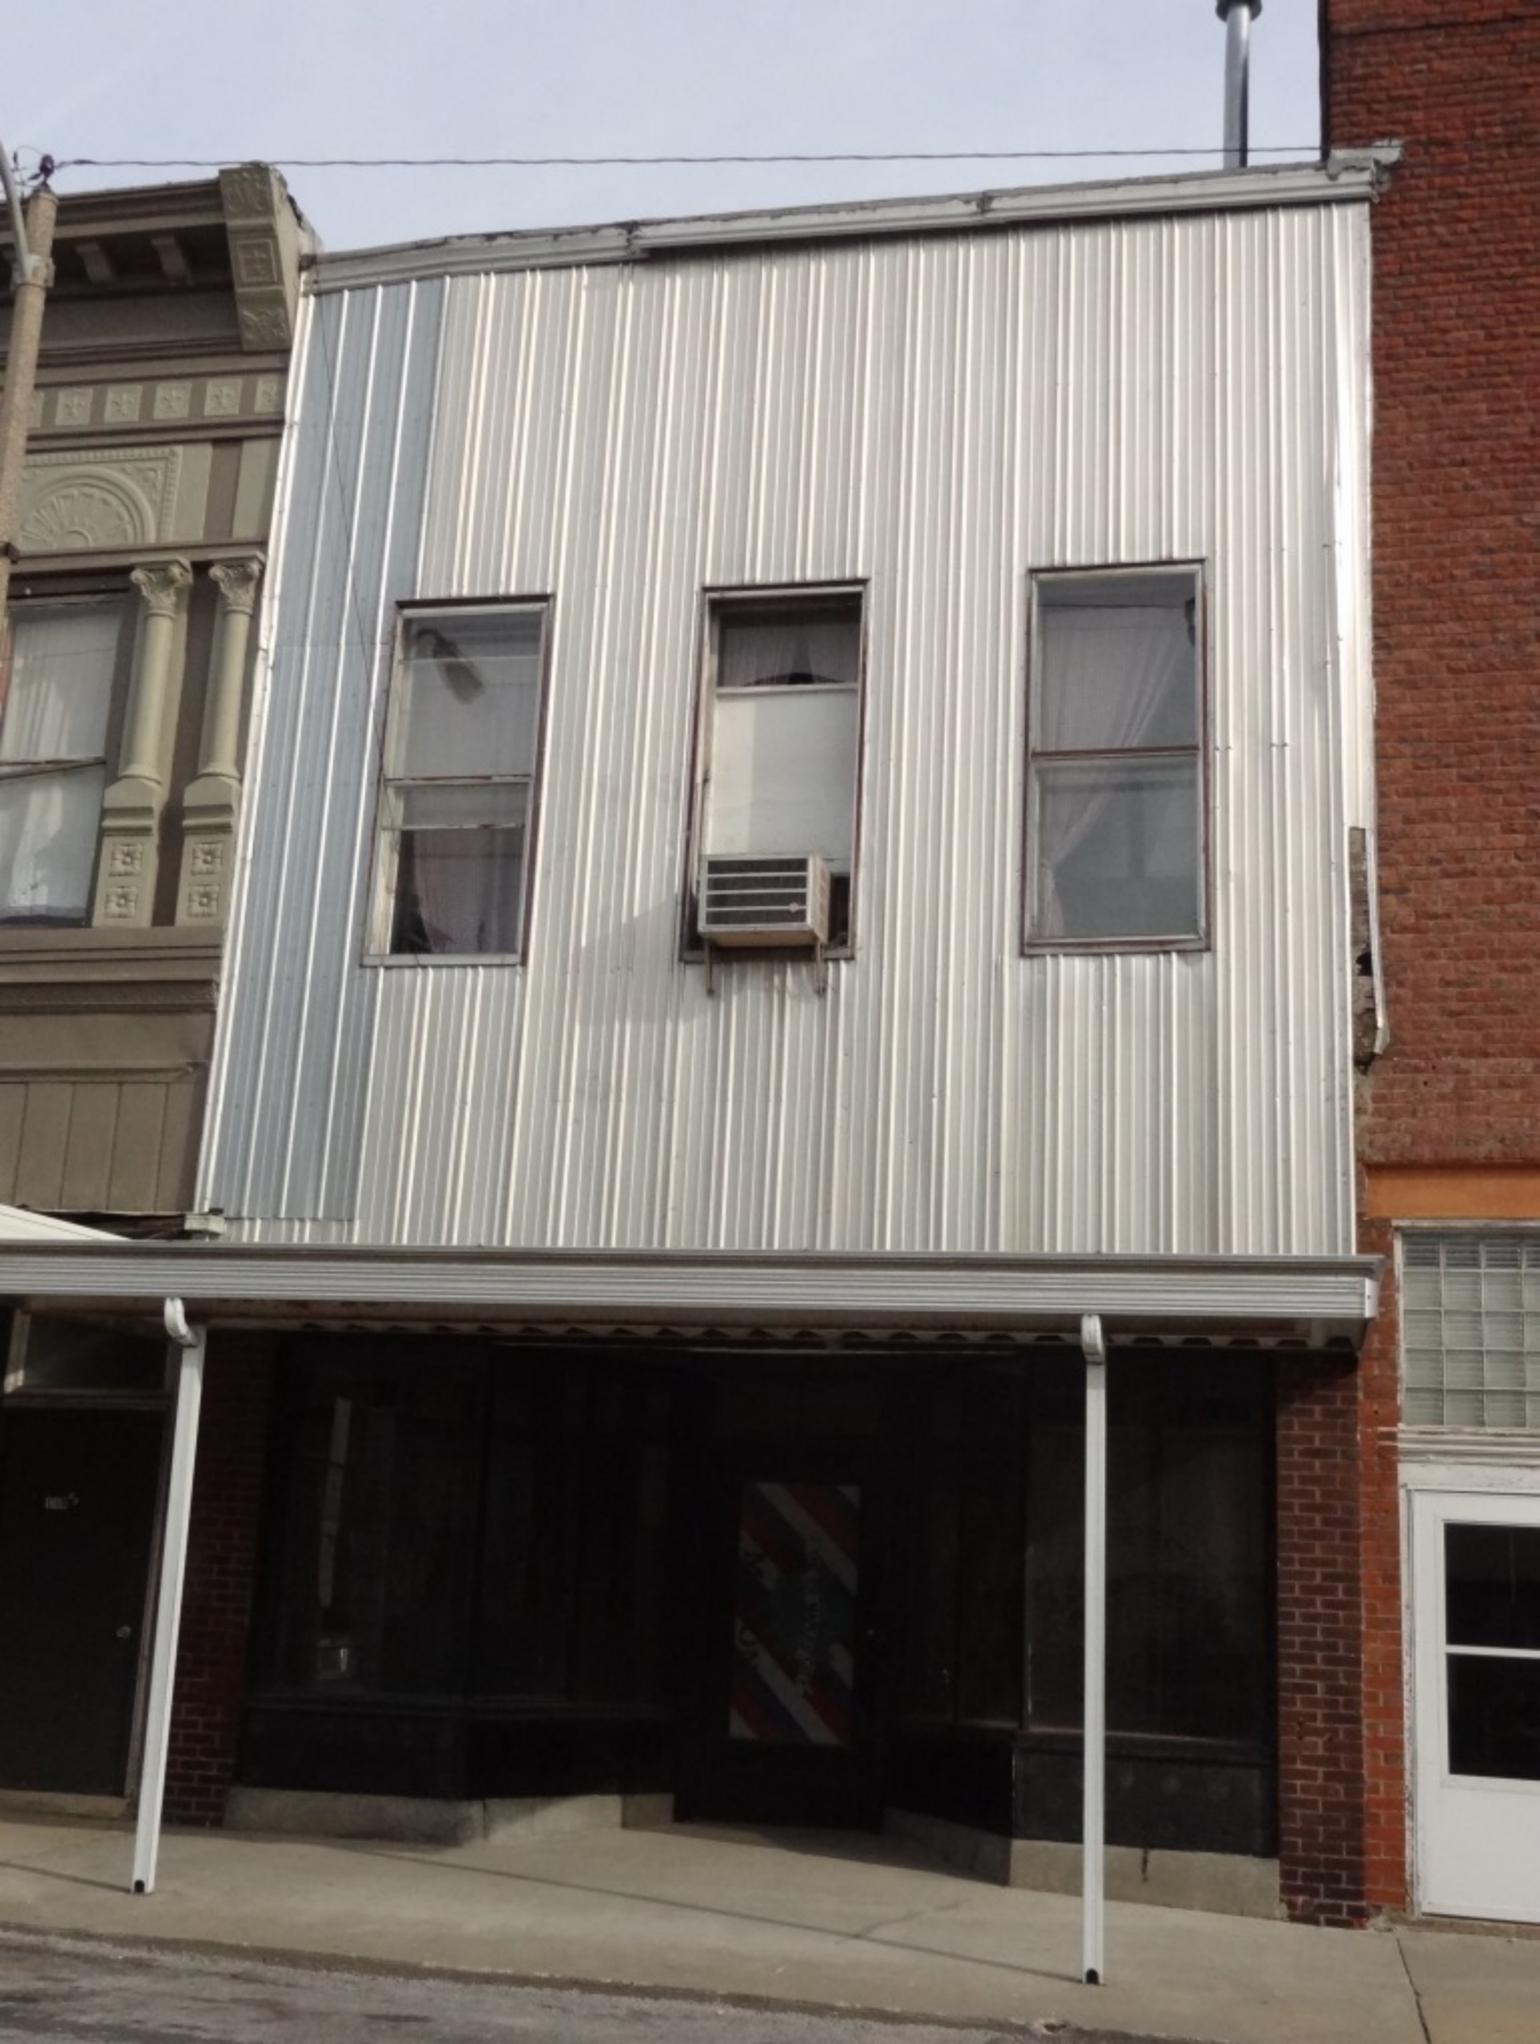
The building was altered c. 1968; this may be when the historic iron cladding was replaced with corrugated metal siding. The replacement metal cladding and windows render the building non-contributing to a potential National Register district.

This building (121 Vine Street) and the eastern half of the building to its west (119 Vine Street) were demolished. The parcel is now a vacant dirt lot.
