1. Survey No. MC-AS-001-001		2. Survey name: Downtown Macon Commercial Historic District	
3. County: Macon		4. Address (Street No.) Lots 11-13 block 93	Street (name) East Bourke Street (100 block)
5. City: Macon	Vicinity: <input type="checkbox"/>	6. Geographical Reference:	7. Township/Range/Section: T: R: S:
8. Historic name (if known):		9. Present/other name (if known): City of Macon Parking Lot #3	
10. Ownership: <input checked="" type="checkbox"/> Private <input type="checkbox"/> Public		11a. Historic use (if known): Commercial	11b. Current use: vacant

42. Current owner/address: City of Macon Macon, MO 63552	43. Form prepared by (name and org.): Kristi Chase MO SHPO	44. Survey date: 9/24/2014
		45. Date of revisions:

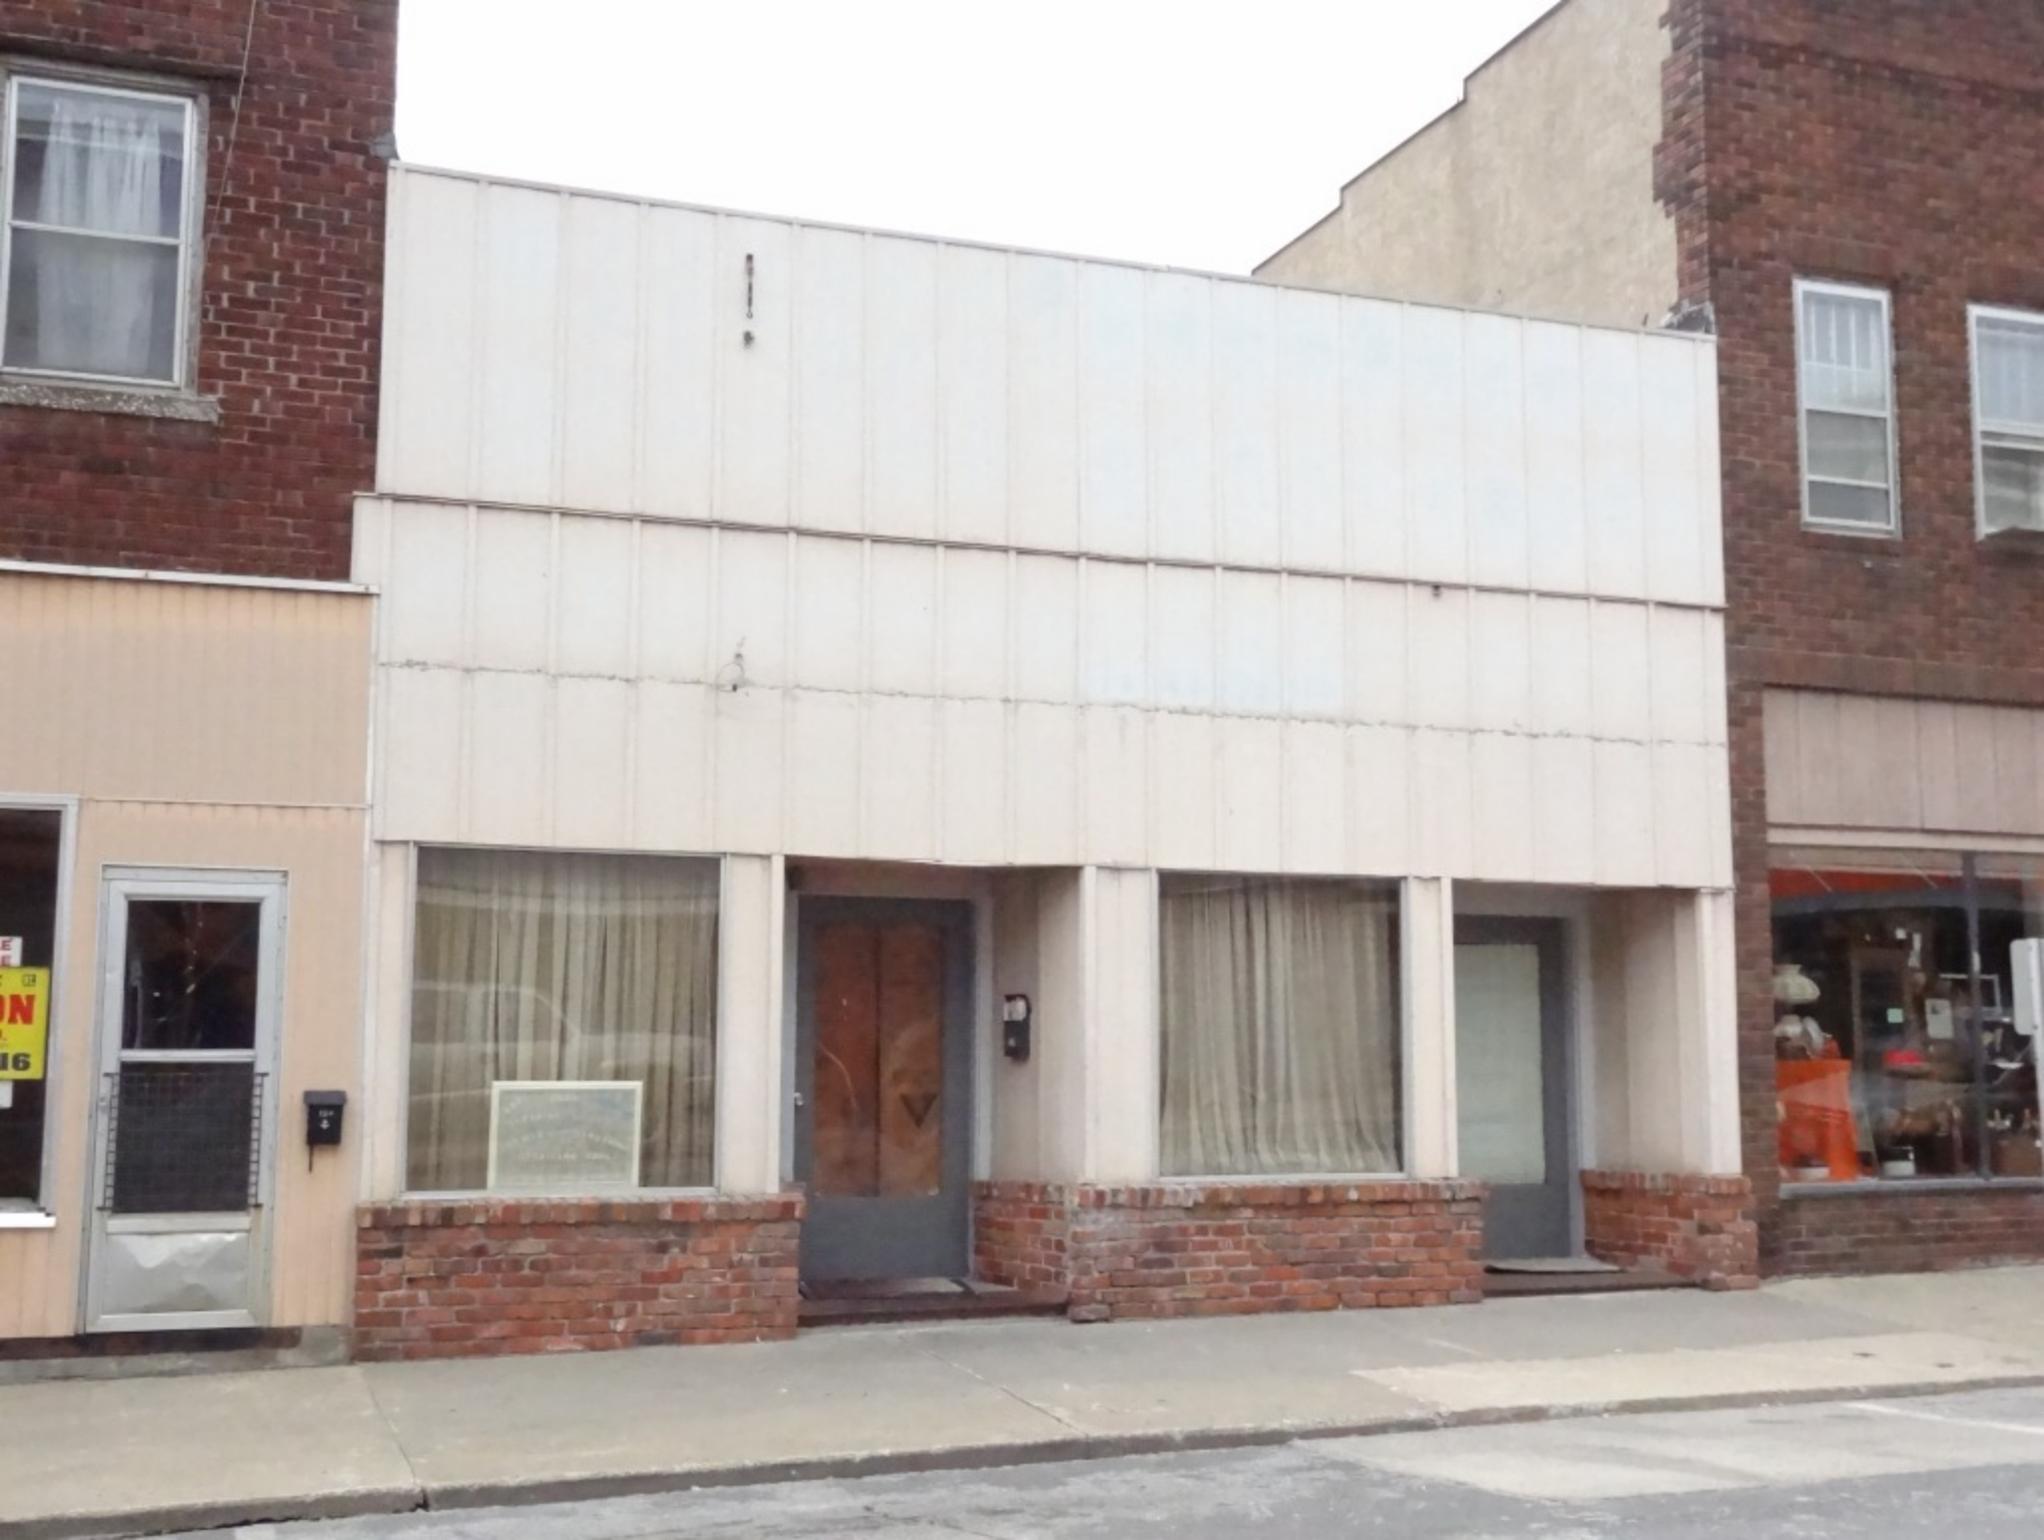
This square, one-part commercial block building has four bays comprised of two storefronts. The westernmost bay contains a concrete step and recessed wood door with a single glazed light and wood surround. The western center bay contains a plate glass display window that aligns with the plane of the façade. The bulkheads are clad in brick. Square metal-clad posts are at the corners of the display. The two eastern bays are identical to the western bays. The upper portion of the façade is clad entirely in vertical metal panels.

Tax assessor records indicate that alterations to the building occurred c. 1963. The façade has been covered with metal panels, and the storefront replaced with non-historic materials. These alterations likely render the building non-contributing to a potential National Register district.

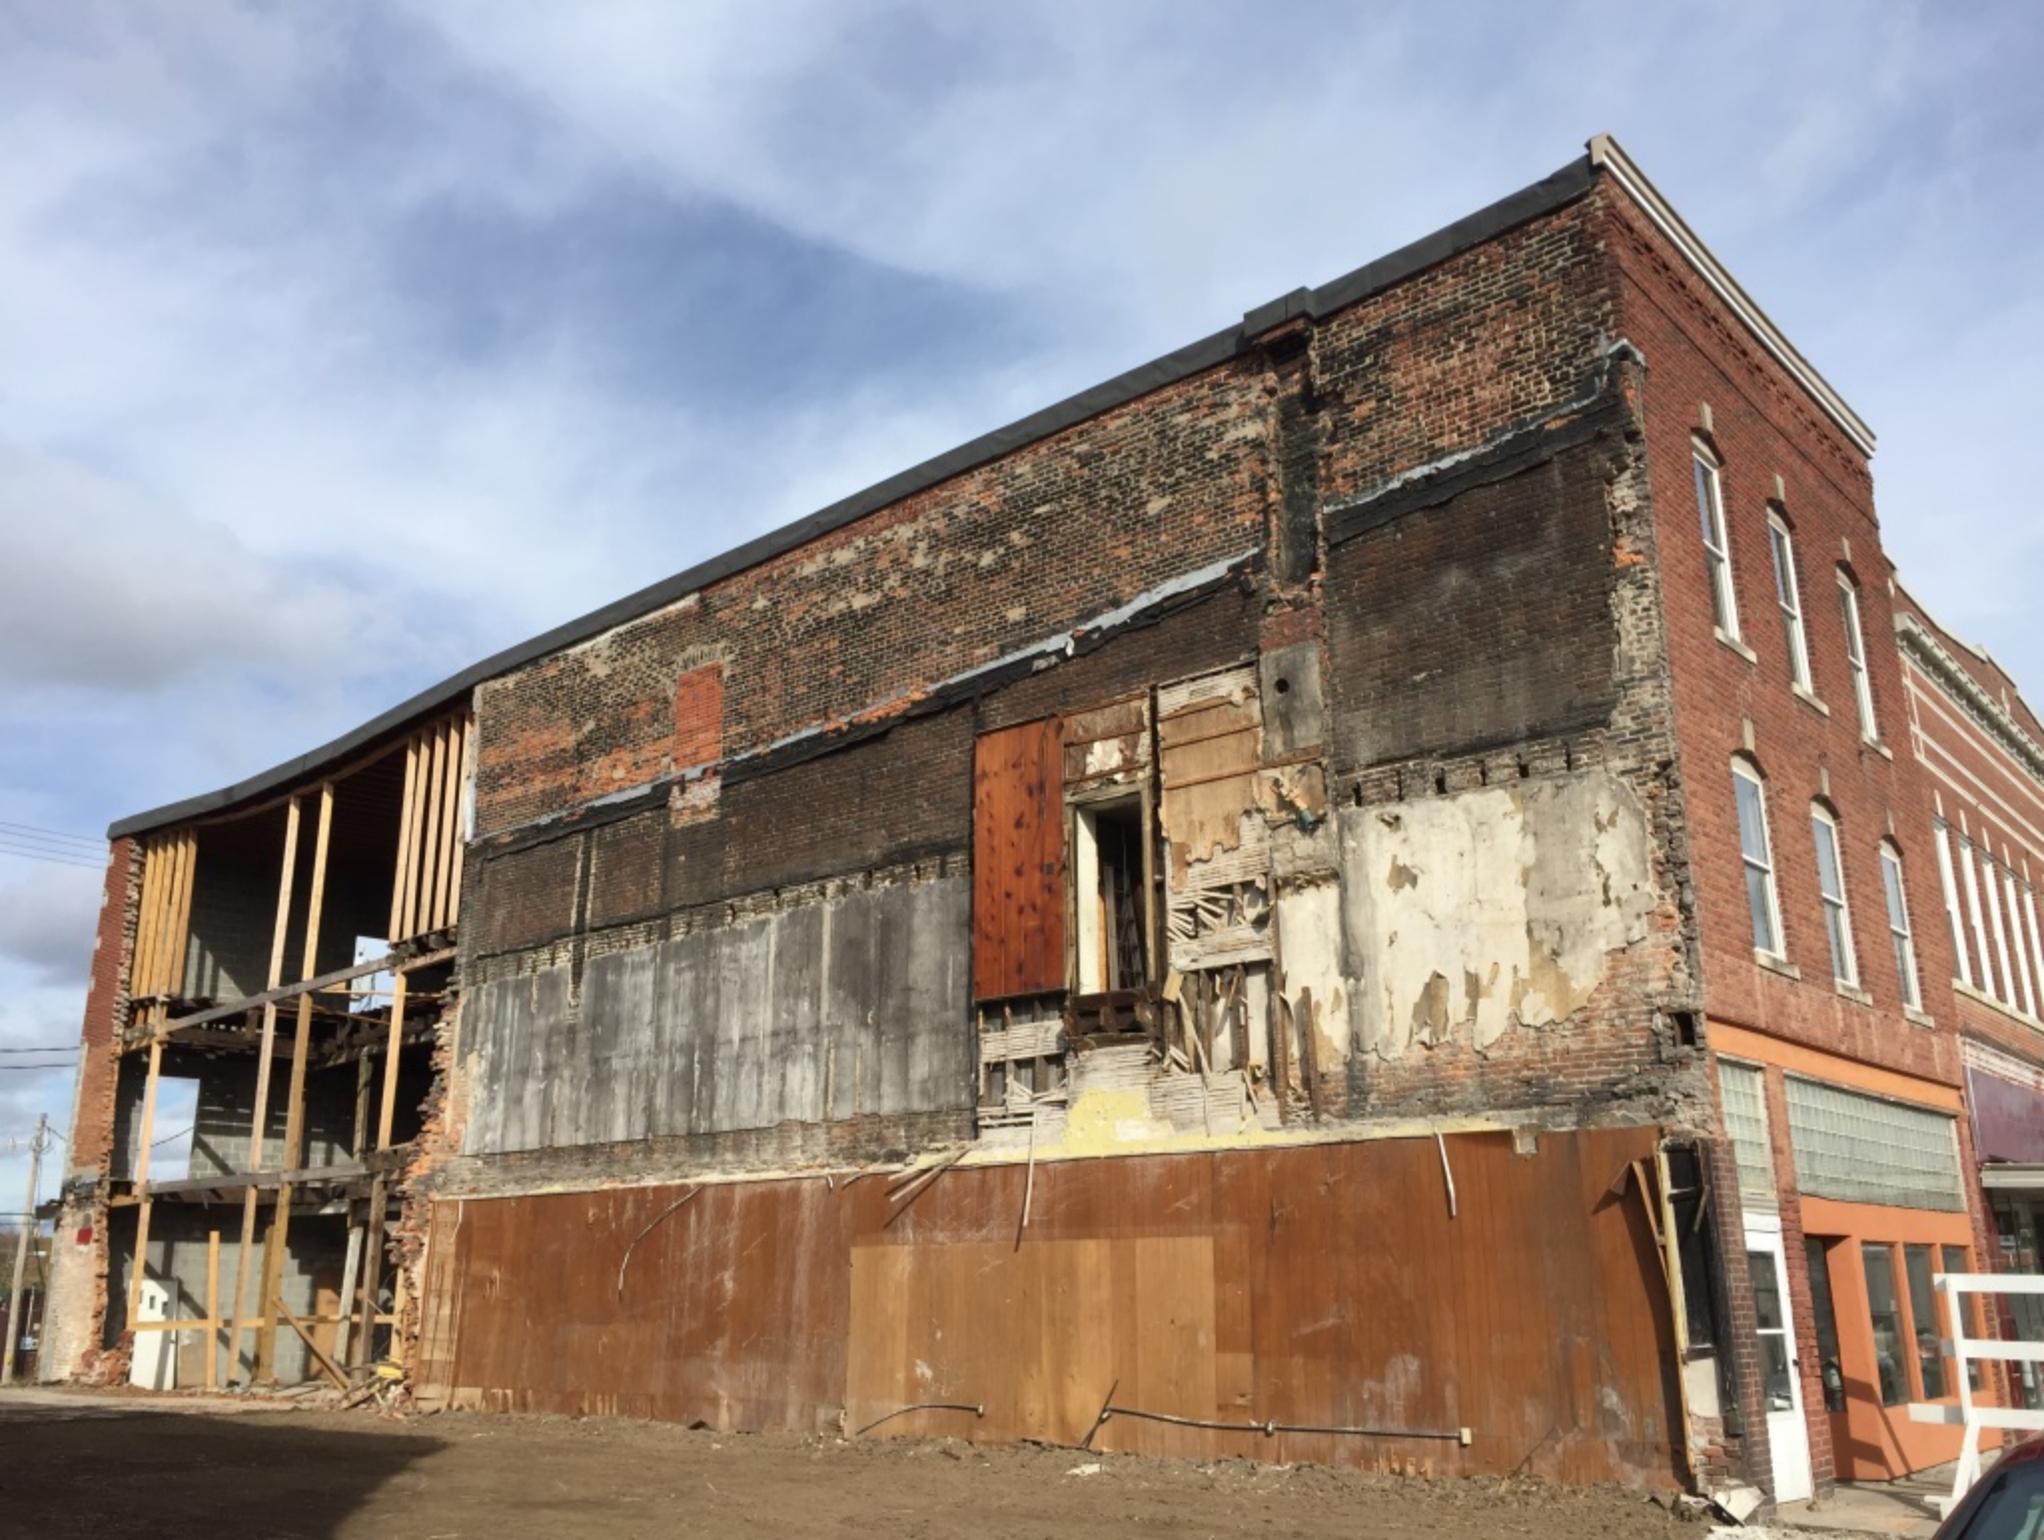
The west elevation of this building is now exposed due to the demolition of the neighboring two-part commercial block building in October 2015.

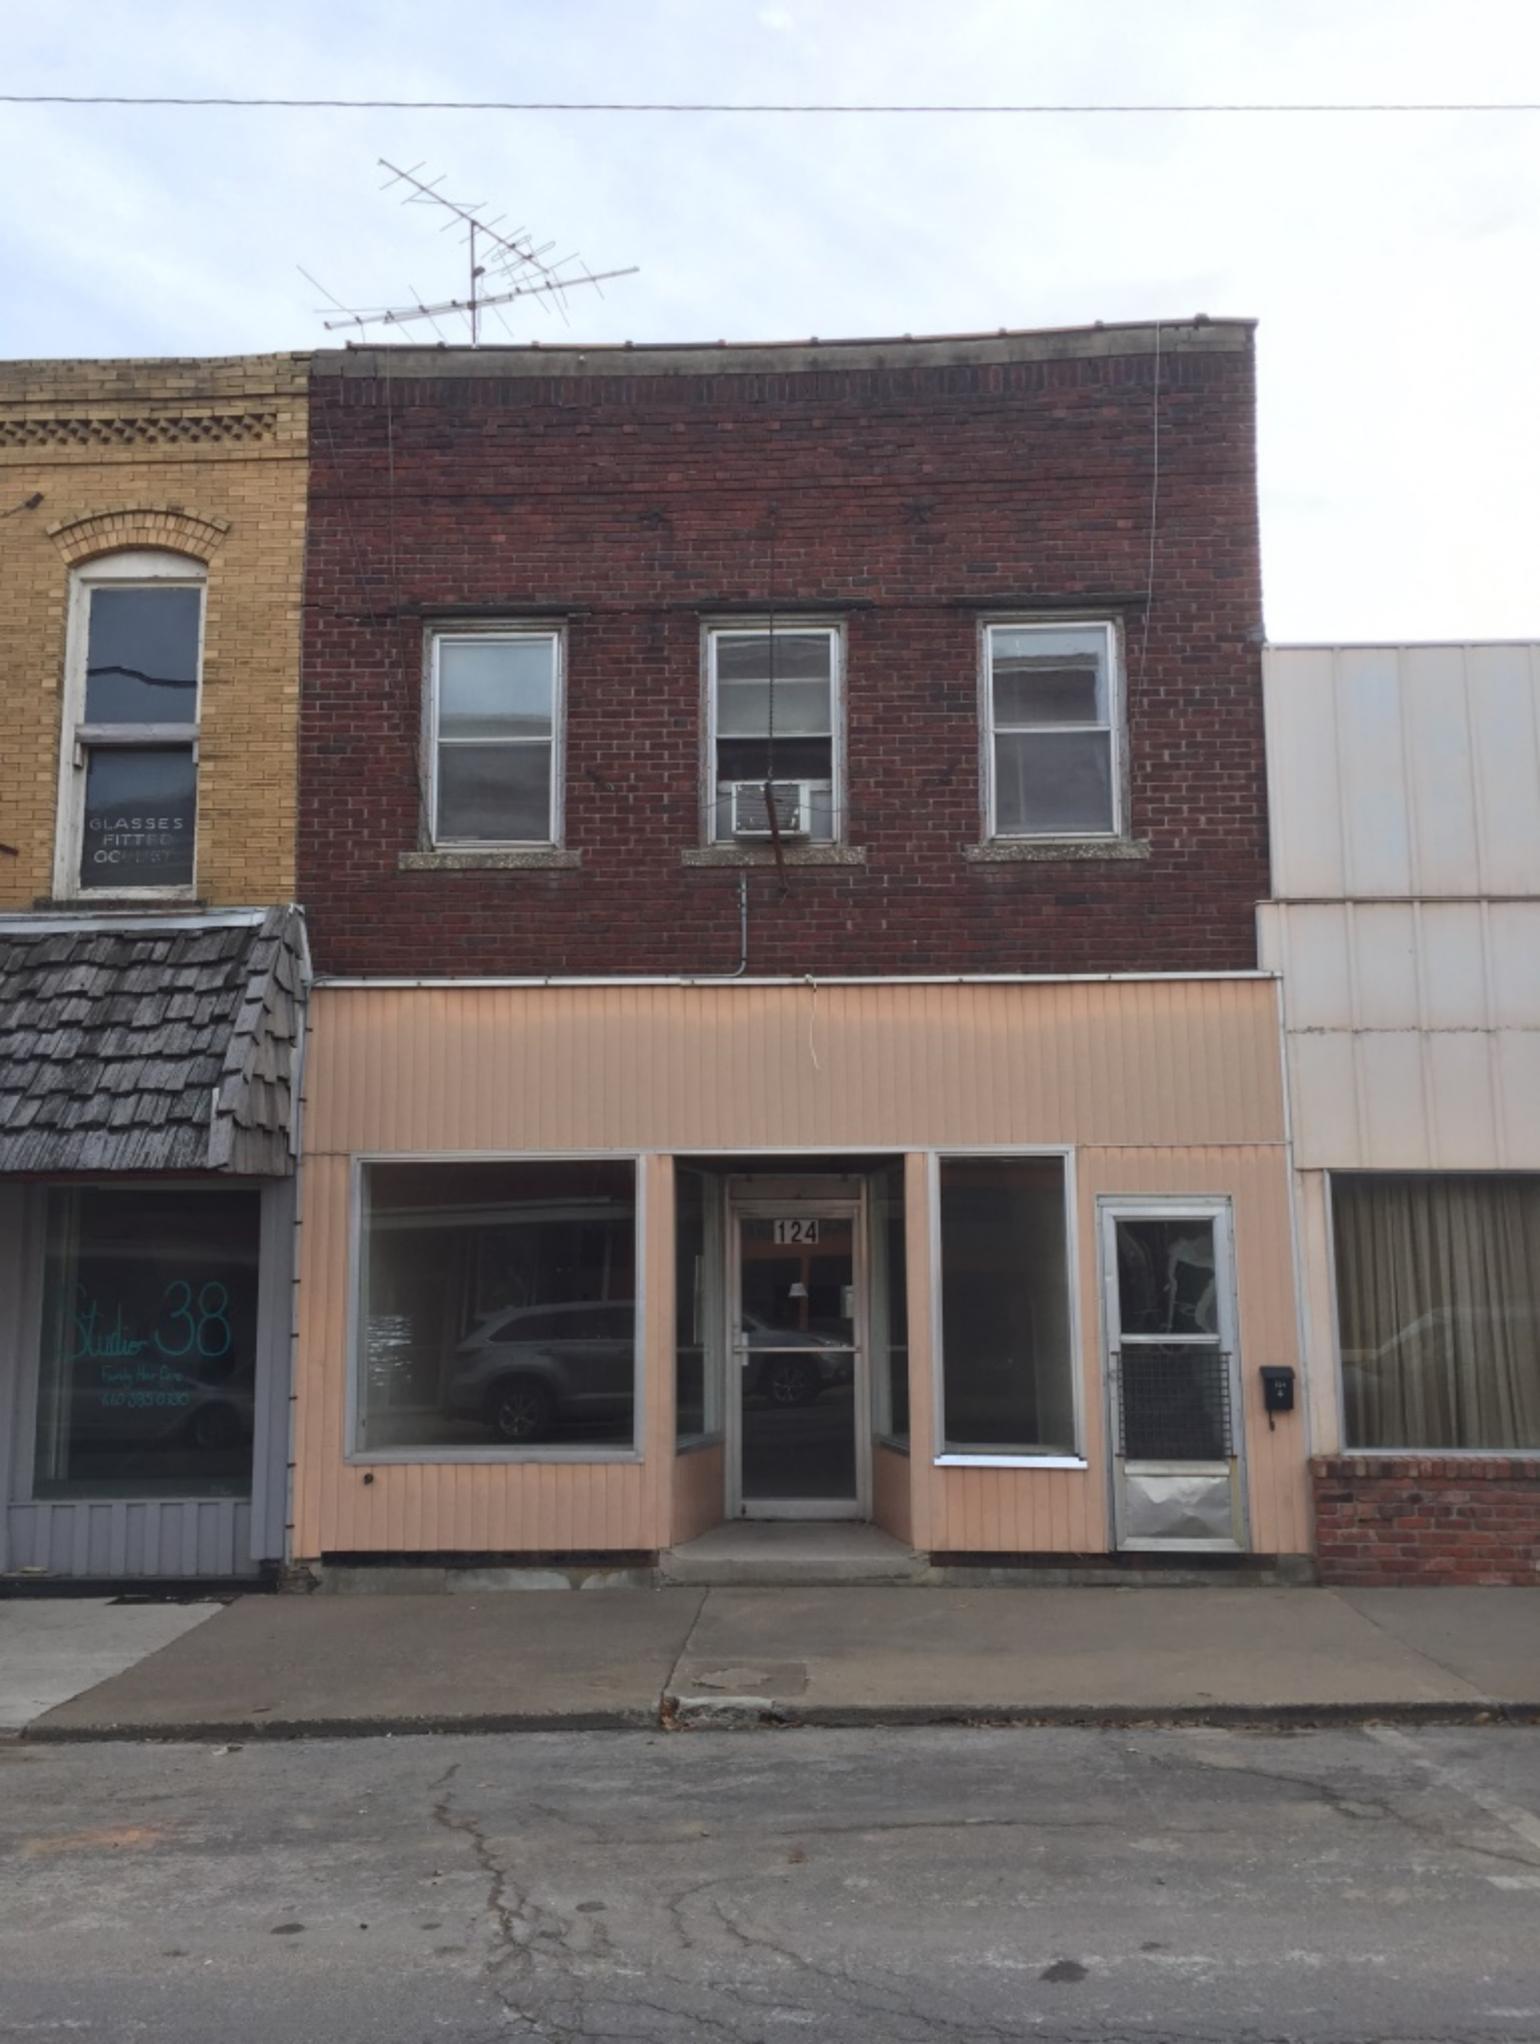
This rectangular, two-part commercial block building has four bays on its first story. The westernmost bay contains an aluminum screen door leading to the second floor. The three remaining bays comprise the storefront entrance. The westernmost bay of the three contains two narrow plate glass display windows, with the innermost window inset perpendicular to the center bay. The center bay has a glass and aluminum recessed entrance door with a concrete step. The easternmost bay contains one narrow plate glass display window that extends back out to align with the façade and then a larger square plate glass display window. The first story exterior is clad in vinyl. The second story is clad in red brick and has three bays. All three bays contain 1/1 aluminum double-hung windows with concrete aggregate sills. The center window contains an air conditioning unit. The wall above the windows contains a decorative extended row of stretcher bricks. The cornice features corbeled brick resembling dentil molding, a row of stretcher bricks, and two rows of parged bricks.

Alterations to the building occurred c. 1976, likely resulting in the alteration of the first floor storefront. Despite alterations, the building retains its historic massing, fenestration pattern, and brick cladding on the second story; it would likely contribute to a potential National Register district.

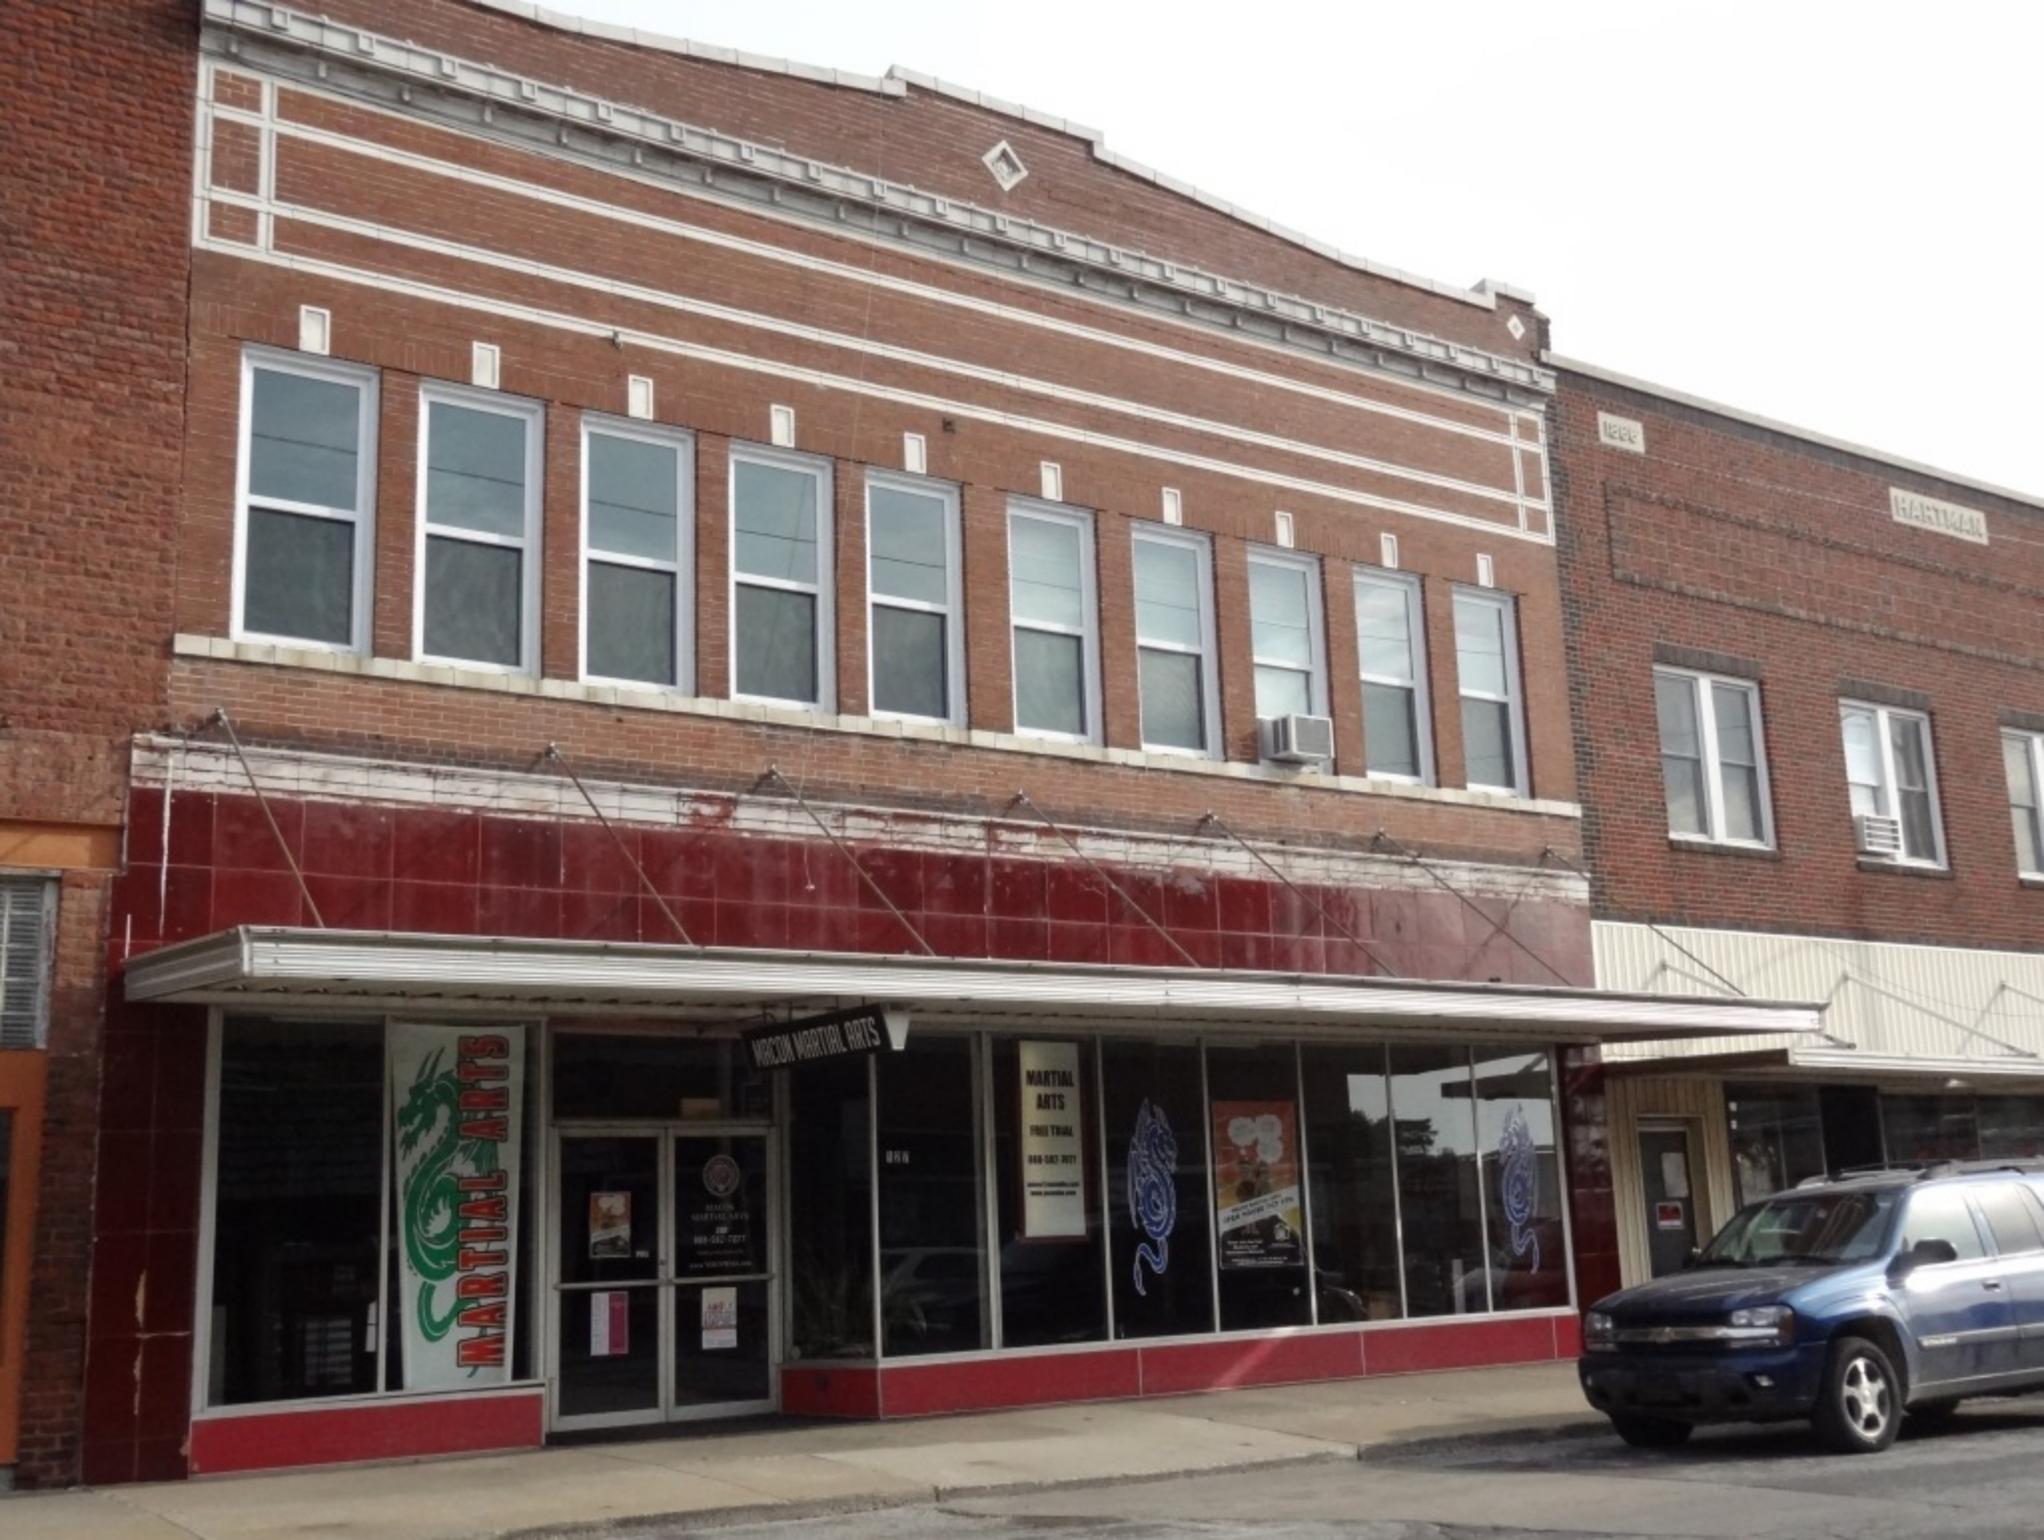
This rectangular, two-part commercial block brick building has three bays on its first floor, comprising one storefront. The eastern bay contains a wide plate glass display window with eight lights. The westernmost light is angled perpendicular to the building to meet the second bay, a pair of recessed glass and aluminum entrance doors with a single transom. The western bay contains a plate glass display window with three lights that extends back out to align with the plane of the façade. The bulkheads below the display windows are clad with fiberglass panels. The remaining exterior wall is clad with glazed masonry up to the second story. A full-width metal awning attached to the building with suspension cords extends out over the first story. The second story is clad in brick and has ten bays, each containing a non-historic 1/1 double-hung vinyl window and a stone sill course. Over the windows is a lintel course of soldier bricks, with a stone rectangular keystone above each bay. Above the lintel course is a decorative, full-width rectangular stone outline. The cornice is marked by decorative stone with interspersed dentils. A stepped parapet conceals the flat roof. The parapet is decorated with stone coping and features a stone diamond-shaped decorative element in the center and at both corners.

Alterations occurred to the building c. 1960 and likely resulted in the replacement of the storefront windows. The second story windows were likely replaced within the past decade. Despite these alterations, the building retains enough historic material to be contributing to a potential National Register district.

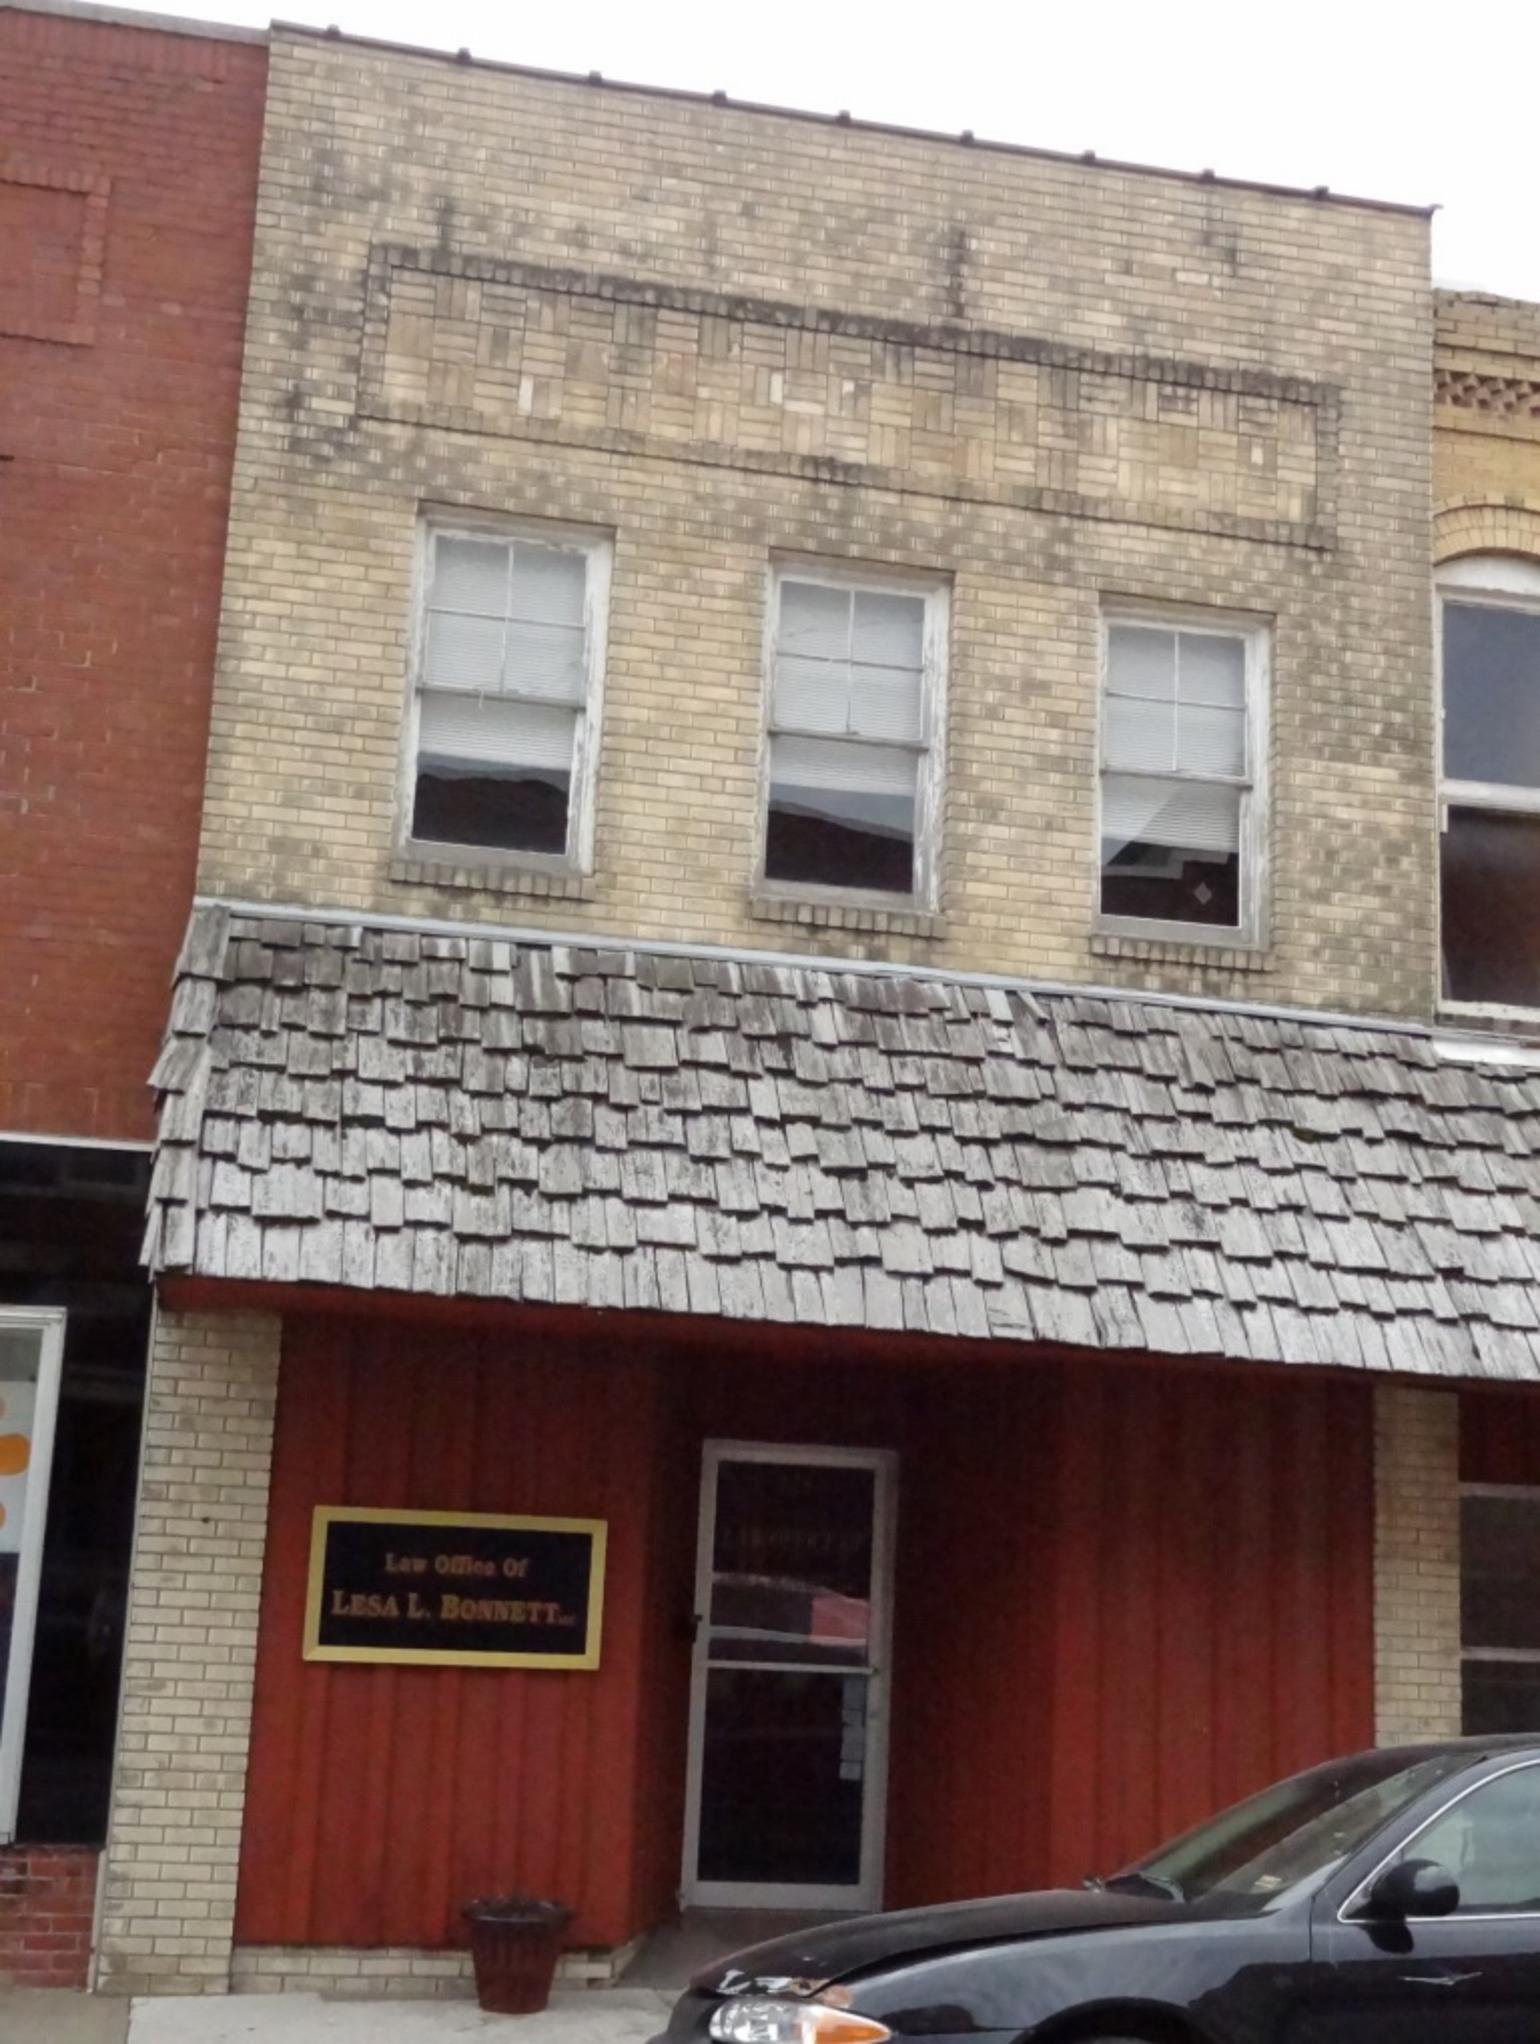
This blonde striated brick, rectangular two-part commercial block building shares a first-story wood shingle mansard awning with 126 Vine Street. The first floor of the building has one bay containing a centered, recessed aluminum and glass entrance door. The first floor is primarily clad with vertical board and batten wood paneling. Blonde brick piers are visible at each end of the first story. The wood shingle awning conceals the exterior wall up to the second story. The second story is clad with blonde brick and has three bays. Each bay contains a historic 4/1 wood double-hung window with a brick sill. The wall above the windows contains a decorative rectangular panel of brick arranged in a parquet pattern. The cornice is capped with metal flashing.

Tax assessor records indicate that alterations to the building took place c. 1964. This likely resulted in the mansard awning and wood paneled storefront. Despite alterations, the building retains enough historic fabric to contribute to a potential National Register district.

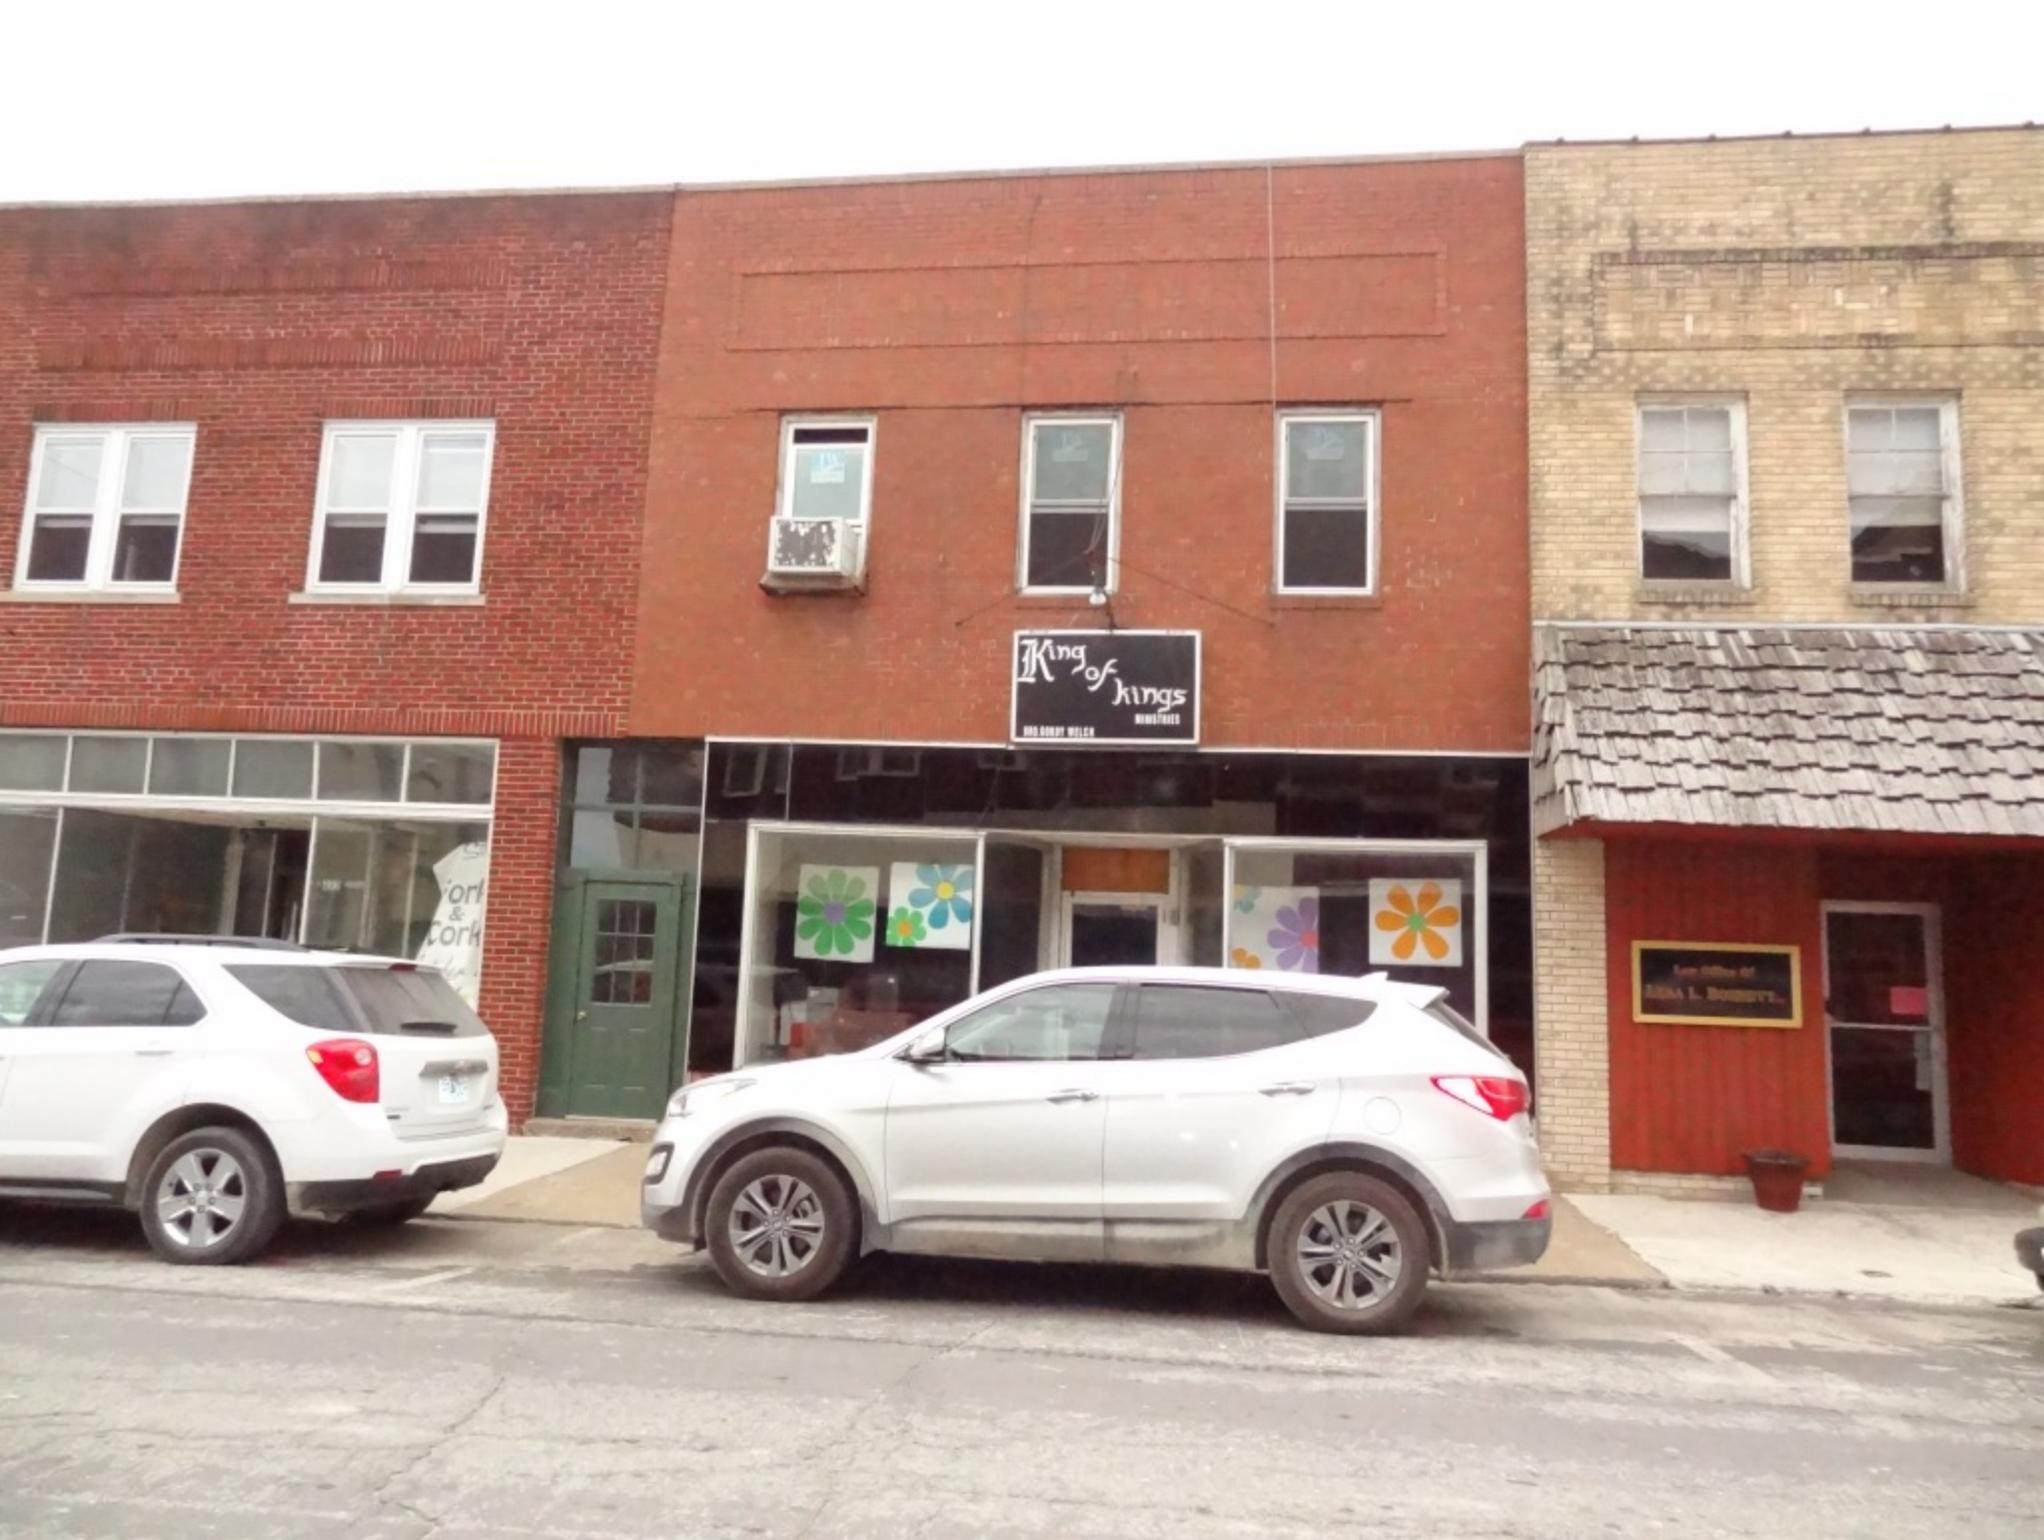
This rectangular, two-part commercial block brick building has three bays on the first story. The central bay contains a recessed aluminum and glass entry door with a boarded-up transom. The door is flanked by plate glass display windows that extend back out to align with the plane of the façade. The bulkheads are clad in brick, and the exterior wall is clad with black Vitrolite up to the second story. A modern sign is attached to the building directly above the Vitrolite. The second story is clad in brick and has three bays. Each bay contains a non-historic 1/1 double-hung aluminum window with a brick sill and flat arch lintel course. The easternmost window bay contains an air conditioning unit. Above the windows, a long rectangular outline of brick headers extends out slightly and contains brick arranged in a parquet pattern. The cornice is marked by a line of soldier bricks capped with concrete.

Despite alterations, the building retains enough historic fabric to contribute to a potential National Register district.
