1. Survey No. MC-AS-001-001		2. Survey name: Downtown Macon Commercial Historic District	
3. County: Macon		4. Address (Street No.) Lots 11-13 block 93	Street (name) East Bourke Street (100 block)
5. City: Macon	Vicinity: <input type="checkbox"/>	6. Geographical Reference:	7. Township/Range/Section: T: R: S:
8. Historic name (if known):		9. Present/other name (if known): City of Macon Parking Lot #3	
10. Ownership: <input checked="" type="checkbox"/> Private <input type="checkbox"/> Public		11a. Historic use (if known): Commercial	11b. Current use: vacant

42. Current owner/address: City of Macon Macon, MO 63552	43. Form prepared by (name and org.): Kristi Chase MO SHPO	44. Survey date: 9/24/2014
		45. Date of revisions:

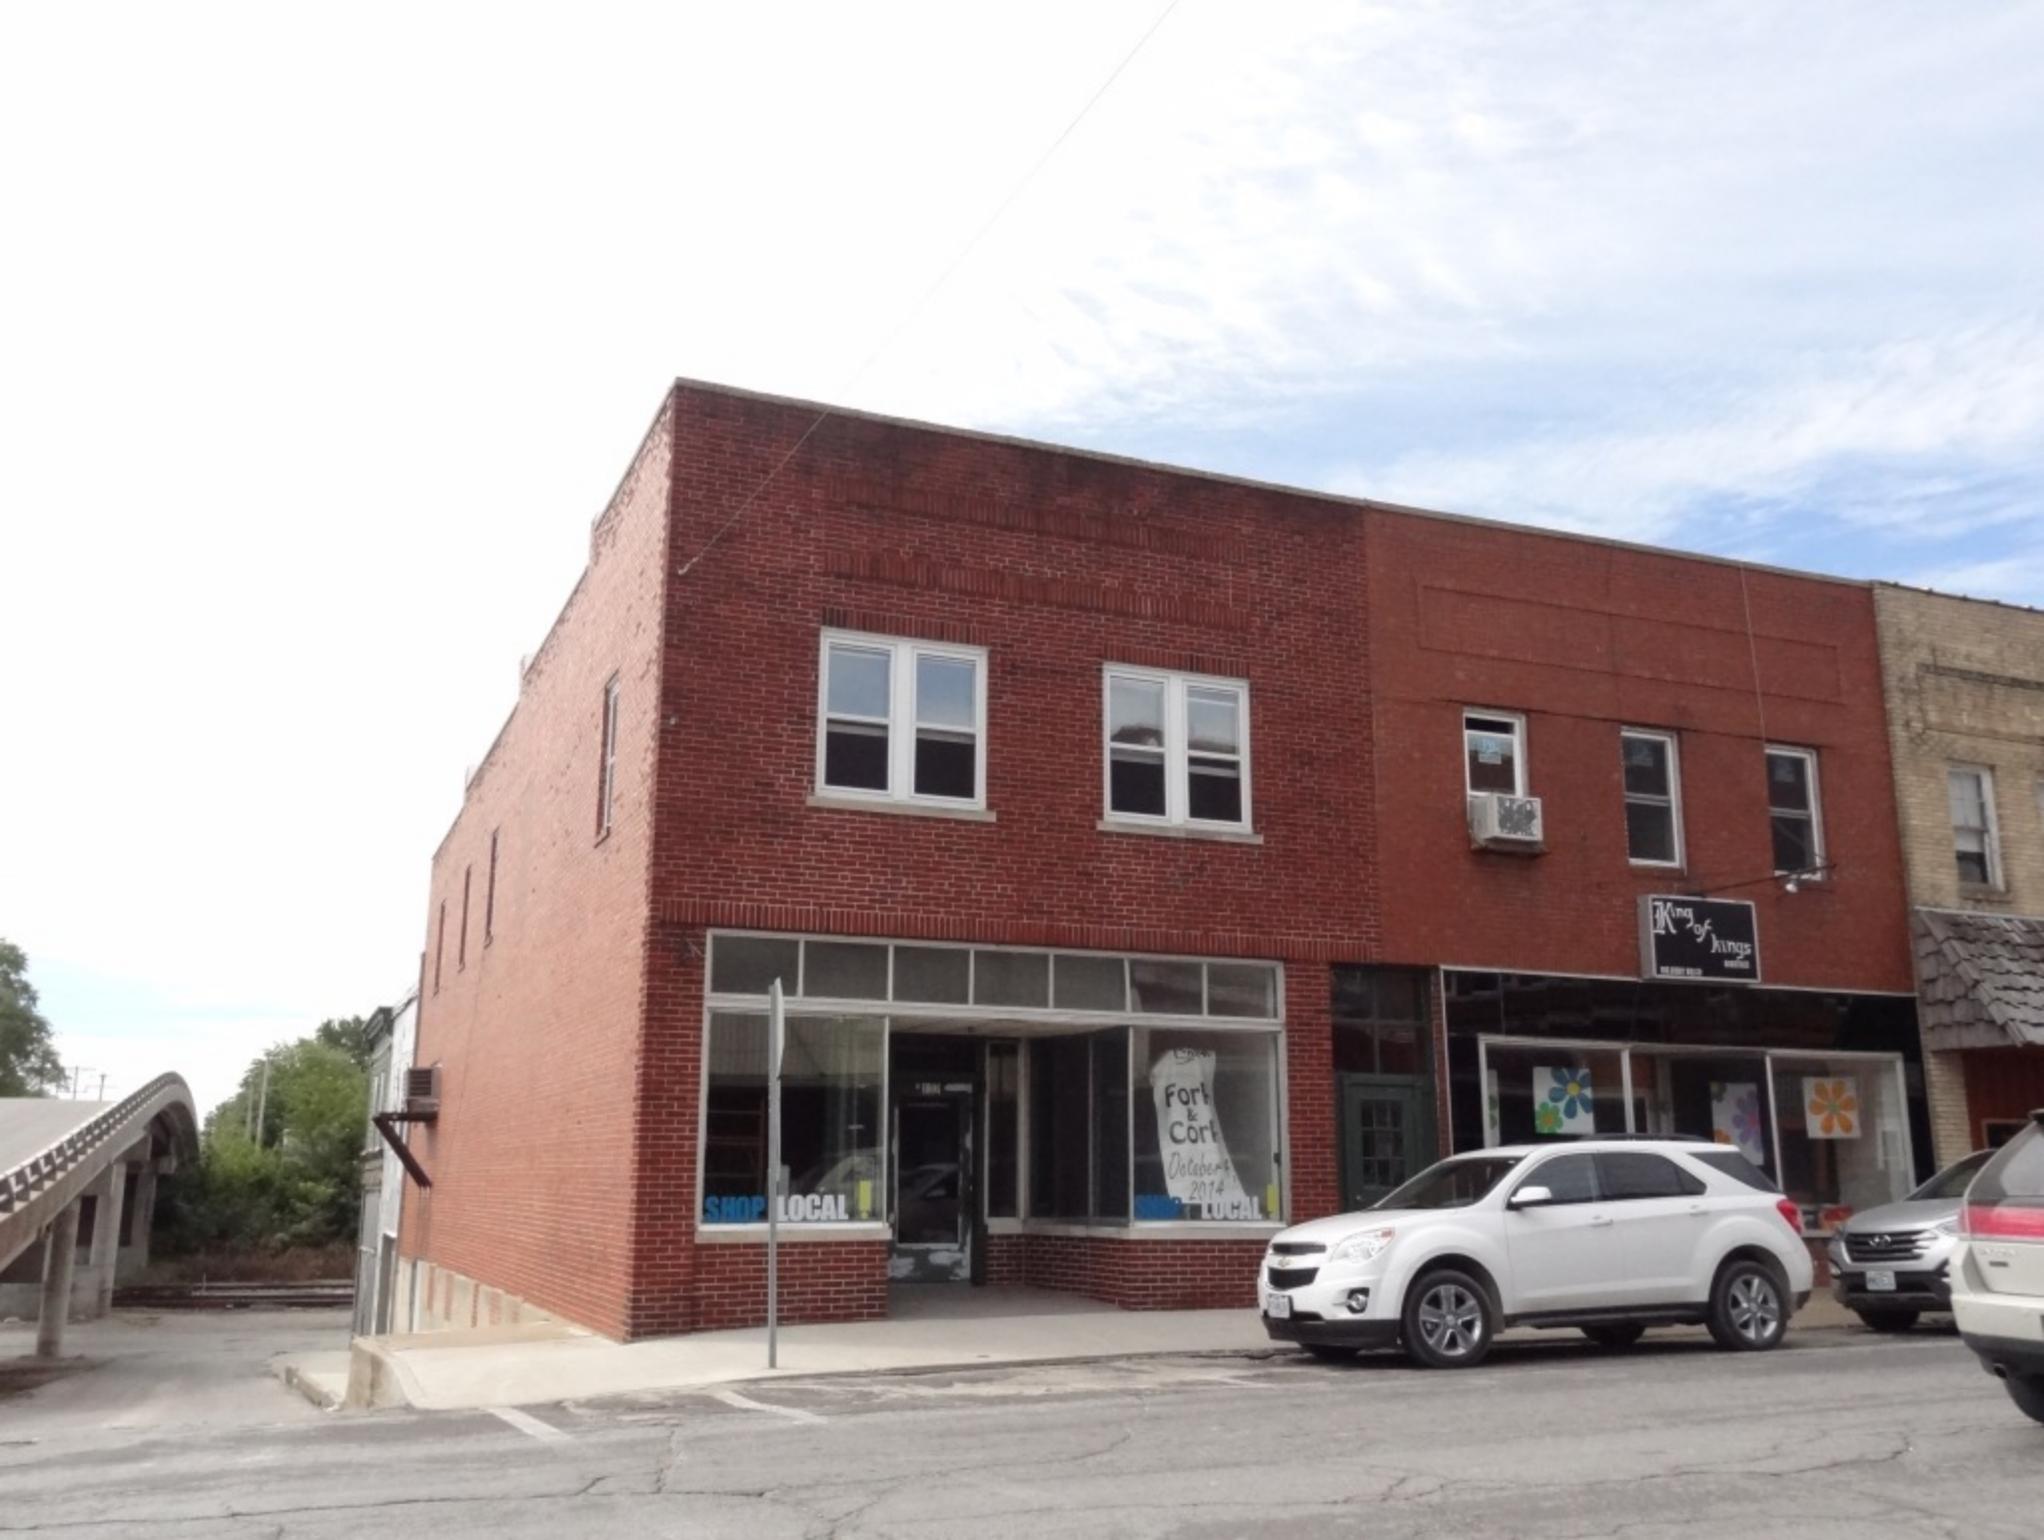
This rectangular, two-part commercial block brick building has three bays on the first story comprising one storefront. The central bay contains a deeply recessed historic wood entry door with a single glazed light and a transom. The door is flanked by plate glass display windows with concrete sills that extend back out to align with the plane of the façade. A transom with seven lights extends across the storefront over the three bays. The bulkheads and exterior walls are clad in a red brick veneer. A belt course of soldier bricks forms a visual dividing line between the first and second stories. The second story has two bays, each containing a pair of non-historic 1/1 double-hung vinyl windows with concrete sills and flat arch brick lintels. A rectangular outline of stretcher and soldier bricks creates a decorative element on the wall above the windows. The cornice is marked by a row of parged brick.

Tax assessor records indicate the building was altered c. 1955. The second story historic windows were replaced with double-hung vinyl windows sometime in the late twentieth century. Despite alterations, the building retains enough historic fabric to contribute to a potential National Register district.
